Alaska Department of Fish and Game

112-42-10160

CORRECTION

Water body name: Corner Creek

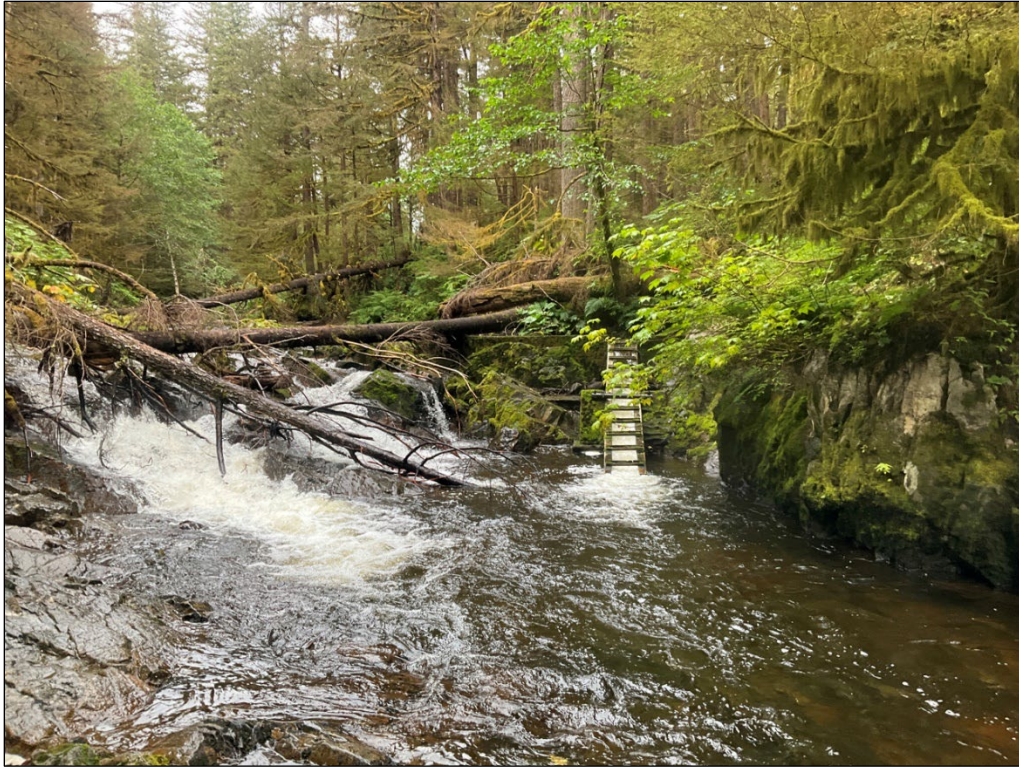
1483	57.722411	-135.109659	Fish pass built in 1996 by the forest service. Lots of spawning pink salmon.	12-15

Figure 1.—Fish pass at waypoint 1483.

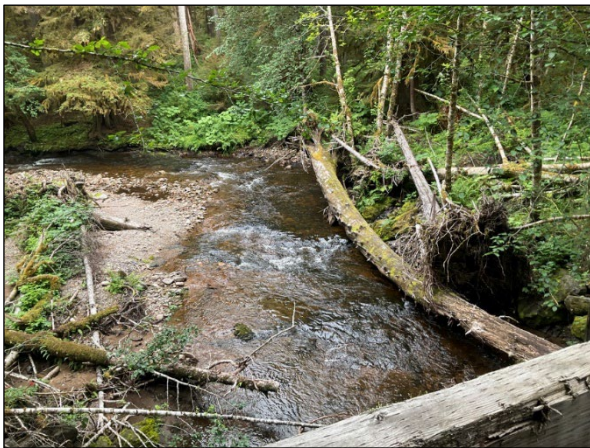
Findings: We surveyed the road crossing of this cataloged stream using a backpack electrofisher and GPS. We visually identified and captured juvenile coho salmon, cutthroat trout, Dolly Varden, and spawning pink salmon (Figure 1). We also found that the stream path incorrectly mapped (Table 1; Figures 2, 3).

Figure 2.—Channel at waypoint 1308

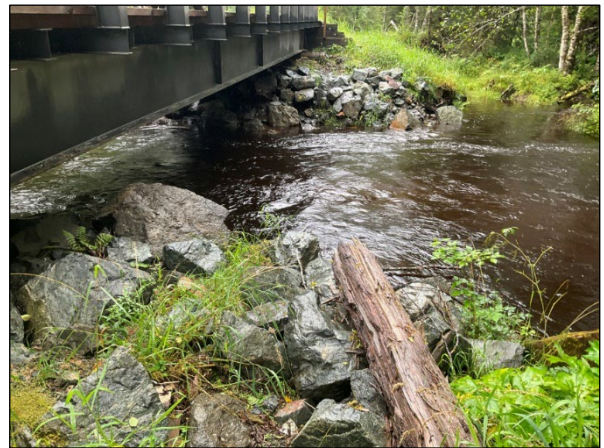
Waypoint	Latitude	Longitude	Notes	Stream Width ft	Stream Substrate	Habitat Features	Gradient %	Sample Effort	Sample Results
1239	57.709028	-135.083887	Drainage of the fen. One coho smolt.		Fine Organic		0-1		2 CT 10 CO 1 DV
1240	57.709844	-135.084642	Confluence, numerous young of the year coho throughout	12-15	Large Gravel Small Gravel	Spawning Substrate	1-2	VI	20 CO
1305	57.721702	-135.106493	No stream or crossing found						
1306	57.722180	-135.107504	Spur road is not accessible with ATV						
1307	57.722578	-135.108960	Possibly remnants of a stream but no stream or crossing currently. No streams within 100ft of this line.						
1308	57.724010	-135.113863	Waypoint for route correction of cataloged stream. Stream bends to cross road at ~30' tall bridge. Adult pinks observed from bridge on 8/18/22 return.						
1437	57.708791	-135.084897	Adult pinks above bridge. New rip rap armoring that constricts the stream						3 P

Figure 3.—Channel at waypoint 1437
