Alaska Department of Fish and Game

Habitat Section
Southeast Region

114-34-10100 Tributary 5

ADDITION

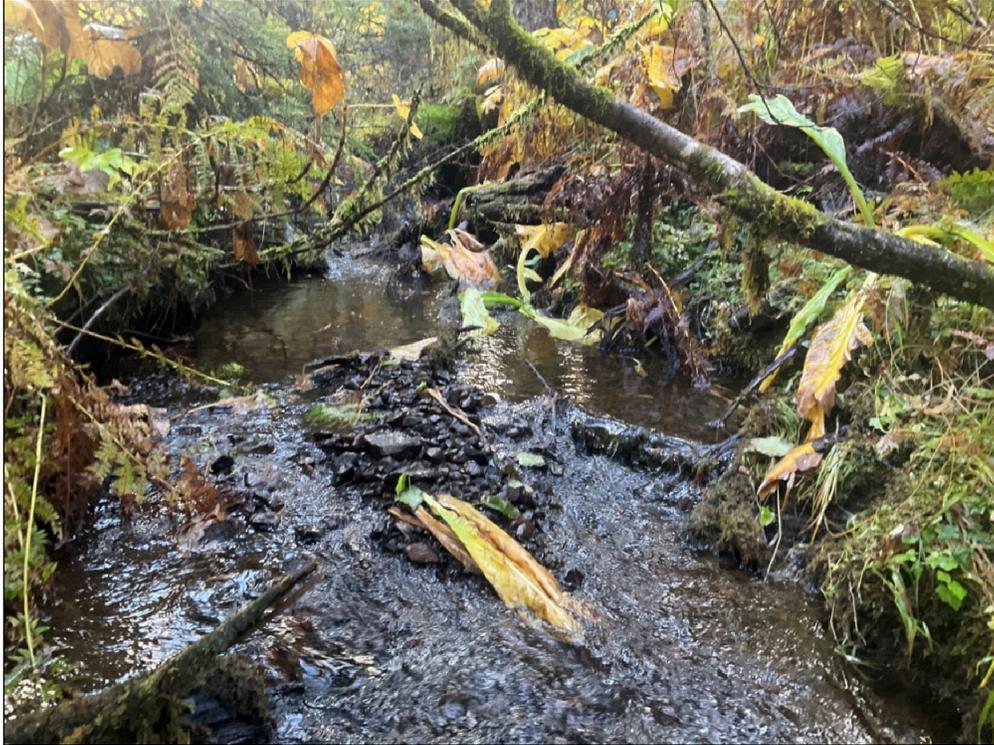
Figure 1.—Channel at waypoint 883.

Findings: We surveyed this uncataloged stream using a backpack electrofisher and GPS. We captured juvenile coho salmon, Dolly Varden, cutthroat trout, and sculpin. The tributary stream flows through a gravel-dominated channel with lots of cut banks, and through a reach with quality spawning substrate (Table 1; Figures 1–3).

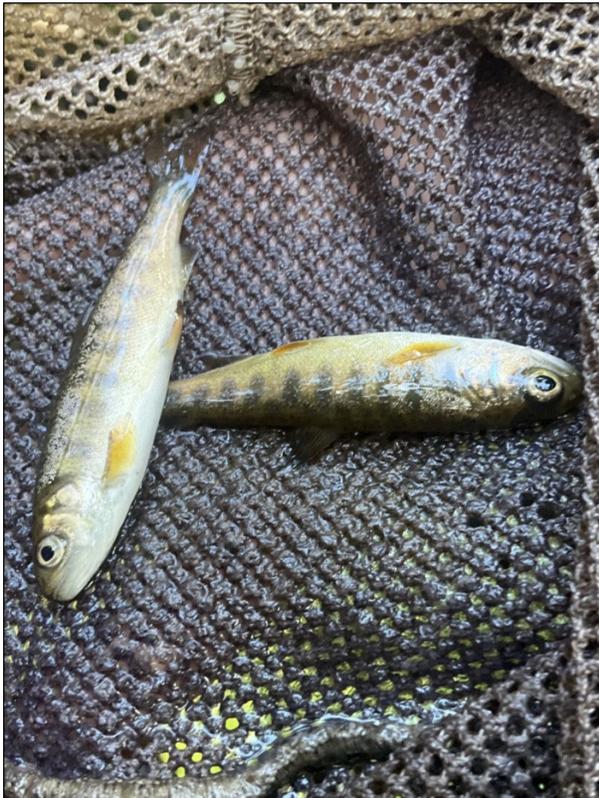
Figure 2.—Juvenile coho salmon captured at waypoint 883.

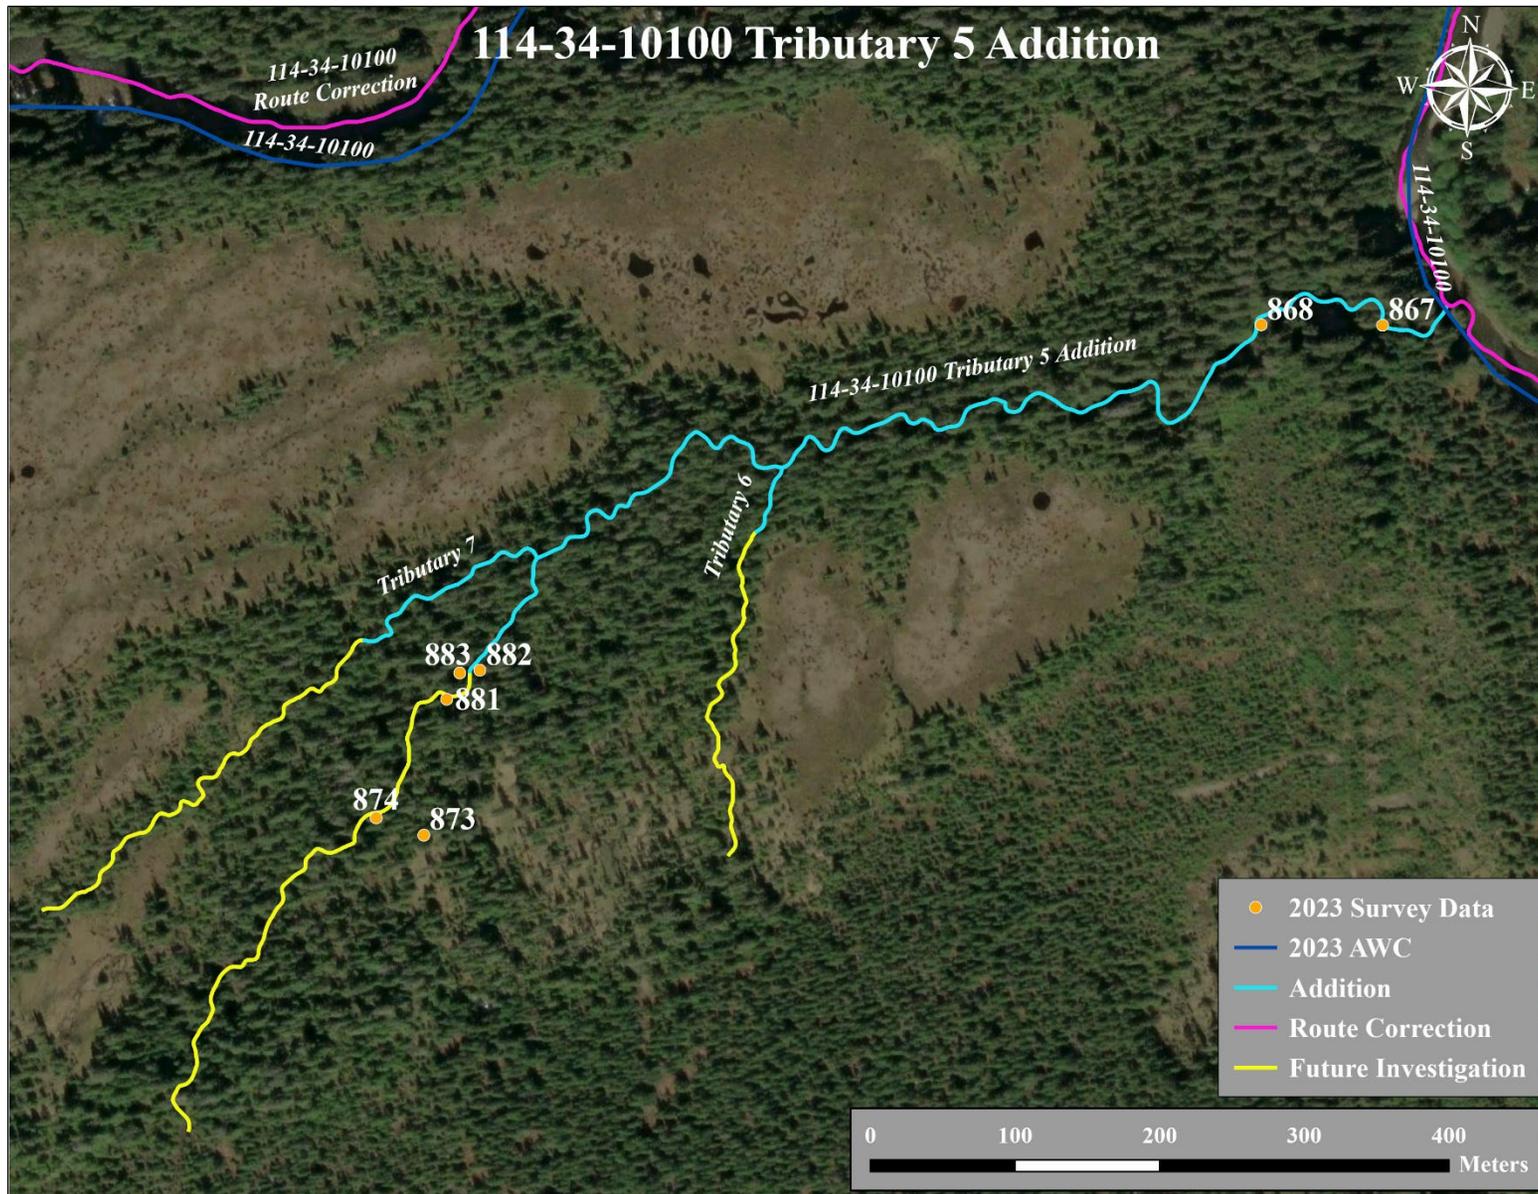
Figure 4.–114-34-10100 tributary 5 addition map.

Recommendations: Add this uncataloged stream to the anadromous waters catalog for rearing coho salmon (Figure 4).
