# Alaska Department of Fish and Game

Habitat Section  
Southeast Region

**113-44-10054**

## BACKUP INFORMATION

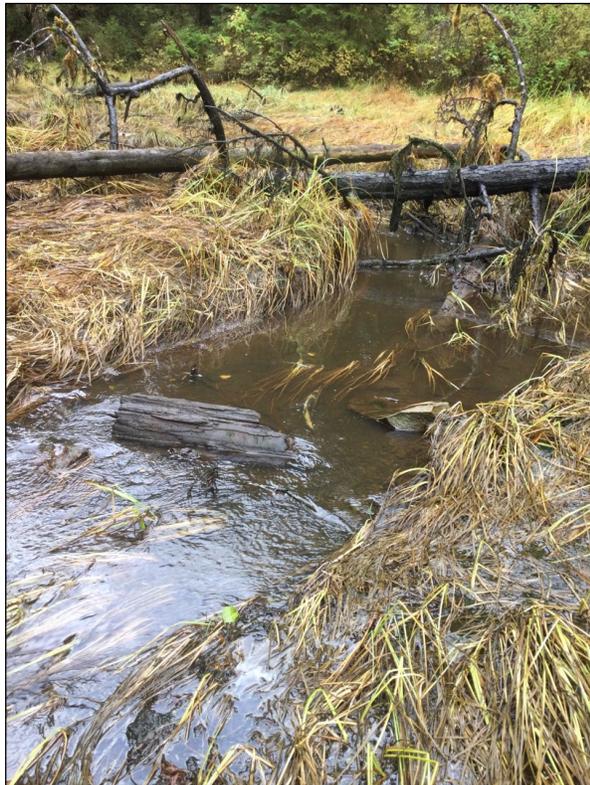
**Findings:** I observed dozens of pink salmon carcasses and a live individual in the stream. The stream had redds throughout the intertidal (Table 1; Figures 1, 2).

Figure 1.—Channel at waypoint 3156, live pink salmon in center.

**Recommendations:** Add pink salmon spawning to the species list. (Figure 3).

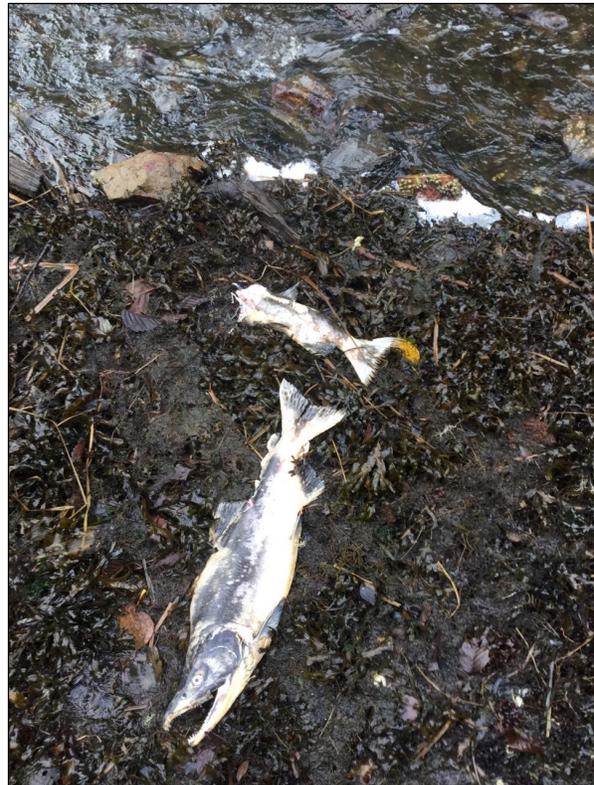
Figure 2.—Pink salmon carcasses.
