# **Appendix: Gull Cove**

Guide to direct fieldwork for cataloging anadromous water bodies in Southeast Alaska

**Alaska Department of Fish and Game**

# **GULL COVE SURVEYS**

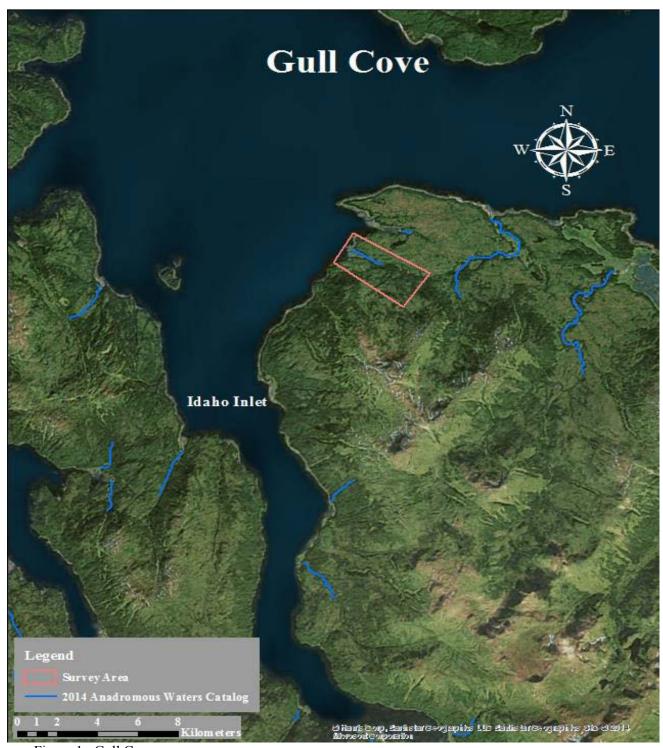
Figure 1.—Gull Cove survey map.

Gull Cove, located at the head of Idaho Inlet on the north side of Chichagof Island, provides a refuge for mariners during Icy Strait storms (Figure 1).

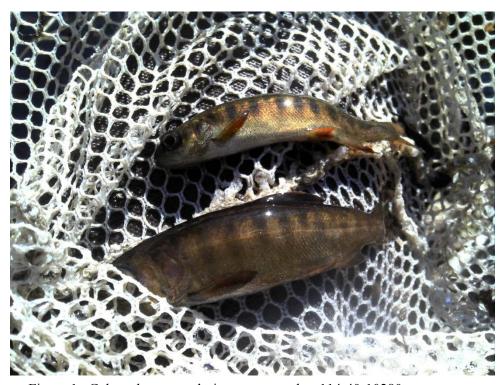
**Findings:** We surveyed this stream for fish using a GPS and a backpack electrofisher. The route for this stream differs from the current AWC. We captured rearing coho salmon throughout the stream, including above the current anadromous section (Table 1, Figure 1). Due to time constraints we had to stop the survey early, there was no change in the habitat so there is a possibility there are salmon above where we ended survey.

Figure 1.—Coho salmon caught in stream number 114-40-10280.

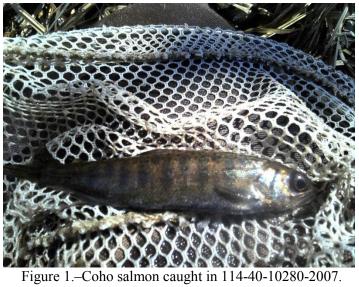
**Findings:** We tracked and fish sampled in stream number 114-40-10280-2007 using a GPS and a backpack electrofisher (Table 1). We caught juvenile coho salmon, Dolly Varden char, and cutthroat trout (Figure 1). We encountered a 4' drop in the stream into a small pool that could be a potential fish barrier (Figure 2). We electrofished and minnow trapped above the drop and caught no fish. The stream meanders through a forested area and transitions into meadows.

Figure 2.–Rick Hoffman standing above 4' drop in 114-40-10280-2007.

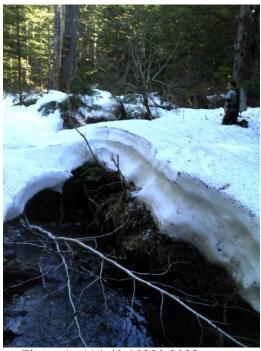
Figure 1.–114-40-10280-2022.

**Findings:** We tracked and fish sampled stream number 114-40-10280-2022 using a GPS and backpack electrofisher (Table 1). We caught juvenile coho salmon, Dolly Varden char, and cutthroat trout. We stopped the survey when the creek became much steeper and there was too much snow to continue (Figure 1).

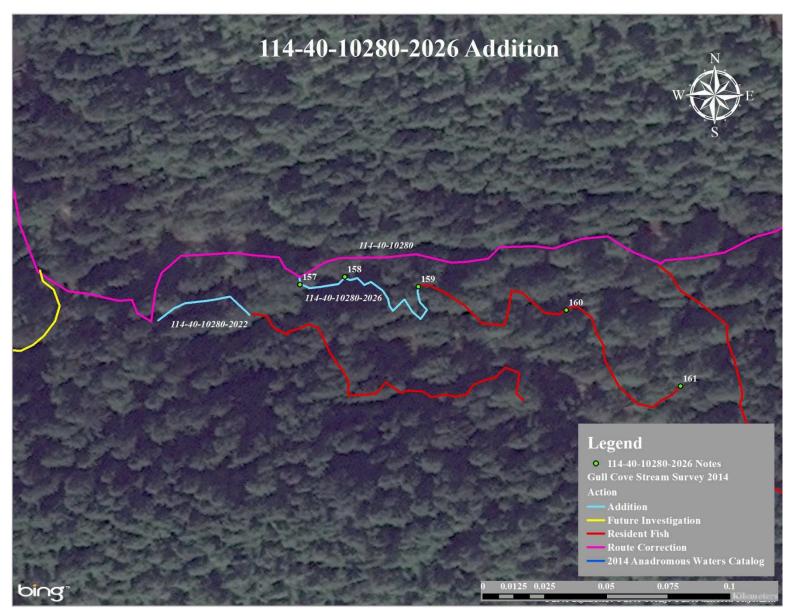
Figure 1.–114-40-10280-2026 addition map.

**Findings:** We tracked and fish sampled stream number 114-40-10280-2026 using a GPS and backpack electrofisher(Table 1). We caught juvenile coho salmon, Dolly Varden char, and

cutthroat trout. The tributary ends at a seep.

**Recommendations:** Add this stream to the AWC (Figure 1).

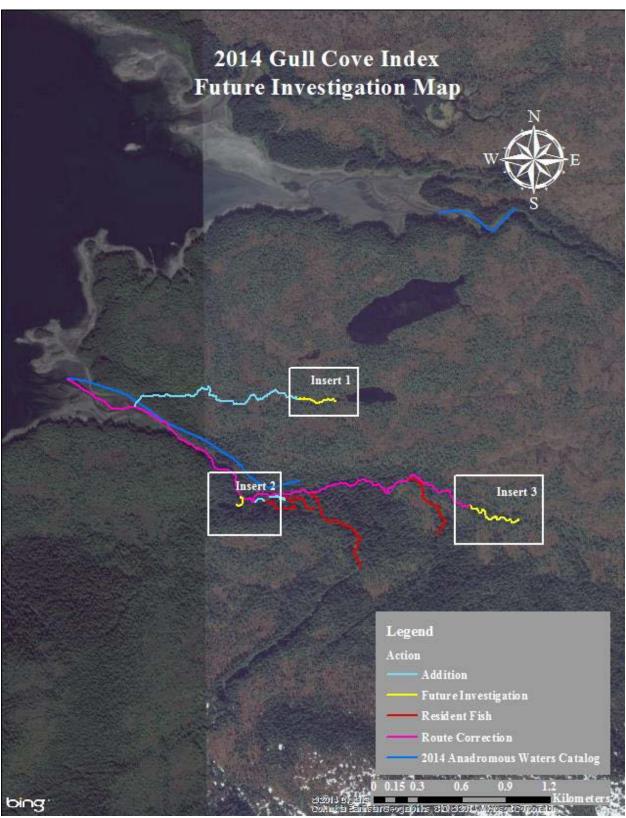
Figure 1.–2014 Gull Cove index future investigation map.

Table 1.—Start points of Gull Cove streams requiring future investigation.
