Appendix H: Icy Bay

Guide to direct fieldwork for cataloging anadromous water bodies in Southeast Alaska

ICY BAY SURVEYS

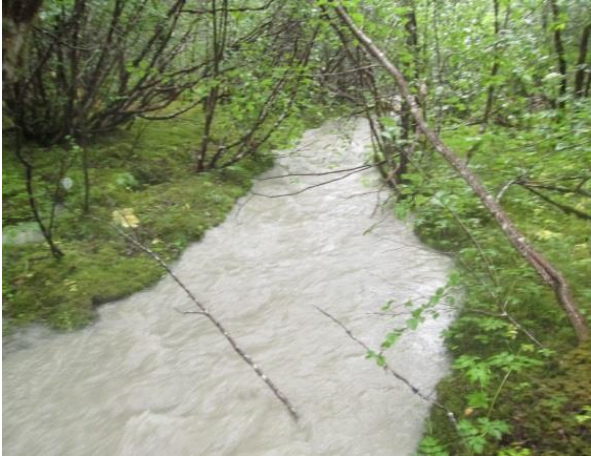
Figure 1.—Main new channel.

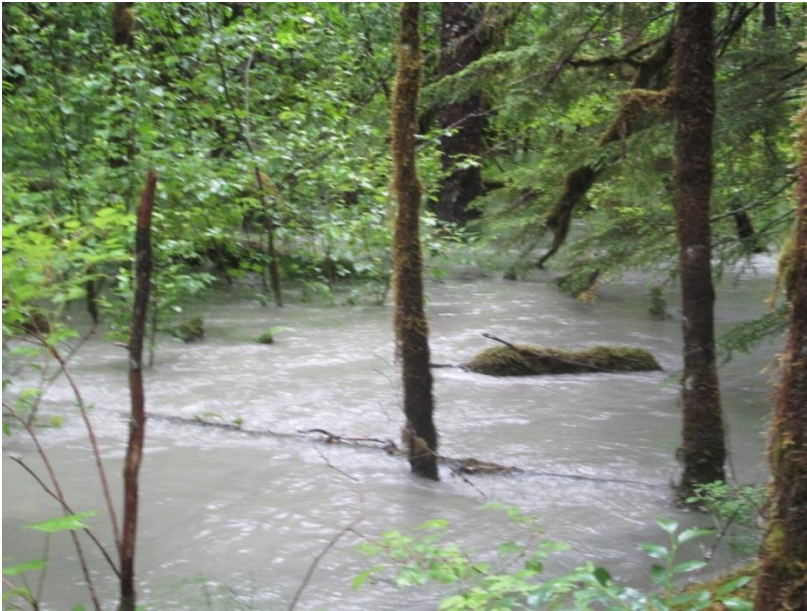
Figure 3.—Watson Creek flowing through forest in undefined channel.

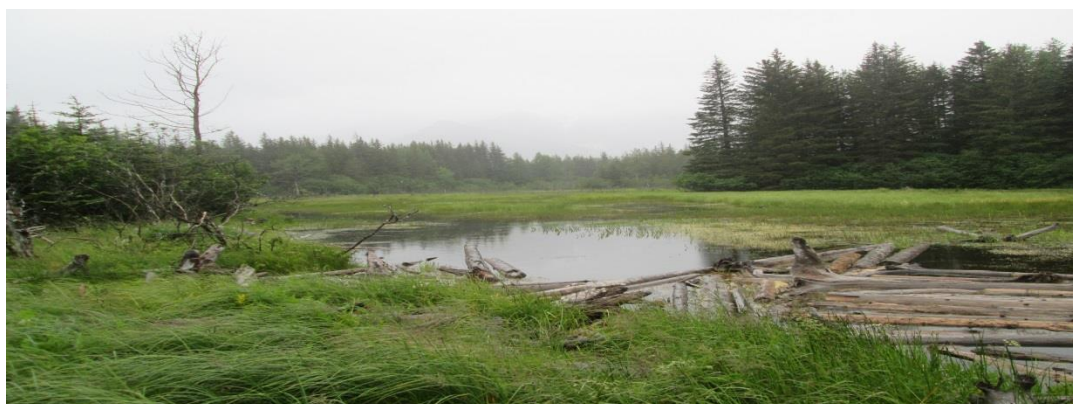
Figure 3.–Looking downstream from defined channel on marsh/pond.

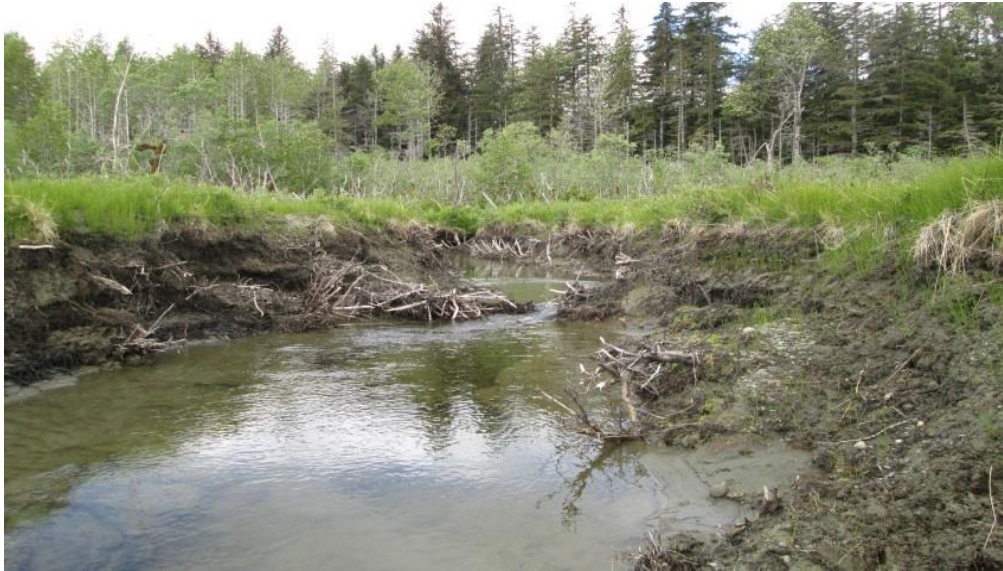
Figure 3.—The stream is cutting back through the sediment layer that had been deposited here when beavers were active in area.

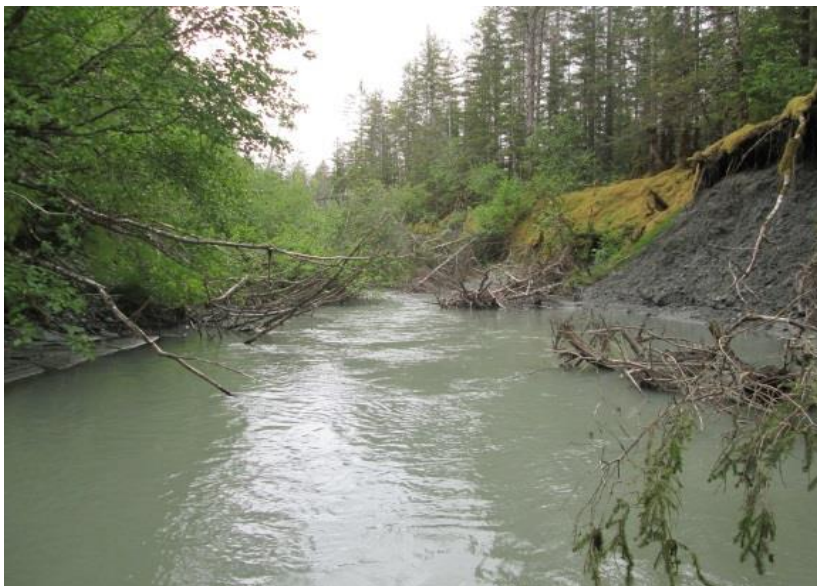
Figure 1.—Looking upstream on the east branch of Priest River.

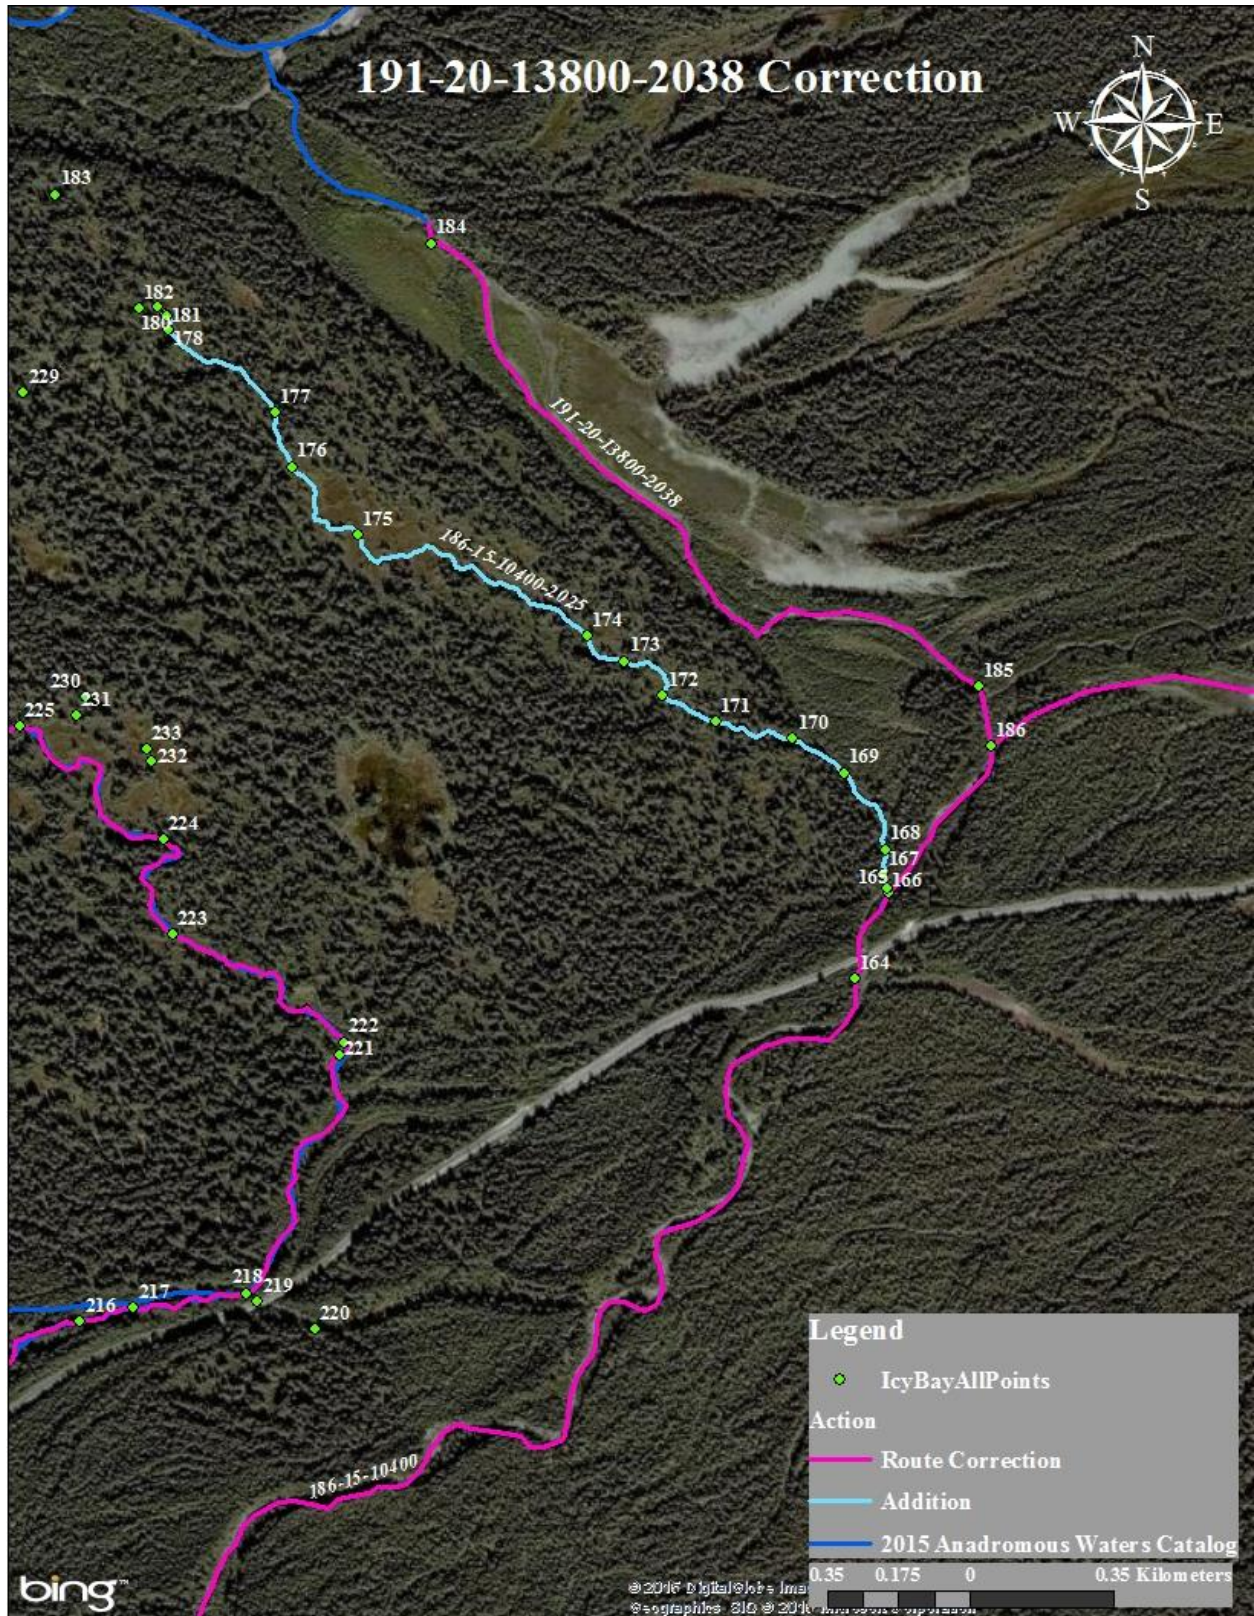
Figure 2.–191-20-13800-2038 route correction map.

Waypoint	Latitude	Longitude	Notes	Sample Effort	Sample Results
163	59.9640	-141.6294	Mouth of Watson Creek.		
164	59.9728	-141.6145	Road bridge over Watson Creek.		
165	59.9737	-141.6137	Tributary channel on river left, but stream is dry.		
166	59.9738	-141.6138	Tributary entering river right.		
186	59.9753	-141.6115	Possible second place that Wanton Creek entering.		
185	59.9760	-141.6118	Wanton Creek entering river left.		
184	59.9809	-141.6238	Branch of Priest River.

Recommendations: Please correct this stream in the AWC (Figure 2).
