**ENVIRONMENTAL ASSESSMENT
UPPER STILES CREEK SHOOTING RANGE IMPROVEMENT PROJECT,
CHENA RIVER STATE RECREATION AREA, ALASKA**

June 12, 2025

**U.S. Fish and Wildlife Service
Alaska Region
Office of Conservation Investment
1011 East Tudor Road
Anchorage, Alaska 99503**

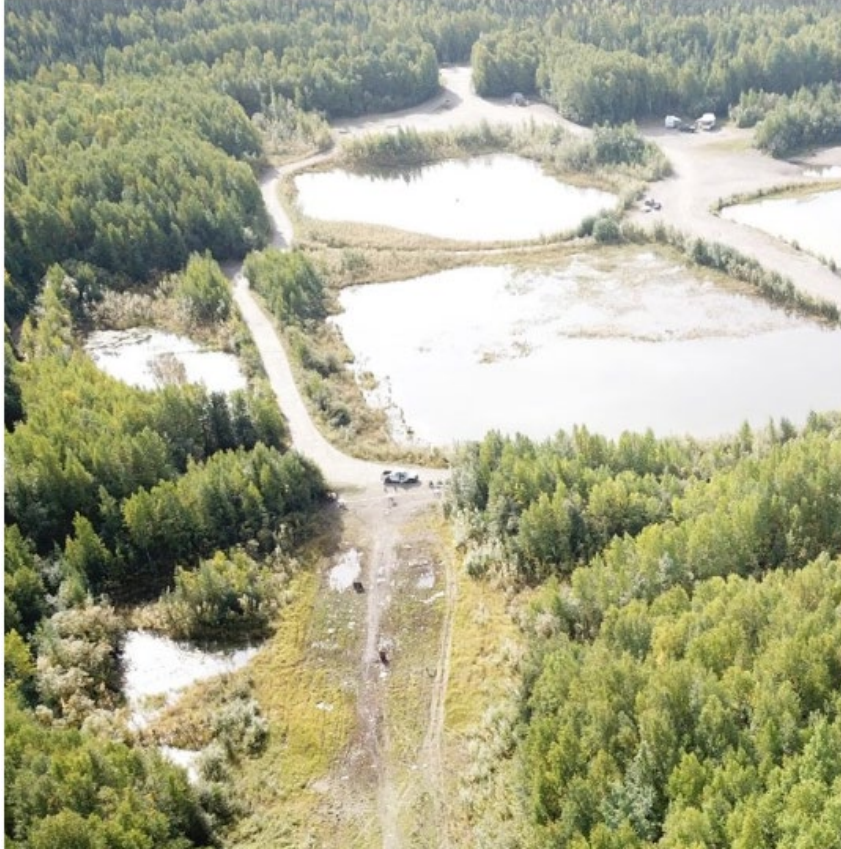
Figure 5. Small, perched culvert draining Wetland B into Wetland C is visible in this DNR Public Notice website. Picture facing south. Ponded water visible in Wetlands H and D. Photo appears to be taken in early fall.

The assessment areas (AA's) analyzed for this project were comprised of distinct wetlands within the footprint of direct impact of the range expansion (areas to receive fill material). An additional buffer area of 100 feet was added to the areas of direct impact to represent the secondary impacts (dust, noise, erosion and sedimentation, etc.) each wetland would receive as a result of the primary impact. There were five AA's in total (Figure 4). Two wetland AA's (A and B) are abutting open water areas of under 20 acres; therefore, the open water was considered as part of the AA for each of these wetlands. Wetlands B and C were considered one AA unit because it appears they are hydrologically connected by a perched culvert under the range access road (Figure 5).

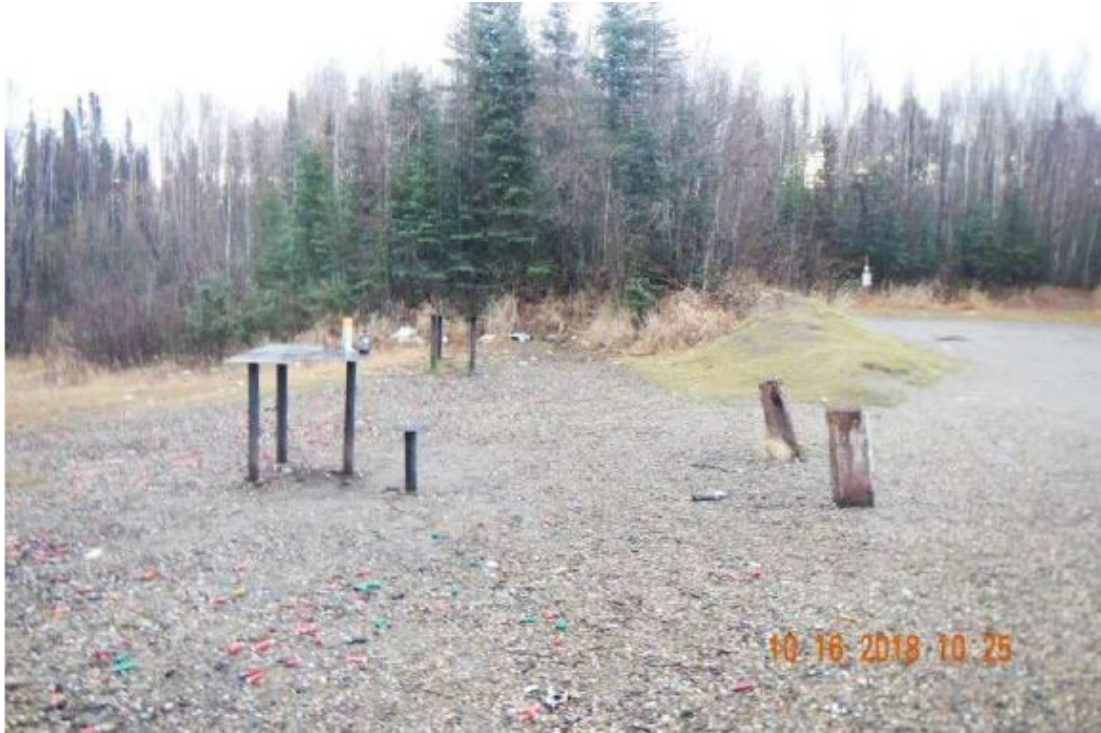
Figure 5.—Existing firing line and makeshift shooting tables.
