Fish Passage Assessment and Culvert Inventory on the King Cove and Cold Bay Road Systems

December 2018

Alaska Department of Fish and Game

FISHERY DATA SERIES NO. 18-28

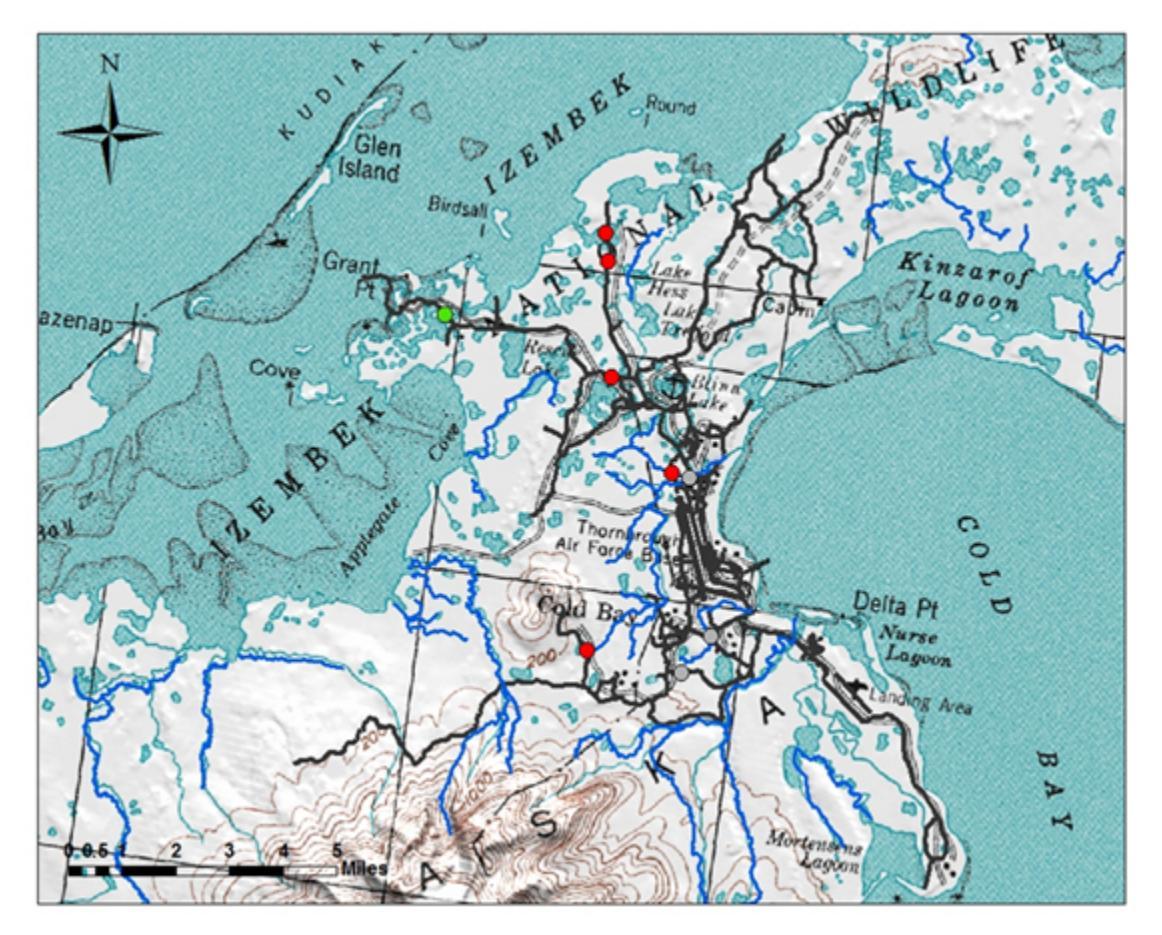
Of the 10 assessed sites in Cold Bay, the project rated 6 sites Red (60%), or crossings likely to be inadequate for fish passage; 3 sites Gray (30%), or crossings may be inadequate for fish passage; and 1 site Green (10%), or crossings are likely adequate for fish passage (Table 2, Figure 6).

Figure 6.–Site map showing assessed site locations and their ratings on the road system in Cold Bay and the Izembek NWR.

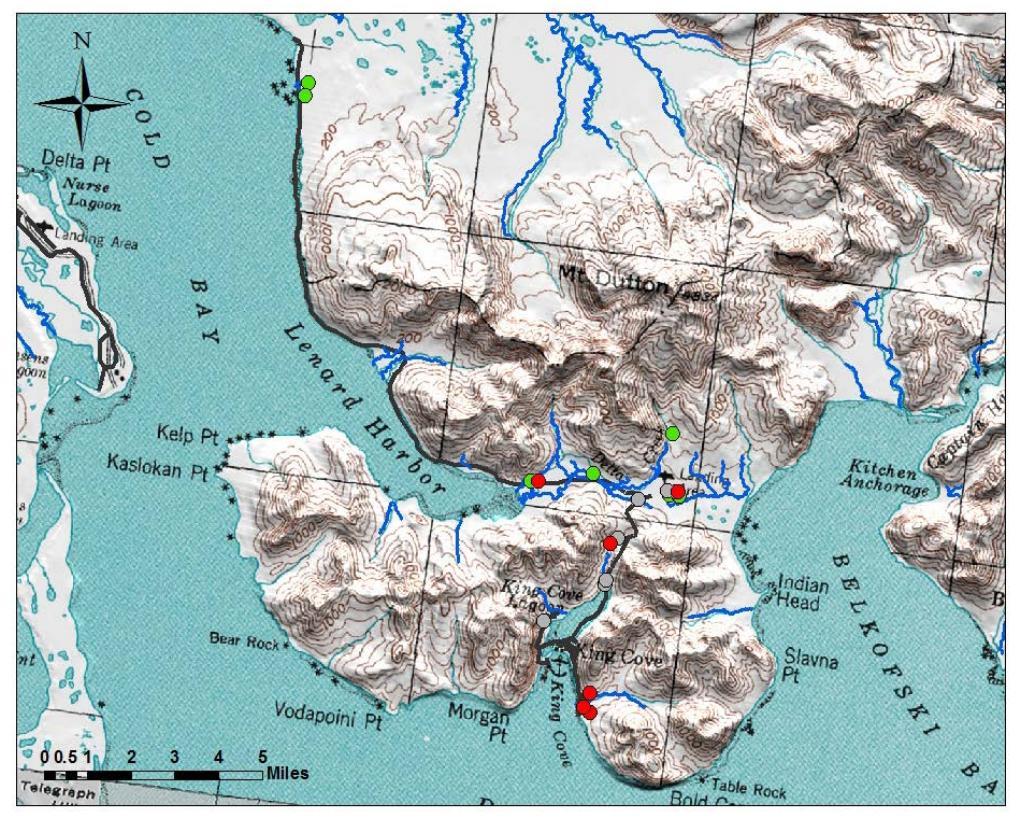
Figure 8.-Site map showing assessed site locations and their ratings on the road system in King Cove.

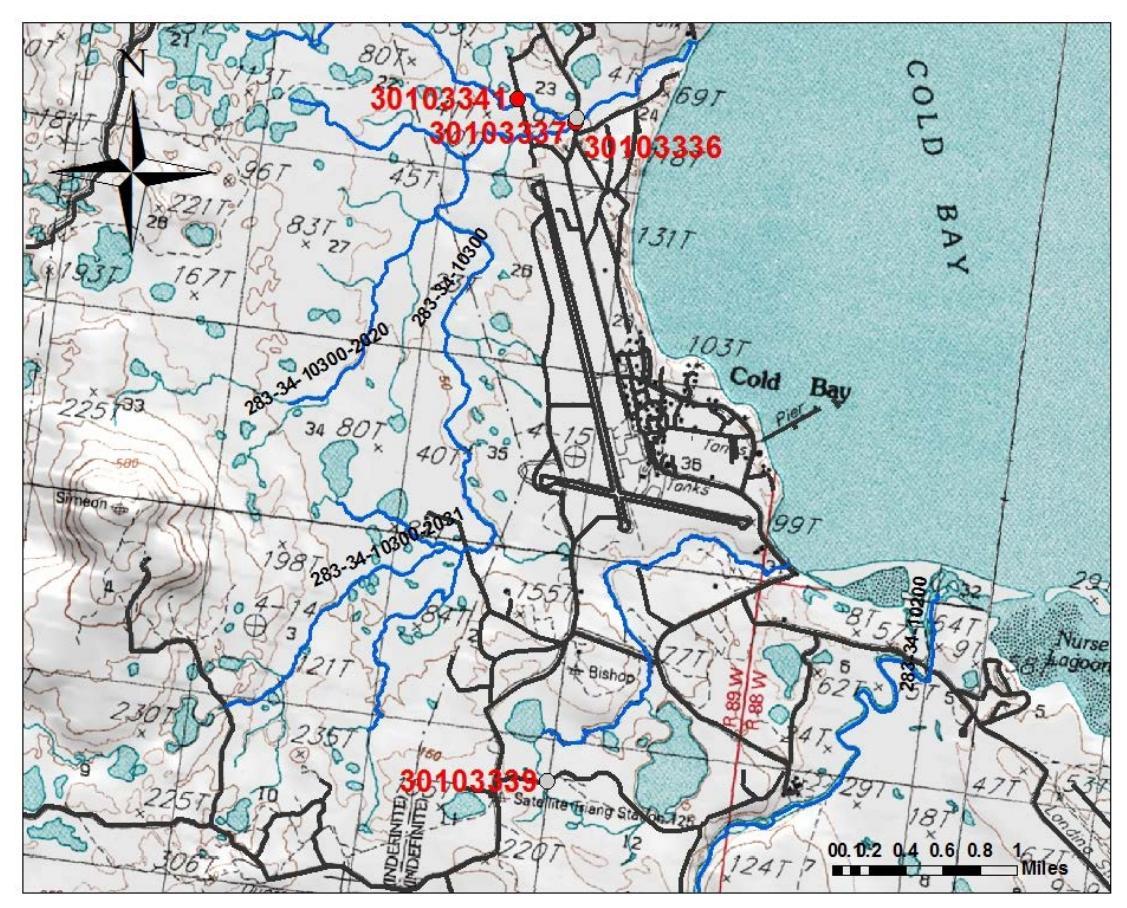
Of the 6 Red and 3 Gray assessed culverts, the project identified 4 culvert sites of concern and high priority for replacement and restoration (Table 2, Figure 9). These recommendations are based on culvert condition, severity of the barrier, estimated upstream habitat, cataloged anadromous habitat above site, and identified species usage. Except for site 30103338, which was replaced with a stream simulation culvert in 2009 (ADF&G 2009), the remaining sites all show signs of significant deterioration and it is recommended that these culverts be replaced for proper road maintenance and that those replacements consider fish passage for resident species found in those systems.

Figure 9.-Map showing culvert of concern on the Cold Bay and Izembek NWR road systems

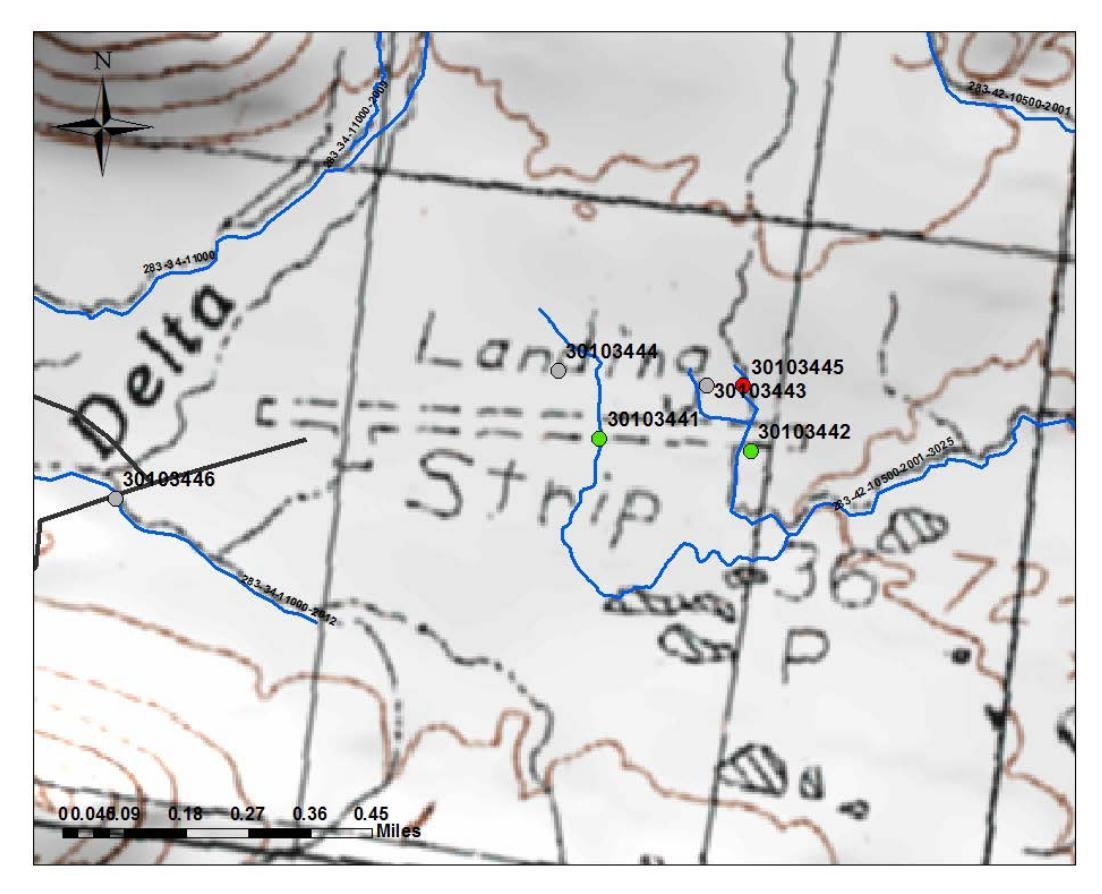
Figure 22.–Map of the culverts around the King Cove airport.

The King Cove airport has 2 anadromous streams that pass under the runway. Both sites 30103441 (AWC # 283-42-10500-2001-3025-4019) and 30103442 (AWC # 283-42-10500-2001-3025-4020) were rated Green by assessment crews, but there are also 3 culverts upstream on an airport access road that are of concern for fish passage (Figure 22). A very large number of spawning pink salmon were observed to be using these streams at the time of survey.

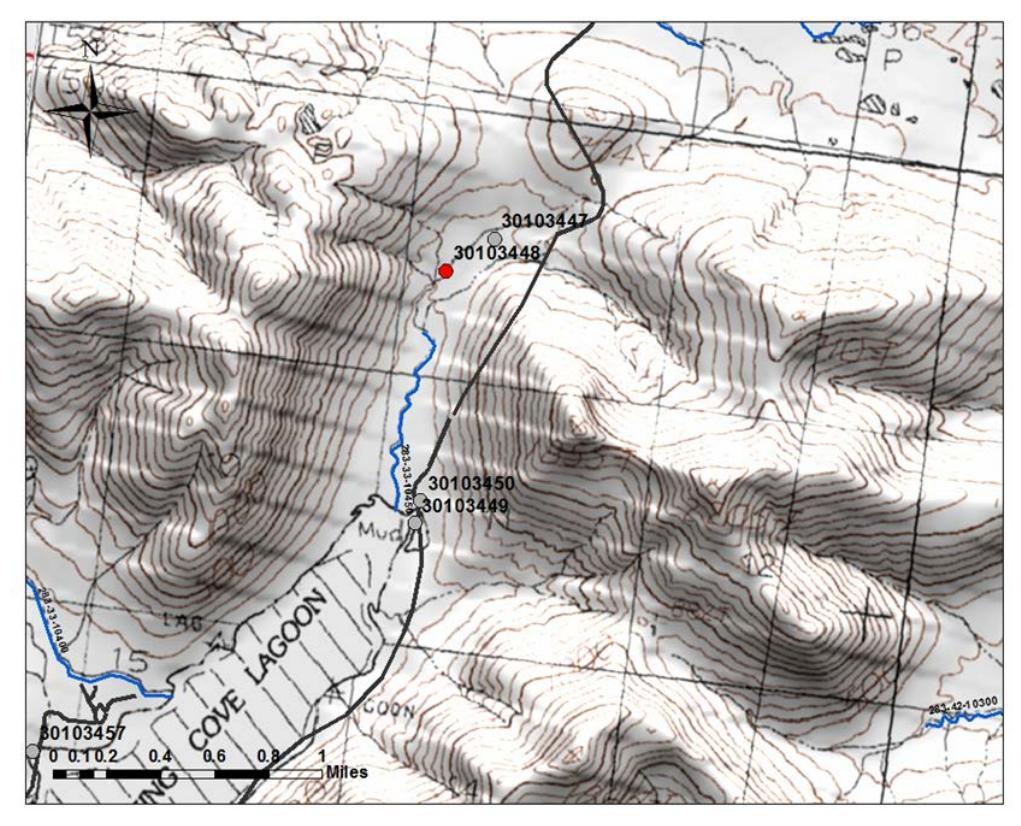
Site is on the shooting range off Airport Road about 3 miles from King Cove (Figure 33). The stream is cataloged in the AWC for chum and pink salmon about 0.3 miles downstream of this culvert. Assessment crews observed fish at the site, most likely Dolly Varden char. Satellite imagery shows about another half mile of potential habitat upstream. Recommend replacement with a stream simulation culvert (Figures 34-36).

Figure 33.-Map of culverts on the northern end of King Cove Lagoon.

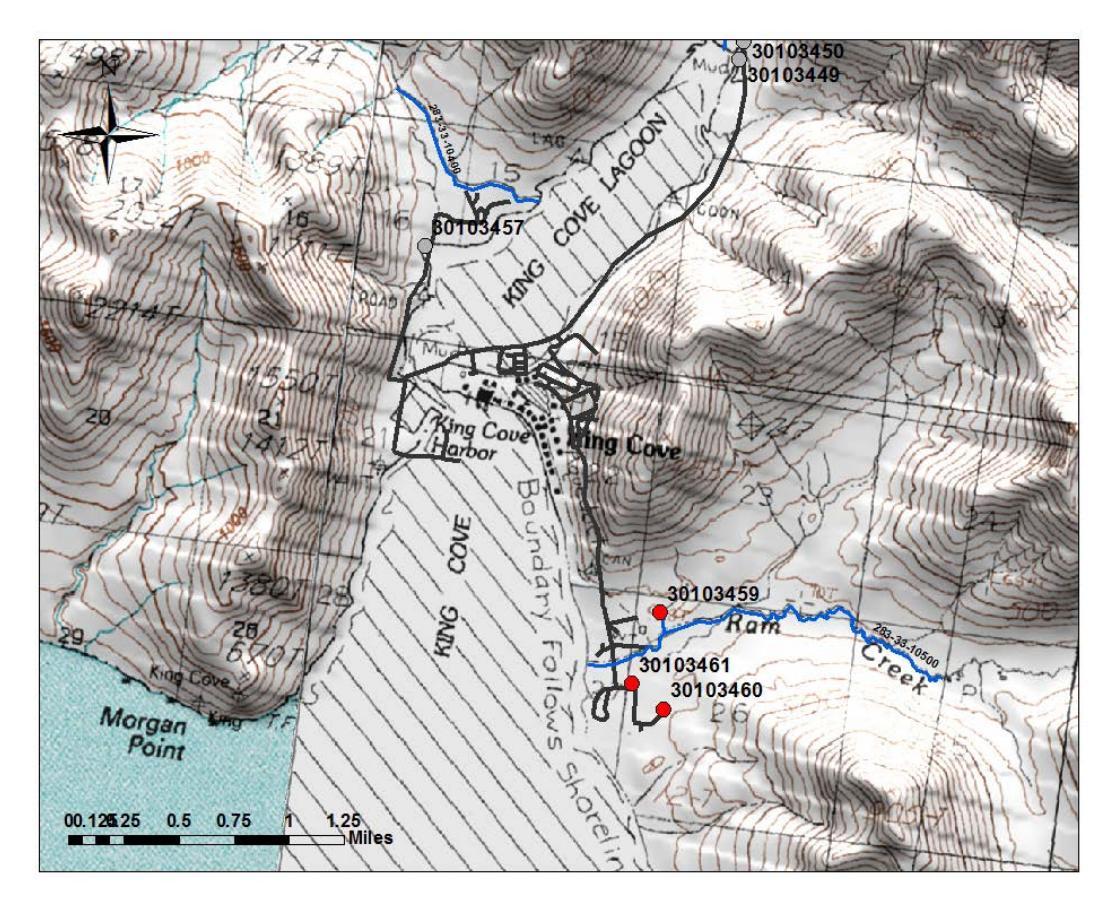
Site is about 1000 feet upstream from the confluence with Ram Creek (AWC # 283-33-10500) and about 950 feet downstream of site 30103460 (Figure 37). The assessment crew observed adult pink salmon and Dolly Varden char up- and downstream from this site. Site consists of 2 culverts, with one capturing all the flow at the time of survey. Culvert has a Red outfall and adult fish were observed leaping to pass through the crossing and stacking up below the culvert. Recommend replacing culverts with a stream simulation culvert (Figures 38–40).

Figure 37.-Map of culverts around the City of King Cove and western King Cove Lagoon

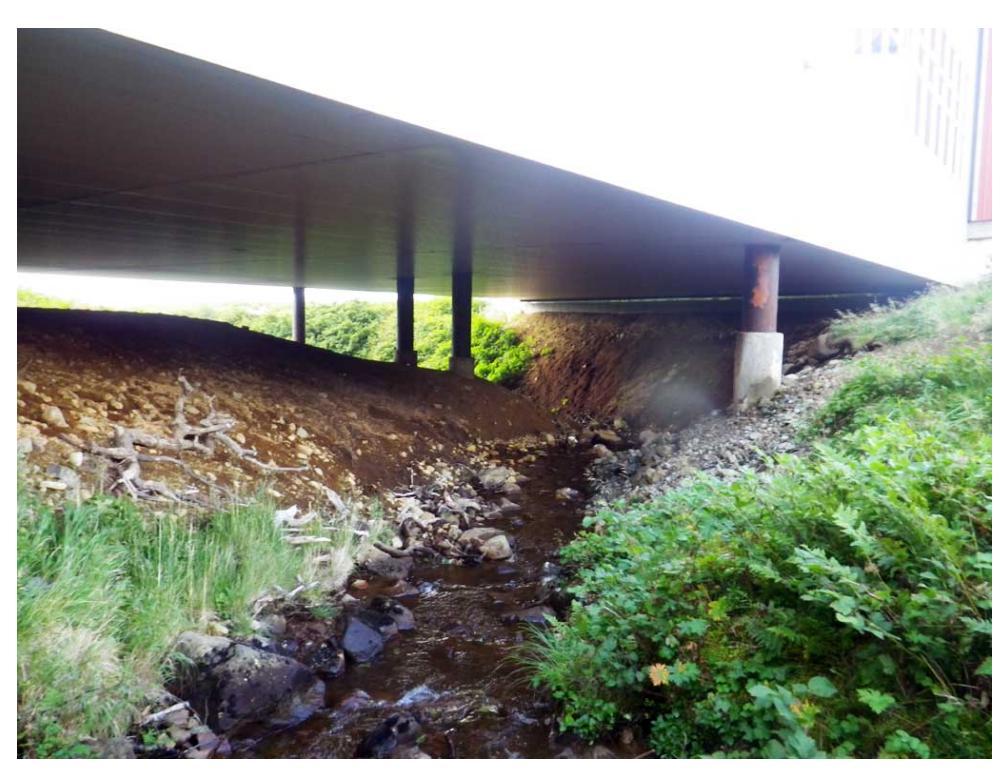
This site is about 700 feet upstream from the confluence with Ram Creek (AWC#283-33-10500) (Figure 37). The creek is documented for pink salmon up to the road crossing. The culvert has a Red outfall and gradient and a Gray constriction ratio. The assessment crew observed fish upstream and downstream of site, likely Dolly Varden char. Creek flows under the new King Cove school about 300 feet downstream of the culvert. The project recommends replacement with a stream simulation culvert (Figures 44–47).

Figure 46.–Site 30103459, 300 feet downstream of culvert showing creek flowing under new King Cove school.

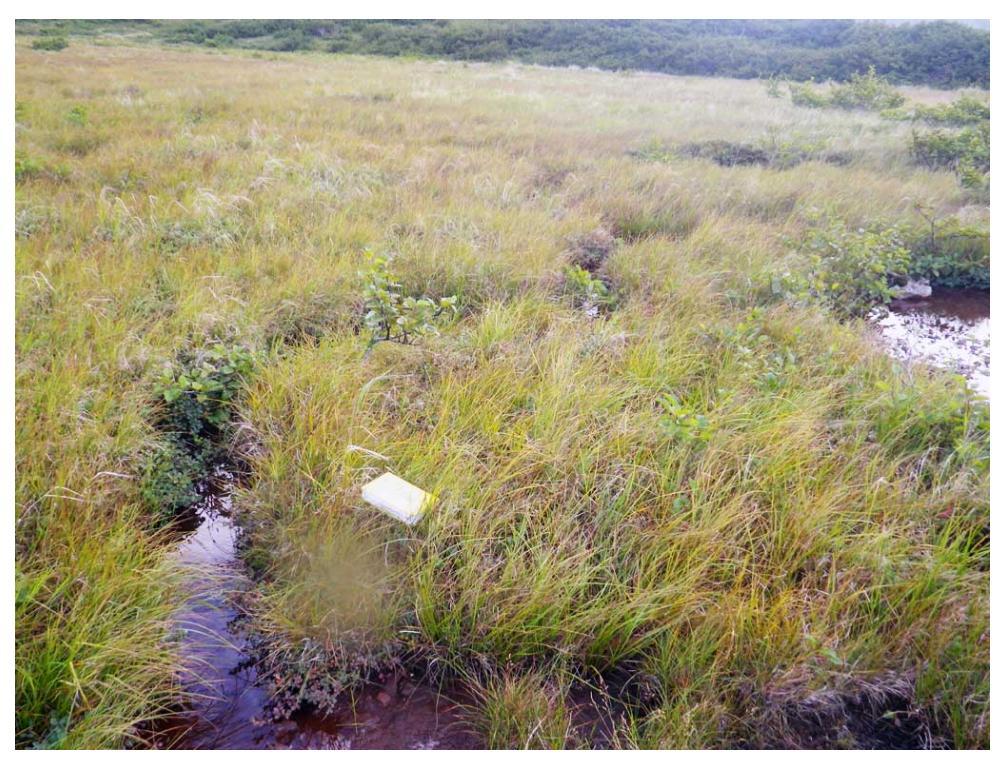
Figure 47.–Site 3013459, habitat 400 feet upstream from culvert.
