Fish Passage Assessment and Prioritization of Culverts in Gustavus, Haines, Juneau, Skagway, and Sitka, 2011–2012

May 2020

Alaska Department of Fish and Game

FISHERY DATA SERIES NO. 20-12

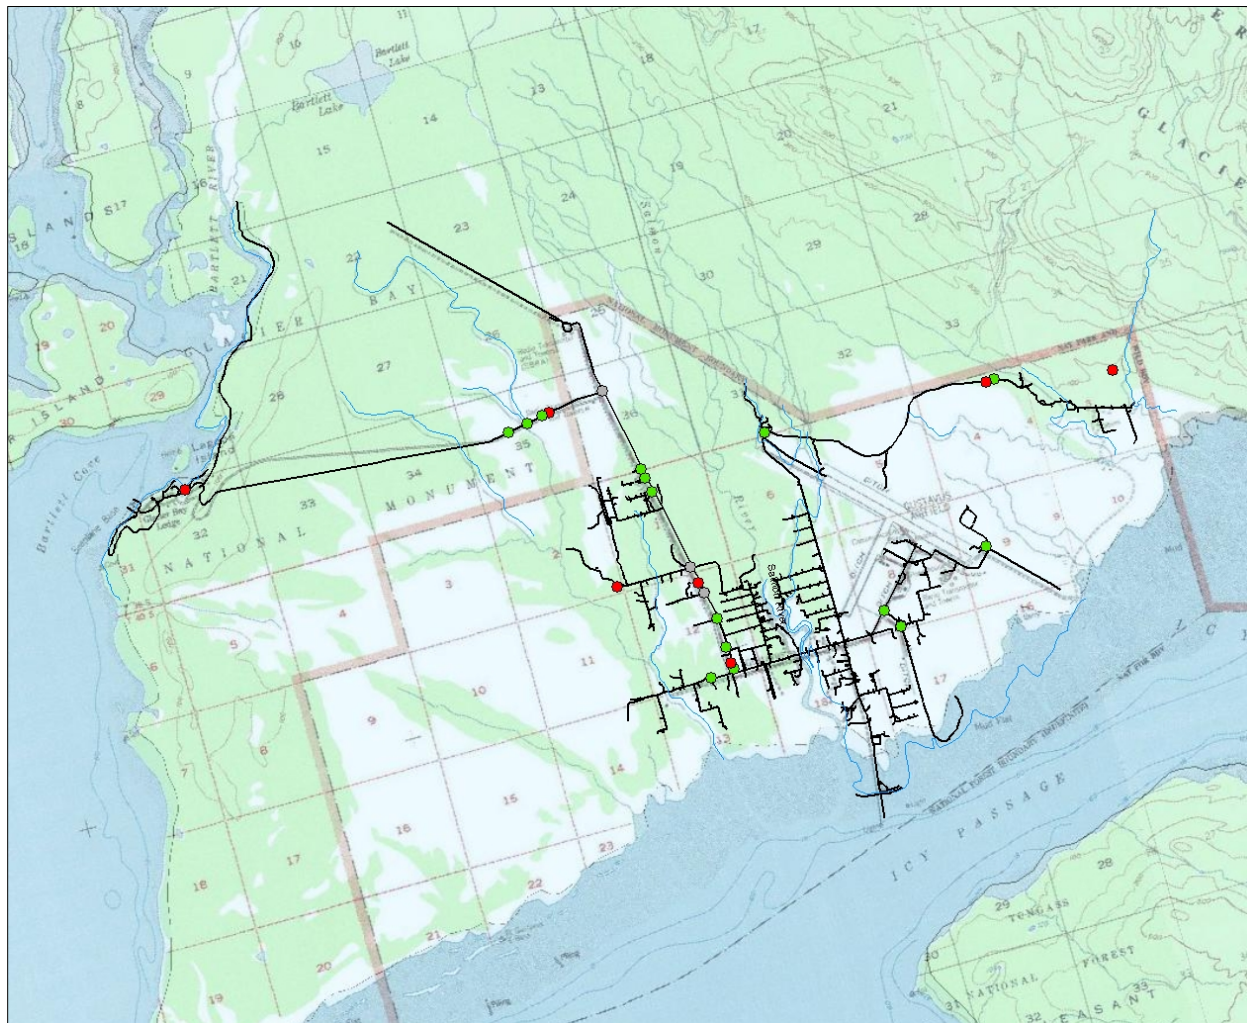
In Gustavus, 5 sites (25%) on known fish bearing streams were rated Red where the crossing was assumed to be adequate for juvenile fish passage, 3 sites (15%) were rated Gray where the crossing may be inadequate for juvenile fish passage, and 12 sites (60%) were rated Green where the crossing was assumed to be inadequate for juvenile fish passage (Table 3, Figure 11). The project found one culvert site (4%) with an outfall greater than 1 foot (Table 4).

Figure 11.—Map showing surveyed culvert locations in Gustavus and their site ratings.

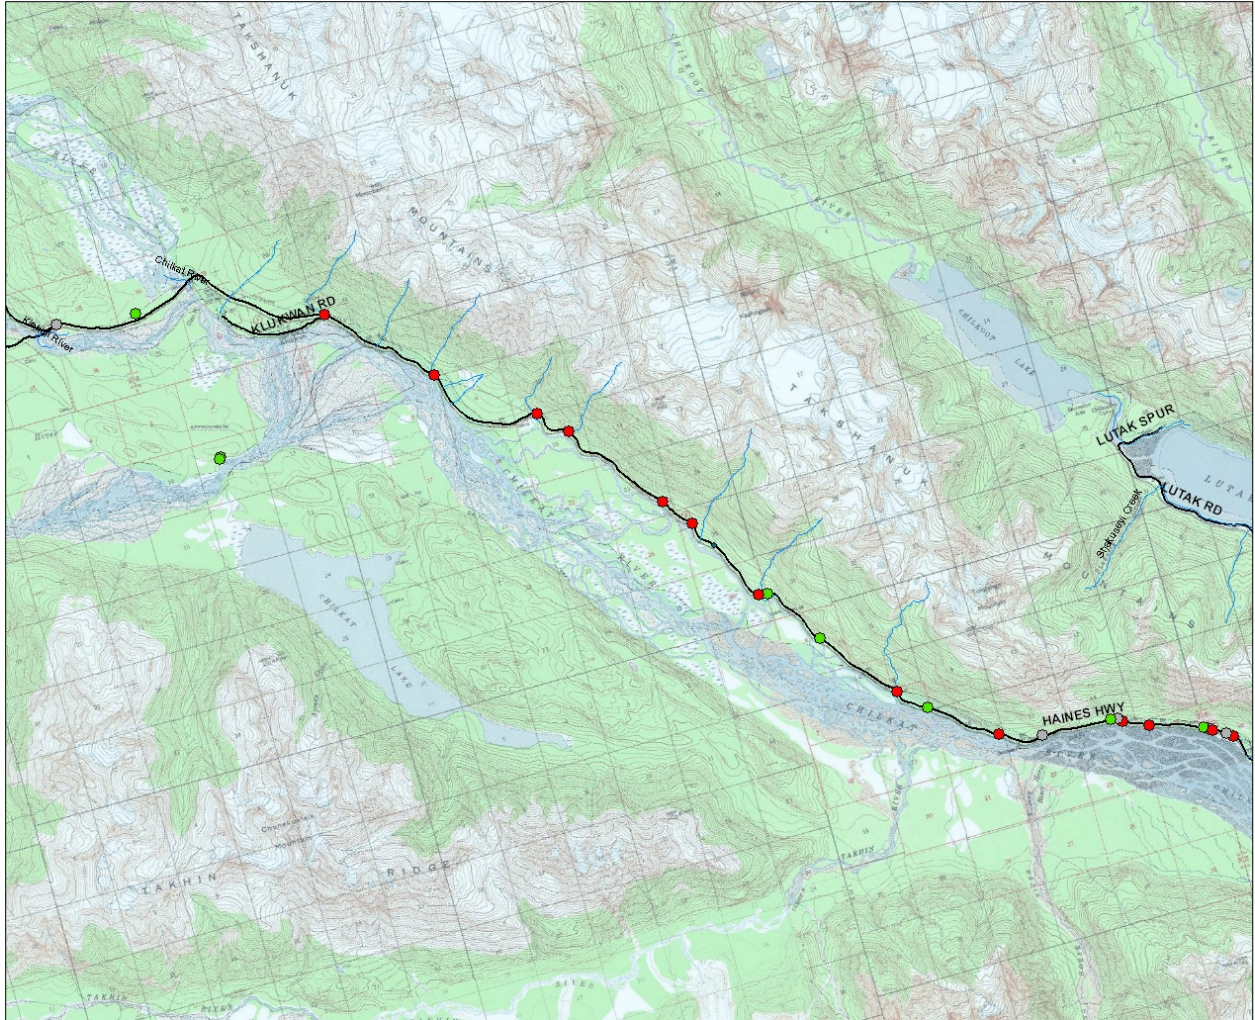
Figure 13.—Map showing assessed sites and site ratings along the Haines Highway from approximately milepost 7 to milepost 28.

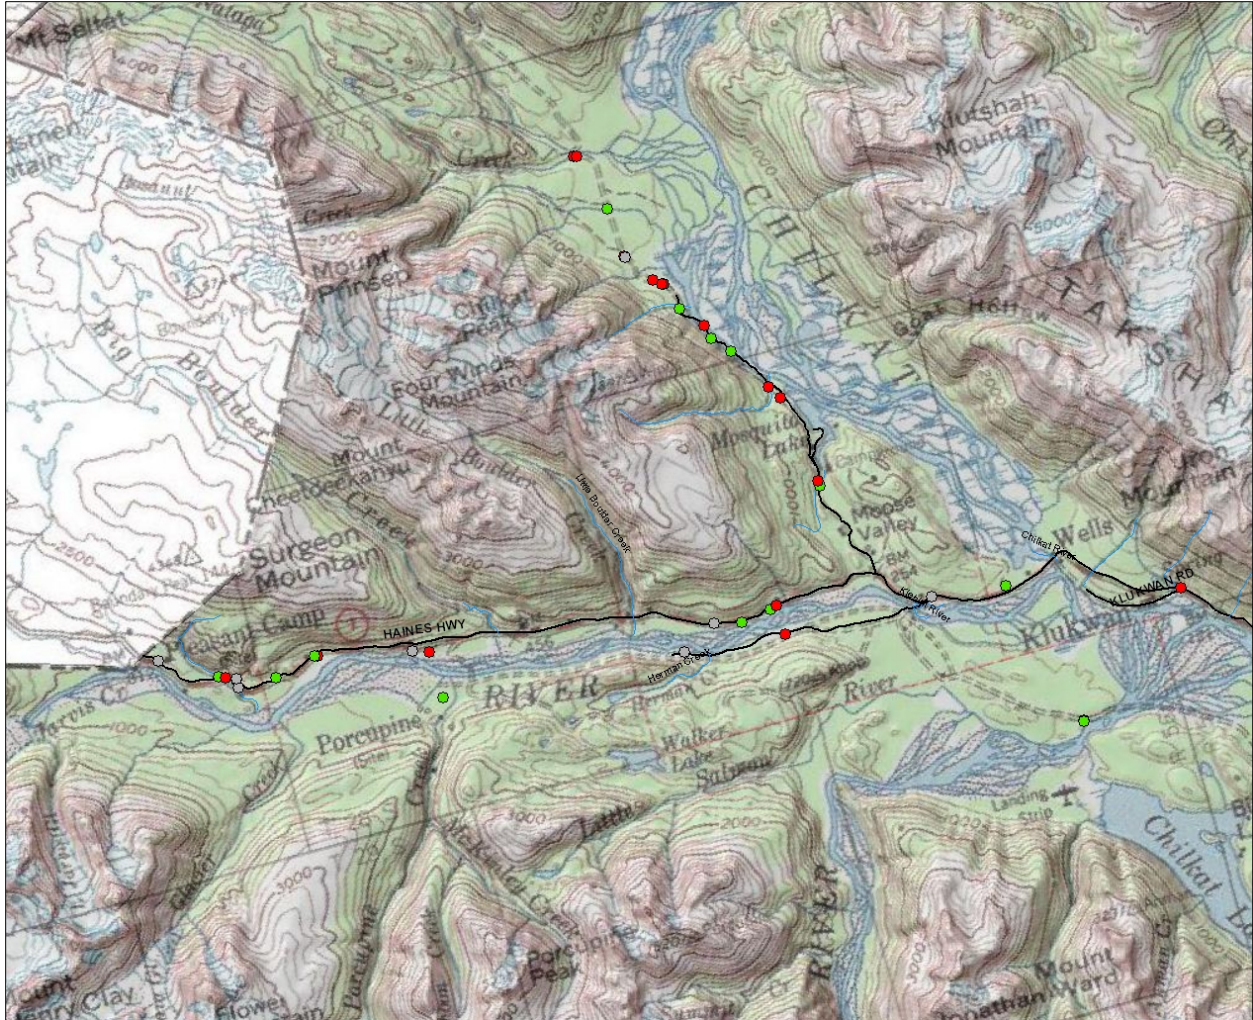
Figure 14.—Map showing assessed site locations and site ratings along the upper Haines highway from Klukwan to the border and sites along the Mosquito Lake and Kelsall Roads.

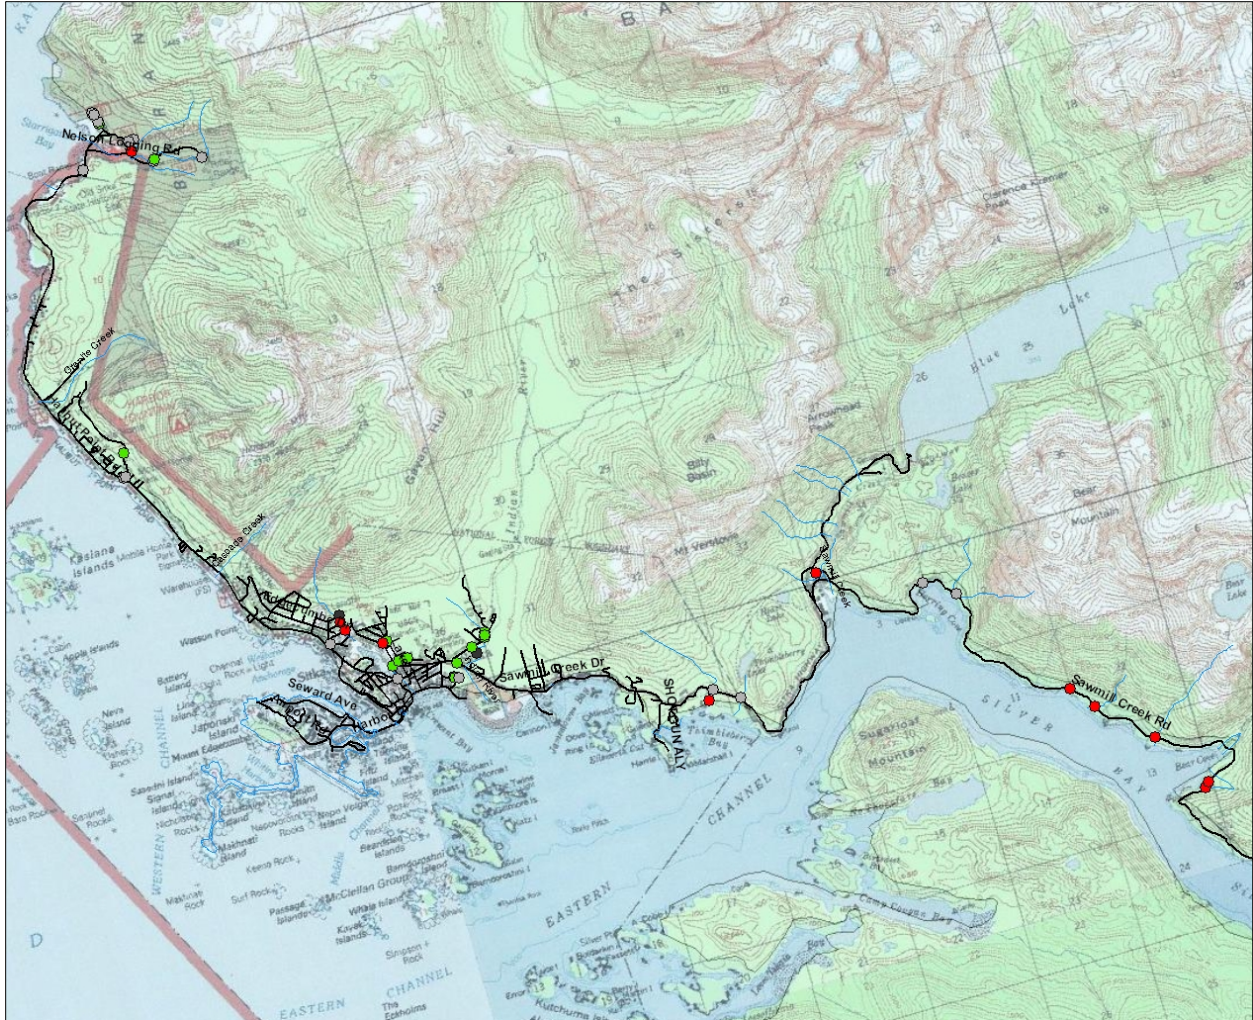
Figure 16.—Map showing surveyed culvert locations and site rating in the Sitka area.

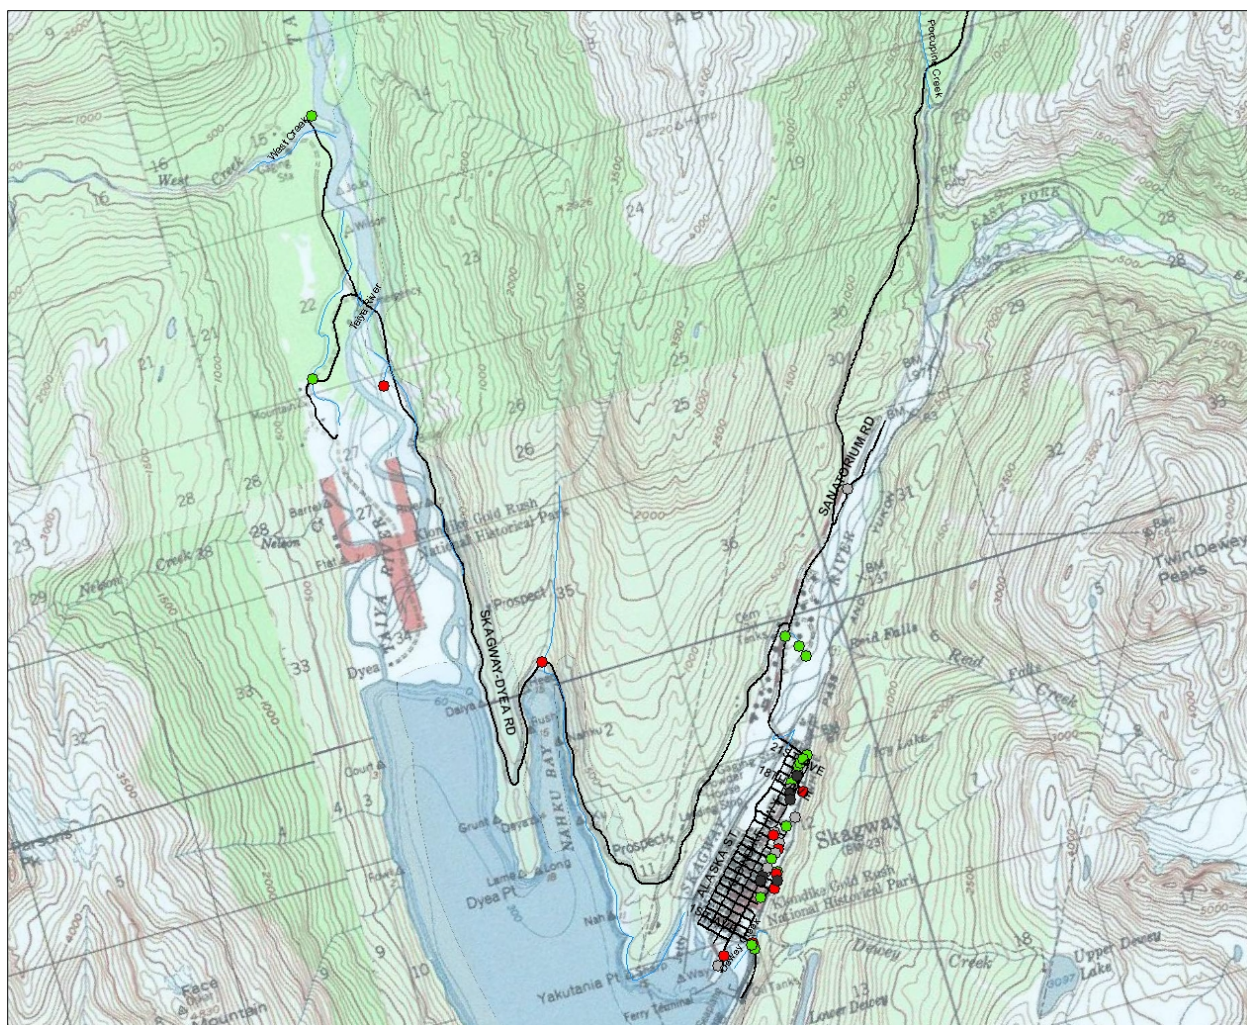
In the Skagway area on streams known to be fish bearing 8 sites (20%) were rated as Red, 11 sites (27.5%) were rated Gray, 14 sites (35.0%) were rated Green and 7 sites (17.5%) were not able to be rated due to their location on private property and were rated Black (Table 3, Figures 17 and 18). The project documented one site (2.3%) with an outfall over 1 foot and one culvert (2.3%) with a gradient exceeding 4% (Table 4).

Figure 17.—Assessed site locations and site ratings in the Skagway area.

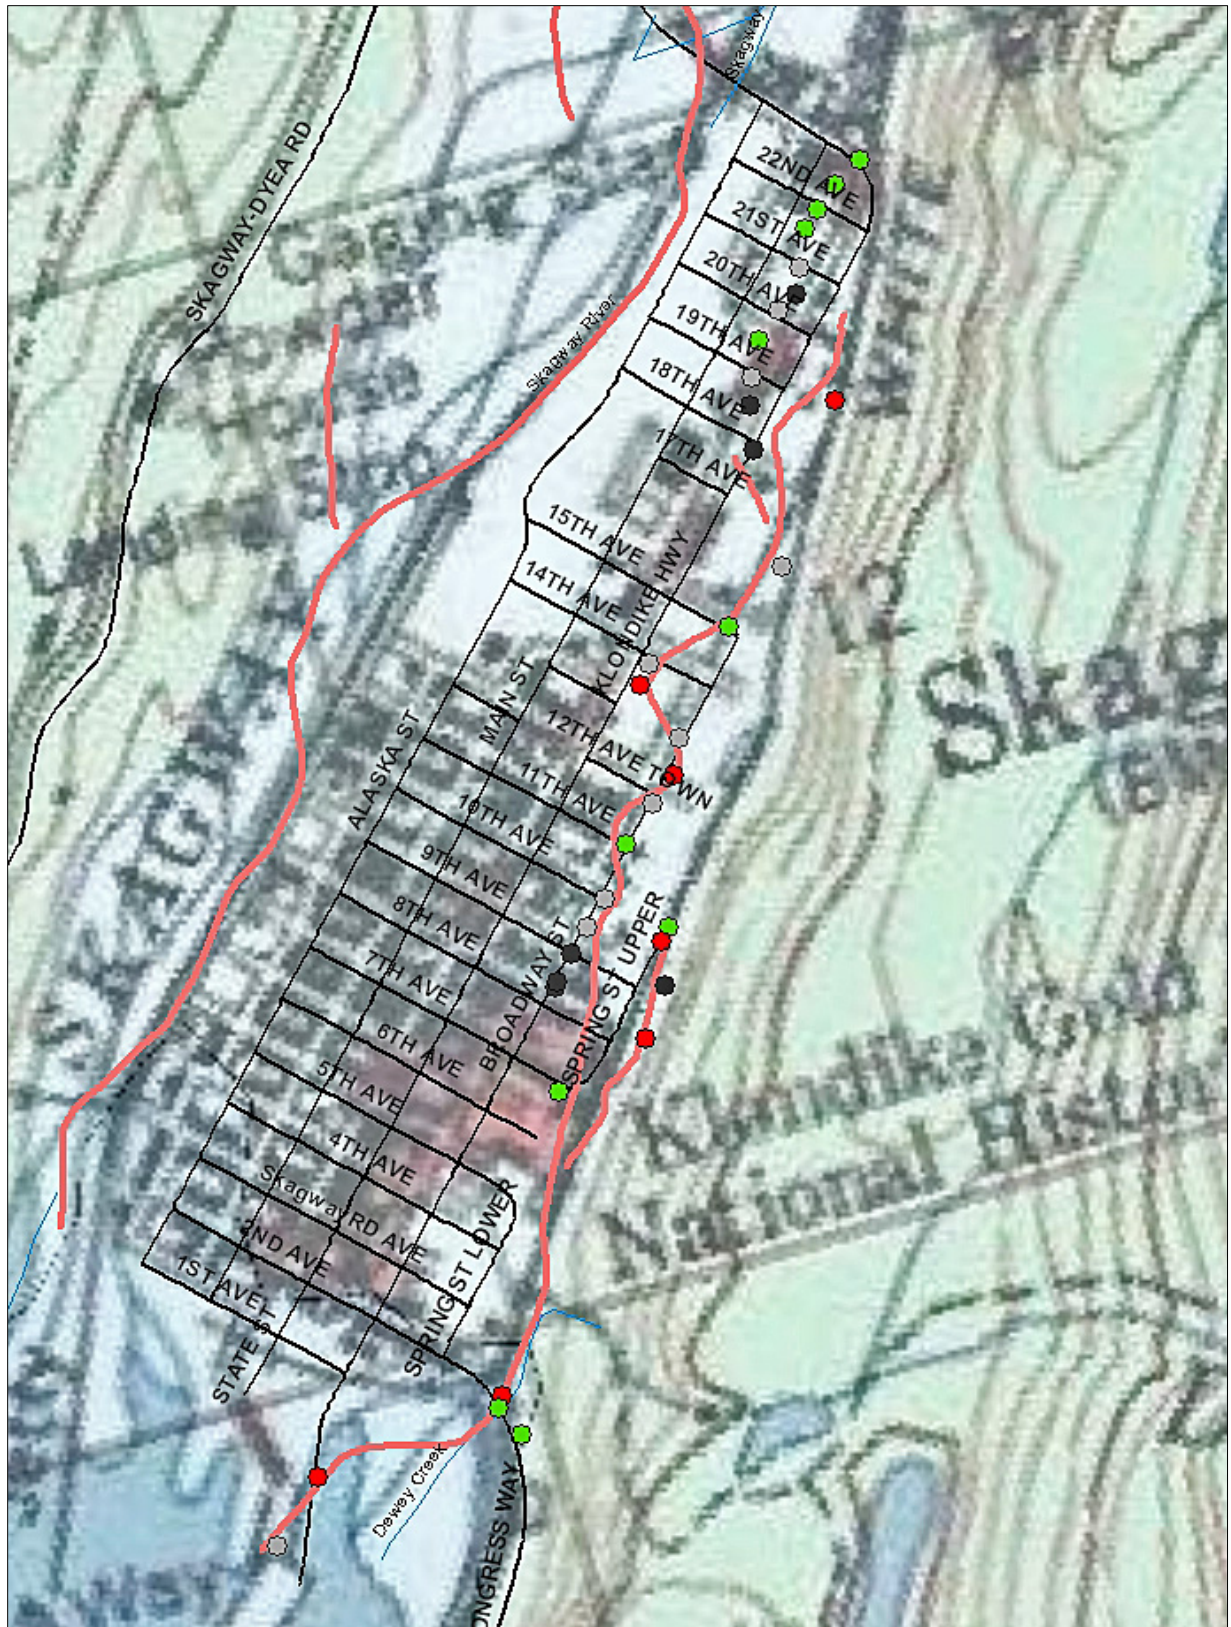
Of the 43 sites assessed in the Skagway area, 31 were on Pullen Creek. Pullen Creek has three branches that run through downtown Skagway and the White Pass and Yukon Route rail yard. Pullen Creek also gets a significant amount of flow from a hydroelectric plant. All three branches eventually combine near Pullen Pond, an artificial pond used for rearing Chinook salmon and then empties into Taiya Inlet via a fish ladder next to a cruise ship dock. According to the Pullen Creek Action Plan (TIWC 2006), Pullen Creek has been heavily manipulated and rechanneled and runs through dozens of private properties as it meanders through town (Figure 18). Over much of its length Pullen Creek is only about 2 to 3 feet wide with a gravel and sand substrate (TIWC 2006).

Figure 18.—Assessed sites and site ratings for culverts in downtown Skagway on the Pullen Creek complex.
