# Fish Passage Assessment, Inventory, and Prioritization of Culverts on the Ketchikan, Petersburg, and Wrangell Road Systems, 2013–2016

June 2021

Alaska Department of Fish and Game

### FISHERY DATA SERIES NO. 21-01

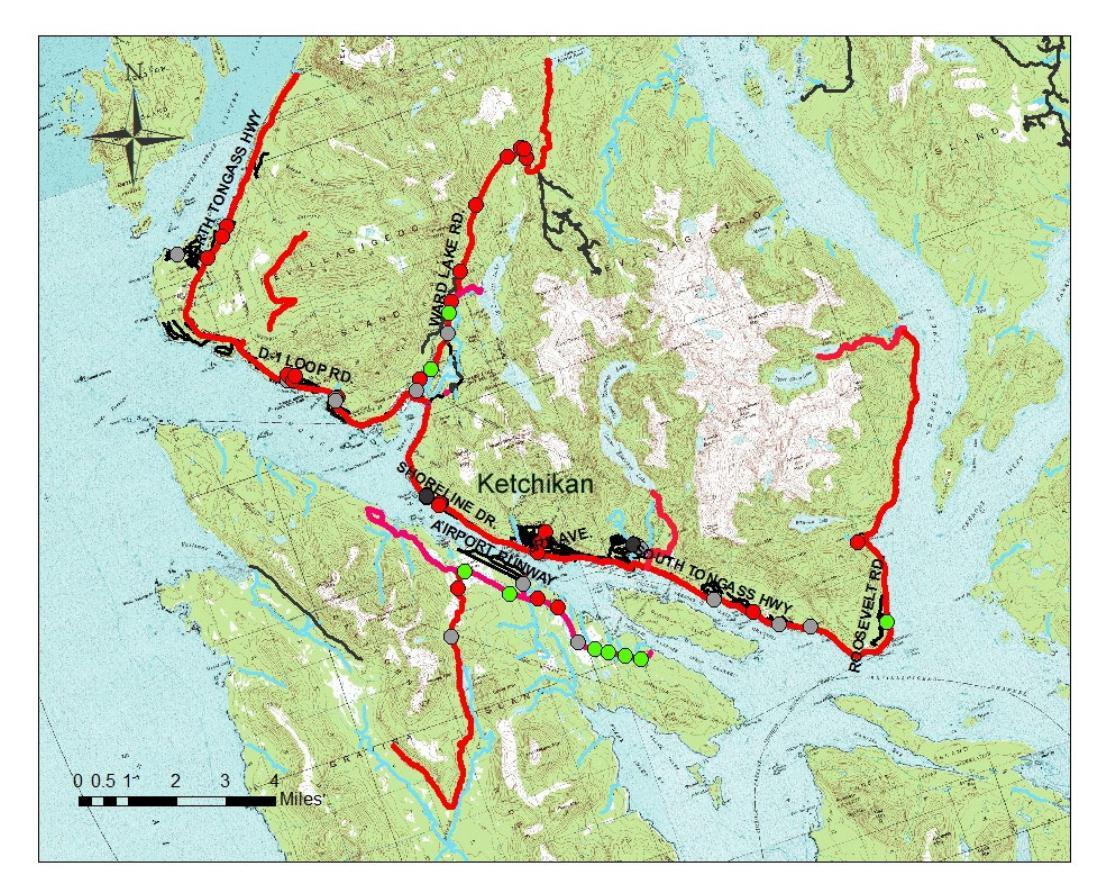
In 2013, 57 sites were assessed on 87 miles of roads (Figure 9, Table 1). The major factors affecting fish passage at sites assessed in Ketchikan were steep culvert gradients, culvert outfall height, sediment accumulation at the inlet, and constriction (Table 5). Thirty sites were rated Red (52.6%), 14 sites Gray (24.5%), 11 sites Green (19.3%), and 2 sites Black (3.5%) (Table 3). Among these sites, there were 26 Red (55.3%), 11 Gray (23.4%), 9 Green (19.2%), and 1 Black (2%) located on known fish-bearing streams (Table 2); the rest were located on streams the survey crew judged to have habitat potential to bear fish. Twenty-three sites were potential adult barriers of which 18 sites had an outfall height greater than 1 ft, 13 sites had an overall gradient greater than 4%, and 8 sites had both an outfall height greater than 1 ft and a gradient greater than 4% (Table 4).

Figure 9.-Map showing assessed culvert sites on the Ketchikan road system, with color-coded ratings.

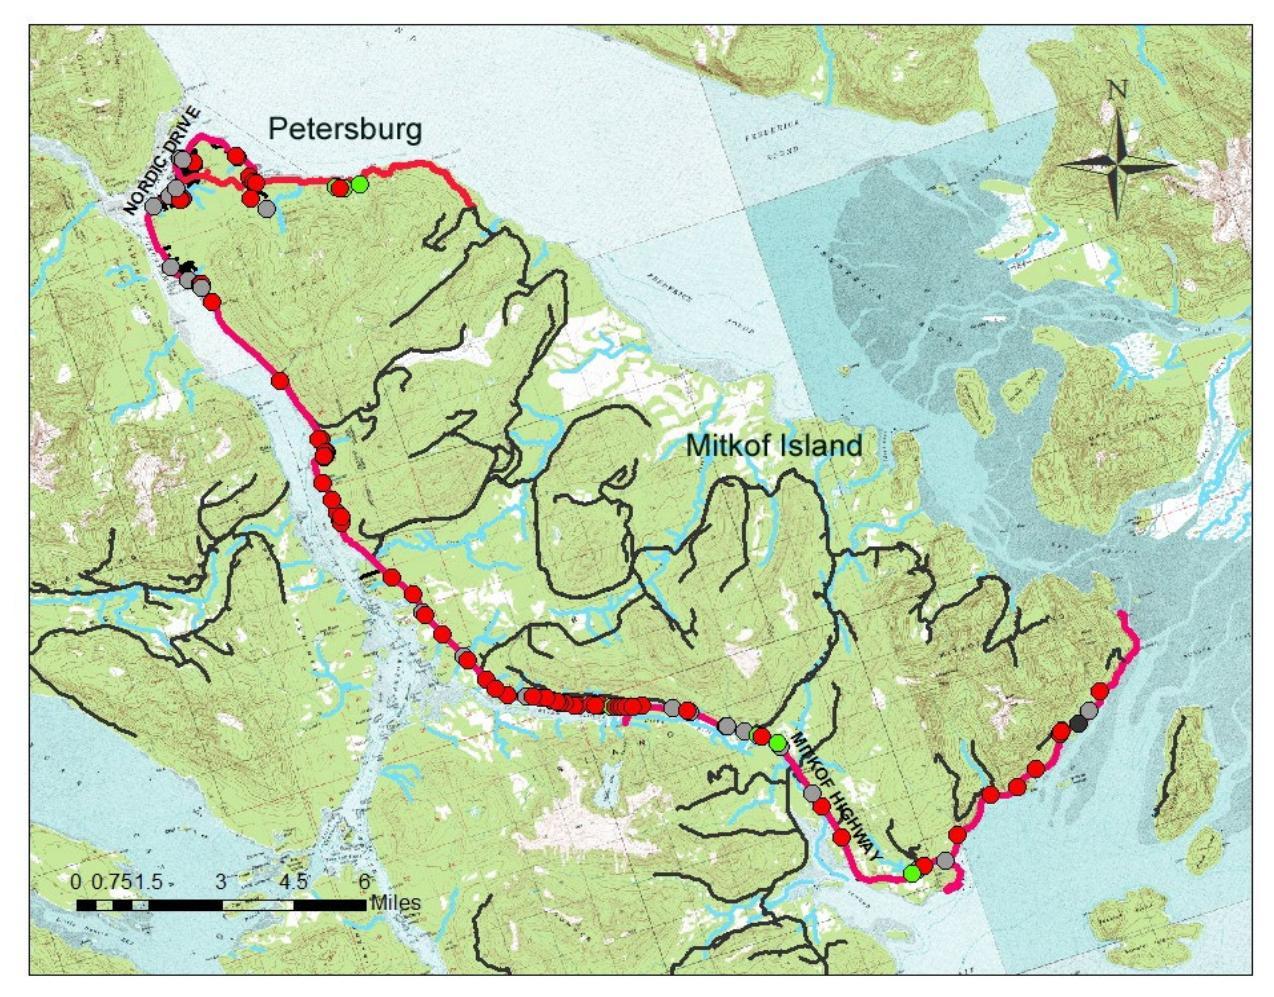
In 2013 and 2014, 102 fish passage sites were assessed on over 75 miles of roads in the Petersburg area (Figure 10, Table 1). The major factors affecting fish passage at sites assessed in Petersburg were Red culvert gradients, Red outfall heights, and Gray constriction ratios (Table 5). Sixty-nine sites were rated Red (67.6%), 24 sites Gray (23.5%), 8 sites Green (7.8%), and 1 site Black (1%) (Table 3). Sixty-nine Red sites, 19 Gray sites, and 8 Green sites were on streams known to be fish bearing (Table 2). Thirty-eight sites were potential adult barriers of which 22 sites had outfall

Figure 10.-Map of the sites assessed for fish passage on the Petersburg road system, with color-coded ratings.

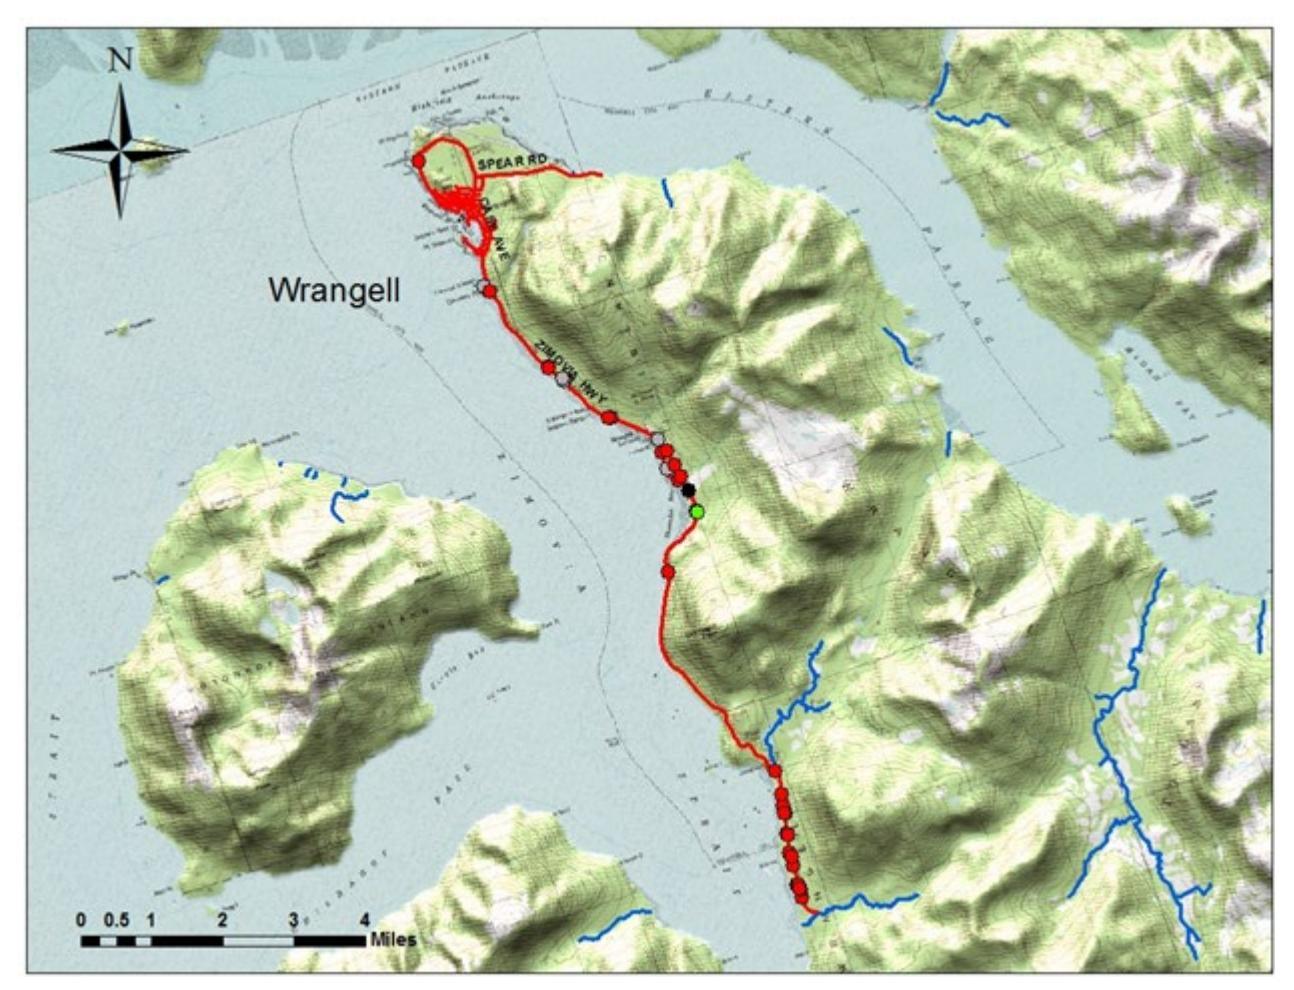
In 2014 and 2016, fish passage assessment crews assessed 38 sites in the Wrangell area on over 24 miles of roads (Figure 11, Table 1). The major factors affecting fish passage at sites assessed in the Wrangell area were Red culvert gradient, Red outfall height, and Gray constriction ratio (Table 5). Thirty sites were rated Red (78.9%), 5 sites Gray (13.2%), 1 site Green (2.6%), and 2 sites Black (5.3%) (Table 3). Of those, 15 Red sites (78.9%), 3 Gray sites (15.8%), and 1 Green site (5.3%) were located on streams known to be fish bearing (Table 2). The project found 27 potential adult barriers of which 17 sites had an outfall height greater than 1 ft, 19 sites had a culvert gradient greater than 4%, and 9 of the 27 sites had both an outfall height greater than 1 ft and a gradient greater than 4% (Table 4).

Figure 11.-Map showing sites assessed for fish passage on the Wrangell road system, with color-coded ratings.

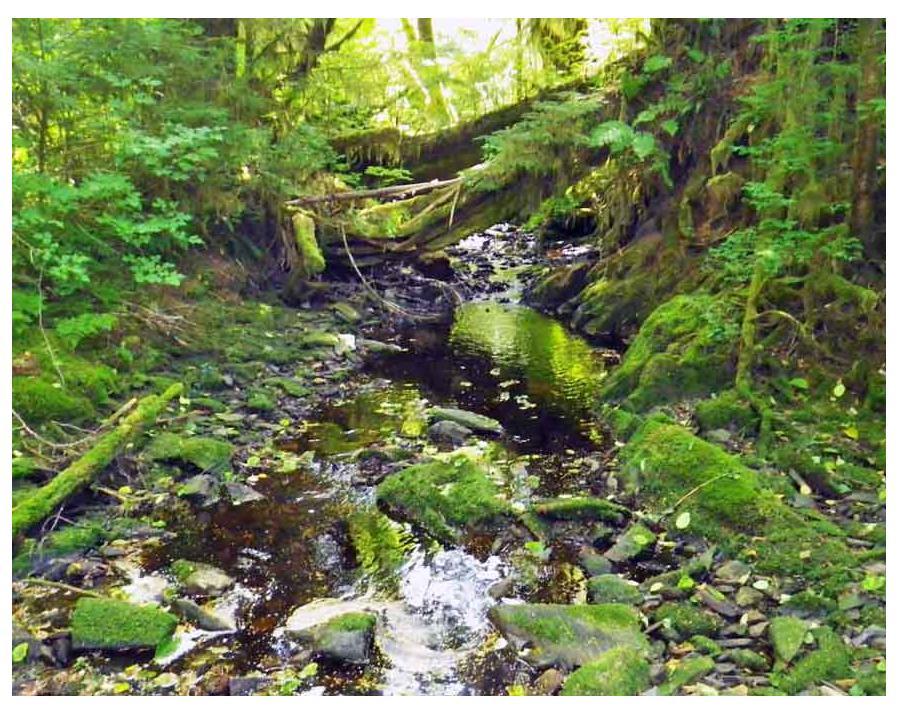
Figure 13.–Site 10103229, North Tongass Highway, Trollers Creek (AWC# 101-90-10705), Ketchikan, upstream habitat above culvert.

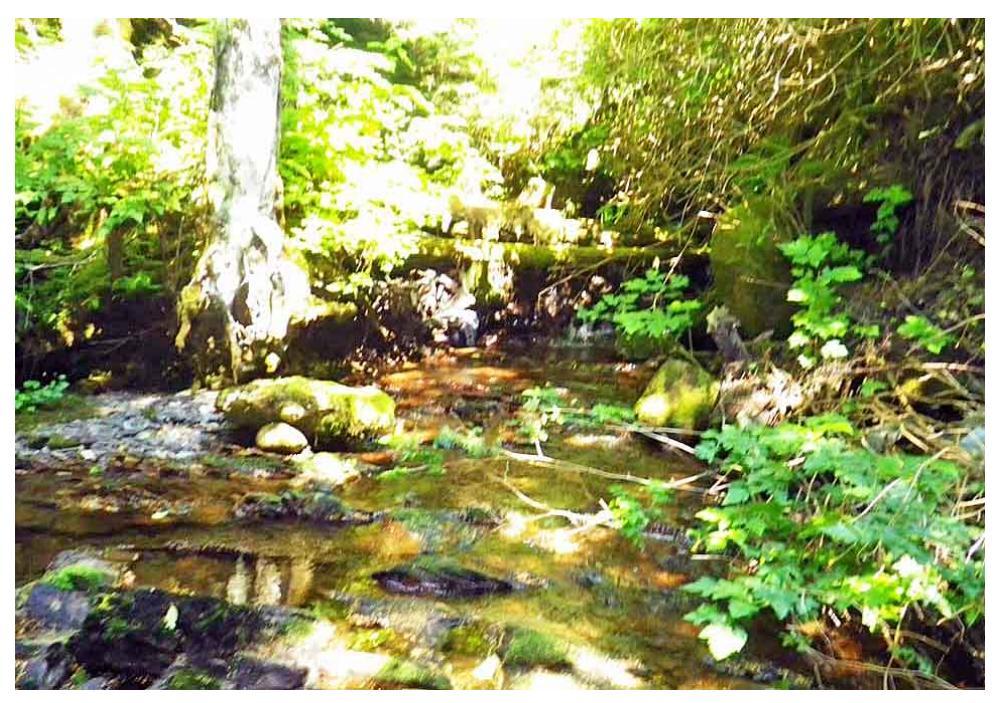
Figure 16.–Site 10103208, South Tongass Highway, unnamed creek (AWC# 101-47-10300), Ketchikan, upstream habitat above culvert.

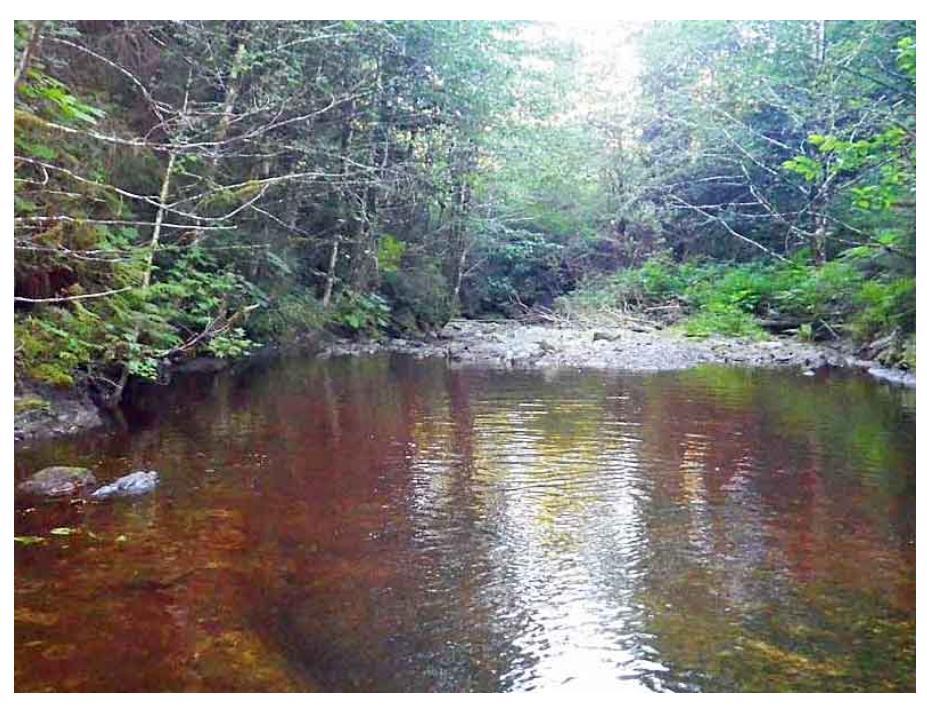
Figure 19.-Site 10103174, Ward Lake Road, unnamed creek, Ketchikan, upstream habitat above culvert.

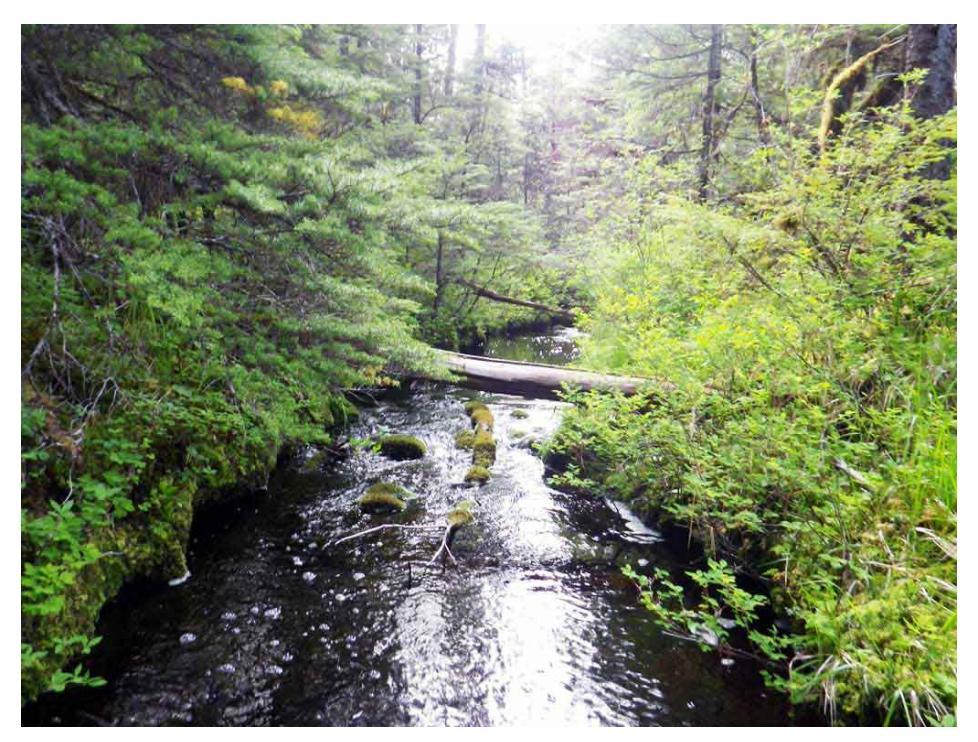
Figure 21.–Site 10203301, Mitkof Highway, Letti Creek (AWC# 106-44-10070), Petersburg, upstream habitat above culvert.

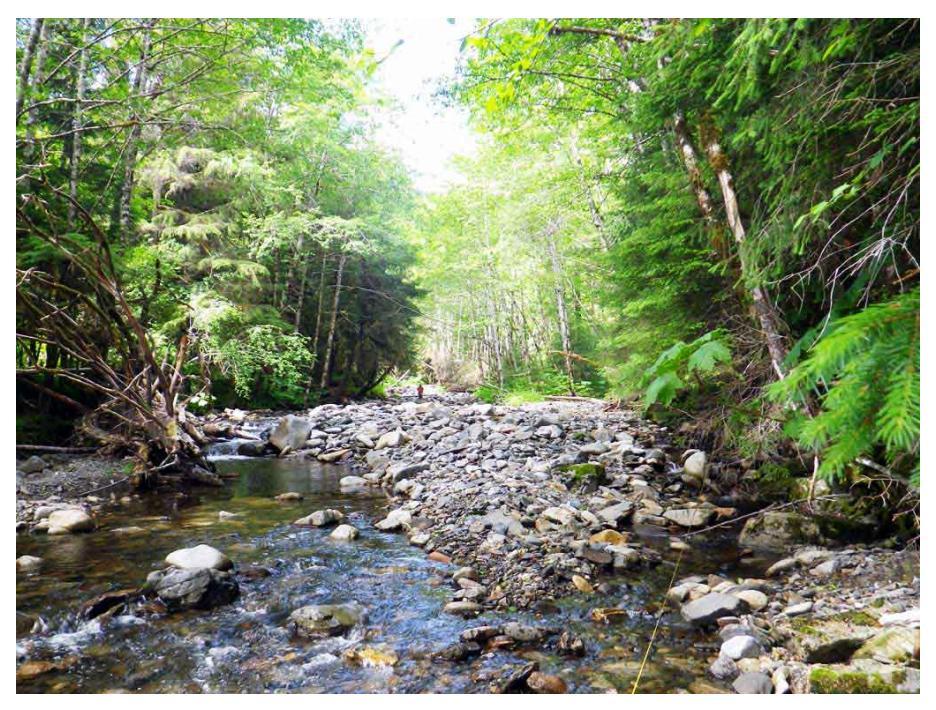
Figure 24.–Site 10203133, Mitkof Highway, unnamed creek (AWC Stream #108-40-10600), Petersburg, upstream habitat above culverts.

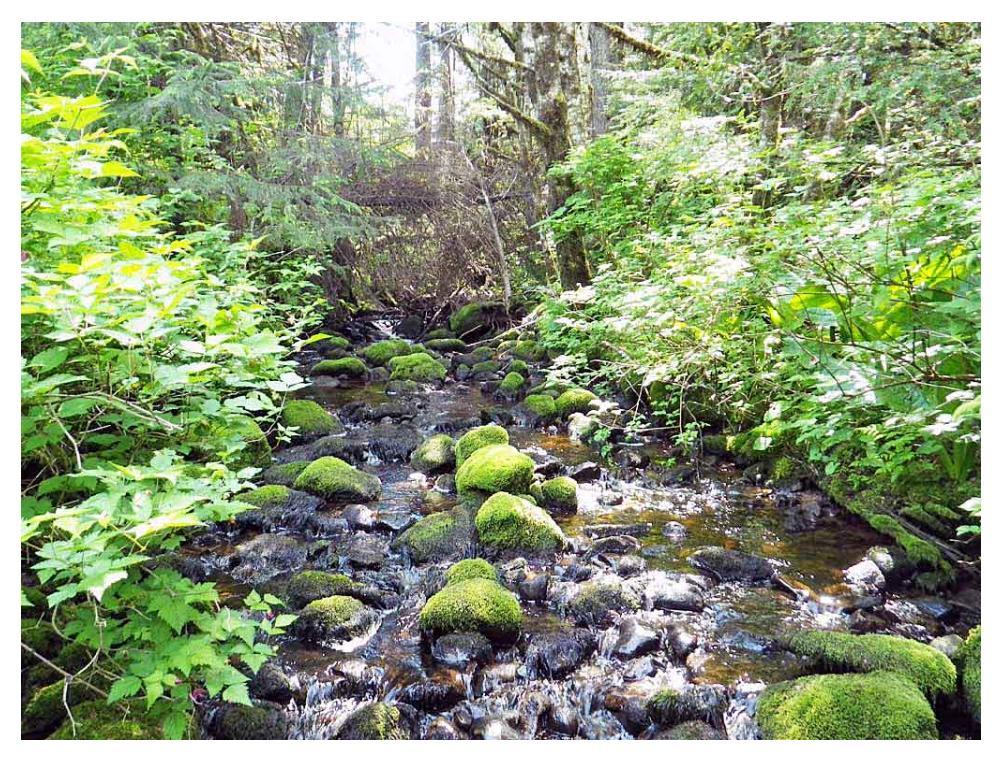
Figure 27.–Site 10203171, Sandy Beach Road, unnamed creek (AWC Stream #108-60-10051), Petersburg, upstream habitat above culvert.

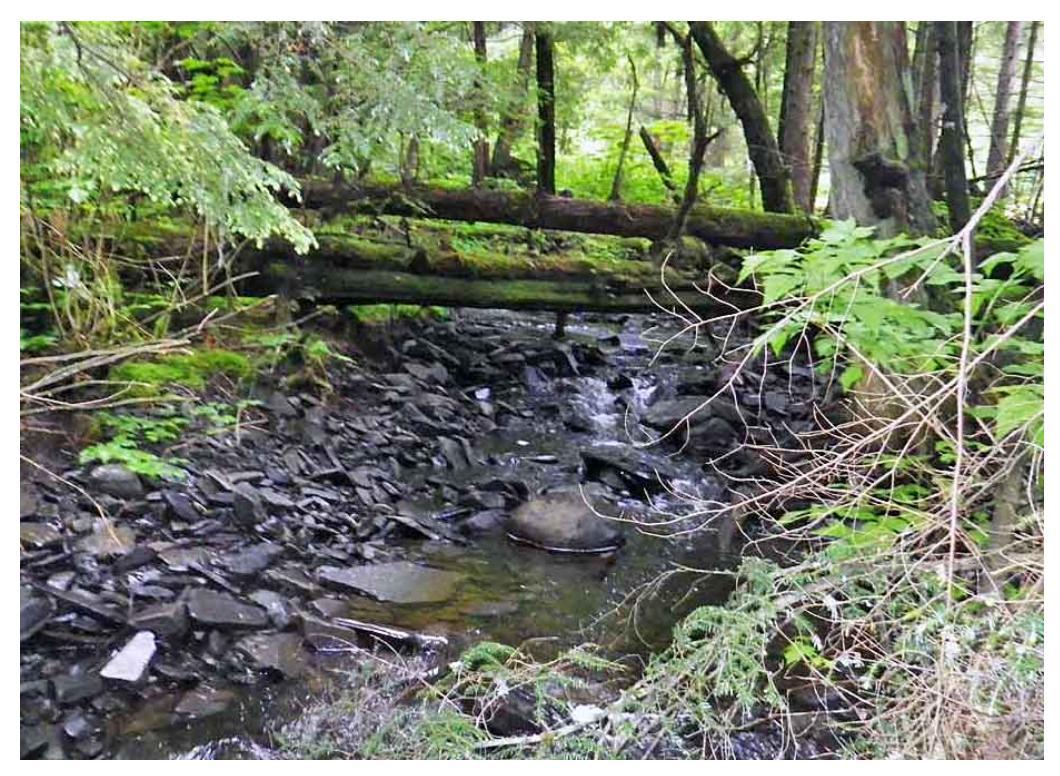
Figure 30.–Site 10203312, Zimovia Highway, Playground Creek (AWC# 108-40-10282), Wrangell, upstream habitat above culverts.

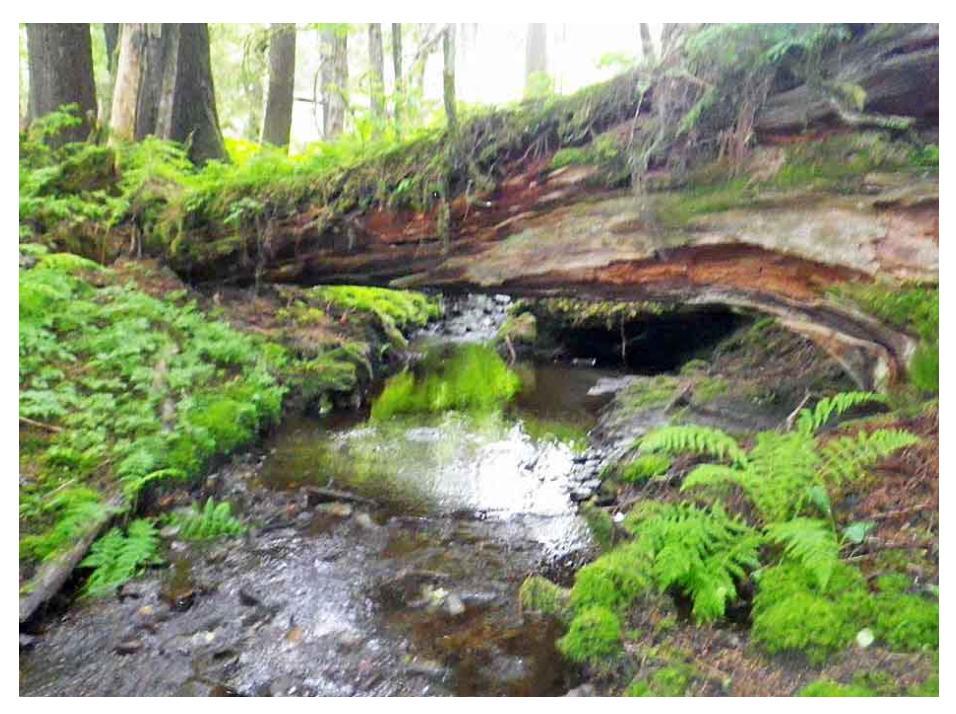
Figure 33.–Site 10203315. Zimovia Highway, unnamed creek (AWC# 108-40-10290), Wrangell, upstream habitat above culverts.

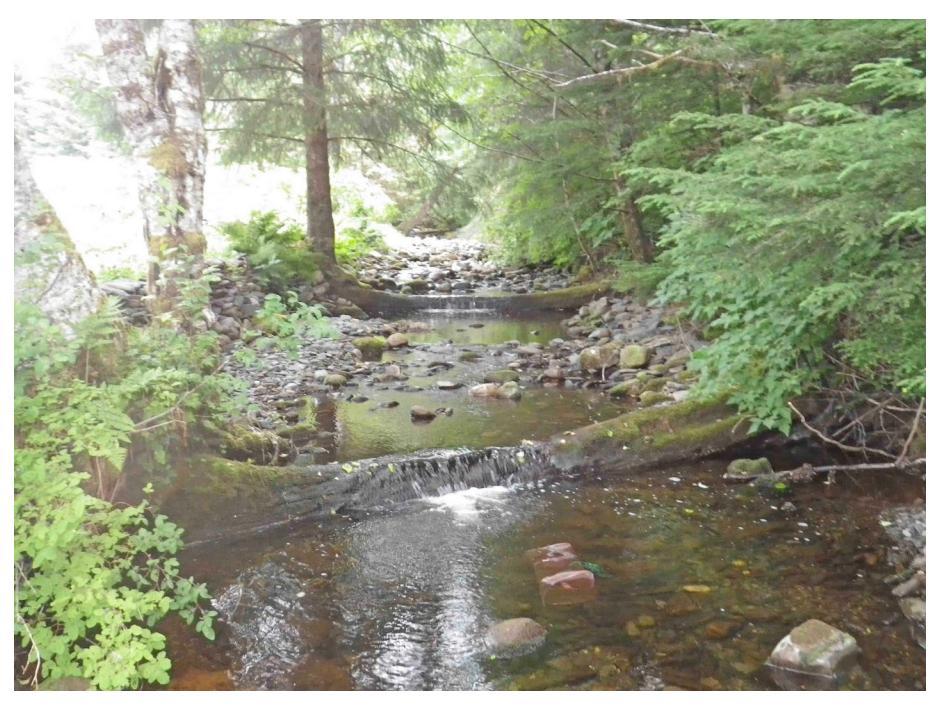
Figure 36.-Site 10203506, Zimovia Highway, unnamed stream, Wrangell, upstream habitat above culvert.
