Repair of the Lower Diversion Weir at Frazer Lake, 2003

Regional Information Report<sup>1</sup> No. 4K03-48

Alaska Department of Fish and Game  
Division of Commercial Fisheries  
211 Mission Road  
Kodiak, Alaska 99615

September 2003

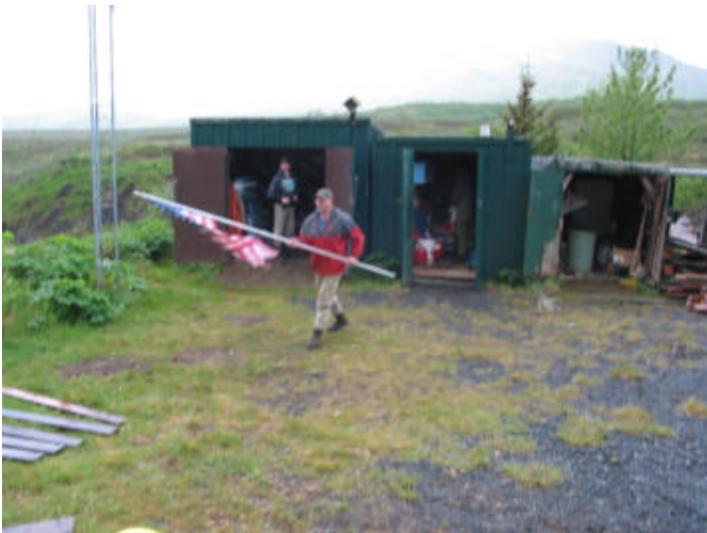
Figure 26. The storage sheds used at Frazer Lake, 2003.

There are currently three sheds at the Frazer Lake facility (Figure 26). One shed is used for tools, and storing the tractor, one is used for fuel, and one is used for miscellaneous items. While these sheds are adequate for the project, it would be better, if there was one large shed that utilized the space more efficiently.
