Nomination Form  
Anadromous Waters Catalog

Region Southcentral USGS Quad(s) Seward A-3  
 Anadromous Waters Catalog Number of Waterway 226-40-16670  
 Name of Waterway "Anderson Creek"  USGS Name  Local Name  
 Addition  Deletion  Correction  Backup Information

SUBJECT: Trip Report – Anderson Creek  
Chenega Hydro Electric Project

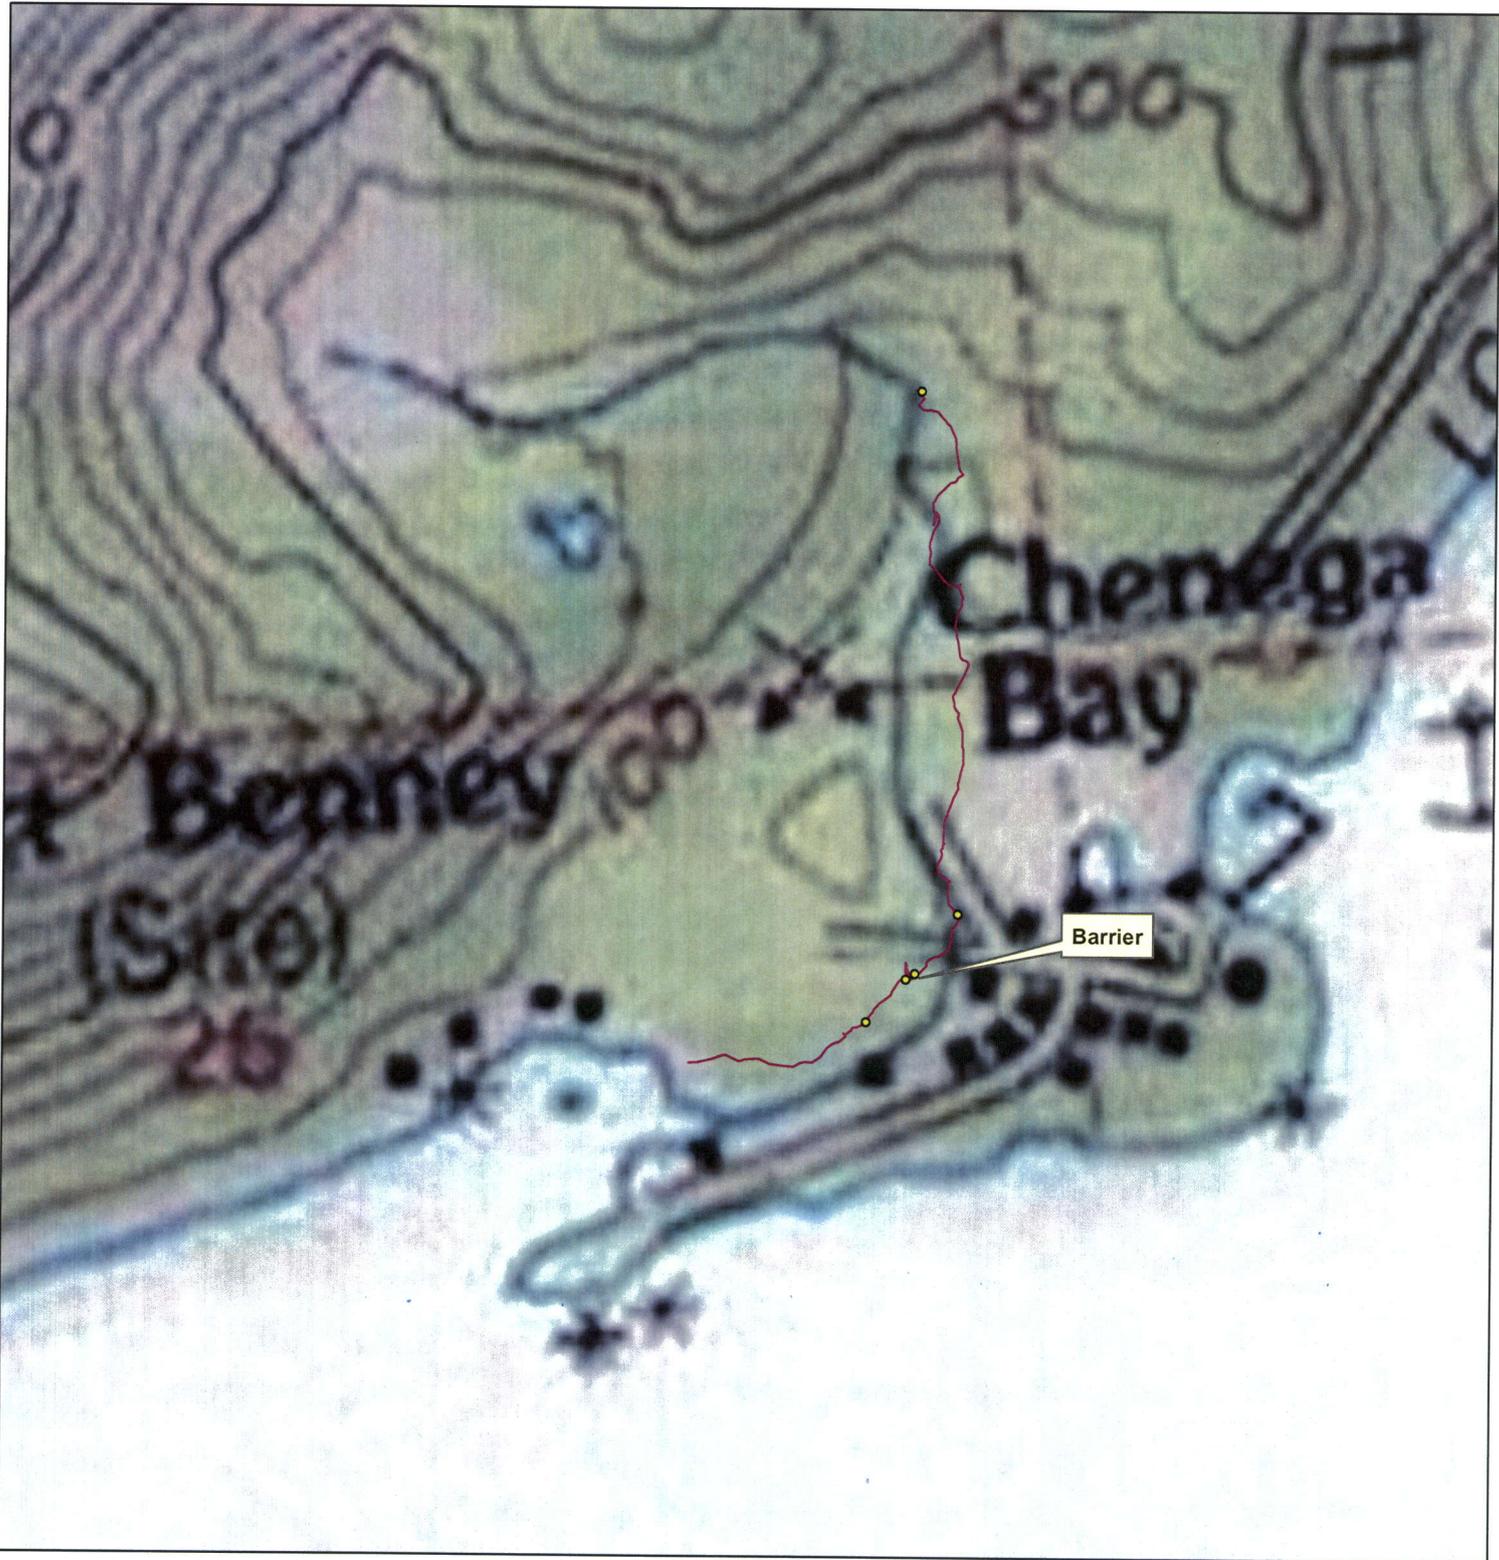
During a stream evaluation for a hydroelectric project, I observed a 10-foot high barrier that will not pass fish. The specified portion of this creek should be reduced to the location of the barrier. See the August 29, 2012 trip report.
