# Appendix F: Haines

## Guide to direct fieldwork for cataloging anadromous water bodies in Southeast Alaska

## HAINES STREAM SURVEYS

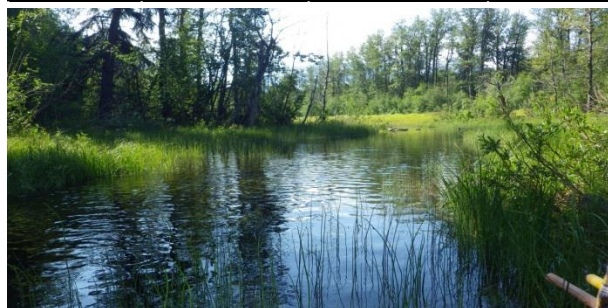
**Findings:** We surveyed 14 Mile Creek using a handnet and a GPS (Table 1). Upstream of the Haines Highway this stream is a mix between a pond and marsh (Figure 1). We found that the stream route differs from what is shown in the AWC.

Figure 1.–Looking upstream on 14 Mile Creek above the Haines Highway culvert.

**Recommendations:** Correct the current route in the Anadromous Waters Catalog (Figure 2).

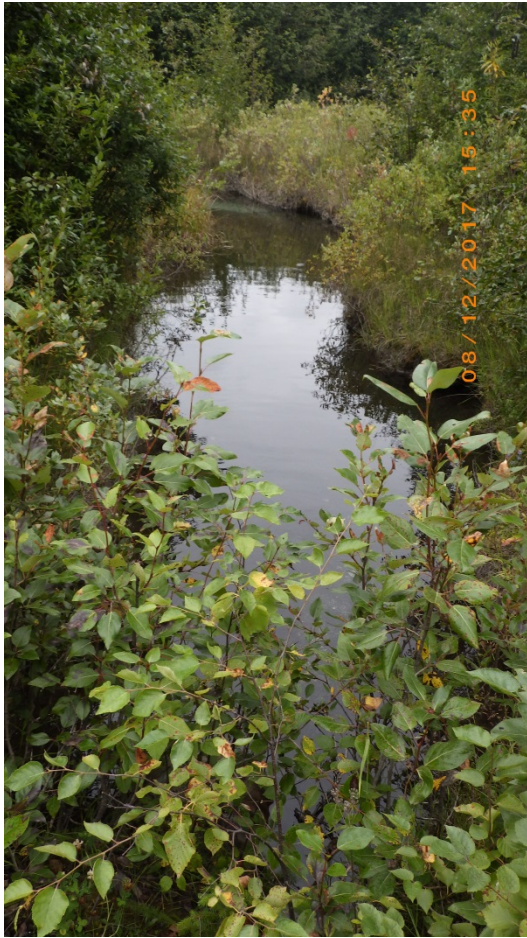
**Findings:** We surveyed this stream with a GPS. We found the current stream course in the catalog to be inaccurate. We followed the stream from the confluence with the Chilkat River up to the anadromous fish barrier upstream of the Haines Highway (Table 1, Figures 1-3).

Figure 1.—Channel downstream of Haines Highway culvert.

**Recommendations:** Correct the stream course in the Anadromous Waters Catalog.

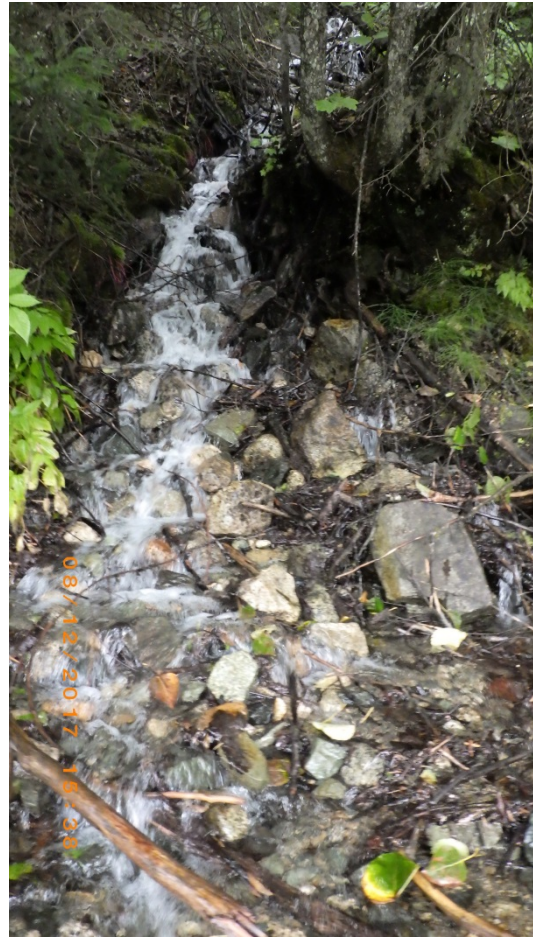
Waypoint	Latitude	Longitude	Notes	Sample Effort	Sample Results
1102	59.3332	-135.7480	Culvert downstream of Haines Highway.		
1103	59.3333	-135.7477	Culvert upstream of Haines Highway.		
1104	59.3334	-135.7477	Stream bed.		
1105	59.3334	-135.7477	Steep cascade, over 25% gradient for over 25 m. Definite fish barrier.

Figure 2.—Cascade at WP 1105.

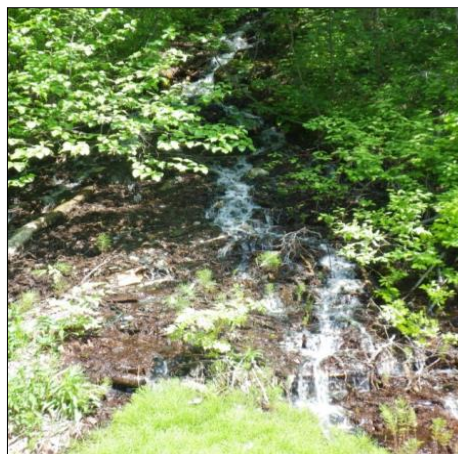
Figure 2.—Barrier falls on ditch at WPT 46.

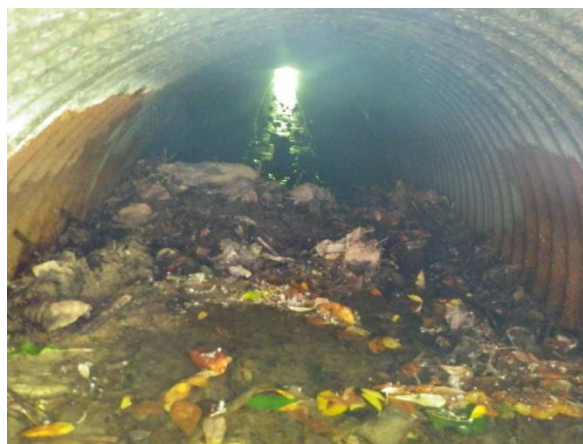
Figure 2.–16.9 Mile Creek culvert inlet below the Haines Highway with large debris mound that creates a 2ft drop.

**Recommendations:** Adding this stream to the AWC (Figure 3).

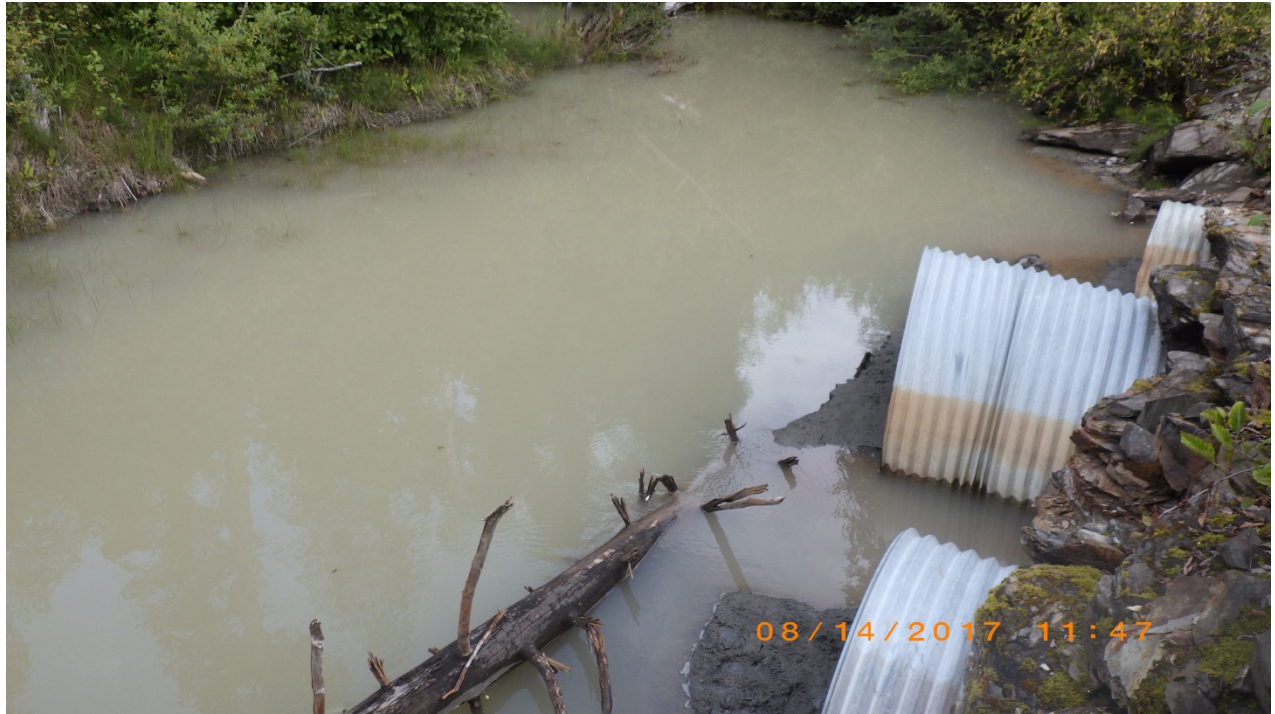
Waypoint	Latitude	Longitude	Notes	Sample Effort	Sample Results
1116	59.3755	-135.9391	Downstream of road, 4 culverts.		
1117	59.3756	-135.9393	Upstream of road, sediment built up in 2 river left culverts. Minnow trap set at 1150 in ~0.5 m. Current moved trap mostly out of water when pulled the next day at 0920.	MT	2 DV
1118	59.3759	-135.9395	Minnow trap set at 1157 under over hanging alders. Pulled at 0920 the next day. CO ranged from 55-70 mm.	MT	3 CO, 2 DV

Figure 2.—Upstream of Chilkat Landing road.

**Recommendations:** Correct this stream course in the Anadromous Waters Catalog.

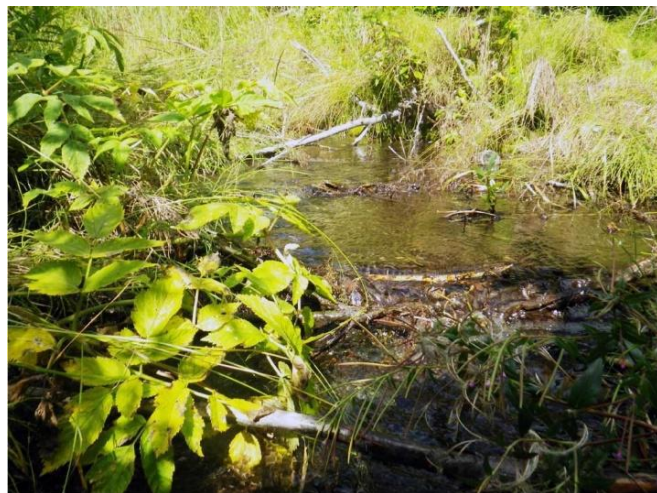
Waypoint	Latitude	Longitude	Notes	Sample Effort	Sample Results
562	59.3998	-135.8784	Culvert outlet.		
563	59.4000	-135.8783	Culvert inlet, not embedded, moderate gradient, slight inlet perch.

Figure 1.–21.5 Mile Creek looking upstream from the culvert inlet.

**Recommendations:** Shortening the cataloged portion to the downstream end of the Haines Highway culvert (Figure 3).

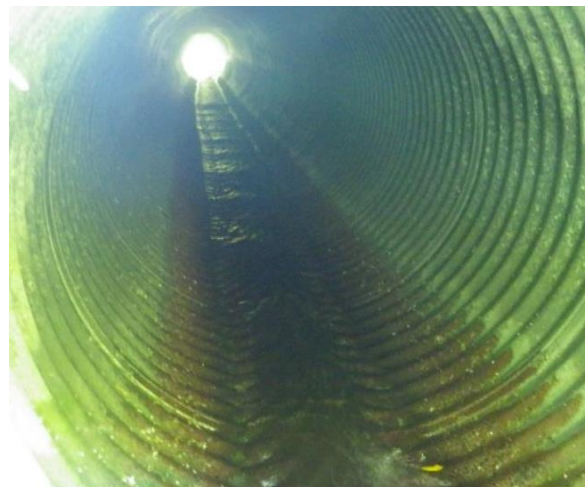
Figure 2.–21.5 Mile Creek looking downstream.

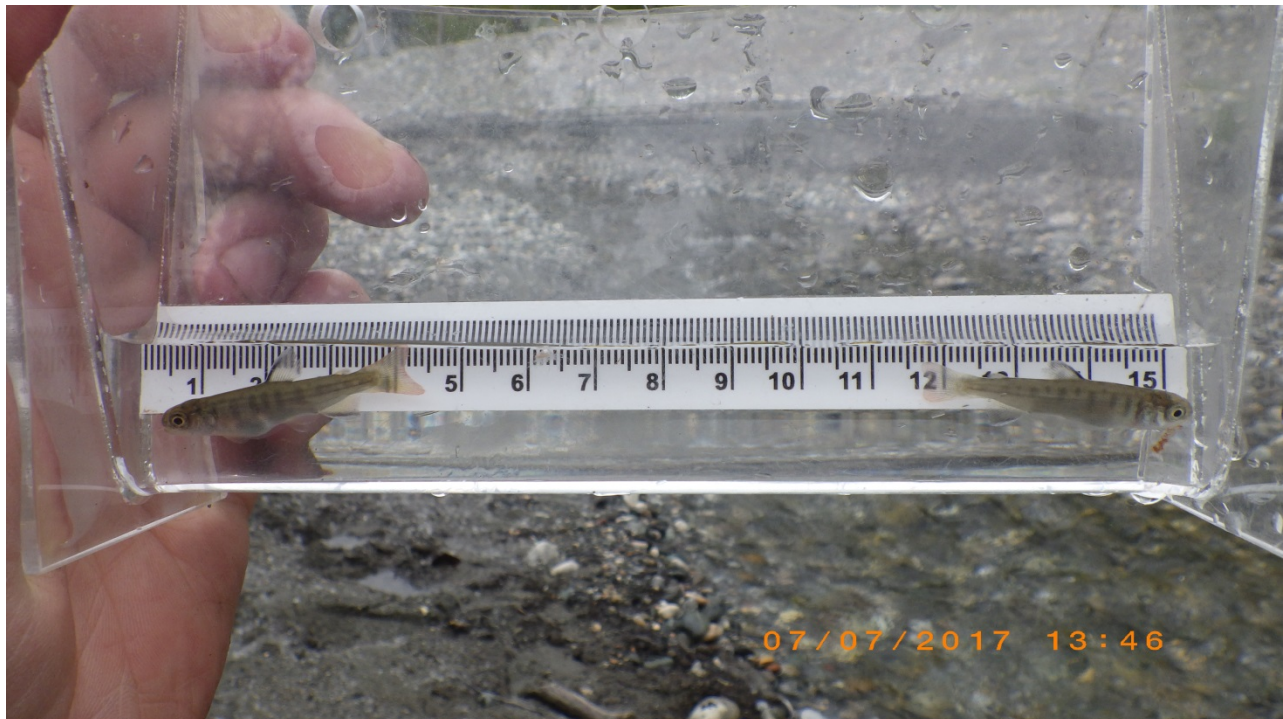
Figure 3.–Juvenile coho salmon captured.

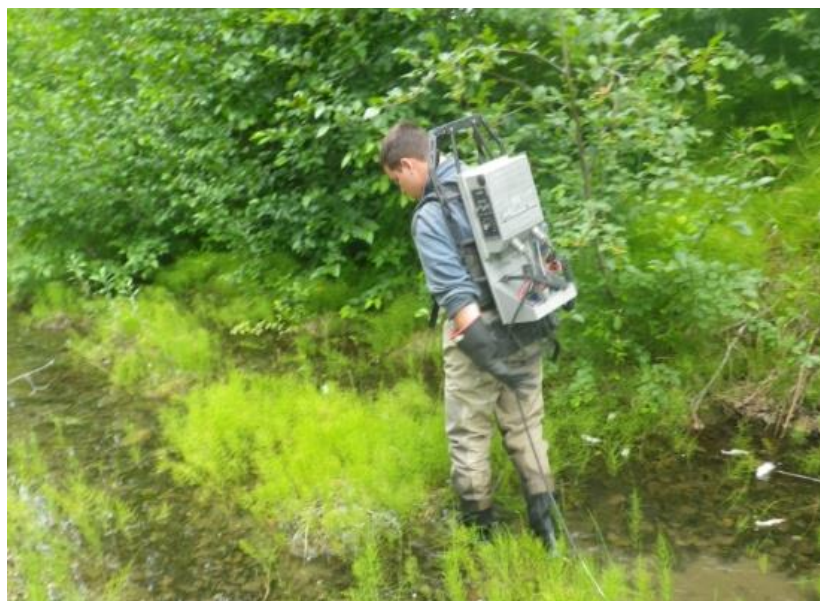
Figure 1.—Rick Hoffman electrofishing Herman Creek tributary.

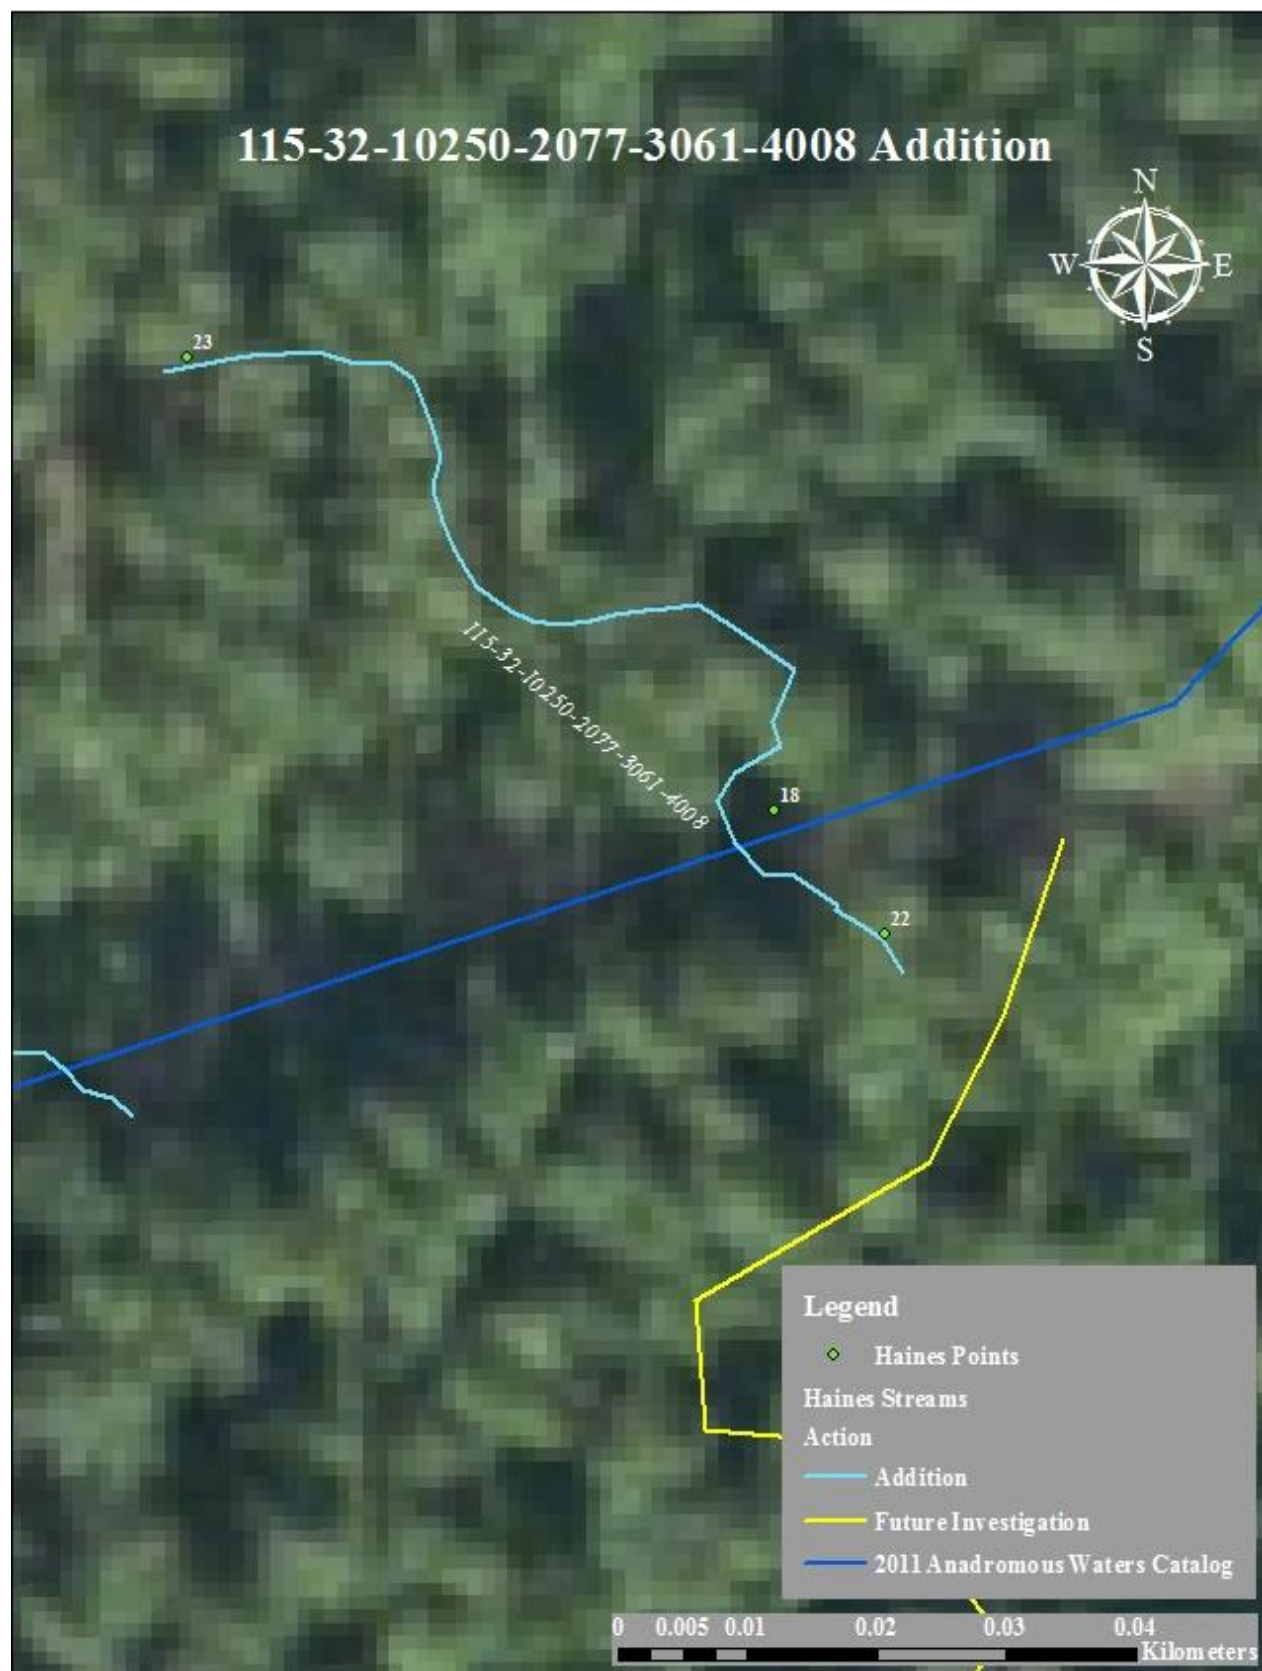
Figure 2.—115-32-10250-2077-3061-4008 addition map.

**115-32-10250-2077-3061-4008****ADDITION****Water body name:****Survey date:** 7/16/2011**Water body number:** 115-32-10250-2077-3061-4008**Species & Lifestage:** CO**Watershed:** Klehini River**MTR:** C028S055E **Quad:** Skagway B-3**Findings:** We surveyed this tributary to Herman Creek using a backpack electrofisher, handnet and a GPS (Table 1, Figure 1). Coho salmon were caught in the upper extent of this tributary.**Recommendations:** Add stream to the Anadromous Waters Catalog (Figure 2).**Nomination:** 11-543

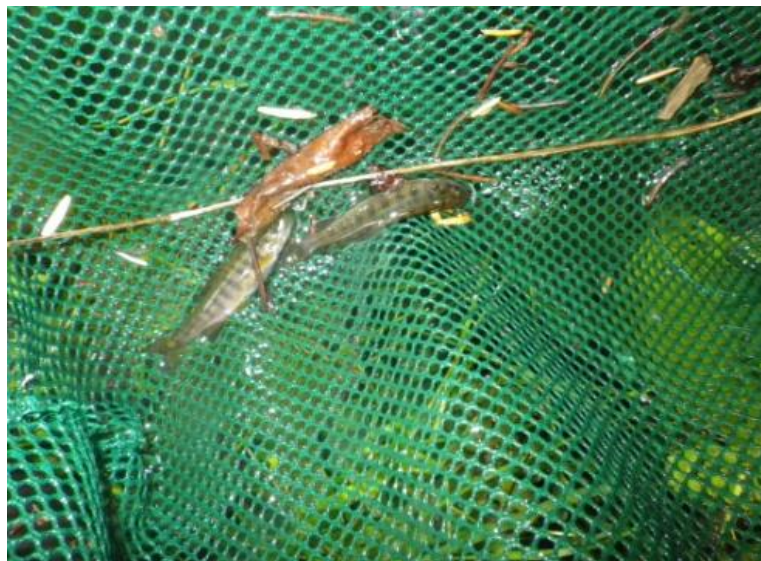
Figure 1.—Coho salmon netted in 115-32-10250-2077-3061-4012.

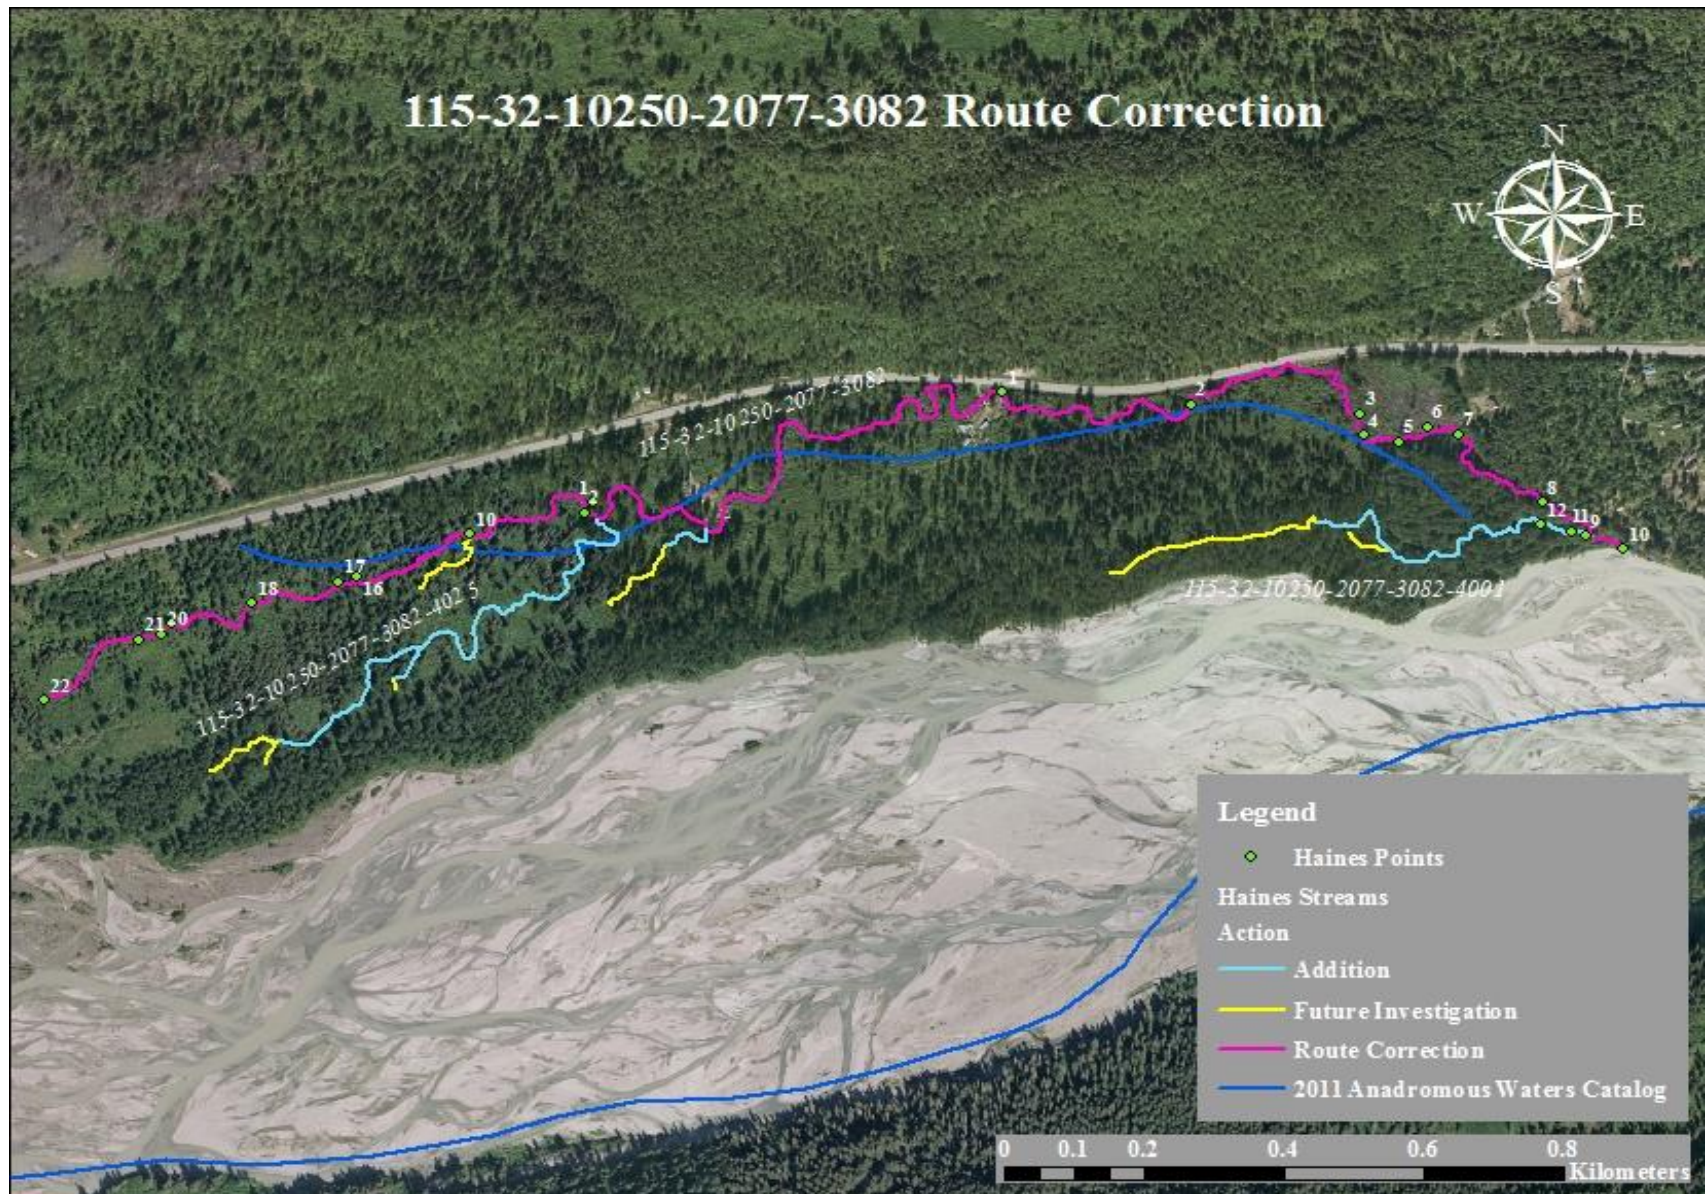
Figure 1.—115-32-10250-2077-3082 route correction.

**Findings:** We surveyed this stream using a handnet and a GPS (Table 1). We found that this stream is highly influenced by beaver activity, with many fresh dams present throughout the stream. Rearing Dolly Varden char and coho salmon were abundant throughout stream. The route of 33 Mile Creek mainstem differs from that illustrated in the AWC. The headwaters are in a different location than is currently cataloged, and the mouth enters the Chilkat River in a different area.

**Recommendations:** Correct the current route in the Anadromous Waters Catalog (Figure 1).

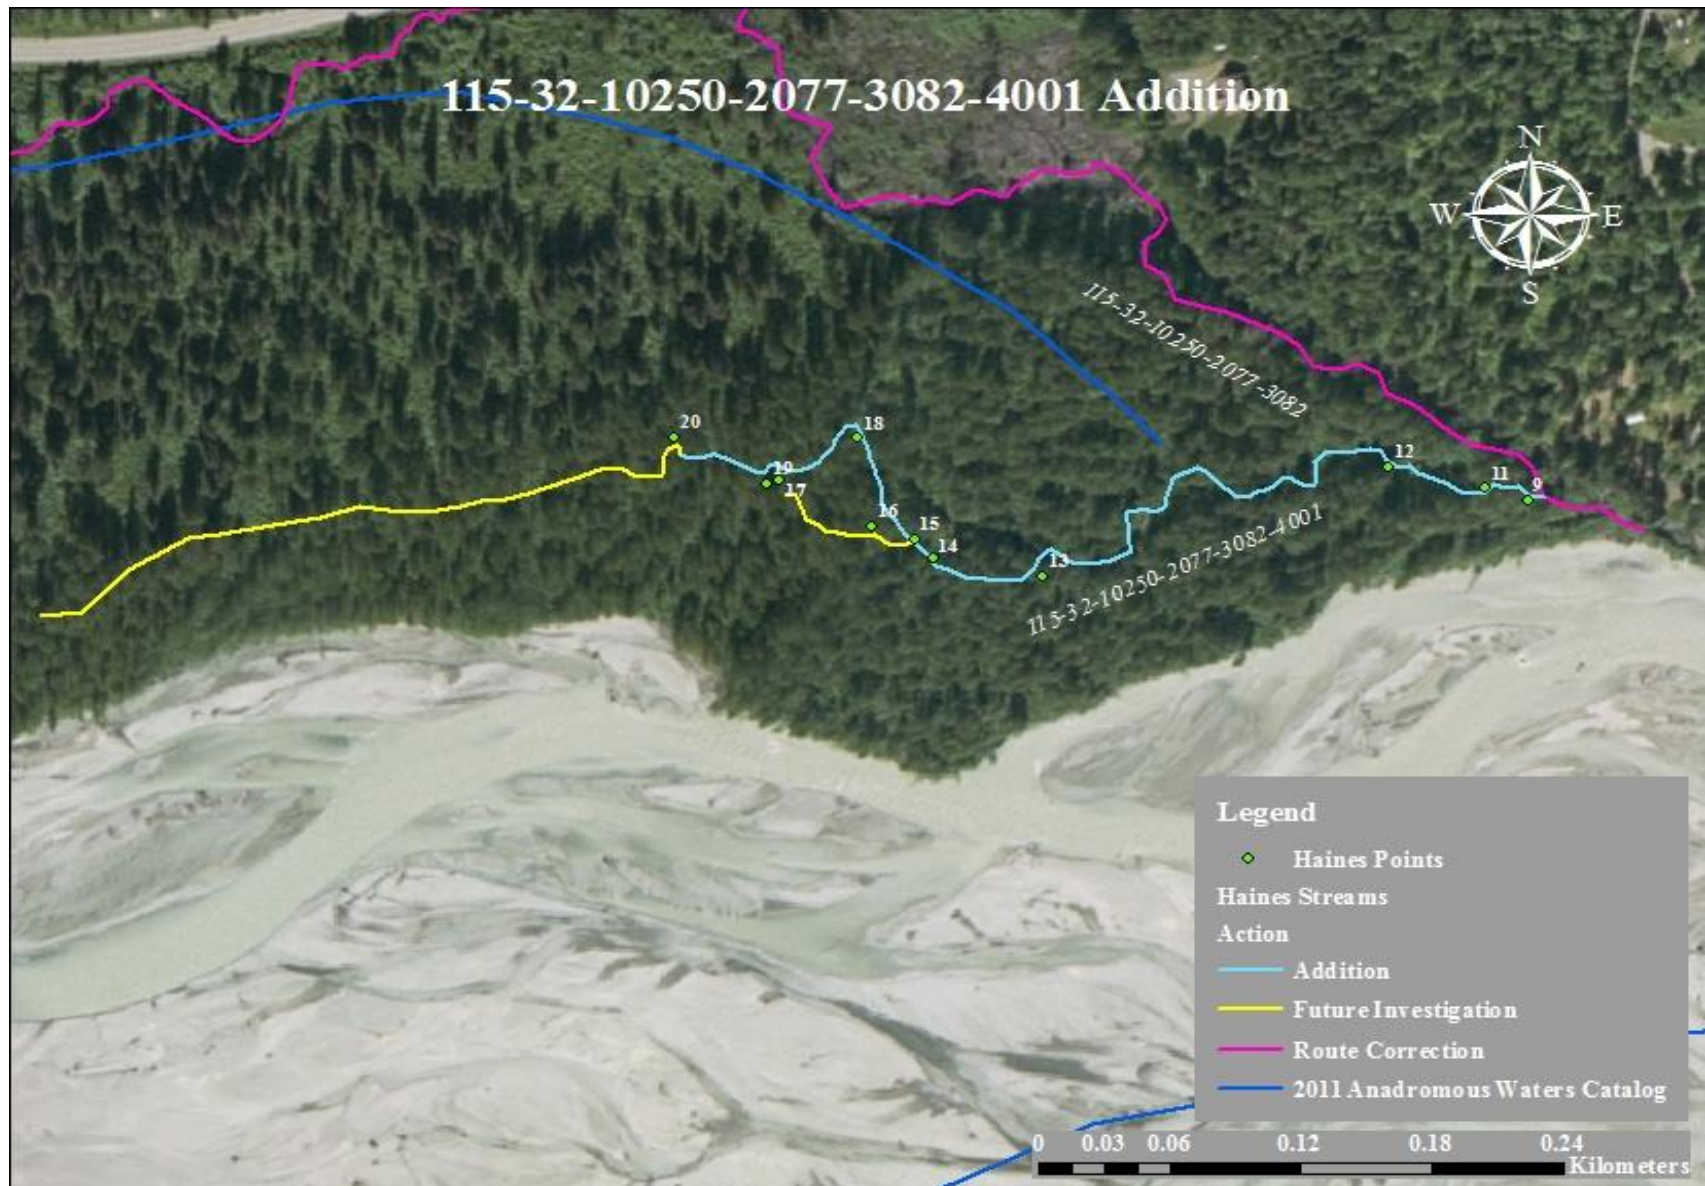
Figure 1.—115-32-10250-2077-3082-4001 addition map.

**Findings:** We surveyed this tributary to 33 Mile Creek using a handnet and a GPS (Table 1). This stream contained adequate flows for rearing fish and is spring fed. It is fed through groundwater seeps originating in the Klehini River flood plain. We found seven dead rearing coho salmon in a dried pool near the stream's source.

**Recommendations:** Add stream to the Anadromous Waters Catalog (Figure 1).

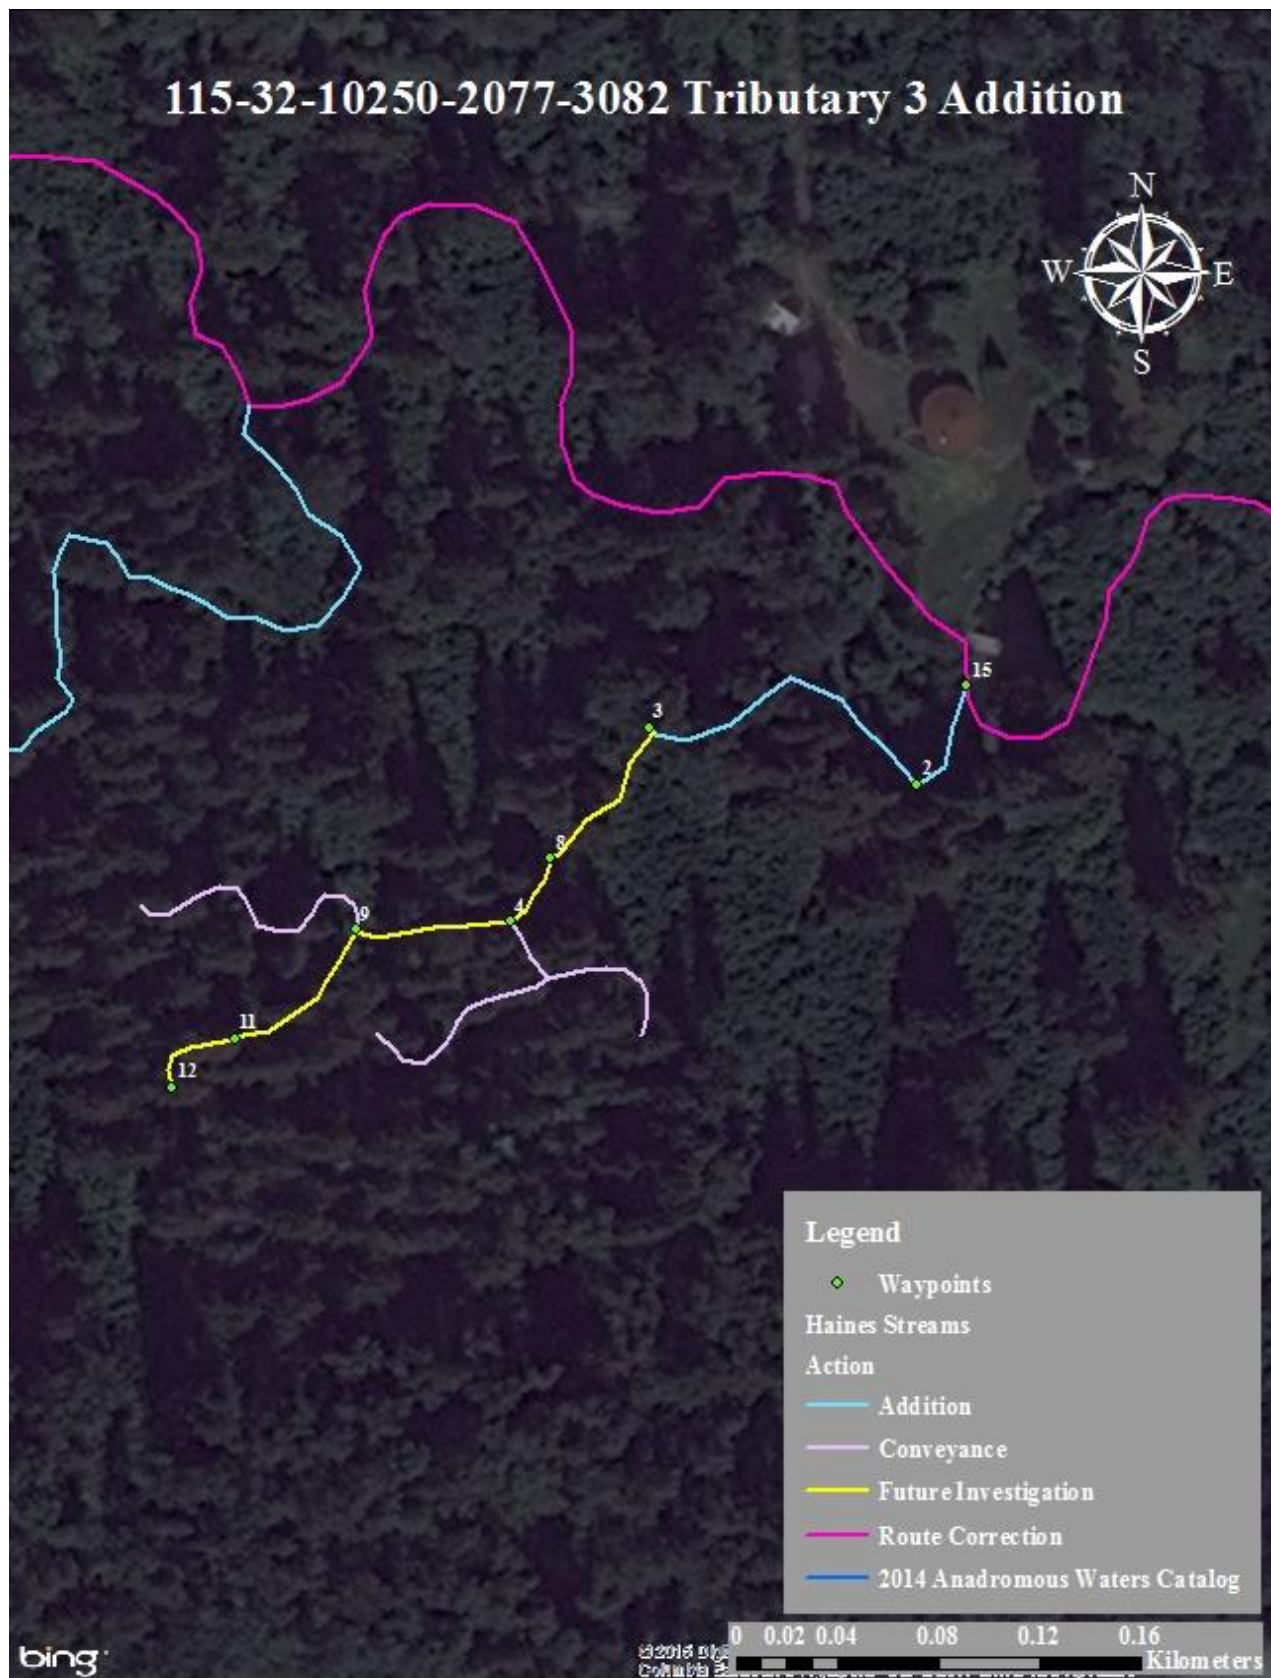
Figure 1.-115-32-10250-2077-3082 tributary 3 addition map.

**115-32-10250-2077-3082 TRIBUTARY 3****ADDITION****Water body name:****Survey date:** 9/23/2011**Water body number:** 115-32-10250-2077-3082 Tributary 3**Species & Lifestage:** COrp**Watershed:** Klehini River**MTR:** C028S054E **Quad:** Skagway B-4**Findings:** This is a small tributary to 33 Mile Creek (Table 1). There was not much flow in this tributary, but found anadromous and resident fish.**Recommendations:** Add stream to the Anadromous Waters Catalog (Figure 1).**Nomination:** 16-534

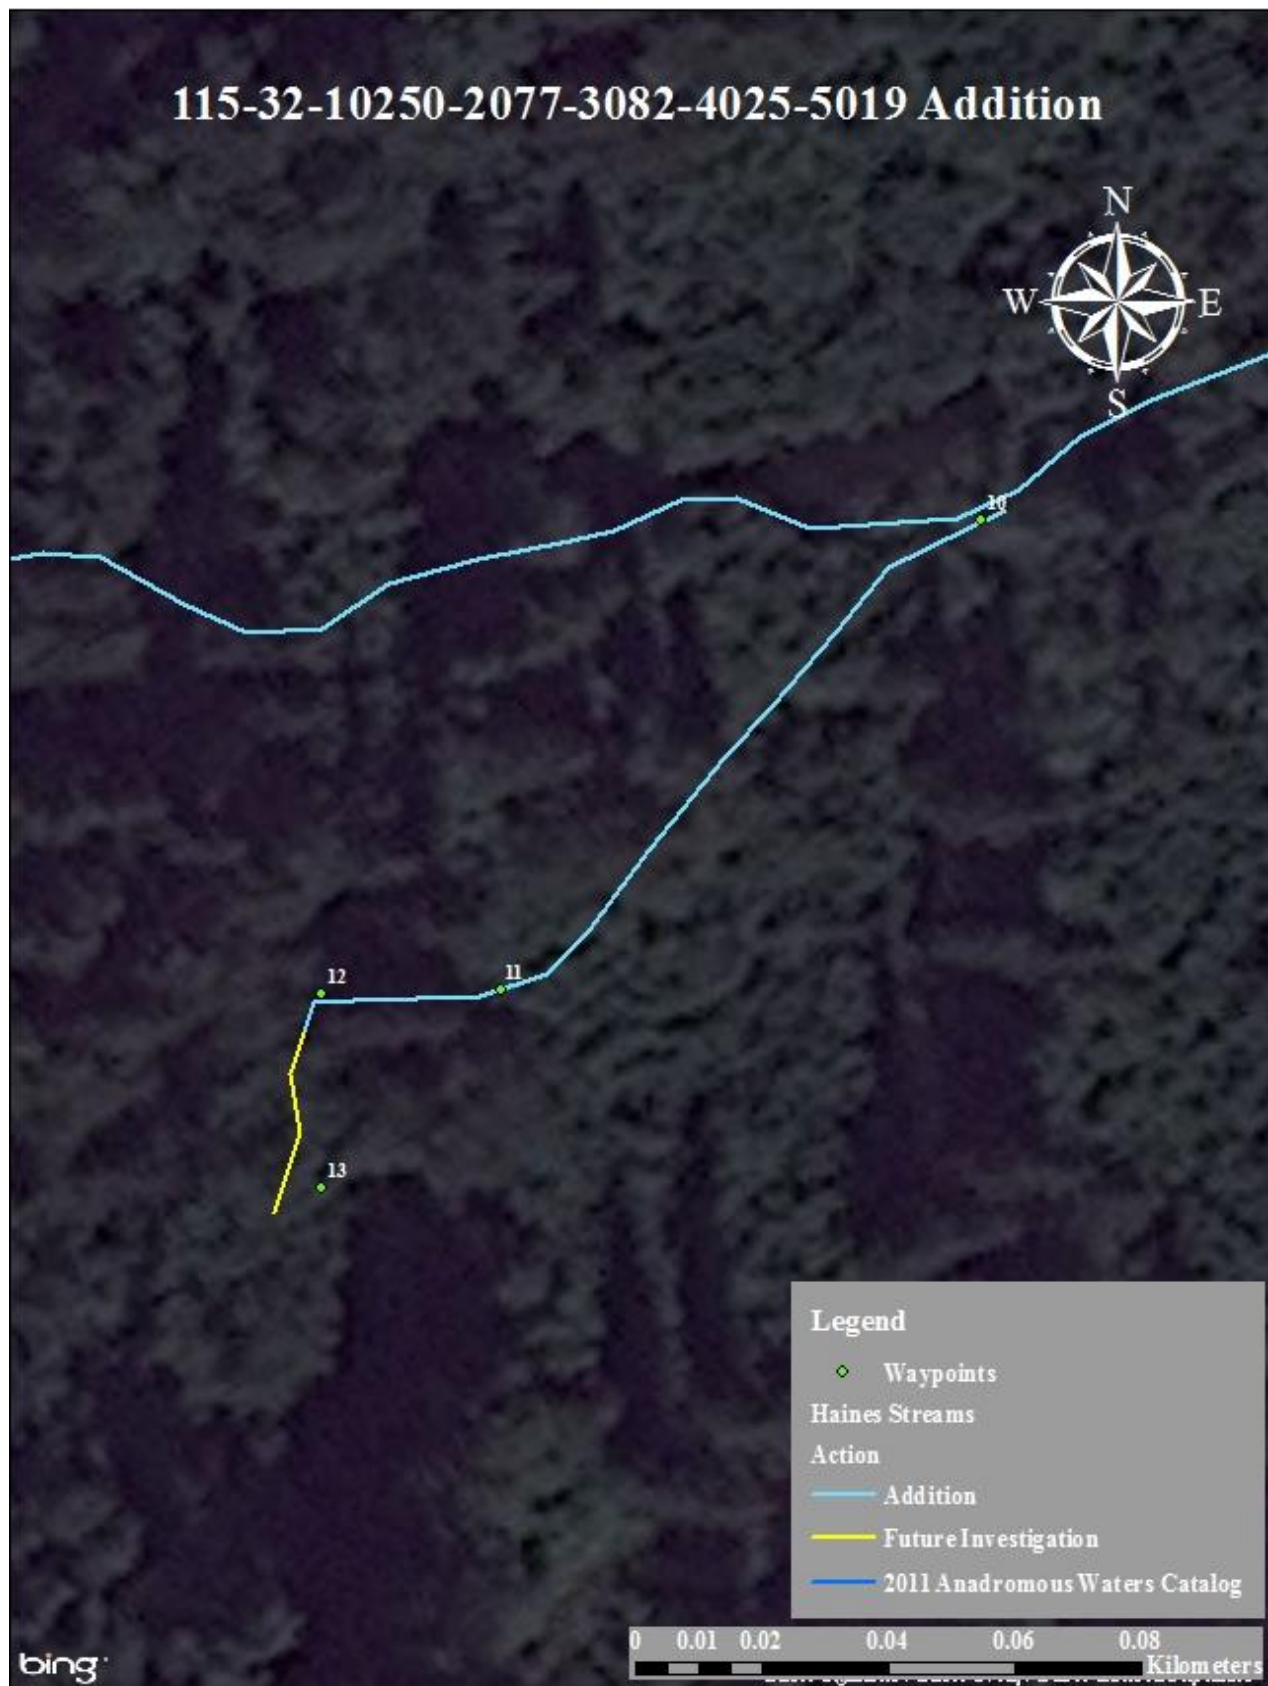
Figure 1.—115-32-10250-2077-3082-4025-5019 addition map.  
Haines

**115-32-10250-2077-3082-4025-5019****ADDITION****Water body name:****Survey date:** 8/2/2011**Water body number:** 115-32-10250-2077-3082-4025-5019**Species & Lifestage:** CO**Watershed:** Klehini River**MTR:** C028S054E **Quad:** Skagway B-4**Findings:** This is a small and short tributary to a tributary to 33 Mile Creek (Table 1). The stream ends by becoming a dry stream channel.**Recommendations:** Add stream to the Anadromous Waters Catalog (Figure 1).**Nomination:** 11-545

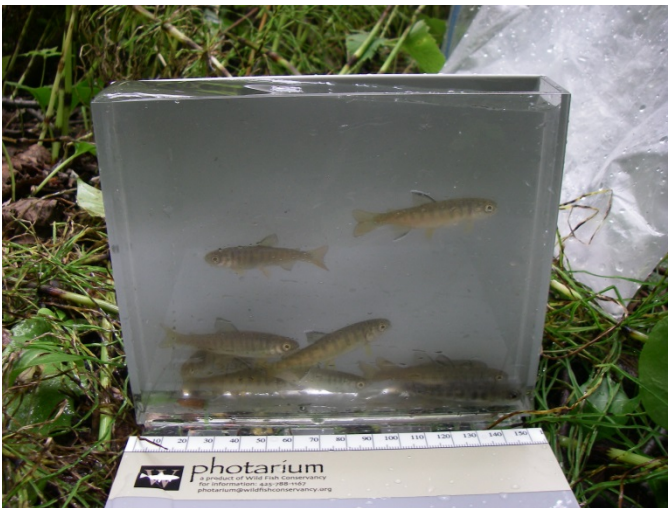
Figure 1.–Coho salmon captured at waypoint 3.

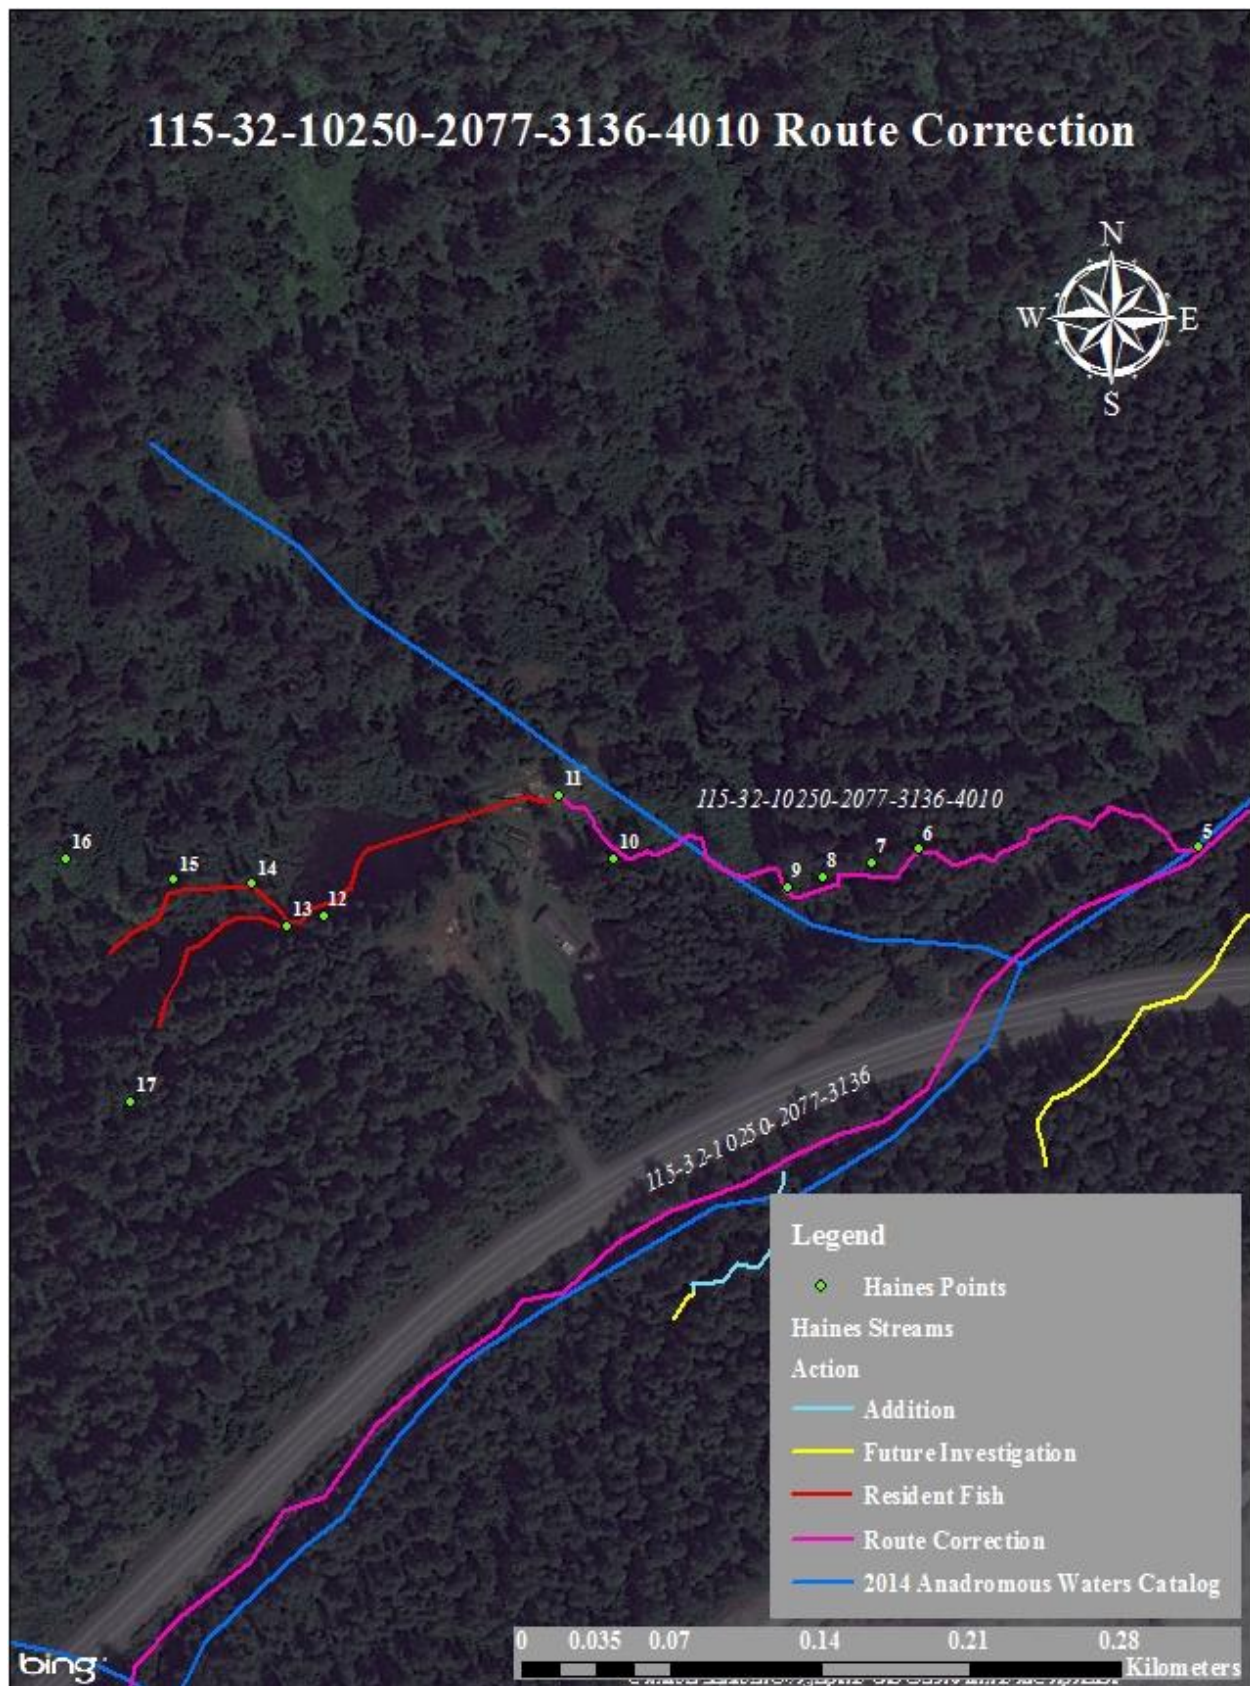
Figure 1.—115-32-10250-2077-3136-4010 route correction map.  
Haines

**Findings:** We surveyed this stream using a backpack electrofisher and a GPS (Table 1). We captured only rearing Dolly Varden char. We found that the stream route is dramatically different than what is currently cataloged.

**Recommendations:** Update this stream to reflect the field verified route (Figure 1).

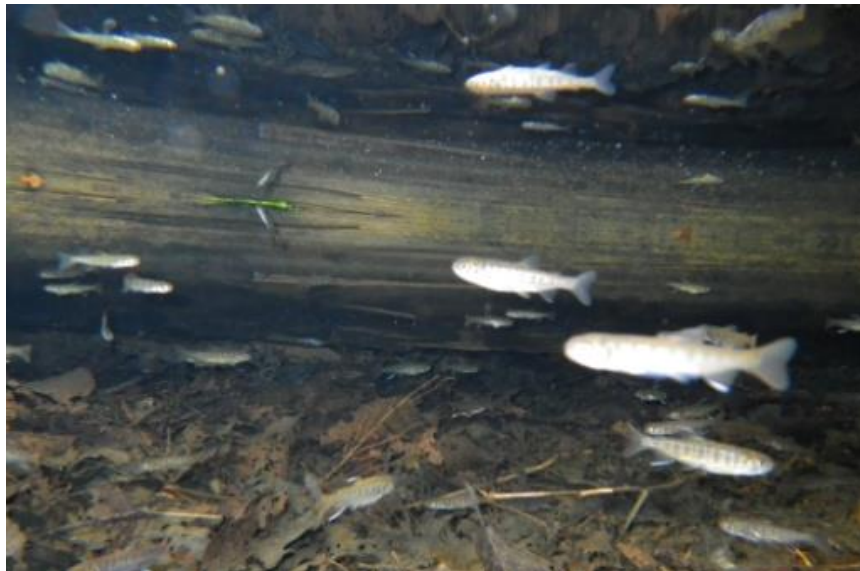
Figure 1.—School of juvenile coho salmon in 37 Mile Creek tributary.

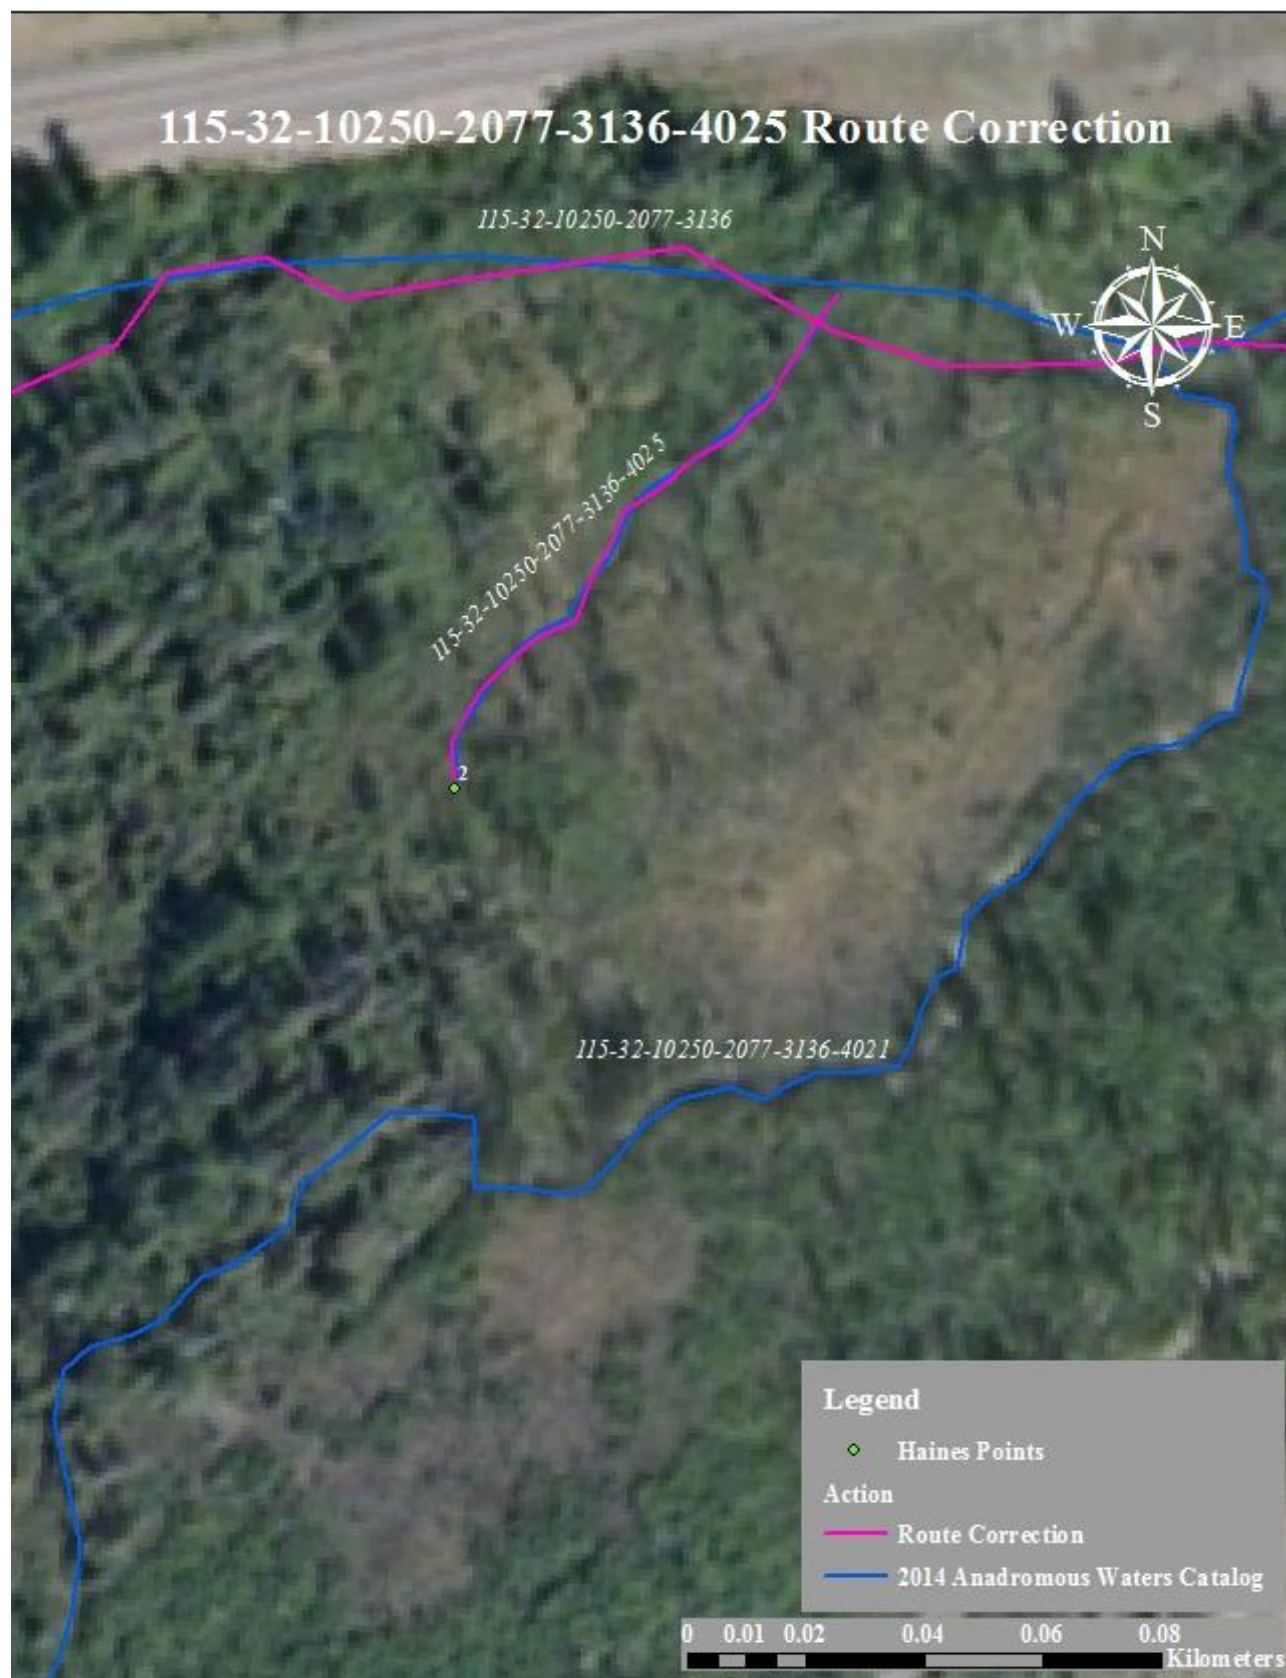
Figure 1.—115-32-10250-2077-3136-4025 correction map.

**Findings:** We conducted a foot survey of this stream and found that stream originates in a spring at a location different from what is cataloged (Table 1).

**Recommendations:** Update this stream to reflect the field verified upper extent (Figure 1).
