# Appendix F: Haines

## Guide to direct fieldwork for cataloging anadromous water bodies in Southeast Alaska

## HAINES STREAM SURVEYS

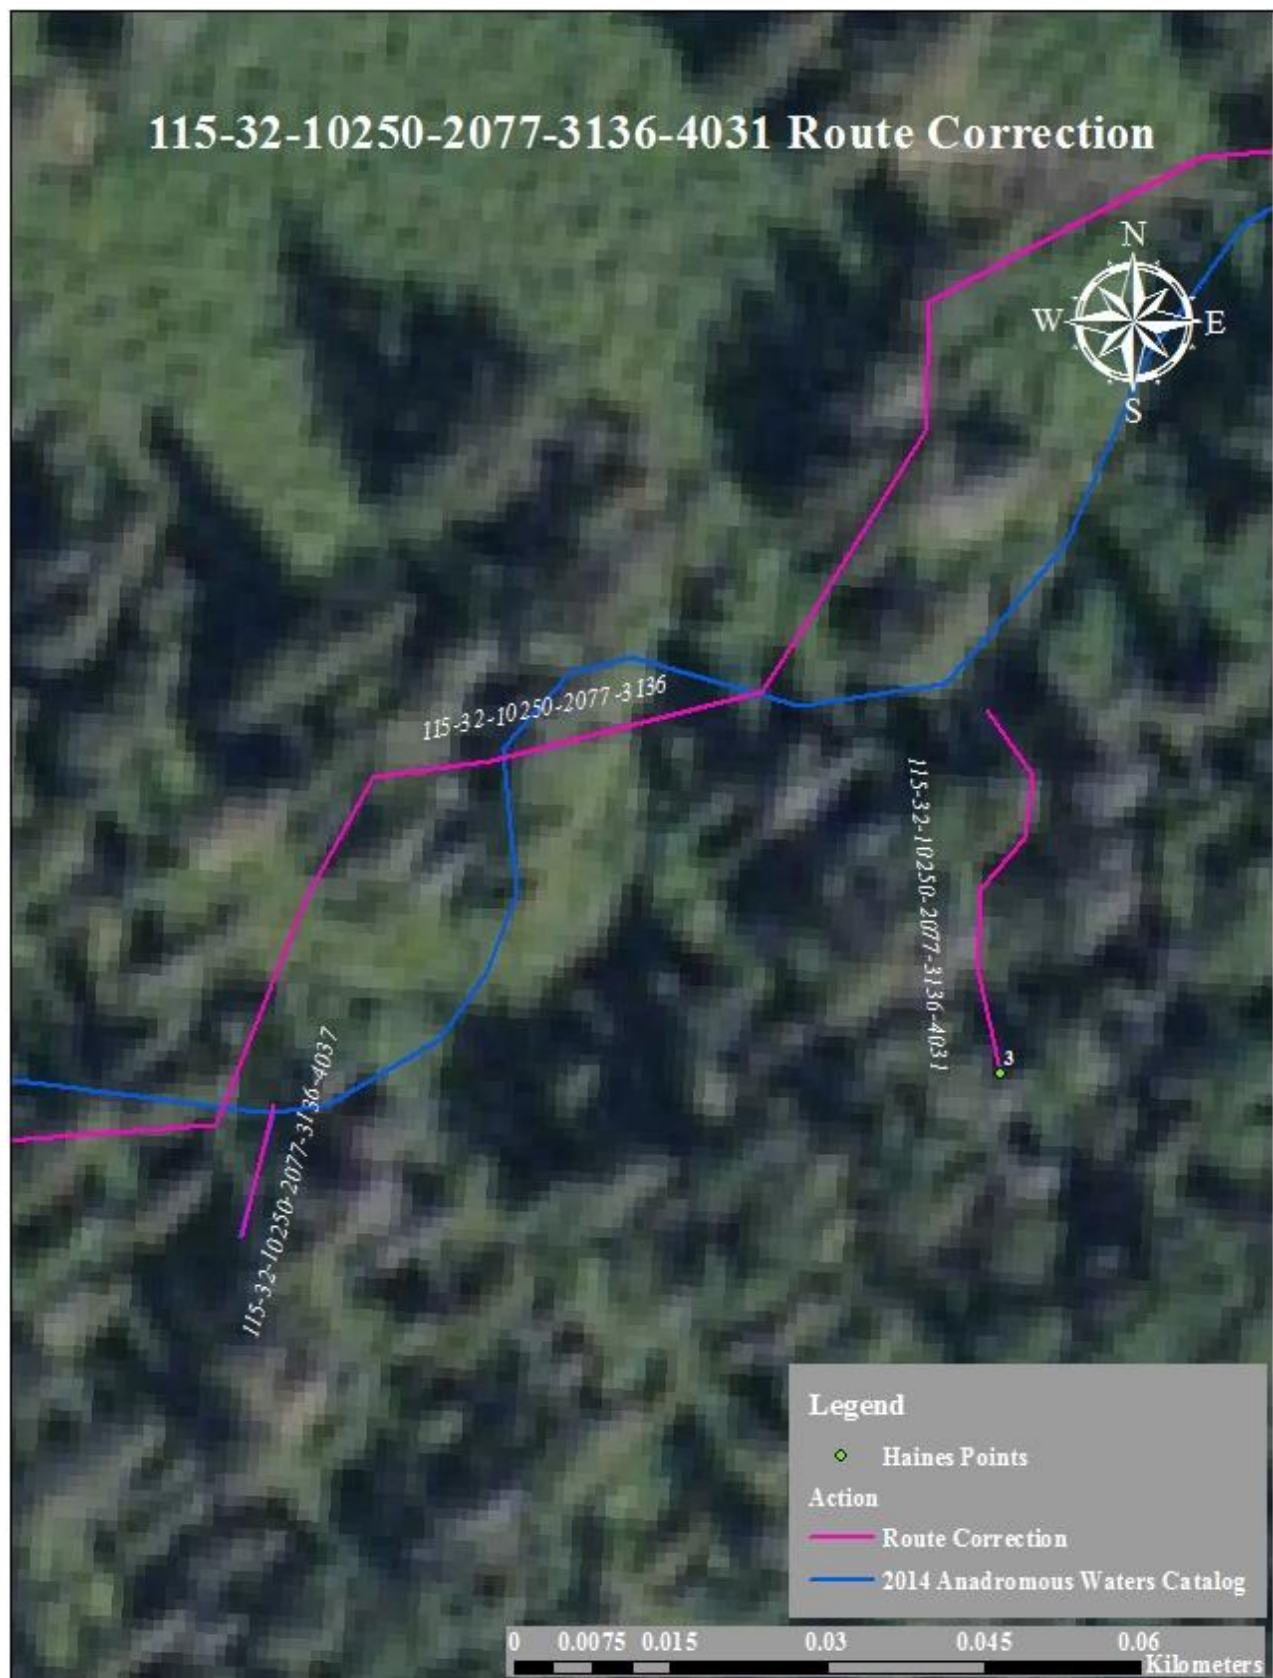
Figure 1.-115-32-10250-2077-3136-4031 route correction map.

**Findings:** We conducted a foot survey of this stream and found that it originates in a spring at a point different from what is cataloged (Table 1).

**Recommendations:** Update this stream to reflect the field verified upper extent (Figure 1).

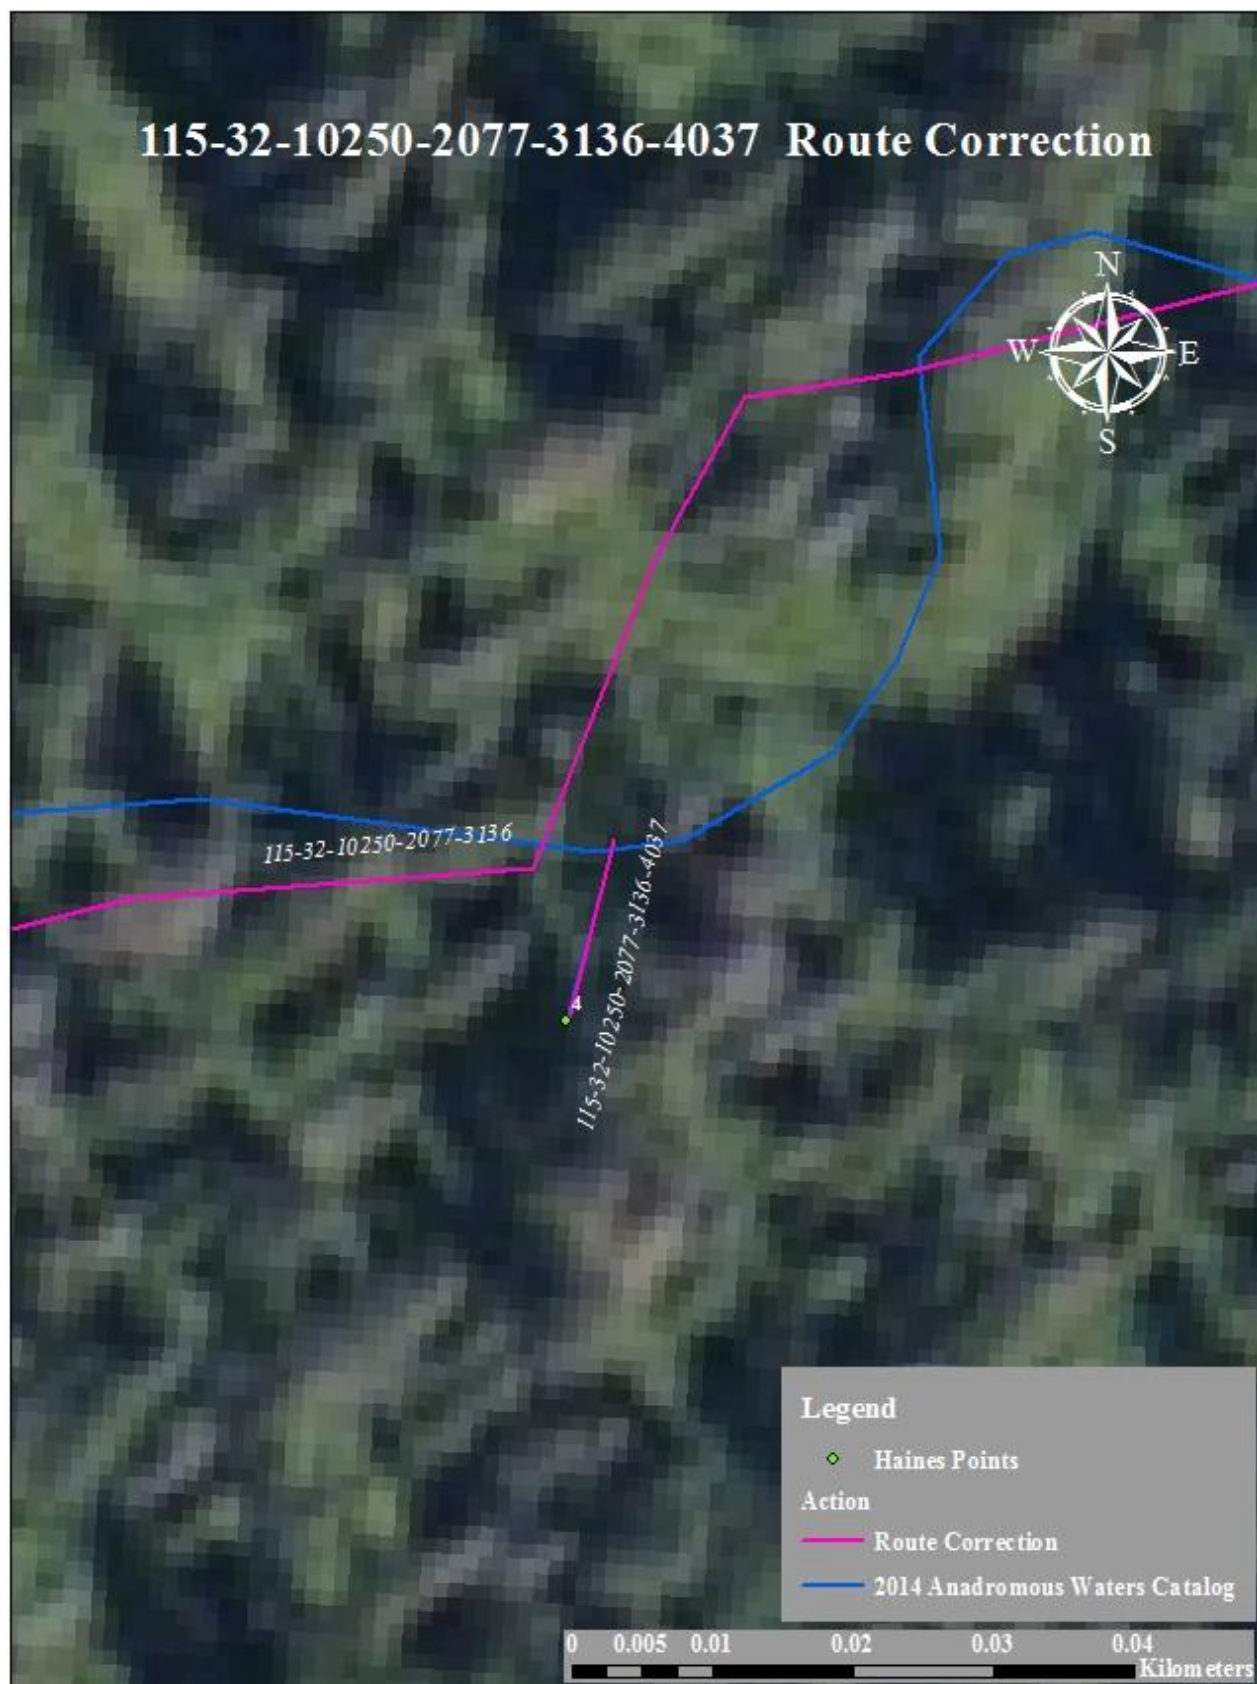
Figure 1.—115-32-10250-2077-3136-4037 route correction map.  
Haines

**Findings:** We conducted a foot survey of this stream and found that it originates in a spring at a point different from what is cataloged (Table 1).

**Recommendations:** Update this stream's upper point to reflect the field verified location (Figure 1).

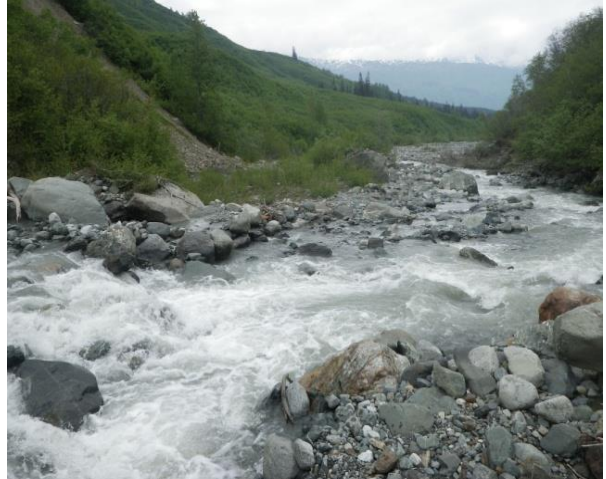
Figure 2.—Glacier Creek at in area of small cascades near WPT #429.

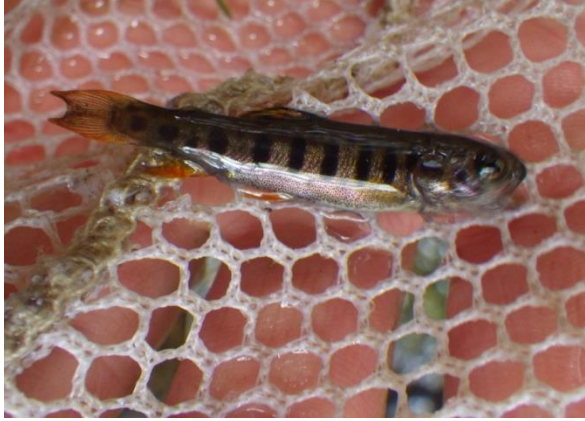
**Findings:** We surveyed this stream using a backpack electrofisher, minnow traps, and a GPS (Table 1). We captured Dolly Varden char, cutthroat trout, and coho salmon (Figure 1). We observed an old culvert beneath an overgrown road that did not block fish passage (Figure 2). The stream contains deep pools, and gravel substrates (Figure 3).

Figure 1.—Coho salmon captured while electrofishing.

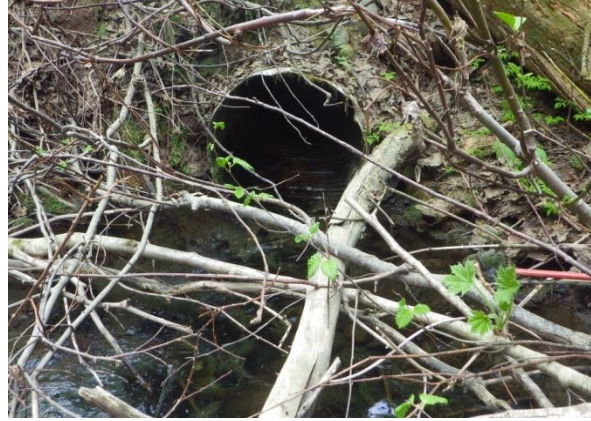
Figure 2.—Culvert under overgrown road.

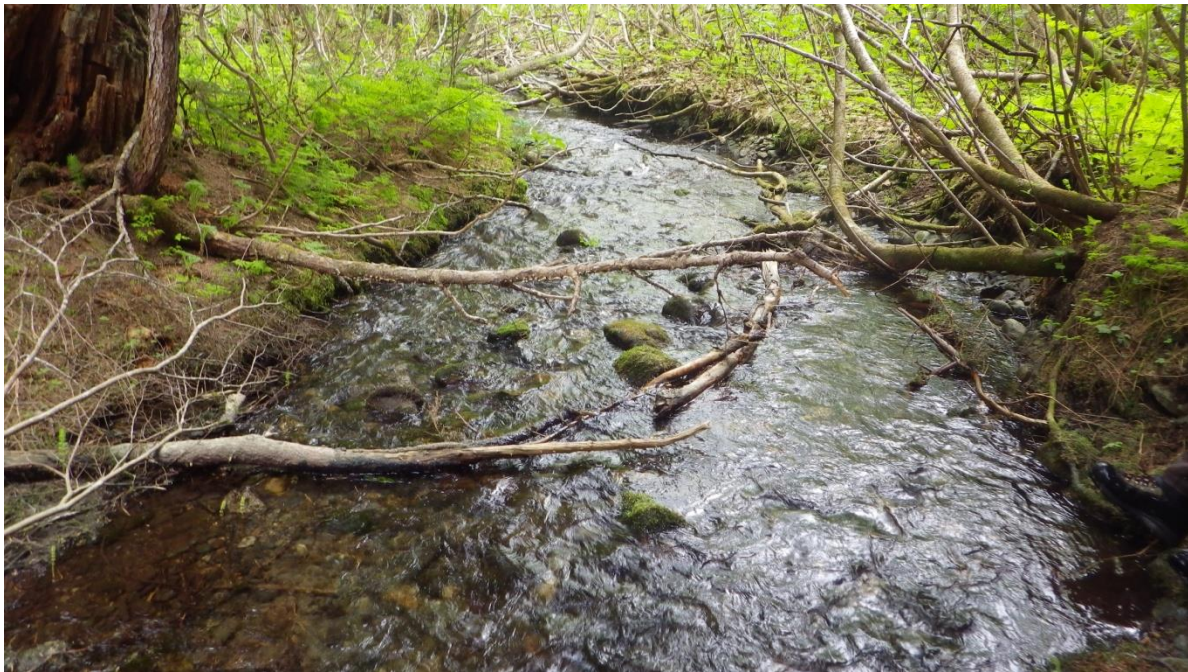
Figure 3.—Gravel reach of stream number 115-32-10250-2077-3151-4010.

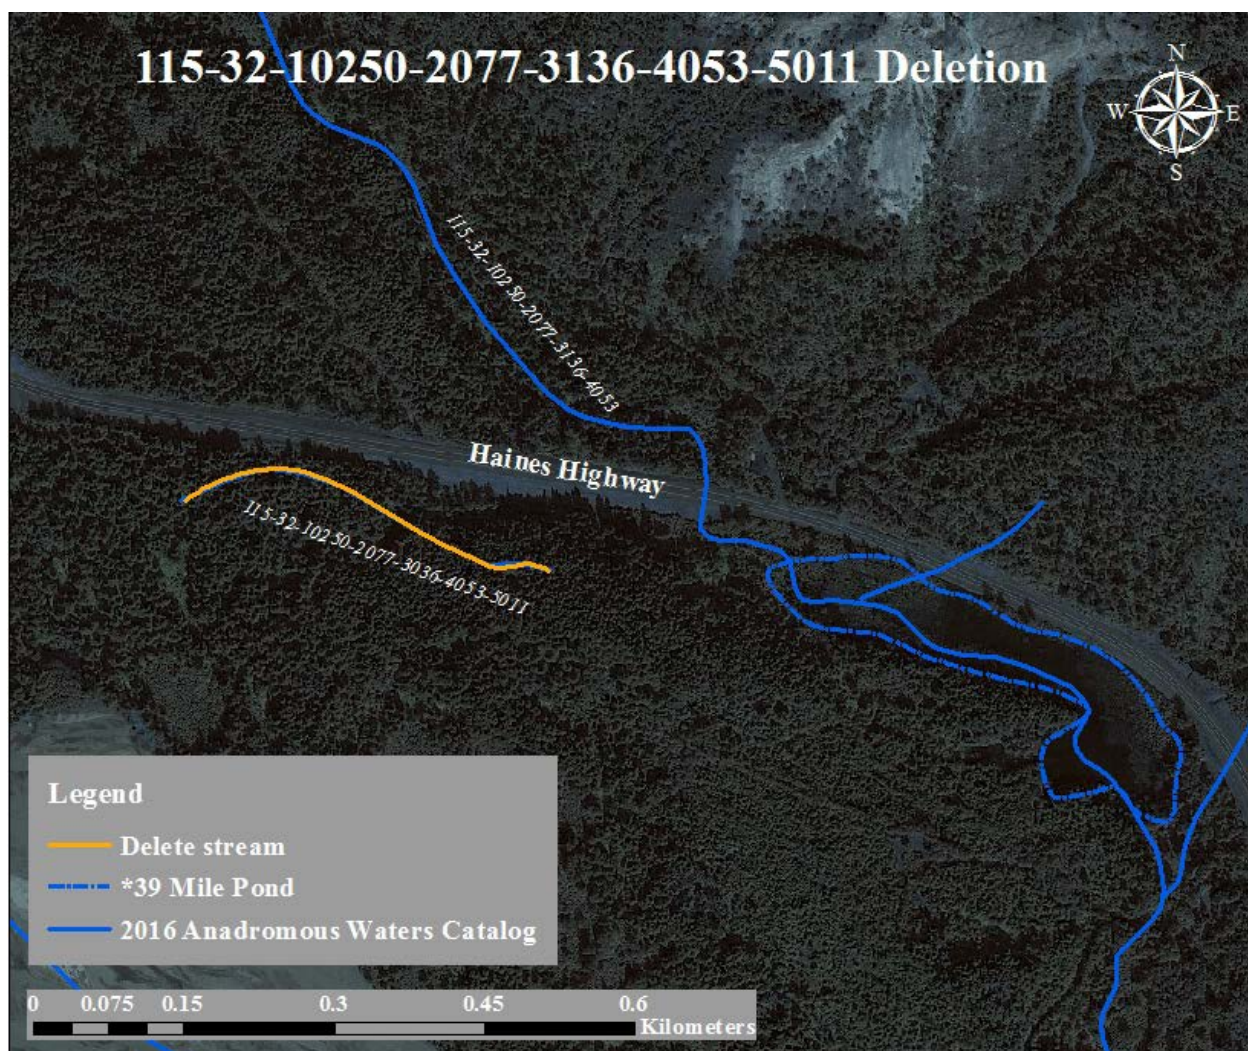
Figure 1.—115-32-10250-2077-3136-4053-5011 deletion map.

**Findings:** I surveyed the area on 6/8/2016 and observed a swale backwatered by 39 Mile Pond (Stream No. 115-32-10250-2077-3136-4053-0010) adjacent to Haines Highway. The existing stream arc is about 100 m offset and west of the swale. Rich Chapell (Haines Sport Fish Area Management Biologist) also surveyed the area on 7/7/2016 and did not find a stream. Since backwaters of cataloged streams (39 Mile Pond) are included in the AWC by the regulatory definition of *stream*, the swale is not eligible for listing in the AWC.

**Recommendations:** Delete stream in the AWC (Figure 1).

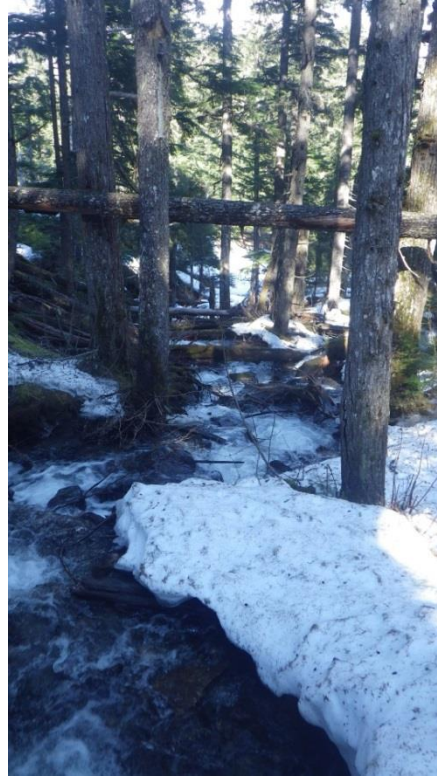
Figure 2.—Looking downstream from the top of the steep channel barrier on Sarah Creek.

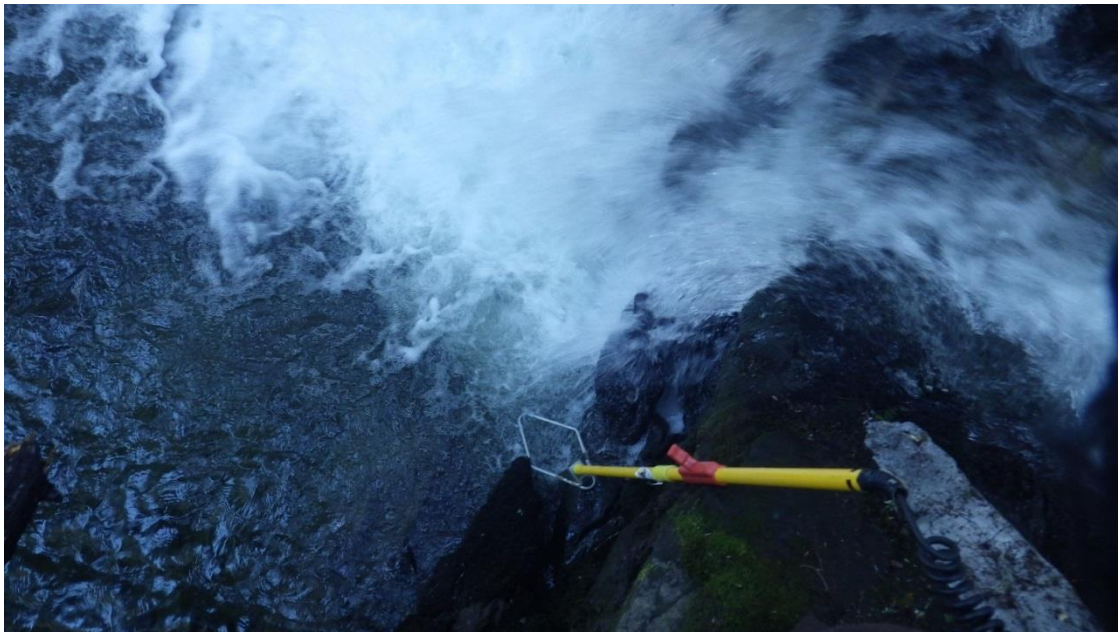
Figure 3.—A 5' falls with no jump pool within the steep channel barrier on Sarah Creek.

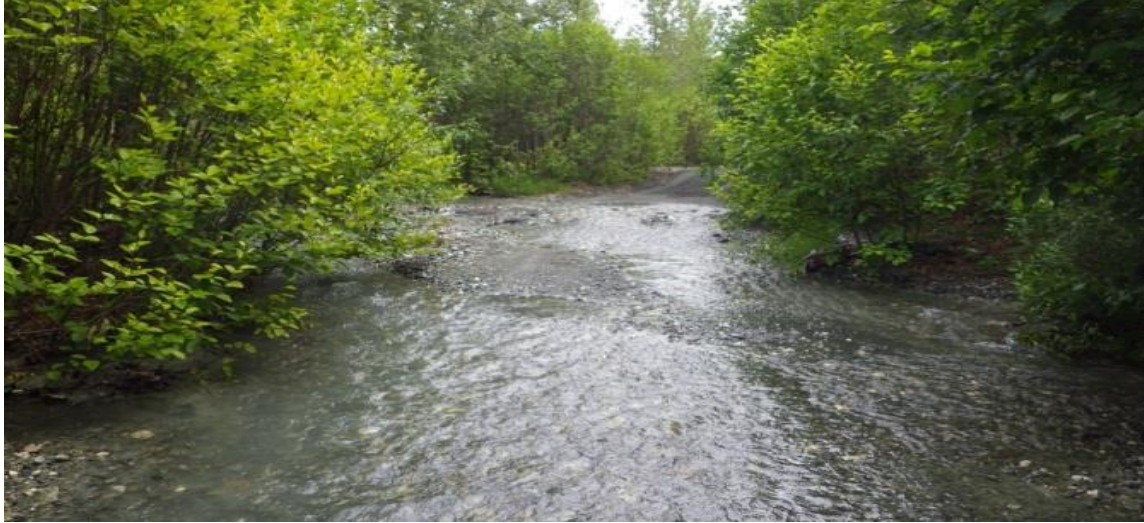
Figure 1.–Looking downstream at 115-32-10250-2078 where it crosses a road at WPT #50.

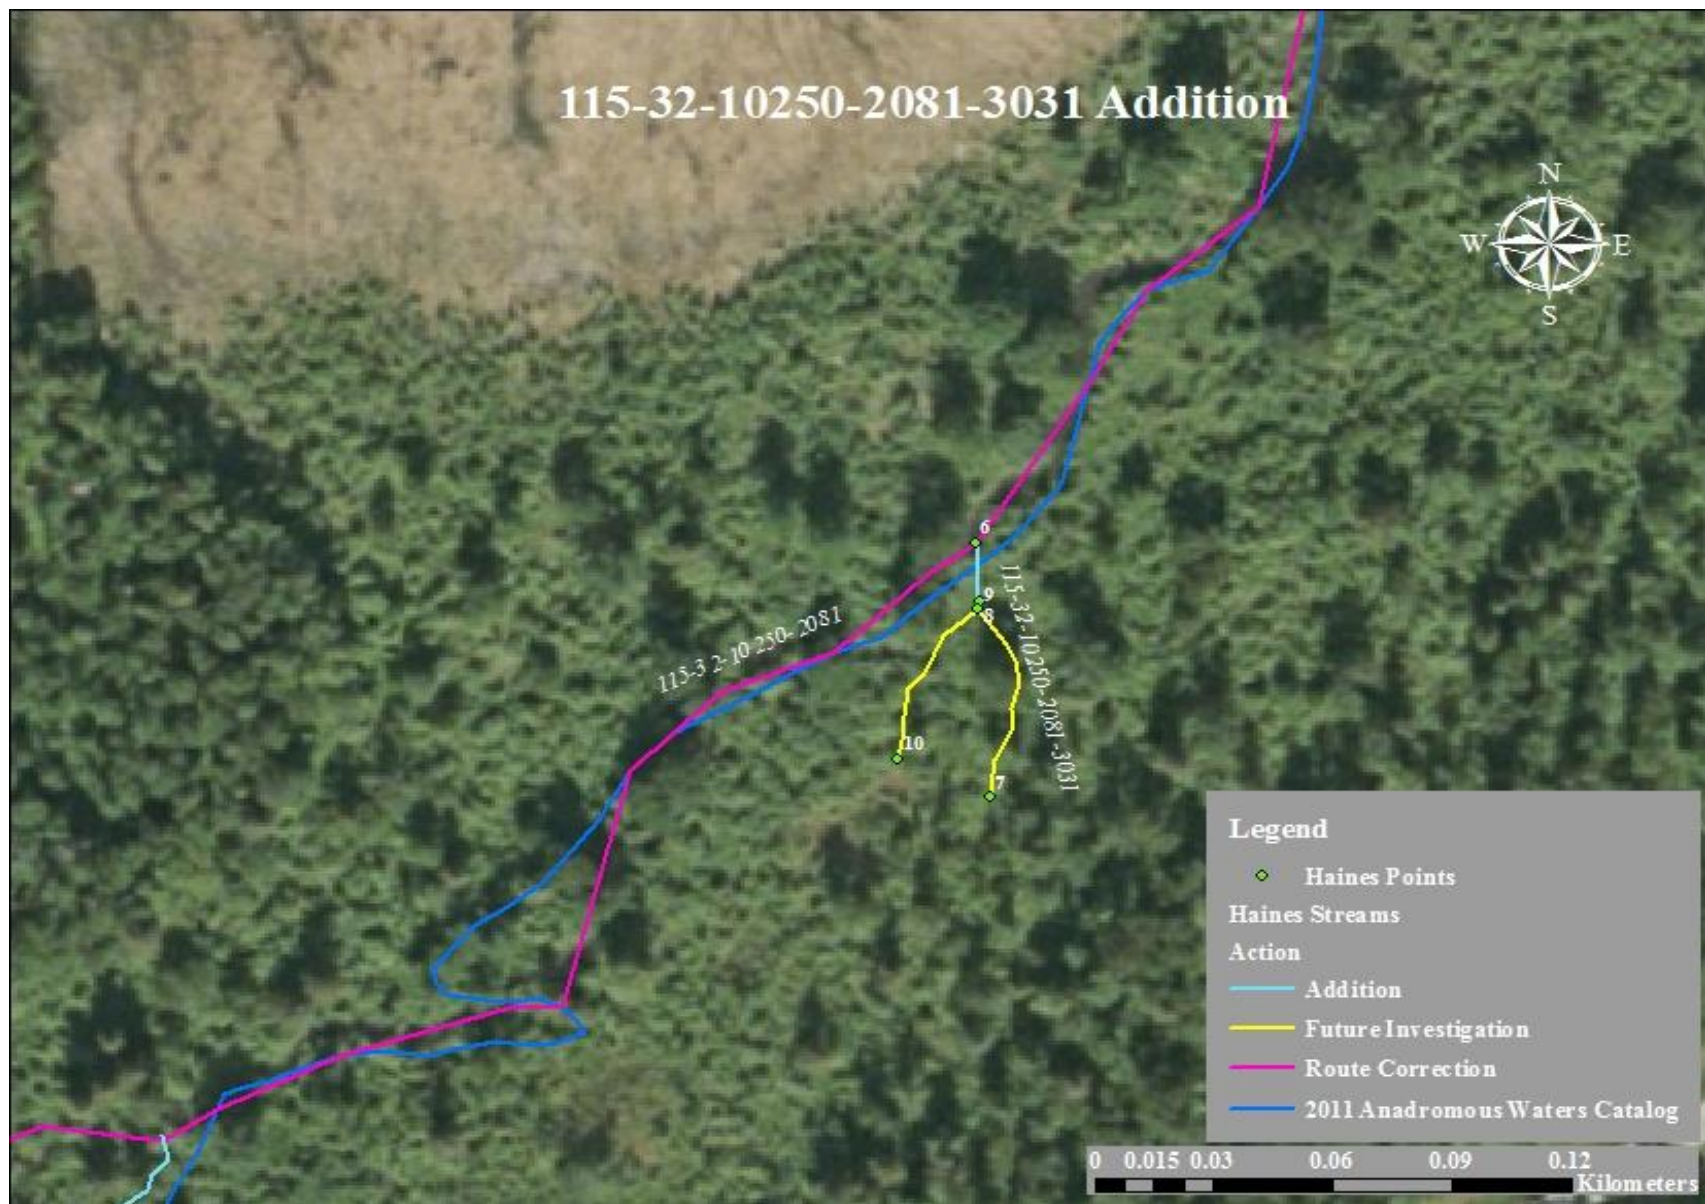
Figure 1.-115-32-10250-2081-3031 addition map.

**115-32-10250-2081-3031****ADDITION****Water body name:****Survey date:** 8/9/2012**Water body number:** 115-32-10250-2081-3031**Species & Lifestage:** CO**Watershed:** Kelsall River-Chilkat River**MTR:** C028S056E **Quad:** Skagway B-3**Findings:** We surveyed this stream using a backpack electrofisher and a GPS (Table 1). We captured rearing coho salmon mid-way up the stream.**Recommendations:** Add stream to the Anadromous Waters Catalog (Figure 1).**Nomination:** 12-597

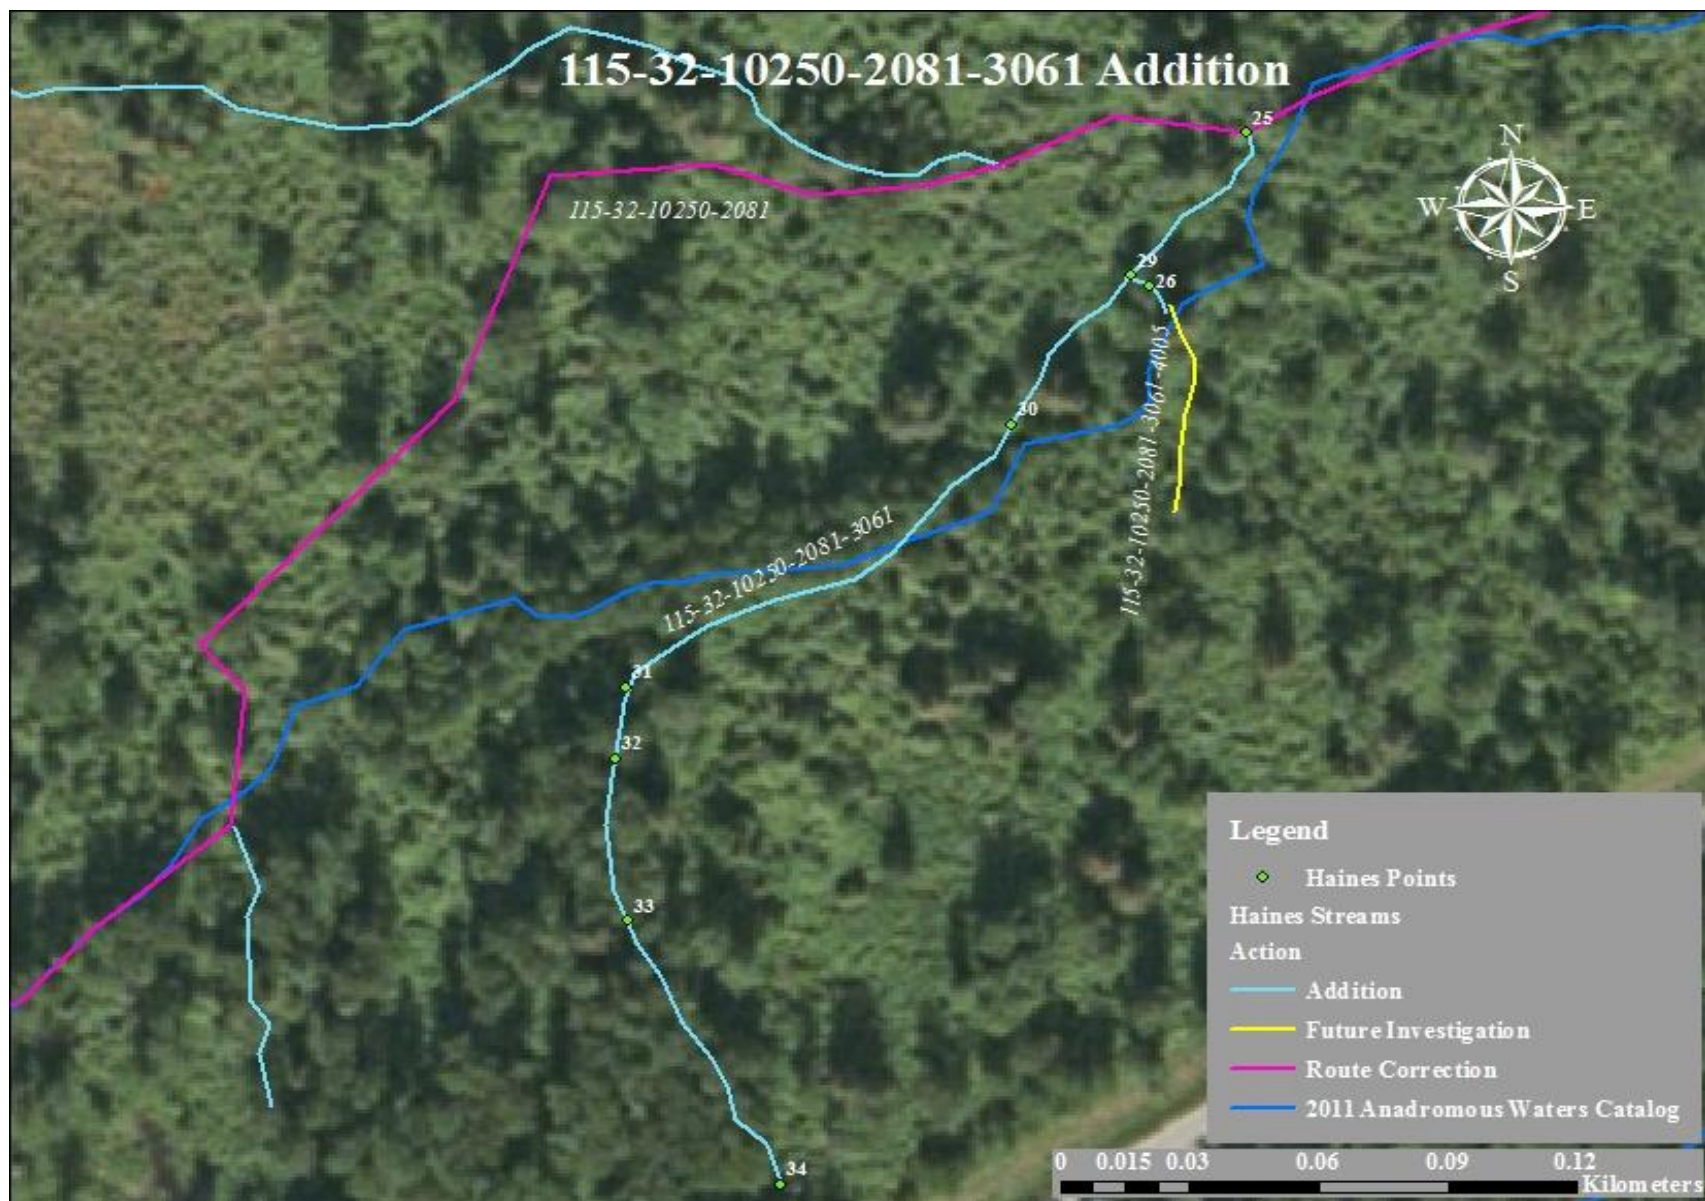
Figure 1.-115-32-10250-2081-3061 addition map.

**Findings:** We surveyed this stream Muskrat Creek using a backpack electrofisher and a GPS (Table 1). We found sockeye salmon spawning in the lower portion and rearing coho salmon near the top of this stream that ends adjacent to the Haines Highway.

**Recommendations:** Add stream to the Anadromous Waters Catalog (Figure 1).

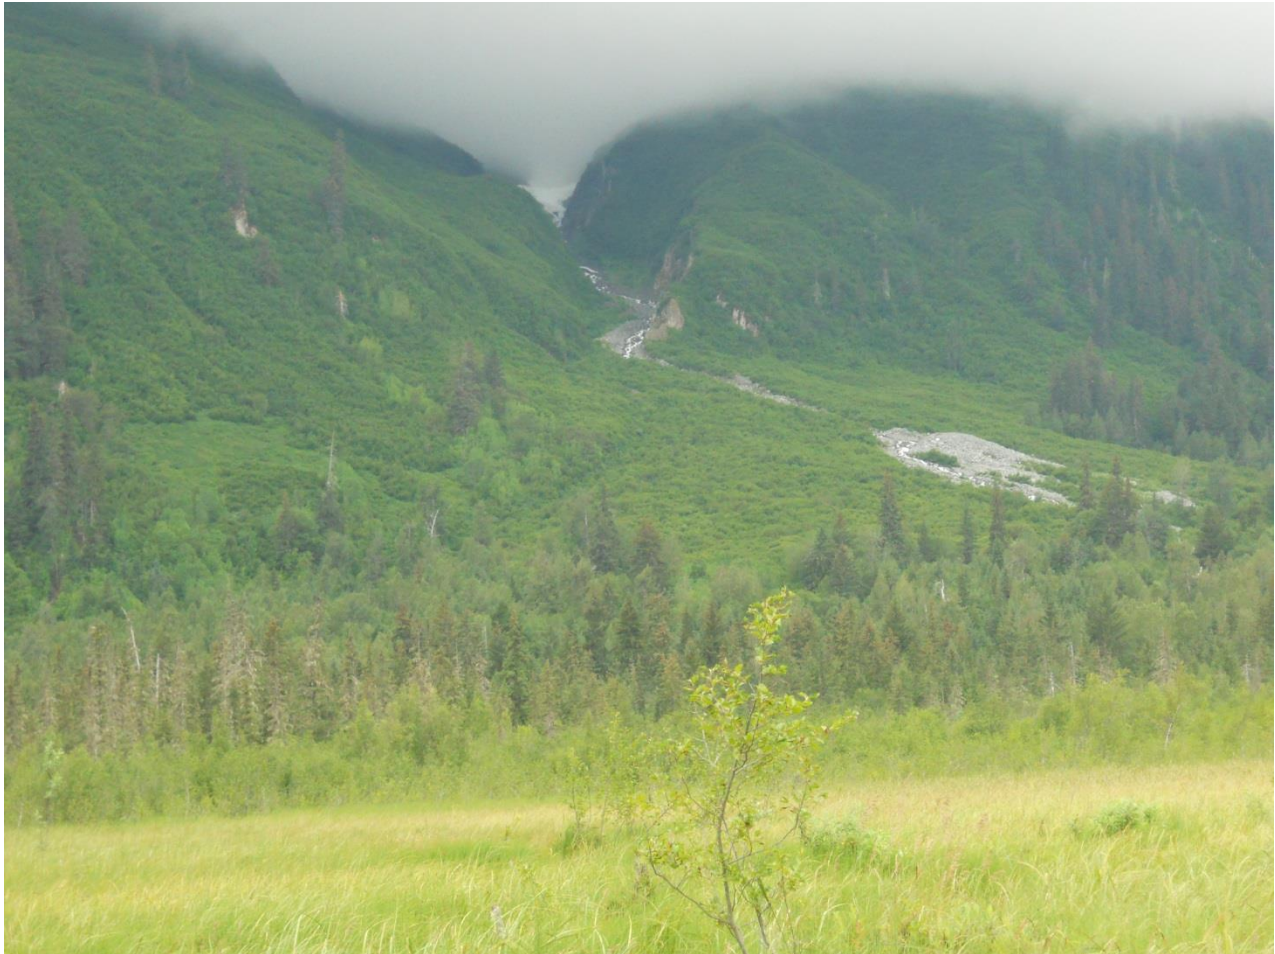
**Findings:** We surveyed this stream using a handnet and a GPS (Table 1). We visually observed sockeye salmon and captured coho salmon, Dolly Varden char and cutthroat trout. This stream is much more sinuous than the catalog illustrates and is glacial (Figure 1).

Figure 1.–Looking up towards the glacier that feeds stream number 115-32-10250-2137-3025.

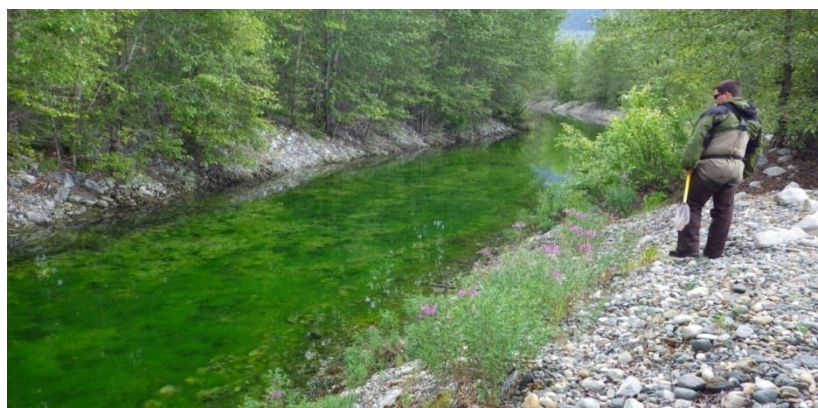
Figure 1.—Representative reach of spawning channel.

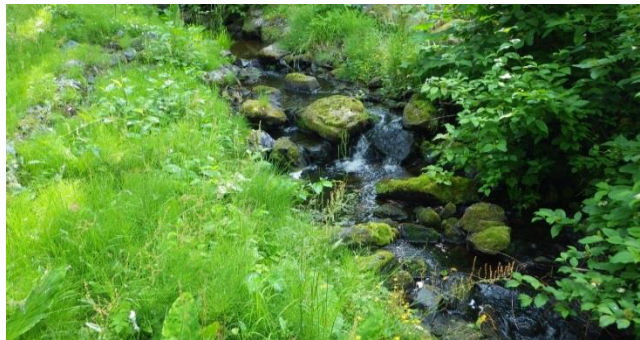
Figure 1.–Man-made rock fish ladder.

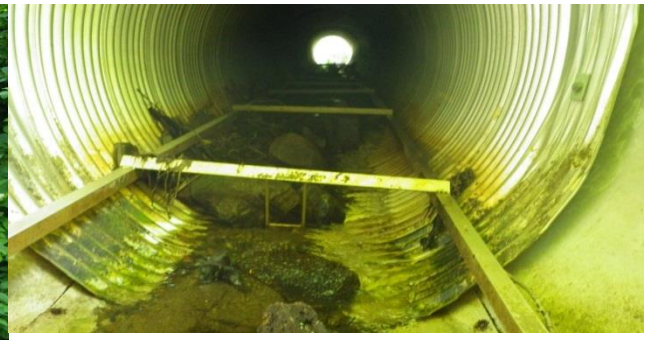
Figure 2.–Culvert beneath Mud Bay Road with fish passage modifications.

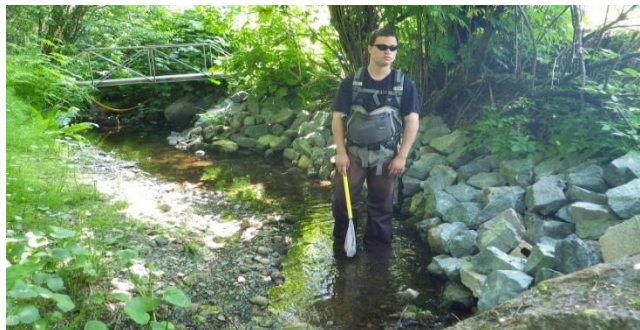
Figure 3.–Residential rock revetment to prevent stream bank erosion.

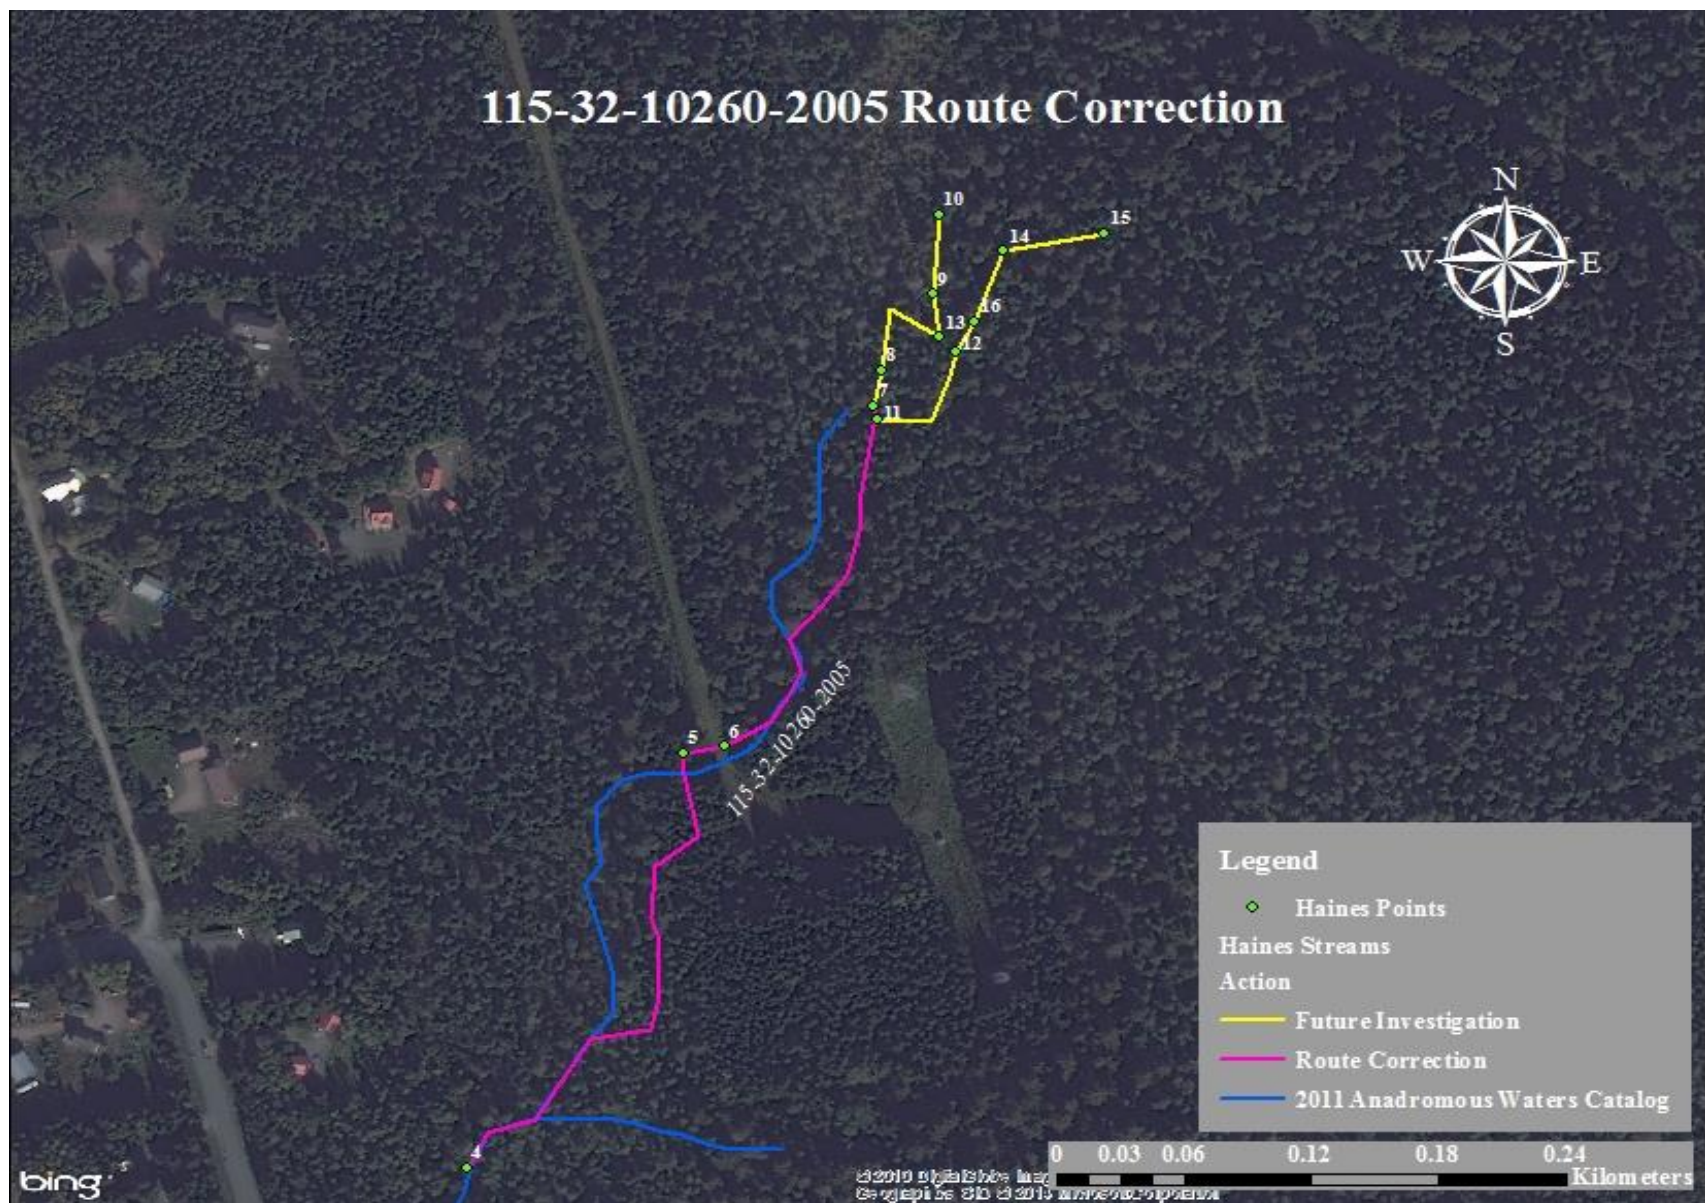
Figure 1.-115-32-10260-2005 route correction.

**Findings:** Holgate Creek was surveyed to determine route accuracy and upper extent (Table 1). Fish were observed visually throughout the system, but no trapping events yielded any fish. The habitat was ideal for rearing and substrate varied between muddy organics and large mossy cobbles.

**Recommendations:** Correct the current route in the Anadromous Waters Catalog (Figure 1).

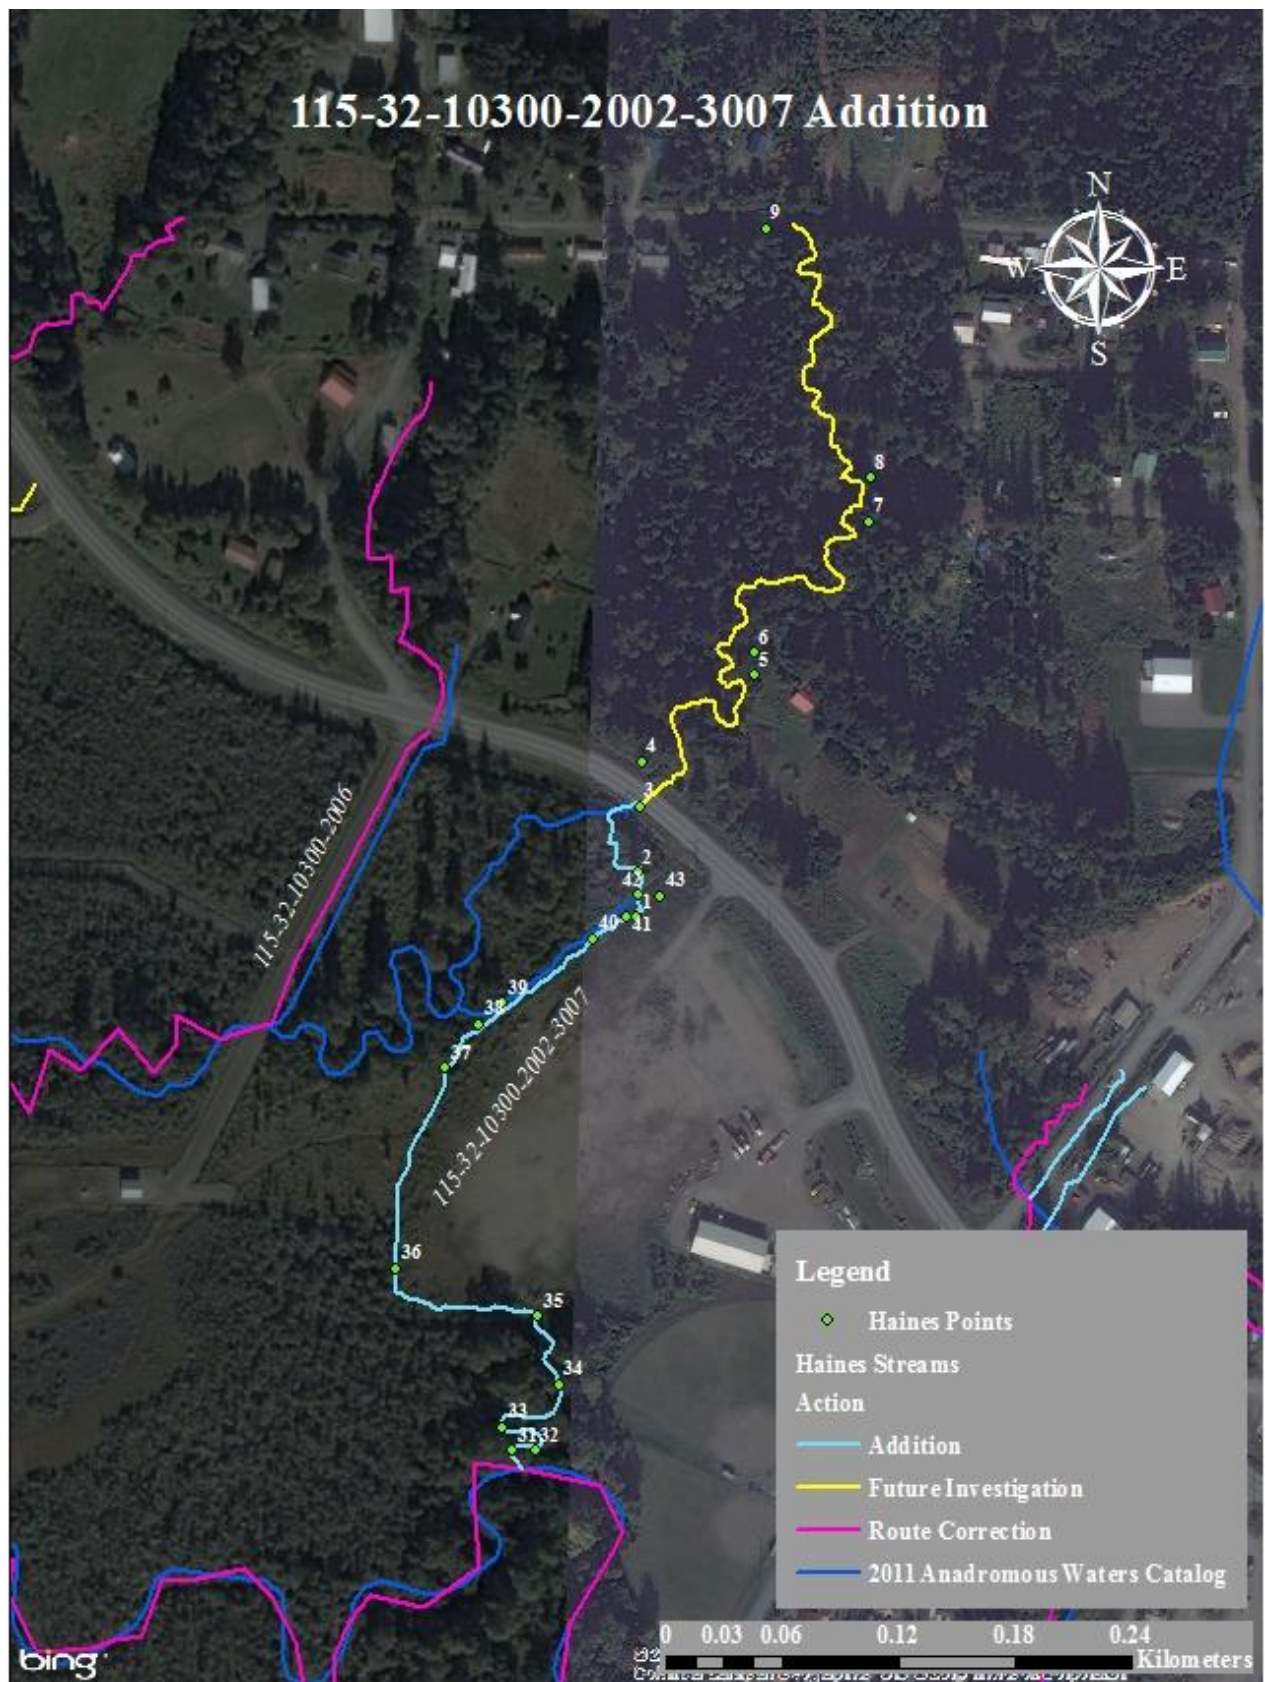
Figure 2.—115-32-10300-2002-3007 addition map.

**Findings:** We surveyed this tributary to Sawmill Creek using a handnet and a GPS (Table 1). After meandering through a forested area, the stream crosses the highway and runs along the side of a gravel lot. The area associated with the gravel lot is highly altered by recent development. Numerous coho salmon were found in the area (Figure 1); we also found one large (300+mm) dead cutthroat trout.

**Recommendations:** Add stream to the Anadromous Waters Catalog. It would be beneficial to collaborate with property owners on adjacent gravel to ensure future protection of this stream (Figure 2).

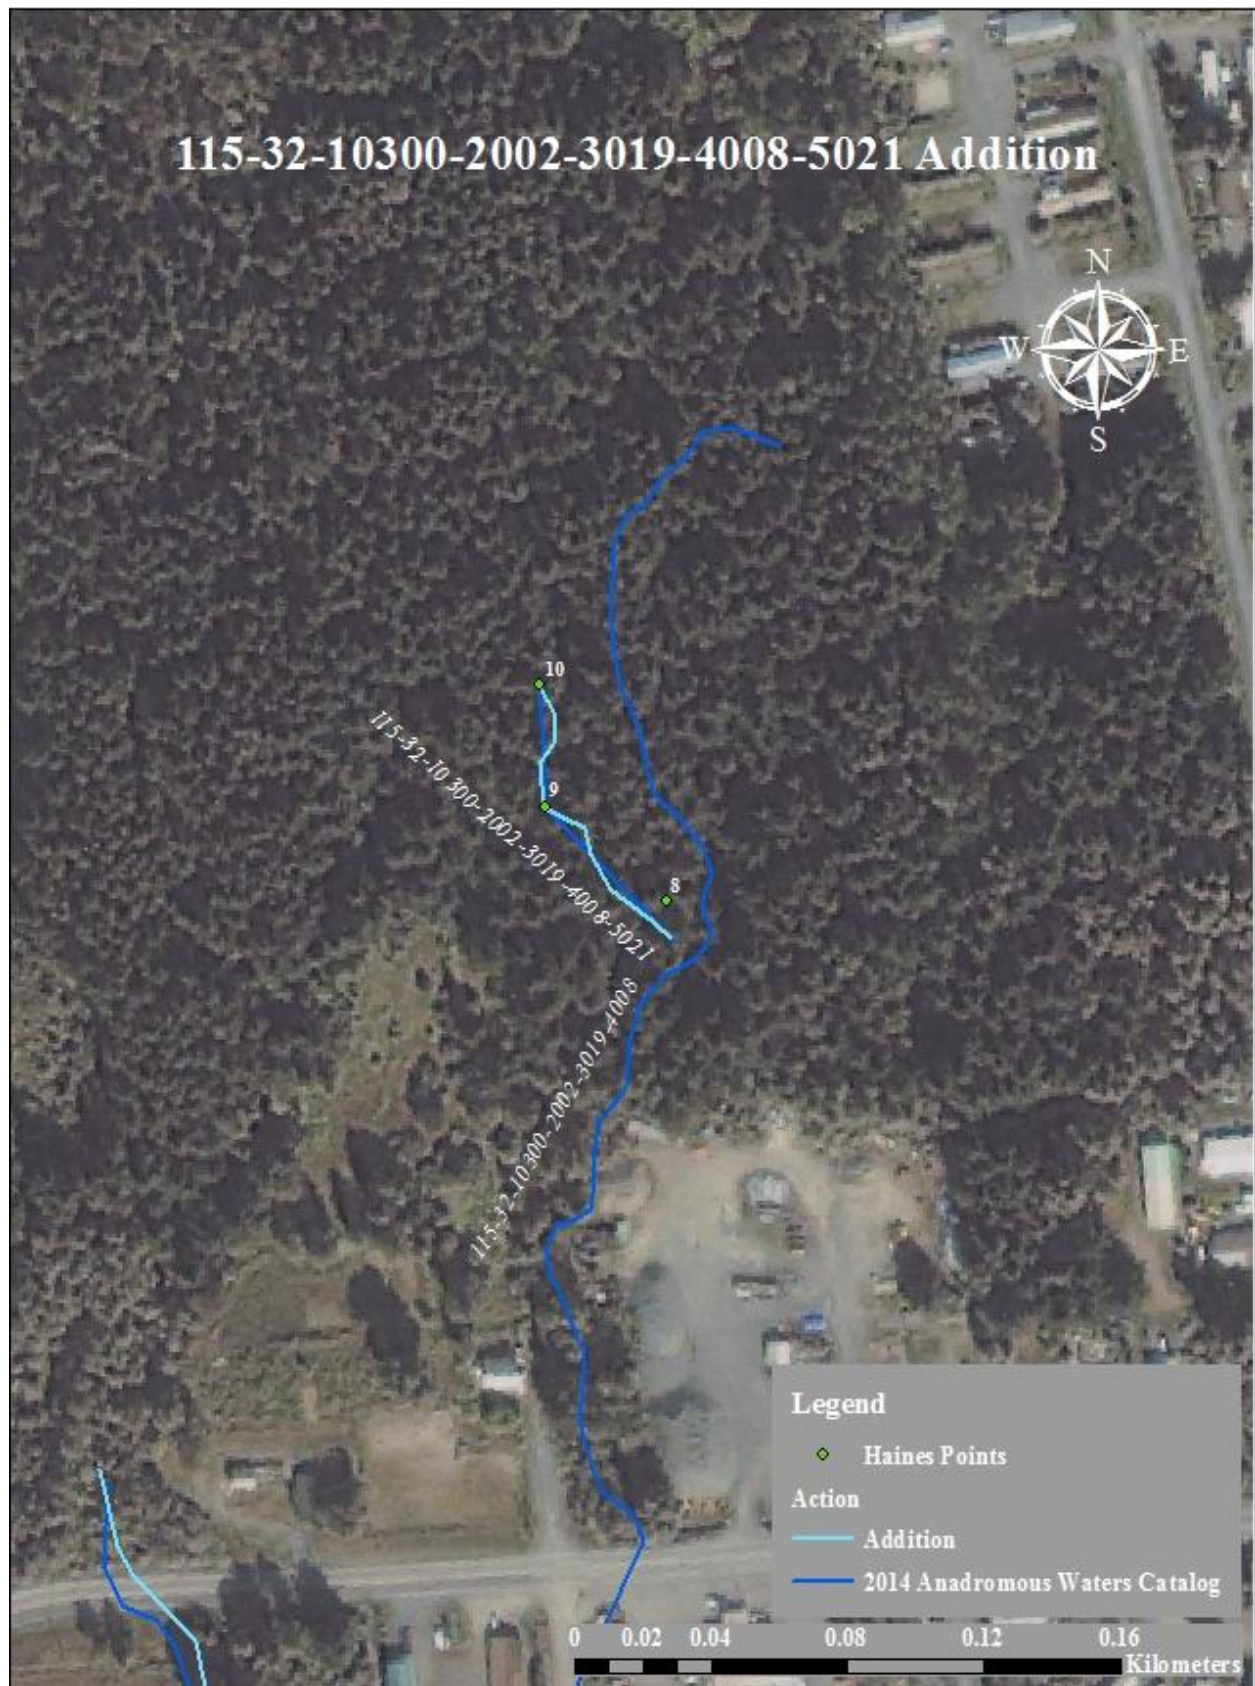
Figure 1.—115-32-10300-2004-3019-4008-5021 addition map.  
Haines

**Findings:** We surveyed this stream using visual observations, minnow traps, and a GPS (Table 1). I observed spawning coho salmon displaying redd-building behavior and rearing cutthroat were captured in minnow traps.

**Recommendations:** Add this stream to the AWC (Figure 1).
