# Appendix F: Haines

## Guide to direct fieldwork for cataloging anadromous water bodies in Southeast Alaska

## HAINES STREAM SURVEYS

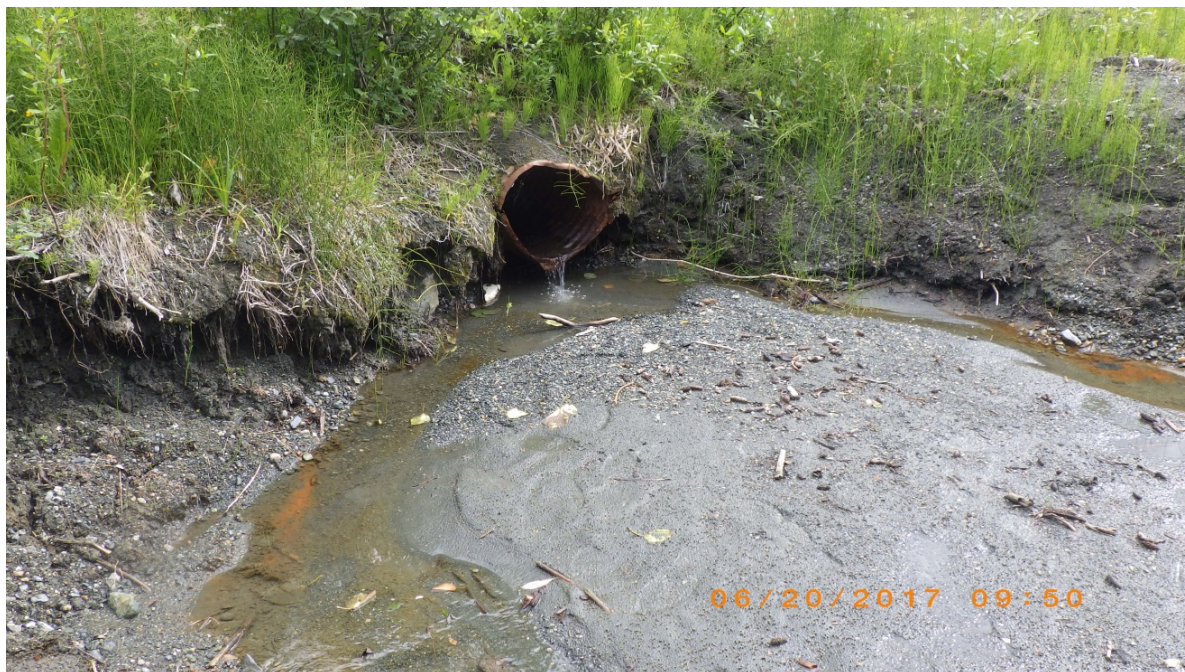
**Findings:** We surveyed this stream with a minnow traps, hand nets, and a GPS. We captured juvenile coho salmon and observed many others below the perched culvert (Table 1, Figure 1-3). The stream is dominated by fine organic substrate. A route correction for stream 115-32-10300-2010 will be submitted.

Figure 1.-Haines Highway culvert.

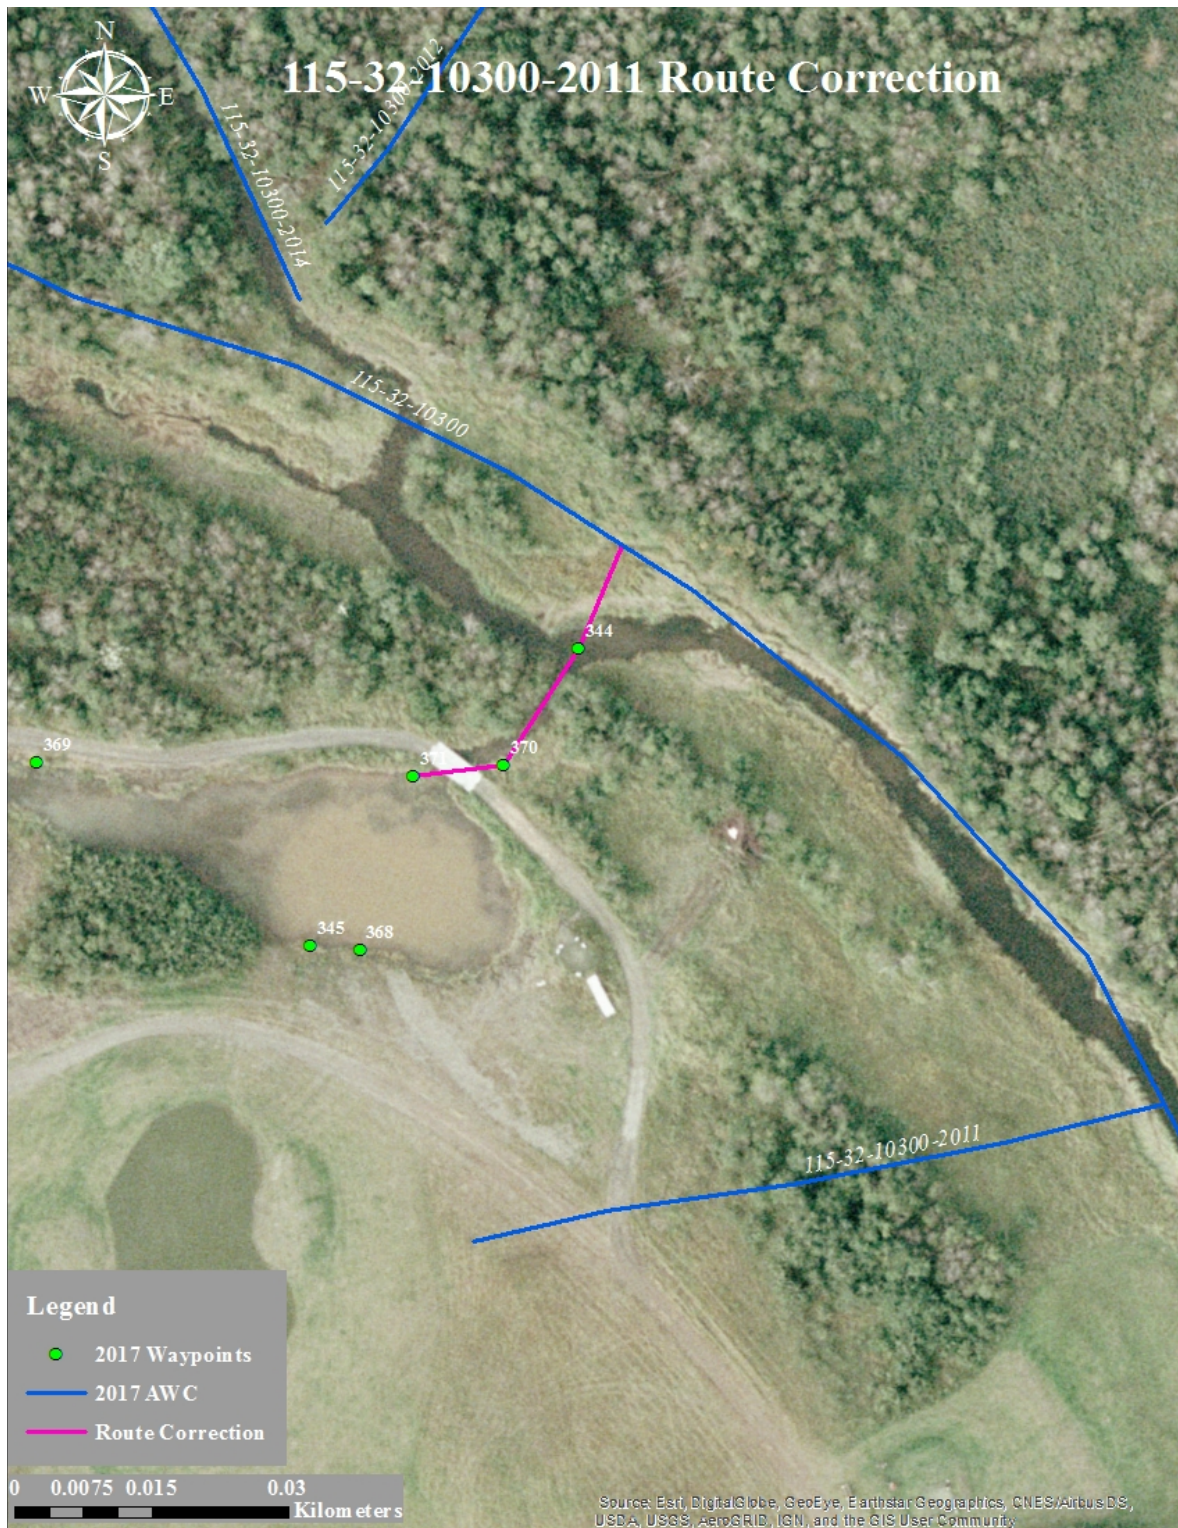
Figure 3.-115-32-10300-2011 route correction map.

**Findings:** We surveyed this waterbody with minnow traps and a GPS. We observed the current Anadromous Waters Catalog stream course to be inaccurate. We followed the short stream from the confluence with 115-32-10300 to the 115-32-10300-2011-0010 (Figure 1). Additionally, we were able to capture three-spined stickleback and coho salmon in the stream (Table 1, Figures 2, 3).

**Recommendations:** Correct the stream course in the Anadromous Waters Catalog.

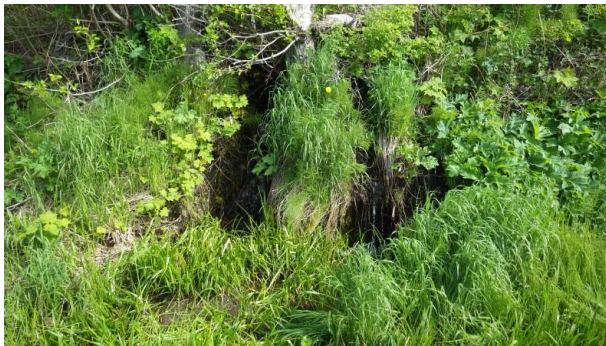
Waypoint	Latitude	Longitude	Notes	Sample Effort	Sample Results
1185	59.2448	-135.5162	Inlet of culvert. Vegetated ditch along road.		
1186	59.2449	-135.5182	Two 7 ft earthen waterfalls. Fish passage barrier.	EF	2 CO, 4 DV

Figure 1.—Fish passage barrier on Stream No. 115-32-10300-2032.

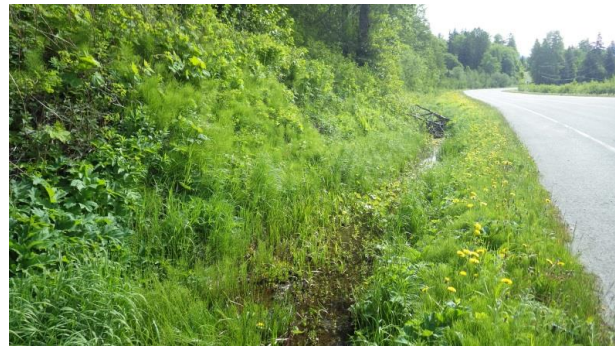
Figure 2.—Stream No. 115-32-10300-2032 in the ditch along the Haines highway.

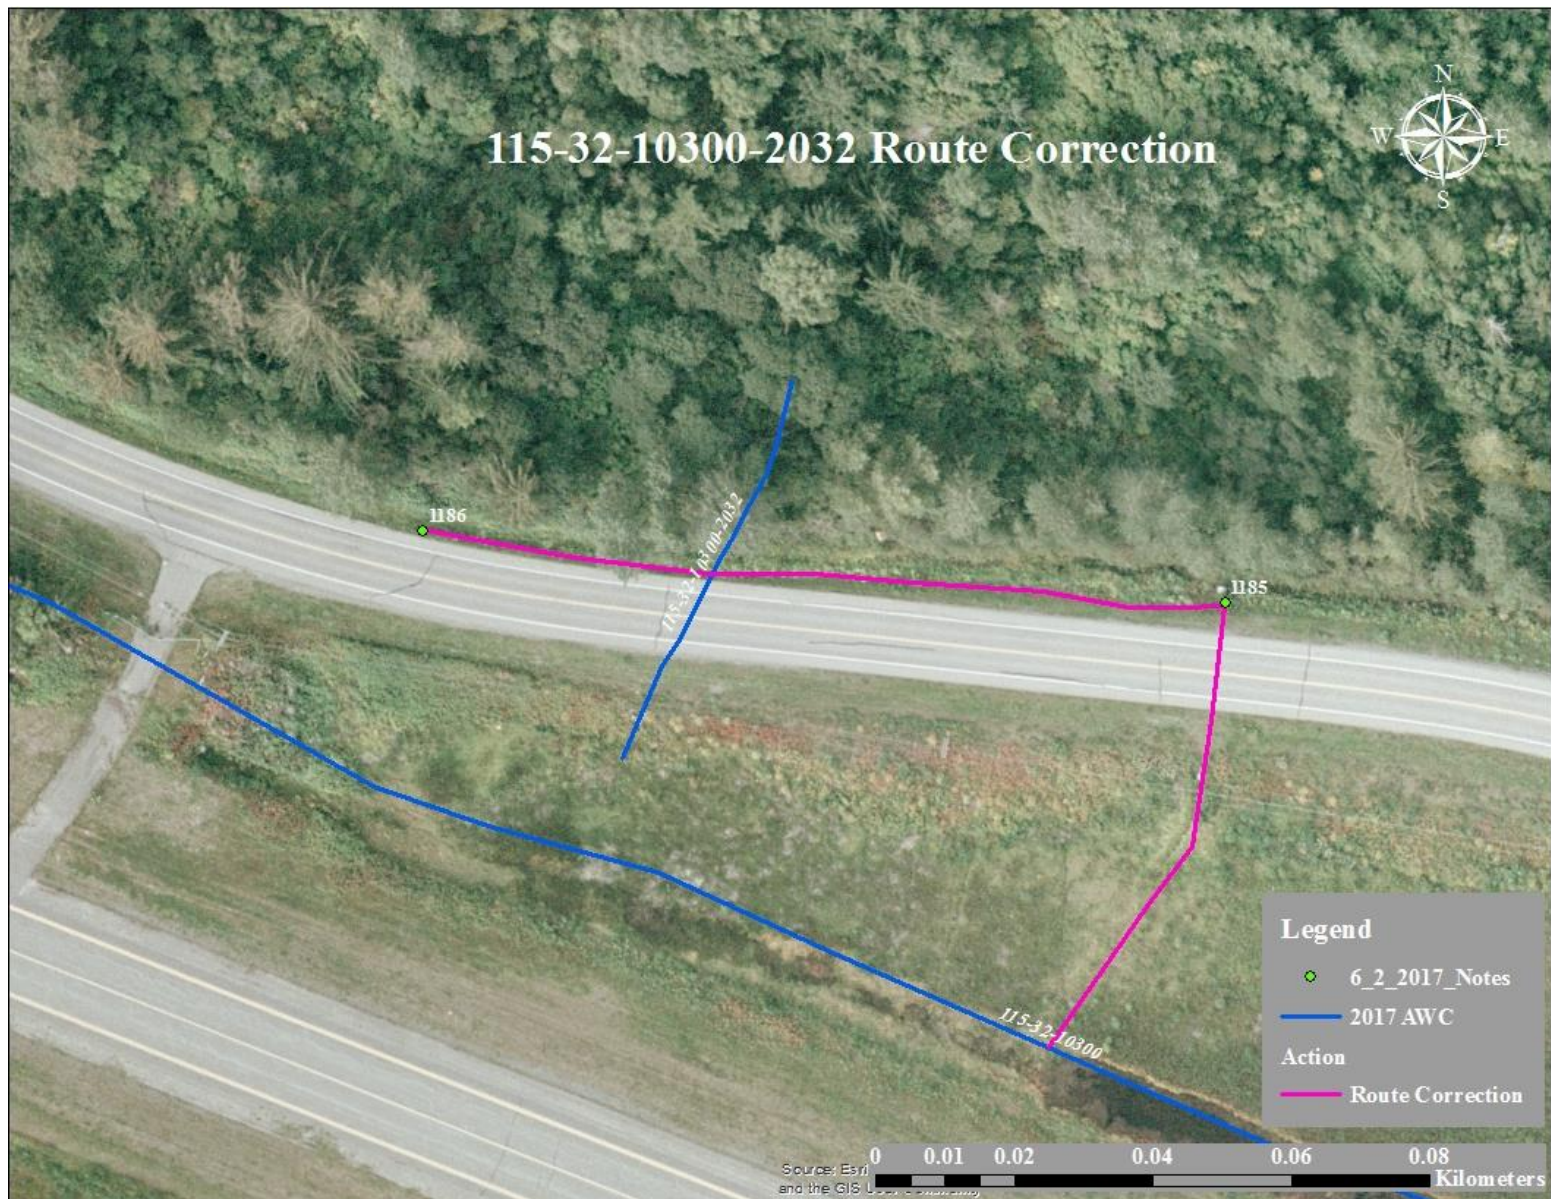
Figure 3.—115-32-10300-2032 route correction map.

**Recommendations:** Update this stream's course to reflect the field verified route (Figure 3).

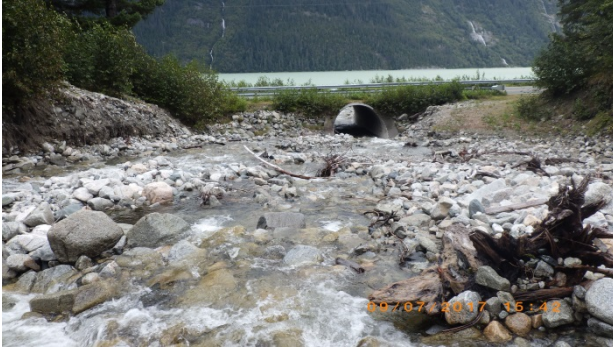
**Findings:** On August 4, 2017 we surveyed this stream using a backpack electrofisher, hand nets, and a GPS. We observed adult pink salmon in the stream and captured Dolly Varden char. We returned on September 7, 2017 and observed spawning adult pink salmon above where they were seen prior. The stream is in an active slide area and shows evidence of frequently changing course (Table 1, Figures 1-4).

Figure 1.–Shakuseyi Creek facing downstream at WP 934.

**Recommendations:** Add this stream to the catalog for spawning pink salmon.

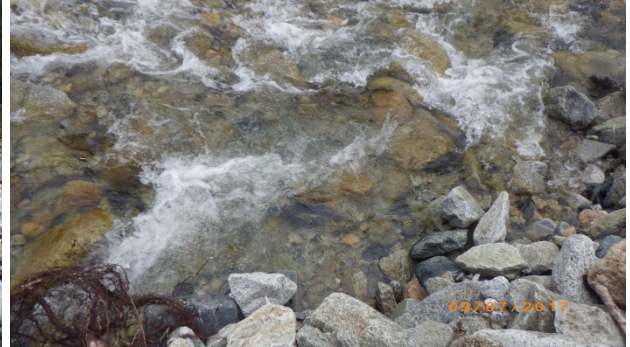
Figure 2.–Spawning pair of pink salmon.

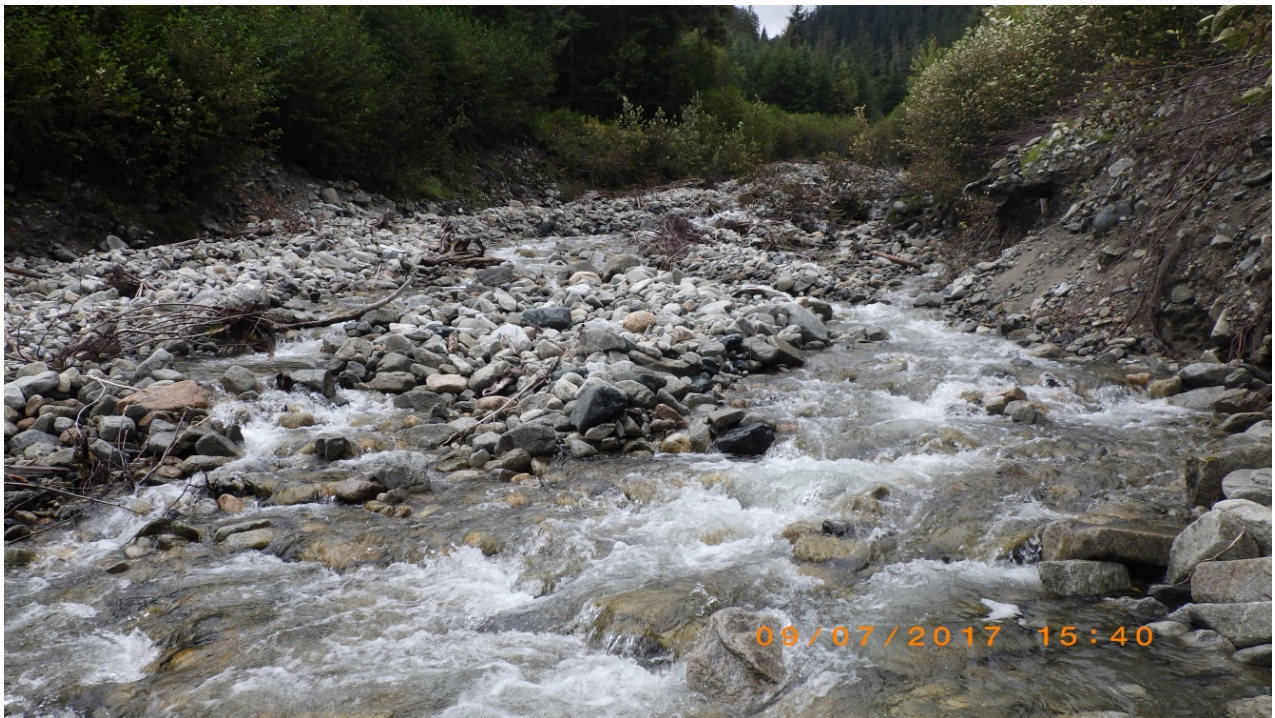
Figure 3.–Shakuseyi Creek facing upstream at WP 934.

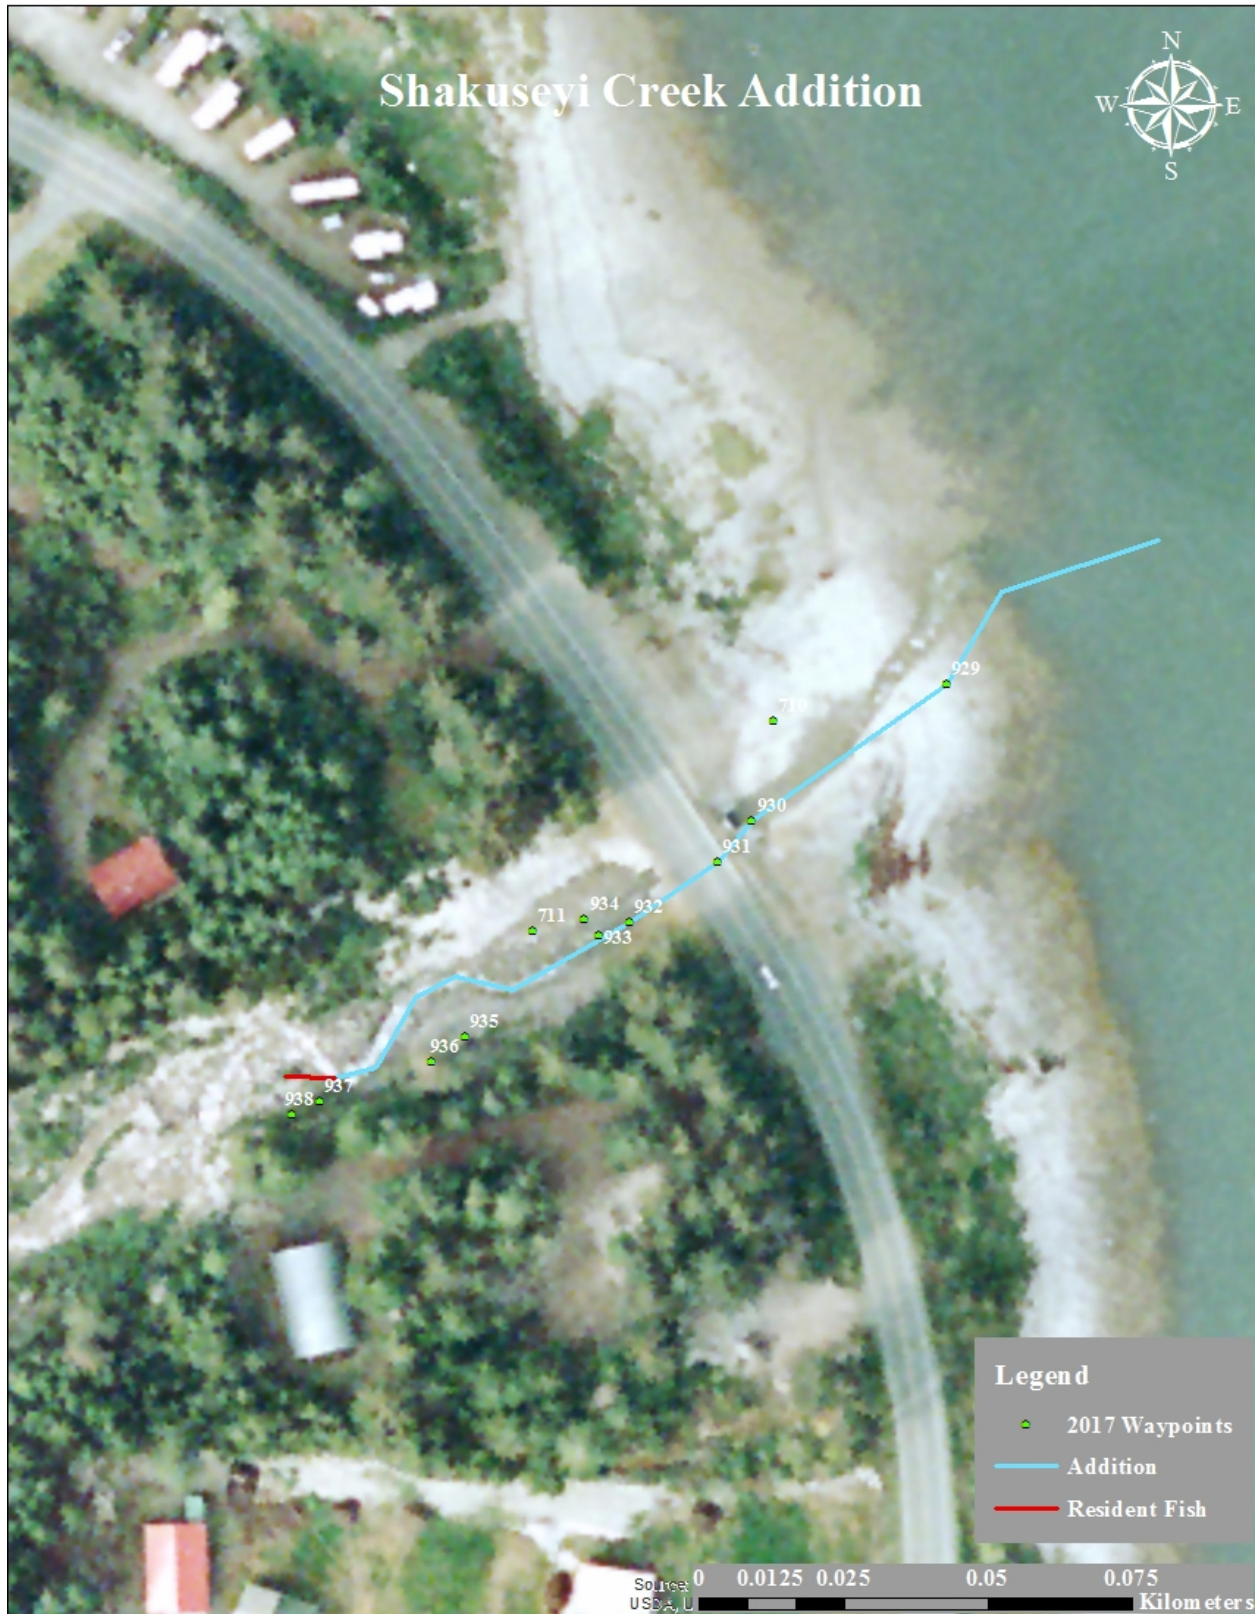
Figure 4.-Shakuseyi Creek addition map.

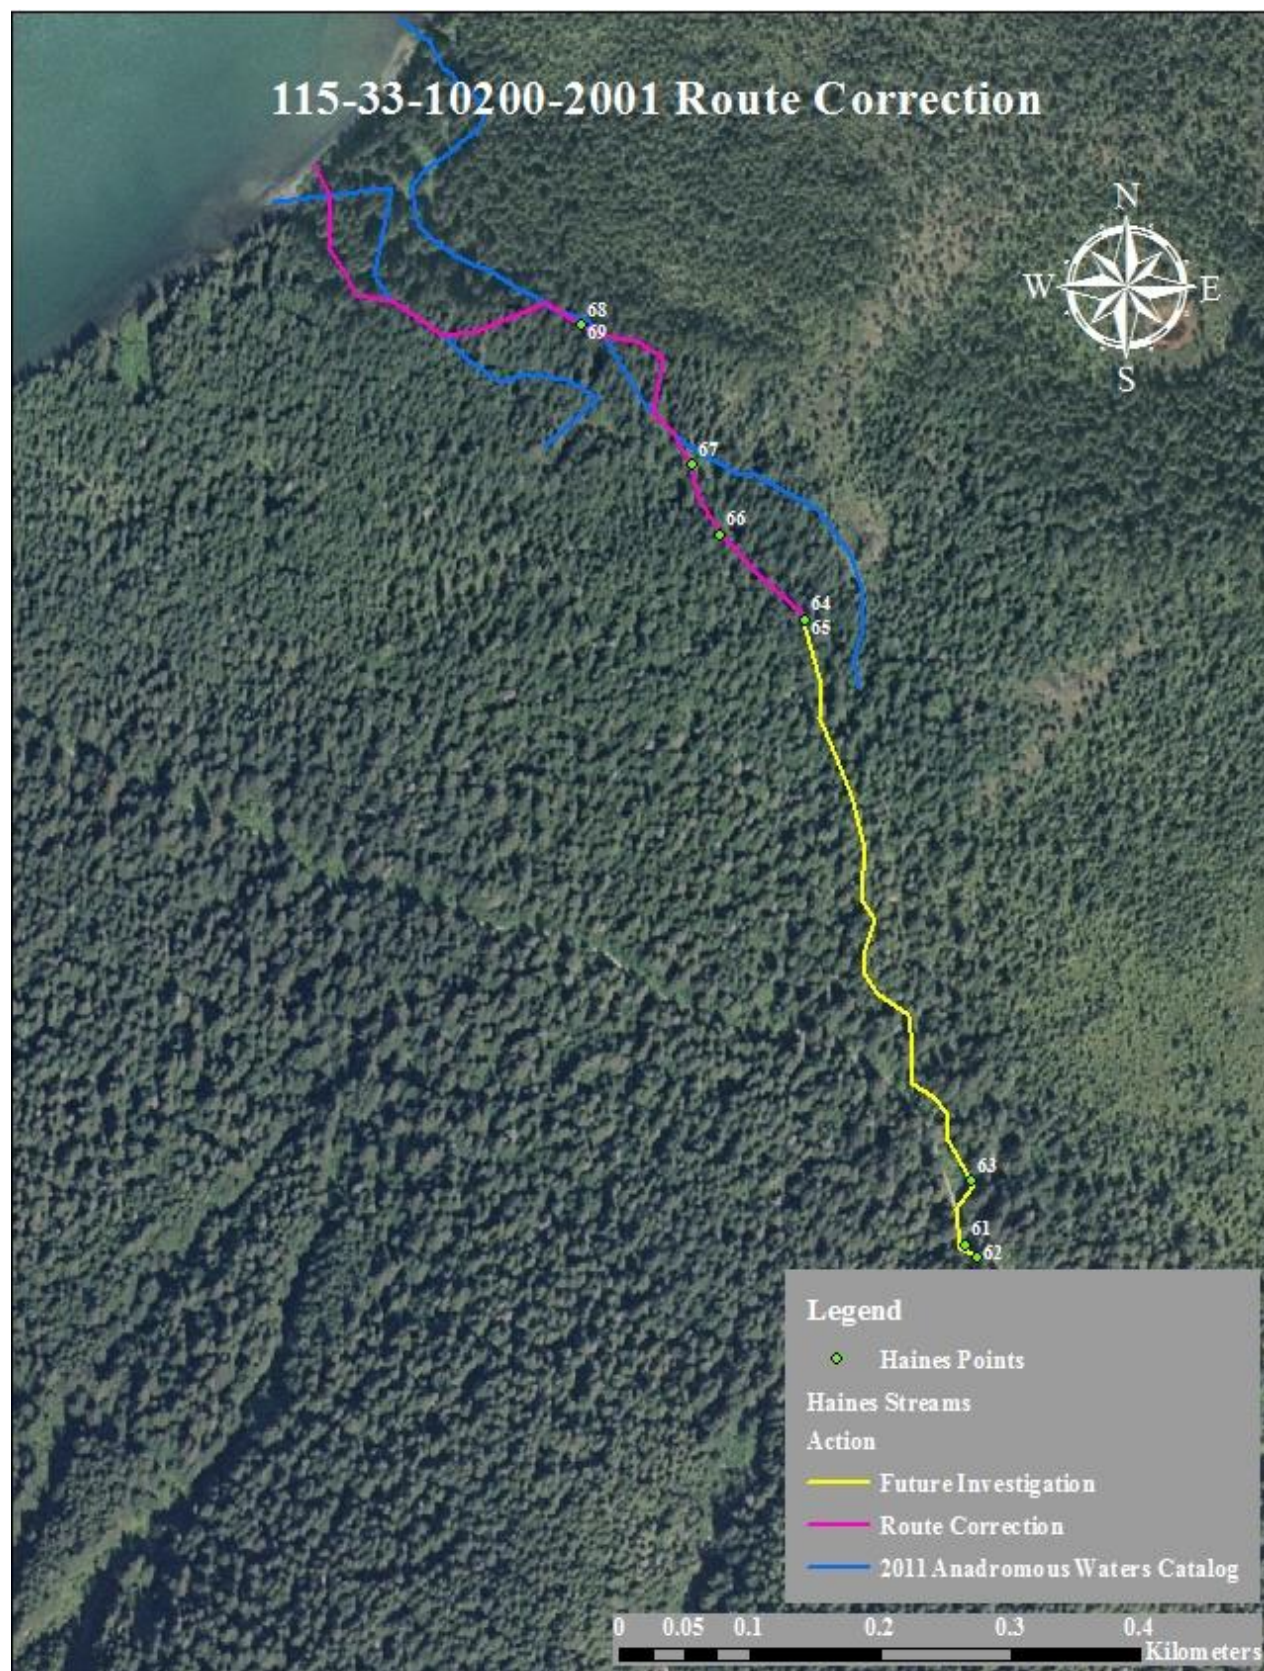
**Findings:** We surveyed this stream using a backpack electrofisher and a GPS (Table 1). The upper section of State Park Slough is a high gradient clear water stream comprised of mostly cobble and boulder substrate. Midway down the stream the gradient starts to mellow and eventually levels and spreads out before reaching Chilkoot Lake. According to the AWC there is another anadromous stream that should have intersected with our State Park Slough track. We did not see another stream, however, State Park Slough spreads out and broadens in the lower section of the stream which may have caused us to miss the intersection, or the stream no longer exists.

Figure 1.—115-33-10200-2001 route correction.

**Recommendations:** Correct the current course in the Anadromous Waters Catalog (Figure 1).

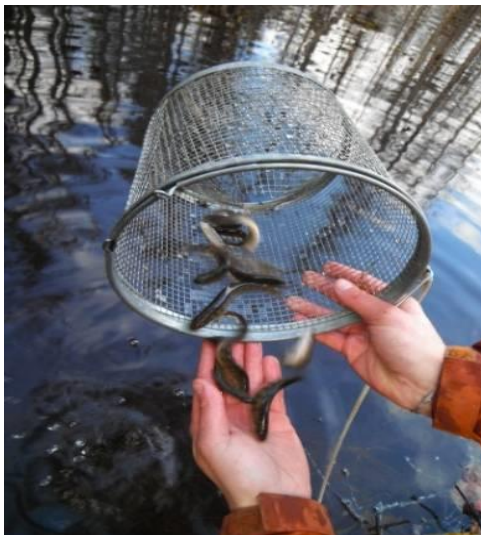
Figure 1.–Coho captured in stream number 115-33-10200-2012.

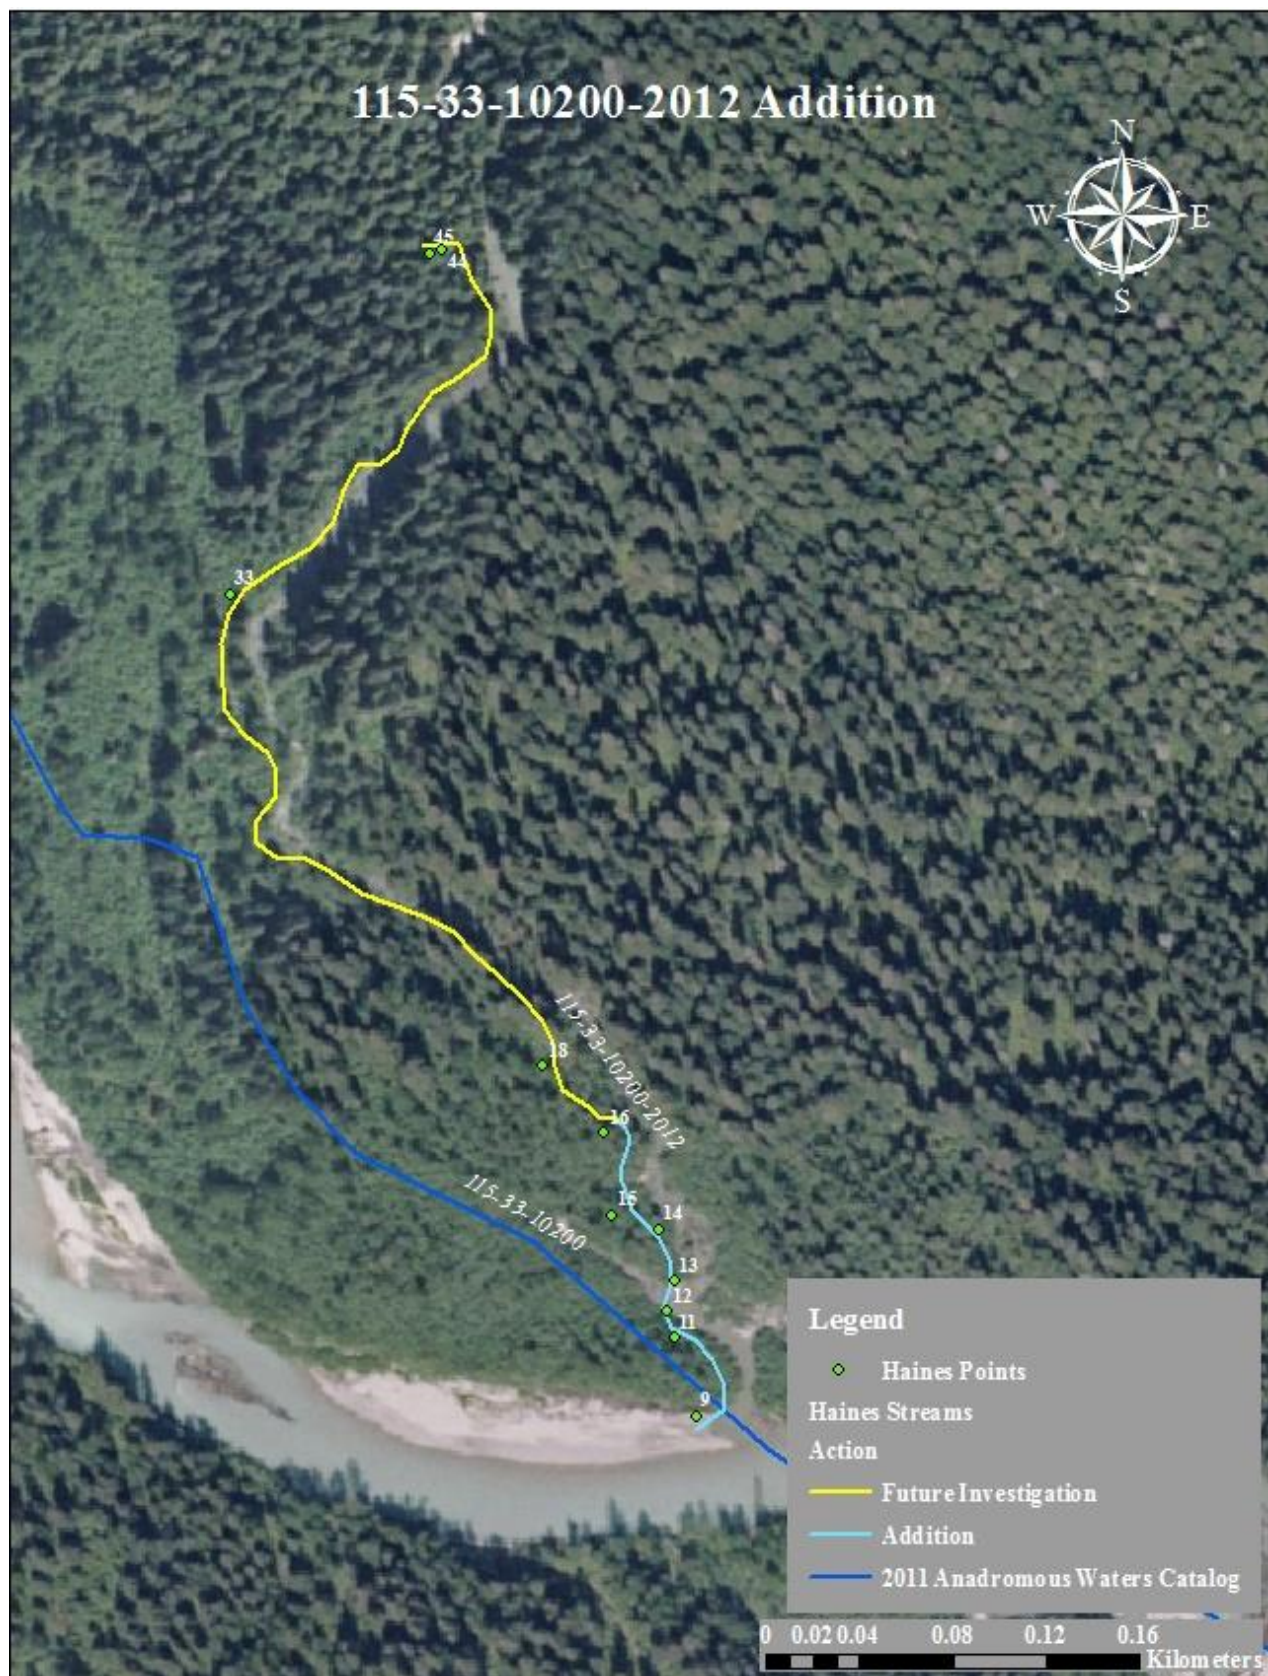
Figure 2.—115-33-10200-2012 addition map.

**Recommendations:** Add stream to the Anadromous Waters Catalog (Figure 2).

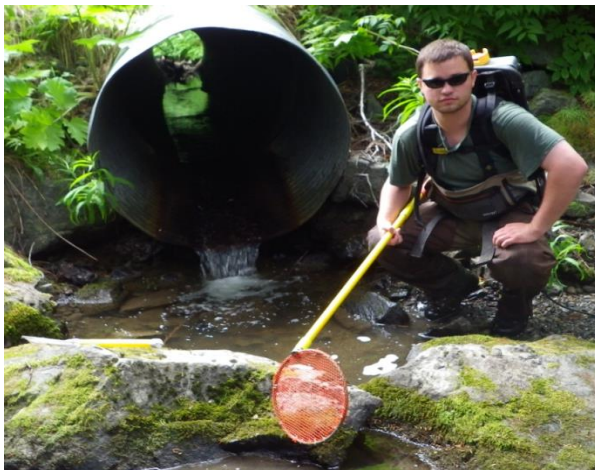
**Findings:** We found rearing coho salmon up to a perched culvert that passes below Mud Bay Road (Table 1, Figure 1). Potential rearing habitat continues for at least a quarter mile upstream of the crossing. We ended our survey at private property signs and will request permission from land owner to continue surveying while in Haines conducting work. We also encountered an old culvert under an abandoned, overgrown road downstream. The culvert had some debris accumulating at the inlet but was not blocking fish passage (Figure 2). We captured Dolly Varden char, cutthroat trout, and rainbow trout upstream of the perched culvert (Figure 3).

Figure 1.–Rick Hoffman stands in front of perched culvert below Mud Bay Road.

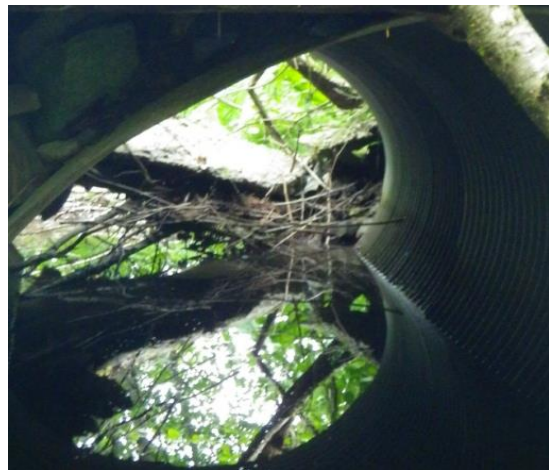
Figure 2.–Culvert under overgrown road.

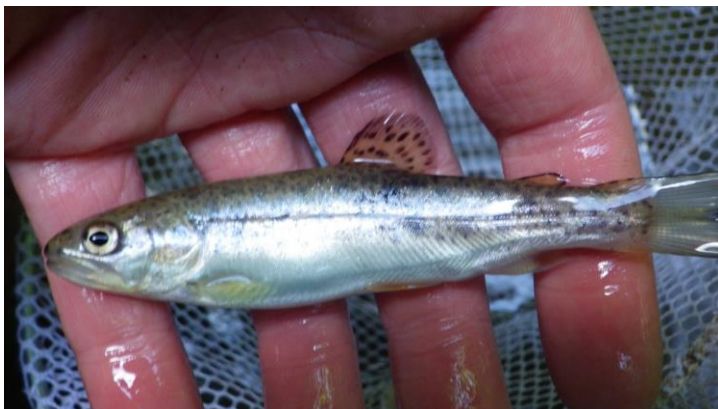
Figure 3.–Rainbow trout captured above perched culvert.

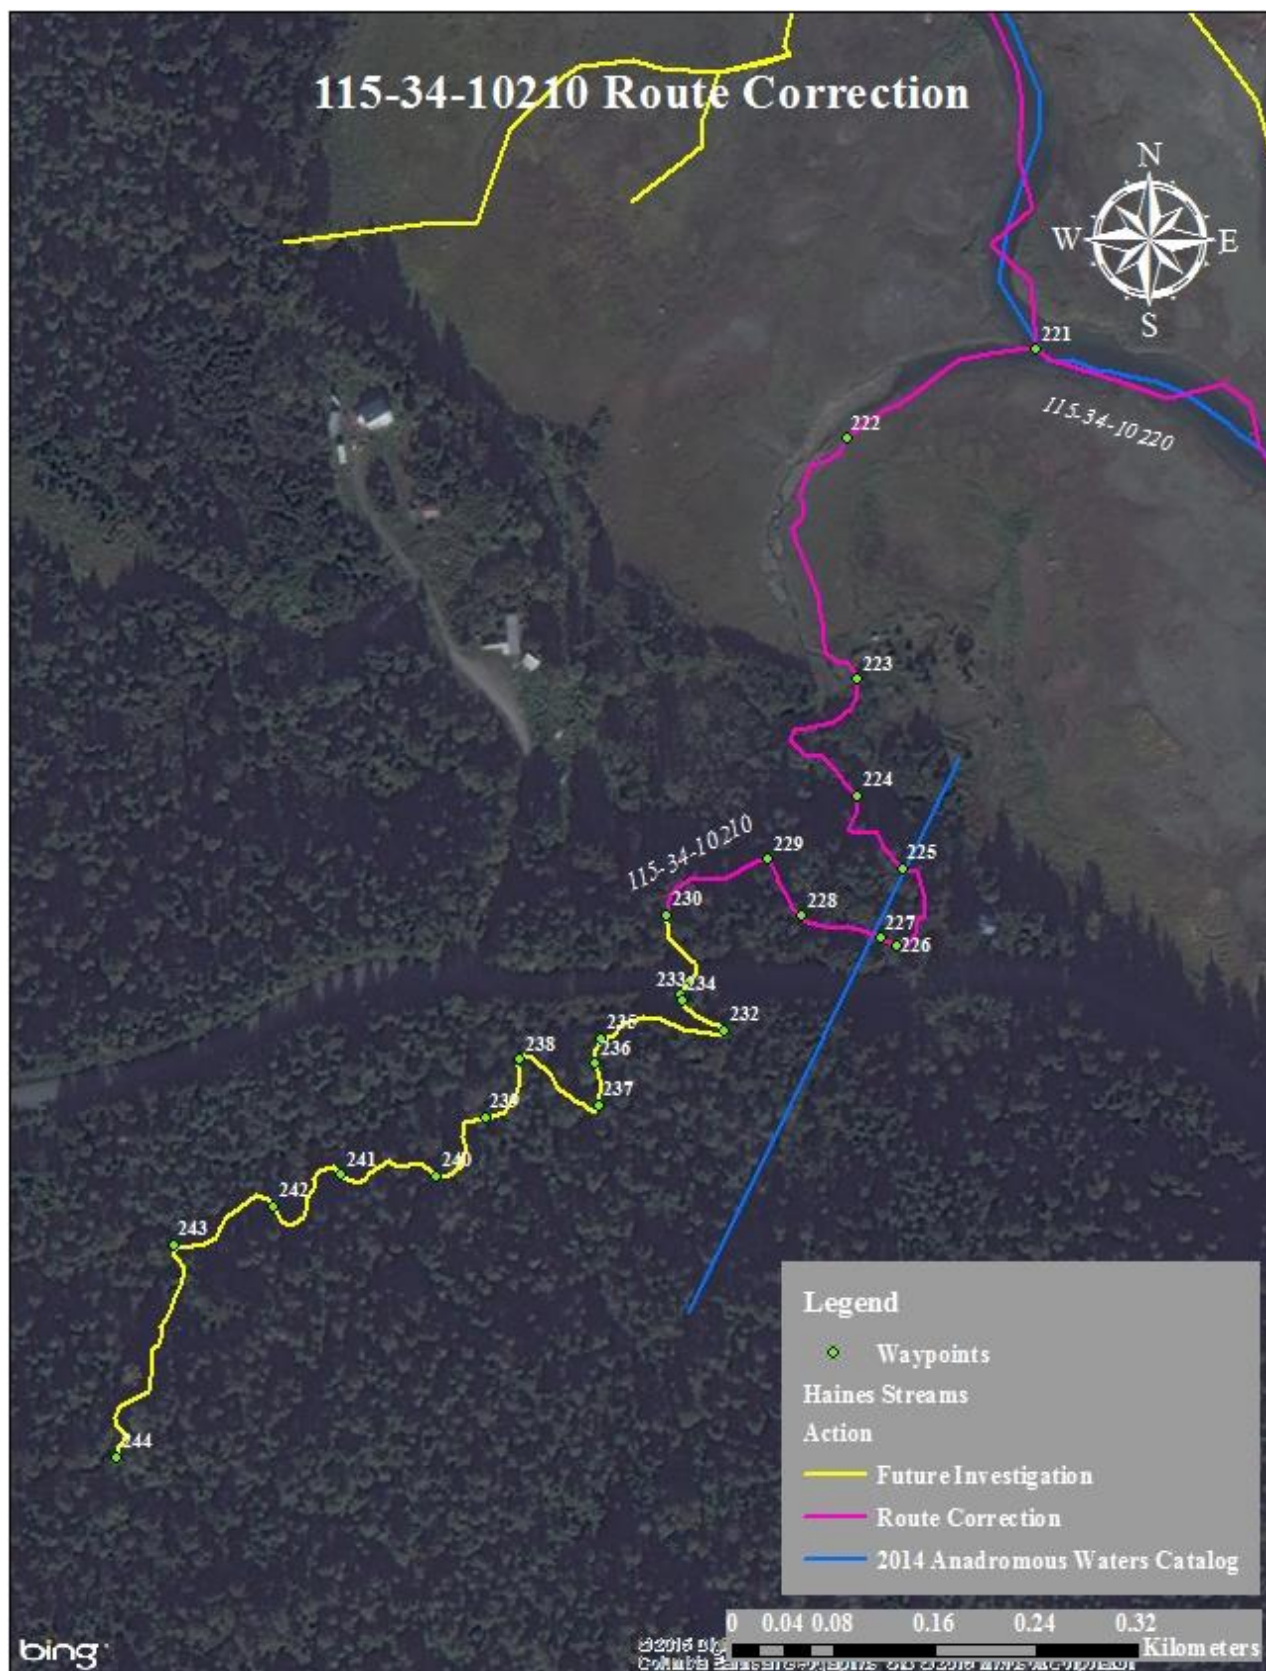
Figure 4.—115-34-10210 route correction map.

**Recommendations:** Updating the stream arc in the Anadromous Waters Catalog (Figure 4).

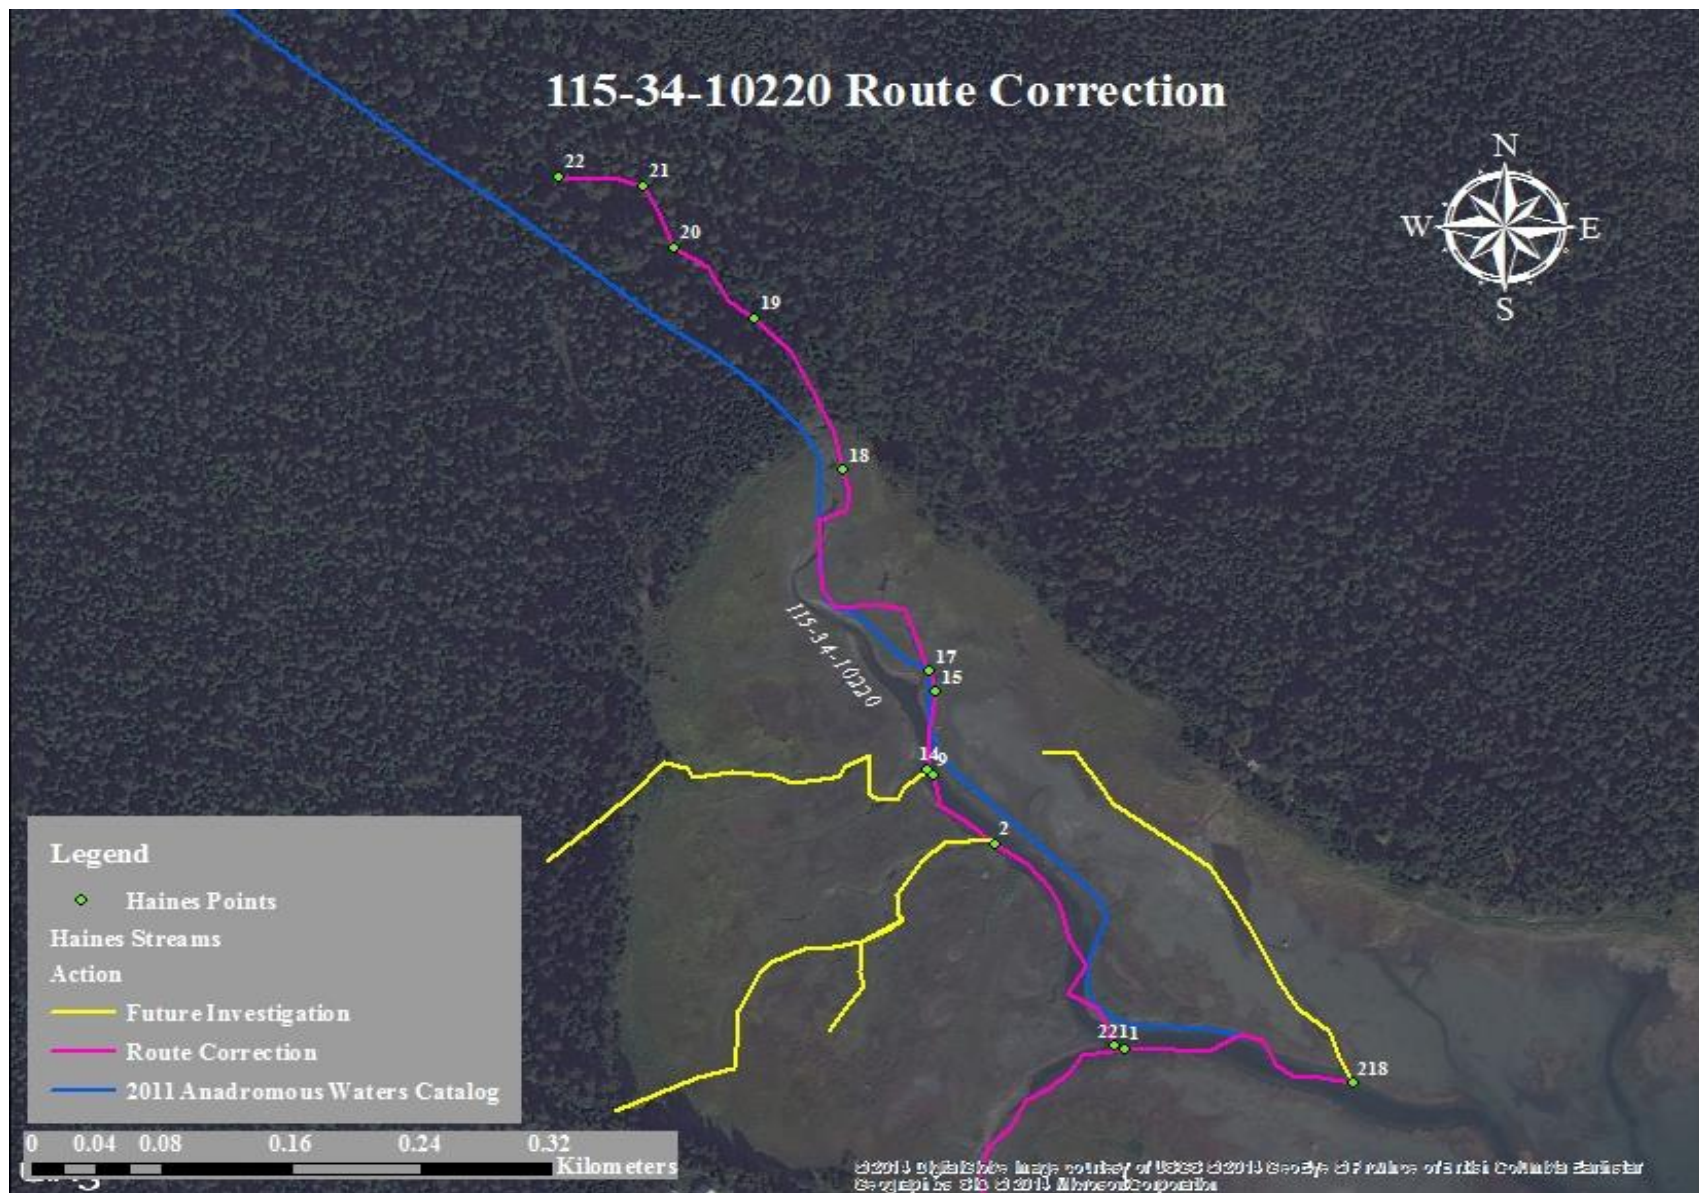
**Findings:** Over the course of three days of surveying we mapped out the mainstem and associated tributaries of stream 115-34-10220, and found the AWC to be incorrect on the upper section of the stream (Table 1).

Figure 1.—115-34-10220 route correction map.

**Recommendations:** Correct the current route in the Anadromous Waters Catalog (Figure 1).
