Alaska Department of Fish and Game

Habitat Section
Southeast Region

114-33-10230 Tributary 11

ADDITION

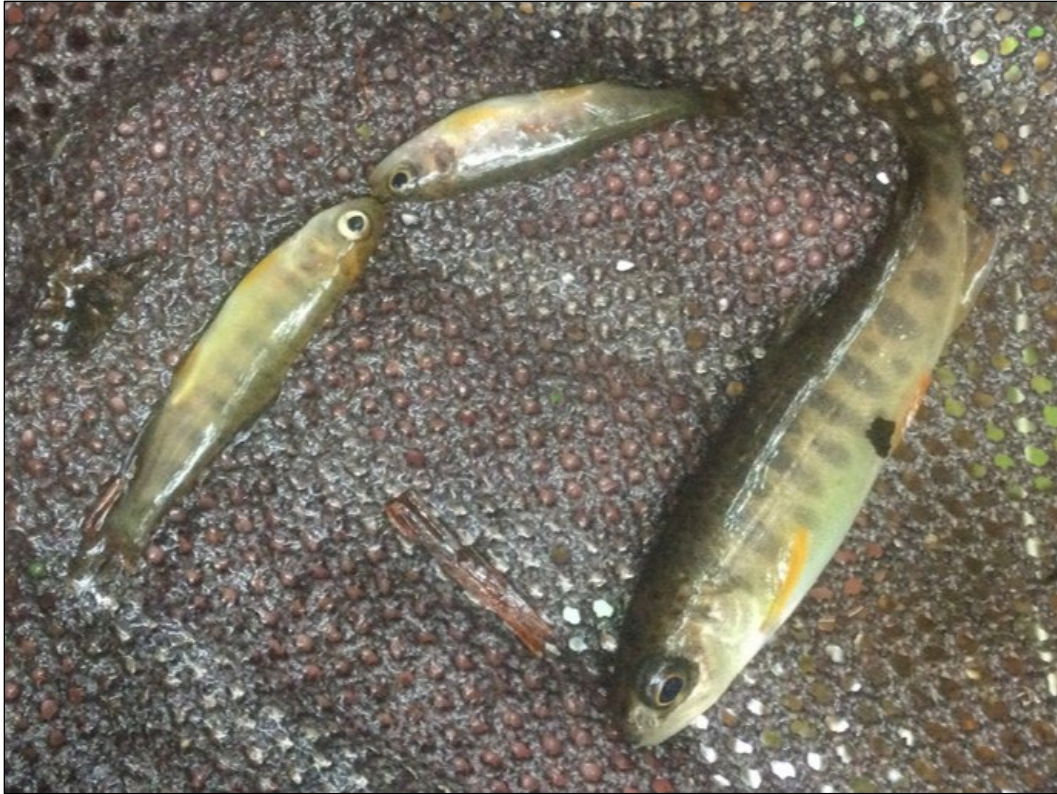
Findings: We surveyed this uncataloged stream using a backpack electrofisher and GPS and captured juvenile coho salmon (Figure 1). The tributary stream falls over a rootwad/debris jam and flows through a gravel channel, passing through a 4 ft wide culvert (Table 1; Figures 2–4).

Figure 1.—Juvenile coho salmon captured at waypoint 1807.

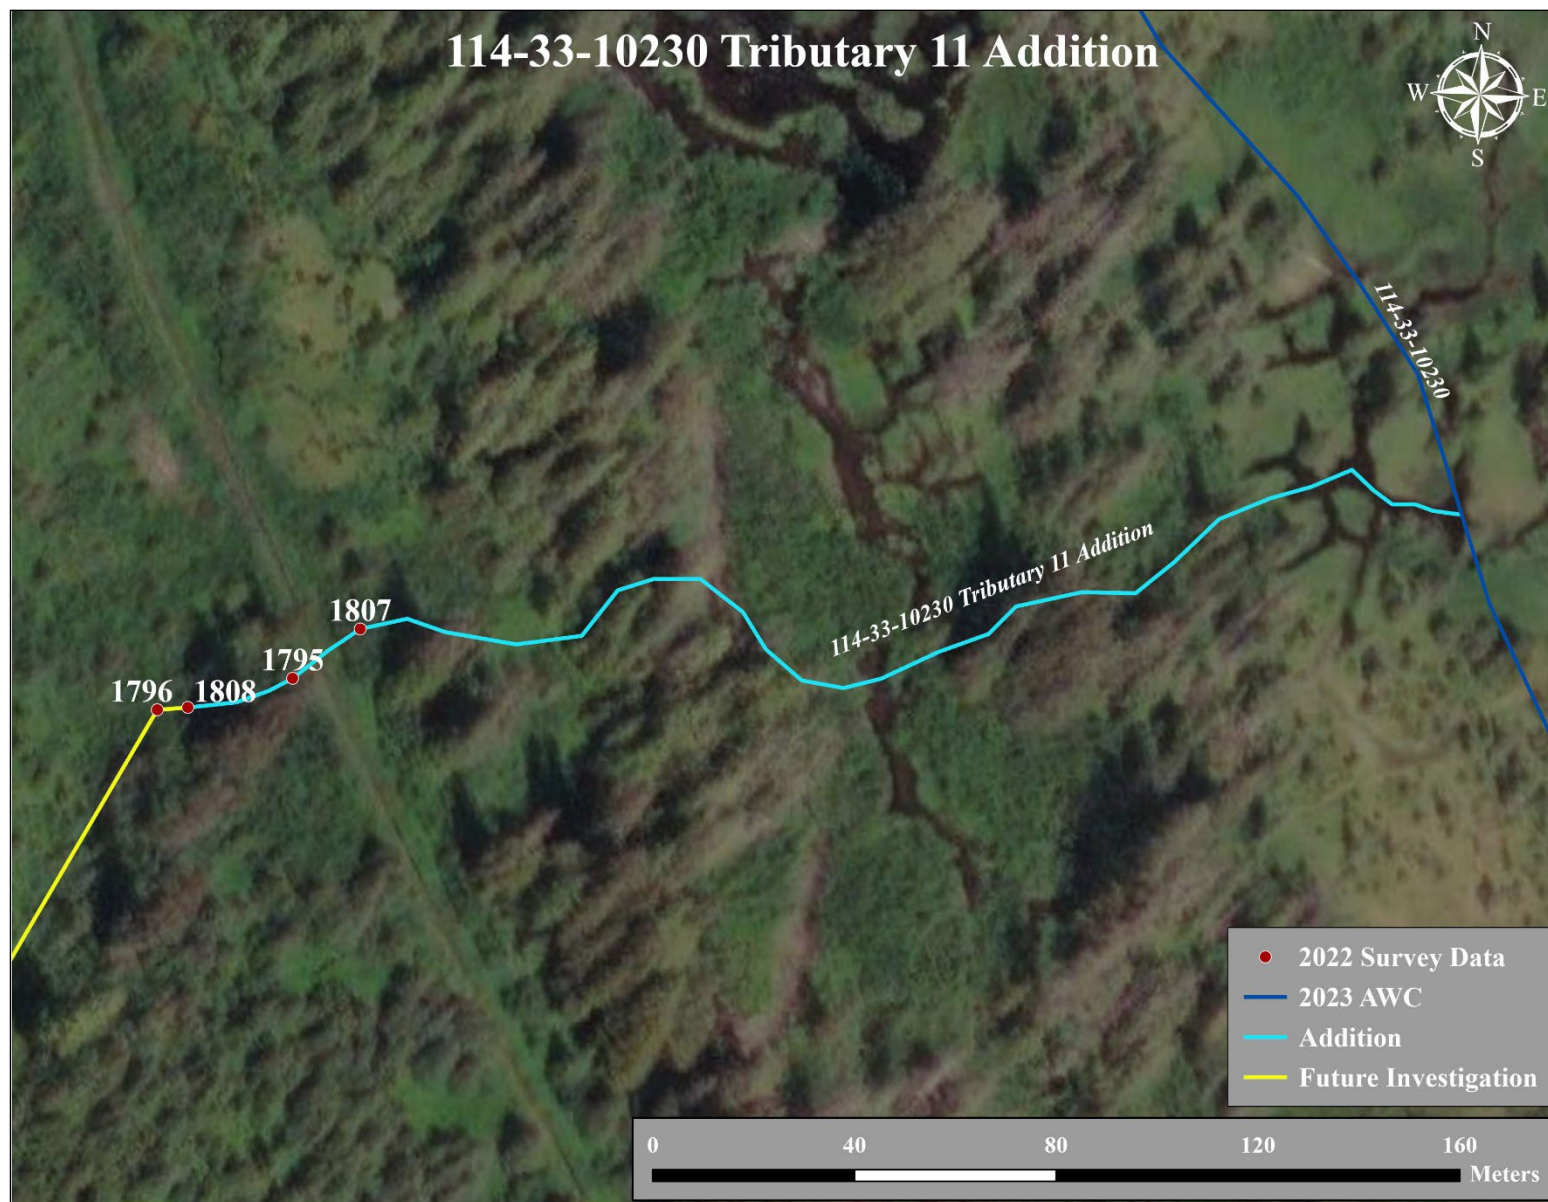
Figure 5.—114-33-10230 tributary 11 addition map.

Recommendations: Add this uncataloged stream to the anadromous waters catalog for rearing coho salmon (Figure 5).
