**Technical Report No. 08-01**

## **A SURVEY OF STREAM CROSSING STRUCTURES IN THE NORTH SLOPE OILFIELDS**

**by William A. Morris  
and Jack F. Winters**

**February 2008**

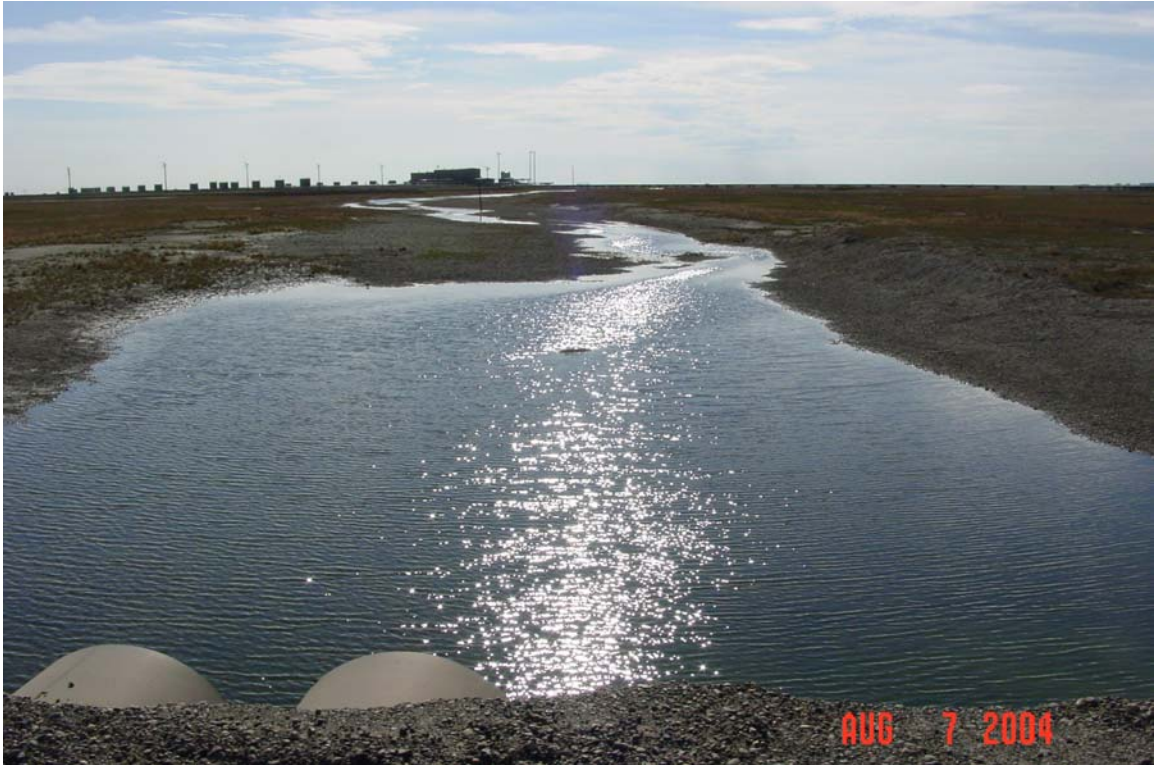
**Photograph 1. Sag C Creek upstream of road.**

REMEDICATION RECOMMENDATIONS: Remove gravel from culverts,  
increase conveyance

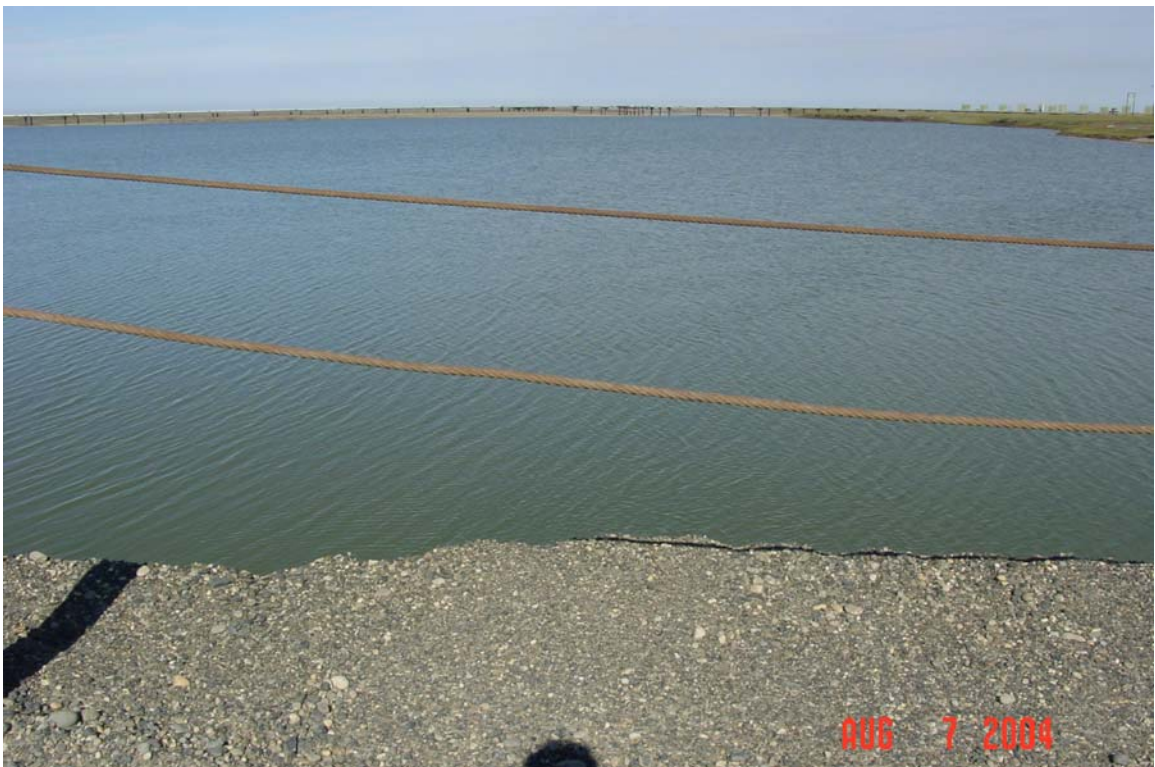
**Photograph 2. Sag C Creek looking downstream into Sag Mine Site C or Vern Lake.**

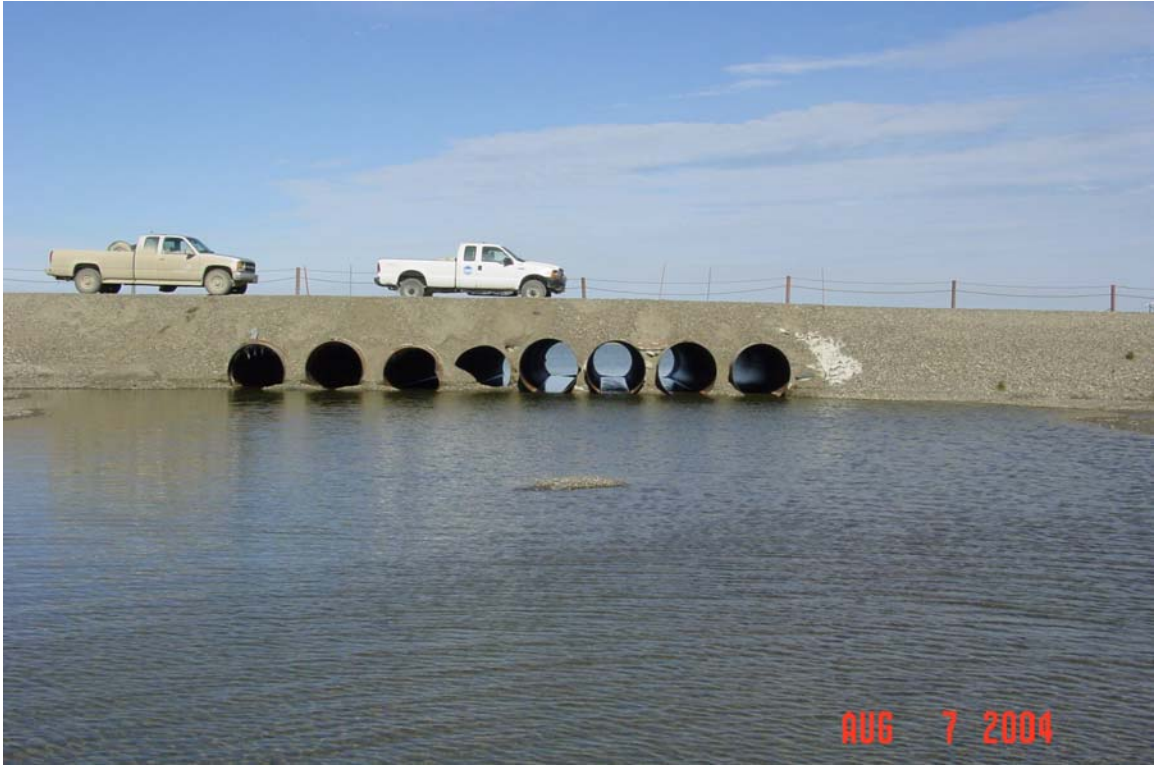
**Photograph 3. Sag C Creek culvert inlets.**

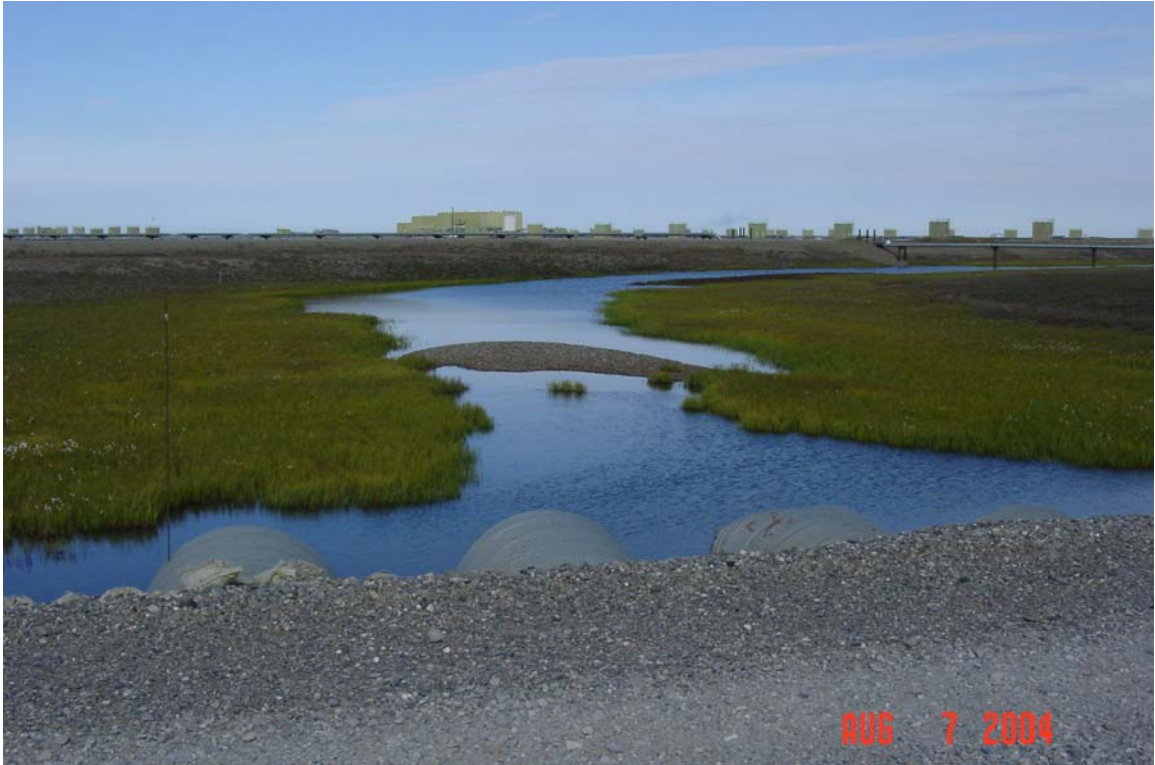
OUTLET: Sand bag armor, gobi mat, significant outwash gravel blocking the stream, minor outlet damage

**Photograph 4. Washout Creek downstream of road. Gravel outwash is blocking the entire stream channel at the flow conditions present during the inspection.**

REMEDIATION RECOMMENDATIONS: Remove outwash gravels, increase water conveyance through the crossing

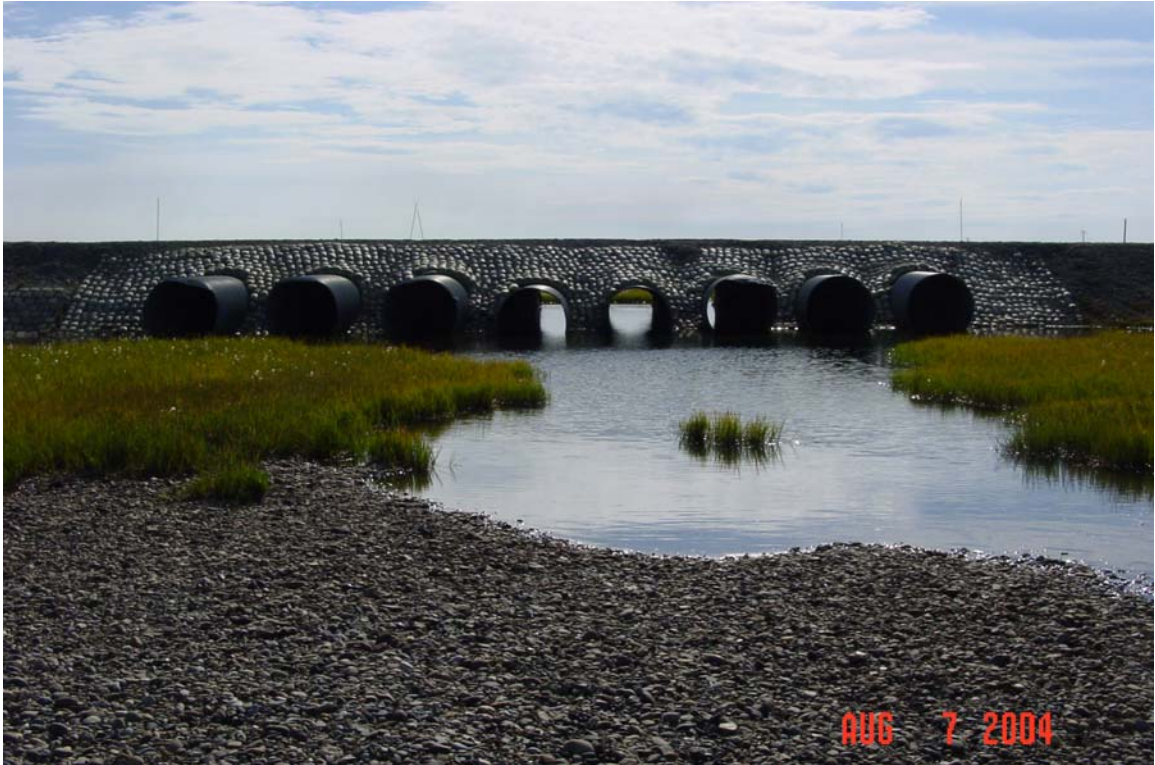
**Photograph 6. Washout Creek culvert outlets looking upstream from gravel outwash.**

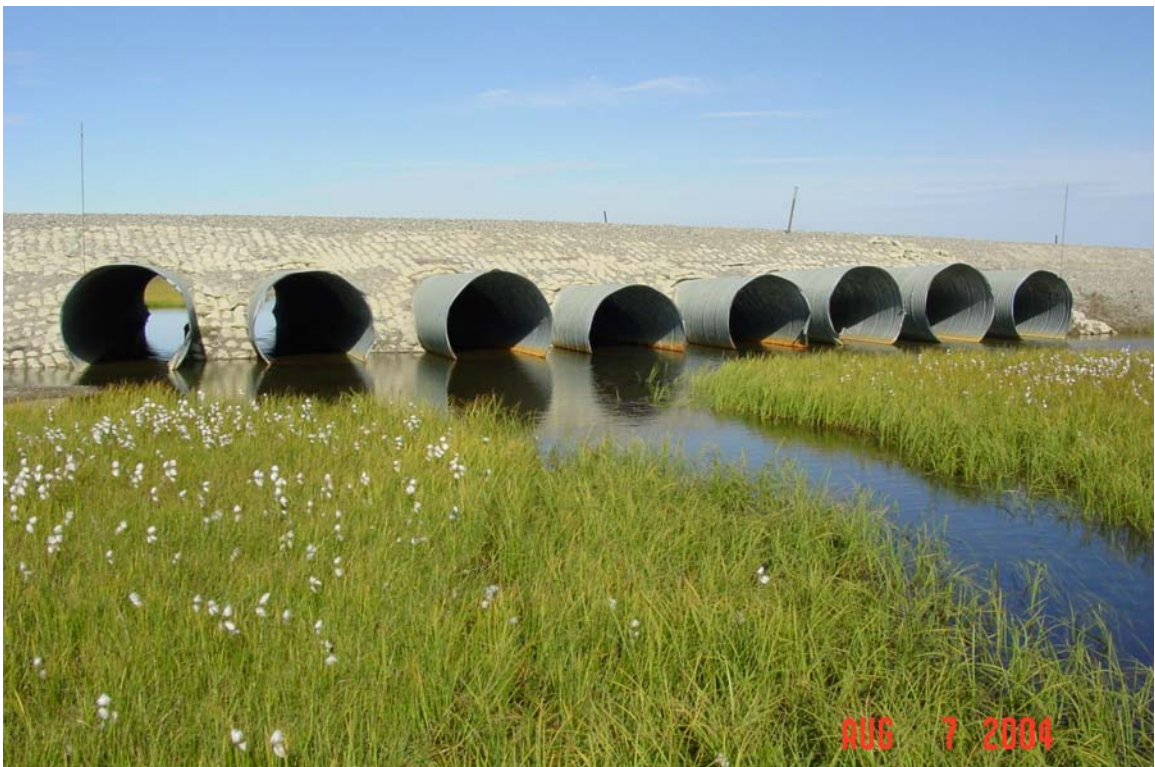
INLET: Sand bag armor, gobi mat, minor inlet damage

**Photograph 7. Washout Creek culvert inlets.**

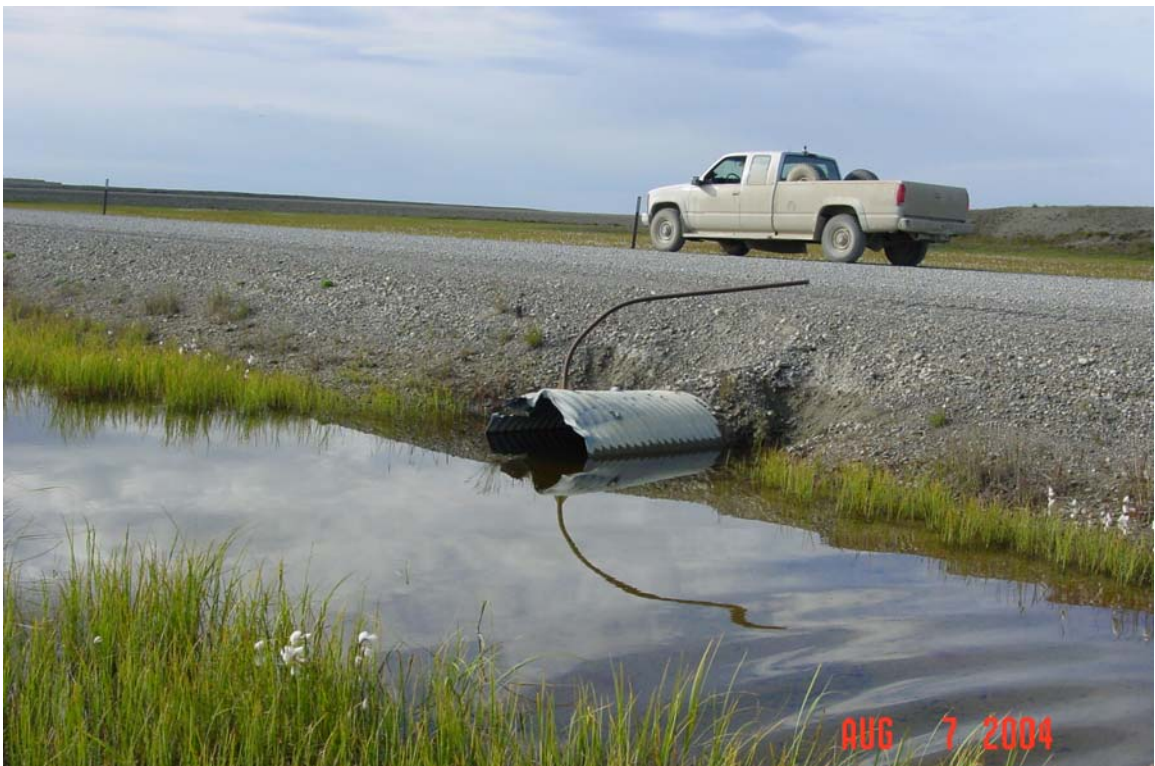
**Photograph 9. Duck Island Creek culvert inlet. Note minor road prism erosion and high-water mark above culvert.**

REMEDICATION RECOMMENDATIONS: Increase water conveyance through this crossing

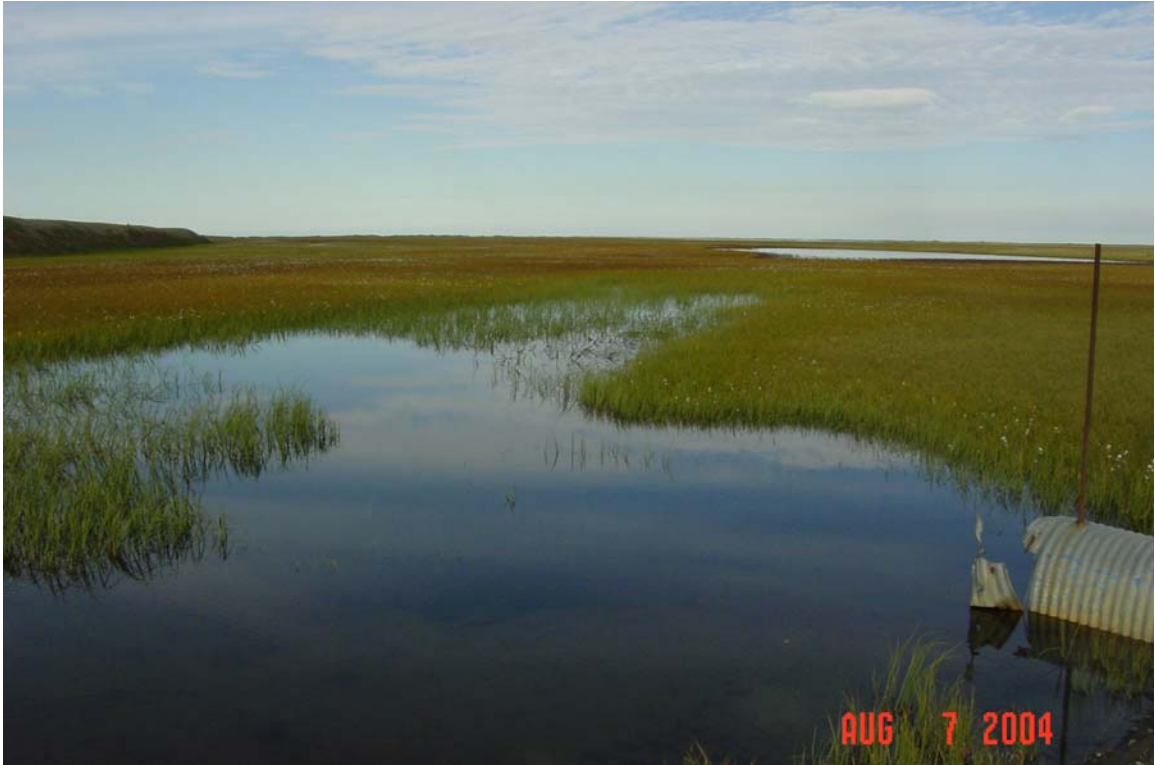
OUTLET: Damage to culvert end, gobi mat armor

**Photograph 10. Duck Island Creek downstream of road. Note outlet damage to culvert.**

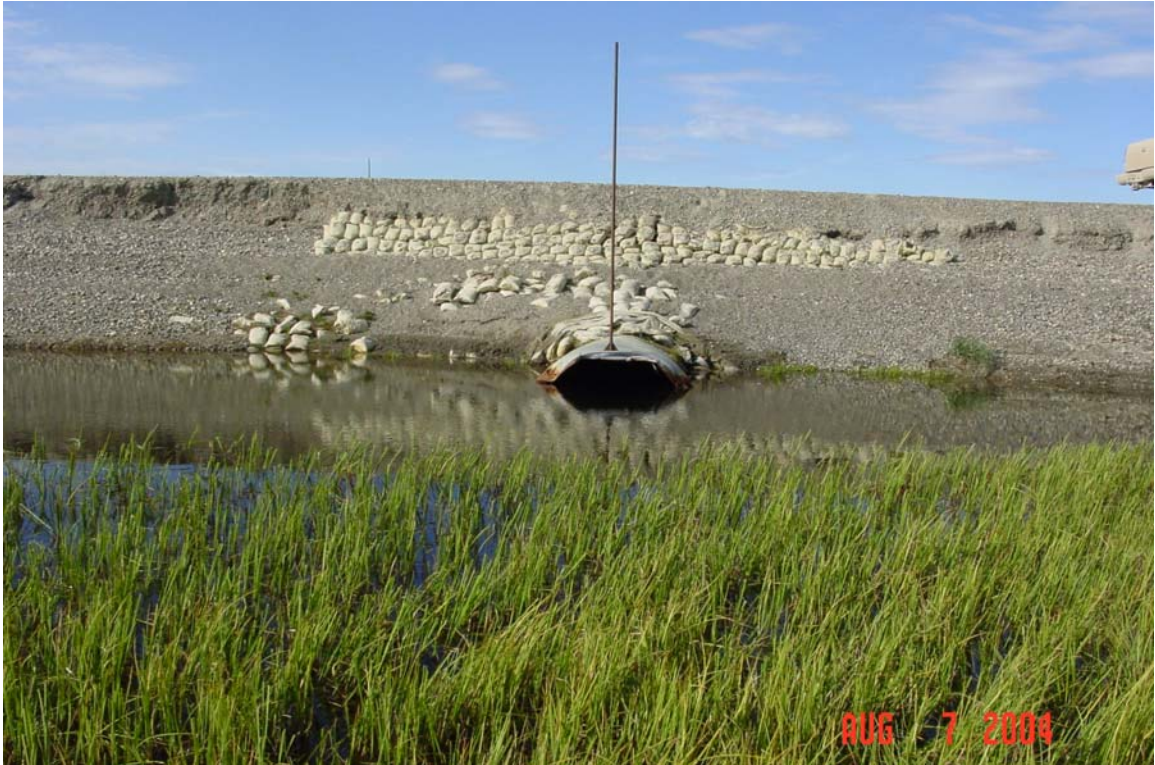
**Photograph 14. South Fork Endicott Creek culvert inlet. Note the road prism erosion and high-water mark above culvert.**

REMEDICATION RECOMMENDATIONS: Increase water conveyance past this crossing with larger or additional culverts

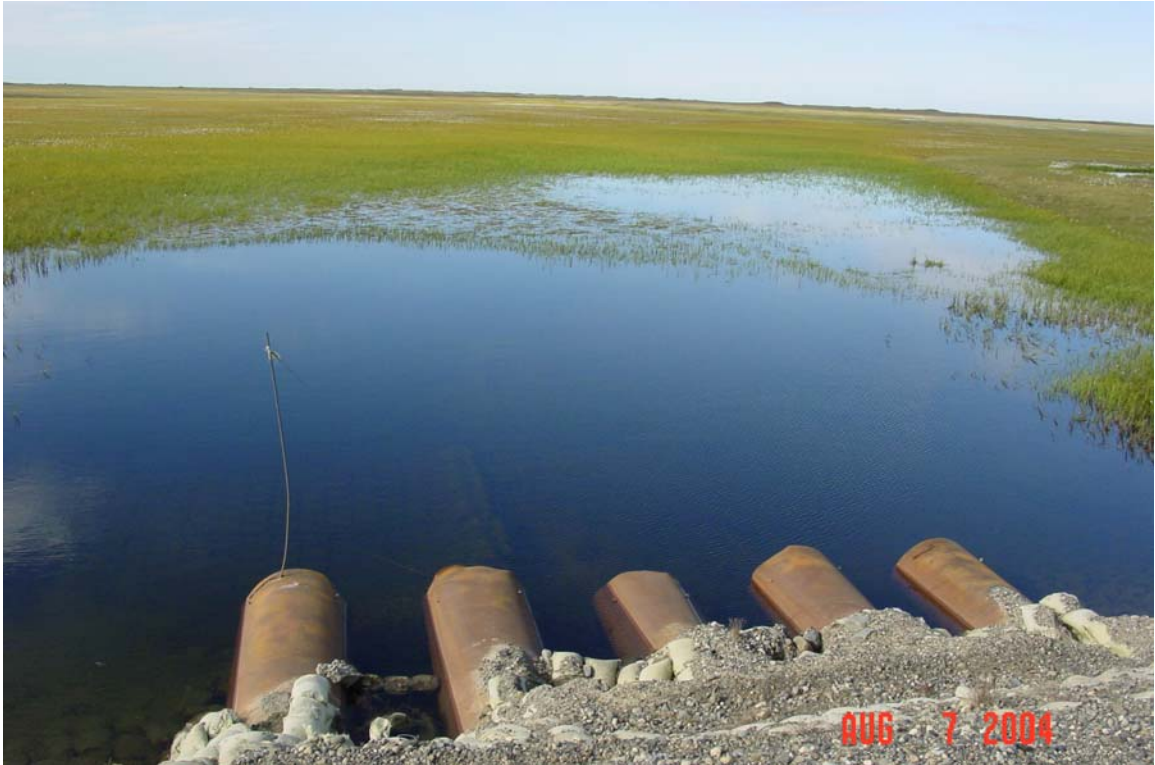
**Photograph 16. North Fork Endicott Creek downstream of road, with sand bag armor and road prism erosion.**

REMEDICATION RECOMMENDATIONS: Replace with larger culverts to increase water conveyance past this crossing

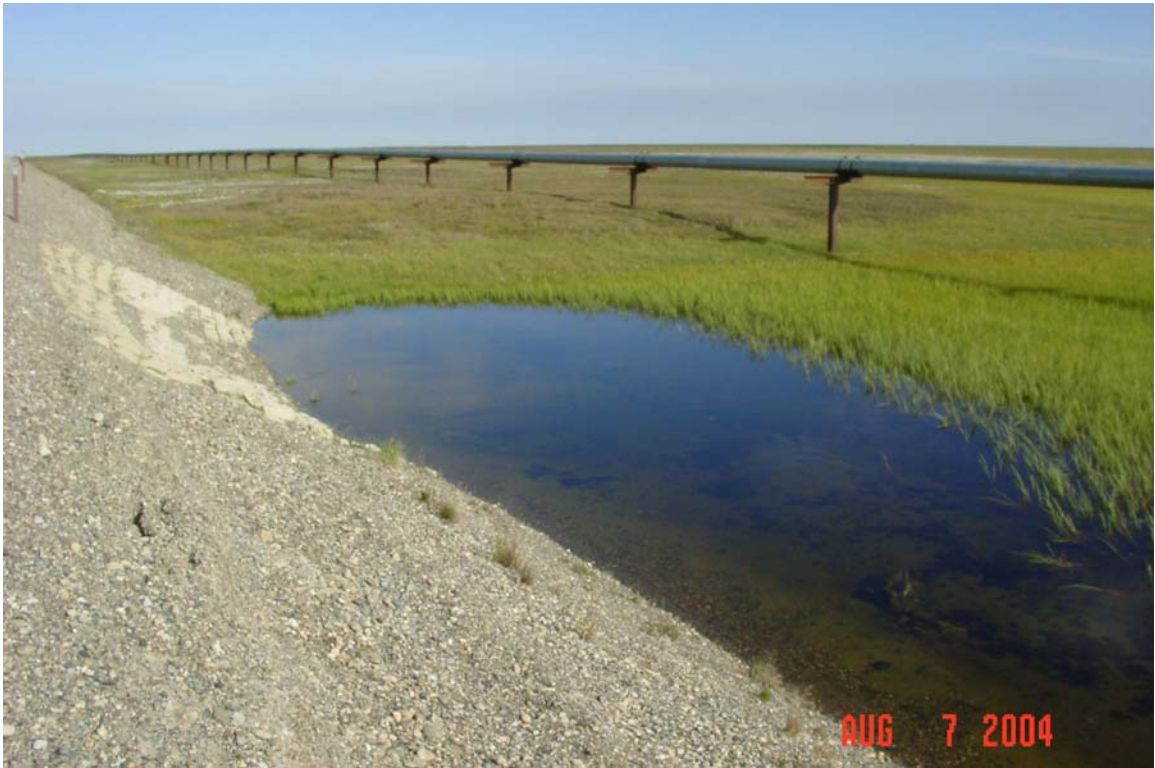
**Photograph 18. North Fork Endicott Creek looking north at submerged culvert inlets.**

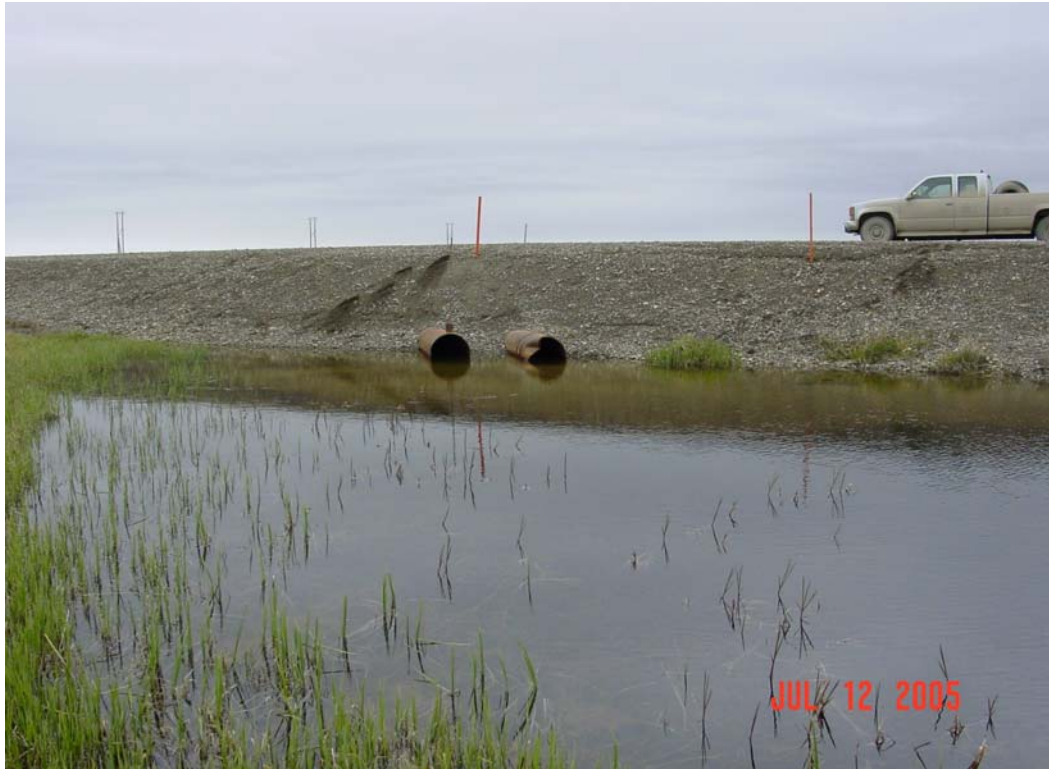
**Photograph 27. Washout Creek Tributary culvert inlets. Damage to one of the inlet pipes can be seen as well as high water mark above pipes.**

REMEDICATION RECOMMENDATIONS: Cut ends of culverts to match road  
width

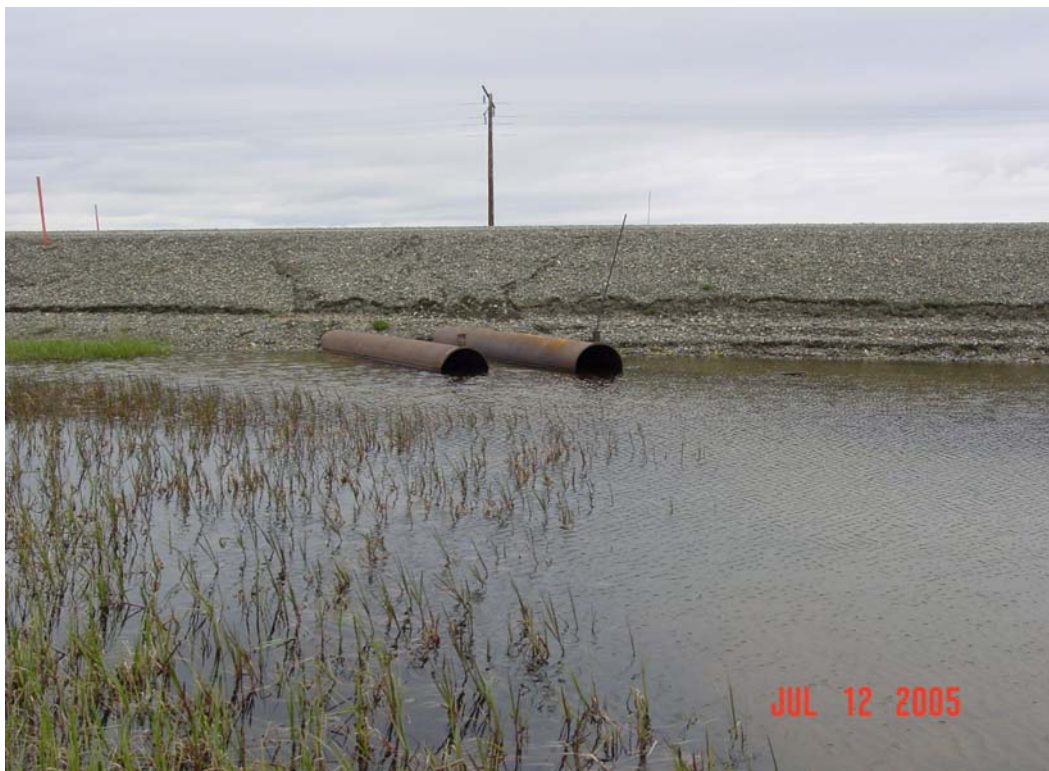
**Photograph 28. Washout Creek Tributary culvert outlets. Note highwater marks above or at top of pipe elevation.**

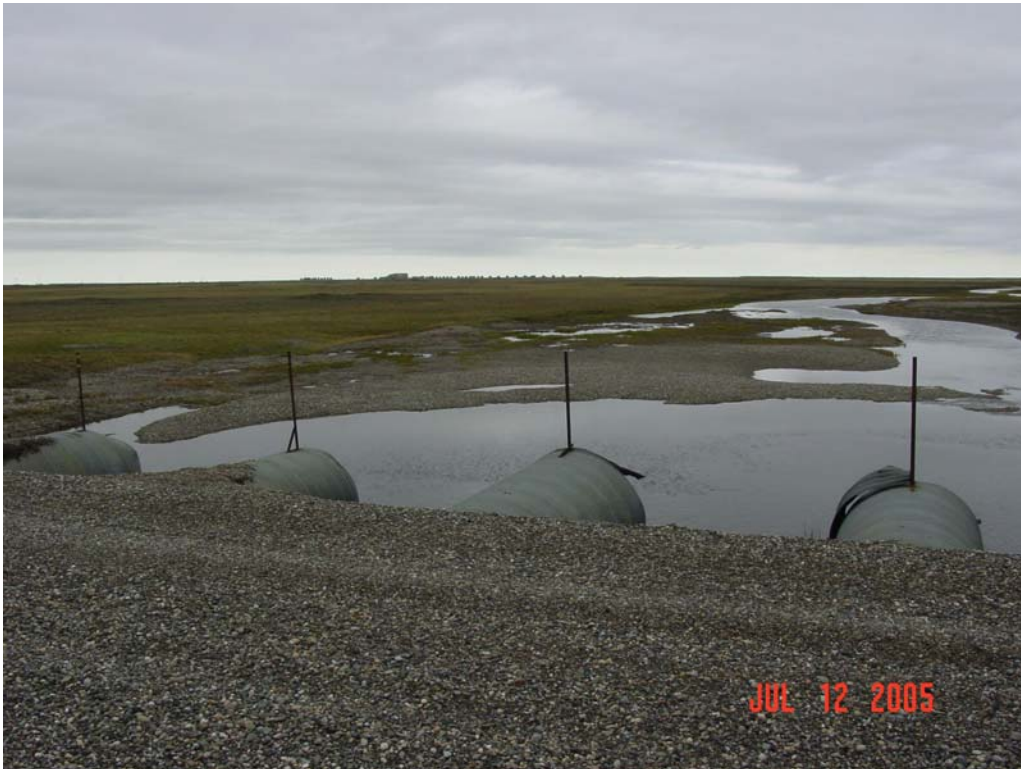
**Photograph 30. Washout Creek downstream of road. Large quantities of outwash gravel are visible.**

REMEDATION RECOMMENDATIONS: Remove outwash gravel, fix damaged pipes, increase water conveyance past this crossing with larger pipes or a bridge

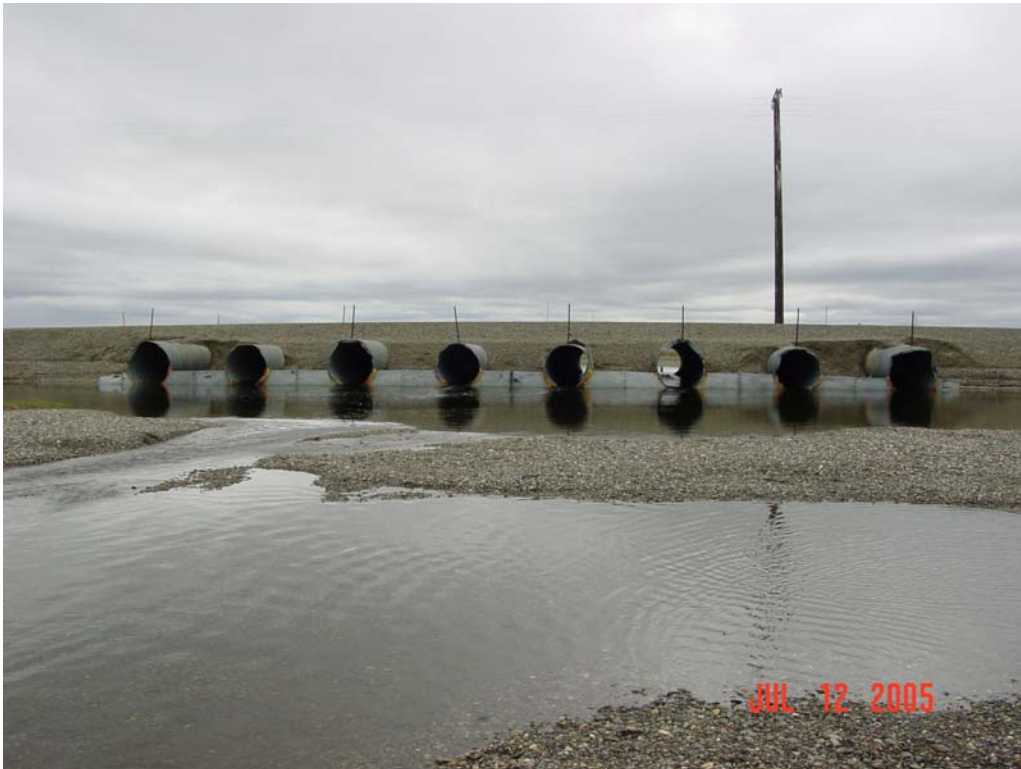
**Photograph 32. Washout Creek culvert outlets. Damage to all outlets can be observed along with significant gravel outwash and road prism erosion.**

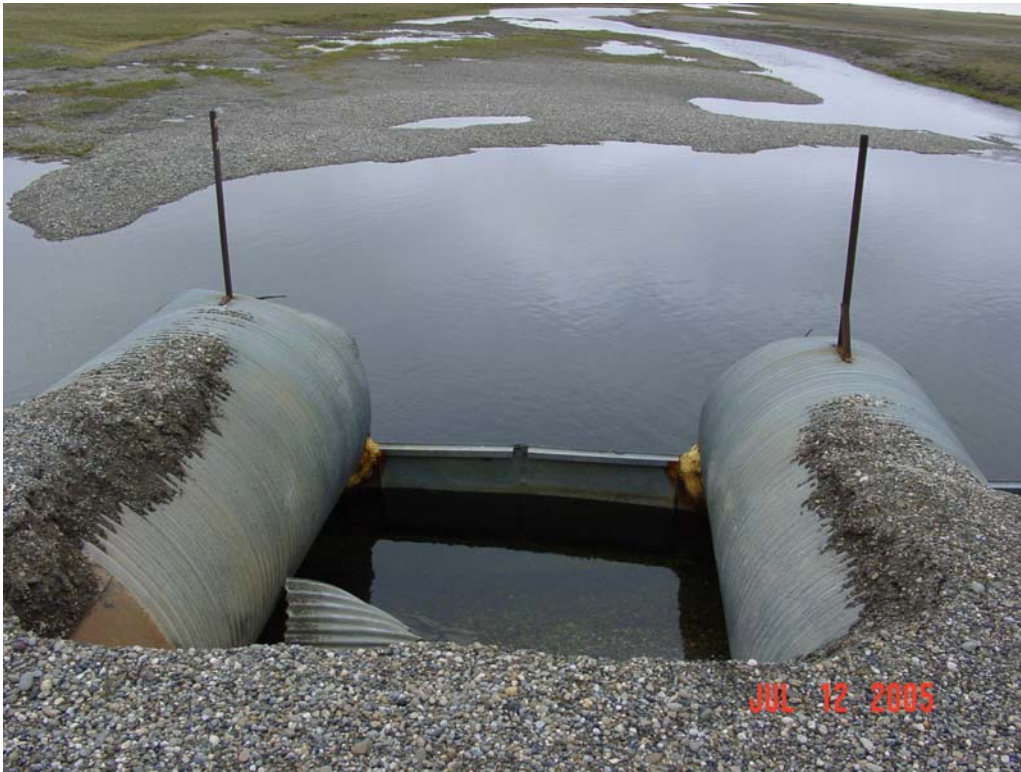
**Photograph 33. Washout Creek looking downstream at damaged culvert armoring and gravel outwash.**

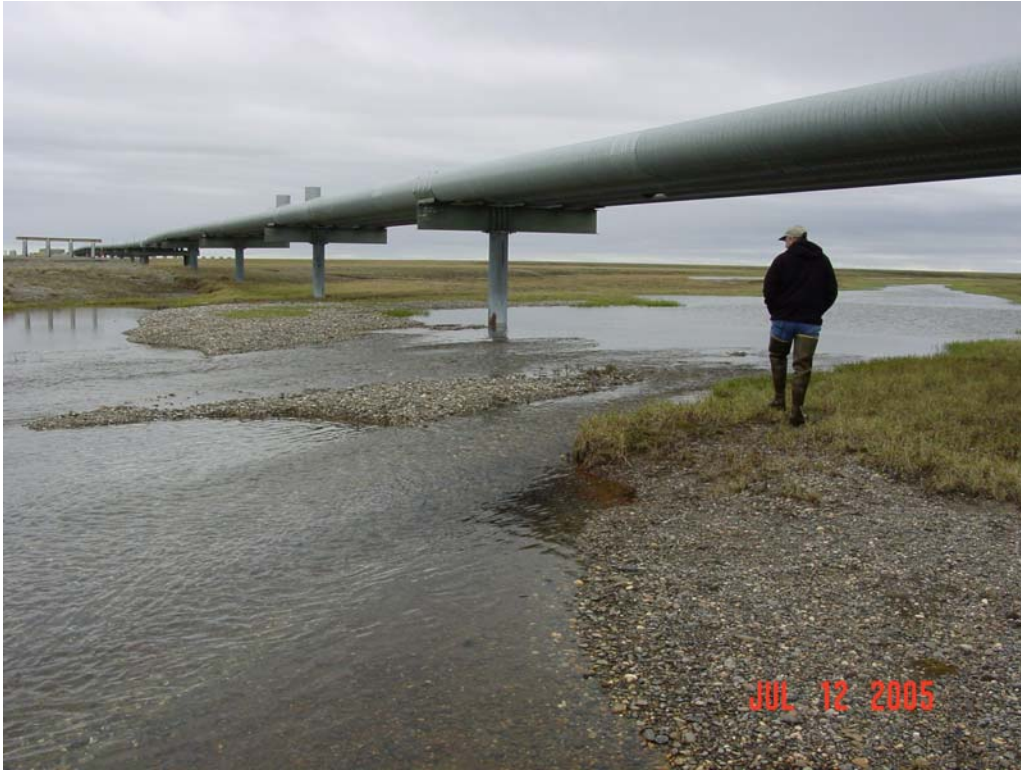
**Photograph 34. Washout Creek DS-16 work pad old low water crossing looking upstream and southeast. Excessive gravel remains in stream channel.**

REMEDICATION RECOMMENDATIONS: Remove outwash gravels

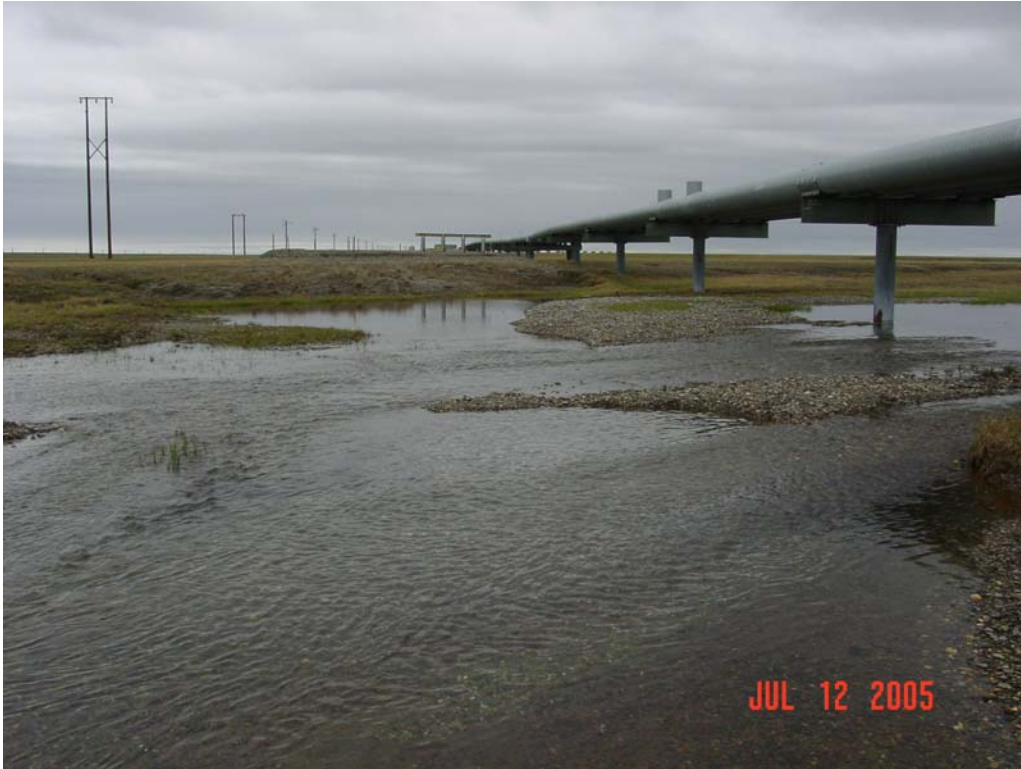
**Photograph 35. Washout Creek DS-16 work pad old low water crossing looking upstream and southeast. Gravel outwash has formed a wide shallow channel.**

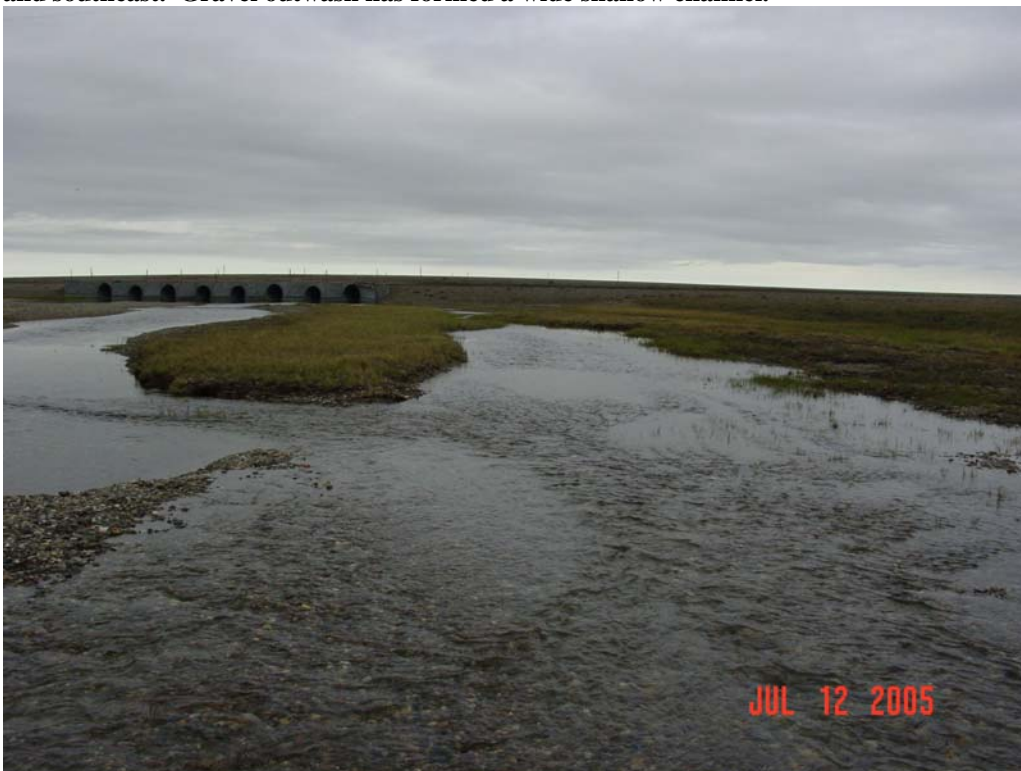
**Photograph 36. Washout Creek between old pipeline work pad low water crossing and DS-16 road looking downstream towards DS-16 road. Gravel outwash is present all the way to road crossing and has formed a shallow terraced stream channel with multiple channels.**

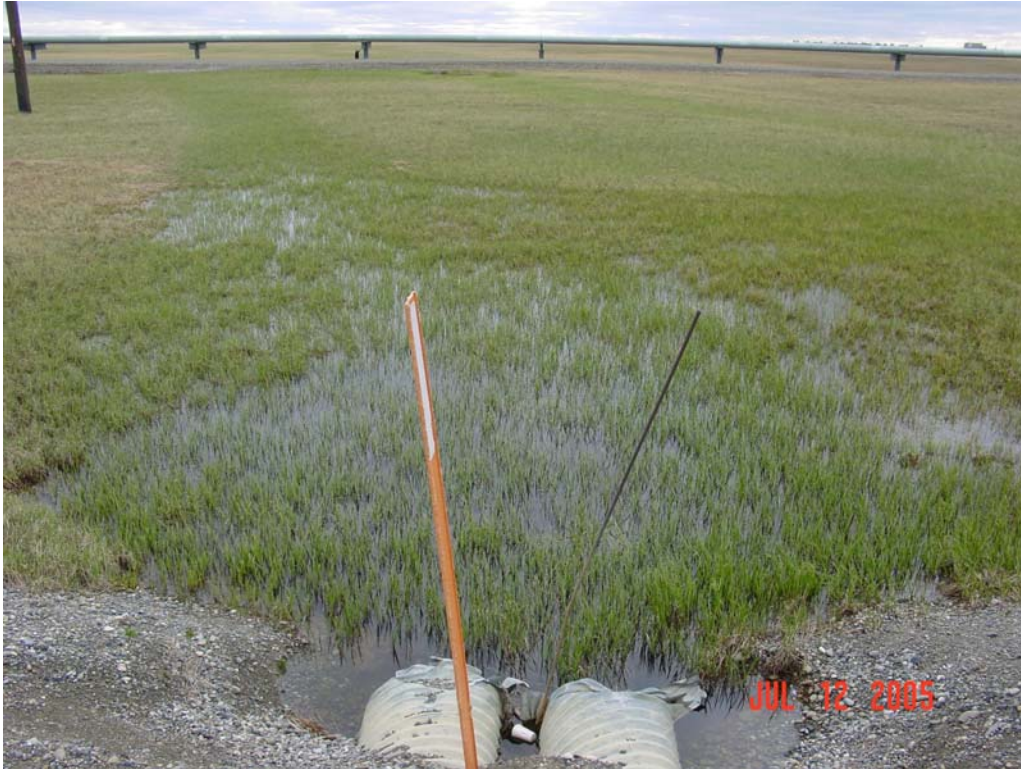
INLET: Culvert ends damaged

**Photograph 37. Unnamed Drill Site 16 Creek upstream of road. Damaged culvert inlets.**

REMEDATION RECOMMENDATIONS: Repair culvert ends, shorten pipes to match road width, replace with a single larger pipe

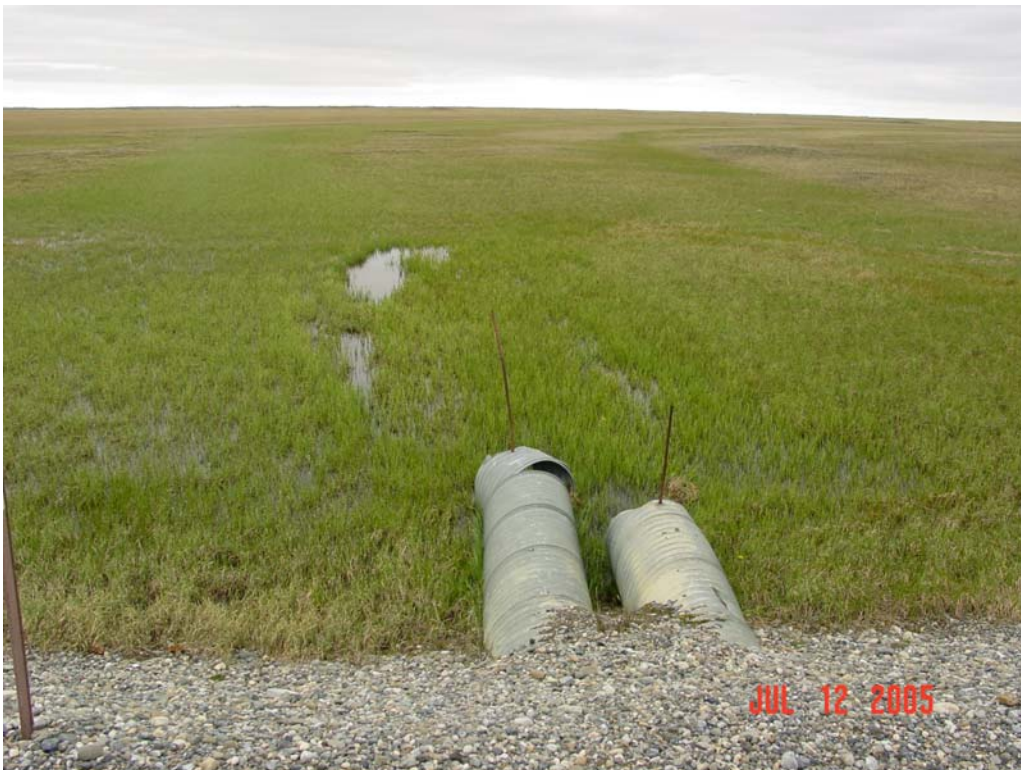
OUTLET: Culvert ends damaged

**Photograph 38. Unnamed Drill Site 16 Creek downstream of road. Damaged culvert outlets.**

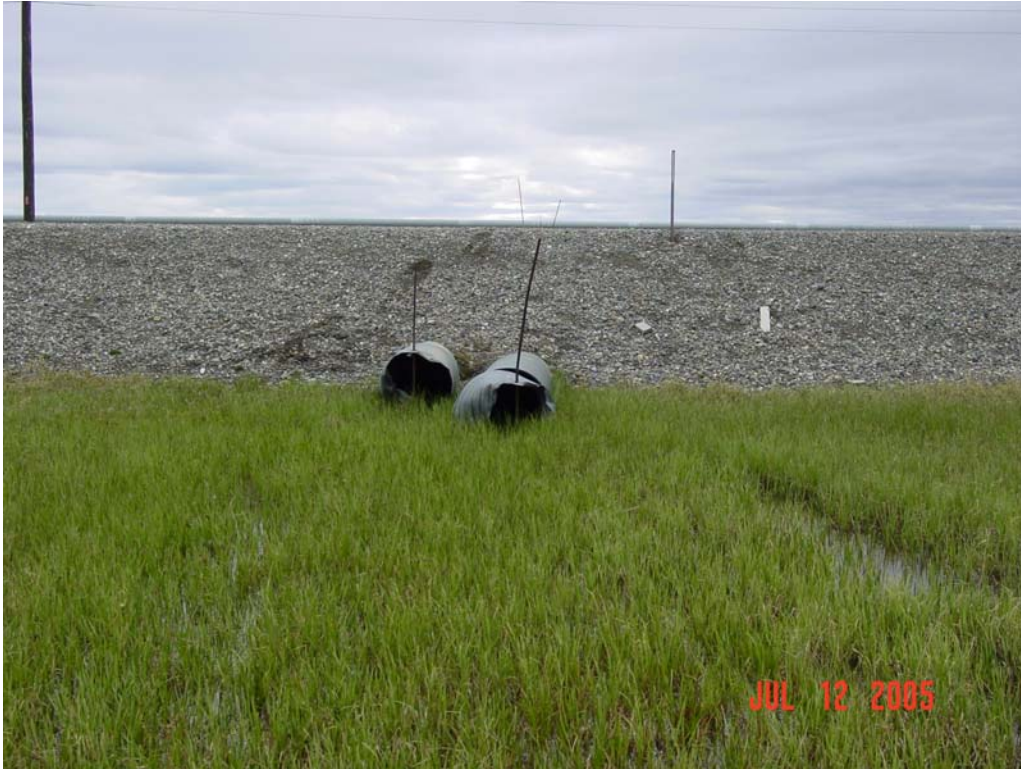
**Photograph 39. Damaged culvert outlets of an unnamed Drill Site 16 Creek.**

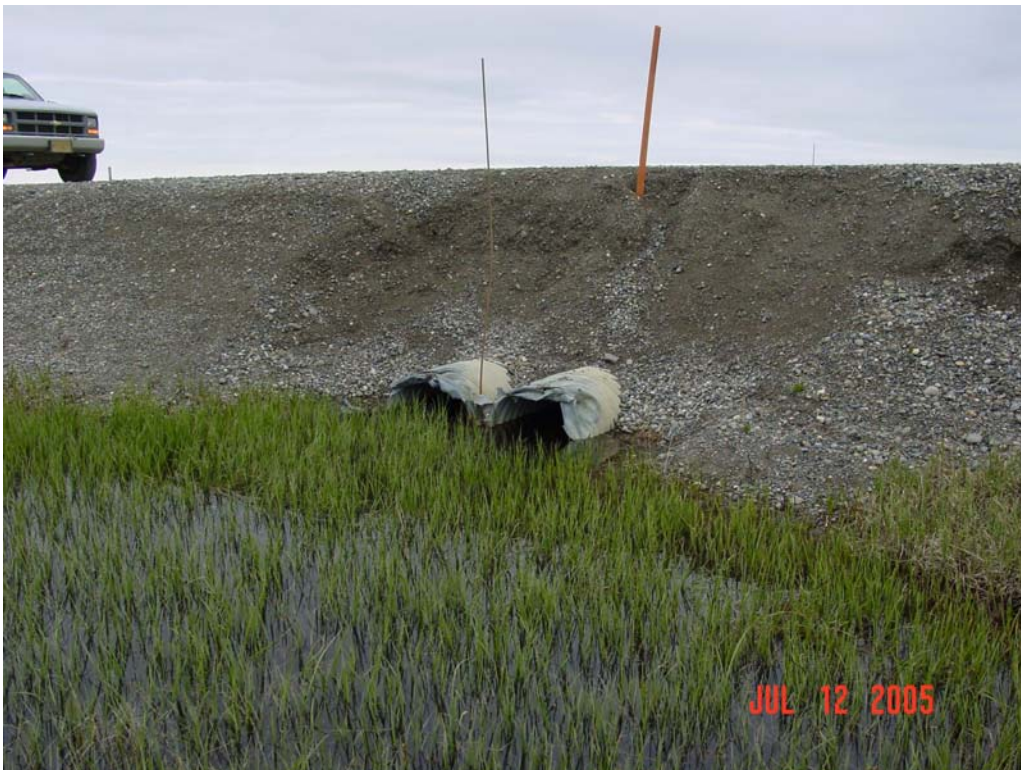
**Photograph 40. Damaged culvert inlets of an unnamed Drill Site 16 Creek.**

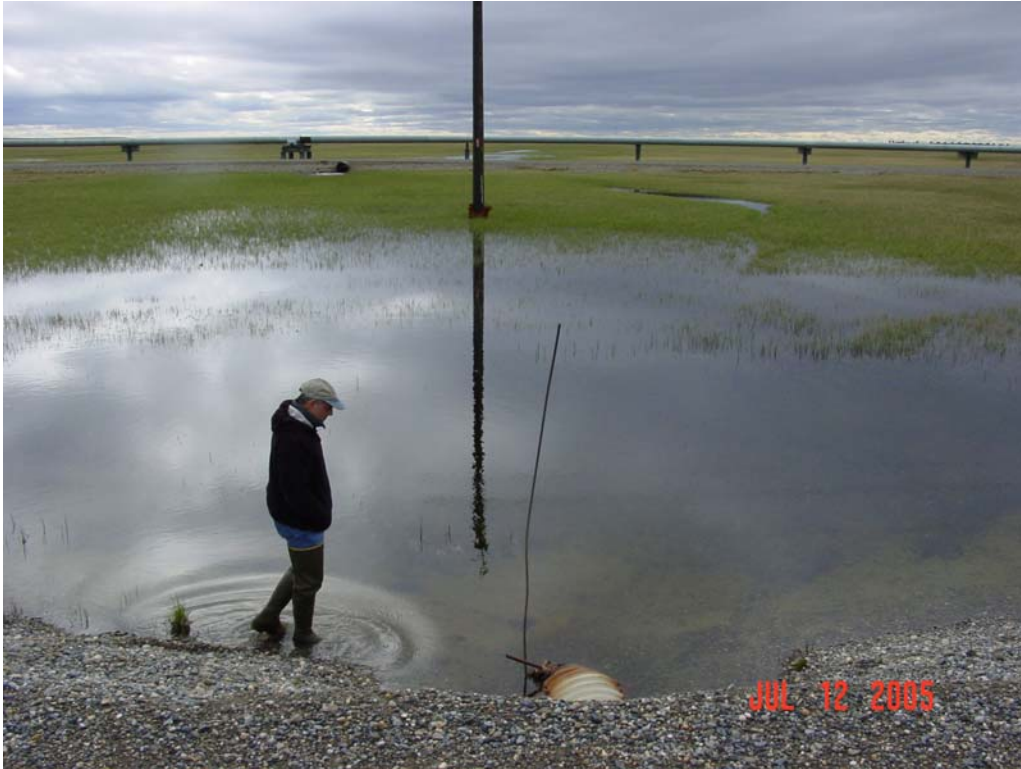
INLET: Damaged inlet partially blocking the culvert, highwater mark several feet above the pipe

**Photograph 41. Unnamed Drill Site 16 Creek upstream of road. Culvert inlet is partially blocked.**

REMEDATION RECOMMENDATIONS: Culvert is severely undersized. Increase water conveyance past this location

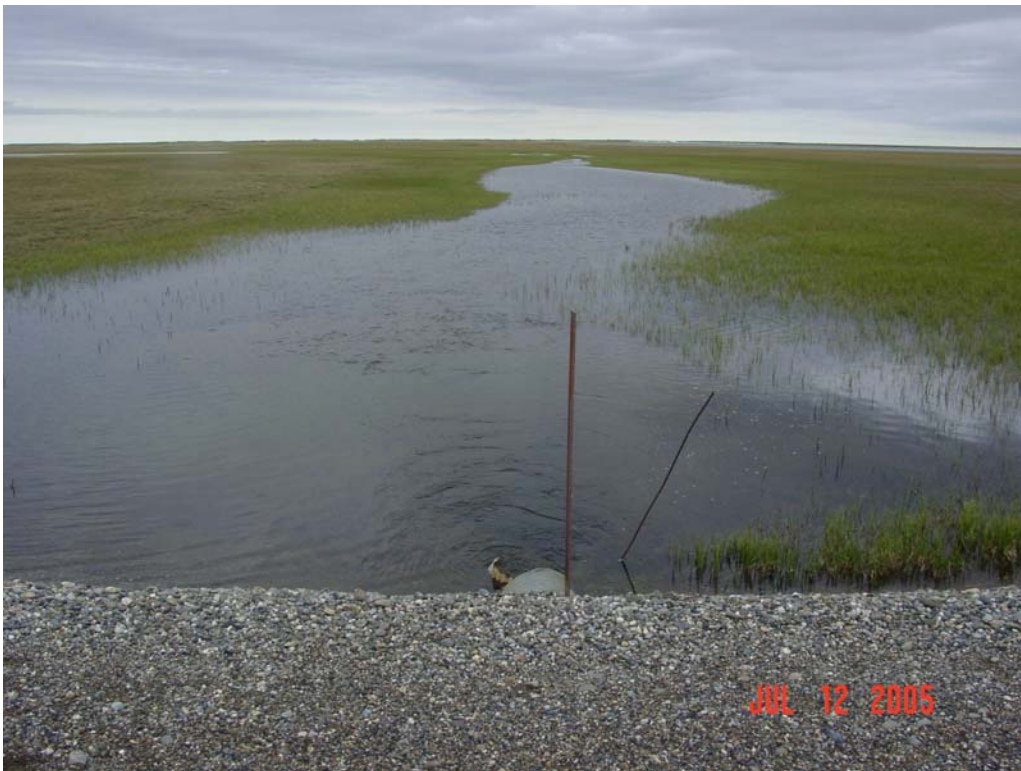
OUTLET: Damaged outlet

**Photograph 42. Unnamed Drill Site 16 Creek downstream of the road. Damage to culvert outlet can be observed. Significant flow was present in this creek at the time of inspection**

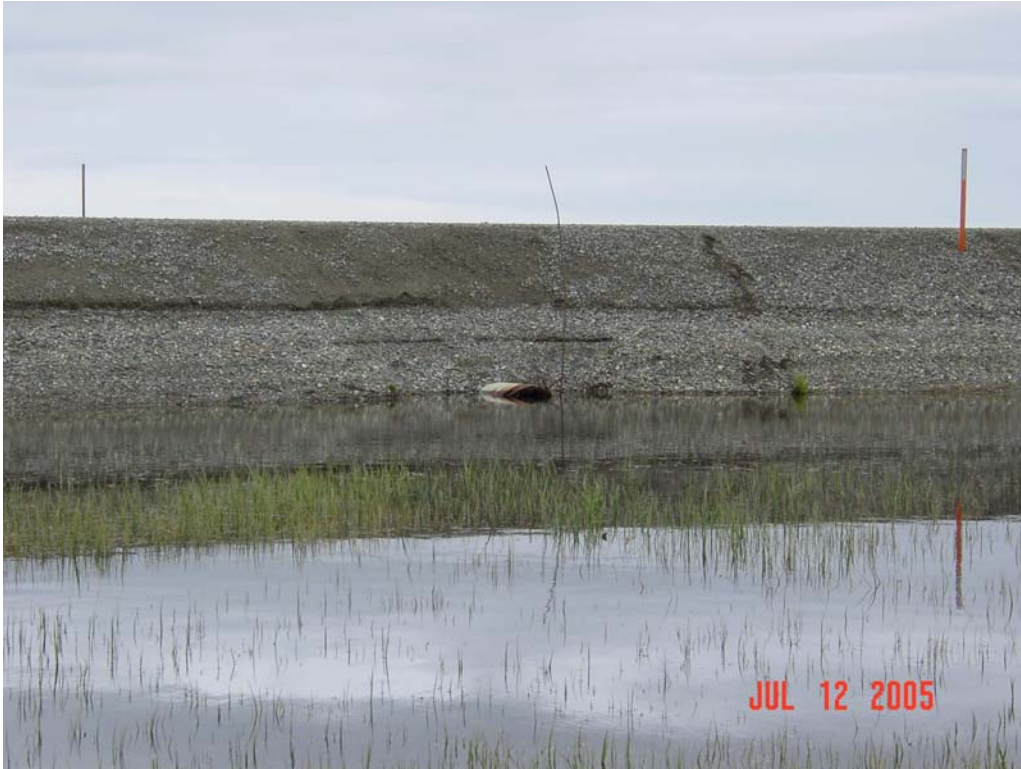
**Photograph 43. Unnamed Drill Site 16 Creek culvert inlet. Highwater mark can be observed significantly above the culvert inlet.**
