**Technical Report No. 08-01**

## **A SURVEY OF STREAM CROSSING STRUCTURES IN THE NORTH SLOPE OILFIELDS**

**by William A. Morris  
and Jack F. Winters**

**February 2008**

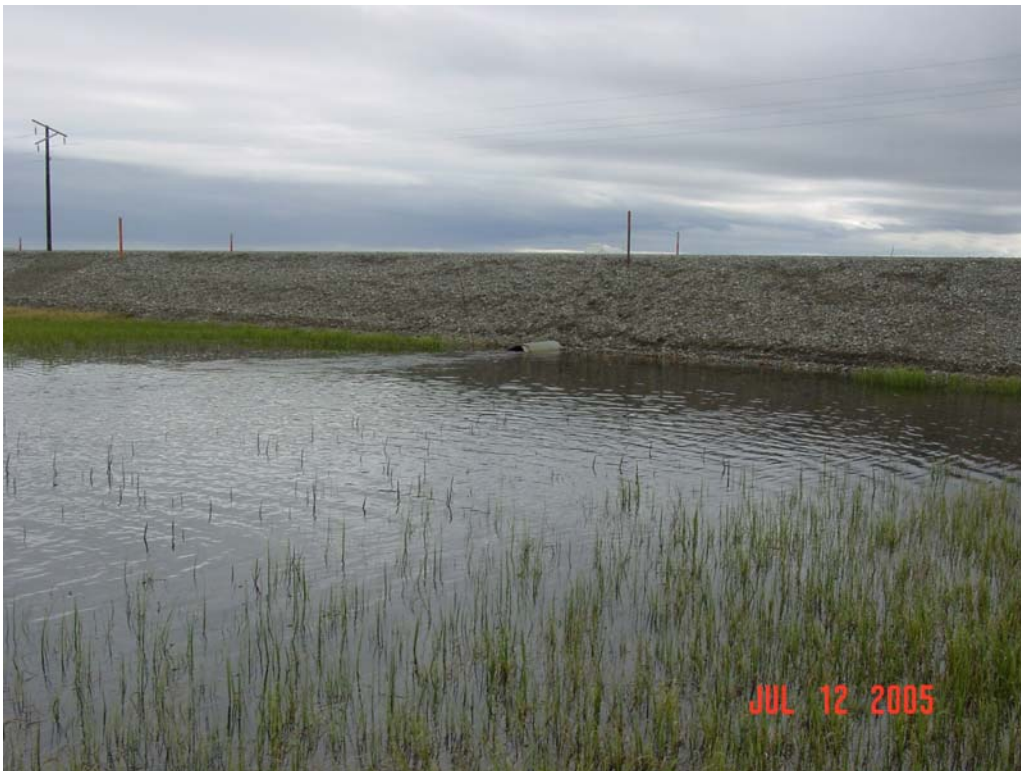
**Photograph 44. Unnamed Drill Site 16 Creek culvert outlet. Highwater mark is present above outlet.**

REMEDATION RECOMMENDATIONS: Culvert is severely undersized. Increase water conveyance past this location

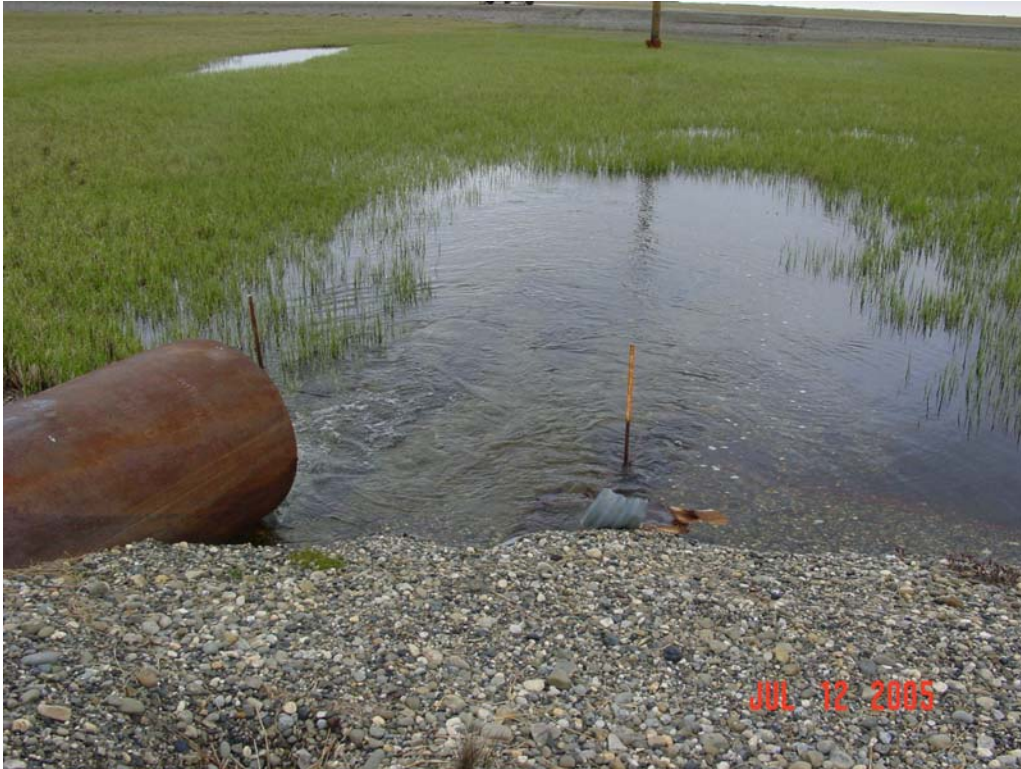
OUTLET: 18 inch culvert damaged; 36 inch pipe perched

**Photograph 45. Unnamed Drill Site 16 Creek downstream of the work pad crossing. Damage to the corrugated pipe can be seen along with significant flow from the perched smooth wall pipe.**

REMEDATION RECOMMENDATIONS: Remove crossing or reset 36 inch smooth wall pipe to eliminated the perched condition and replace 18 inch culvert, match length to workpad width.

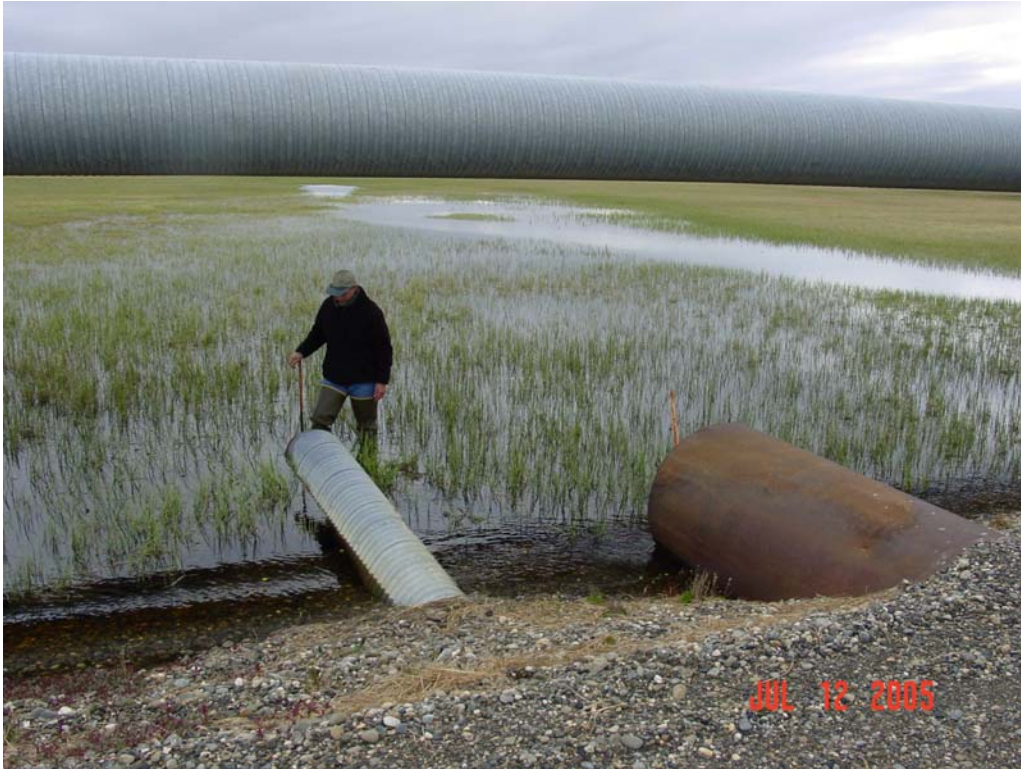
**Photograph 46. Significant ponding of the Unnamed Drill Site 16 Creek upstream of the work pad crossing.**

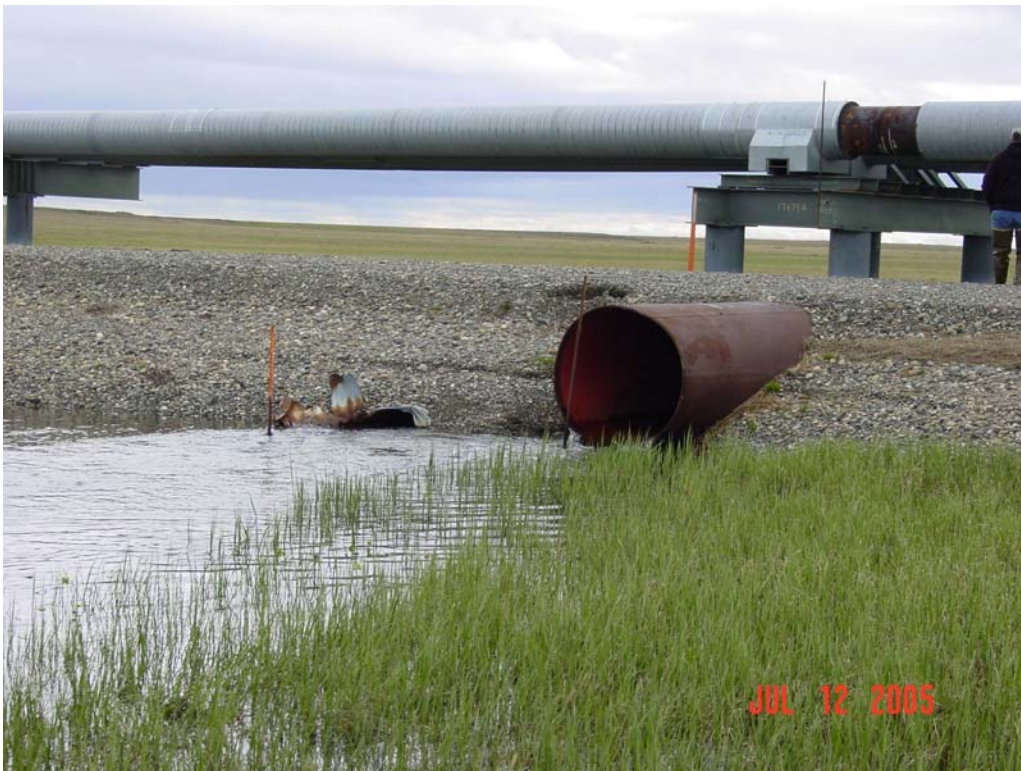
**Photograph 47. Unnamed Drill Site 16 Creek culvert outlets at the work pad crossing. Note the damaged to corrugated pipe and the perched smooth wall pipe.**

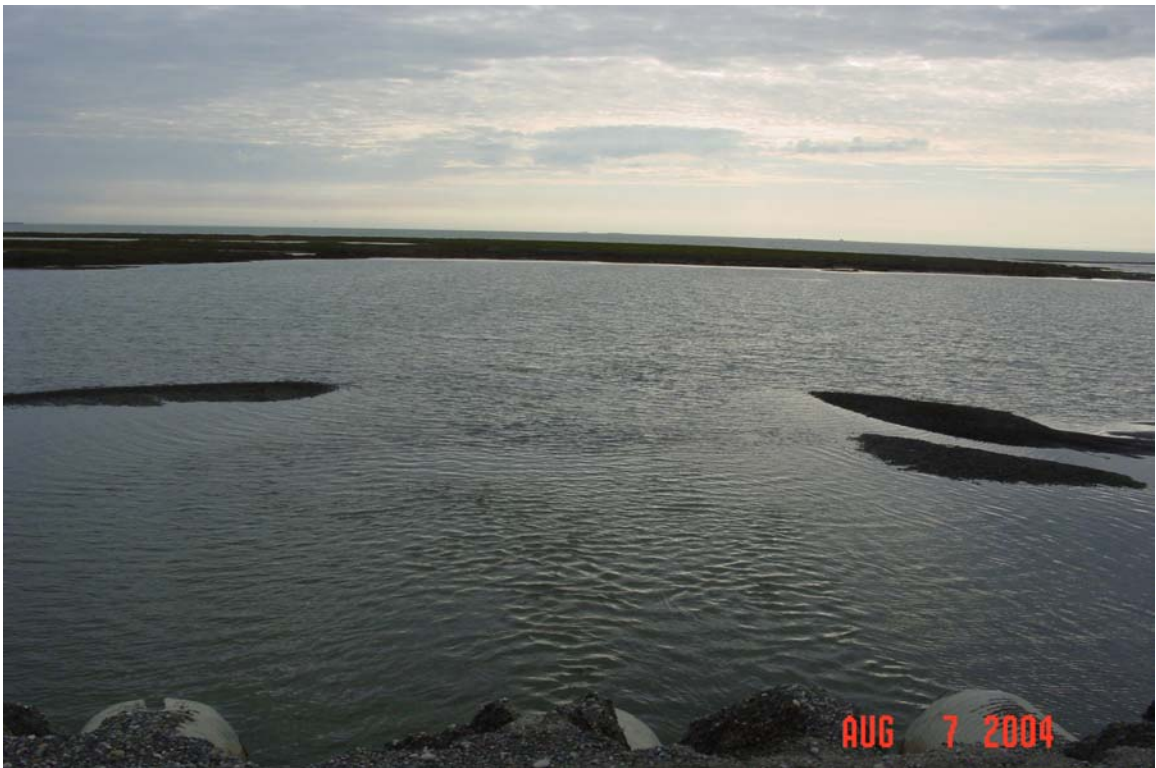
OUTLET: Significant scour and outwash gravels, significant road prism erosion, minor culvert outlet damage

**Photograph 56. LGI Estuary Creek downstream of the road, with extensive gravel outwash.**

REMEDICATION RECOMMENDATIONS: Repair road damage, increase water conveyance past this location

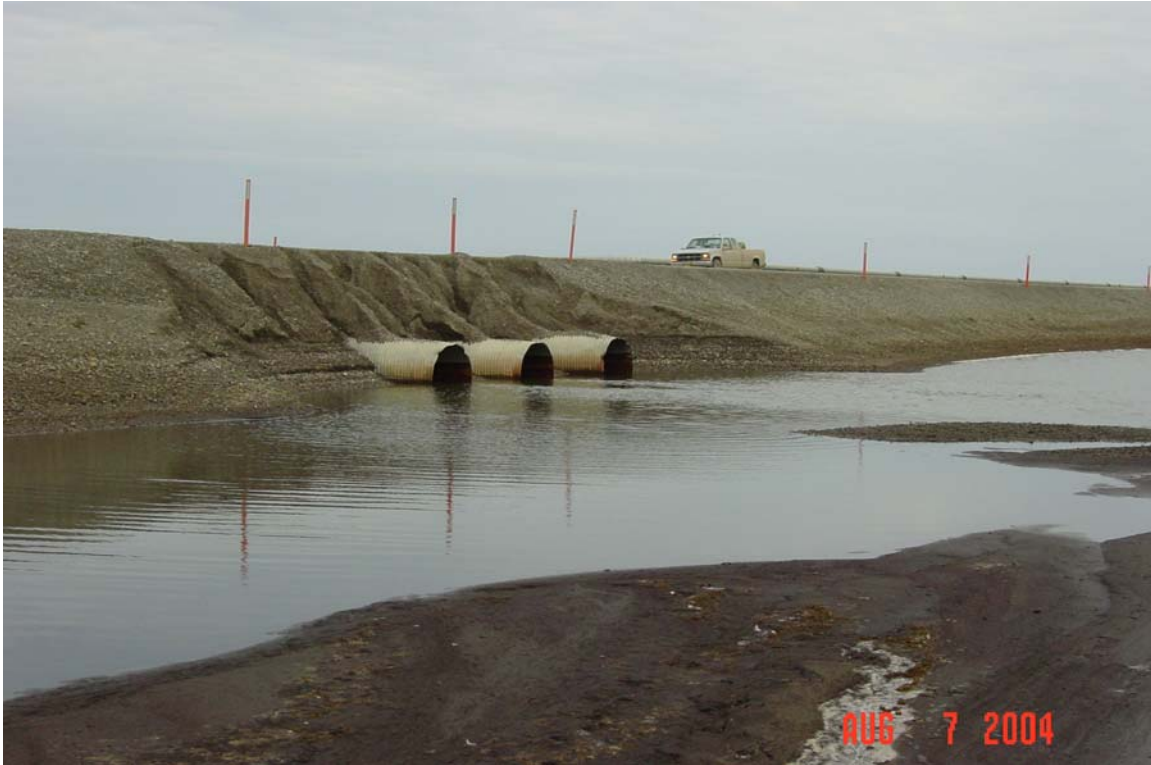
**Photograph 57. LGI Estuary Creek culvert outlets, with significant gravel outwash and road prism erosion.**

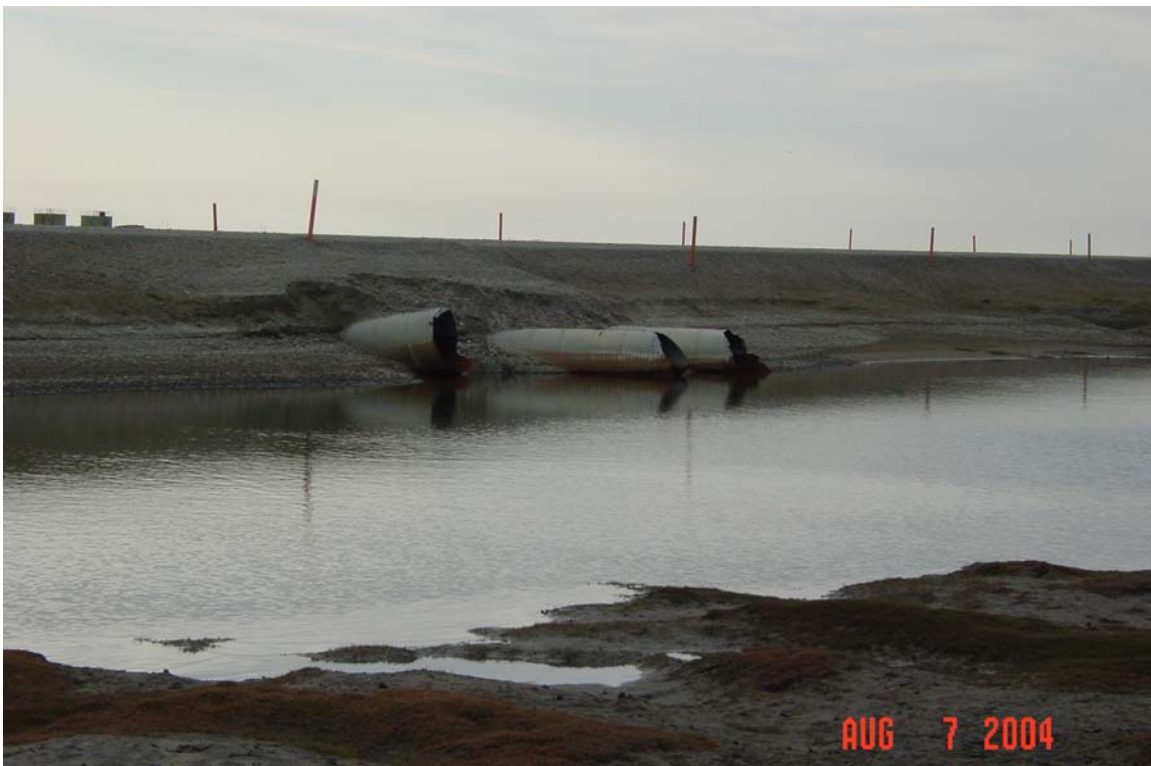
INLET: Minor inlet damage, one inlet elevated, significant scour and road prism erosion

**Photograph 58. LGI Estuary Creek culvert inlets. Significant road prism erosion can be seen as well as severe damage to some culverts. High water mark is above pipes.**

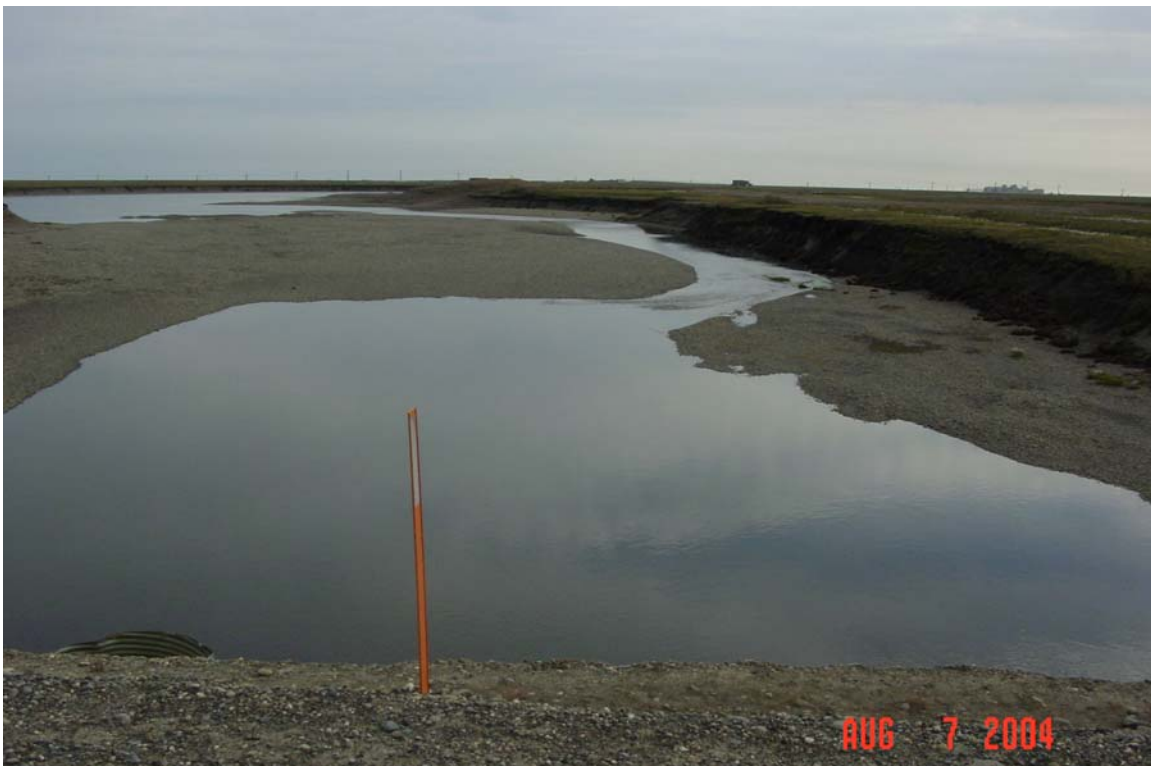
**Photograph 60. Putuligayuk River downstream of the Drill Site 15 Road. A large volume of outwash and residual gravel is present, as is an actively eroding riverbank.**

REMEDICATION RECOMMENDATIONS: Increase water conveyance past the site or  
install a bridge; remove inlet gravel bar; remove extensive outwash gravels

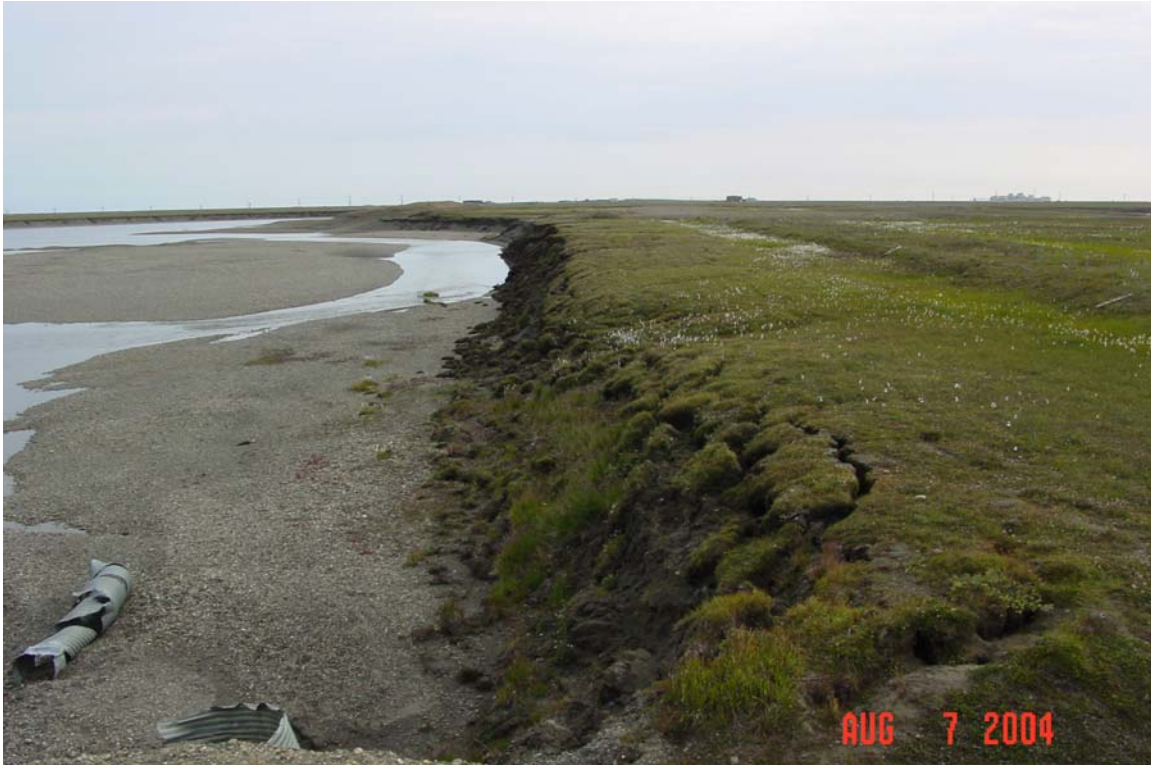
**Photograph 61. Putuligayuk River downstream of the Drill Site 15 Road. Actively eroding tundra banks and debris are present on the downstream side of the crossing.**

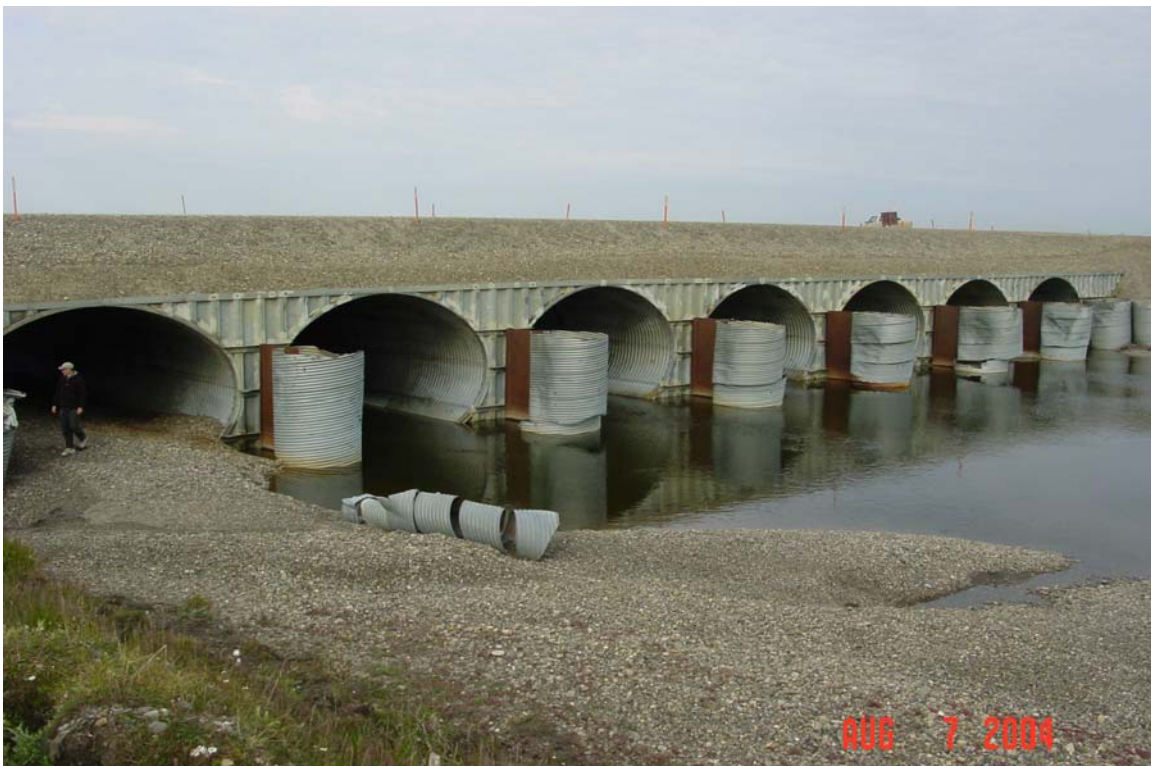
**Photograph 62. Putuligayuk River culvert outlets, with gravel outwash, debris and culvert armor damage.**

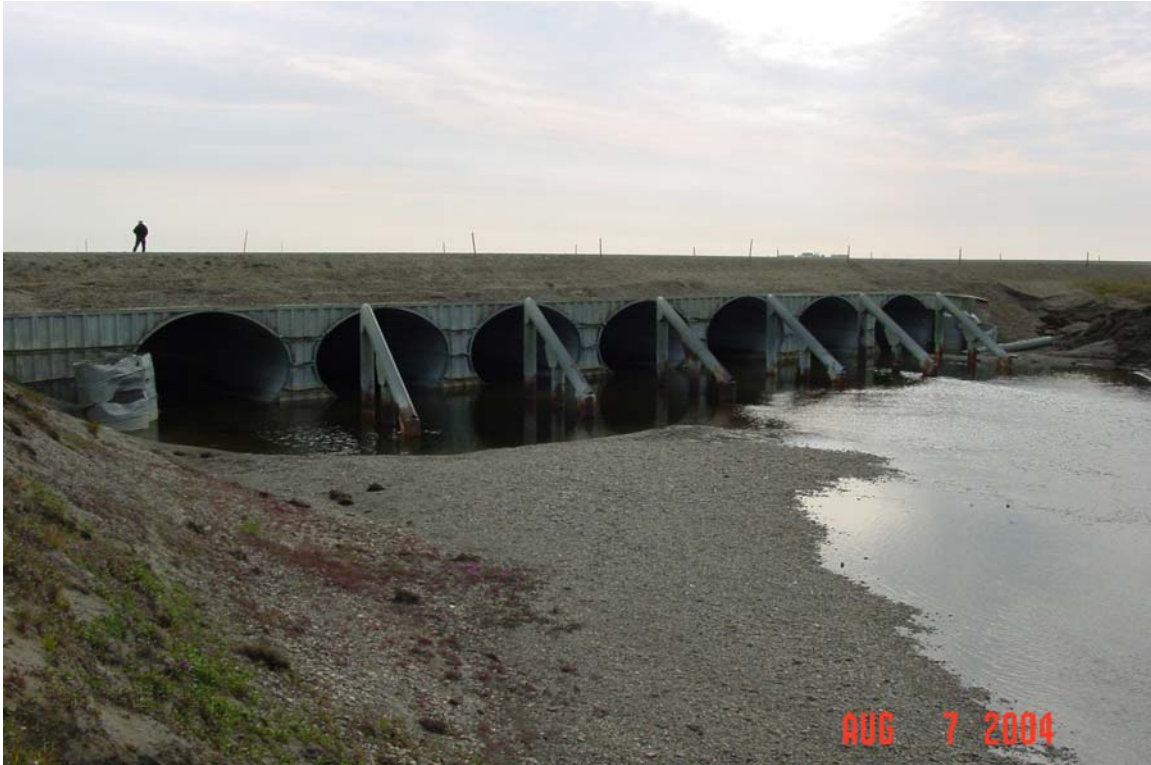
**Photograph 63. Putuligayuk River culvert inlets at the Drill Site 15 road. Damage to armor, bank erosion, and gravel deposition from scour can be seen. A washed out culvert can also be observed in the stream channel.**

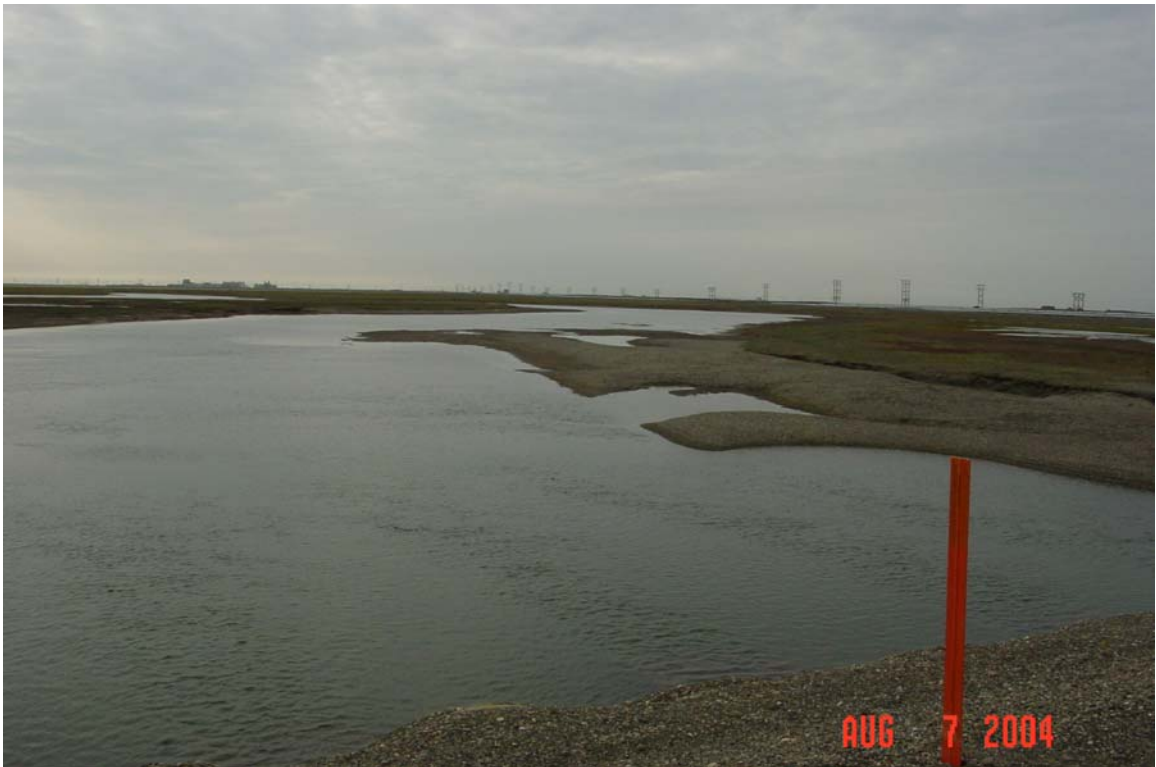
**Photograph 65. Putuligayuk River downstream of the West Dock Road. Extensive outwash gravels are present downstream.**

REMEDIATION RECOMMENDATIONS: Remove outwash gravels, increase water conveyance past this crossing

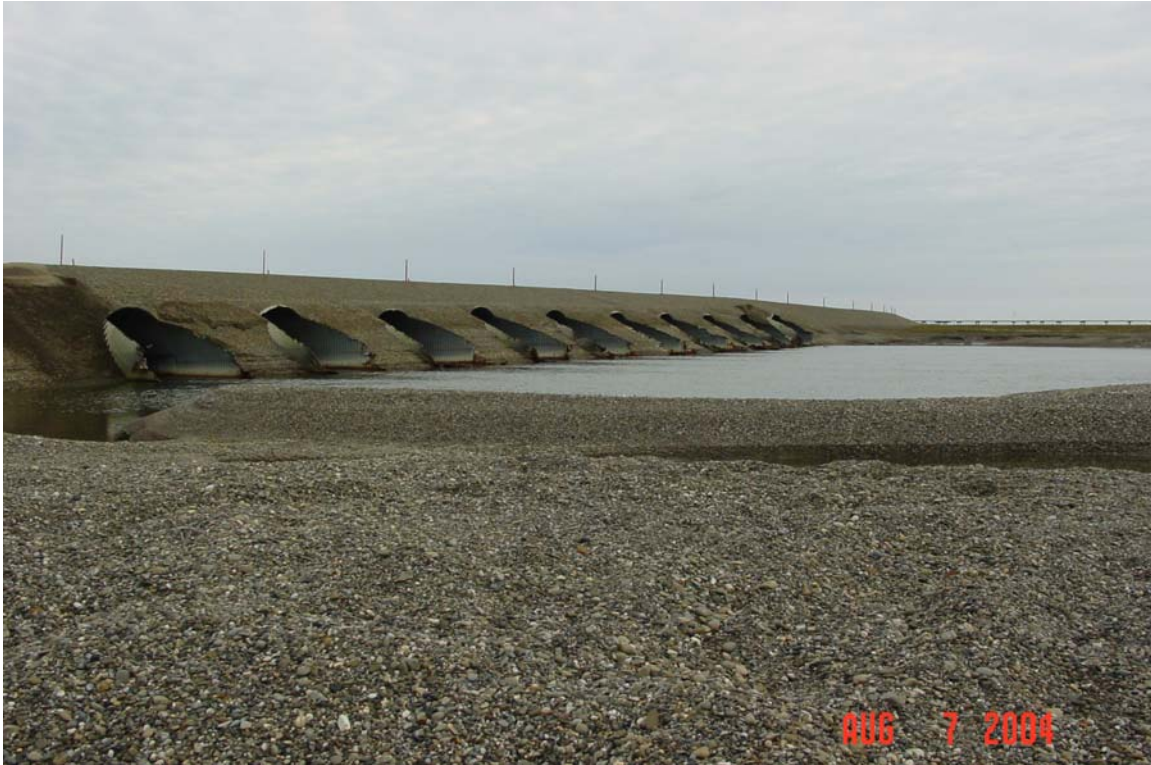
**Photograph 66. Putuligayuk River looking at the downstream side of crossing. Damage to outlets, significant gravel outwash and road prism erosion is evident.**

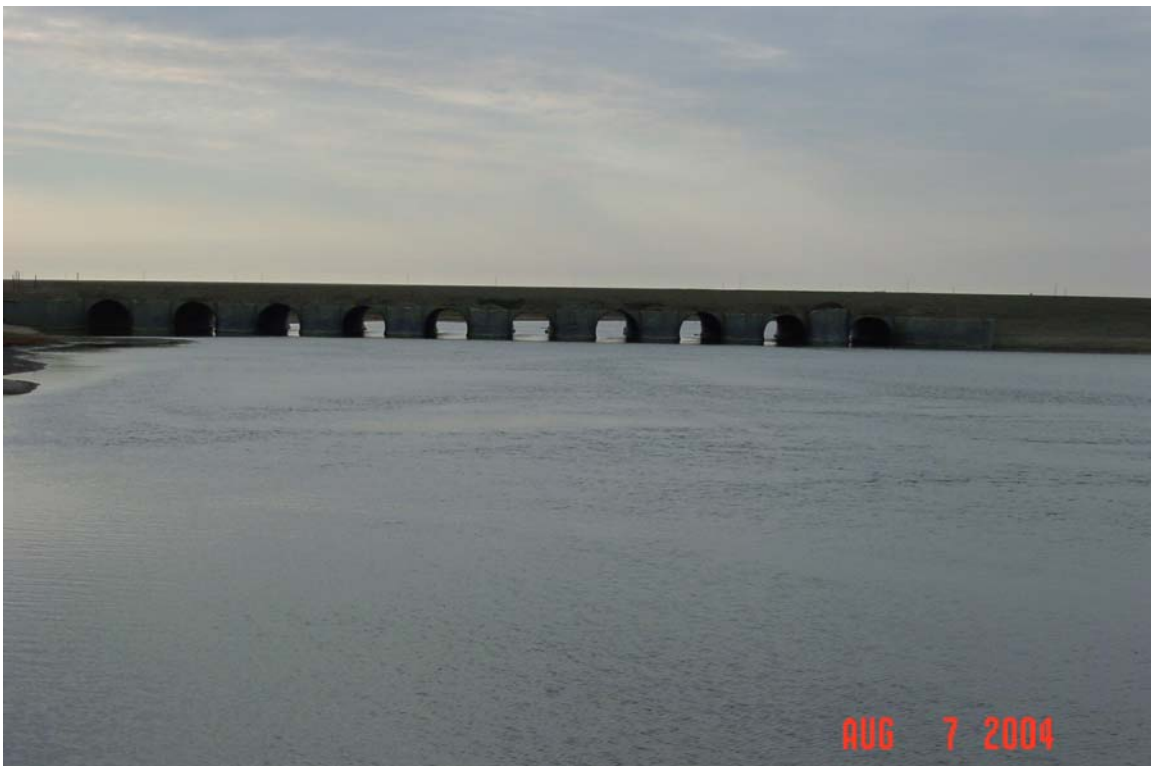
**Photograph 67. Putuligayuk River looking at the upstream side of the road crossing. Damage to armor and upstream gravel deposition can be seen.**

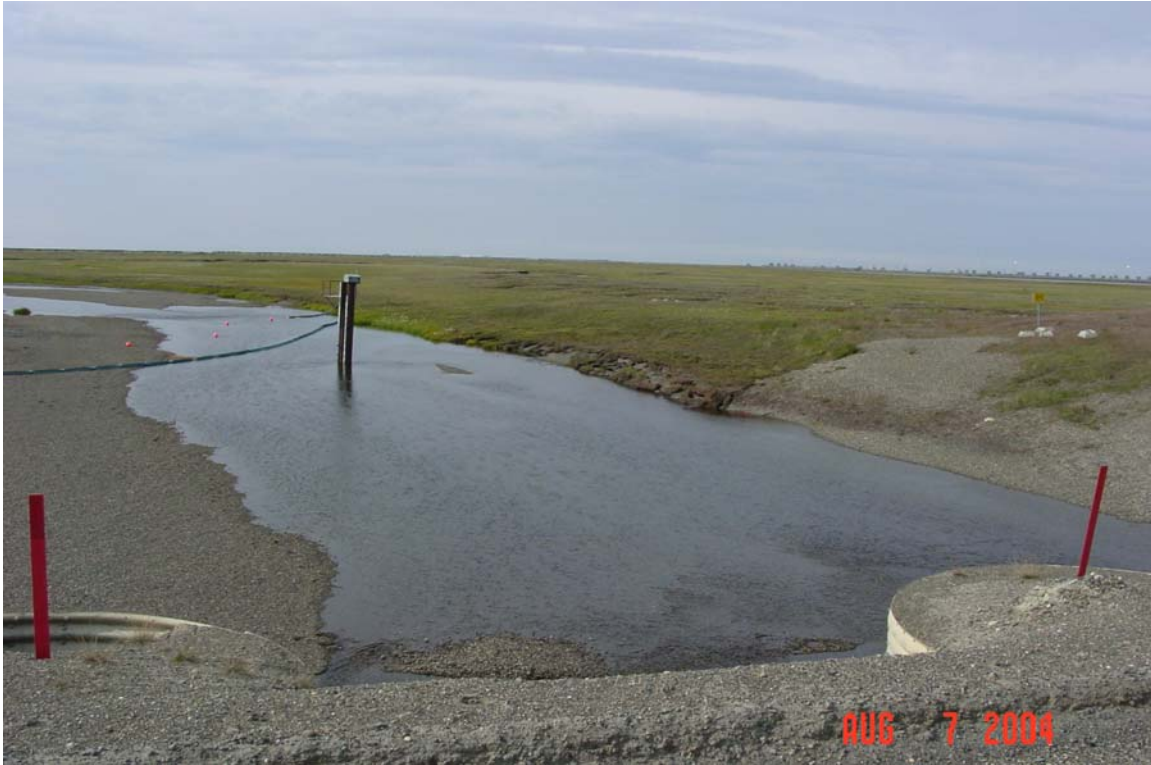
**Photograph 68. Putuligayuk River upstream of the Spine Road Crossing. Upstream gravel deposition (accretion) can be observed as well as some tundra erosion.**

REMEDIATION RECOMMENDATIONS: Installing a bridge at this location is the preferred remediation. Alternatively, remove part or all of the downstream gobi mat and establish a deeper channel to ensure fish passage at low flows.

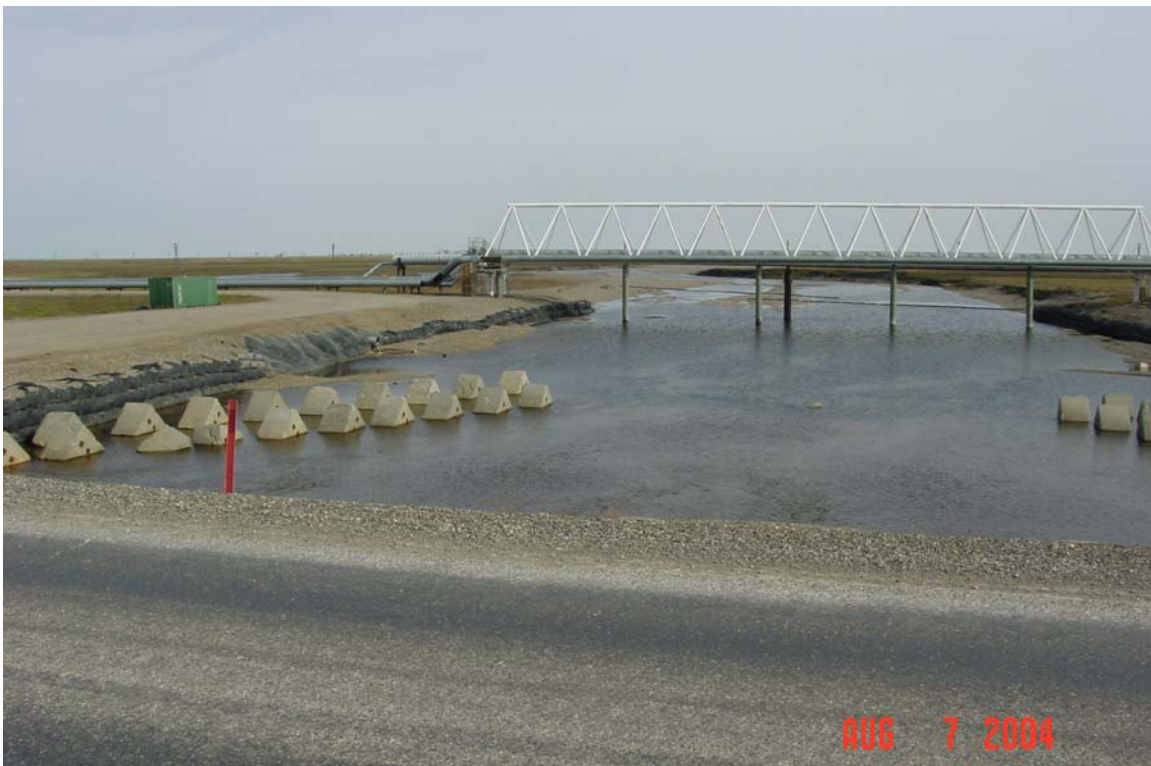
**Photograph 69. Putuligayuk River downstream of the Spine Road crossing. Wide Gobi mat apron, Dragon's Teeth, gabion baskets, failing erosion protection and gravel outwash can be seen.**

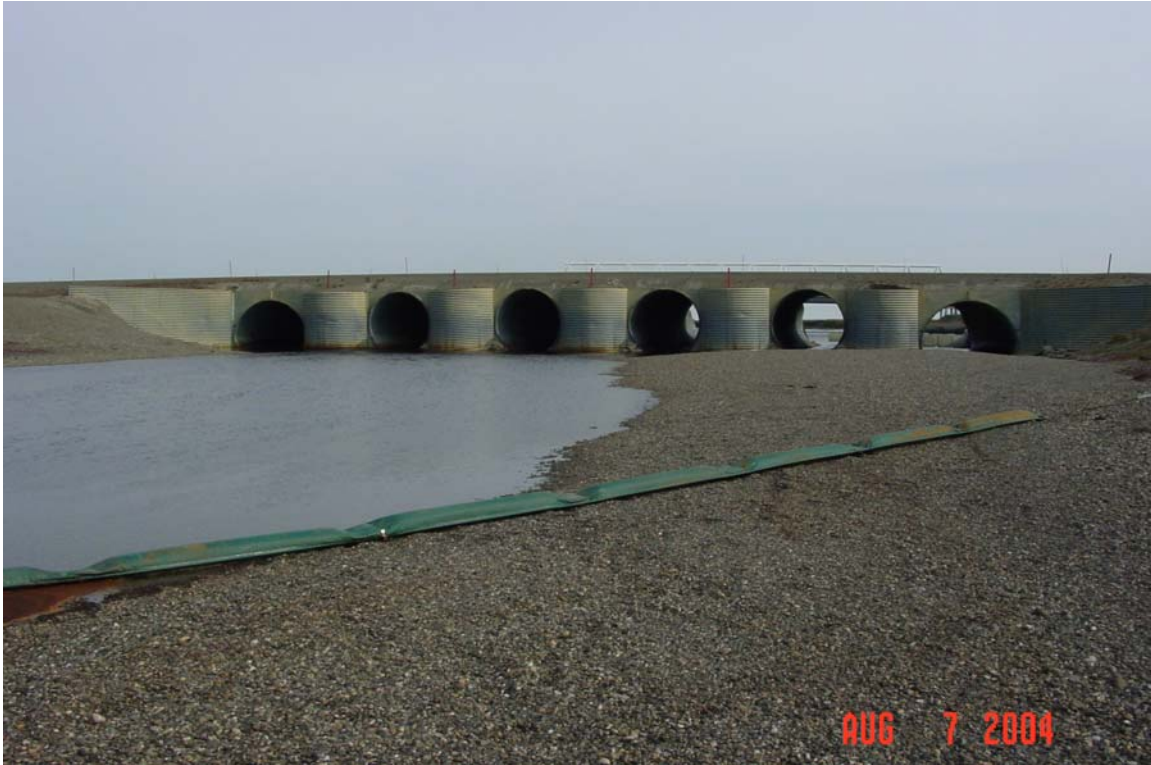
**Photograph 70. Putuligayuk River culvert inlets at the Spine Road. Gravel deposition can be observed.**

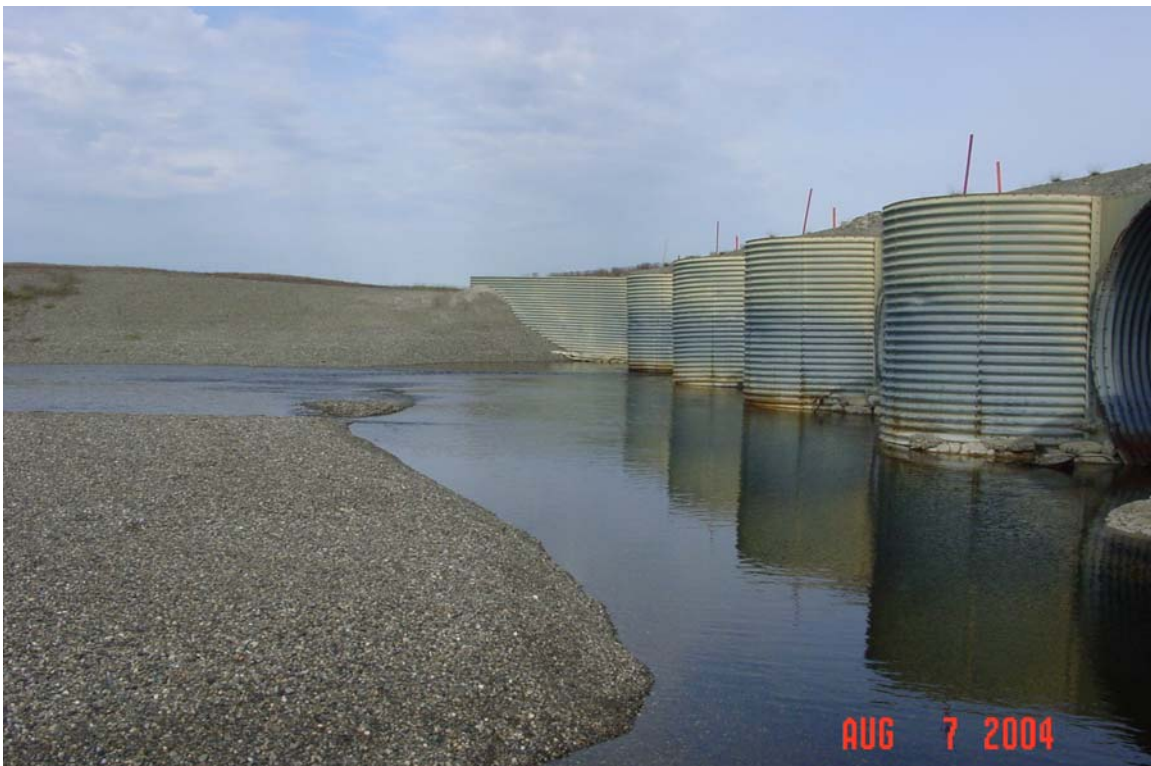
**Photograph 71. Putuligayuk River culvert inlets, with extensive gravel bars at the inlets and scour immediately upstream of the culverts.**

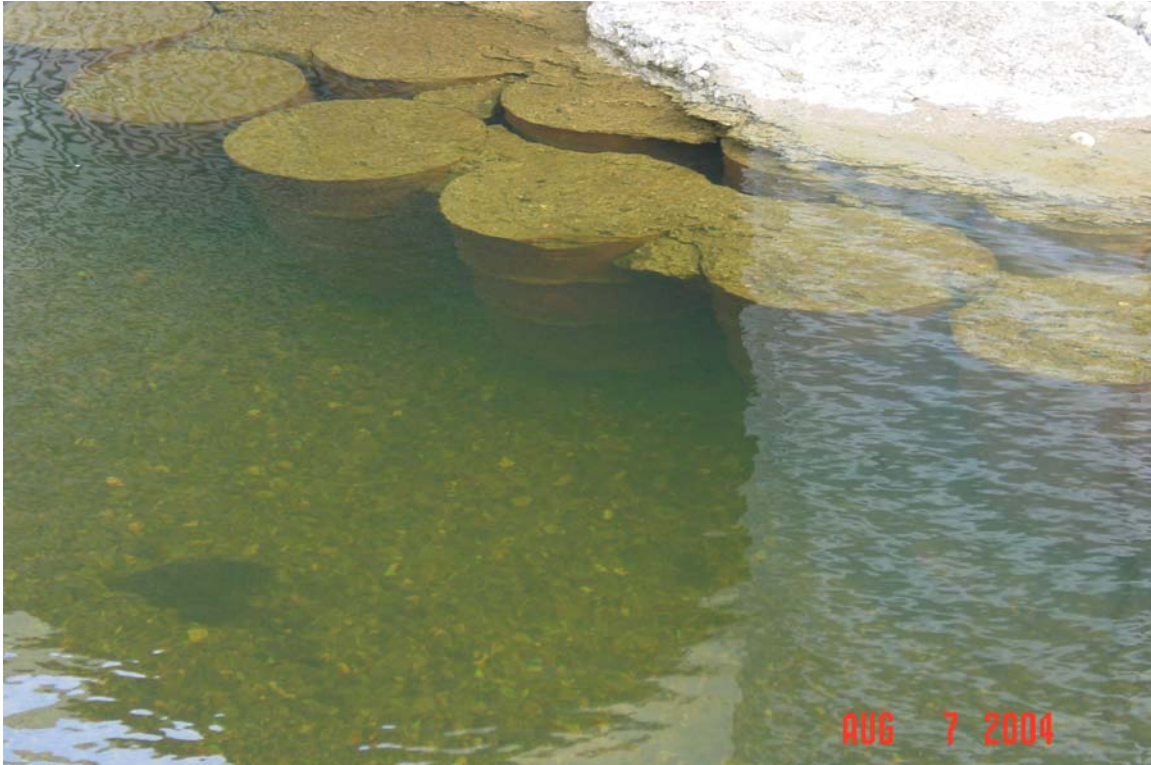
**Photograph 72. Concrete-filled barrel armor has been undercut by scour at the inlets to the Putuligayuk River Spine Road culverts.**

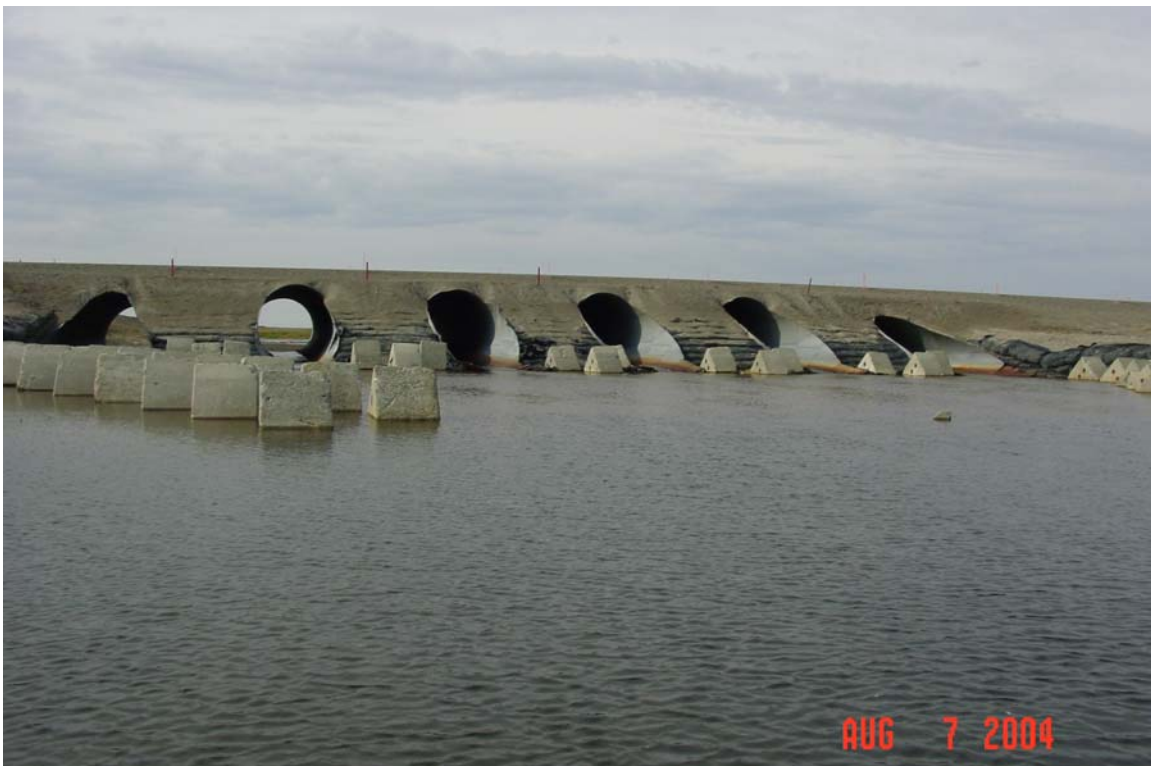
**Photograph 73. Putuligayuk River culvert outlets at the Spine Road.**

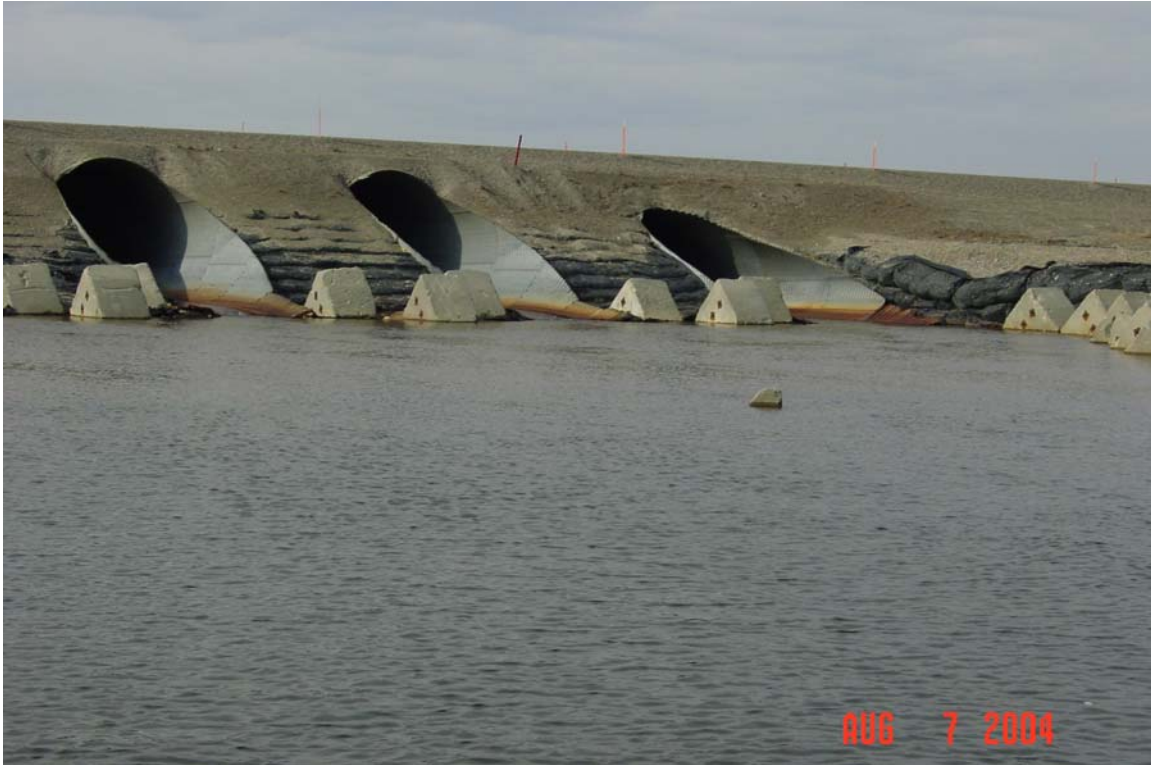
**Photograph 74. Putuligayuk River culvert outlets. Culvert aprons slope down to gobi mat creating a chute of water.**

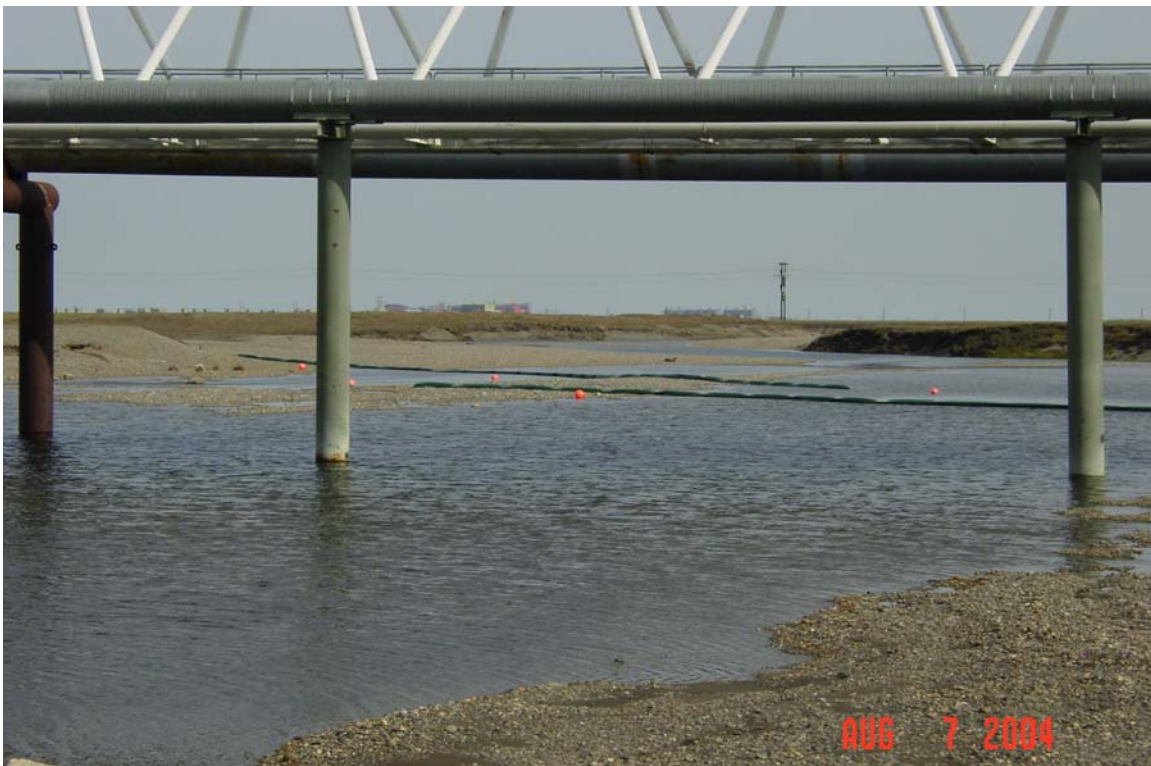
**Photograph 75. Extensive gravel outwash and actively eroding tundra banks in the Putuligayuk River downstream of the Spine Road crossing and pipeline bridge.**

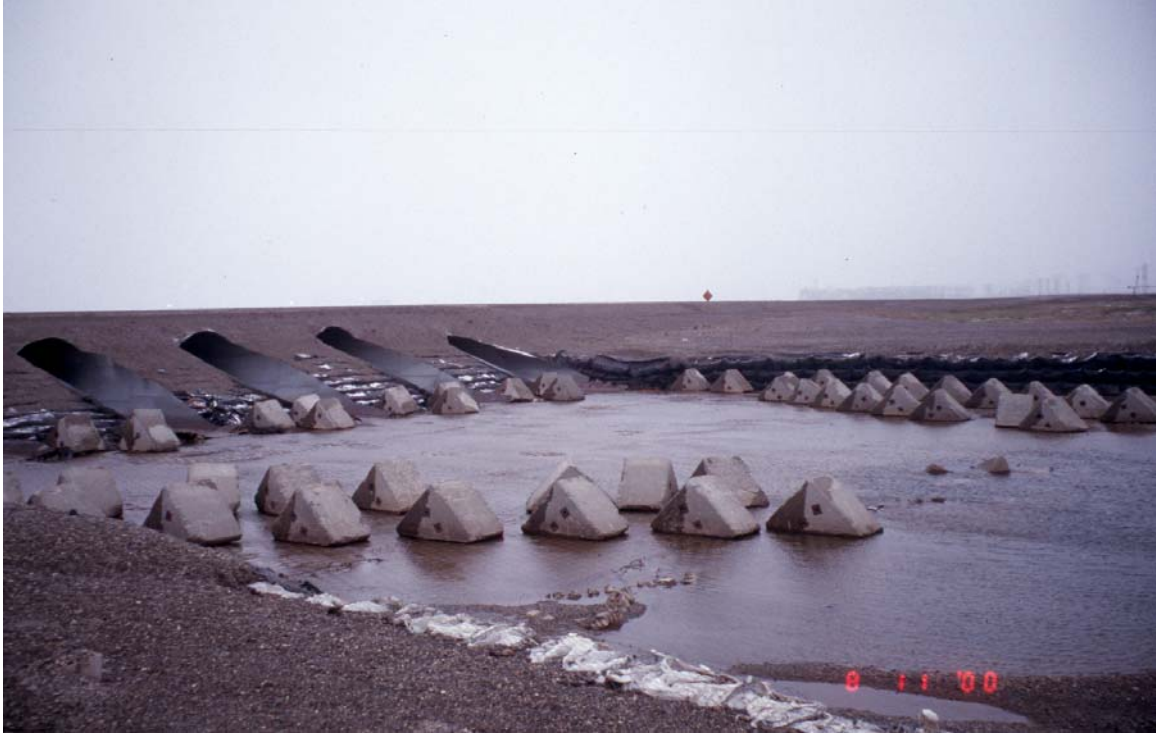
**Photograph 76. Putuligayuk River downstream of the Spine Road crossing. Exposed goby mat can be observed at these flow conditions. The structure is likely a complete blockage to both upstream and downstream movement of fish at low flows.**

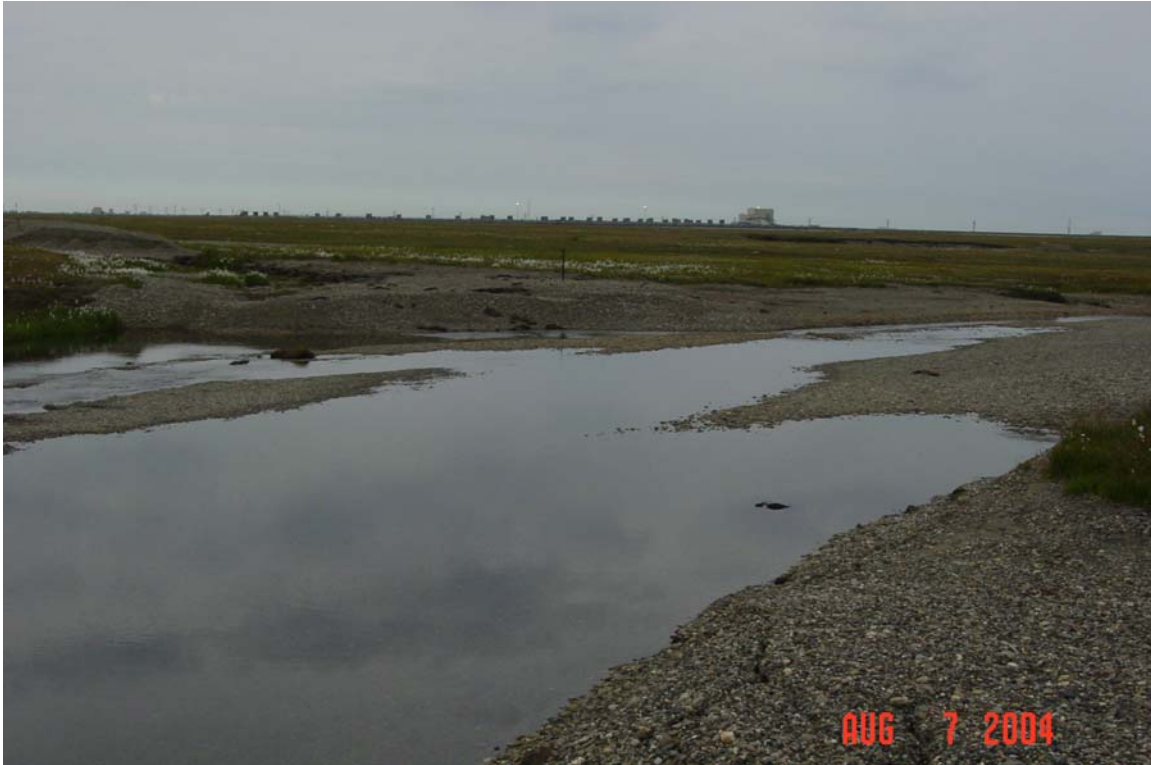
**Photograph 77. Putuligayuk River Tributary at old Kugaruk Pipeline work pad crossing, looking downstream. A large quantity of gravel outwash is present.**

REMEDIATION RECOMMENDATIONS: Remove extraneous gravel, deepen stream channel

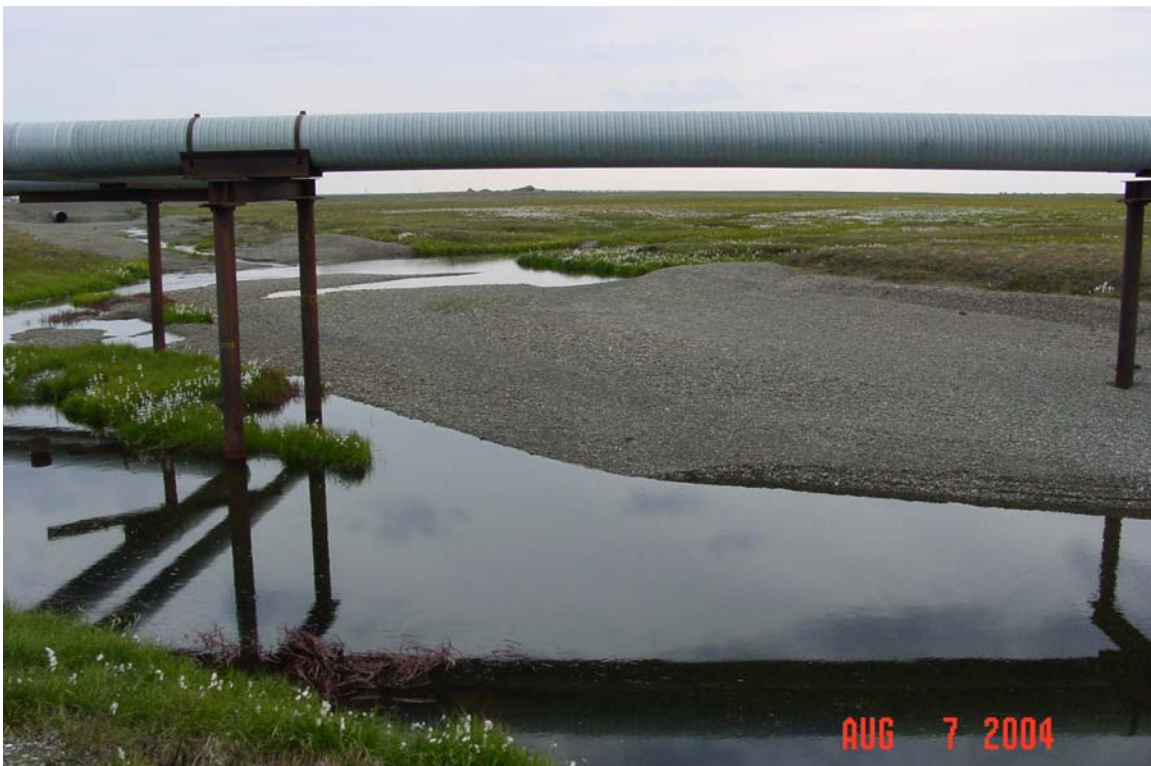
**Photograph 78. Putuligayuk River Tributary looking upstream towards the Pump 1 Drain. The creek is flowing out of the tundra at the upper right of the ponded water upstream from the pipeline.**
