**Technical Report No. 08-01**

## **A SURVEY OF STREAM CROSSING STRUCTURES IN THE NORTH SLOPE OILFIELDS**

**by William A. Morris  
and Jack F. Winters**

**February 2008**

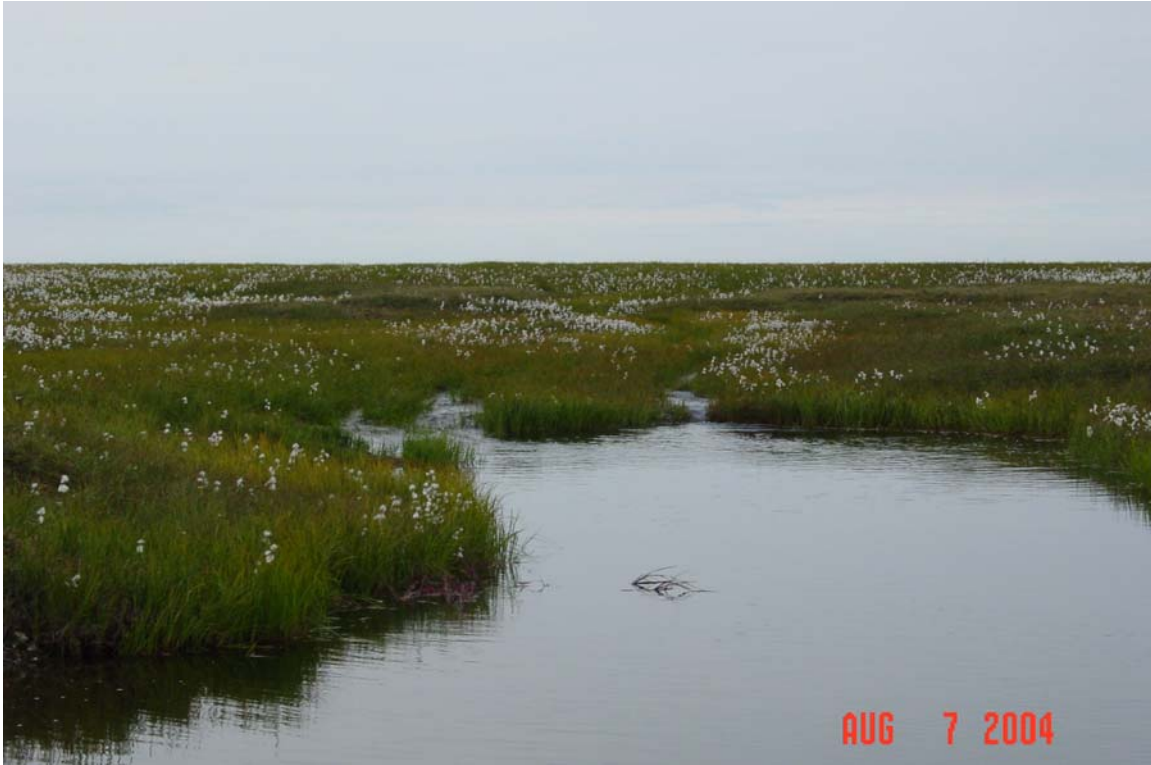
**Photograph 79. Tundra wetland drainage flowing into the disturbed area between the Pump 1 Drain and the old KPL pad crossing. The drainage was intercepted by the KPL road and has rerouted its flow (See map).**

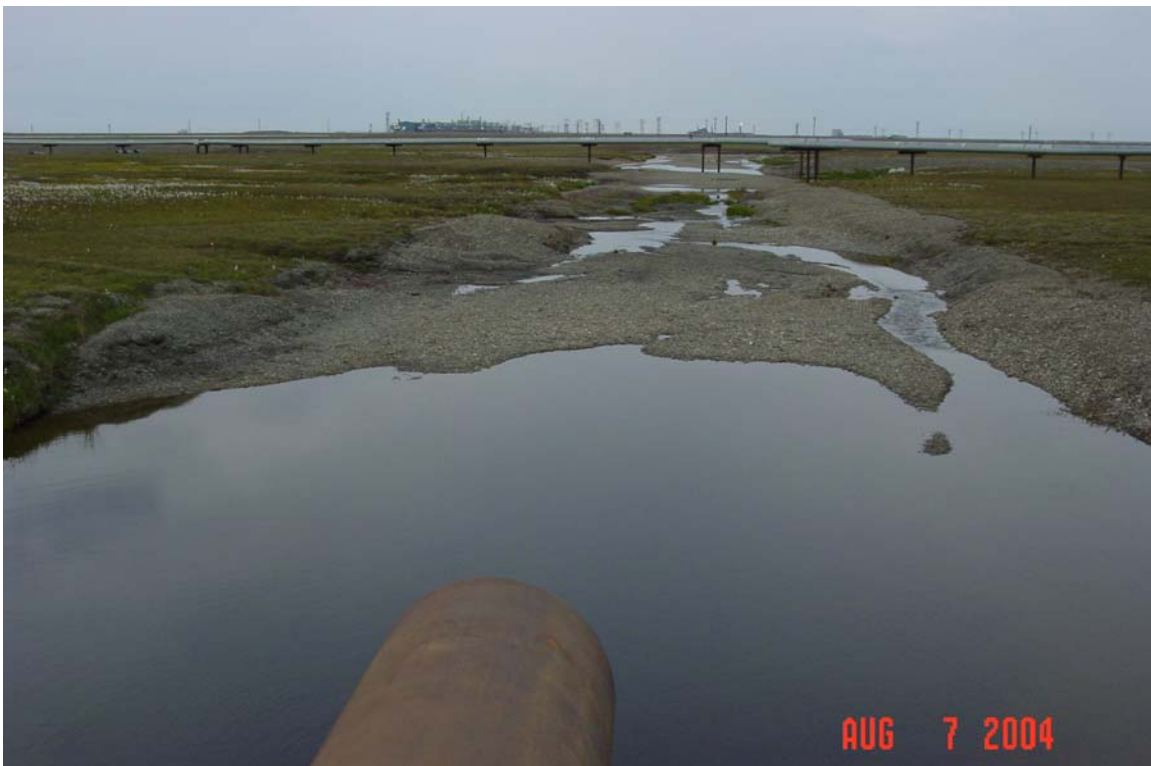
**Photograph 81. Pump 1 Drain to the Putuligayuk River downstream of the X Pad Road. Significant gravel outwash is present.**

REMEDATION RECOMMENDATIONS: Remove extraneous gravel, deepen stream channel downstream of the X Pad road crossing

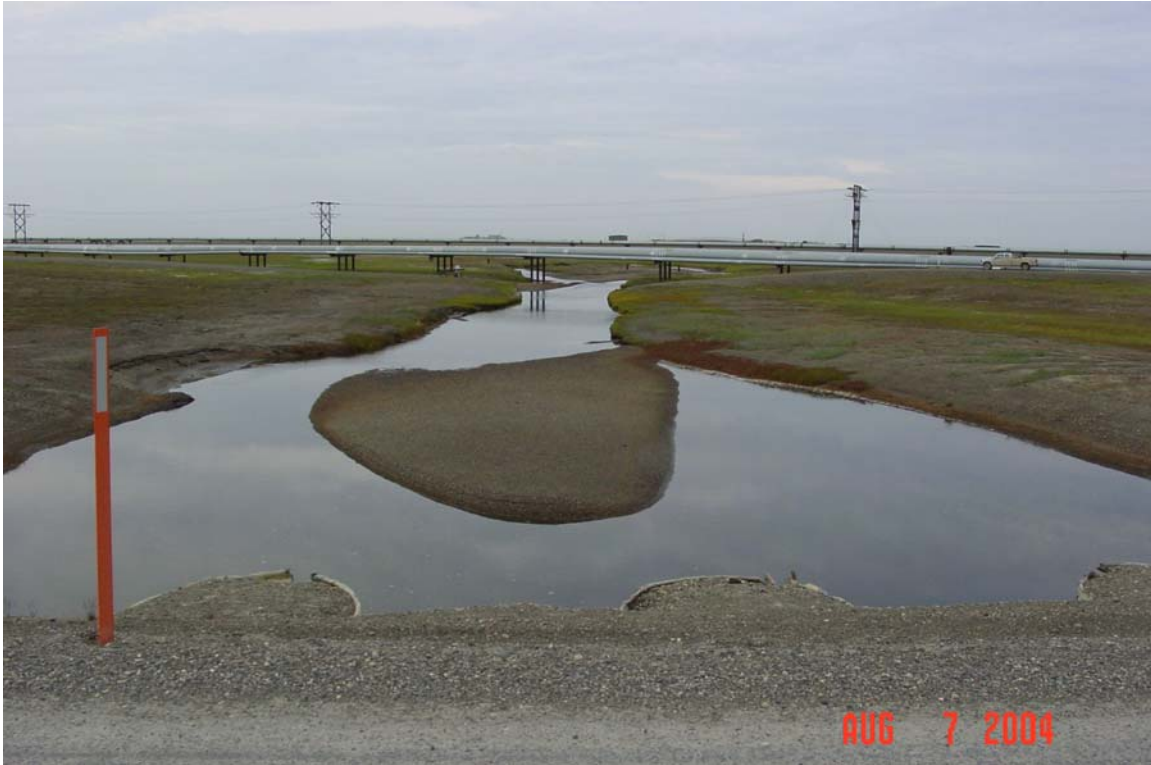
INLET: Corrugated metal bin walls, bin wall steel torn and damaged, gravel bar upstream of culverts partially blocking flow, deep scour pool

**Photograph 82. The Little Putuligayuk River upstream of the West Dock Road. A large gravel bar has formed upstream of the culverts. Bank erosion is evident.**

REMEDIATION RECOMMENDATIONS: Remove upstream and downstream accumulated gravels, increase water conveyance past this crossing

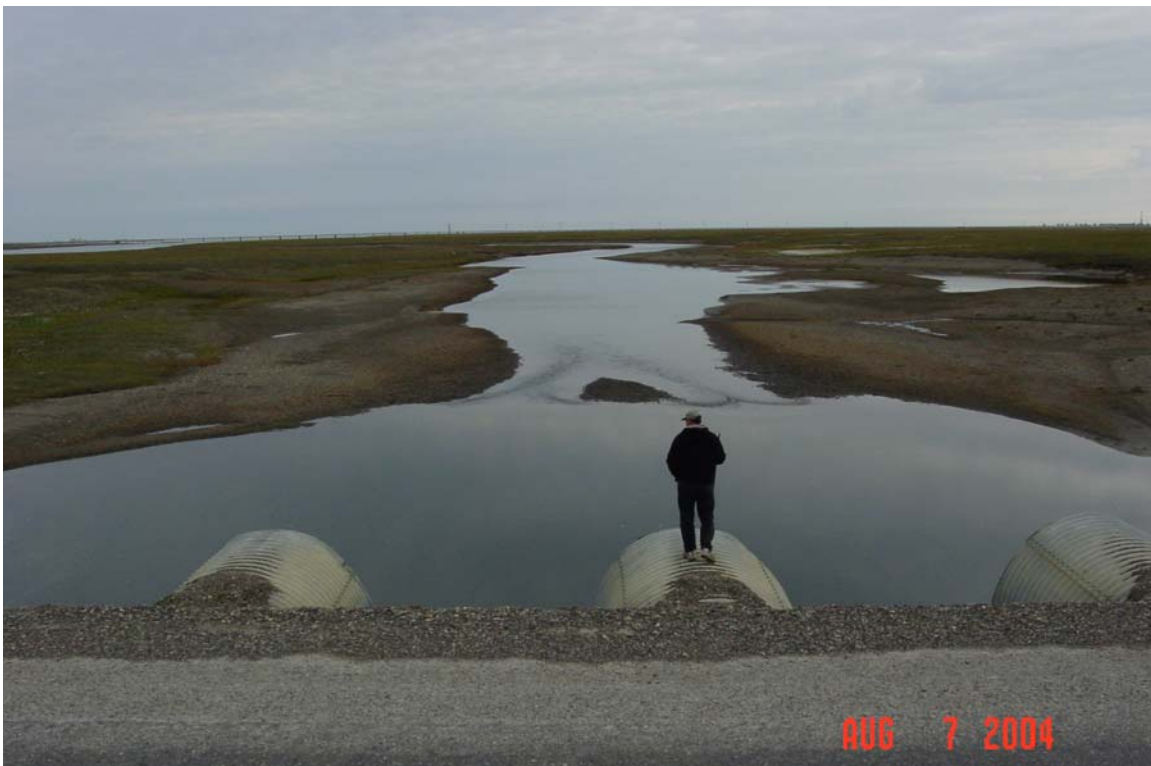
OUTLET: No downstream armor, culvert ends slightly damaged, some road embankment erosion, outwash gravels present, deep scour pool

**Photograph 83. The Little Putuligayuk River downstream of the West Dock Road. A large scour pool, gravel outwash and a split channel around outwash gravel occurs at present flow.**

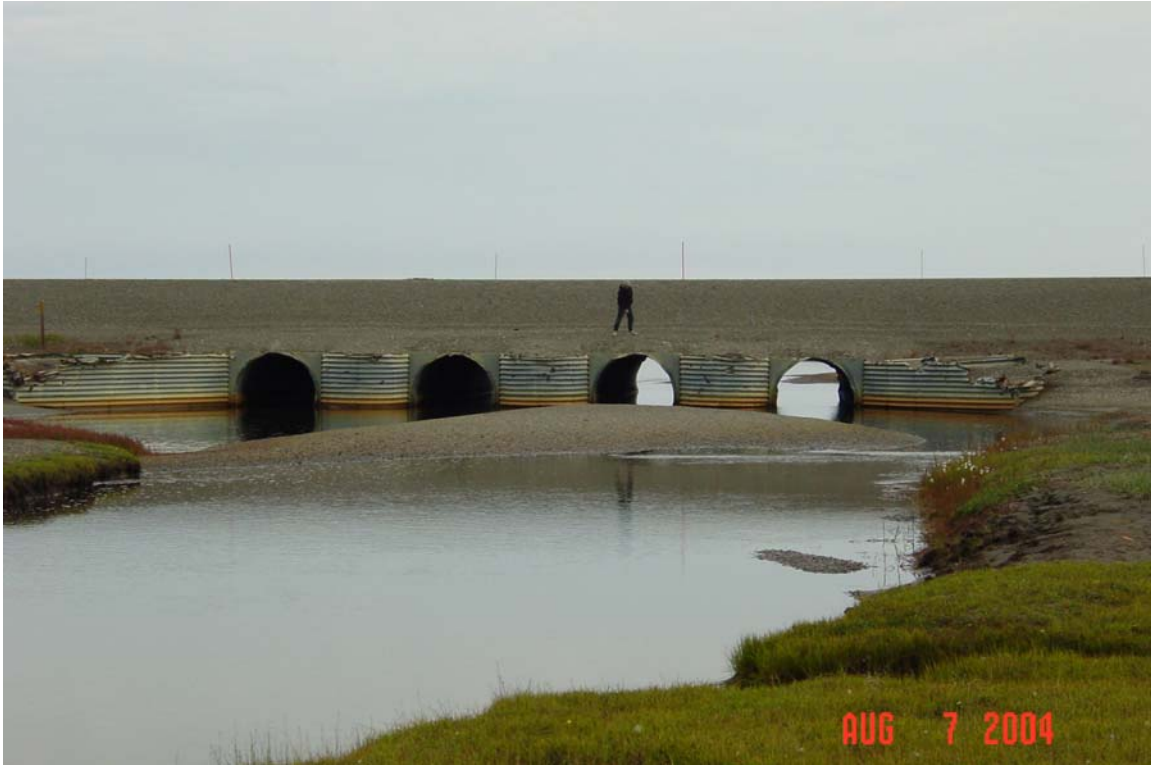
**Photograph 84. Little Putuligayuk River culvert inlets. A significant gravel bar has formed in front of the culverts. Damaged inlet armoring is present. The high water mark is above the culverts.**

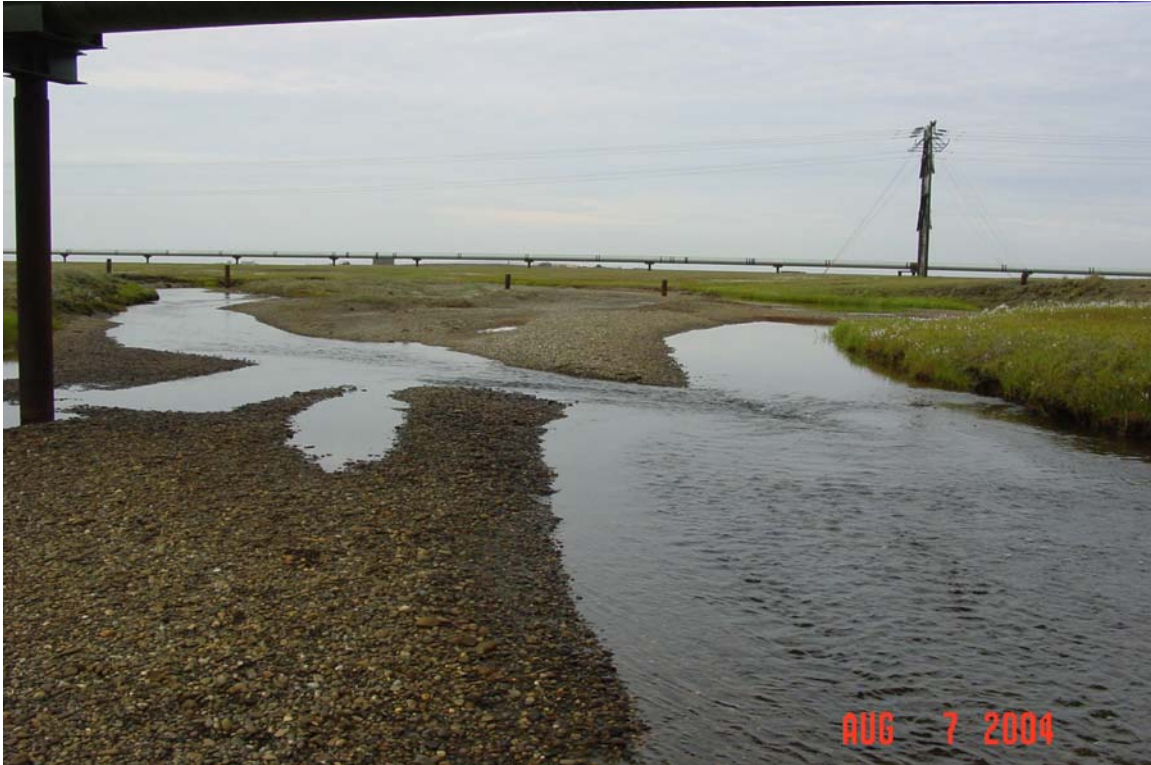
**Photograph 86. Little Putuligayuk River old low water crossing area, looking immediately upstream. Gravel accretion and split channel can be seen.**

REMEDATION RECOMMENDATIONS: Remove extraneous gravel from the floodplain upstream of the crossing.

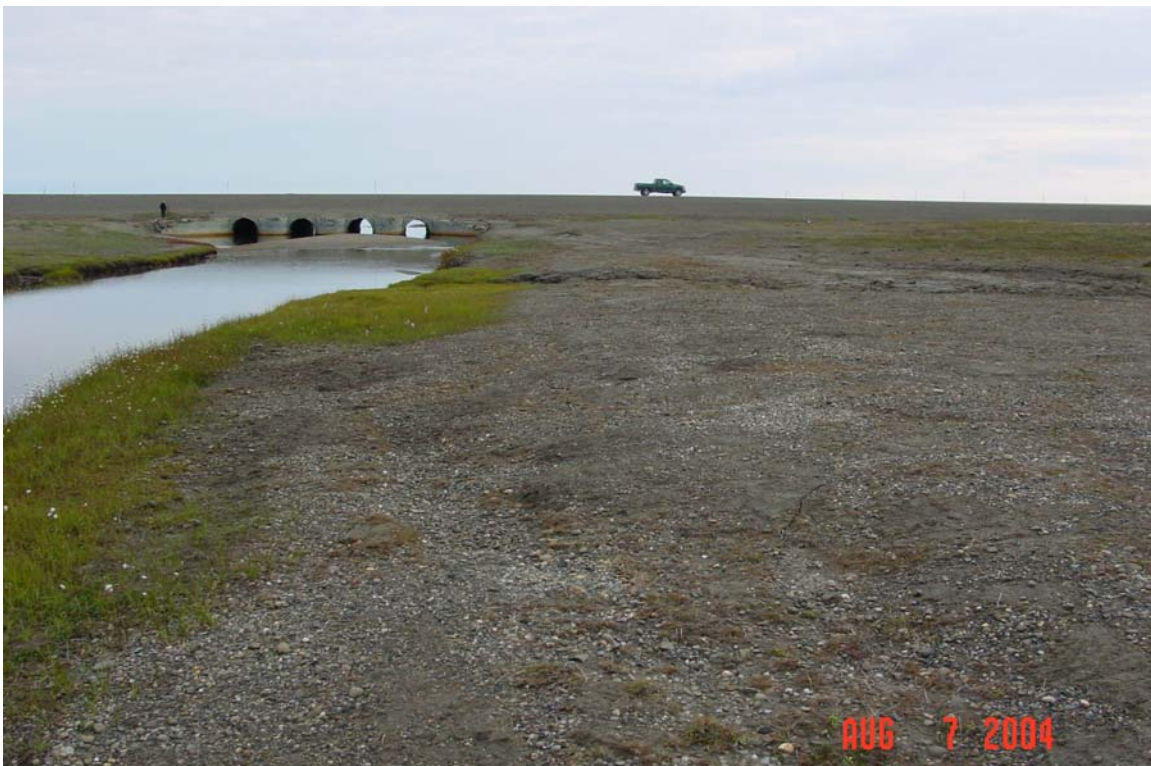
**Photograph 87. Little Putuligayuk River old low water crossing looking downstream to the West Dock Road. Significant gravel outwash onto surrounding tundra is present.**

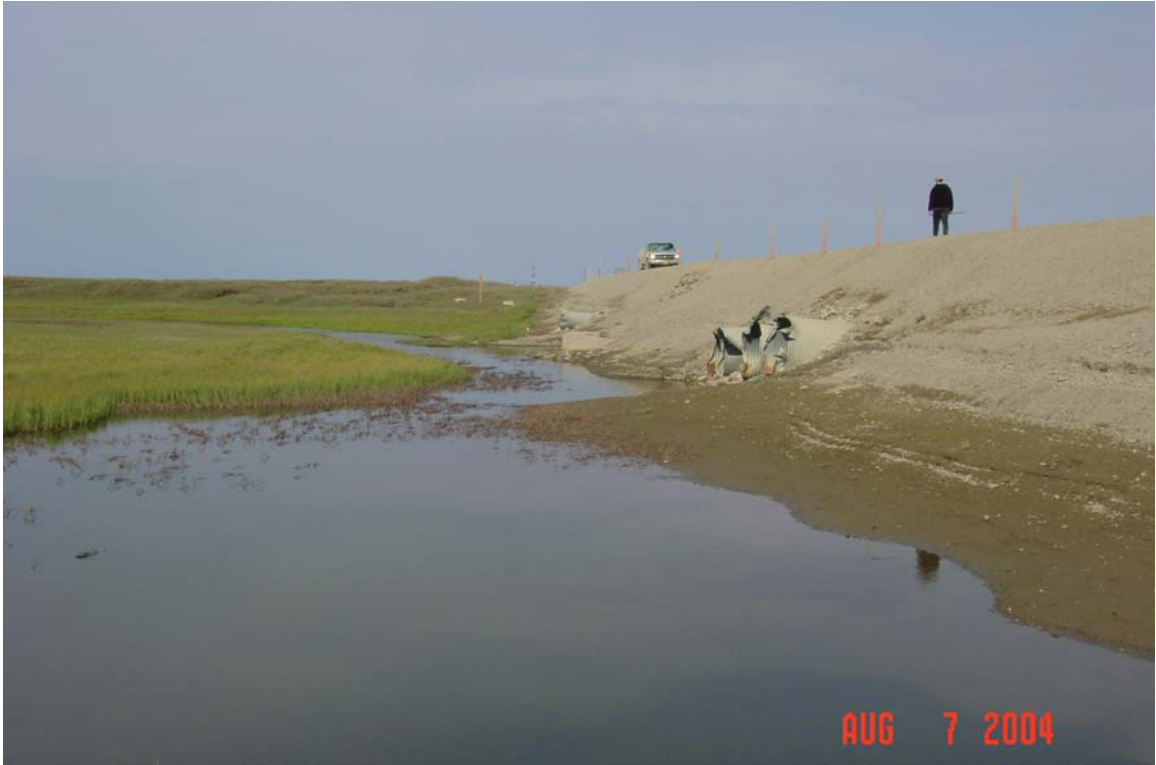
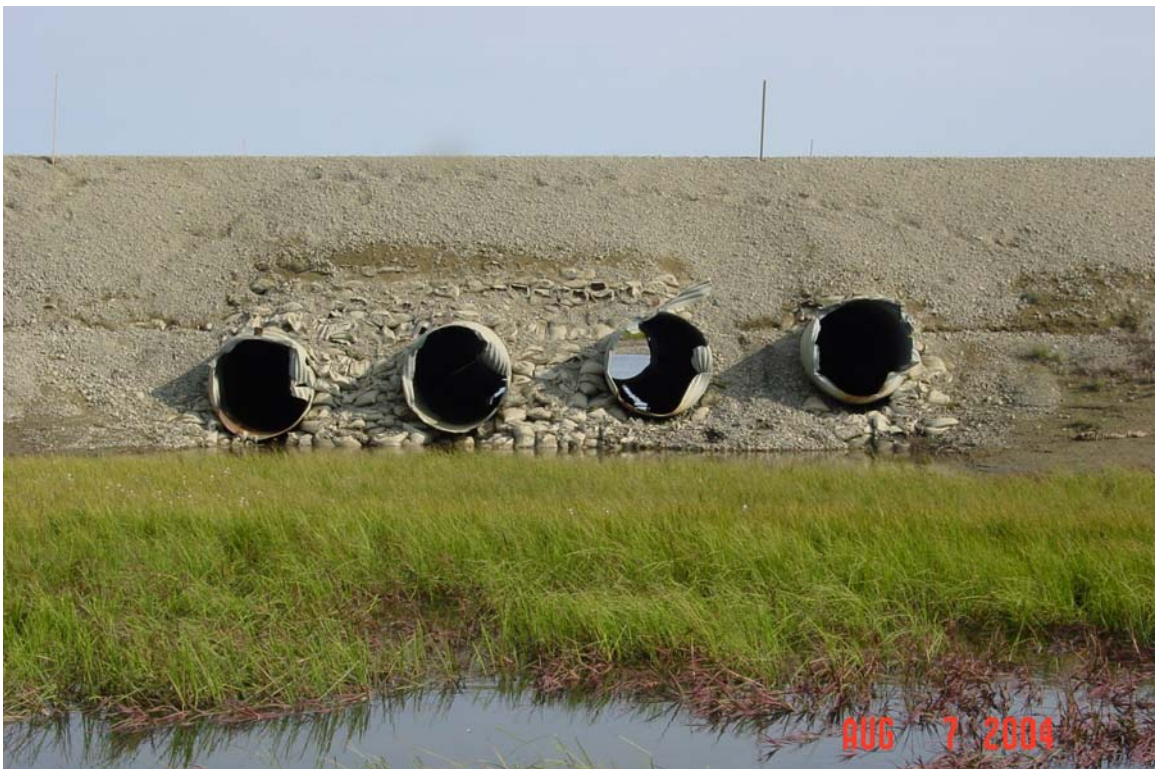
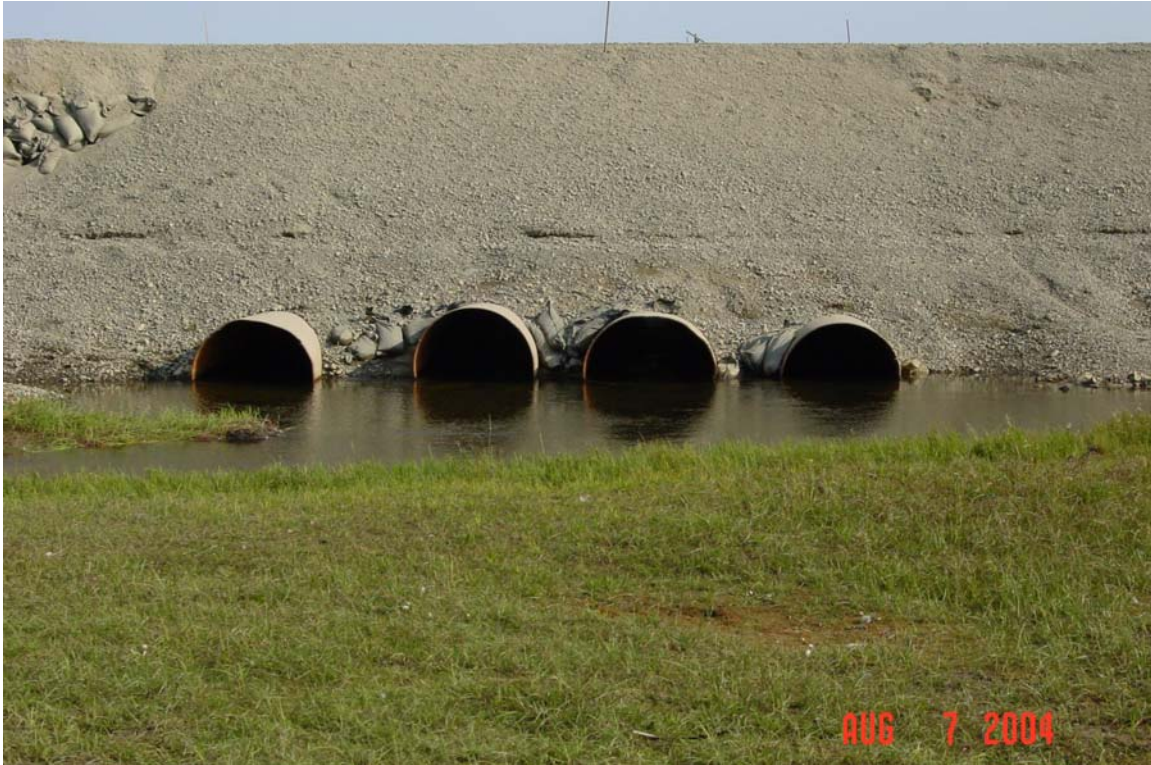
INLET: Partial sand bag armor, damaged culvert inlets, culverts mis-aligned with the stream, significant ponding in spring/early summer from inadequate conveyance capacity, whirlpools at submerged culvert inlets

REMEDIATION RECOMMENDATIONS: Remove downstream outwash gravels, increase water conveyance by installing a bridge and removing all culverts.

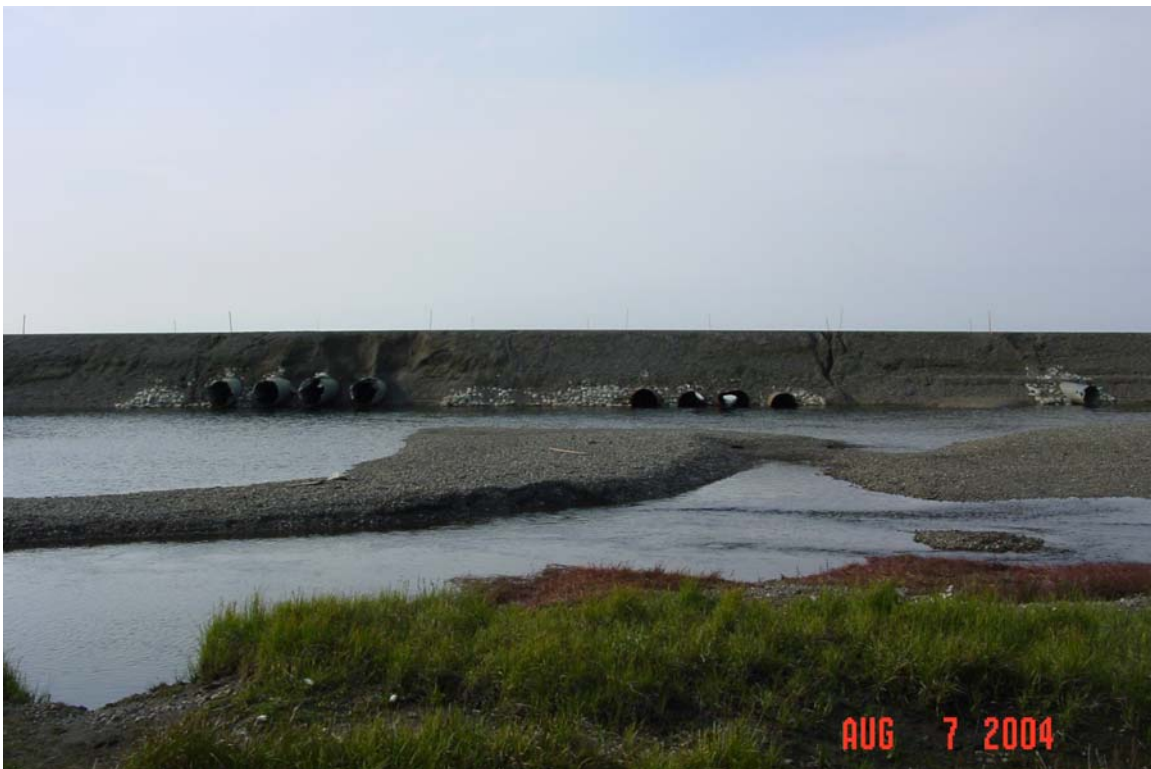
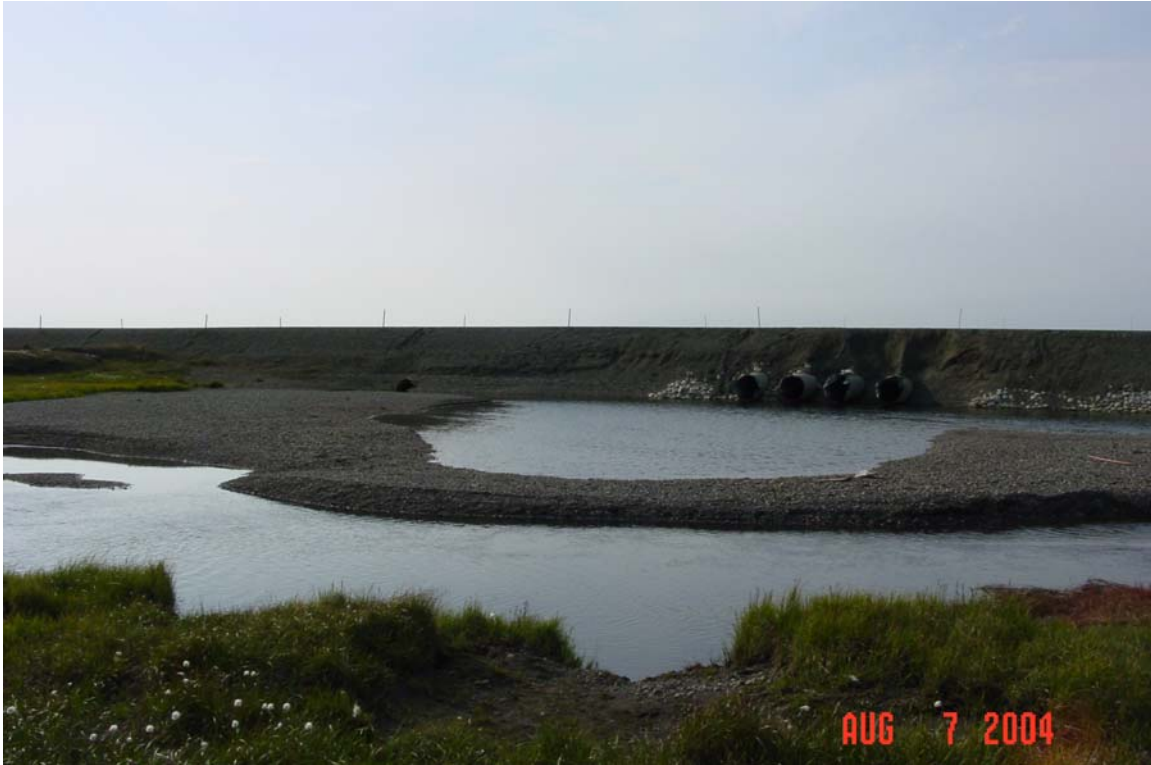
OUTLET: Partial sand bag armor, damaged culvert outlets, significant road prism erosion, scour pools, extensive outwash gravels that at low flows may impede upstream movements of fish, stream channel has cut and bypassed a meander bend

**Photograph 97. Little Putuligayuk River culvert outlets, with a massive gravel outwash berm and road erosion.**

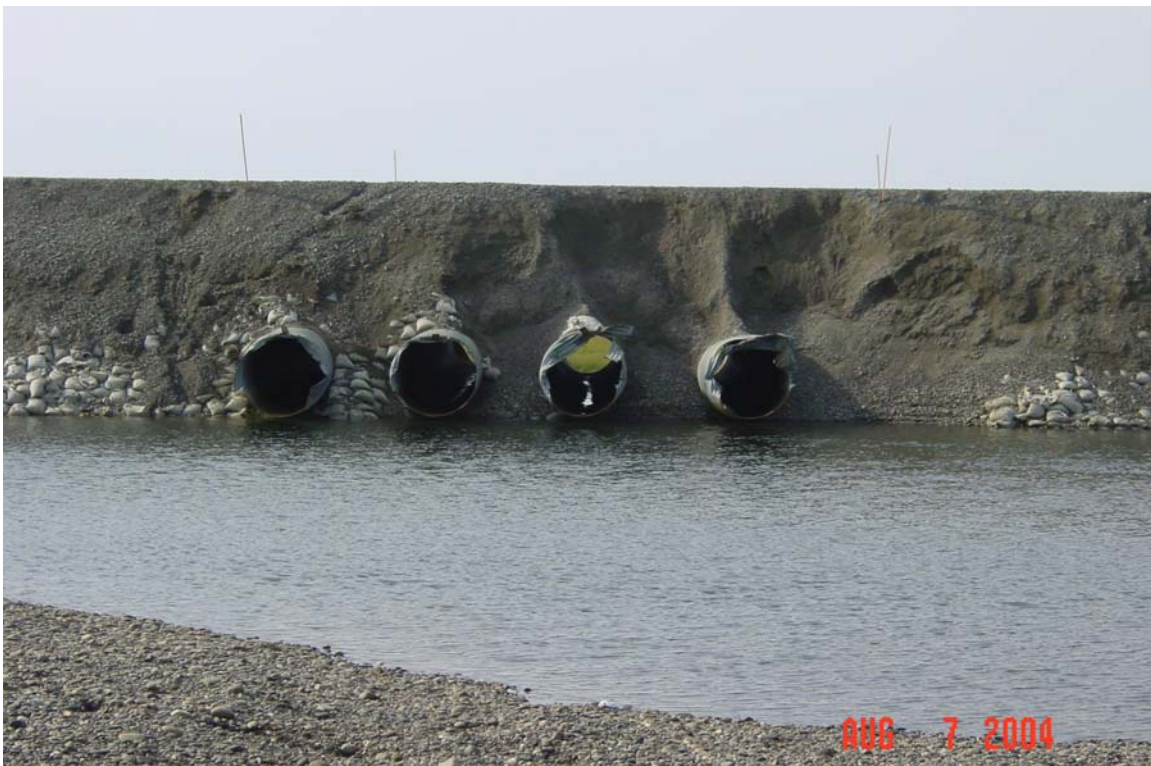
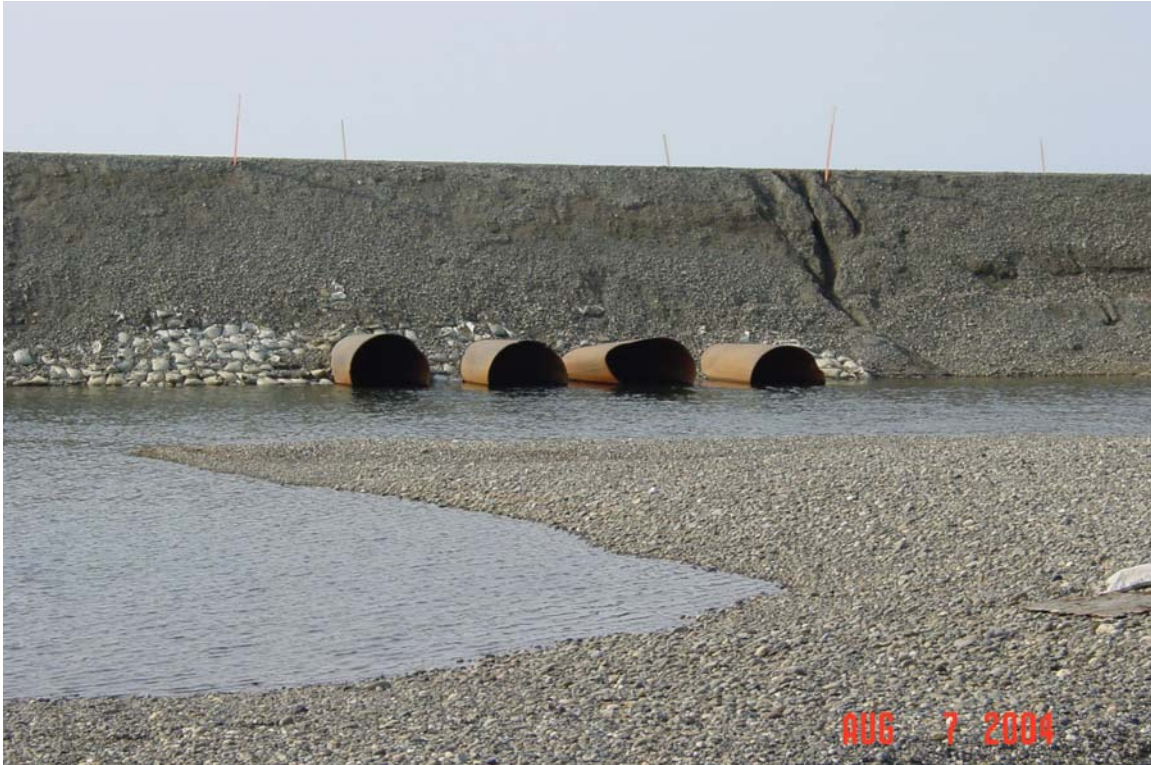
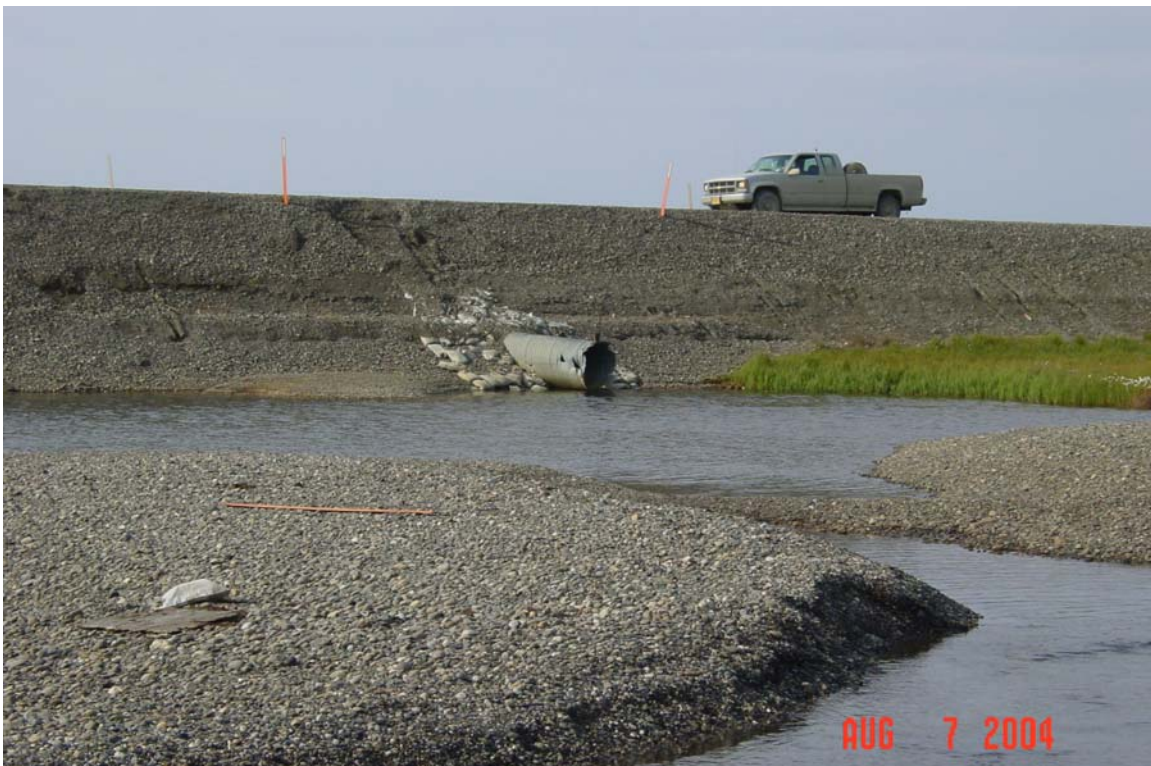
**Photograph 99. Little Putuligayuk River culvert outlets, with gravel outwash berm, road erosion and severe culvert damage.**

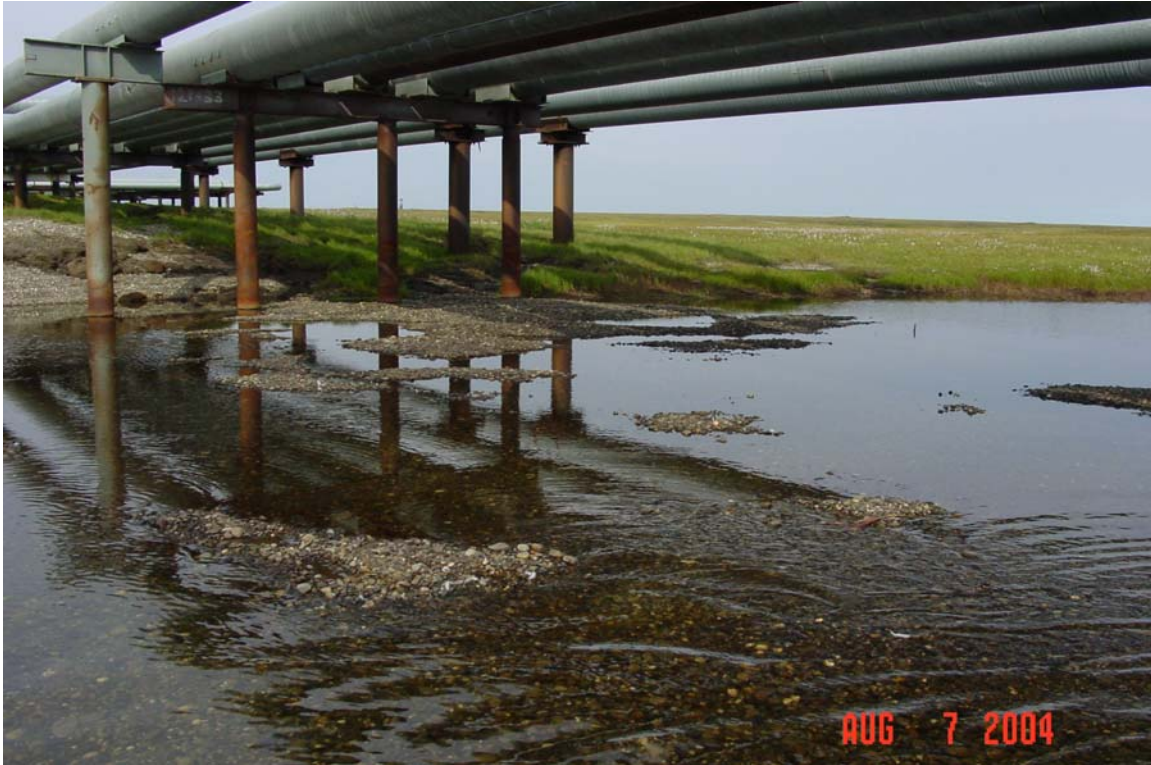
**Photograph 104. Little Putuligayuk River old low water crossing. Significant gravel remains in stream channel creating a wide shallow bar across the width of the creek.**

REMEDATION RECOMMENDATIONS: Remove outwash gravels and remove material to deepen the stream at the crossing

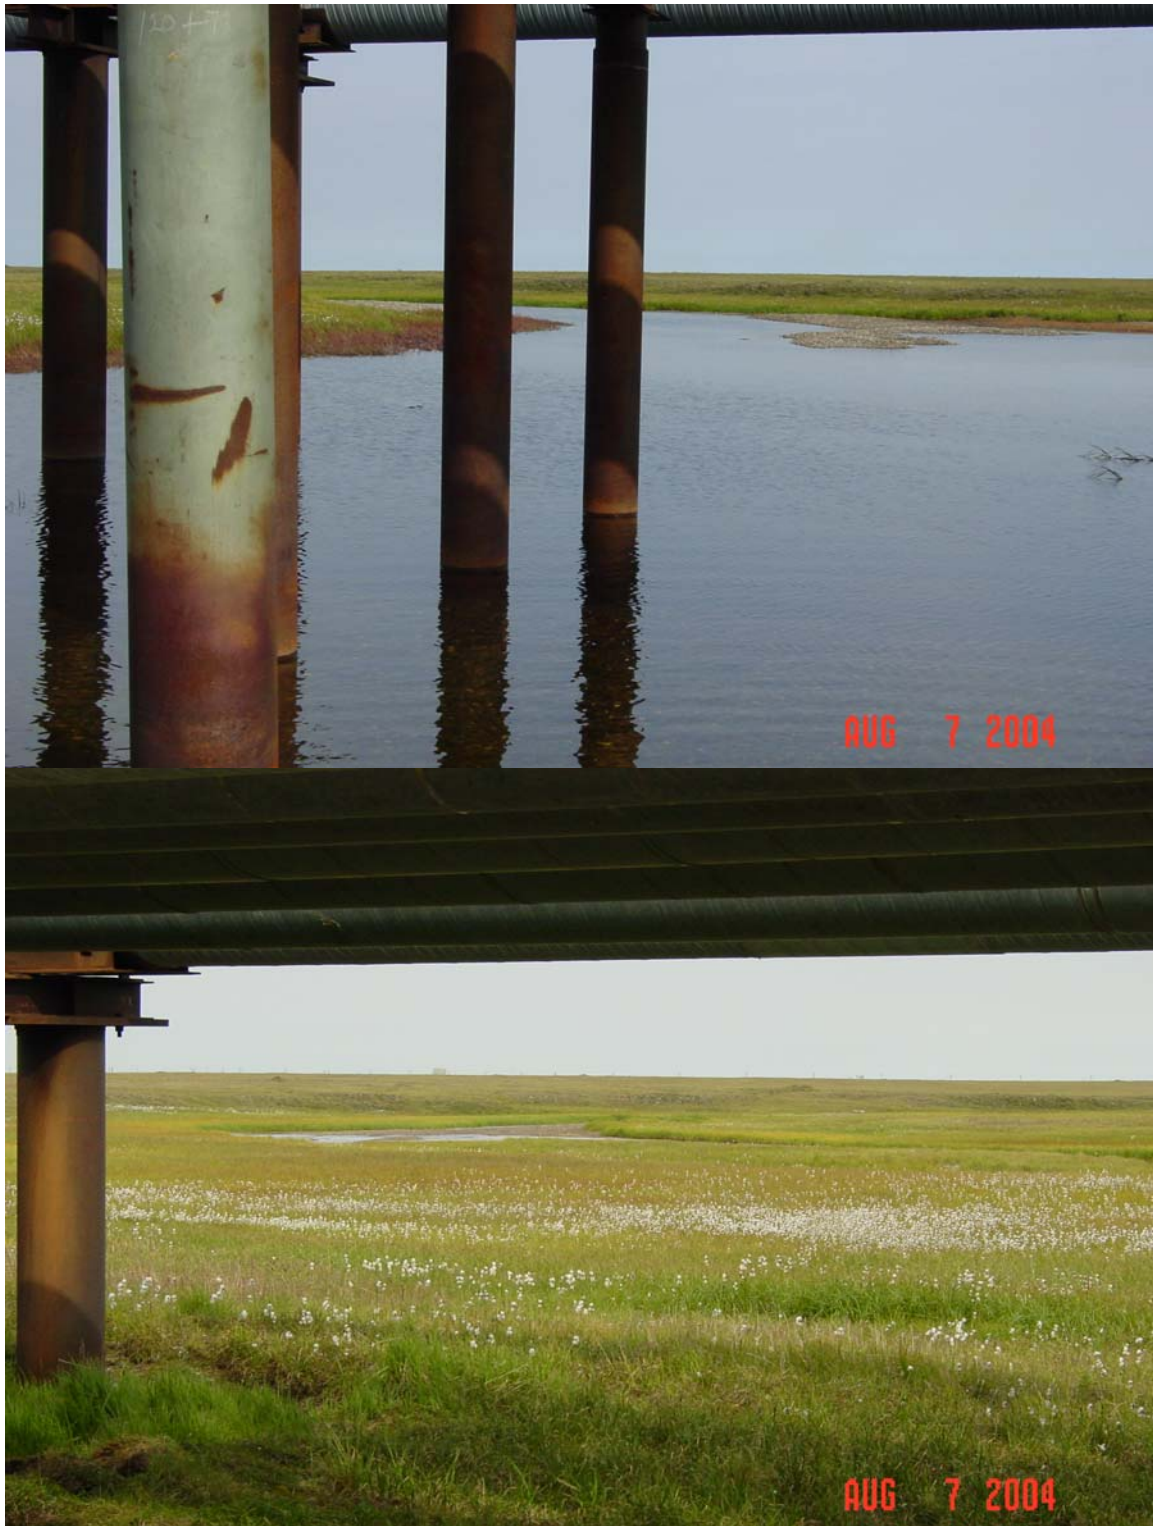
**Photograph 105.** Compilation of pictures of the Little Putuligayuk River downstream of the old low water crossing. Gravel outwash is present in stream channel immediately downstream of the crossing (top) and for a considerable downstream (bottom and map).

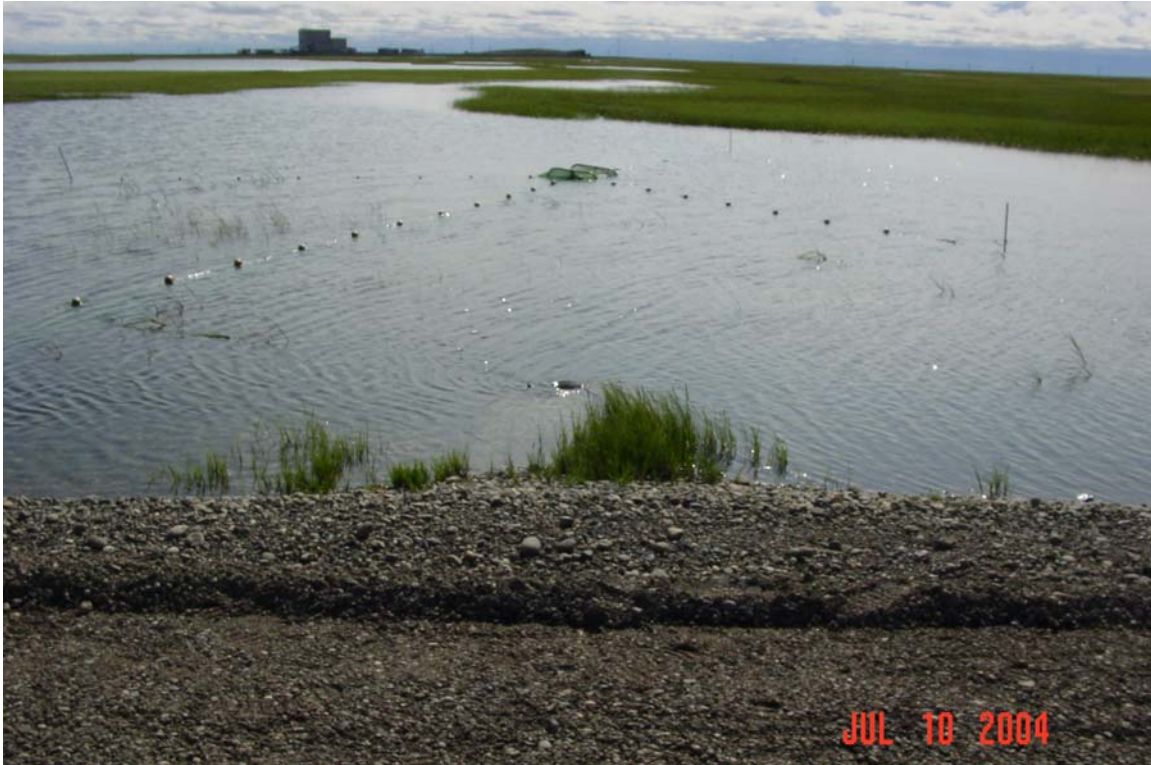
**Photograph 106. Fawn Creek upstream of the GC1 to GC2 Road. Water is ponded above the crossing; culvert is submerged in the foreground.**

REMEDICATION RECOMMENDATIONS: Replace with a larger culvert(s). This will increase the potential for fish to reach D Pad Lake.

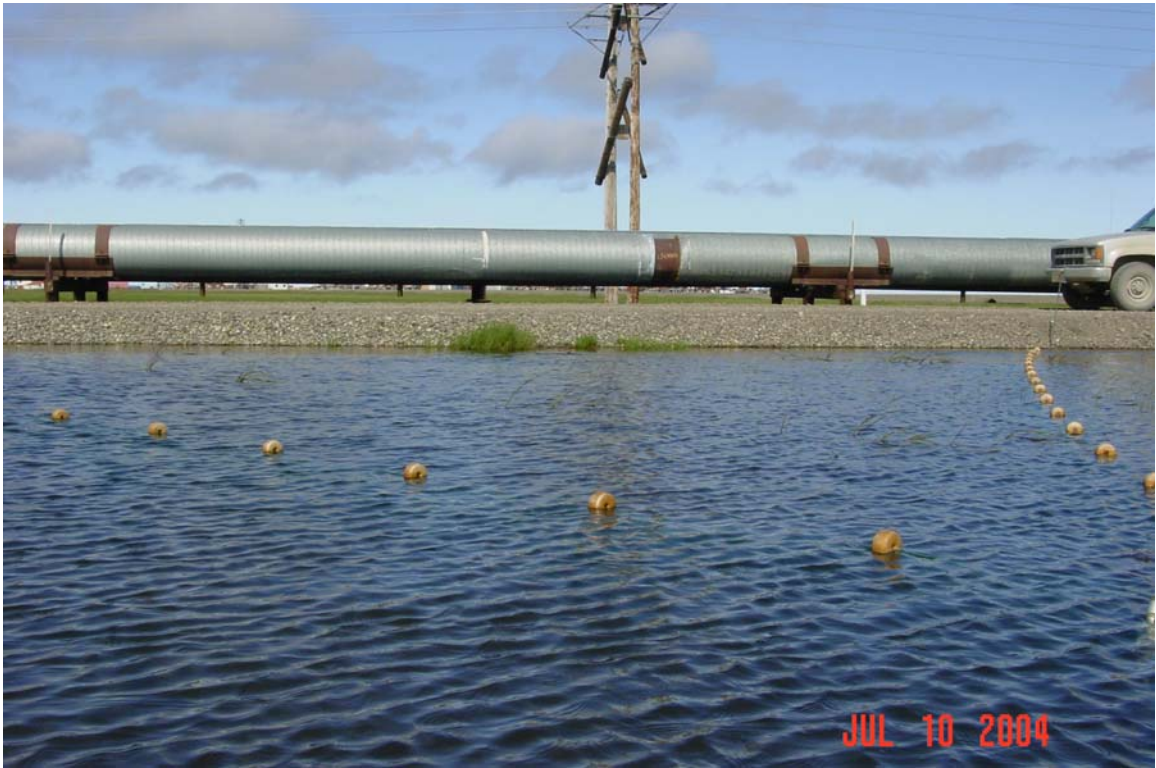
**Photograph 108. Fawn Creek looking at upstream side of crossing; culvert is submerged.**

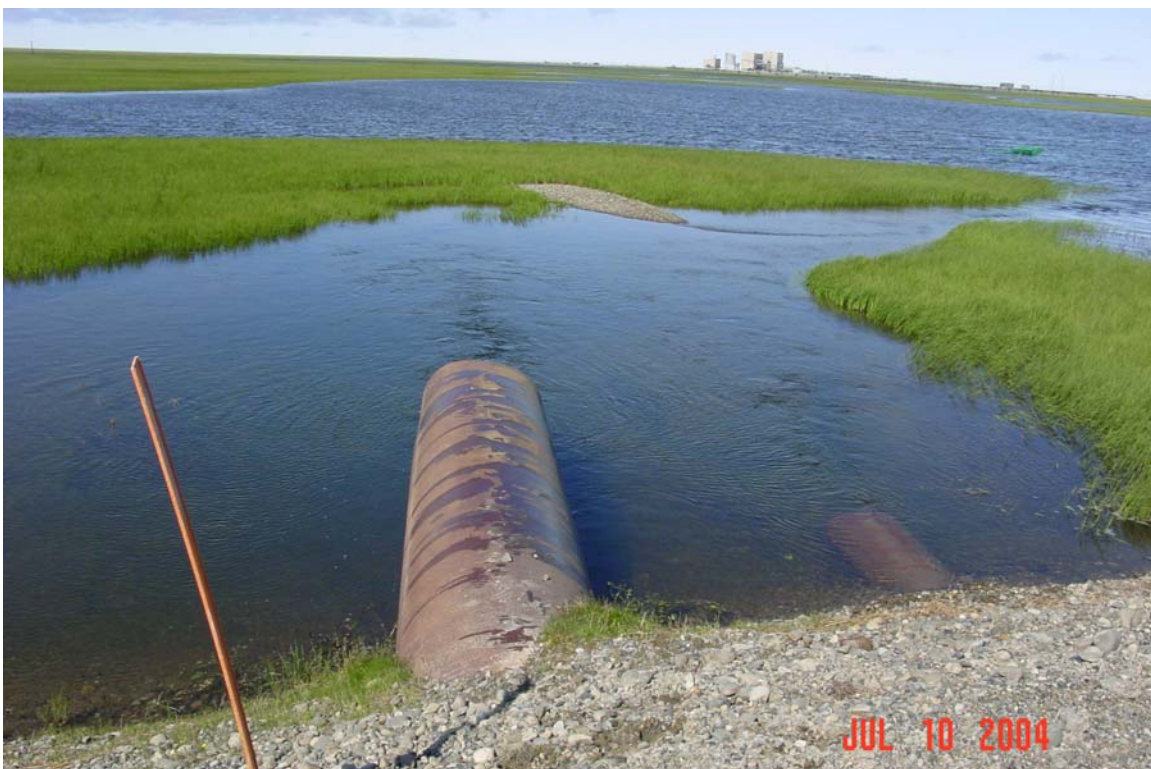
**Photograph 111. Fawn Creek downstream of the Spine Road to F-Pad Road access. Limited gravel outwash and deep scour pool present. The larger pipe is elevated considerably above the scoured stream bed.**

REMEDIATION RECOMMENDATIONS: Reset the 36 inch culvert to rest on the bottom and cut the length to fit the road width. Fill in the scour pool. Remove outwash gravels. Increase conveyance with larger and additional culverts. Alternatively, remove the crossing and associated road as drill sites can be accessed by other routes.

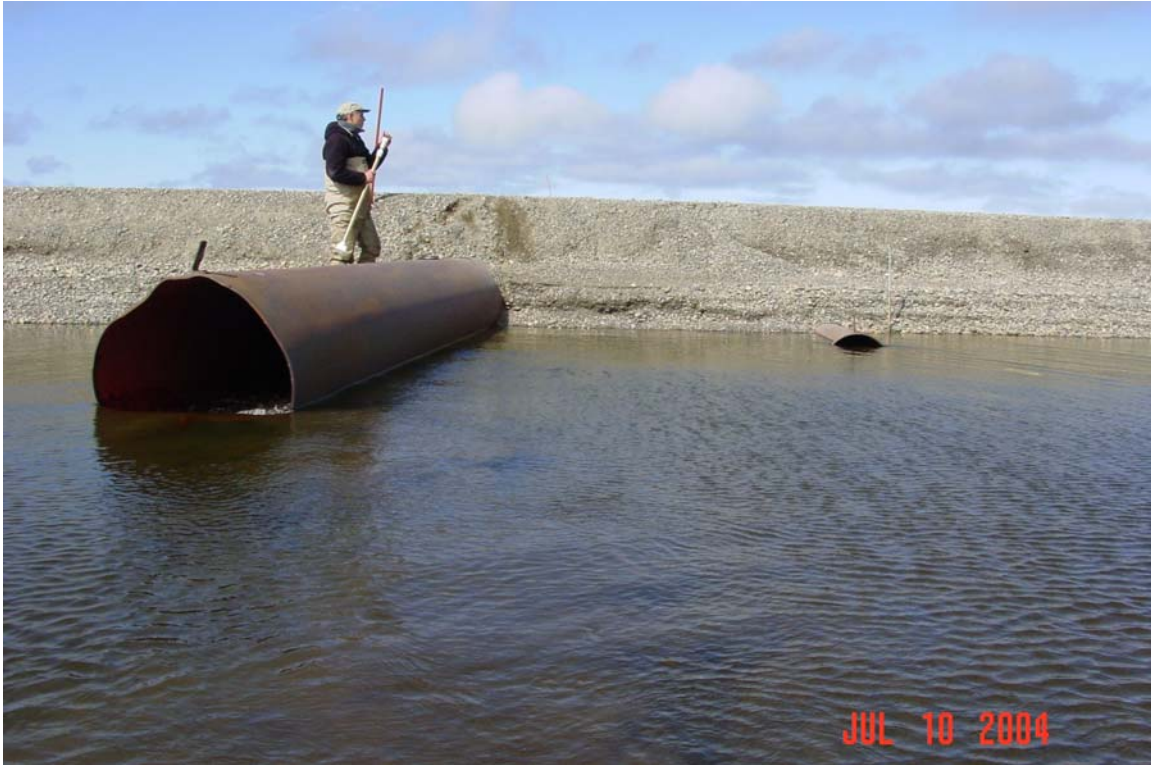
**Photograph 112. Fawn Creek culvert inlets. The highwater mark can be seen above the pipes as well as road bed erosion. Water velocity is increased as it passes into the undersized culverts. Note the hydraulic drop into the large pipe.**

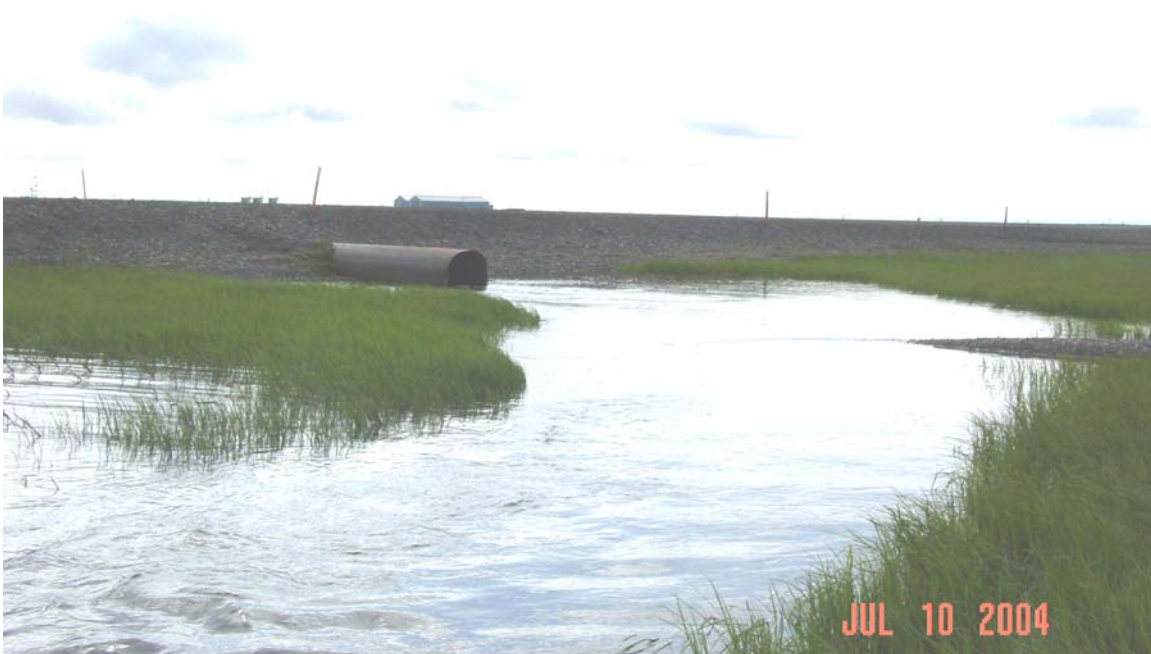
**Photograph 113. Fawn Creek culvert outlets.**

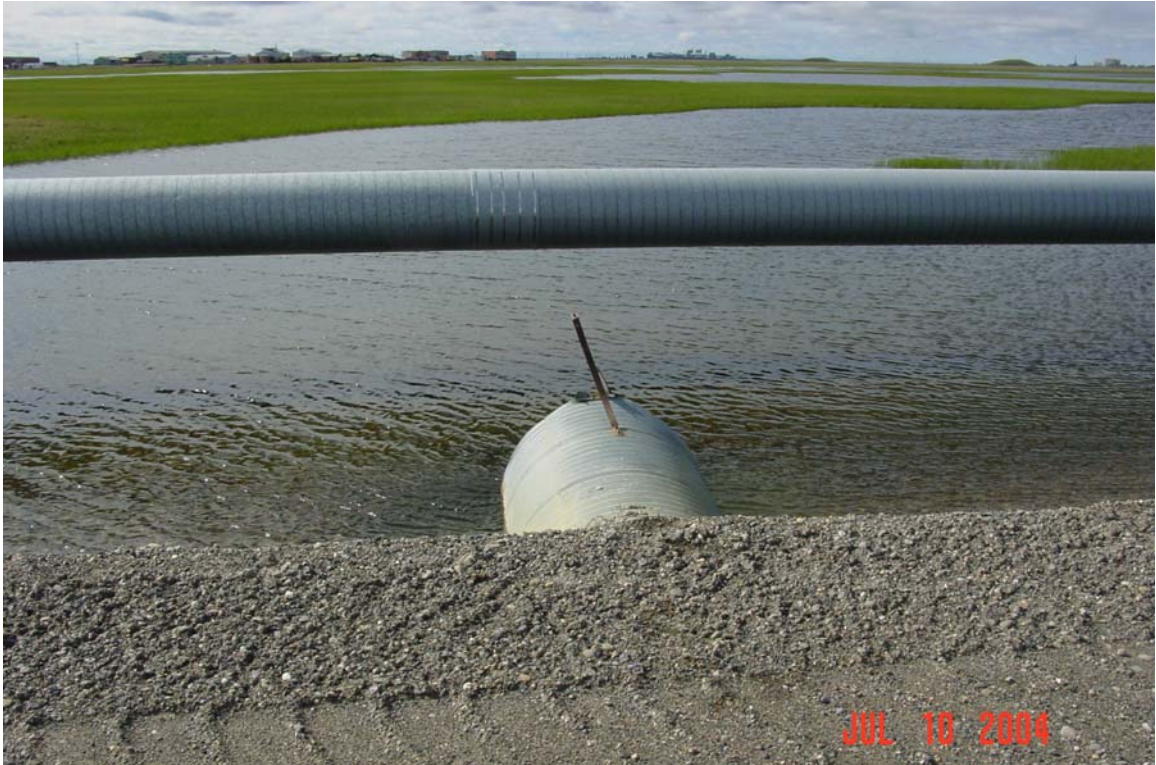
**Photograph 114. Fawn Creek upstream of the F-Pad to GC-1 road crossing.**

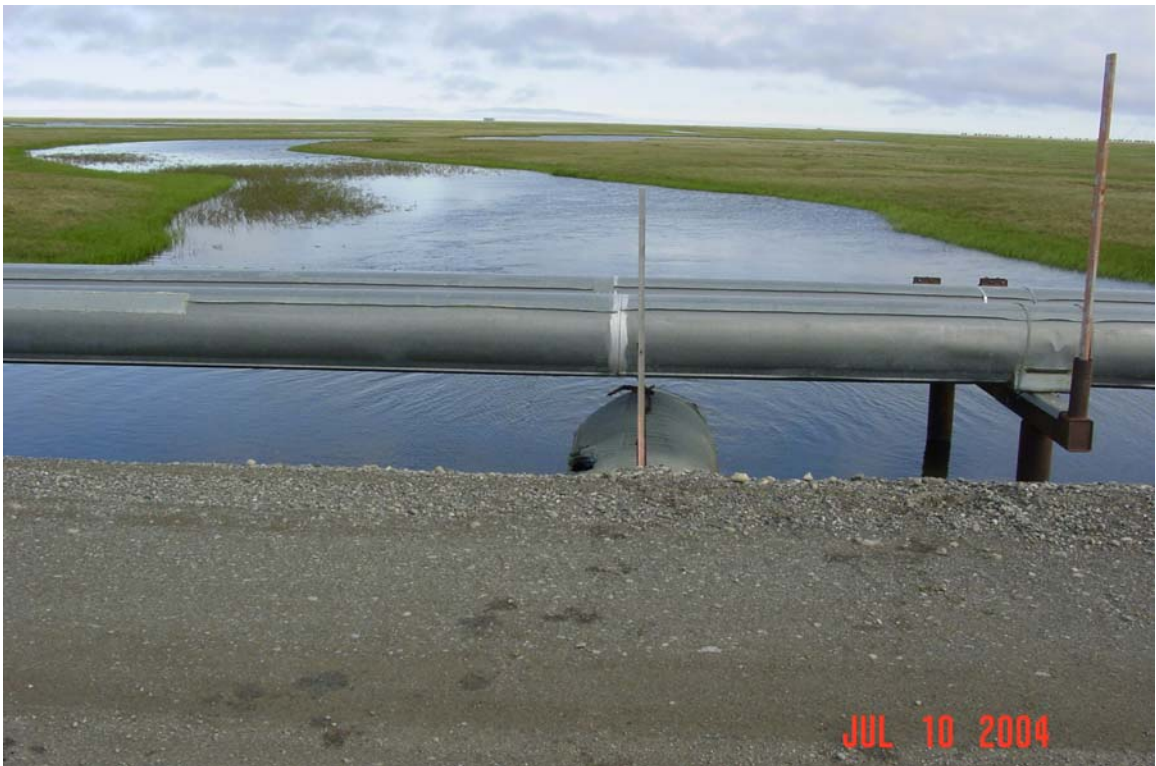
**Photograph 115. Fawn Creek downstream of the F-Pad to GC-1 Road.**
