**Technical Report No. 08-01**

## **A SURVEY OF STREAM CROSSING STRUCTURES IN THE NORTH SLOPE OILFIELDS**

**by William A. Morris  
and Jack F. Winters**

**February 2008**

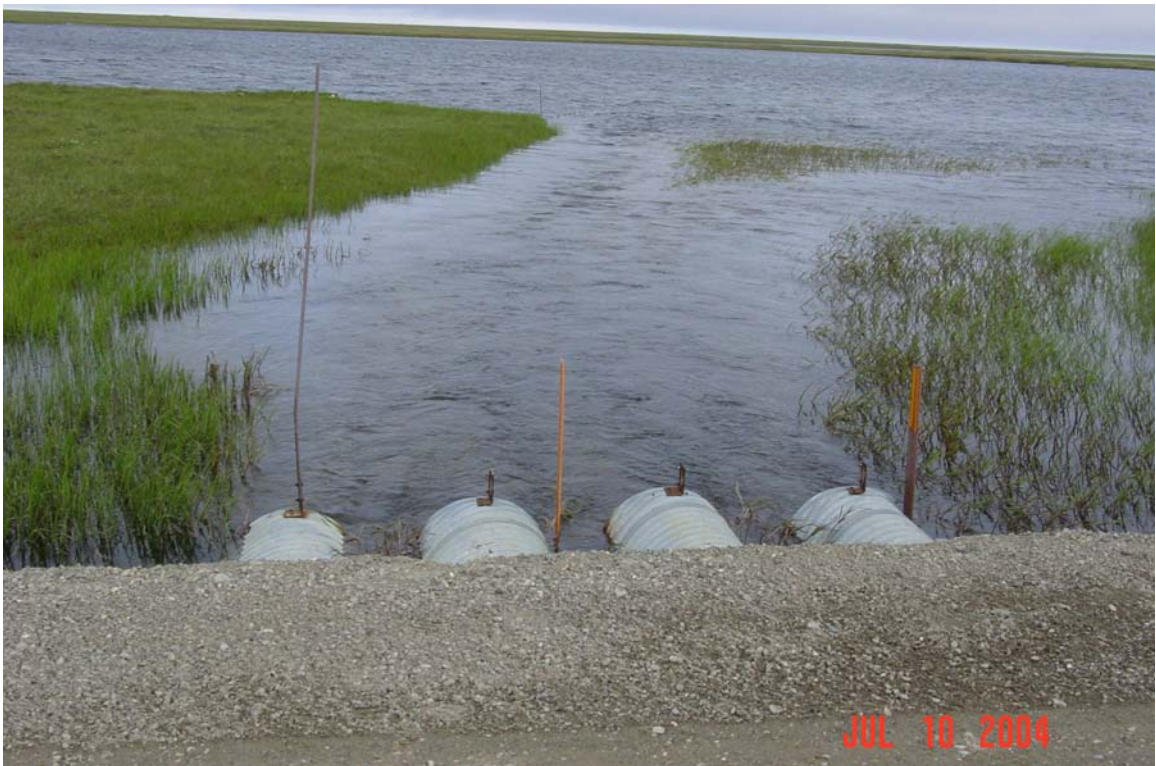
**Photograph 119. Fawn Creek culvert outlets downstream of the F-Pad to E-Pad Road.**

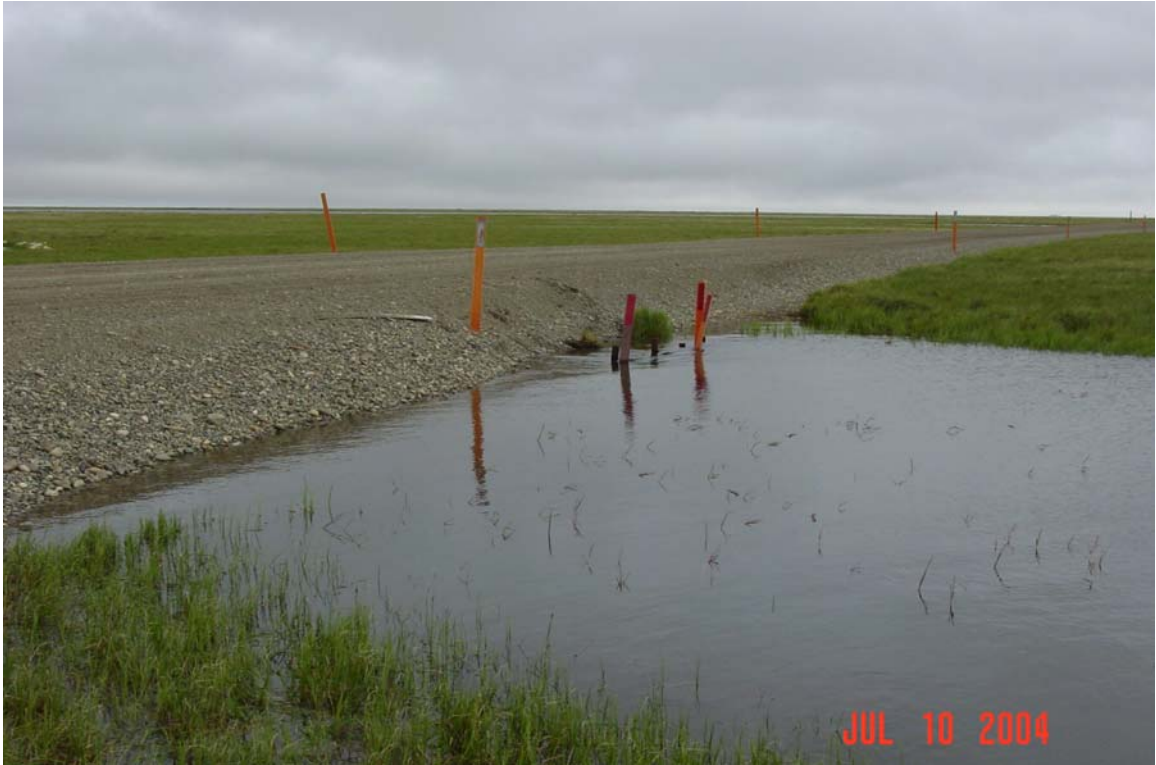
**Photograph 120. Fawn Creek culvert inlets.**

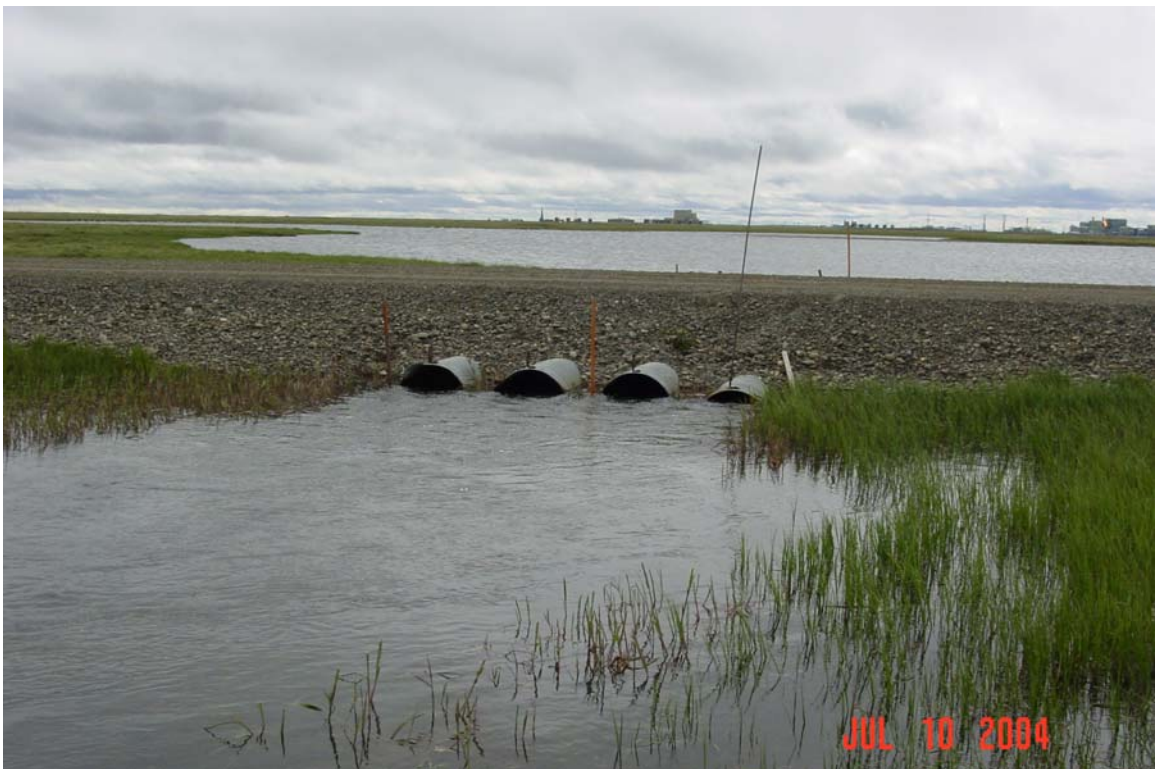
**Photograph 121. Fawn Creek culvert outlets. Note the difference in water surface elevation between the upstream and downstream sides of the road.**

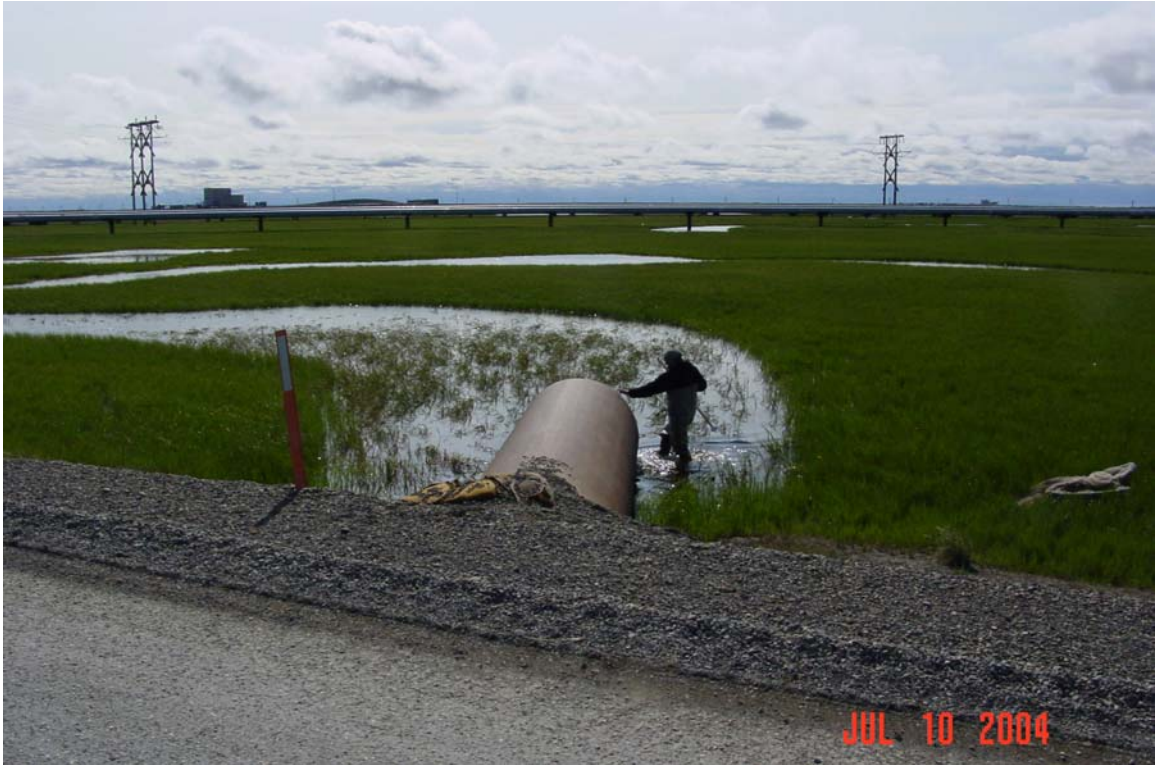
**Photograph 122. Fawn Creek upstream of the Spine Road crossing.**

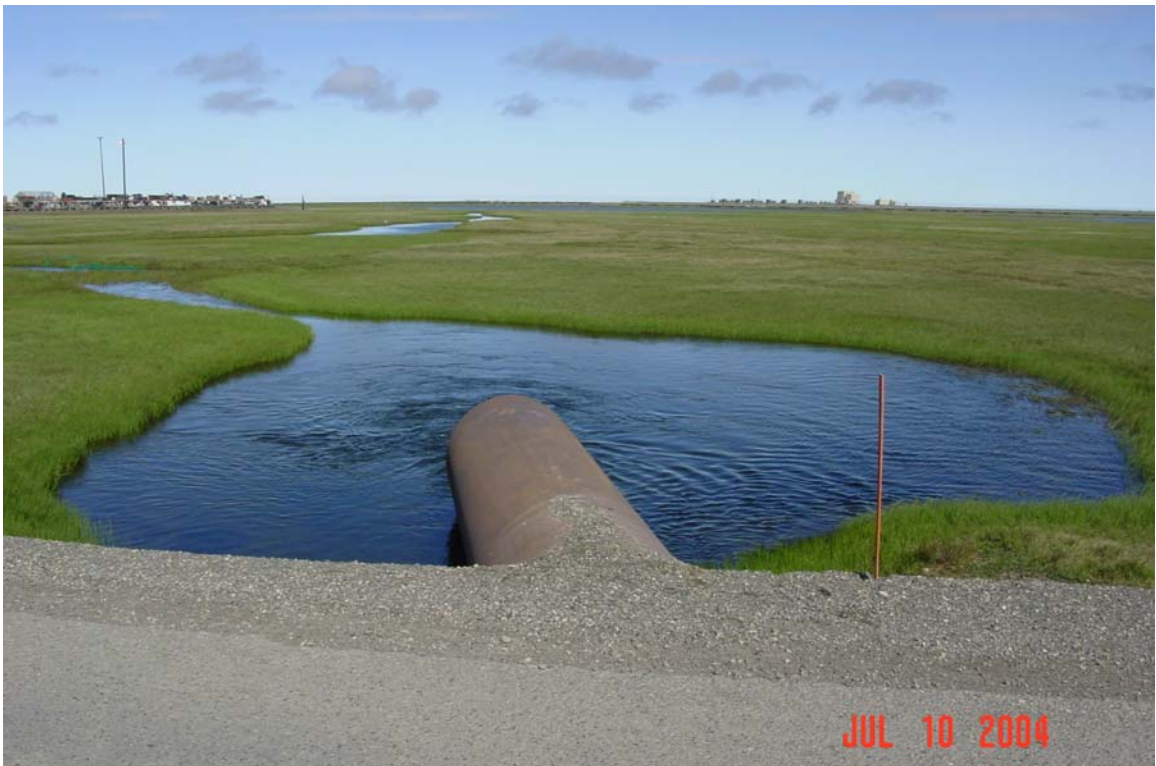
**Photograph 123. Fawn Creek downstream of the Spine Road crossing and its large scour pool.**

REMEDIALATION RECOMMENDATIONS: Reset the existing culvert to provide for fish passage; shorten the culvert to fit the road width; fill in the downstream plunge pool; and add an additional culvert for breakup flows.

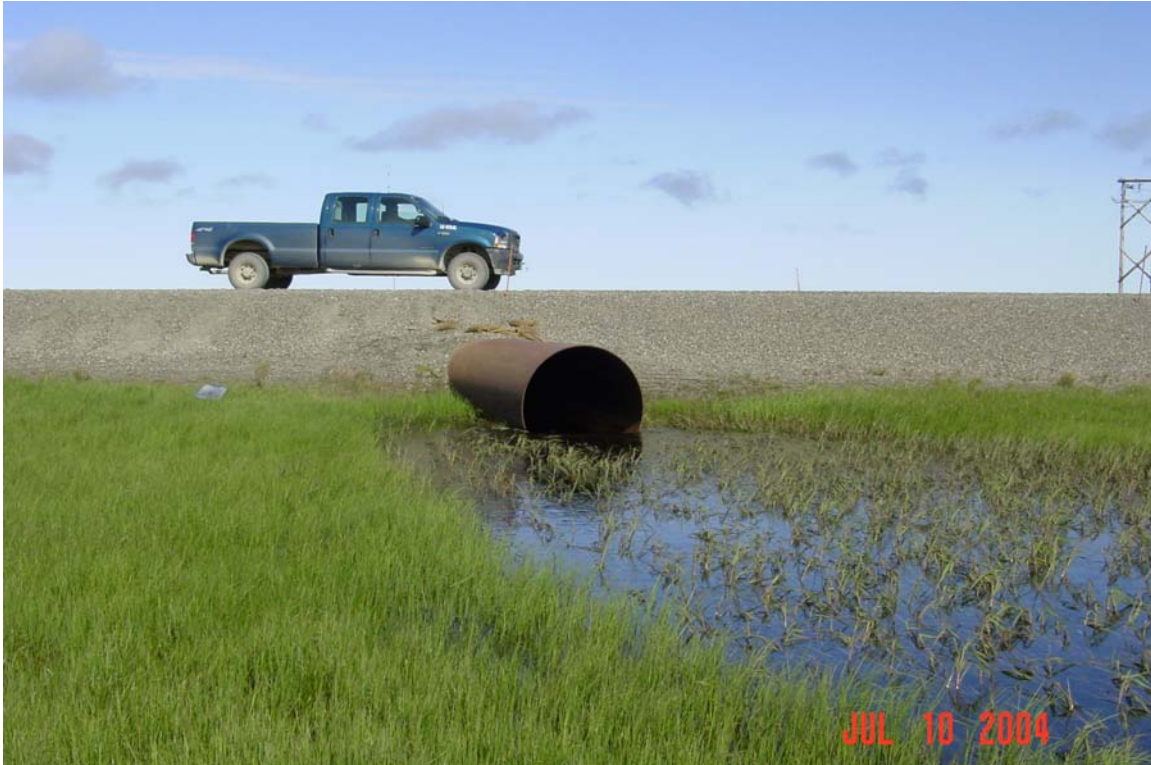
**Photograph 124. Fawn Creek culvert inlet.**

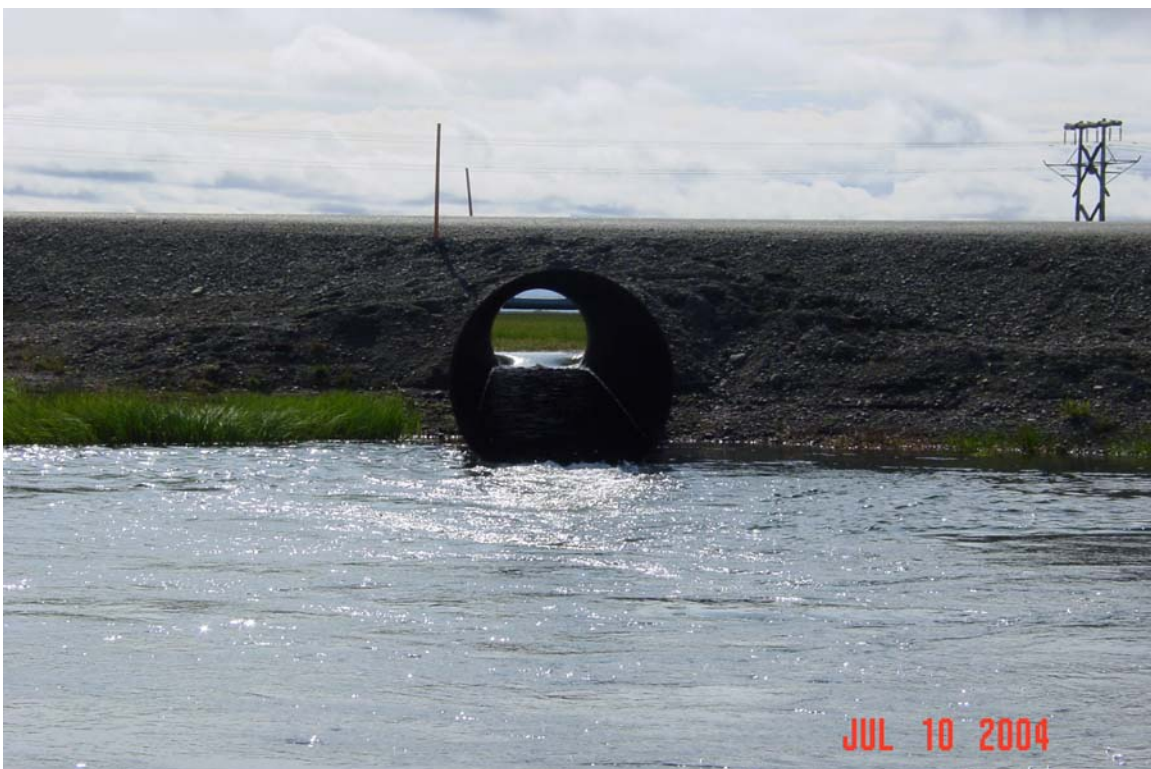
**Photograph 125. Fawn Creek culvert outlet. Significant drop in elevation as water enters the pipe at the upstream side of the crossing occurs with a resultant increased velocity.**

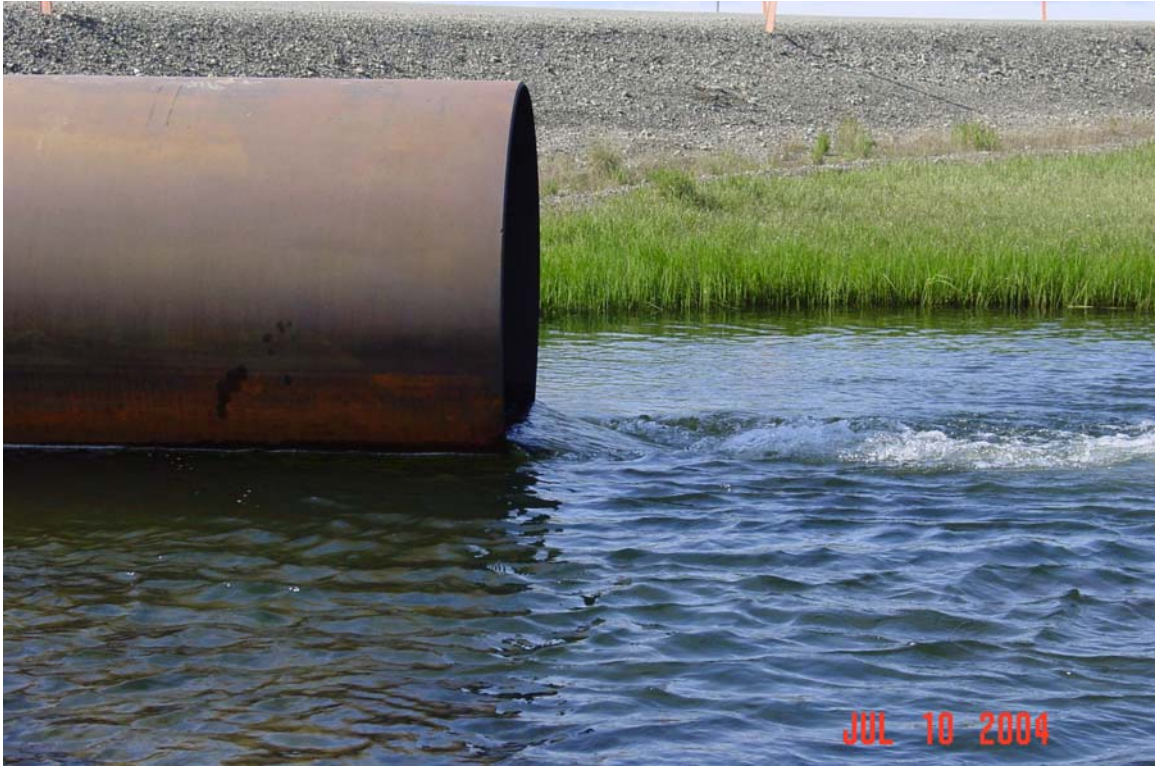
**Photograph 126. Fawn Creek culvert outlet. Culvert outlet is slightly perched creating a barrier to passage at most flows for most fish species identified using the system.**

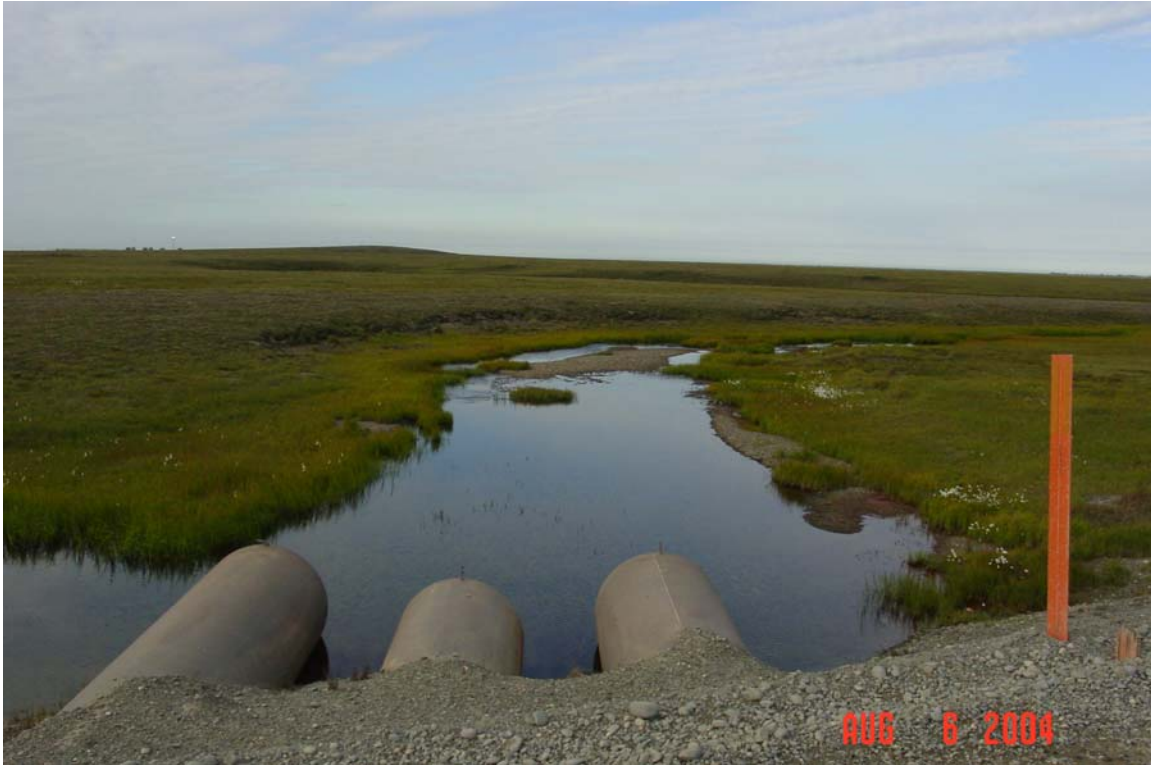
**Photograph 127. Leach Creek downstream of the Spine Road crossing. Significant gravel outwash is present in the stream channel.**

REMEDIALATION RECOMMENDATIONS: Increase water conveyance at this crossing, remove outwash gravels

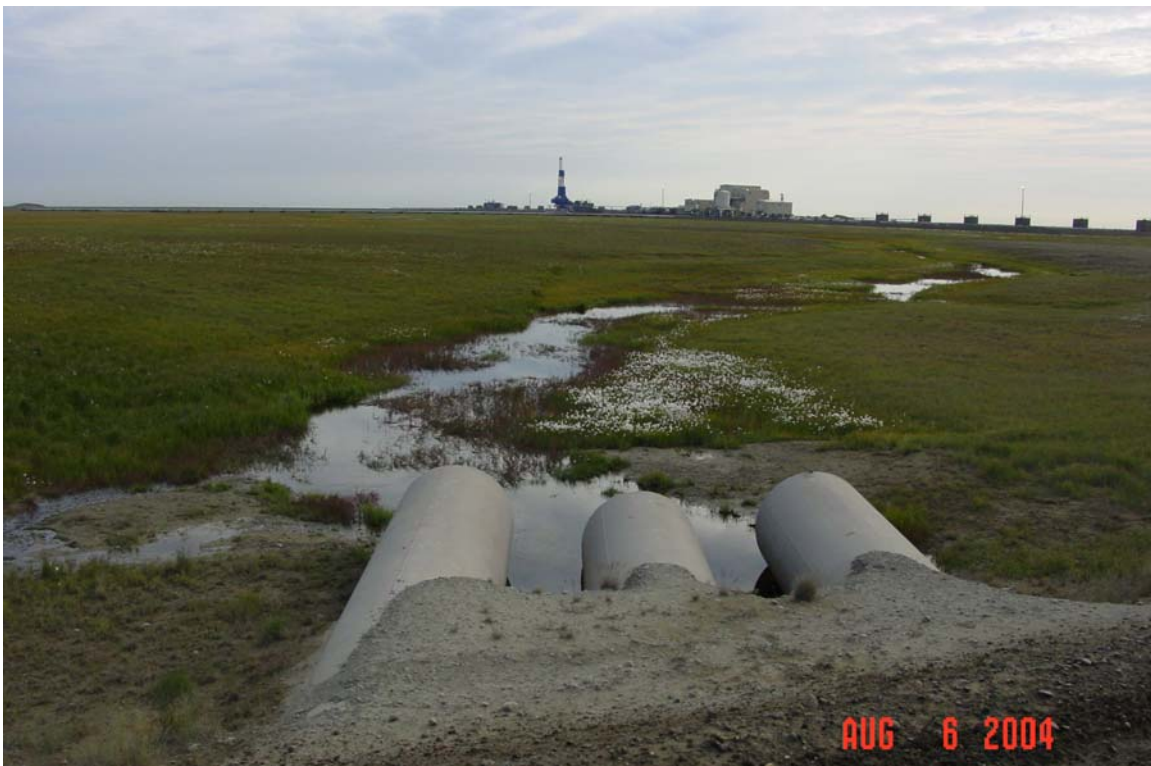
**Photograph 128. Leach Creek upstream of the Spine Road crossing.**

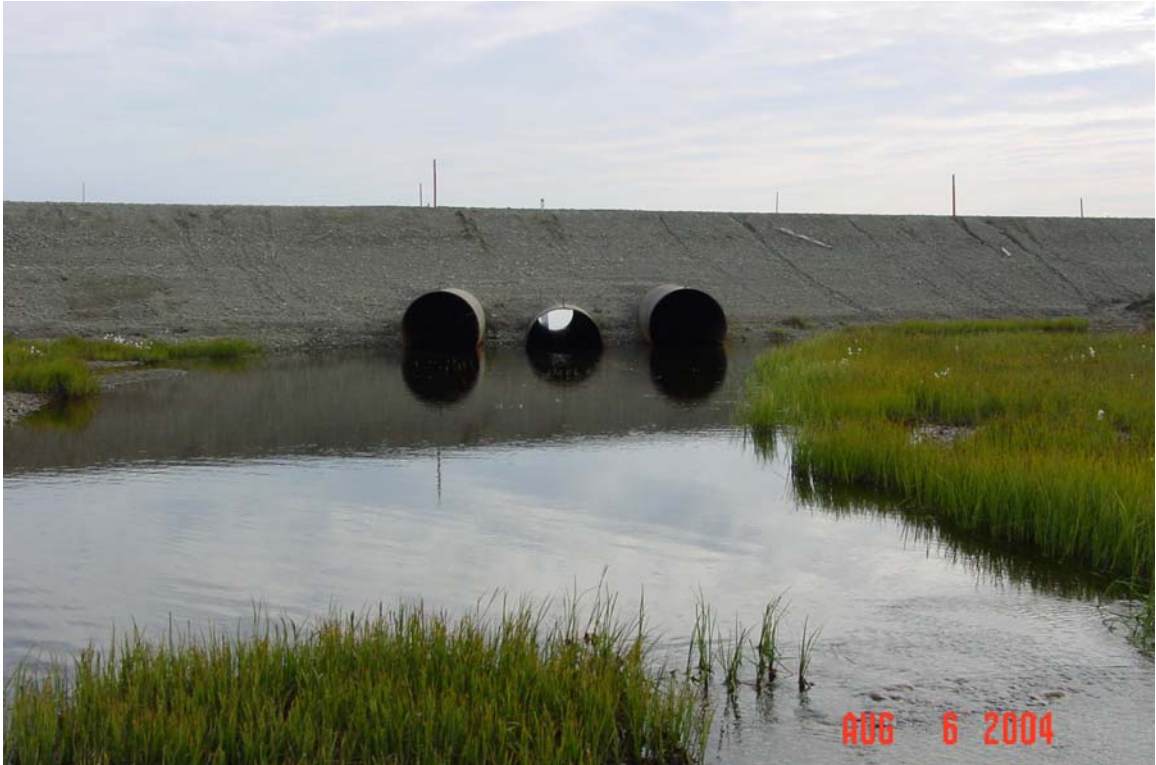
**Photograph 129. Leach Creek culvert outlets.**

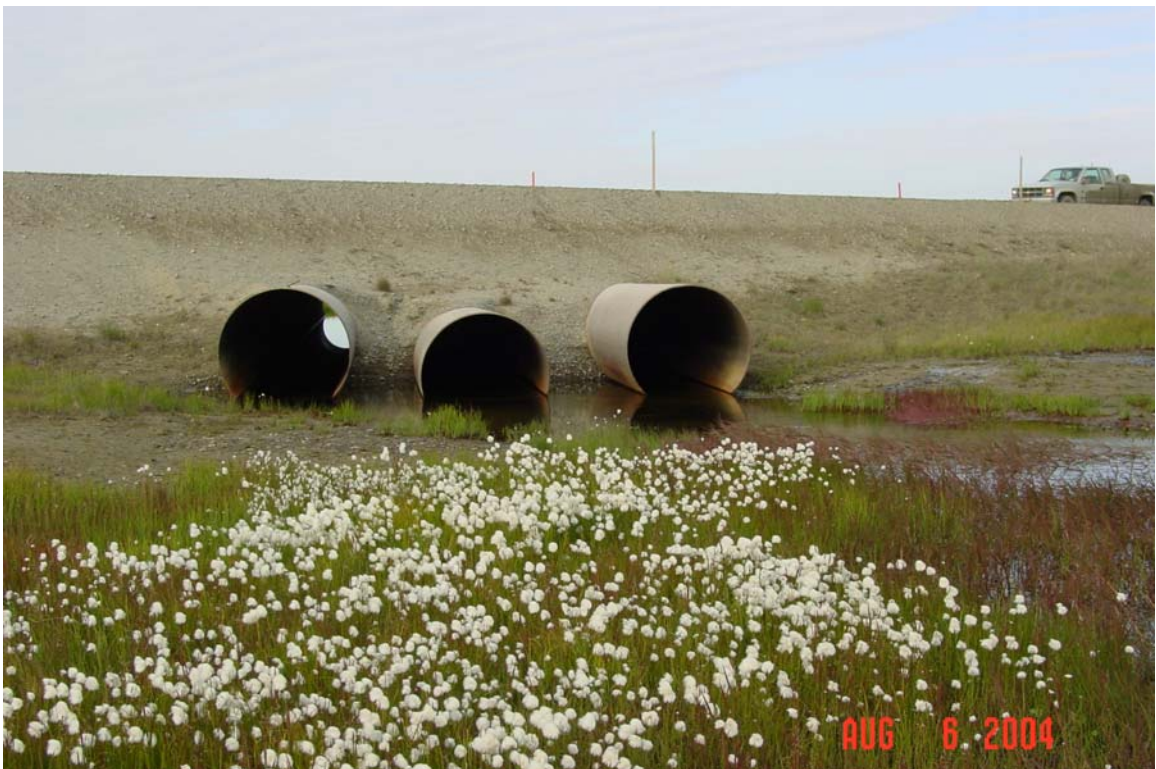
**Photograph 130. Leach Creek culvert inlets. High water mark is at or just above pipes.**

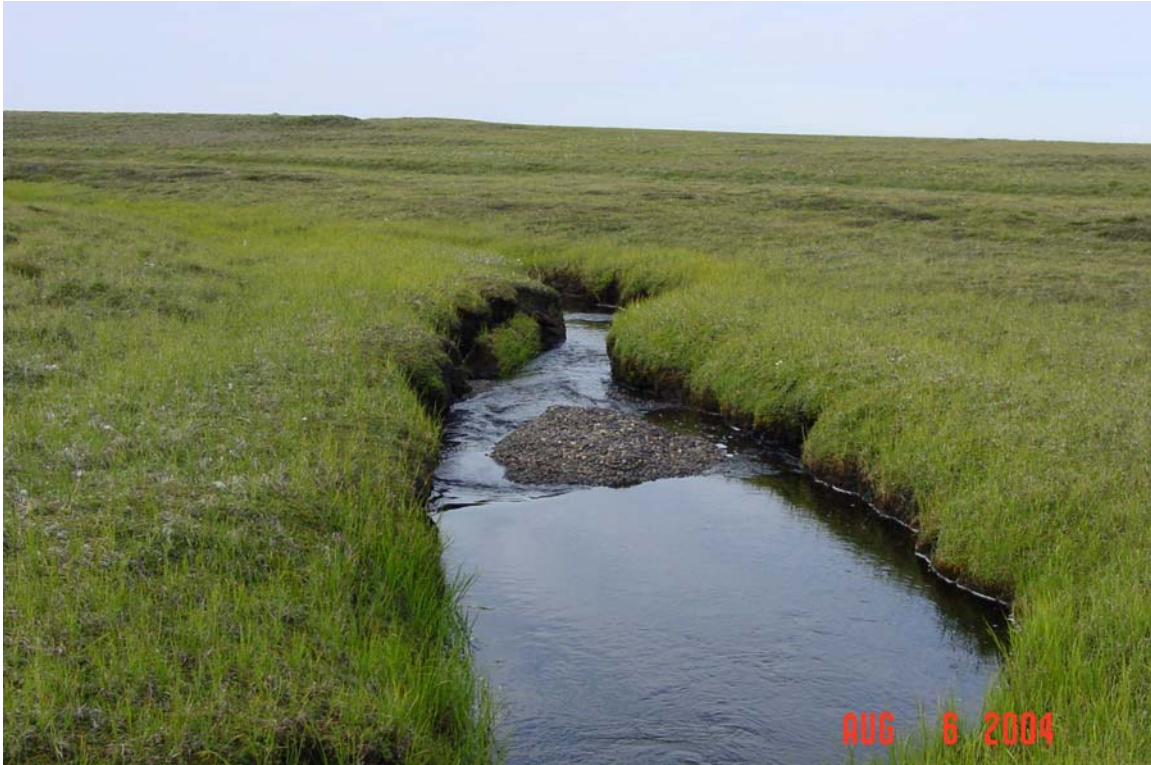
**Photograph 131. Gravel outwash and stream cutting in Leach Creek just downstream of the Spine Road crossing. It is uncertain if the undersized stream crossing is causing the morphological shift in this channel. However, the terraces and cutting visible in this photograph suggest that channel changes have been fairly recent.**

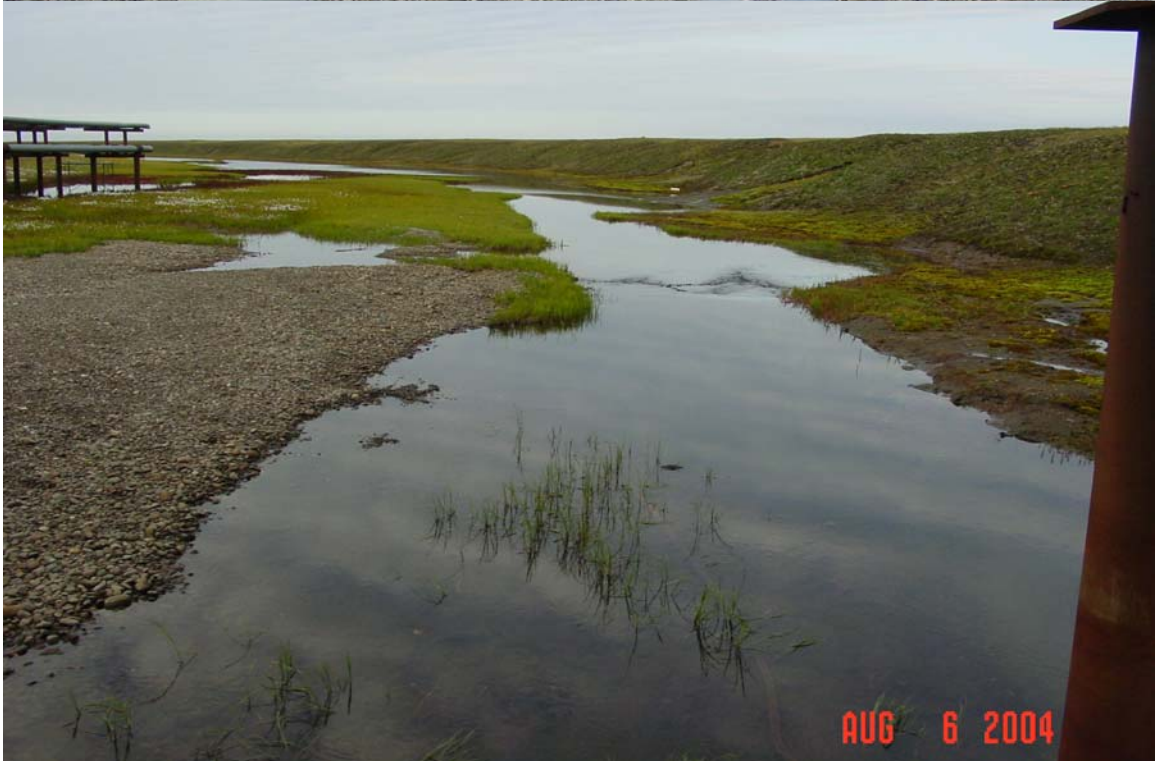
OUTLET: Significant gravel outwash, culverts damaged, debris in stream channel and on banks

**Photograph 132. Leach Creek downstream of the R Pad Road. Significant gravel outwash and debris is in the stream channel and on the stream banks.**

REMEDATION RECOMMENDATIONS: Remove debris and construction materials from stream, increase water conveyance past this crossing location

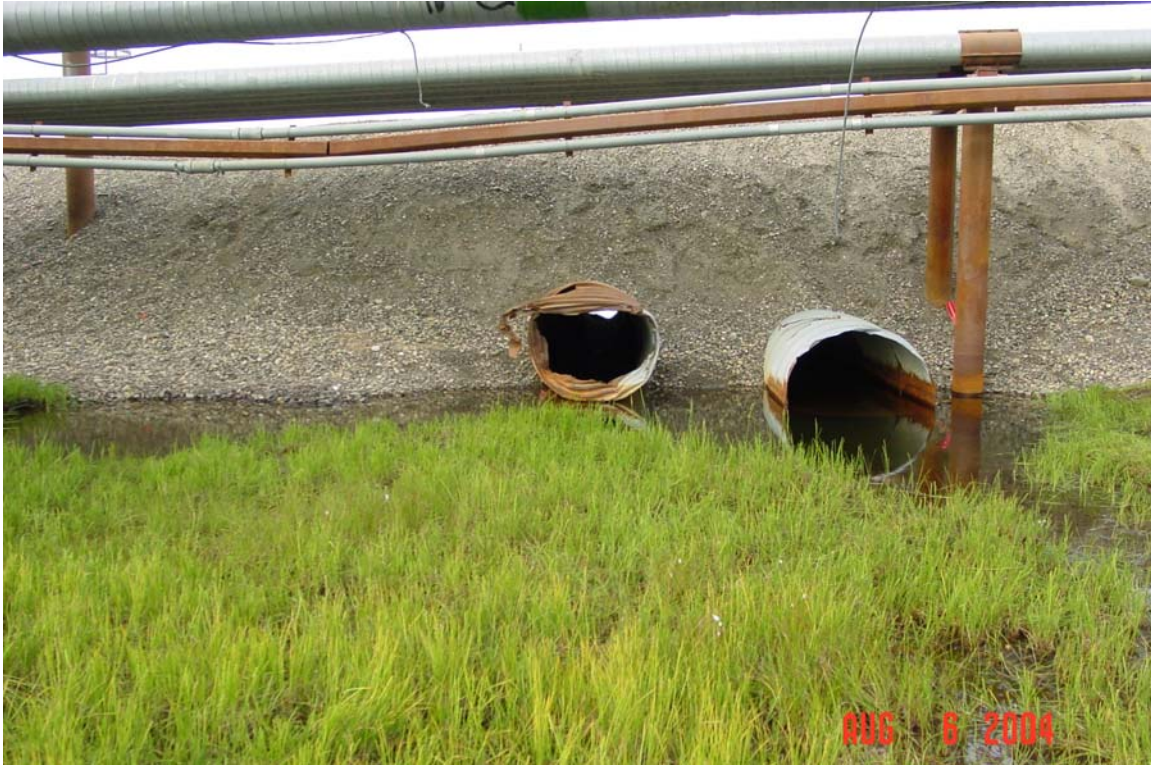
INLET: Culverts not aligned with stream, culverts damaged, culverts off stream bottom, construction materials in stream channel, high water mark at or above pipes

**Photograph 135. Leach Creek culvert inlets. Significant damage and culvert misalignment (channel is to the left).**

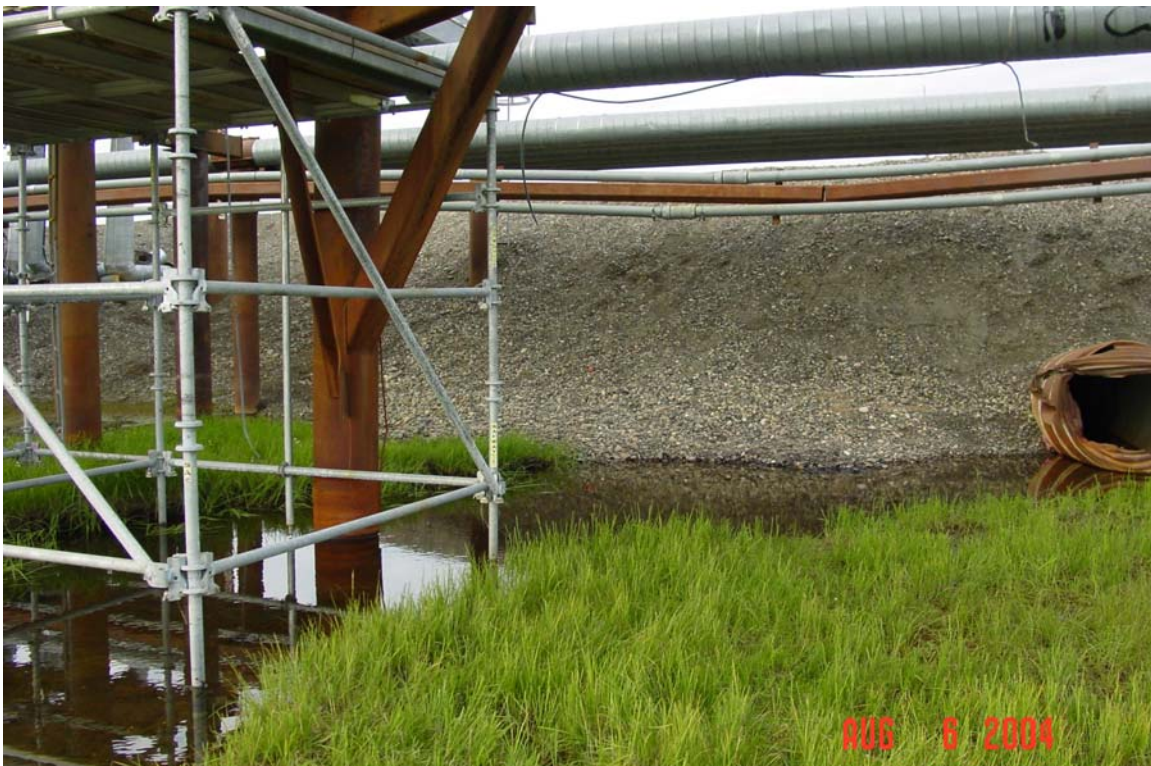
**Photograph 136. Leach Creek culvert inlets. Highwater mark is above the culverts. Scaffolding is erected in stream channel, no active work appeared to be occurring.**

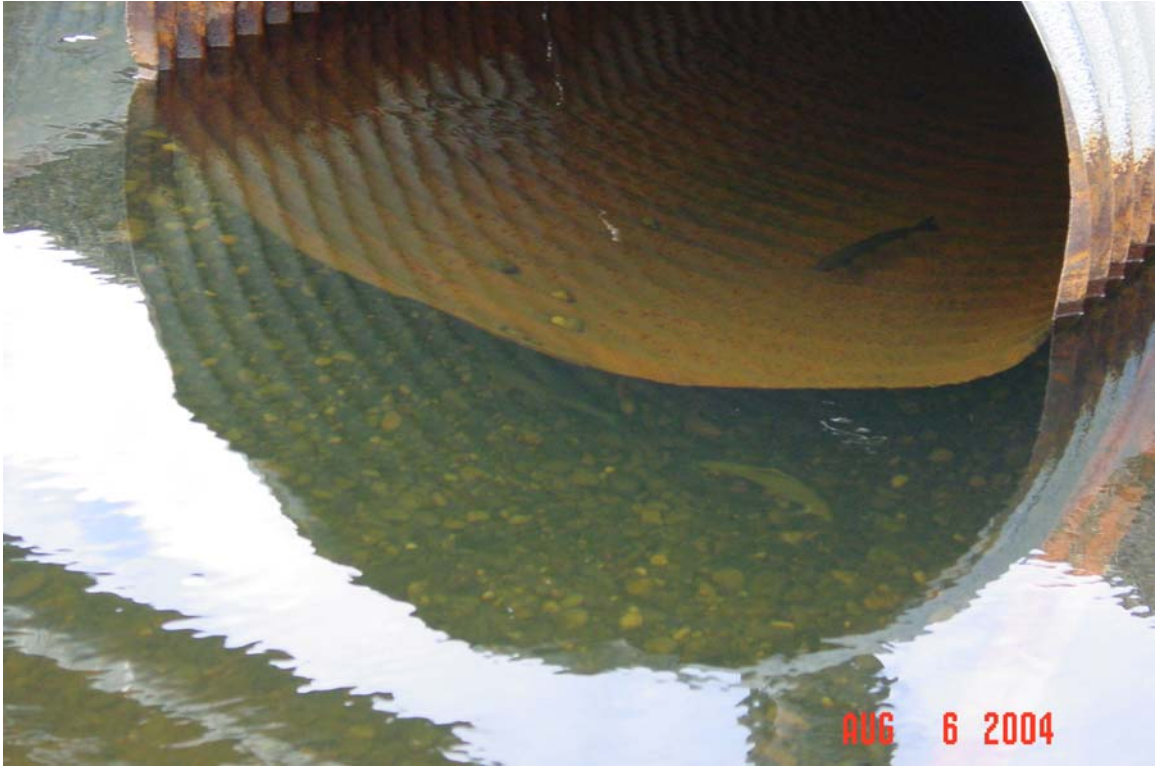
**Photograph 137. Leach Creek culvert inlet. Several Arctic grayling can be seen under and inside the scoured out culvert inlet.**

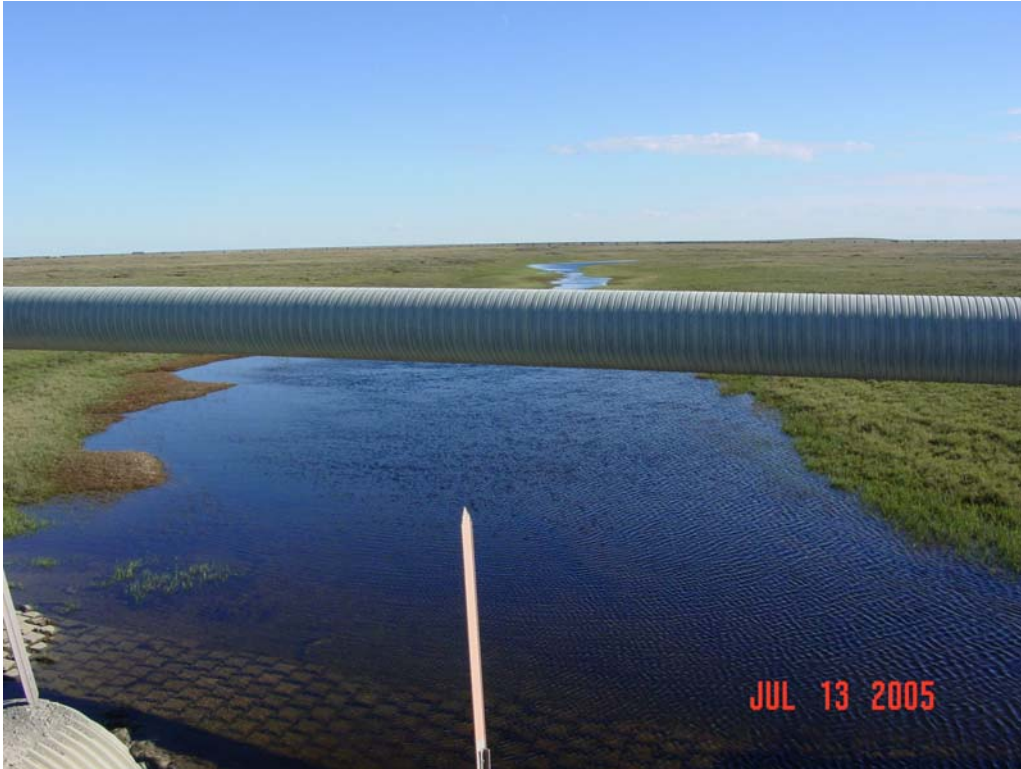
**Photograph 138. Sakonowyak River upstream of the Spine Road.**

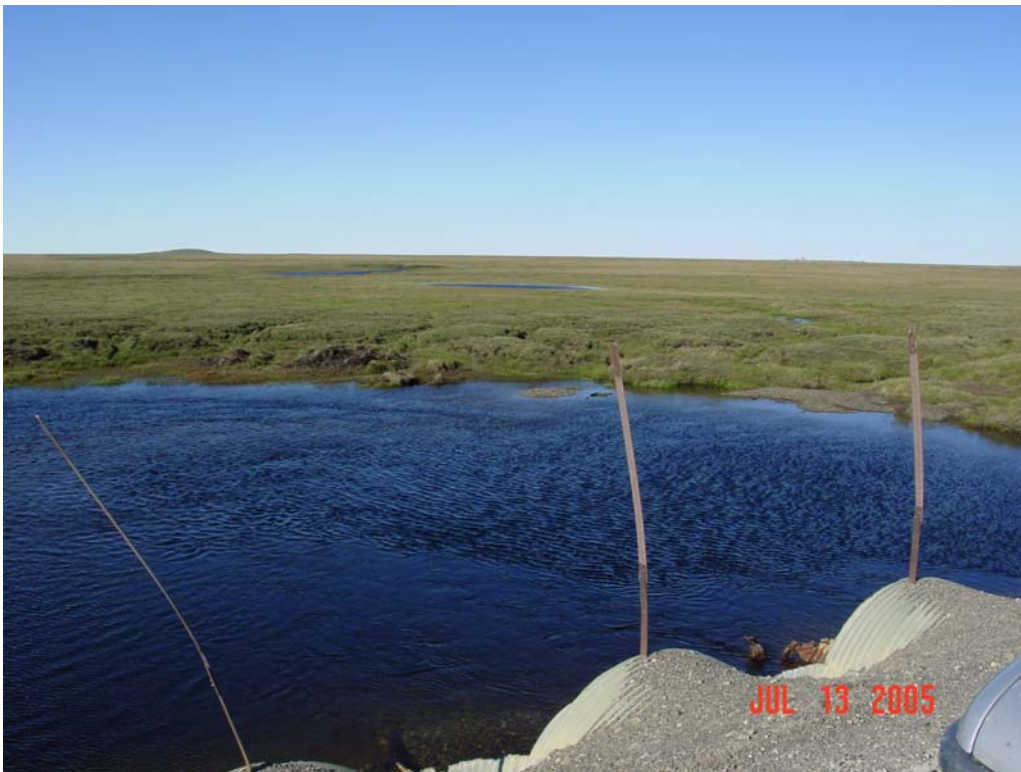
**Photograph 139. Deep scour pool and gravel outwash at the eastern portion of the Spine Road crossing of the Sakonowyak River.**

REMEDIATION RECOMMENDATIONS: Replace with a bridge. Remove accumulated outwash gravels and re-establish stream channel similar to that found above the culvert battery.

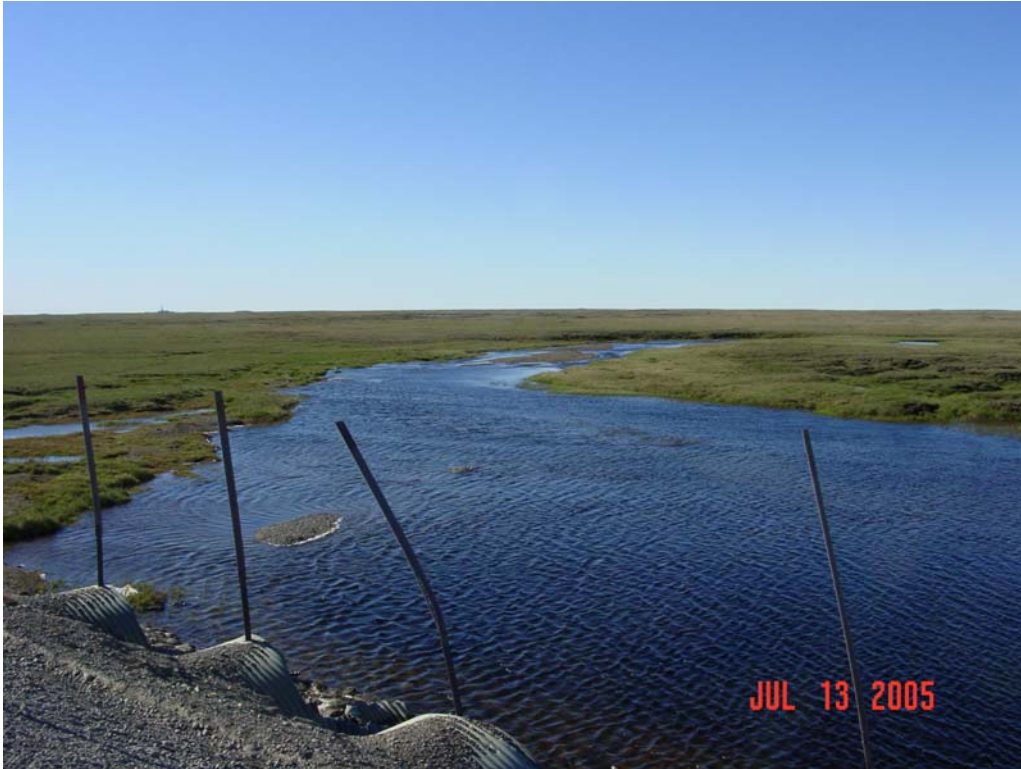
**Photograph 140. Gravel outwash and deep scour downstream of the western portion of the Spine Road crossing of the Sakonowiyak River.**

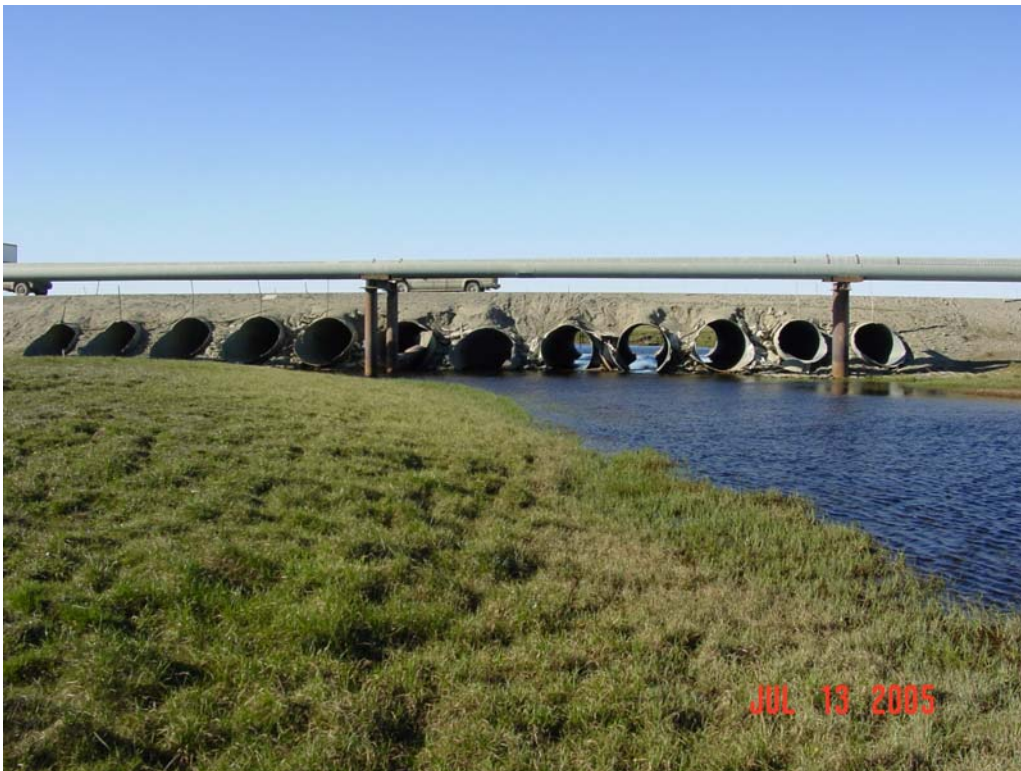
**Photograph 141. Road erosion and damaged culvert inlets at the Sakonowiyak River Spine Road crossing.**

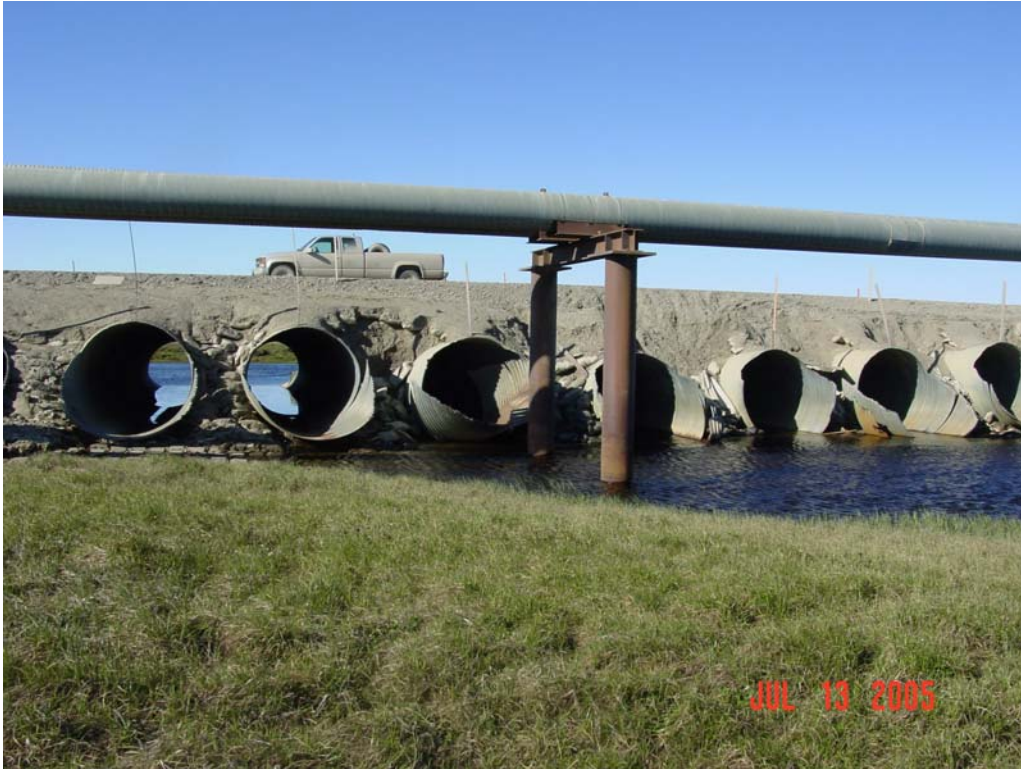
**Photograph 142. Road erosion and damaged culvert inlets at the Spine Road crossing of the Sakonowak River.**

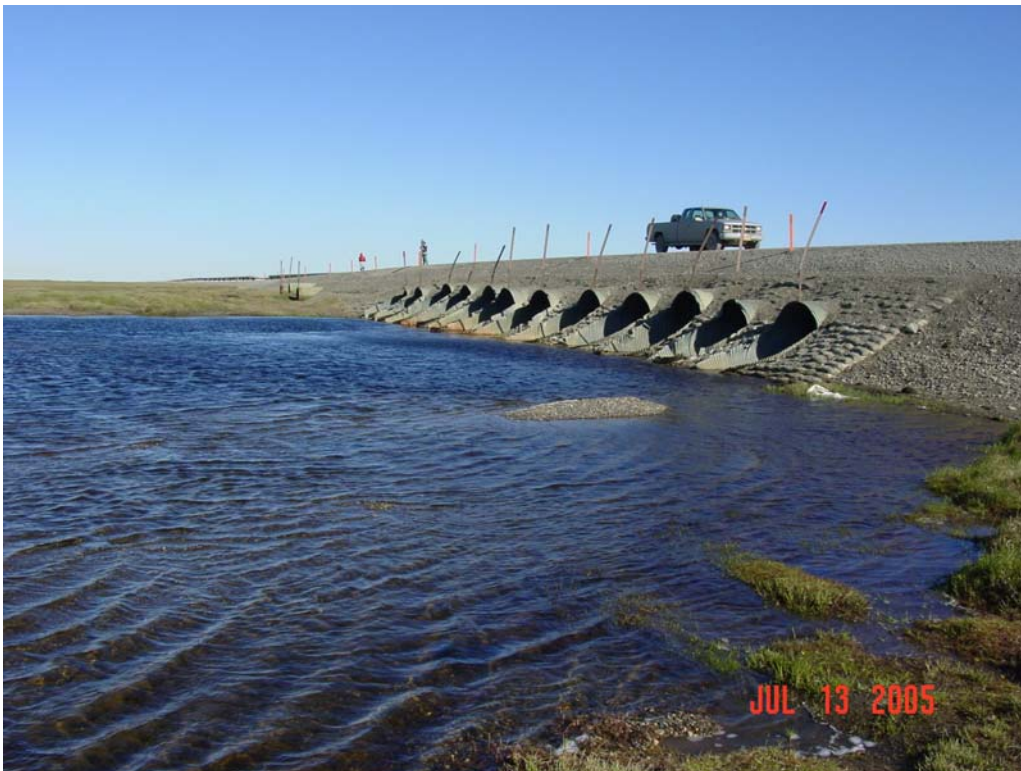
**Photograph 143. Sakonowak River culvert outlets, with gravel outwash in the foreground and additional highwater pipes in the background.**

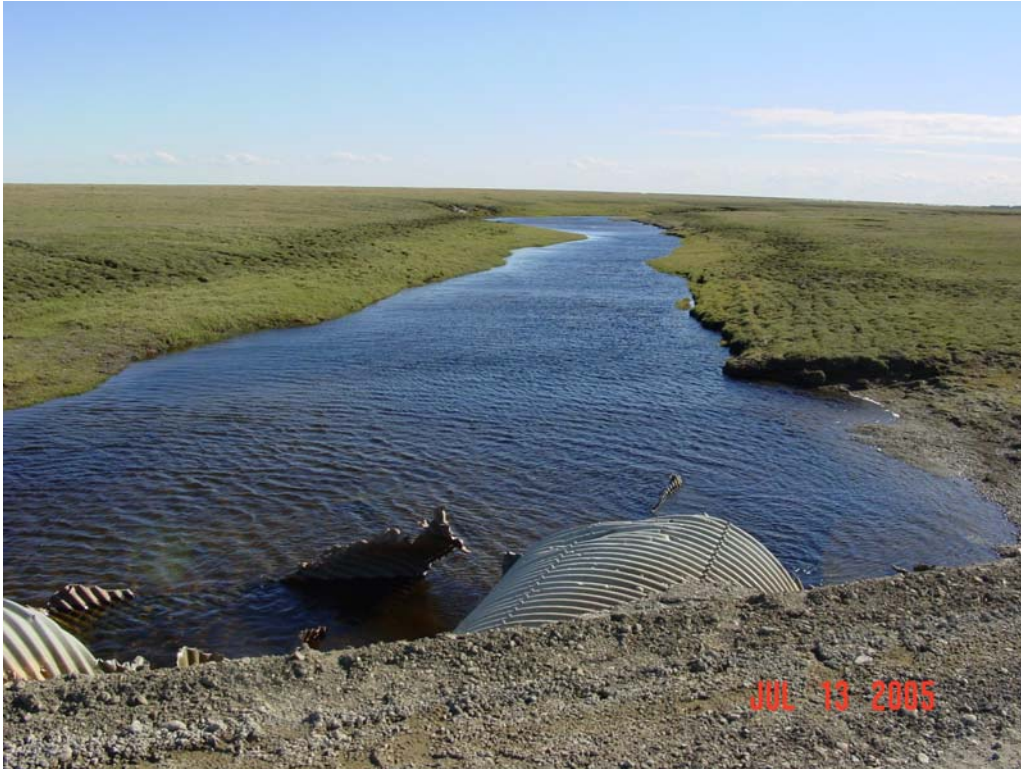
INLET: Sand bag armor, high water mark 4 to 5 feet above culvert inlets, road prism erosion, substantial damage to culvert inlets, sand bag armor and armor reinforcement

**Photograph 144. Damaged culvert inlets at the Smith Creek crossing of the Spine Road.**

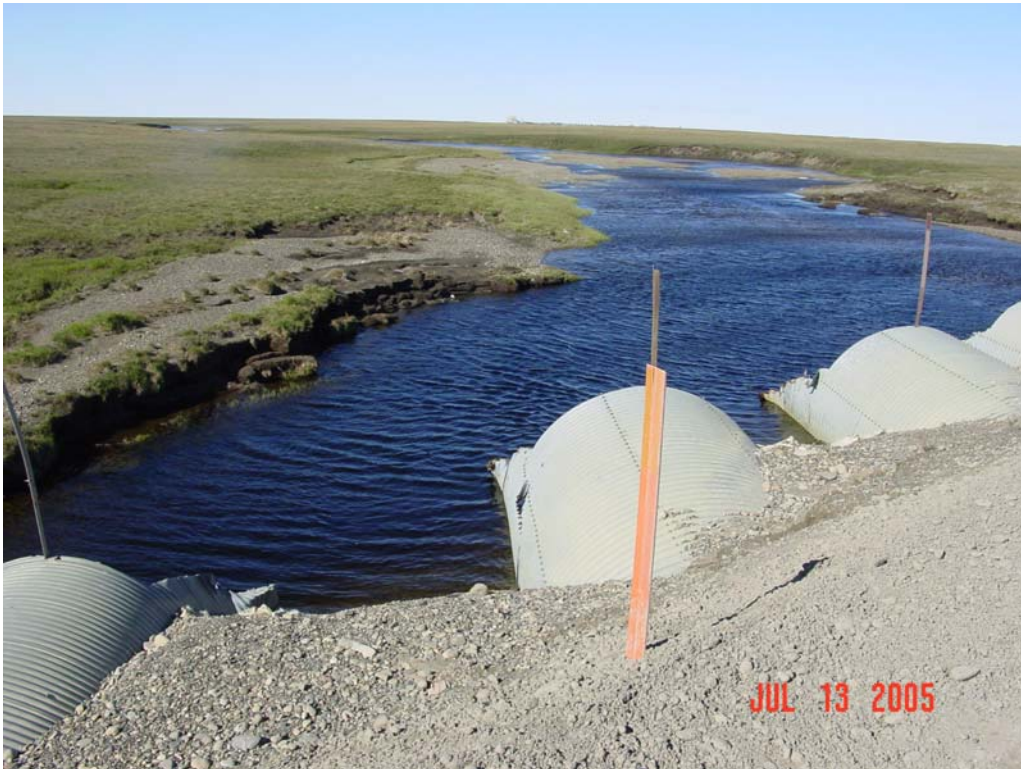
OUTLET: Sand bag armor; outwash gravels present for a considerable distance downstream, torn sand bags downstream of the crossing, 10 to 12 foot deep scour, some culvert outlet damage, some road prism erosion, high water mark above culvert outlets

**Photograph 145. Smith Creek downstream of the Spine Road. Damage to outlets, outlet scour, bank erosion and significant gravel outwash can be seen.**

REMEDIATION RECOMMENDATIONS: Replace with a bridge. Remove accumulated outwash gravels and re-establish stream channel similar to that found above the culvert battery. Remove sand bags that have washed downstream.
