**Technical Report No. 08-01**

## **A SURVEY OF STREAM CROSSING STRUCTURES IN THE NORTH SLOPE OILFIELDS**

**by William A. Morris  
and Jack F. Winters**

**February 2008**

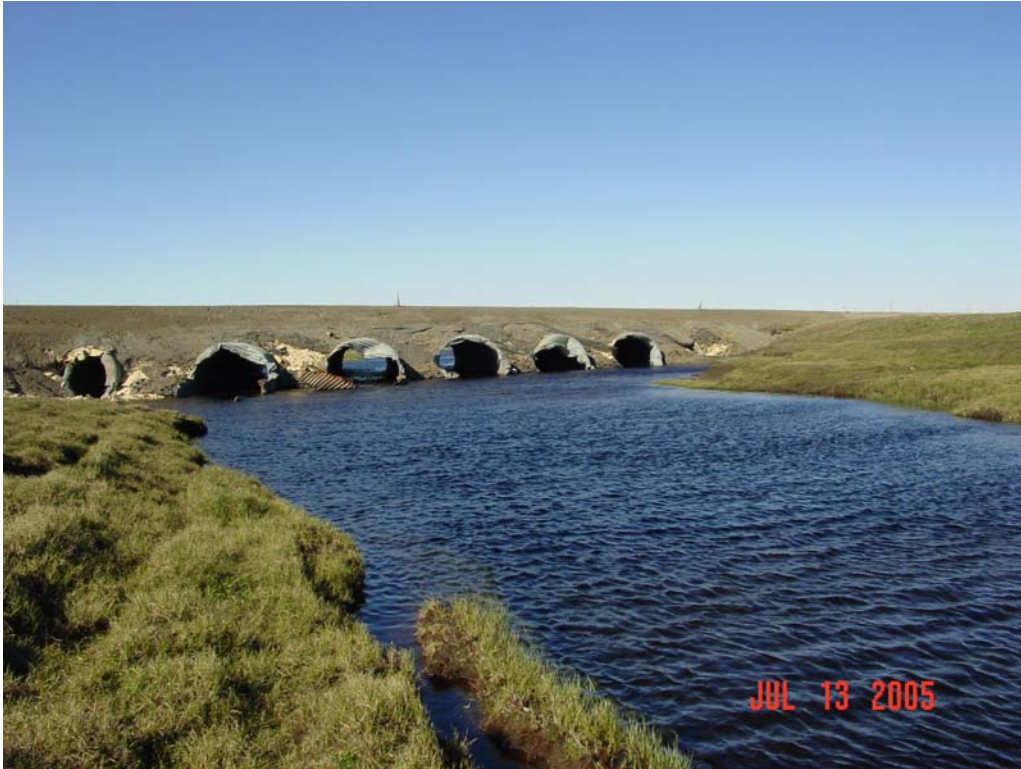
**Photograph 146. Smith Creek culvert inlets at the Spine Road crossing.**

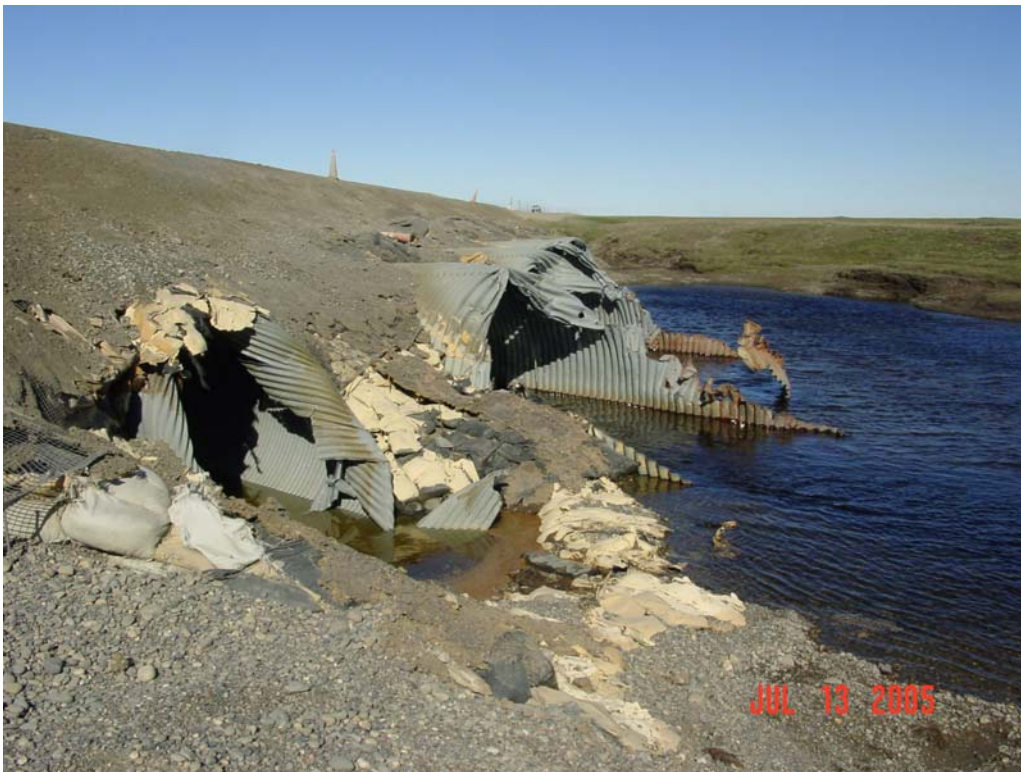
**Photograph 147. Smith Creek at the Spine Road crossing. Severe damage to culvert inlets, significant road and armor erosion, and upstream scour.**

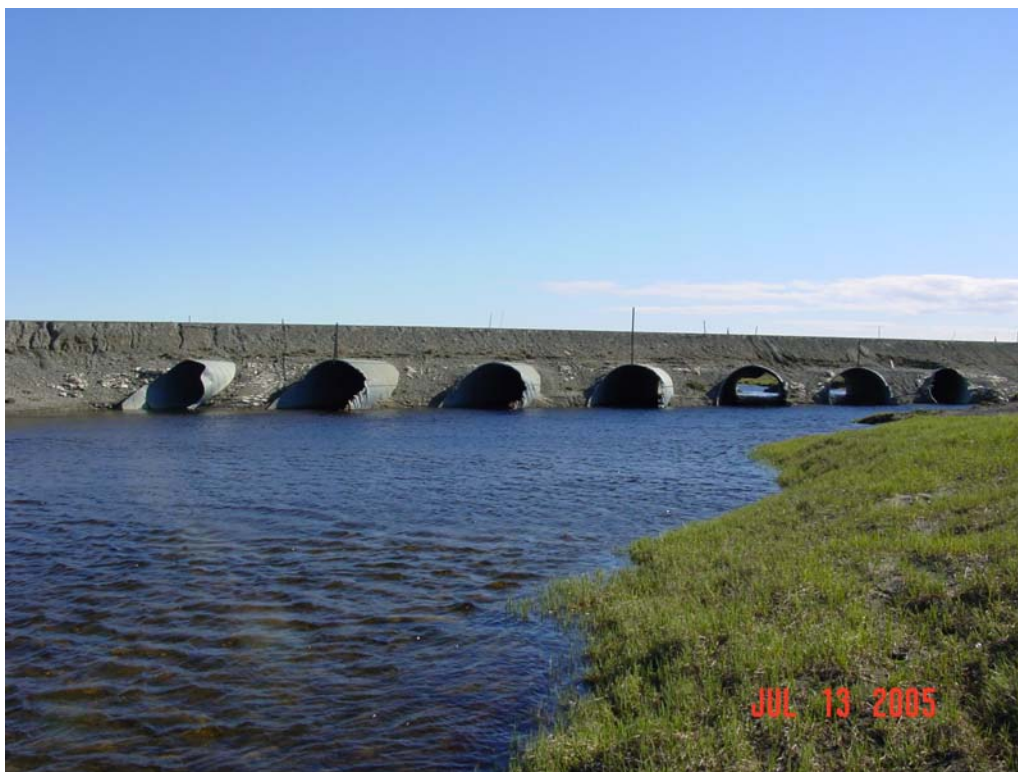
**Photograph 149. Smith Creek culvert outlets. Some damage to outlets can be seen as well as some minimal road erosion.**

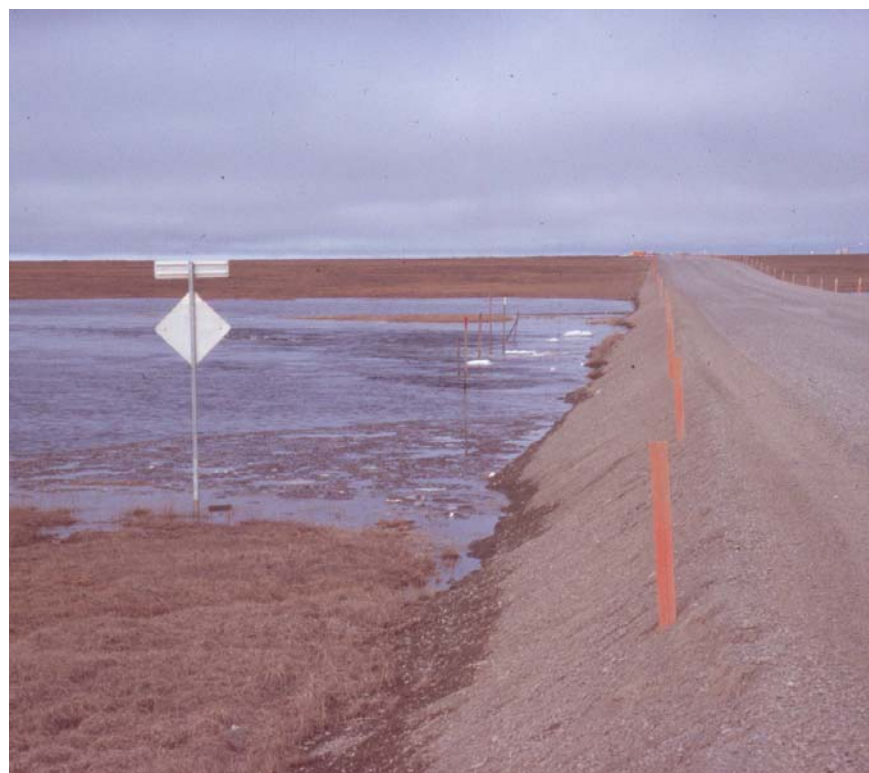
**Photograph 150. Smith Creek downstream of the crossing during break-up, June 9, 2005. High velocities can be observed.**

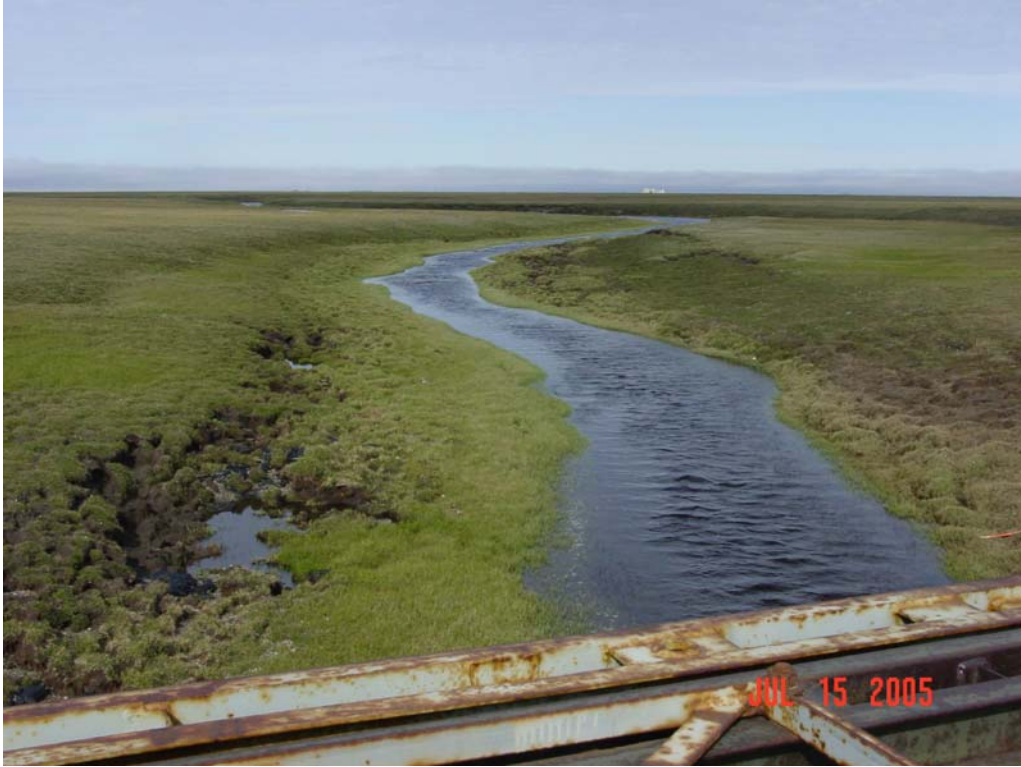
**Photograph 151. Smith Creek downstream of the Kuparuk Pipeline access road bridge.**

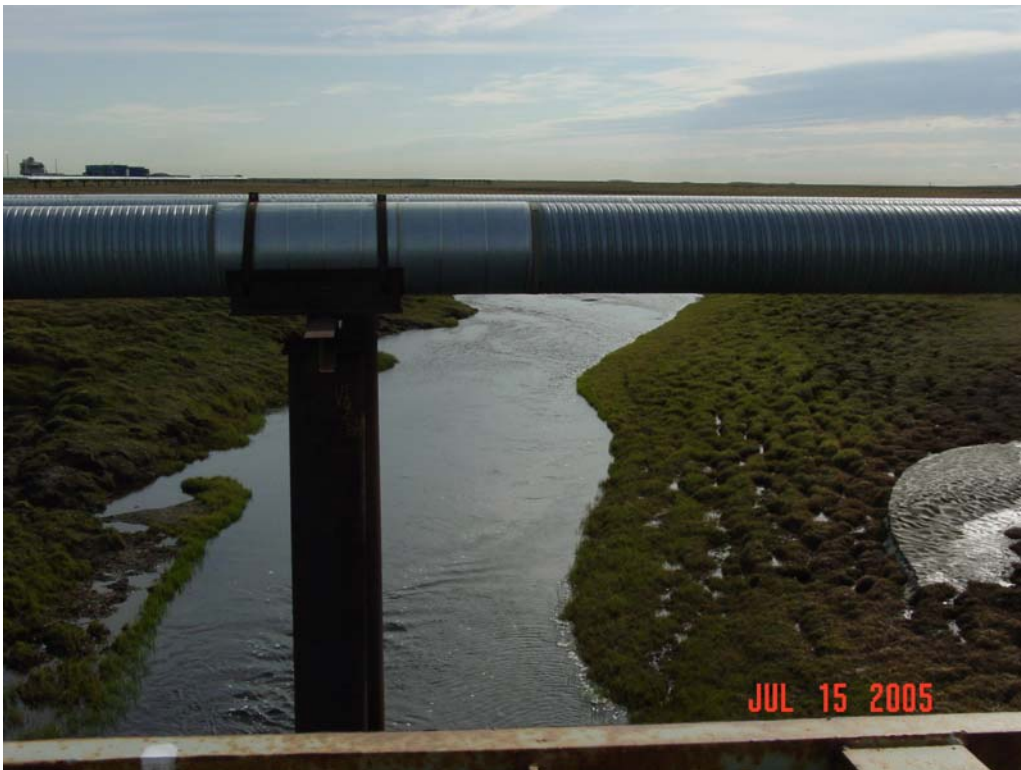
**Photograph 152. Smith Creek upstream of the Kuparuk Pipeline access road bridge.**

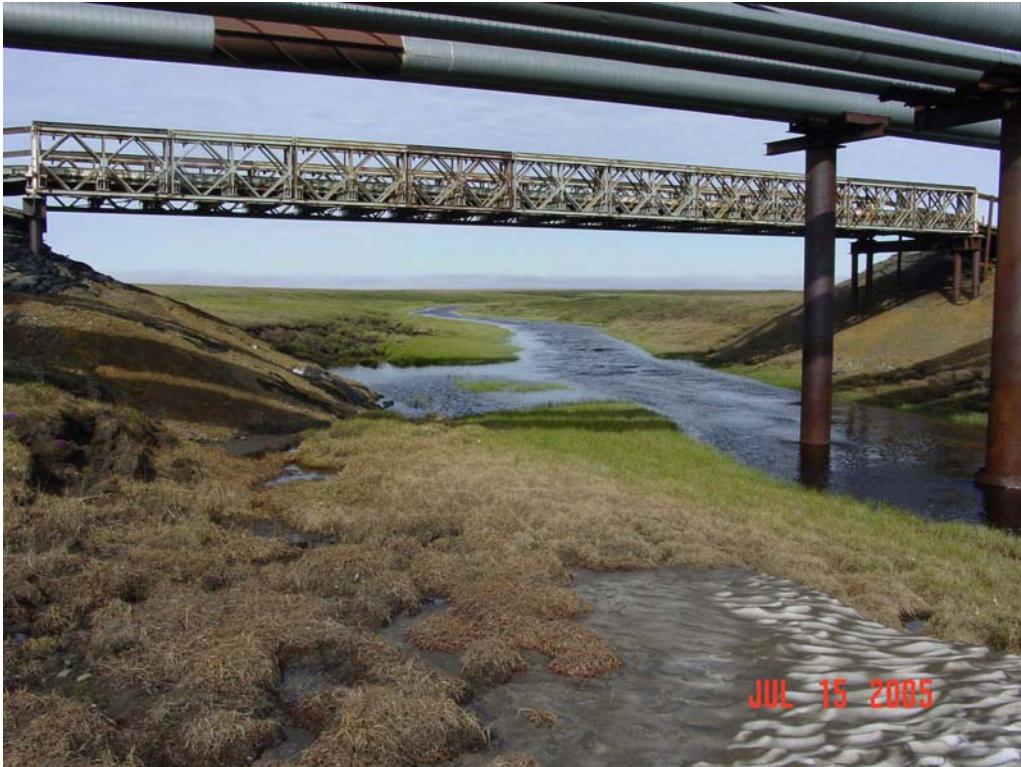
**Photograph 153. Downstream view of the Smith Creek bridge.**

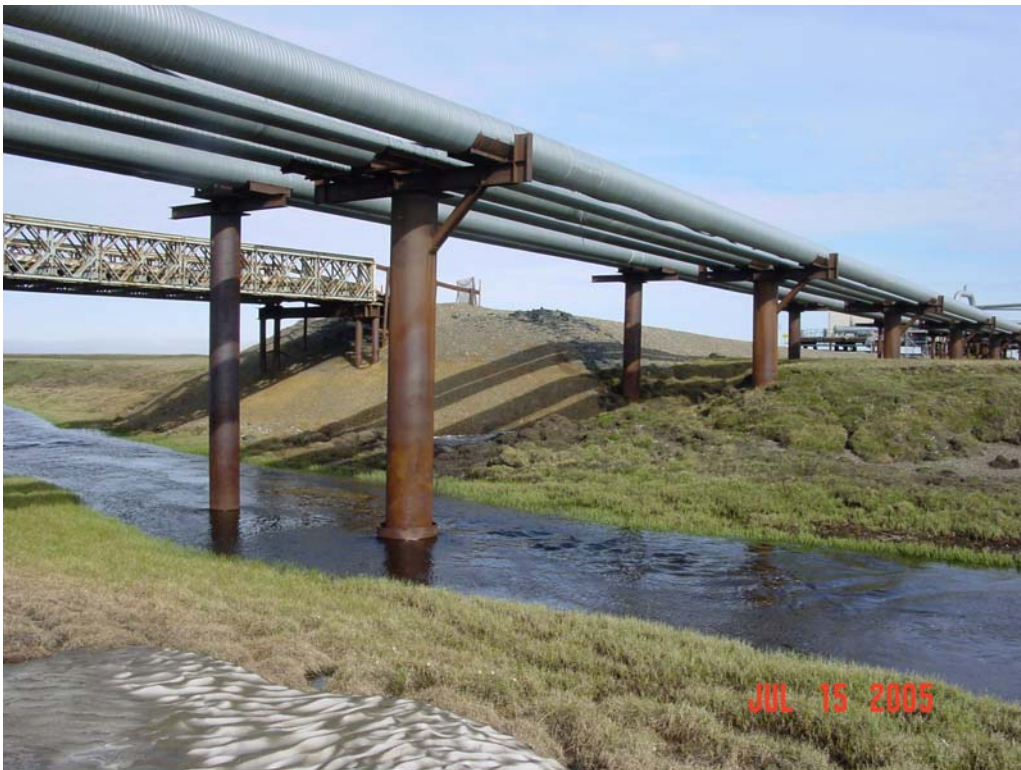
CROSSING STRUCTURE: Bridge with sand bag armor on both abutments. Some sand bag armor failure associated with ice at breakup. Some tundra erosion around the abutment slopes. Some sand bags on tundra downstream of bridge. Bridge does not span full bankfull stream width. Abutment slopes restrict breakup flows.

**Photograph 154. East abutment of the Smith Creek bridge.**

REMEDATION RECOMMENDATIONS: Remove sand bags from creek, address armor erosion

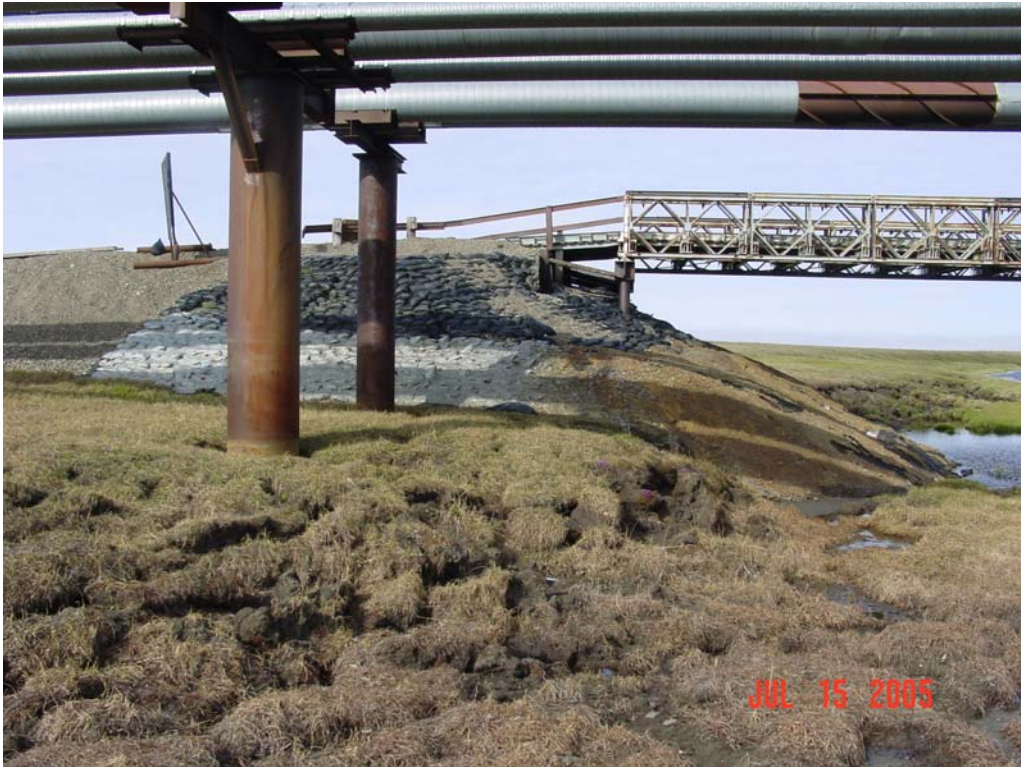
**Photograph 155. West abutment of the Smith Creek bridge.**

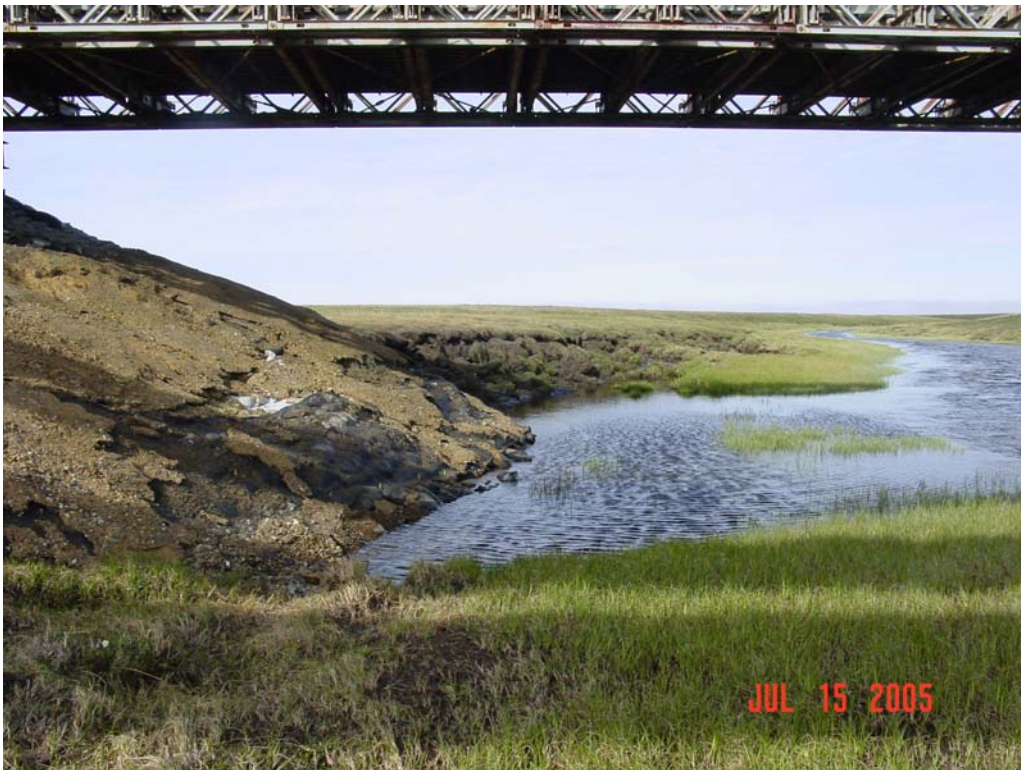
**Photograph 156. West abutment erosion, sand bag disturbance and tundra erosion.**

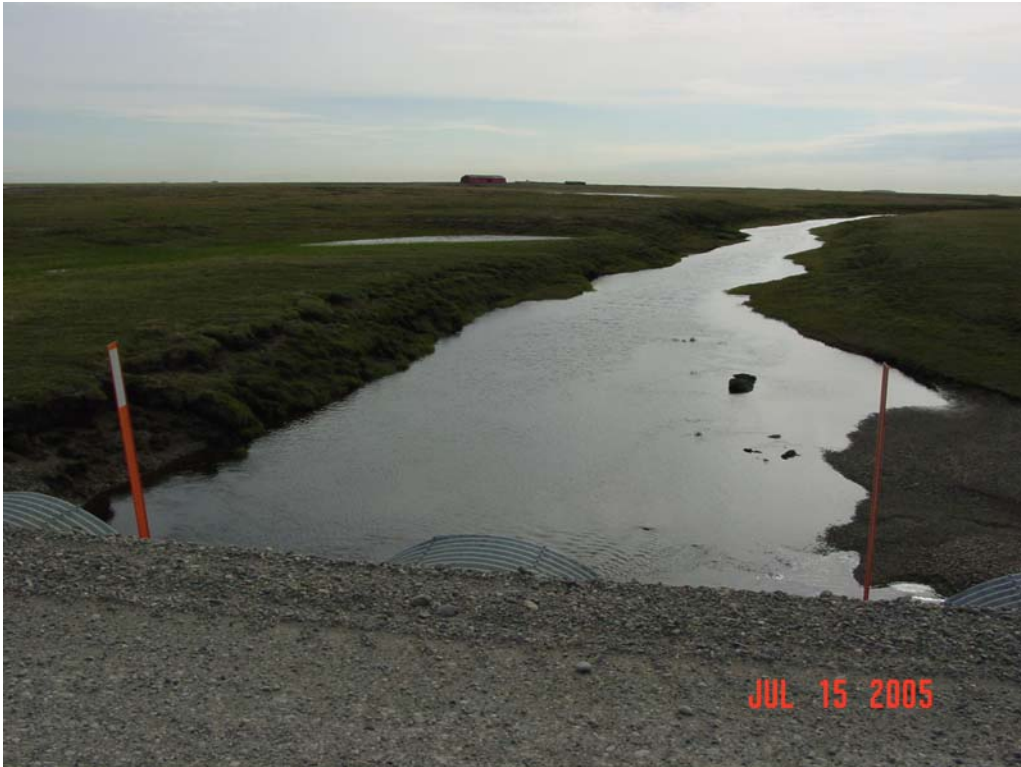
**Photograph 157. Smith Creek upstream of the W Pad access road.**

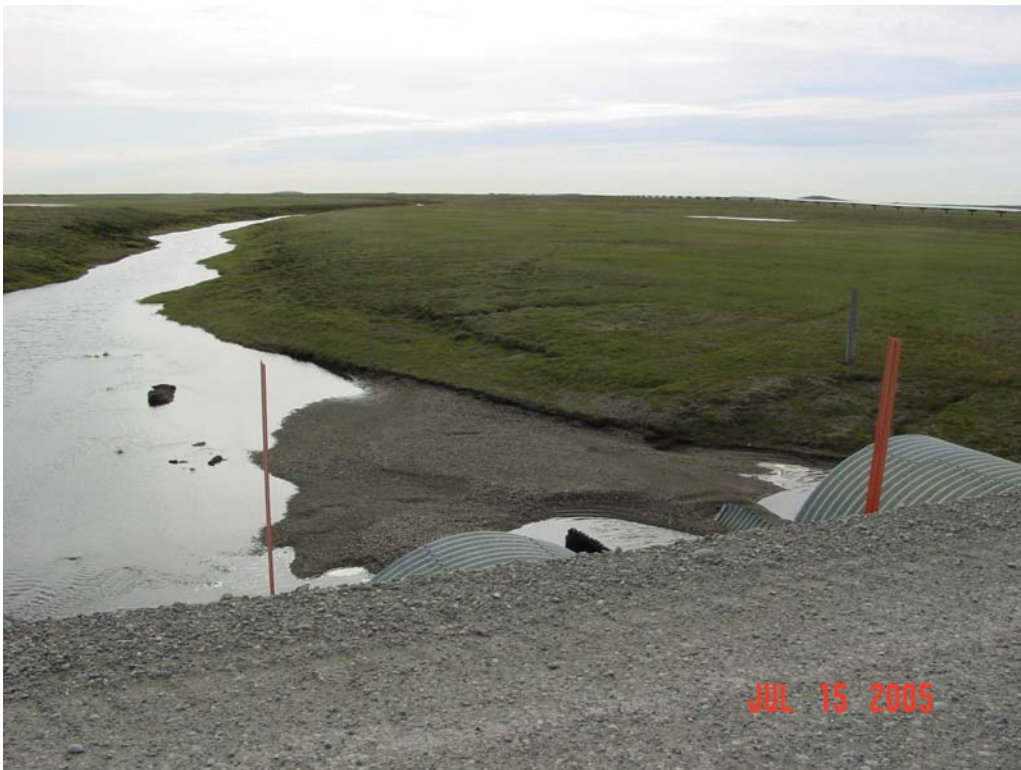
INLET: Sand bag armor, some tundra erosion, gravel deposits in front of three of the culvert inlets, some culvert inlet damage

**Photograph 158. Smith Creek upstream of the W Pad access road. Gravel deposition at culvert inlets.**

REMEDICATION RECOMMENDATIONS: Repair damaged culverts. Remove upstream and downstream gravel deposits.

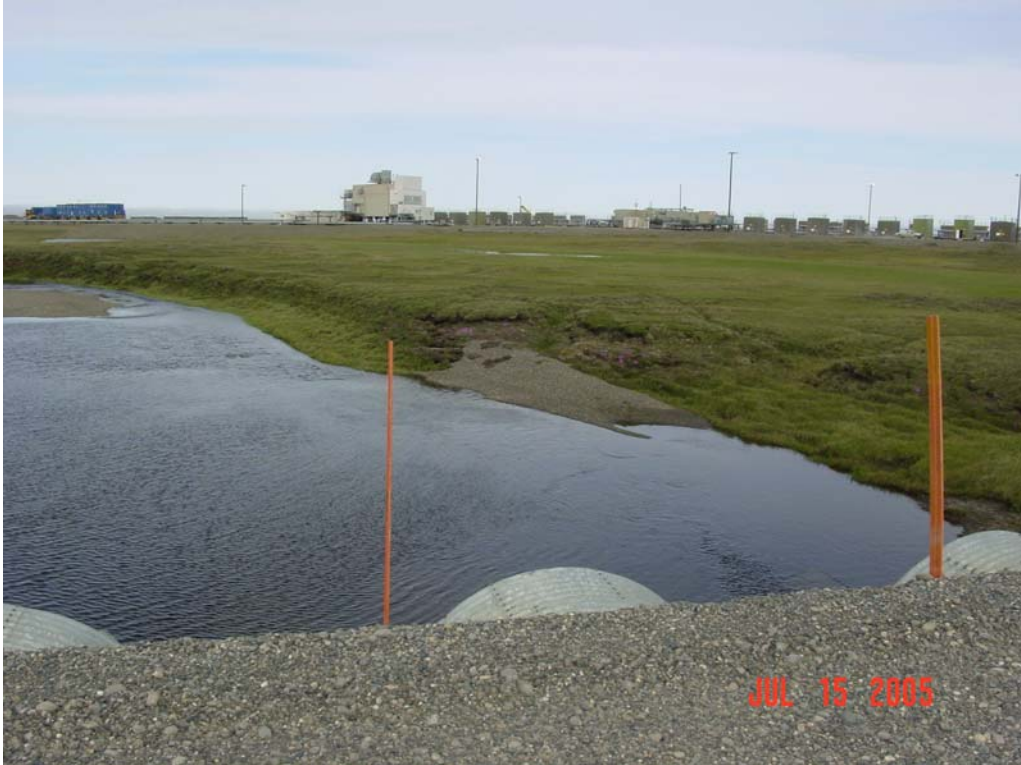
**Photograph 159. Smith Creek downstream of the W Pad access road crossing.**

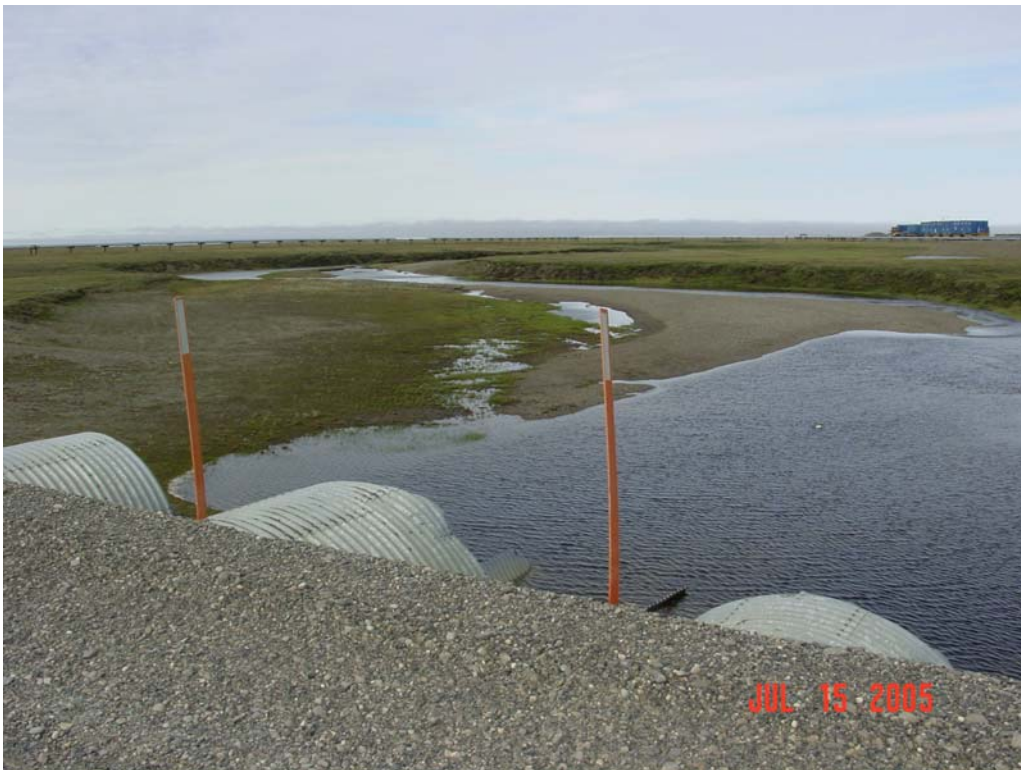
OUTLET: Sand bag armor, substantial gravel deposits downstream, scour up to 10 feet deep, culverts with active flow 3 feet off the stream bottom, culvert aprons damaged

**Photograph 160. Smith Creek downstream of the W Pad access road crossing. Extensive outwash gravels present downstream.**

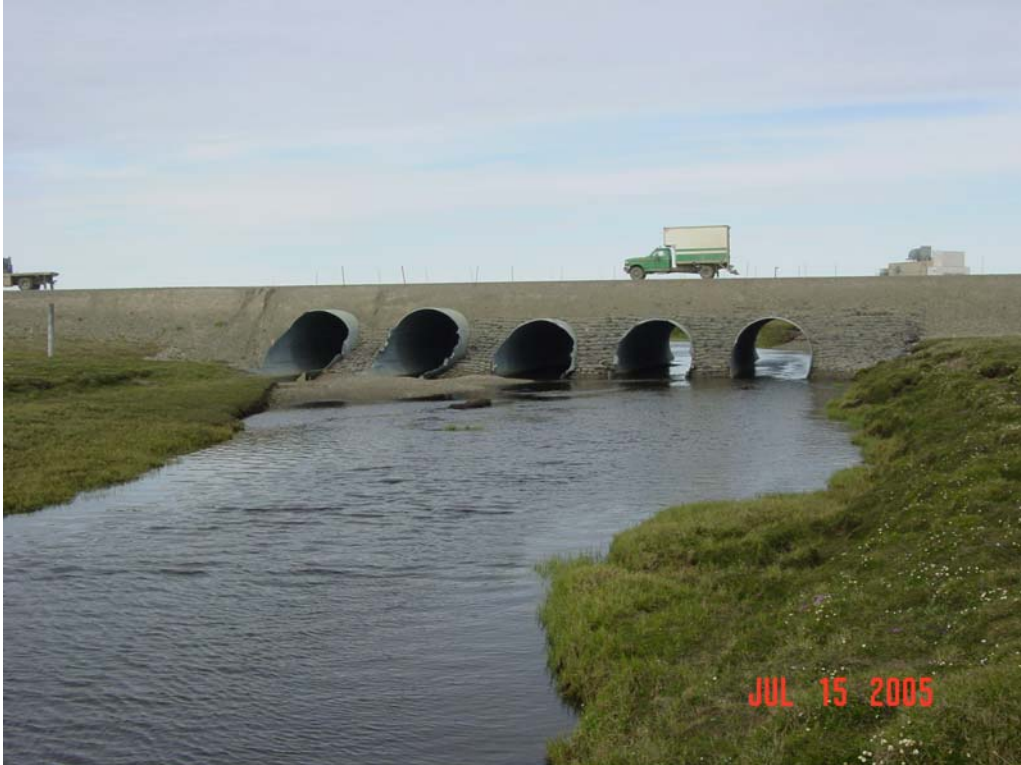
**Photograph 161. Smith Creek culvert inlets. The gravel bar was blocking 4 of the 5 culverts during the low flows observed in July 2007.**

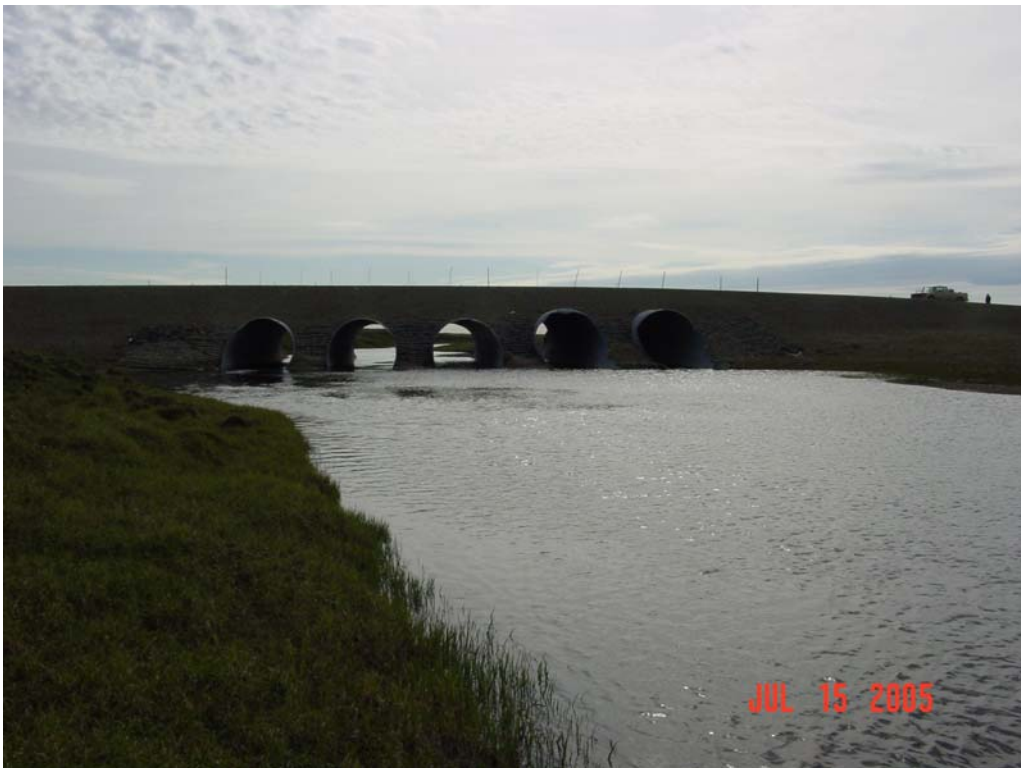
**Photograph 162. Smith Creek culvert outlets.**

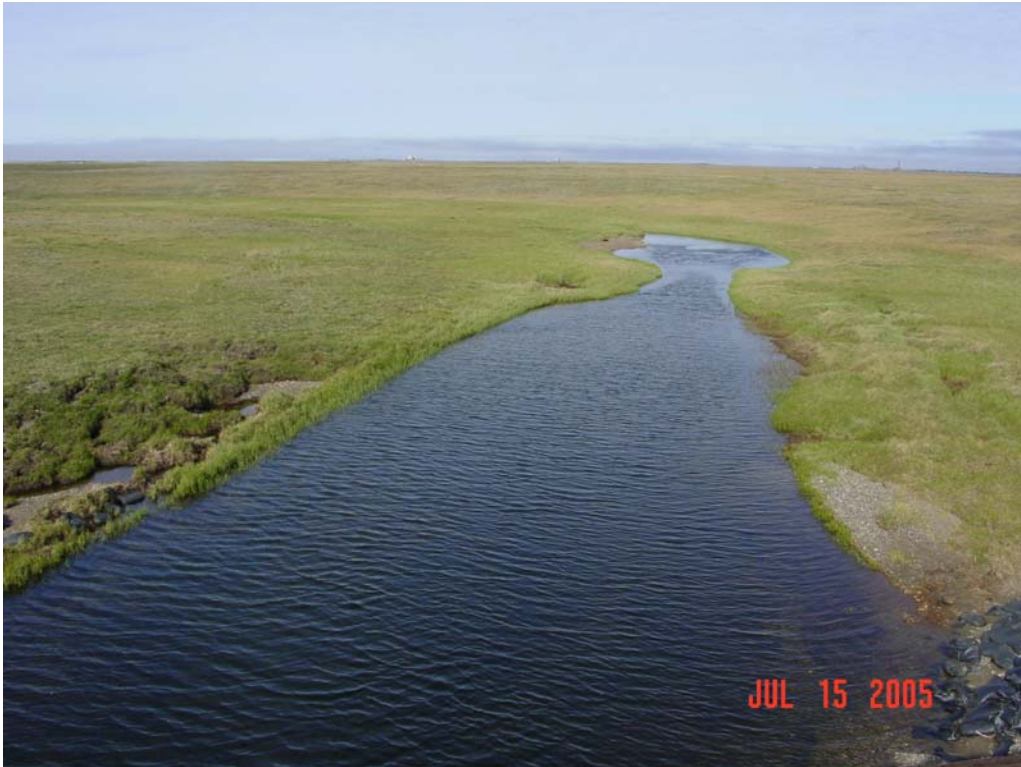
CROSSING STRUCTURE: Bridge with sand bag armor on both abutments. Substantial sand bag armor failure likely associated with ice at breakup. Gravel outwash on tundra downstream of bridge. Some debris and sand bags on the tundra and in the stream downstream of bridge. Bridge does not span full bankfull stream width. Abutment slopes restrict breakup flows.

**Photograph 163. Pebble Creek downstream of the Kuparuk Pipeline access road bridge.**

REMEDIATION RECOMMENDATIONS: Remove debris and sand bags from the creek, address sand bag erosion.

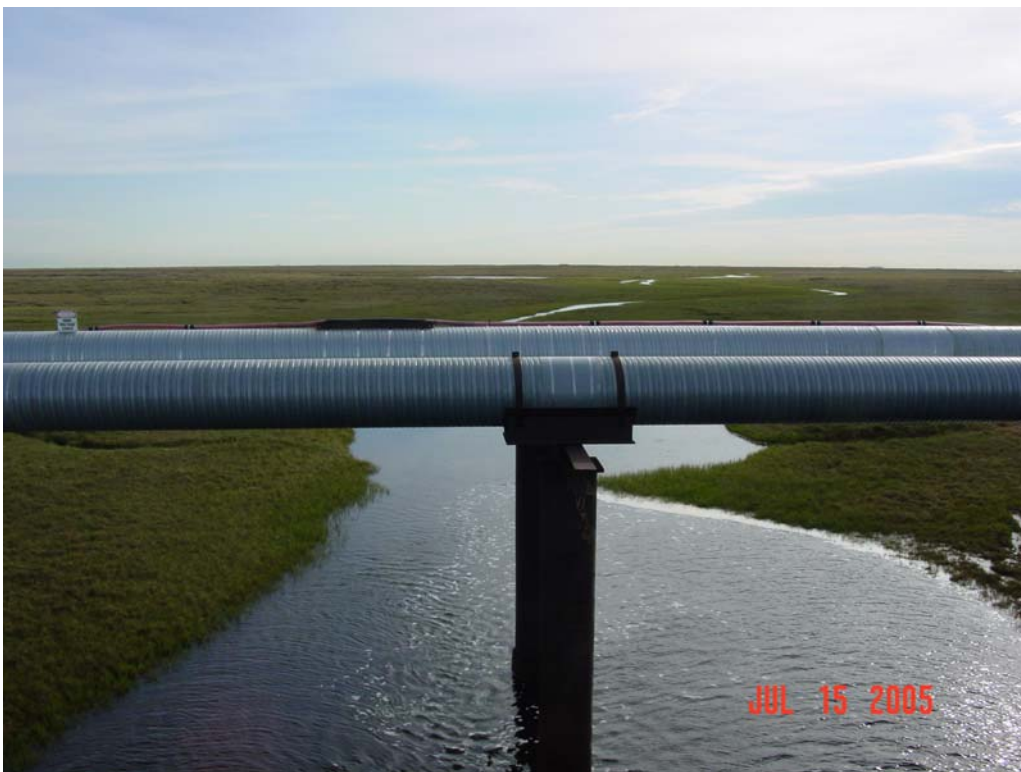
**Photograph 164. Pebble Creek upstream of the Kuparuk Pipeline access road bridge.**

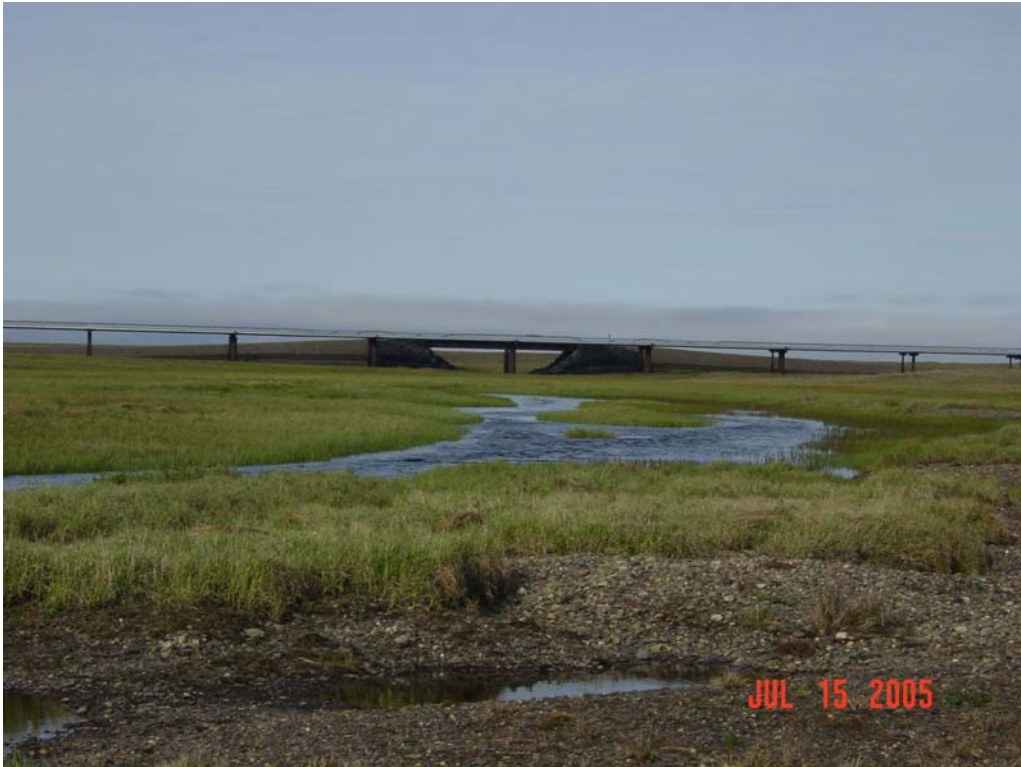
**Photograph 165. Pebble Creek bridge viewed from upstream.**

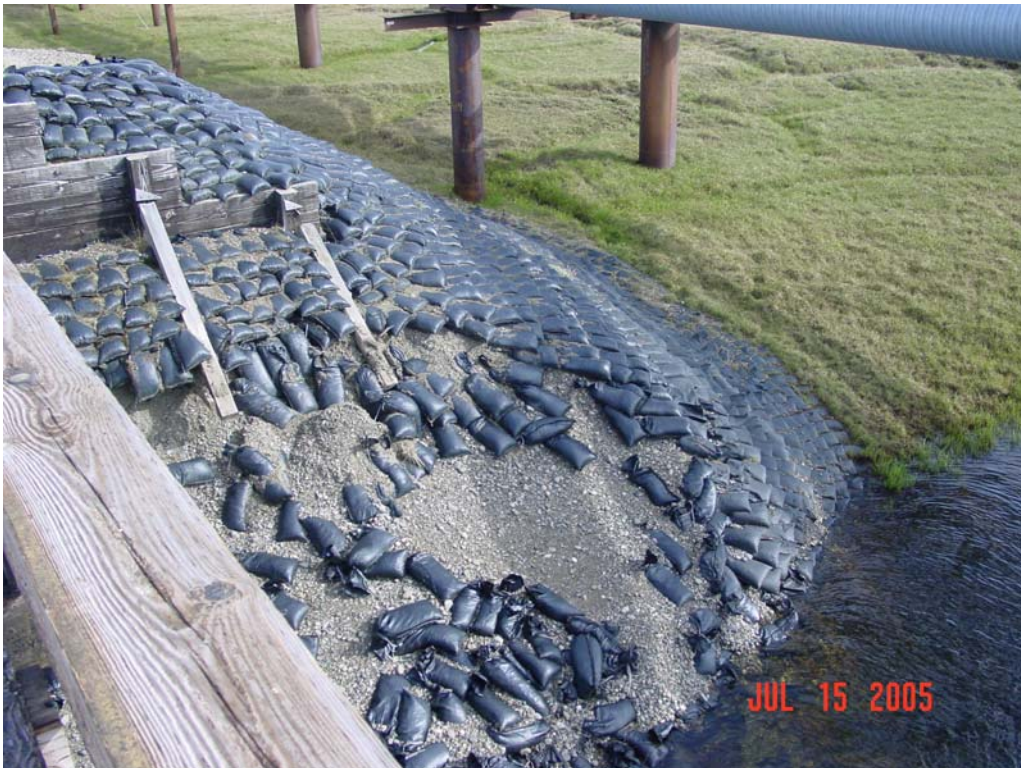
**Photograph 166. Eroded sandbag armor on the east abutment.**

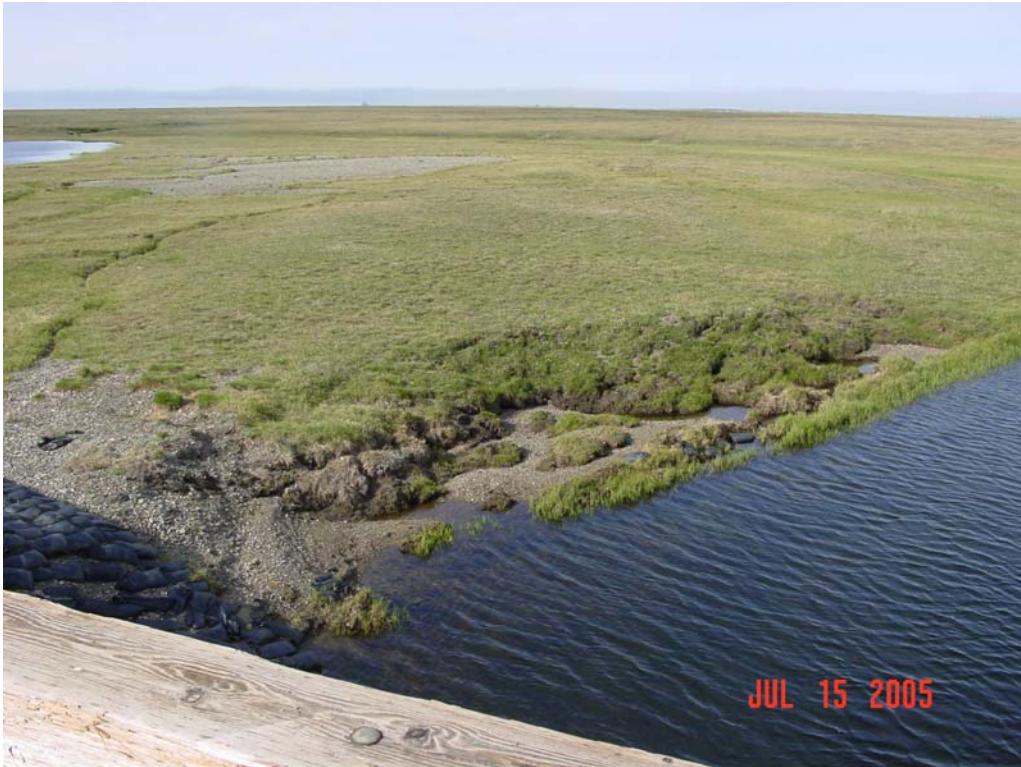
**Photograph 167. Tundra erosion and some gravel outwash on the west bank of Pebble Creek.**

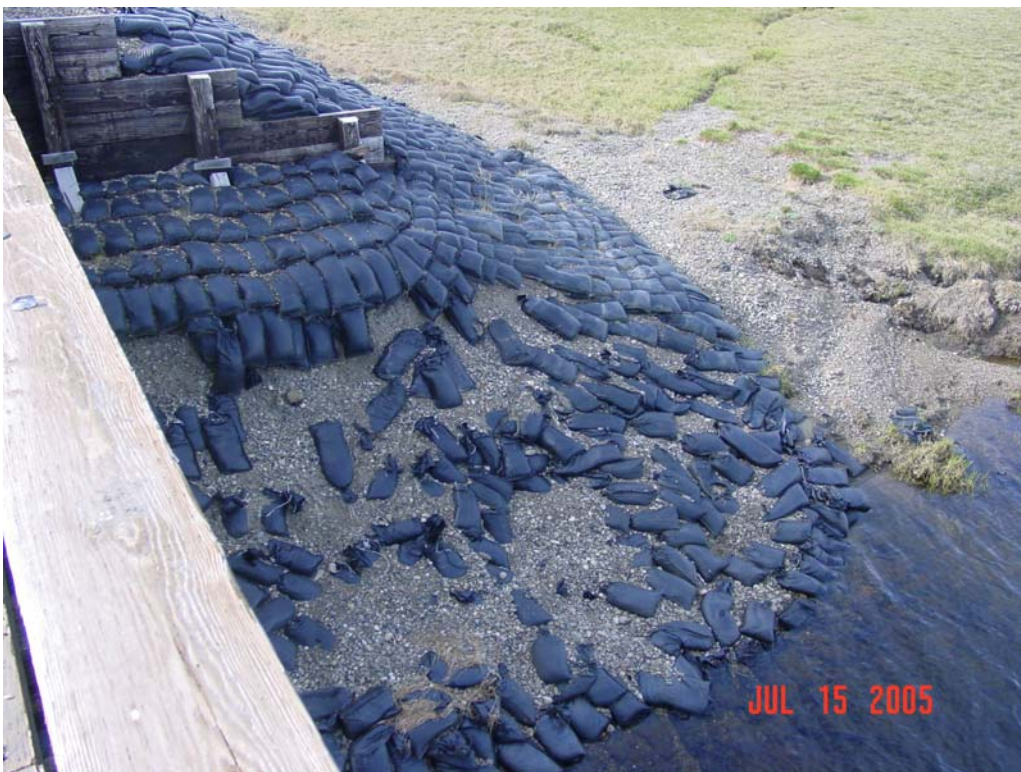
**Photograph 168. Sand bag armor erosion on the west abutment of the Pebble Creek bridge.**

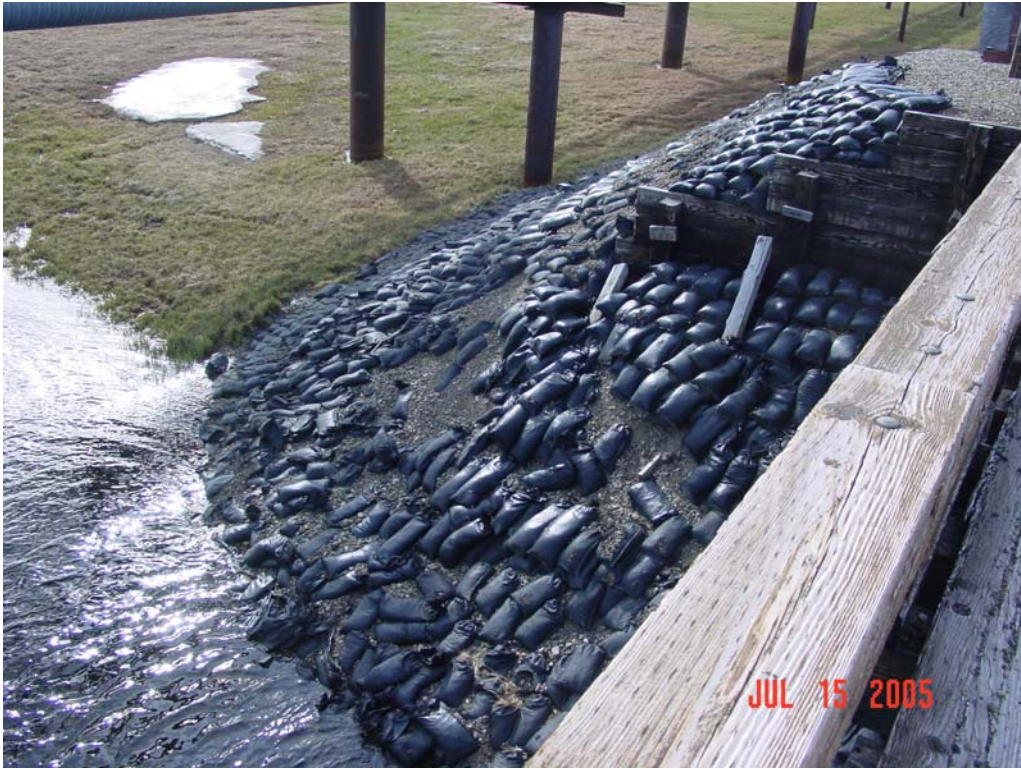
**Photograph 169. Sand bag armor erosion on the upstream portion of the west abutment of the Pebble Creek bridge.**

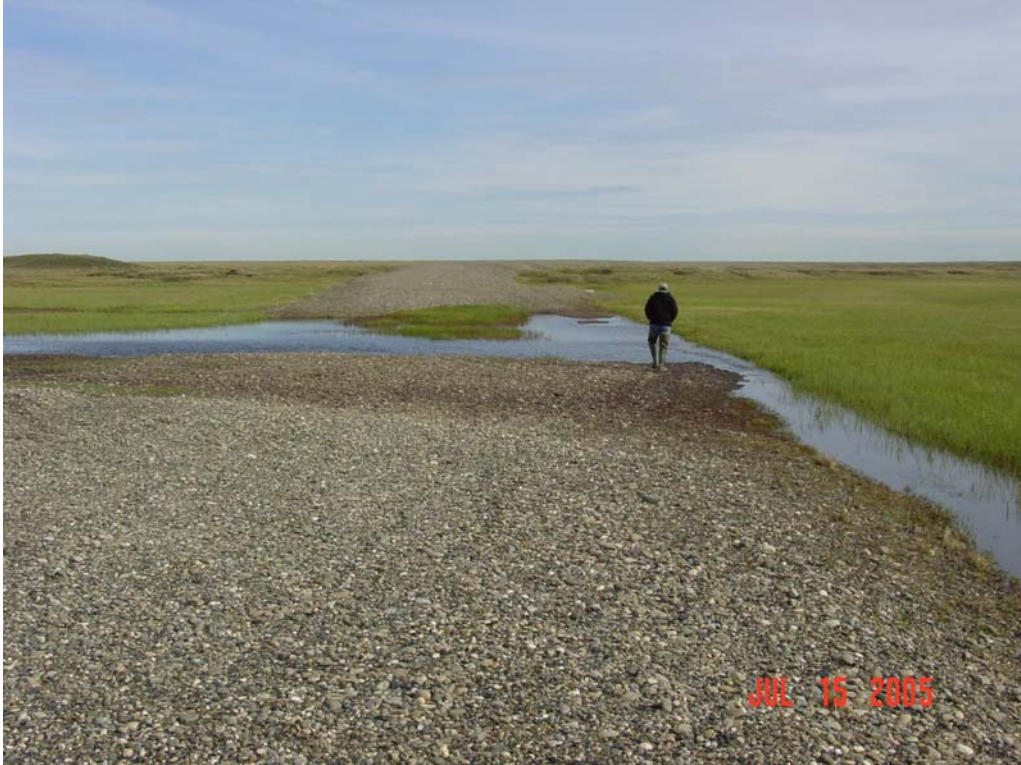
**Photograph 170. Pebble Creek flowing over the breached access road.**

REMEDIATION RECOMMENDATIONS: Remove all culverts and outwash gravels.  
Reestablish the stream crossing at this location. Remove the access road.

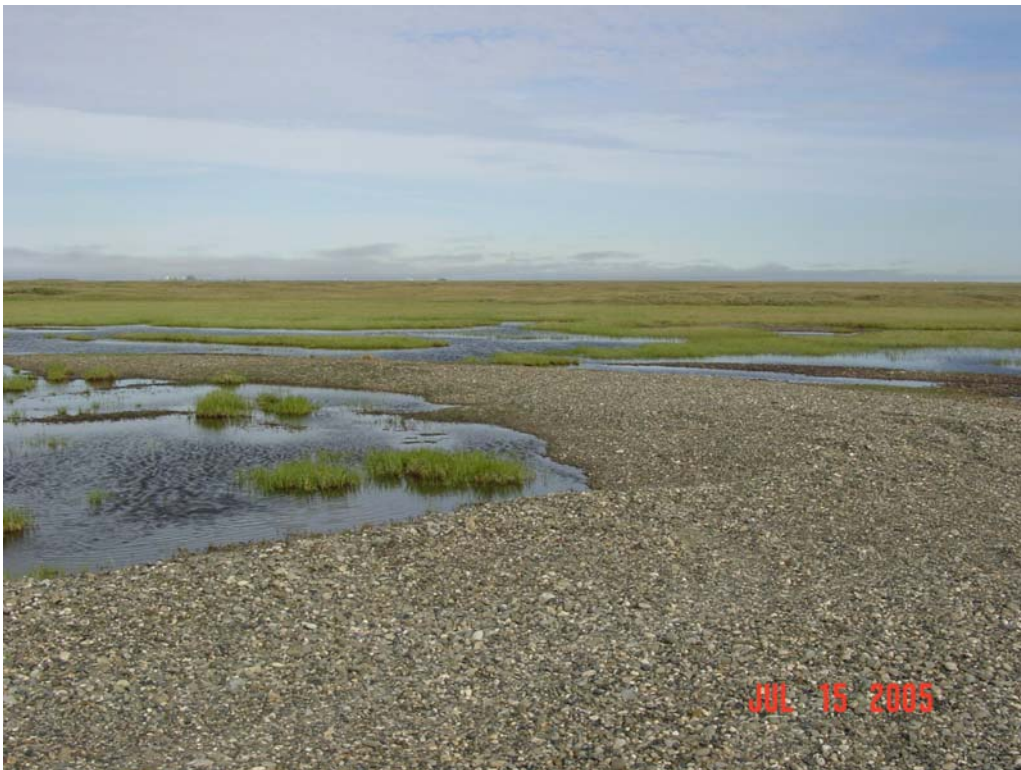
OUTLET: Some outlets buried or submerged, damaged outlets. Substantial outwash  
gravel present.

**Photograph 171. Outwash gravels downstream of the breached road crossing.**

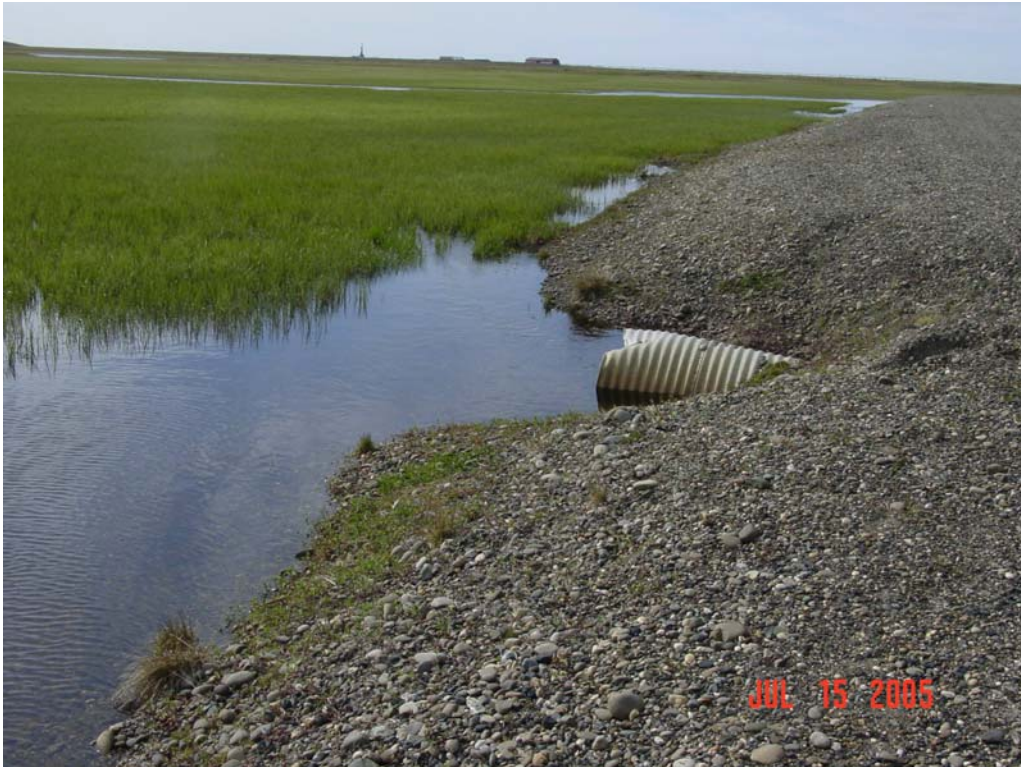
**Photograph 172. Pebble Creek upstream of and paralleling the access road.**

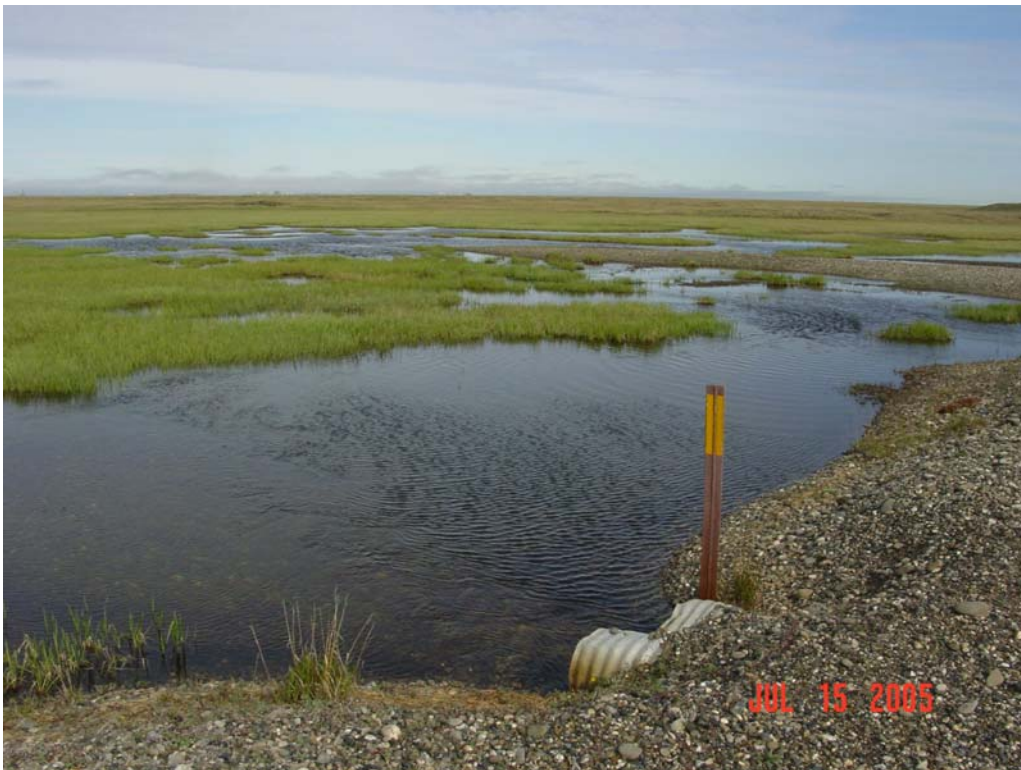
**Photograph 173. Pebble Creek downstream of the breached road crossing.**

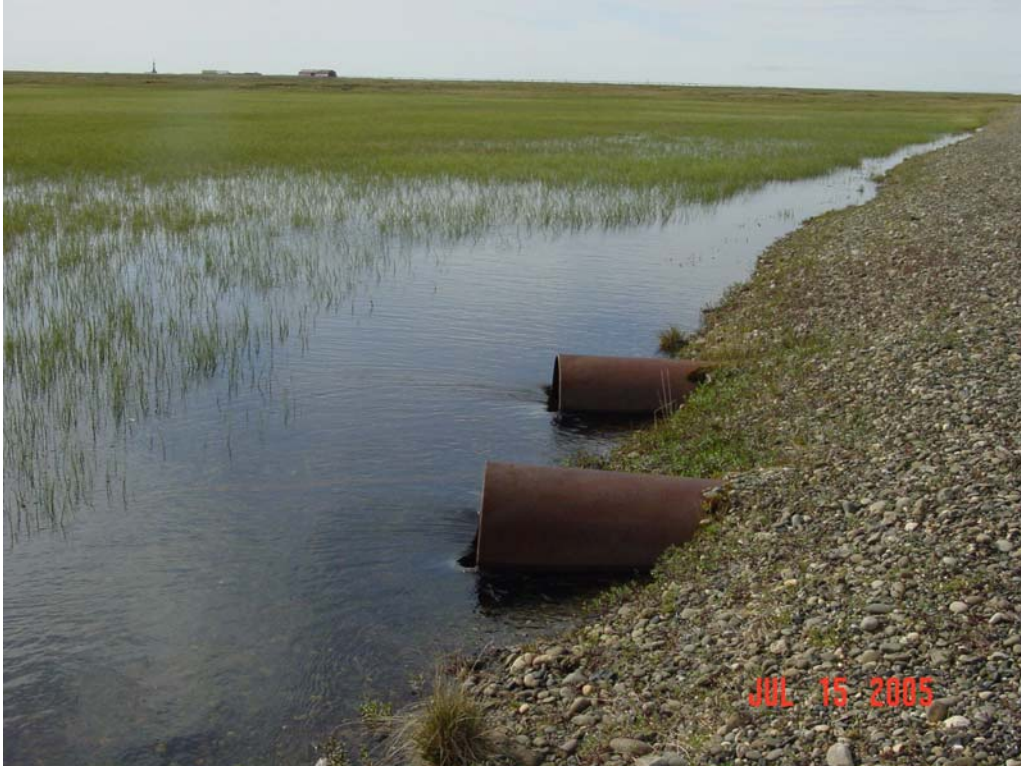
INLET: Some inlets buried or submerged, damaged inlets.

**Photograph 174. Exposed Pebble Creek culvert inlets.**
