**Technical Report No. 08-01**

## **A SURVEY OF STREAM CROSSING STRUCTURES IN THE NORTH SLOPE OILFIELDS**

**by William A. Morris  
and Jack F. Winters**

**February 2008**

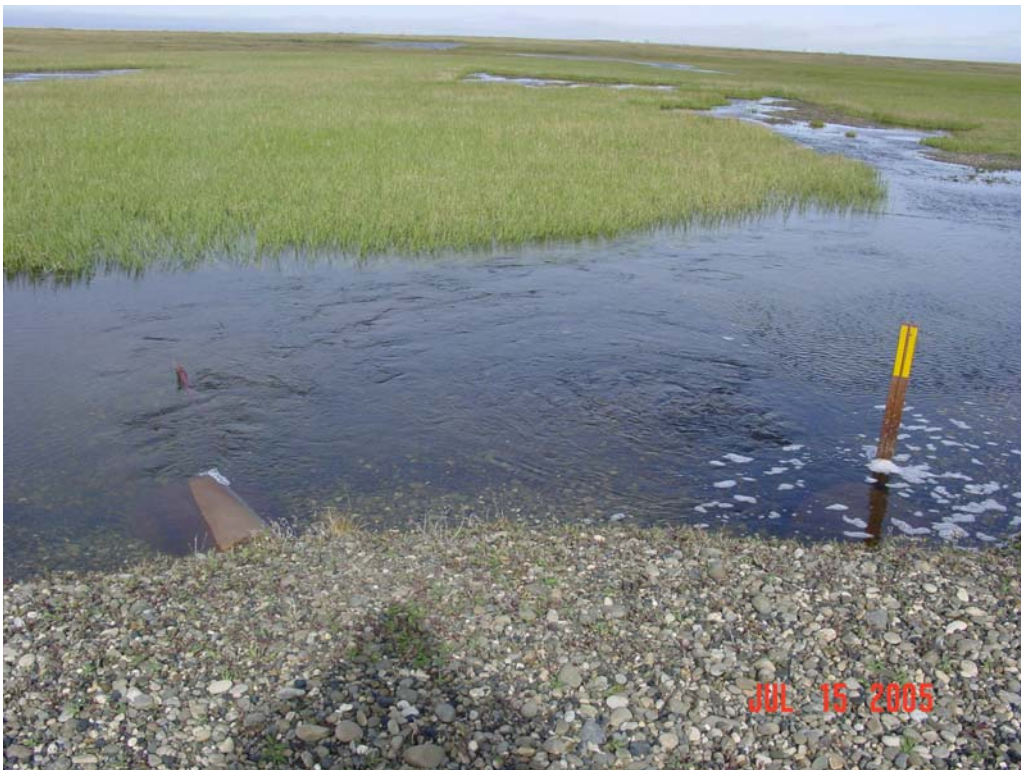
OUTLET: Some outlets buried or submerged, damaged outlets. Substantial outwash  
gravel present.

**Photograph 175. Submerged Pebble Creek culvert outlets.**

REMEDIATION RECOMMENDATIONS: Remove all culverts and outwash gravels.  
Reestablish the stream crossing at this location. Remove the access road.

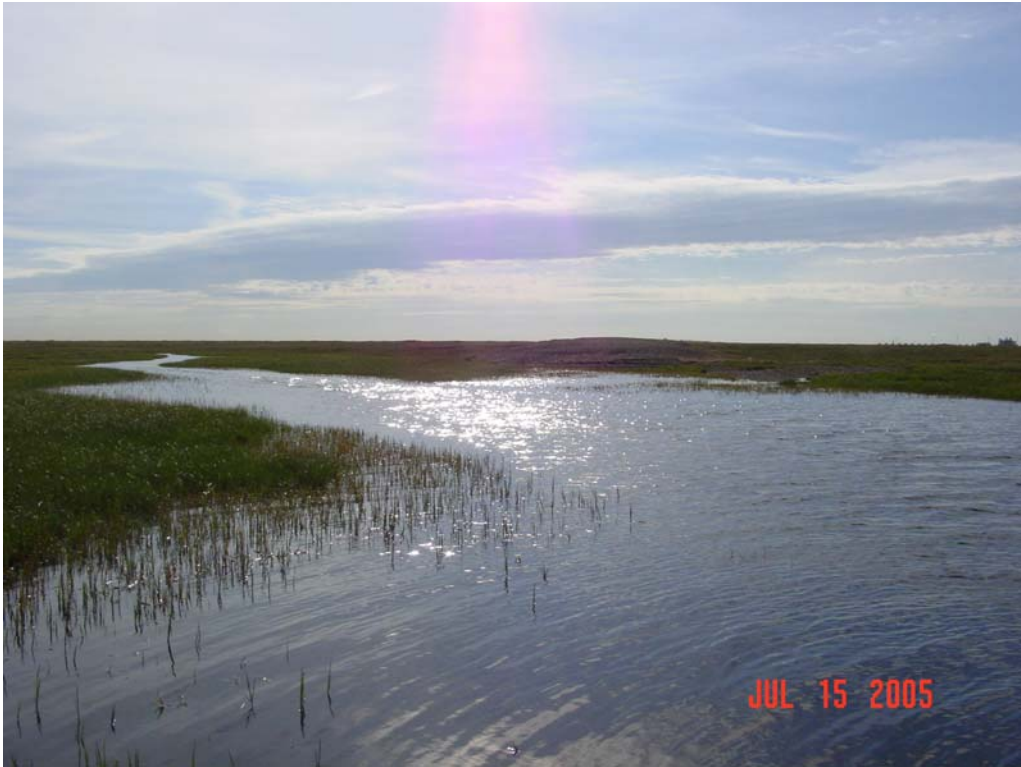
**Photograph 176. Pebble Creek upstream of the road crossing. Gravel fill was removed in the area of the center of the photograph.**

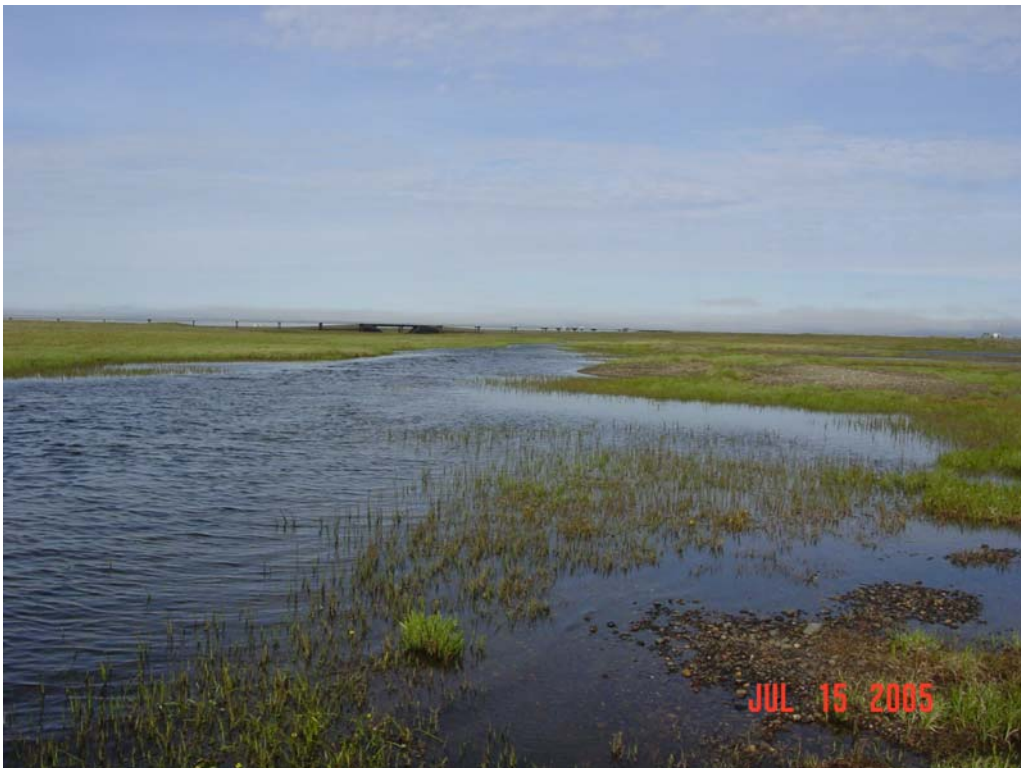
**Photograph 177. Pebble Creek downstream of the gravel road removal area. Former gravel roadbed is partially flooded and colonized by aquatic vegetation.**

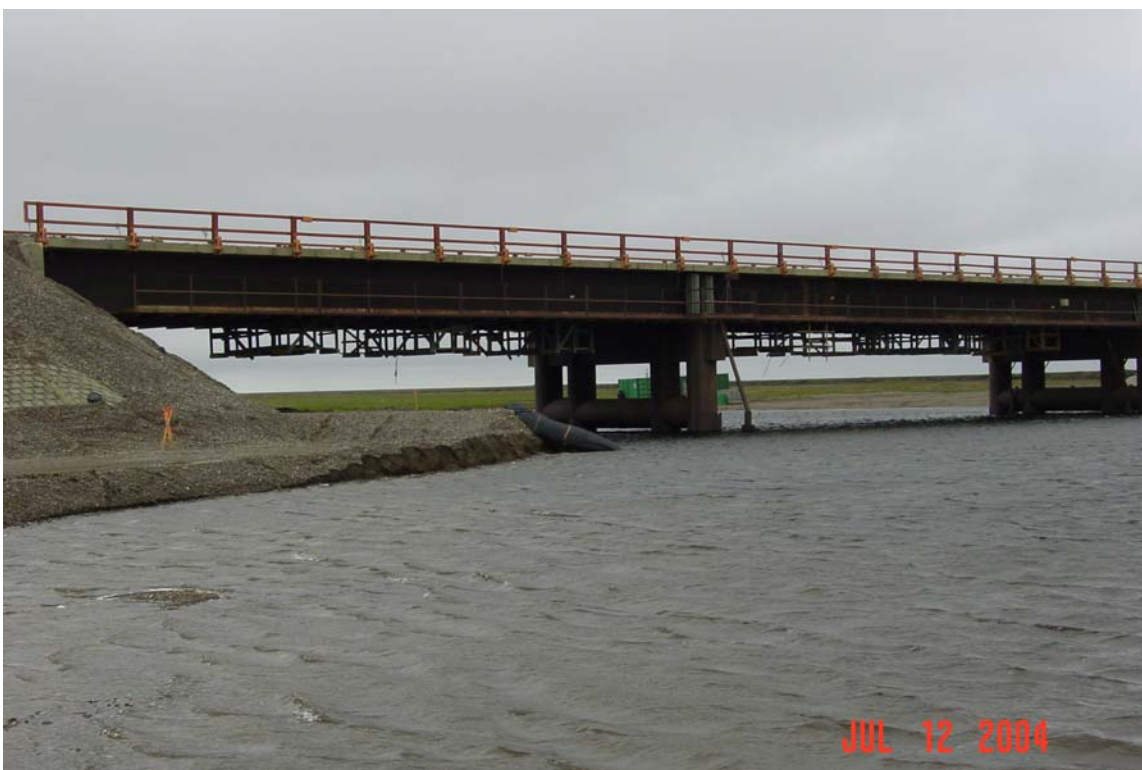
**Photograph 184. Kugaruk River Central Channel bridge temporary repair.**

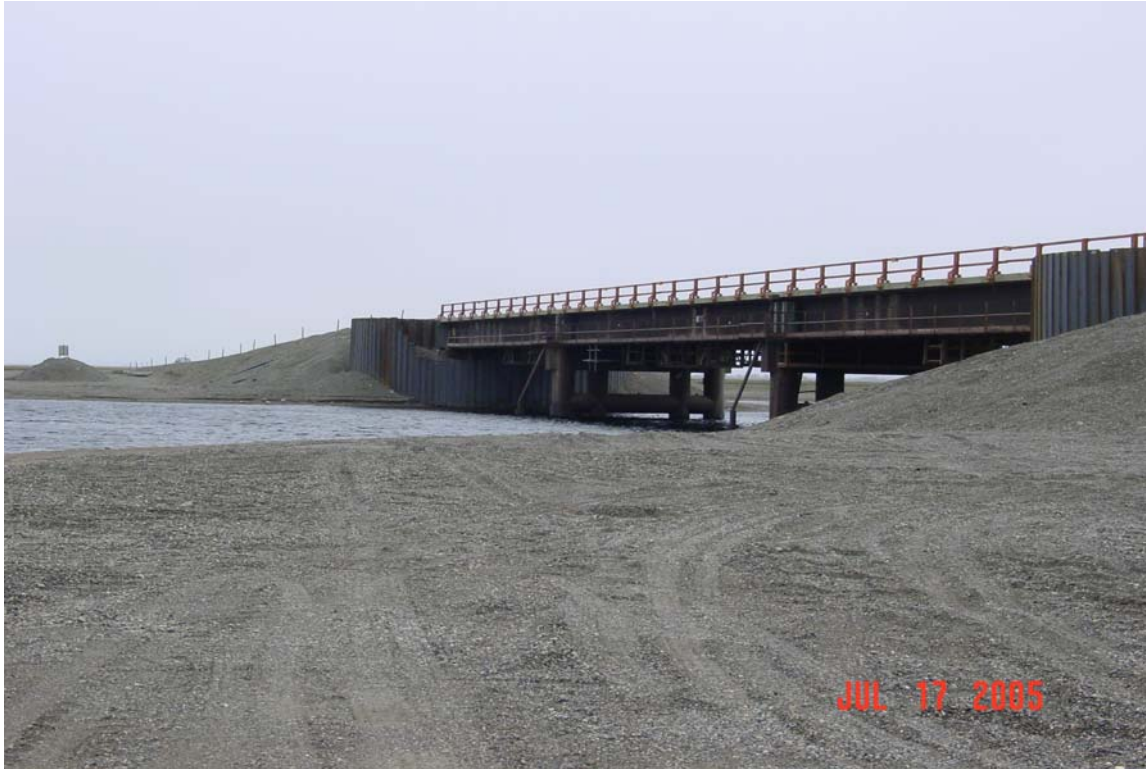
**Photograph 185. Kugaruk River Central Channel bridge final repair with sheet pile abutments.**

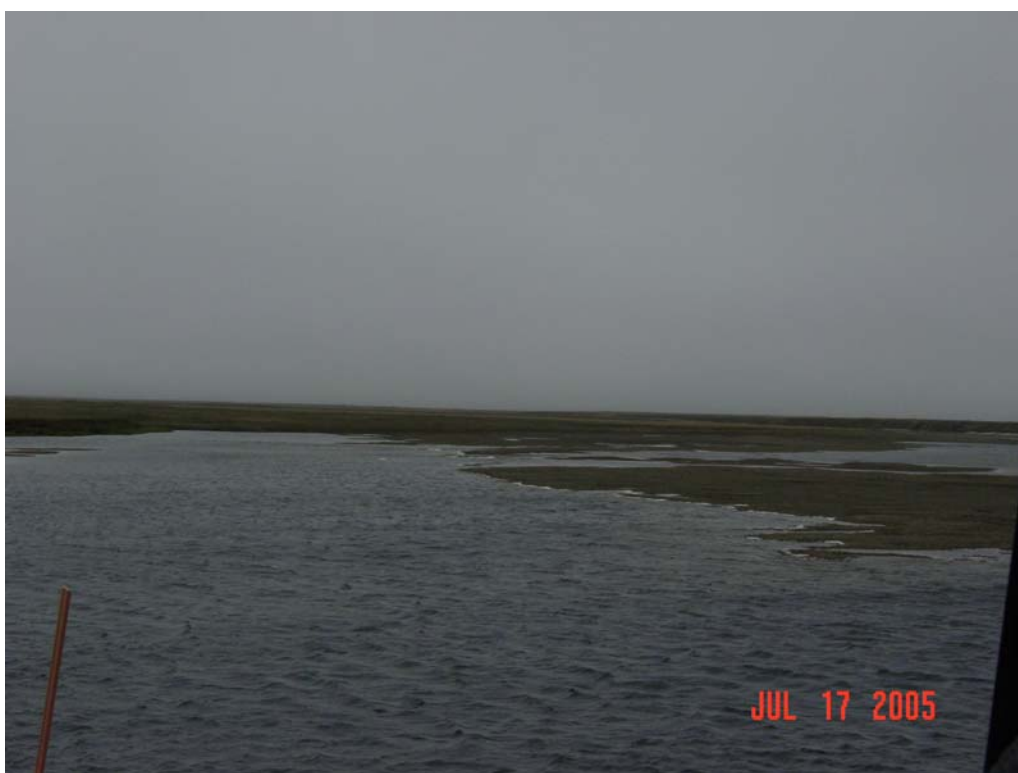
**Photograph 188. Kugaruk River West Channel looking upstream from Spine Road. River is flowing from the west (right) into an excavated channel constructed to align flow with the bridge.**

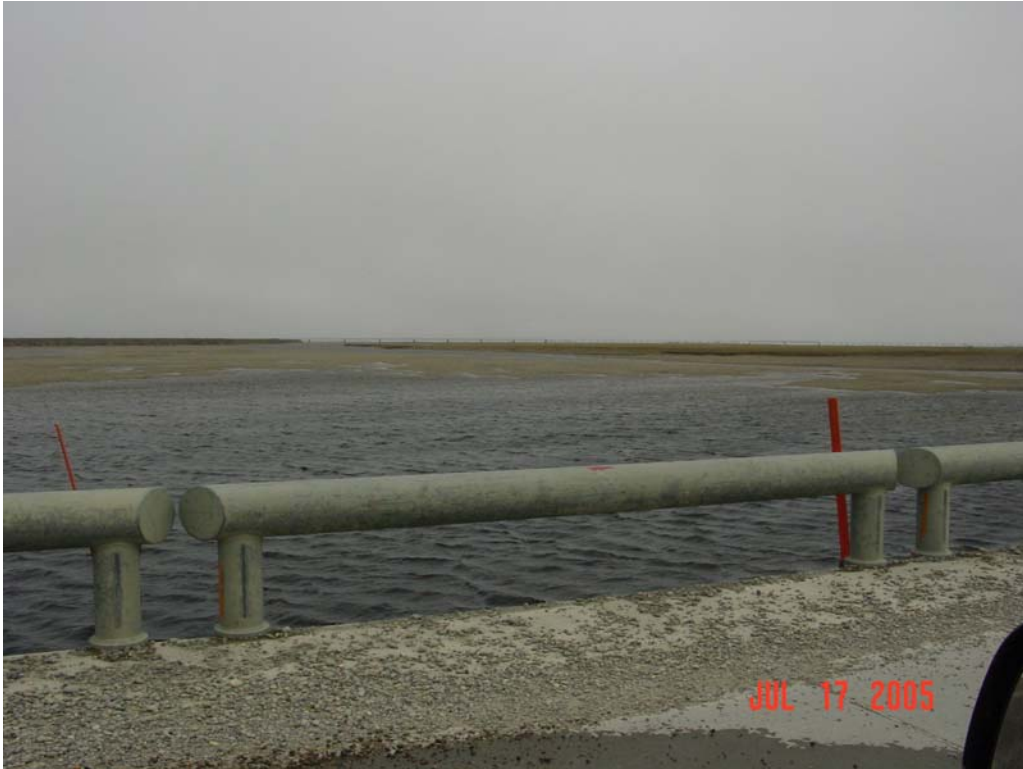
**Photograph 189. Kugaruk River West Channel downstream of the Spine Road bridge. Significant gravel deposits are present downstream.**

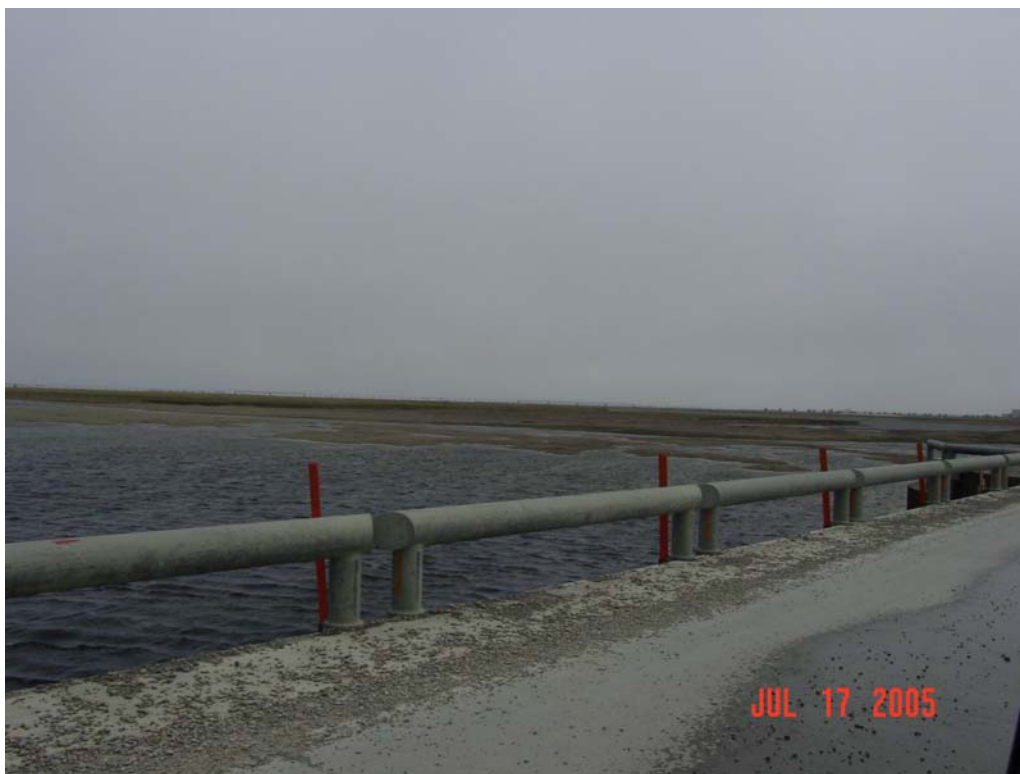
**Photograph 190. Kuparuk River West Channel bridge looking downstream and east from bridge. At normal summer water levels, water passes under the bridge into the large scour hole and then is diverted east flowing along the toe of the road prior to regaining northward flow.**

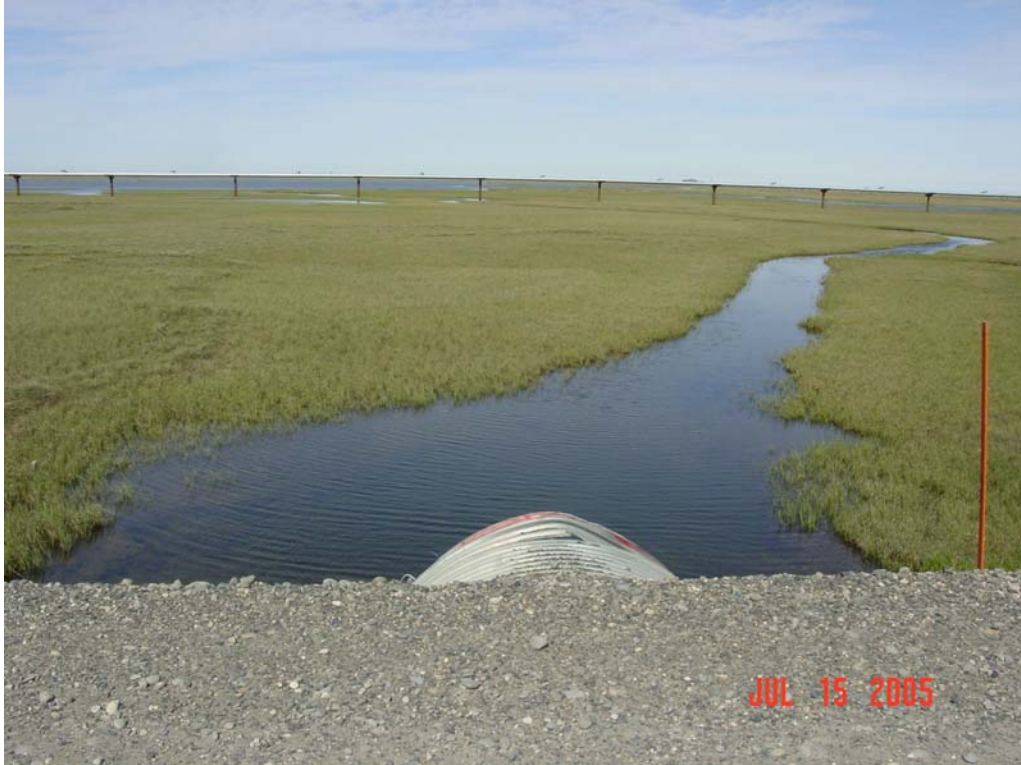
OUTLET: Damage to the upper edge of the culvert outlet, road prism erosion

**Photograph 191. Milne S Pad Creek downstream of the S Pad access road.**

REMEDIATION RECOMMENDATIONS: Repair road prism, repair culvert end

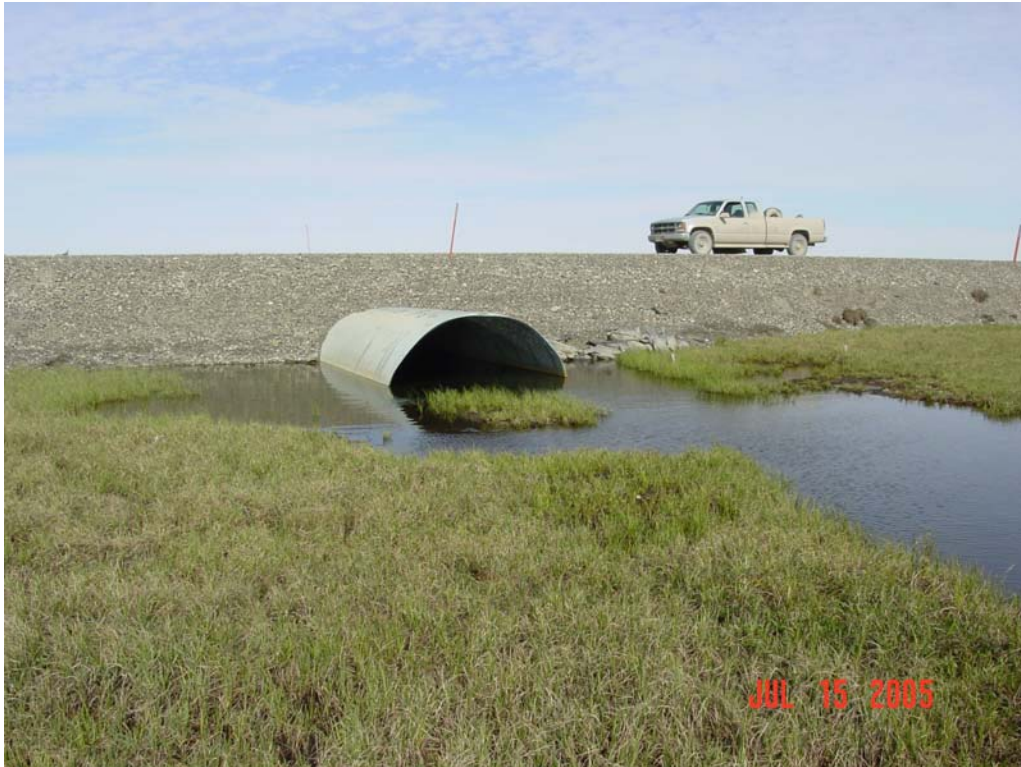
**Photograph 193. Milne S Pad Creek culvert inlet.**

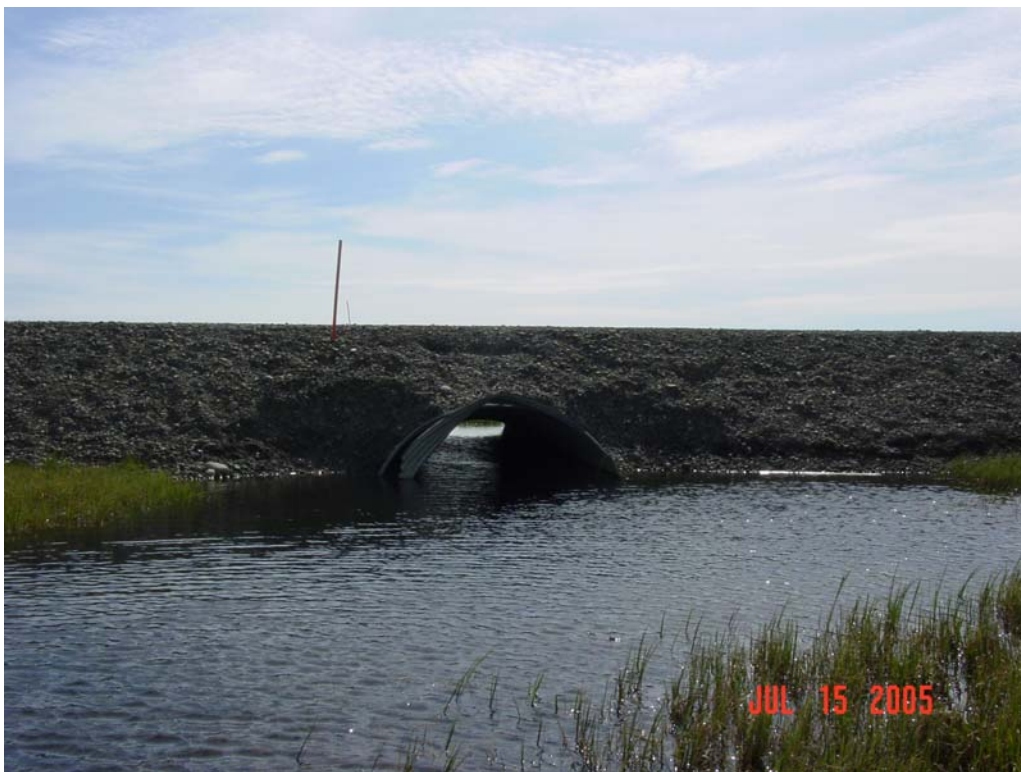
**Photograph 194. Milne S Pad Creek culvert outlet.**

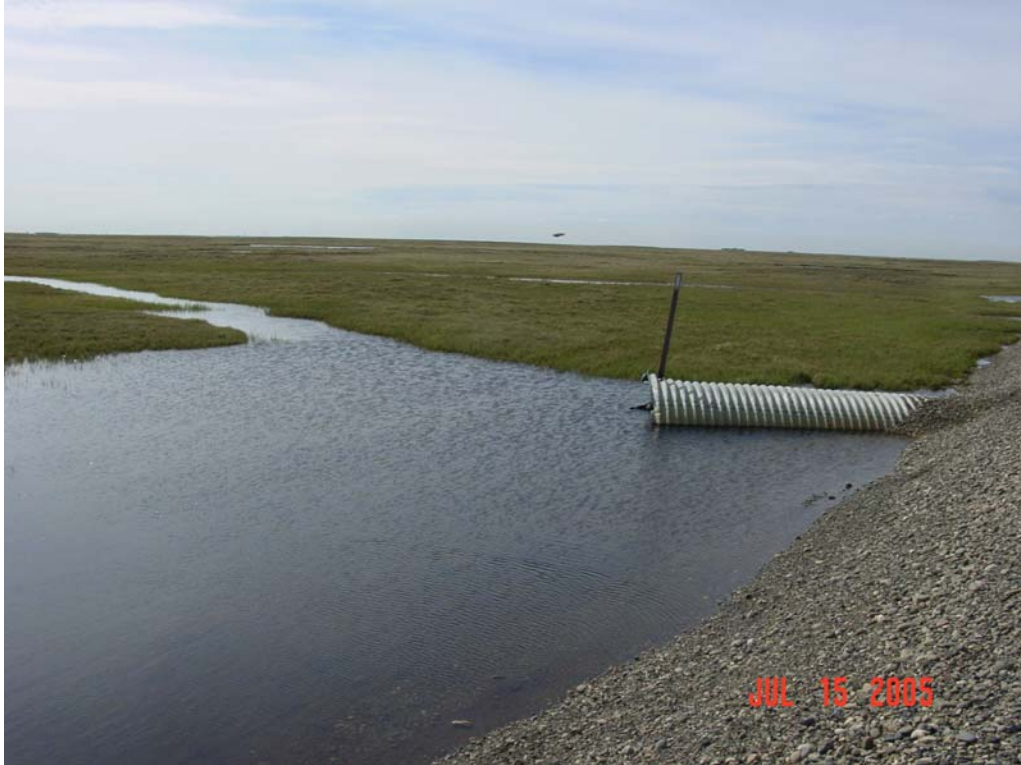
**Photograph 195. Cascade Creek upstream of the K Pad access road.**

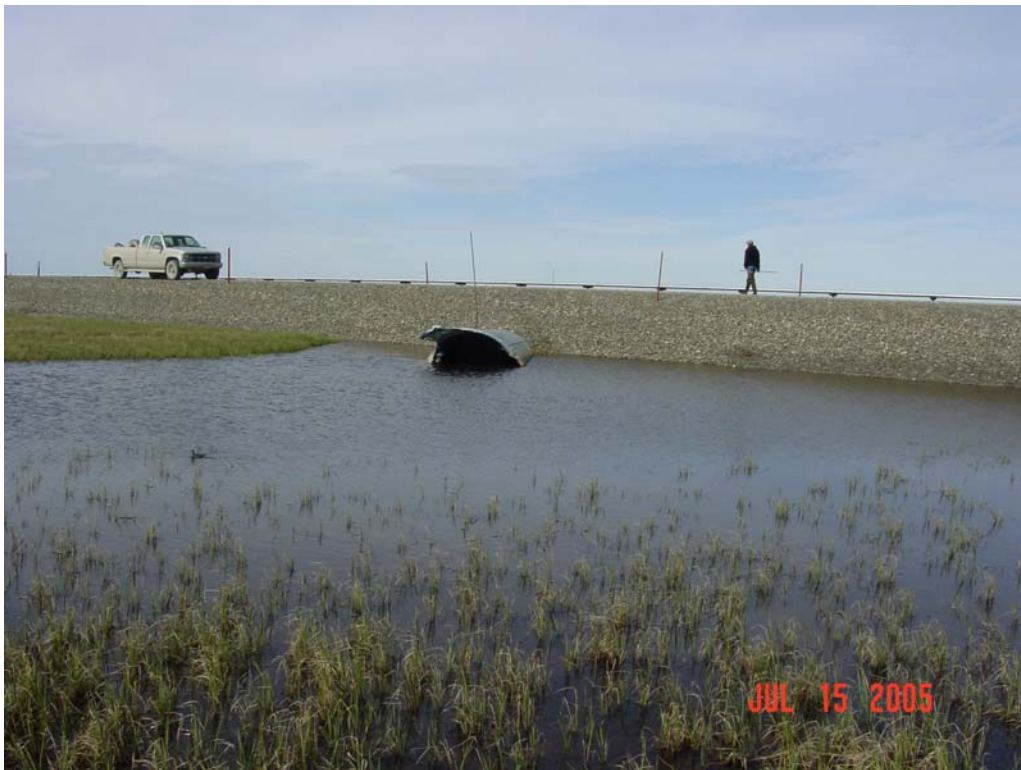
INLET: Inlet damage, culvert extends significantly beyond road fill, high water mark on the road fill 1 to 2 feet above the top of the culvert, culvert bowed considerably

**Photograph 196. Damaged Cascade Creek culvert inlet.**

REMEDICATION RECOMMENDATIONS: Cut culvert to match road width, consider increasing water conveyance past this crossing location

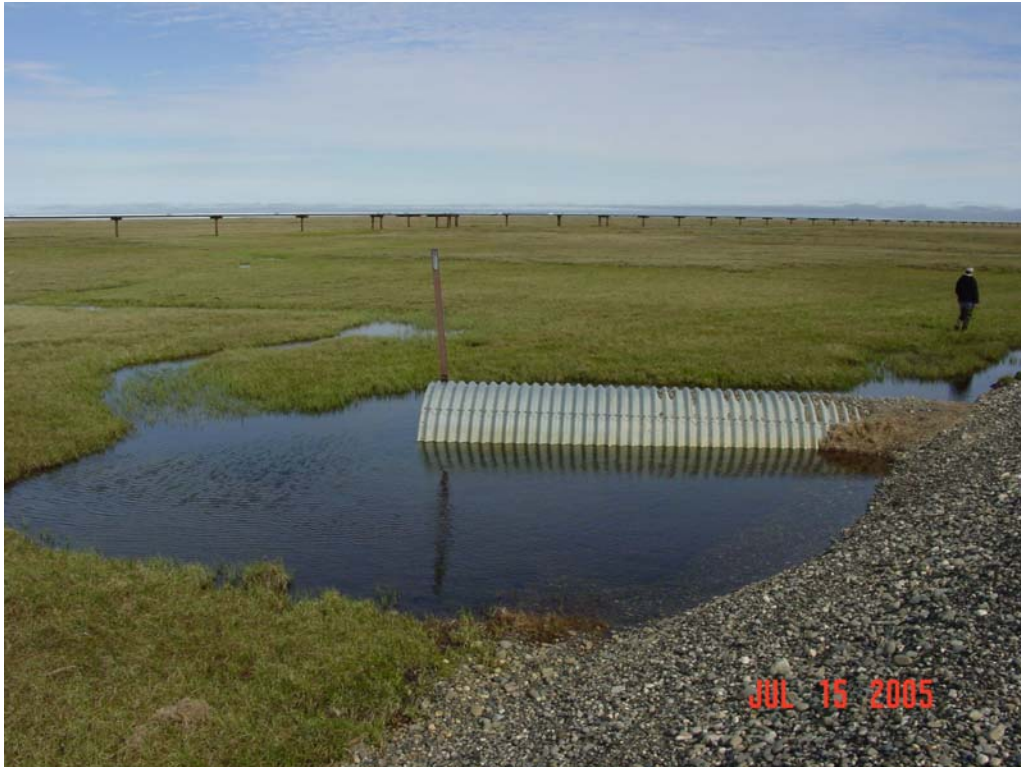
**Photograph 197. Cascade Creek downstream of the K Pad access road.**

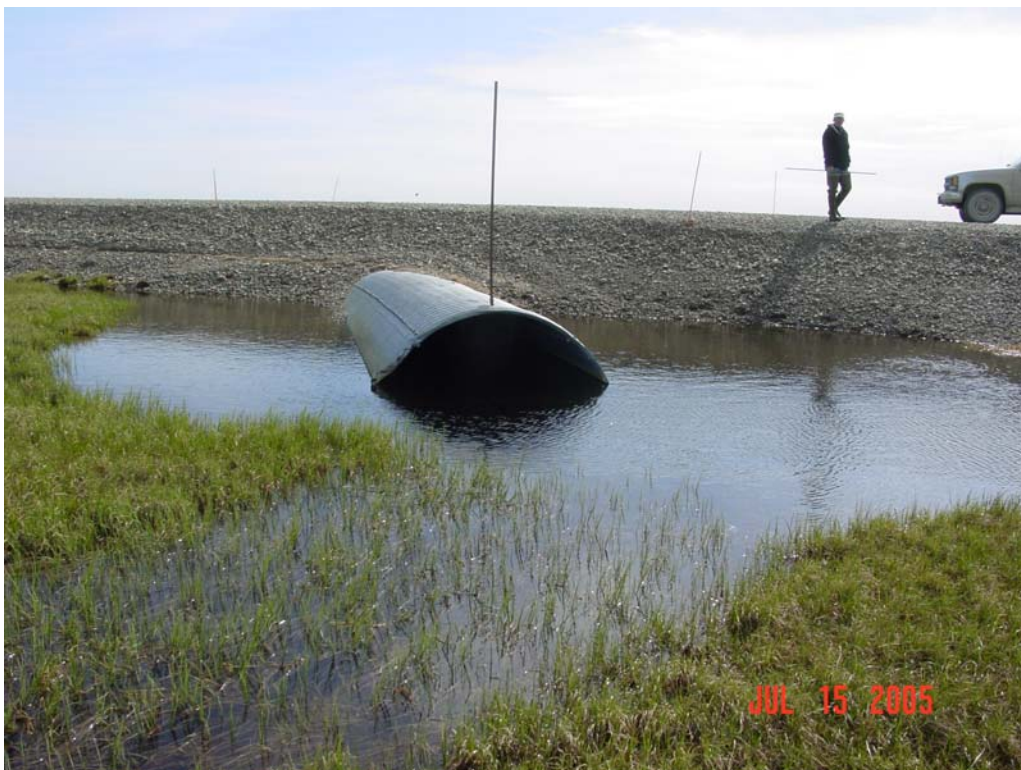
**Photograph 198. Cascade Creek culvert outlet.**

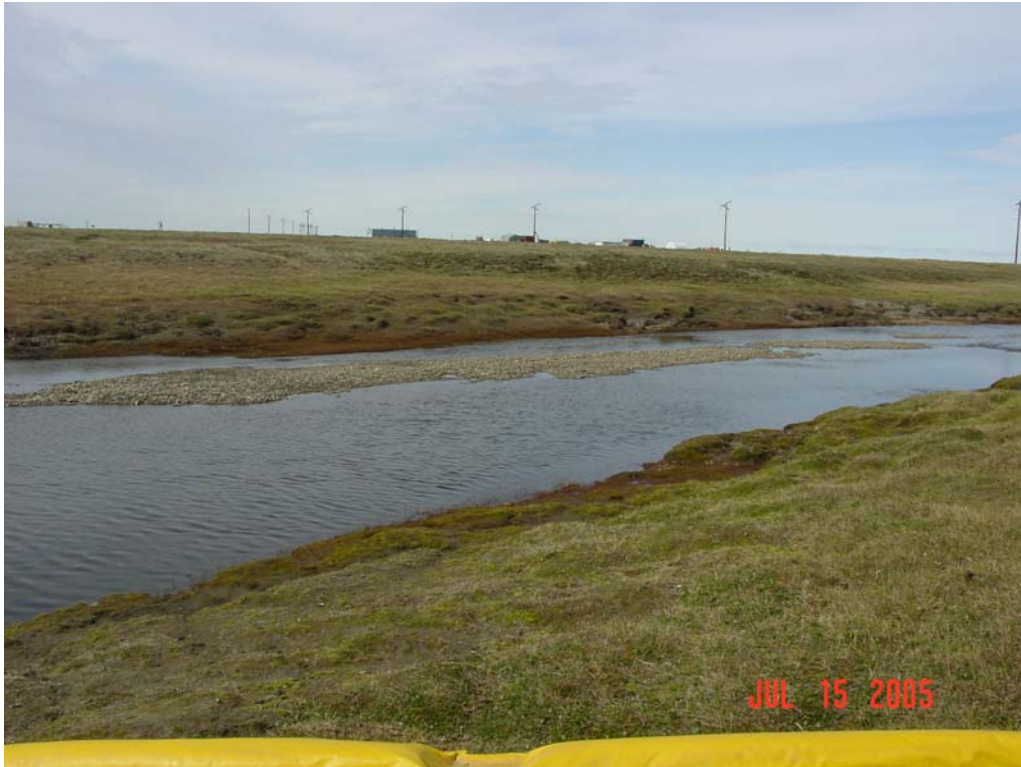
**Photograph 201. Gravel outwash downstream of the bridge.**

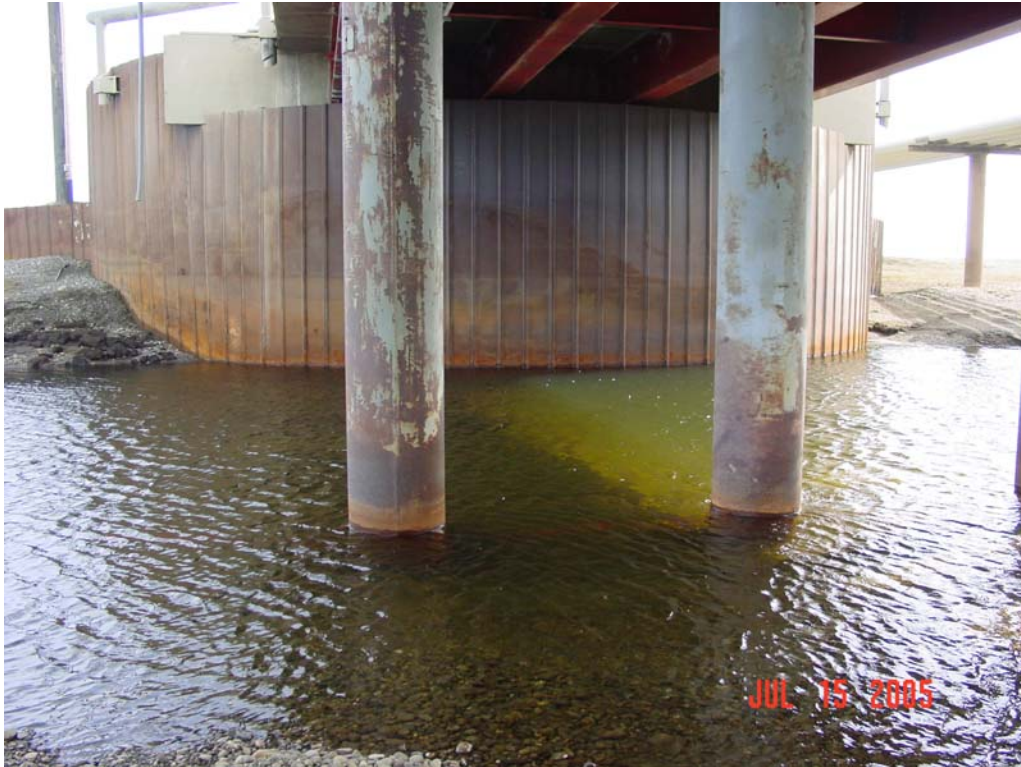
**Photograph 203. Abutment encroaching in the stream channel.**

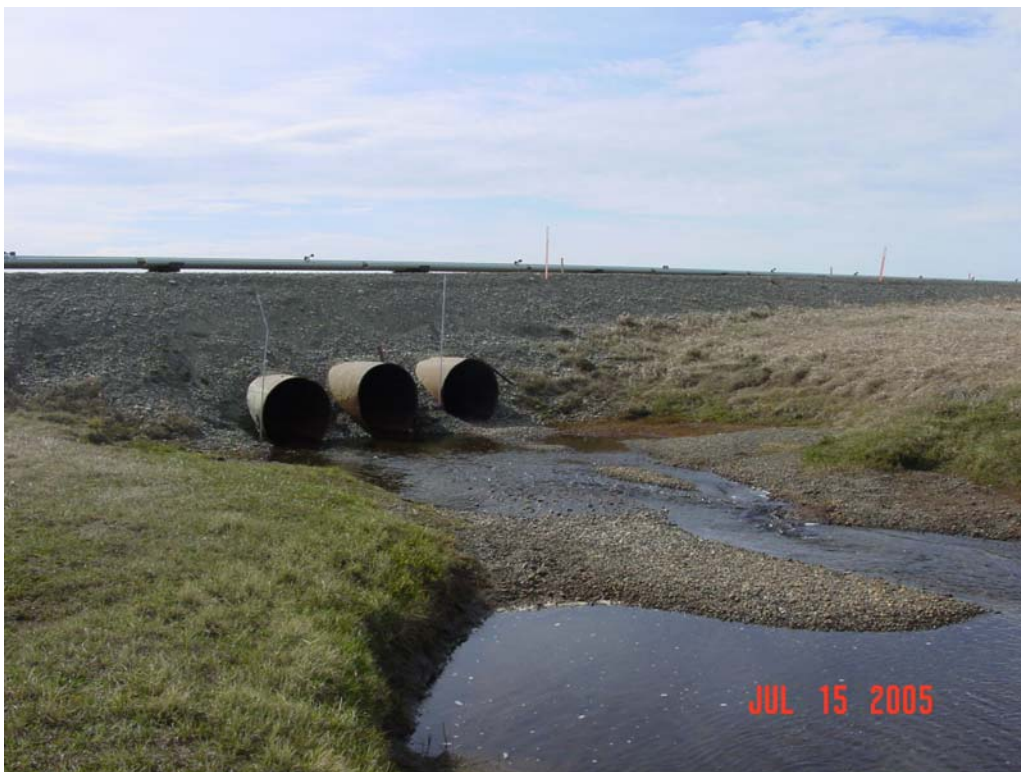
**Photograph 208. Lower West Central Creek culvert outlets with outwash gravels.**

REMEDATION RECOMMENDATIONS: Increase water conveyance past this crossing, remove outwash gravels downstream of culverts

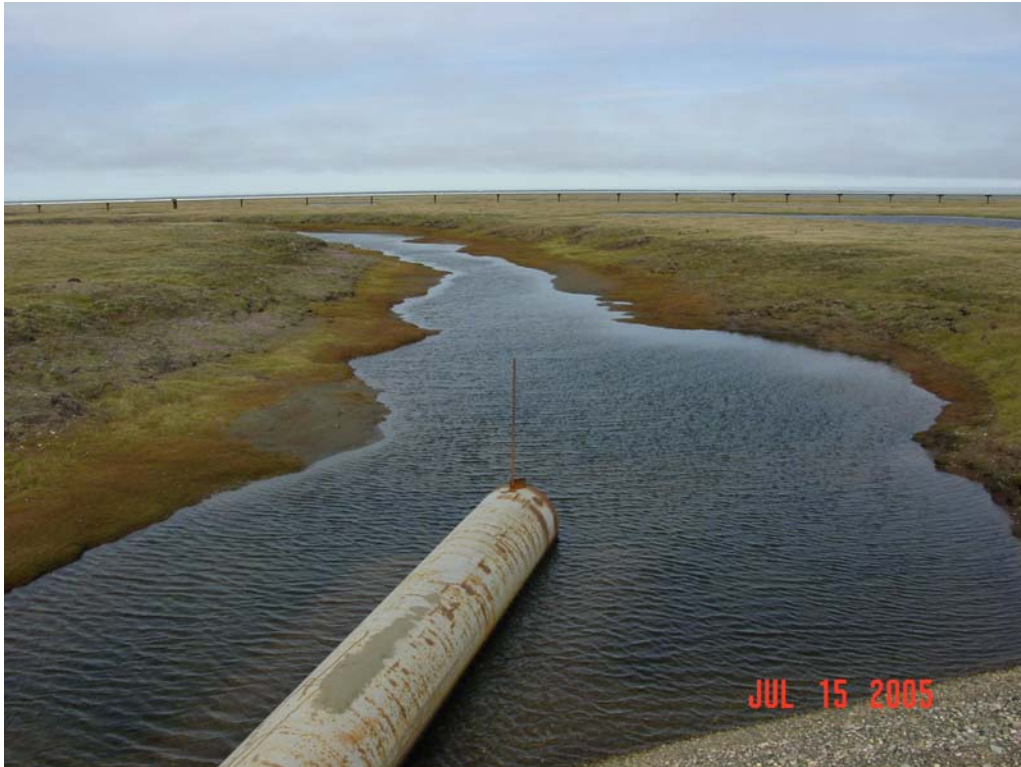
**Photograph 209. No Point Creek downstream of the Milne Point F Pad road. Note the excessively long visible pipe with two submerged pipes beneath it.**

REMEDIATION RECOMMENDATIONS: Shorten pipes to match road width; reset pipes as the two currently submerged pipes will be frozen solid and unavailable to carry breakup flows.

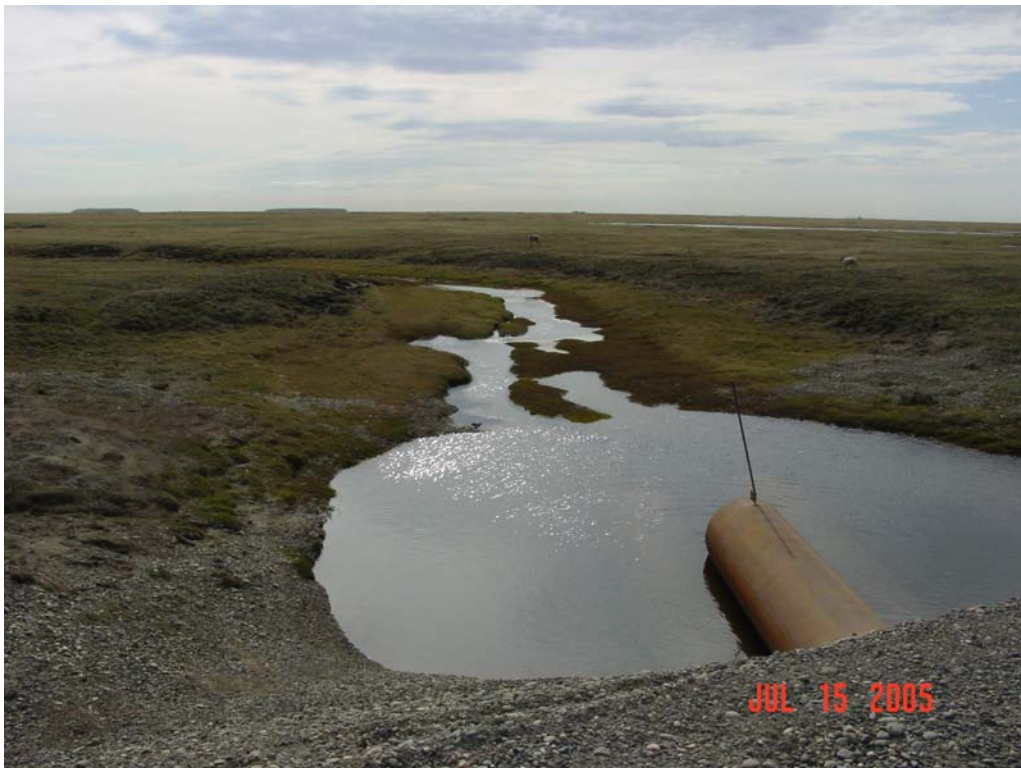
**Photograph 210. No Point Creek upstream of the Milne Point F Pad road. Note the two submerged excessively long pipes.**

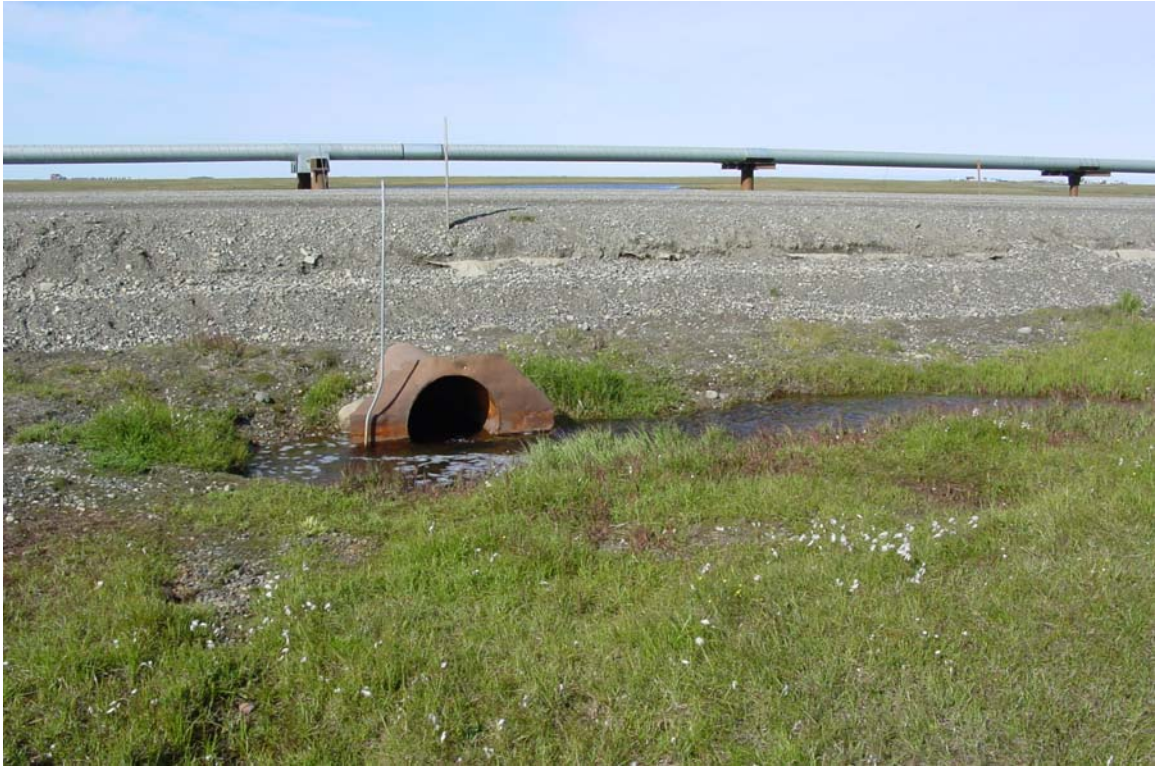
**Photograph 213. Milne B Pad Creek culvert inlet with high water mark several feet above the culvert.**

REMEDIATION RECOMMENDATIONS: Increase water conveyance past this crossing location

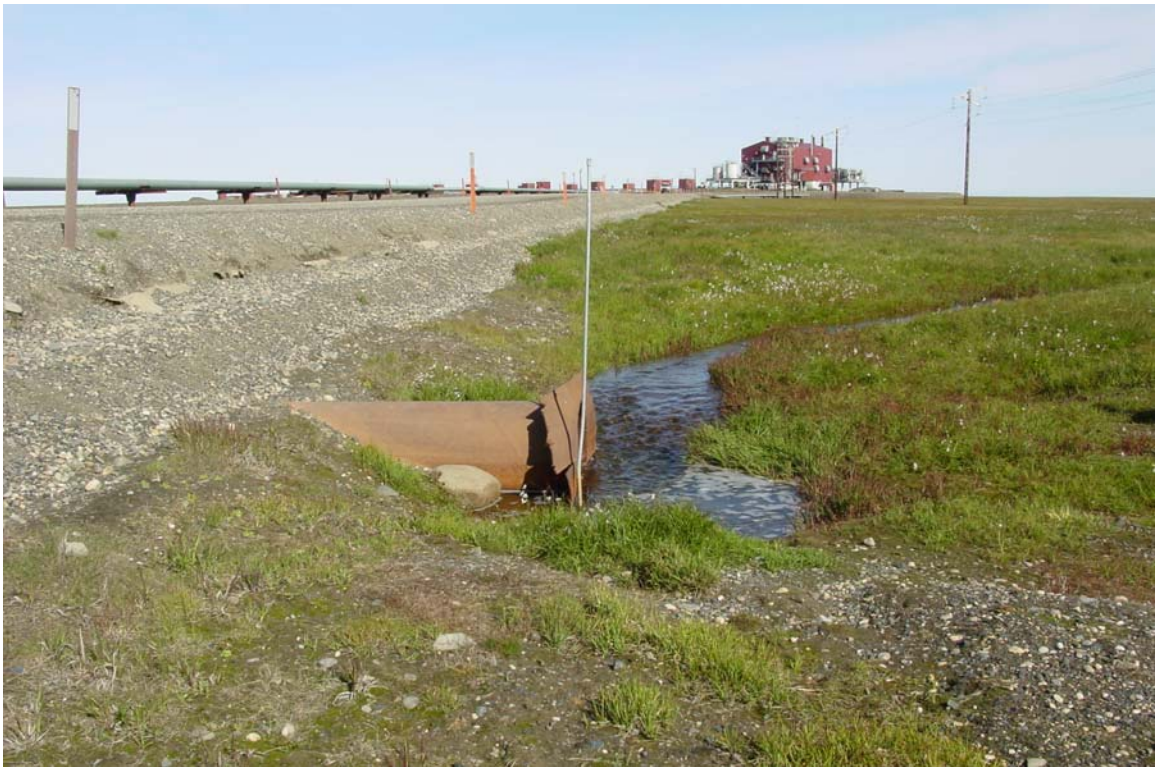
**Photograph 214. Milne B Pad Creek culvert inlet misaligned with creek.**

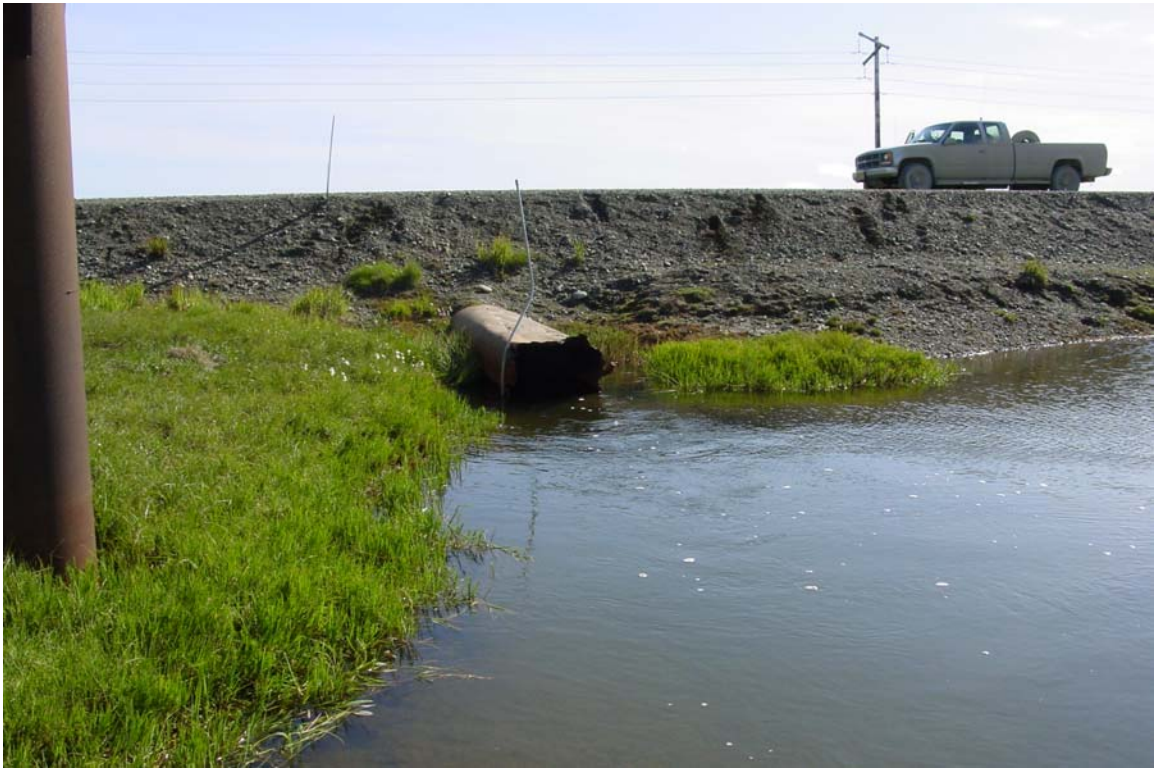
**Photograph 215. Milne B Pad Creek flattened culvert outlet.**

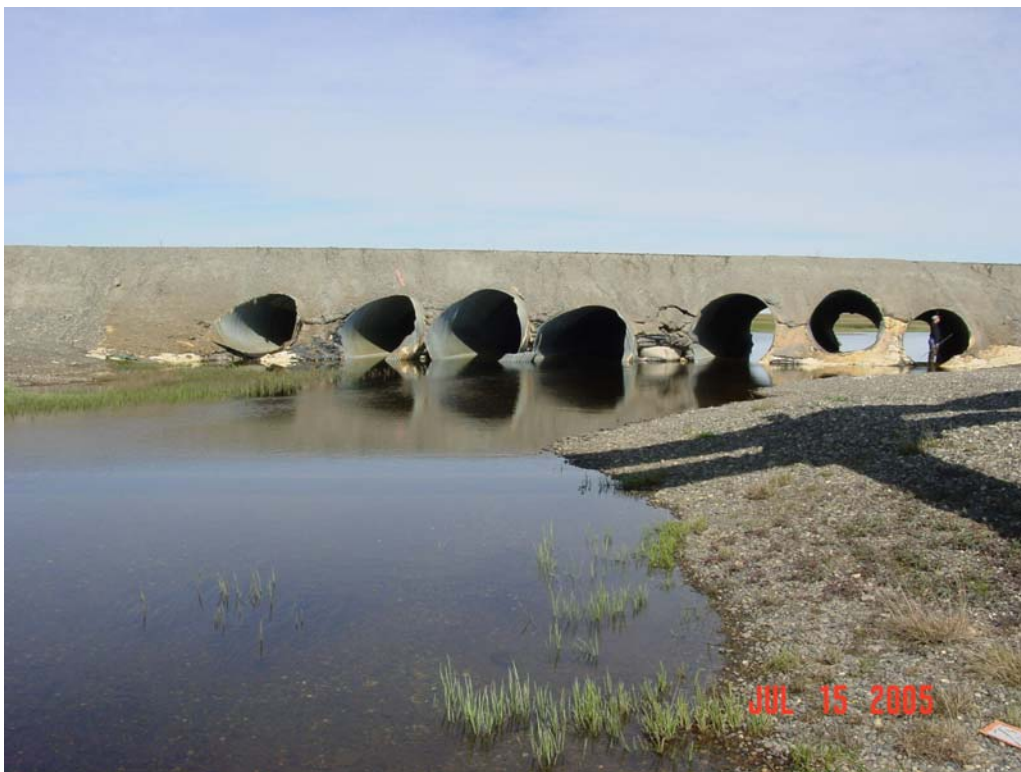
INLET: Sand bag armor with sprayed overlay, substantial culvert inlet damage and damage to sand bags and armor overlay, high water mark above highest culvert

**Photograph 217. East Creek culvert inlets with inlet damage, sand bag and road prism erosion and damaged armor overlay.**

REMEDIATION RECOMMENDATIONS: Removal of downstream outwash gravels to improve upstream movements of fish during periods of low flow. Remove the culvert battery and install a bridge at this location.

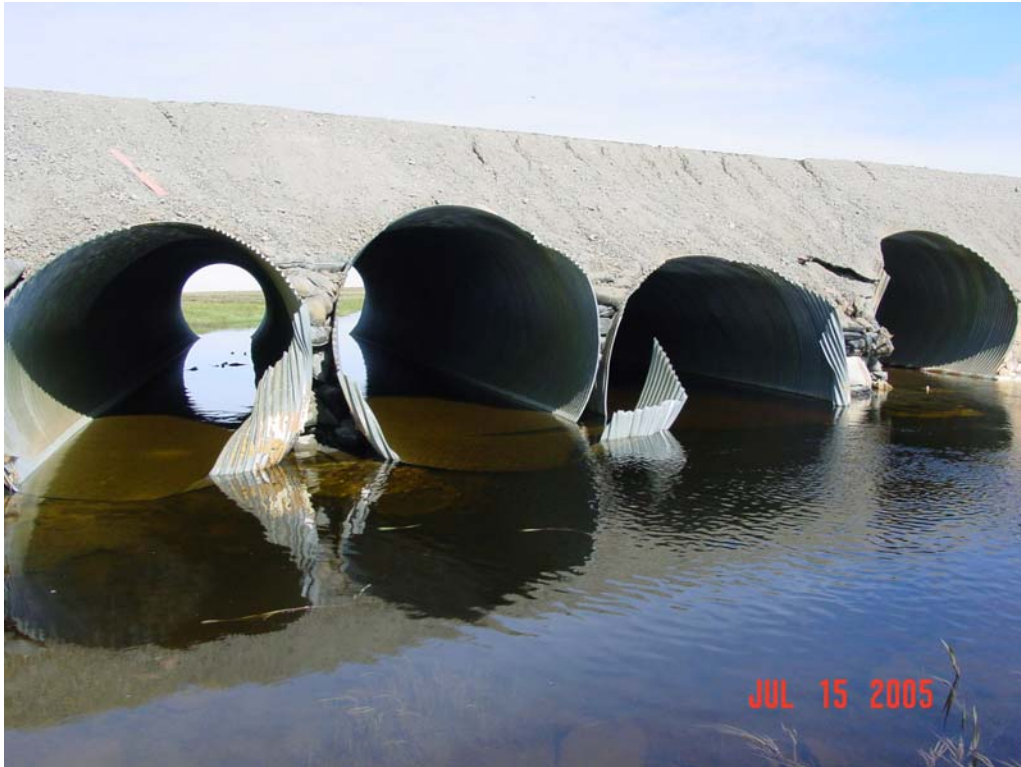
**Photograph 218. East Creek culvert inlets with substantial damage.**

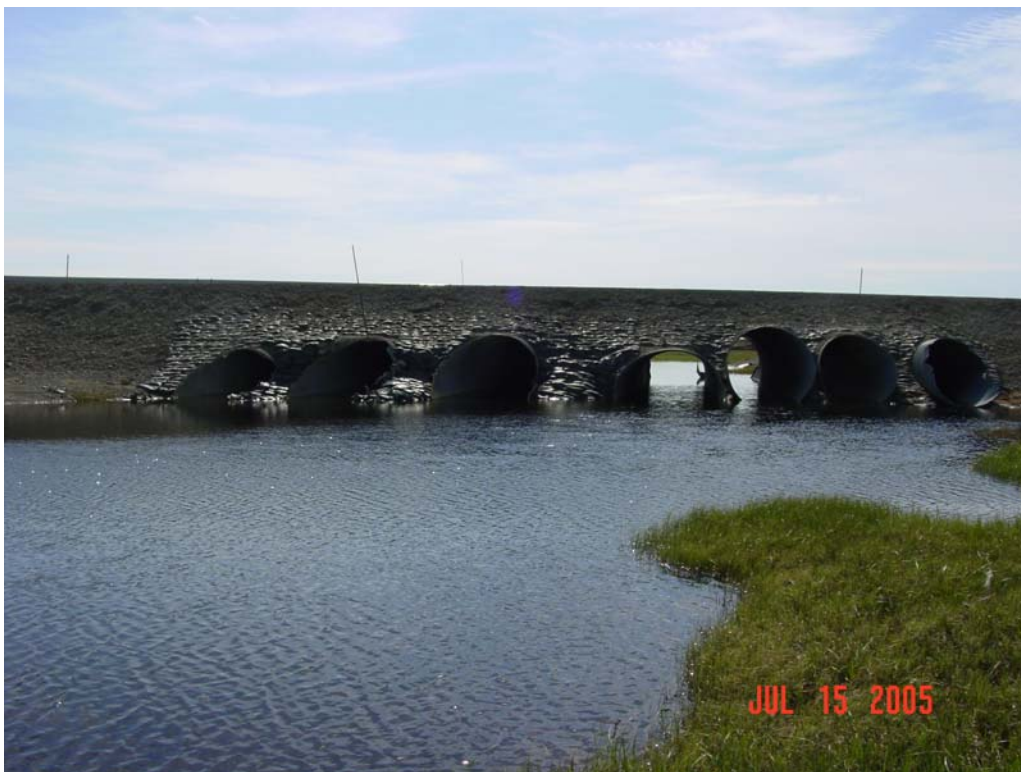
**Photograph 219. East Creek culvert outlets with sand bag armor.**

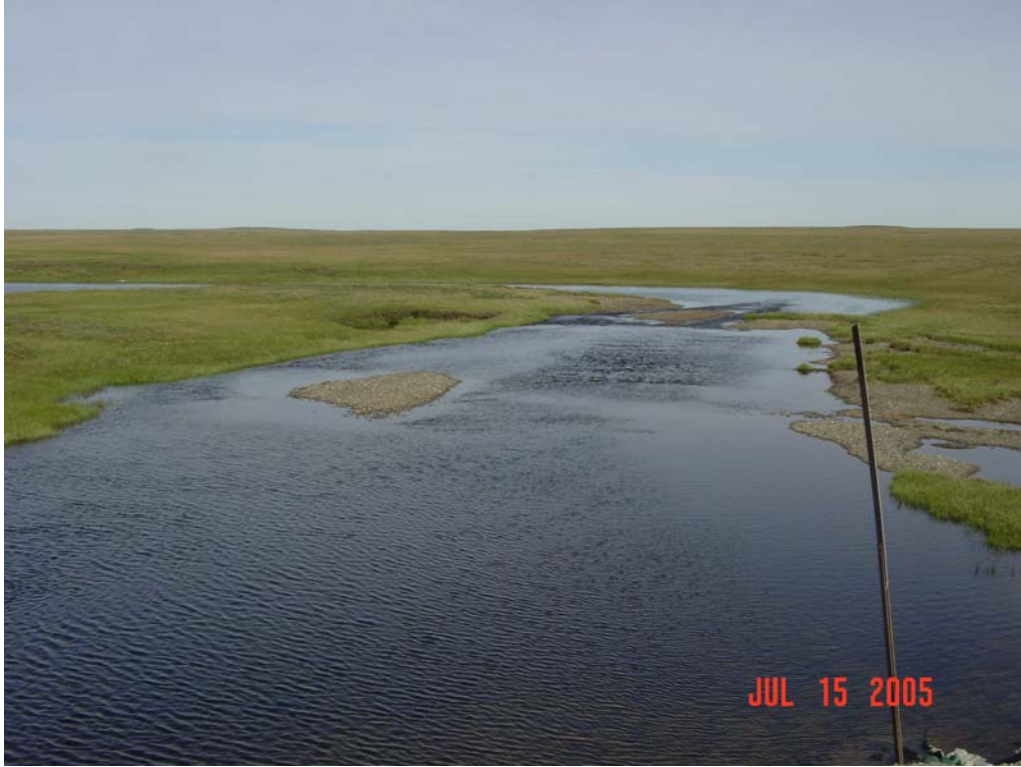
**Photograph 220. Outwash gravels downstream of the East Creek Spine Road culverts. Outwash gravel deposits may restrict some fish species upstream movements during periods of low flow.**
