**Technical Report No. 08-01**

## **A SURVEY OF STREAM CROSSING STRUCTURES IN THE NORTH SLOPE OILFIELDS**

**by William A. Morris  
and Jack F. Winters**

**February 2008**

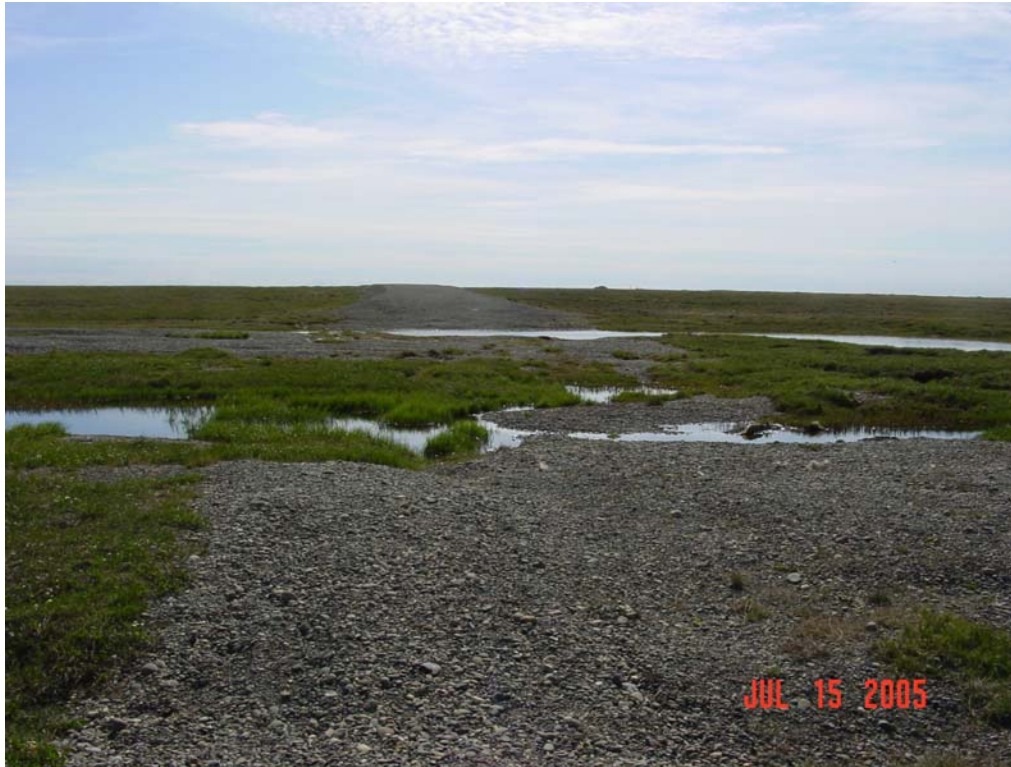
**Photograph 221. East Creek with substantial remnant gravel at the MP-1 crossing.**

REMEDIATION RECOMMENDATIONS: Remove remaining outwash gravels in the vicinity of the crossing and stabilize the site to minimize further erosion. Install a bridge at this location if development occurs at the MP-1 pad or nearby locations.

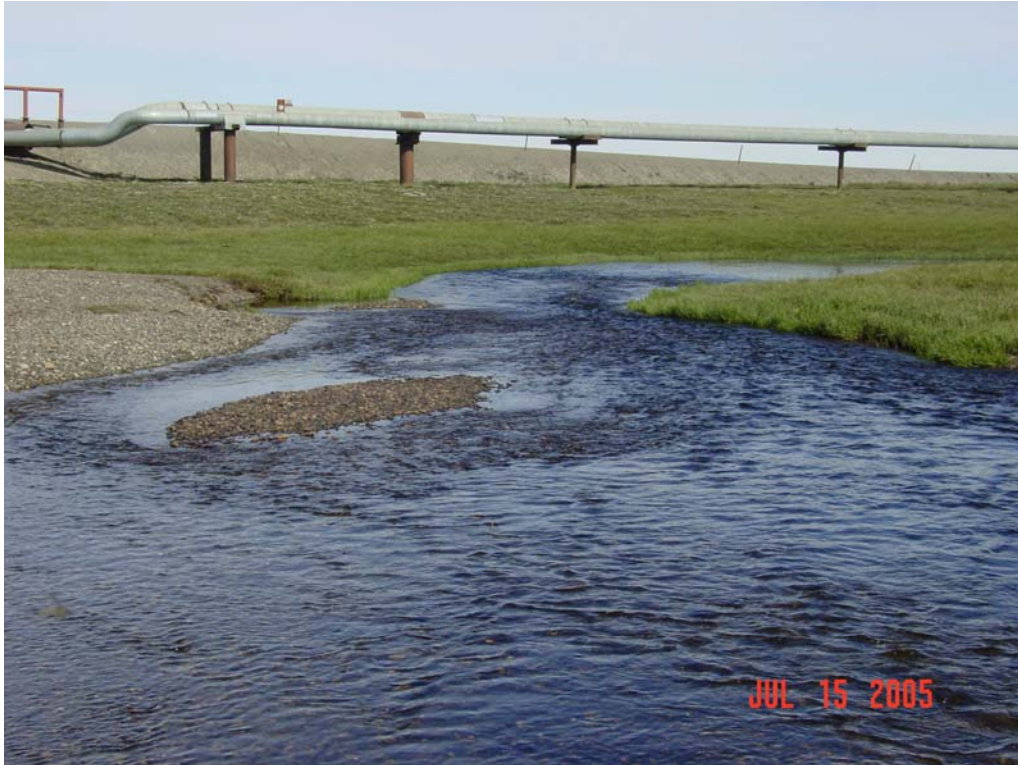
**Photograph 222. Gravel deposition downstream of the MP-1 crossing.**

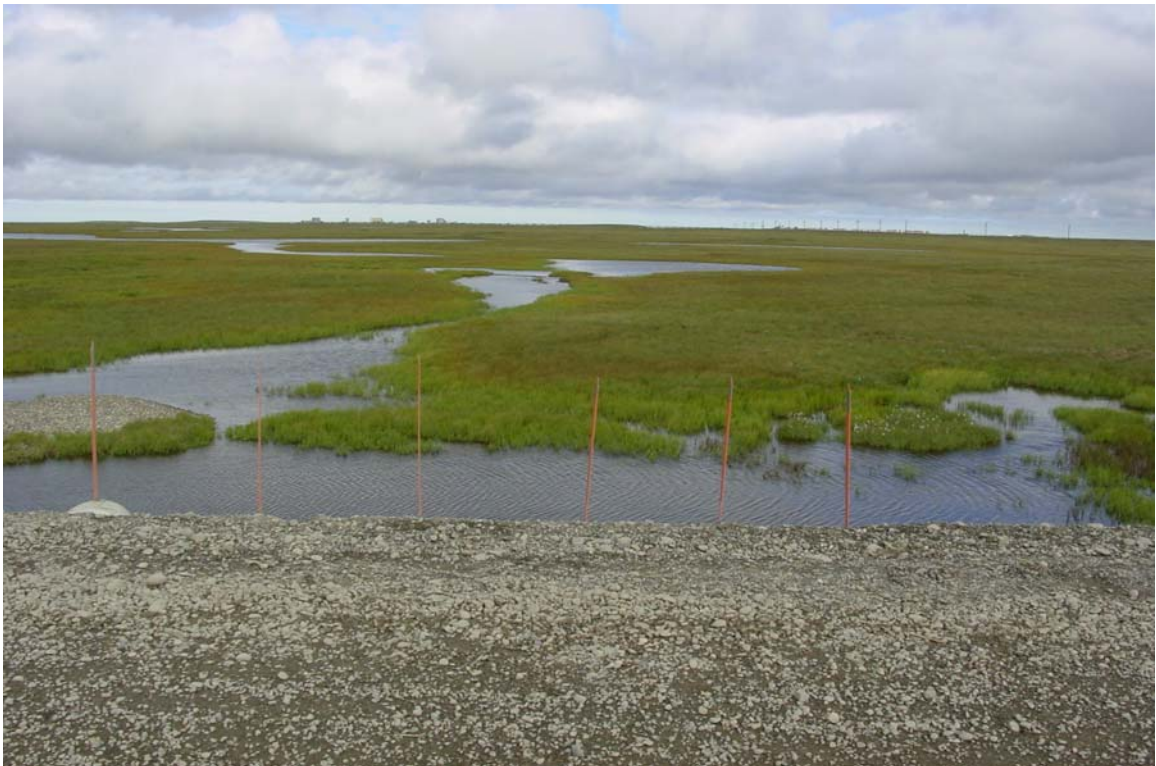
**Photograph 224. Culvert outlets and scour pool for the eastern portion of the culvert battery, August 8, 2006.**

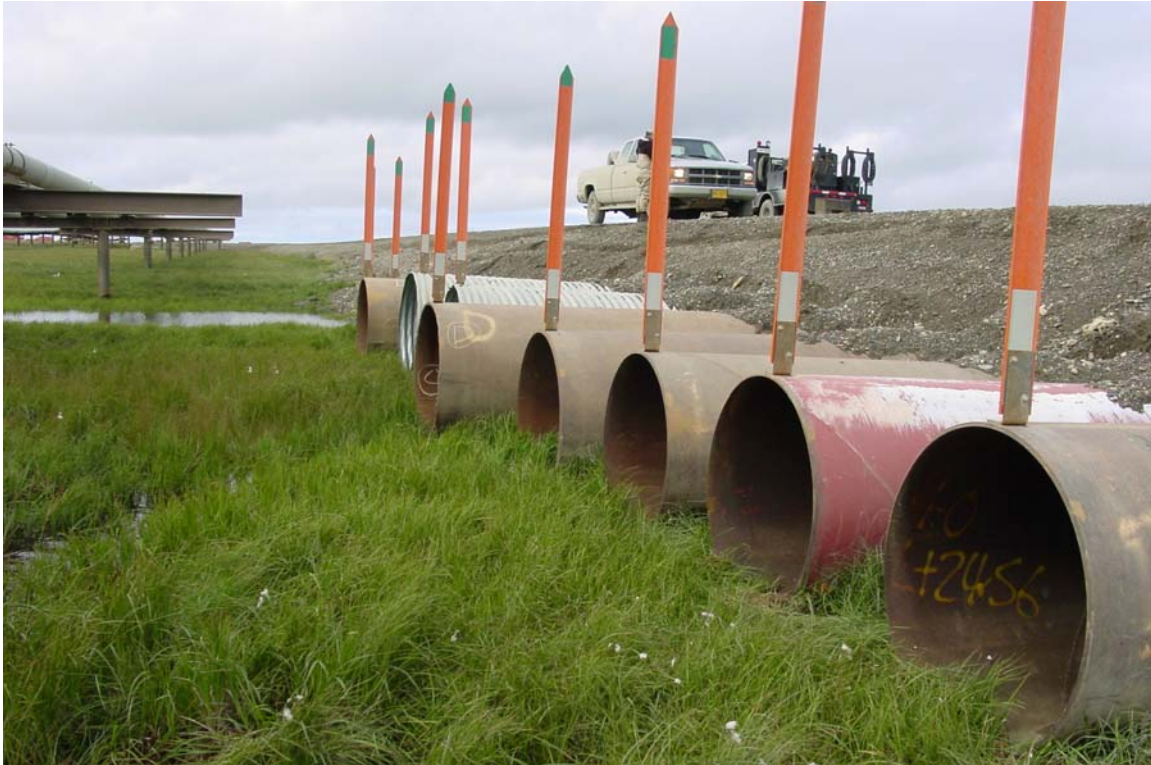
**Photograph 227. West Fork West Fork Central Creek culvert inlets misaligned with creek and blocked by vegetation, August 8, 2006.**

REMEDIATION RECOMMENDATIONS: Align larger corrugated culvert with the creek, remove outwash gravels

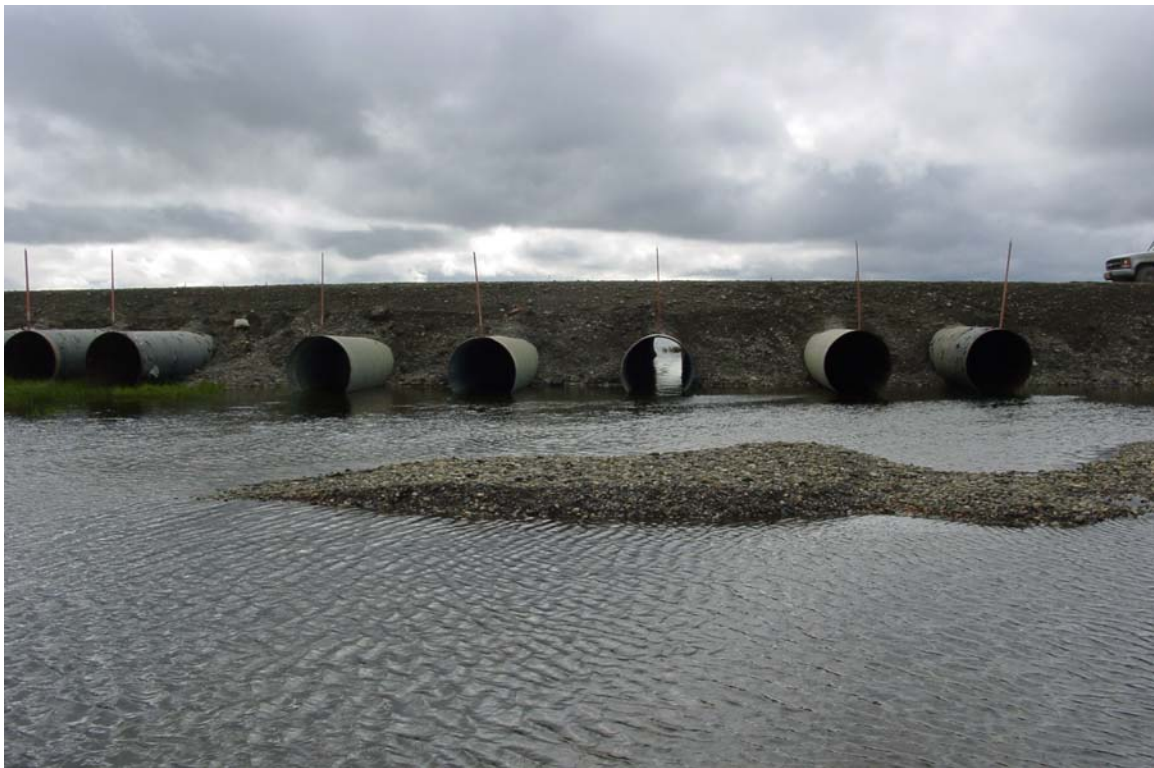
**Photograph 232. East Fork West Fork Central Creek culvert outlets and outwash gravels, August 8, 2006.**

REMEDIATION RECOMMENDATIONS: Remove outwash gravel and debris at this  
crossing

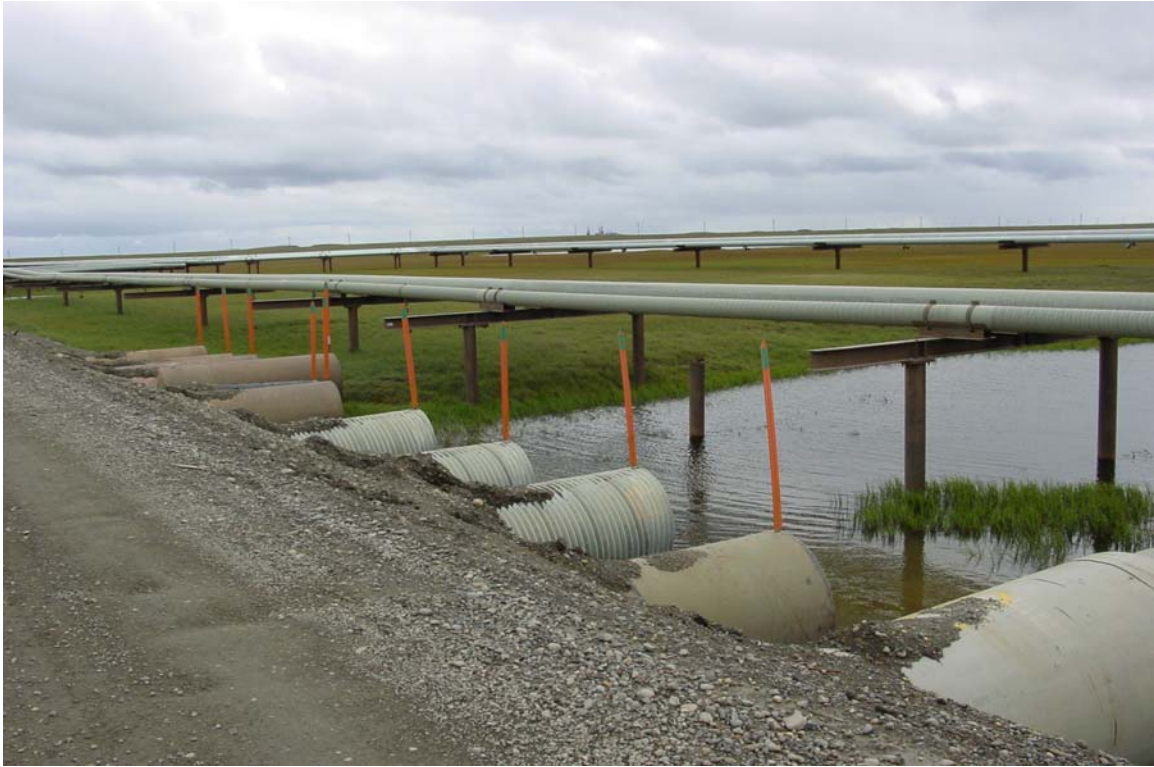
**Photograph 233. East Fork West Fork Central Creek culvert inlets, August 8, 2006.**

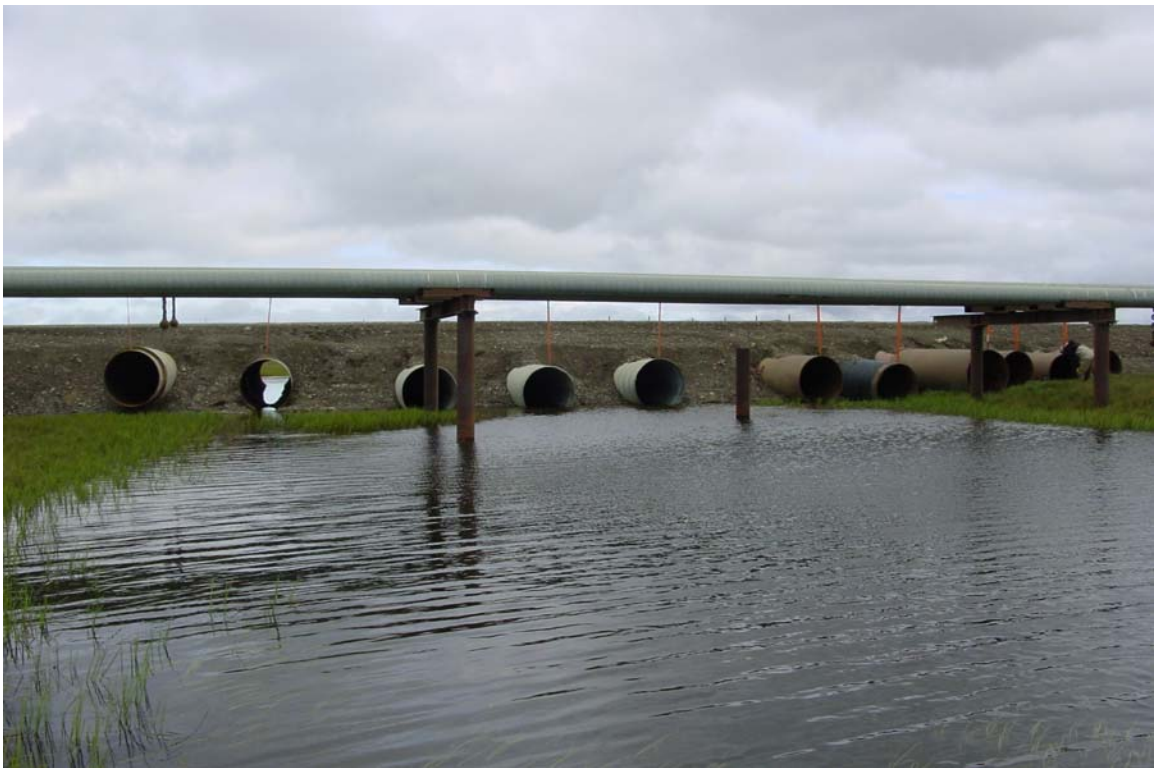
**Photograph 234. East Fork West Fork Central Creek culvert inlets, August 8, 2006.**

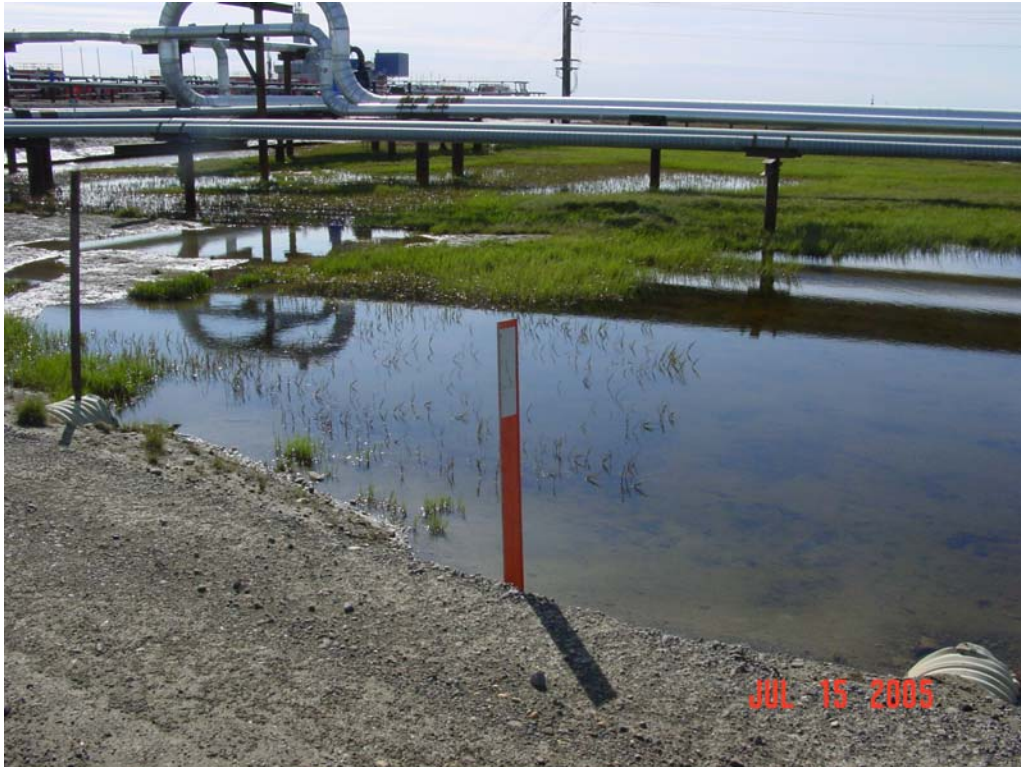
**Photograph 235. East Fork Central Creek upstream of the Spine Road crossing at Drill Site 1D.**

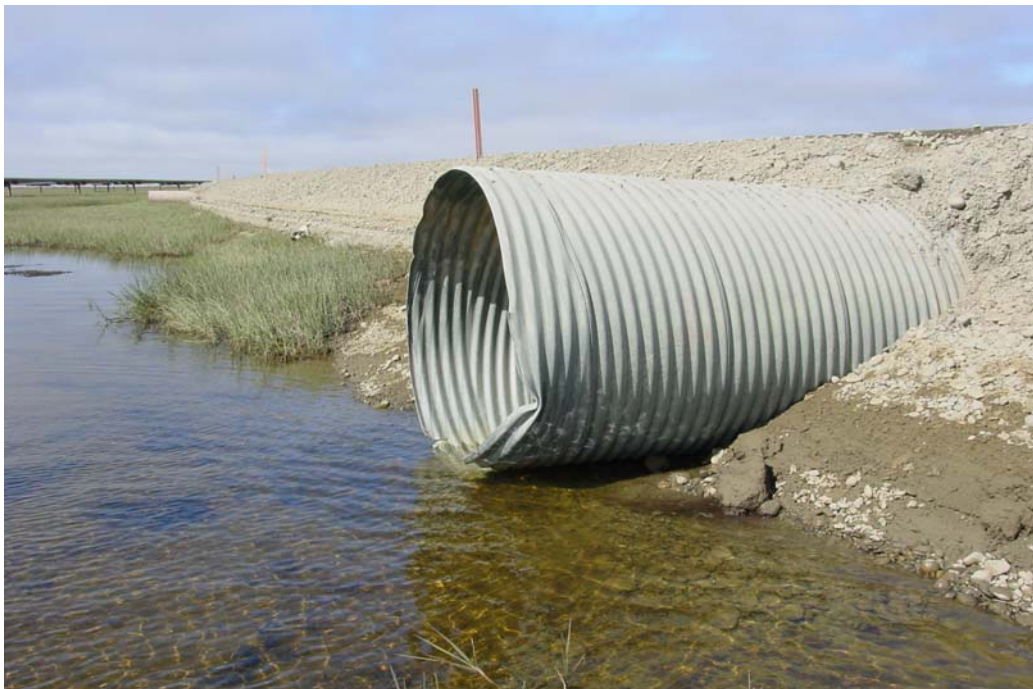
INLET: Slight inlet damage; inlet should be set deeper

**Photograph 236. East Fork Central Creek 48 inch culvert inlet, July 8, 2007. This pipe replaced an existing 24 inch culvert.**

REMEDIATION RECOMMENDATIONS: Reset culvert to enhance fish passage

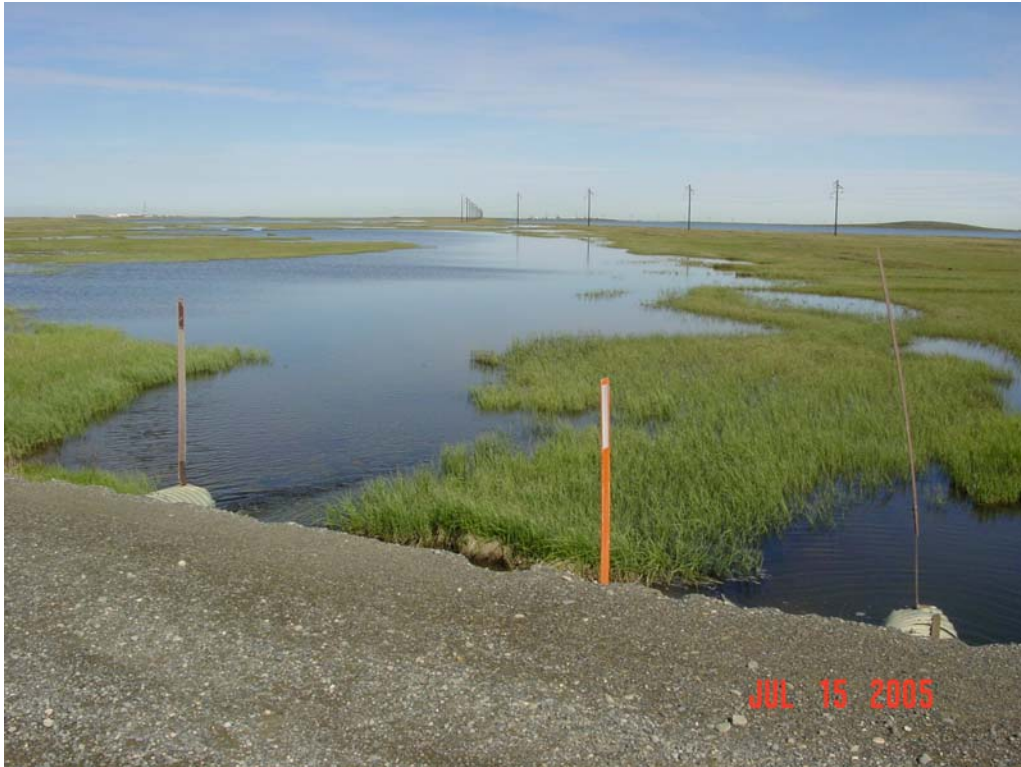
**Photograph 237. East Fork Central Creek downstream of the Spine Road crossing at Drill Site 1D.**

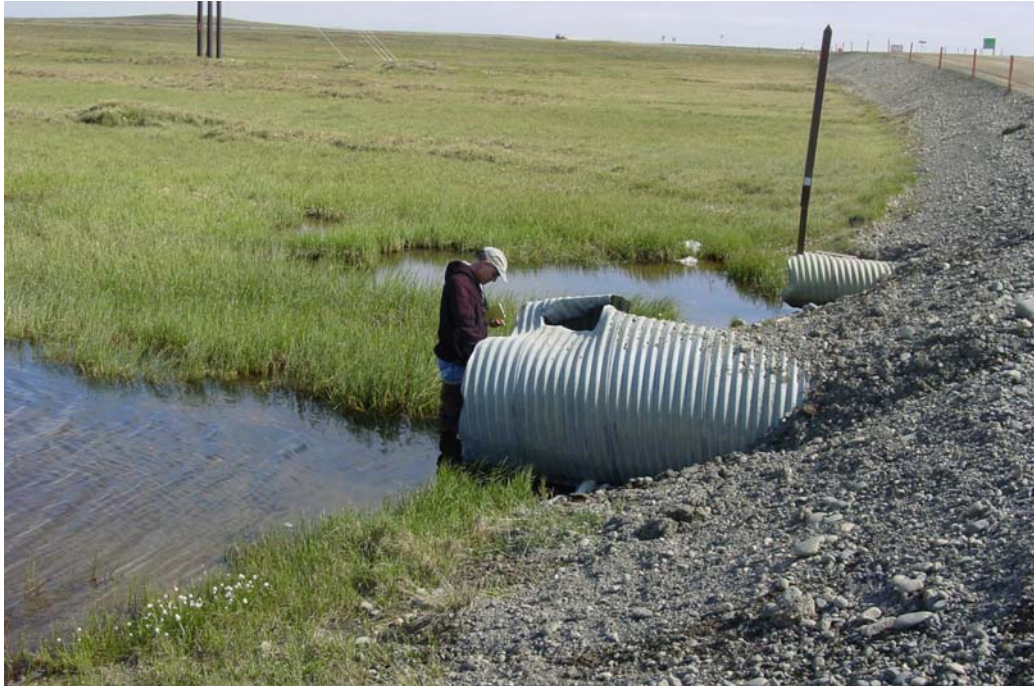
OUTLET: Outlet of larger pipe damaged; smaller pipe perched

**Photograph 238. Damaged outlet of the East Fork Central Creek 48 inch culvert, July 8, 2007.**

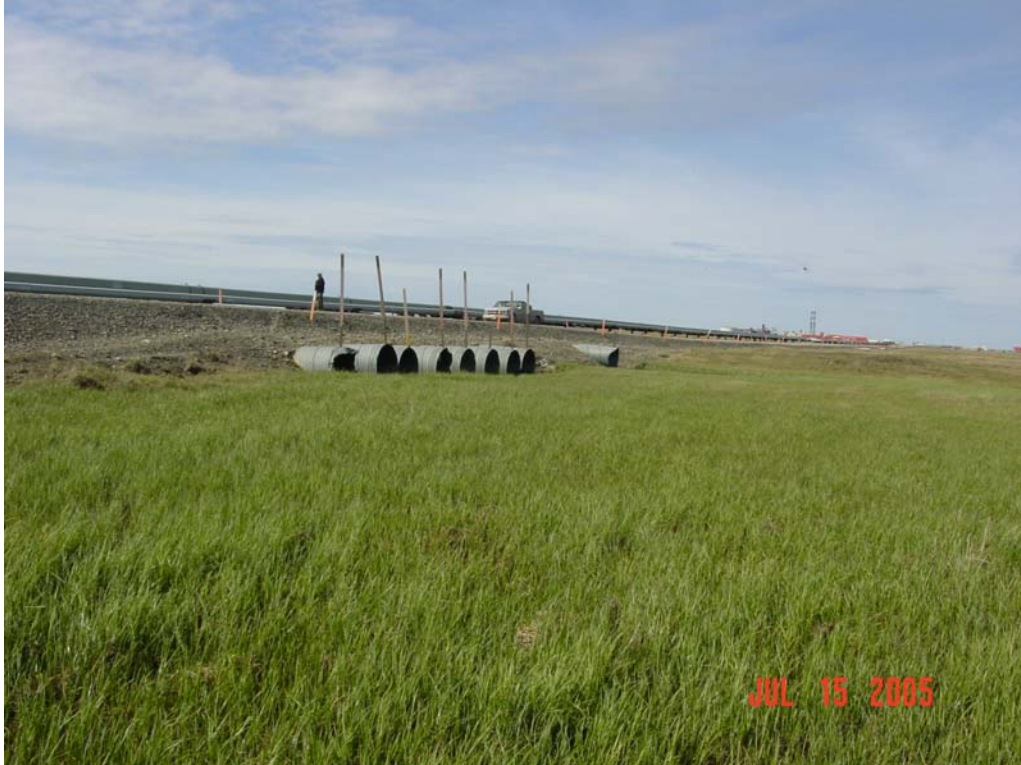
OUTLET: partial sand bag armor, damage to some culvert outlets, scour 5 to 6 feet  
deep at the east culvert

**Photograph 239. Main culvert battery outlets of East Fork Central Creek along the Kuparuk Pipeline Road crossing between Drill Site 1C and CPF-1.**

REMEDICATION RECOMMENDATIONS: Increase conveyance at the east culvert,  
repair east culvert inlet, repair main battery culverts

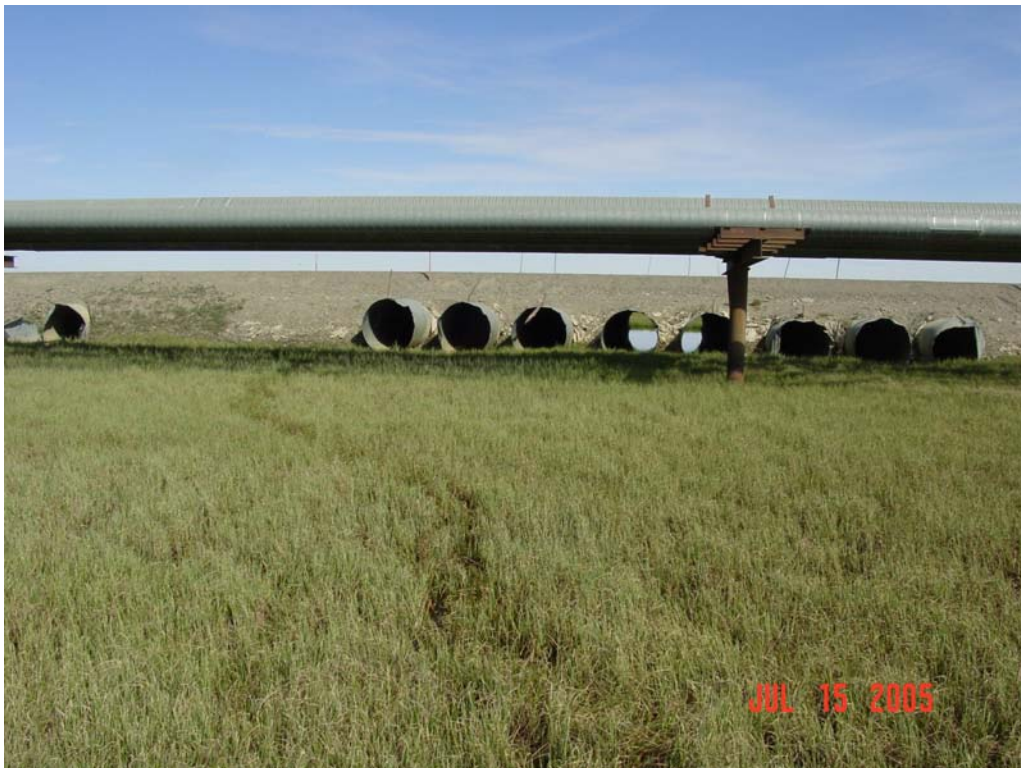
INLET: partial sand bag armor, inlet apron damage

**Photograph 240. Main culvert battery inlets of East Fork Central Creek along the Kuparuk Pipeline Road crossing between Drill Site 1C and CPF-1.**

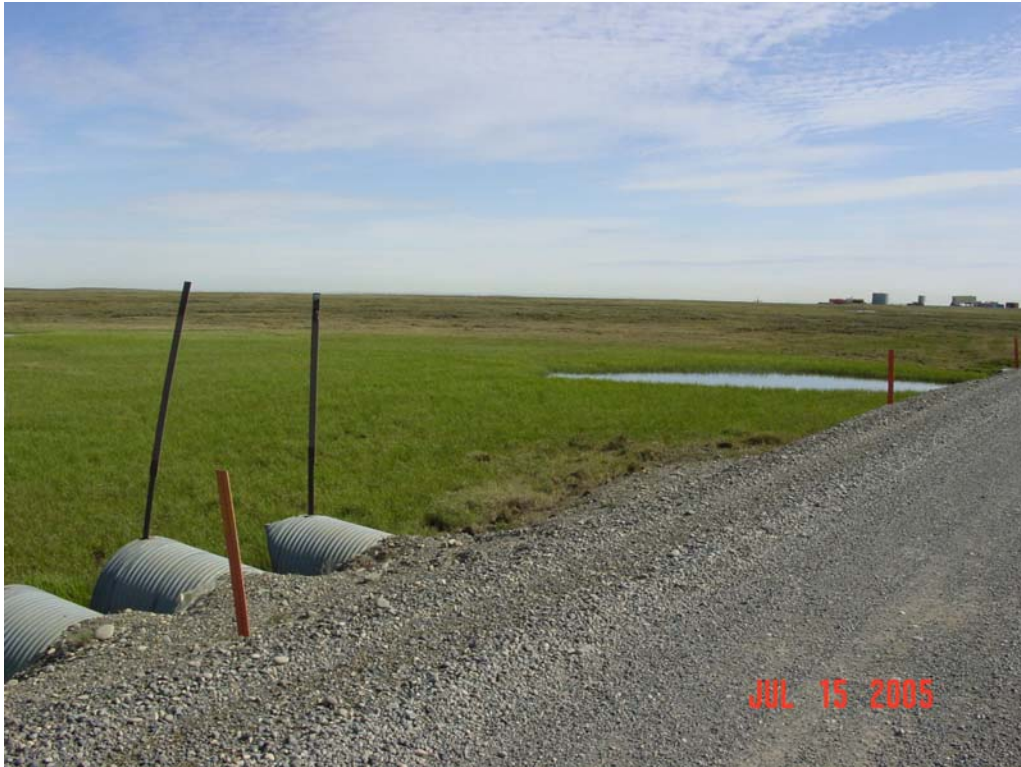
**Photograph 241. Main battery outlets and scour pool of the single culvert carrying all of the creek flow.**

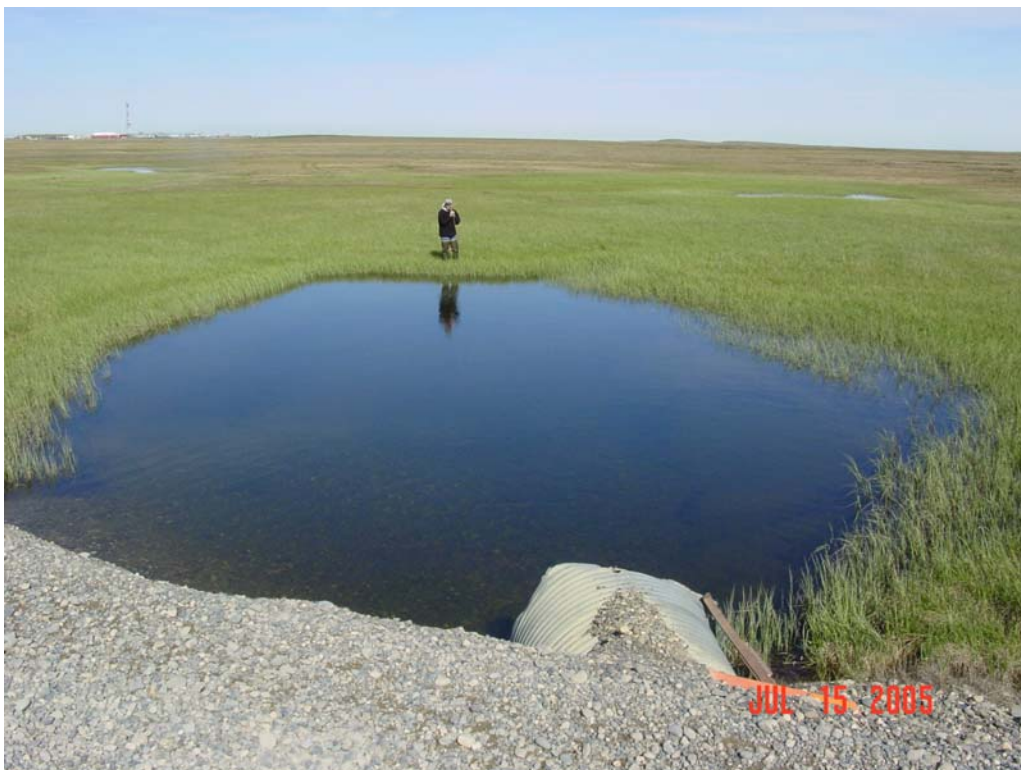
**Photograph 242. Five to six foot deep scour pool at the outlet of the culvert carrying all of the creek flow.**

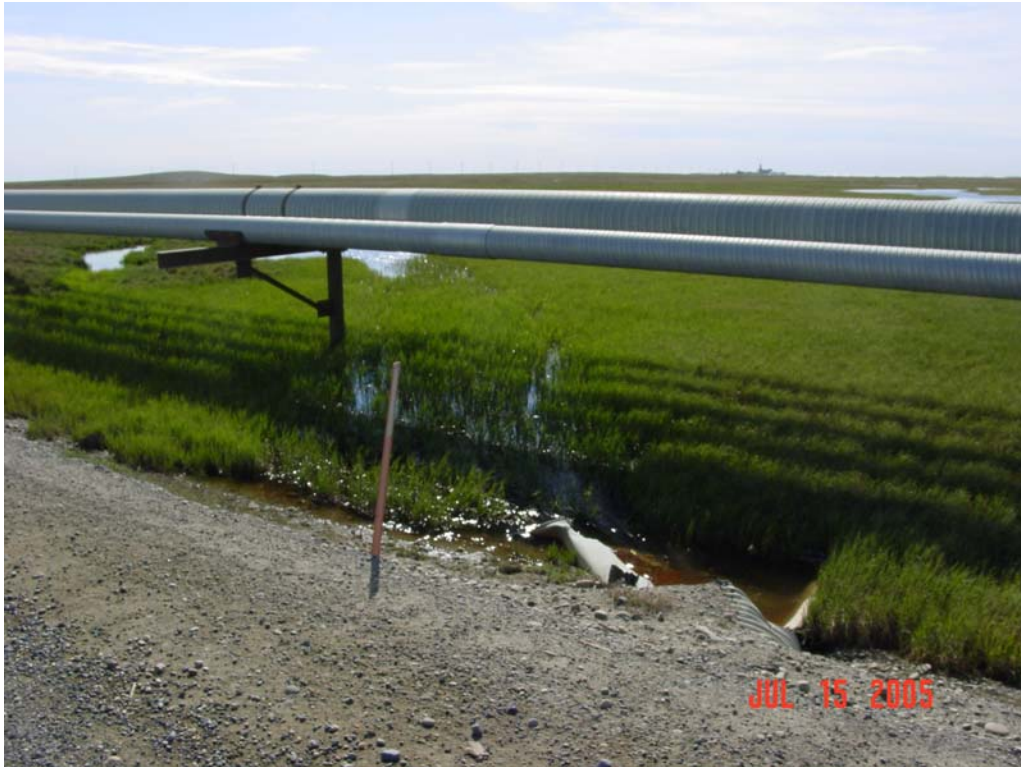
**Photograph 243. East Fork Central Creek upstream of the 48 inch culvert carrying all of the creek flow.**

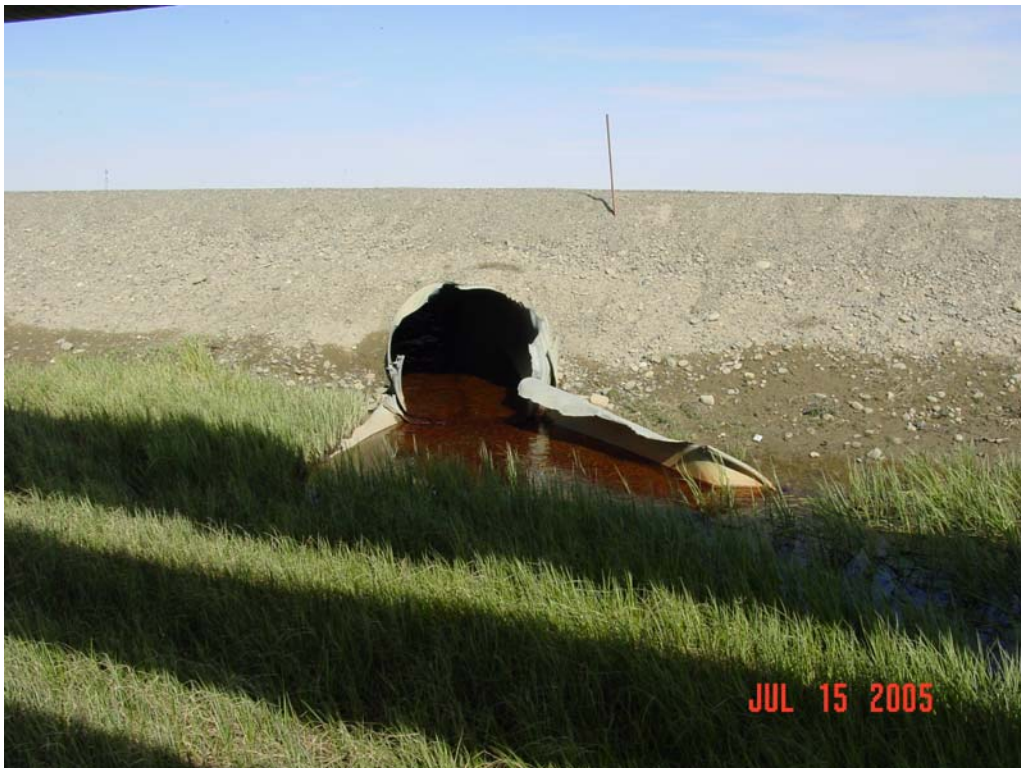
**Photograph 244. Damaged culvert apron and inlet.**

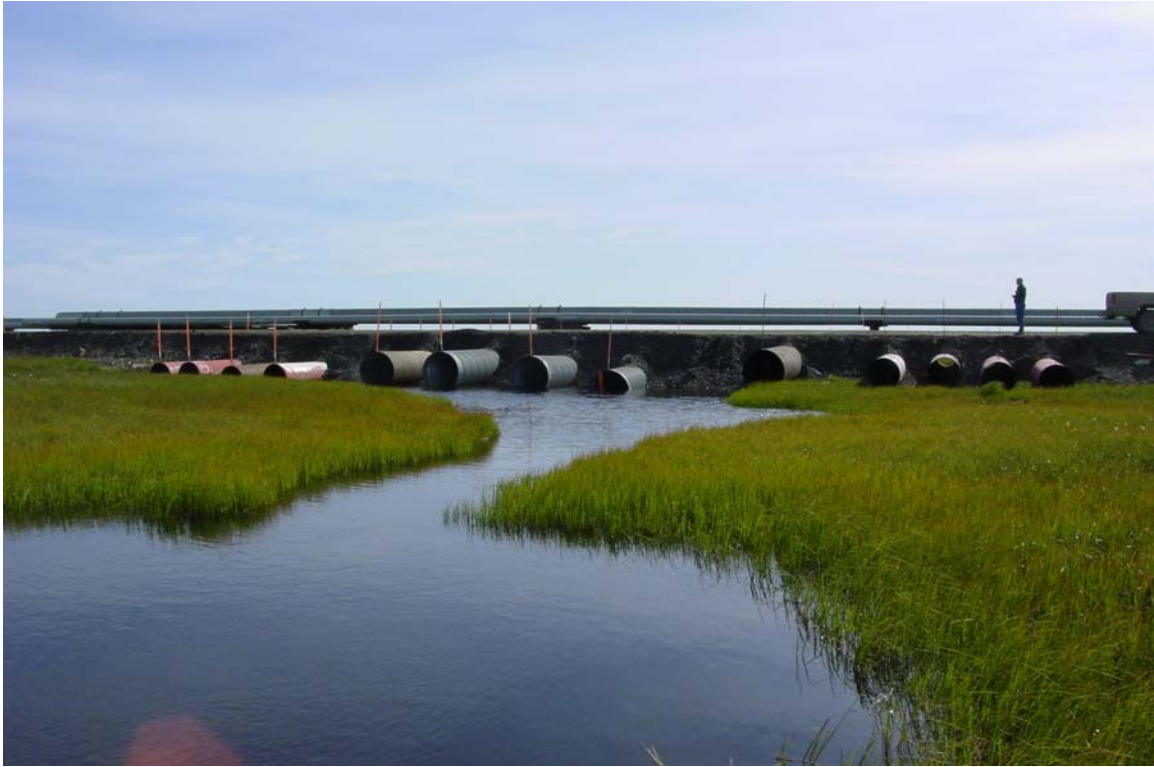
**Photograph 247. West Fork Central Creek culvert outlets, August 9, 2006.**

REMEDIATION RECOMMENDATIONS: Remove gravel outwash and culvert debris.

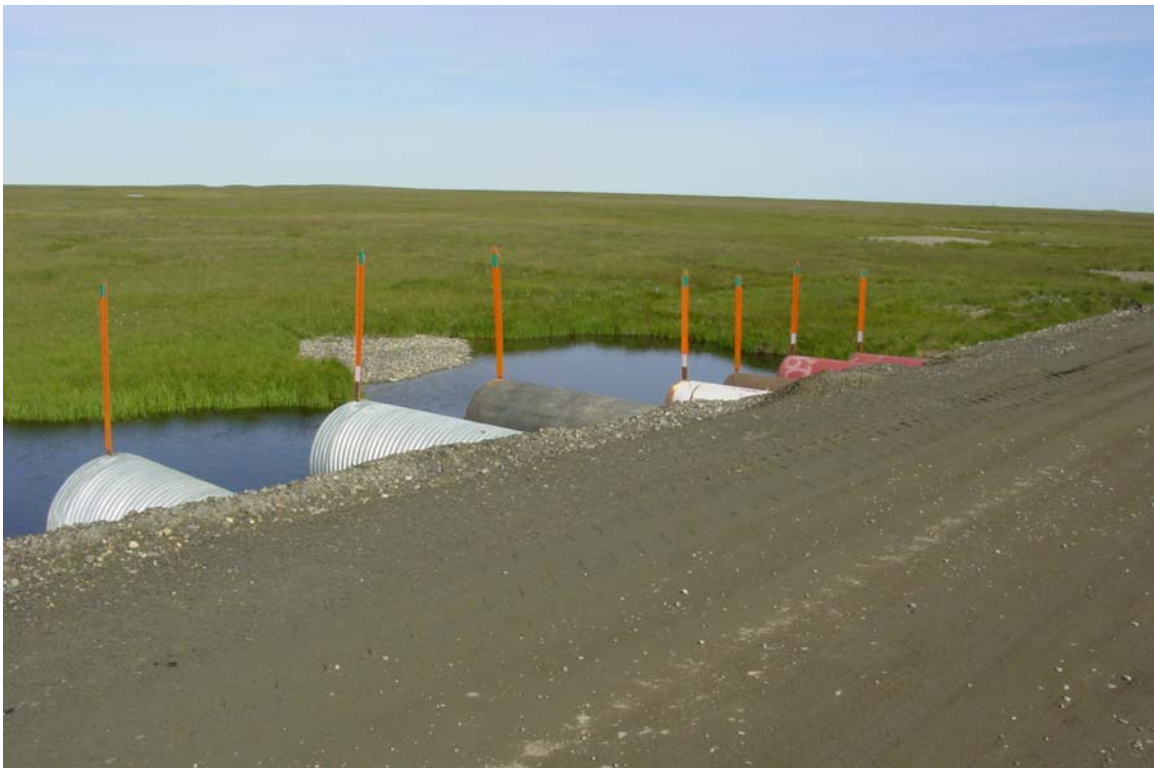
**Photograph 248. West Fork Central Creek scour pool and outwash gravels, August 9, 2006.**

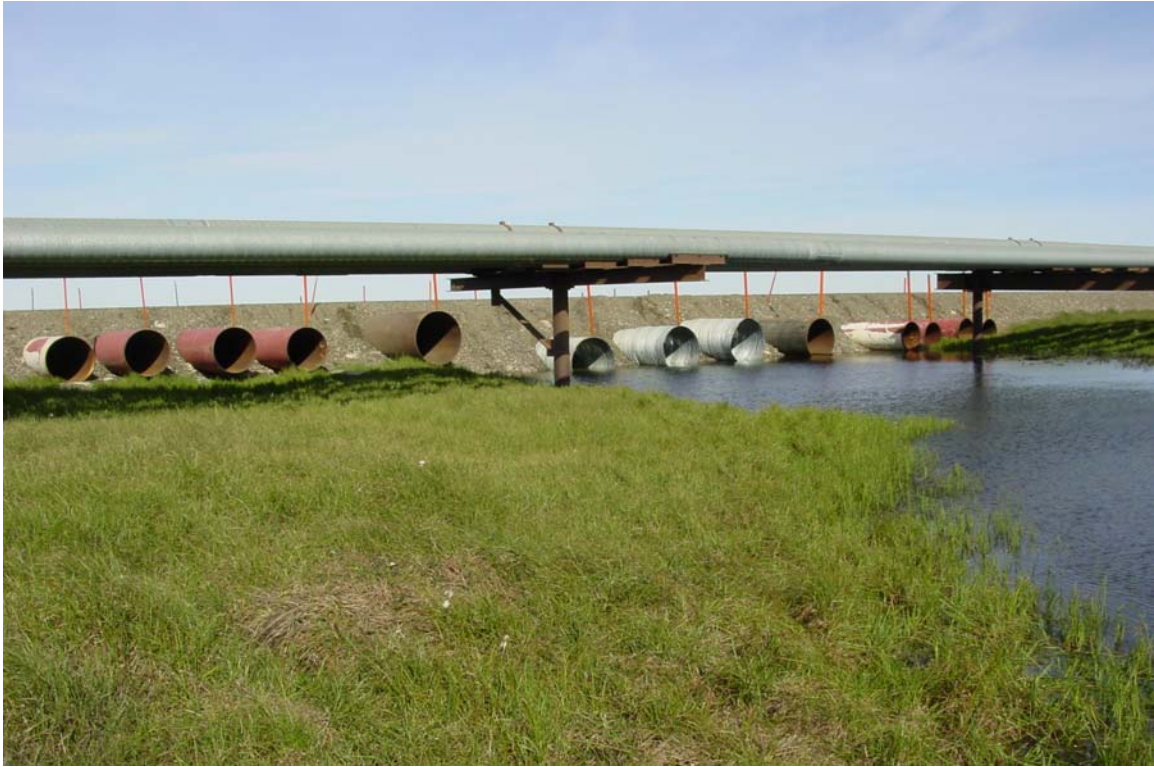
**Photograph 249. West Fork Central Creek culvert inlets, August 9, 2006.**

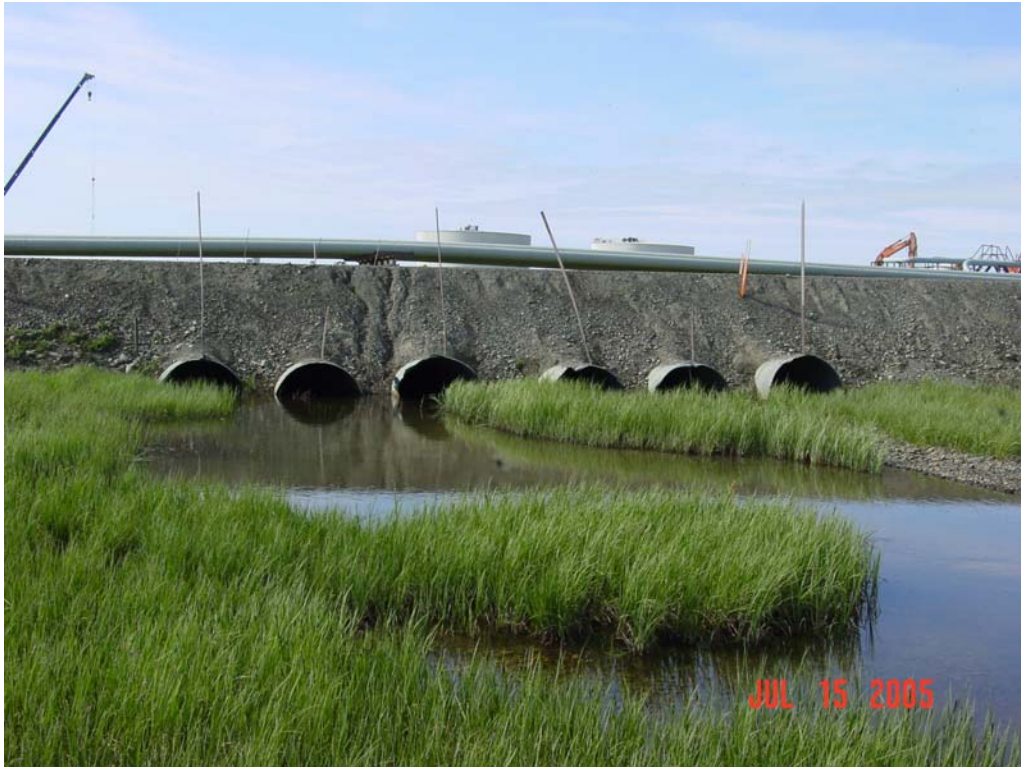
OUTLET: outwash gravels present, considerable gravel and ice inside culverts, all culverts bowed, minor culvert outlet damage

**Photograph 252. East Fork Ugnuravik River culvert outlets.**

REMEDICATION RECOMMENDATIONS: Remove outwash gravels and cables, increase water conveyance past this crossing.

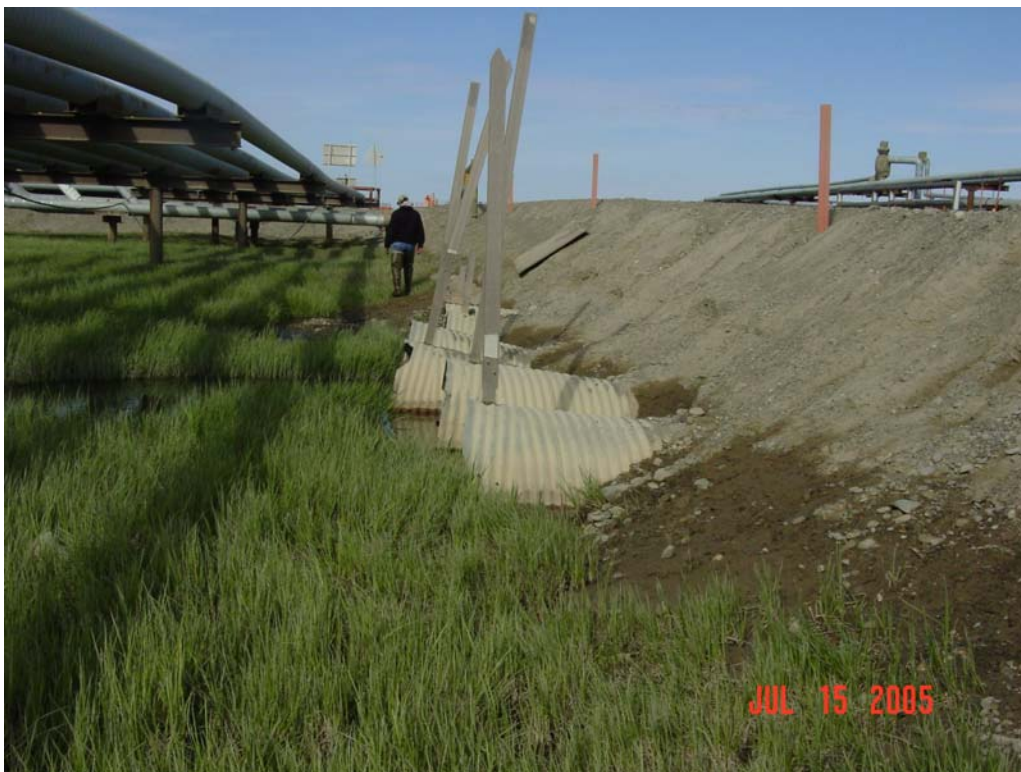
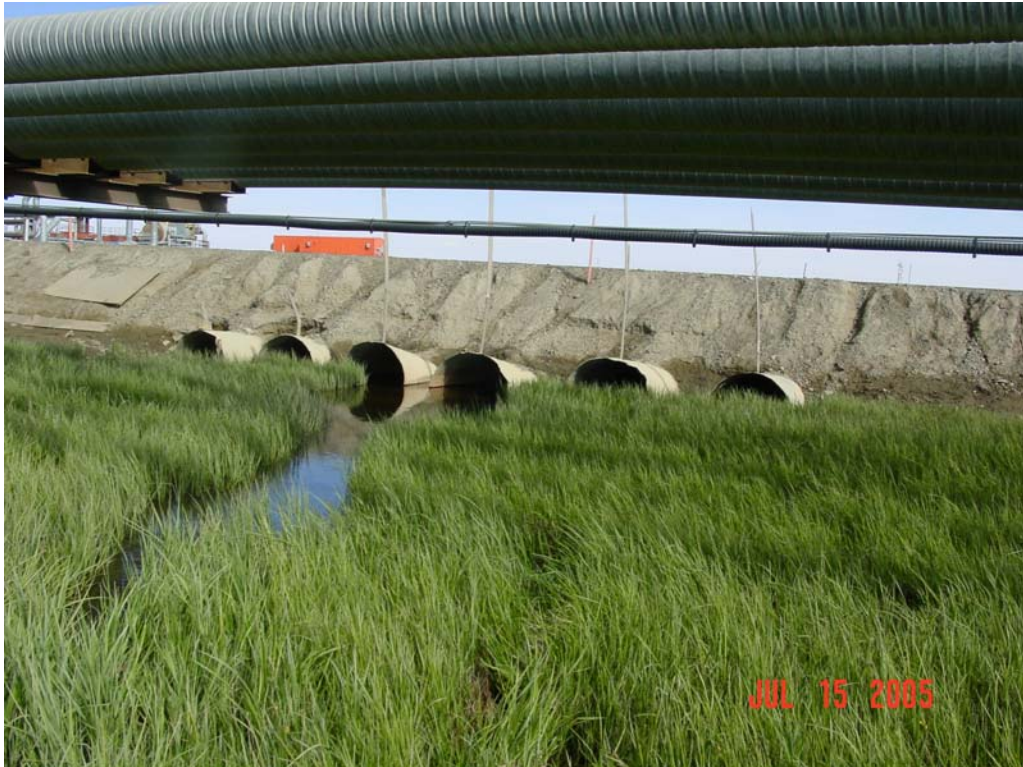
INLET: Minor inlet damage, high water mark 2 feet above culvert inlets, cable and debris in stream upstream of culverts

**Photograph 253. East Fork Ugnuravik River culvert inlets.**

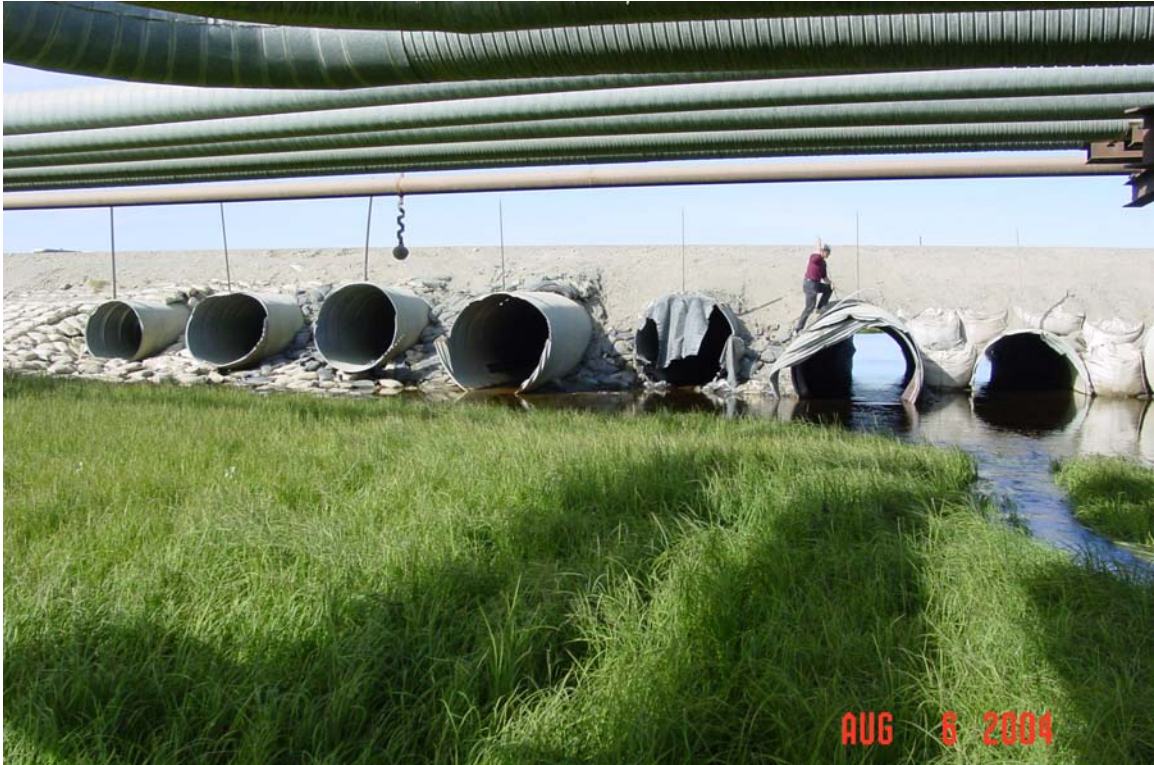
INLET: Small and large sand bag armor, substantial inlet damage

**Photograph 257. The western half of the Ugnuravik River culvert battery inlets.**

REMEDIALATION RECOMMENDATIONS: Repair culverts, increase water conveyance past this crossing.

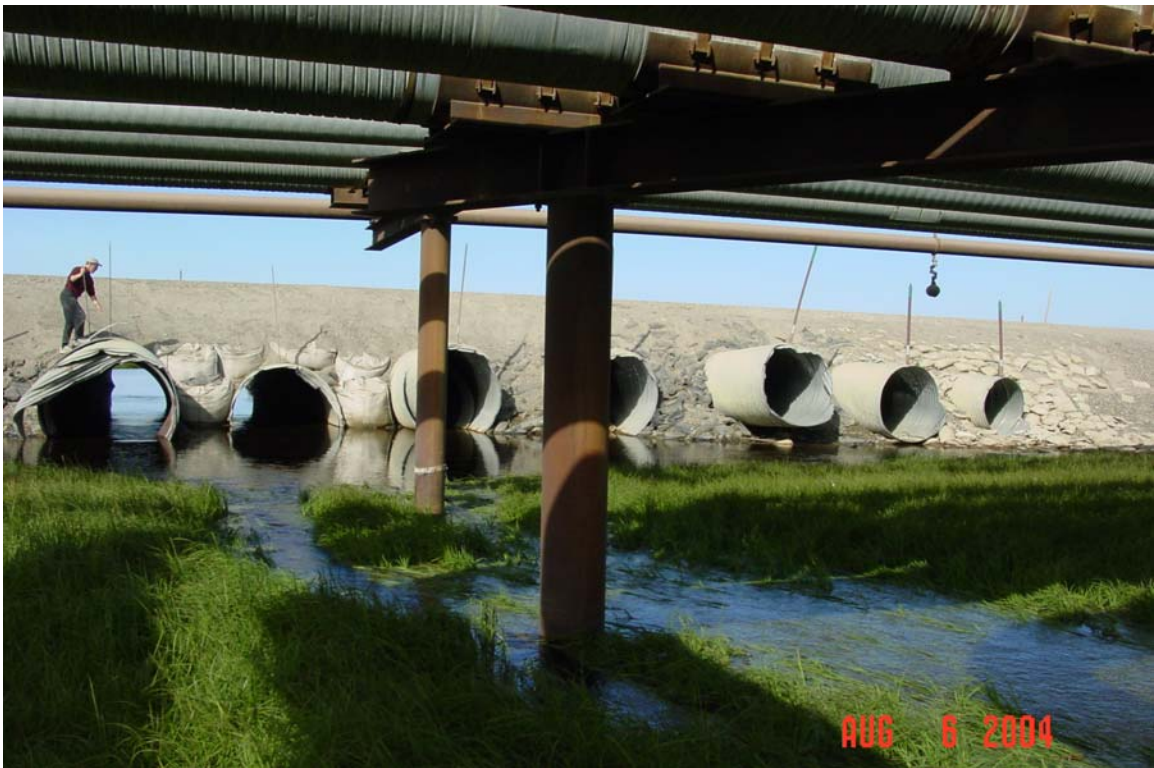
**Photograph 258. The eastern half of the Ugnuravik River culvert battery inlets.**

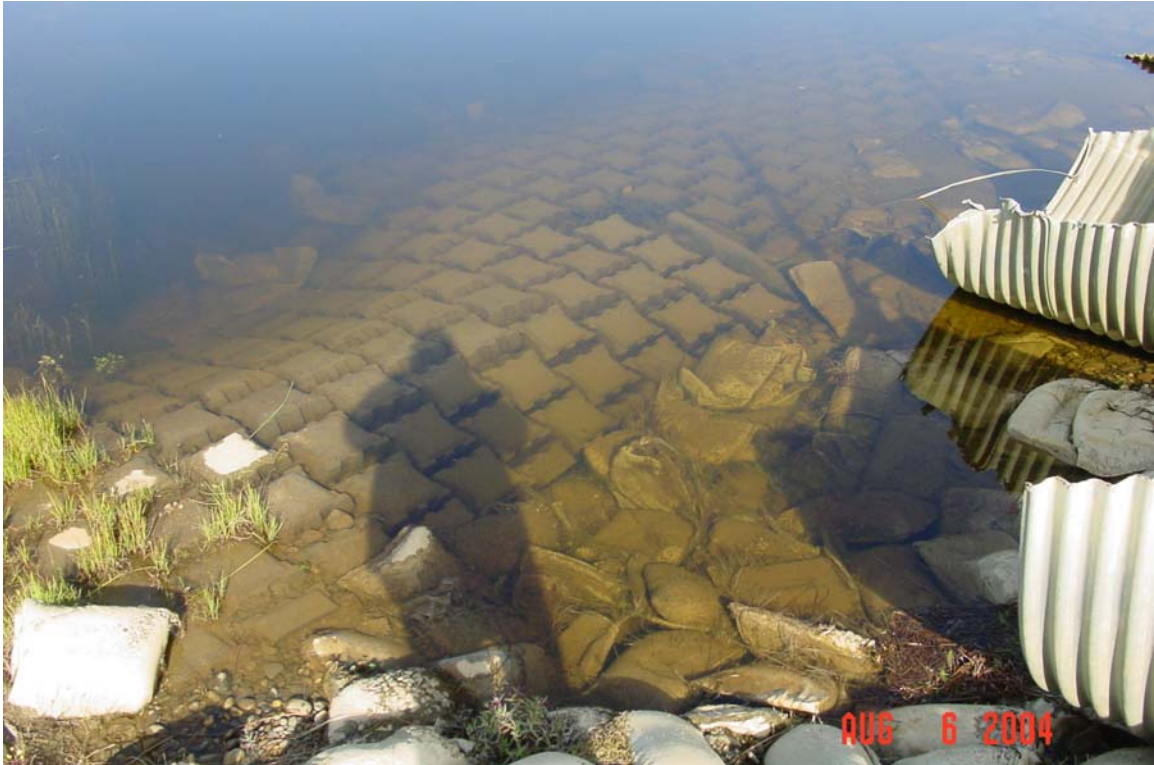
OUTLET: Gobi mat and sand bag armor, apron and culvert outlet damage, displaced sand bags, 6 to 10 foot deep scour pool, outwash gravels present

**Photograph 259. Slumped and scoured gobi mat, and displaced sand bags at the culvert outlets.**
