**Technical Report No. 08-01**

## **A SURVEY OF STREAM CROSSING STRUCTURES IN THE NORTH SLOPE OILFIELDS**

**by William A. Morris  
and Jack F. Winters**

**February 2008**

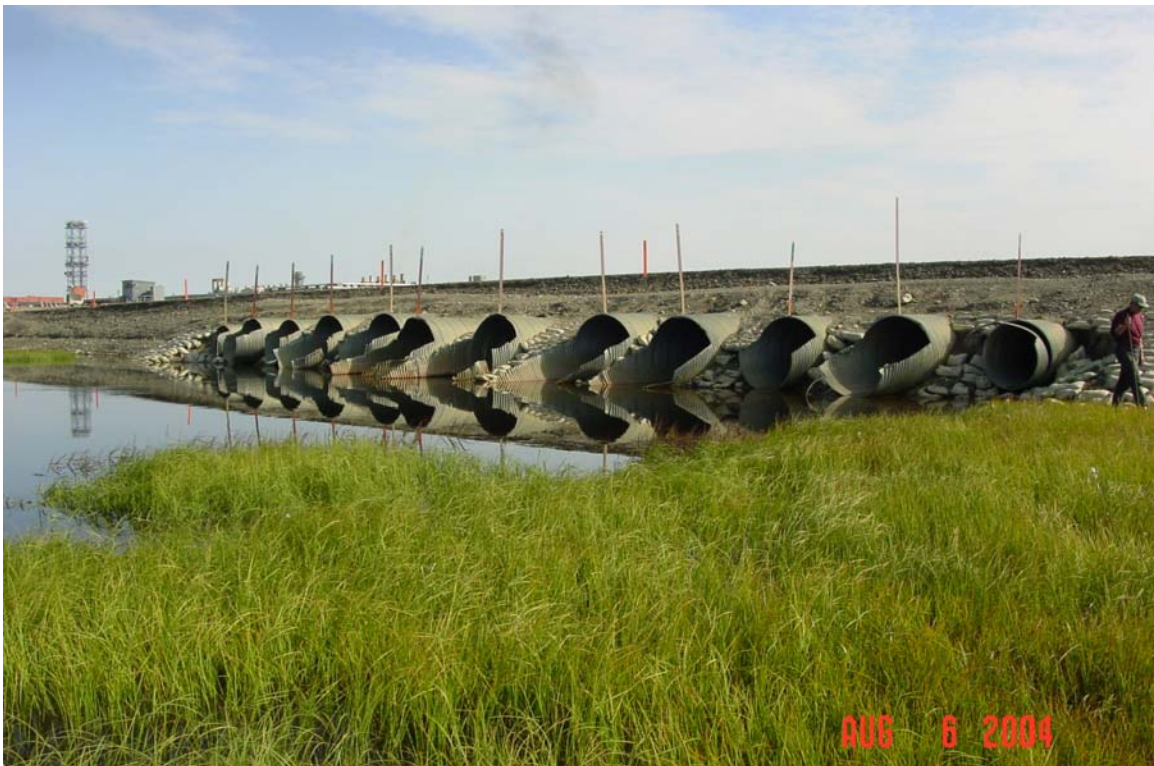
OUTLET: Gobi mat and sand bag armor, apron and culvert outlet damage, displaced sand bags, 6 to 10 foot deep scour pool, outwash gravels present

**Photograph 260. Ugnuravik River culvert outlets at the Spine Road crossing.**

REMEDIALATION RECOMMENDATIONS: Repair culverts, increase water conveyance past this crossing.

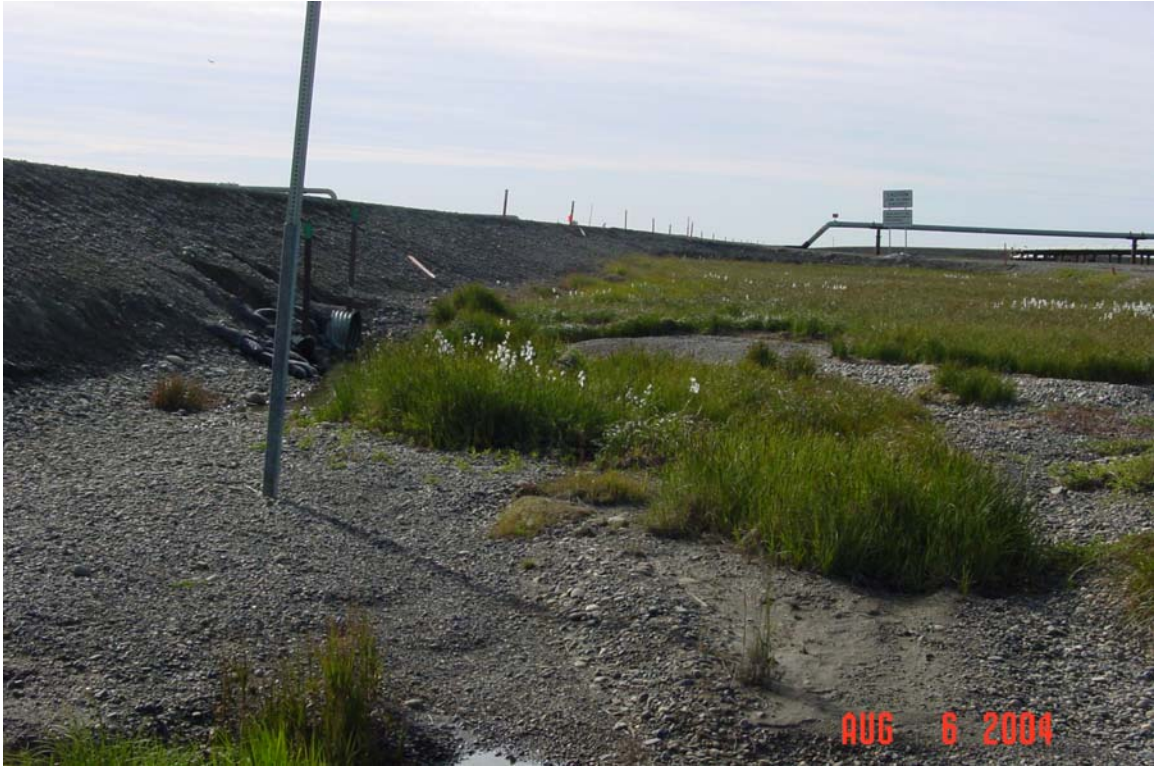
**Photograph 261. Outwash gravels at the western margin of the Ugnuravik River culvert outlets.**

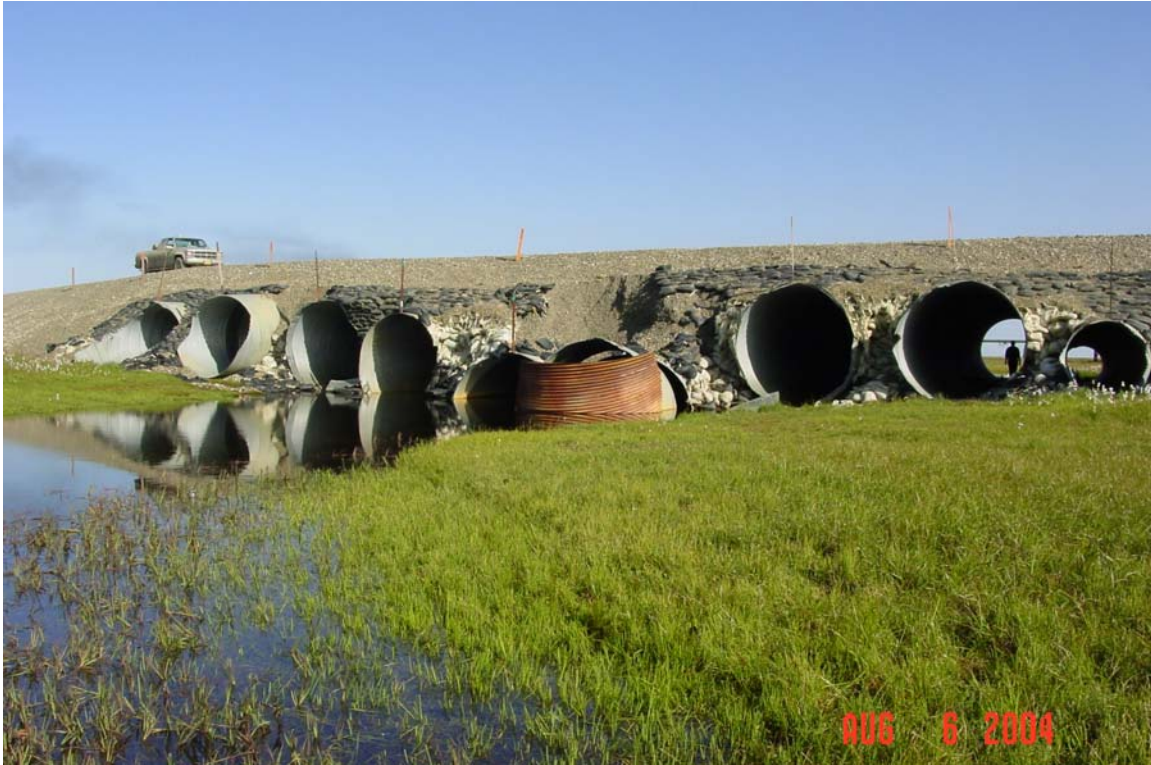
INLET: Sand bag armor eroded, road prism erosion; severe culvert inlet damage blocking one culvert set for fish passage in 2004

**Photograph 264. Ugnuravik River culvert inlets. Note the road prism erosion, sand bag armor destruction, and the culvert apron completely blocking the inlet of one culvert (Repaired by 2006).**

REMEDIATION RECOMMENDATIONS: Repair damaged culverts

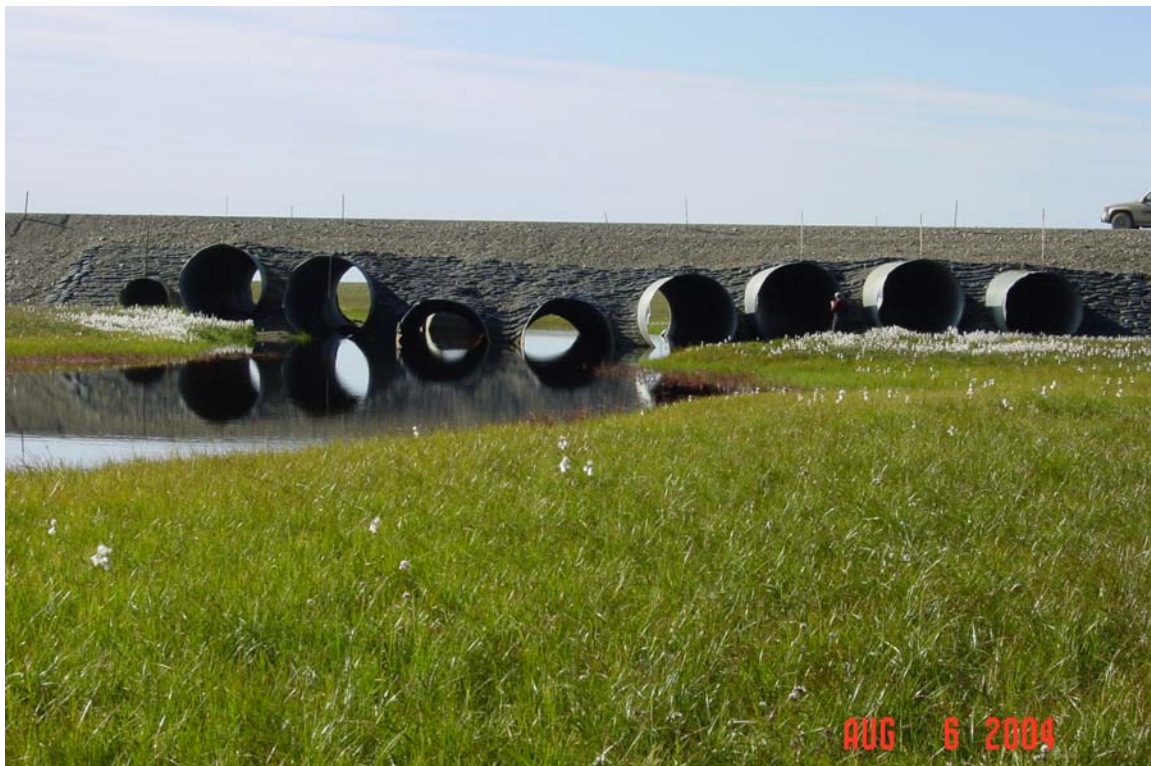
OUTLET: Intact sand bag armor, minor damage to outlets, deep scour pool

**Photograph 265. Ugnuravik River culvert outlets.**

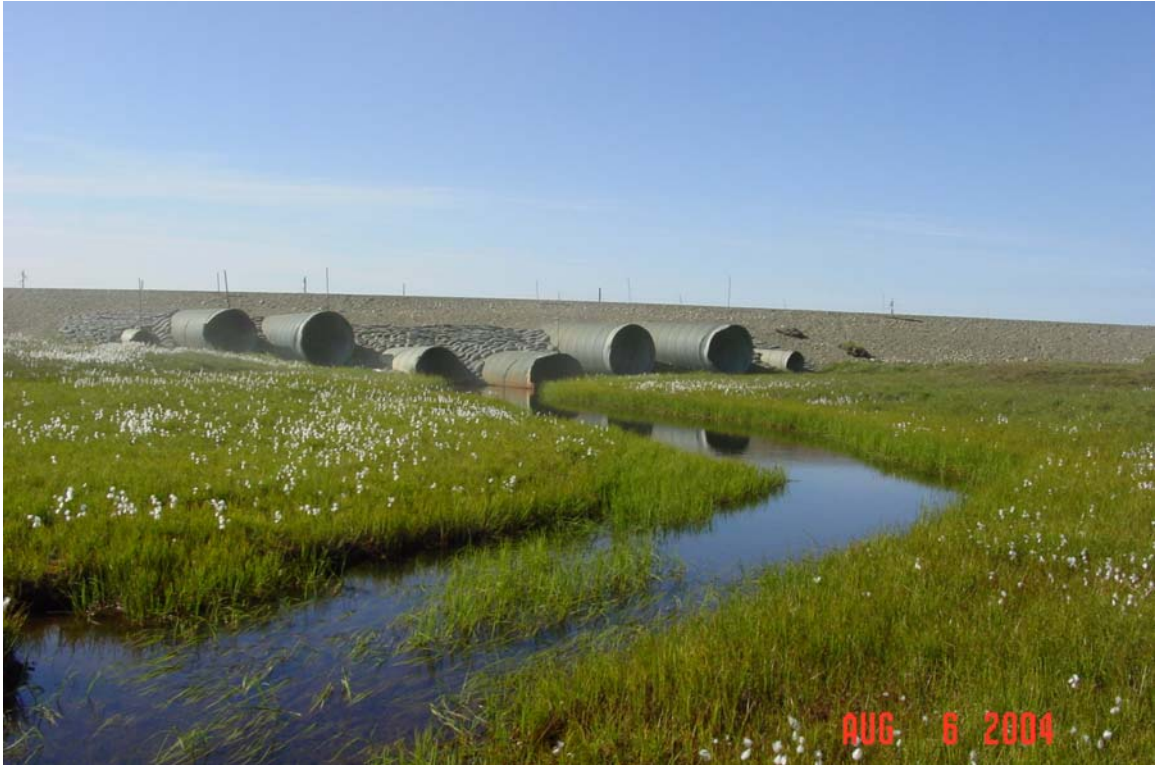
**Photograph 272. Charlie Creek culvert outlets.**

REMEDICATION RECOMMENDATIONS: Repair culvert inlets

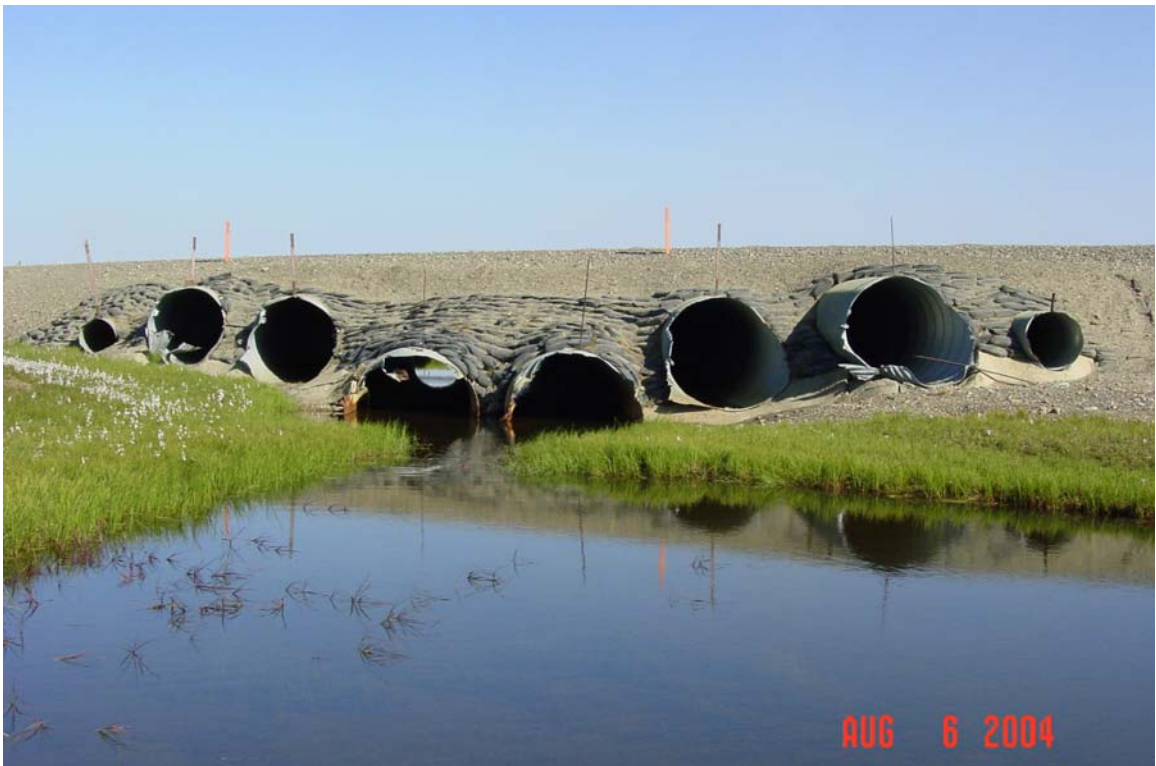
**Photograph 273. Charlie Creek culvert inlets.**

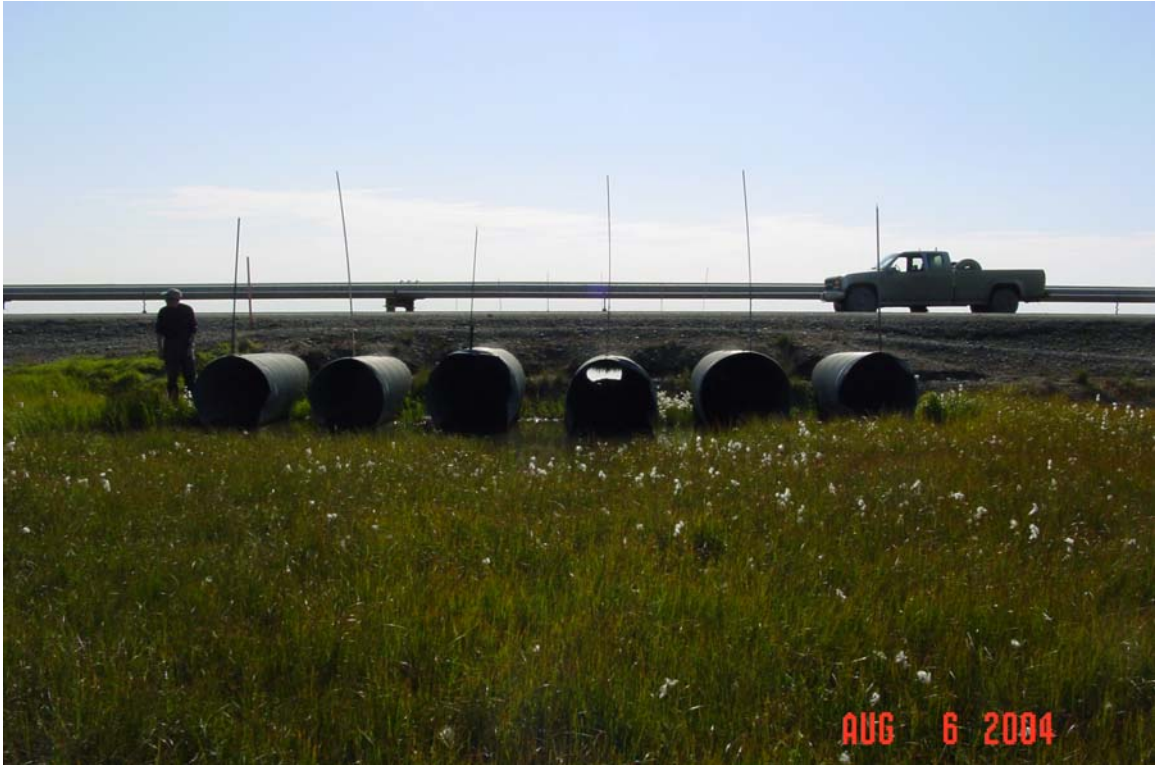
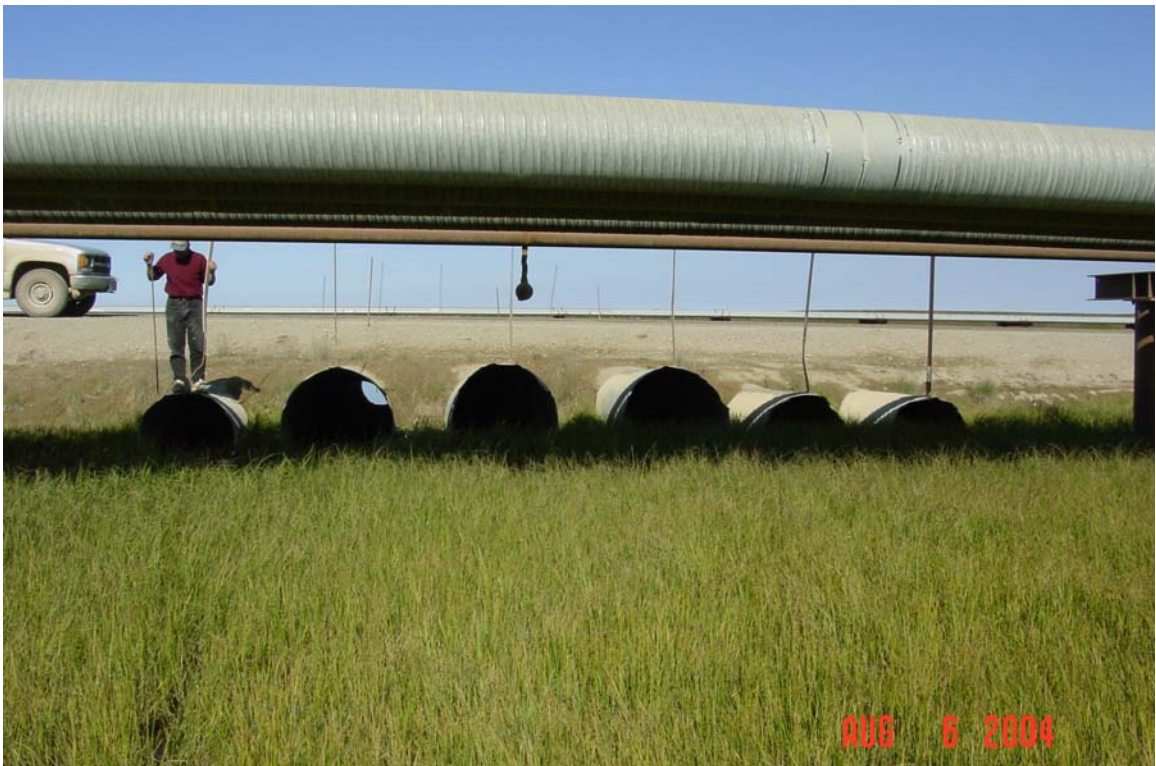
INLET: Minor inlet damage, culverts partially crushed, gravel in some culverts

OUTLET: Minor outlet damage

**Photograph 276. East Fork Charlie Creek culvert outlets.**

**Photograph 277. East Fork Charlie Creek culvert inlets.**

REMEDICATION RECOMMENDATIONS: Repair culverts, remove gravel from  
culverts

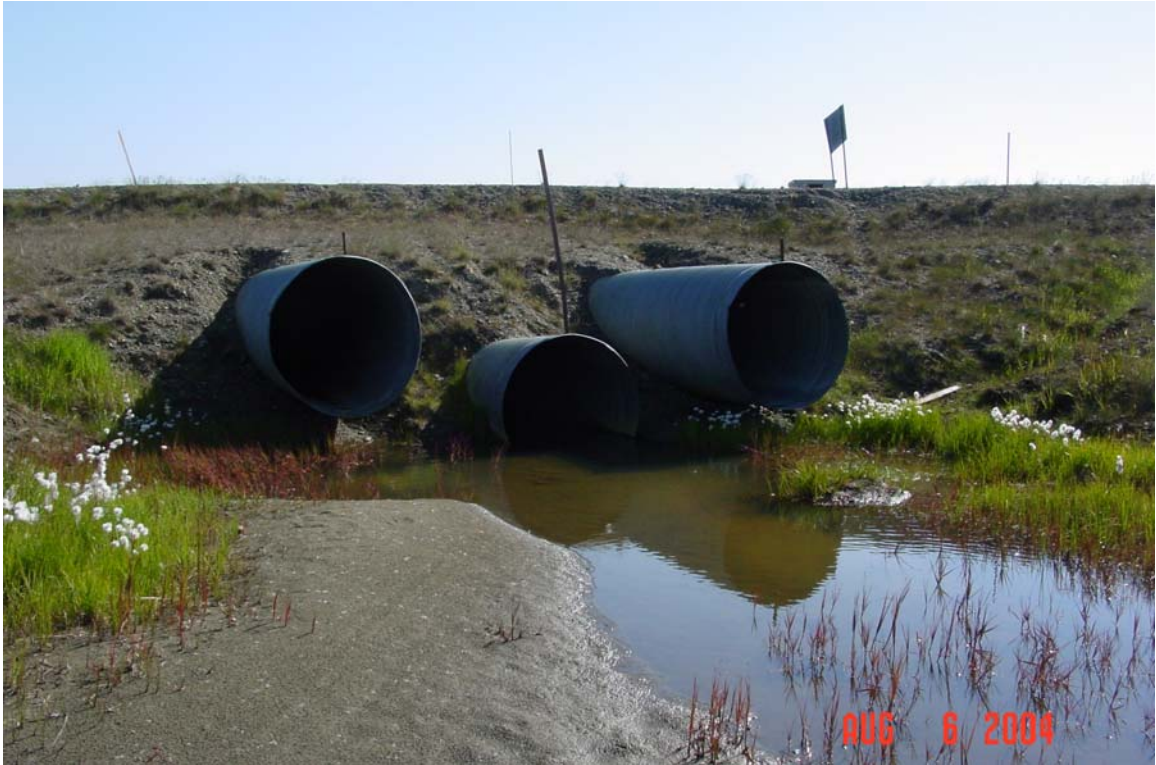
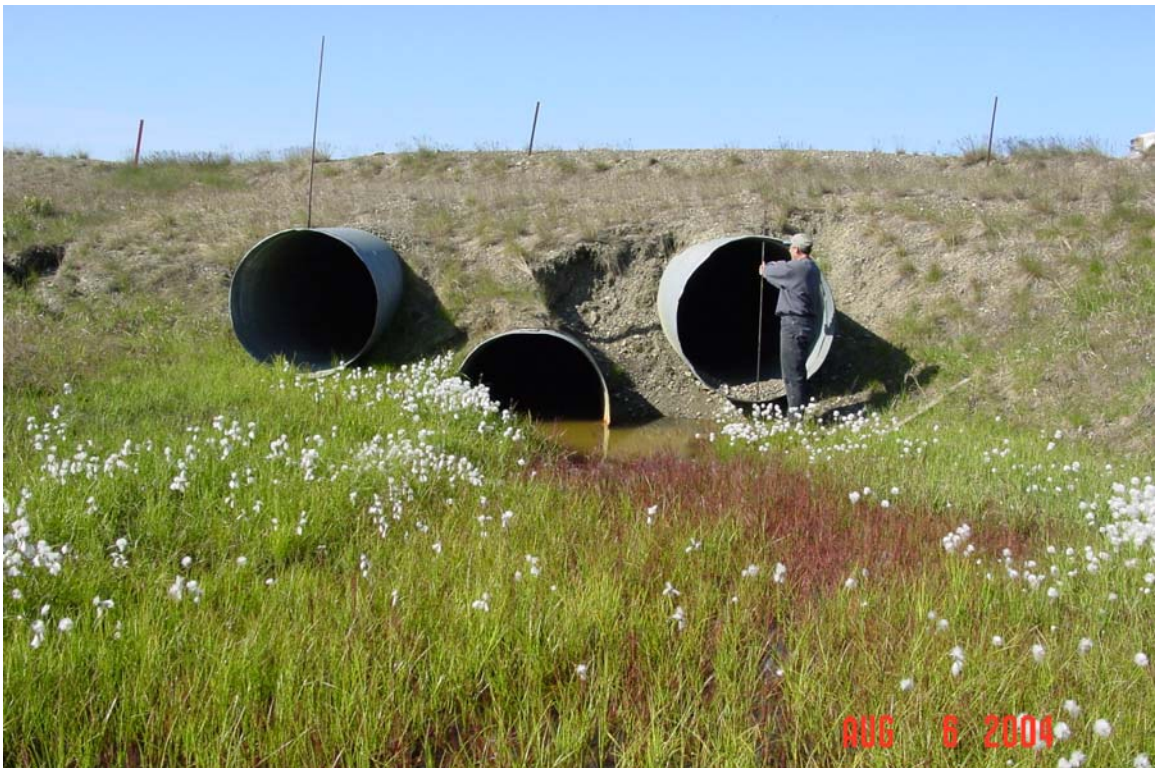
OUTLET: Good condition

**Photograph 280. Charlie Creek culvert outlets.**

**Photograph 281. Charlie Creek culvert inlets.**

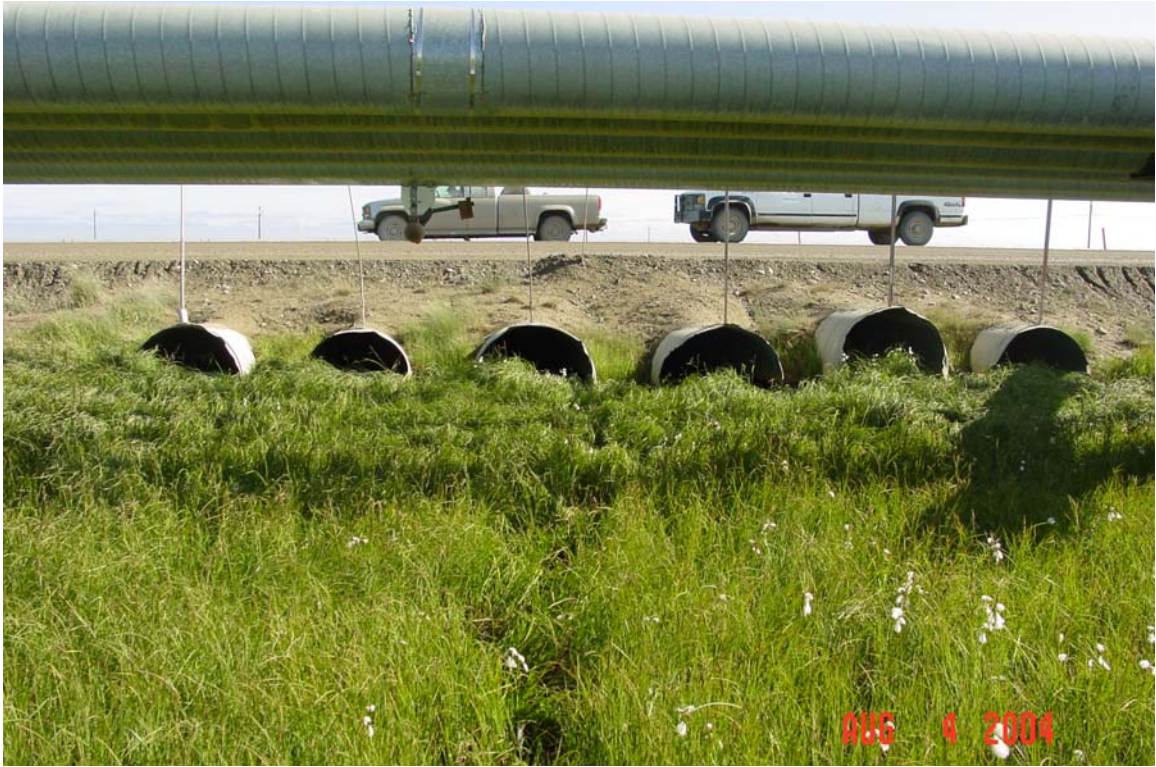
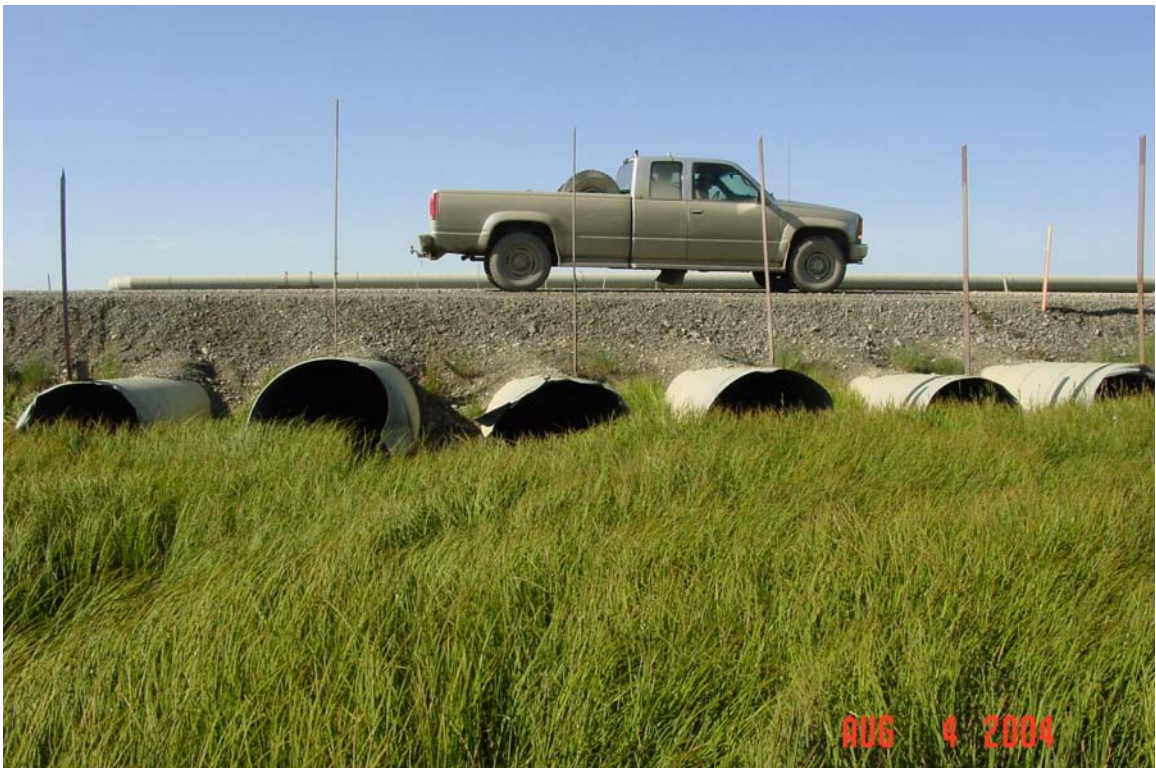
INLET: Minor inlet damage

OUTLET: Minor outlet damage

**Photograph 284. Charlie Creek culvert inlets.**

**Photograph 285. Charlie Creek culvert outlets.**

REMEDICATION RECOMMENDATIONS: Repair damaged culvert ends

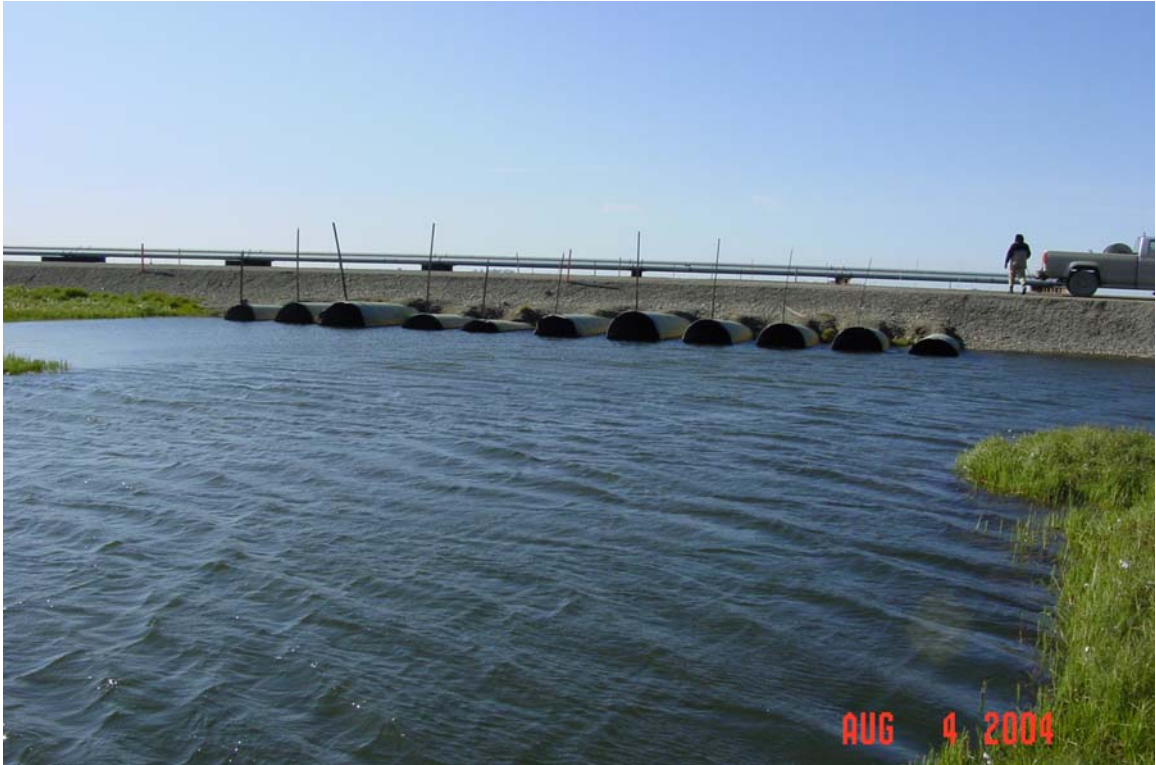
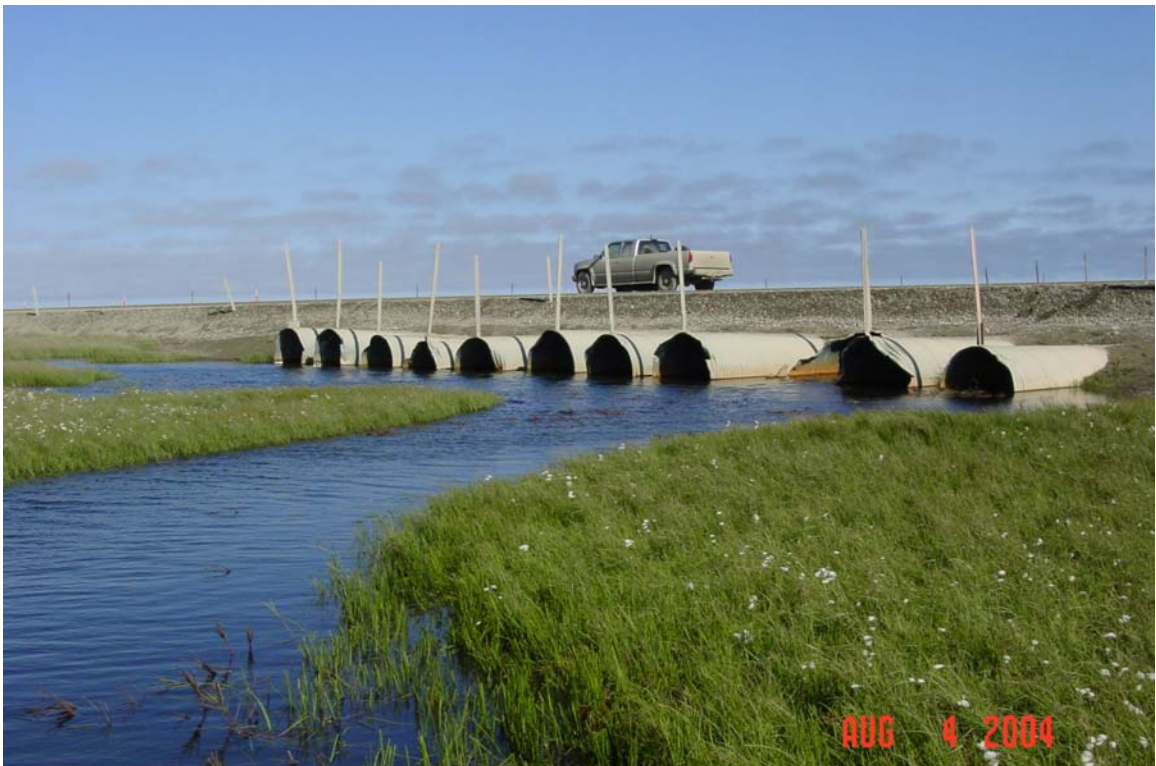
INLET: Minor inlet damage, some culverts partially crushed and bowed

OUTLET: Minor outlet damage, 6 foot deep scour

**Photograph 288. West Fork Ugnuravik River tributary culvert outlets.**

**Photograph 289. West Fork Ugnuravik River tributary culvert inlets.**

REMEDIATION RECOMMENDATIONS: Replace or repair culverts

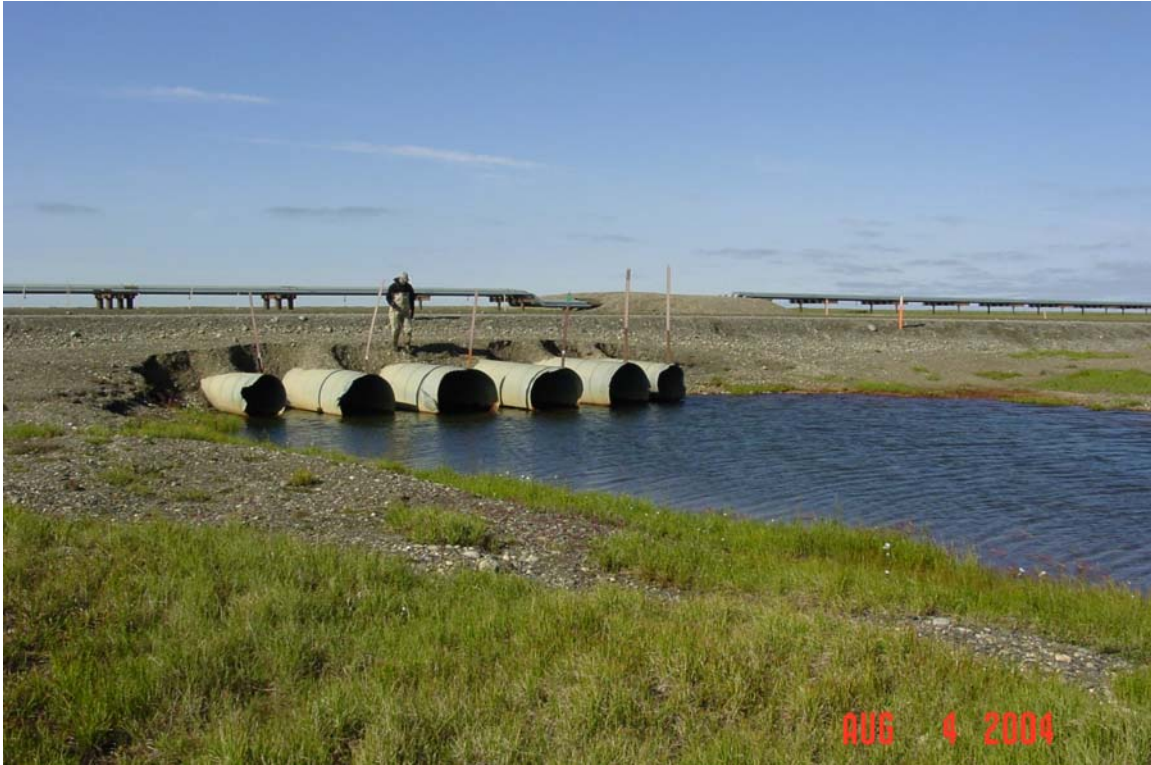
OUTLET: Minor culvert damage, road prism erosion, substantial outwash gravels present

**Photograph 294. West Fork Ugnuravik River culvert outlets with substantial road prism erosion and outwash gravels.**

REMEDIATION RECOMMENDATIONS: Increase water conveyance past this crossing, repair culverts

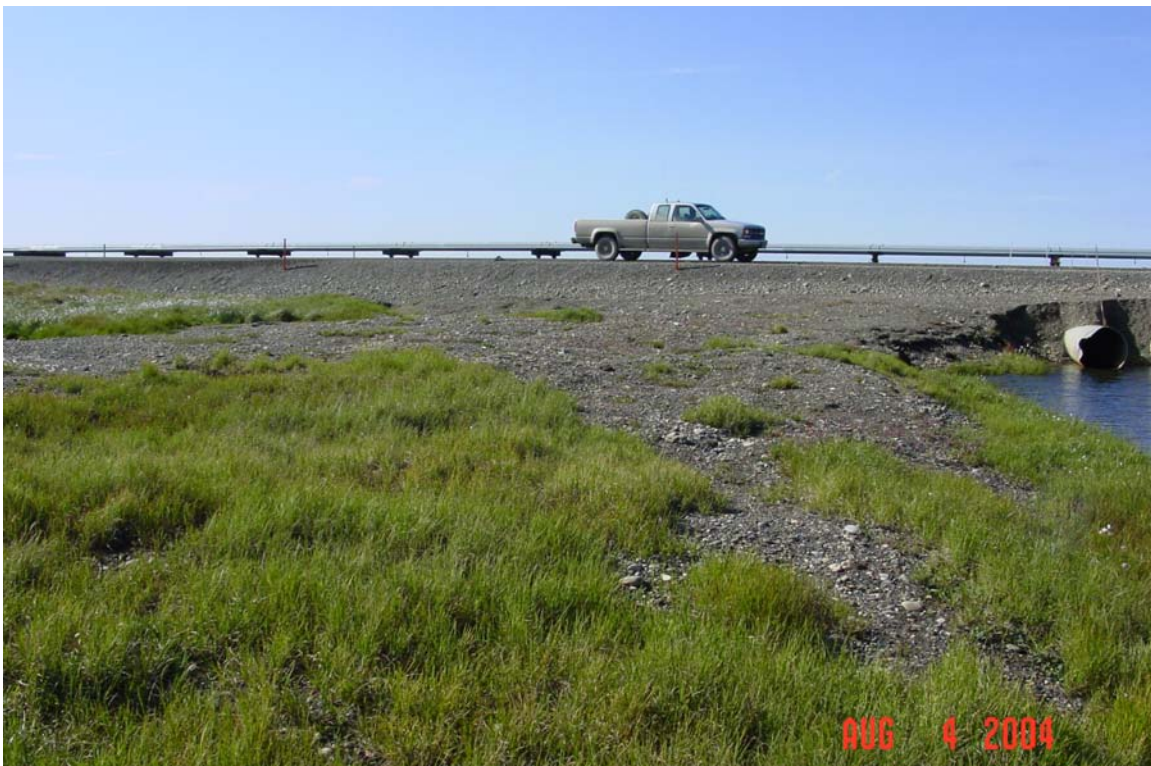
**Photograph 295. Outwash gravels downstream of the West Fork Ugnuravik River culvert battery.**

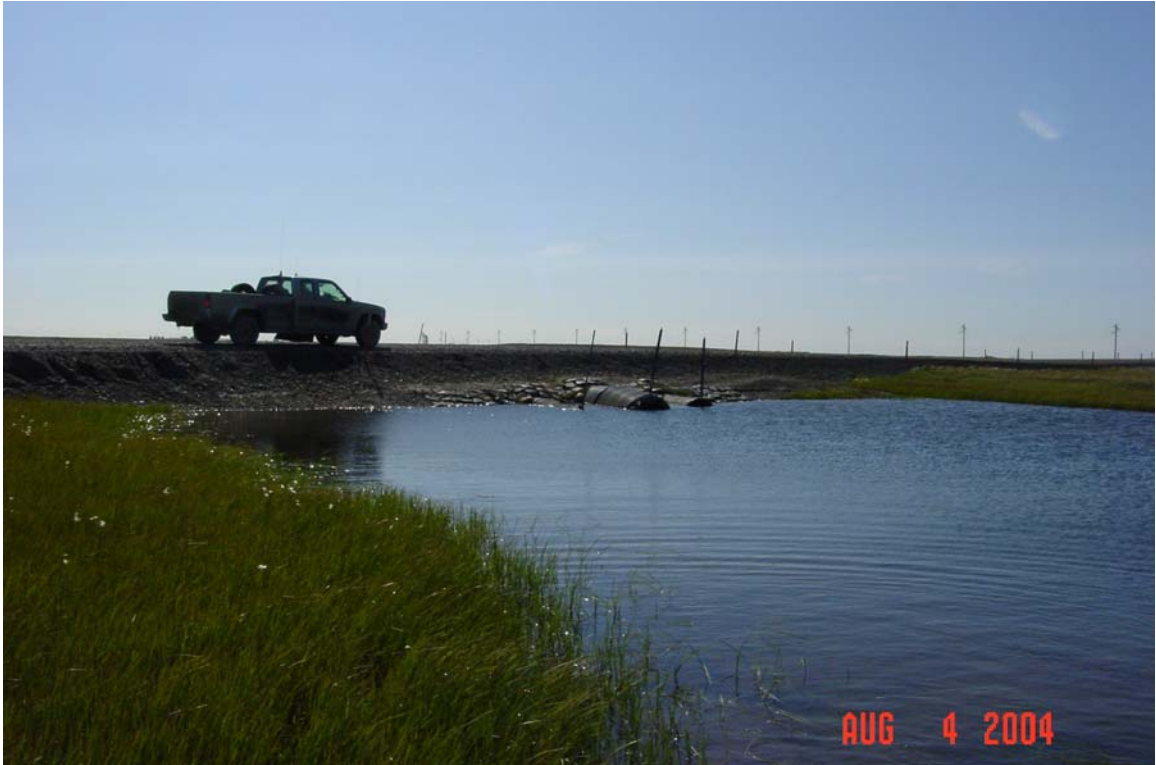
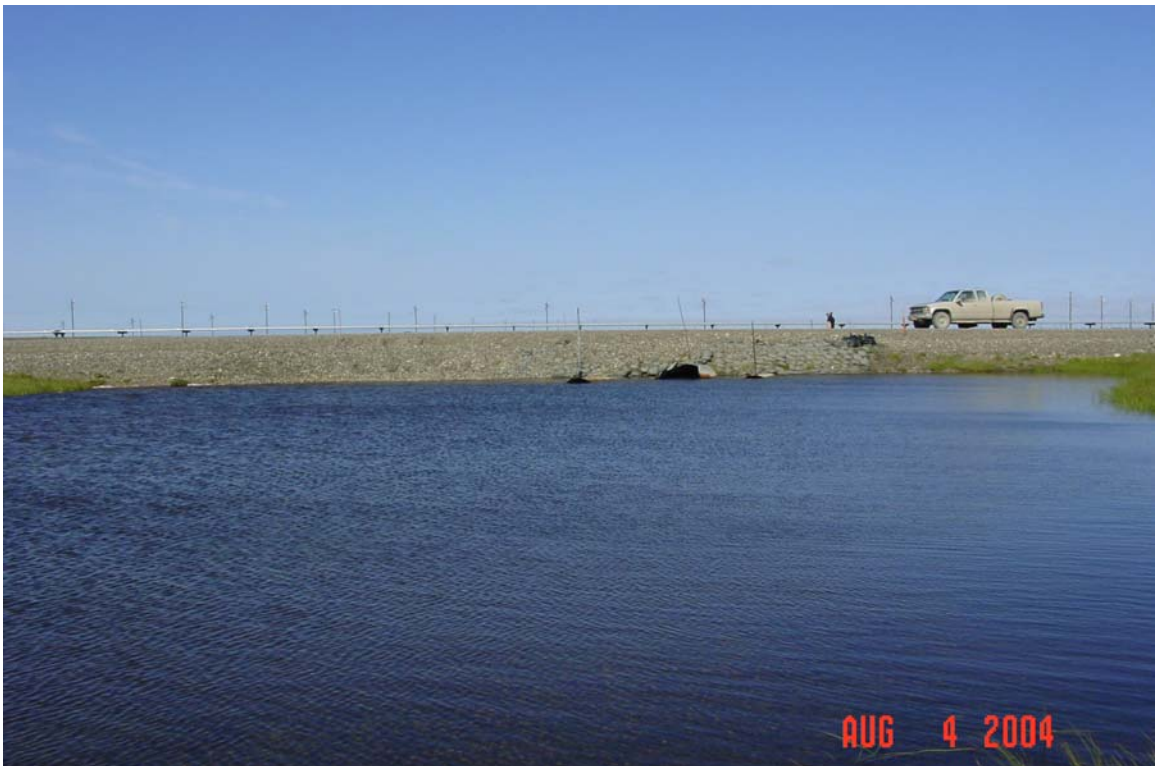
INLET: Sand bag armor, culvert inlet damage, high water mark 0.5 feet from road surface

OUTLET: Sand bag armor, 54 and 42 inch culverts broken, scour pool present

**Photograph 298. Caribou Creek culvert outlets.**

**Photograph 299. Caribou Creek culvert inlets.**

REMEDIATION RECOMMENDATIONS: Repair culverts, increase water conveyance past this crossing

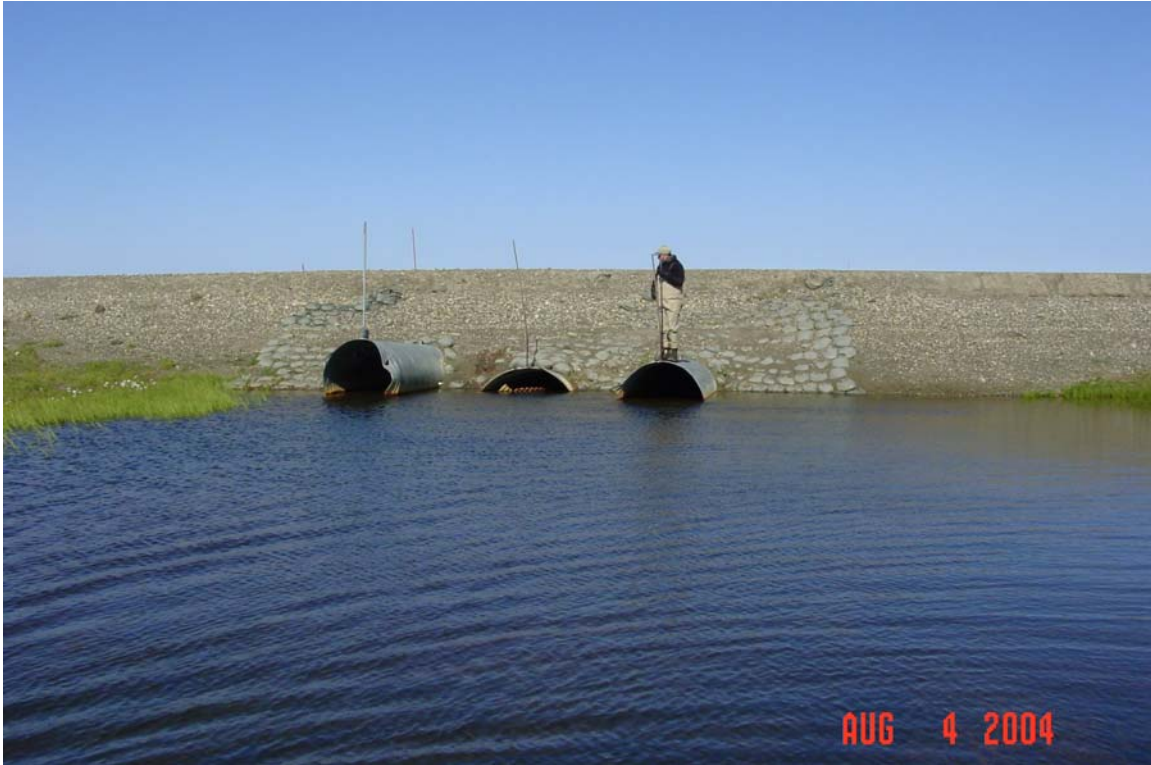
INLET: Sand bag armor, flow obstructed by damaged inlet on the 66 inch culvert, inlet damage to all pipes, high water mark 1 foot above inlets

**Photograph 302. Kalubik Creek tributary (East Fork Nowhere Creek) damaged culvert inlets and a high water mark about 1 foot above the inlets.**

REMEDICATION RECOMMENDATIONS: Repair culverts, reduce culvert length to fit road prism, increase water conveyance past this location

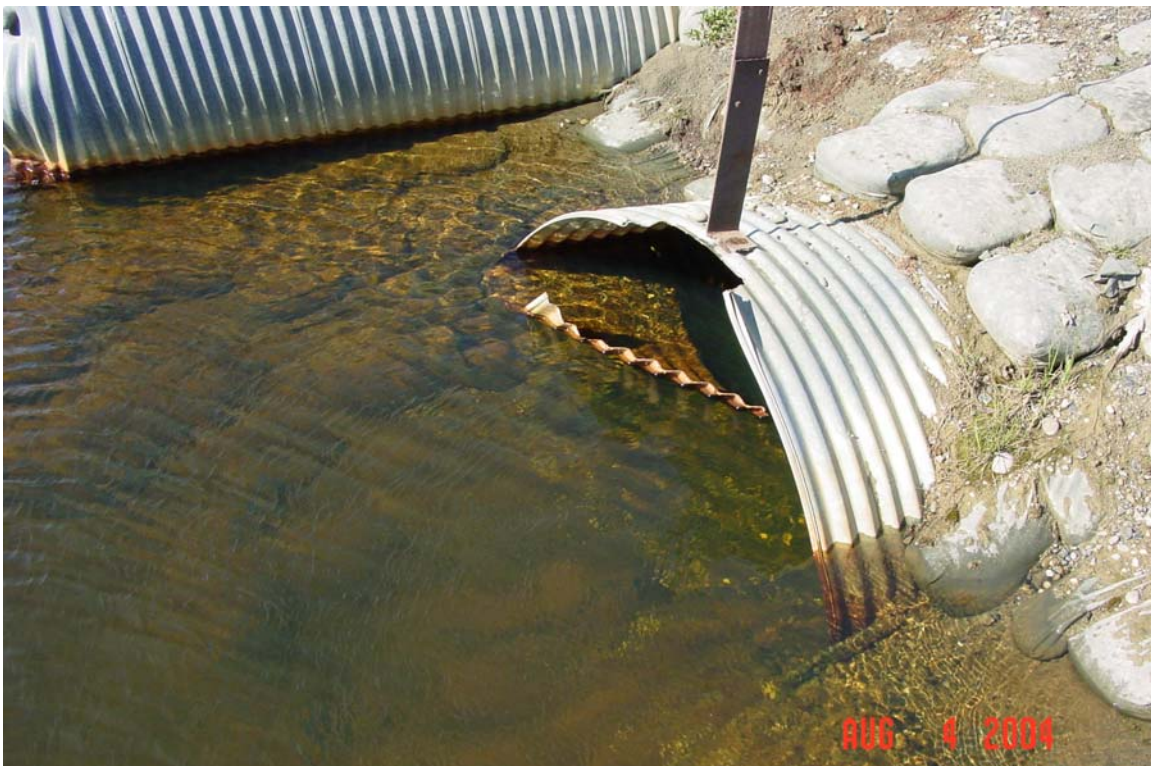
**Photograph 303. Kalubik Creek tributary (East Fork Nowhere Creek) culvert inlet bottom upturned and blocking much of the flow through the culvert.**

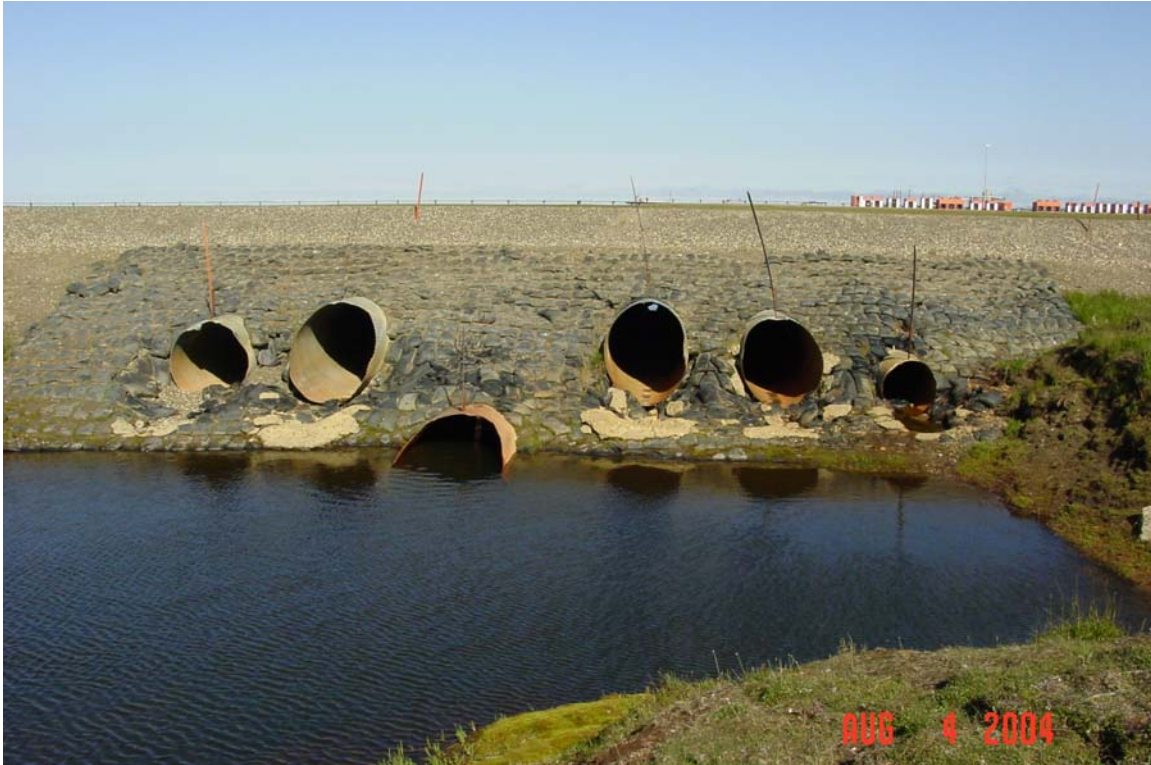
INLET: Sand bag armor, limited concrete inlet aprons, minor inlet damage, some tundra erosion, some sand bag erosion around culvert inlets, high water mark 2 feet above inlets, 72 inch culvert partially collapsed

**Photograph 307. Kalubik Creek tributary (Nowhere Creek) culvert inlets with partial concrete aprons, missing sand bag armor, and a high water mark about 2 feet above the inlets.**

REMEDICATION RECOMMENDATIONS: Repair culverts, replace culverts with a bridge

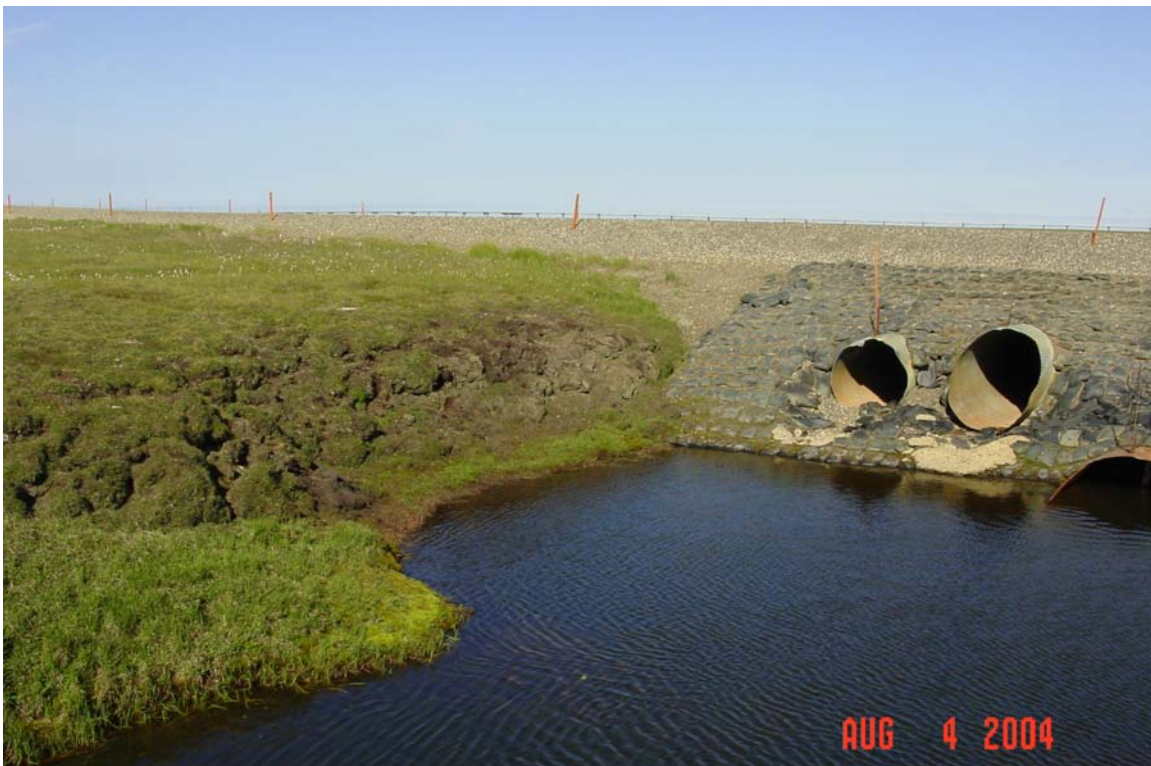
**Photograph 308. Tundra erosion along the western margin of the Kalubik Creek tributary (Nowhere Creek) culvert battery inlet.**

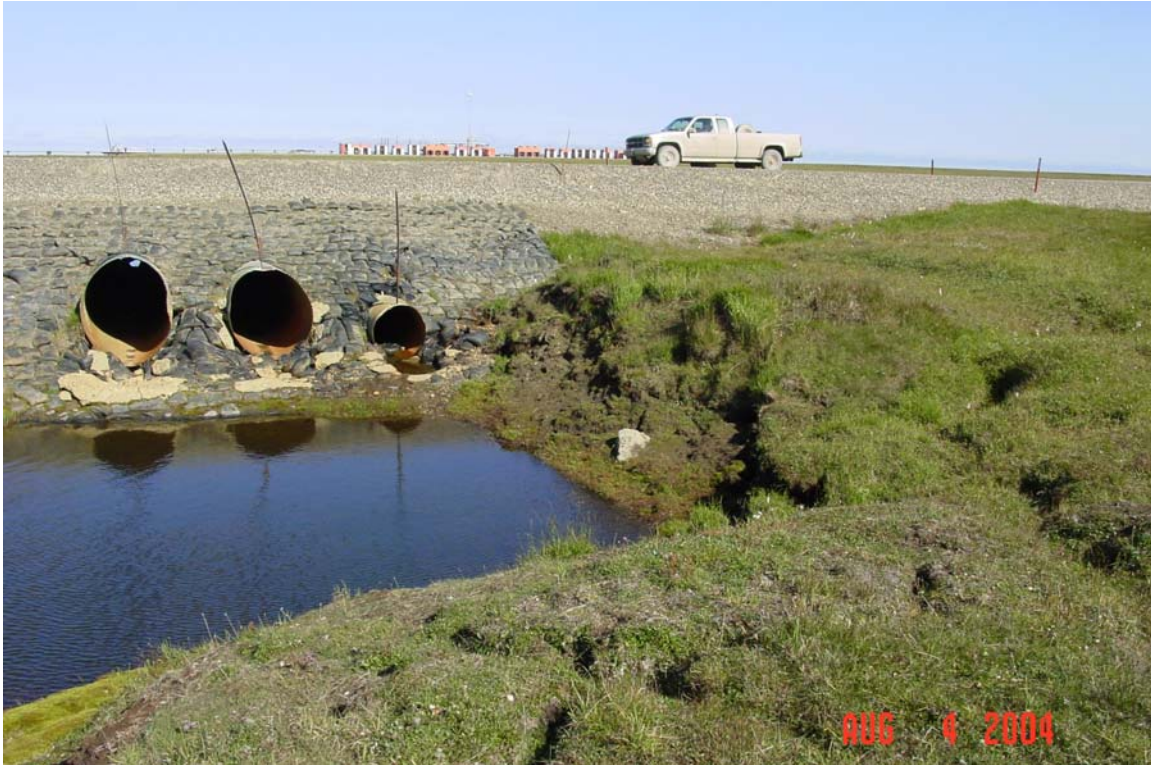
**Photograph 309. Tundra erosion on the eastern margin of the Kalubik Creek tributary (Nowhere Creek) culvert battery inlet.**

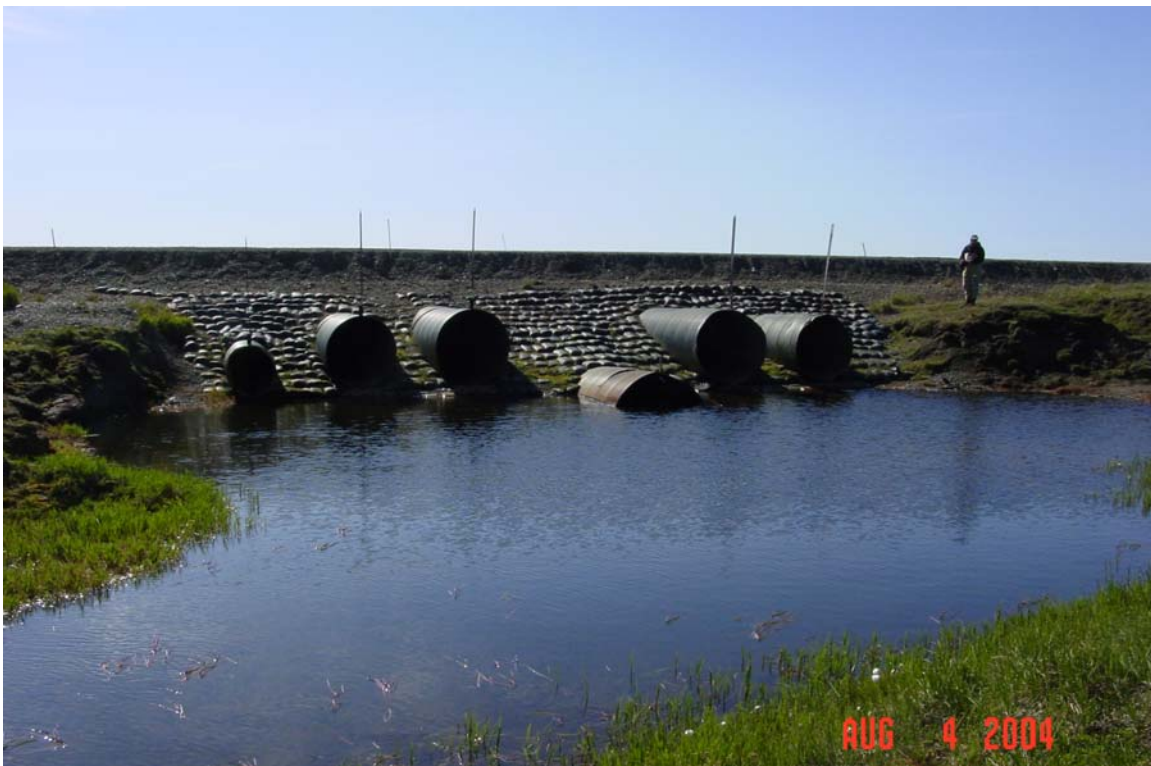
OUTLET: Sand bag armor, minor outlet damage

**Photograph 310. Nowhere Creek culvert outlets.**
