**Technical Report No. 08-01**

## **A SURVEY OF STREAM CROSSING STRUCTURES IN THE NORTH SLOPE OILFIELDS**

**by William A. Morris  
and Jack F. Winters**

**February 2008**

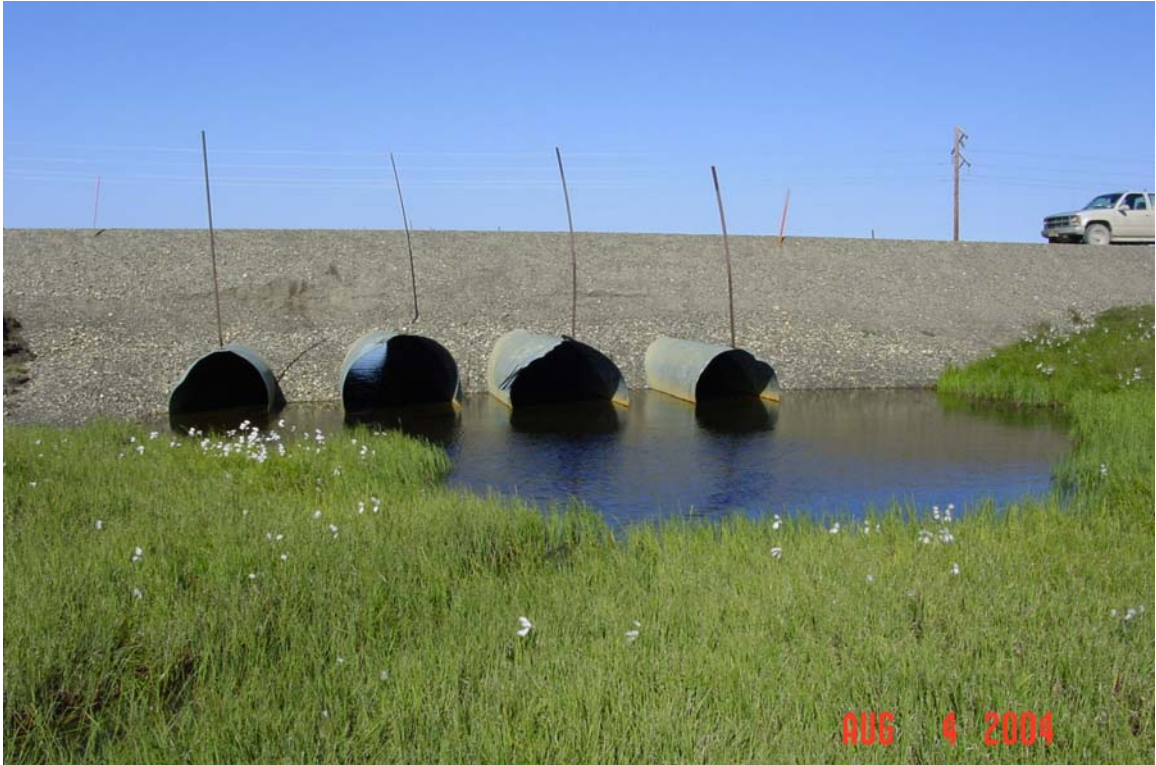
INLET: Minor inlet damage, scour pools upstream of culverts, road prism erosion, high water mark 1 foot above culvert inlets

**Photograph 313. West Fork Nowhere Creek culvert inlets with the high water mark about 1 foot above the inlets.**

REMEDIATION RECOMMENDATIONS: Repair culverts, increase conveyance at this location

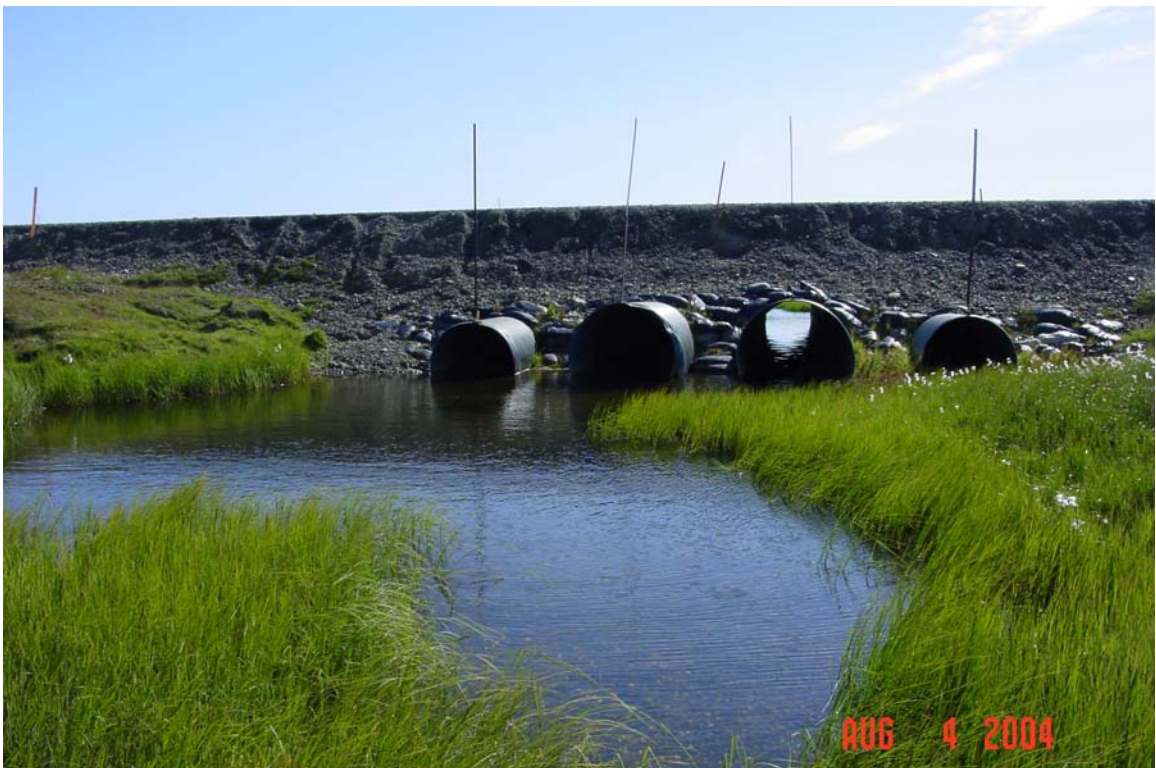
OUTLET: Sand bag armor, minor outlet damage, scour pools downstream of culverts

**Photograph 314. West Fork Nowhere Creek culvert outlets.**

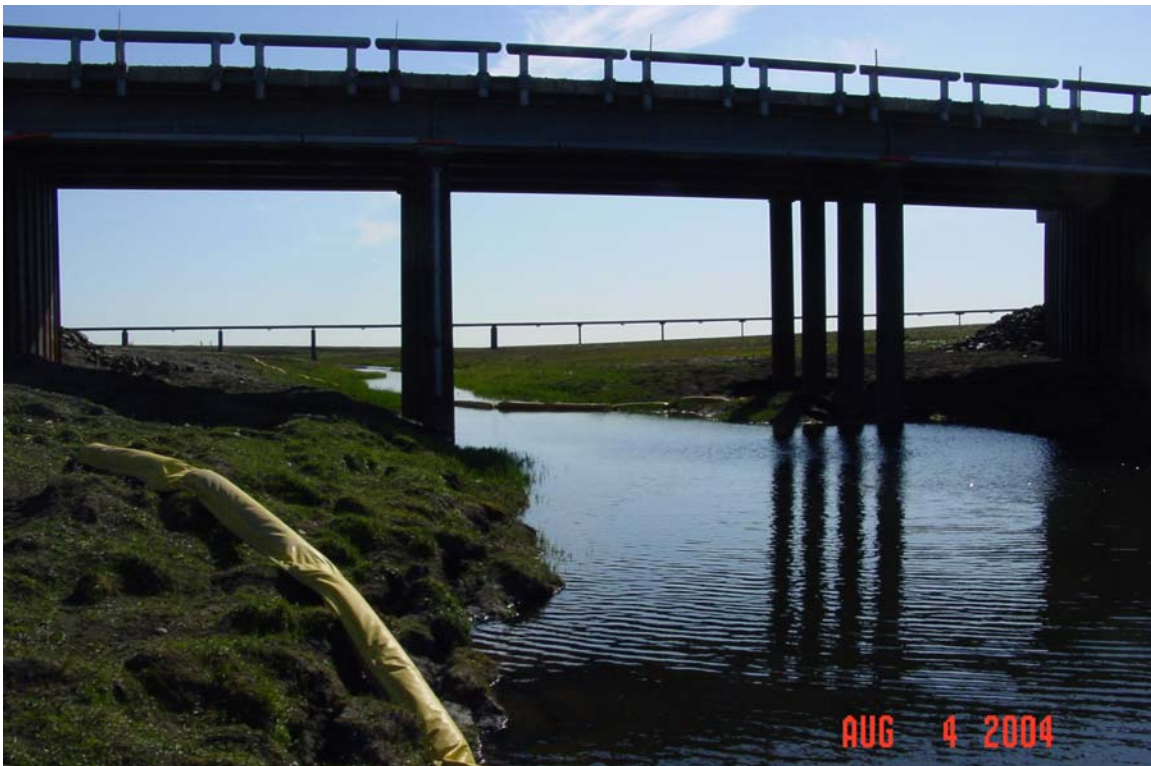
**Photograph 317. Bank scour and slumping on the west bank downstream of the bridge.**

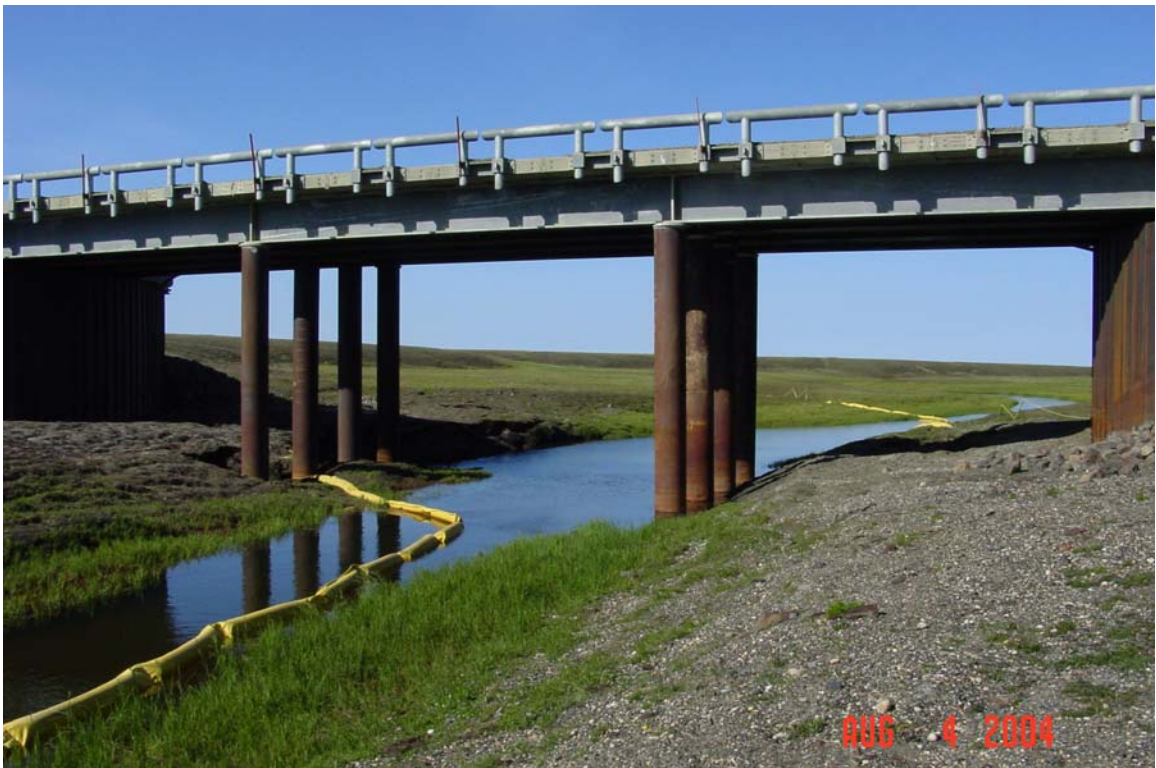
**Photograph 319. Scour around the western bridge piers.**

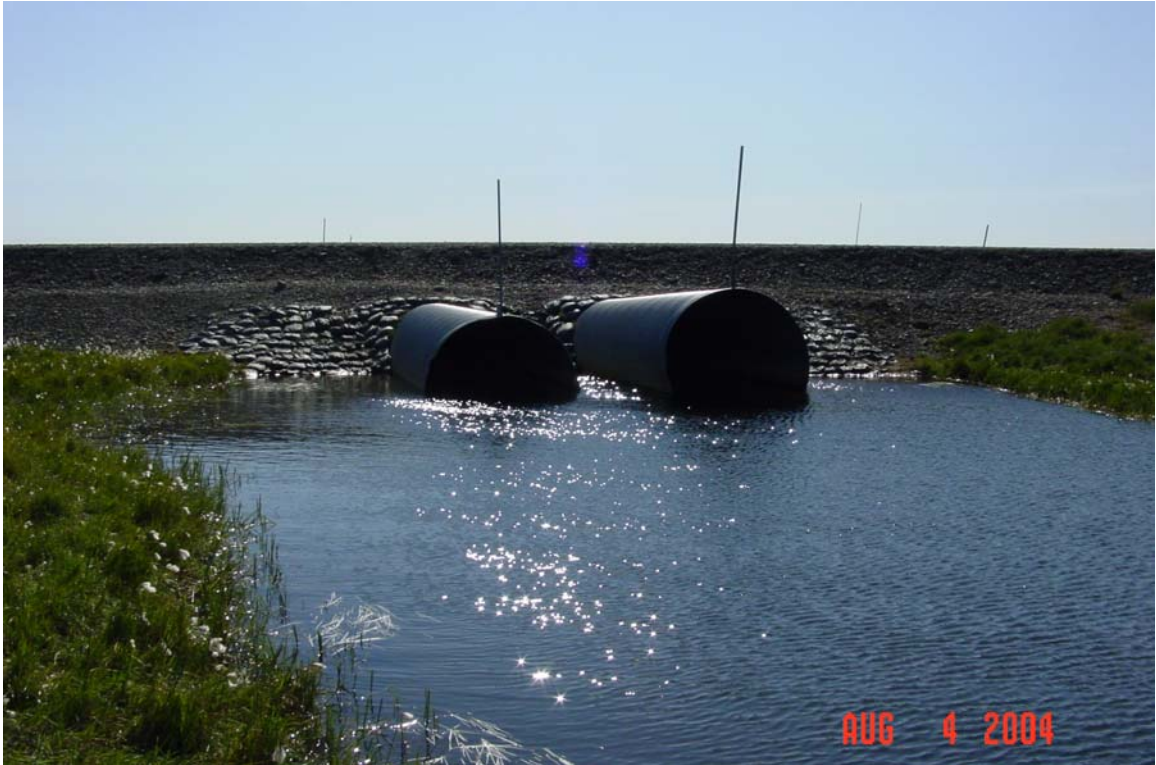
**Photograph 323. Caribou Creek culvert outlets.**

REMEDICATION RECOMMENDATIONS: Repair culverts, cut outlet length to match  
road width

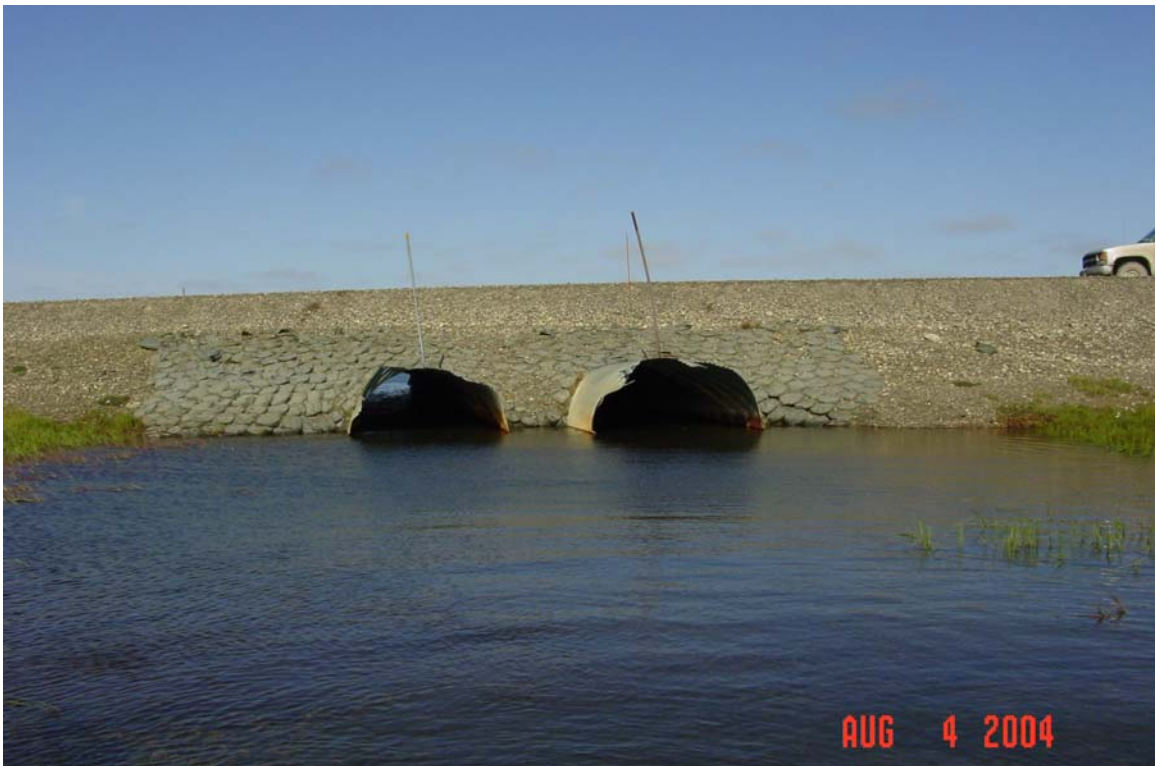
INLET: Sand bag armor, inlet damage

**Photograph 324. Caribou Creek culvert inlets.**

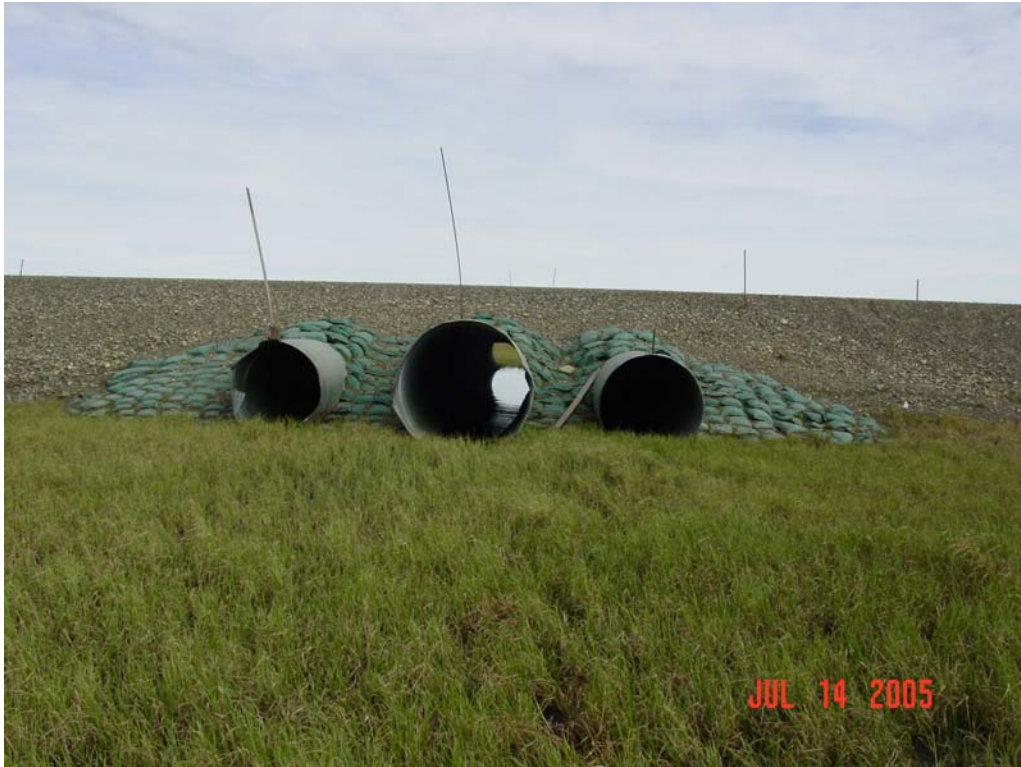
INLET: Sand bag armor, minor culvert damage

**Photograph 327. Ugnuravik River tributary culvert inlets.**

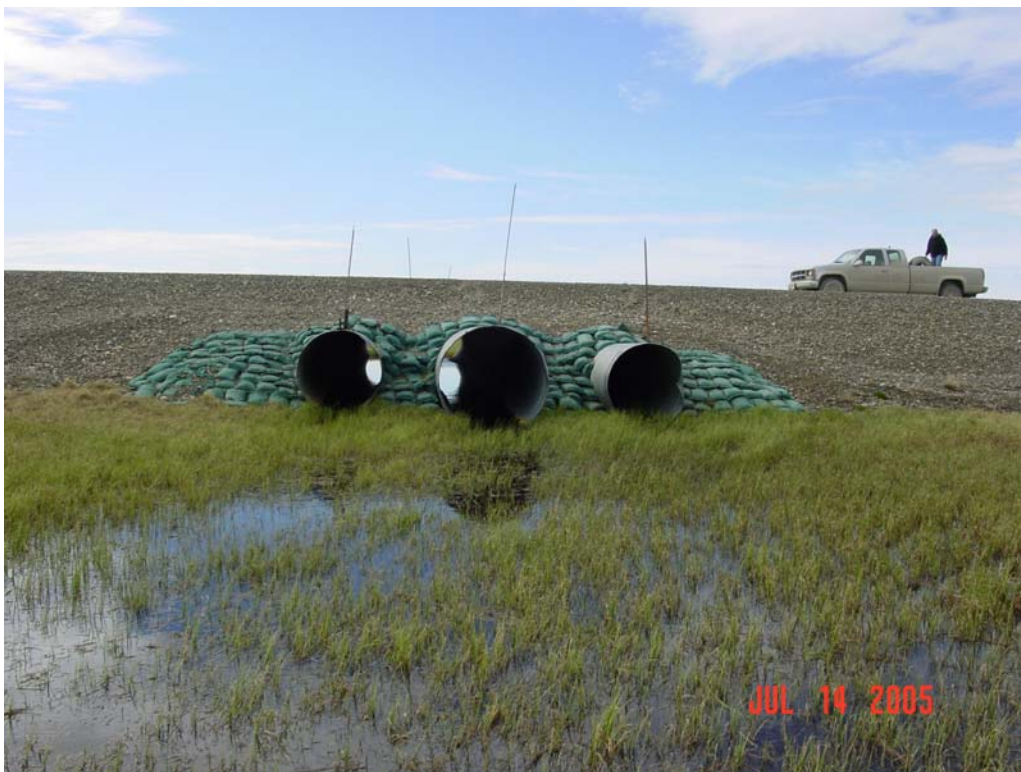
OUTLET: Sand bag armor, minor culvert damage

**Photograph 328. Ugnuravik River tributary culvert outlets.**

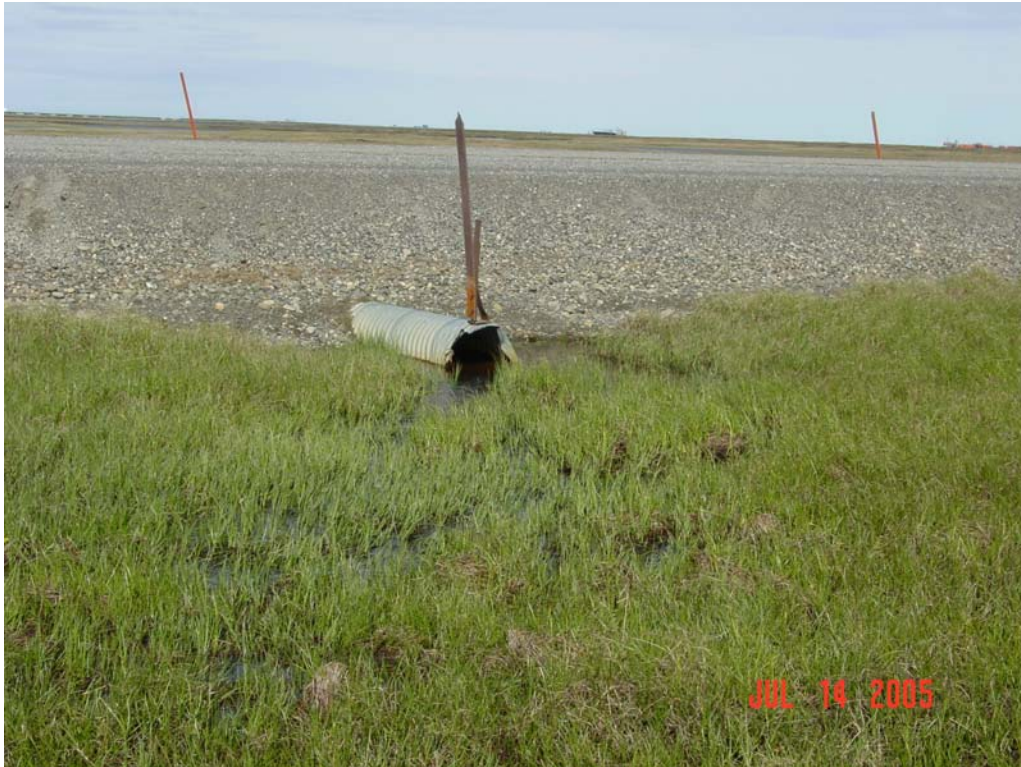
INLET: Minor inlet damage, high water mark one foot above inlet

**Photograph 331. Ugnuravik River tributary culvert inlet.**

REMEDIATION RECOMMENDATIONS: Replace with a larger culvert

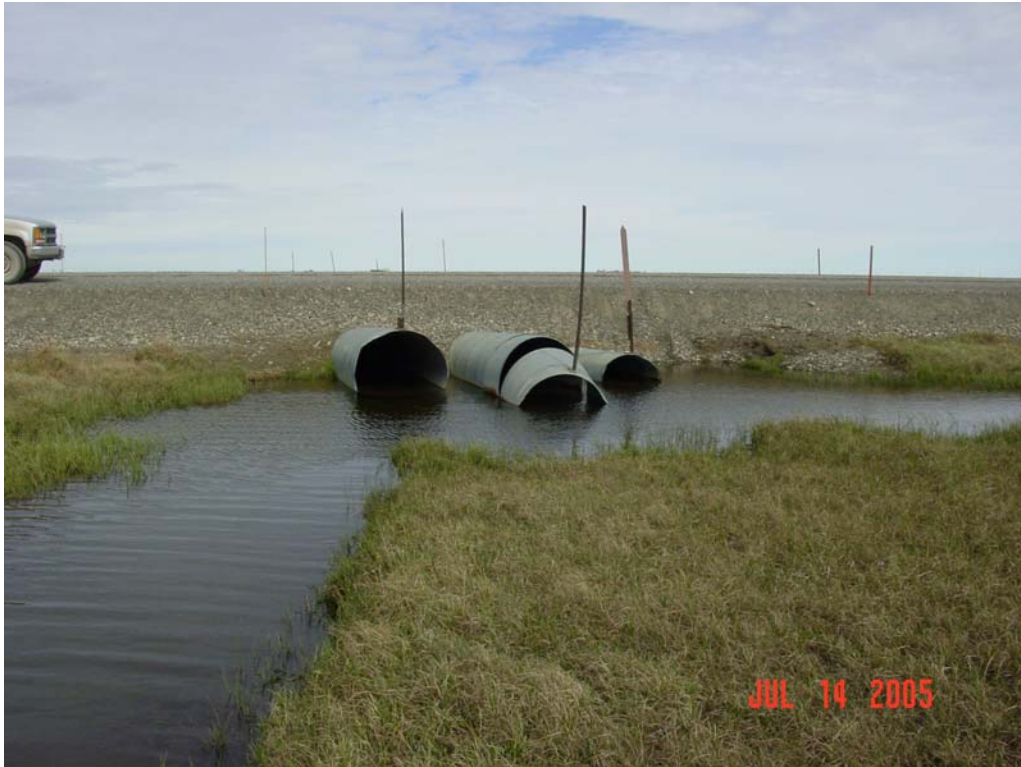
OUTLET: Culverts split, outlet damage

**Photograph 335. Ugnuravik River tributary culvert outlets.**

REMEDICATION RECOMMENDATIONS: Repair culverts, cut length to match road  
width

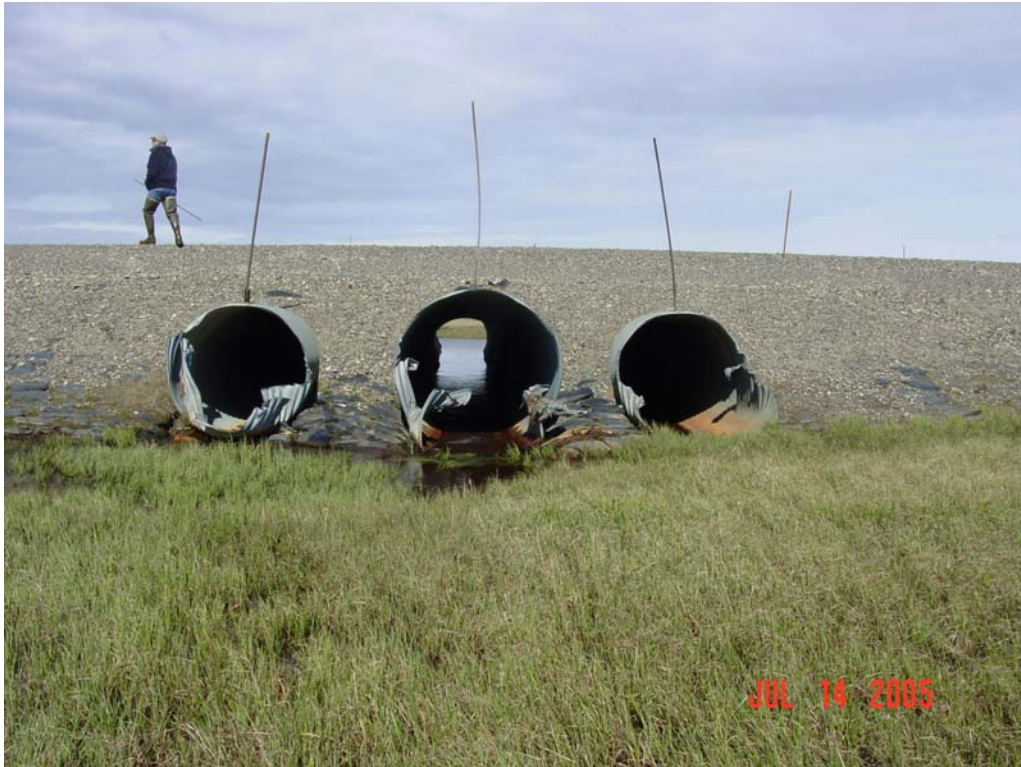
INLET: Sand bag armor, substantial inlet damage, high water mark above culverts

**Photograph 339. Damaged Ugnuravik River tributary culvert inlets.**

REMEDICATION RECOMMENDATIONS: Repair and possibly reset culverts

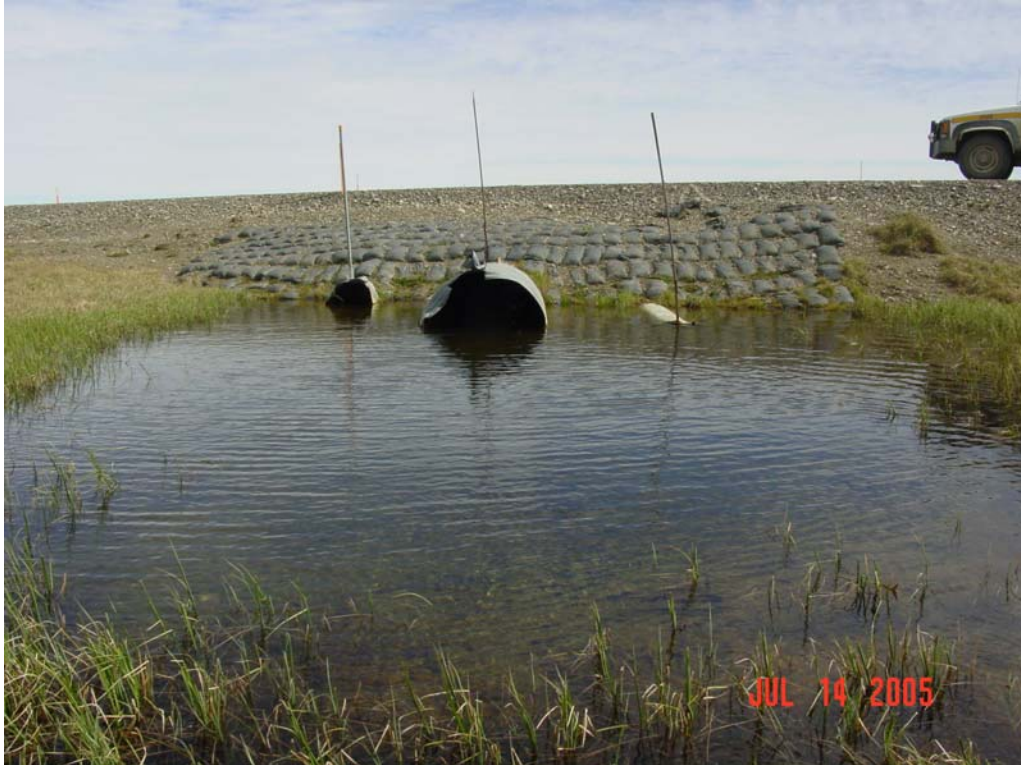
INLET: Sand bag armor, inlet damage,

**Photograph 343. Ugnuravik River tributary culvert inlets.**

REMEDICATION RECOMMENDATIONS: Repair culverts, cut length to match road width

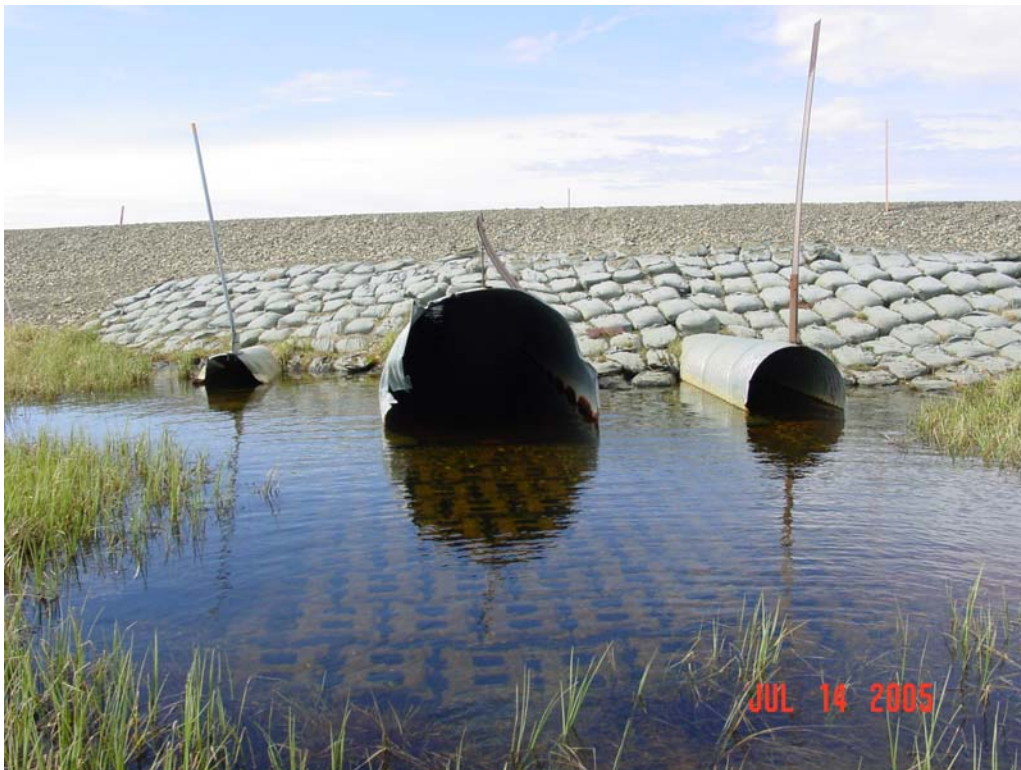
OUTLET: Sand bag armor, outlet damage, gobi mat set below outlets, pipes bowed

**Photograph 344. Ugnuravik River tributary culvert outlets.**

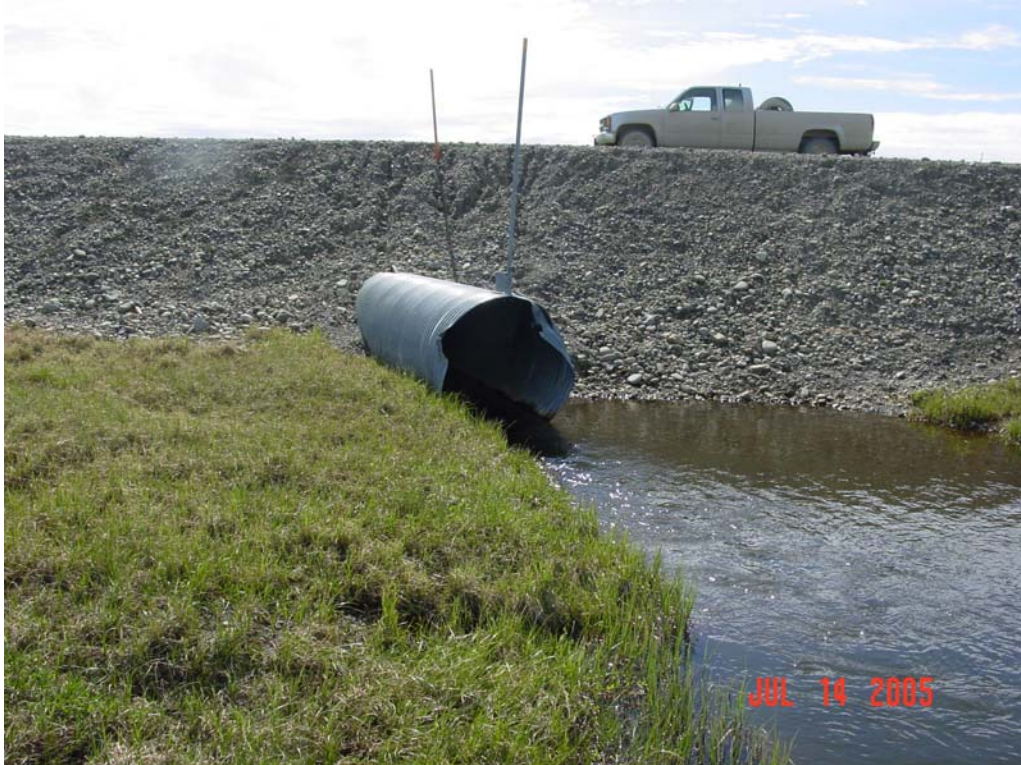
OUTLET: Outlet damage, 8 foot deep scour

**Photograph 347. Ugnuravik River tributary culvert outlet.**

REMEDICATION RECOMMENDATIONS: Repair culvert, cut length to match road  
width, align culvert with the creek

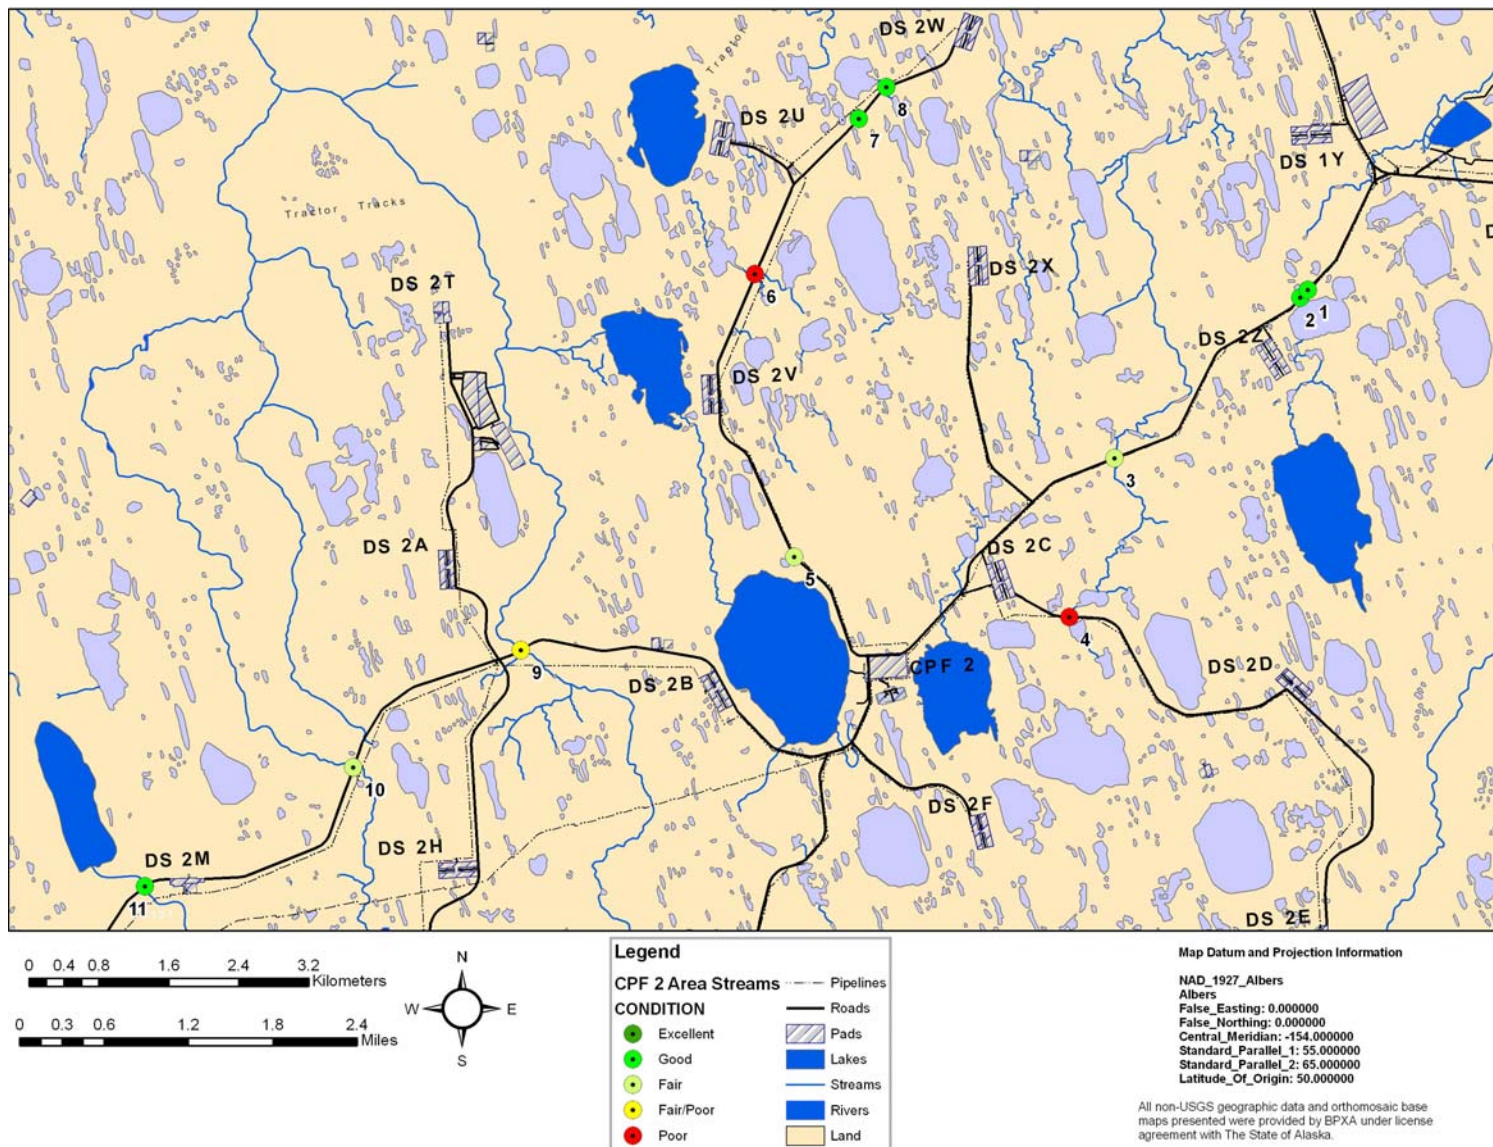
Figure 22. Relative condition of CPF2 area stream crossings.

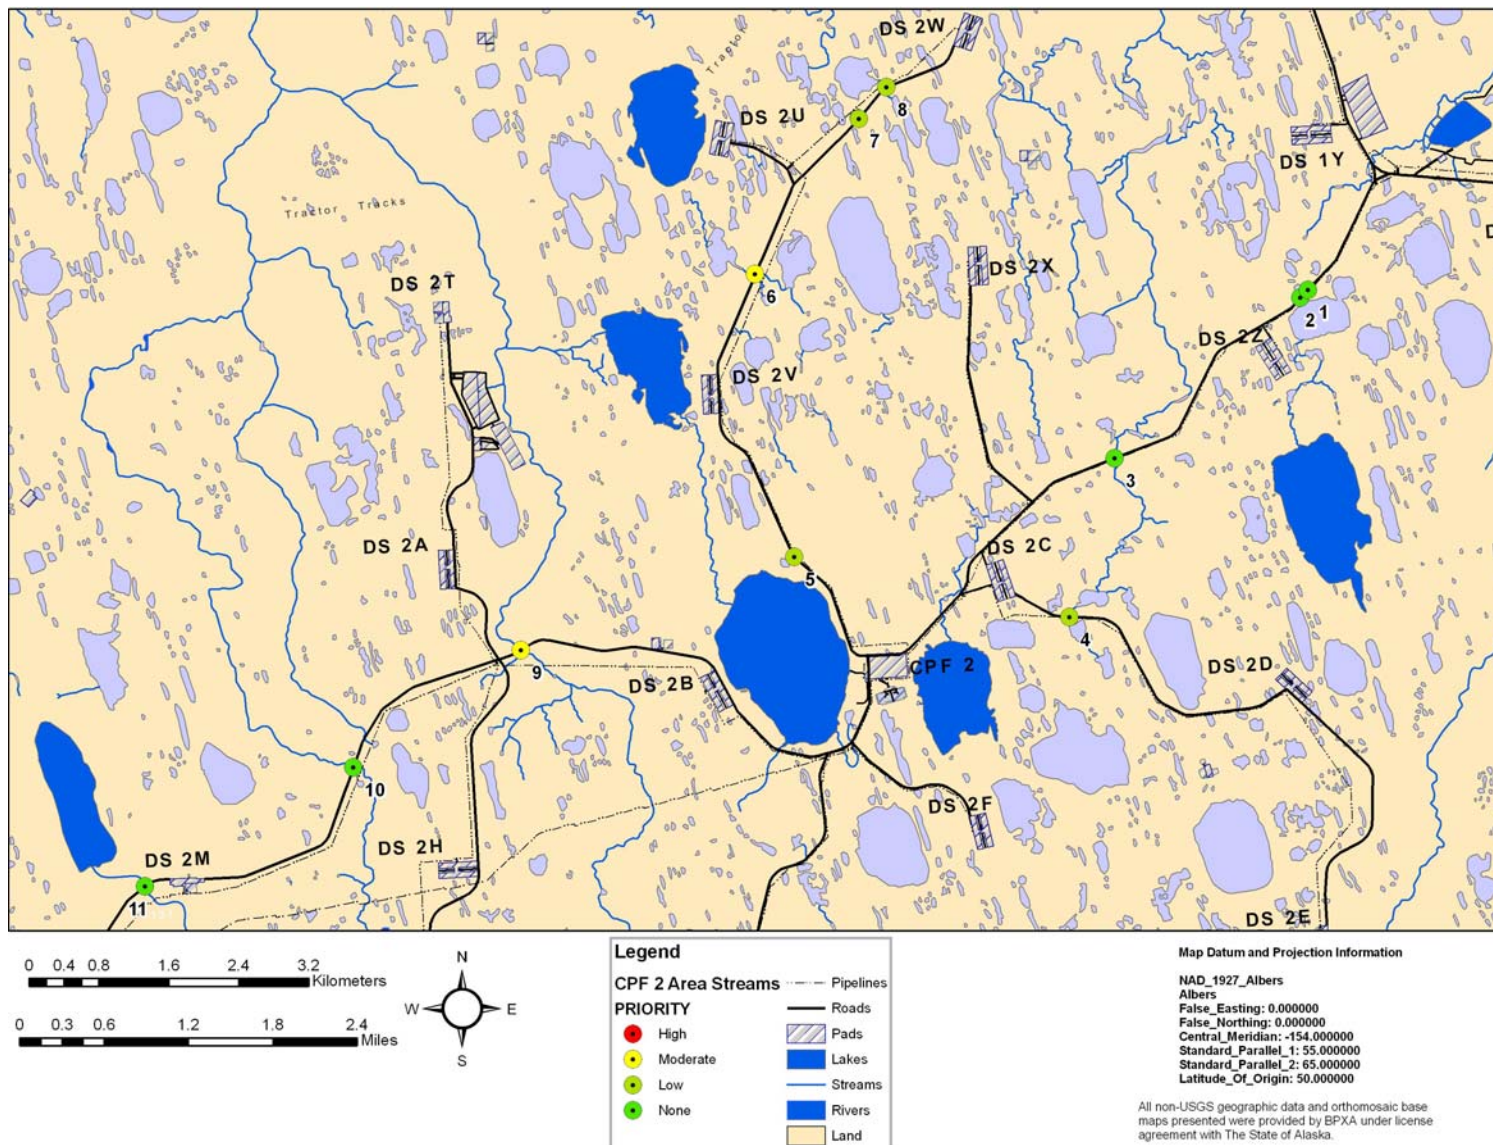
Figure 23. Relative priority for rehabilitation of CPF2 area stream crossings.

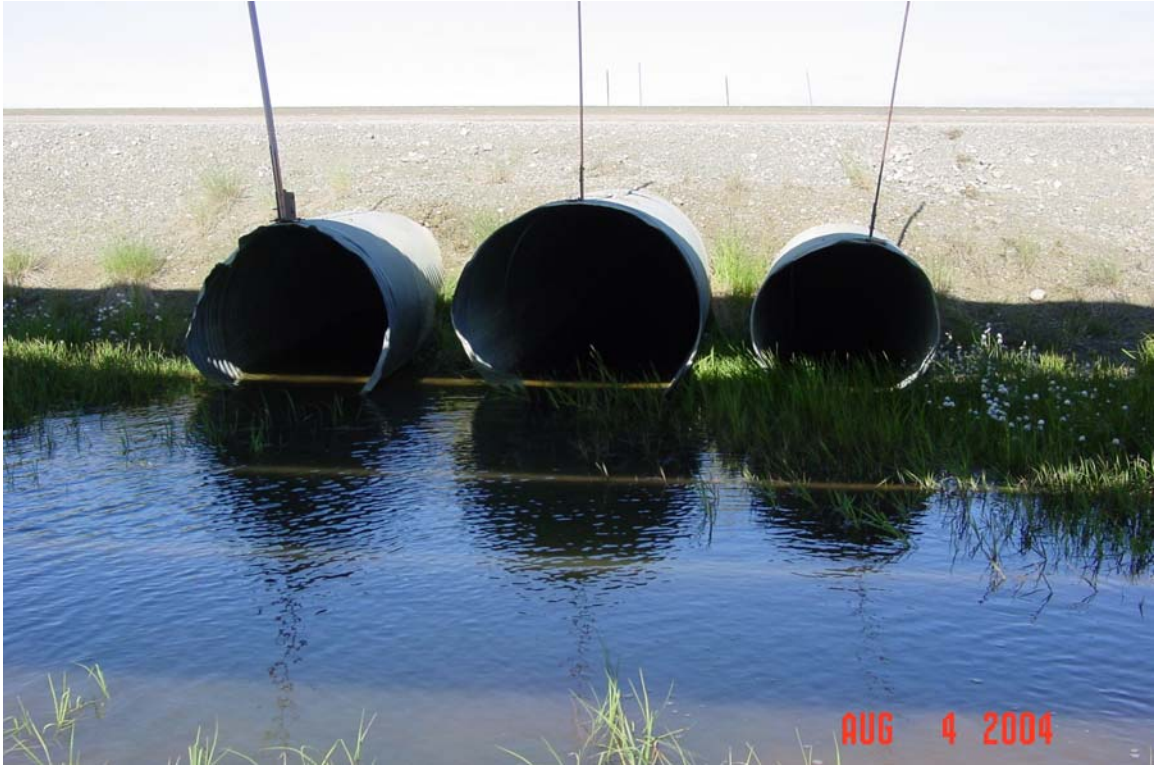
INLET: Minor inlet damage

**Photograph 348. Charlie Creek culvert inlets.**

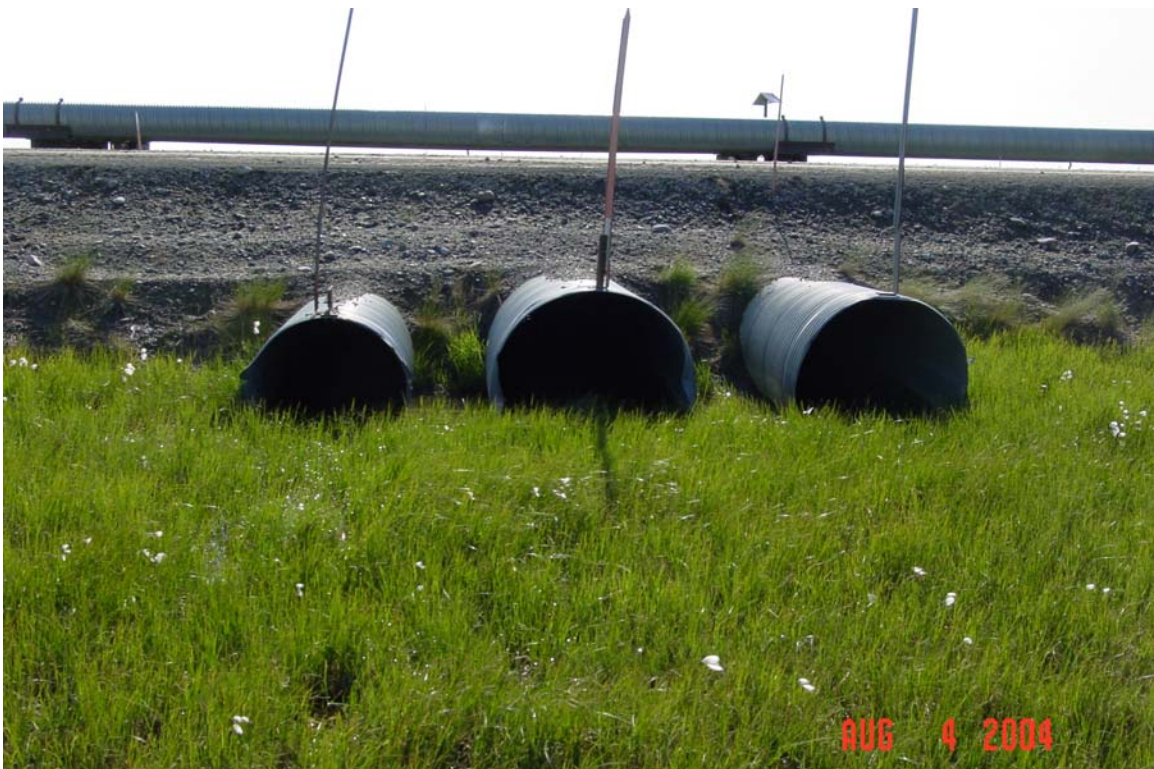
OUTLET: Minor outlet damage

**Photograph 351. Charlie Creek culvert outlets.**

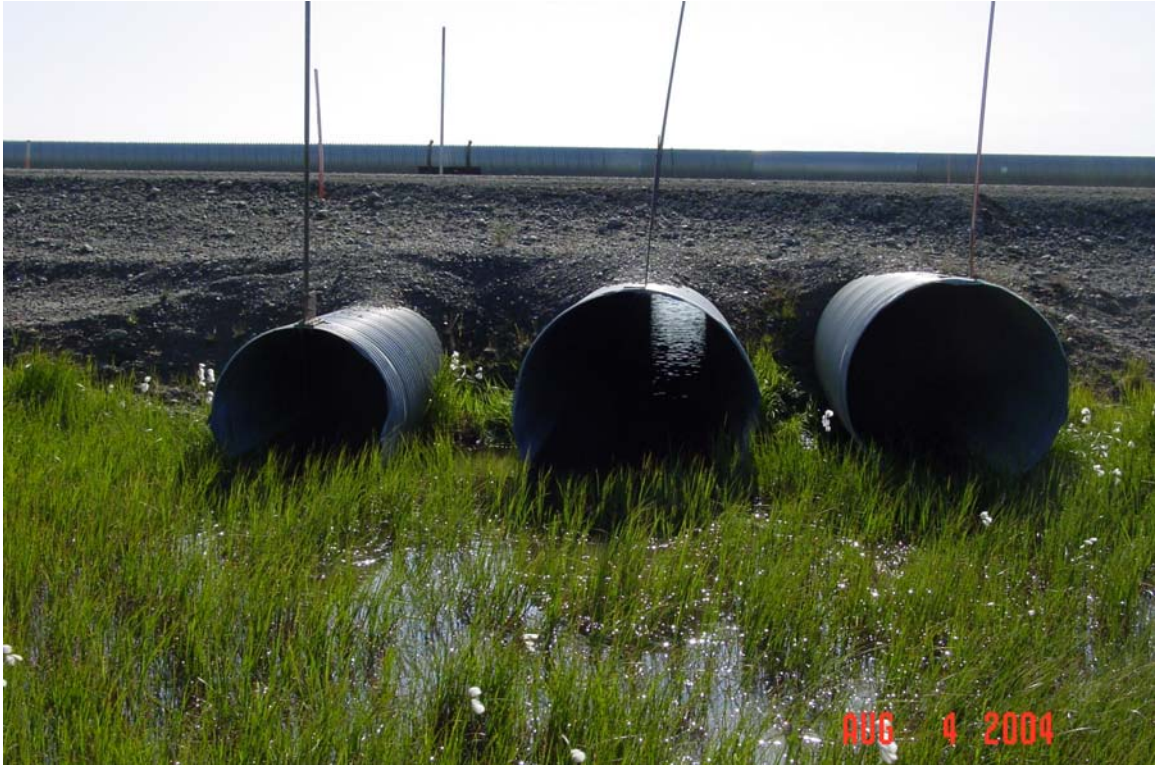
INLET: Minor inlet damage

**Photograph 352. Charlie Creek culvert inlets.**

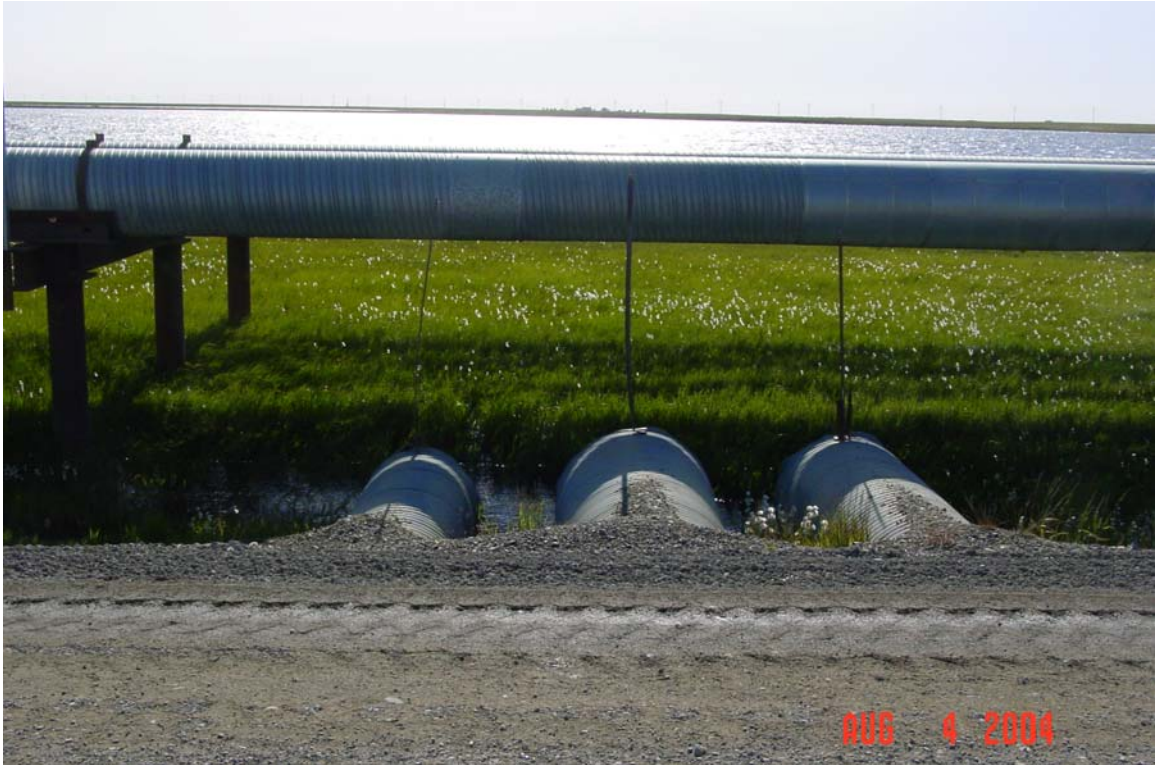
**Photograph 354. Charlie Creek upstream of the Spine Road crossing.**

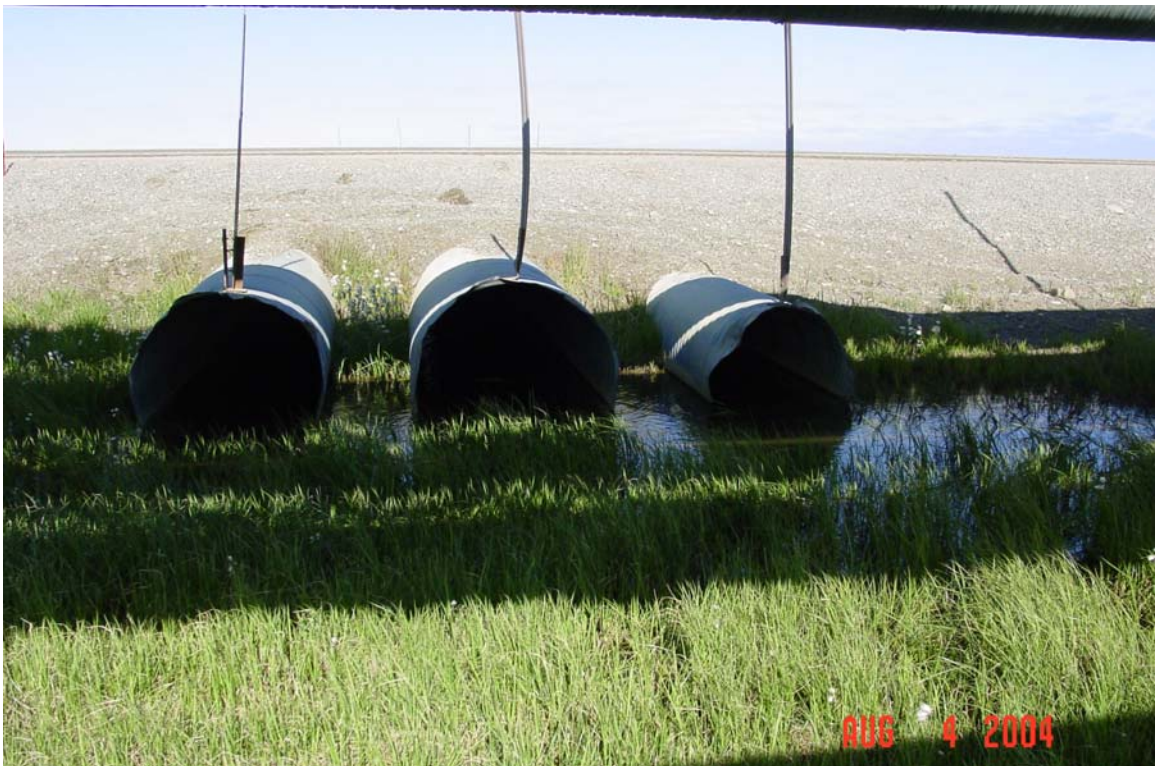
**Photograph 355. Charlie Creek culvert inlets.**

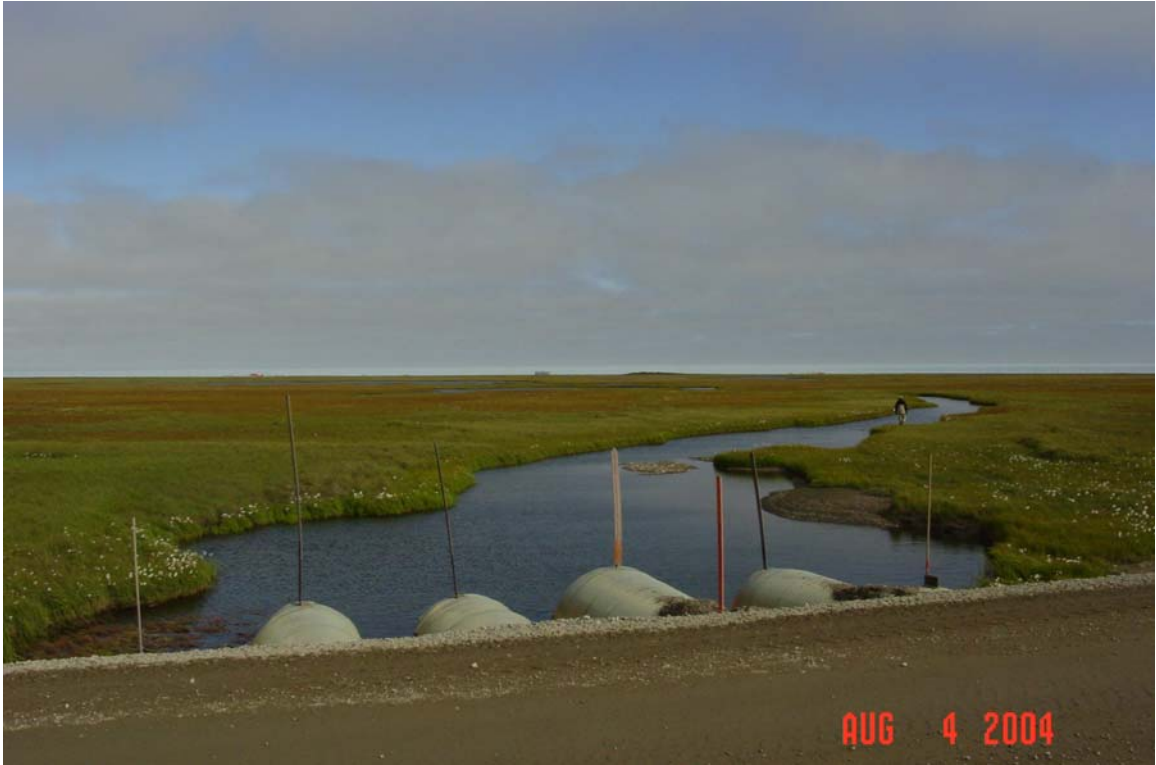
**Photograph 356. West Fork Ugnuravik River downstream of the Spine Road culvert battery.**

REMEDIATION RECOMMENDATIONS: Repair culverts, cut culverts to road width, remove outwash gravels

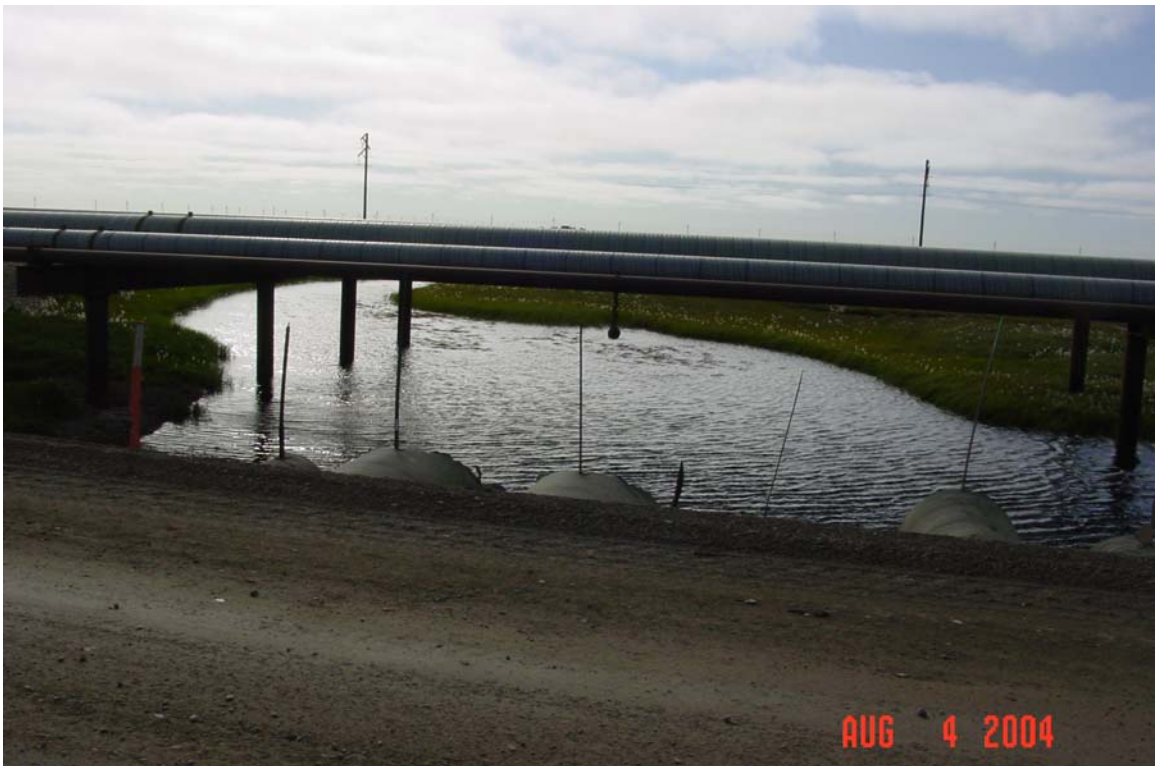
**Photograph 357. West Fork Ugnuravik River upstream of the Spine Road culvert battery.**

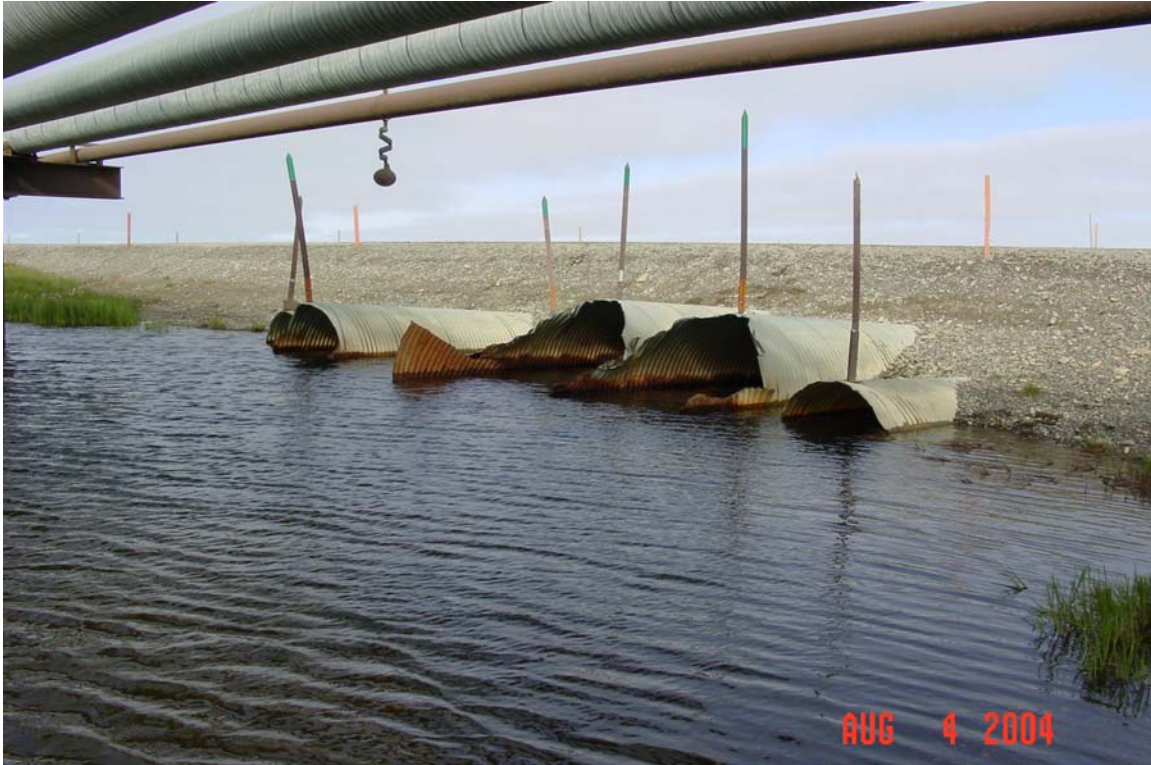
INLET: Inlet and inlet apron damage, high water mark above culverts

**Photograph 358. West Fork Ugnuravik River culvert inlets. Note the high water mark above the culverts and the damaged culvert aprons.**
