**Technical Report No. 08-01**

## **A SURVEY OF STREAM CROSSING STRUCTURES IN THE NORTH SLOPE OILFIELDS**

**by William A. Morris  
and Jack F. Winters**

**February 2008**

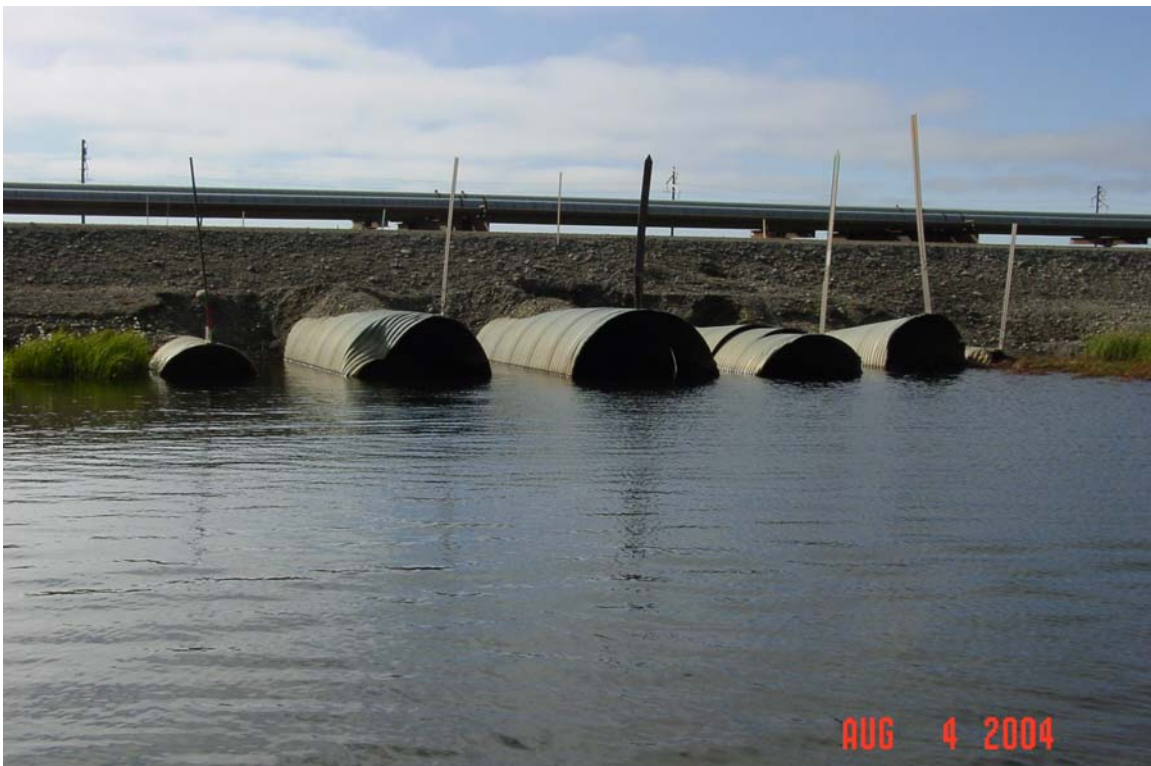
OUTLET: Outlet damage, outlets split and bowed, road prism erosion, scour pool, outwash gravels present

**Photograph 359. West Fork Ugnuravik River culvert outlets. Note the damaged outlets, the split culvert and the bowed culvert.**

REMEDIATION RECOMMENDATIONS: Repair culverts, cut culverts to road width, remove outwash gravels

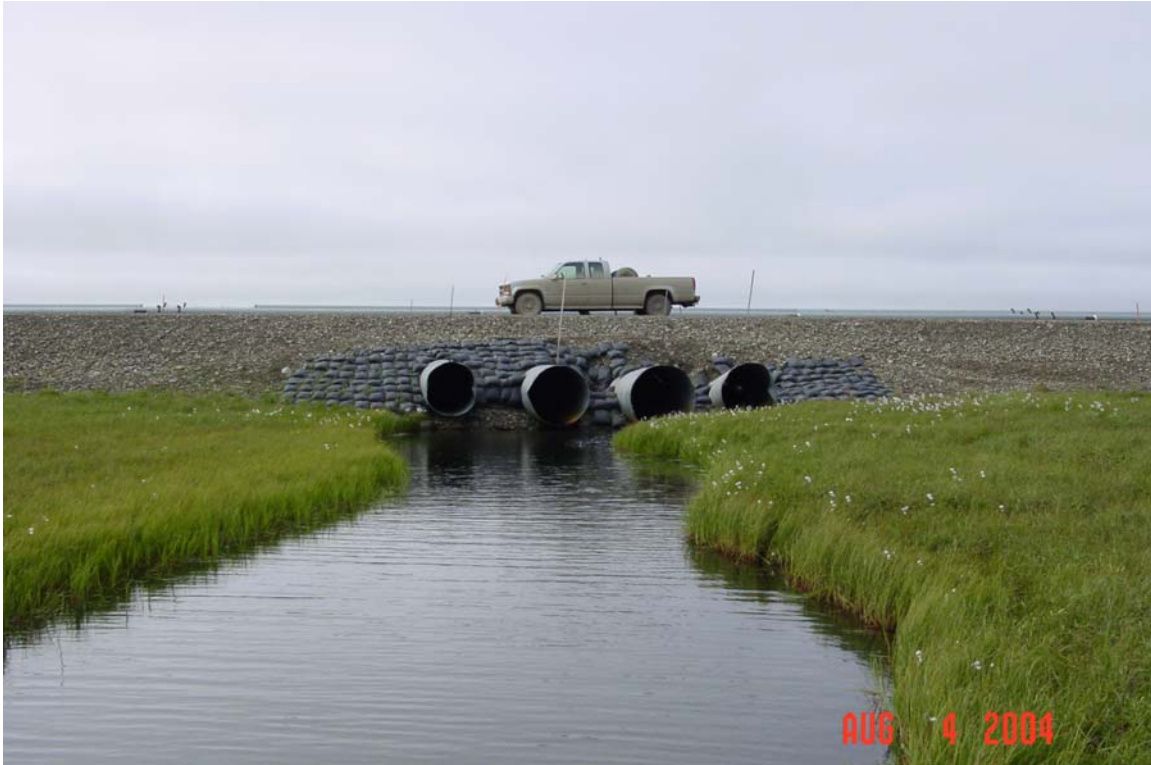
**Photograph 360. West Fork Ugnuravik River culvert outlets.**

REMEDICATION RECOMMENDATIONS: Repair and reset culverts, cut culverts to match road width

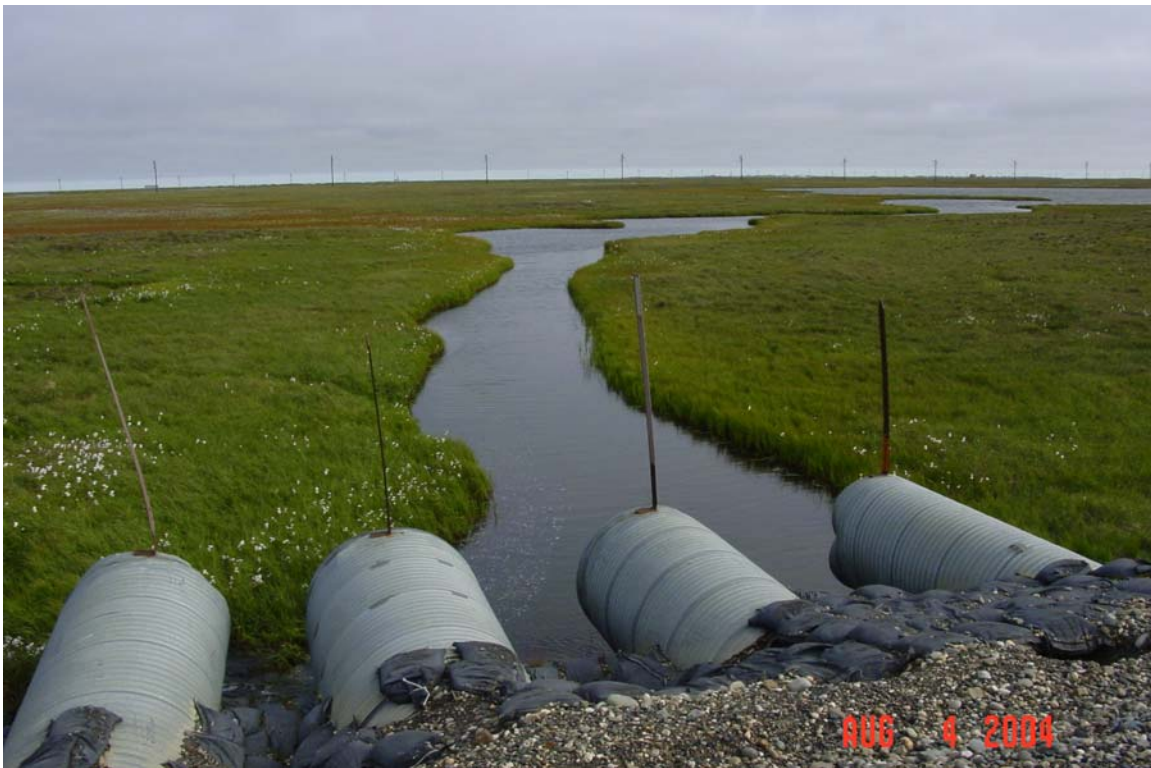
**Photograph 361. West Fork Ugnuravik River downstream of the culvert battery.**

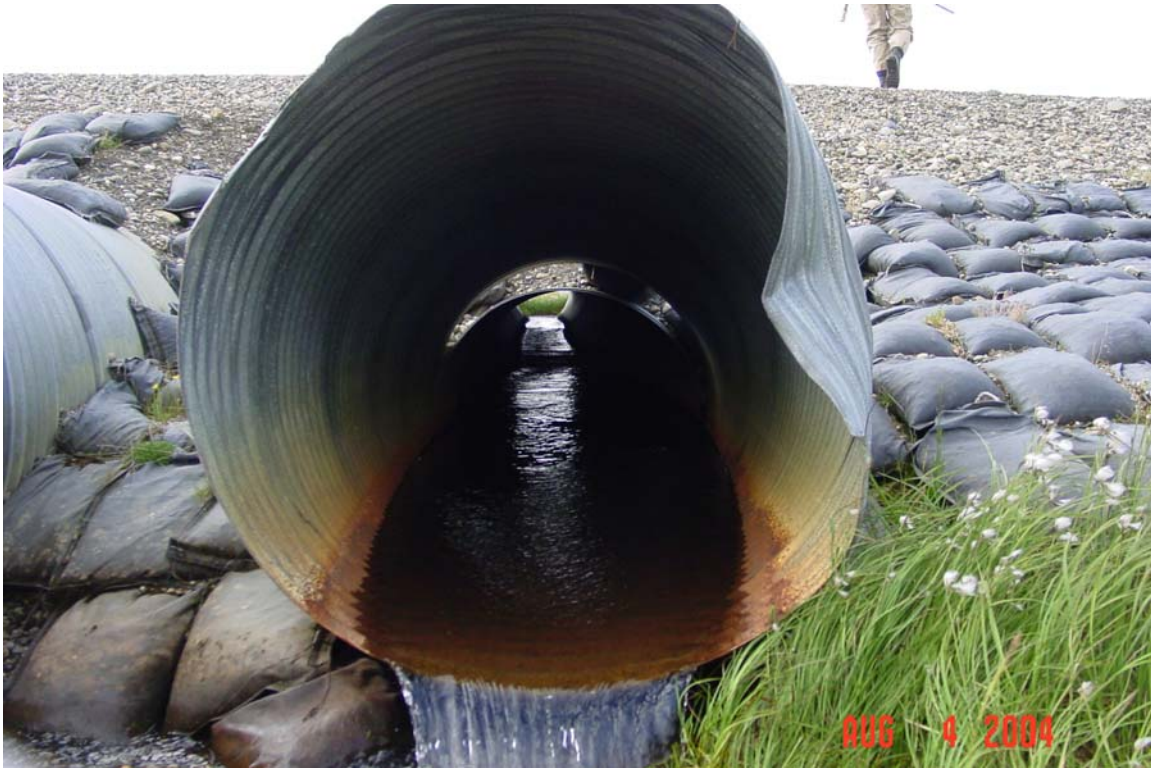
**Photograph 362. Perched, split, and bowed culvert in the West Fork Ugnuravik River crossing.**

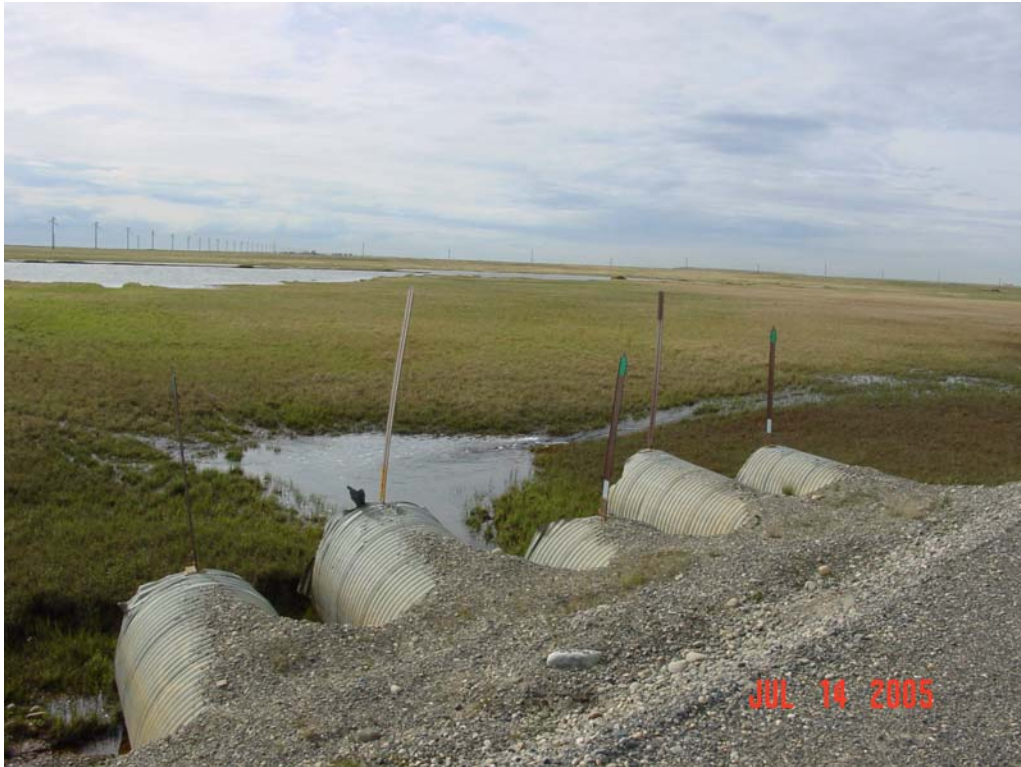
**Photograph 365. Kalubik Creek tributary upstream of the culvert battery.**

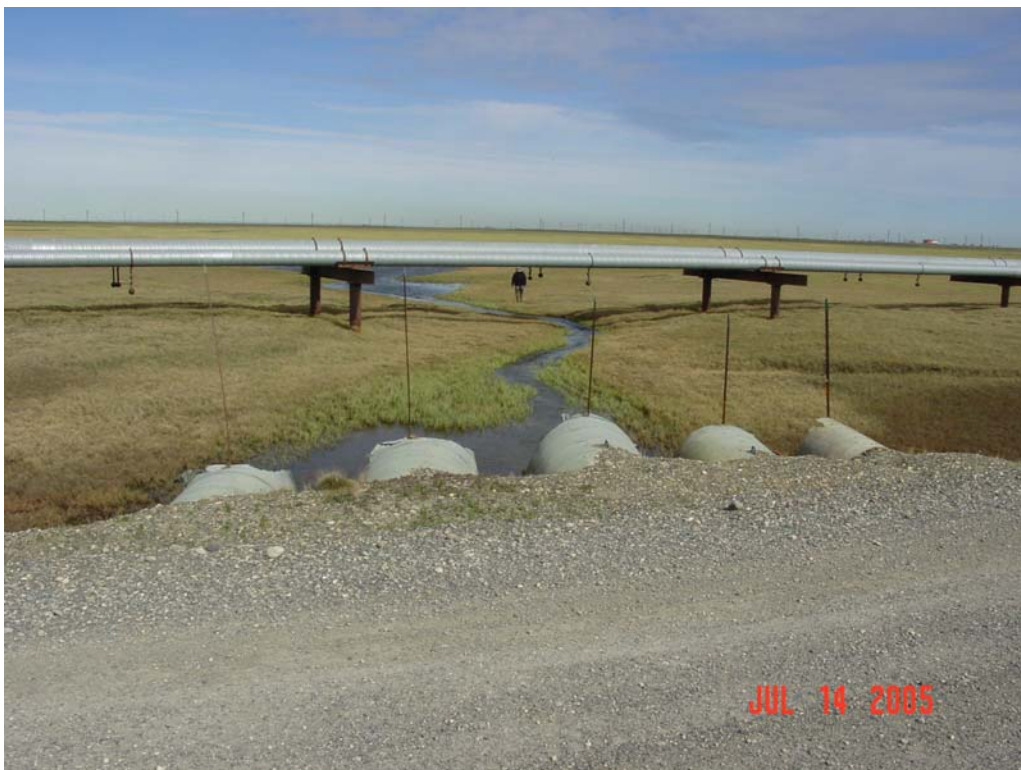
**Photograph 366. Kalubik Creek tributary downstream of the culvert battery.**

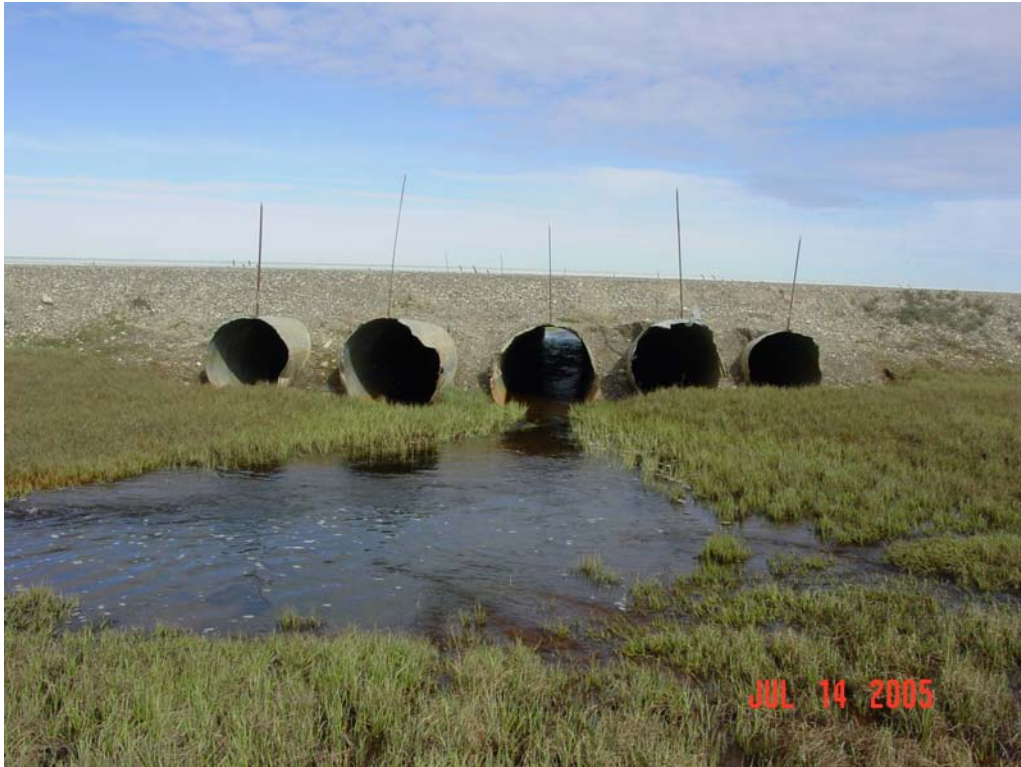
INLET: Minor inlet damage, limited road prism erosion

**Photograph 367. Kalubik Creek tributary culvert inlets.**

REMEDICATION RECOMMENDATIONS: Repair culverts

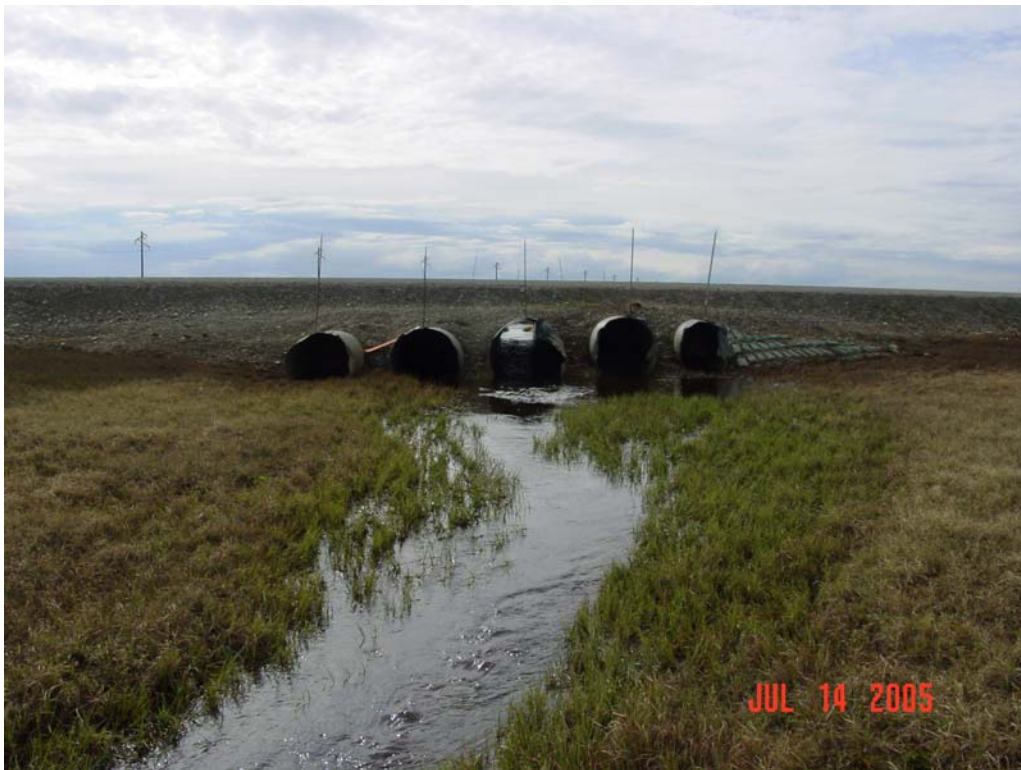
OUTLET: Limited sand bag armor, limited road prism erosion, minor outlet damage

**Photograph 368. Kalubik Creek tributary culvert outlets.**

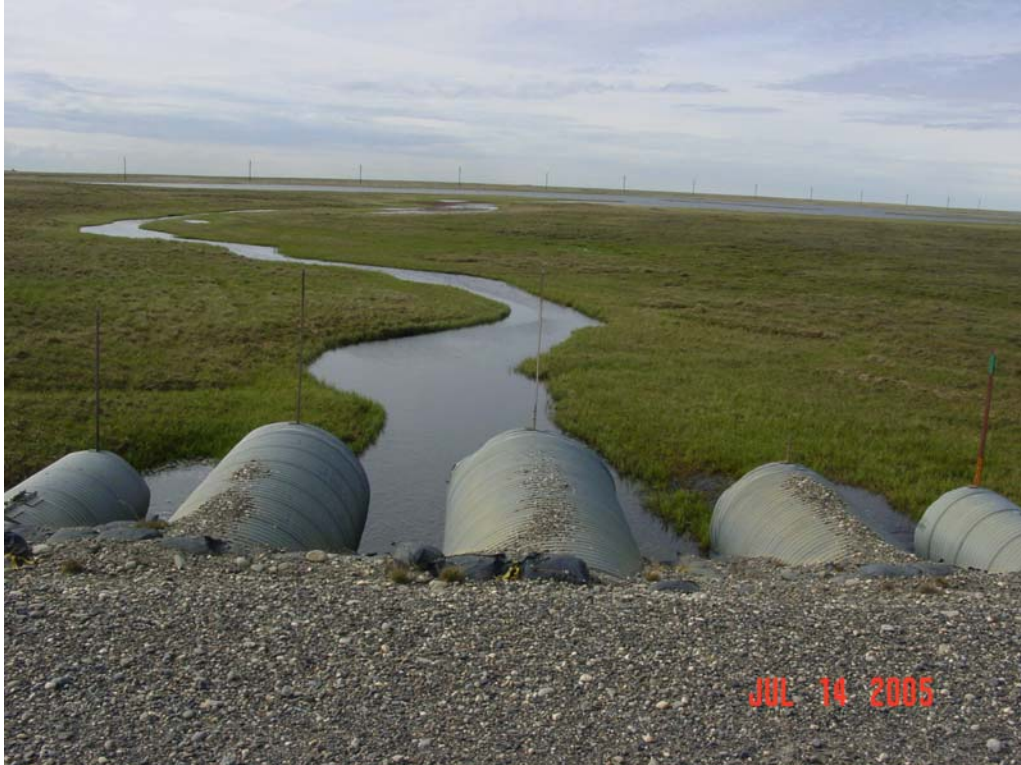
**Photograph 369. Kalubik Creek tributary downstream of the culvert battery.**

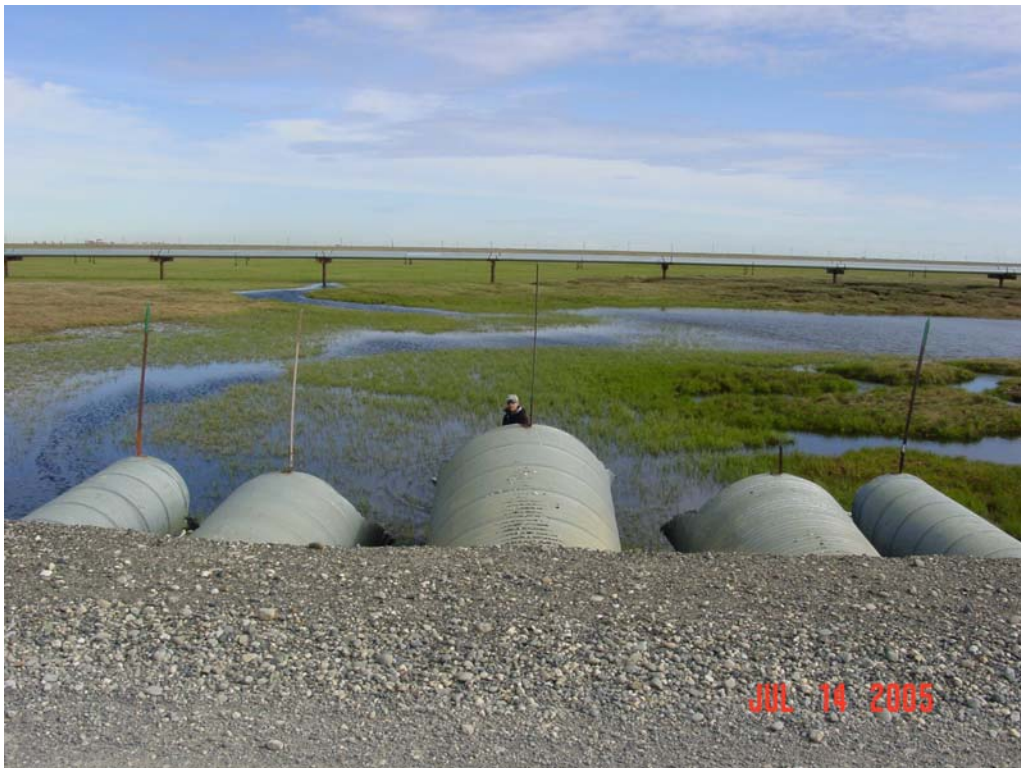
**Photograph 370. Kalubik Creek tributary upstream of the culvert battery.**

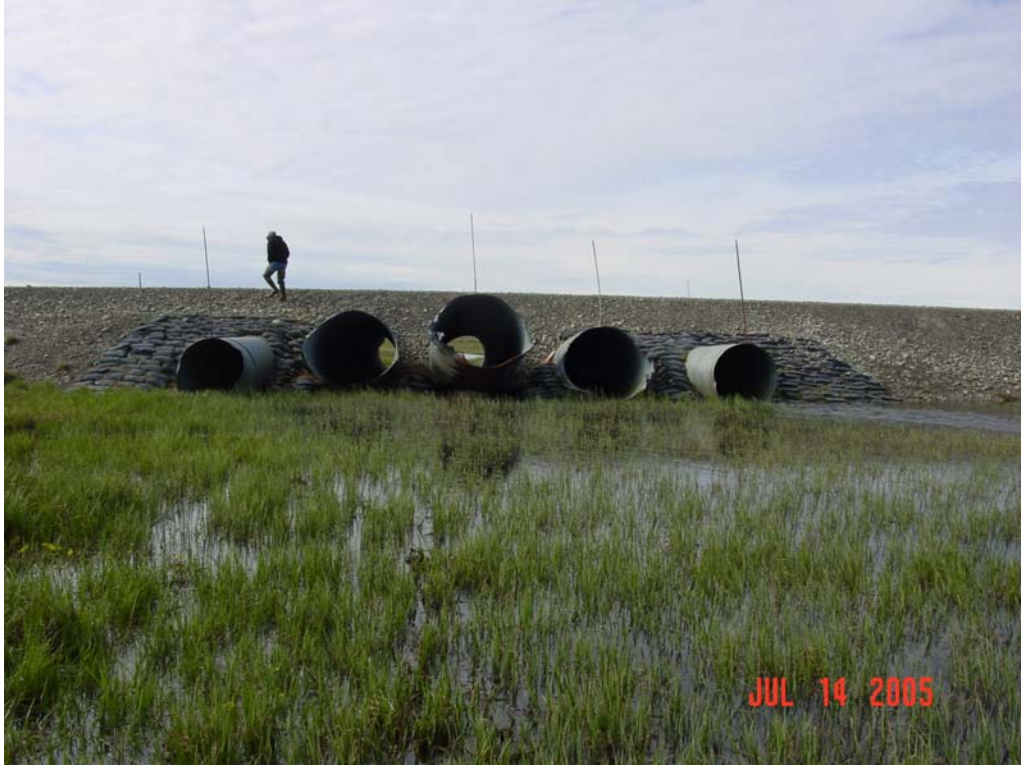
**Photograph 371. Kalubik Creek tributary bowed and perched culvert inlets, coupled with perched outlets, block fish passage.**

REMEDICATION RECOMMENDATIONS: Repair and reset culverts, shorten culvert  
length to match road width

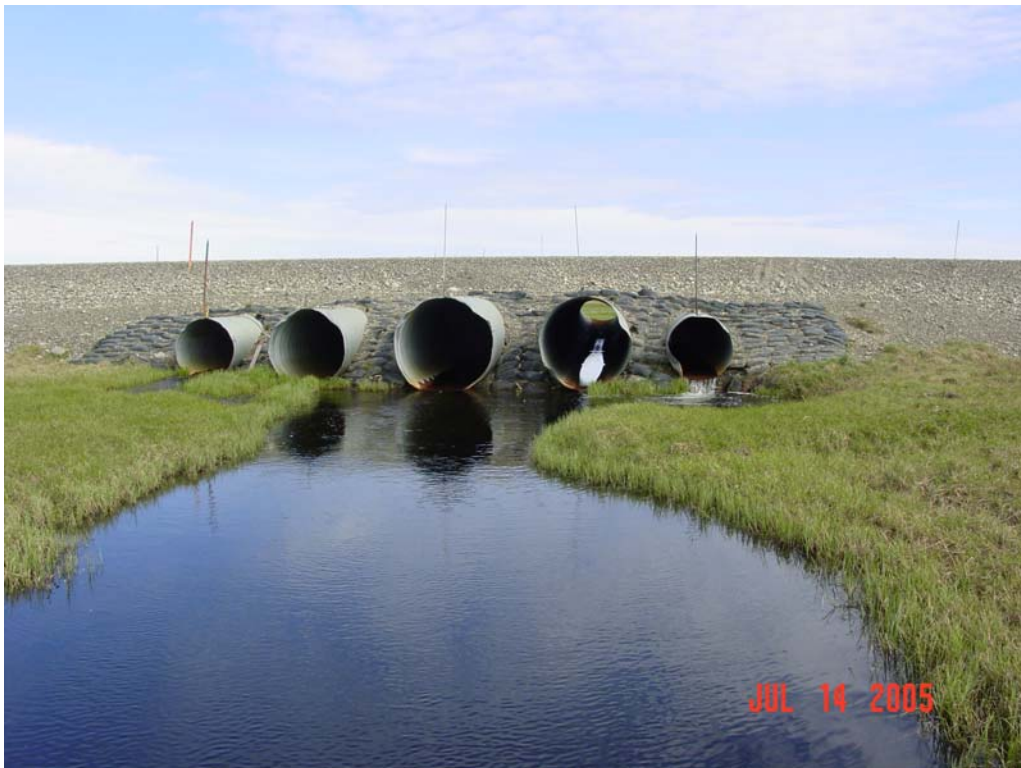
OUTLET: Sand bag armor, minor outlet damage, pipes perched

**Photograph 372. Kalubik Creek tributary culvert outlets, some of which are perched.**

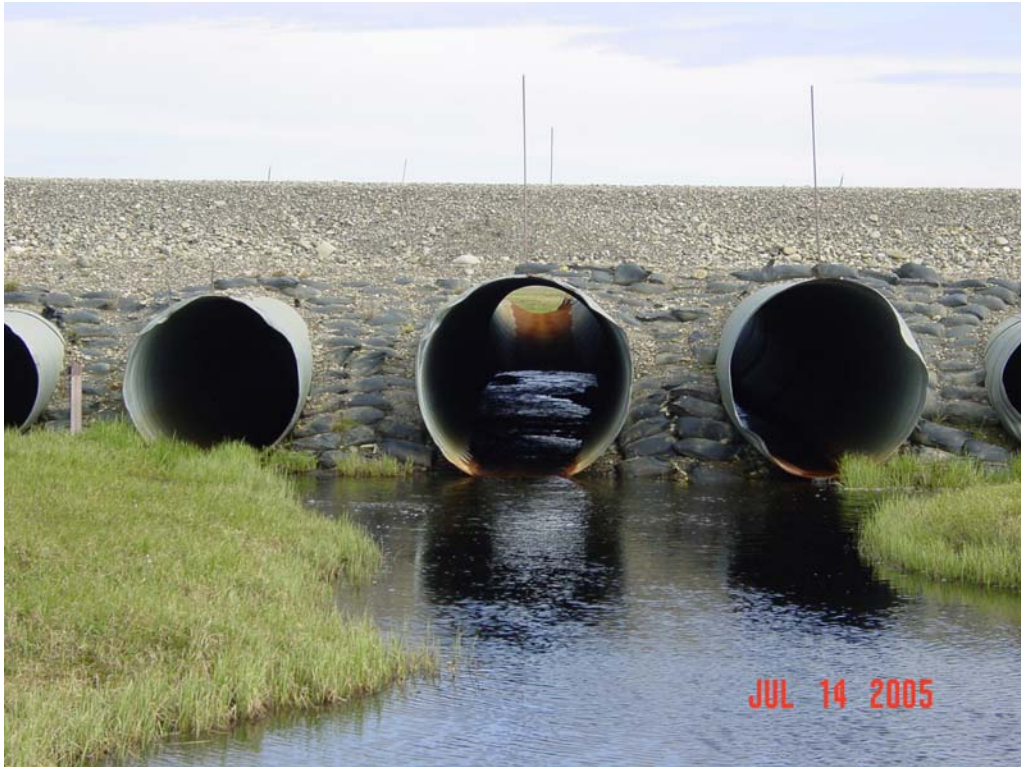
**Photograph 373. Water emanating from the center of the Kalubik Creek tributary culvert with the severely bowed and perched inlet.**

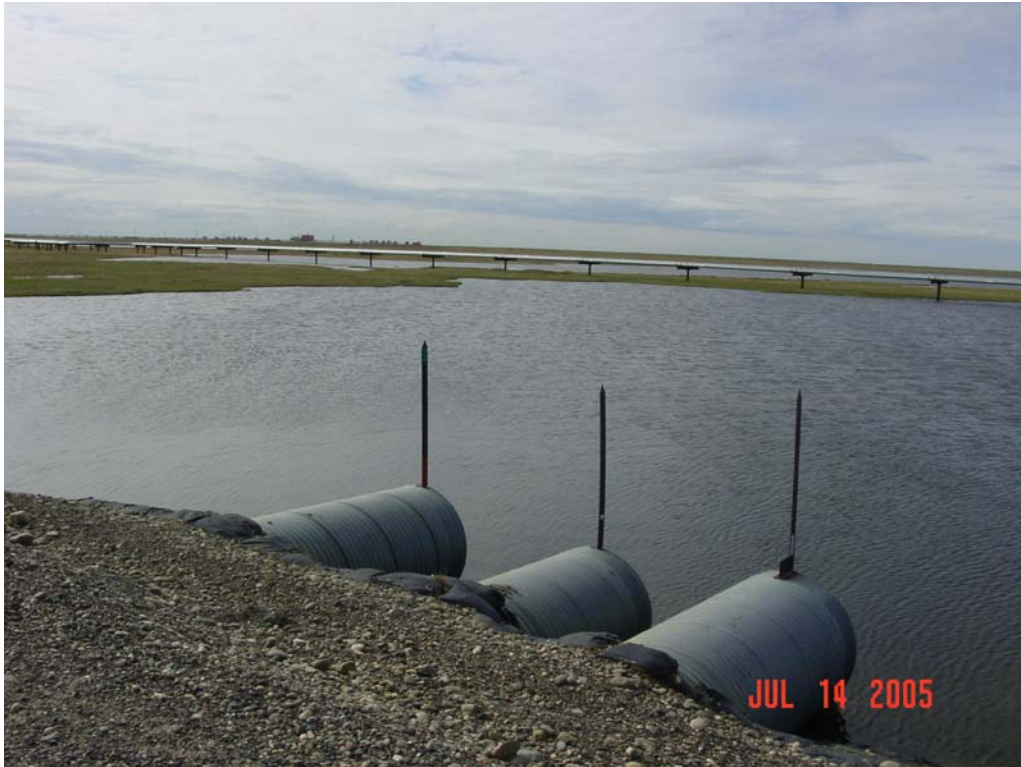
**Photograph 374. Kalubik Creek tributary downstream of the culvert battery.**

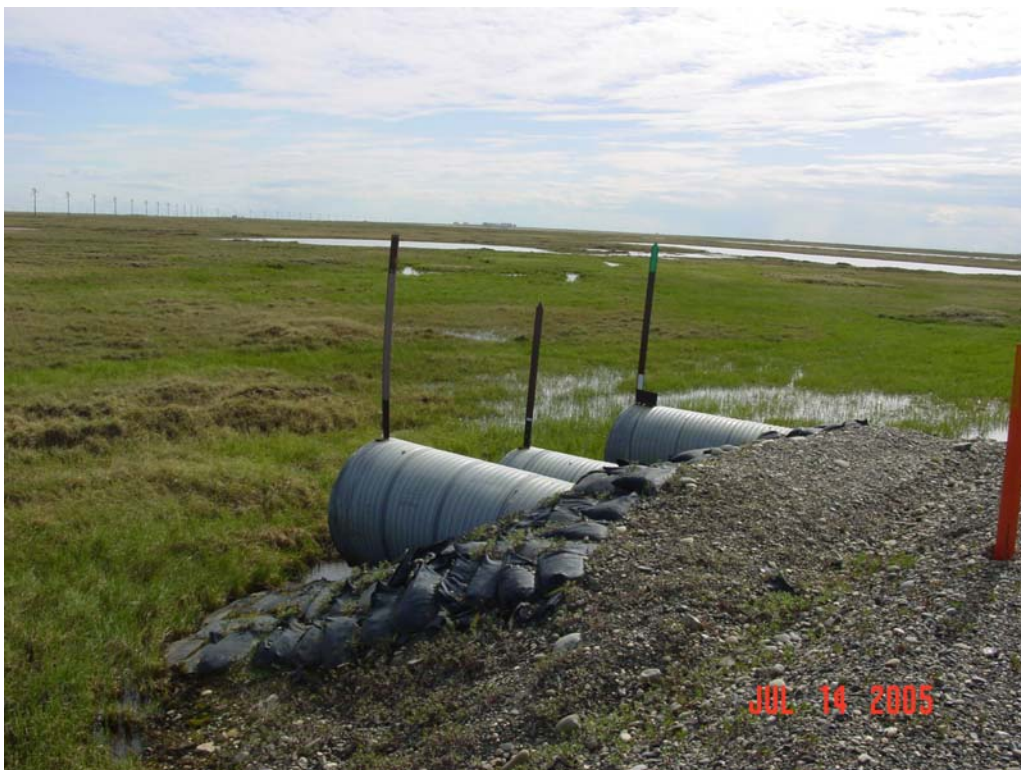
**Photograph 375. Kalubik Creek tributary upstream of the culvert battery.**

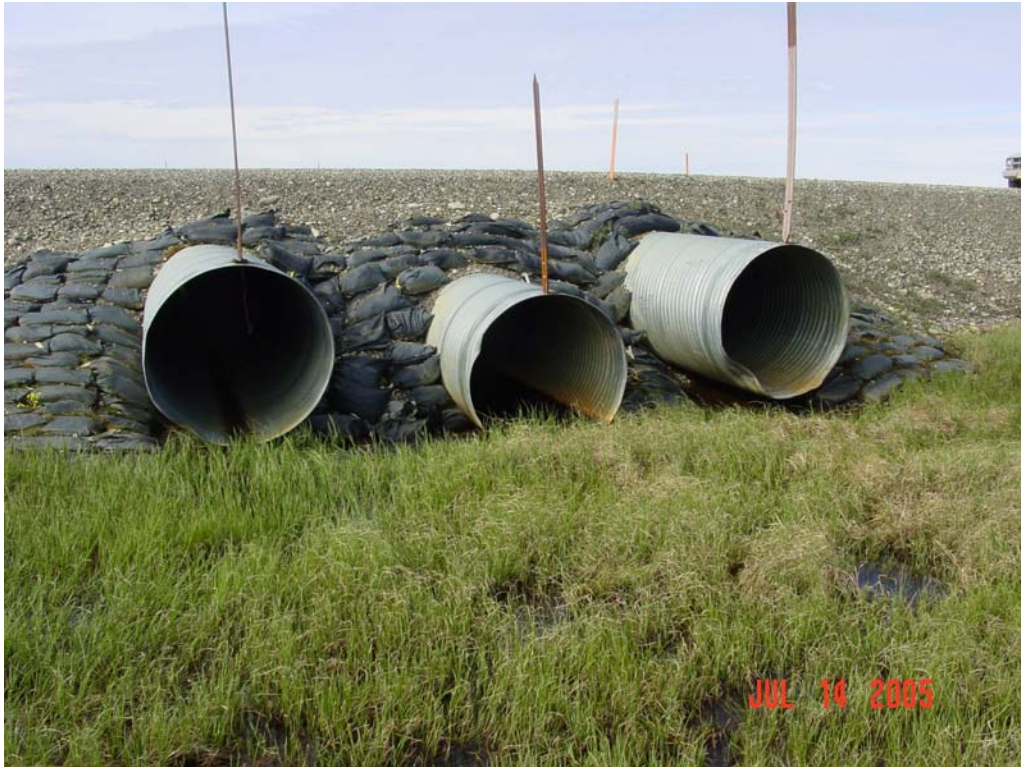
INLET: Sand bag armor, minor inlet damage

**Photograph 376. Kalubik Creek tributary culvert inlets.**

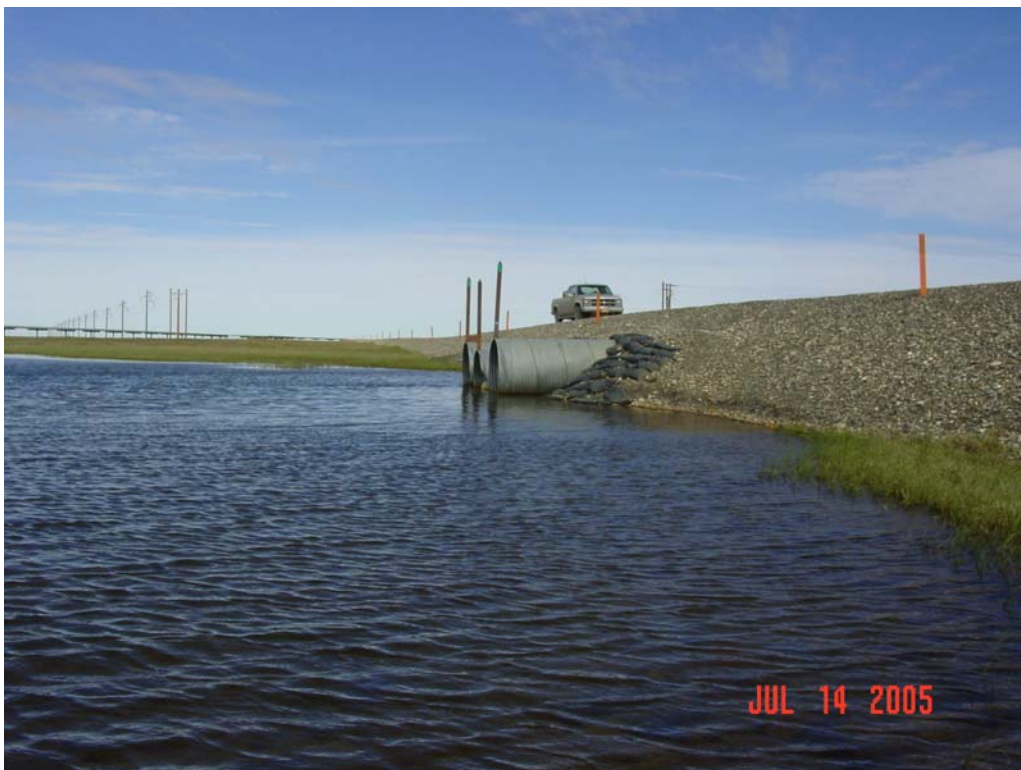
OUTLET: Sand bag armor, minor outlet damage, 4 to 6 foot scour

**Photograph 377. Kalubik Creek tributary culvert outlets.**

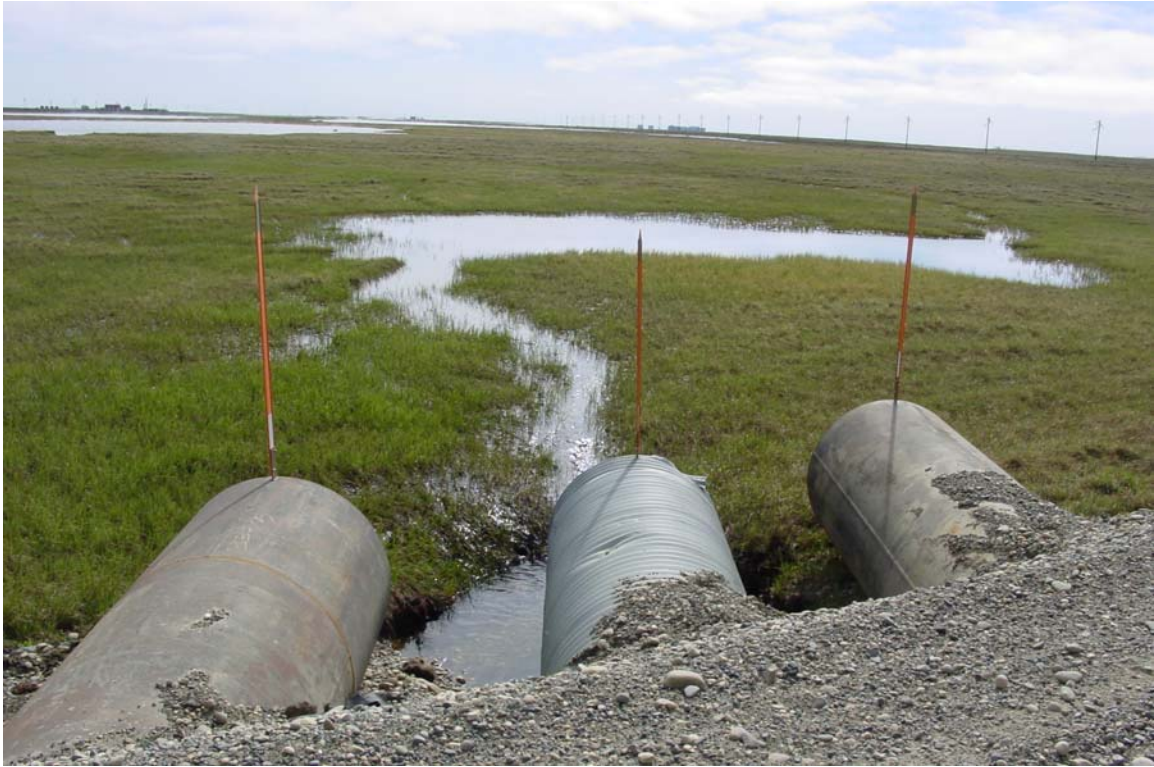
**Photograph 378. Kalubik Creek tributary upstream of the culvert battery.**

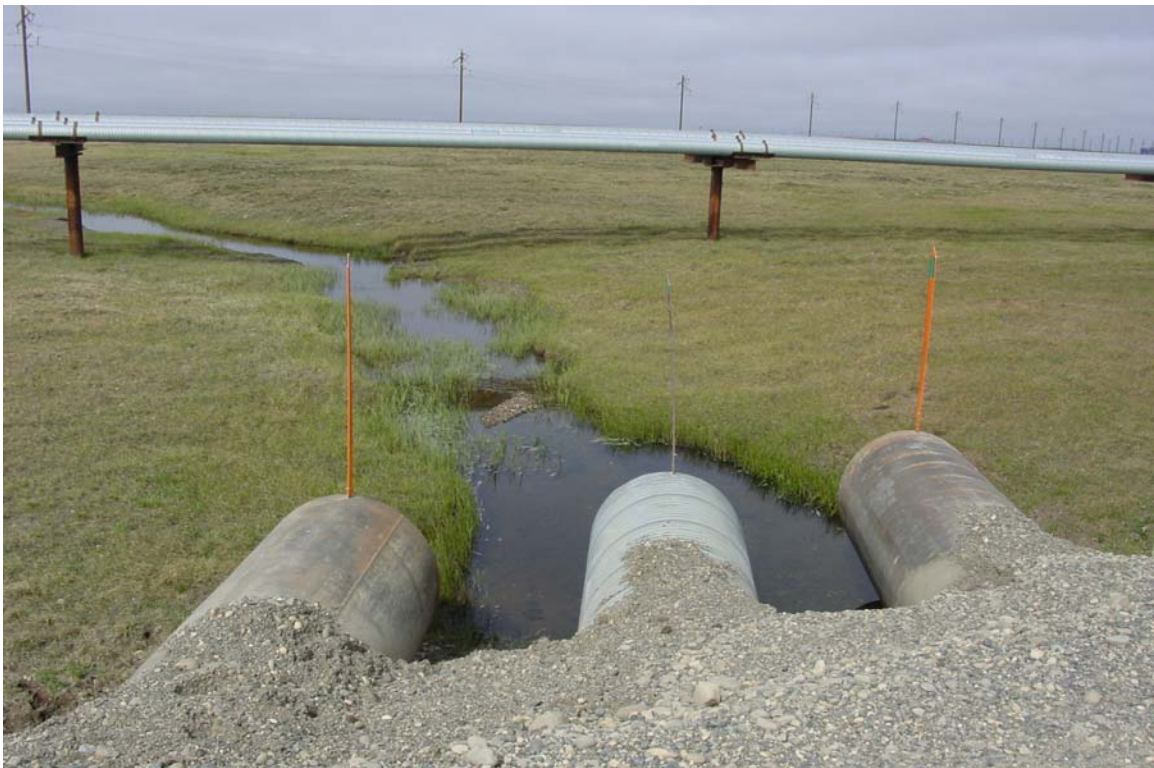
**Photograph 379. Kalubik Creek tributary downstream of the culvert battery.**

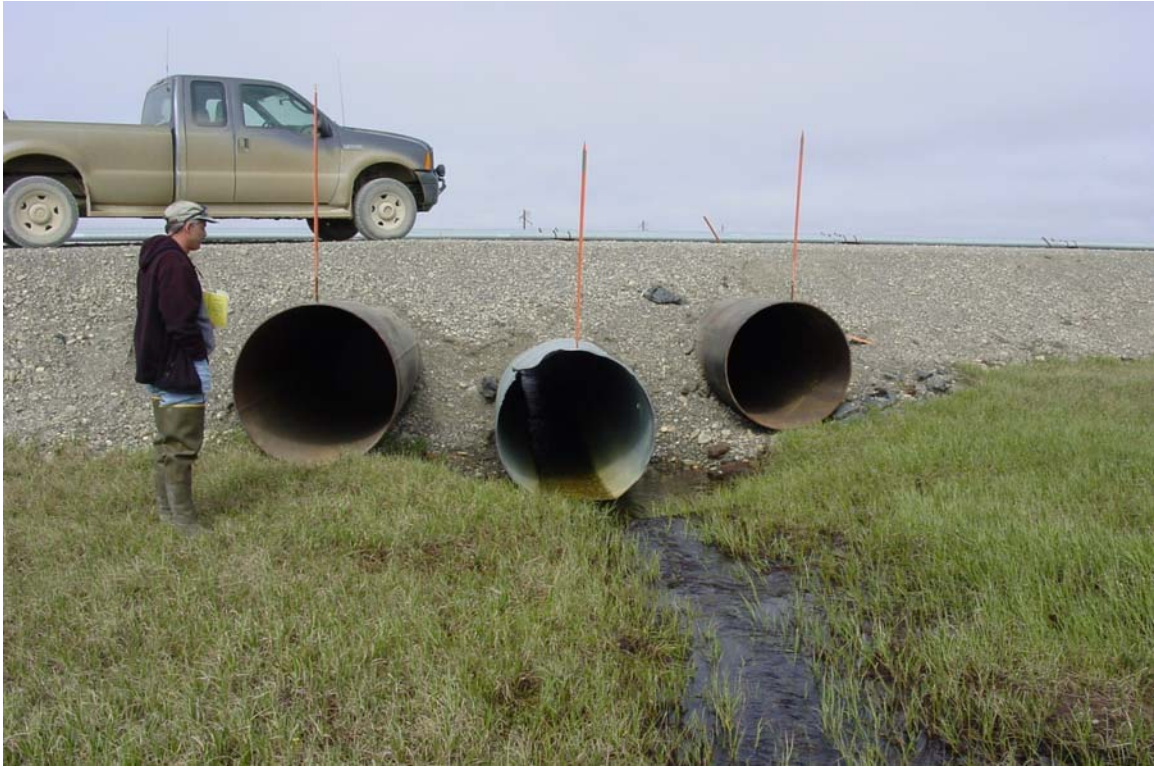
INLET: Sand bag armor remnants from original installation, minor inlet damage

**Photograph 380. Kalubik Creek tributary culvert inlets.**

REMEDIATION RECOMMENDATIONS: Stake tundra sod at inlet of the center pipe to reduce the hydraulic drop into the culvert barrel, remove outwash gravels downstream of crossing

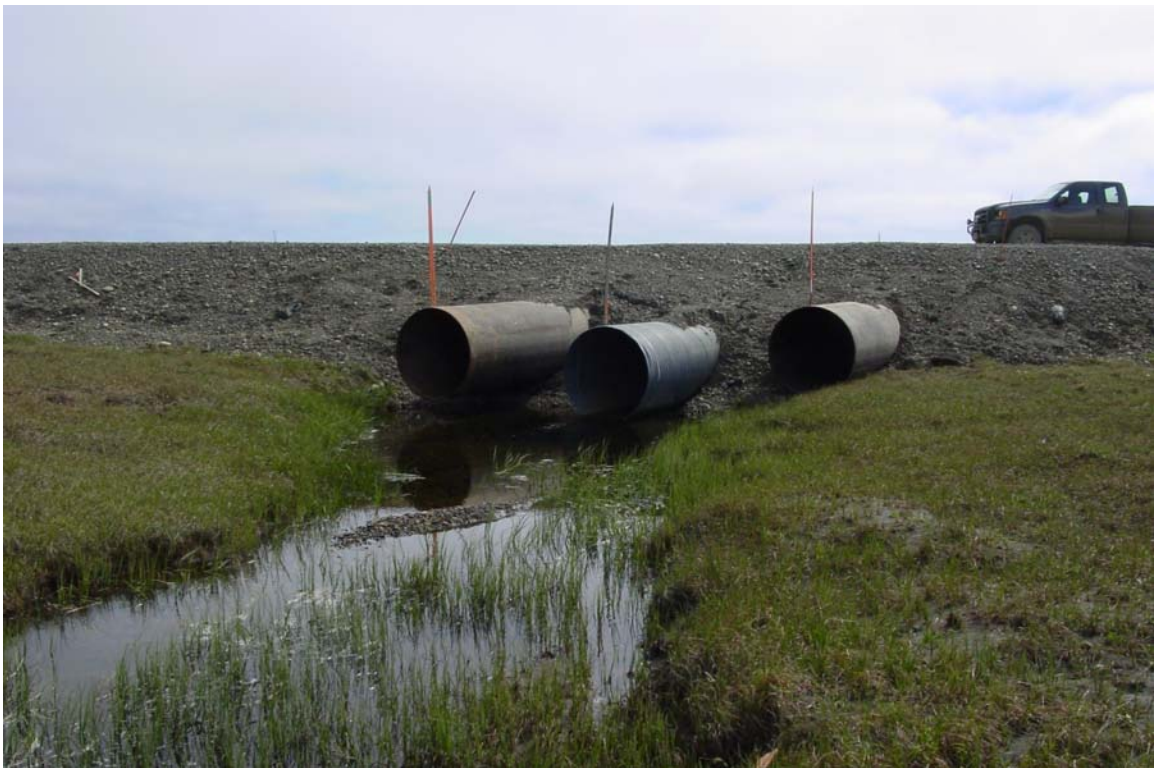
**Photograph 381. Kalubik Creek tributary culvert outlets.**

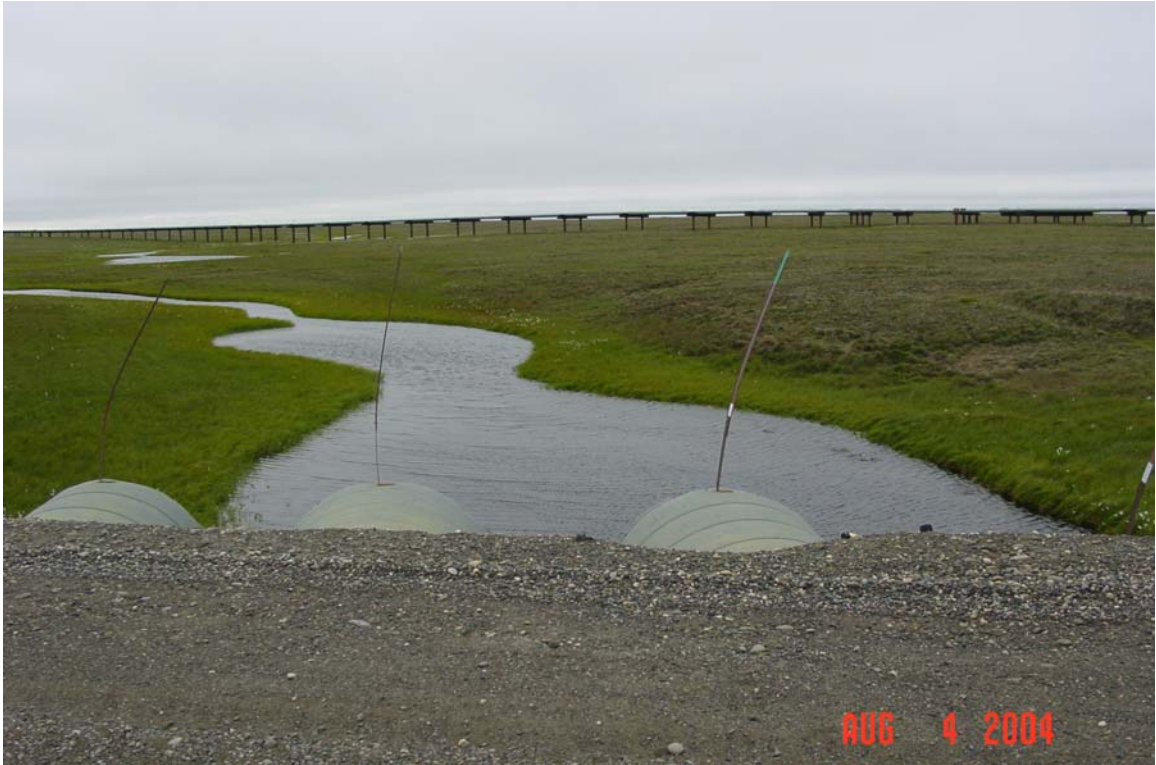
**Photograph 382. Kalubik Creek upstream of the Spine Road culvert battery.**

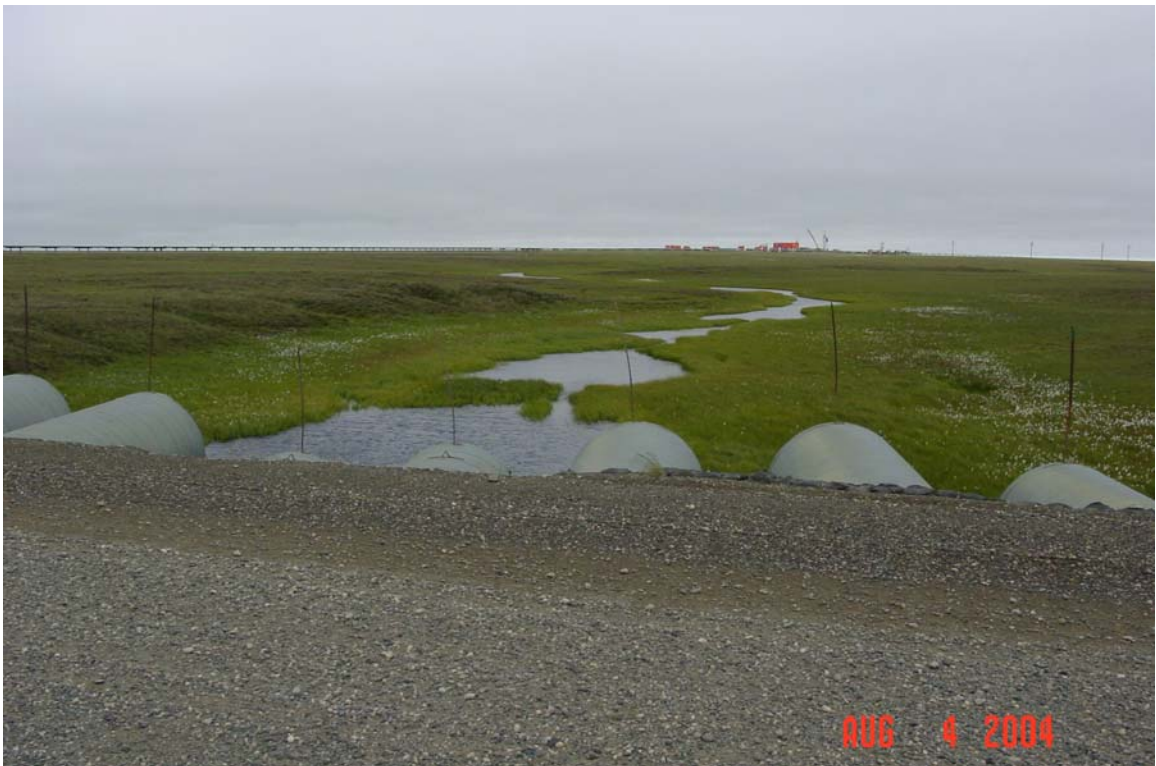
**Photograph 383. Kalubik Creek downstream of the Spine Road culvert battery.**

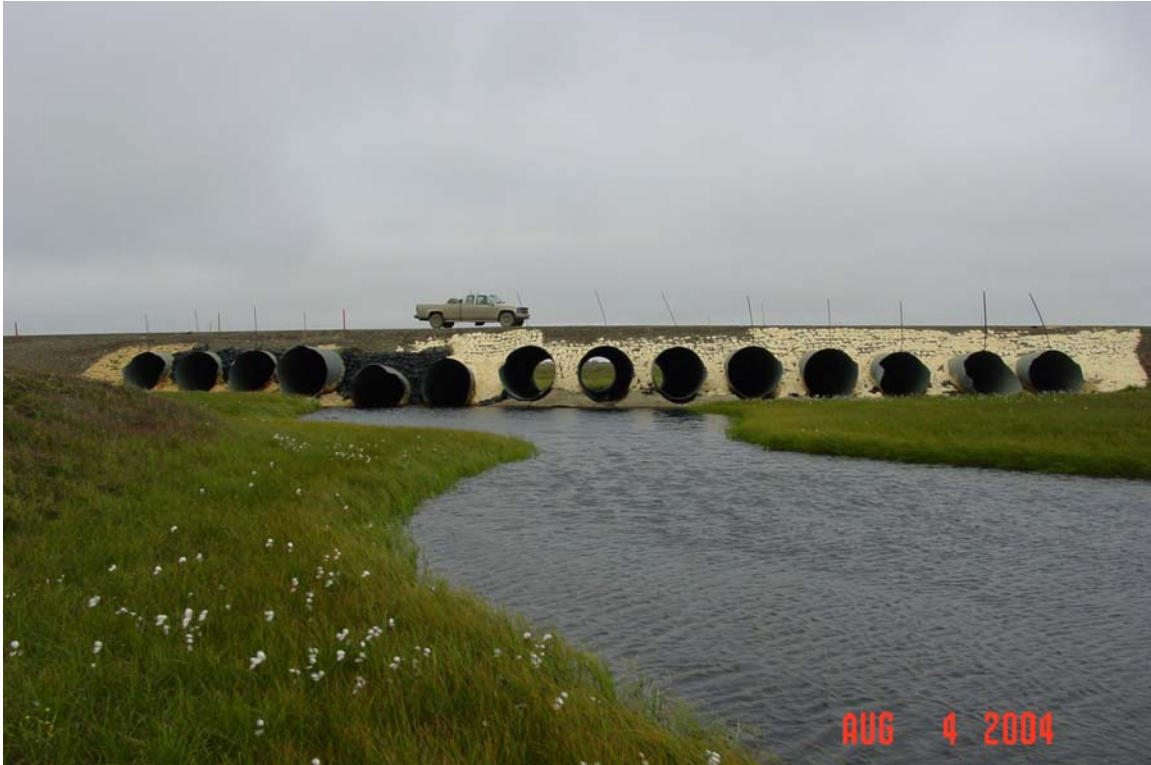
INLET: Sand bag armor, some sprayed with PolyShield urethane overlay reinforcement, concrete aprons cracked and separated from culverts, gobi mat, inlet damage, only 2 culverts in water – both are several feet off the stream bottom, some pipes split, gravel and sand bags within the culverts

**Photograph 384. Culvert inlets at the Kalubik Creek Spine Road crossing. Erosion protection measures include gobi mat, sand bags, concrete aprons, and sand bags sprayed with PolyShield urethane.**

REMEDIATION RECOMMENDATIONS: Repair culverts, shorten culvert lengths to match road width. Replace culverts with a bridge.

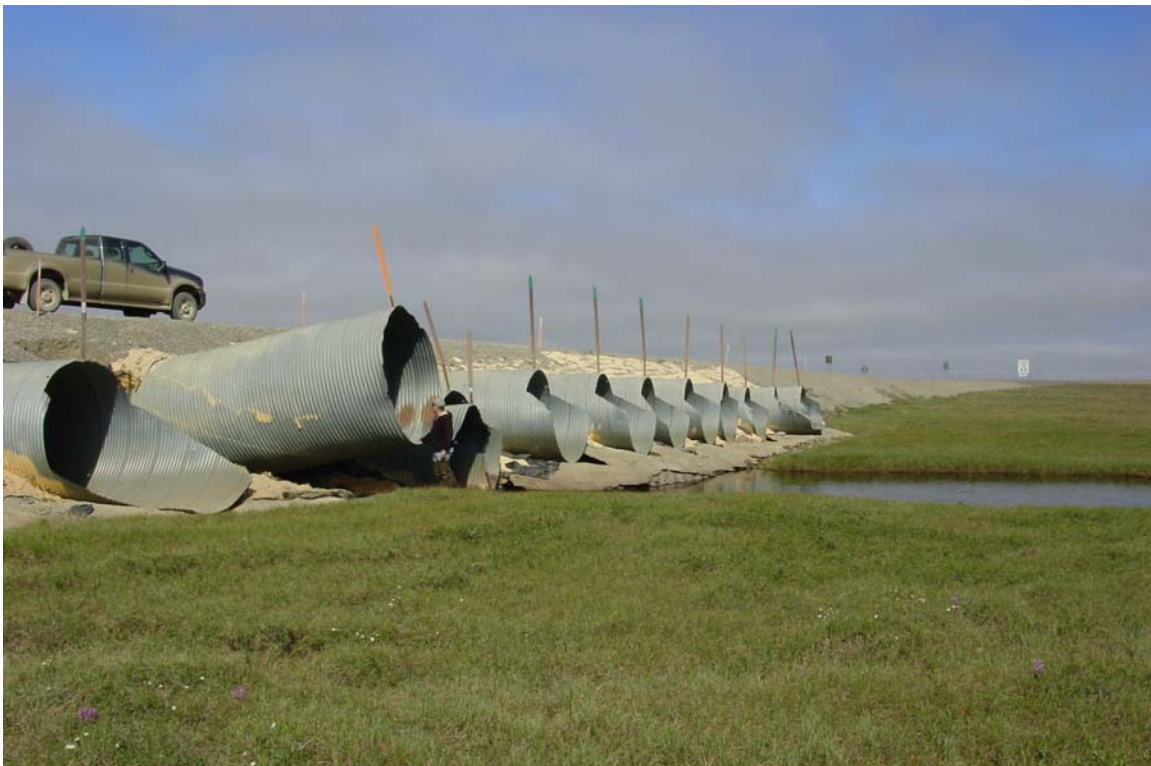
**Photograph 385. Culvert inlets at the Kalubik Creek Spine Road crossing, July 8, 2007.**

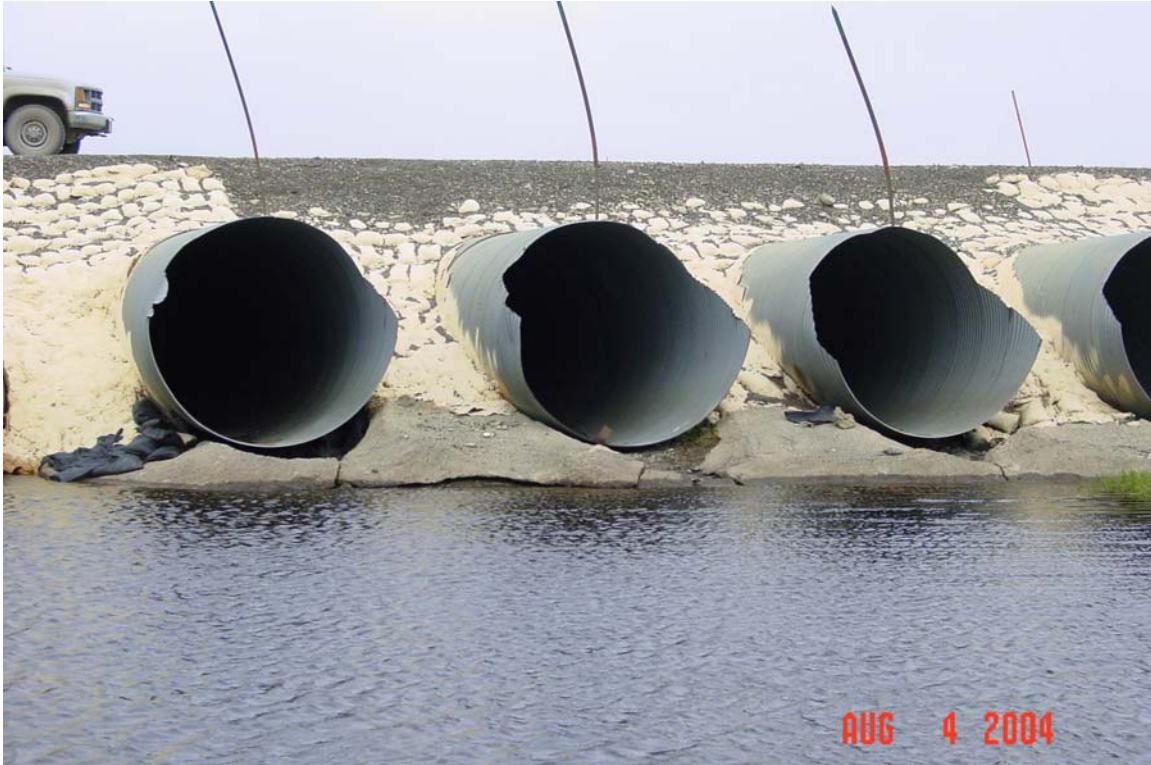
**Photograph 386.** Kalubik Creek Spine Road crossing culvert inlets with cracked and separated concrete aprons, and urethane coated sand bags.
