**Technical Report No. 08-01**

## **A SURVEY OF STREAM CROSSING STRUCTURES IN THE NORTH SLOPE OILFIELDS**

**by William A. Morris  
and Jack F. Winters**

**February 2008**

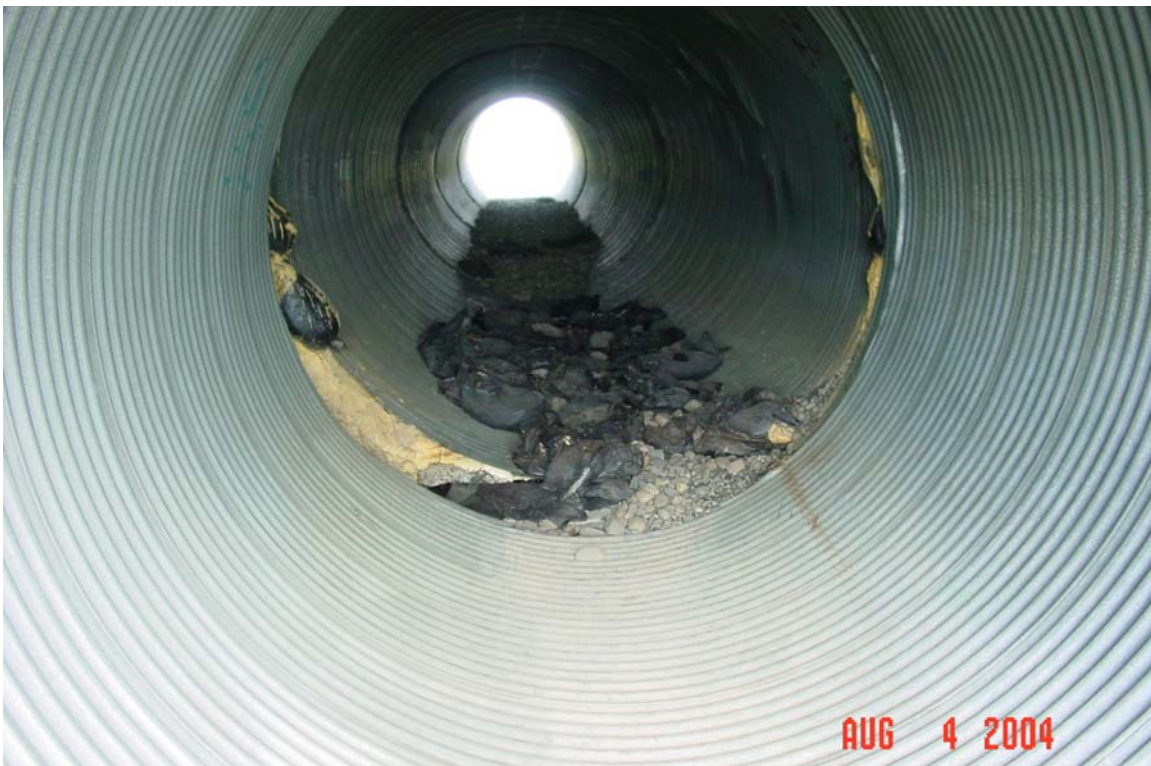
**Photograph 387.** Kalubik Creek Spine Road crossing split culvert with the split sealed with PolyShield. Sand bags present from inlet erosion.

REMEDIATION RECOMMENDATIONS: Repair culverts, shorten culvert lengths to match road width. Replace culverts with a bridge.

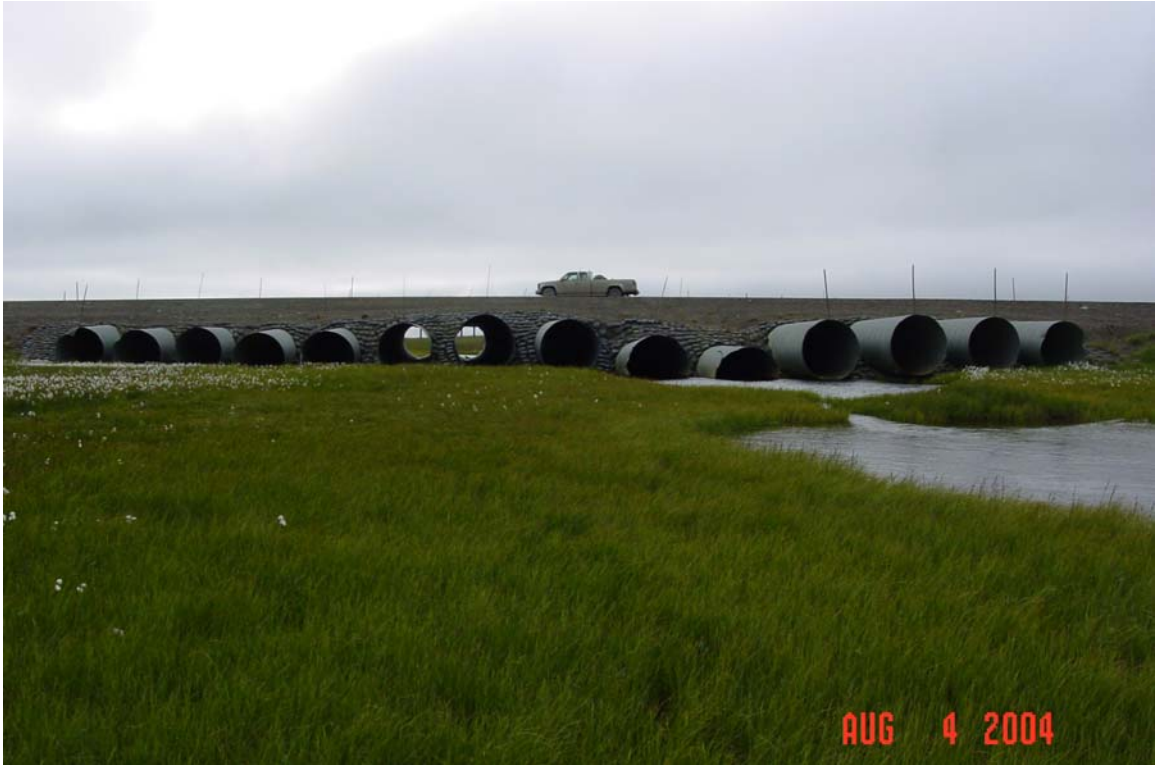
OUTLET: Sand bag armor, gobi mat, damaged outlets, scour pools, outwash gravels

**Photograph 388. Kalubik Creek Spine Road culvert outlets.**

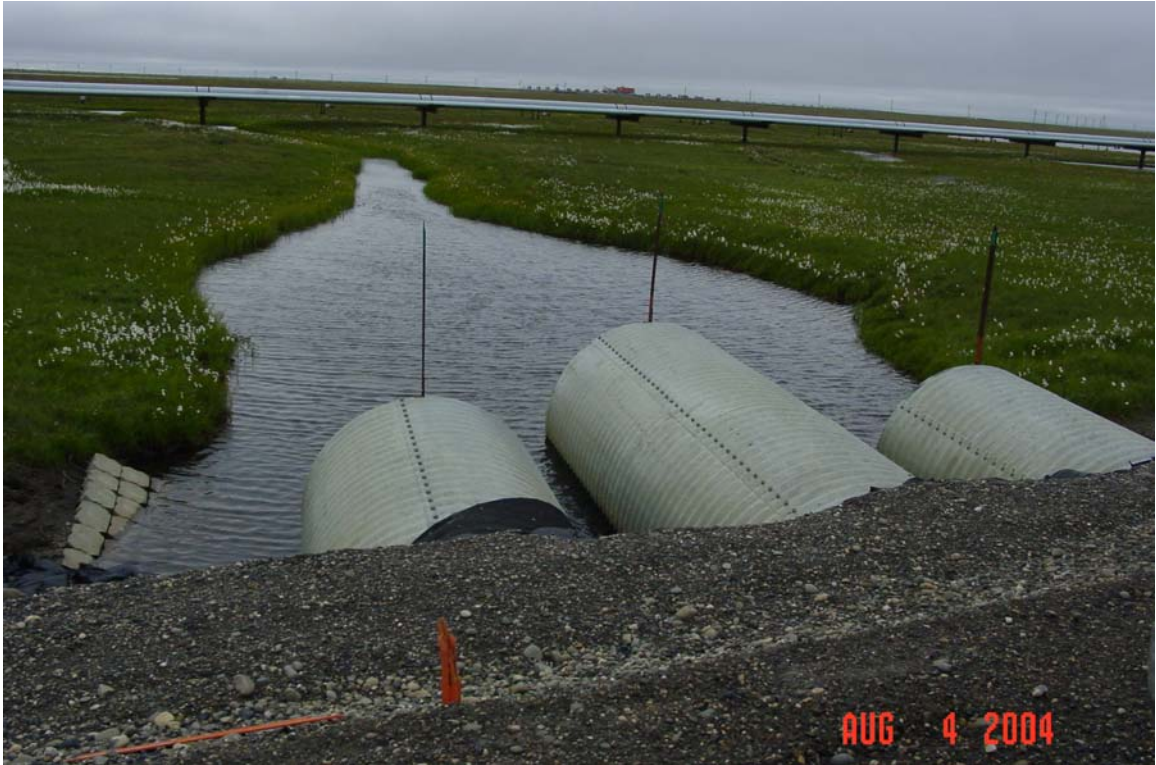
**Photograph 389.** The West Fork of Kalubik Creek upstream of the Spine Road crossing.

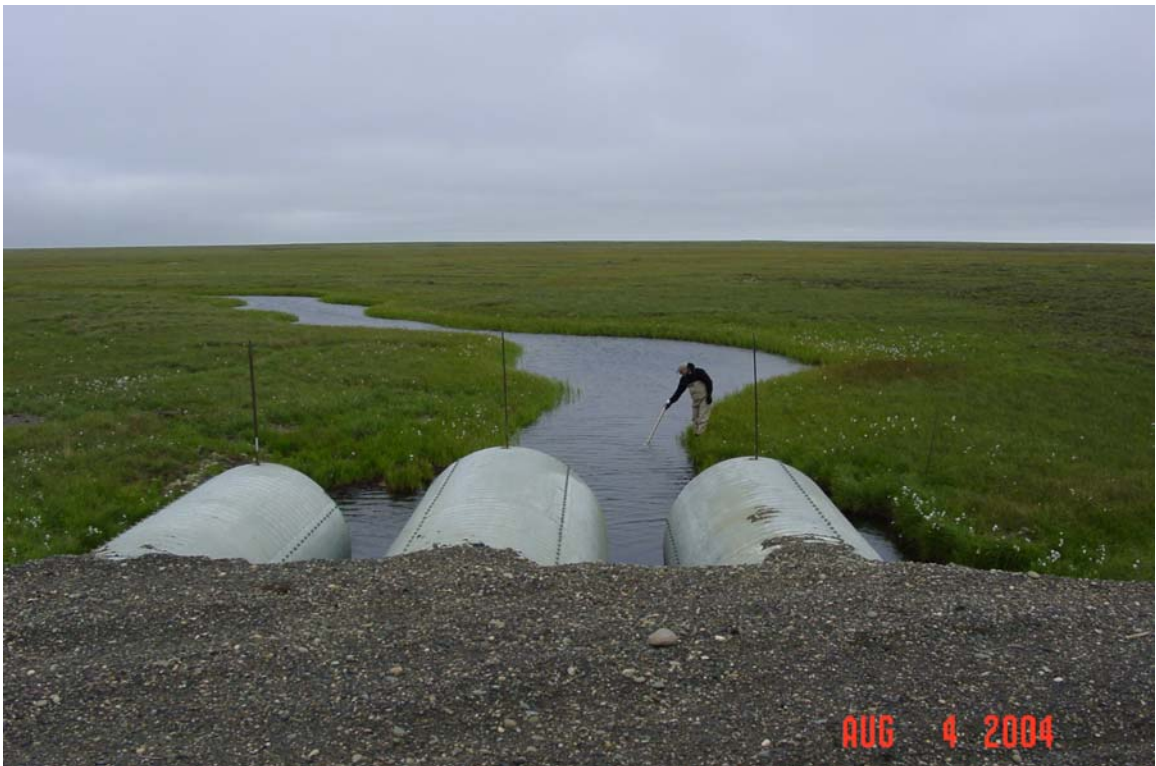
**Photograph 390.** The West Fork of Kalubik Creek downstream of the Spine Road crossing.

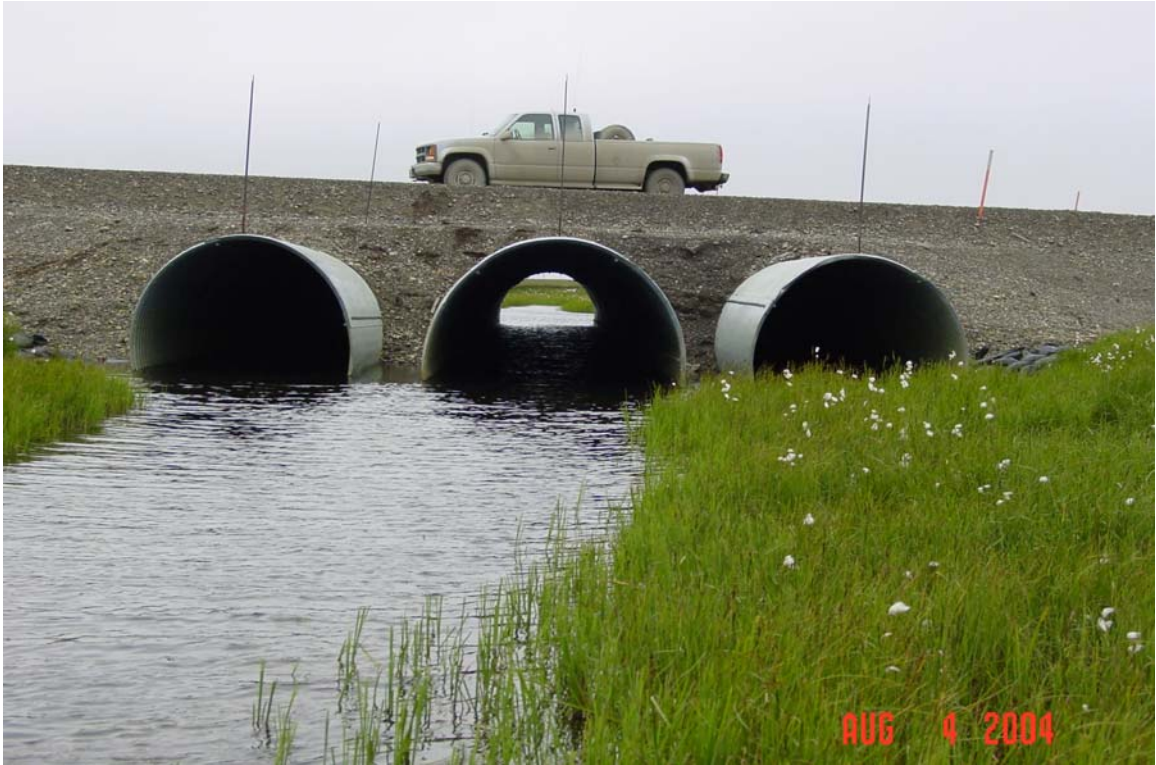
**Photograph 391. West Fork Kalubik Creek culvert outlets.**

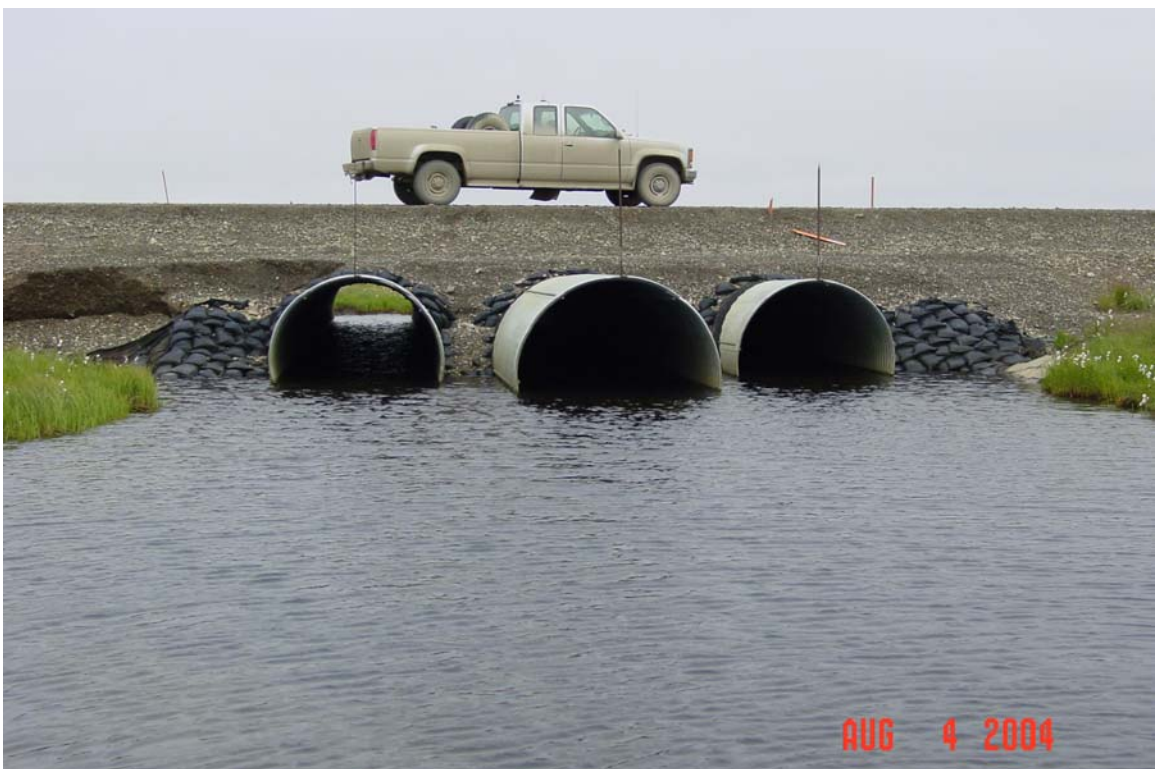
**Photograph 392. West Fork Kalubik Creek culvert inlets. Note the road prism erosion.**

REMEDICATION RECOMMENDATIONS: Repair road bed and armor

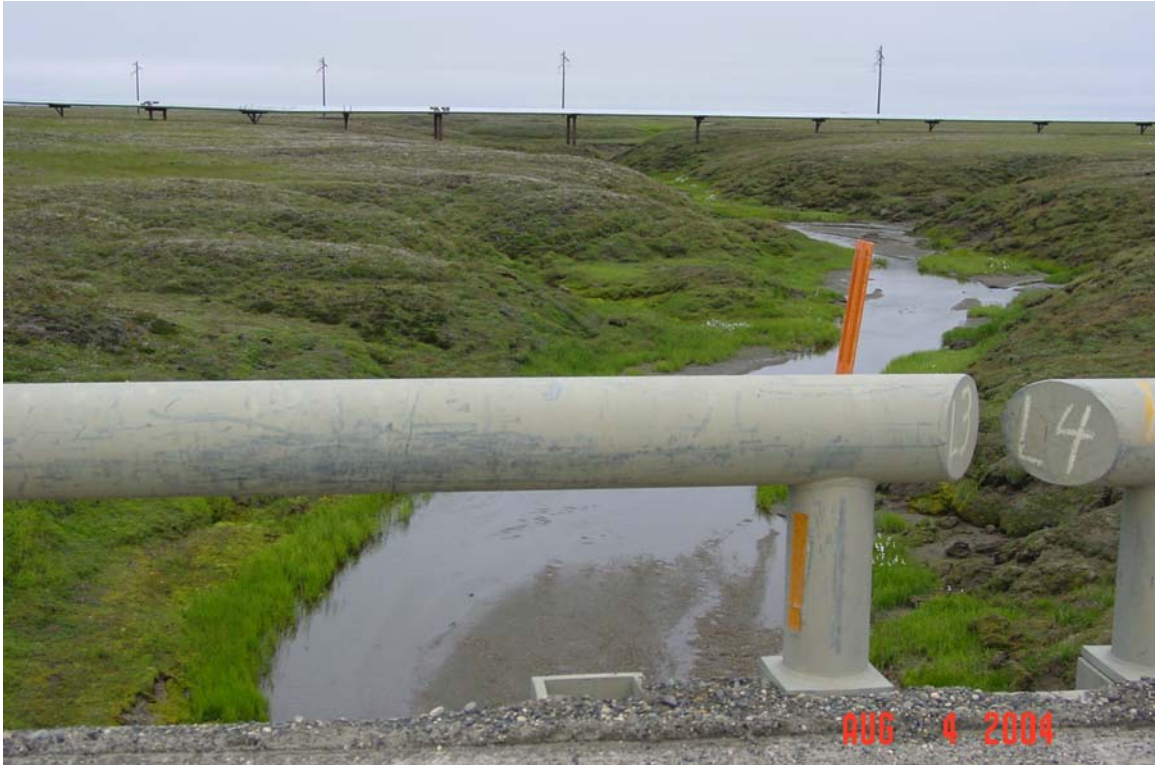
**Photograph 393. Trouble Creek upstream of the bridge.**

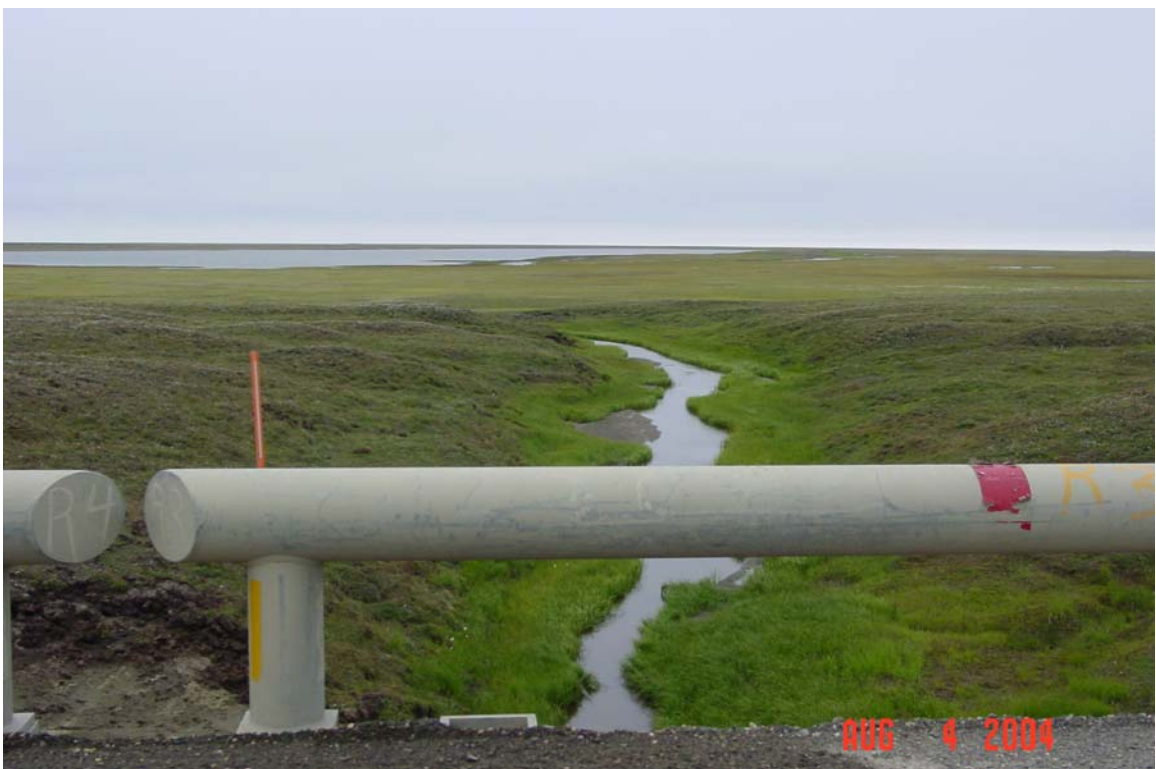
**Photograph 394. Trouble Creek downstream of the bridge.**

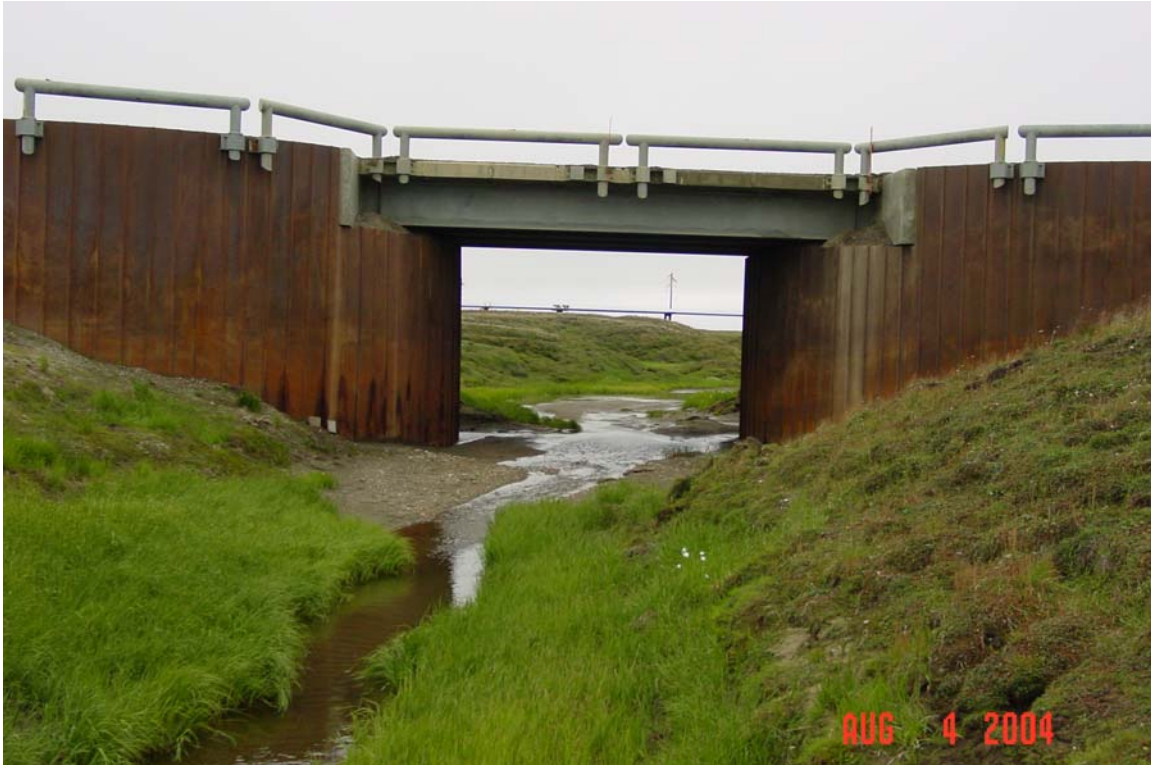
**Photograph 395. The Trouble Creek bridge viewed from downstream. Note the bridge does not span bankfull flows.**

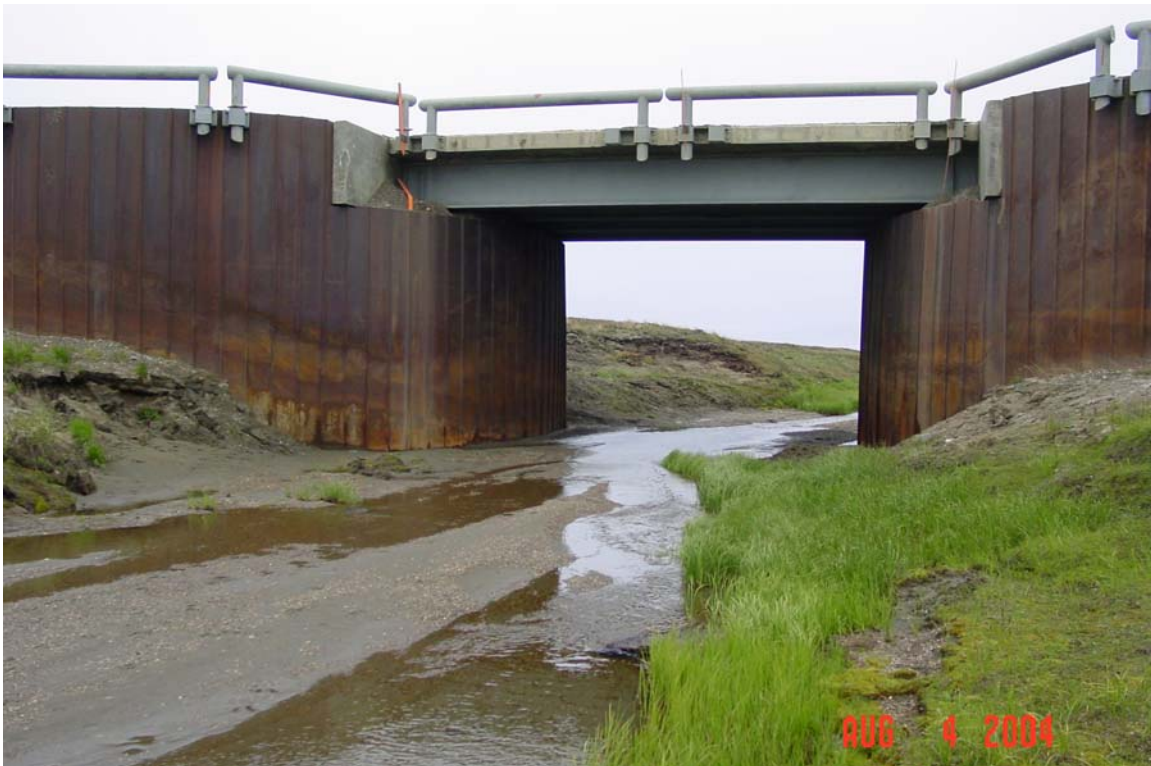
**Photograph 396. The Trouble Creek bridge viewed from upstream. Note the bank erosion upstream of the west abutment.**

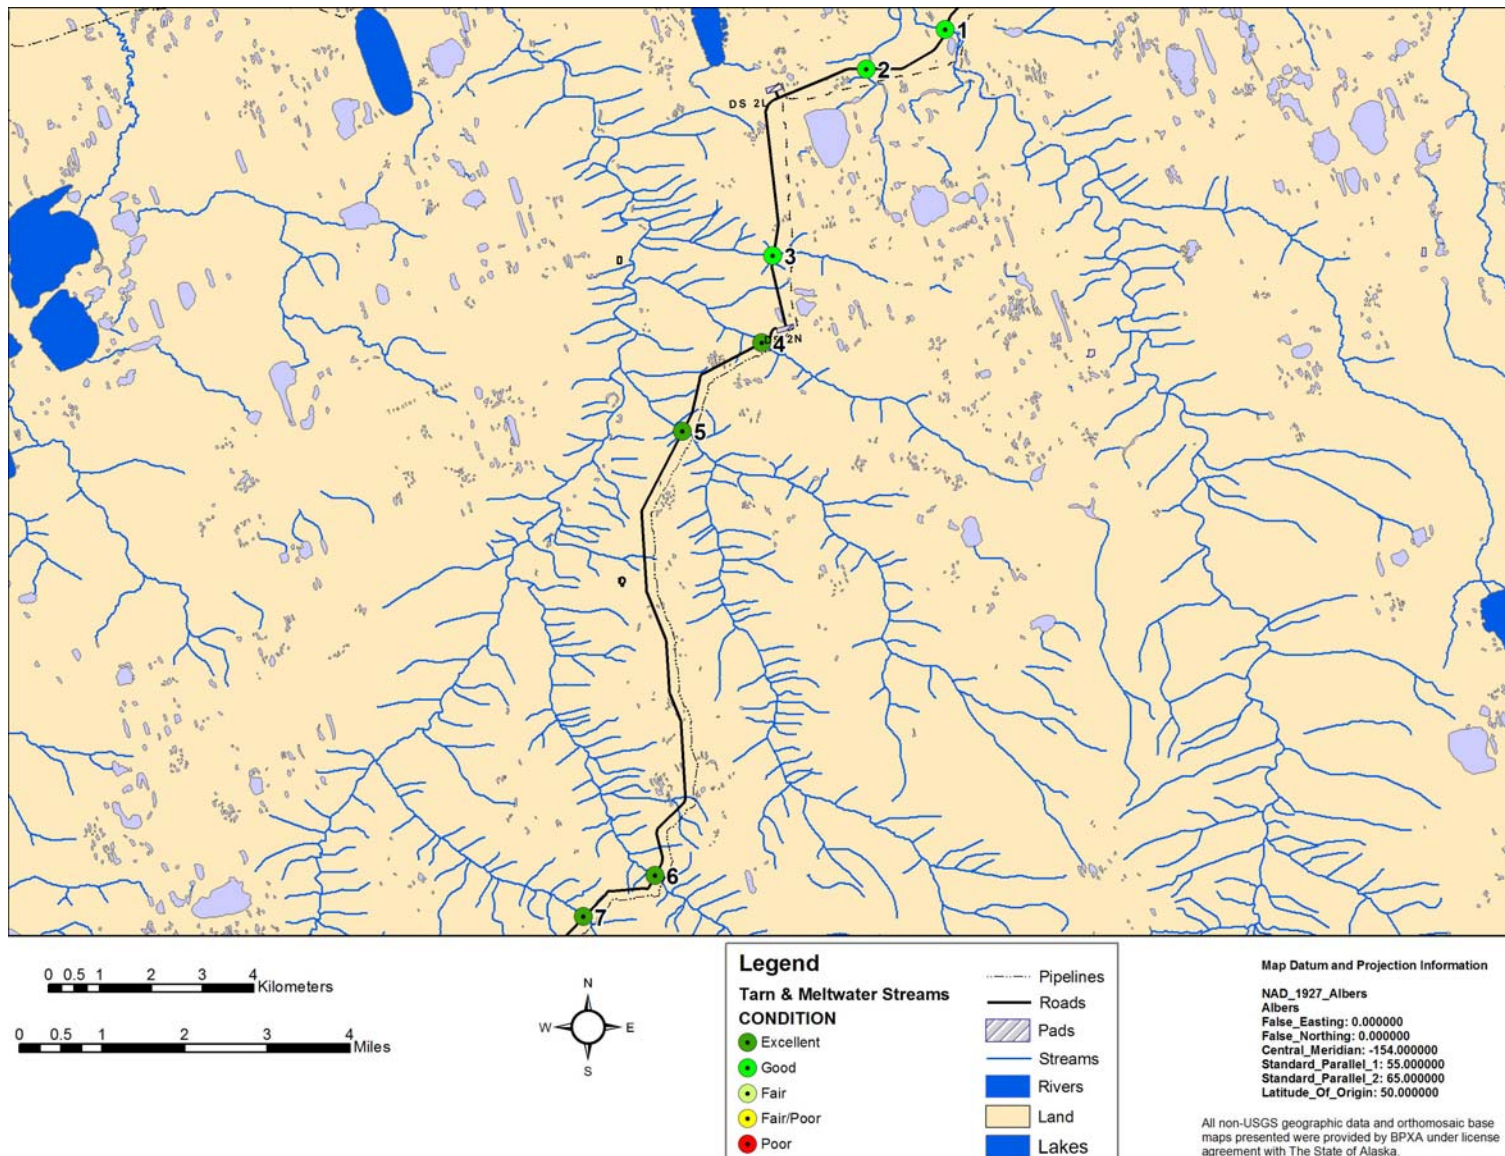
Figure 24. Relative condition of Tarn to Meltwater Road stream crossings.

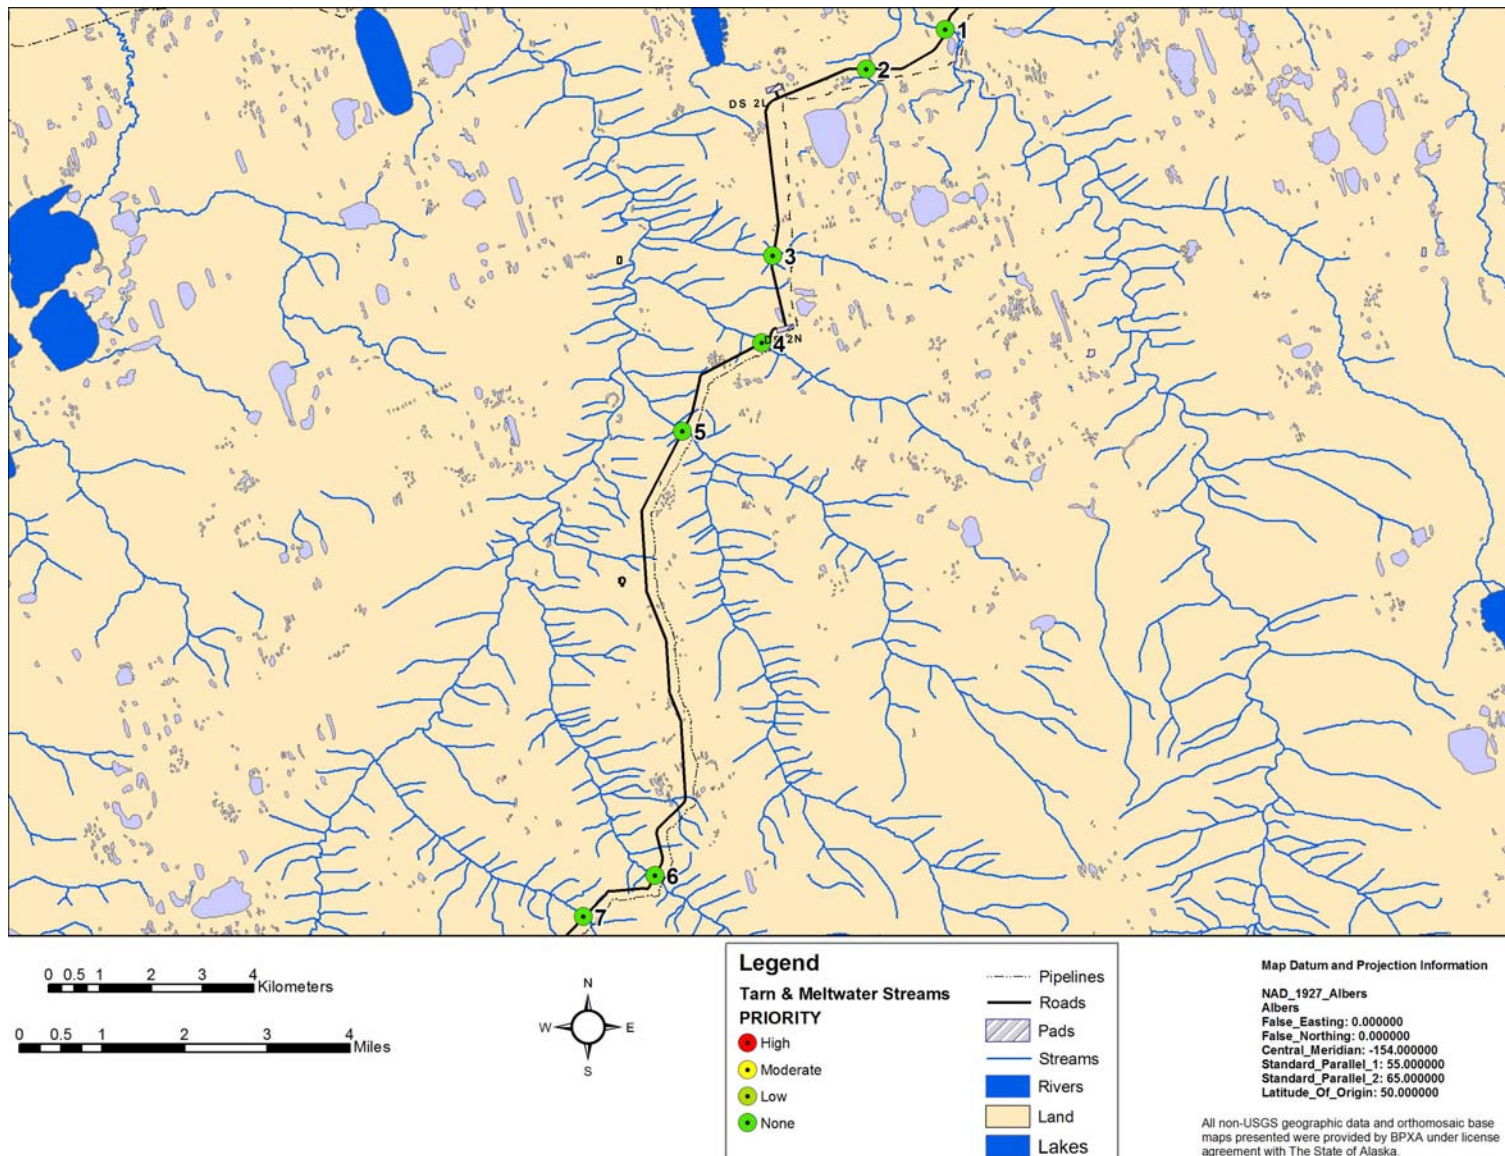
Figure 25. Relative priority for rehabilitation of Tarn to Meltwater Road stream crossings.

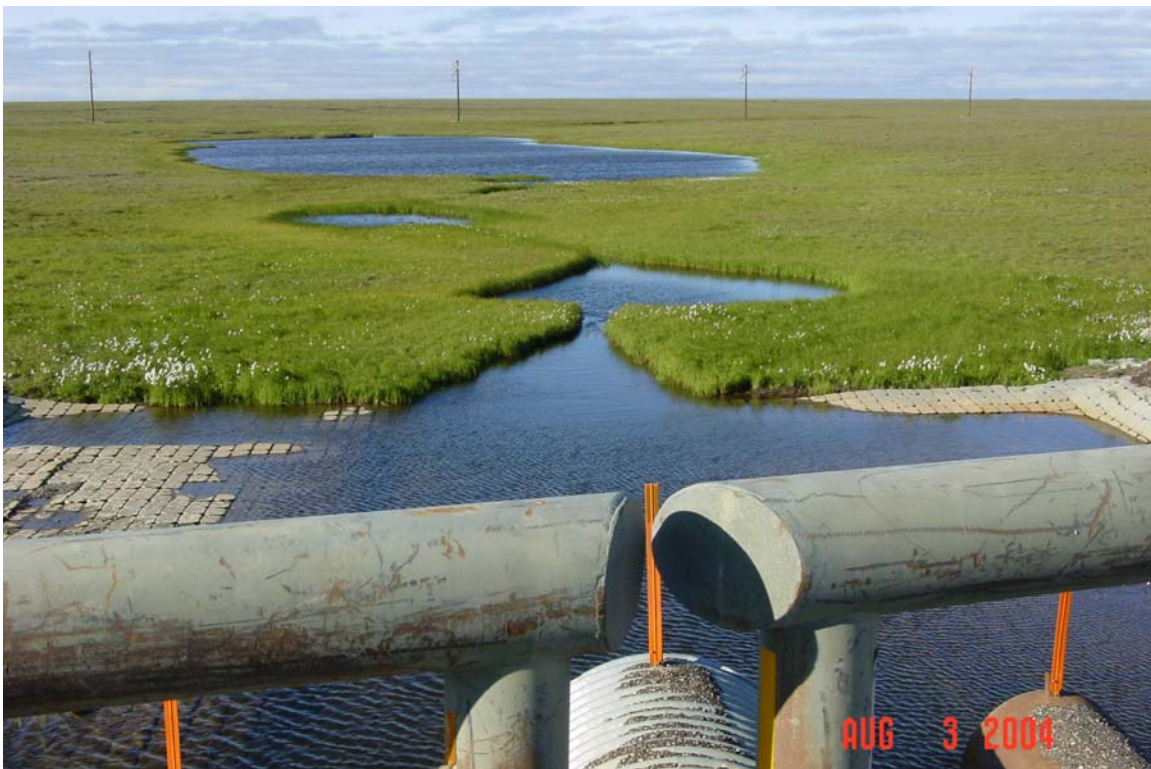
**Photograph 402. Miluveach River tributary looking downstream of the crossing structure. Note the extensive gobi mat armor erosion protection.**

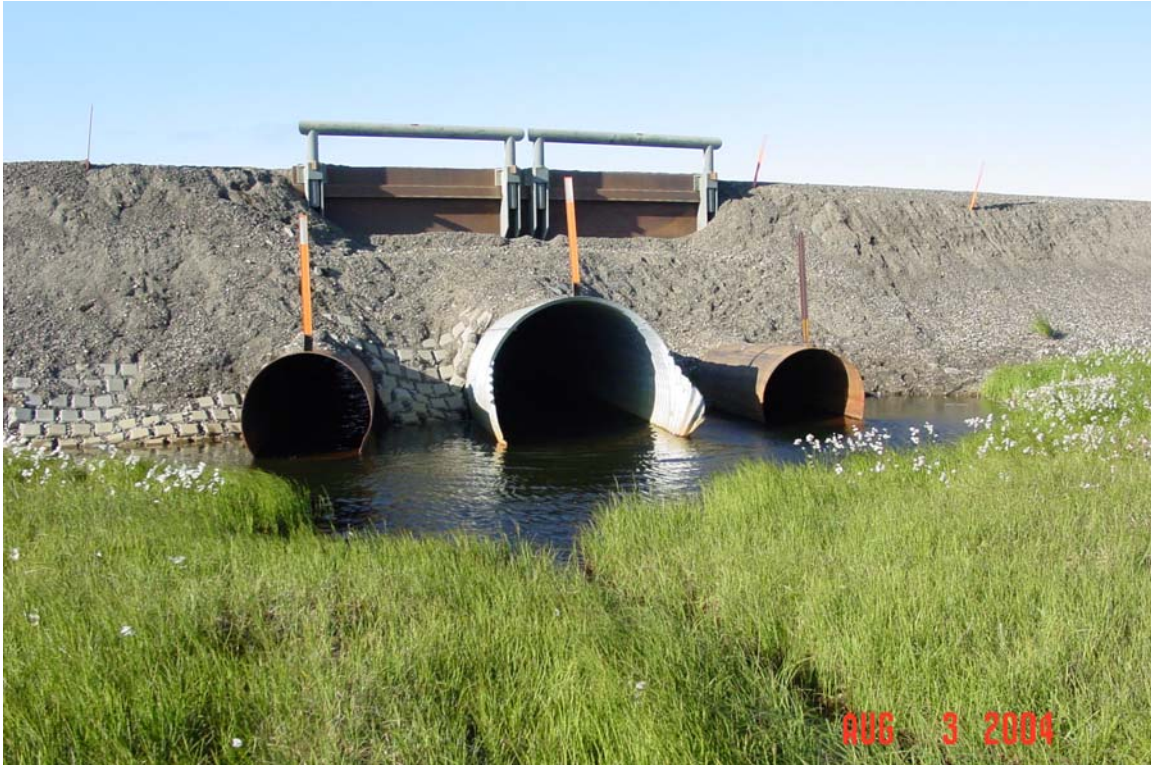
**Photograph 403. Culvert inlets at the Miluveach River tributary. Note the bridge decking over the partially collapsed culvert.**

REMEDIATION RECOMMENDATIONS: None

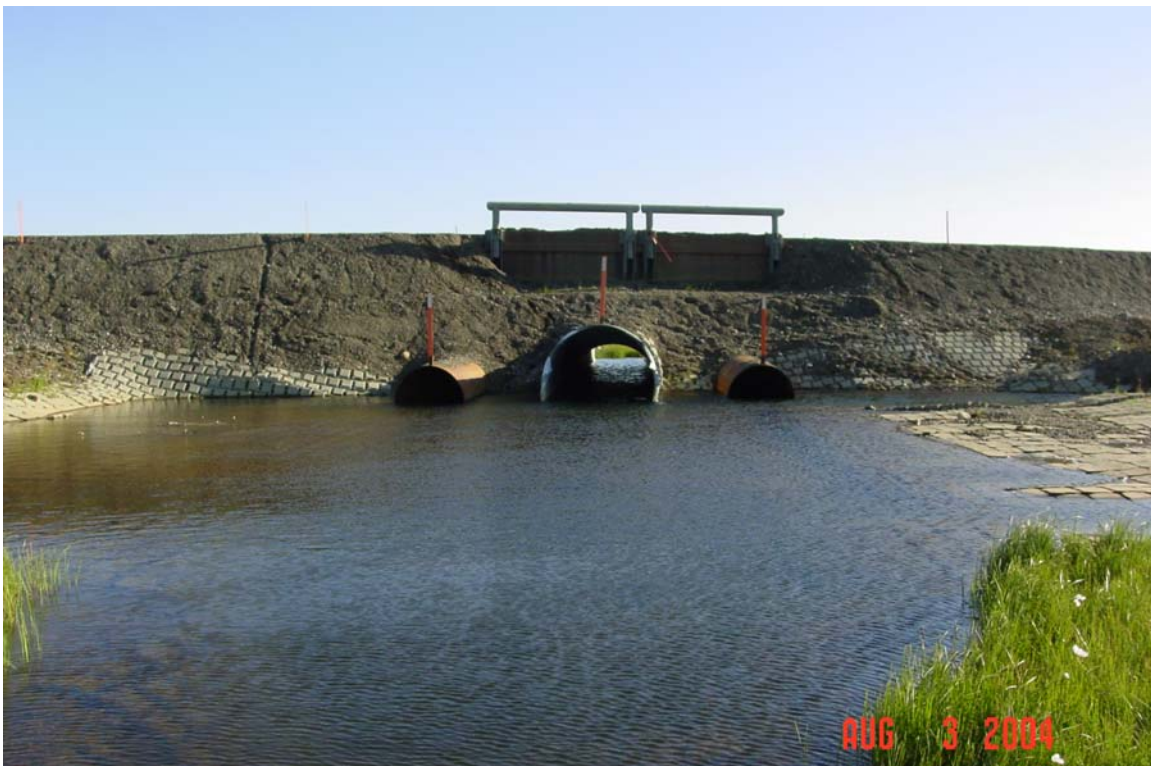
**Photograph 404. Culvert outlets at the Miluveach River tributary. Note the extensive gobi mat armor erosion protection and the bridge decking over the partially collapsed 8 foot culvert.**

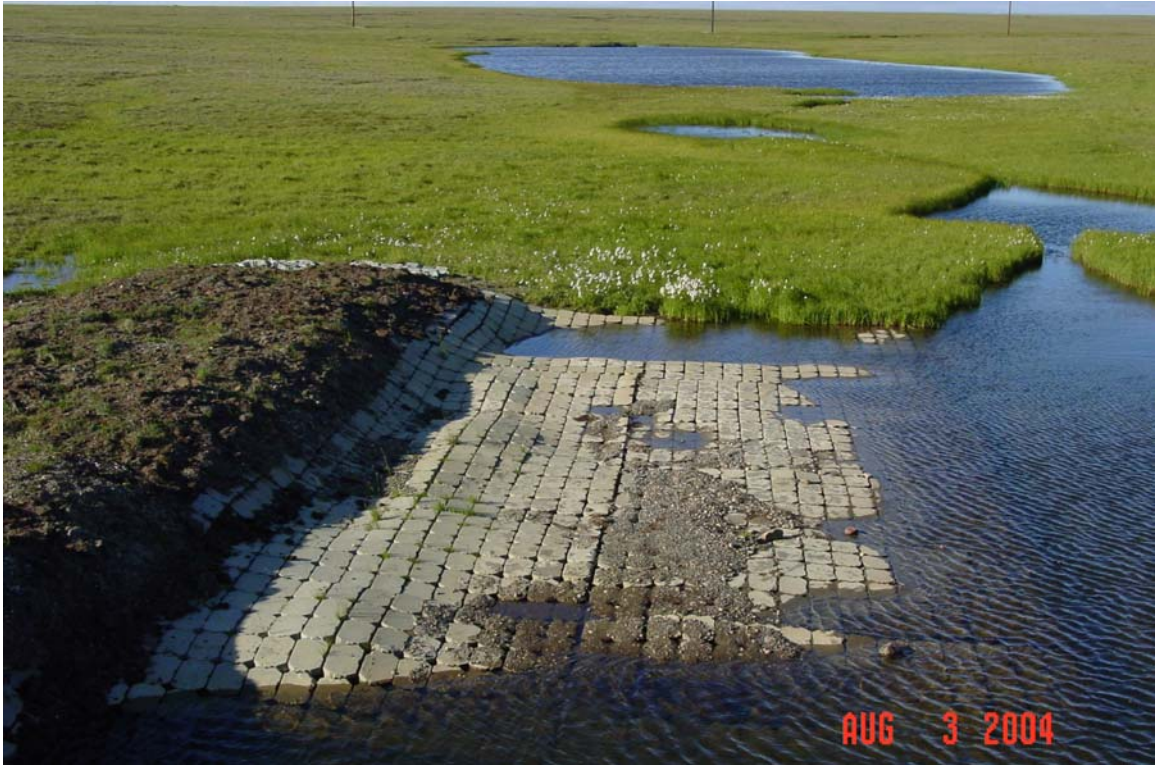
**Photograph 405. Soil berms holding the downstream gobi mat armor erosion protection.**

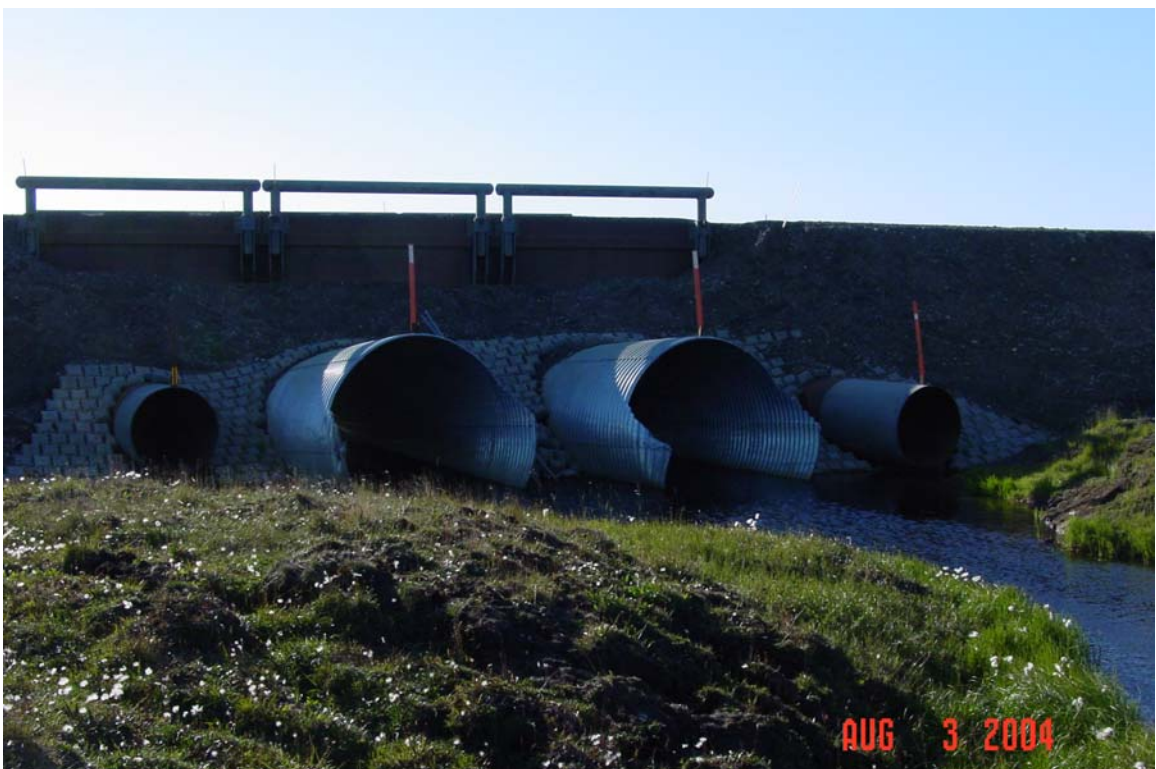
INLET: Gobi mat armor, minor inlet damage

**Photograph 407. Kachemach River tributary culvert battery inlets.**

REMEDIATION RECOMMENDATIONS: None

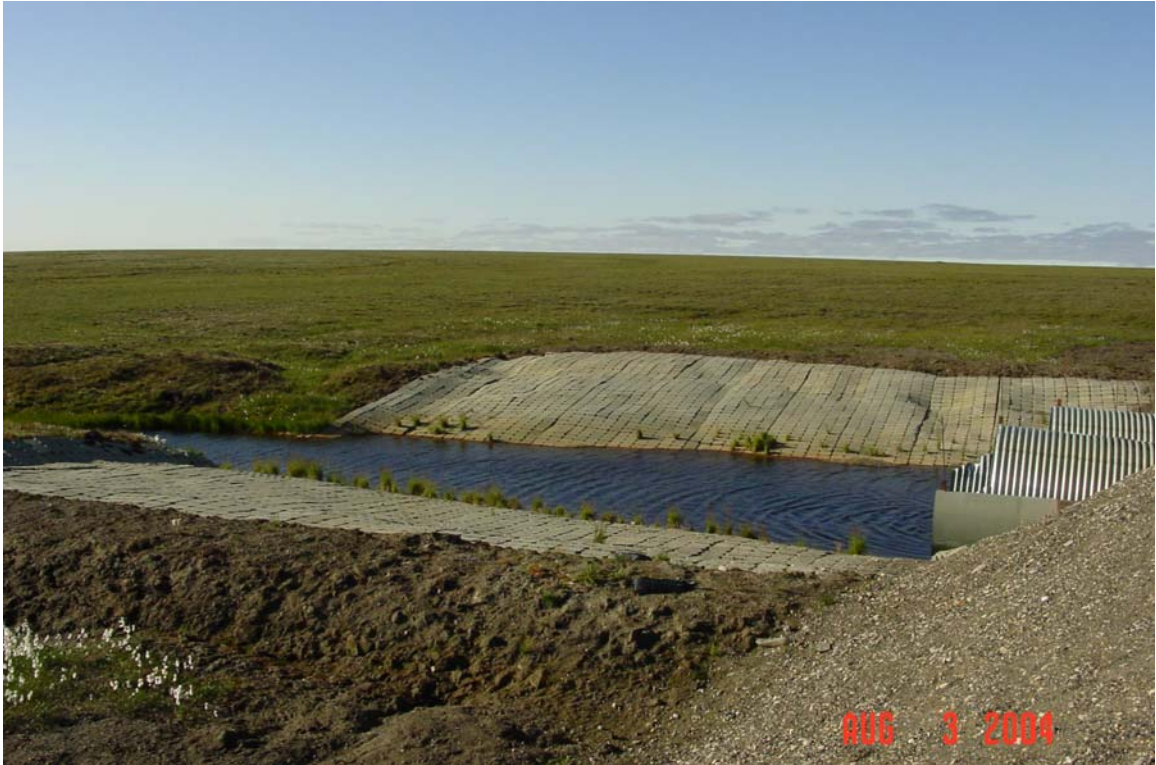
**Photograph 408. Kachemach River tributary culvert outlets with extensive gobi mat erosion protection.**

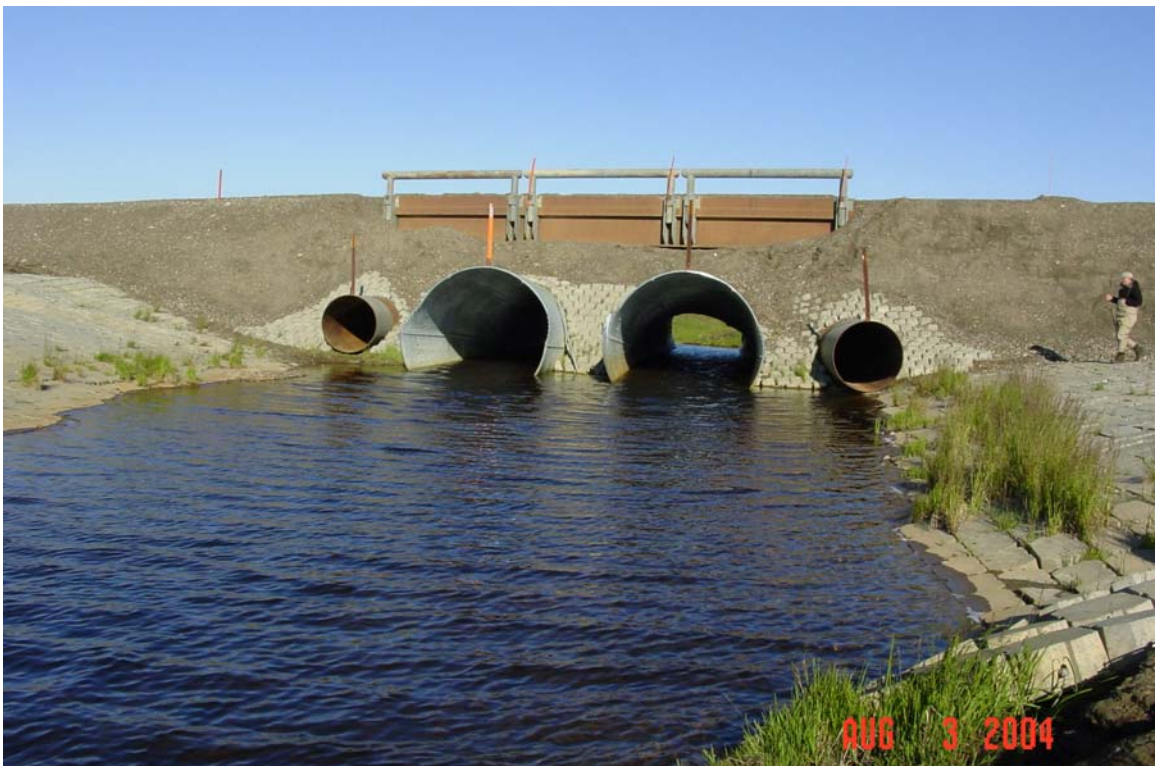
**Photograph 409. Kachemach River tributary culvert outlets with extensive gobi mat armoring. Note the steel bridge decking over the partially collapsed 12 foot multiplate culverts.**
