**A SURVEY OF RECREATIONAL OFF-ROAD VEHICLE (ORV)
STREAM CROSSINGS ALONG TRAILS ORGINATING FROM
THE NABESNA ROAD IN WRANGELL-ST. ELIAS NATIONAL
PARK AND PRESERVE**

February 2009

Alaska Department of Fish and Game
Division of Habitat

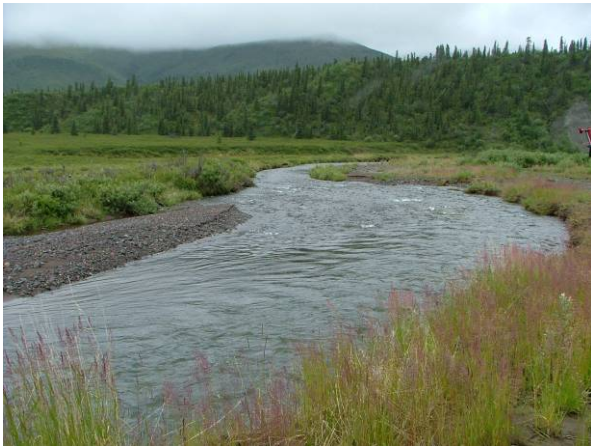
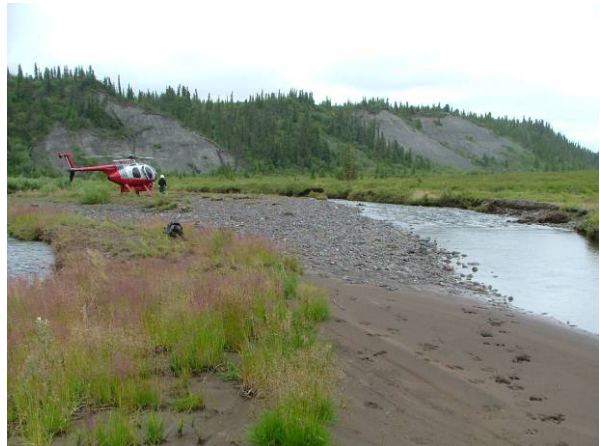
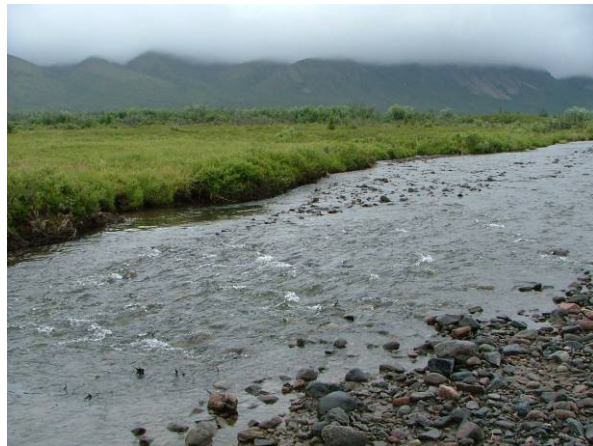
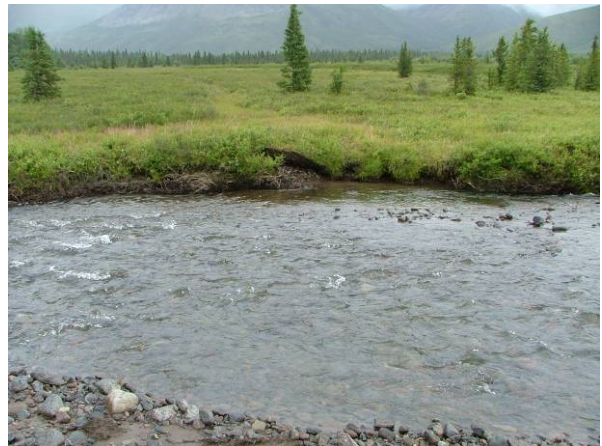
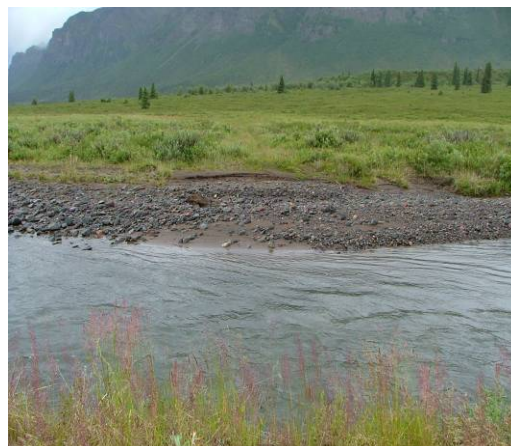
Downstream view from crossing CL-1.

Additional downstream view CL-1 (notice stream splits into two channels).

Upstream view from crossing CL-1.

View of right bank.

Left bank.

WATERBODY TYPE: stream **FLOODPLAIN:** flat **STREAM MORPHOLOGY:** C **H₂O STAGE:** 3
WATERBODY SLOPE: est. 2 % **BANKFULL WIDTH:** 75 (ft.) **FLOODPLAIN WIDTH:** 300+ (ft.)
SUBSTRATE (%): Bedrock ____ Boulder ____ Cobble _50_ Gravel _50_ Sand ____ Silt/Clay ____ Organic ____
COMMENTS: Bad transition, steep entry on left bank. Note: Clinometer unavailable, waterbody slope is an estimate.

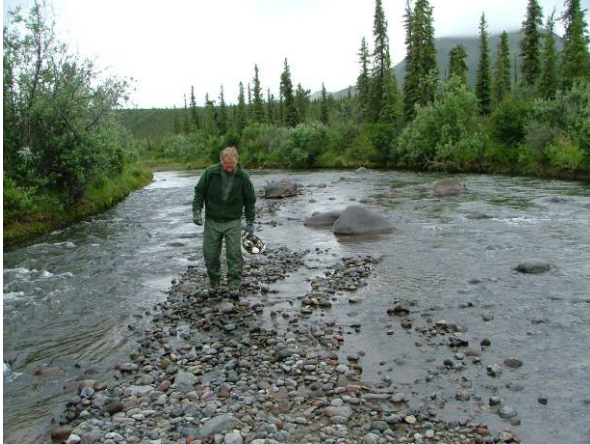
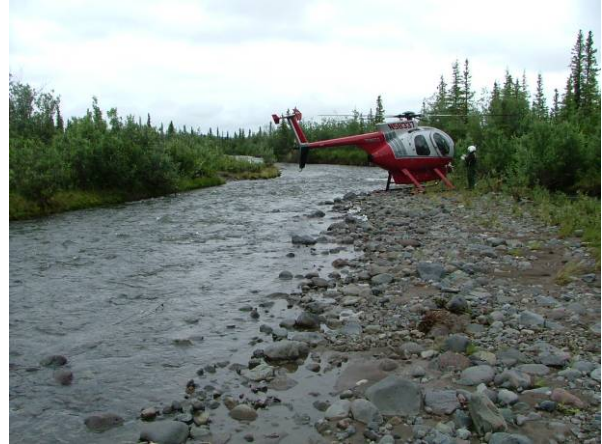
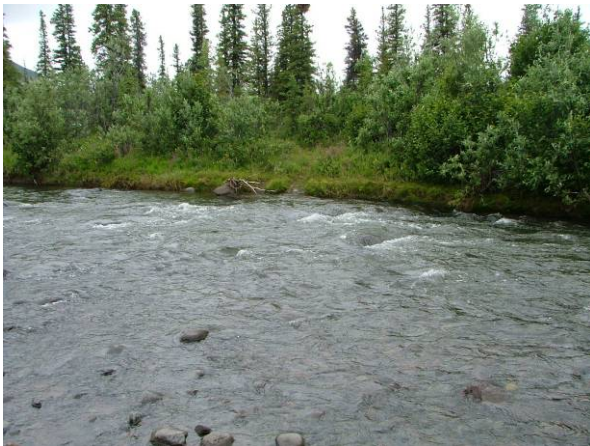
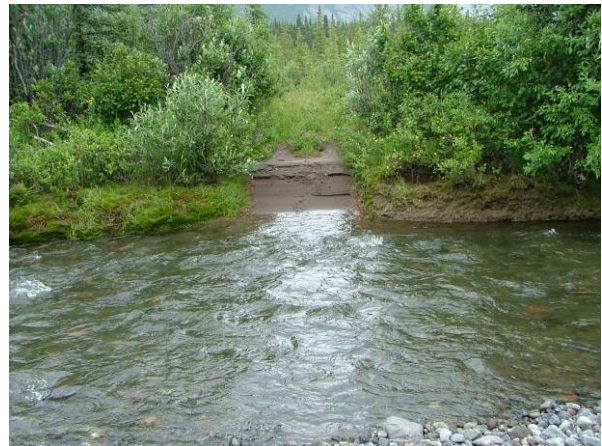
Upstream view from crossing CL-2.

Downstream view from crossing CL-2.

Left bank.

Right bank.

DATE: 7/22/08 **TIME:** 1:00 pm **STATION NO.** CL-2 **HABITAT :** Riffle **WATER COLOR:** Clear
WATERBODY NAME/DESCRIPTION: Unnamed tributary from Tanada Peak Glacier to the Copper River (no fish data available for this tributary, which leads to an uncataloged portion of the Copper River).
GPS LATITUDE: 62° 23.552 **GPS LONGITUDE:** 143° 41.936
RIPARIAN VEGETATION: Functional, but right hand trail approach is partially degraded
WATERBODY TYPE: stream **FLOODPLAIN:** flat **STREAM MORPHOLOGY:** B **H₂O STAGE:** 3
WATERBODY SLOPE: est. 2 % **BANKFULL WIDTH:** 50 (ft.) **FLOODPLAIN WIDTH:** 100 + (ft.)
SUBSTRATE (%): Bedrock ____ Boulder _5_ Cobble _40_ Gravel _55_ Sand ____ Silt/Clay ____ Organic ____
COMMENTS: Adequate for current level of use. Note: Clinometer unavailable, waterbody slope is an estimate.

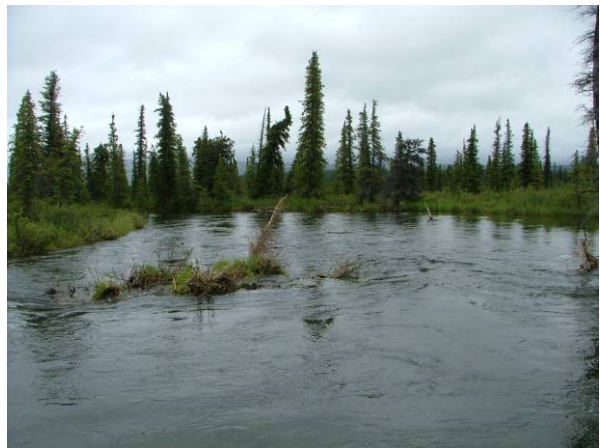
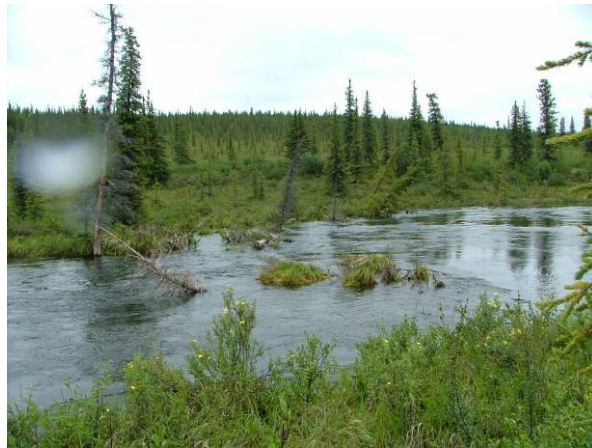
Downstream view from crossing CL-3.

View of right bank.

DATE: 7/22/08 **TIME:** 1:20 pm **STATION NO.** CL-3 **HABITAT :** Riffle, pool **WATER COLOR:** Clear
WATERBODY NAME/DESCRIPTION: Copper Lake outlet to the Copper River (no fish data available for this tributary but it leads to a portion of the Copper River that is cataloged as sockeye present).
GPS LATITUDE: 62° 24.873 **GPS LONGITUDE:** 143° 39.671 **RIPARIAN VEGETATION:** Functional
WATERBODY TYPE: stream **FLOODPLAIN:** flat **STREAM MORPHOLOGY:** C **H₂O STAGE:** 4
WATERBODY SLOPE: est. 2 % **BANKFULL WIDTH:** 50 (ft.) **FLOODPLAIN WIDTH:** 150 (ft.)
SUBSTRATE (%): Bedrock ____ Boulder ____ Cobble ____ Gravel _100_ Sand ____ Silt/Clay ____ Organic ____
COMMENTS: No discernable crossing (trail fans out), may be one toward Copper River near private cabin. Too deep to cross to get photo of left bank. Note: Clinometer unavailable, waterbody slope is an estimate.

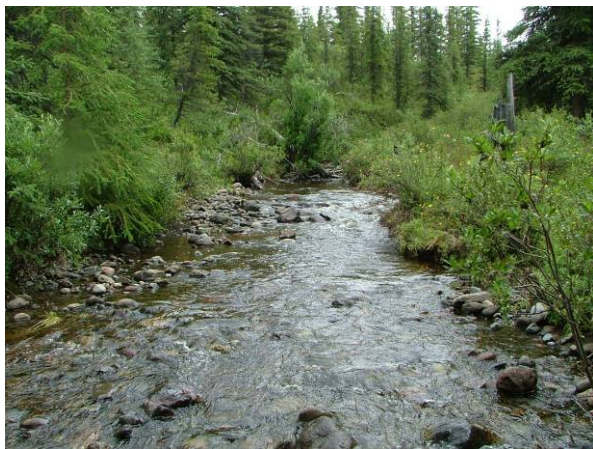
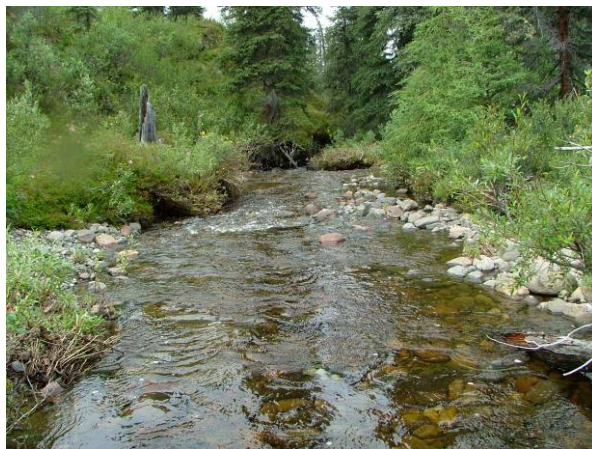
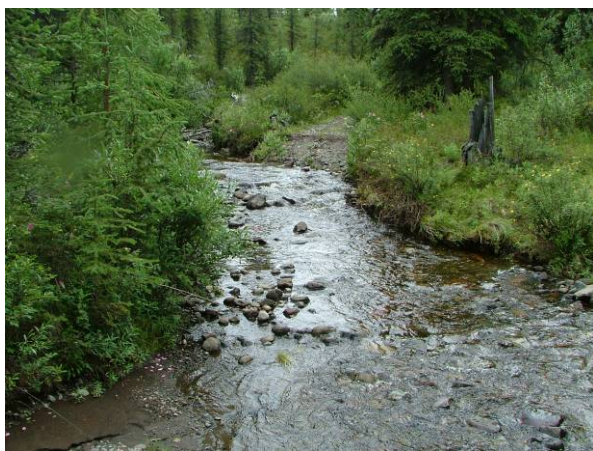
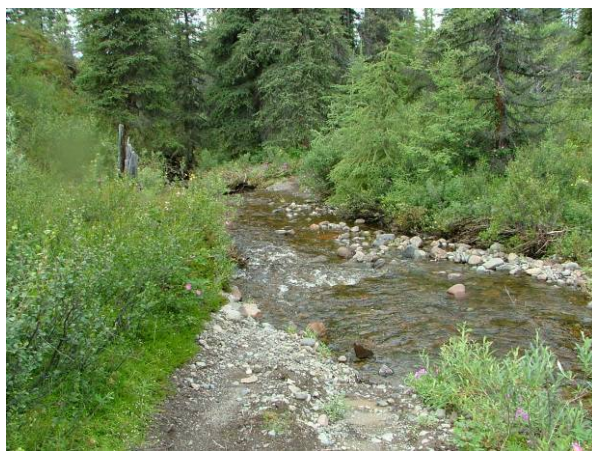
Upstream view from crossing CL-4.

Downstream view from crossing CL-4.

Left bank.

Right bank.

COMMENTS: Trail approaches are mostly rock. Stream dropping off high bench into the Copper River. Note: Clinometer unavailable, waterbody slope is an estimate.

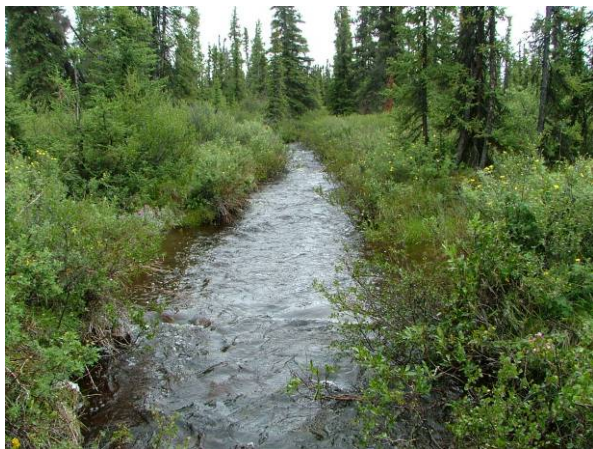
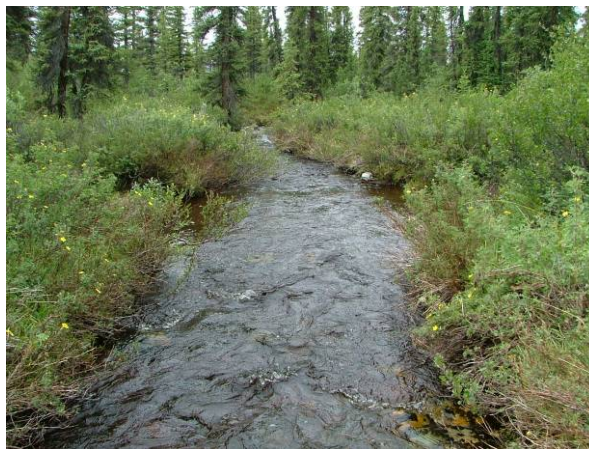
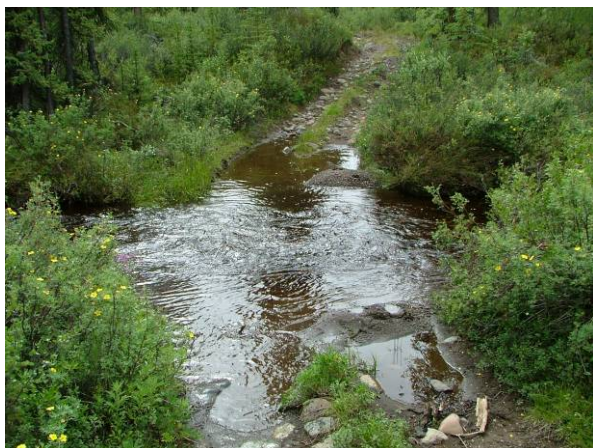
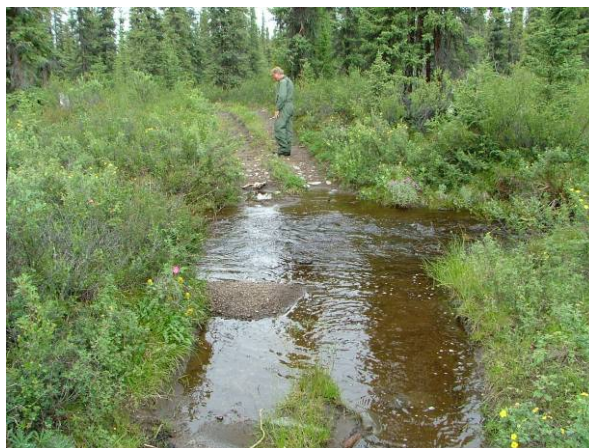
Upstream view from crossing CL-5.

Downstream view from crossing CL-5.

Left bank.

Right bank.

DATE: 7/22/08 **TIME:** 2:30 pm **STATION NO.** CL-5 **HABITAT :** Riffle **WATER COLOR:** Clear, stained
WATERBODY NAME/DESCRIPTION: Unnamed tributary to the Copper River (no fish data available but this tributary leads to a portion of the Copper River that is cataloged as sockeye present)
GPS LATITUDE: 62° 29.444 **GPS LONGITUDE:** 143°37.762
RIPARIAN VEGETATION: Functional, but both bank approaches are downcut and partially degraded
WATERBODY TYPE: stream **FLOODPLAIN:** flat **STREAM MORPHOLOGY:** B **H₂O STAGE:** 3
WATERBODY SLOPE: est. 2 % **BANKFULL WIDTH:** 10 (ft.) **FLOODPLAIN WIDTH:** 25 (ft.)
SUBSTRATE (%): Bedrock ____ Boulder ____ Cobble _50_ Gravel _50_ Sand ____ Silt/Clay ____ Organic ____
COMMENTS: Trail approaches are gradual and rock/sand. Stream dropping off high bench into Copper River. Note: Clinometer unavailable, waterbody slope is an estimate.

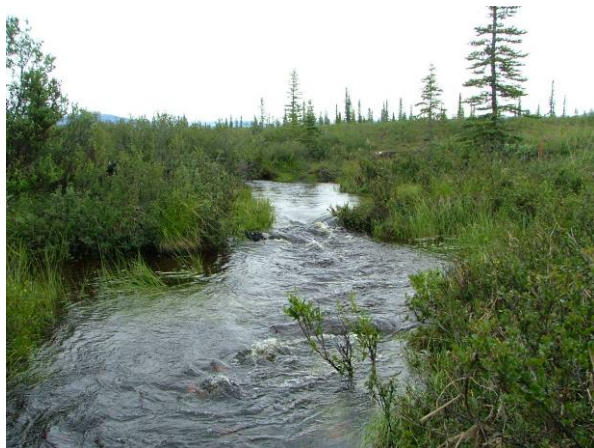
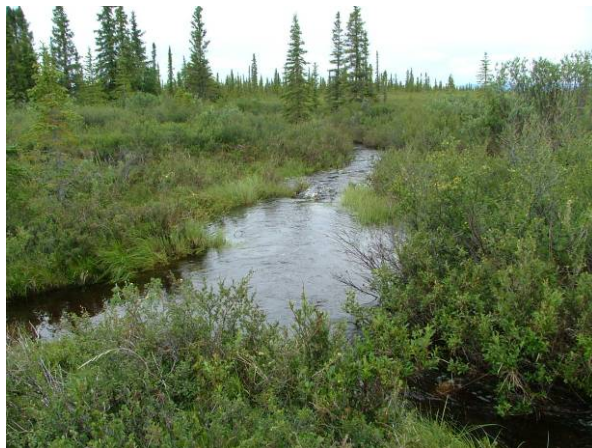
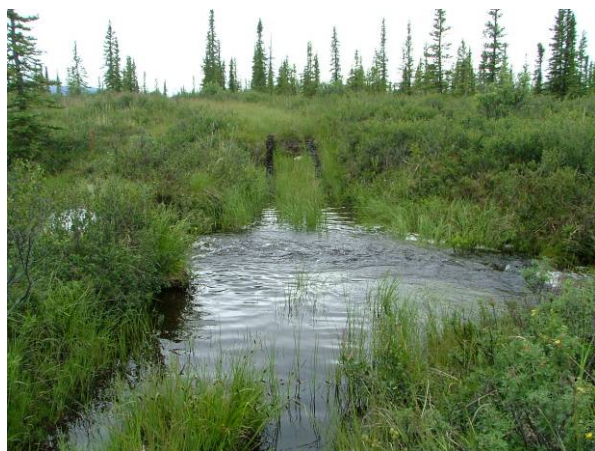
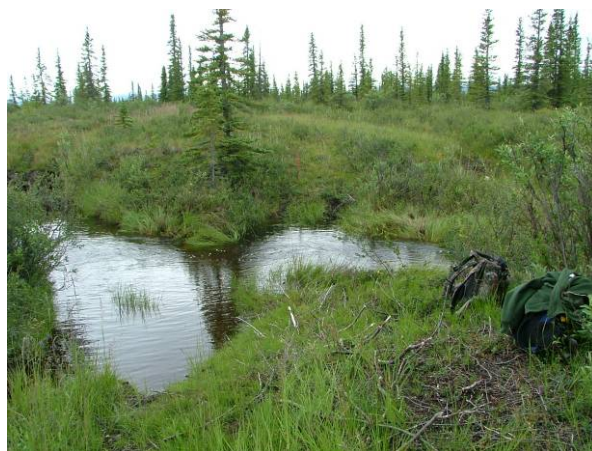
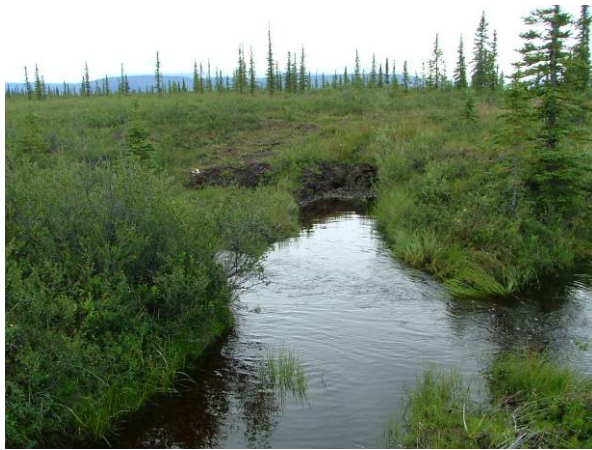
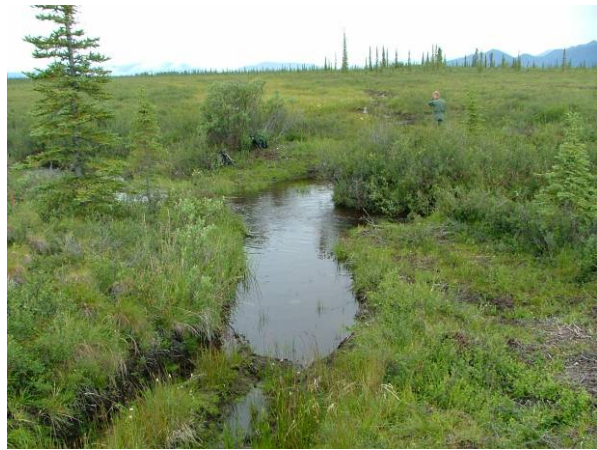
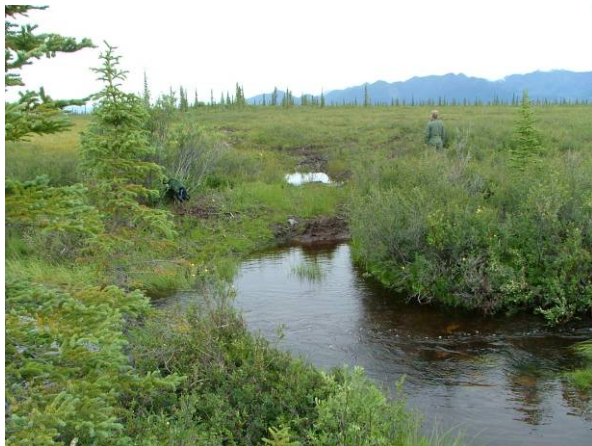
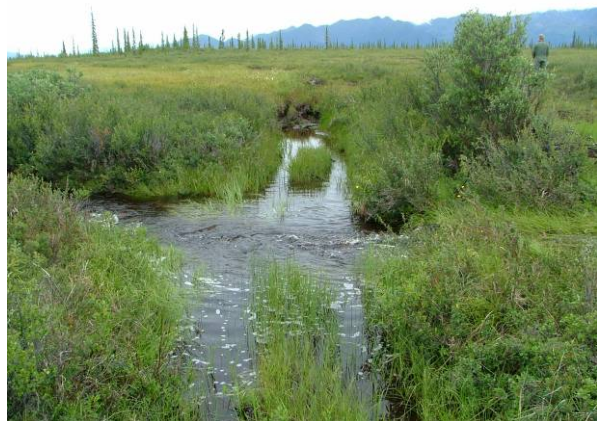
Upstream view from crossing CL-6.

Downstream view from crossing CL-6.

Left bank.

Additional view of left bank.

Third view of left bank.

View of right bank from crossing CL-6.

Additional view of right bank.

Third view of right bank.

COMMENTS: Three crossings at this site. Approaches are set back 10 ft. from channel. Flooded with semi-solid but muddy base, some entrenchment from ATV tracks; possible run-off from upland trail. Minimal soil exposed at the 3 entrance points. Note: Clinometer unavailable, waterbody slope is an estimate.

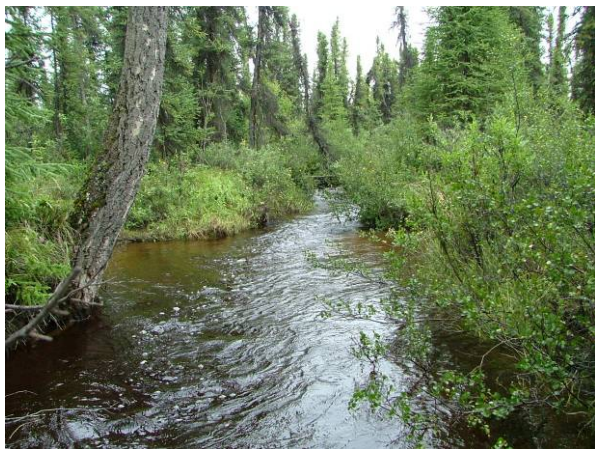
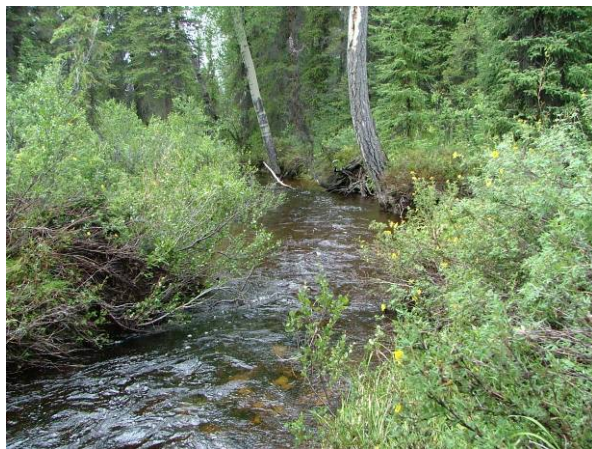
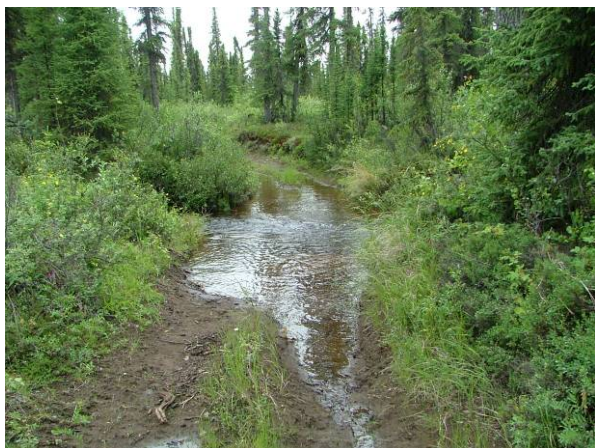
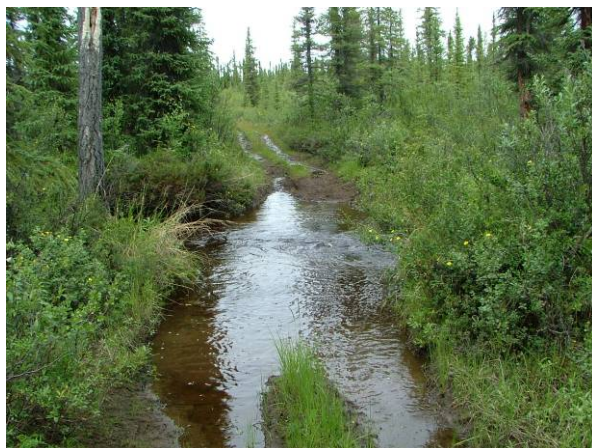
Upstream view from crossing CL-7.

Downstream view from crossing CL-7.

Left bank.

Right bank.

DATE: 7/22/08 **TIME:** 4:40 pm **STATION NO.** CL-7 **HABITAT :** Riffle **WATER COLOR:** Clear, stained
WATERBODY NAME/DESCRIPTION: Unnamed tributary to the Copper River (no fish data available for this tributary but it leads to a portion of the Copper River that is cataloged as sockeye present)
GPS LATITUDE: 62° 34.011 **GPS LONGITUDE:** 143° 40.865
RIPARIAN VEGETATION: Functional, but both bank approaches are downcut and partially degraded
WATERBODY TYPE: stream **FLOODPLAIN:** flat **STREAM MORPHOLOGY:** B **H₂O STAGE:** 4
WATERBODY SLOPE: est. 2 % **BANKFULL WIDTH:** 15 (ft.) **FLOODPLAIN WIDTH:** 30 (ft.)
SUBSTRATE (%): Bedrock ____ Boulder ____ Cobble _50_ Gravel _40_ Sand _10_ Silt/Clay ____ Organic ____
COMMENTS: Trail approaches are set back, mostly sand, low grade with minor upper trail run-off. Note:
 Clinometer unavailable, waterbody slope is an estimate.

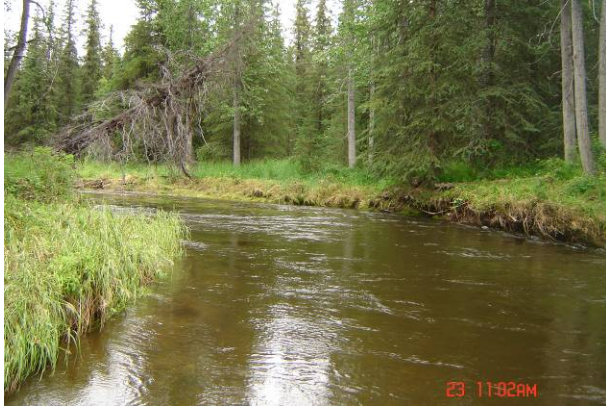
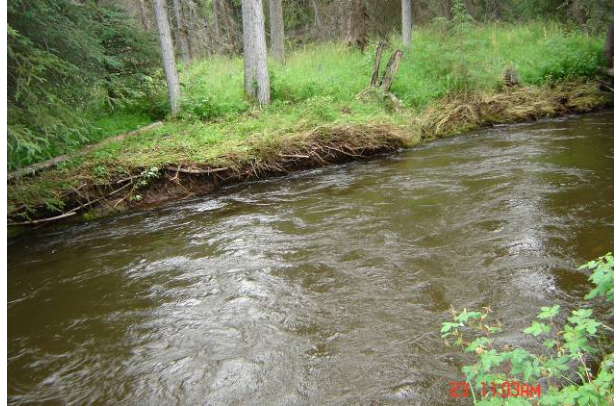
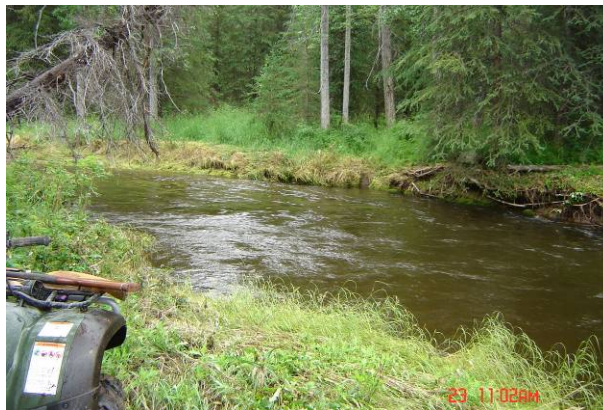
Upstream view from crossing TC-1.

Downstream view from crossing TC-1.

Left bank.

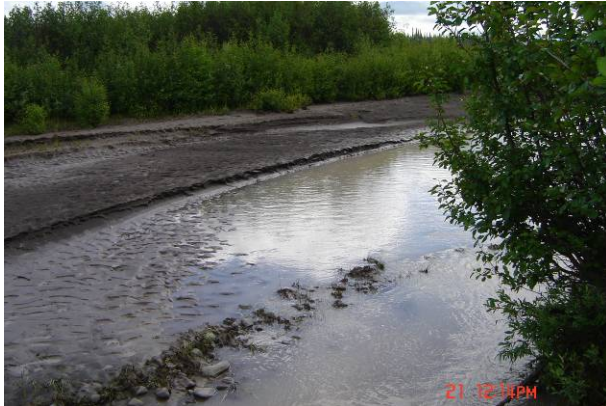
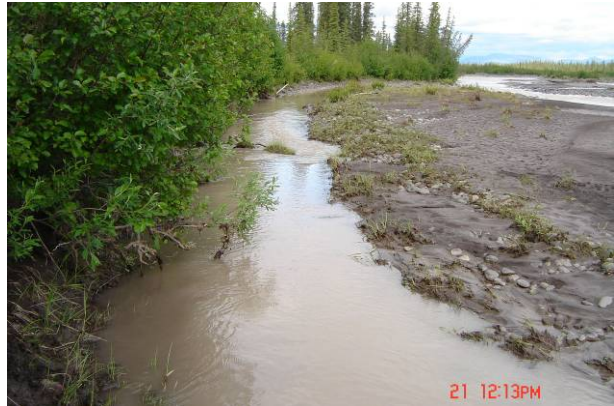
This trail is located within the Copper River watershed. We surveyed two crossings along this trail. The BT-1 crossing was an old crossing that was very difficult to identify as the trail is not heavily used. Locating an actual crossing along Drop Creek (DC-1) was also very difficult to identify for the same reason. The data collected for both of these crossings was taken from a representative reach within the general area of the suspected crossing. Both crossings were in good condition.

Upstream view from the crossing (BT-1).

Downstream view from the crossing (BT-1).

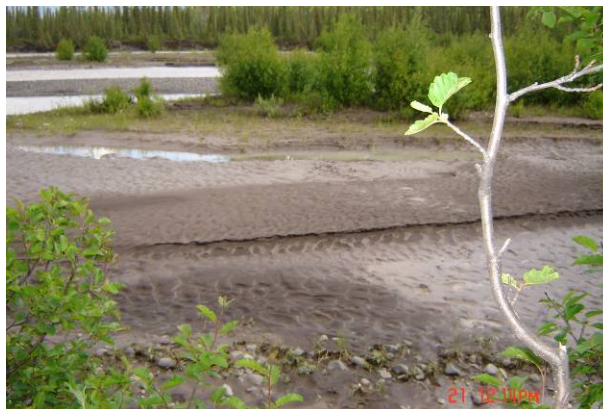
View of the right bank of the Copper River from the crossing (BT-1).

DATE: 7/21/08 **TIME:** 12:00 pm **STATION NO.** BT-1 **HABITAT :** Riffle, side channel **WATER COLOR:** Glacial
WATERBODY NAME/DESCRIPTION: Copper River (cataloged as sockeye present in this stretch)
GPS LATITUDE: 62°32.396 **GPS LONGITUDE:** 143° 40.423 **RIPARIAN VEGETATION:** Functional for channel type
WATERBODY TYPE: river **FLOODPLAIN:** flat **STREAM MORPHOLOGY:** D **H₂O STAGE:** 3
WATERBODY SLOPE: 1 % **BANKFULL WIDTH:** 50 (ft.) **FLOODPLAIN WIDTH:** 500 (ft.)
SUBSTRATE (%): Bedrock ____ Boulder ____ Cobble _25_ Gravel _25_ Sand ____ Silt/Clay _50_ Organic ____
COMMENTS: It was very difficult to identify an actual crossing since the trail is not heavily used. The data collected was taken from a representative reach within the general area of the suspected crossing. No point was plotted on the map (Figure 2).

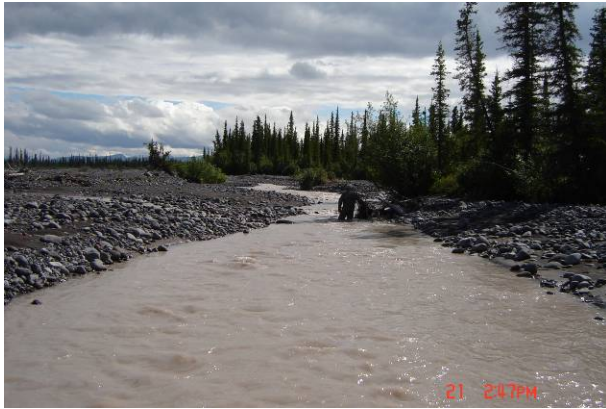
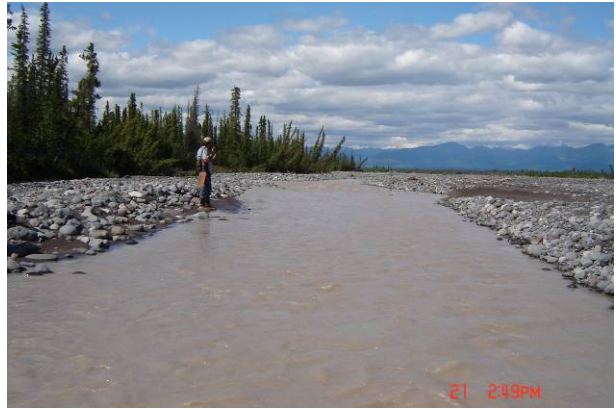
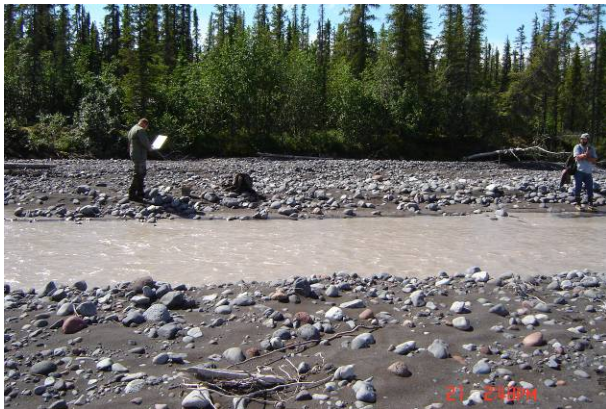
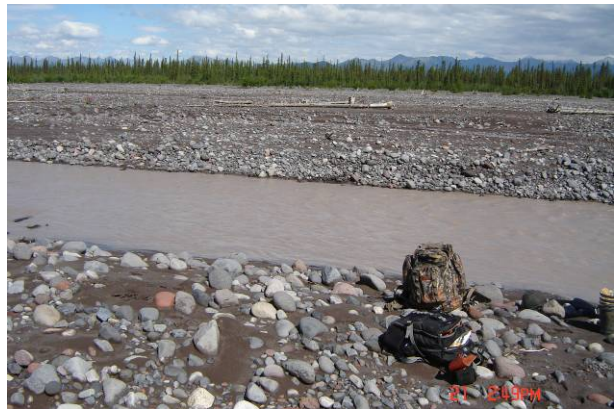
Upstream view from the crossing DC-1.

Downstream view from the crossing DC-1.

Left bank view from the crossing DC-1.

View of right bank from crossing DC-1.

DATE: 7/21/08 **TIME:** 2:30 pm **STATION NO.** DC-1 **HABITAT :** Riffle **WATER COLOR:** Glacial
WATERBODY NAME/DESCRIPTION: Drop Creek (no fish data available)
GPS LATITUDE: unknown **GPS LONGITUDE:** unknown **RIPARIAN VEGETATION:** Functional for channel type
WATERBODY TYPE: stream **FLOODPLAIN:** flat **STREAM MORPHOLOGY:** D **H₂O STAGE:** 3
WATERBODY SLOPE: 0.5 % **BANKFULL WIDTH:** variable **FLOODPLAIN WIDTH:** variable
SUBSTRATE (%): Bedrock ____ Boulder ____ Cobble _75_ Gravel _20_ Sand ____ Silt/Clay _5__ Organic ____
COMMENTS: It was very difficult to identify an actual crossing since the trail is not heavily used. The data collected were taken from a representative reach within the general area of the suspected crossing. Tried to locate Latitude: 62° 33'36.8", Longitude: 143° 48'34.8" and believe we were close to this location, but were not able to specifically identify trail location. GPS data not plotted on map.

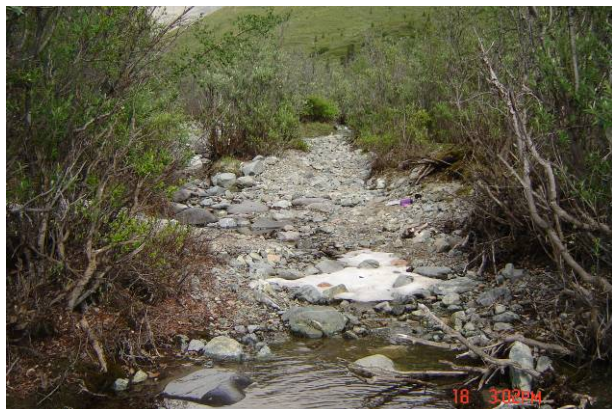
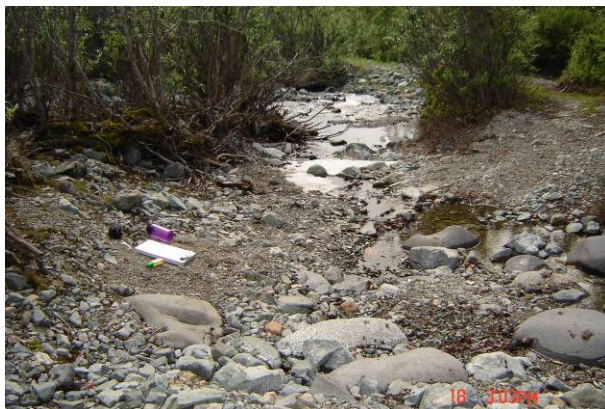
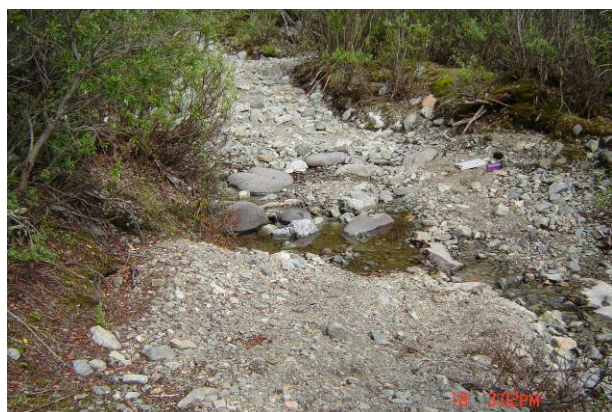
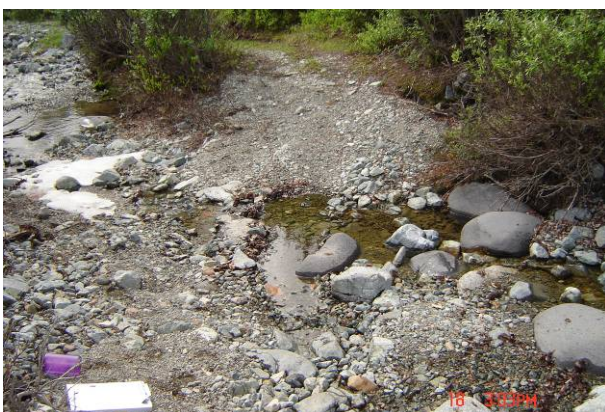
Upstream view from crossing CC-1

Downstream view from crossing CC-1.

View of left bank from crossing CC-1.

View of right bank from crossing CC-1.

DATE: 7/18/08 **TIME:** 3:00 pm **STATION NO.** CC-1 **HABITAT :** Riffle **WATER COLOR:** Clear
WATERBODY NAME/DESCRIPTION: Unnamed tributary to Natat Creek (no fish data for this tributary but leads to a portion of Natat Creek, approximately 10 miles downstream, which is cataloged as king present and king spawning).
GPS LATITUDE: 62° 26.326 **GPS LONGITUDE:** 143° 28.178 **RIPARIAN VEGETATION:** Functional
WATERBODY TYPE: stream **FLOODPLAIN:** V-shaped **STREAM MORPHOLOGY:** A **H₂O STAGE:** 1
WATERBODY SLOPE: 6 % **BANKFULL WIDTH:** 15 (ft.) **FLOODPLAIN WIDTH:** 50 (ft.)
SUBSTRATE (%): Bedrock ____ Boulder _10_ Cobble _40_ Gravel _50_ Sand ____ Silt/Clay ____ Organic ____
COMMENTS: Crossing in good condition.

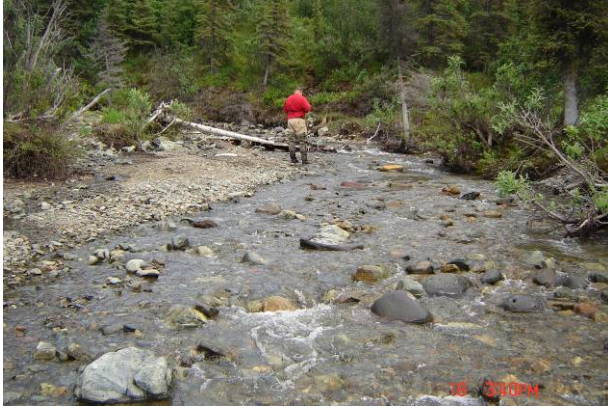
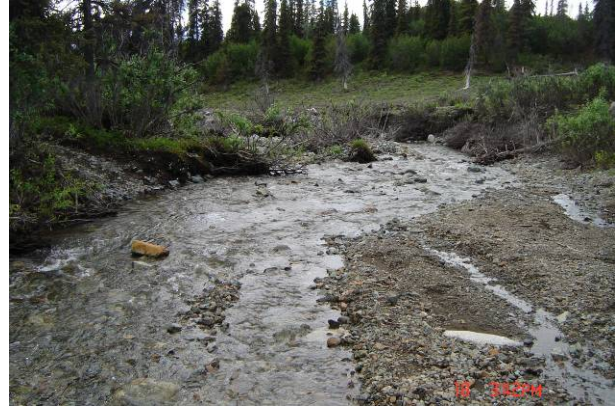
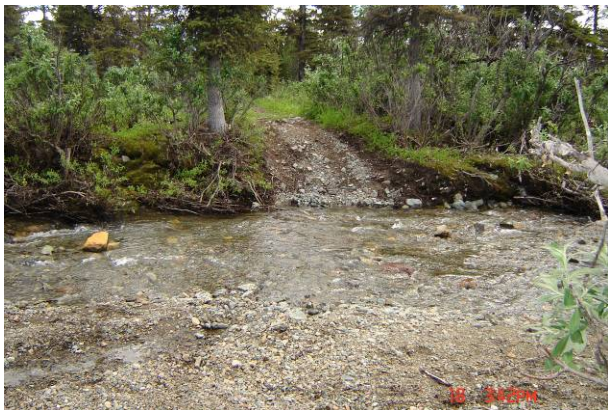
Upstream view from crossing CC-2.

Downstream view from crossing CC-2.

Left bank CC-2.

DATE: 7/1808 **TIME:** 3:40 pm **STATION NO.** CC-2 **HABITAT :** Riffle **WATER COLOR:** Clear
WATERBODY NAME/DESCRIPTION: Unnamed tributary to Natat Creek (no fish data for this tributary but it leads to a portion of Natat Creek, approximately 10 miles downstream, that is cataloged as king present and king spawning).
GPS LATITUDE: 62°35.702 **GPS LONGITUDE:** 143°28.370 **RIPARIAN VEGETATION:** Functional
WATERBODY TYPE: stream **FLOODPLAIN:** V-shaped **STREAM MORPHOLOGY:** A **H₂O STAGE:** 3
WATERBODY SLOPE: 5 % **BANKFULL WIDTH:** 30 (ft.) **FLOODPLAIN WIDTH:** 45 (ft.)
SUBSTRATE (%): Bedrock ____ Boulder _10_ Cobble _40_ Gravel _50_ Sand ____ Silt/Clay ____ Organic ____
COMMENTS: Appears that the original crossing on the right bank has been washed out (see photo of right bank) and a new one started to the upstream side of the old crossing on the right bank.

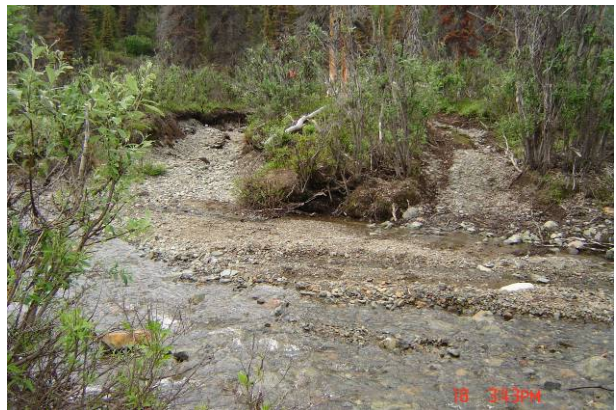
Right bank. Notice washout to the left.

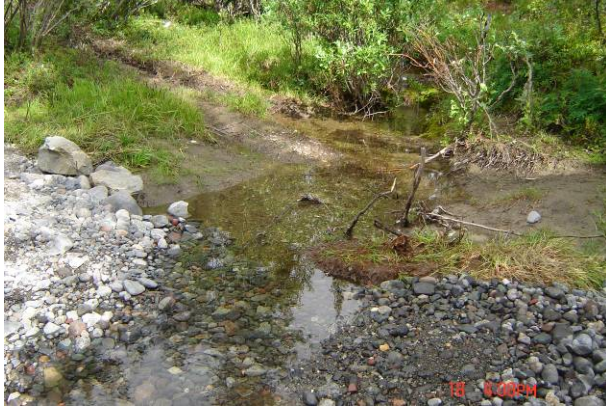
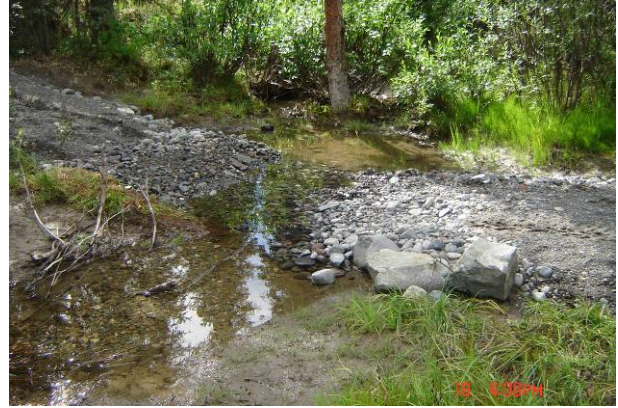
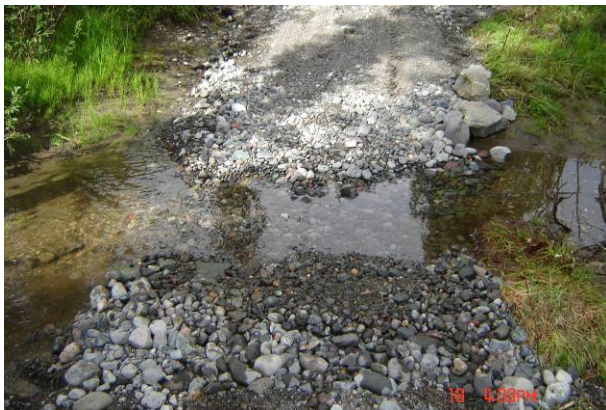
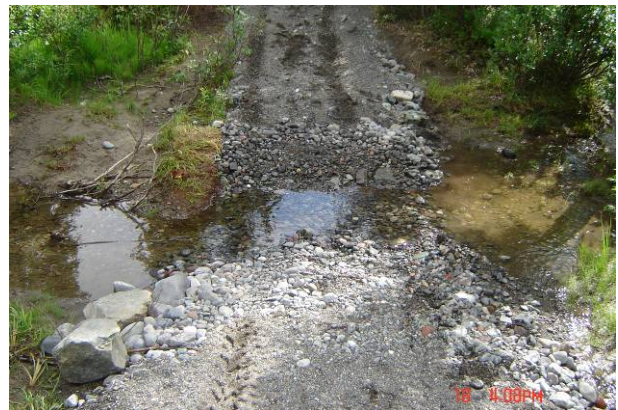
Upstream view from crossing CC-3.

Downstream view from crossing CC-3.

View of right bank.

View of left bank.

DATE: 7/18/08 **TIME:** 4:00 pm **STATION NO.** CC-3 **HABITAT :** Pool, side channel **WATER COLOR:** Clear
WATERBODY NAME/DESCRIPTION: Unnamed tributary to Caribou Creek (no fish data available for this tributary or for Caribou Creek)
GPS LATITUDE: 62°34.640 **GPS LONGITUDE:** 143°29.348 **RIPARIAN VEGETATION:** Functional
WATERBODY TYPE: stream **FLOODPLAIN:** flat **STREAM MORPHOLOGY:** unknown **H₂O STAGE:** 1
WATERBODY SLOPE: 1 % **BANKFULL WIDTH:** 20 (ft.) **FLOODPLAIN WIDTH:** 50-100 (ft.)
SUBSTRATE (%): Bedrock ____ Boulder ____ Cobble ____ Gravel _10_ Sand _20_ Silt/Clay _70_ Organic ____
COMMENTS: Crossing has already been hardened.

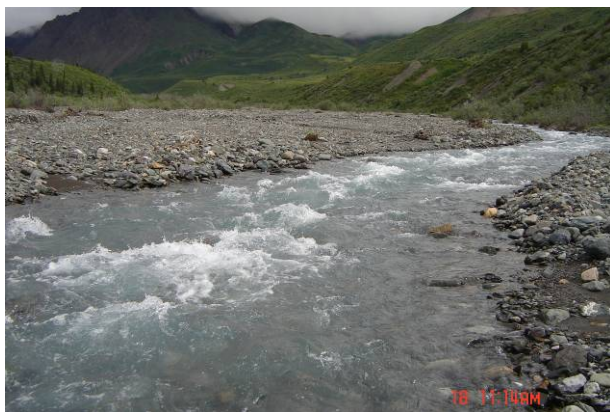
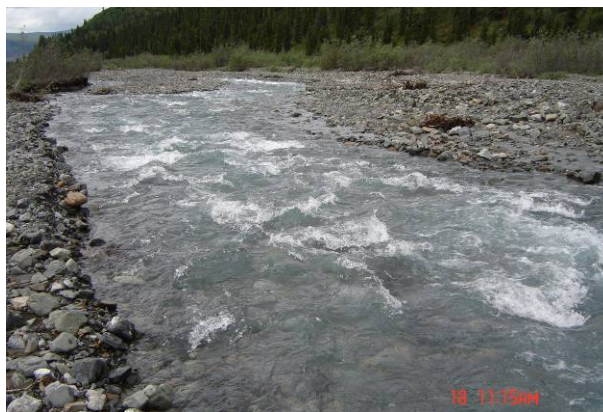
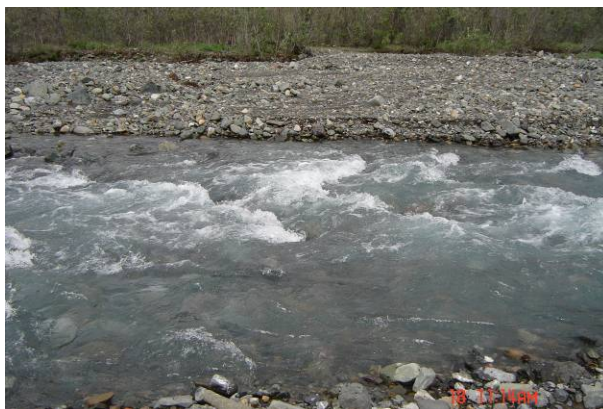
Upstream view from crossing LC-1.

Downstream view from crossing LC-1.

Right bank.

COMMENTS: Crossing appears to be in good condition. Conditions of the entire trail are the same (cobble, boulders, and gravel with indistinguishable crossings, all in good condition) and assume the same is true further upstream.

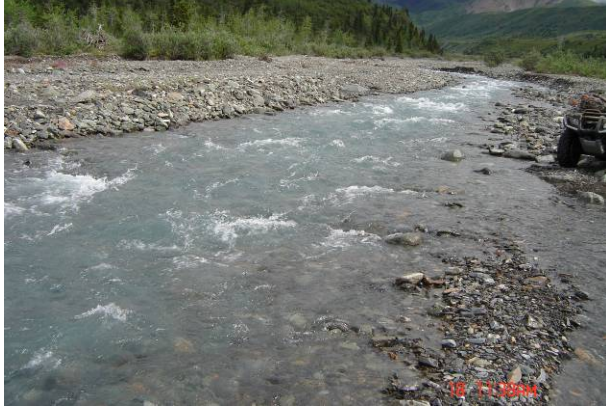
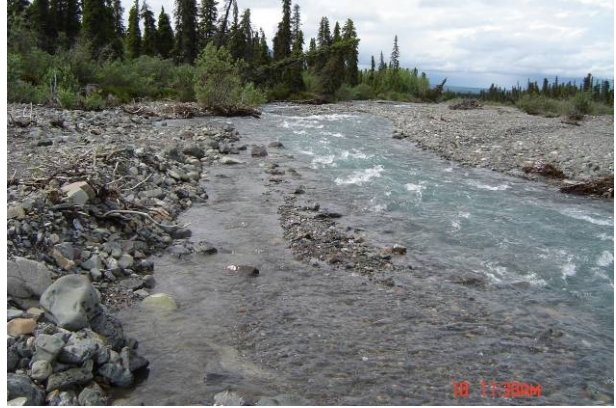
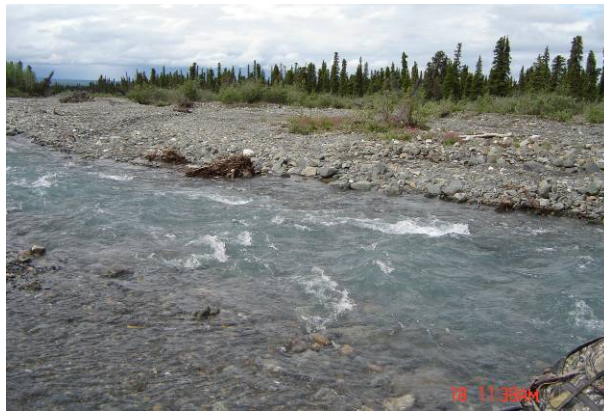
Upstream view from crossing LC-2.

Downstream view from crossing LC-2.

Right bank.

COMMENTS: Made 3 random crossings between LC-1 and LC-2, each of which was very similar to LC-1.

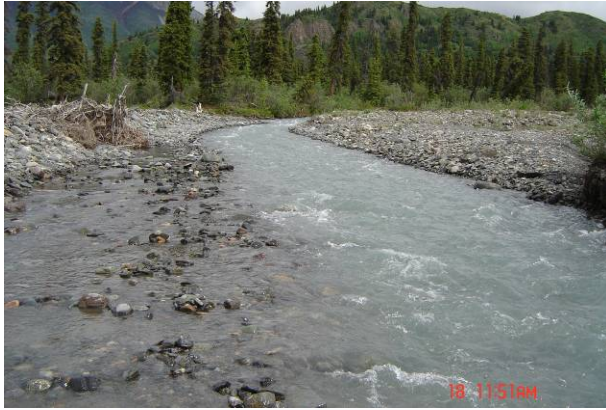
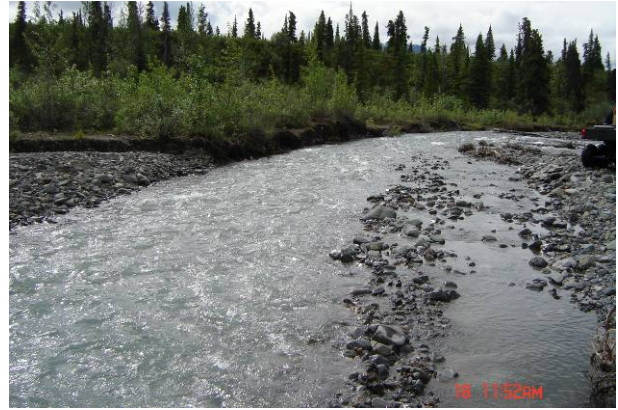
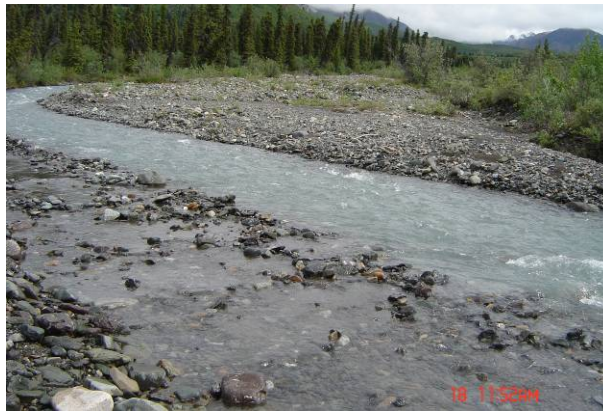
Upstream view from crossing LC-3.

Downstream view from crossing LC-3

Left bank.

COMMENTS: Crossing in good condition.

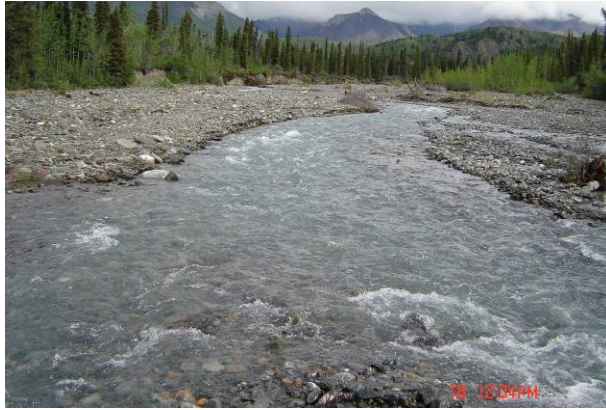
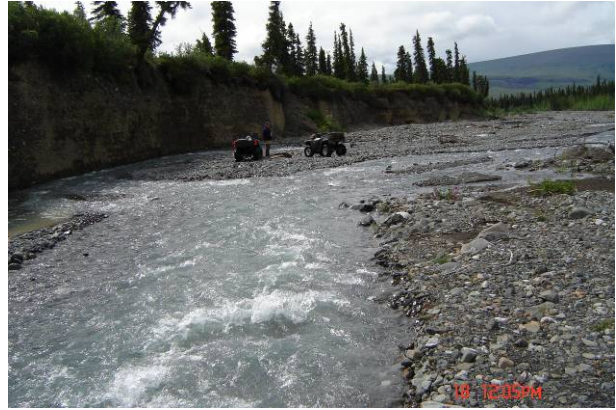
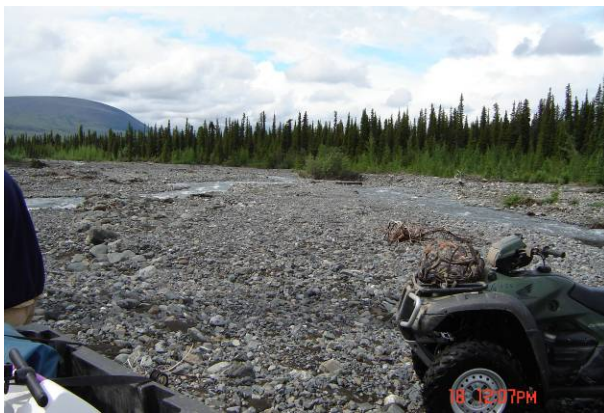
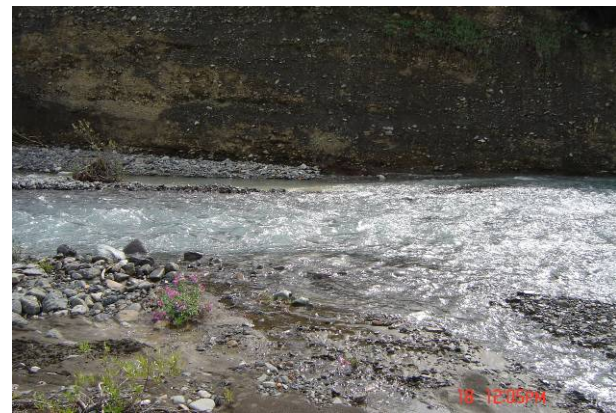
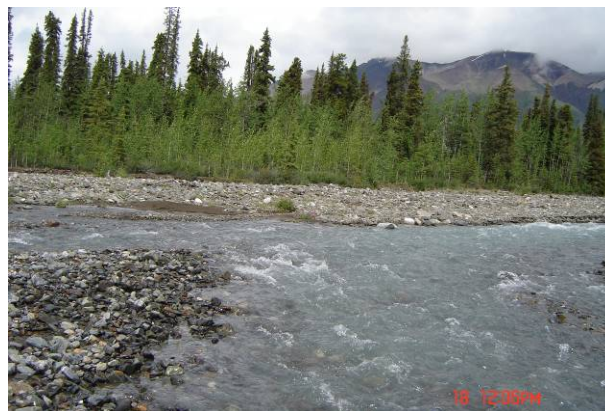
Upstream view from crossing LC-4.

Downstream view of crossing LC-4.

Additional downstream view of crossing.

Left bank.

View of right bank.

COMMENTS: Crossing in good condition. Made 4 random crossings between LC -3 and LC-4 all of which have similar conditions to LC-3 crossing.

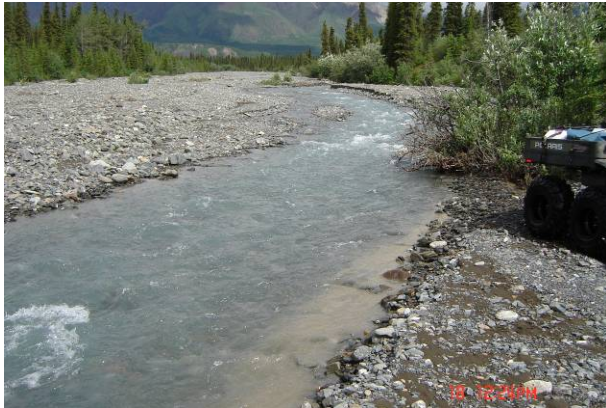
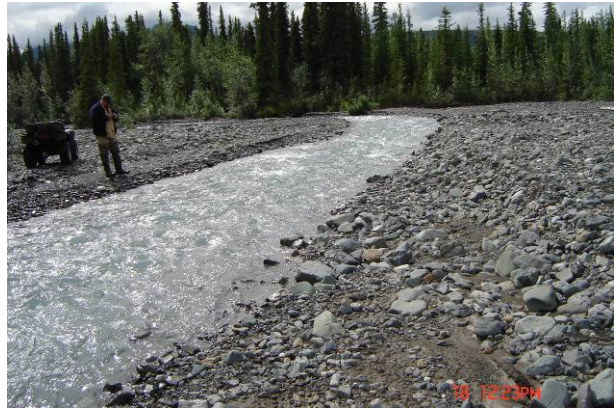
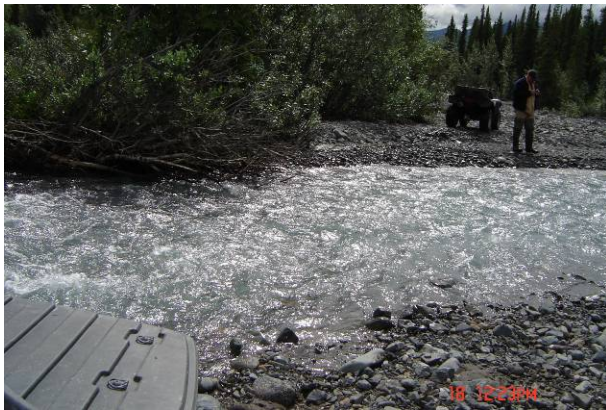
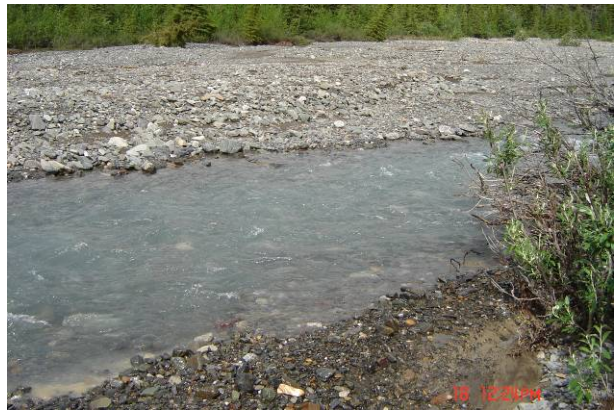
Upstream view from crossing LC-5.

Downstream view from crossing LC-5.

Left bank.

Right bank.

COMMENTS: Crossing in good condition. Made 12 random crossings of between LC-4 and LC-5 all of which had similar conditions to LC-4. Most of these random crossings were of ephemeral streams with cobbles and gravels and very shallow water (less than 6 inches deep).

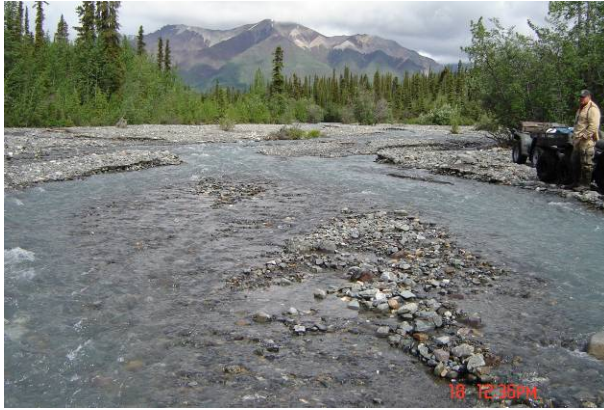
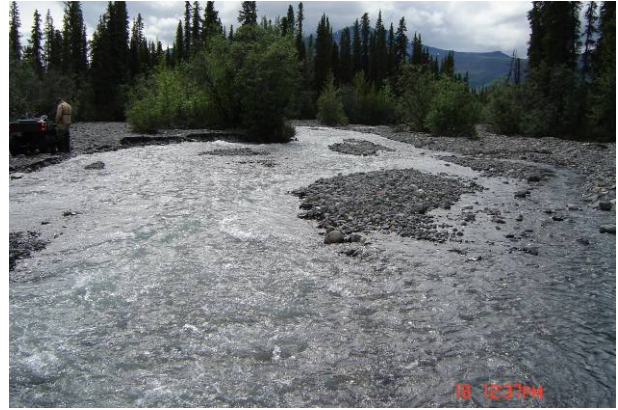
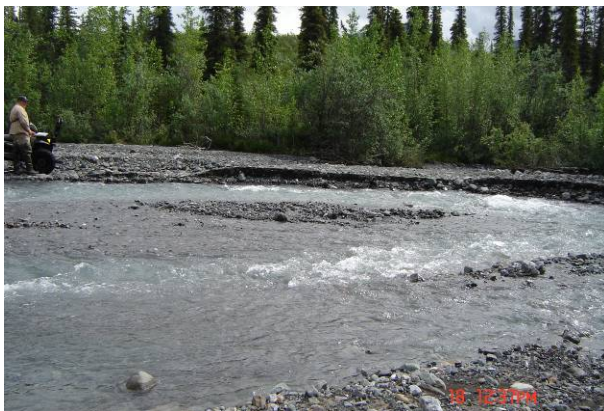
Upstream view from crossing LC-6.

Downstream view from crossing LC-6.

Left bank.

COMMENTS: Crossing in good condition.
