**A SURVEY OF RECREATIONAL OFF-ROAD VEHICLE (ORV)
STREAM CROSSINGS ALONG TRAILS ORGINATING FROM
THE NABESNA ROAD IN WRANGELL-ST. ELIAS NATIONAL
PARK AND PRESERVE**

February 2009

Alaska Department of Fish and Game
Division of Habitat

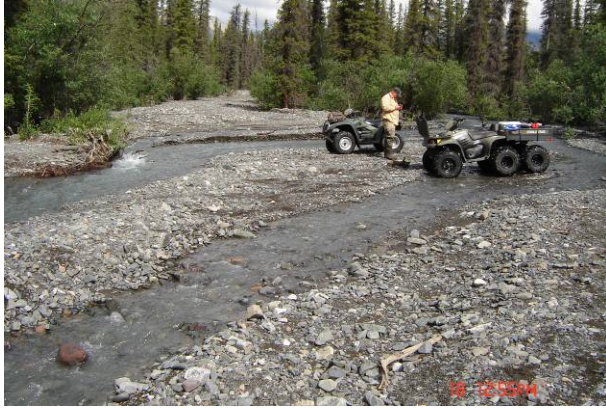
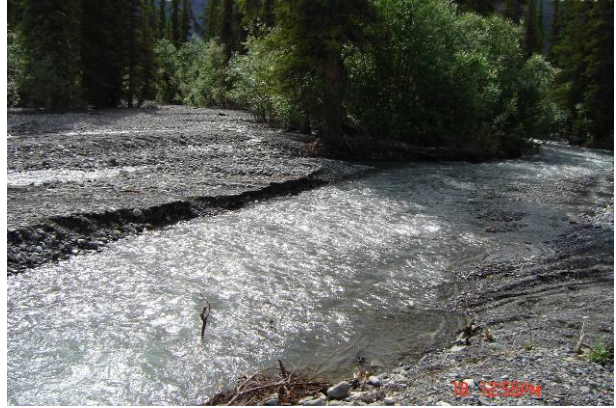
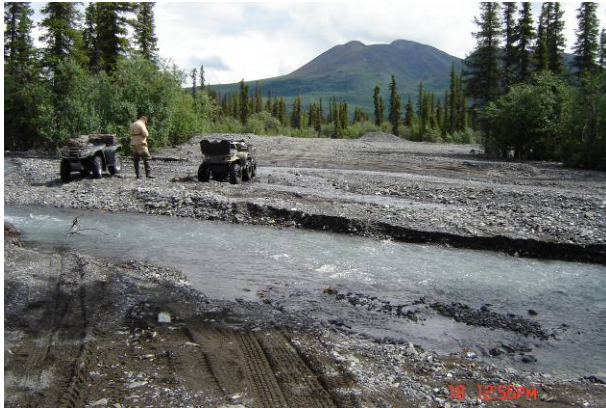
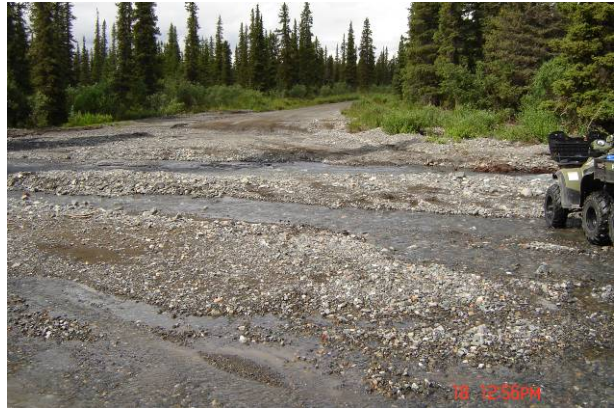
Upstream view from the crossing on the Nabesna Road.

Downstream view from crossing LC-7.

DATE: 7/18/08 **TIME:** 12:30 pm **STATION NO.** LC-7 **HABITAT :** Riffle **WATER COLOR:** Clear
WATERBODY NAME/DESCRIPTION: Lost Creek at the Nabesna Road (no fish data available)
GPS LATITUDE: 62° 31.554 **GPS LONGITUDE:** 143° 10.591 **RIPARIAN VEGETATION:** Functional for channel type
WATERBODY TYPE: stream **FLOODPLAIN:** flat **STREAM MORPHOLOGY:** D **H₂O STAGE:** 3
WATERBODY SLOPE: no data collected **BANKFULL WIDTH:** no data collected **FLOODPLAIN WIDTH:** no data collected
SUBSTRATE (%): Bedrock ____ Boulder ____ Cobble _50_ Gravel _50_ Sand ____ Silt/Clay ____ Organic ____
COMMENTS: Unconfined crossing at the Nabesna Road which shifts with flood events. AK DOT/PF maintains this crossing within the road right -of -way. This crossing could be recommended for improvement.

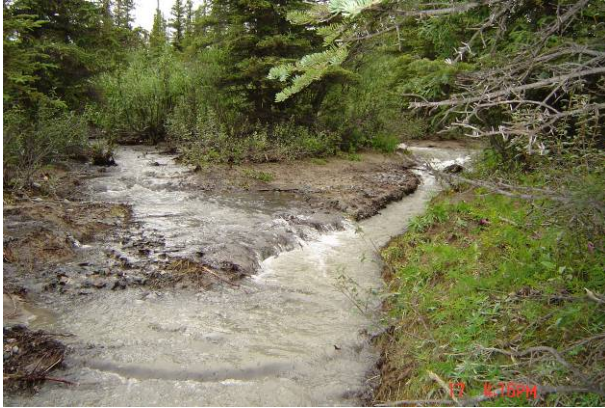
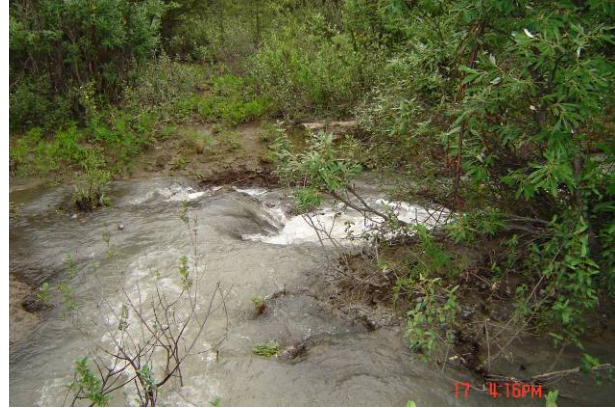
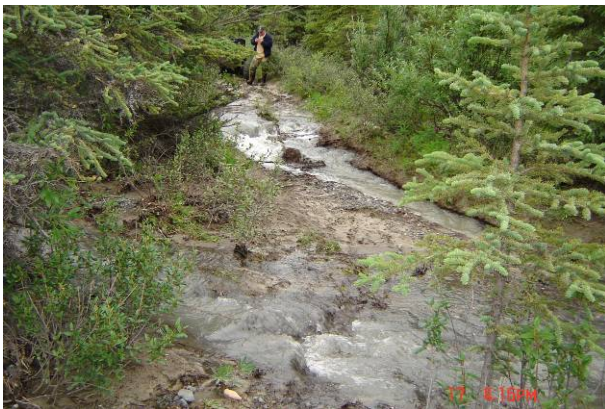
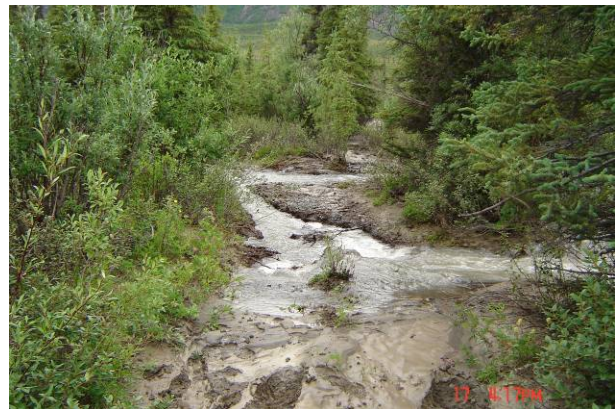
Upstream view from crossing LC1S.

Downstream view from crossing LC1S.

COMMENTS: Recently flooded, crossing somewhat washed out. Can see evidence of material that had sloughed off into the stream at the crossing. Sediment deposits on banks. Water cutting a trench through the trail. Water levels too high to cross. Partial plunge that has been created is not a barrier to fish (if present) currently.

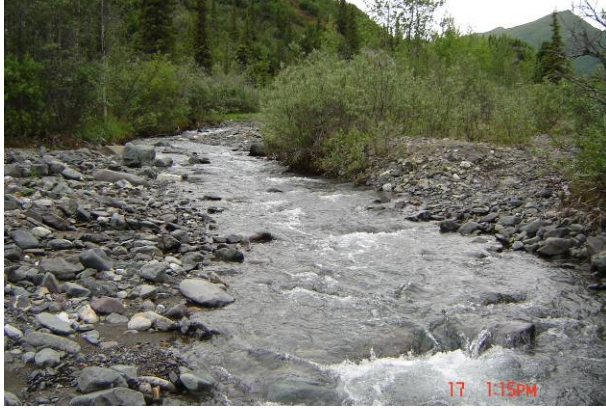
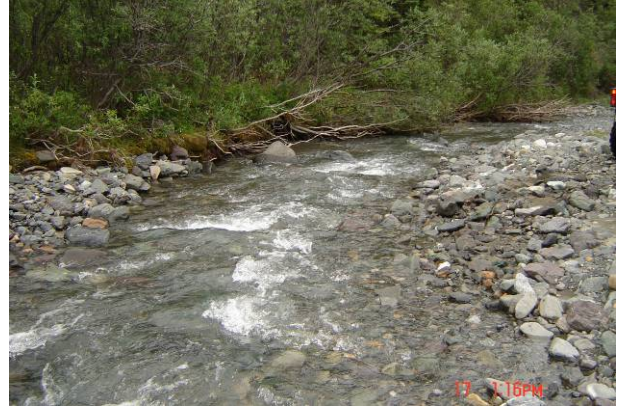
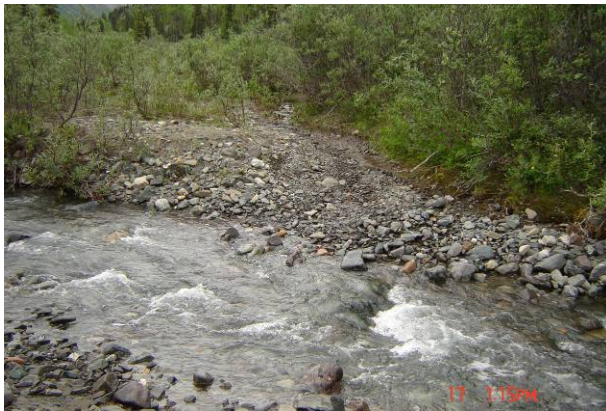
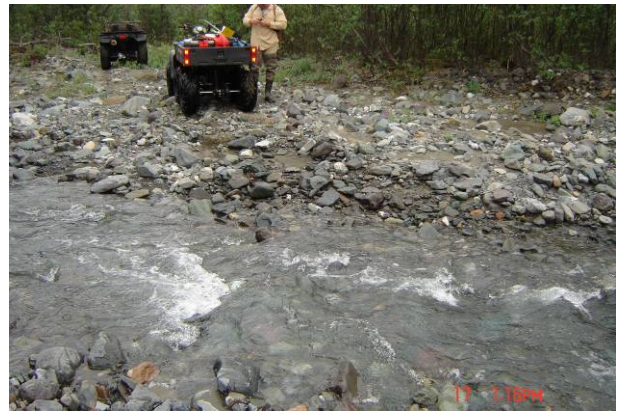
Upstream view from crossing TR-1.

Downstream view from crossing TR-1.

COMMENTS: Crossing in good condition. There may be an additional crossing or two upstream from this point, but increasing size of boulders precluded use by ATV's. Assumption was made that any additional upstream crossings would be very similar to this one because of the streambed substrate composition that has been observed up to this point.

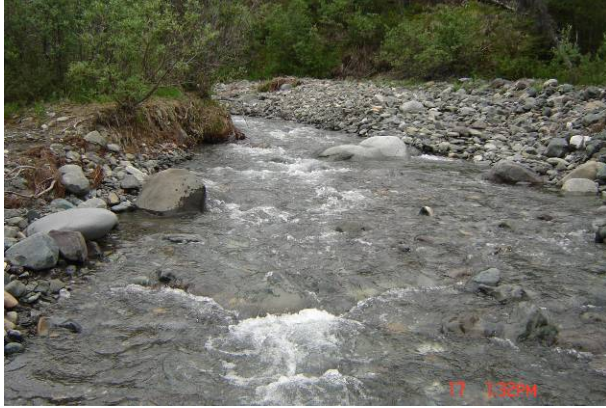
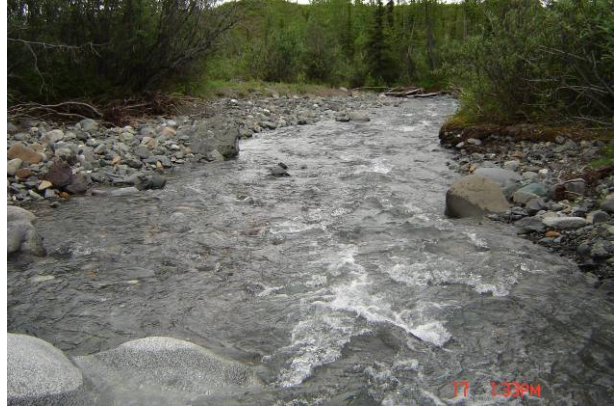
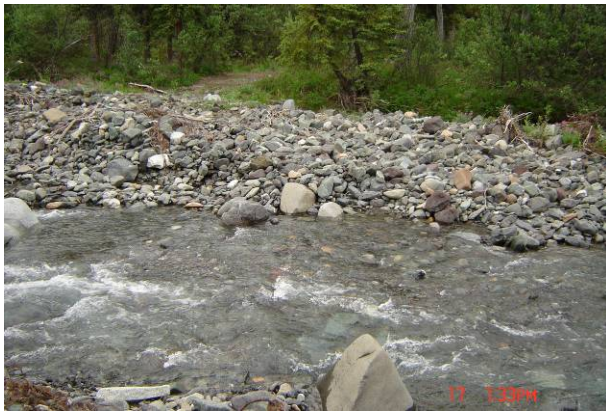
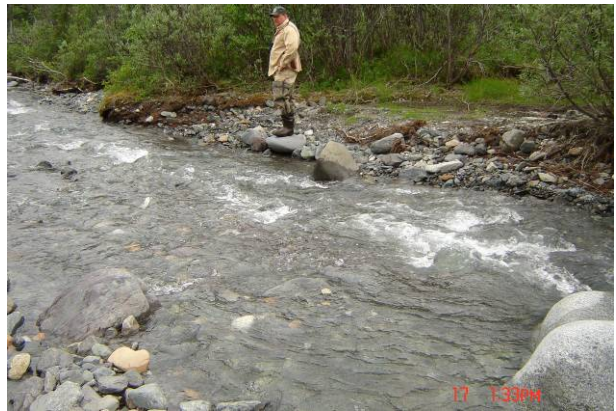
Upstream view from crossing TR-2.

Downstream view from crossing TR-2.

COMMENTS: This crossing was within 100 feet downstream of TR-1 and was in good condition.

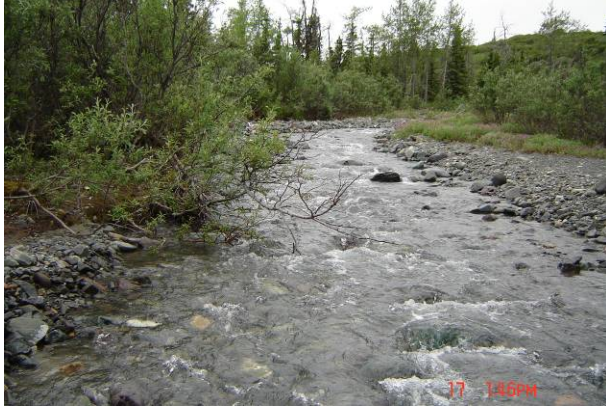
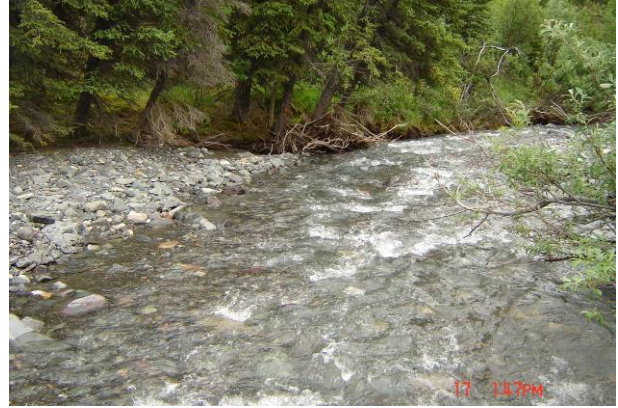
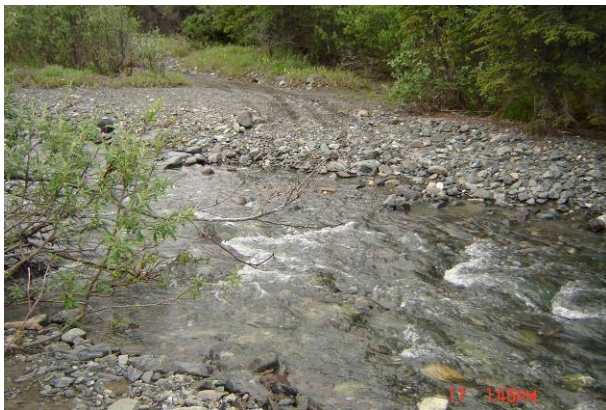
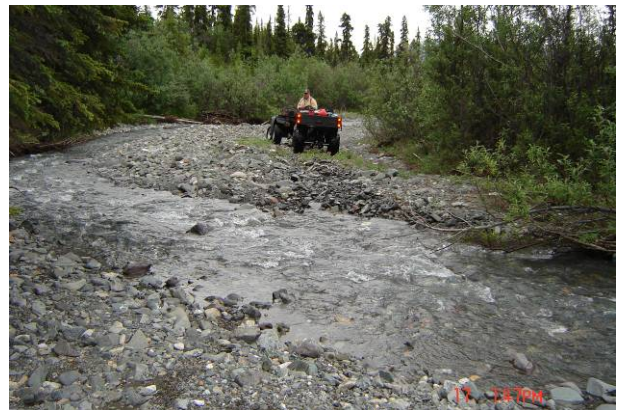
Upstream view from crossing TR-3.

Downstream view from crossing TR-3.

COMMENTS: Crossing in good condition.

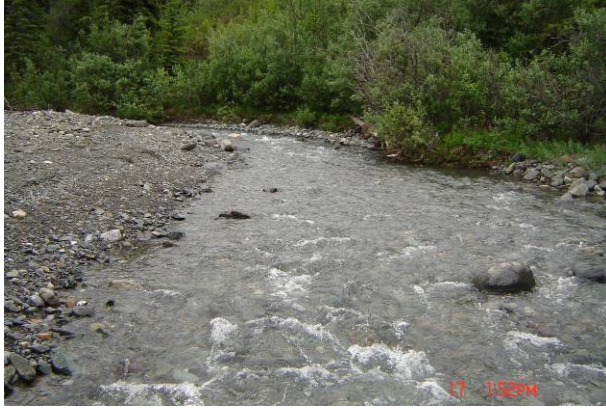
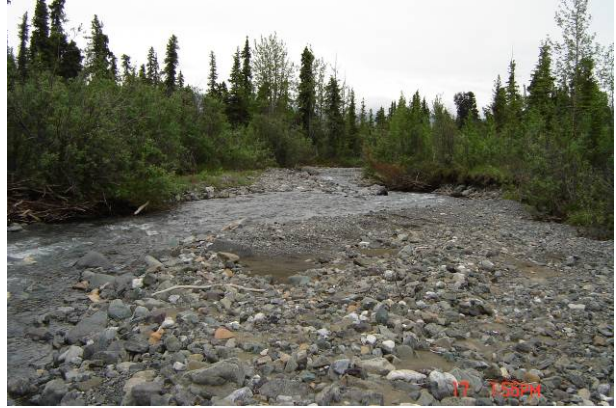
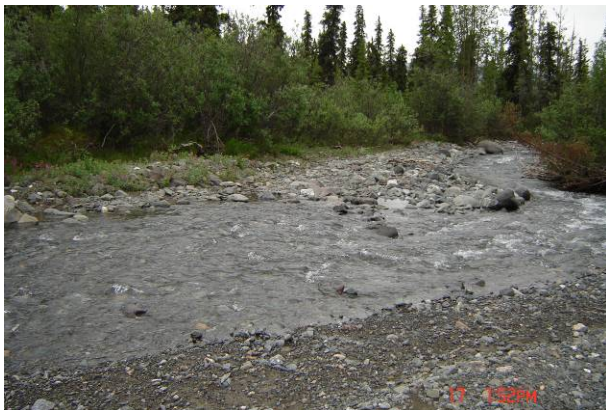
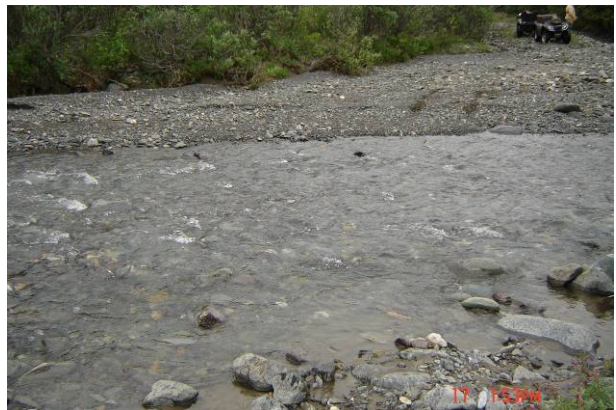
Upstream view from crossing TR-4.

Downstream view from crossing TR-4.

COMMENTS: Crossing in good condition. Between TR-1 and TR-4, 4 random crossings were made, all having similar conditions to the previous crossing. All of the random crossings were in good condition.

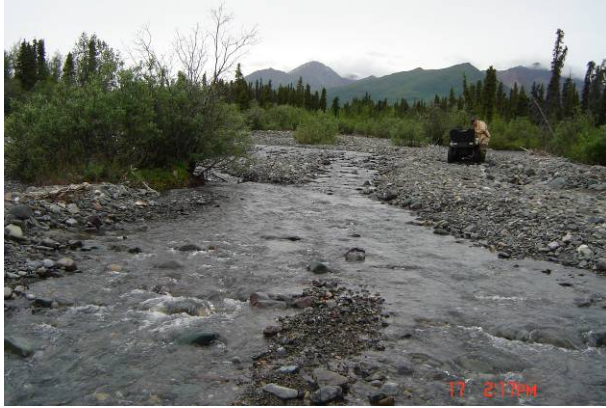
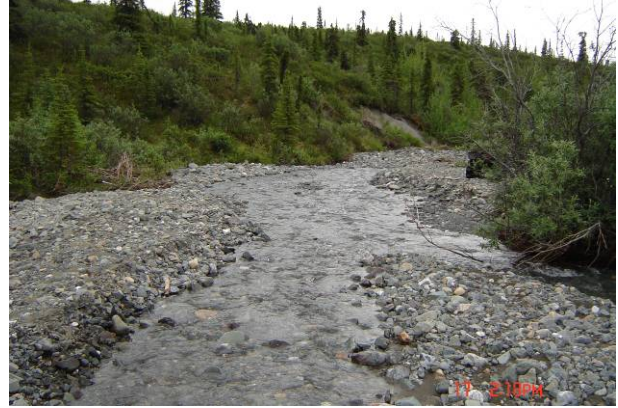
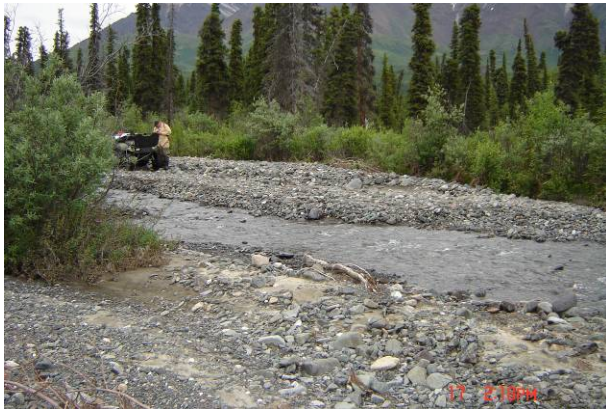
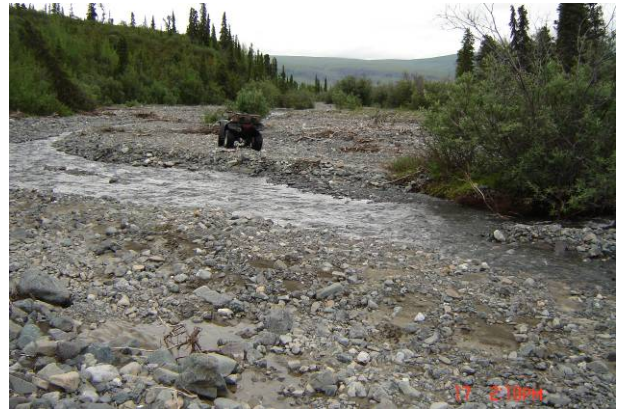
Upstream view from crossing TR-5.

Downstream view from crossing TR-5.

COMMENTS: Crossing indistinguishable so estimated approximate crossing location. Good condition. Trail is now located entirely in the streambed and no longer on banks (uplands) and continues to follow the streambed until the end of the trail (TR-9 last site documented).

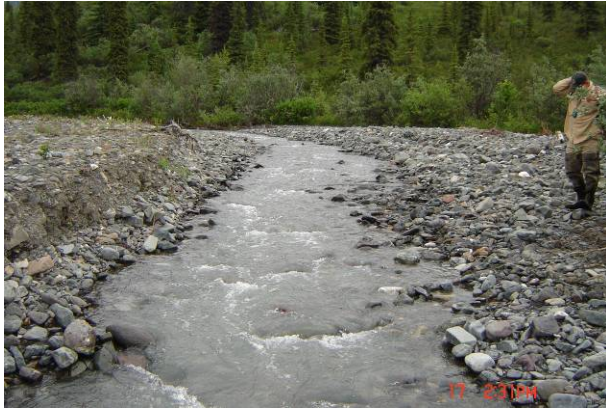
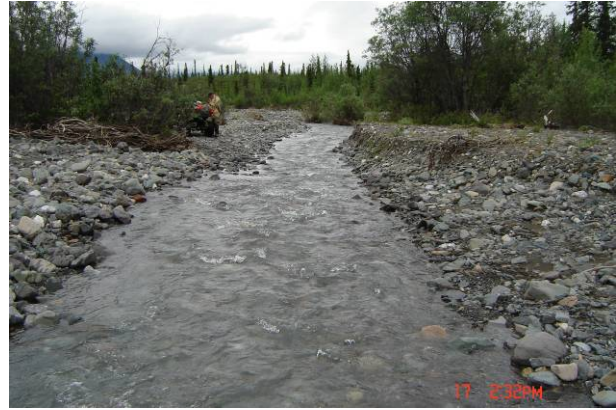
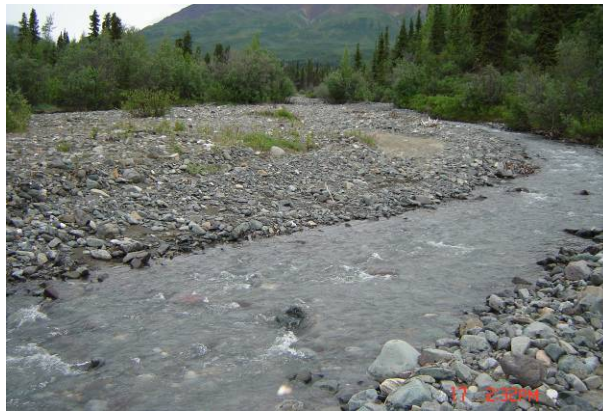
Upstream view from crossing TR-6.

Downstream view from crossing TR-6.

DATE: 7/17/08 **TIME:** 2:25 pm **STATION NO.** TR-6 **HABITAT :** Riffle **WATER COLOR:** Clear
WATERBODY NAME/DESCRIPTION: Trail Creek (no fish data available)
GPS LATITUDE: 62° 32.872 **GPS LONGITUDE:** 143° 14.050 **RIPARIAN VEGETATION:** Functional – at risk
WATERBODY TYPE: stream **FLOODPLAIN:** flat **STREAM MORPHOLOGY:** B **H₂O STAGE:** 2
WATERBODY SLOPE: 2 % **BANKFULL WIDTH:** 25 (ft.) **FLOODPLAIN WIDTH:** 250 (ft.)
SUBSTRATE (%): Bedrock ____ Boulder ____ Cobble _70_ Gravel _30_ Sand ____ Silt/Clay ____ Organic ____
COMMENTS: Crossing in good condition. Made 4 random crossings between TR-5 and TR-6 as there was no distinguishable trail. All of the random crossings were in good condition and were very similar to the conditions found at TR-5.

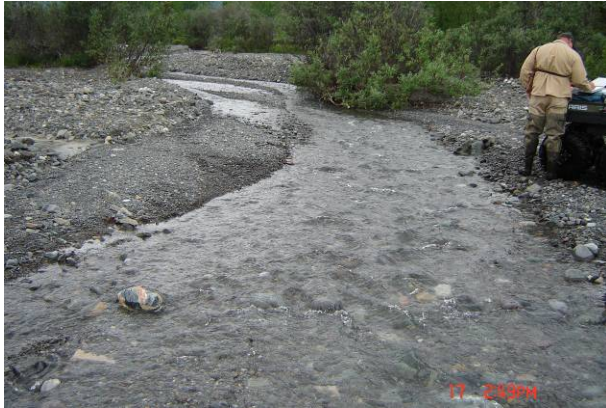
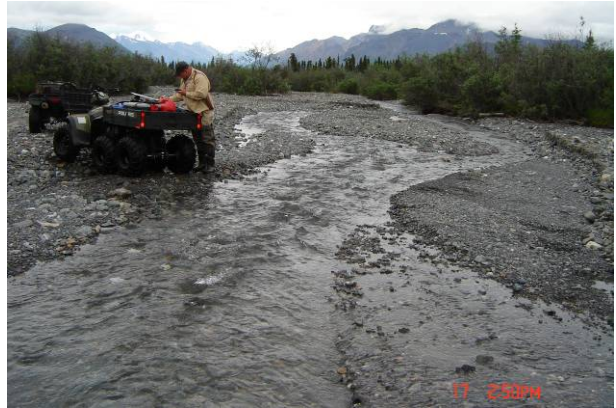
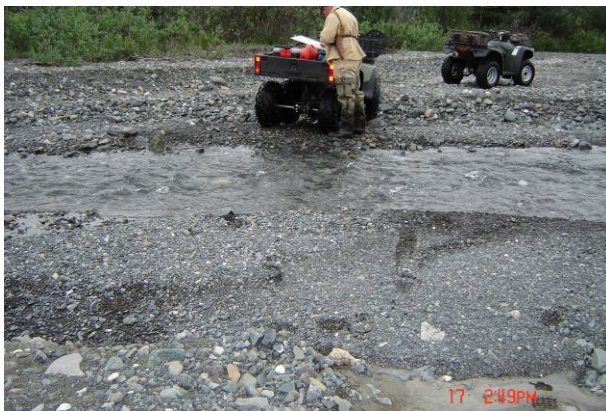
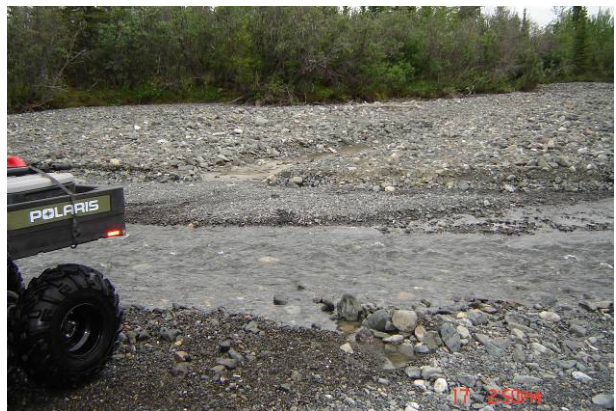
Upstream view from crossing TR-7.

Downstream view from crossing TR-7.

COMMENTS: Trail was undefined. From TR-6 to TR-7, 5 random crossings were made, all of which were very similar to the crossing at TR-6. All of the random crossings were in good condition

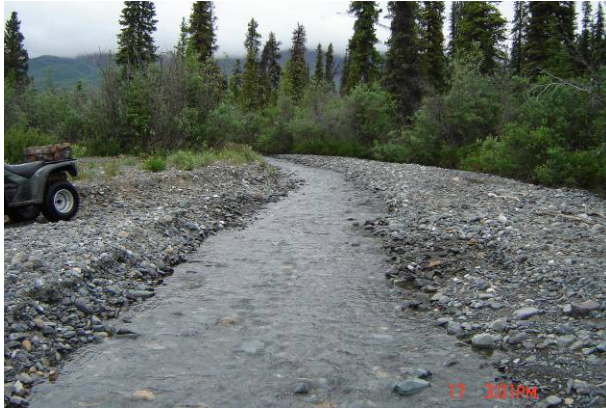
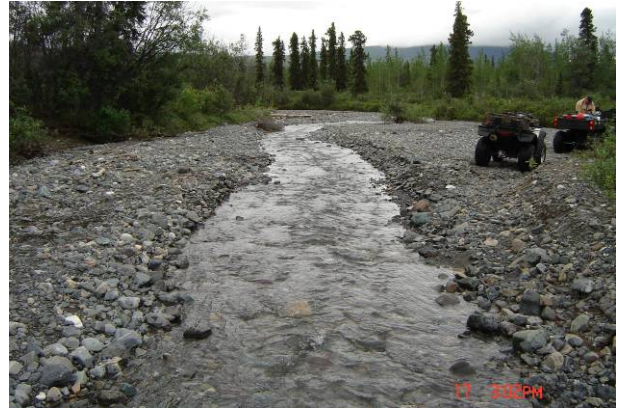
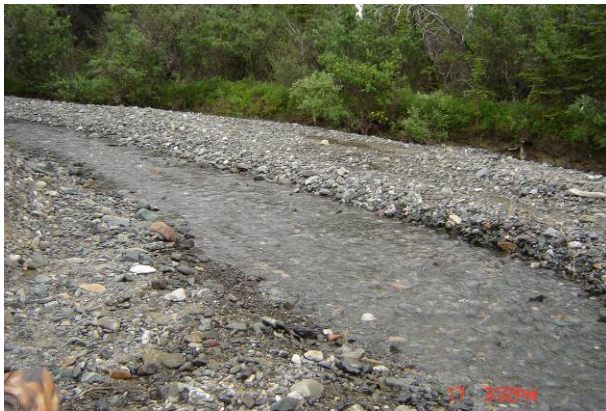
Upstream view from crossing TR-8.

Downstream view from crossing TR-8.

COMMENTS: Made 3 random crossings between TR-7 and TR-8, all of which have similar conditions to the crossing at TR-7. Trail was undefined. All random crossings were in good condition.

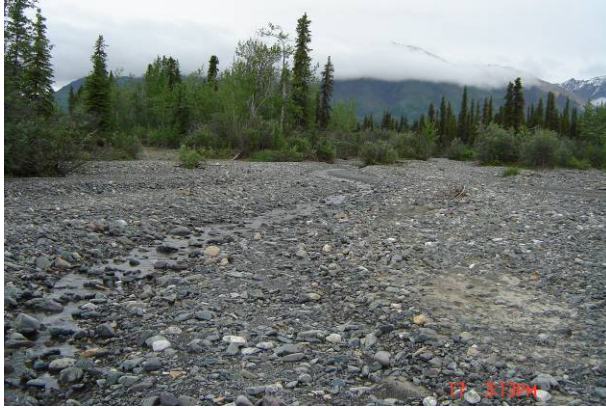
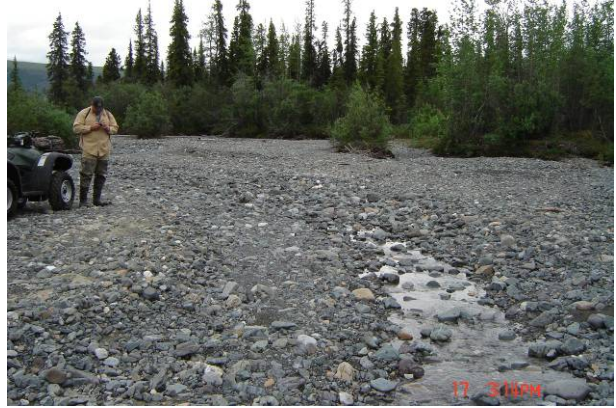
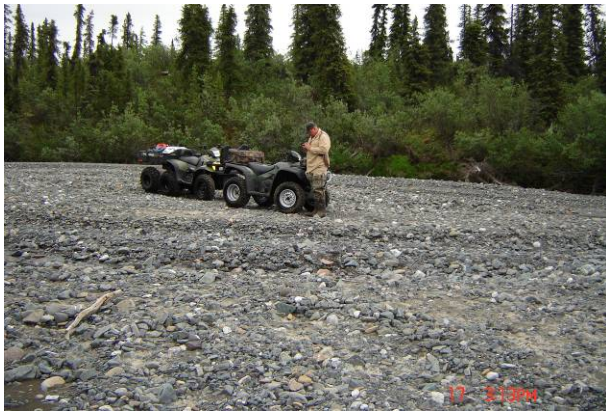
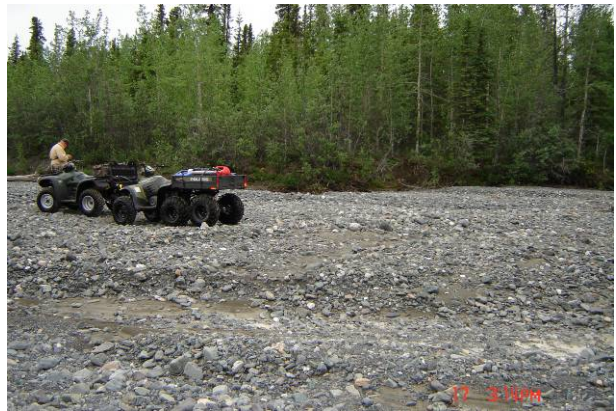
Upstream view from crossing TR-9.

Downstream view from crossing TR-9.

COMMENTS: End of trail on the north side of the Nabesna Road, where stream goes subterranean. Between TR-8 and TR-9, made 7 random crossings with similar conditions to TR-8. All random crossing were in good condition. From TR-5 to TR-9, the trail is in the streambed and not on the banks as it was upstream from TR-5.

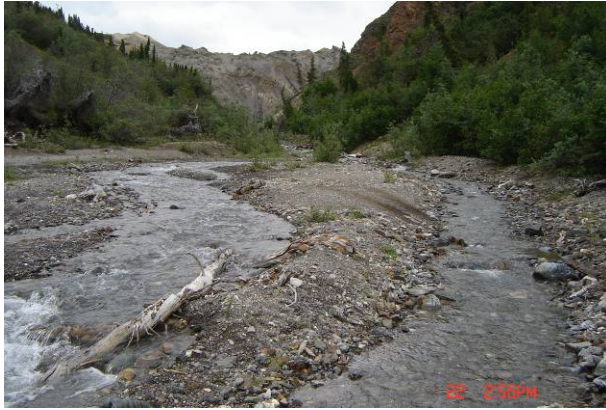
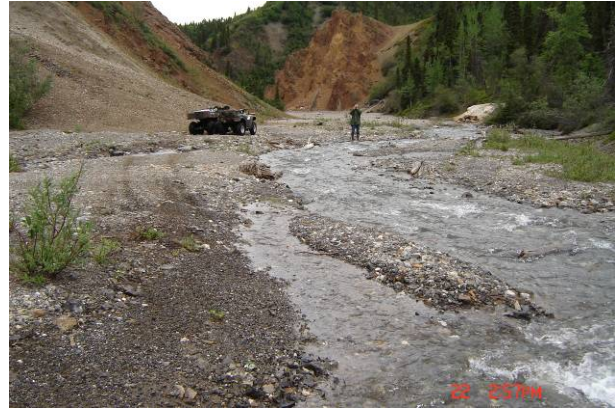
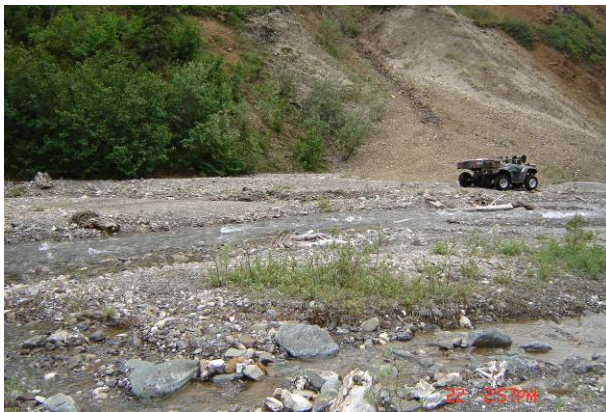
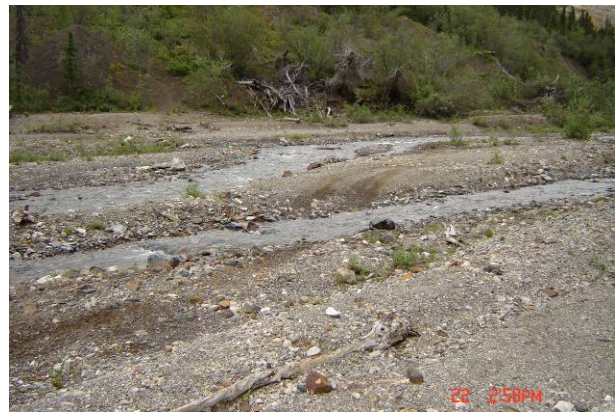
Upstream of crossing SC-1.

Downstream of crossing SC-1.

COMMENTS: There are 2 crossings in this location, each about 30 feet apart; both are in good condition. **NOTE:** data collection was started at the fork to the mineral springs and Soda Lake. Assumption was made that there may be approximately 6 more crossings upstream from this junction and that they should be very similar to crossing SC-3 (see below). The composition of the substrate we have been seeing in the streambed is most likely the condition further upstream. We do not anticipate that there will be issues with any additional crossings that may be located upstream.

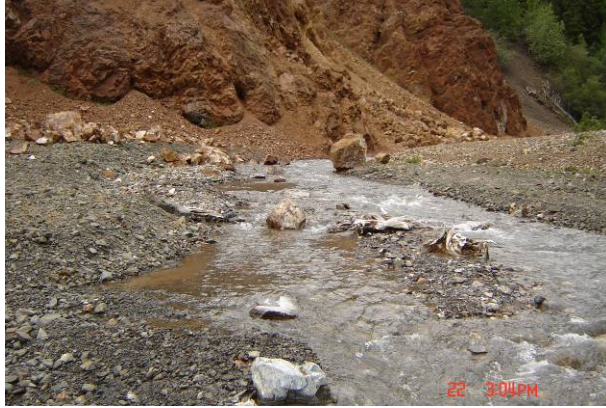
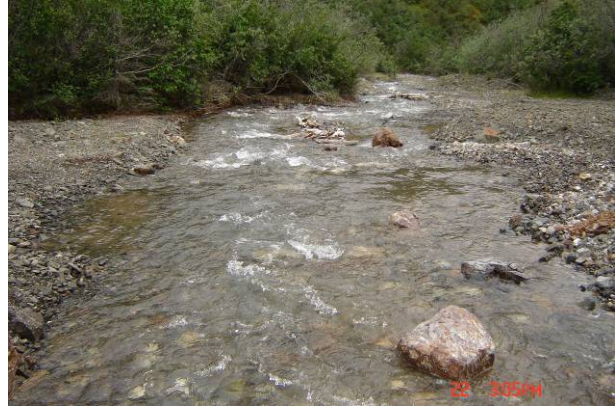
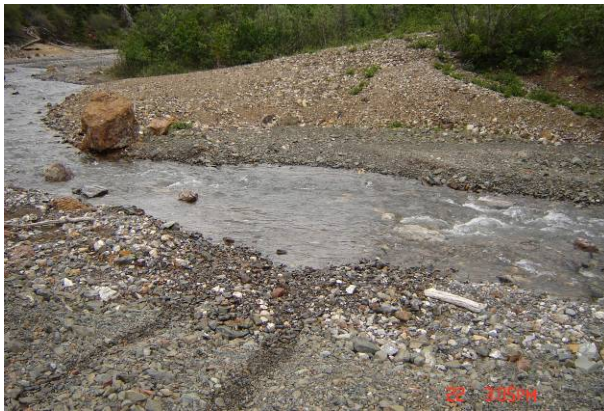
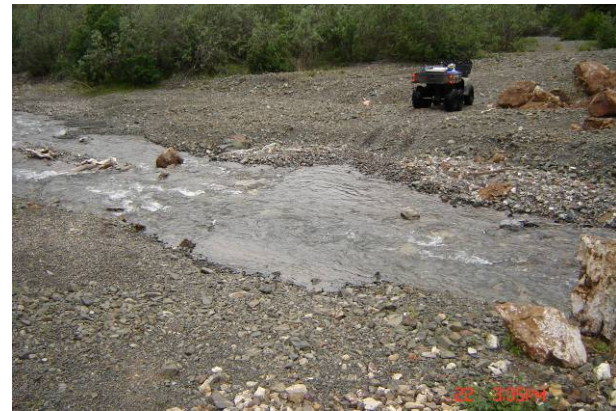
Upstream view from crossing SC-2.

Downstream view from crossing SC-2.

COMMENTS: Crossing in good condition.

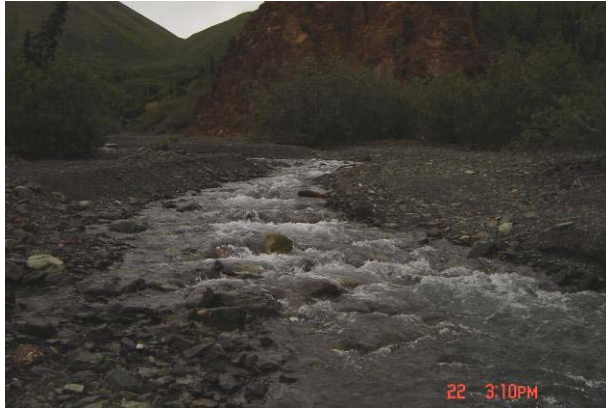
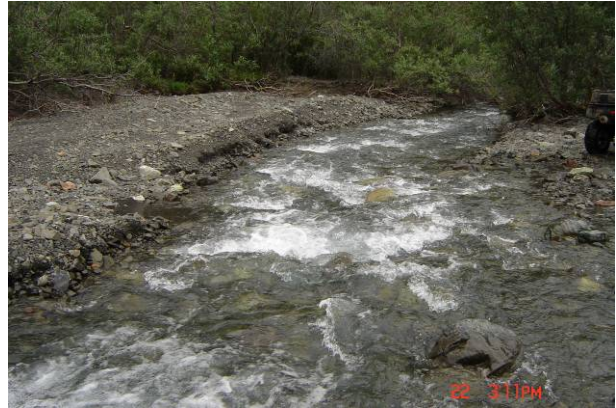
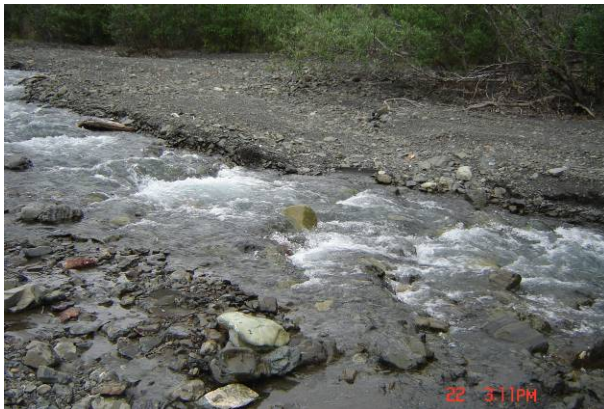
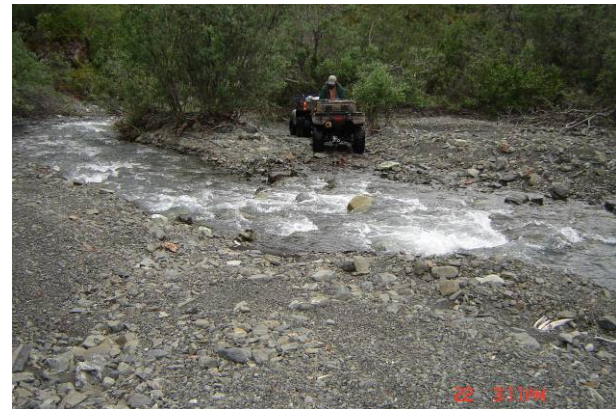
Upstream view from crossing SC-3.

Downstream view from crossing SC-3.

COMMENTS: Upstream from this point (excluding the fork to Mineral Springs) there are approximately 6 more crossings. Based on topography and general characteristics of the area, the assumption was made that the crossings upstream are very similar to that which is found in this location (see note under crossing SC-1 above).

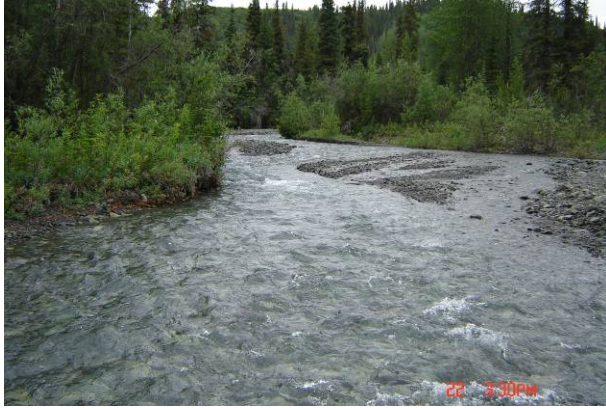
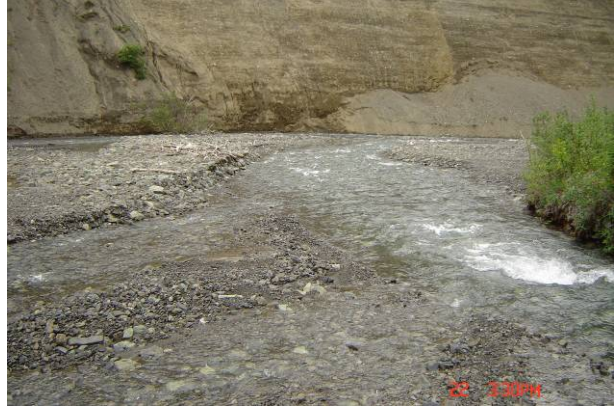
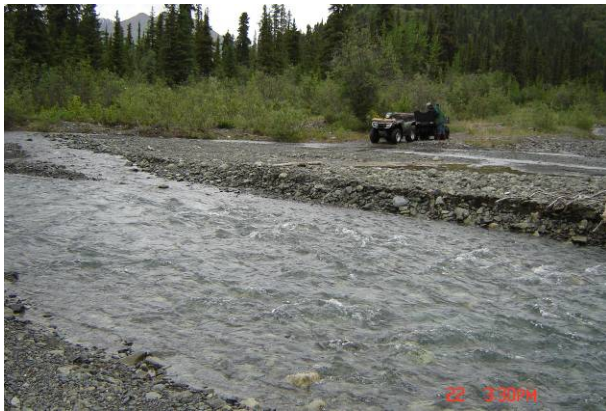
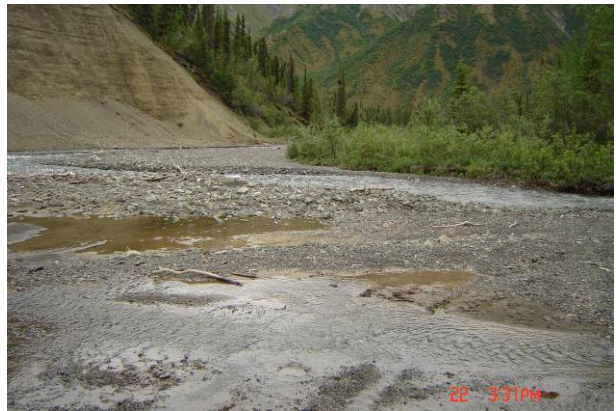
Upstream view from crossing SC-4.

Downstream view from crossing SC-4.

COMMENTS: Made 9 random crossings between SC-3 and SC-4, which were very similar to SC-3. All were in good condition.

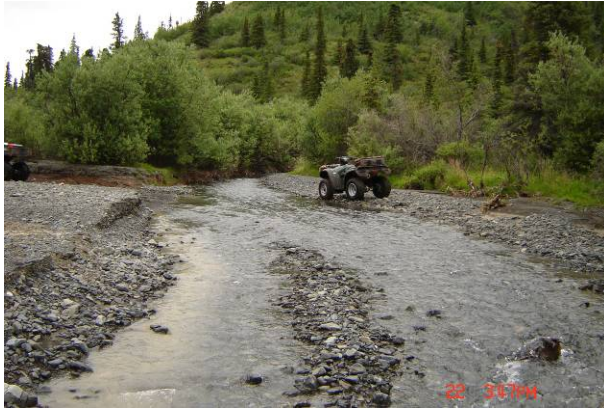
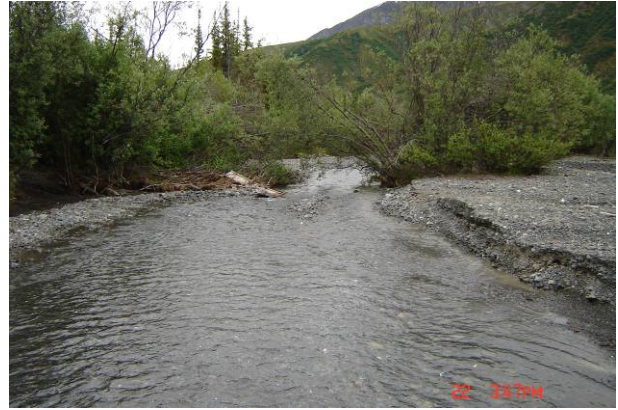
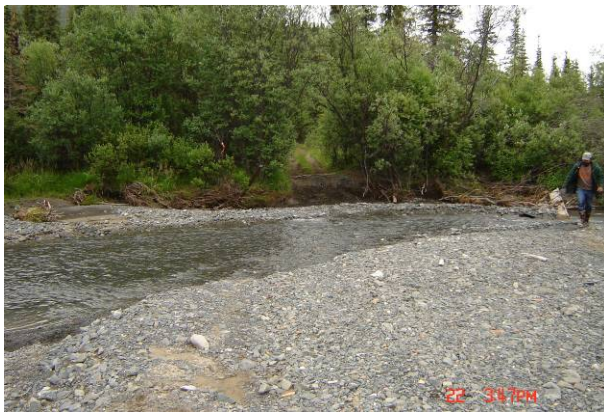
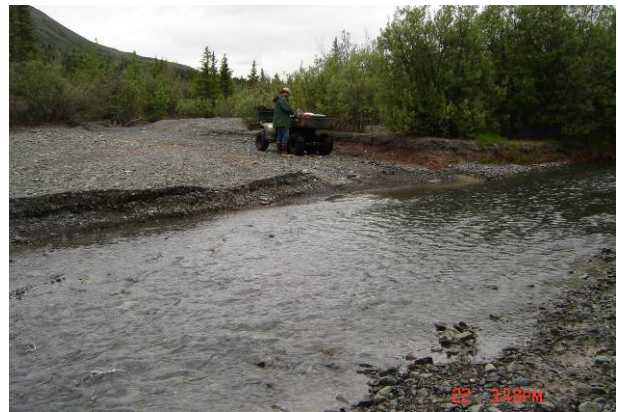
Upstream view from crossing SC-5.

Downstream view from crossing SC-5.

COMMENTS: Crossing in good condition.

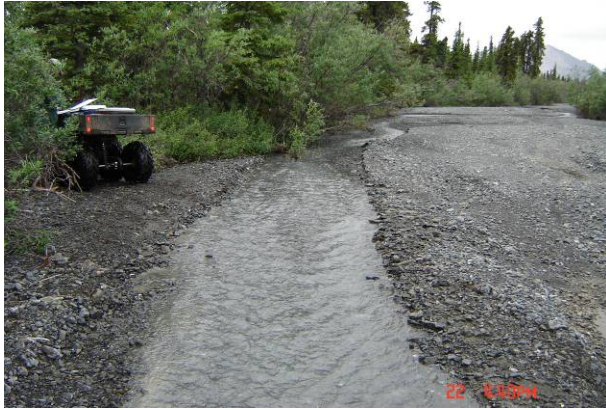
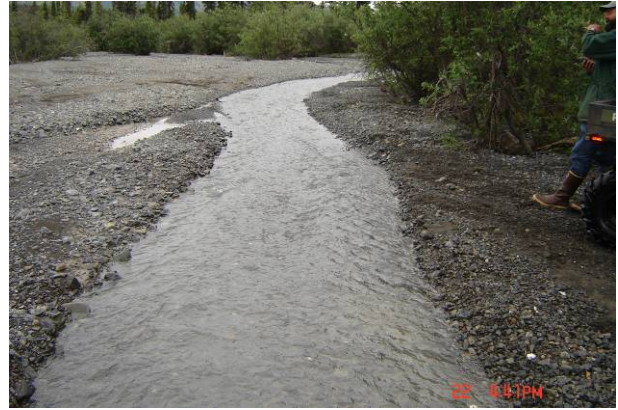
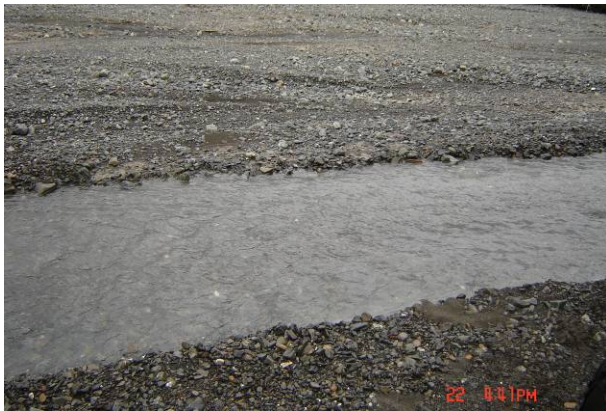
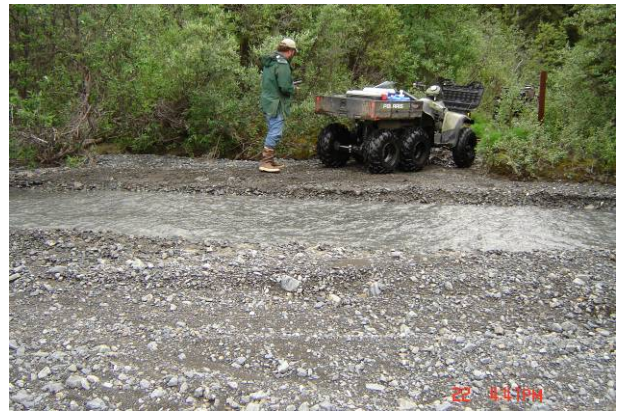
Upstream view from crossing SC-6.

Downstream view from crossing SC-6.

COMMENTS: Crossing in good condition.

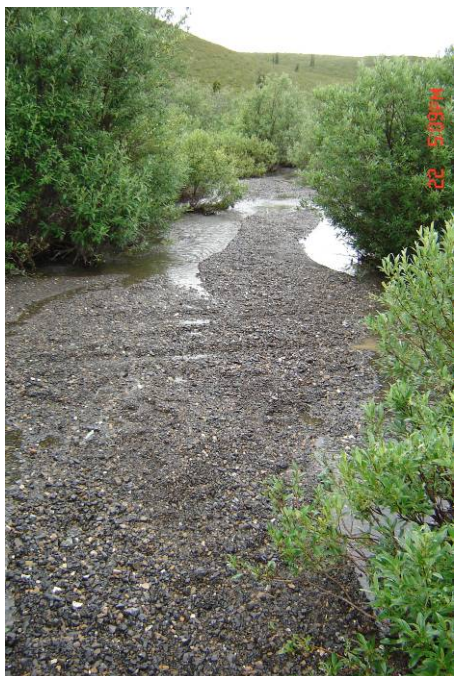
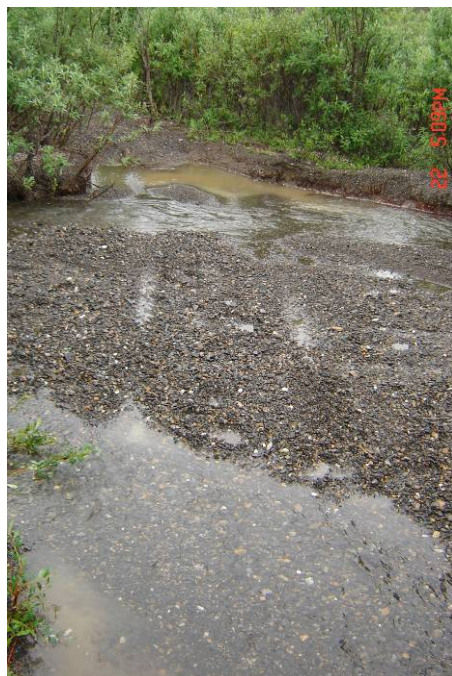
Downstream view from crossing SC-7.

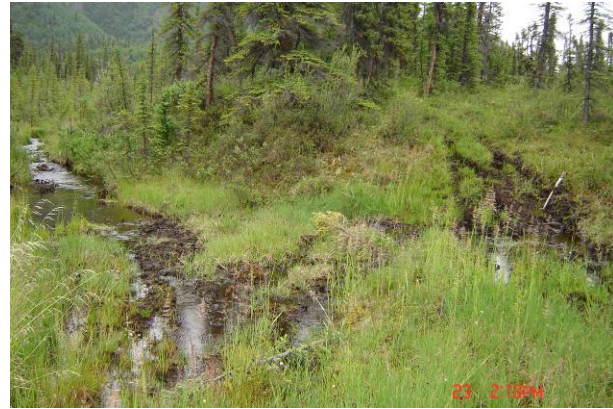
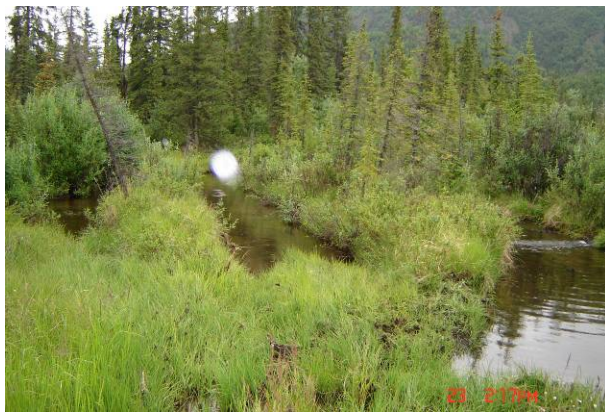
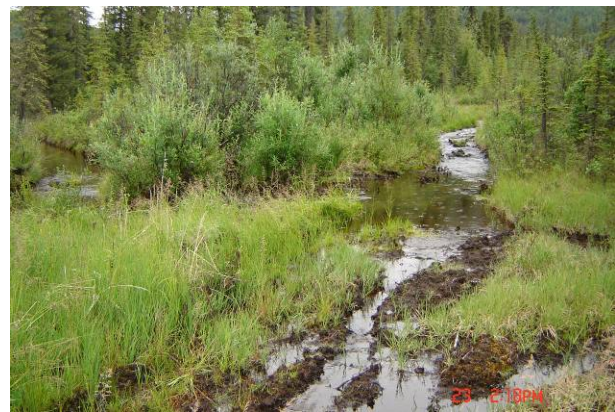
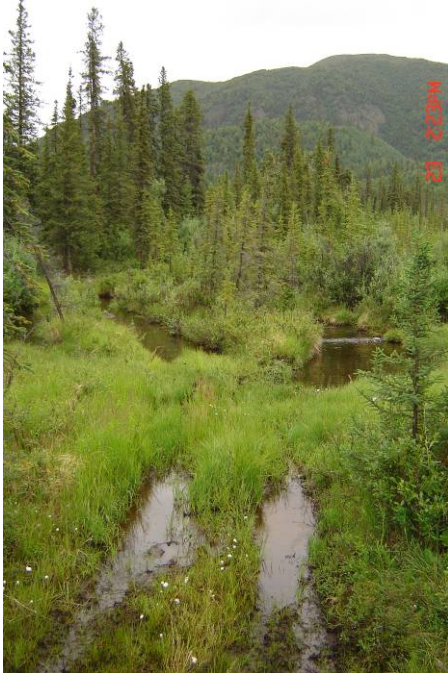
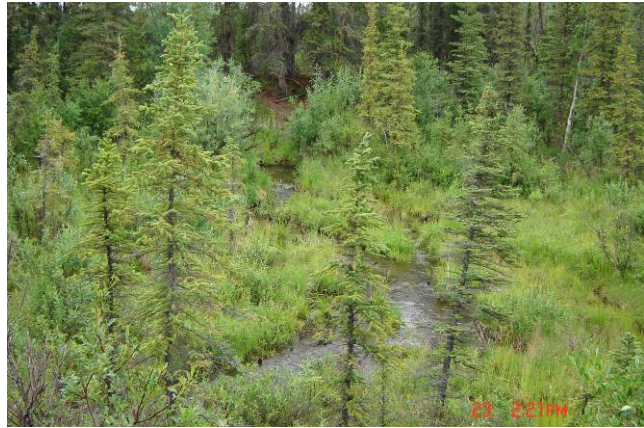
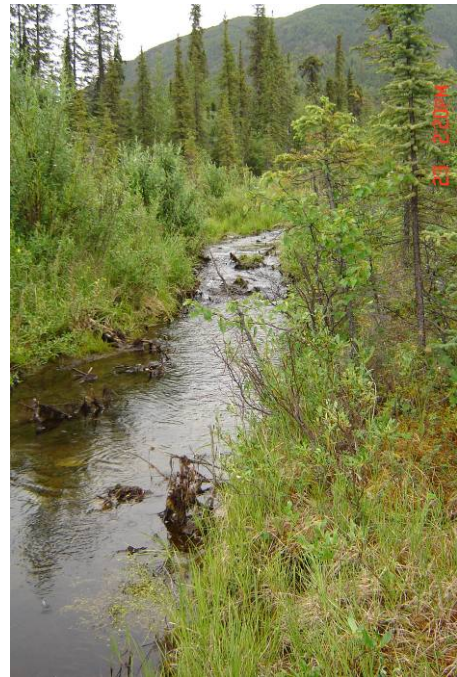
Right bank.

Additional view of right bank.

Third view of right bank.

Right bank from SLT-1.

View from further upstream of crossing.

Additional upstream view.

COMMENTS: Crossing in very poor condition. There are three cuts perpendicular to the stream from ATV use, each cut less than 50 ft. apart. These cuts are causing rutting in the streambed as the substrate is somewhat soft and altering water flow where water backs up into the cuts during high flows.

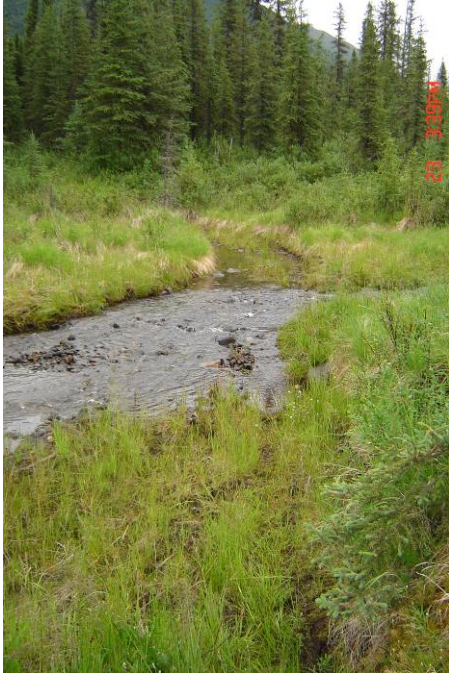
Right bank of SLT-2.

COMMENTS: Heavily scarred crossing, much like the conditions found at SLT-1, although much drier right before the approaches. Like SLT-1, there are 3 cuts at the crossing, each about 25 feet apart, with very deep ruts, approximately 1-2 feet deep. It was difficult to ascertain where the stream channel location is at the crossing.

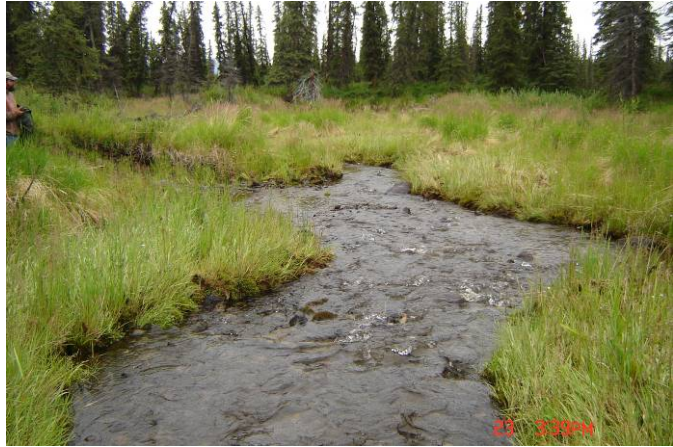
Downstream view from crossing SLT-2.

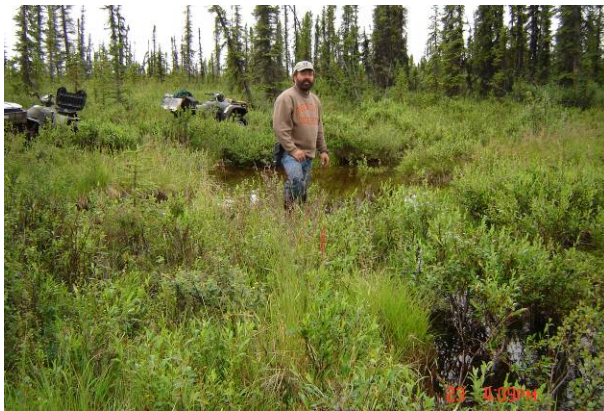
Upstream view from crossing SLT-3.

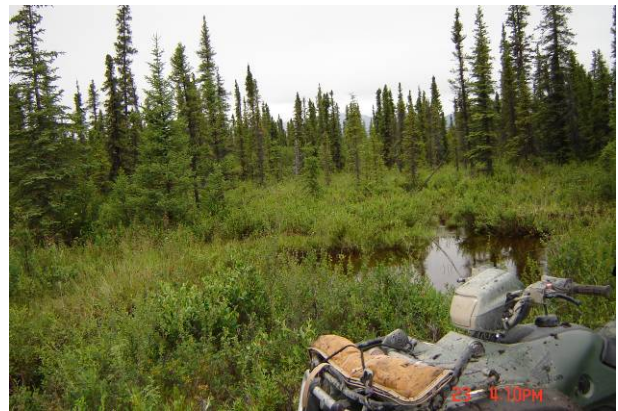
Downstream view from crossing SLT-3.

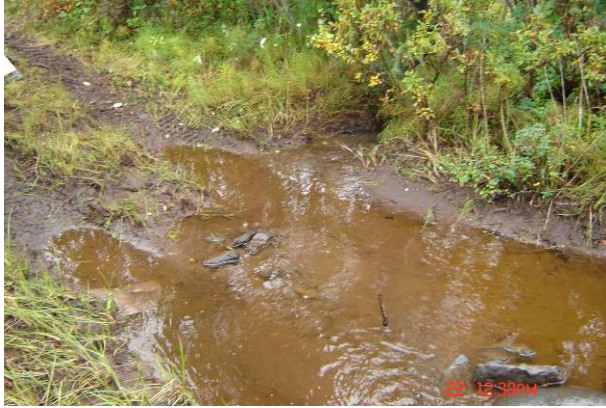
Downstream view from crossing TLT-1.

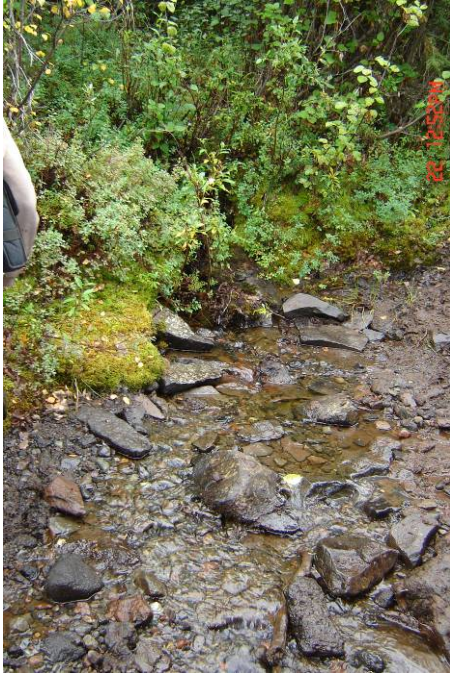
Upstream view from crossing TLT-2.

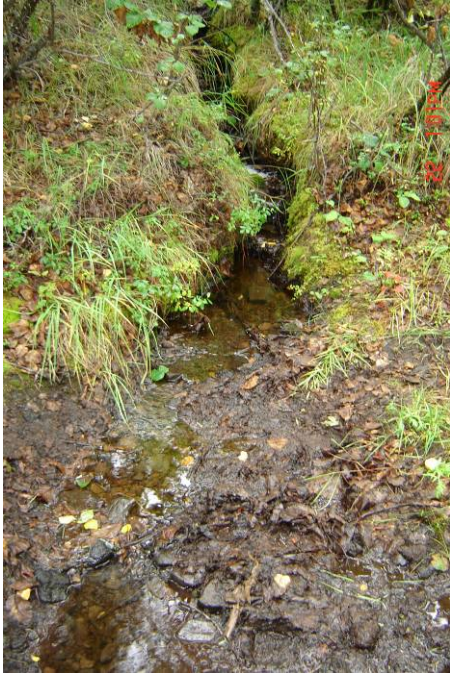
Upstream view from crossing TLT-3.

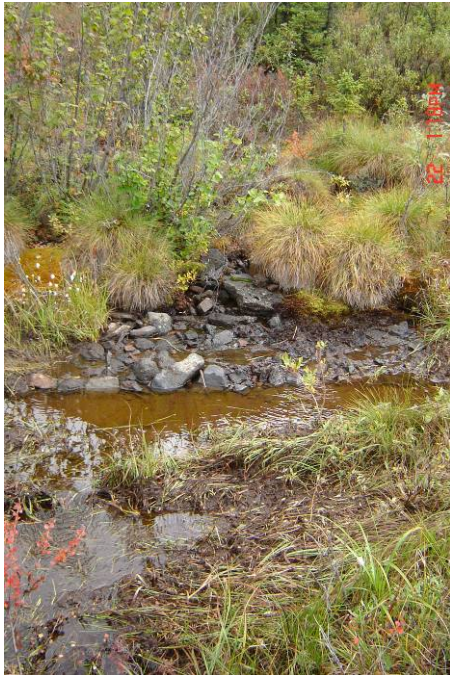
Upstream view from crossing TLT-4.
