**A SURVEY OF RECREATIONAL OFF-ROAD VEHICLE (ORV)
STREAM CROSSINGS ALONG TRAILS ORGINATING FROM
THE NABESNA ROAD IN WRANGELL-ST. ELIAS NATIONAL
PARK AND PRESERVE**

February 2009

Alaska Department of Fish and Game
Division of Habitat

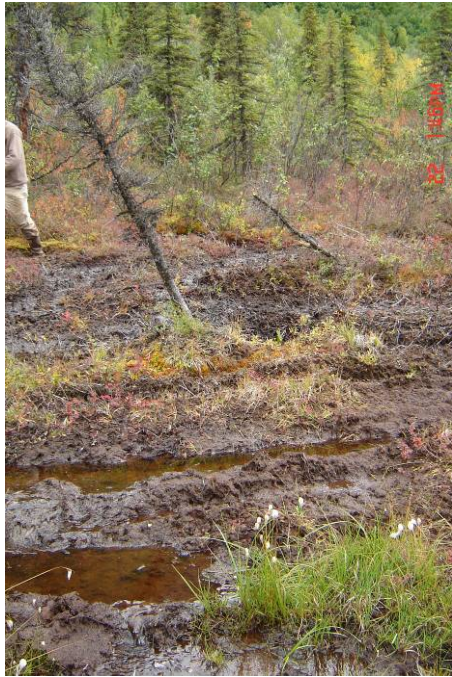
Upstream view from crossing TLT-5.

COMMENTS: Crossing very soft and with multiple tracks running through it. Additional crossing only 50 feet away from this one and in similar condition.

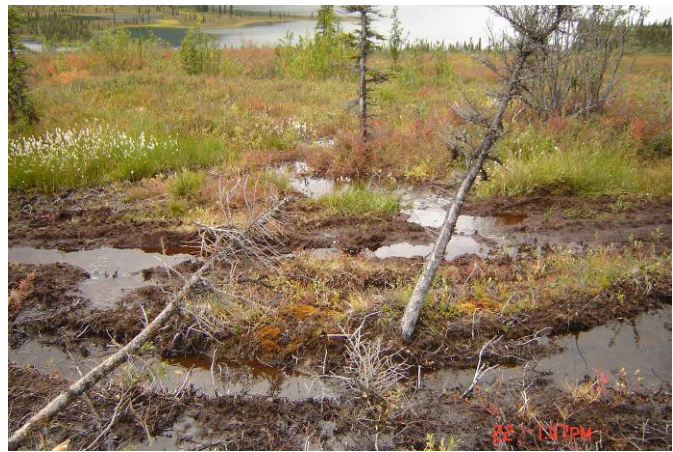
Downstream view from crossing TLT-5.

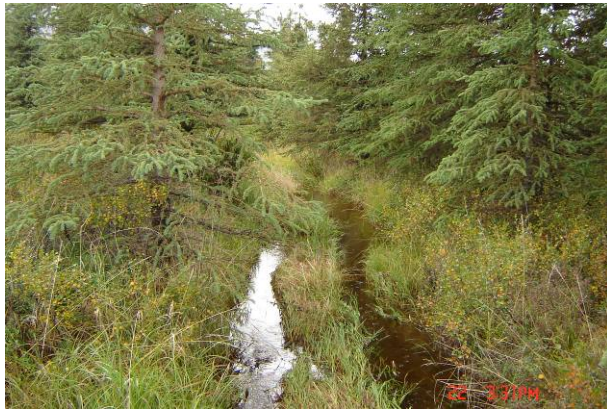
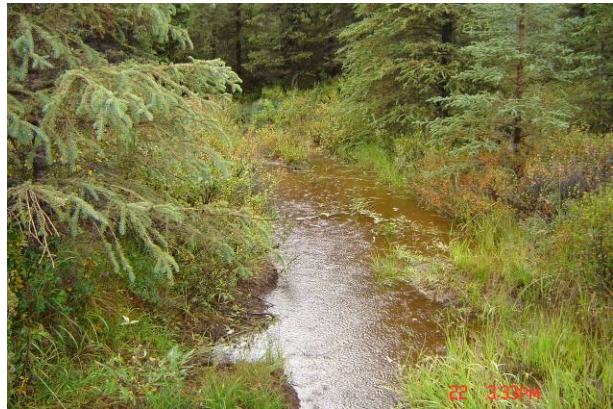
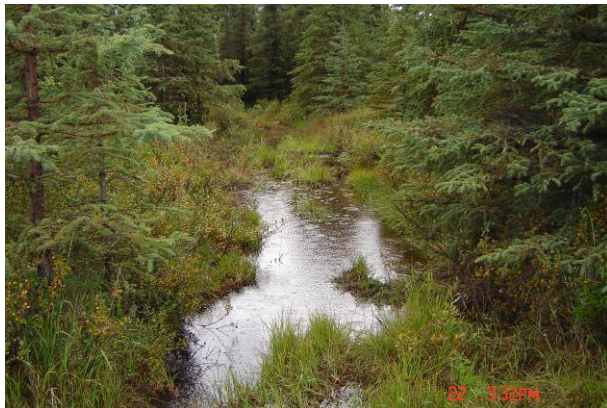
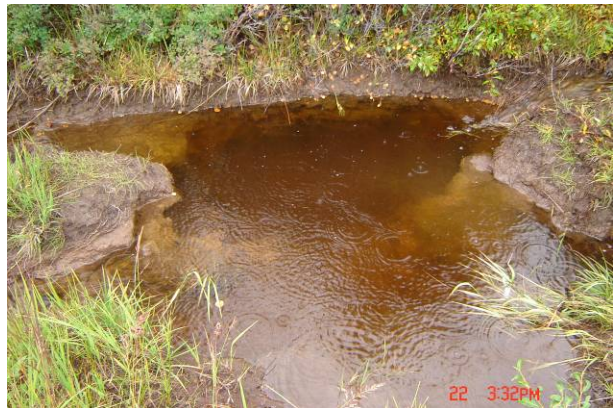
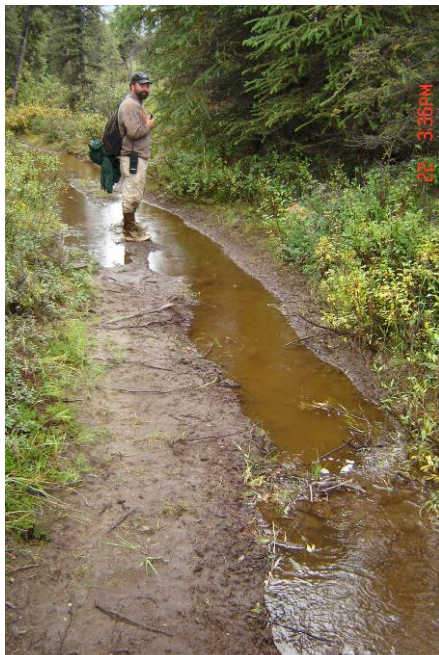
Inundated portion of trail located between crossings TLT-7 and TLT-16 (see Figure 9 above)

A portion of Tanada Lake Trail (located between crossings TLT-7 and TLT-16) is inundated with runoff from wetlands to the east of the trail. There was no discernible crossing. Refer to Figure 10 above for the location of this site. It appears that water from the adjacent wetland has been intercepted by the trail, and a portion of the trail has essentially become a new streambed. This could also simply be sheet flow from above average precipitation this year.

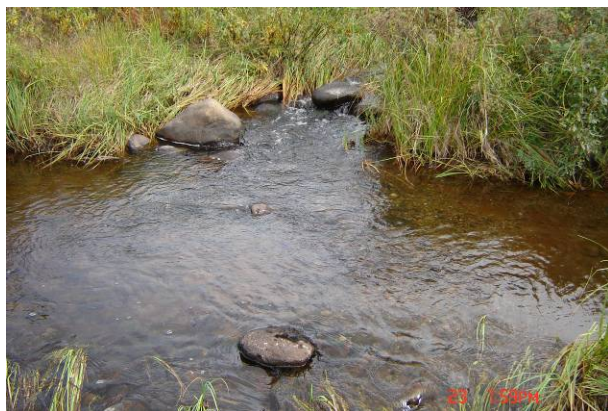
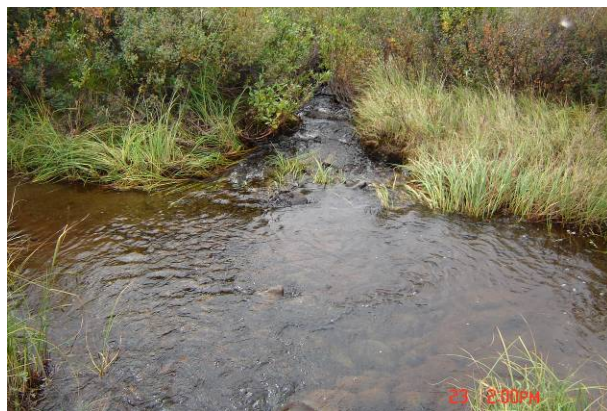
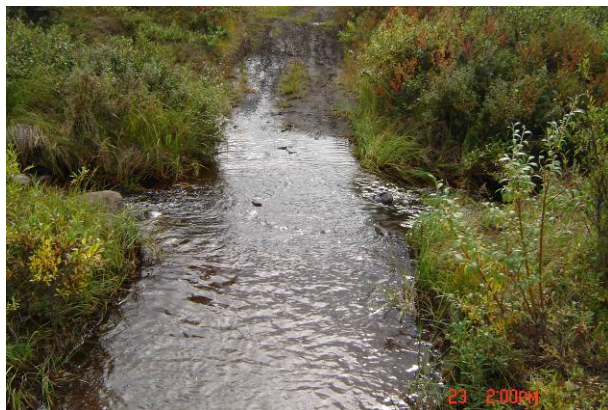
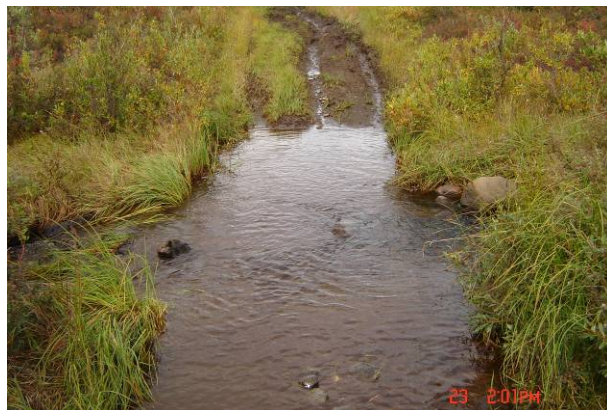
Upstream view from crossing TLT-8.

COMMENTS: This crossing is located at the northernmost part of the trail (even though it is labeled #8). Weakened approaches on both banks. This crossing is less than a mile from Tanada Creek. **NOTE:** There was one crossing about 100 ft. north of this crossing that was discovered during the aerial recon done the next day. It appeared to be in the same condition of this crossing.

TLT7	No	None	
TLT8	Yes - should be repaired	None	This crossing is located at the northernmost part of the trail (even though it is labeled #8). Weakened and rutted approaches on both banks. This crossing is less than a mile from Tanada Creek. NOTE: There was one crossing about 100 ft. north of this crossing that was discovered during the aerial recon done the next day. It appeared to be in the same condition of this crossing.
TLT9	Yes - should be repaired if this channel actually drains into Tanada Creek	None	Stream fans out into a wetland therefore no defined stream bed or streambank. Degraded approaches with severe rutting on both banks which may contribute to water quality issues.
TLT10	Yes - should be repaired if this channel actually drains into Tanada Creek	None	Degraded crossing with moderate rutting on both approaches which may contribute to water quality issues.

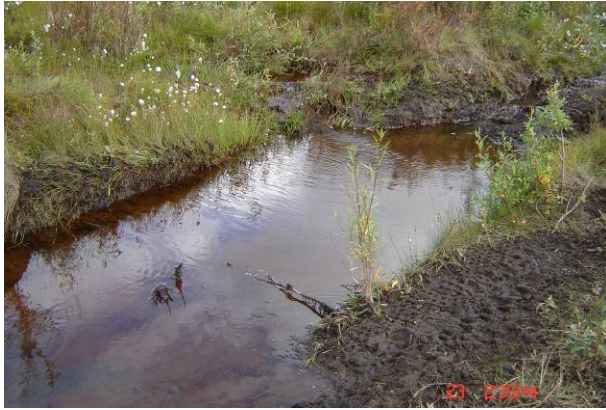
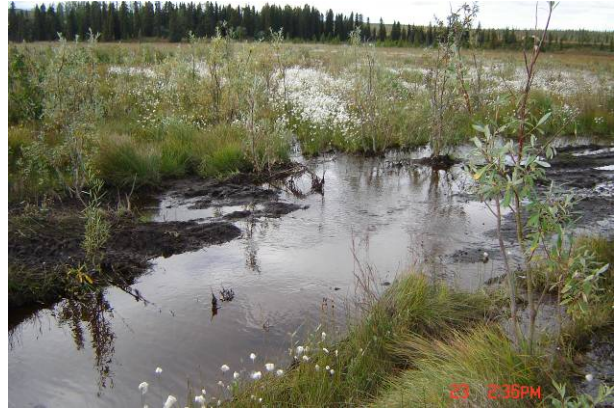
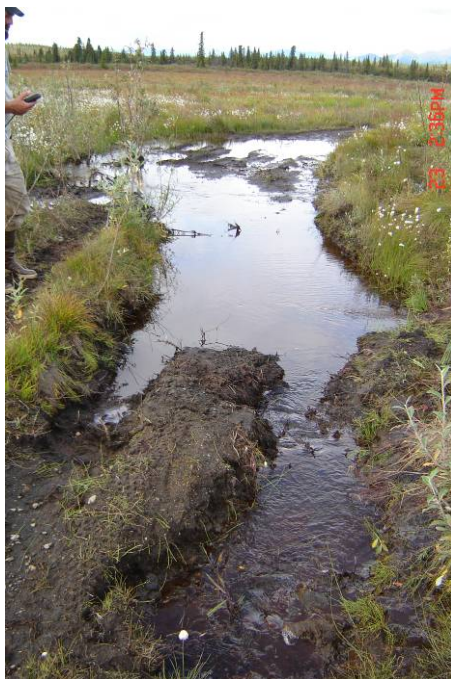
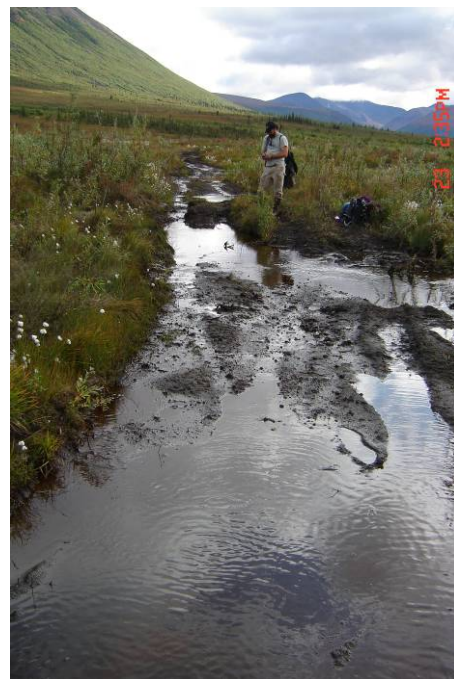
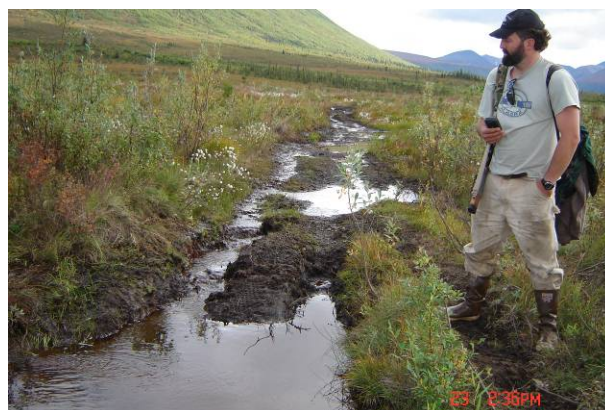
Upstream view from crossing TLT-9.

DATE: 8/23/08 **TIME:** 2:32 pm **STATION NO.** TLT-9 **HABITAT :** Undefined seep **WATER COLOR:** Clear
WATERBODY NAME/DESCRIPTION: Unnamed, intermittent tributary to unnamed pond (no fish data available).
GPS LATITUDE: 62° 28.735 **GPS LONGITUDE:** 143° 22.231
RIPARIAN VEGETATION: Functional – at risk, with severe rutting at both approaches
WATERBODY TYPE: stream **FLOODPLAIN:** flat **STREAM MORPHOLOGY:** B **H₂O STAGE:** 5
WATERBODY SLOPE: 4 % **BANKFULL WIDTH:** n/a **FLOODPLAIN WIDTH:** n/a
SUBSTRATE (%): Bedrock ___ Boulder ___ Cobble ___ Gravel _10_ Sand _50_ Silt/Clay ___ Organic _40_
COMMENTS: Channel fans out into wetland, therefore no defined bed and bank. Drains into unnamed pond and not into Tanada Lake. Degraded approaches on both banks may contribute to water quality issues in the pond.

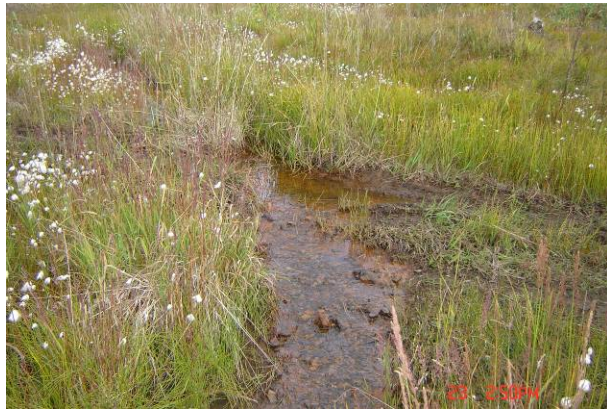
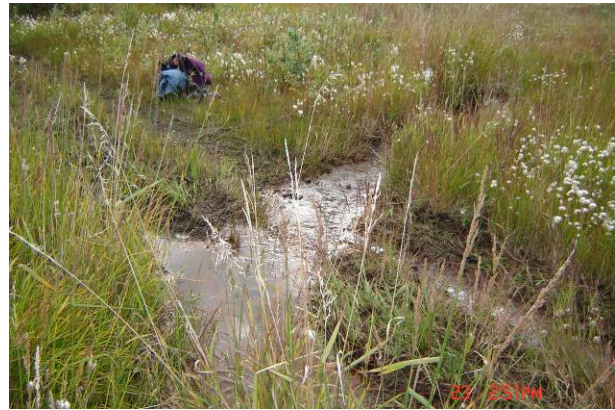
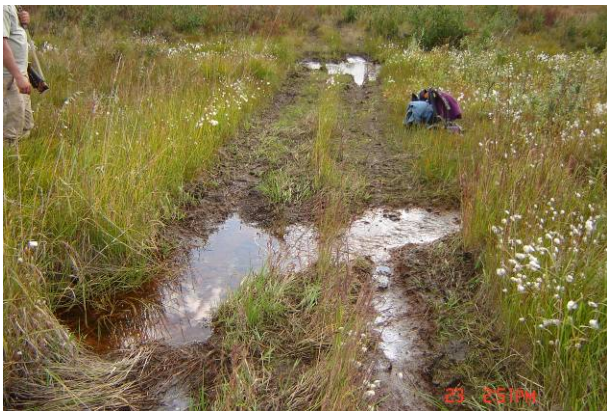
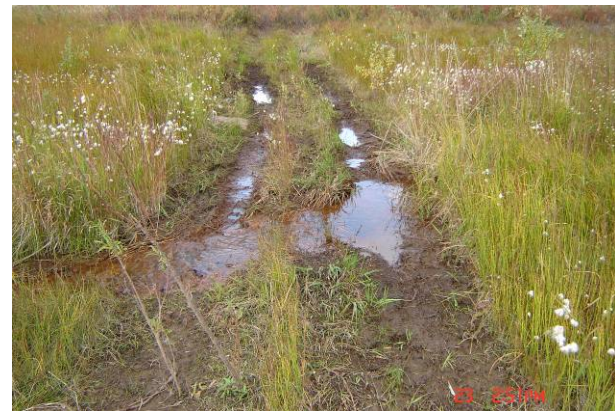
Upstream view from crossing TLT-10.

DATE: 8/23/08 **TIME:** 2:50 pm **STATION NO.** TLT-10 **HABITAT :** Seep, Riffle **WATER COLOR:** Clear
WATERBODY NAME/DESCRIPTION: Unnamed, intermittent tributary to Tanada Creek (no fish data available for this tributary but it leads to a portion of Tanada Creek that is cataloged as sockeye present and king present. Tanada Creek also supports grayling and slimy sculpin).
GPS LATITUDE: 62° 28.659 **GPS LONGITUDE:** 143° 22.166
RIPARIAN VEGETATION: Functional, with moderate rutting at both approaches
WATERBODY TYPE: stream **FLOODPLAIN:** flat **STREAM MORPHOLOGY:** B **H₂O STAGE:** 5
WATERBODY SLOPE: 2 % **BANKFULL WIDTH:** 1 (ft.) **FLOODPLAIN WIDTH:** 6 (ft.)
SUBSTRATE (%): Bedrock ___ Boulder ___ Cobble ___ Gravel _80_ Sand ___ Silt/Clay _10_ Organic _10_
COMMENTS: Degraded crossing may contribute to water quality issues.

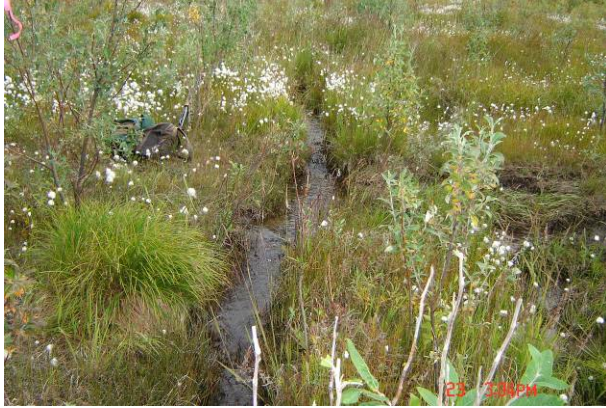
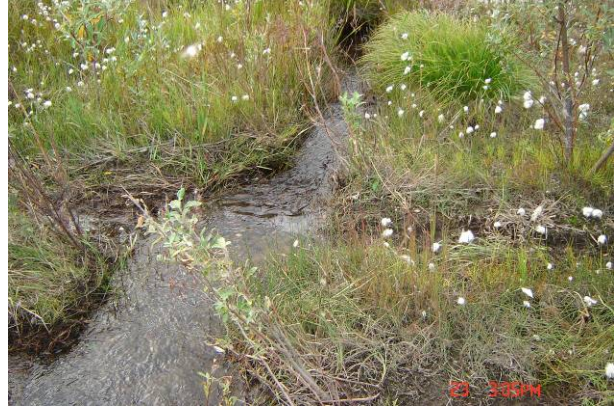
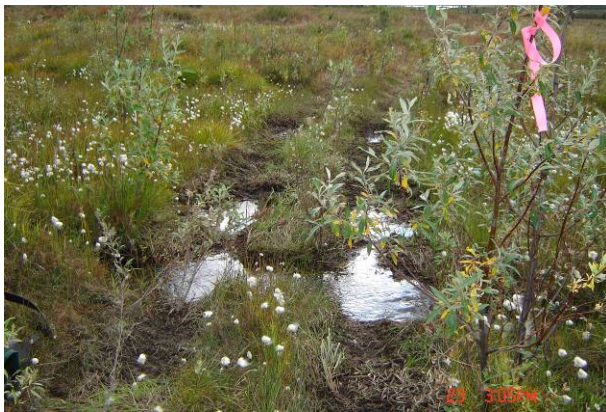
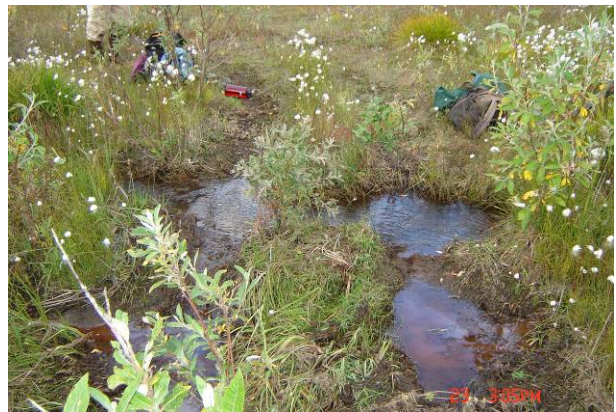
Upstream view from crossing TLT-11.

COMMENTS: Degraded crossing may contribute to water quality issues.

Site		Crossing	Comments
Site ID	Negative Impact to Fish Habitat	Barrier to Fish Passage	
TLT11	Yes - should be repaired if this channel actually drains into Tanada Creek	None	Degraded crossing with moderate rutting on both approaches which may contribute to water quality issues.
TLT12	Yes - should be repaired	None	Stream drains through a wetland and into Tanada Creek where there is sockeye spawning habitat. Crossing is degraded with moderate rutting on both approaches. Current conditions may contribute to water quality issues and have a potential negative impact on spawning habitat.
TLT13	Yes - should be repaired	None	Stream runs through a wetland, into the crossing and then channels into Tanada Creek where there is sockeye spawning habitat. The crossing, which is located approximately 400 feet from the creek, is degraded with moderate rutting on both approaches. Current condition may contribute to water quality issues and have potential negative impact to spawning habitat.

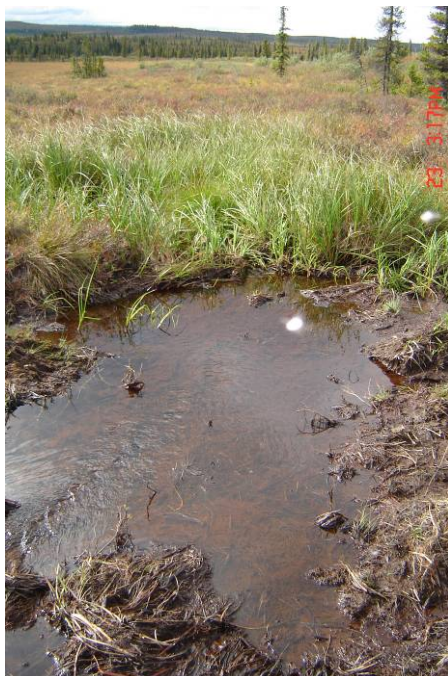
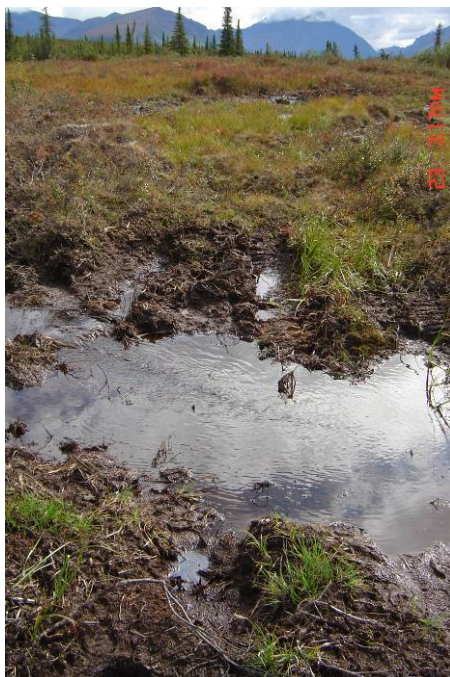
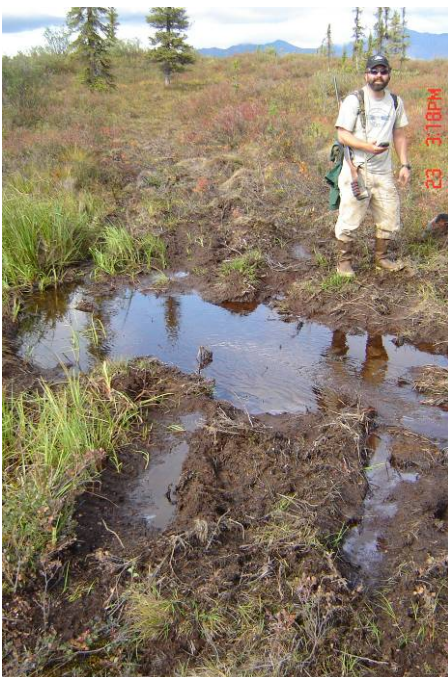
COMMENTS: Drains through a wetland and into Tanada Creek where there is sockeye spawning habitat. The crossing, which is located approximately 1500 feet from the creek, is degraded and may contribute to water quality issues and have potential negative impact to spawning habitat.

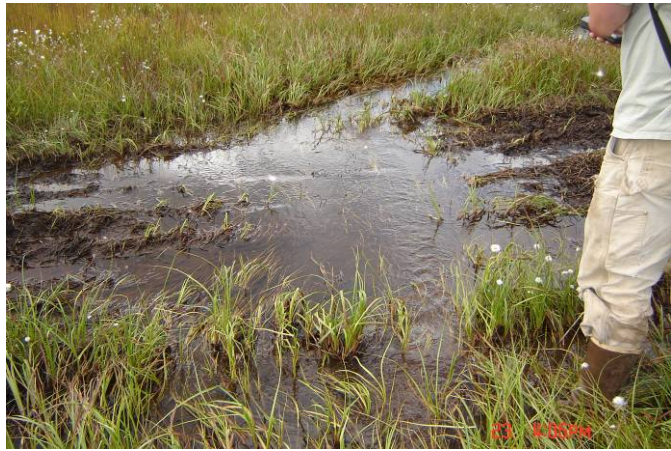
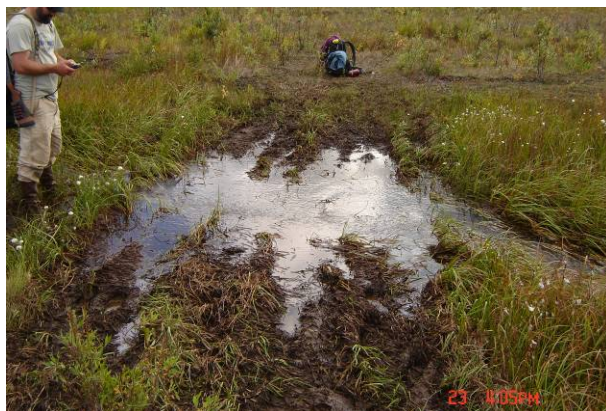
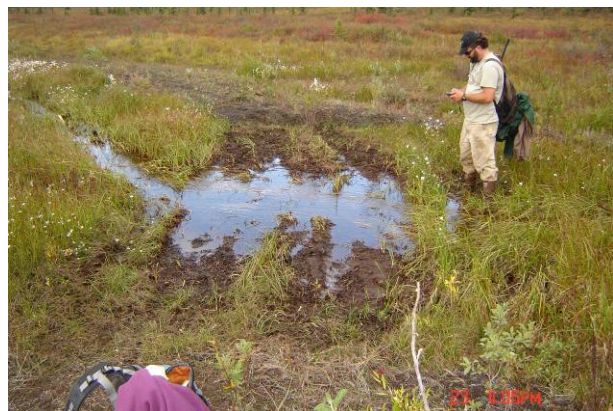
Downstream view from crossing TLT-13.

COMMENTS: Stream runs through a wetland, into the crossing and then channels into Tanada Creek where there is sockeye spawning habitat. The crossing, which is located approximately 400 feet from the creek, is degraded and may contribute to water quality issues and have potential negative impact to spawning habitat.

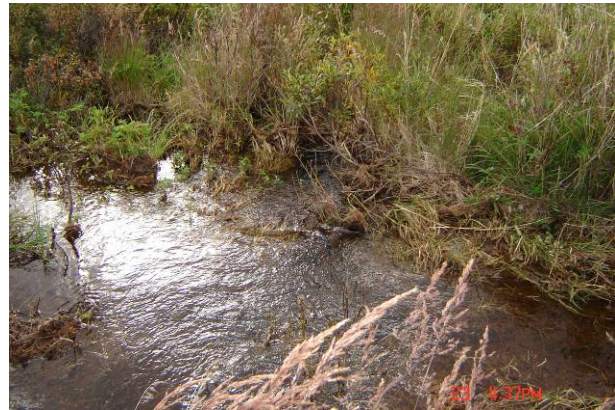
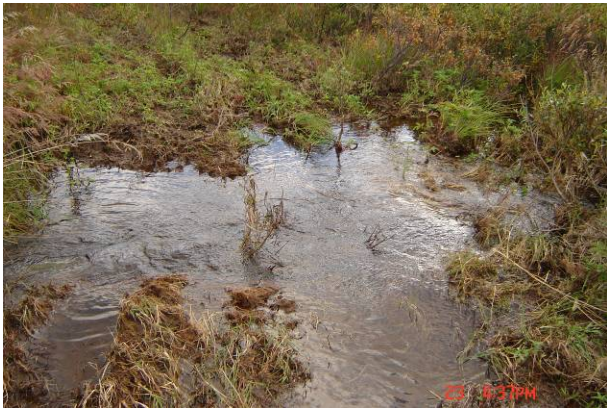
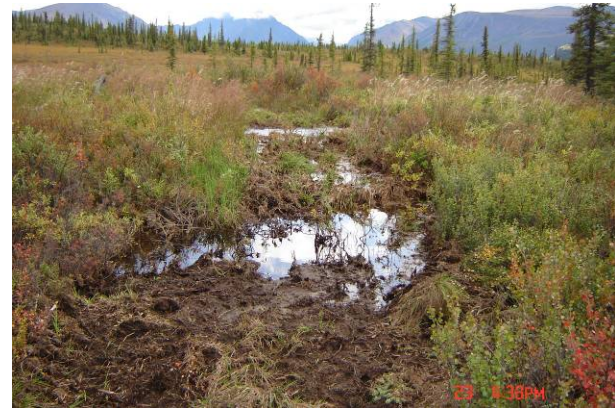
COMMENTS: Crossing very degraded and located within 1500 ft. of Tanada Lake. Not possible to cross with high water conditions and unsure about ability to cross with lower water levels. Current conditions contribute to water quality issues.

TLT14	Yes - should be repaired	None	Crossing very degraded with significant rutting on left bank approach. This crossing is located within 1500 ft. of Tanada Lake. Not possible to cross with high water conditions and unsure about ability to cross with lower water levels. Current conditions contribute to water quality issues.
TLT15	No	None	Partially degraded left bank.
TLT16	Partially; will worsen with increased use	None	Right bank cut deep. Some erosion.

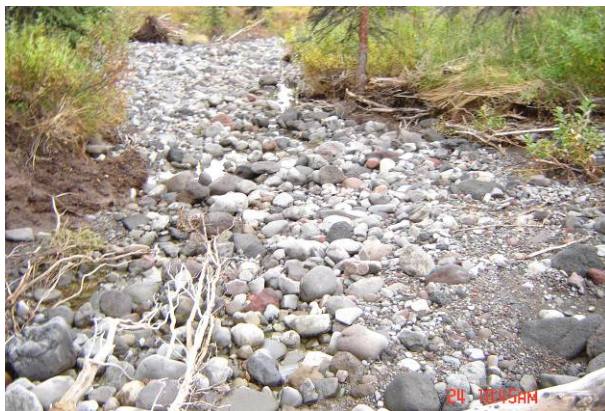
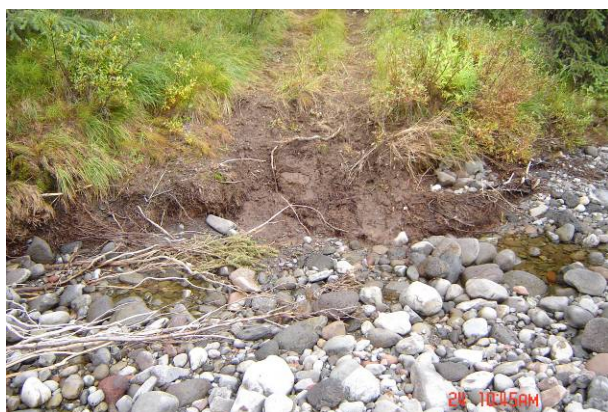
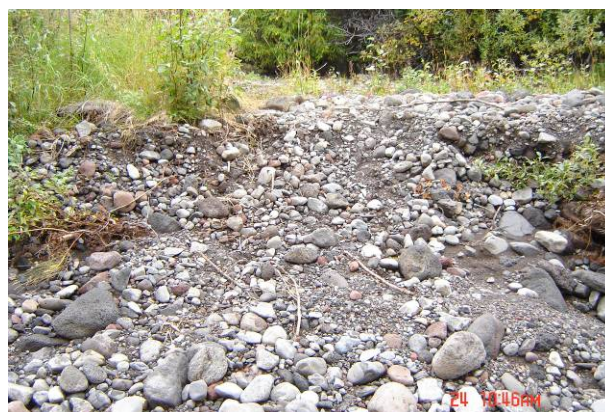
DATE: 8/24/08 **TIME:** 10:41 am **STATION NO.** TLT-15 **HABITAT :** Riffle **WATER COLOR:** Clear
WATERBODY NAME/DESCRIPTION: Unnamed tributary to Tanada Lake (no fish data available for this tributary but it leads to Tanada Lake which is cataloged as sockeye spawning. Tanada Lake also supports burbot, grayling and slimy sculpin).
GPS LATITUDE: 62° 26.375 **GPS LONGITUDE:** 143° 20.998 **RIPARIAN VEGETATION:** Functional
WATERBODY TYPE: stream **FLOODPLAIN:** flat **STREAM MORPHOLOGY:** B **H₂O STAGE:** 1
WATERBODY SLOPE: 4 % **BANKFULL WIDTH:** 30 (ft.) **FLOODPLAIN WIDTH:** 60 (ft.)
SUBSTRATE (%): Bedrock ___ Boulder _30_ Cobble _50_ Gravel _20_ Sand ___ Silt/Clay ___ Organic ___
COMMENTS: Partially degraded left bank.

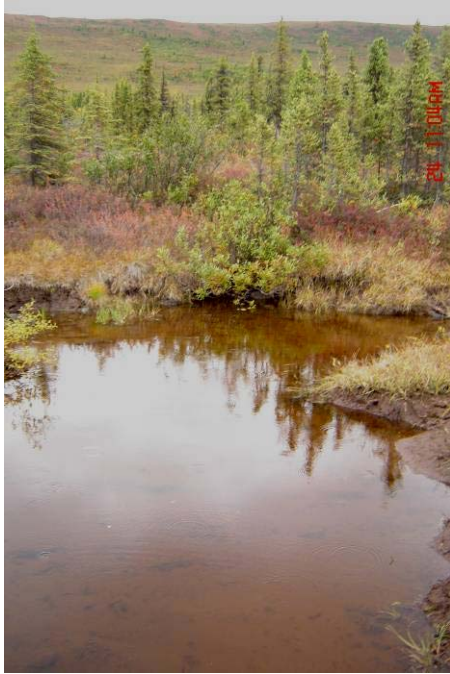
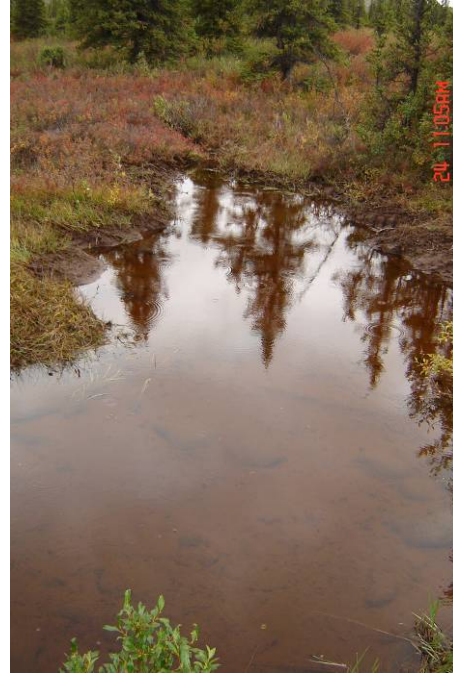
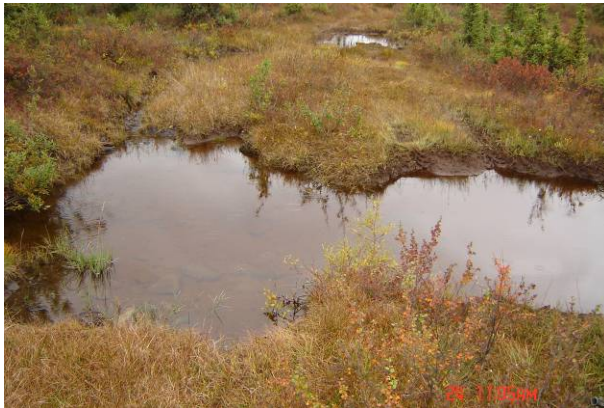
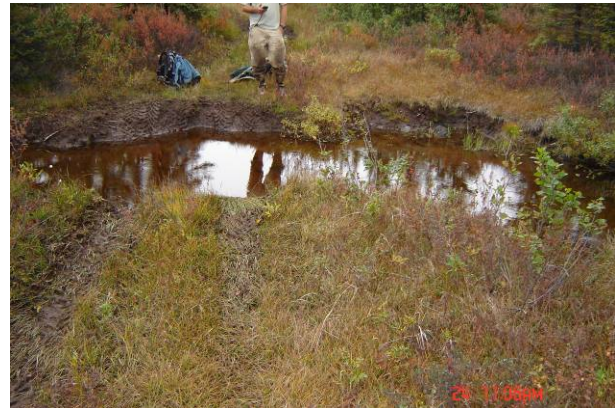
Upstream view from crossing TLT-16.

DATE: 8/24/08 **TIME:** 11:00 am **STATION NO.** TLT-16 **HABITAT :** Riffle **WATER COLOR:** Clear
WATERBODY NAME/DESCRIPTION: Unnamed tributary to Tanada Lake (no fish data available for this tributary but it leads to Tanada Lake which is cataloged as sockeye spawning. Tanada Lake also supports burbot, grayling and slimy sculpin).
GPS LATITUDE: 62° 26.219 **GPS LONGITUDE:** 143° 20.871 **RIPARIAN VEGETATION:** Functional
WATERBODY TYPE: stream **FLOODPLAIN:** flat **STREAM MORPHOLOGY:** B **H₂O STAGE:** 4
WATERBODY SLOPE: 2 % **BANKFULL WIDTH:** 1 (ft.) **FLOODPLAIN WIDTH:** 3 (ft.)
SUBSTRATE (%): Bedrock ___ Boulder ___ Cobble _5_ Gravel _20_ Sand ___ Silt/Clay ___ Organic _95_
COMMENTS: Approaches are short but steep, and slightly eroded.

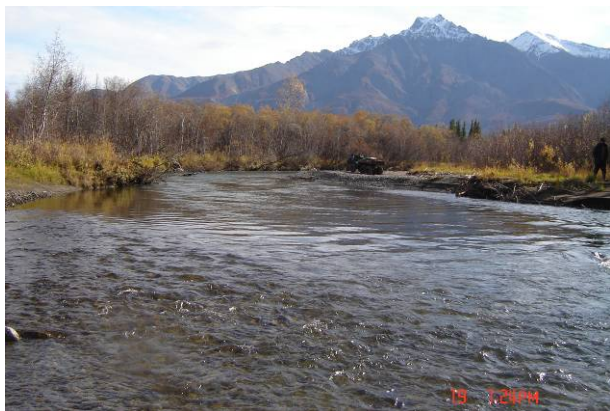
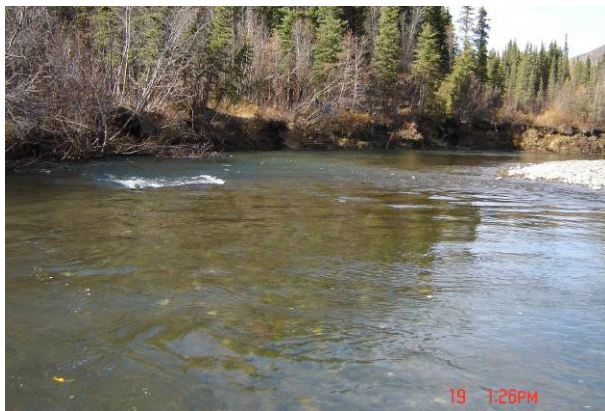
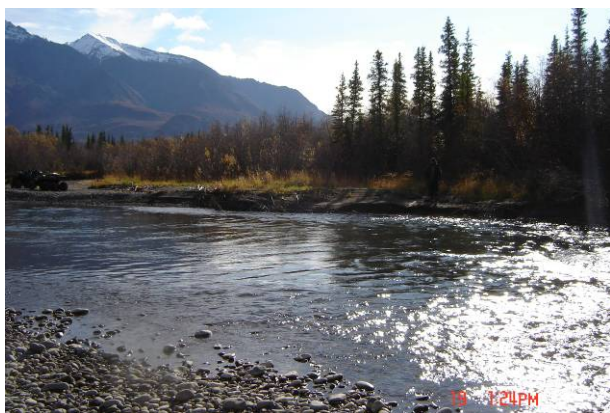
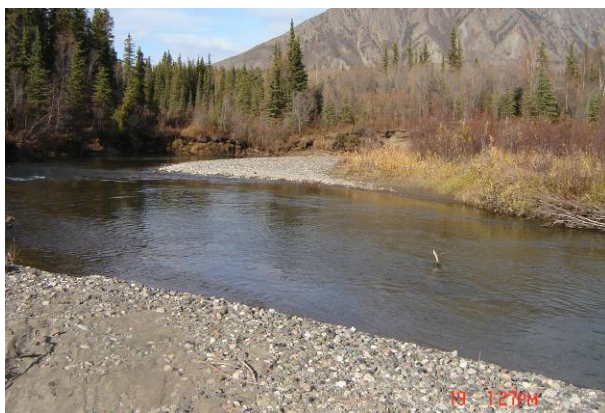
Upstream view from crossing JC-1.

DATE: 9/20/08 **TIME:** 1:15 pm **STATION No.** JC-1 **HABITAT :** Riffle **WATER COLOR:** Clear
WATERBODY NAME/DESCRIPTION: Jack Creek (supports grayling, slimy sculpin and burbot)
GPS LATITUDE: 62° 23.649 **GPS LONGITUDE:** 142°53.490 **RIPARIAN VEGETATION:** Functional
WATERBODY TYPE: stream **FLOODPLAIN:** flat **STREAM MORPHOLOGY:** C **H₂O STAGE:** 3
WATERBODY SLOPE: 1.5 % **BANKFULL WIDTH:** 85 (ft.) **FLOODPLAIN WIDTH:** 120 (ft.)
SUBSTRATE (%): Bedrock ____ Boulder ____ Cobble _15_ Gravel _60_ Sand _20_ Silt/Clay _5_ Organic ____
COMMENTS: Crossing in good condition.

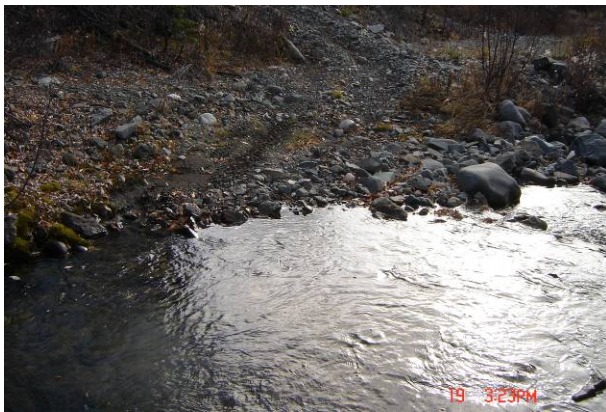
Left bank.

COMMENTS: Crossing in good condition.

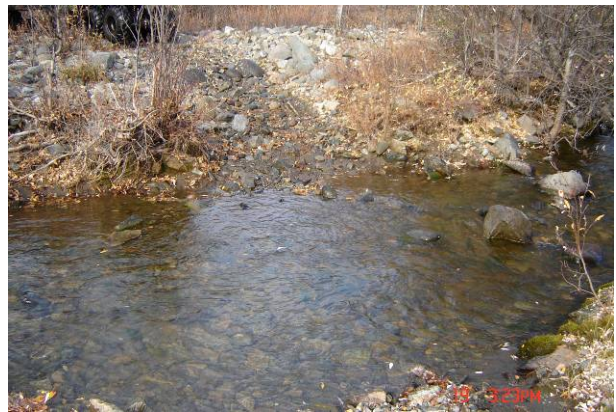
Right bank.

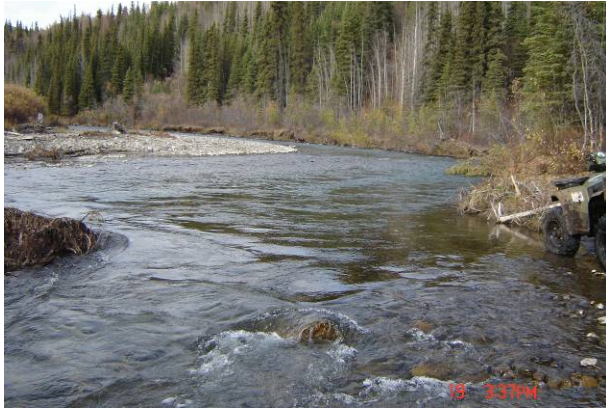
Upstream view from crossing JC-3.

COMMENTS: Crossing in good condition.

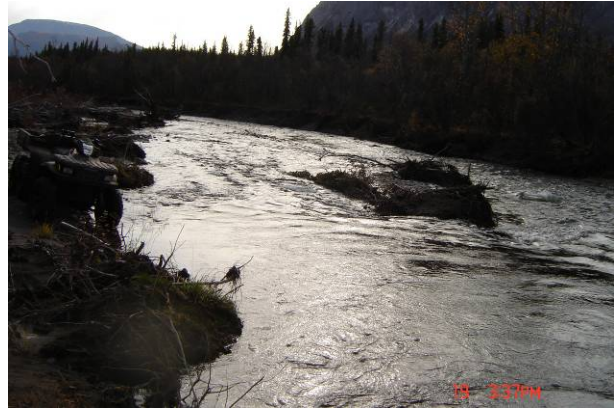
Downstream view.

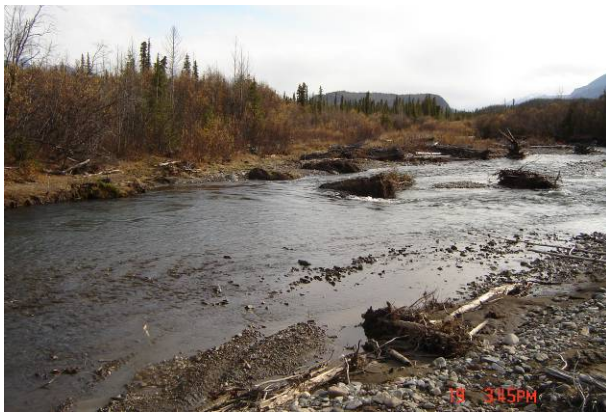
Left bank.

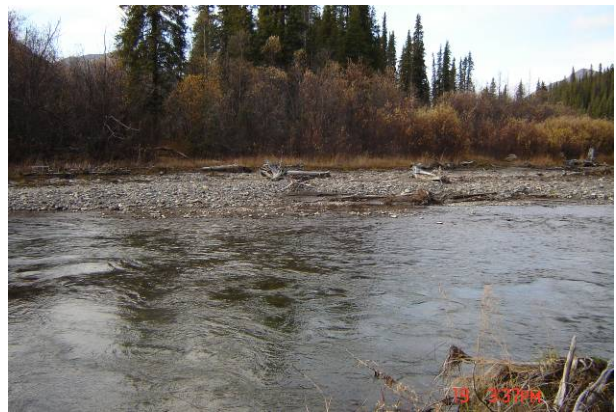
Right bank.
