**CAMP CREEK****CORRECTION****Water body name:****Survey date:** 7/8/2014**Water body number:** 186-15-10400-2011**Species & Lifestage:** COs**Watershed:** White River-Frontal Gulf of Alaska**MTR:** C022S022E **Quad:** Icy Bay D-2

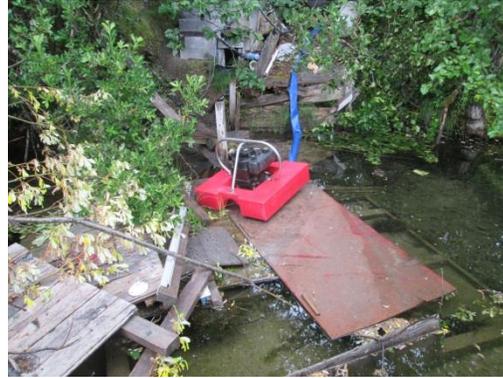
Figure 2.—Water intake on creek near camp.

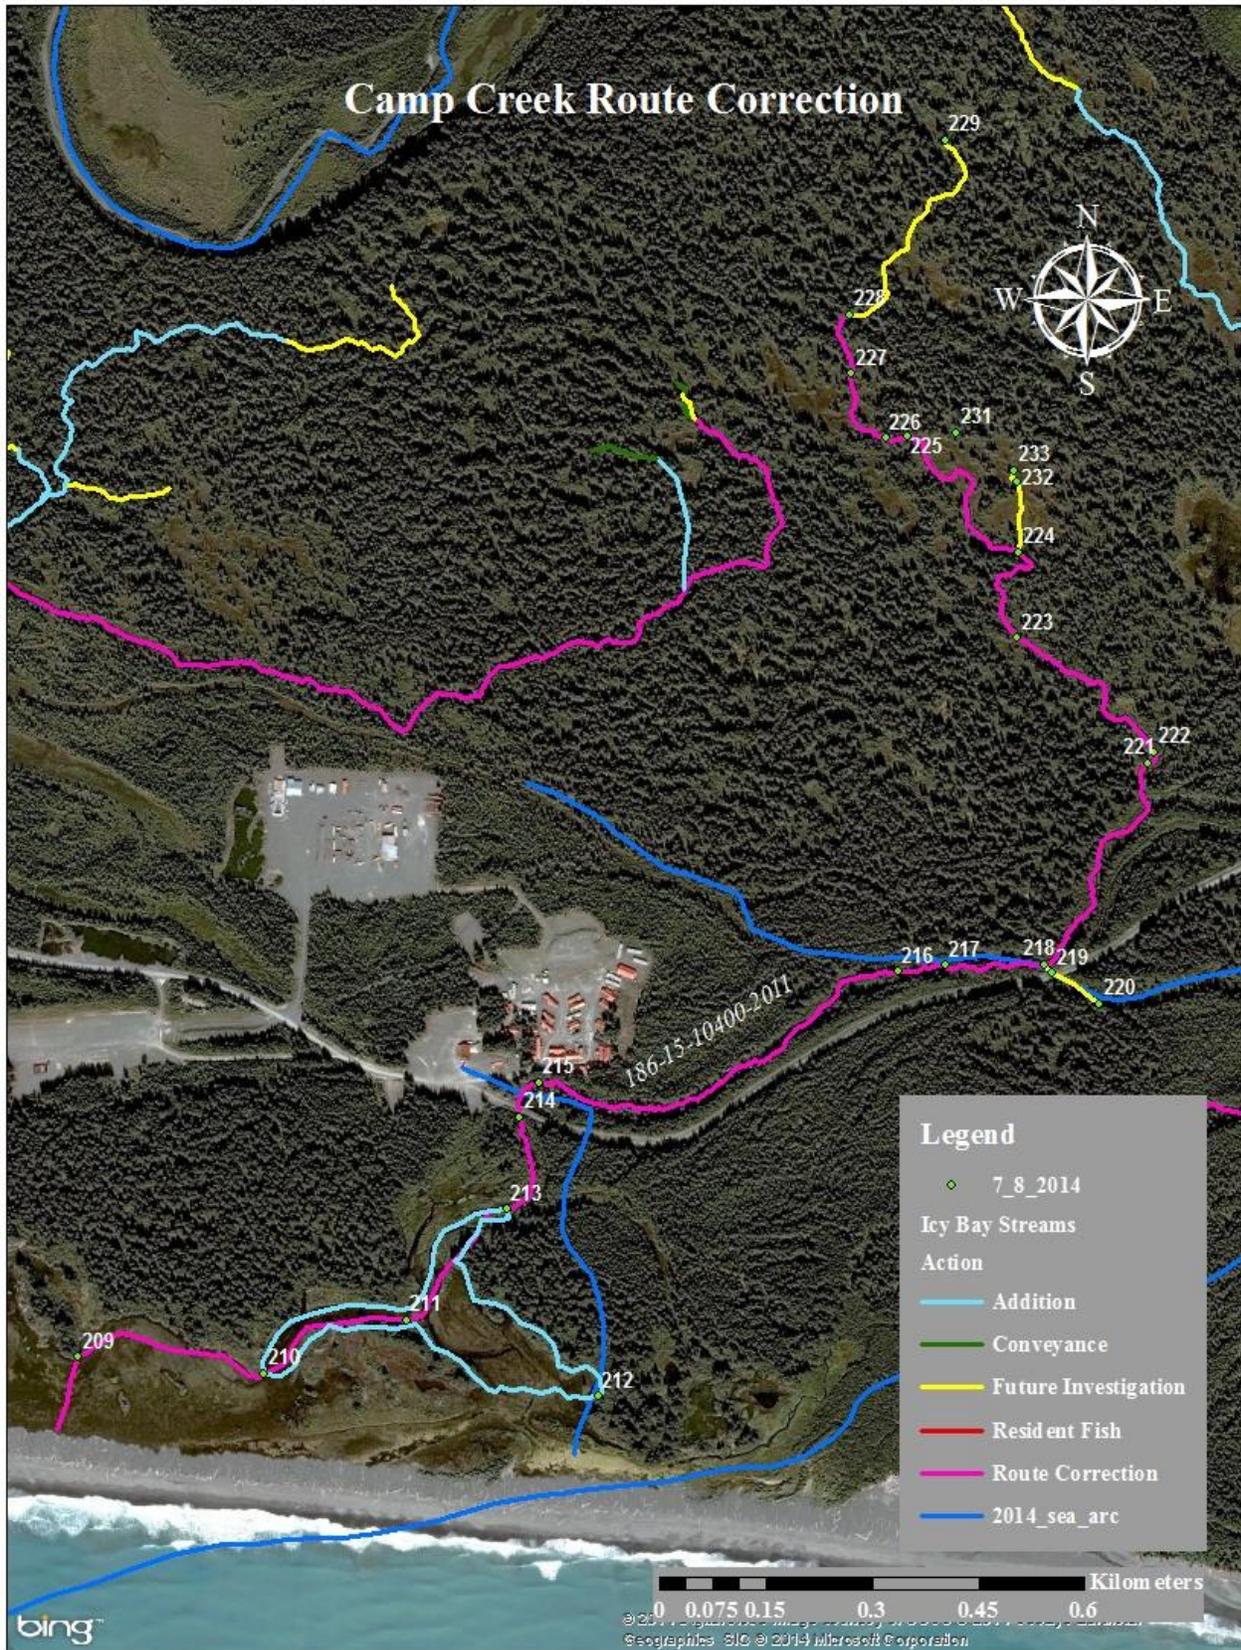
Figure 4.–Camp Creek route correction map.

**Recommendations:** Correct the current route in AWC and add rearing coho.
