Appendix: Juneau

Guide to direct fieldwork for cataloging anadromous water bodies in Southeast Alaska

JUNEAU STREAM SURVEYS

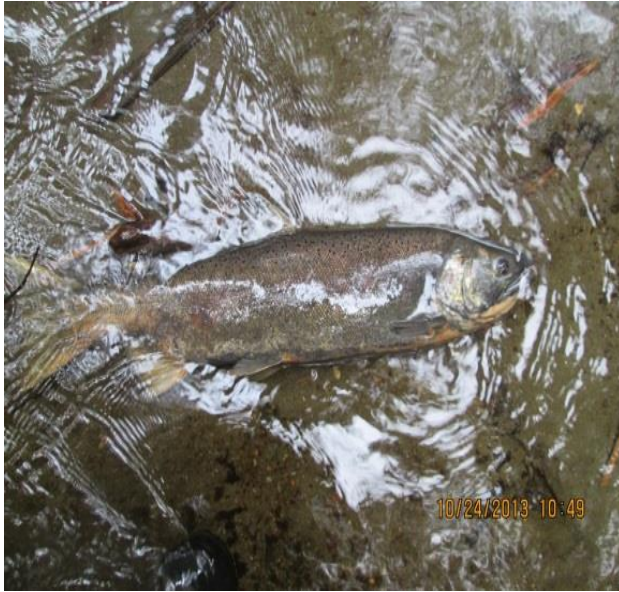
Figure 1.—Adult female coho salmon.

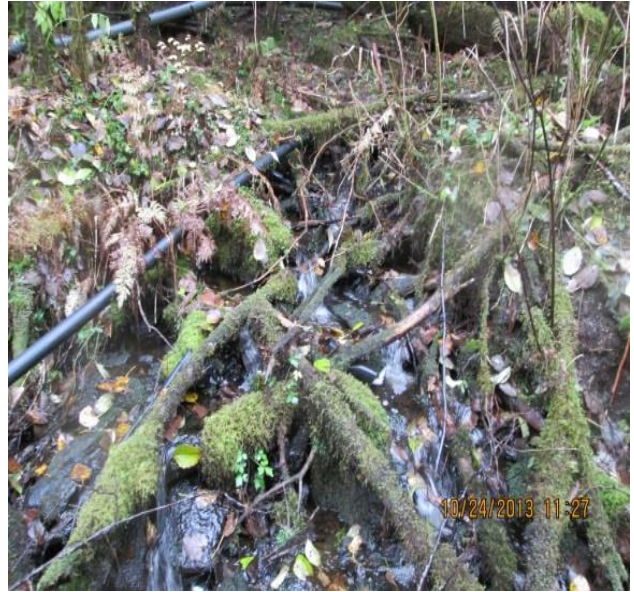
Figure 2.—Possible cascade barrier.

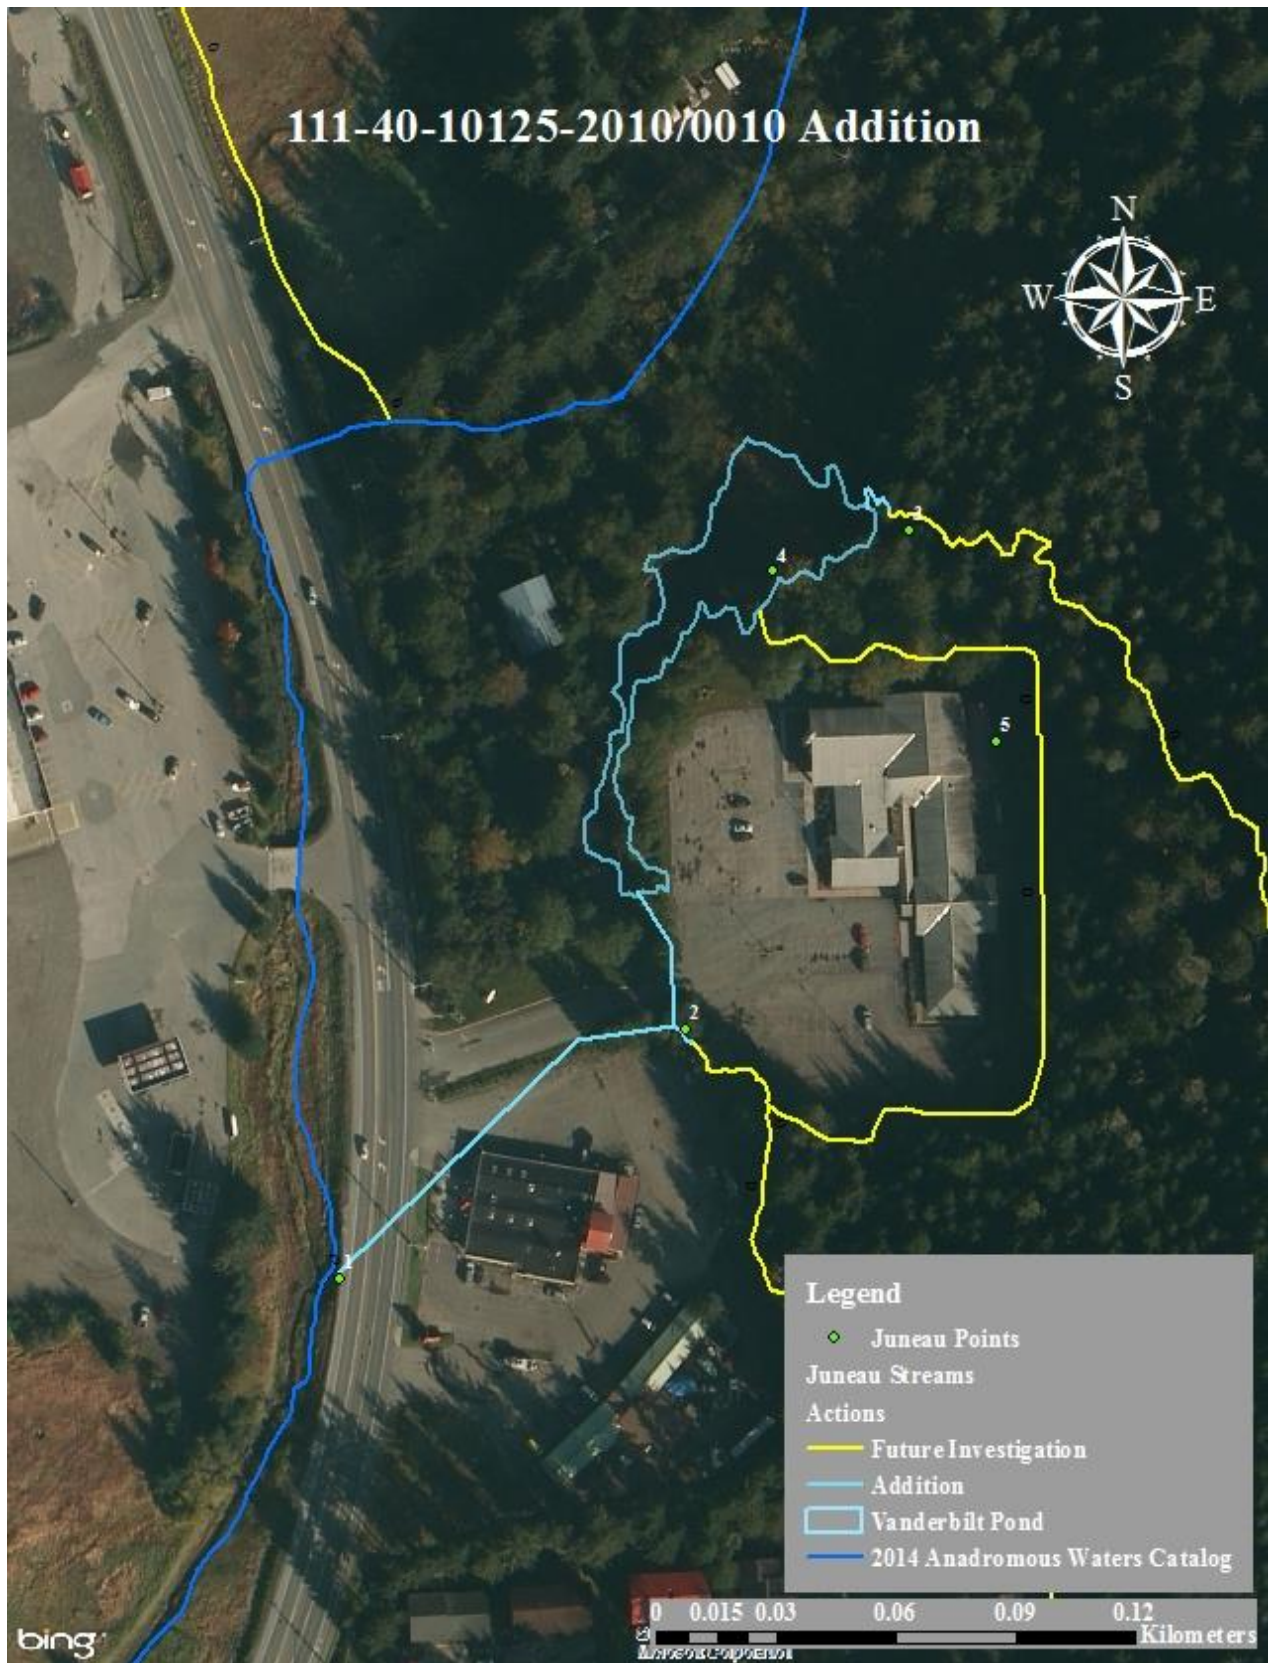
Figure 1.-111-40-10125-2010/0010 addition map.

Recommendations: Add stream to the Anadromous Waters Catalog (Figure 1).

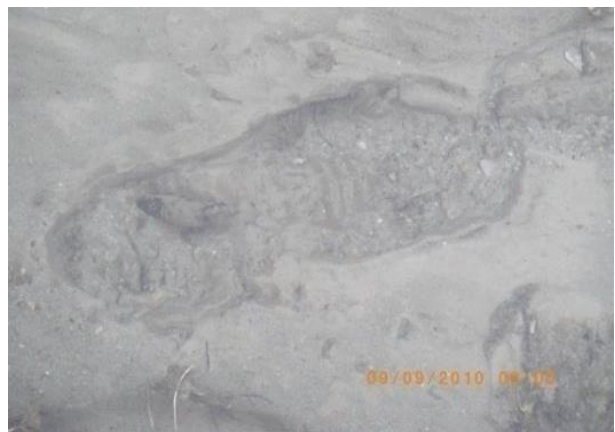
Figure 4.—Footprint in sediment.

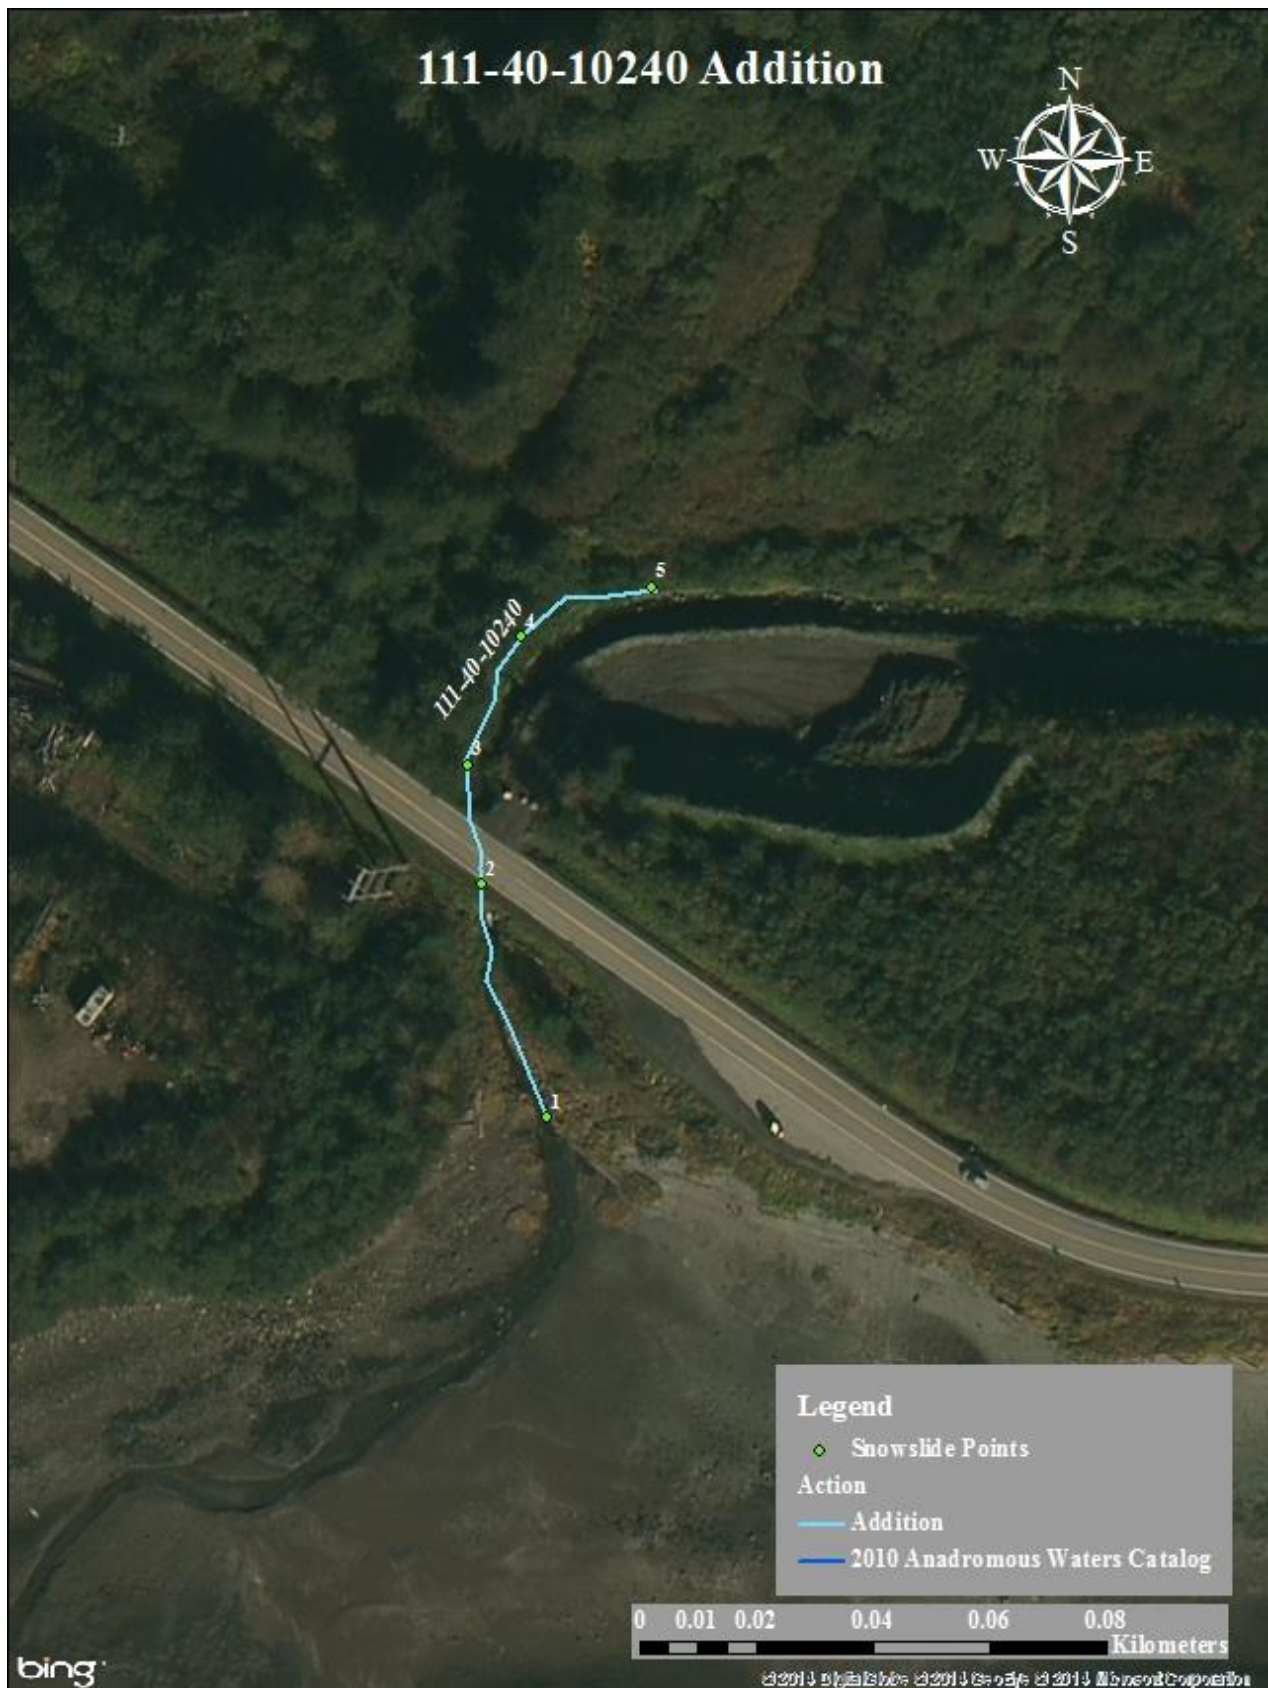
Figure 7.—111-40-10240 addition map.

Recommendations: Add stream to the AWC and monitor for riparian regrowth and bank stabilization. Install a fish pipe (Figure 7).

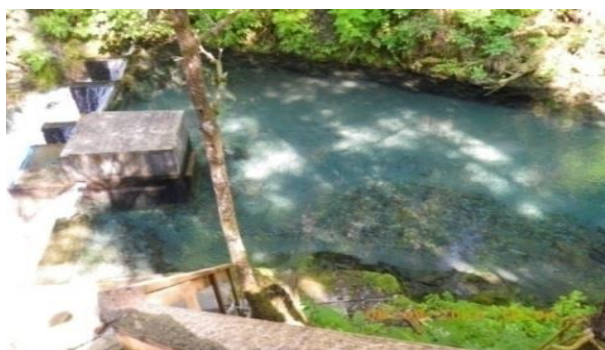
Figure 2.—Looking down at dam above falls.

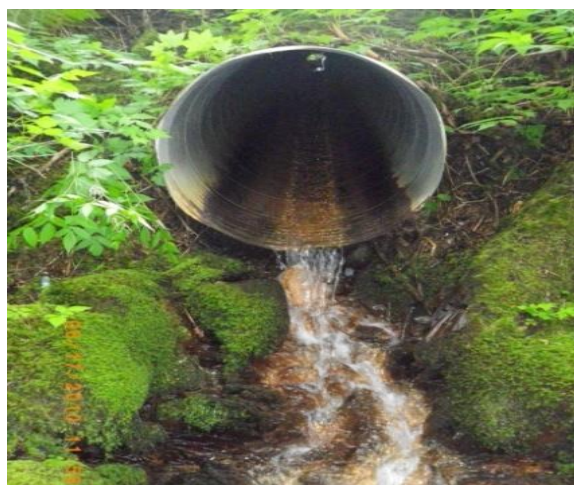
Figure 1.—Outlet of perched culvert.

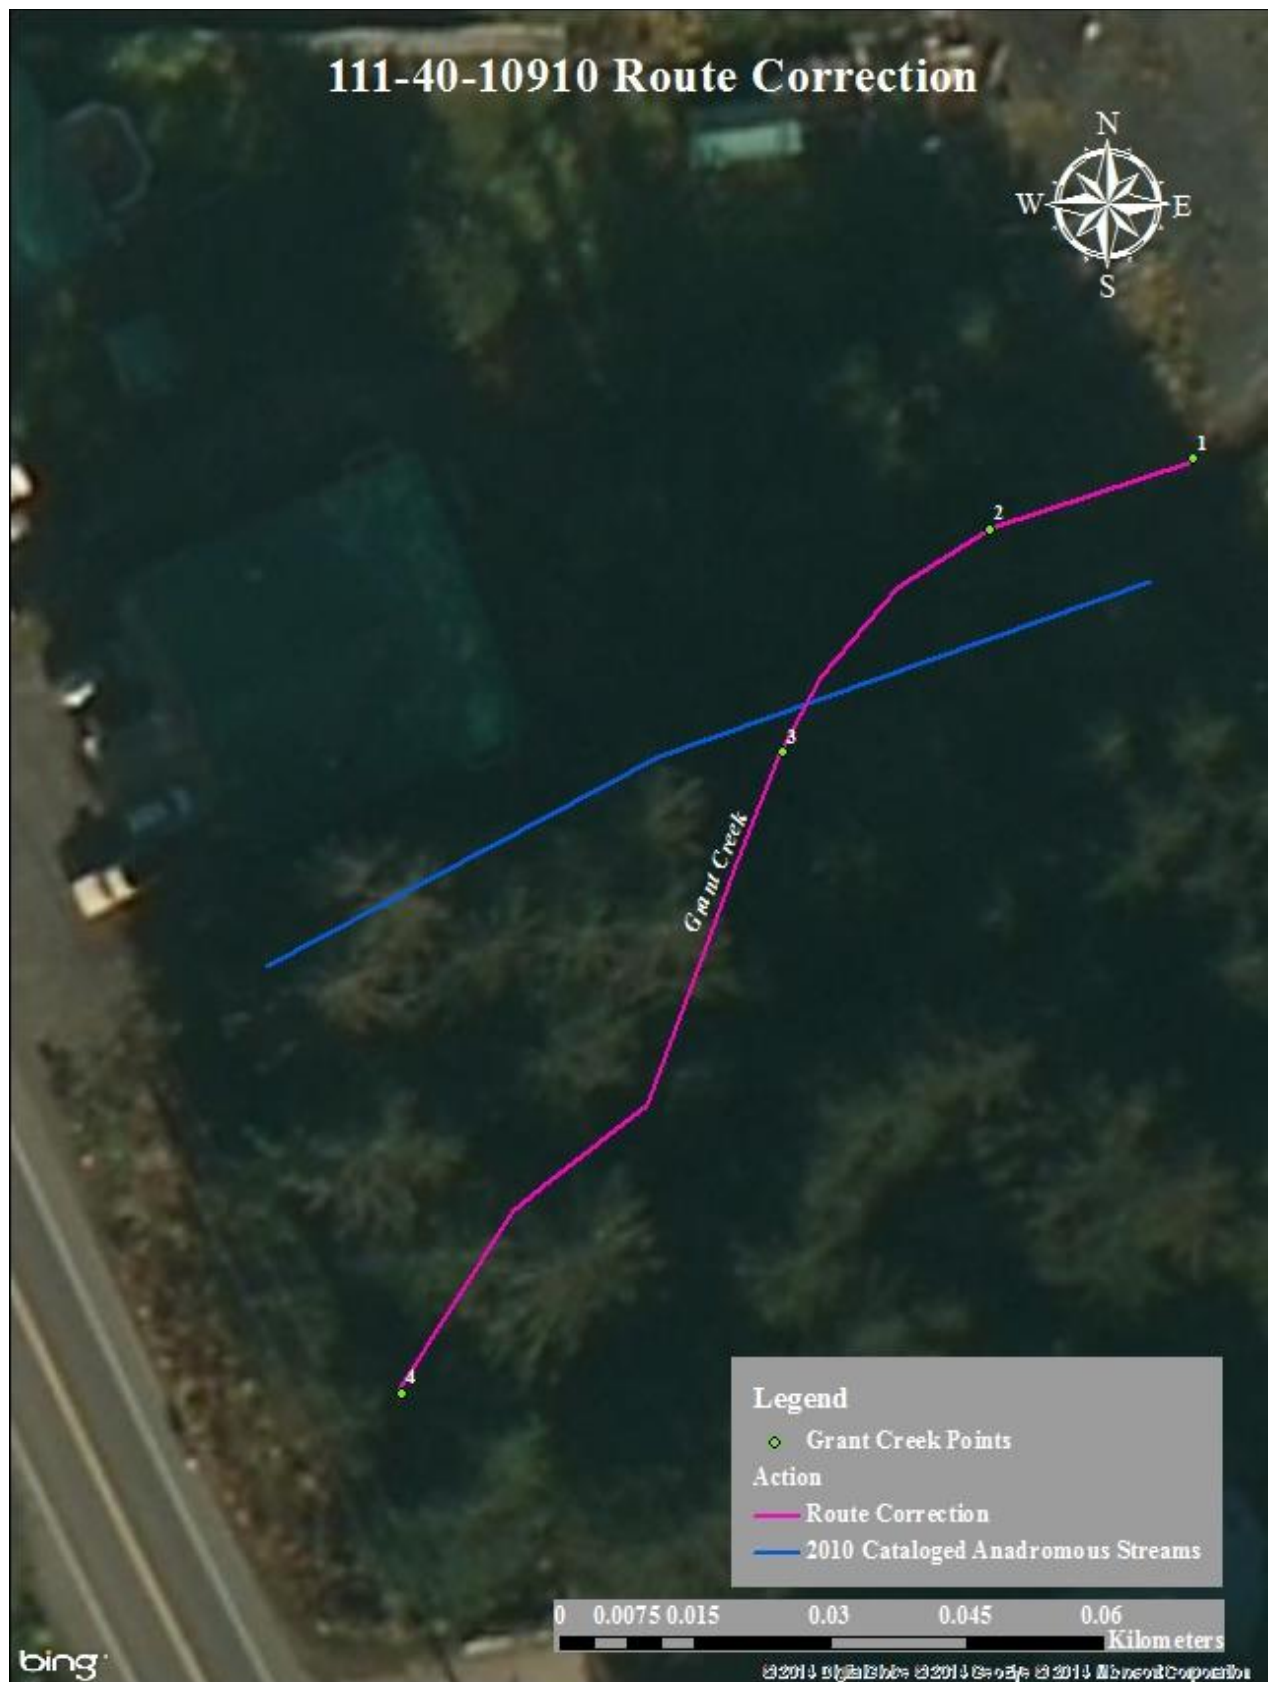
Figure 3.-111-40-10910 route correction map.

Recommendations: Correct the current stream route in the AWC (Figure 3).

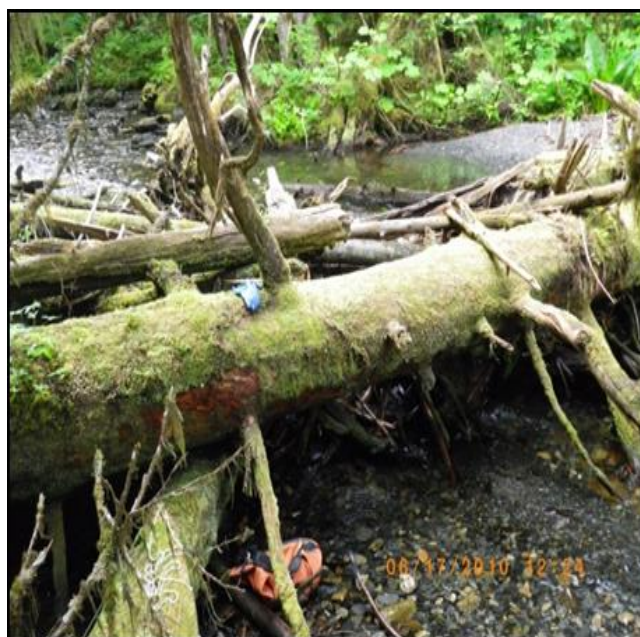
Figure 2.–Elevated streambed and log jam.

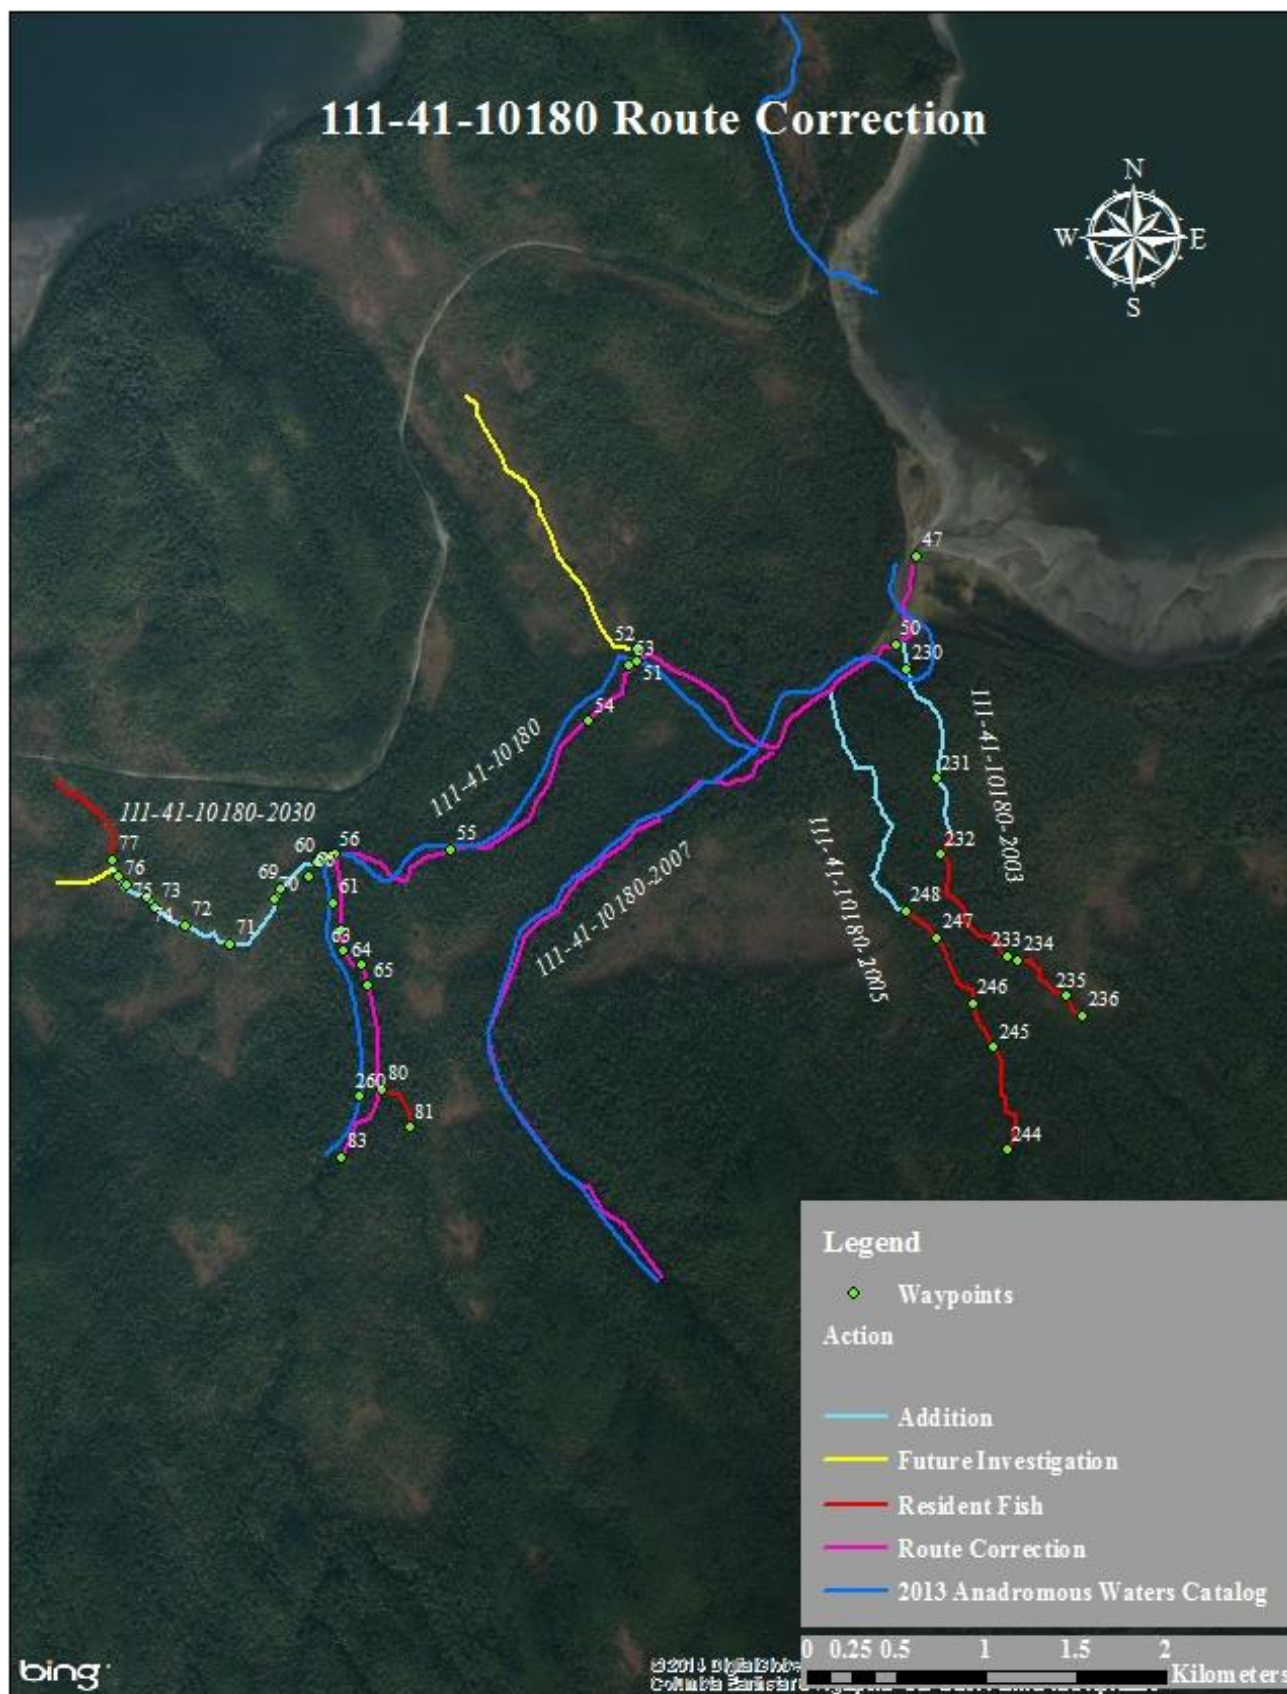
Figure 2.—111-41-10180 route correction map.

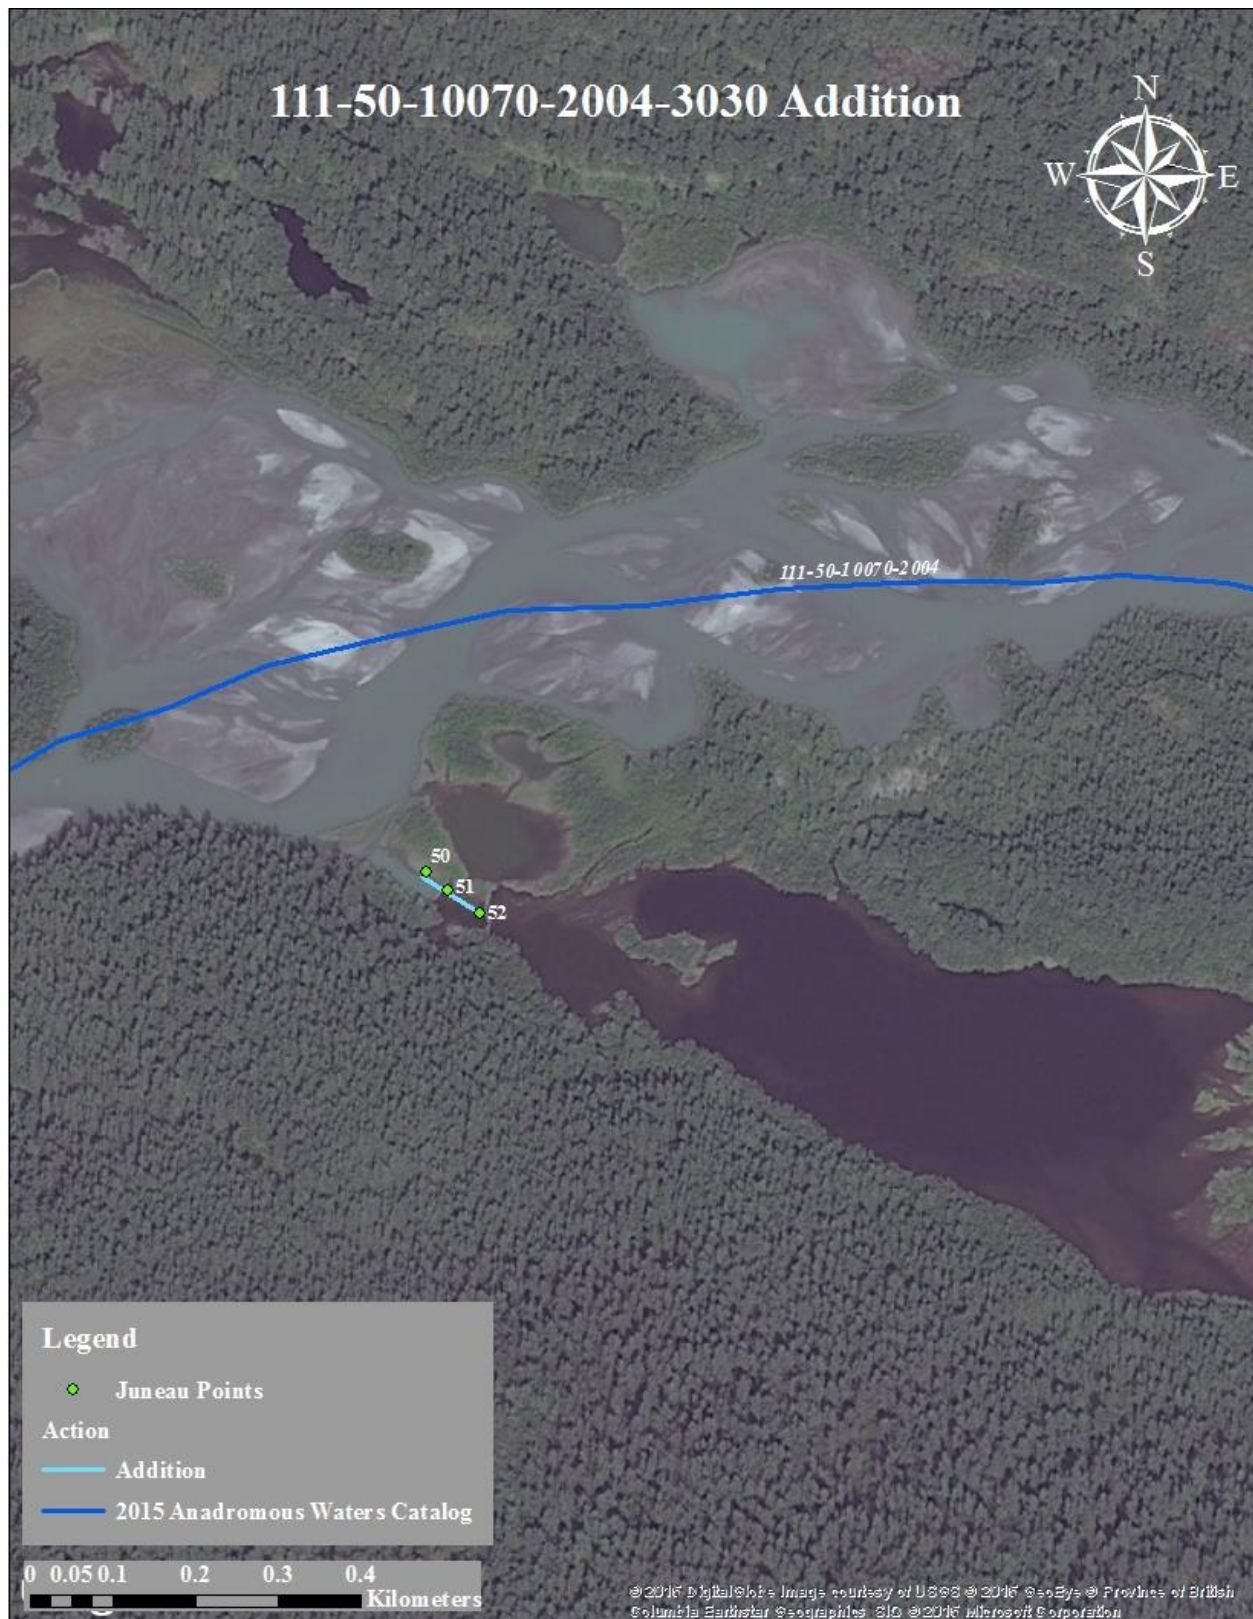
Figure 3.—111-50-10070-2004-3030 addition map.

111-50-10070-2004-3030**ADDITION****Water body name:****Survey date:** 4/24/2015**Water body number:** 111-50-10070-2004-3030**Species & Lifestage:** COr**Watershed:** Herbert River-Eagle River**MTR:** C038S065E **Quad:** Juneau C-3**Findings:** We surveyed this beaver impoundment with baited minnow traps and a GPS (Table 1). This beaver lake provides habitat for rearing coho.**Recommendations:** Add stream to the AWC. Last coho captured at waypoint 52.**Nomination:** 15-613

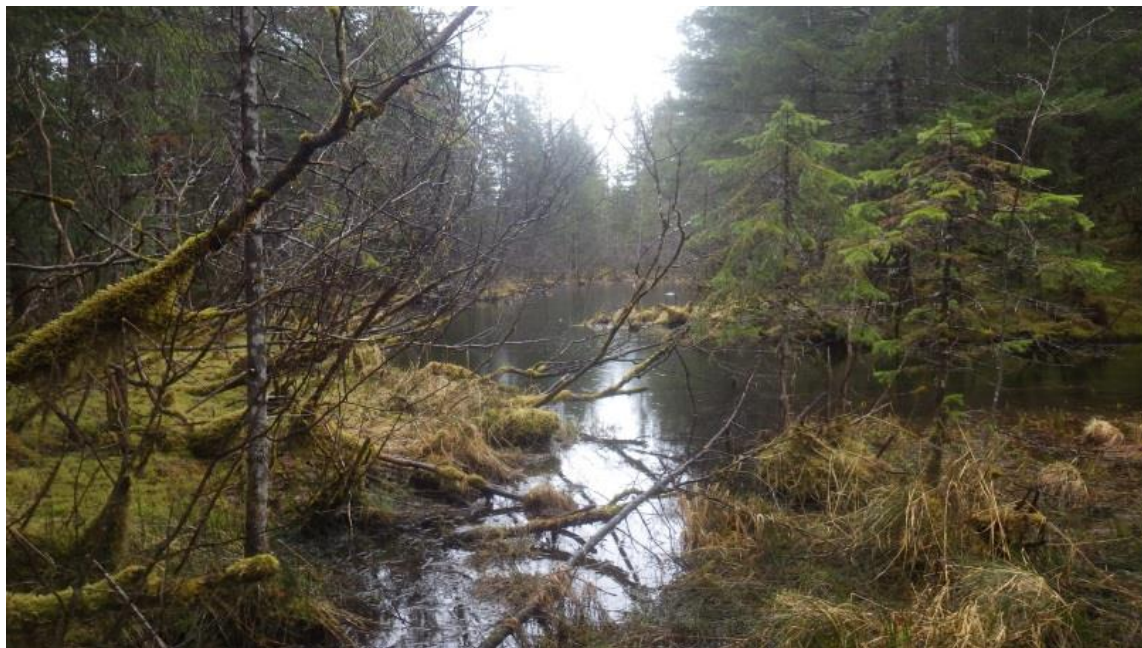
Figure 1.–Beaver complex 1 and upper extent of anadromy, waypoint 11.

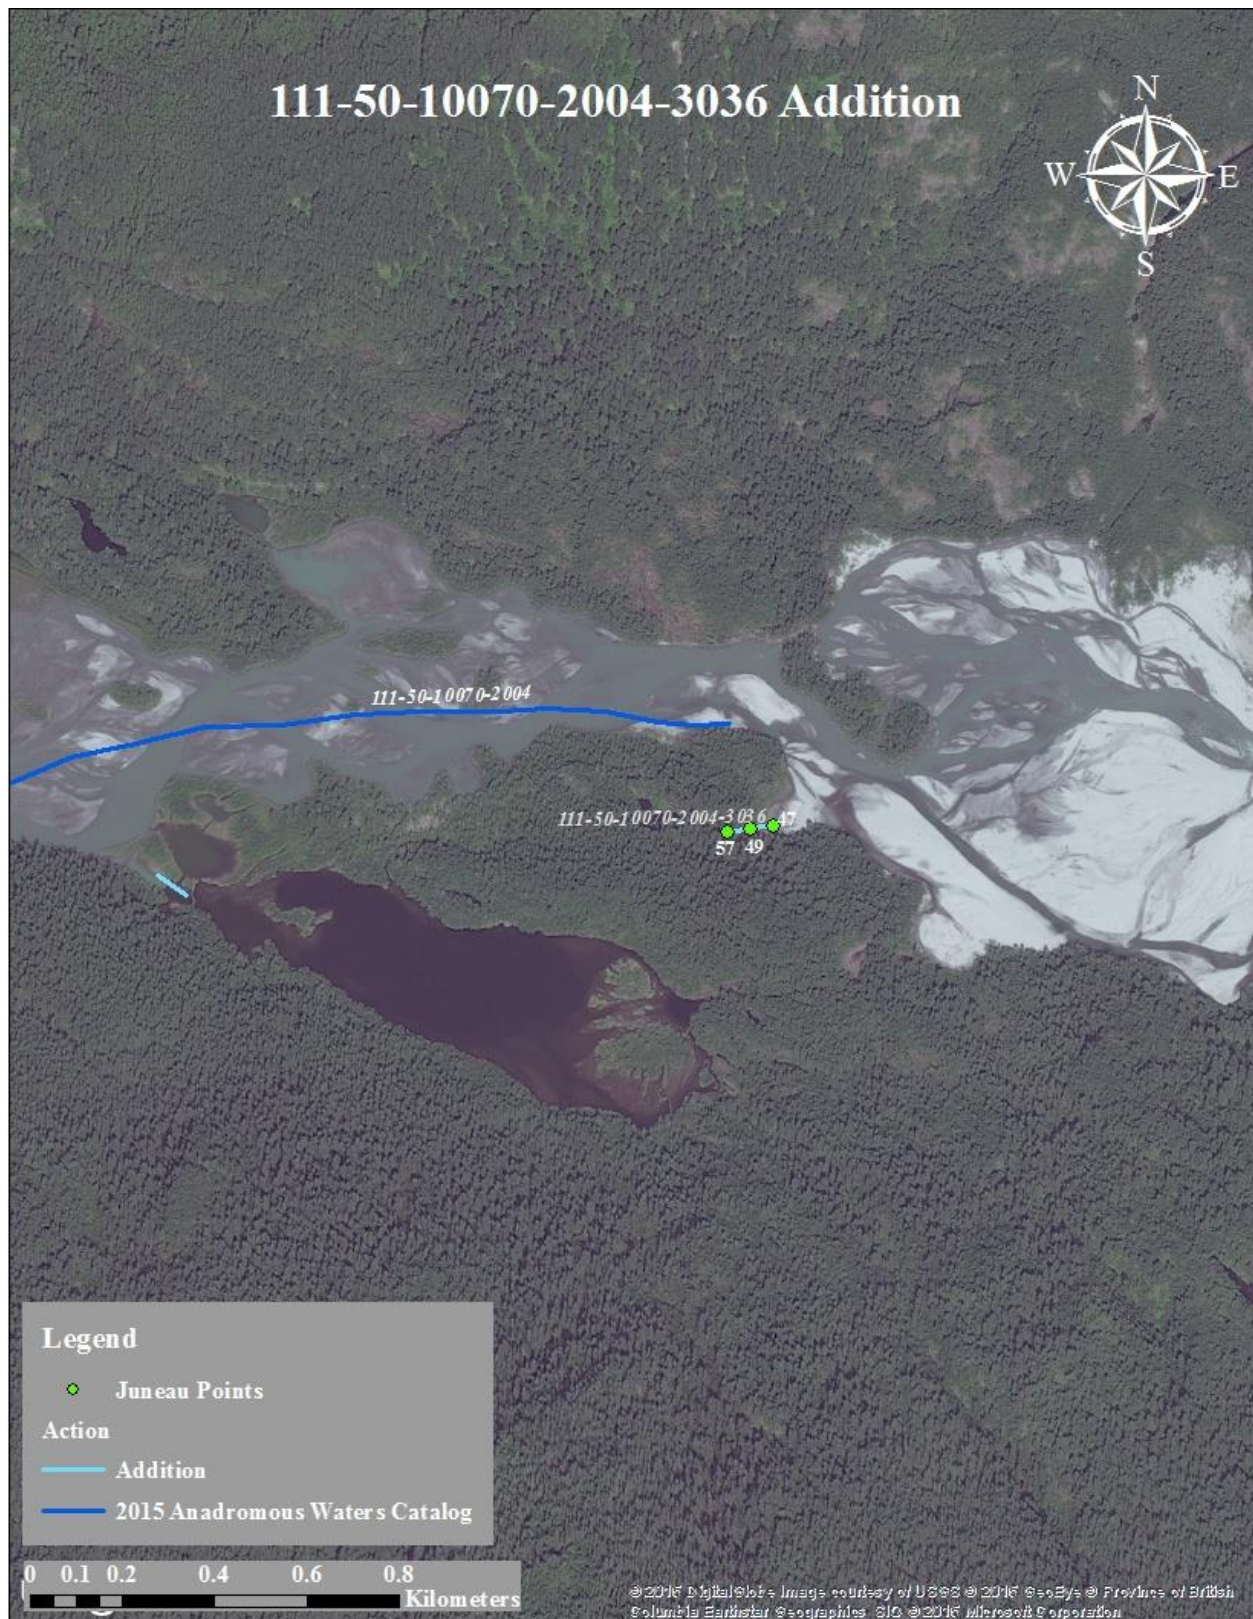
Figure 3.—111-50-10070-2004-3036 addition map.

Recommendations: Add stream to the AWC, caught coho salmon up to WP 49 (Figure 3).

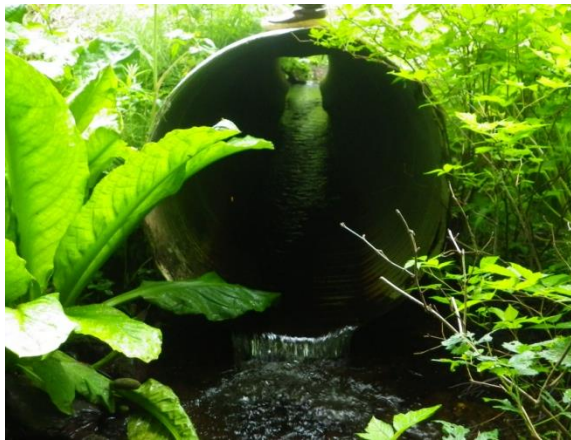
Figure 1.–Perched culvert conveying flows beneath Lena Loop road.

Findings: We conducted a survey of Campground Creek using a backpack electrofisher and a GPS (Table 1). We found that the mainstem of Campground Creek should extend where 111-50-10310-2008 is cataloged. The amount of flow through these two culverts shows which is mainstem and tributary (Figures 1, 2). We captured most of our fish below Glacier Highway (Figure 3).

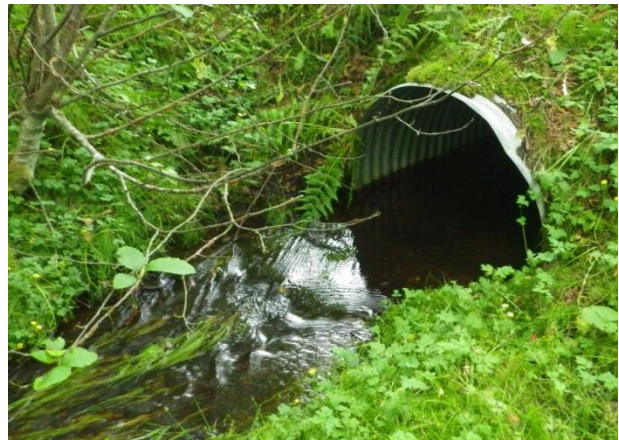
Figure 2.–Culvert currently for cataloged tributary of Campground Creek.

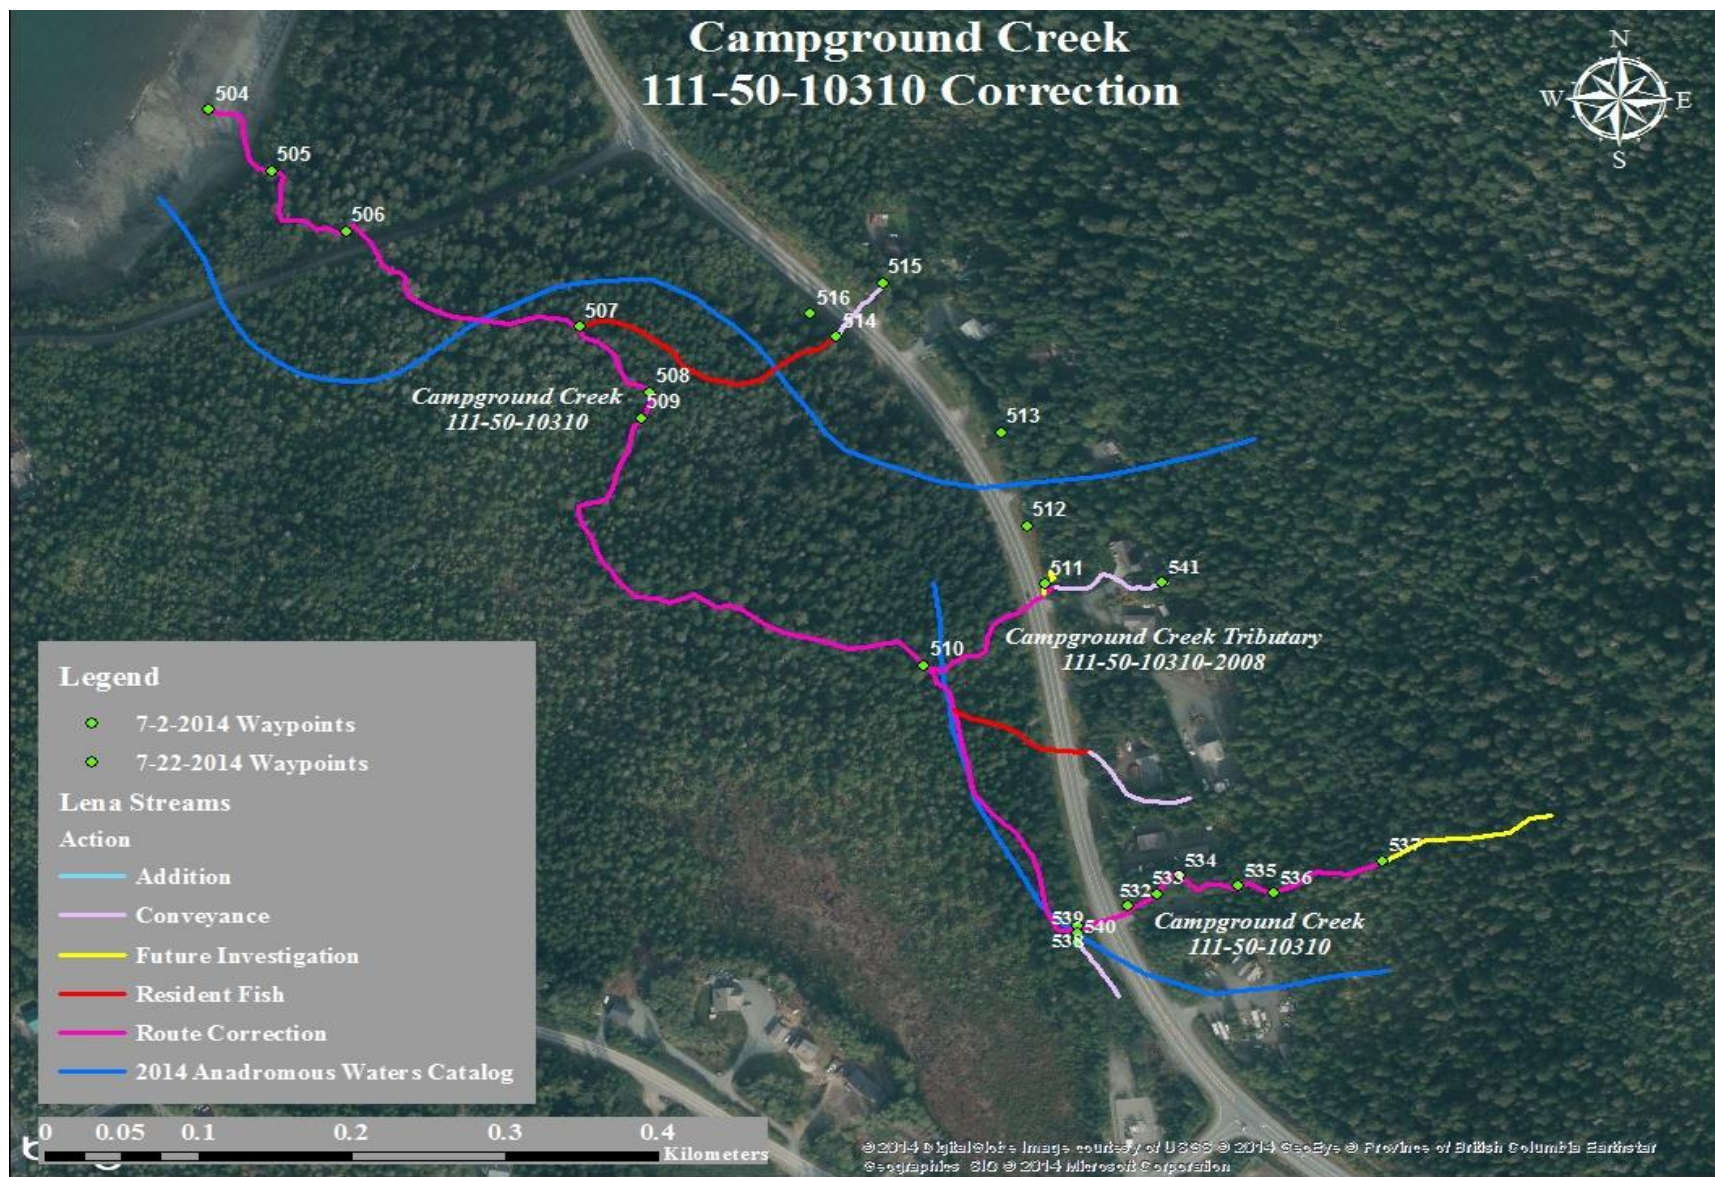
Figure 4.–111-50-10310 correction map.

Recommendations: Update the stream route and switch the cataloged mainstem and tributary (Figure 4).

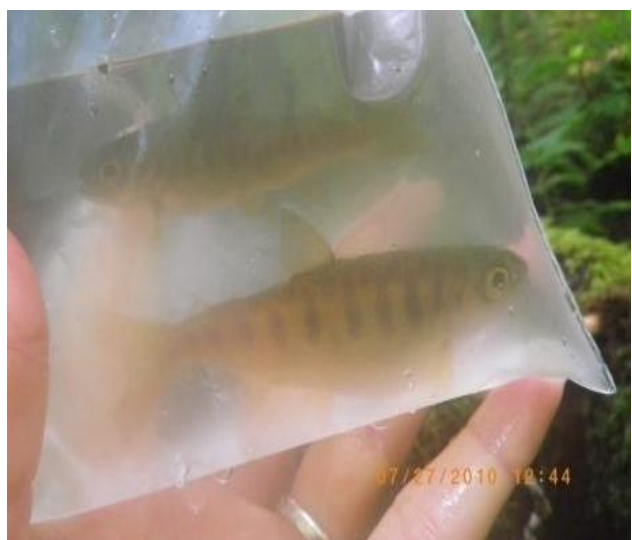
Figure 1.–CO in Lake Creek.

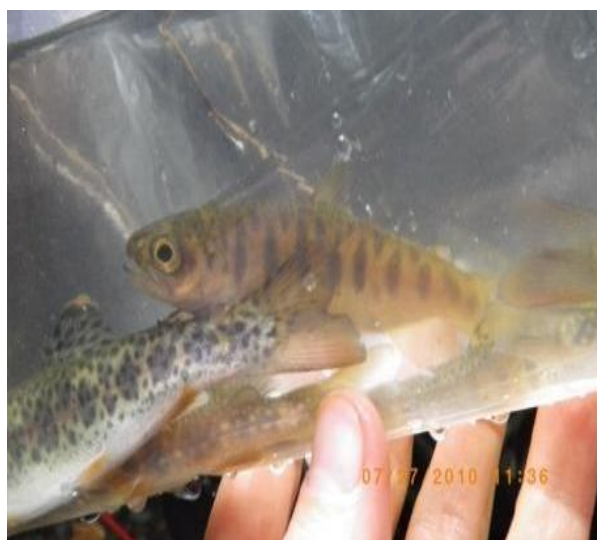
Figure 2.–CT and CO in Lake Creek.

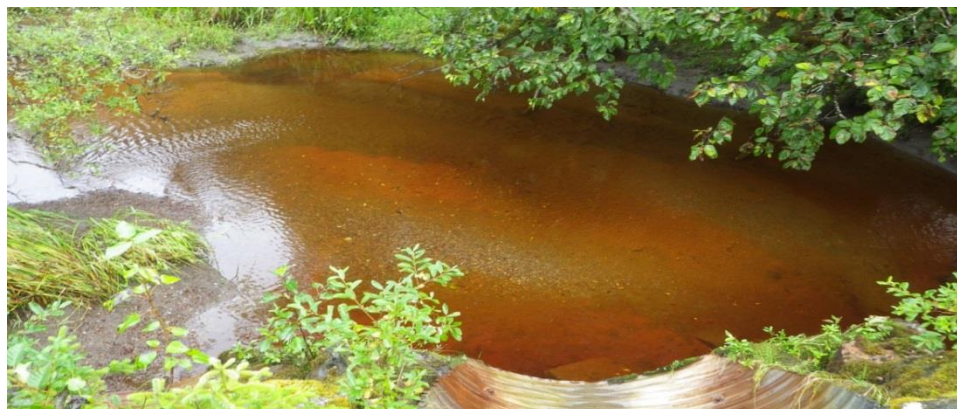
Figure 1.–Looking upstream from set of 4 culverts under Montana Creek Road, near waypoint 53.

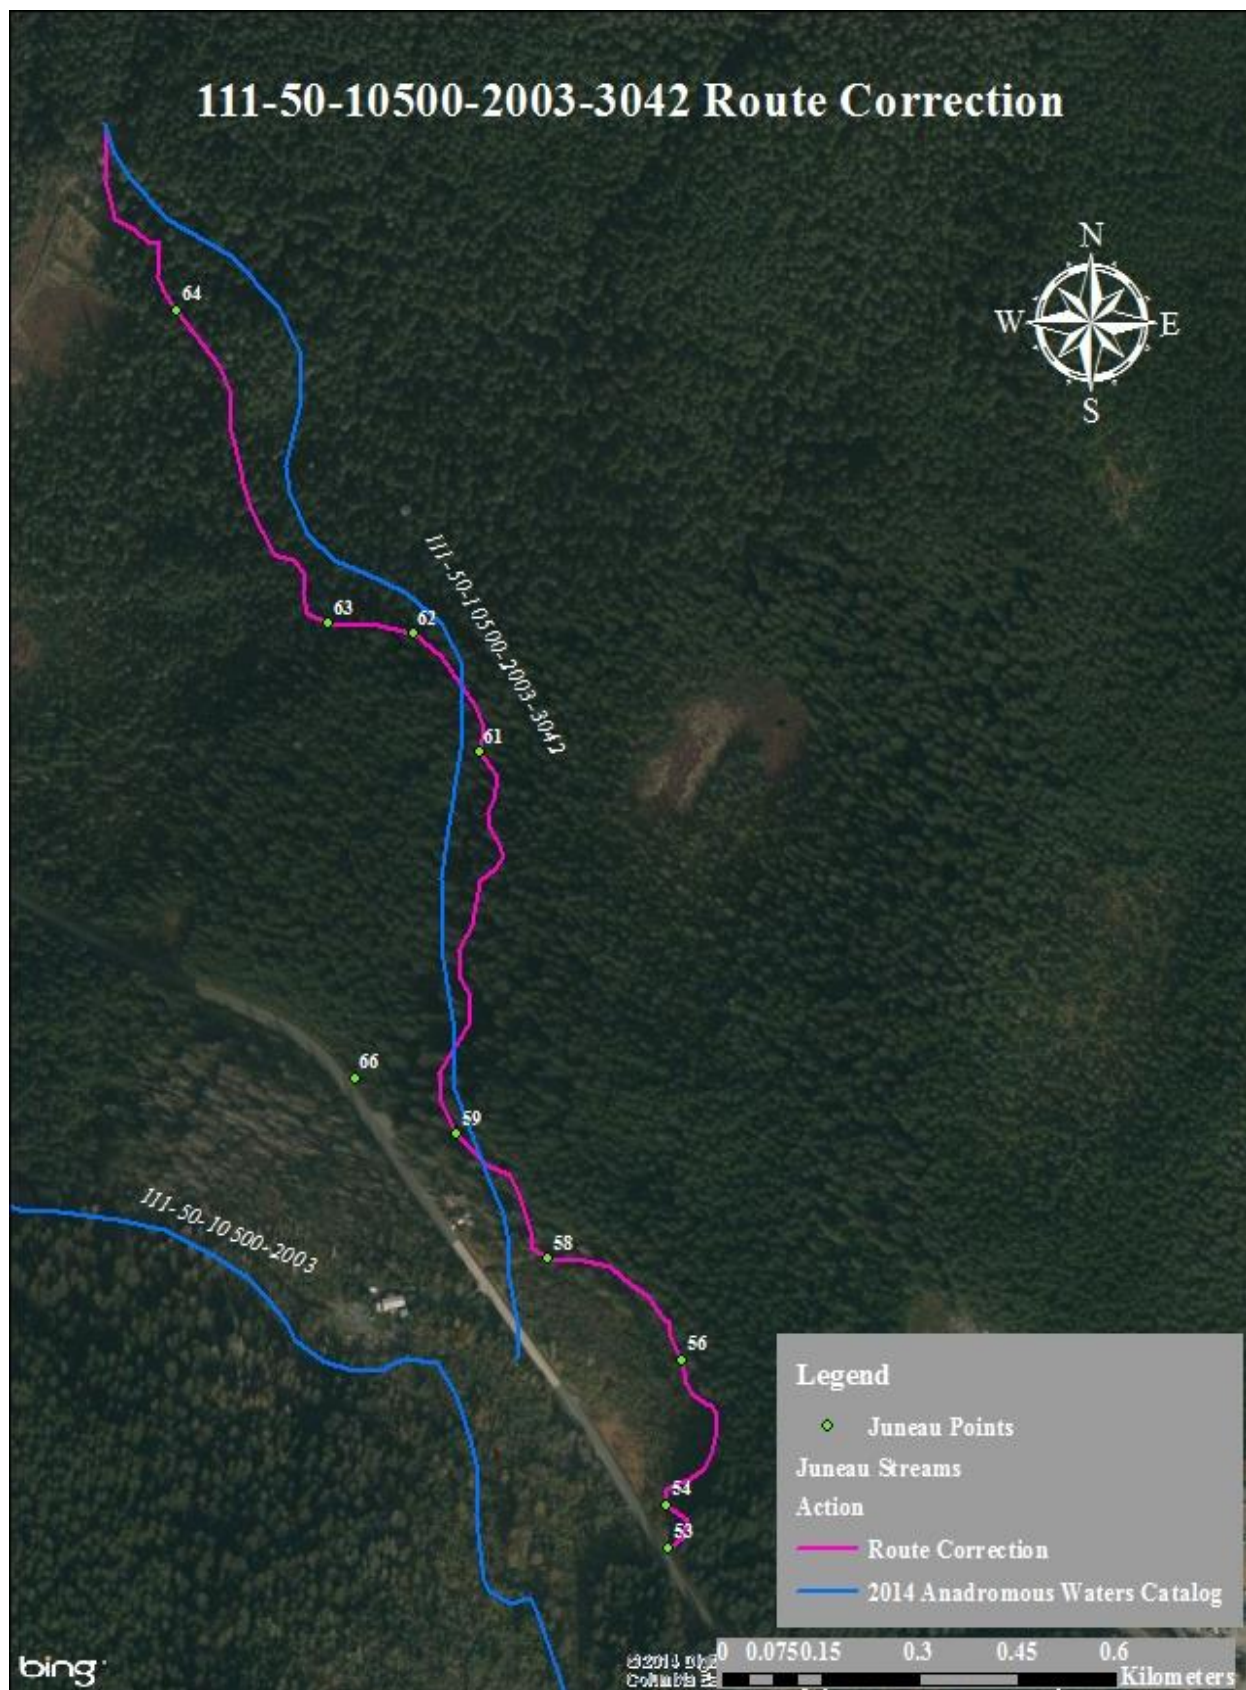
Figure 2.—111-50-10500-2003-3042 route correction map.

Recommendations: Update the stream course to reflect the field verified route (Figure 2).

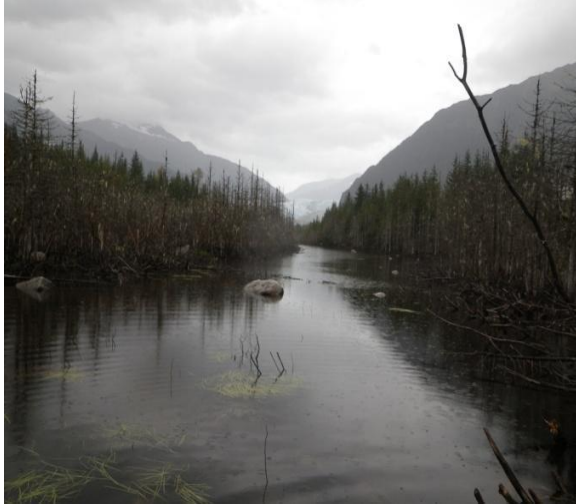
Figure 1.–Looking upstream on beaver pond.
