Appendix: Juneau

Guide to direct fieldwork for cataloging anadromous water bodies in Southeast Alaska

JUNEAU STREAM SURVEYS

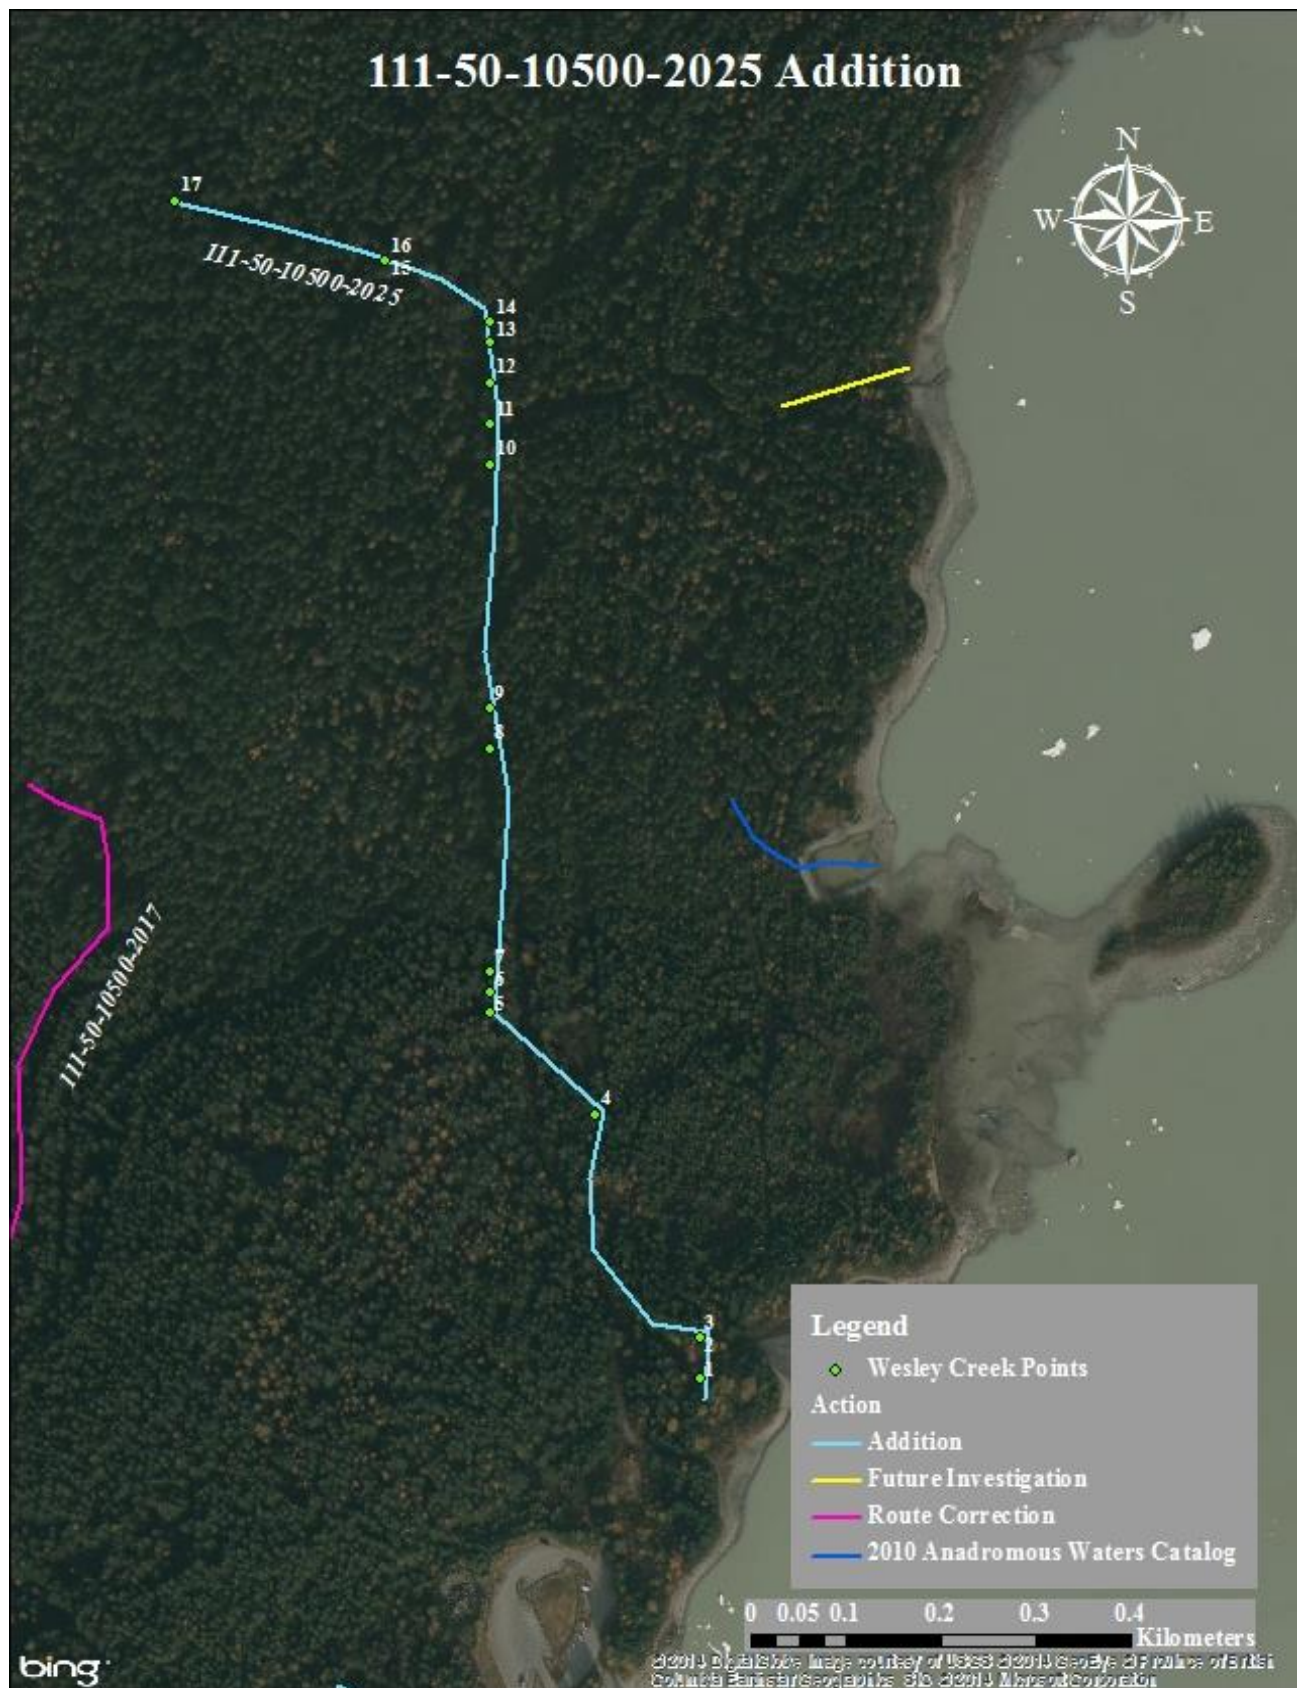
Figure 1.—111-50-10500-2025 addition map.

Recommendations: Add stream to the AWC (Figure 1).**Nomination:** 10-762

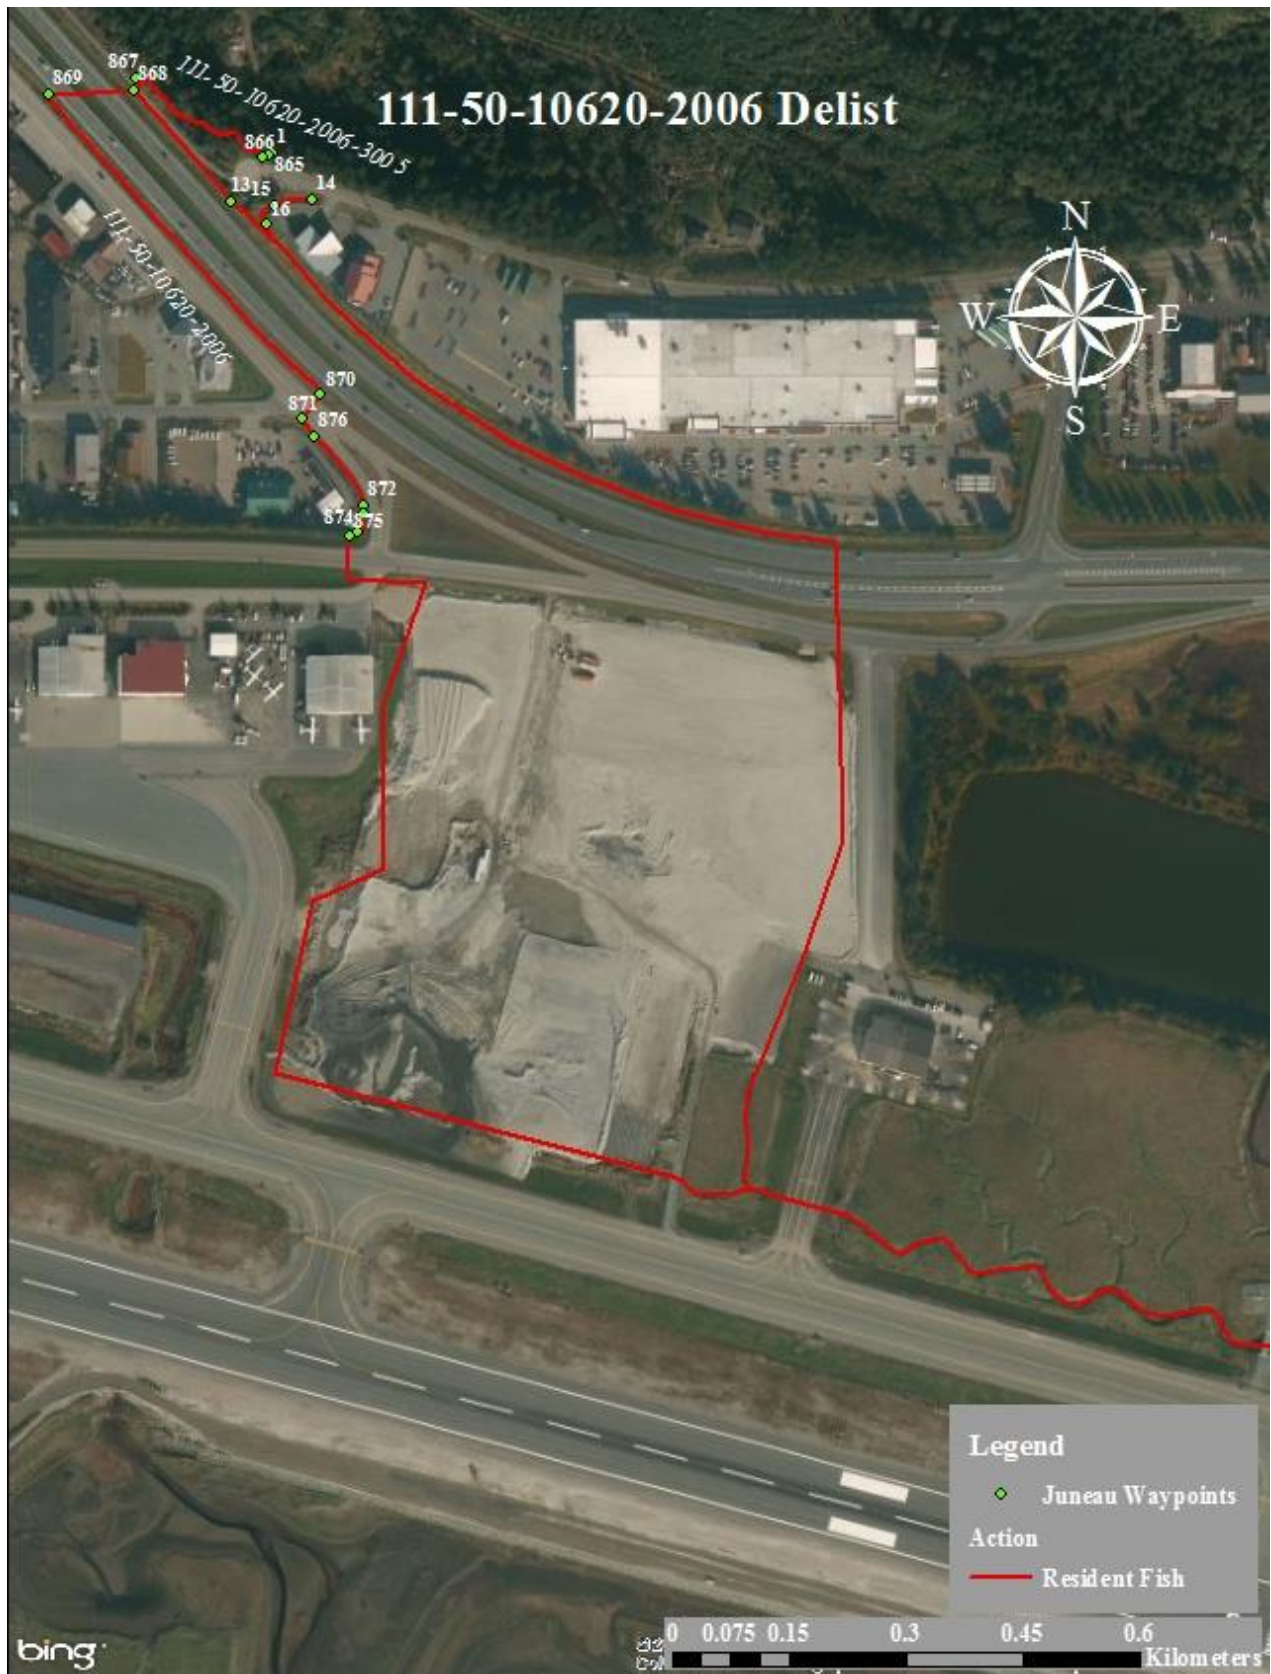
Figure 3.—111-50-10620-2006 delist map.

Recommendations: Remove stream from the AWC (Figure 3).

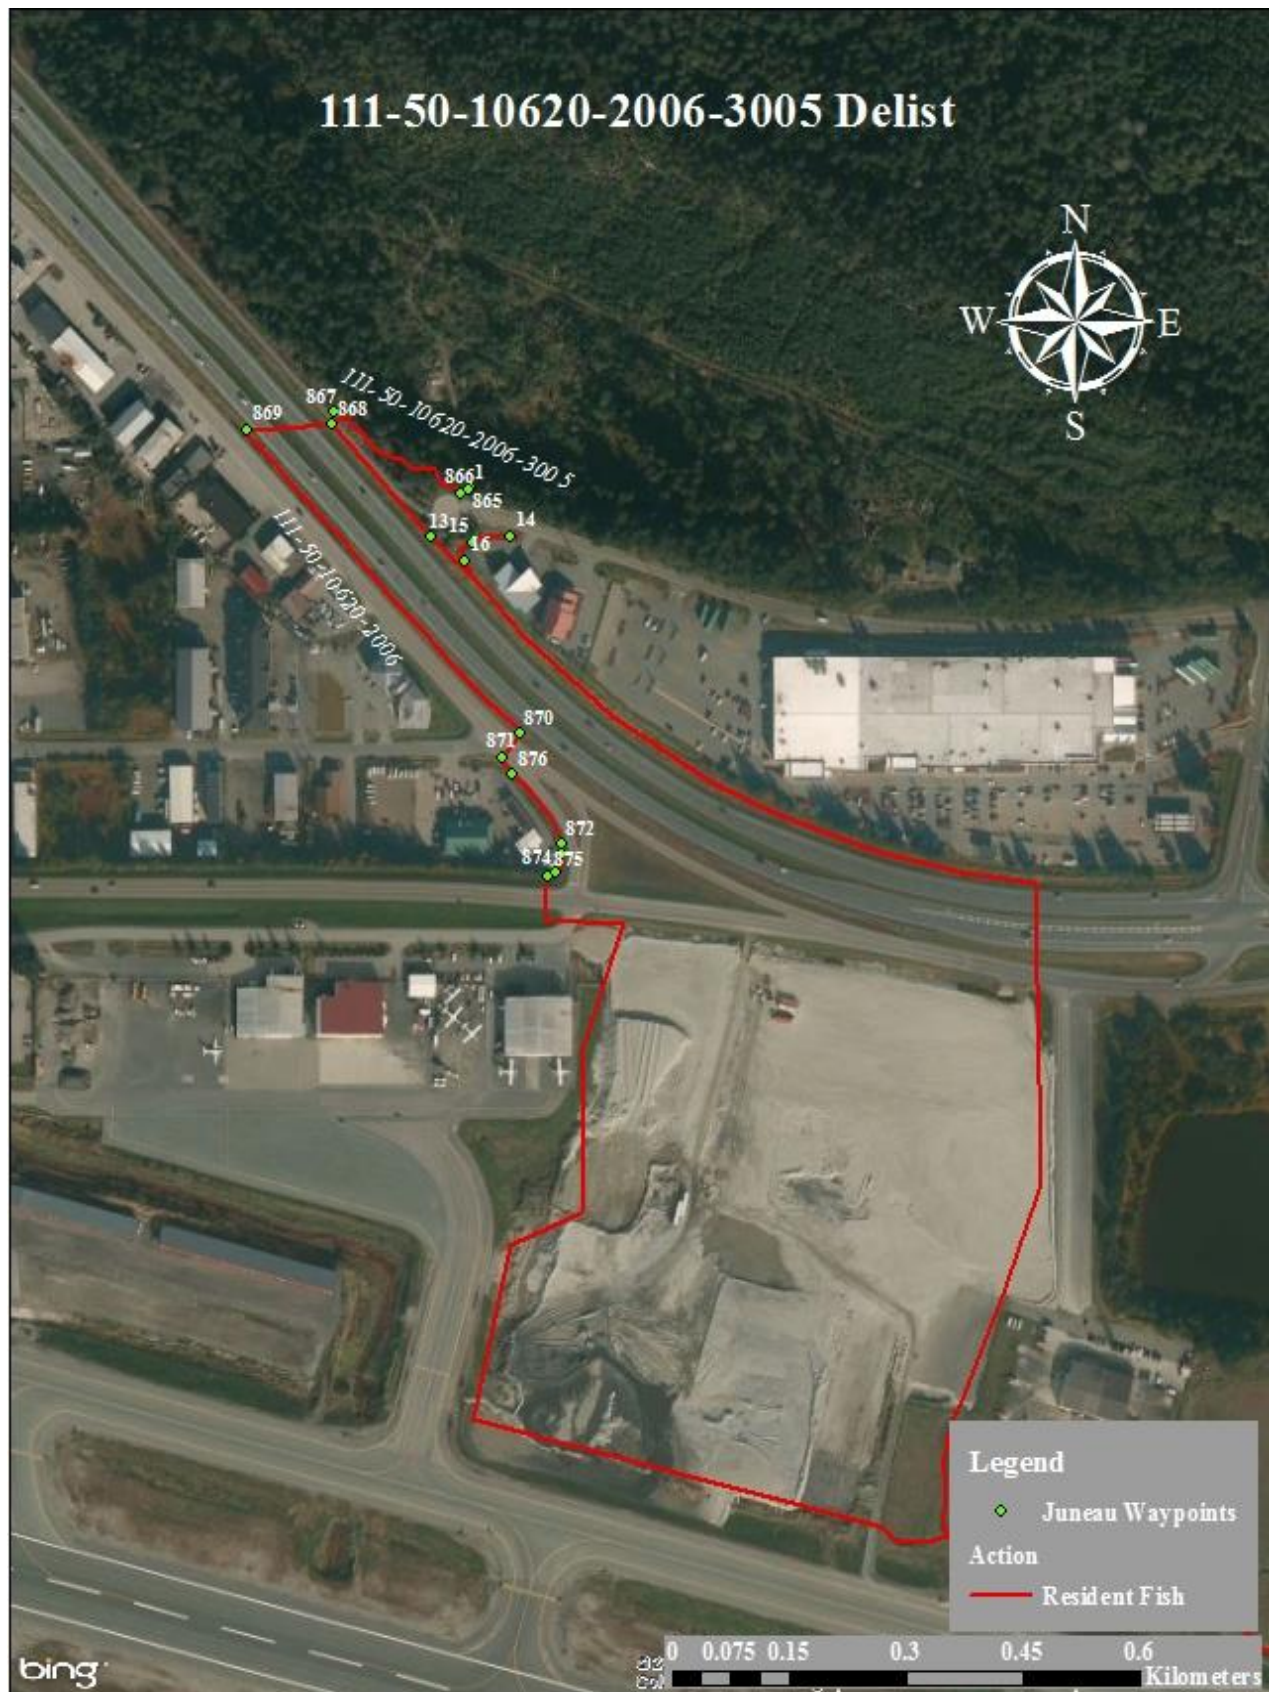
Figure 1.—111-50-10620-2006-3005 delist map.

Recommendations: Remove stream from the AWC (Figure 1).

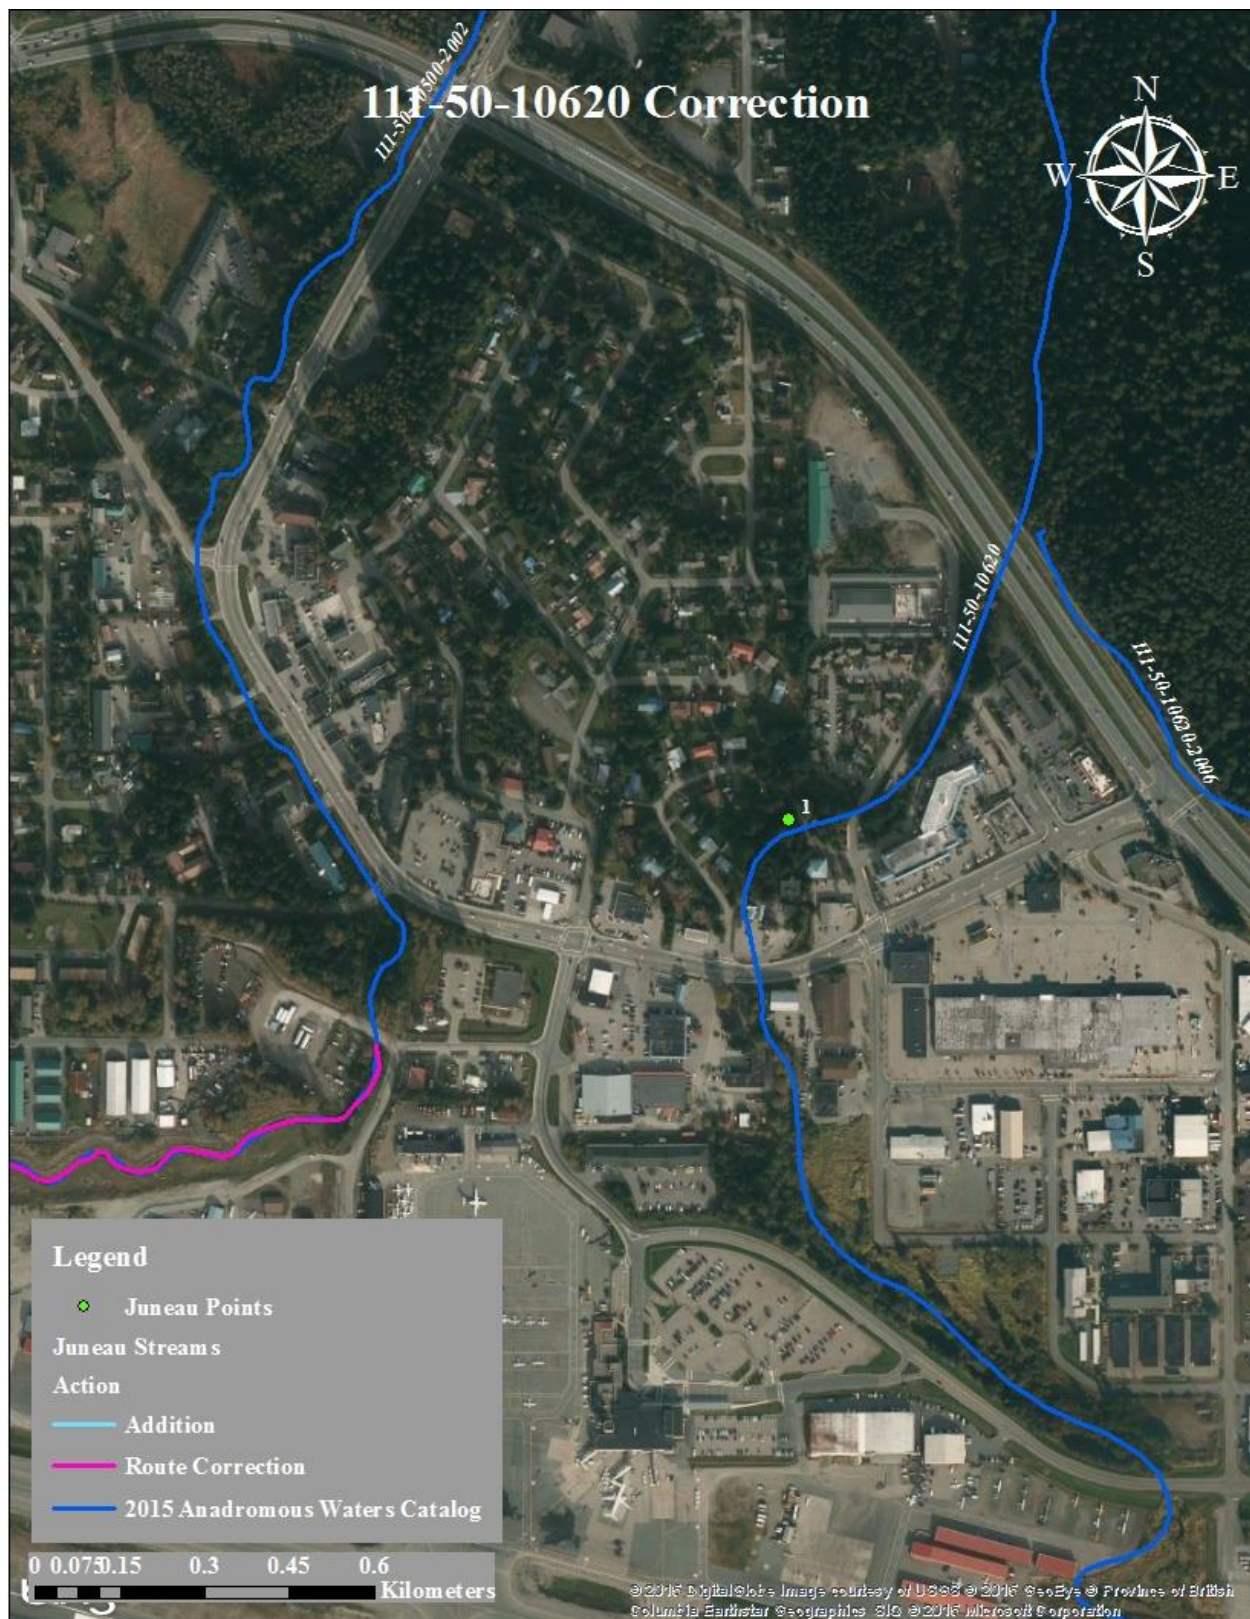
Figure 1.–111-50-10620 species correction map.

111-50-10620**CORRECTION****Water body name:** Jordan Creek**Survey date:** 8/21/2009**Water body number:** 111-50-10620**Species & Lifestage:** CHp, COp, CTp, DVp, Ps**Watershed:** Mendenhall River-Frontal Gastineau Channel**MTR:** C040S066E**Quad:** Juneau B-2**Findings:** Pink salmon were observed near the Jordan Avenue bridge and three redds (Table 1).**Recommendations:** Please correct the species list to include spawning pink salmon.**Nomination:** 09-1088

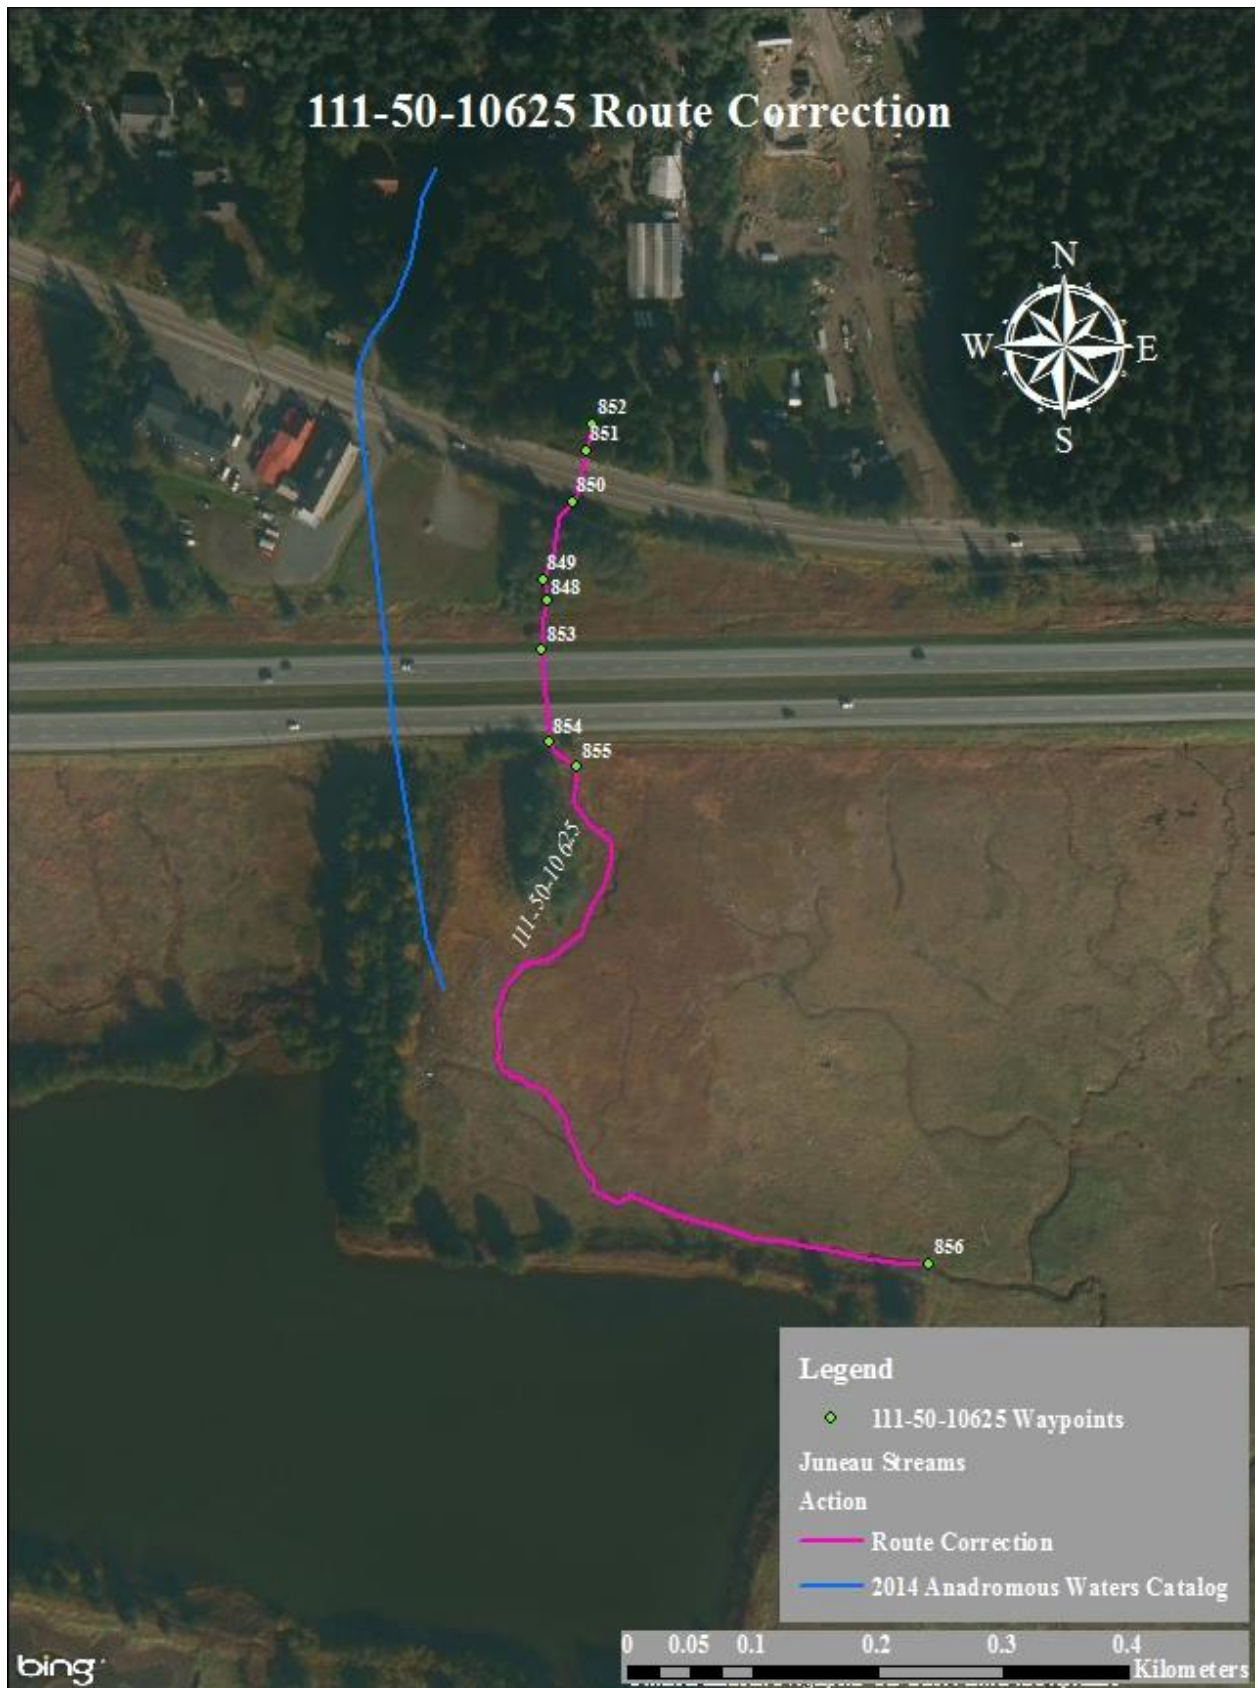
Figure 4.—111-50-10625 route correction map.

Recommendations: Correct the current route in the AWC (Figure 4).

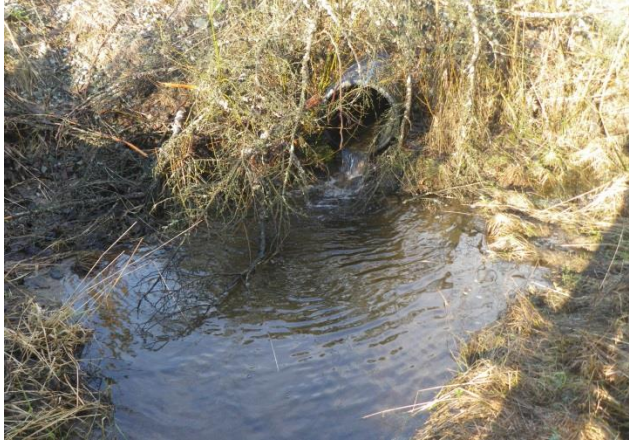
Figure 1.—Smooth wall culvert under Public Works entrance.

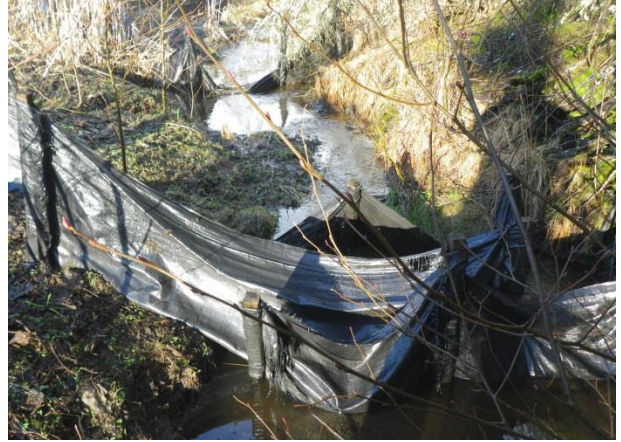
Figure 2.—Three sediment screens in stream that fish can pass.

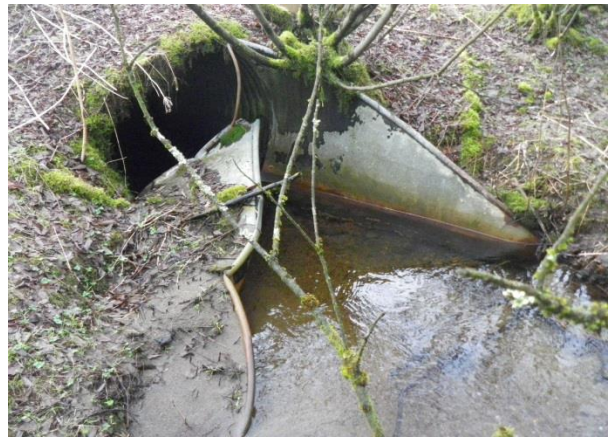
Figure 4.—Inlet of Egan Drive culvert.

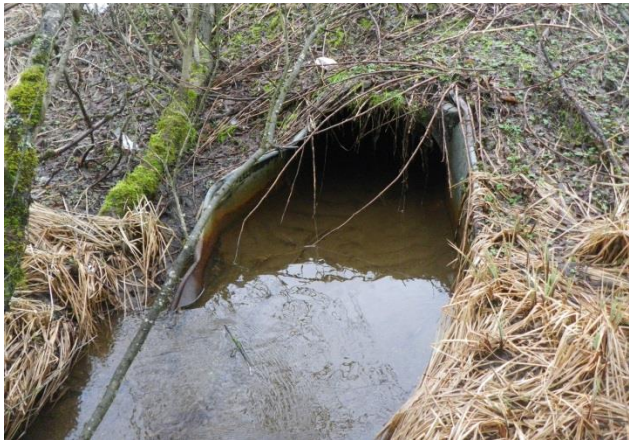
Figure 5.—Outlet of Egan Drive culvert.

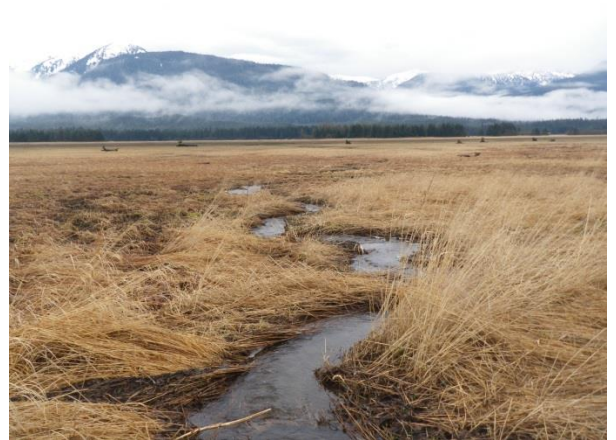
Figure 6.—Stream has a defined channel into Mendenhall Wetlands.

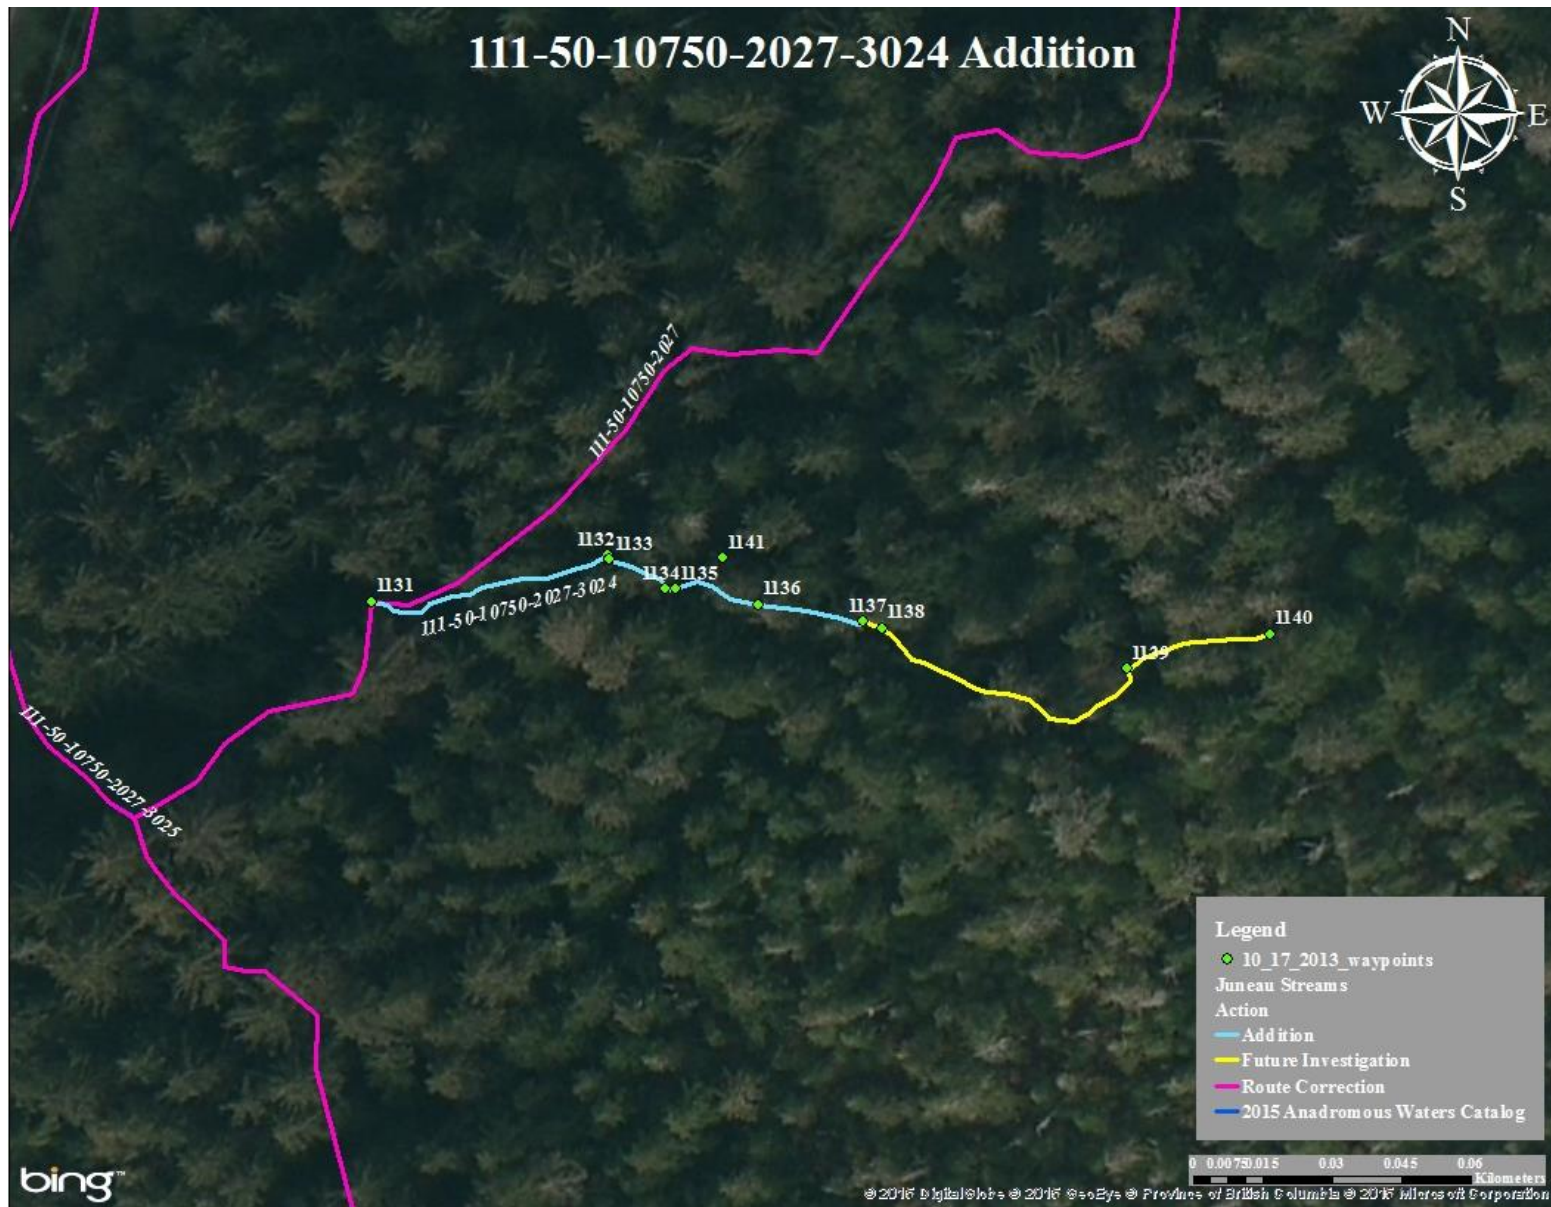
Figure 1.—111-50-10750-2027-3024 addition map.

Recommendations: Add stream to the AWC (Figure 1).

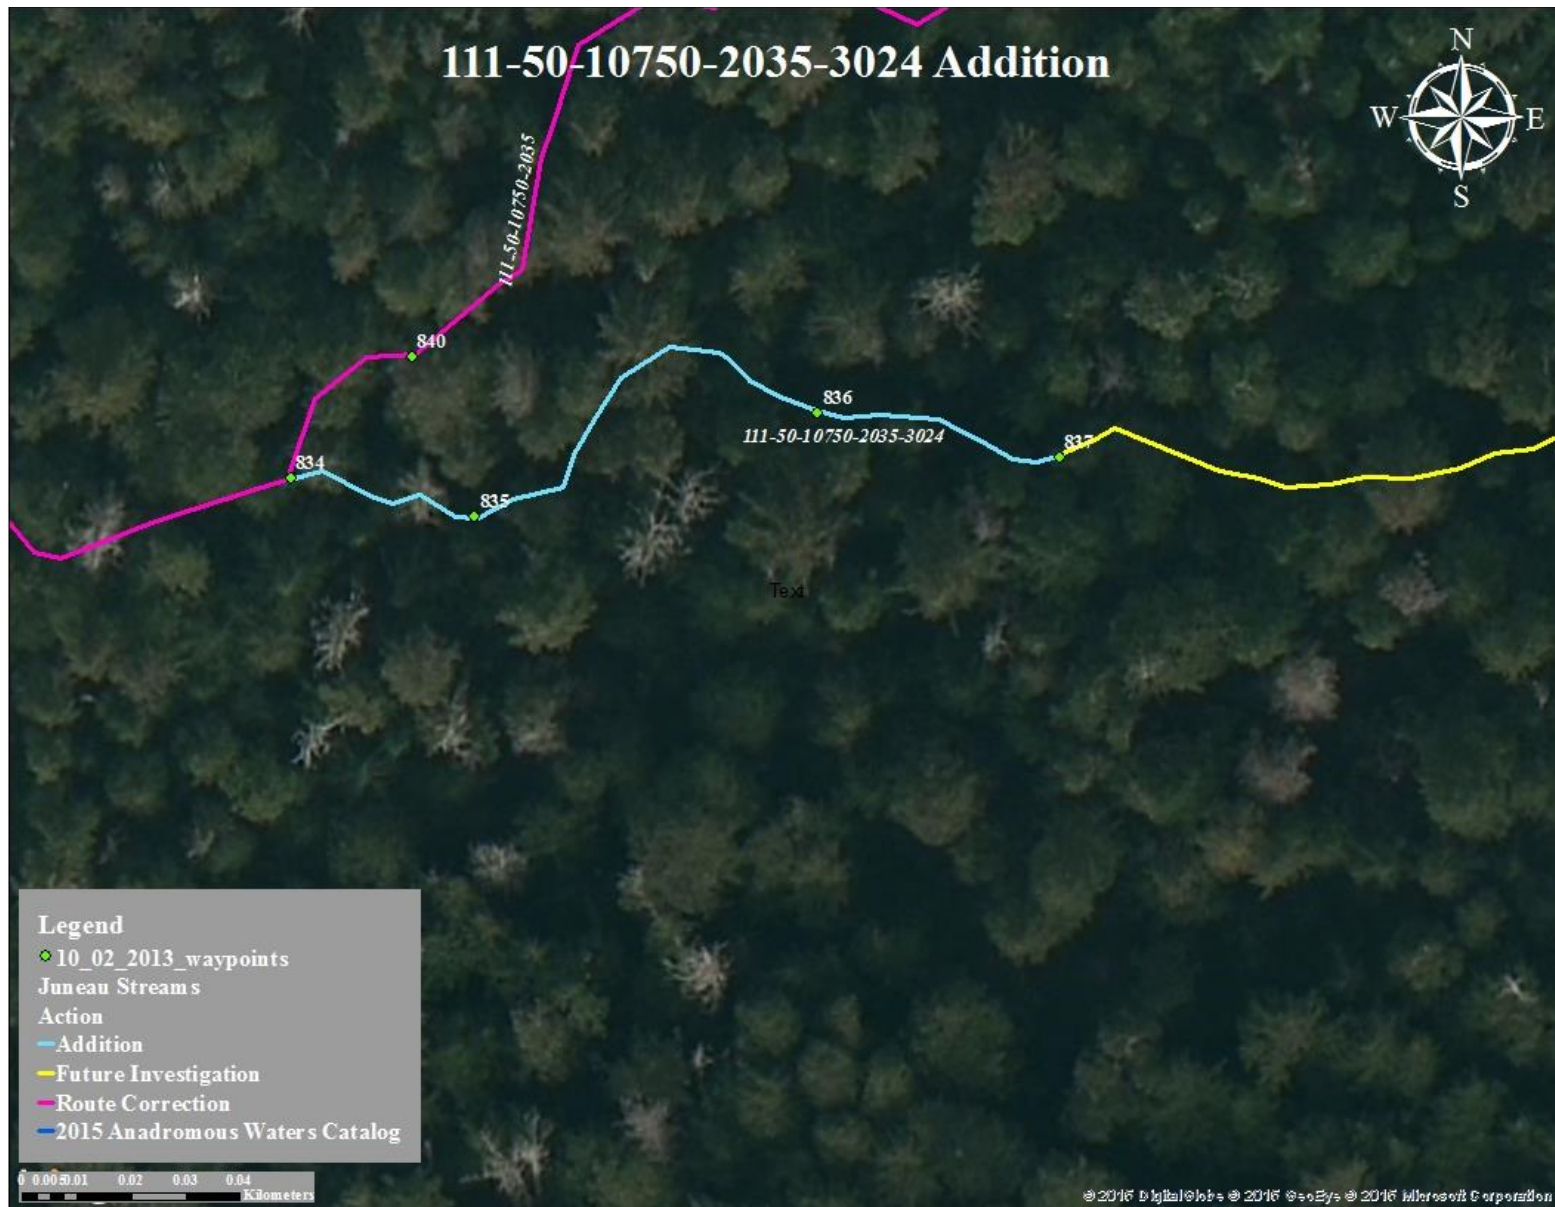
Figure 1.—111-50-10750-2035-3024 addition map.

Recommendations: Add stream to AWC (Figure 1).

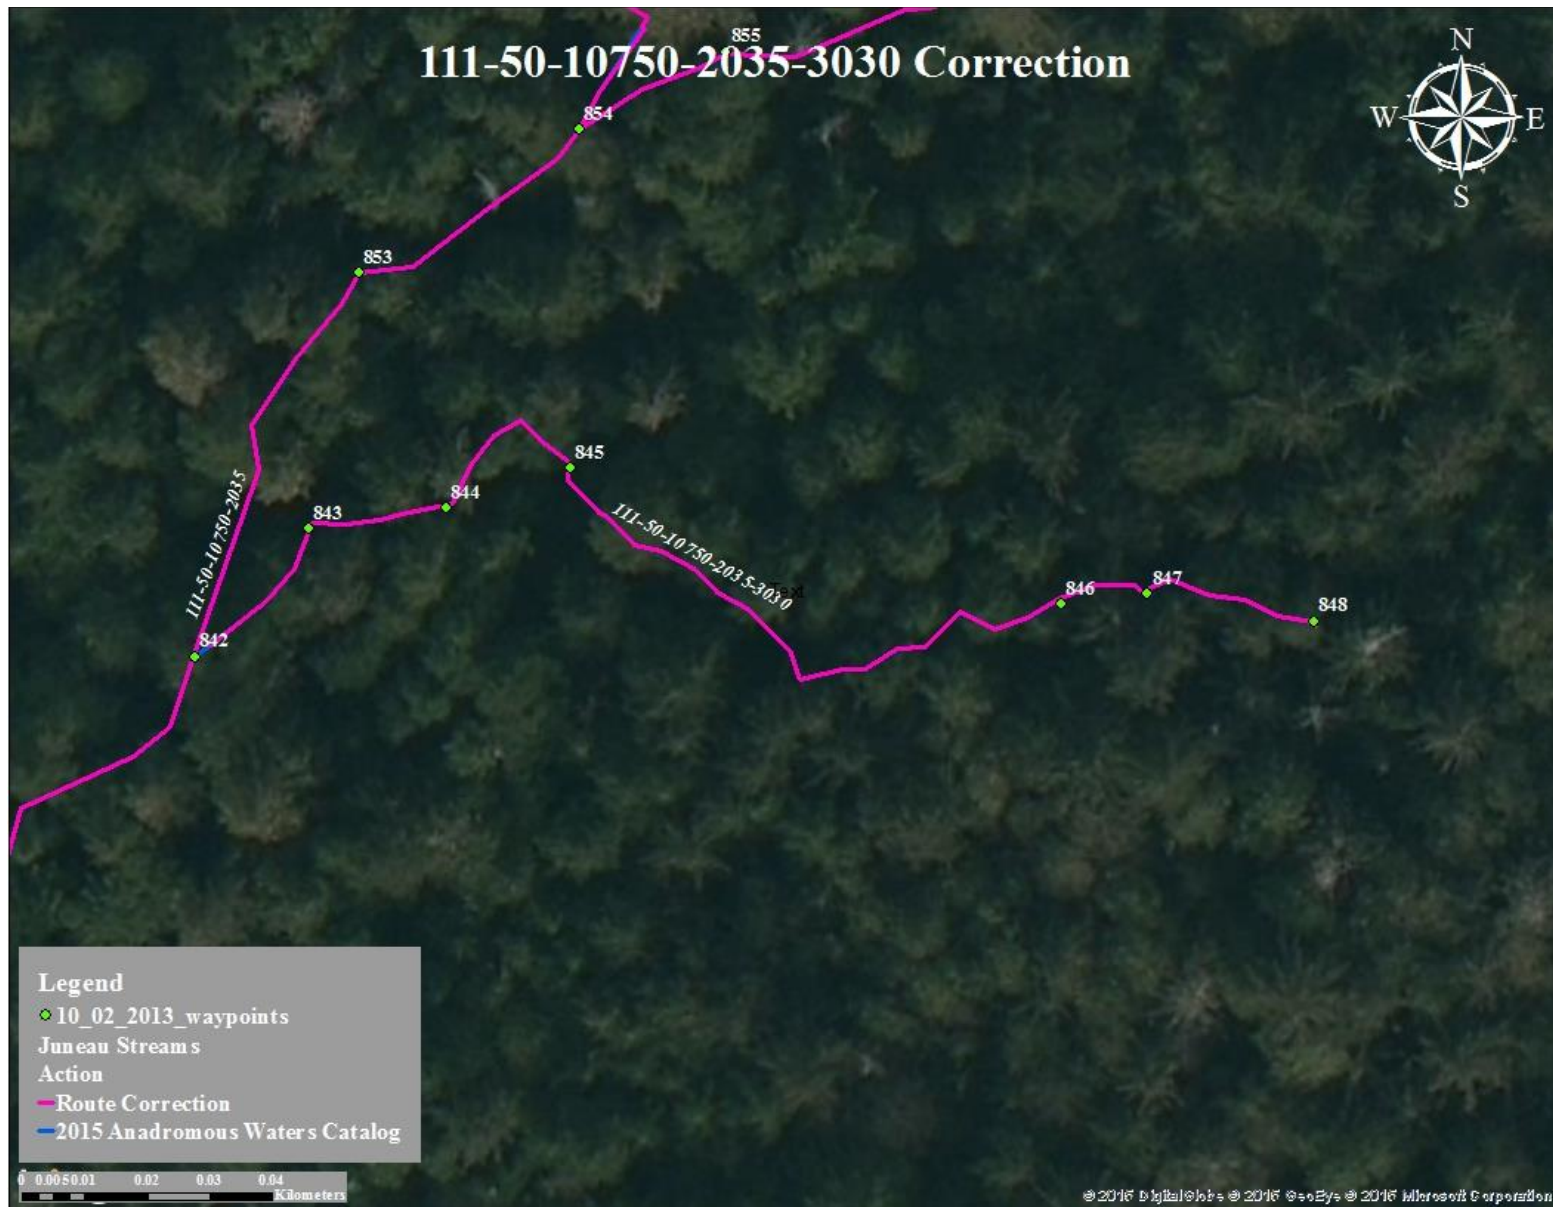
Figure 2.—111-50-10750-2035-3030 correction map.

Recommendations: Correct the current course in AWC (Figure 2).

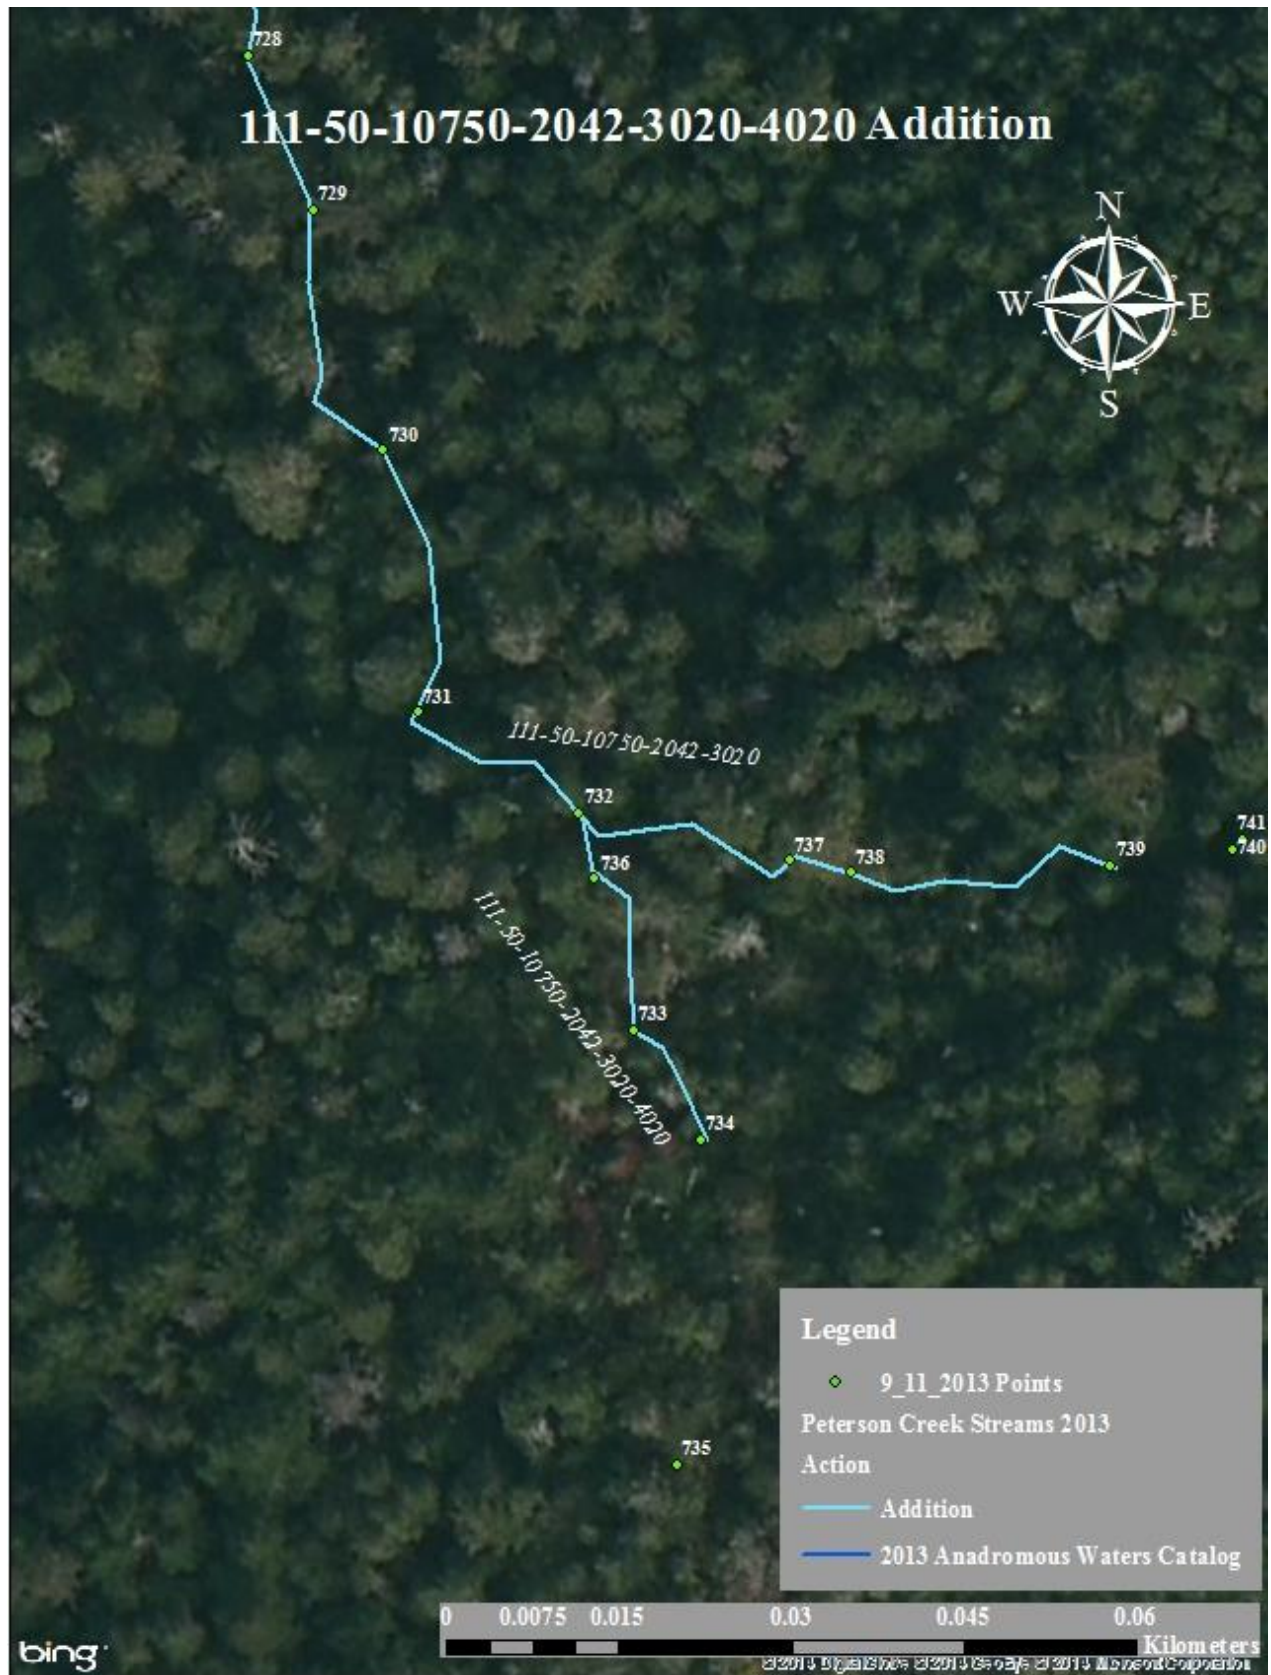
Figure 1.—111-50-10750-2042-3020-4020 addition map.

111-50-10750-2042-3020-4020**ADDITION****Water body name:****Survey date:** 9/11/2013**Water body number:** 111-50-10750-2042-3020-4020**Species & Lifestage:** CO**Watershed:** Admiralty Island-Frontal Lynn Canal**MTR:** C041S066E **Quad:** Juneau B-2**Findings:** We surveyed stream number 111-50-10750-2042-3020-4020 using a backpack electrofisher and a GPS (Table 1). We caught coho salmon. This tributary ends in a mossy seep.**Recommendations:** Add stream to the AWC (Figure 1).**Nomination:** 13-611

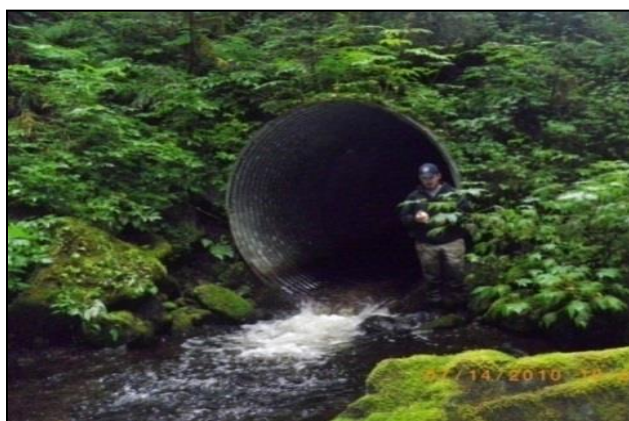
Figure 1.—Field staff at culvert on Bessie Creek.

Findings: We conducted a route correction survey using a GPS (Table 1). We found the stream route is inconsistent with the route mapped in the AWC. There is a large culvert on Bessie Creek that suggest that there is a lot of bedload movement or high flows (Figure 1). A fish barrier falls was found to be about 10' with a 2' pool at base (Figures 2, 3).

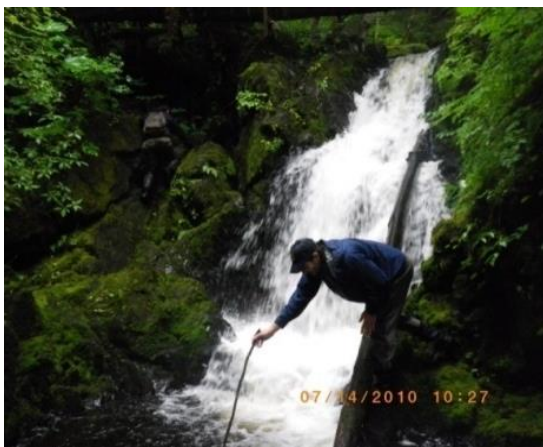
Figure 3.—Field staff measuring Bessie Creek.

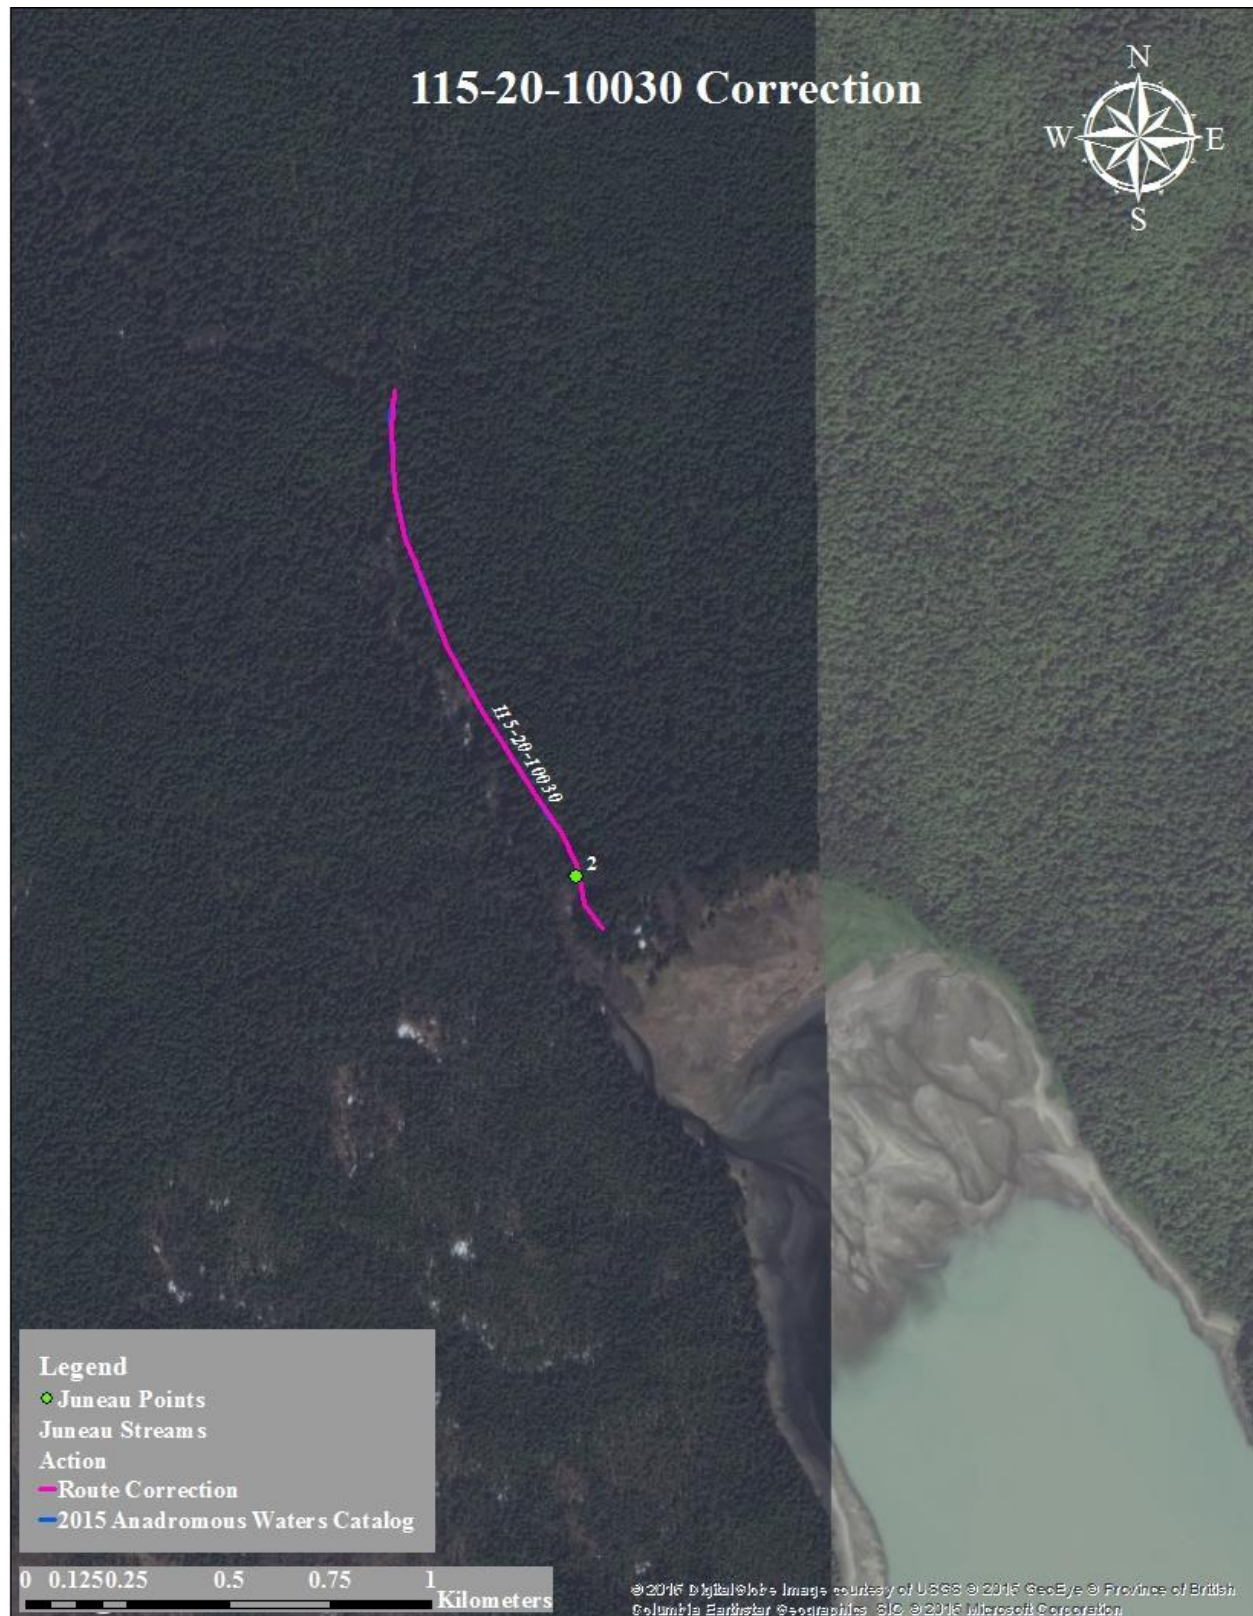
Figure 1.—115-20-10030 correction map.

Recommendations: Add eulachon present to Slate Creek (Figure 1).
