Appendix: Juneau

Guide to direct fieldwork for cataloging anadromous water bodies in Southeast Alaska

JUNEAU STREAM SURVEYS

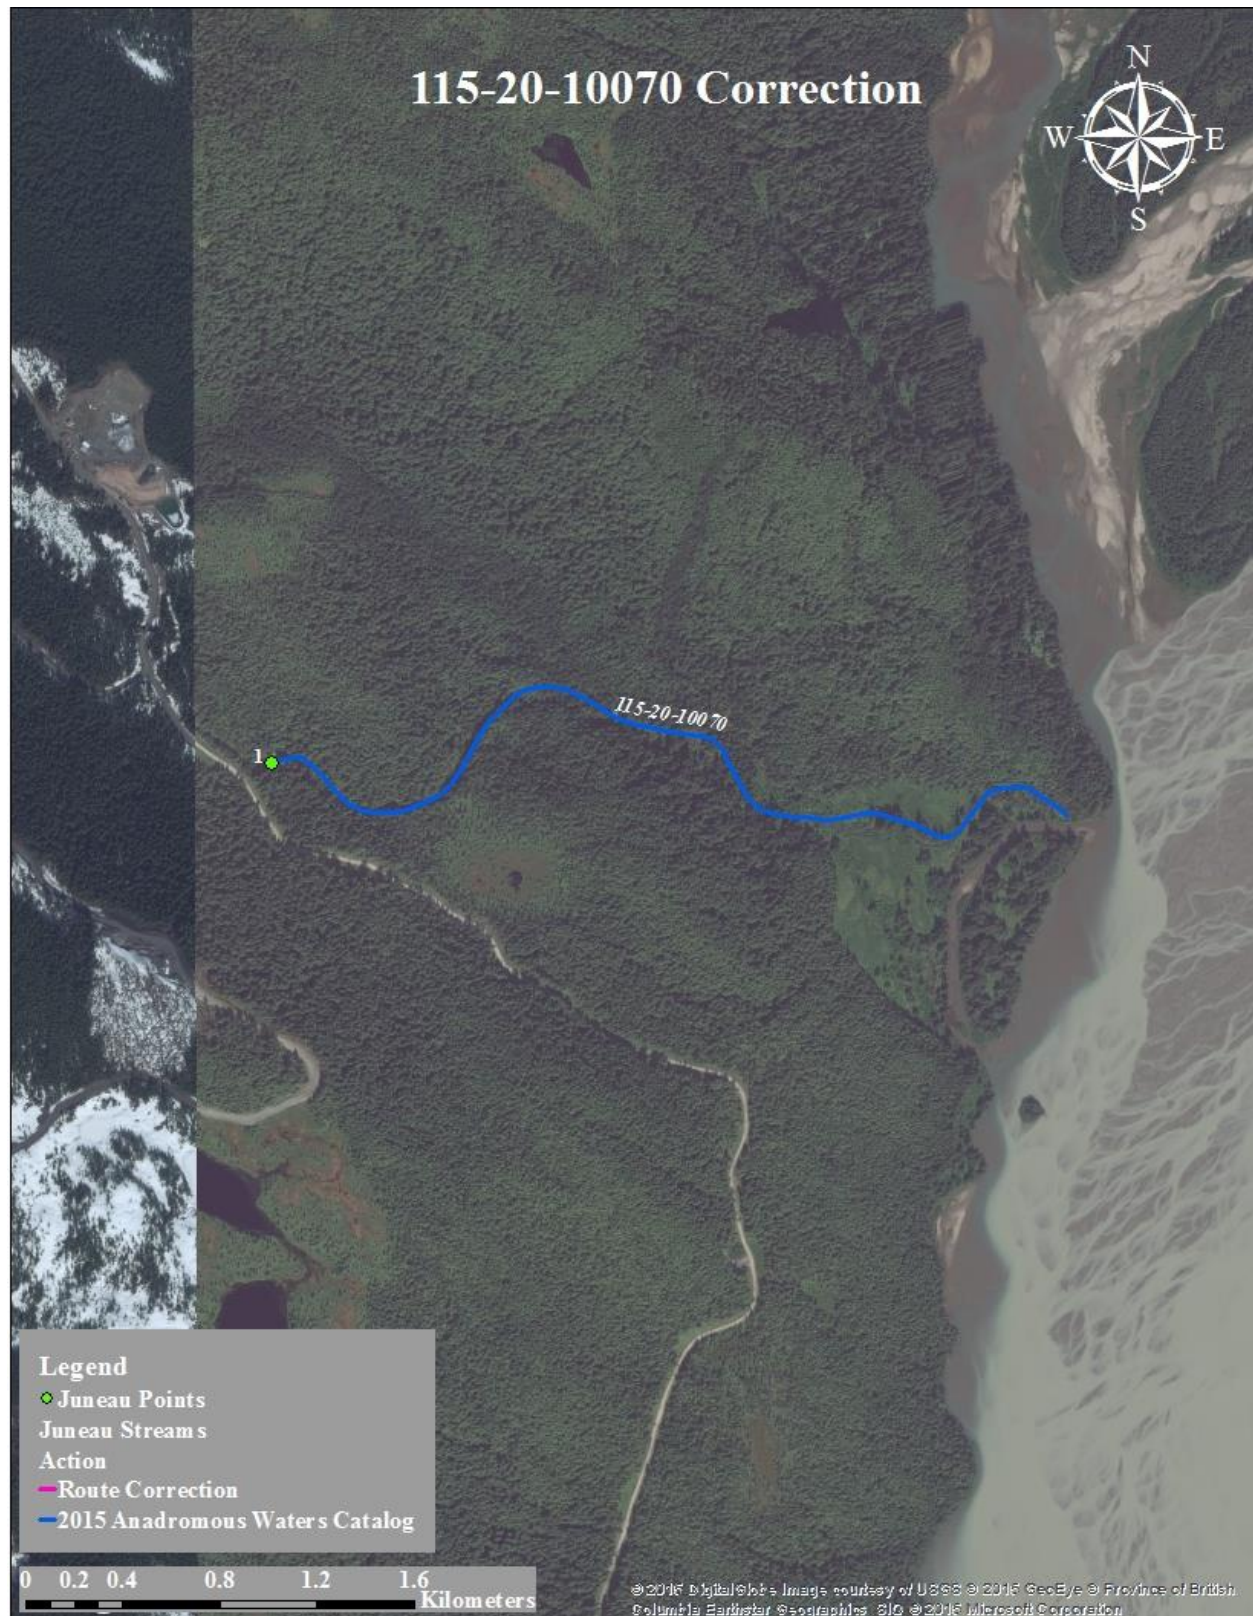
Figure 1.—115-20-10070 correction map.

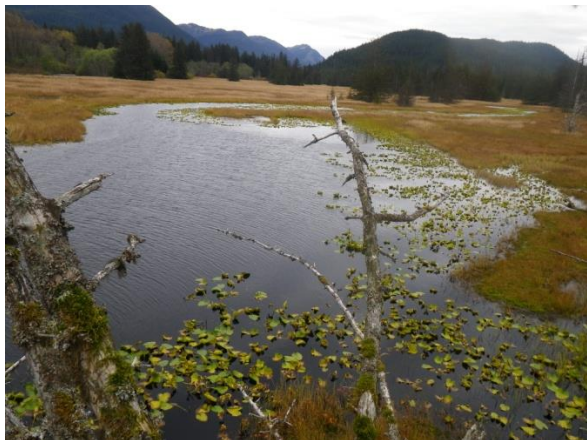
Figure 1.—Beaver pond area connected to stream number 115-20-10620-2002.

Findings: We surveyed this stream using minnow traps, handnet and GPS (Table 1). This large network of beaver ponds and channels supports rearing juvenile coho salmon, cutthroat trout, threespine stickleback, and Dolly Varden char (Figures 1, 2, 3). The numerous beaver dams do not appear to function as barriers to fish passage as we found coho salmon fry above many dams.

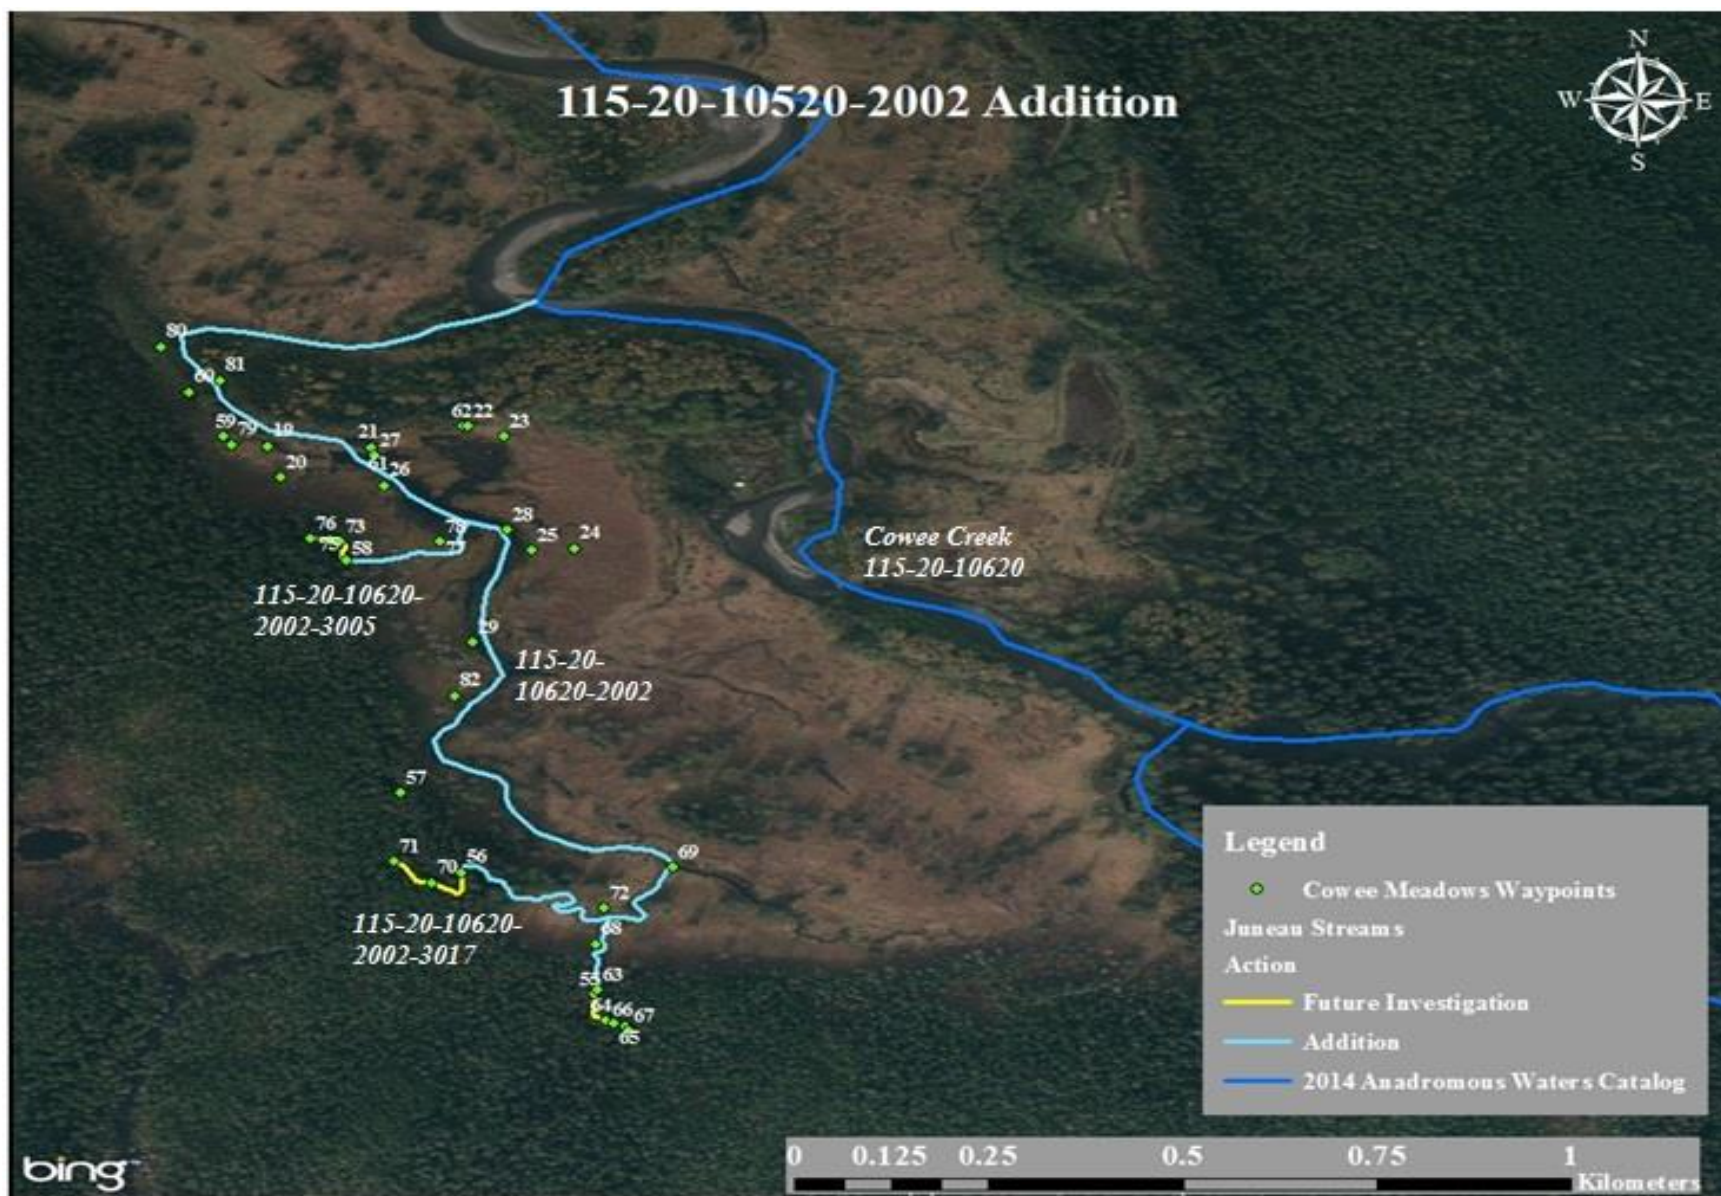
Figure 4.—115-20-10620-2002 addition map.

Recommendations: Add this stream course to the AWC (Figure 4).

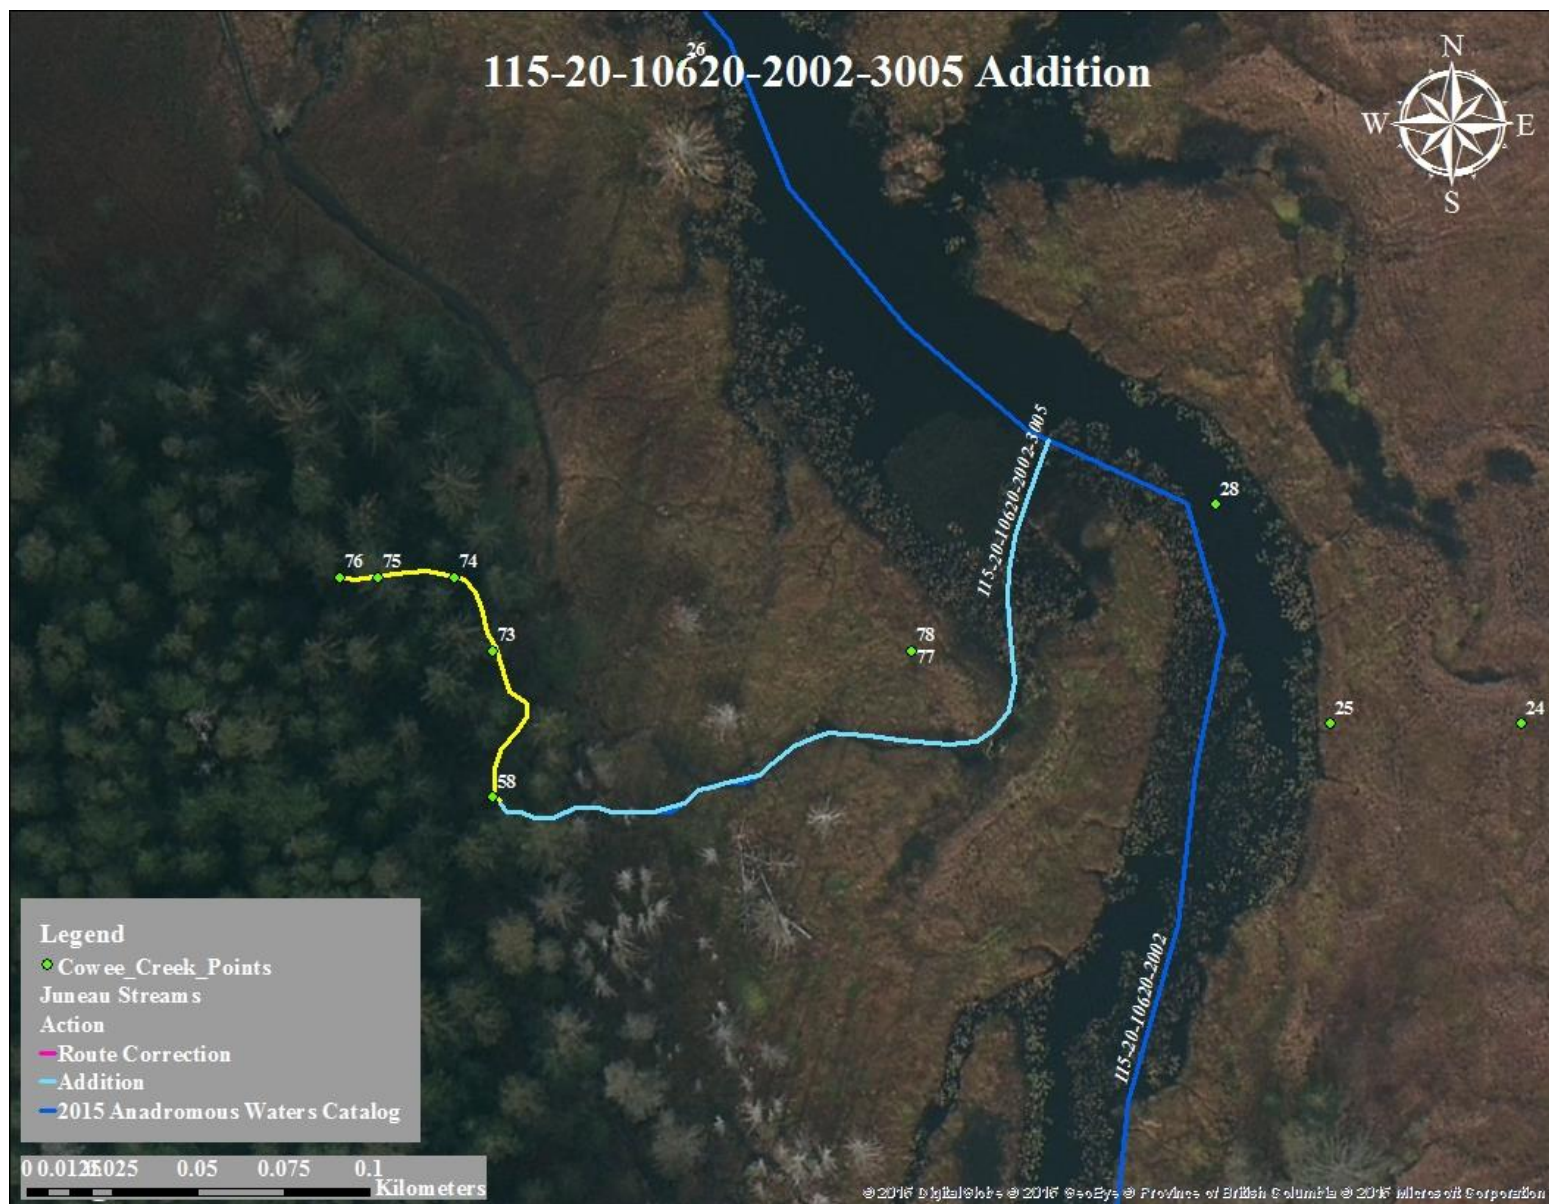
Figure 4.—115-20-10620-2002-3005 addition map.

Recommendations: We recommend adding this stream course to the AWC (Figures 4).

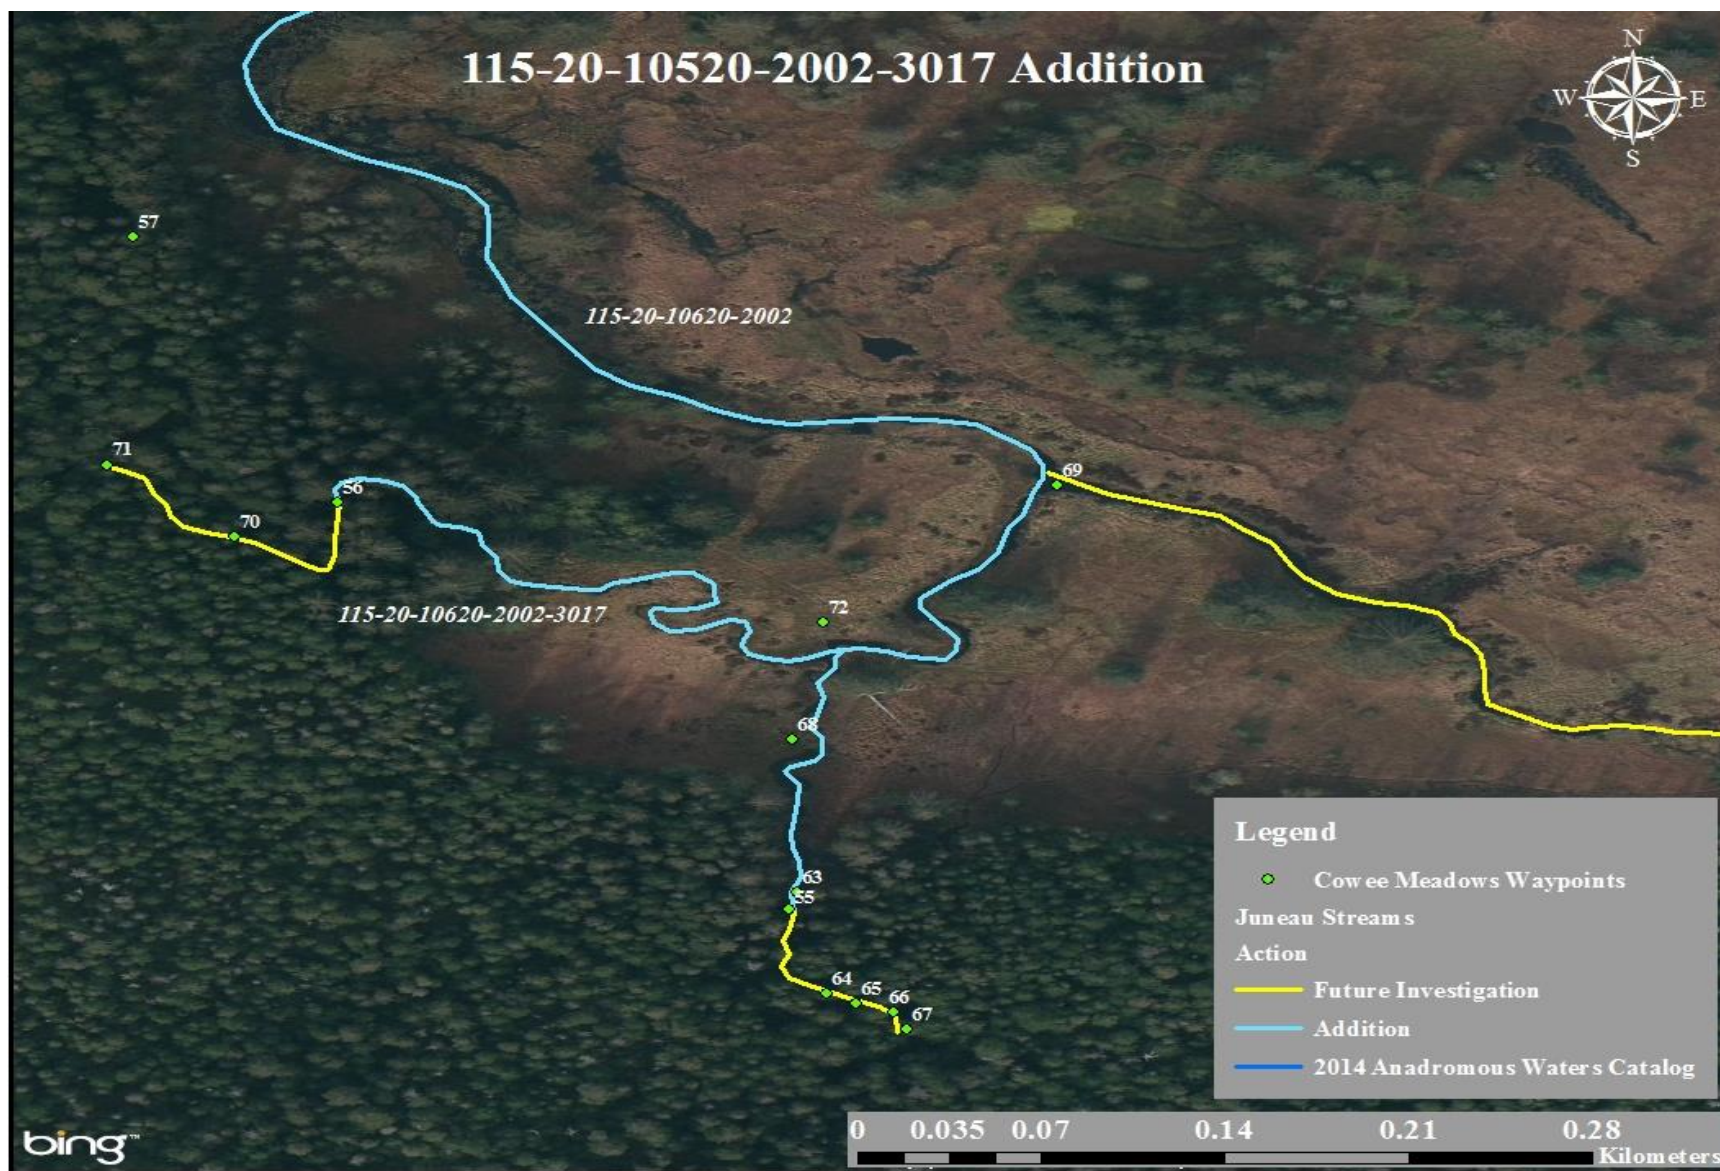
Figure 4.—115-20-10620-2002-3017 addition map.

Recommendations: Add this stream course to the AWC (Figure 4).

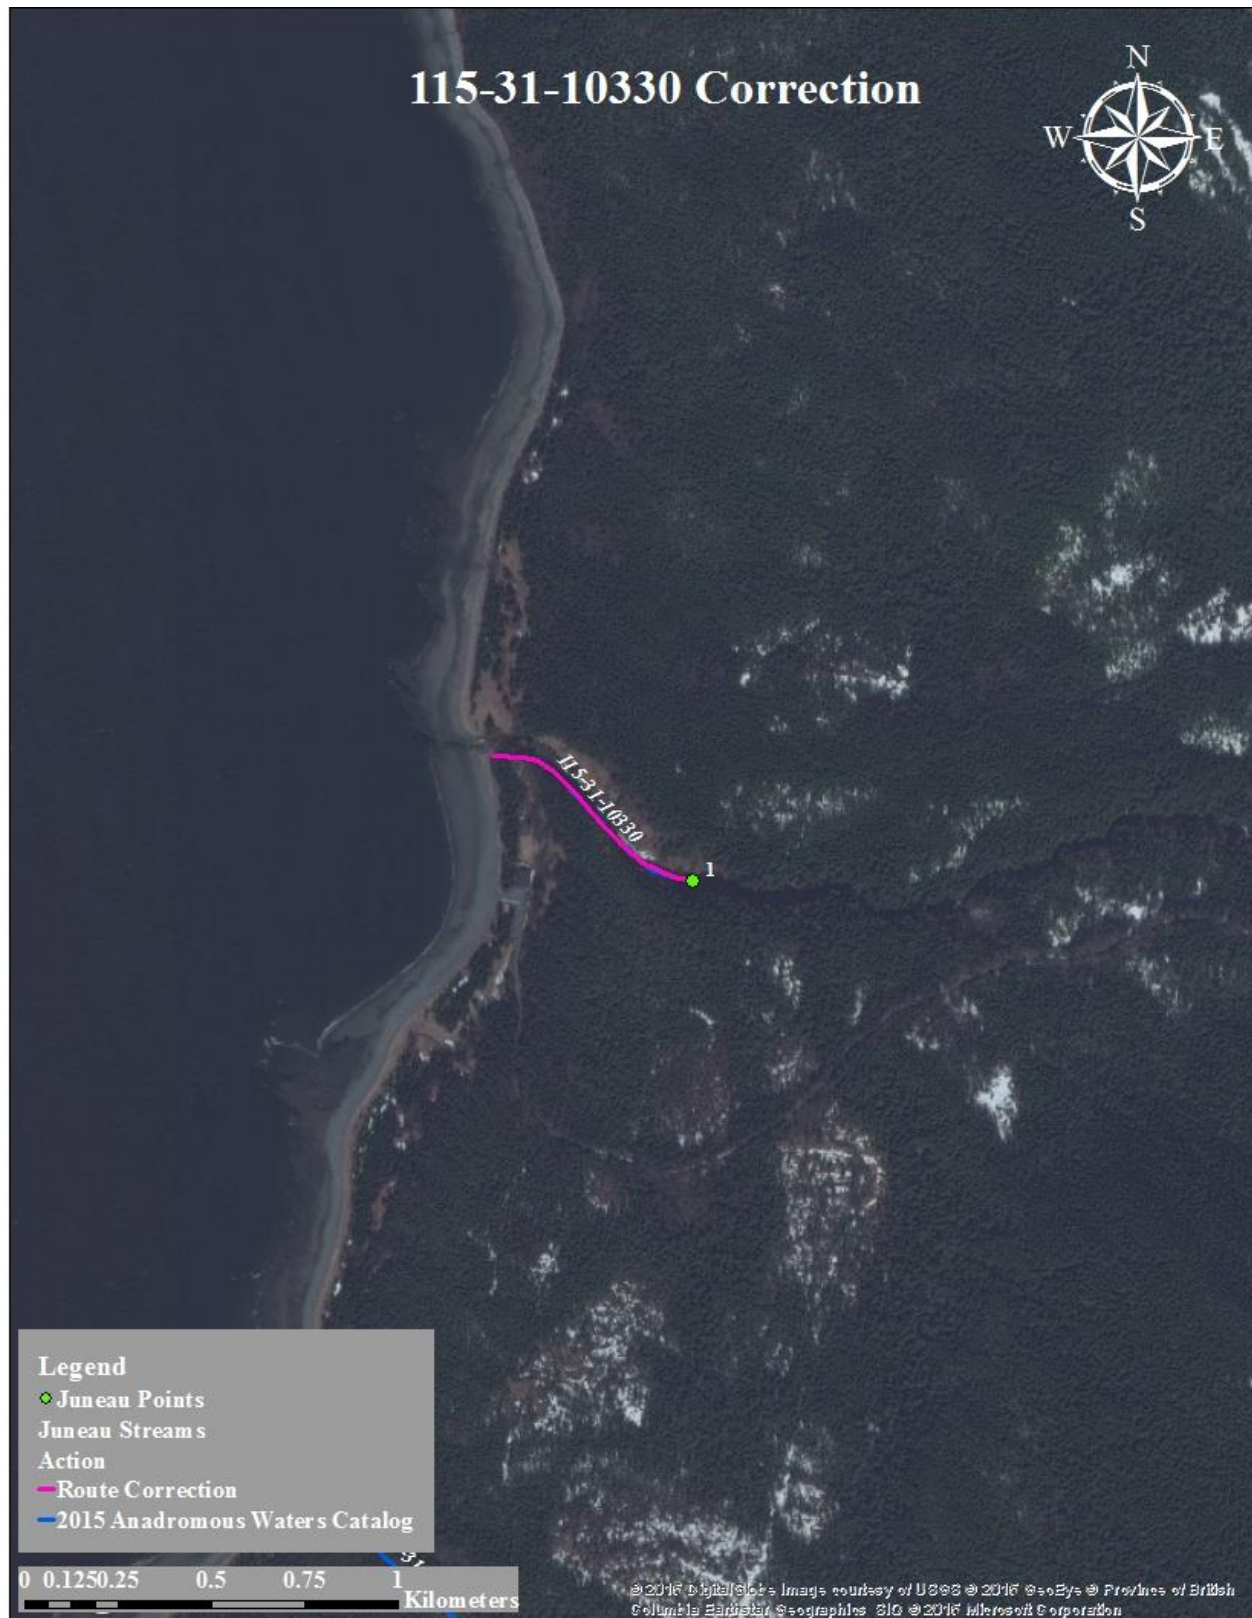
Figure 1.—115-31-10330 correction map.

Recommendations: Reduce the upper extent of anadromy (Figure 1).
