Nomination Form  
Anadromous Waters Catalog

Anadromous Waters Catalog Number of Water Body 113-51-10040-2006

~ADD new AWC Stream #113-51-10040-2006 with COHO salmon REARING.

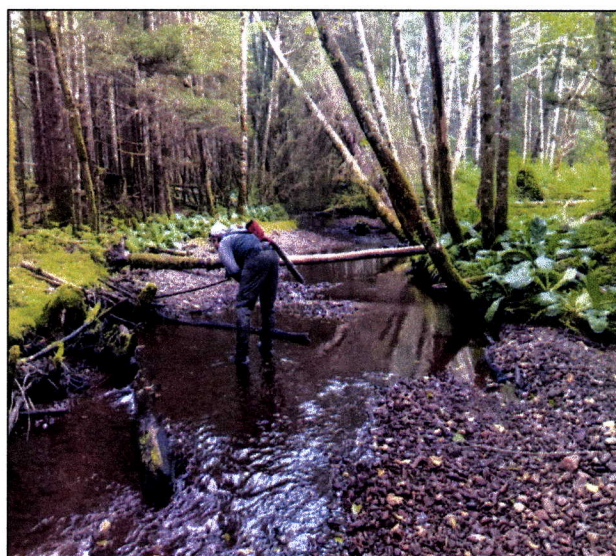
Figure 1.—Channel at waypoint 443, facing upstream.

**Findings:** We surveyed this uncataloged stream using a backpack electrofisher, baited minnow traps, and GPS and captured juvenile coho salmon and Dolly Varden (Table 1; Figures 1–3). Coho salmon were visually identified in this stream by Habitat Biologists due to an electrofisher malfunction; however, a photo of juvenile coho salmon caught at waypoint 444 (tributary 4) is included. Upstream of waypoint 524, the stream went subsurface for several hundred feet, then reforms where we captured only resident fish. Fish habitat continues upstream where continuous surface flow is reestablished.

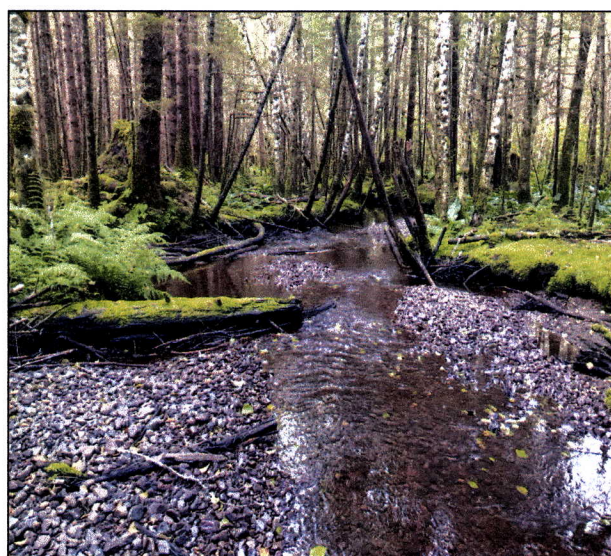
Figure 2.—Channel at waypoint 443, facing downstream.
