Alaska Department of Fish and Game

Habitat Section
Southeast Region

114-31-10130 Tributary 6

ADDITION

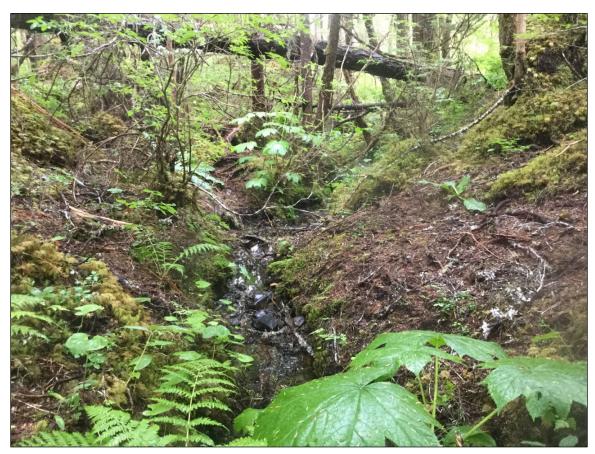
Figure 1.-Channel descending hillside at waypoint 1012.

Findings: We surveyed this uncataloged stream using a backpack electrofisher and GPS. We captured juvenile coho salmon, Dolly Varden, and sculpin. The tributary stream descends a hillside and has gravel substrate (Table 1; Figures 1–3).

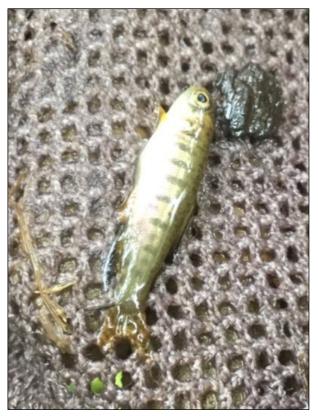
Figure 2.—Juvenile coho salmon captured at waypoint 1017.

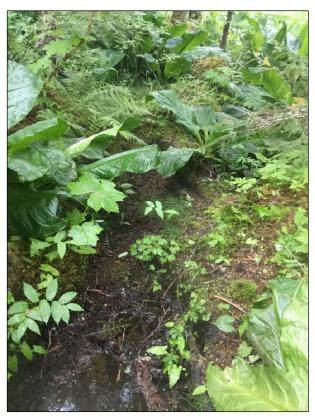
Figure 3.–Disconnected water where LiDAR predicted stream at waypoint 1015.

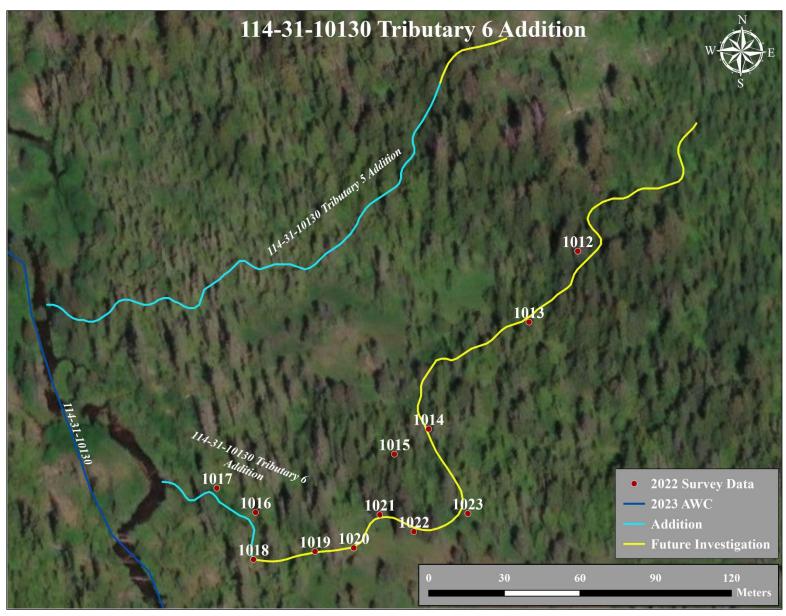
Figure 4.–114-31-10130 tributary 6 addition map.

Recommendations: Add this uncataloged stream to the anadromous waters catalog for rearing

coho salmon (Figure 4). **Nomination:** Pending
