Alaska Department of Fish and Game

Habitat Section
Southeast Region

114-31-10130 Tributary 7

ADDITION

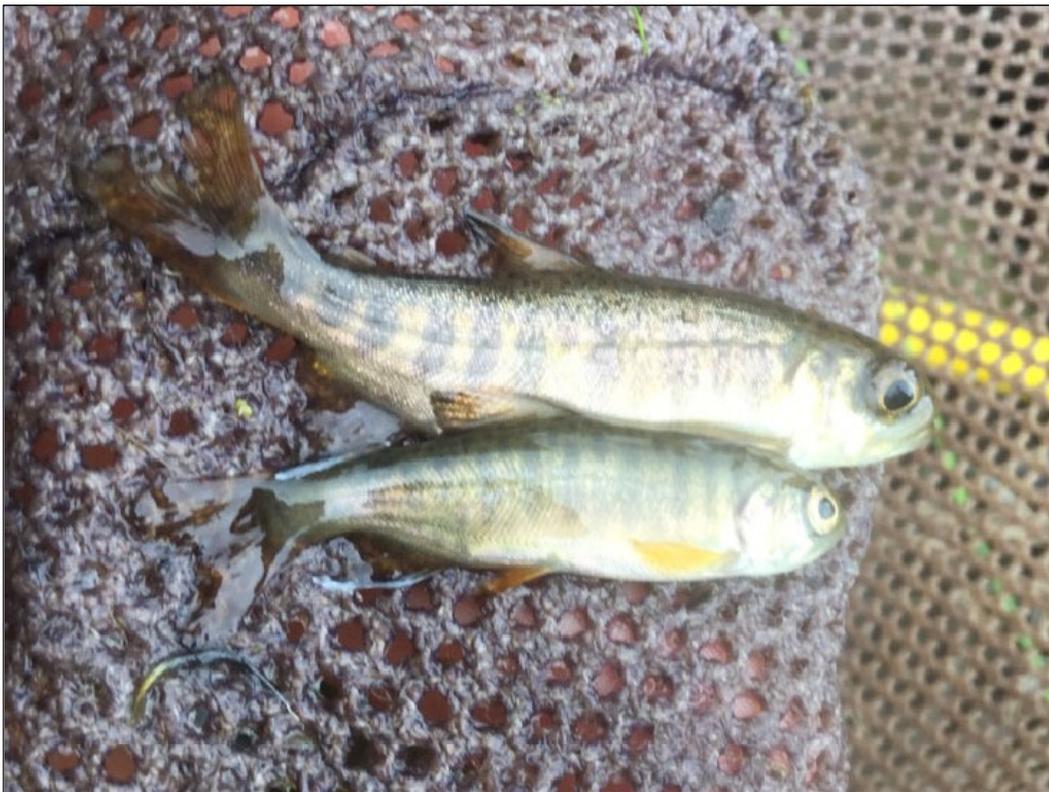
Figure 1.–Juvenile coho salmon captured at waypoint 1028.

Findings: We surveyed this uncataloged stream using a backpack electrofisher and GPS. We captured juvenile coho salmon and Dolly Varden. The tributary stream maintains a low gradient along the base of a hillside and flows through several beaver dams (Table 1; Figures 1–3).

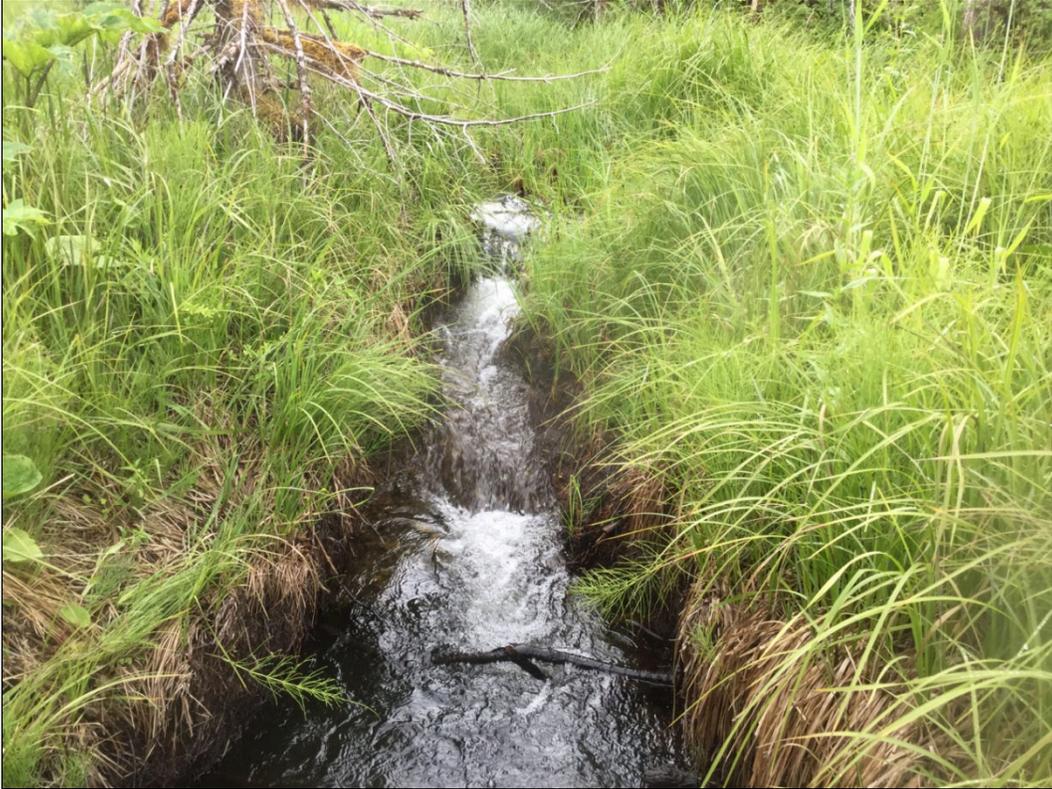
Figure 2.—Channel at waypoint 1028.

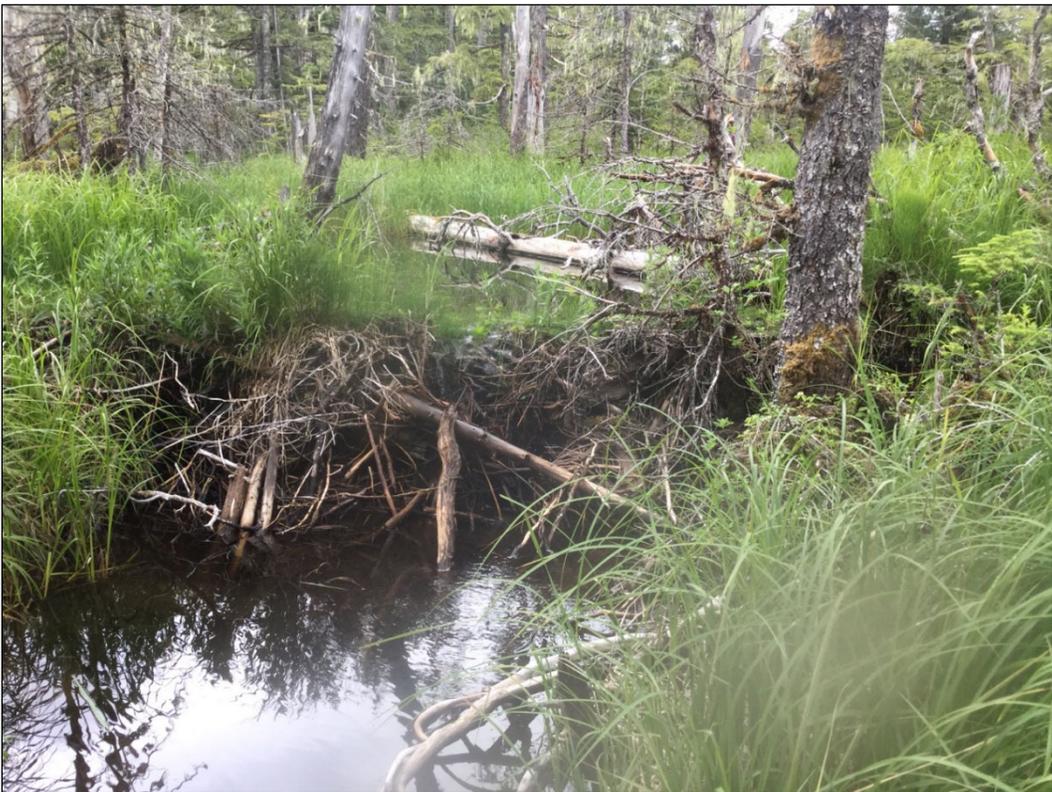
Figure 3.—Beaver dam with ponding above at waypoint 1041.
