## 112-63-10070

## Species Addition / Route Correction

**Water Body Name:** \*Crab Cove Creek (N Head)

**HUC12:** 190103010716

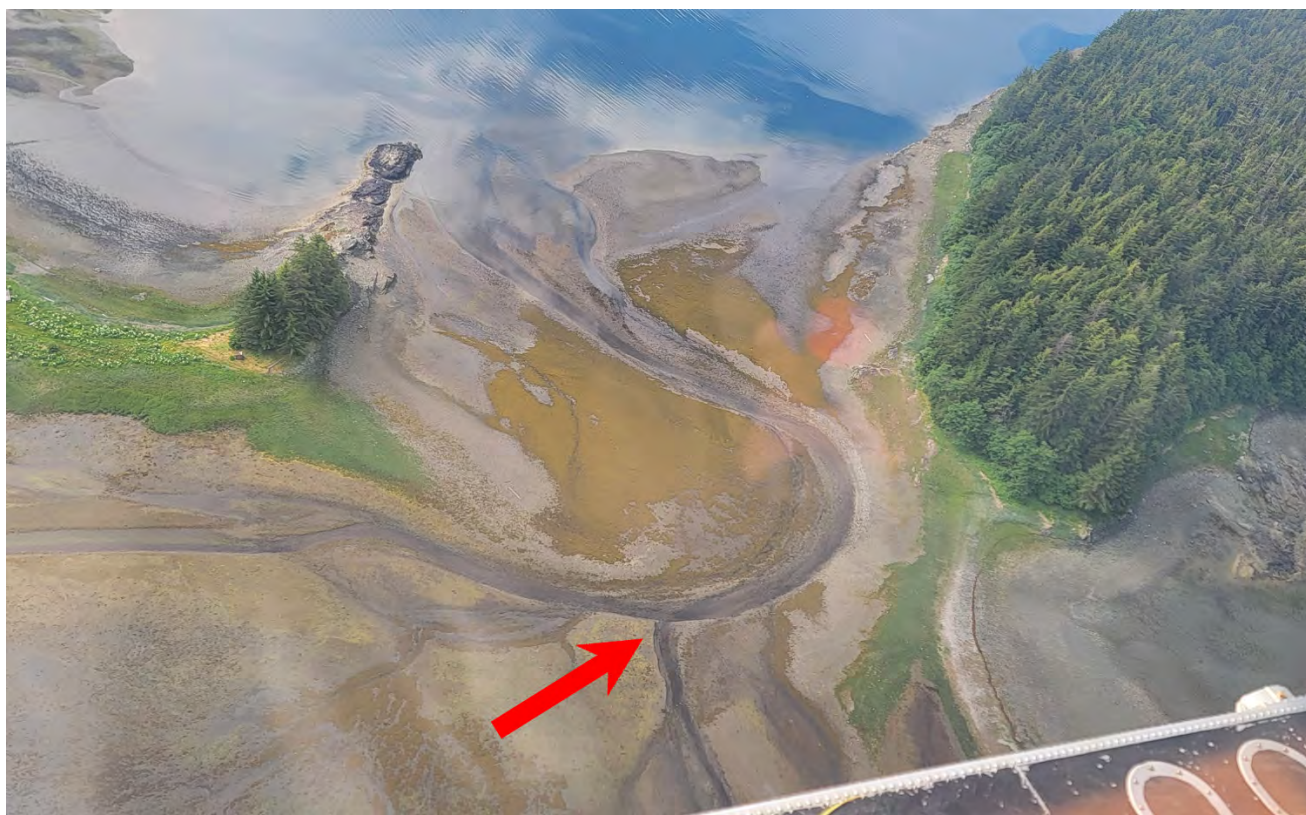
Figure 1.- An aerial view of the confluence (red arrow) of 112-63-10080 (stream entering picture on viewers left) and 112-63-10070 (lower center), as well as saltwater terminus near MLLW. Image captured at 8:16 am, 6/20/24.

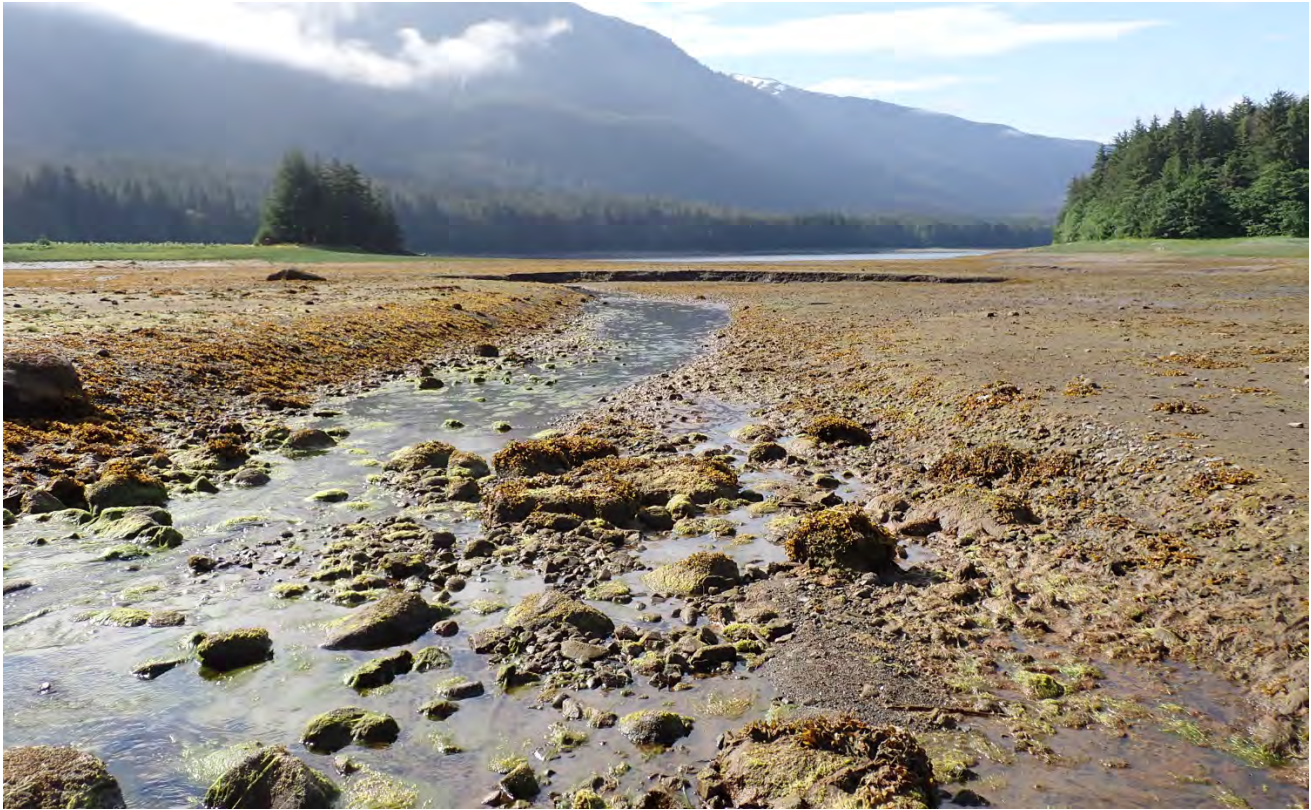
Figure 2.- Looking downstream from waypoint 2 at tideflat reach.

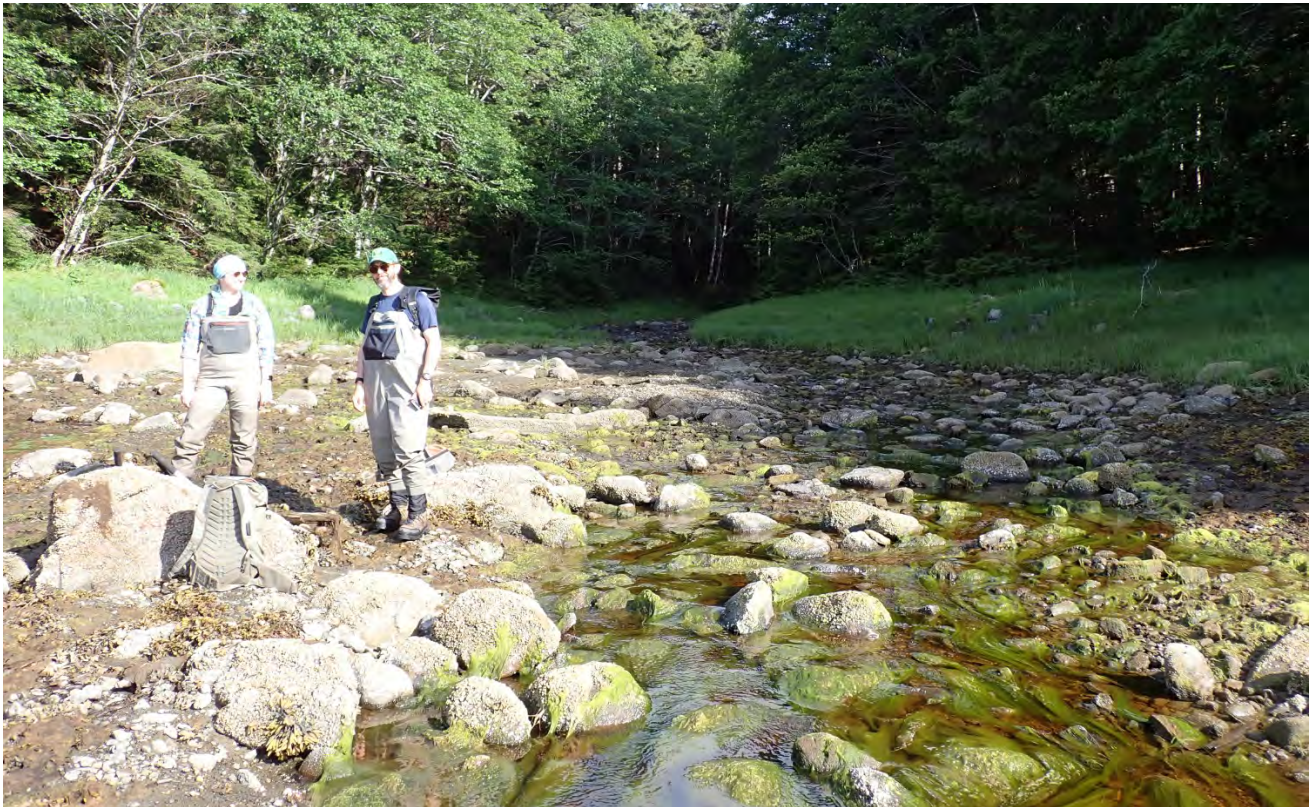
Figure 3.- Looking upstream from waypoint 2 at upper ITZ / meadow reach characteristics, 1.65m Monica S. (left) and 1.83 Dave T. for scale.

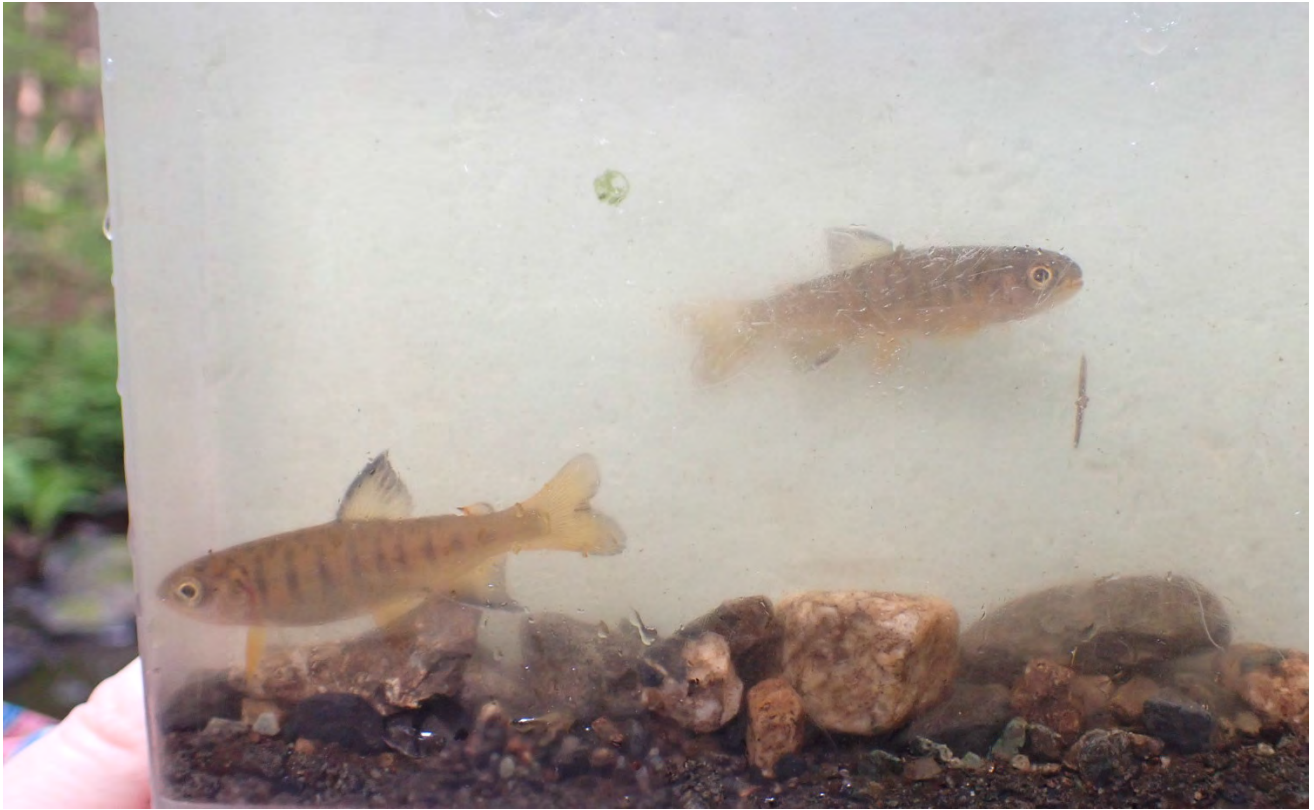
Figure 4.- Juvenile coho salmon captured at waypoint 4.

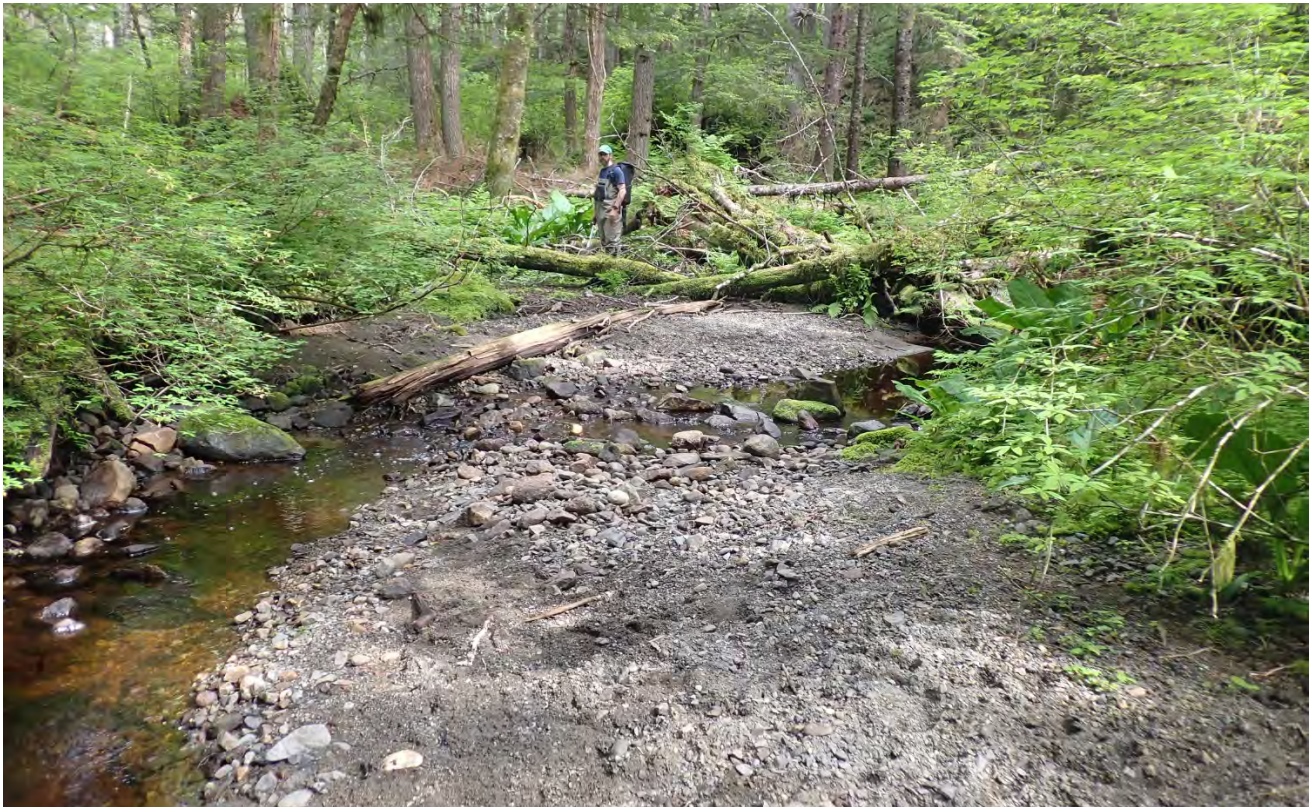
Figure 5.- Looking upstream from waypoint 5 at general stream characteristics encountered between here and waypoint 8.

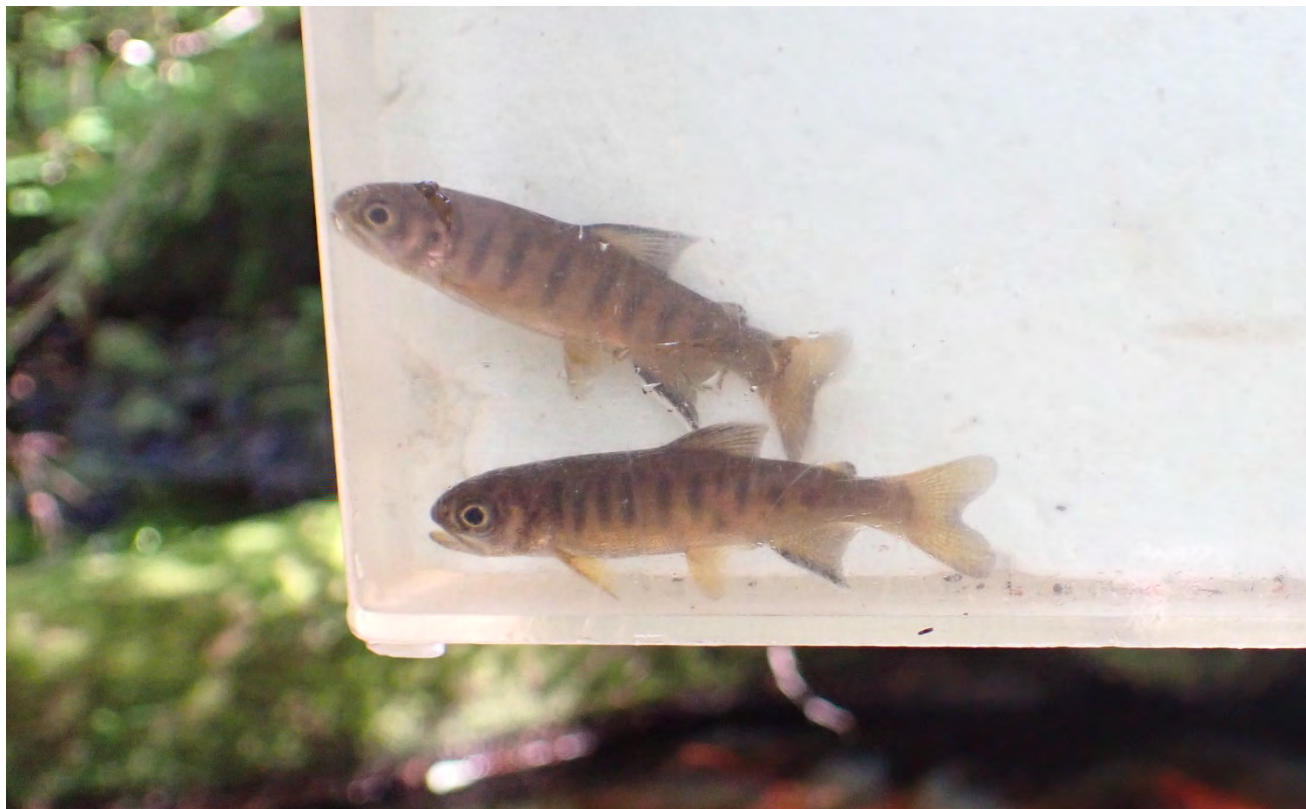
Figure 6.- Juvenile coho captured at waypoint 8.

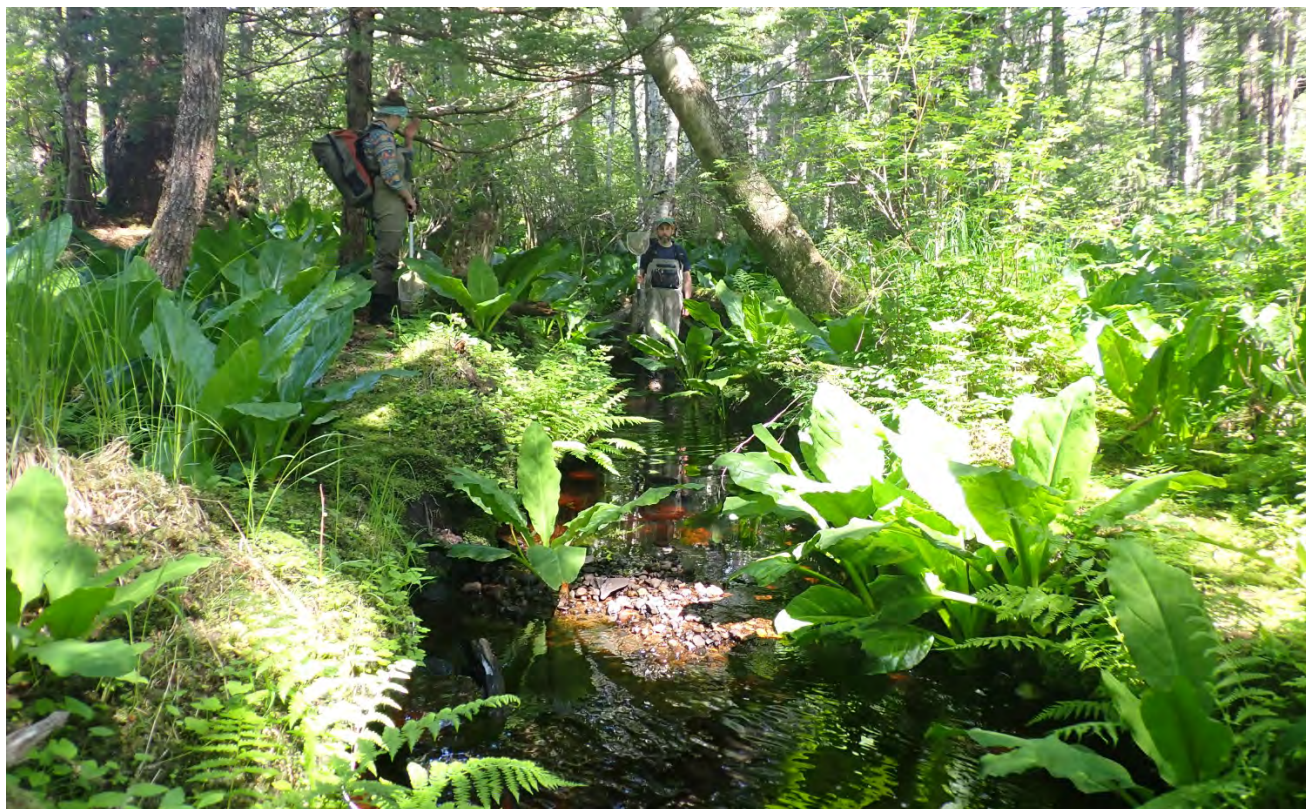
Figure 7.- Looking upstream from waypoint 8 at general stream characteristics encountered between here and waypoint 10.

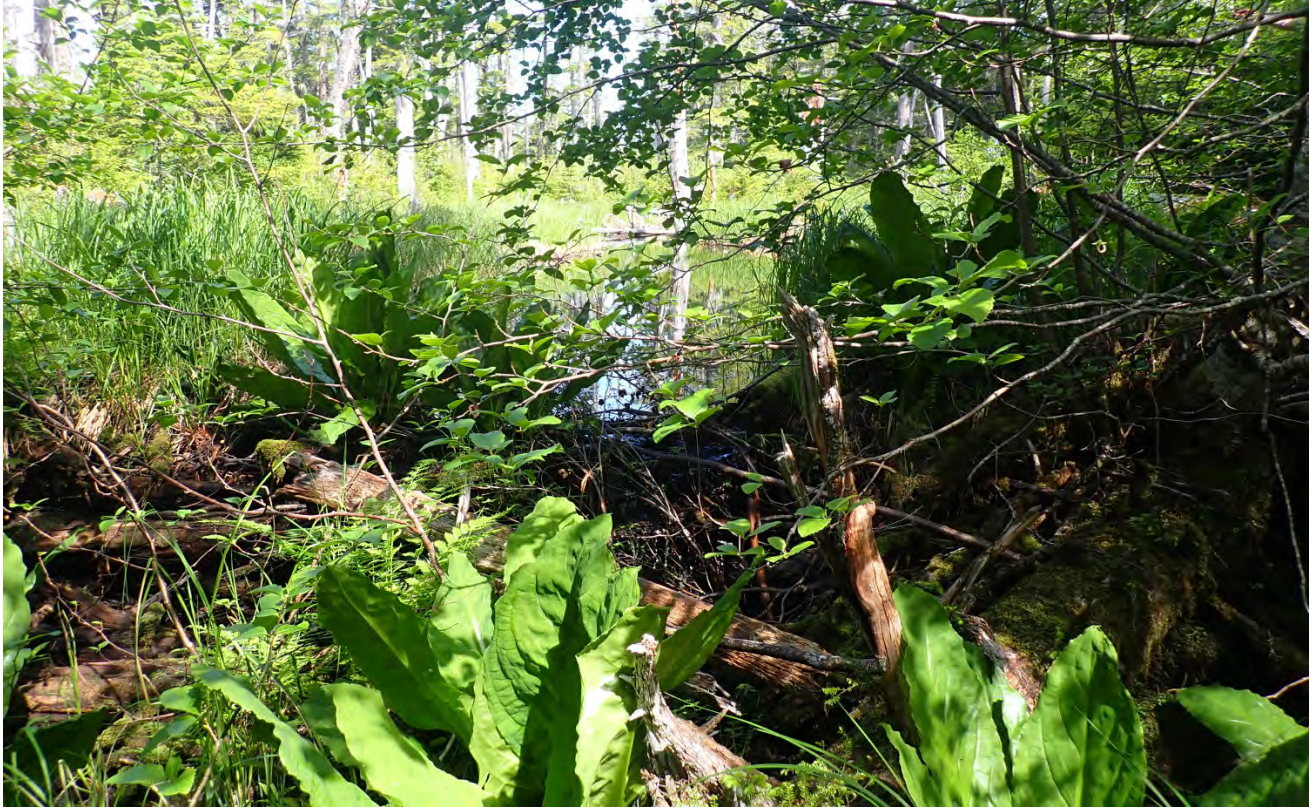
*Figure 8.- Looking upstream at beaver dam noted at waypoint 10.*

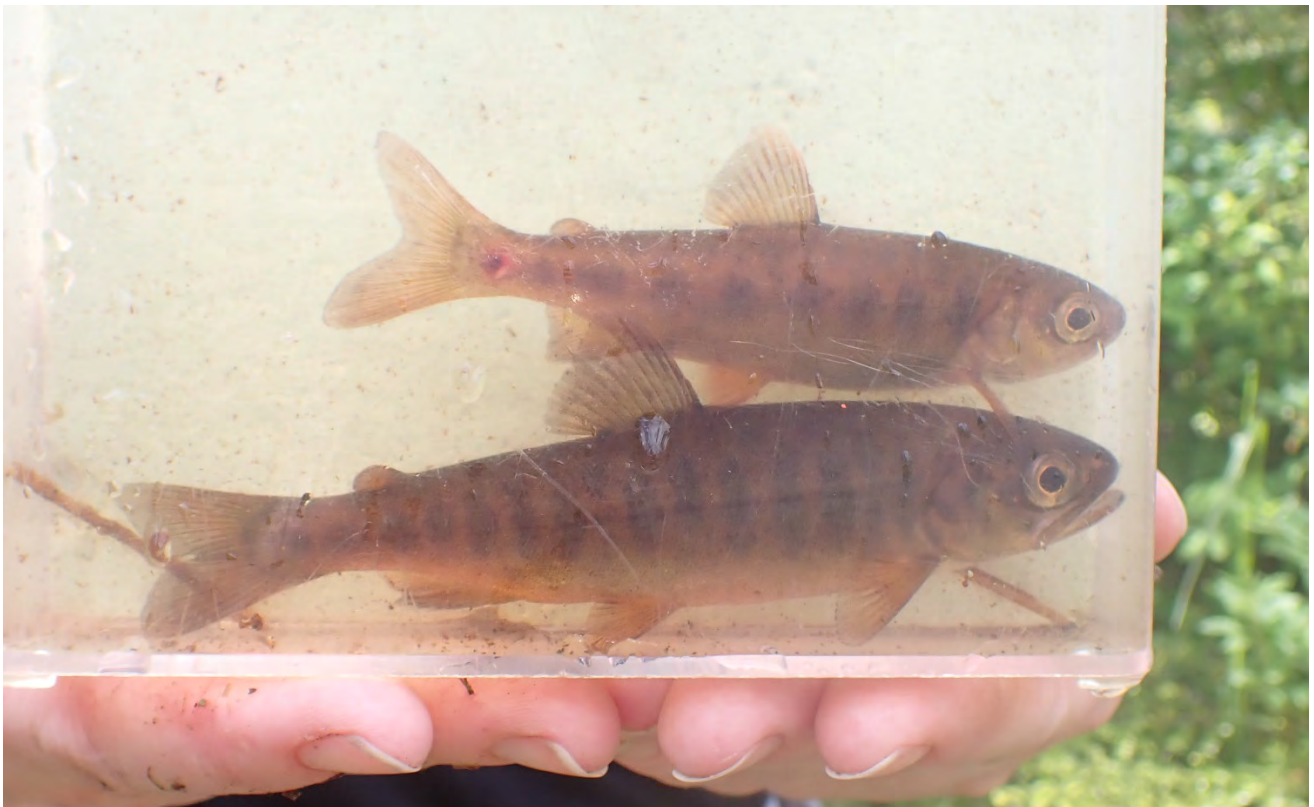
*Figure 9.- Juvenile coho captured at waypoint 11. Both appear age 1+ based on size.*

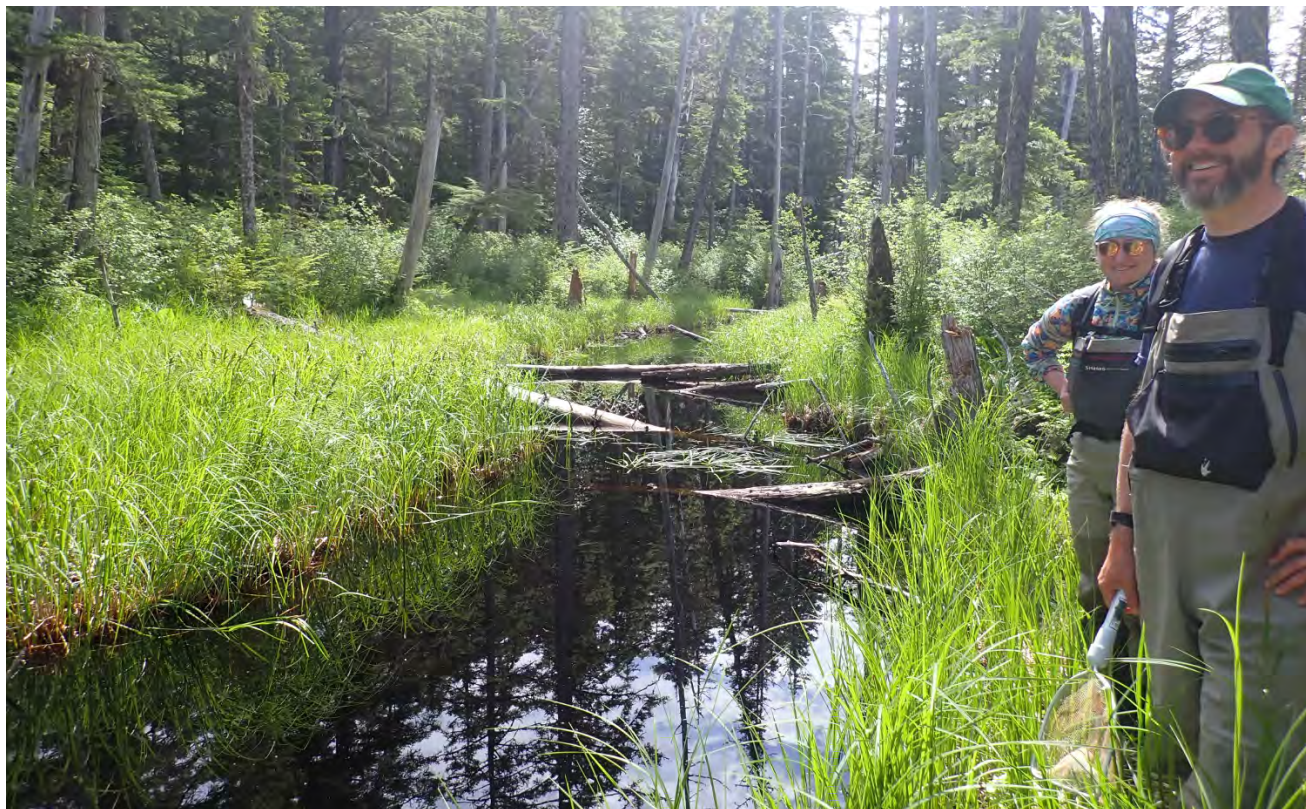
Figure 10.- Looking downstream from waypoint 12 at general characteristics encountered between waypoints 11 and 16.

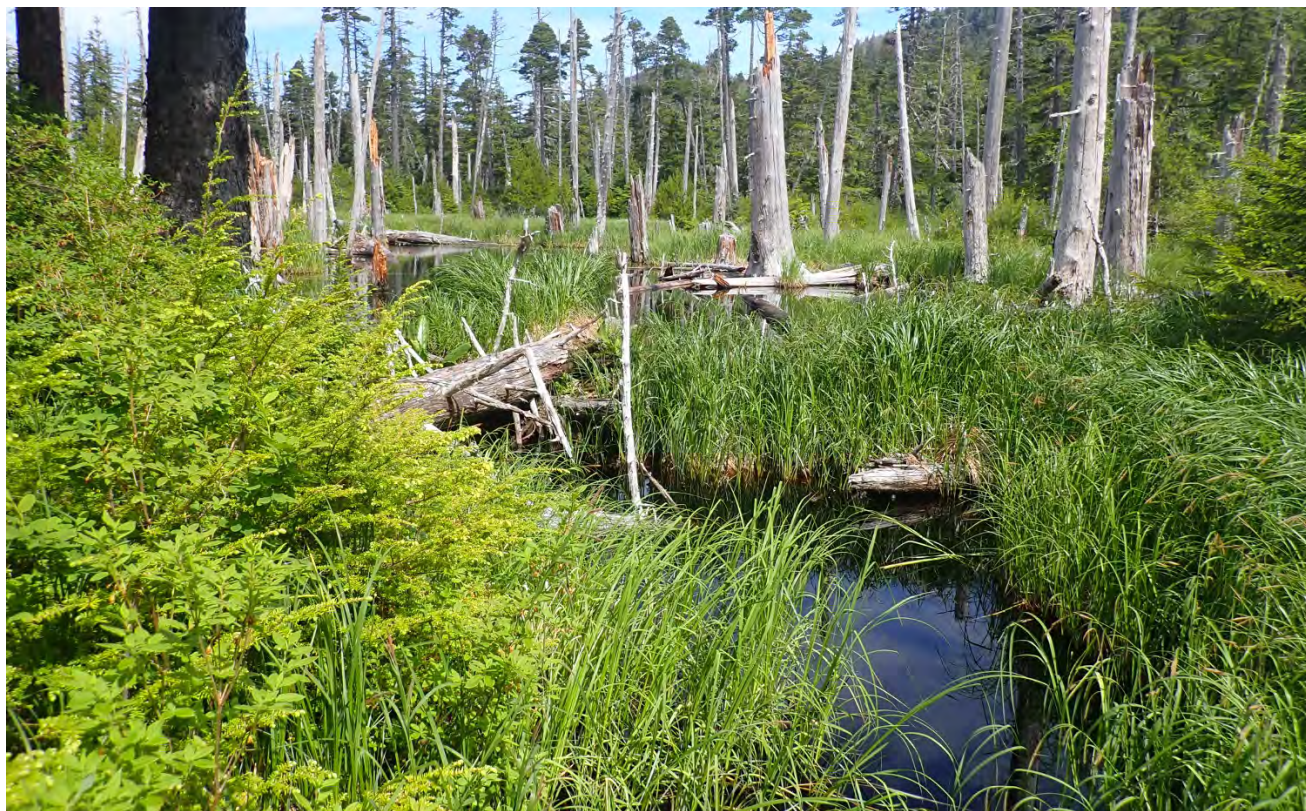
Figure 11.- Looking upstream at beaver dam noted at waypoint 13.

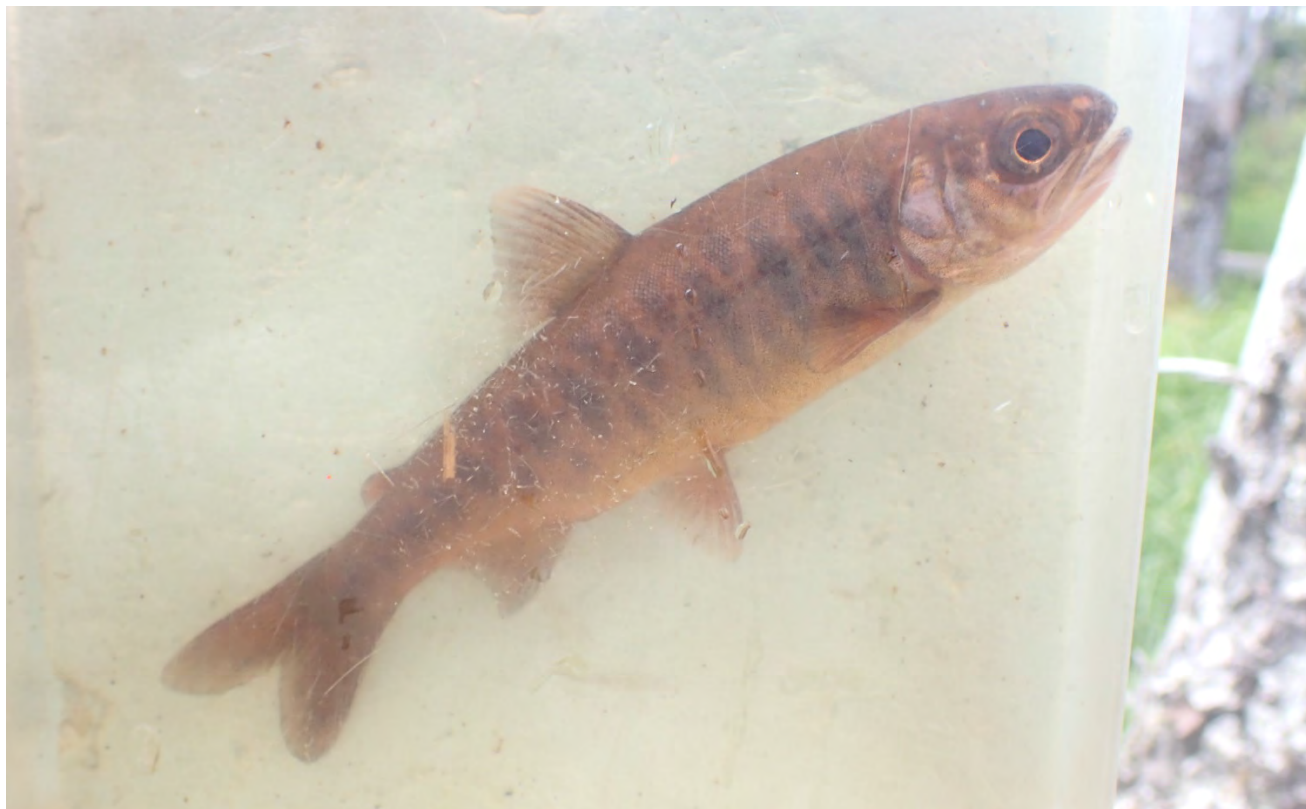
*Figure 12.- Juvenile coho captured at waypoint 16.*
