Nomination for Waters  
Important to Anadromous Fish

Anadromous Water Catalog Number of Waterway 247-50-10300-2080

Name of Waterway Wolf Lake outlet stream  USGS Name  Local Name

# Mat-Su Stream Crossing Structure

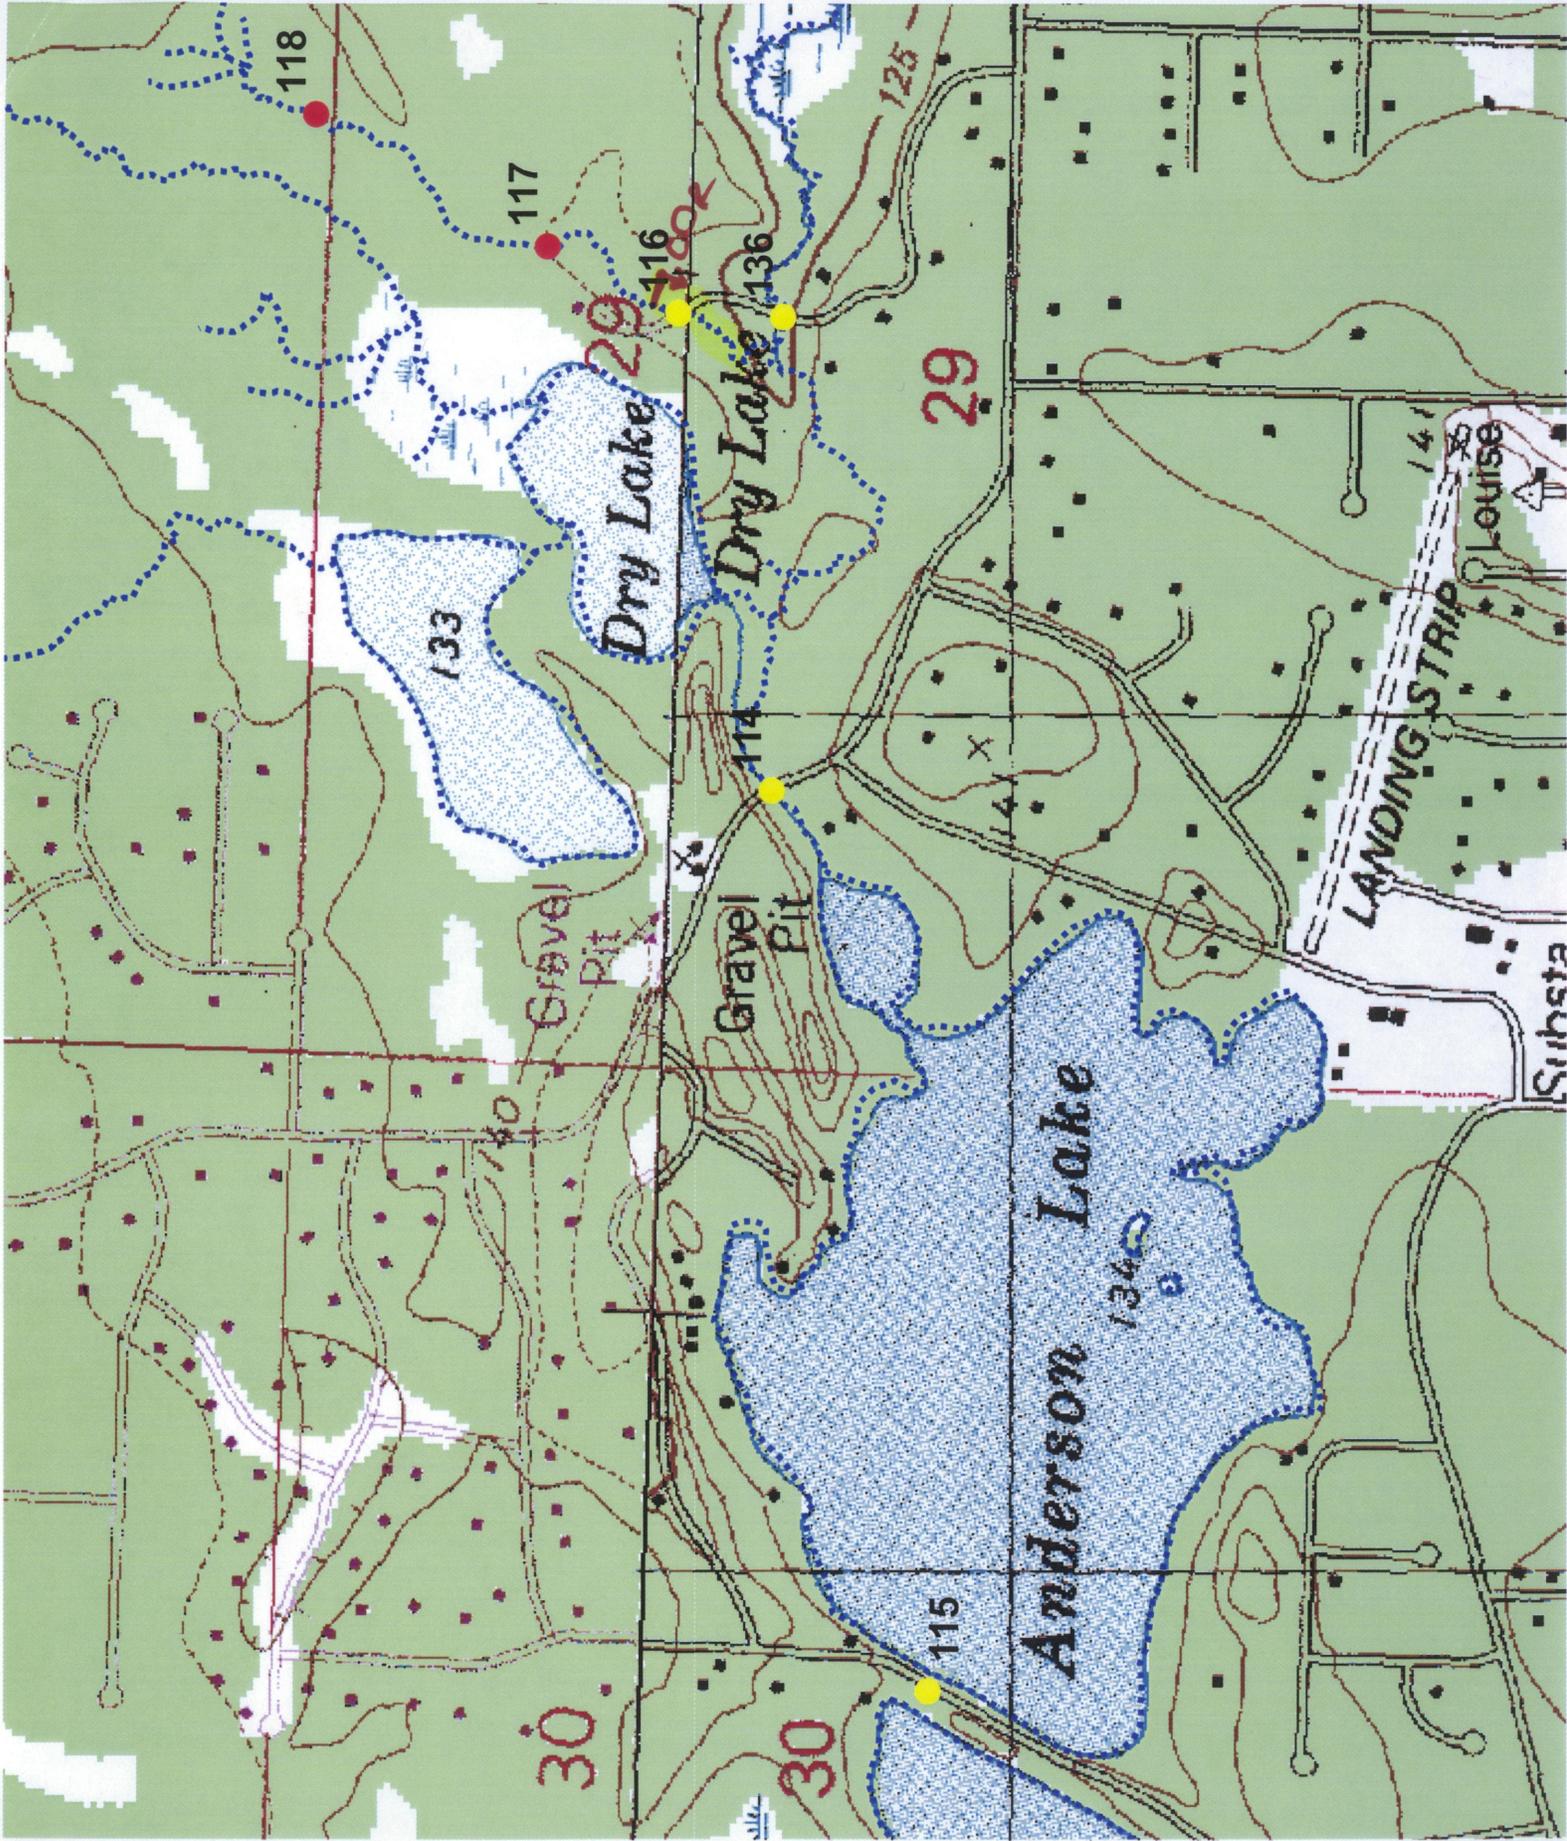
Add coho rearing in addition to coho spawning and extend stream with coho rearing. Coho caught in traps above and below culvert. Upper extent of rearing noted 500 feet upstream based on no blockages between upper trap site. This is also upper extent of possible usage, due to gradient barrier. Stream trapped at four locations upstream and only Dolly Varden captured.

EXTEND STREAM  
247-50-10300-2080 w/ COR
