Anadromous Water Catalog Number of Waterway 221-20-10365

Name of Waterway Sahlin Creek USGS name Local name

STREAM HABITAT ASSESSMENT 1993 - STREAMS

SUBJECT: Anadromous Stream
Nominations
and Corrections
Project R-51

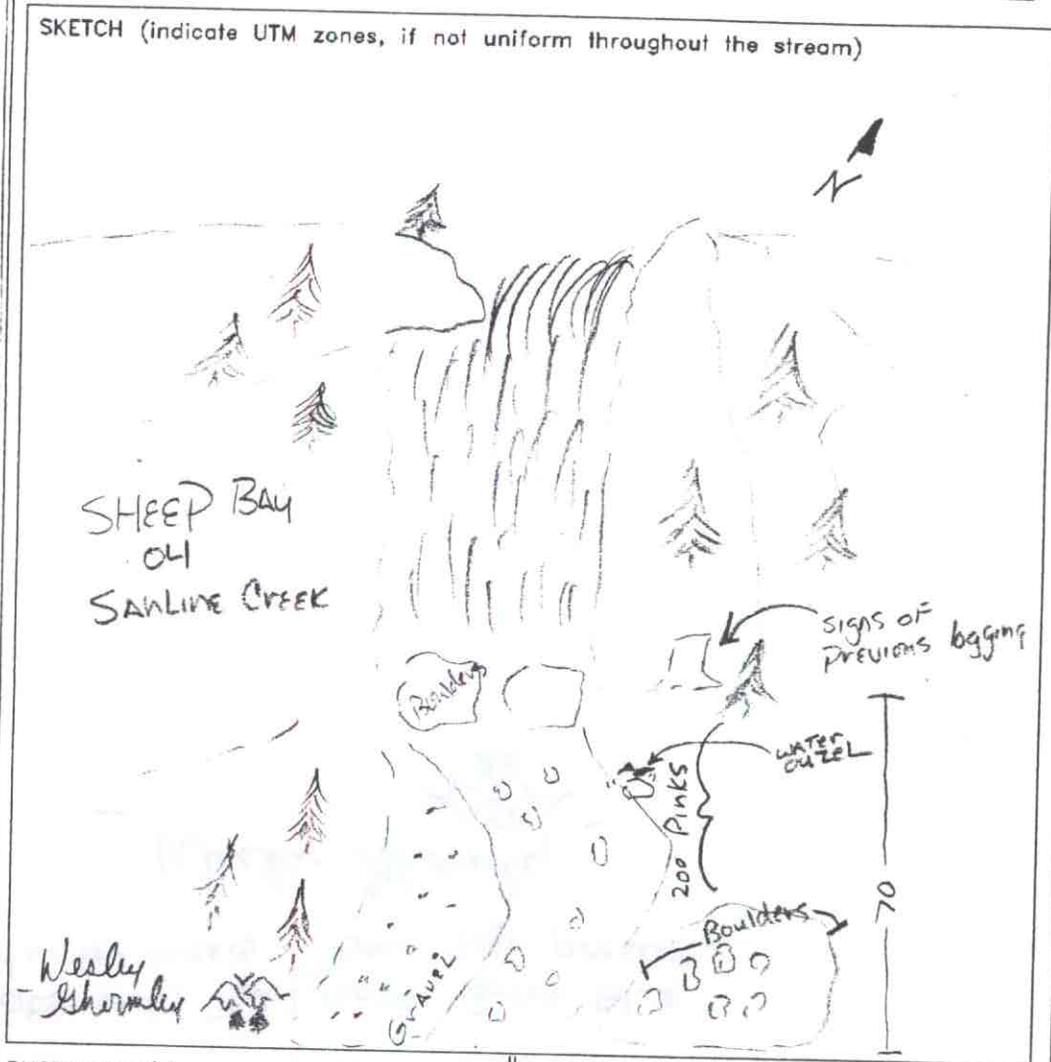
SKETCH (indicate UTM zones, if not uniform throughout the stream)

Comments: 300 adult pink salmon were observed in this stream during a foot survey. The barrier is a 50 meter high falls which also marks the upper extent of adult pinks. Channel width is 16 meters at the mouth and 15 meters at the barrier.

TOTAL BARRIER: n BARRIER TO SPECIES: ALL adults juveniles
 TYPE: fall slide beaverdam logjam spring substrate HEIGHT (m): 50 DIST. FROM UPPER EXTENT (m): 0

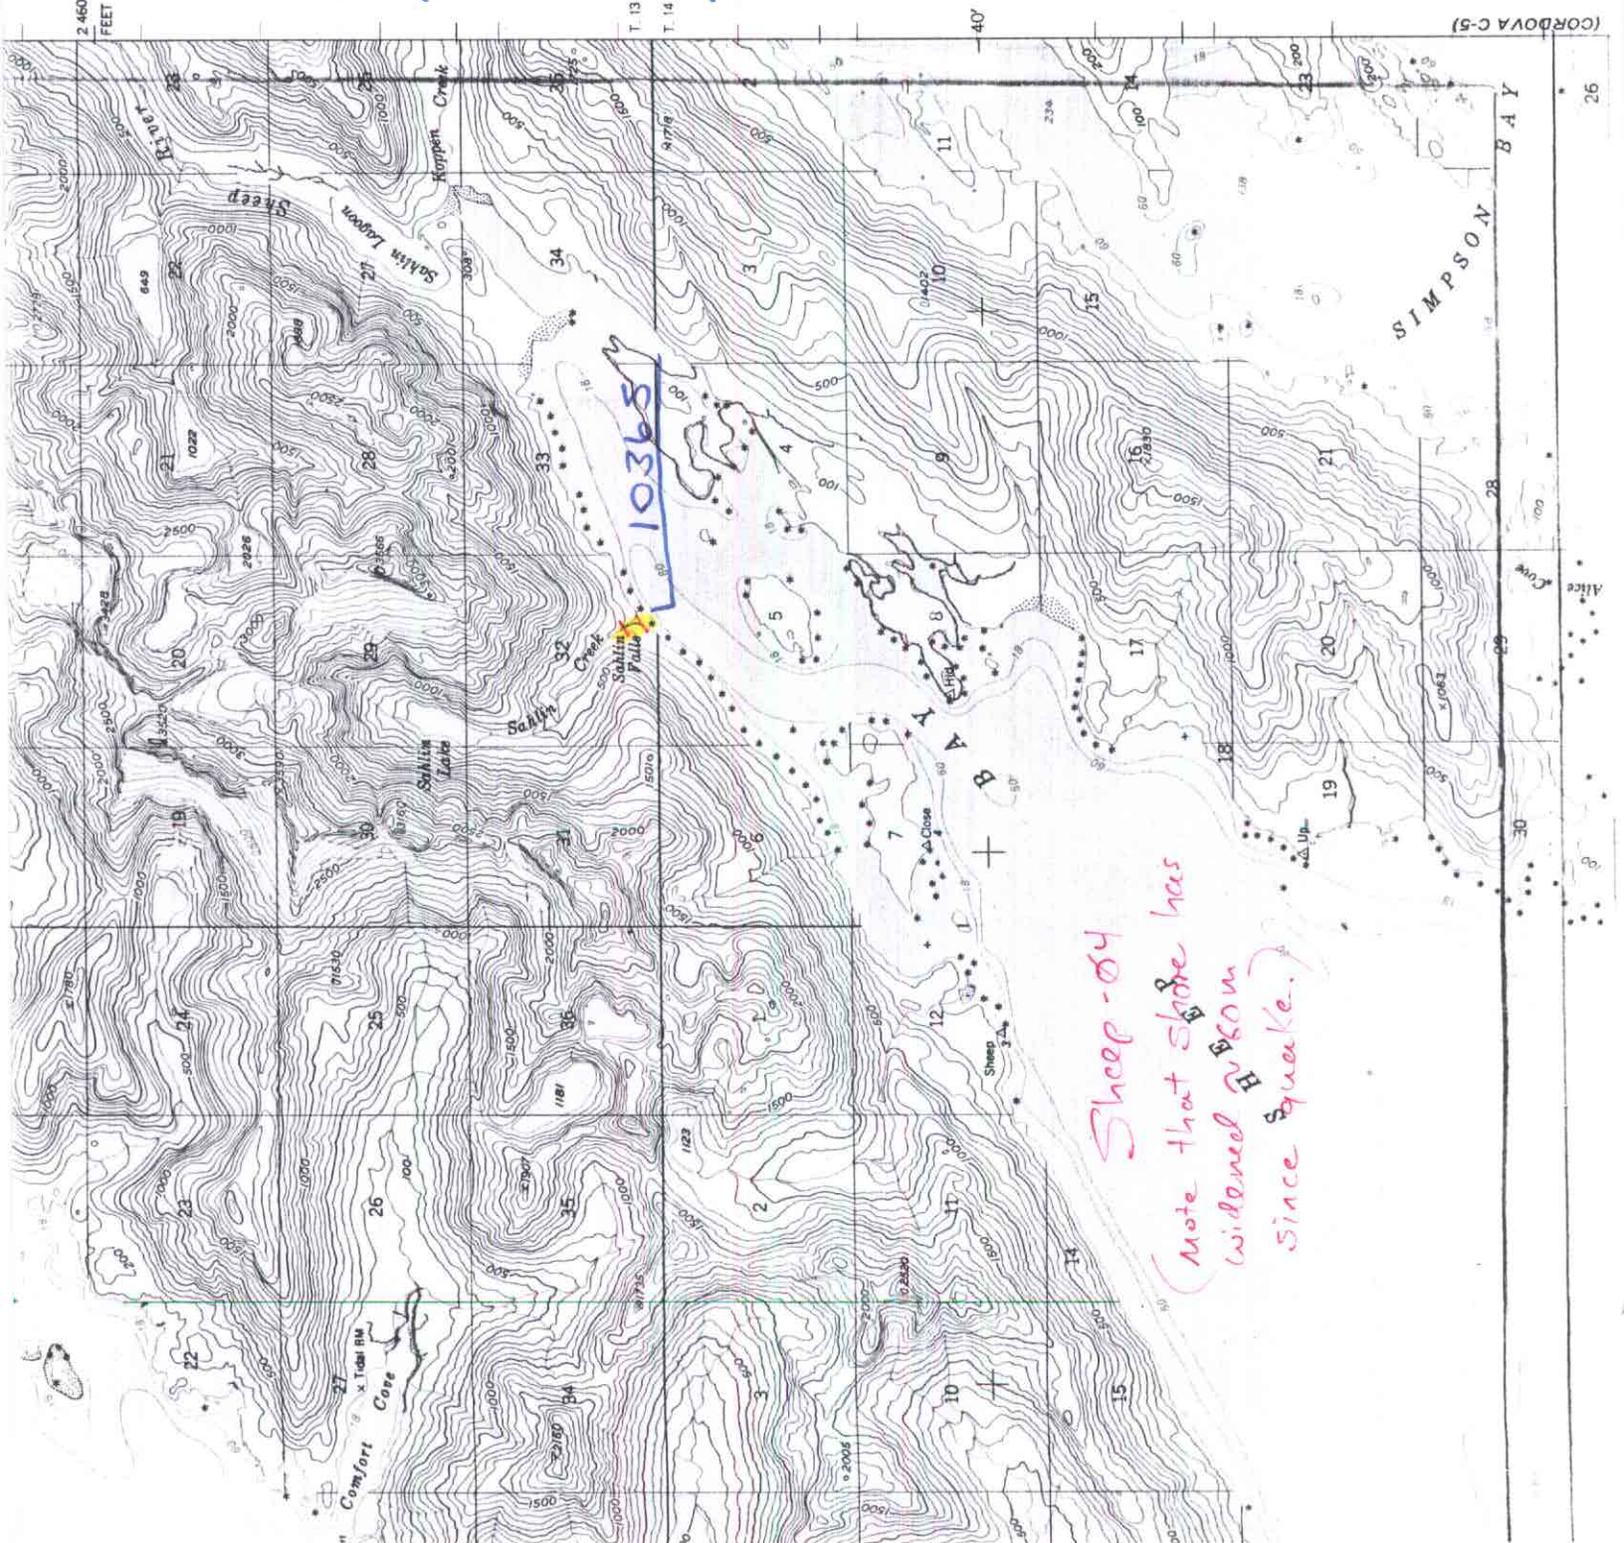
221-20-10365

T. 13 S. SHORT STREAM

Below FALLS
(70m)

Sheep-84
(Note that shore has
widened 750m
since quake.)

There substantial discrepancies among shorelines on the USGS quad sheets, the DNR shoreline, and observed shorelines in this area. In some cases I have attached enlarged plots generated from GPS data and the DNR shoreline to the nomination form in order to illustrate the differences.
