Nomination Form
Fish Distribution Database

Name of Waterway Rink Creek USGS Name Local Name
 Addition Deletion Correction Backup Information

SUBJECT: Rink Creek Drainage Bank
Stabilization Trip Report

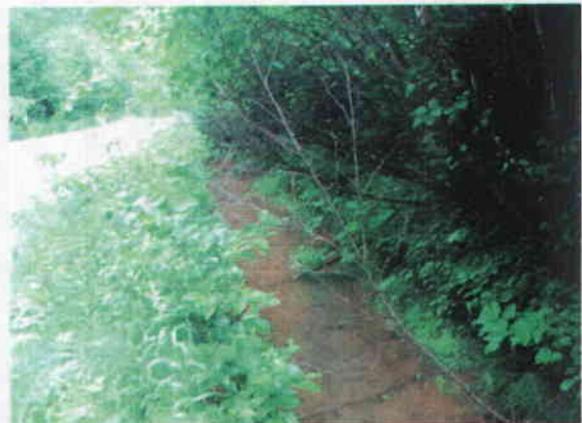
Photo 1. Drainage adjacent to WCR.

The drainage is about 3/4 mile long. The first 1/3 of the drainage is heavily wooded and several hundred feet from WCR (based on initial observations of the area and aerial photos, I did not walk this reach). The remaining 2/3 of the drainage is located at the toe of WCR (see Photo 1 and the attached map).

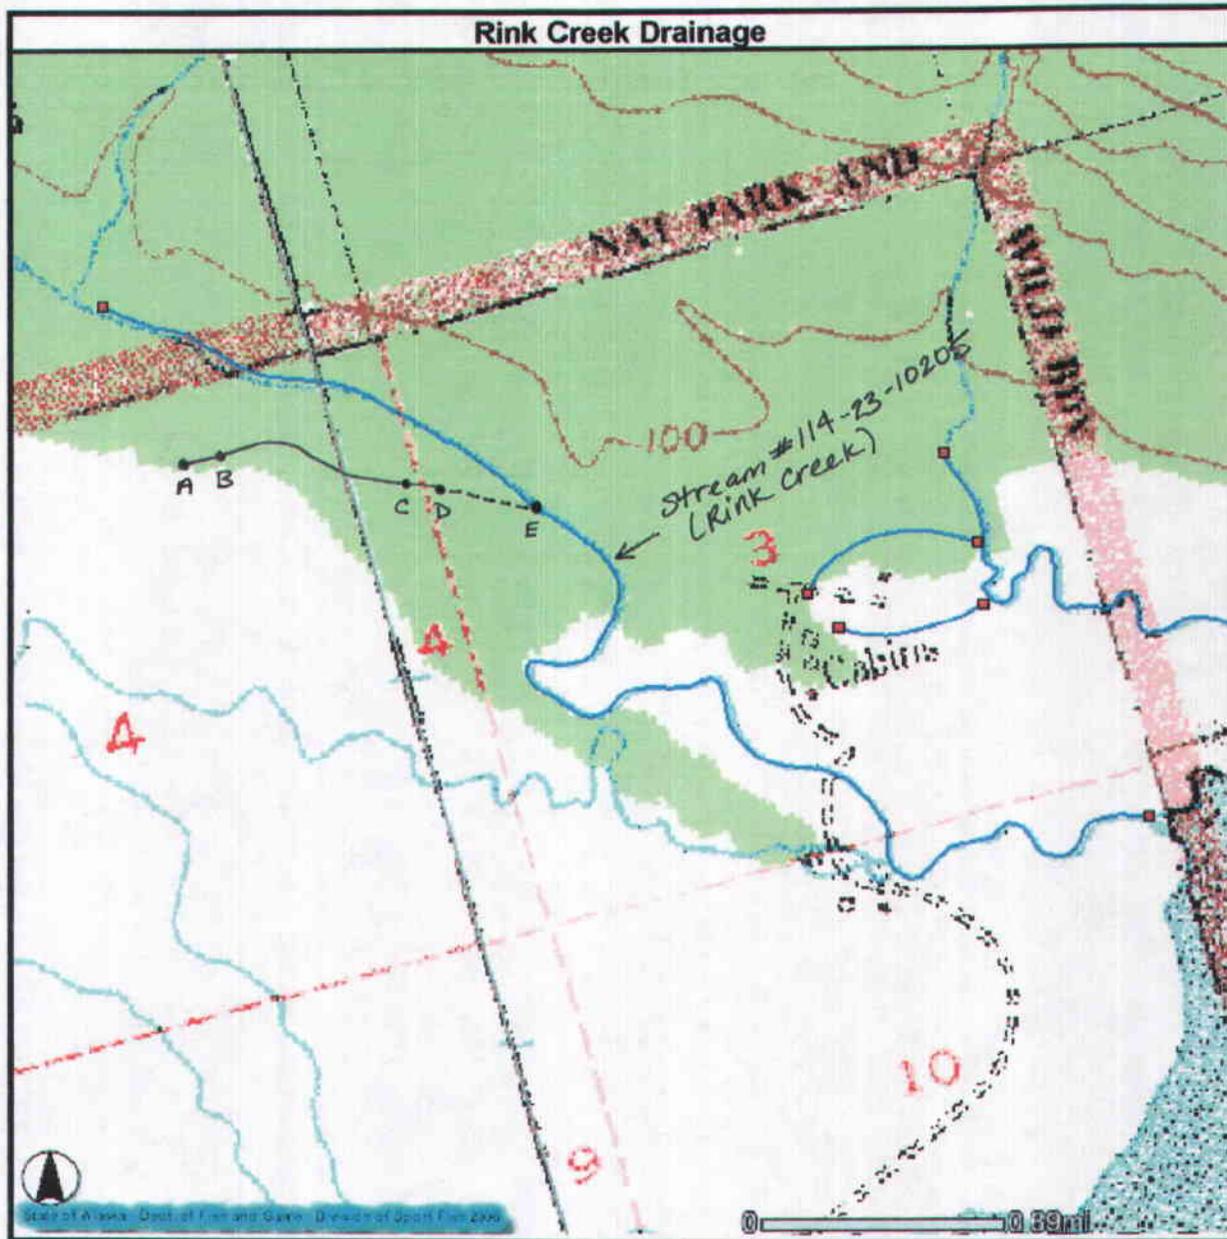
A = 58.4398°, 135.6761°

Upstream fish use extent (not trapped, but cor + DVr observed)

B = 58.4399°, 135.6740° (DVr, cor, TSBp)

C = 58.4378°, 135.6672° (DVr, CTr, cor, TSBp)

D = 58.4374°, 135.6654° (not trapped)

E = 58.4368°, 135.6618°

probable confluence w/ Rink Creek, need to verify on-site

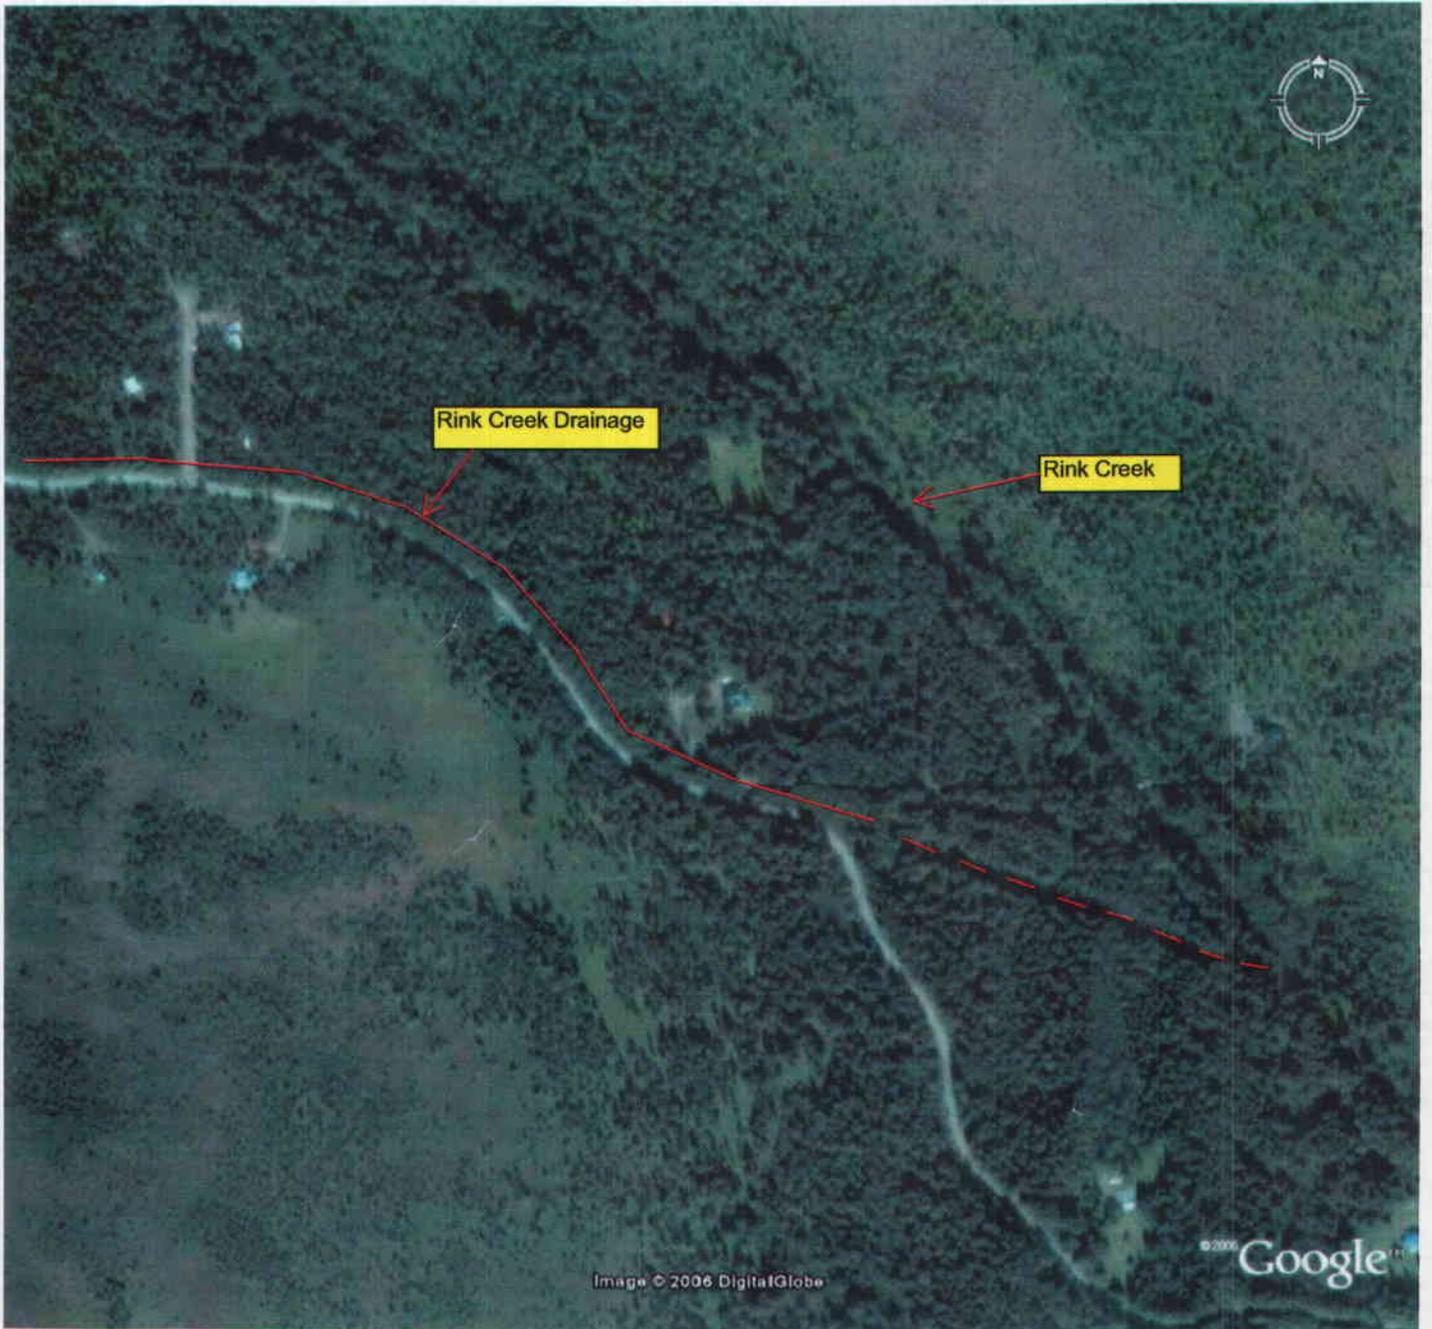
Rink Creek Drainage

Rink Creek
