Nomination Form
Fish Distribution Database

Region Southeast USGS Quad(s) SKAGWAY B-2
 Fish Distribution Database Number of Waterway 115-32-10250-2008 - 3004
 Name of Waterway Waterfall Creek USGS Name Local Name
 Addition Deletion Correction Backup Information

SUBJECT: Haines Hwy MP 3.5-25.3
Trip Report

Stations 269+00 (not cataloged) and 271+25 (cataloged, Waterfall Creek)

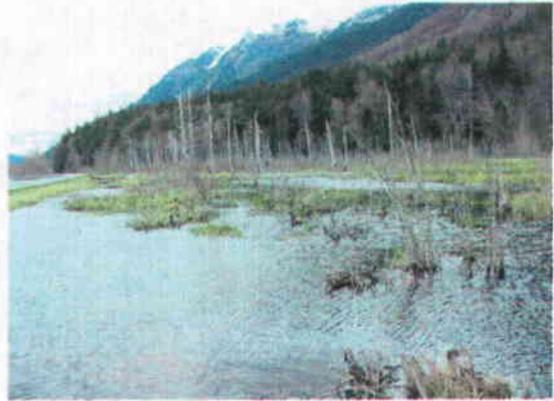
Photo 1. Station 271+25

Waterfall Creek (#115-32-10250-2008) originates below a waterfall next to the road near Station 301+00 and flows eastward parallel to the road at the upslope edge of a wetland. The stream was connected to the wetland, which was flooded to the shoulder of the road between about Station 280+00 and 300+00 (see Photo 1). The stream crosses the highway at two locations: near Station 269+00 through a 36" culvert; and near Station 271+25 through a 24" culvert. The crossing at Station 271+25 connects to un-named tributary (#115-32-10250-2008-3005) on the river side of the highway.

Traps were set about 60' downstream of the waterfall in the wetlands at the shoulder of the highway, about 500' from the waterfall, and at the inlet to the culvert at Station 269+00. We observed a 5" fish that appeared to be a cutthroat trout near the trap at the waterfall. The trap, however, caught only Dolly Varden. Coho and king salmon were captured in the wetland next to the highway. Coho and king salmon, and Dolly Varden were caught at the culvert at Station 269+00. The presence of coho and king salmon in the wetland adjacent to the highway demonstrates that the wetland is part of Waterfall Creek and should be considered as anadromous waters.

What we believe to be the tributary on the river side of the highway (#115-32-10250-2008-3005) was dry upstream of the culvert at Station 271+25, and may not support fish at this time.

- Include the wetland as part of Waterfall Creek (map as polygon) in the Catalog
- Extend the upstream extent to just below the waterfall, in the Catalog
- Add king salmon rearing habitat to the Catalog
- Update stream location in the Catalog
- Revisit dry stream segment #115-32-10250-2008-3005 to determine if it should be removed from the Catalog
- Design all stream crossings for fish passage

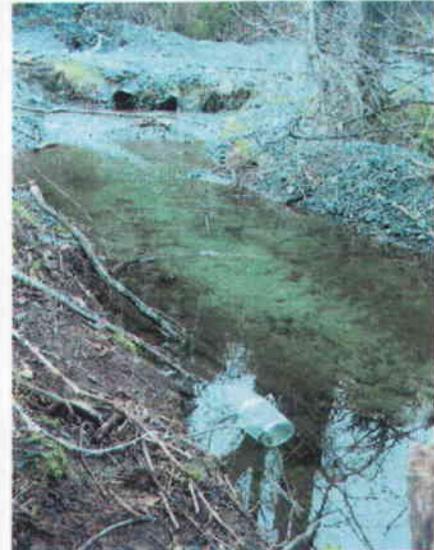
Photo 2. Station 315+50

This stream was identified in the SHI as habitat for rearing coho and Dolly Varden, and potential spawning (redds were observed). Upstream fish habitat is limited to about 50' upstream of the culvert.

A trap set about 40' upstream of the double 24" culverts caught coho salmon, cutthroat trout and Dolly Varden. A trap set about 30' downstream from the outlets caught king and coho salmon, and Dolly Varden (see Photo 2).

- Add to the Catalog as supporting rearing coho and king salmon, cutthroat trout and Dolly Varden
- Design the stream crossing for fish passage

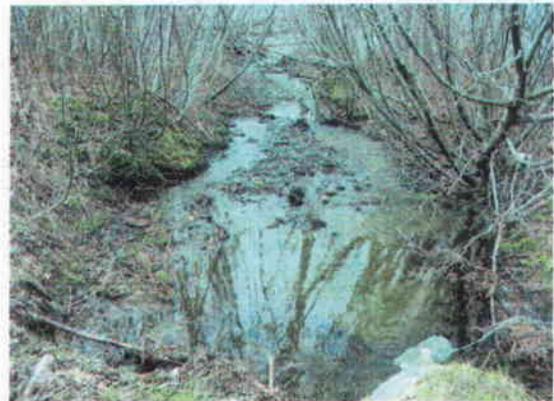
Photo 3. Station 339+00

This stream is below the site of an old cabin located uphill of the highway. It was not identified in the SHI. The clear water channel below the culvert outlet is about 8' wide and up to about 1' deep (see Photo 3). The culvert inlet was about 80% buried. Stream habitat is limited to the channel between the culvert and the Chilkat River (about 30 feet).

- Add to the Catalog as supporting rearing coho and Dolly Varden below the culvert
- Fish passage not required at stream crossing

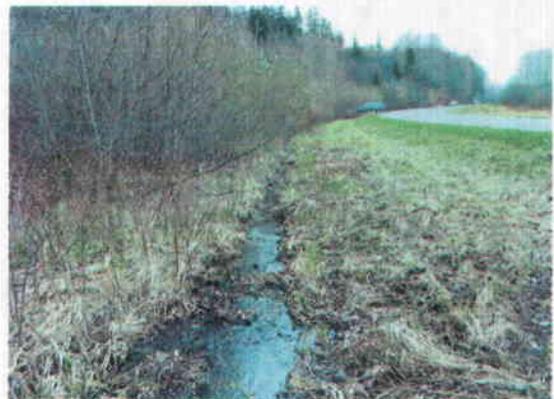
Photo 4. Station 342+00

The SHI identified this stream as supporting rearing coho and Dolly Varden. Coho and king salmon were trapped 300' upstream of the 36" culvert crossing. The culvert is perched and unraveling. The stream meanders along the road upstream of the culvert for about 300', before turning inland (see Photo 4). Potential fish habitat terminates in a high-gradient reach just below a waterfall.

- Add to the Catalog as supporting rearing coho and king salmon

- Design the stream crossing for fish passage

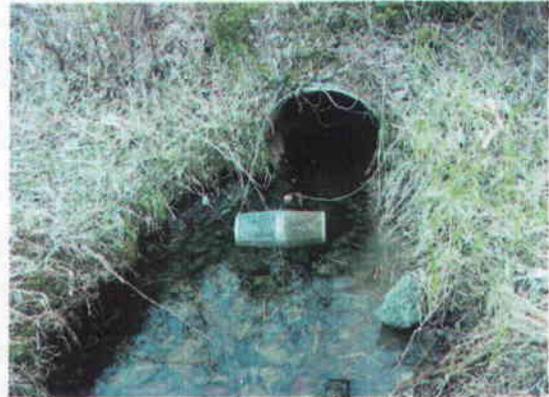
Photo 5. Station 389+25

The SHI identified this stream as supporting rearing coho and Dolly Varden. The stream crosses the highway through a 24" culvert. Coho salmon were trapped at the culvert outlet (see Photo 5), coho and cutthroat were trapped at the inlet. Upstream fish habitat is limited to about 40 feet because of a steep cascade.

- Add to the Catalog as supporting rearing coho salmon and cutthroat trout
- Design the stream crossing for fish passage

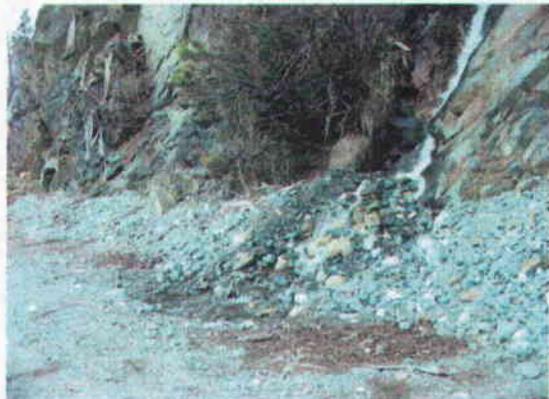
Photo 6. Station 391+75

The SHI identified this stream as providing rearing habitat for coho and Dolly Varden. The stream terminates in a waterfall just upstream of the 24" culvert (see Photo 6). A 10-foot diameter pool identified in the SHI at the bottom of the waterfall was filled with gravel and the stream flowed to the culvert through a shallow gravelly channel. There was no usable habitat above the culvert inlet. The channel above and below the culvert was too shallow to trap. Although not documented, the short stream reach below the culvert probably provides rearing habitat for coho salmon and Dolly Varden char, and good spawning gravels.

- Stream crossing does not need to be designed for fish passage

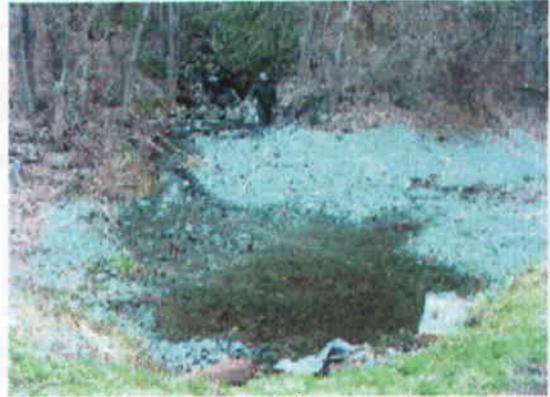
Photo 7. Station 442+75

The SHI identified this stream as supporting rearing coho and Dolly Varden, and possible spawning habitat. The stream crosses the highway through twin 24" culverts that were perched about 6". Fish habitat ends about 75' upstream at a steep cascade (see Photo 7). There was evidence of water flowing across the road as a result of plugged culverts. Coho salmon, steelhead, and cutthroat trout were trapped about 60 feet upstream of the culvert inlet. Coho salmon were trapped just below the outlet.

- Add to the Catalog as supporting rearing coho, cutthroat and steelhead
- Design the stream crossing for fish passage

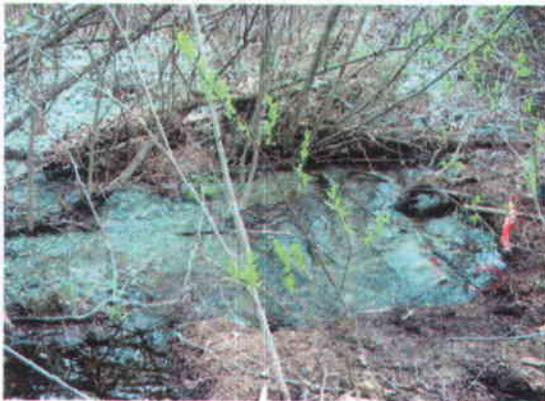
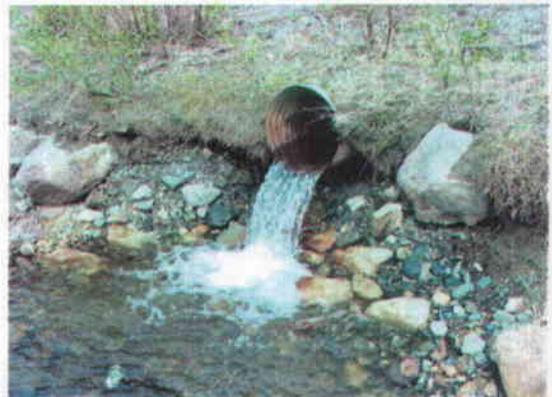
This stream was not identified in the SHI. A trap placed about 100' upstream from the 24" culvert caught cutthroat and Dolly Varden (see Photo 8). Shortly beyond this point the gradient increases significantly. The culvert is perched about 1' and discharges directly to the Chilkat River (see Photo 9). There is enough good upstream habitat to make it worthwhile replacing the culvert with one that improves fish passage.

- Add to the catalog as supporting rearing cutthroat and Dolly Varden
- Design the stream crossing for fish passage

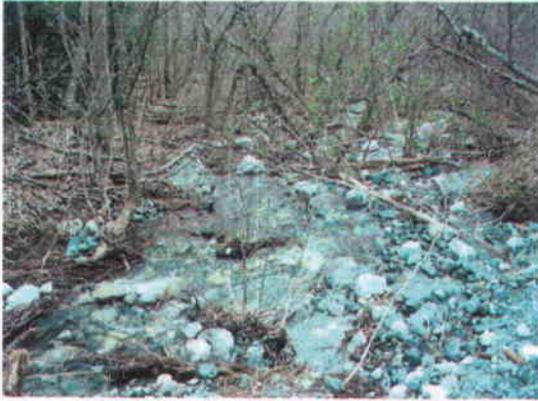
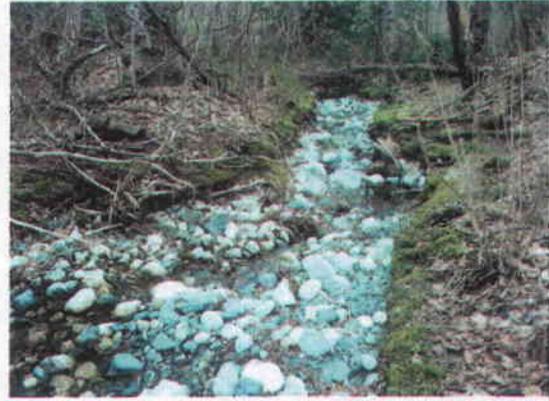
A recent debris flow has blocked the main channel so that a majority of the flow now goes through a new channel near Station 677+00 (see Photo 10), and flows along the road to twin 36-inch culverts near Station 670+00. We observed three cutthroat trout (about 18", 12" and 4") in the new stream channel about 30' upstream from the road. No fish were caught in traps set farther up in this channel. King salmon and cutthroat trout were trapped in the original main channel about 400' upstream from the culverts. There is an opportunity to improve fish passage in this area. The stream flow is now divided into many channels that are filled with gravels to the extent that flow remains subsurface for much of the way. Habitat could be improved by focusing the flow either back into the old main channel (see Photo 11), or improving the new channel.

We confirmed that Inter-Fluve's description of the area was correct. Debris flows have reduced habitat in the main channel and created new channels. These changes have likely reduced the habitat quality because of the more dispersed flows and sediment accumulation. Stream channel improvements here would be appropriate mitigation for the project. This area will require a more detailed look to determine the best approach to habitat improvements, once road alignment plans have been finalized for this area. The current proposed realignment would move the highway upstream of most of the fish habitat.

- Update Catalog to document the new channel locations and upstream extent of cutthroat spawning, and king and coho salmon rearing.
- Design the stream crossing(s) for fish passage

- Consider channel improvements as mitigation
- Take a detailed look at the hydrology and channel morphology to determine where best to route the flows and which channels to improve

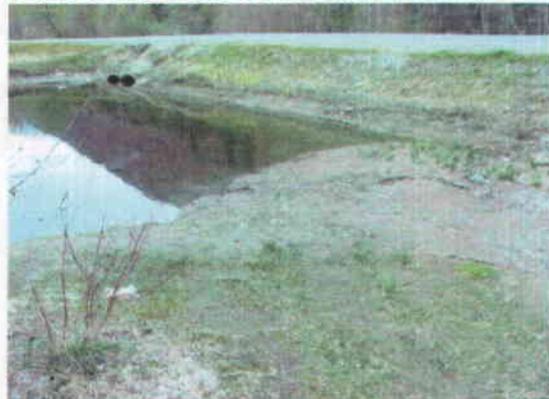
Photo 12. Station 733+50

This stream is cataloged as providing rearing and spawning habitat for coho salmon and Dolly Varden. A slough of the Chilkat River just below the two 36" culverts is used as an informal boat launch area (see Photo 12), resulting in degradation of the stream banks and bed. A trap 45' upstream of the culvert caught coho and king salmon, and Dolly Varden.

This is the location of the informal boat launching area.

- Update the Catalog to add king salmon rearing
- Design the stream crossing for fish passage

- Realign stream to cross more perpendicular to the highway
- Rehabilitate degraded habitat below culvert
- Improve the boat launch area by hardening to reduce habitat degradation, or
- Develop new launching area at a better location and close out this one

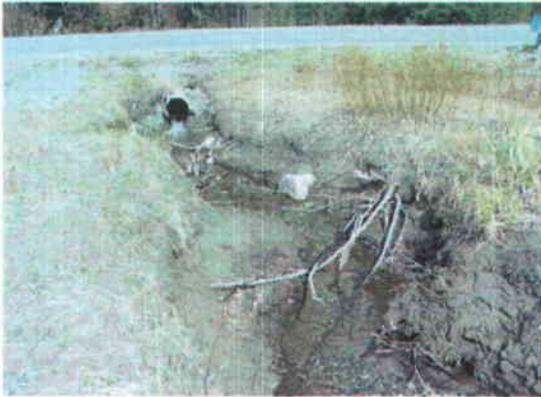
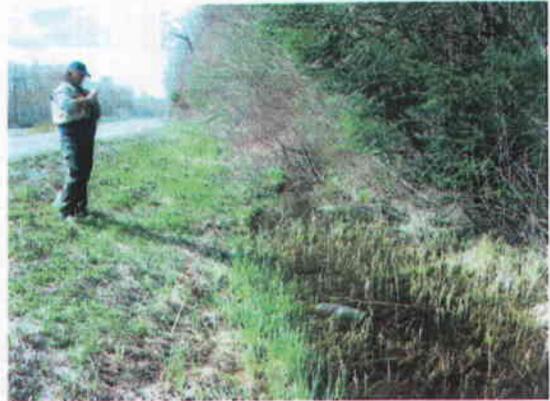
The SHI identified this stream as supporting rearing coho and Dolly Varden. This un-cataloged stream crosses the highway through a perched 24" culvert (see Photo 13). Three traps set within 175' upstream of the culvert inlet caught king and coho salmon and Dolly Varden (see Photo 14). The stream would be filled by the proposed road alignment.

This short stream that we propose to nominate to the Catalog would be mostly filled by the new road alignment.

- Add to the Catalog as supporting king and coho salmon and Dolly Varden
- Construct new channel on riverside of highway
- Fish passage is not required for this stream crossing

- Re-route water from cascades through a new crossing location and create new stream and potentially wetlands on the river side (culvert would not need to be designed to pass fish).

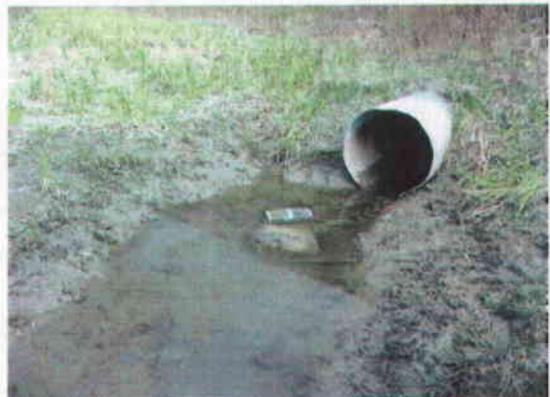
Photo 15. Station 879+75

The SHI identified this stream as supporting rearing coho and Dolly Varden below the culvert. Fish habitat ends at the culvert (see Photo 15). King salmon and Dolly Varden were trapped at the culvert outlet. The stream below the culvert is a slough of the Chilkat River, and is thereby cataloged.

- Fish passage is not required for this stream crossing.

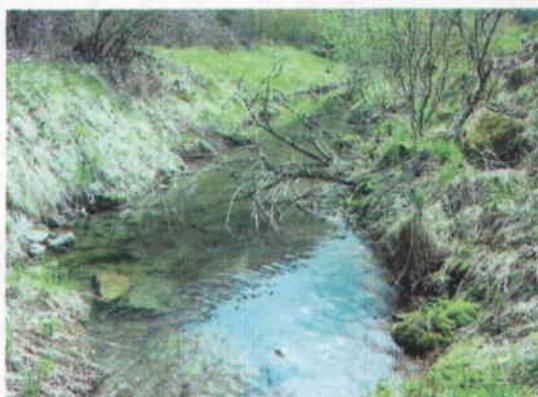
Photo 16. Station 887+90

The Catalog lists this stream as providing rearing habitat for coho salmon and Dolly Varden char, and spawning habitat for coho and chum salmon. The cataloged stream originates from springs on the hillside, and flows through NSRAA's (Northern Southeast Regional Aquaculture Association) incubation boxes. An un-cataloged western tributary collects water from the hillside and joins the cataloged tributary near the culvert inlet (see Photo 16). A trap set in a pond at the uppermost fish habitat extent of the western channel (about 700' upstream of the culvert) didn't catch fish, but king

salmon were caught about 60' downstream of the pond. Dolly Varden char were also trapped in the western tributary.

The road alignment would potentially be moved upslope and would obliterate the existing stream. A new stream would need to be constructed, probably downslope of the existing highway. Additional water that now flows off the hillside and through the highway beyond the existing stream habitat could potentially be intercepted for use in the new stream channel.

- Add the western tributary of 115-32-10250-2060-3002 to the Catalog as supporting rearing king salmon and Dolly Varden char

- Consider intercepting additional water for replacement stream

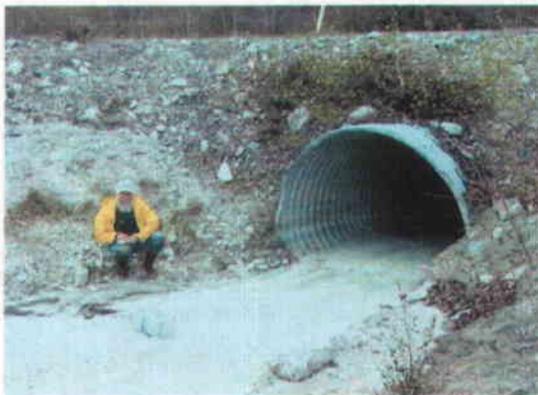
Photo 17. Station 985+00 (dry)

This stream is part of the 19 Mile slide area subject to large influx of gravels from the hillside and upslope streams. The SHI identified this location as rearing habitat for coho salmon and Dolly Varden. The channel was dry upstream and downstream of the culvert to the confluence with Chilkat River (see Photo 17). This is an ephemeral stream that has seasonally heavy flows carrying large amounts of sediment, and may provide fish habitat in the lower vegetated reach.

- Fish passage is not required for this crossing location.

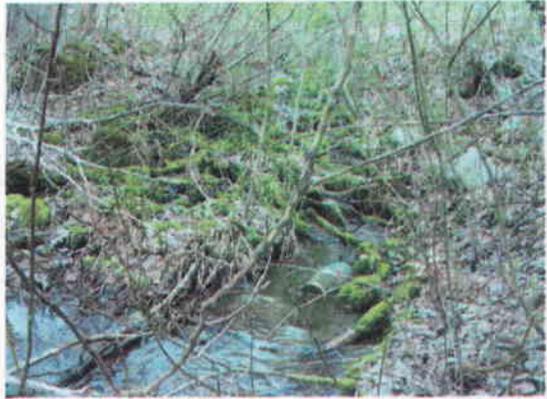
Photo 18. Station 1098+50

This stream may be incorrectly located in the SHI, and is closer to Station 1101+00. The SHI determined that this wasn't a fish stream because a steep drop-off to the Chilkat River. We hiked to the outlet and verified the natural blockage to upstream fish passage. Traps near the culvert outlet (see Photo 18) and 45' upstream of the inlet did not catch fish.

- Fish passage is not required for this crossing location
