State of Alaska
Department of Fish and Game
Sportfish Division

Nomination Form
Fish Distribution Database

Name of Waterway Waterfall Creek USGS Name Local Name
 Addition Deletion Correction Backup Information

SUBJECT: Haines Hwy MP 3.5-25.3
Trip Report

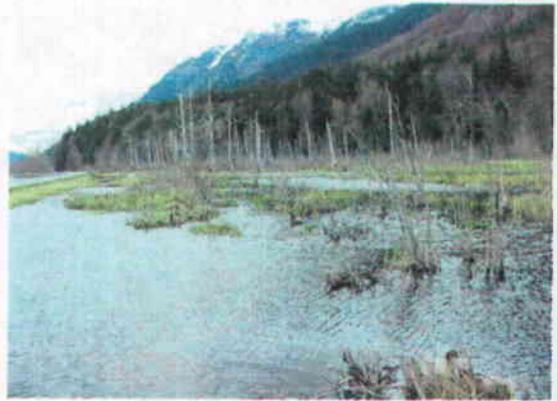
Photo 1. Station 271+25

Waterfall Creek (#115-32-10250-2008) originates below a waterfall next to the road near Station 301+00 and flows eastward parallel to the road at the upslope edge of a wetland. The stream was connected to the wetland, which was flooded to the shoulder of the road between about Station 280+00 and 300+00 (see Photo 1). The stream crosses the highway at two locations: near Station 269+00 through a 36" culvert; and near Station 271+25 through a 24" culvert. The crossing at Station 271+25 connects to un-named tributary (#115-32-10250-2008-3005) on the river side of the highway.

Traps were set about 60' downstream of the waterfall in the wetlands at the shoulder of the highway, about 500' from the waterfall, and at the inlet to the culvert at Station 269+00. We observed a 5" fish that appeared to be a cutthroat trout near the trap at the waterfall. The trap, however, caught only Dolly Varden. Coho and king salmon were captured in the wetland next to the highway. Coho and king salmon, and Dolly Varden were caught at the culvert at Station 269+00. The presence of coho and king salmon in the wetland adjacent to the highway demonstrates that the wetland is part of Waterfall Creek and should be considered as anadromous waters.

What we believe to be the tributary on the river side of the highway (#115-32-10250-2008-3005) was dry upstream of the culvert at Station 271+25, and may not support fish at this time.

- Include the wetland as part of Waterfall Creek (map as polygon) in the Catalog
- Extend the upstream extent to just below the waterfall, in the Catalog
- Add king salmon rearing habitat to the Catalog
- Update stream location in the Catalog
- Revisit dry stream segment #115-32-10250-2008-3005 to determine if it should be removed from the Catalog
- Design all stream crossings for fish passage

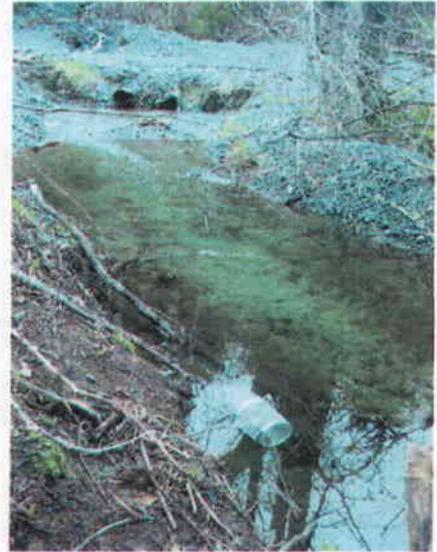
Photo 2. Station 315+50

This stream was identified in the SHI as habitat for rearing coho and Dolly Varden, and potential spawning (redds were observed). Upstream fish habitat is limited to about 50' upstream of the culvert.

A trap set about 40' upstream of the double 24" culverts caught coho salmon, cutthroat trout and Dolly Varden. A trap set about 30' downstream from the outlets caught king and coho salmon, and Dolly Varden (see Photo 2).

- Add to the Catalog as supporting rearing coho and king salmon, cutthroat trout and Dolly Varden
- Design the stream crossing for fish passage

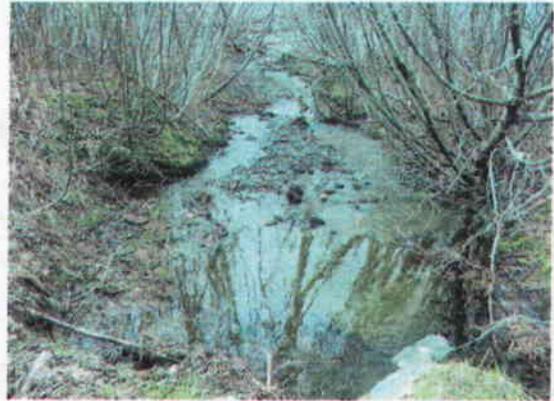
Photo 3. Station 339+00

This stream is below the site of an old cabin located uphill of the highway. It was not identified in the SHI. The clear water channel below the culvert outlet is about 8' wide and up to about 1' deep (see Photo 3). The culvert inlet was about 80% buried. Stream habitat is limited to the channel between the culvert and the Chilkat River (about 30 feet).

- Add to the Catalog as supporting rearing coho and Dolly Varden below the culvert
- Fish passage not required at stream crossing

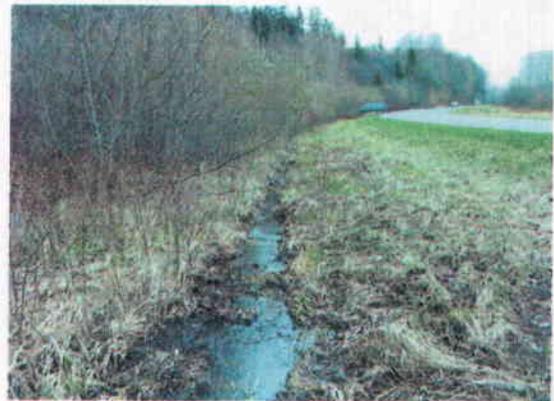
Photo 4. Station 342+00

The SHI identified this stream as supporting rearing coho and Dolly Varden. Coho and king salmon were trapped 300' upstream of the 36" culvert crossing. The culvert is perched and unraveling. The stream meanders along the road upstream of the culvert for about 300', before turning inland (see Photo 4). Potential fish habitat terminates in a high-gradient reach just below a waterfall.

- Add to the Catalog as supporting rearing coho and king salmon

- Design the stream crossing for fish passage

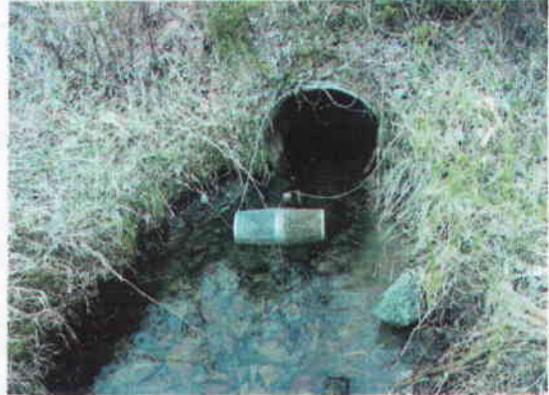
Photo 5. Station 389+25

The SHI identified this stream as supporting rearing coho and Dolly Varden. The stream crosses the highway through a 24" culvert. Coho salmon were trapped at the culvert outlet (see Photo 5), coho and cutthroat were trapped at the inlet. Upstream fish habitat is limited to about 40 feet because of a steep cascade.

- Add to the Catalog as supporting rearing coho salmon and cutthroat trout
- Design the stream crossing for fish passage

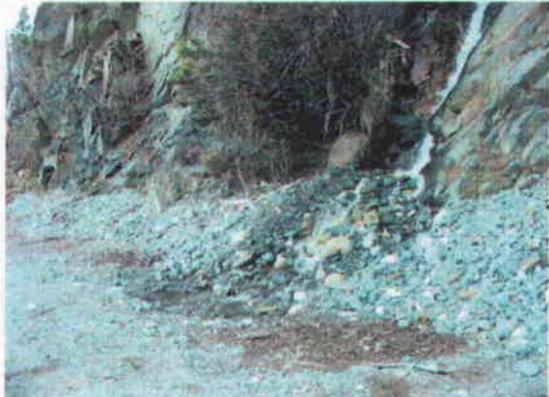
Photo 6. Station 391+75

The SHI identified this stream as providing rearing habitat for coho and Dolly Varden. The stream terminates in a waterfall just upstream of the 24" culvert (see Photo 6). A 10-foot diameter pool identified in the SHI at the bottom of the waterfall was filled with gravel and the stream flowed to the culvert through a shallow gravelly channel. There was no usable habitat above the culvert inlet. The channel above and below the culvert was too shallow to trap. Although not documented, the short stream reach below the culvert probably provides rearing habitat for coho salmon and Dolly Varden char, and good spawning gravels.

- Stream crossing does not need to be designed for fish passage

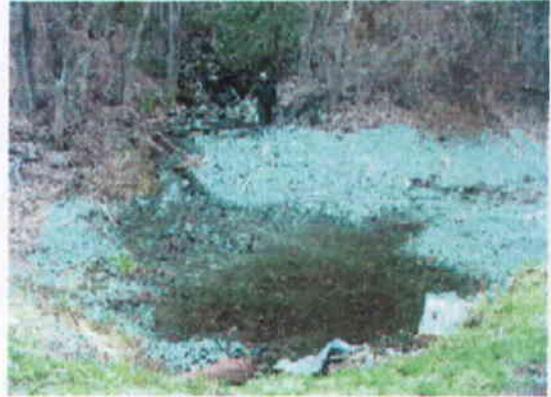
Photo 7. Station 442+75

The SHI identified this stream as supporting rearing coho and Dolly Varden, and possible spawning habitat. The stream crosses the highway through twin 24" culverts that were perched about 6". Fish habitat ends about 75' upstream at a steep cascade (see Photo 7). There was evidence of water flowing across the road as a result of plugged culverts. Coho salmon, steelhead, and cutthroat trout were trapped about 60 feet upstream of the culvert inlet. Coho salmon were trapped just below the outlet.

- Add to the Catalog as supporting rearing coho, cutthroat and steelhead
- Design the stream crossing for fish passage

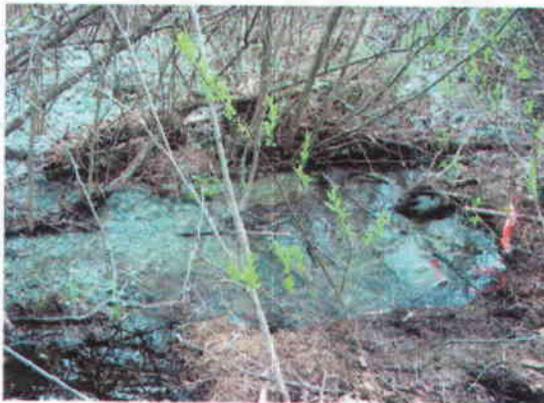
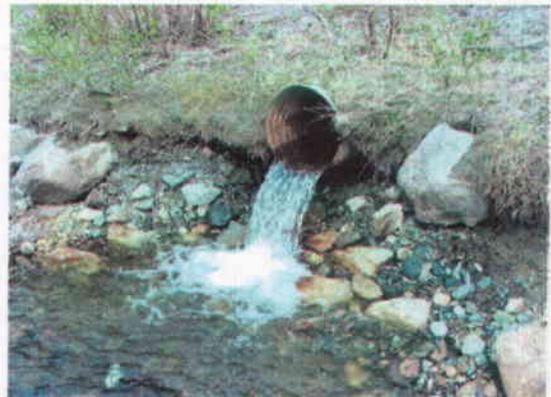
Photo 8. Station 632+00

This stream was not identified in the SHI. A trap placed about 100' upstream from the 24" culvert caught cutthroat and Dolly Varden (see Photo 8). Shortly beyond this point the gradient increases significantly. The culvert is perched about 1' and discharges directly to the Chilkat River (see Photo 9). There is enough good upstream habitat to make it worthwhile replacing the culvert with one that improves fish passage.

- Add to the catalog as supporting rearing cutthroat and Dolly Varden
- Design the stream crossing for fish passage

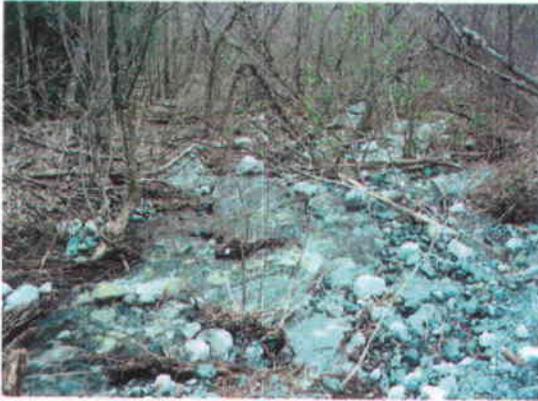
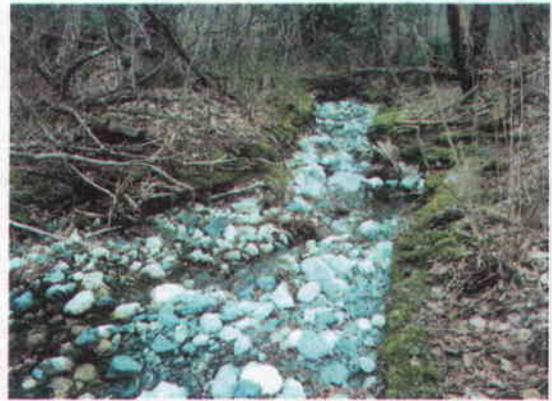
Photo 10. Station 670+00

A recent debris flow has blocked the main channel so that a majority of the flow now goes through a new channel near Station 677+00 (see Photo 10), and flows along the road to twin 36-inch culverts near Station 670+00. We observed three cutthroat trout (about 18", 12" and 4") in the new stream channel about 30' upstream from the road. No fish were caught in traps set farther up in this channel. King salmon and cutthroat trout were trapped in the original main channel about 400' upstream from the culverts. There is an opportunity to improve fish passage in this area. The stream flow is now divided into many channels that are filled with gravels to the extent that flow remains subsurface for much of the way. Habitat could be improved by focusing the flow either back into the old main channel (see Photo 11), or improving the new channel.

We confirmed that Inter-Fluve's description of the area was correct. Debris flows have reduced habitat in the main channel and created new channels. These changes have likely reduced the habitat quality because of the more dispersed flows and sediment accumulation. Stream channel improvements here would be appropriate mitigation for the project. This area will require a more detailed look to determine the best approach to habitat improvements, once road alignment plans have been finalized for this area. The current proposed realignment would move the highway upstream of most of the fish habitat.

- Update Catalog to document the new channel locations and upstream extent of cutthroat spawning, and king and coho salmon rearing.
- Design the stream crossing(s) for fish passage

- Consider channel improvements as mitigation
- Take a detailed look at the hydrology and channel morphology to determine where best to route the flows and which channels to improve

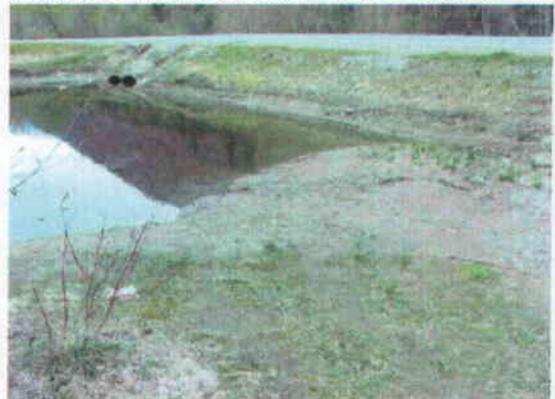
Photo 12. Station 733+50

This stream is cataloged as providing rearing and spawning habitat for coho salmon and Dolly Varden. A slough of the Chilkat River just below the two 36" culverts is used as an informal boat launch area (see Photo 12), resulting in degradation of the stream banks and bed. A trap 45' upstream of the culvert caught coho and king salmon, and Dolly Varden.

This is the location of the informal boat launching area.

- Update the Catalog to add king salmon rearing
- Design the stream crossing for fish passage

- Realign stream to cross more perpendicular to the highway
- Rehabilitate degraded habitat below culvert
- Improve the boat launch area by hardening to reduce habitat degradation, or
- Develop new launching area at a better location and close out this one

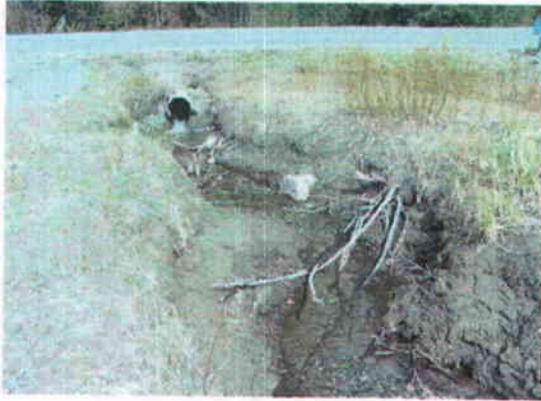
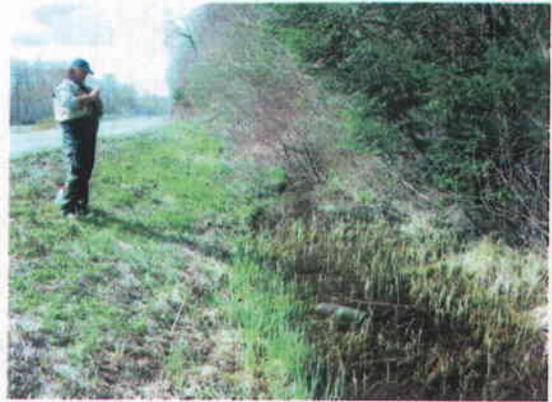
Photo 13. Station 760+00

The SHI identified this stream as supporting rearing coho and Dolly Varden. This un-cataloged stream crosses the highway through a perched 24" culvert (see Photo 13). Three traps set within 175' upstream of the culvert inlet caught king and coho salmon and Dolly Varden (see Photo 14). The stream would be filled by the proposed road alignment.

This short stream that we propose to nominate to the Catalog would be mostly filled by the new road alignment.

- Add to the Catalog as supporting king and coho salmon and Dolly Varden
- Construct new channel on riverside of highway
- Fish passage is not required for this stream crossing

- Re-route water from cascades through a new crossing location and create new stream and potentially wetlands on the river side (culvert would not need to be designed to pass fish).

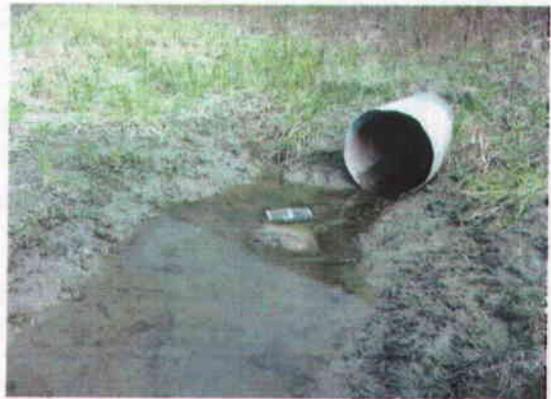
Photo 15. Station 879+75

The SHI identified this stream as supporting rearing coho and Dolly Varden below the culvert. Fish habitat ends at the culvert (see Photo 15). King salmon and Dolly Varden were trapped at the culvert outlet. The stream below the culvert is a slough of the Chilkat River, and is thereby cataloged.

- Fish passage is not required for this stream crossing.

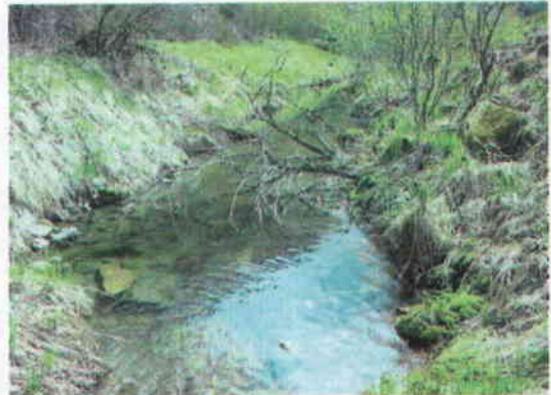
Photo 16. Station 887+90

The Catalog lists this stream as providing rearing habitat for coho salmon and Dolly Varden char, and spawning habitat for coho and chum salmon. The cataloged stream originates from springs on the hillside, and flows through NSRAA's (Northern Southeast Regional Aquaculture Association) incubation boxes. An un-cataloged western tributary collects water from the hillside and joins the cataloged tributary near the culvert inlet (see Photo 16). A trap set in a pond at the uppermost fish habitat extent of the western channel (about 700' upstream of the culvert) didn't catch fish, but king

salmon were caught about 60' downstream of the pond. Dolly Varden char were also trapped in the western tributary.

The road alignment would potentially be moved upslope and would obliterate the existing stream. A new stream would need to be constructed, probably downslope of the existing highway. Additional water that now flows off the hillside and through the highway beyond the existing stream habitat could potentially be intercepted for use in the new stream channel.

- Add the western tributary of 115-32-10250-2060-3002 to the Catalog as supporting rearing king salmon and Dolly Varden char

- Consider intercepting additional water for replacement stream

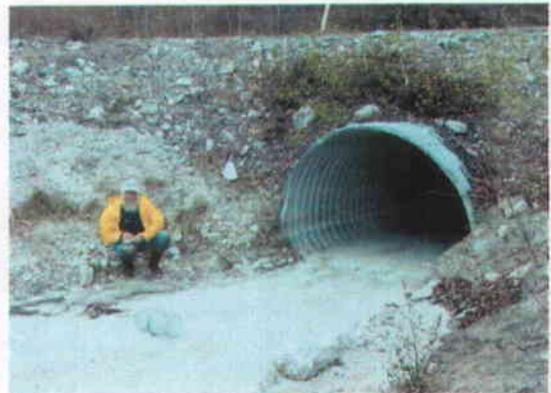
Photo 17. Station 985+00 (dry)

This stream is part of the 19 Mile slide area subject to large influx of gravels from the hillside and upslope streams. The SHI identified this location as rearing habitat for coho salmon and Dolly Varden. The channel was dry upstream and downstream of the culvert to the confluence with Chilkat River (see Photo 17). This is an ephemeral stream that has seasonally heavy flows carrying large amounts of sediment, and may provide fish habitat in the lower vegetated reach.

- Fish passage is not required for this crossing location.

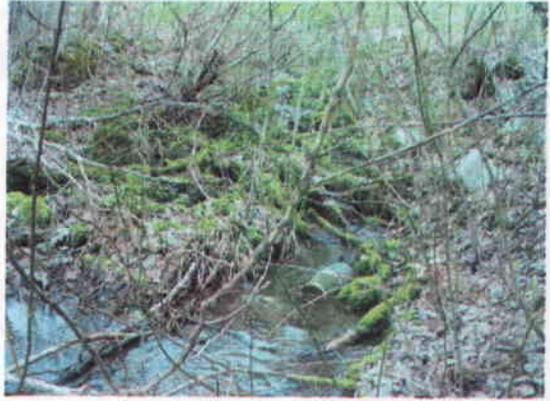
Photo 18. Station 1098+50

This stream may be incorrectly located in the SHI, and is closer to Station 1101+00. The SHI determined that this wasn't a fish stream because a steep drop-off to the Chilkat River. We hiked to the outlet and verified the natural blockage to upstream fish passage. Traps near the culvert outlet (see Photo 18) and 45' upstream of the inlet did not catch fish.

- Fish passage is not required for this crossing location
