State of Alaska  
Department of Fish and Game  
Sportfish Division

Nomination Form  
Fish Distribution Database

Name of Waterway Chilkat River  USGS Name  Local Name

SUBJECT: Haines Hwy MP 3.5-25.3  
Trip Report

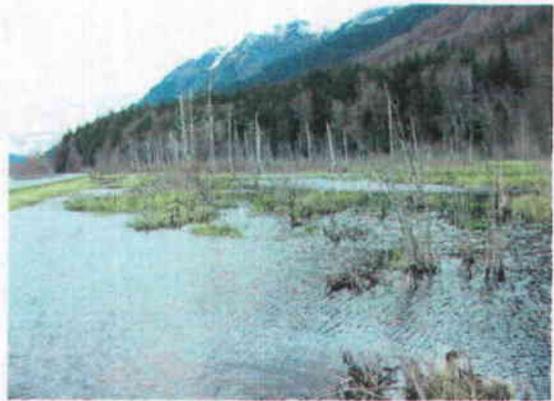
Photo 1. Station 271+25

Traps were set about 60' downstream of the waterfall in the wetlands at the shoulder of the highway, about 500' from the waterfall, and at the inlet to the culvert at Station 269+00. We observed a 5" fish that appeared to be a cutthroat trout near the trap at the waterfall. The trap, however, caught only Dolly Varden. Coho and king salmon were captured in the wetland next to the highway. Coho and king salmon, and Dolly Varden were caught at the culvert at Station 269+00. The presence of coho and king salmon in the wetland adjacent to the highway demonstrates that the wetland is part of Waterfall Creek and should be considered as anadromous waters.

What we believe to be the tributary on the river side of the highway (#115-32-10250-2008-3005) was dry upstream of the culvert at Station 271+25, and may not support fish at this time.

- Include the wetland as part of Waterfall Creek (map as polygon) in the Catalog
- Extend the upstream extent to just below the waterfall, in the Catalog
- Add king salmon rearing habitat to the Catalog
- Update stream location in the Catalog
- Revisit dry stream segment #115-32-10250-2008-3005 to determine if it should be removed from the Catalog
- Design all stream crossings for fish passage

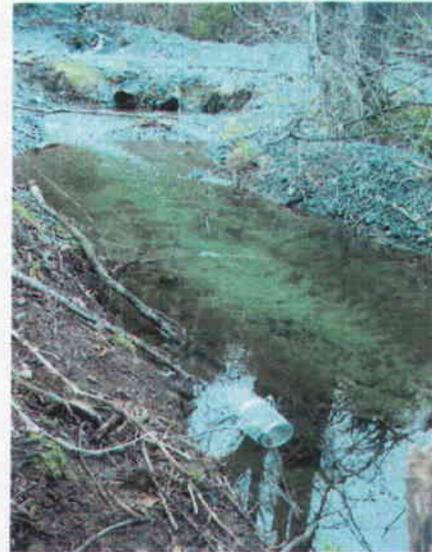
**Photo 2. Station 315+50**

This stream was identified in the SHI as habitat for rearing coho and Dolly Varden, and potential spawning (redds were observed). Upstream fish habitat is limited to about 50' upstream of the culvert.

A trap set about 40' upstream of the double 24" culverts caught coho salmon, cutthroat trout and Dolly Varden. A trap set about 30' downstream from the outlets caught king and coho salmon, and Dolly Varden (see Photo 2).

- Add to the Catalog as supporting rearing coho and king salmon, cutthroat trout and Dolly Varden
- Design the stream crossing for fish passage

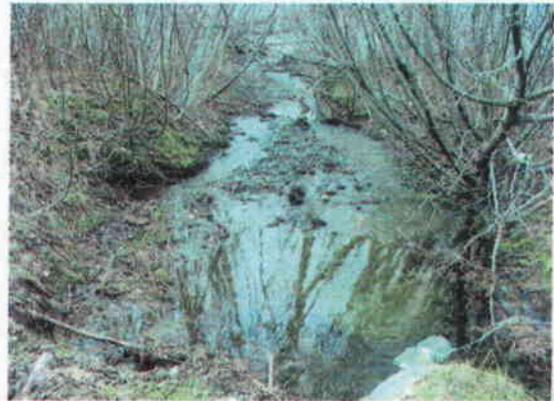
**Photo 3. Station 339+00**

This stream is below the site of an old cabin located uphill of the highway. It was not identified in the SHI. The clear water channel below the culvert outlet is about 8' wide and up to about 1' deep (see Photo 3). The culvert inlet was about 80% buried. Stream habitat is limited to the channel between the culvert and the Chilkat River (about 30 feet).

- Add to the Catalog as supporting rearing coho and Dolly Varden below the culvert
- Fish passage not required at stream crossing

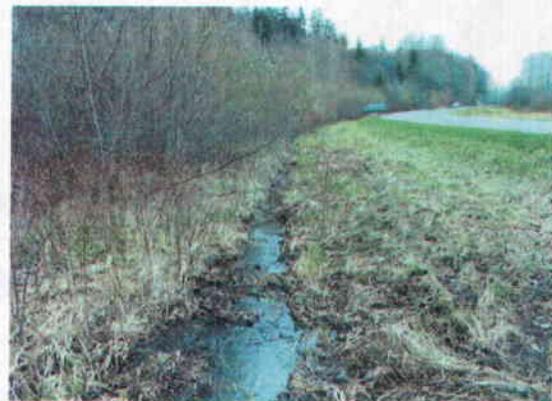
**Photo 4. Station 342+00**

The SHI identified this stream as supporting rearing coho and Dolly Varden. Coho and king salmon were trapped 300' upstream of the 36" culvert crossing. The culvert is perched and unraveling. The stream meanders along the road upstream of the culvert for about 300', before turning inland (see Photo 4). Potential fish habitat terminates in a high-gradient reach just below a waterfall.

- Add to the Catalog as supporting rearing coho and king salmon

- Design the stream crossing for fish passage

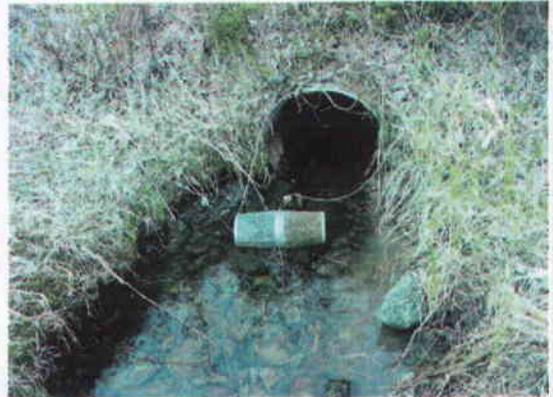
Photo 5. Station 389+25

The SHI identified this stream as supporting rearing coho and Dolly Varden. The stream crosses the highway through a 24" culvert. Coho salmon were trapped at the culvert outlet (see Photo 5), coho and cutthroat were trapped at the inlet. Upstream fish habitat is limited to about 40 feet because of a steep cascade.

- Add to the Catalog as supporting rearing coho salmon and cutthroat trout
- Design the stream crossing for fish passage

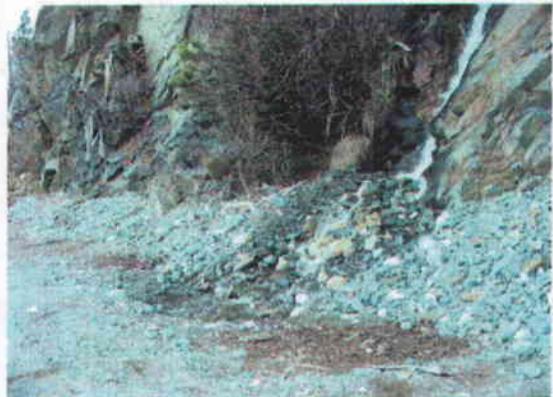
Photo 6. Station 391+75

The SHI identified this stream as providing rearing habitat for coho and Dolly Varden. The stream terminates in a waterfall just upstream of the 24" culvert (see Photo 6). A 10-foot diameter pool identified in the SHI at the bottom of the waterfall was filled with gravel and the stream flowed to the culvert through a shallow gravelly channel. There was no usable habitat above the culvert inlet. The channel above and below the culvert was too shallow to trap. Although not documented, the short stream reach below the culvert probably provides rearing habitat for coho salmon and Dolly Varden char, and good spawning gravels.

- Stream crossing does not need to be designed for fish passage

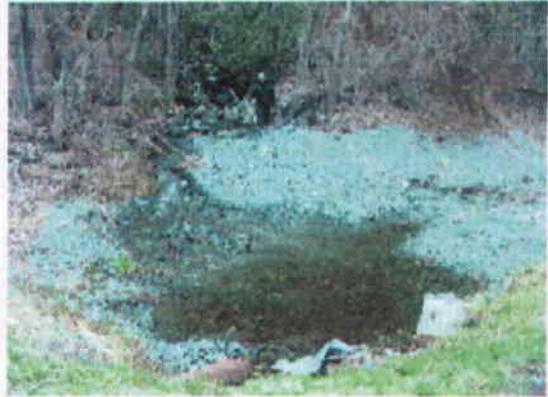
Photo 7. Station 442+75

The SHI identified this stream as supporting rearing coho and Dolly Varden, and possible spawning habitat. The stream crosses the highway through twin 24" culverts that were perched about 6". Fish habitat ends about 75' upstream at a steep cascade (see Photo 7). There was evidence of water flowing across the road as a result of plugged culverts. Coho salmon, steelhead, and cutthroat trout were trapped about 60 feet upstream of the culvert inlet. Coho salmon were trapped just below the outlet.

- Add to the Catalog as supporting rearing coho, cutthroat and steelhead
- Design the stream crossing for fish passage

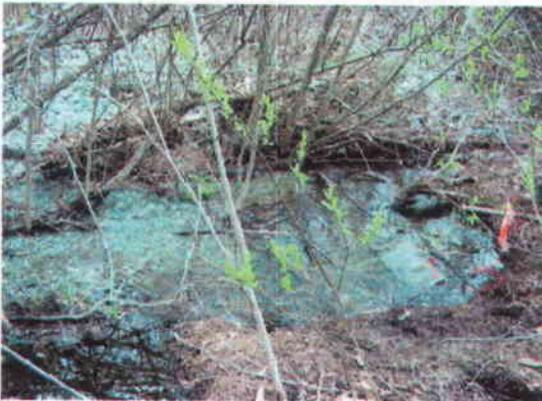
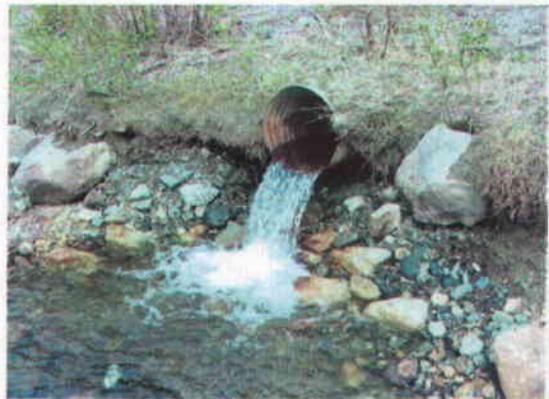
Photo 8. Station 632+00

This stream was not identified in the SHI. A trap placed about 100' upstream from the 24" culvert caught cutthroat and Dolly Varden (see Photo 8). Shortly beyond this point the gradient increases significantly. The culvert is perched about 1' and discharges directly to the Chilkat River (see Photo 9). There is enough good upstream habitat to make it worthwhile replacing the culvert with one that improves fish passage.

- Add to the catalog as supporting rearing cutthroat and Dolly Varden
- Design the stream crossing for fish passage

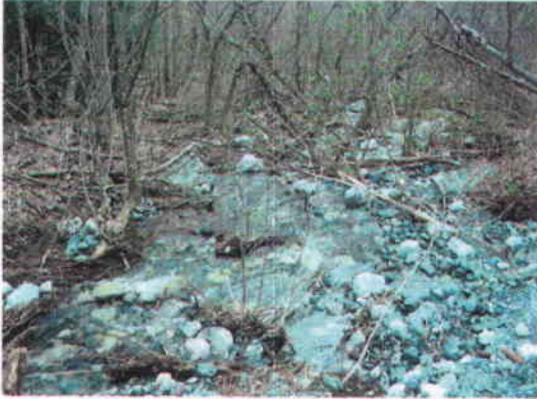
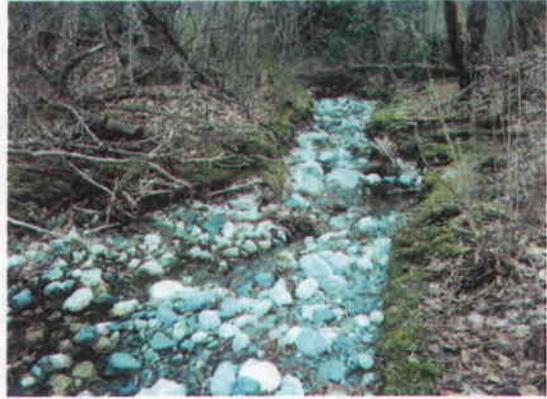
**Photo 10. Station 670+00**

A recent debris flow has blocked the main channel so that a majority of the flow now goes through a new channel near Station 677+00 (see Photo 10), and flows along the road to twin 36-inch culverts near Station 670+00. We observed three cutthroat trout (about 18", 12" and 4") in the new stream channel about 30' upstream from the road. No fish were caught in traps set farther up in this channel. King salmon and cutthroat trout were trapped in the original main channel about 400' upstream from the culverts. There is an opportunity to improve fish passage in this area. The stream flow is now divided into many channels that are filled with gravels to the extent that flow remains subsurface for much of the way. Habitat could be improved by focusing the flow either back into the old main channel (see Photo 11), or improving the new channel.

We confirmed that Inter-Fluve's description of the area was correct. Debris flows have reduced habitat in the main channel and created new channels. These changes have likely reduced the habitat quality because of the more dispersed flows and sediment accumulation. Stream channel improvements here would be appropriate mitigation for the project. This area will require a more detailed look to determine the best approach to habitat improvements, once road alignment plans have been finalized for this area. The current proposed realignment would move the highway upstream of most of the fish habitat.

- Update Catalog to document the new channel locations and upstream extent of cutthroat spawning, and king and coho salmon rearing.
- Design the stream crossing(s) for fish passage

- Consider channel improvements as mitigation
- Take a detailed look at the hydrology and channel morphology to determine where best to route the flows and which channels to improve

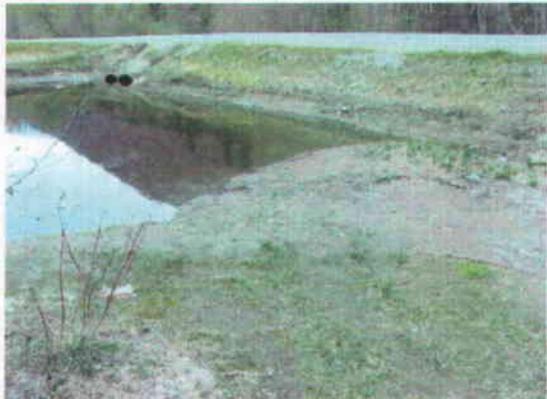
**Photo 12. Station 733+50**

This stream is cataloged as providing rearing and spawning habitat for coho salmon and Dolly Varden. A slough of the Chilkat River just below the two 36" culverts is used as an informal boat launch area (see Photo 12), resulting in degradation of the stream banks and bed. A trap 45' upstream of the culvert caught coho and king salmon, and Dolly Varden.

This is the location of the informal boat launching area.

- Update the Catalog to add king salmon rearing
- Design the stream crossing for fish passage

- Realign stream to cross more perpendicular to the highway
- Rehabilitate degraded habitat below culvert
- Improve the boat launch area by hardening to reduce habitat degradation, or
- Develop new launching area at a better location and close out this one

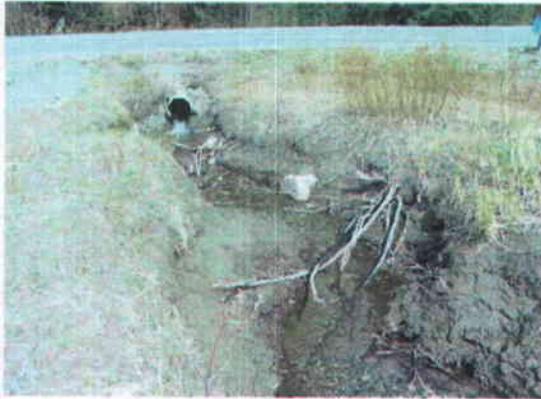
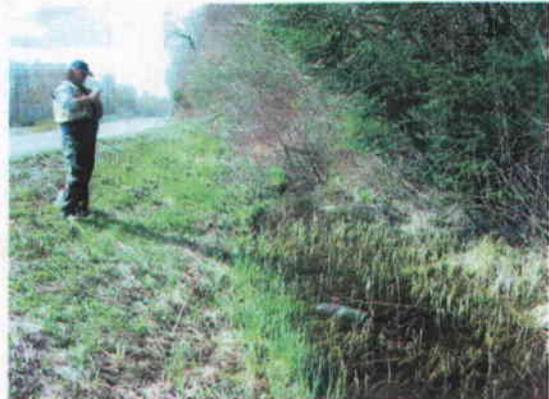
Photo 13. Station 760+00

The SHI identified this stream as supporting rearing coho and Dolly Varden. This un-cataloged stream crosses the highway through a perched 24" culvert (see Photo 13). Three traps set within 175' upstream of the culvert inlet caught king and coho salmon and Dolly Varden (see Photo 14). The stream would be filled by the proposed road alignment.

This short stream that we propose to nominate to the Catalog would be mostly filled by the new road alignment.

- Add to the Catalog as supporting king and coho salmon and Dolly Varden
- Construct new channel on riverside of highway
- Fish passage is not required for this stream crossing

- Re-route water from cascades through a new crossing location and create new stream and potentially wetlands on the river side (culvert would not need to be designed to pass fish).

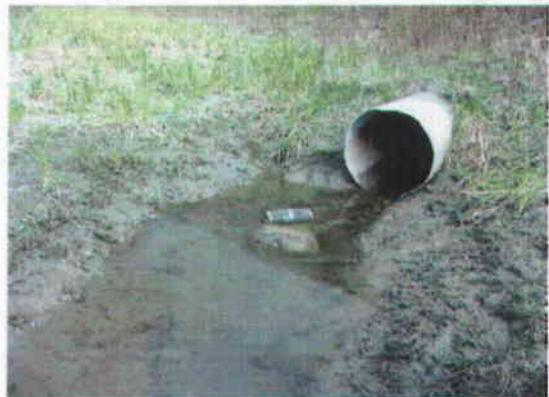
Photo 15. Station 879+75

The SHI identified this stream as supporting rearing coho and Dolly Varden below the culvert. Fish habitat ends at the culvert (see Photo 15). King salmon and Dolly Varden were trapped at the culvert outlet. The stream below the culvert is a slough of the Chilkat River, and is thereby cataloged.

- Fish passage is not required for this stream crossing.

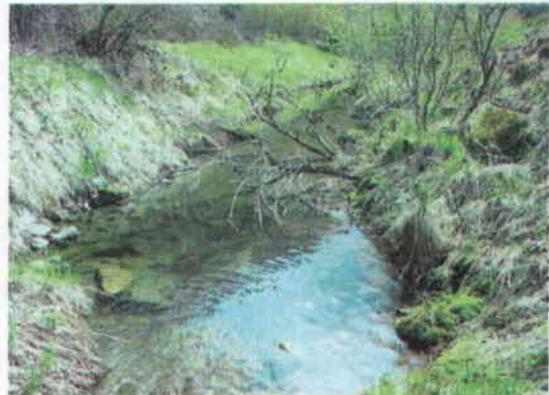
Photo 16. Station 887+90

The Catalog lists this stream as providing rearing habitat for coho salmon and Dolly Varden char, and spawning habitat for coho and chum salmon. The cataloged stream originates from springs on the hillside, and flows through NSRAA's (Northern Southeast Regional Aquaculture Association) incubation boxes. An un-cataloged western tributary collects water from the hillside and joins the cataloged tributary near the culvert inlet (see Photo 16). A trap set in a pond at the uppermost fish habitat extent of the western channel (about 700' upstream of the culvert) didn't catch fish, but king

salmon were caught about 60' downstream of the pond. Dolly Varden char were also trapped in the western tributary.

The road alignment would potentially be moved upslope and would obliterate the existing stream. A new stream would need to be constructed, probably downslope of the existing highway. Additional water that now flows off the hillside and through the highway beyond the existing stream habitat could potentially be intercepted for use in the new stream channel.

- Add the western tributary of 115-32-10250-2060-3002 to the Catalog as supporting rearing king salmon and Dolly Varden char

- Consider intercepting additional water for replacement stream

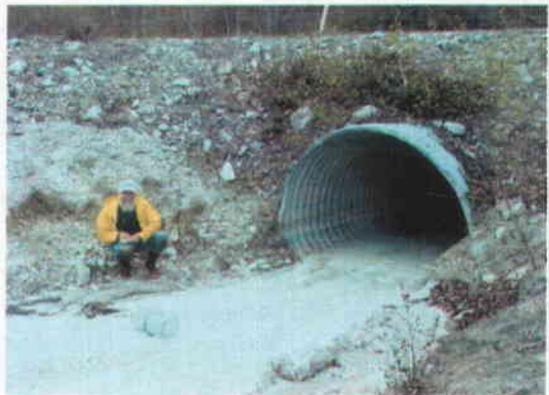
Photo 17. Station 985+00 (dry)

This stream is part of the 19 Mile slide area subject to large influx of gravels from the hillside and upslope streams. The SHI identified this location as rearing habitat for coho salmon and Dolly Varden. The channel was dry upstream and downstream of the culvert to the confluence with Chilkat River (see Photo 17). This is an ephemeral stream that has seasonally heavy flows carrying large amounts of sediment, and may provide fish habitat in the lower vegetated reach.

- Fish passage is not required for this crossing location.

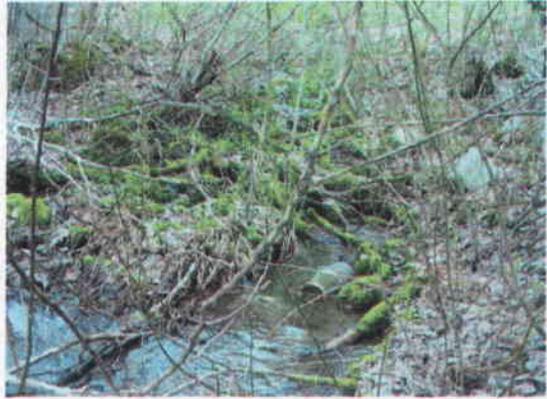
Photo 18. Station 1098+50

This stream may be incorrectly located in the SHI, and is closer to Station 1101+00. The SHI determined that this wasn't a fish stream because a steep drop-off to the Chilkat River. We hiked to the outlet and verified the natural blockage to upstream fish passage. Traps near the culvert outlet (see Photo 18) and 45' upstream of the inlet did not catch fish.

- Fish passage is not required for this crossing location
