Nomination Form
Fish Distribution Database

Region Southeast USGS Quad(s) SKAGWAY B-2
 Fish Distribution Database Number of Waterway 115-32-10250-2040
 Name of Waterway Thirteen Mile Creek USGS Name Local Name
 Addition Deletion Correction Backup Information

SUBJECT: Haines Hwy MP 3.5-25.3
Trip Report

The Department of Transportation and Public Facilities (DOTPF) is proposing to widen and realign the Haines Highway between MP 3.5 and 25.3 to bring the highway up to National Highway System standards. The project would impact the Chilkat River and numerous smaller anadromous and resident fish streams. Fish Habitat permits would be required for stream crossings, relocation, and bank stabilization. A *Stream and Habitat Inventory* (SHI) was conducted in 2005 by Inter-Fluve, Inc. that identified fish streams impacted by the project. While many of the streams are documented in the *Catalog of Waters Important to the Spawning, Rearing or Migration of Anadromous Fishes* (Catalog), the survey found anadromous fish in many streams that are not in the Catalog. We conducted a field survey May 9-16, 2006 to supplement the Inter-Fluve survey, and to nominate additional anadromous fish streams

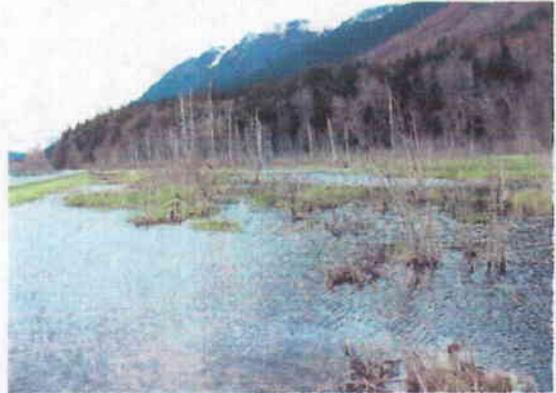
Photo 1. Station 271+25

Traps were set about 60' downstream of the waterfall in the wetlands at the shoulder of the highway, about 500' from the waterfall, and at the inlet to the culvert at Station 269+00. We observed a 5" fish that appeared to be a cutthroat trout near the trap at the waterfall. The trap, however, caught only Dolly Varden. Coho and king salmon were captured in the wetland next to the highway. Coho and king salmon, and Dolly Varden were caught at the culvert at Station 269+00. The presence of coho and king salmon in the wetland adjacent to the highway demonstrates that the wetland is part of Waterfall Creek and should be considered as anadromous waters.

What we believe to be the tributary on the river side of the highway (#115-32-10250-2008-3005) was dry upstream of the culvert at Station 271+25, and may not support fish at this time.

- Include the wetland as part of Waterfall Creek (map as polygon) in the Catalog
- Extend the upstream extent to just below the waterfall, in the Catalog
- Add king salmon rearing habitat to the Catalog
- Update stream location in the Catalog
- Revisit dry stream segment #115-32-10250-2008-3005 to determine if it should be removed from the Catalog
- Design all stream crossings for fish passage

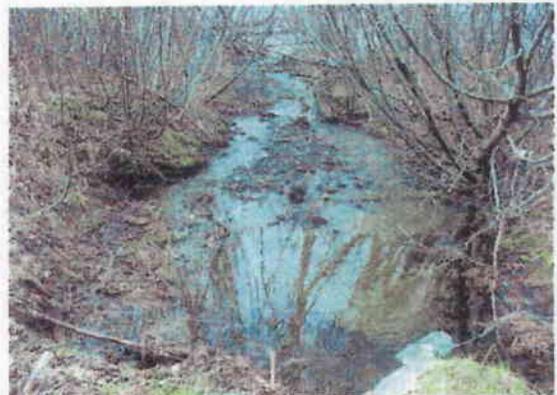
Photo 3. Station 339+00

This stream is below the site of an old cabin located uphill of the highway. It was not identified in the SHI. The clear water channel below the culvert outlet is about 8' wide and up to about 1' deep (see Photo 3). The culvert inlet was about 80% buried. Stream habitat is limited to the channel between the culvert and the Chilkat River (about 30 feet).

- Add to the Catalog as supporting rearing coho and Dolly Varden below the culvert
- Fish passage not required at stream crossing

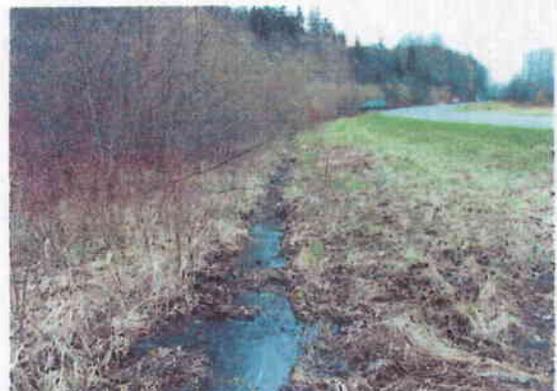
Photo 4. Station 342+00

The SHI identified this stream as supporting rearing coho and Dolly Varden. Coho and king salmon were trapped 300' upstream of the 36" culvert crossing. The culvert is perched and unraveling. The stream meanders along the road upstream of the culvert for about 300', before turning inland (see Photo 4). Potential fish habitat terminates in a high-gradient reach just below a waterfall.

- Add to the Catalog as supporting rearing coho and king salmon

- Design the stream crossing for fish passage

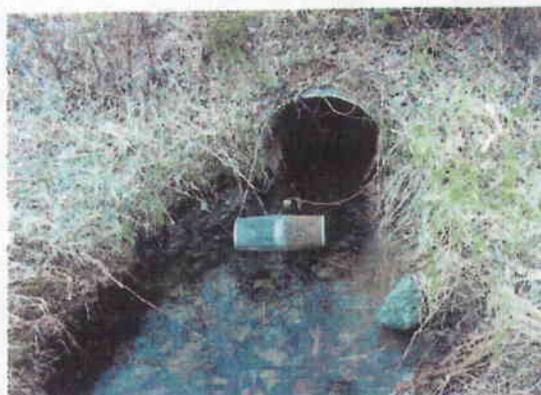
Photo 5. Station 389+25

The SHI identified this stream as supporting rearing coho and Dolly Varden. The stream crosses the highway through a 24" culvert. Coho salmon were trapped at the culvert outlet (see Photo 5), coho and cutthroat were trapped at the inlet. Upstream fish habitat is limited to about 40 feet because of a steep cascade.

- Add to the Catalog as supporting rearing coho salmon and cutthroat trout
- Design the stream crossing for fish passage

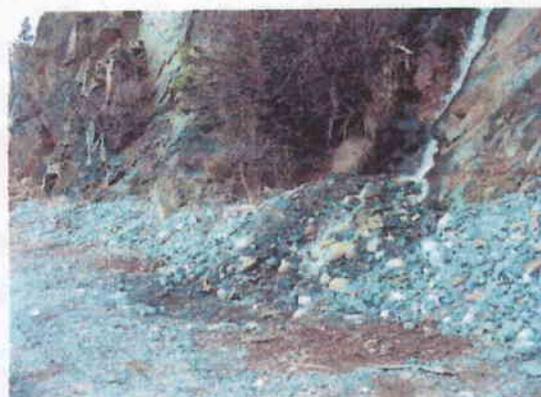
Photo 6. Station 391+75

The SHI identified this stream as providing rearing habitat for coho and Dolly Varden. The stream terminates in a waterfall just upstream of the 24" culvert (see Photo 6). A 10-foot diameter pool identified in the SHI at the bottom of the waterfall was filled with gravel and the stream flowed to the culvert through a shallow gravelly channel. There was no usable habitat above the culvert inlet. The channel above and below the culvert was too shallow to trap. Although not documented, the short stream reach below the culvert probably provides rearing habitat for coho salmon and Dolly Varden char, and good spawning gravels.

- Stream crossing does not need to be designed for fish passage

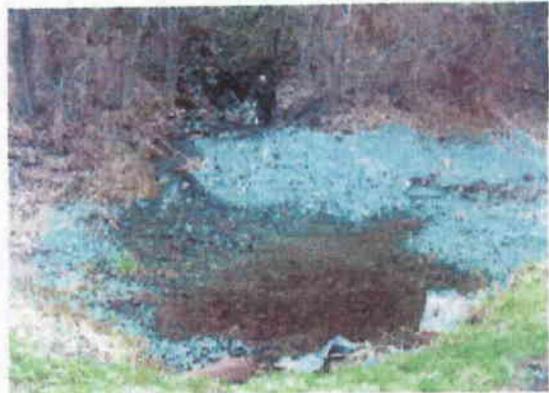
Photo 7. Station 442+75

The SHI identified this stream as supporting rearing coho and Dolly Varden, and possible spawning habitat. The stream crosses the highway through twin 24" culverts that were perched about 6". Fish habitat ends about 75' upstream at a steep cascade (see Photo 7). There was evidence of water flowing across the road as a result of plugged culverts. Coho salmon, steelhead, and cutthroat trout were trapped about 60 feet upstream of the culvert inlet. Coho salmon were trapped just below the outlet.

- Add to the Catalog as supporting rearing coho, cutthroat and steelhead
- Design the stream crossing for fish passage

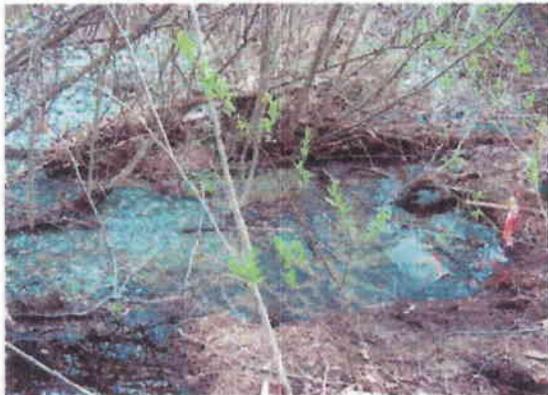
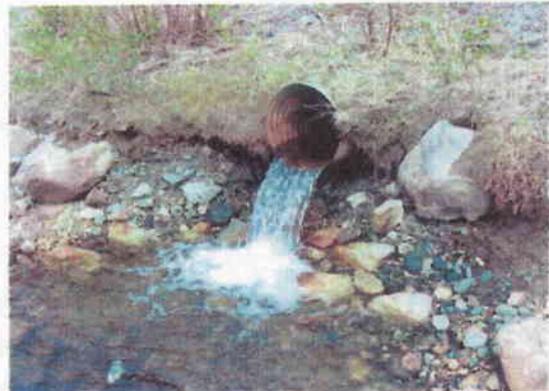
Photo 8. Station 632+00

This stream was not identified in the SHI. A trap placed about 100' upstream from the 24" culvert caught cutthroat and Dolly Varden (see Photo 8). Shortly beyond this point the gradient increases significantly. The culvert is perched about 1' and discharges directly to the Chilkat River (see Photo 9). There is enough good upstream habitat to make it worthwhile replacing the culvert with one that improves fish passage.

- Add to the catalog as supporting rearing cutthroat and Dolly Varden
- Design the stream crossing for fish passage

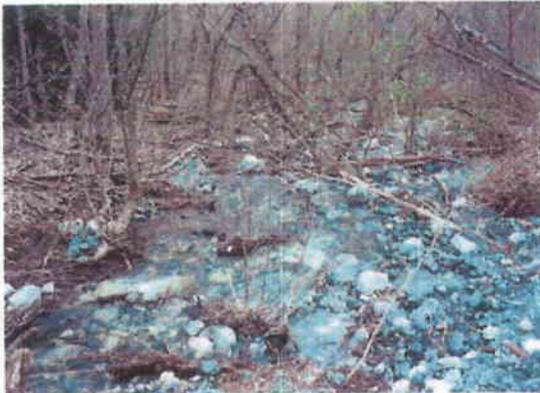
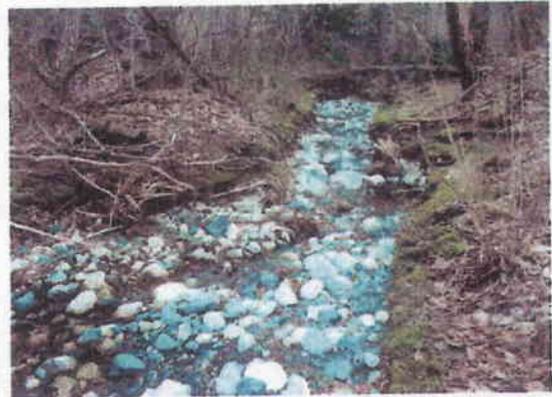
Photo 10. Station 670+00

A recent debris flow has blocked the main channel so that a majority of the flow now goes through a new channel near Station 677+00 (see Photo 10), and flows along the road to twin 36-inch culverts near Station 670+00. We observed three cutthroat trout (about 18", 12" and 4") in the new stream channel about 30' upstream from the road. No fish were caught in traps set farther up in this channel. King salmon and cutthroat trout were trapped in the original main channel about 400' upstream from the culverts. There is an opportunity to improve fish passage in this area. The stream flow is now divided into many channels that are filled with gravels to the extent that flow remains subsurface for much of the way. Habitat could be improved by focusing the flow either back into the old main channel (see Photo 11), or improving the new channel.

We confirmed that Inter-Fluve's description of the area was correct. Debris flows have reduced habitat in the main channel and created new channels. These changes have likely reduced the habitat quality because of the more dispersed flows and sediment accumulation. Stream channel improvements here would be appropriate mitigation for the project. This area will require a more detailed look to determine the best approach to habitat improvements, once road alignment plans have been finalized for this area. The current proposed realignment would move the highway upstream of most of the fish habitat.

- Update Catalog to document the new channel locations and upstream extent of cutthroat spawning, and king and coho salmon rearing.
- Design the stream crossing(s) for fish passage

- Consider channel improvements as mitigation
- Take a detailed look at the hydrology and channel morphology to determine where best to route the flows and which channels to improve

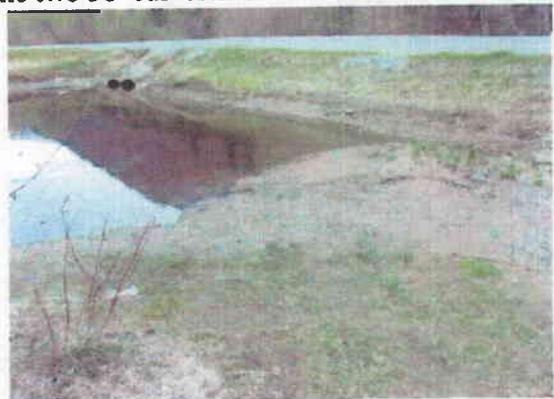
Photo 12. Station 733+50

This stream is cataloged as providing rearing and spawning habitat for coho salmon and Dolly Varden. A slough of the Chilkat River just below the two 36" culverts is used as an informal boat launch area (see Photo 12), resulting in degradation of the stream banks and bed. A trap 45' upstream of the culvert caught coho and king salmon, and Dolly Varden.

This is the location of the informal boat launching area.

- Update the Catalog to add king salmon rearing
- Design the stream crossing for fish passage

- Realign stream to cross more perpendicular to the highway
- Rehabilitate degraded habitat below culvert
- Improve the boat launch area by hardening to reduce habitat degradation, or
- Develop new launching area at a better location and close out this one

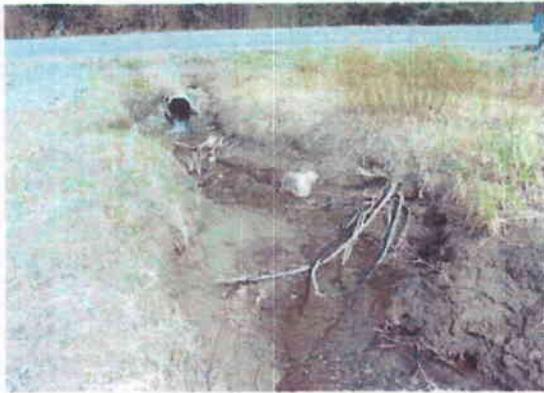
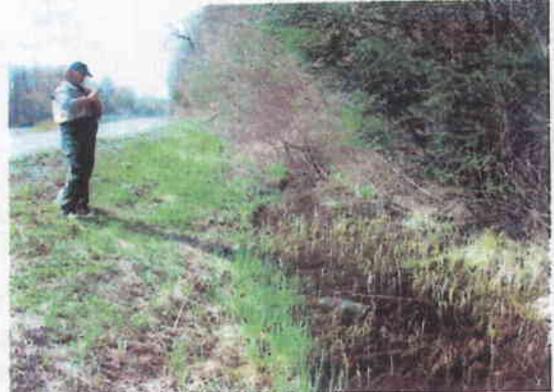
Photo 13. Station 760+00

The SHI identified this stream as supporting rearing coho and Dolly Varden. This un-cataloged stream crosses the highway through a perched 24" culvert (see Photo 13). Three traps set within 175' upstream of the culvert inlet caught king and coho salmon and Dolly Varden (see Photo 14). The stream would be filled by the proposed road alignment.

This short stream that we propose to nominate to the Catalog would be mostly filled by the new road alignment.

- Add to the Catalog as supporting king and coho salmon and Dolly Varden
- Construct new channel on riverside of highway
- Fish passage is not required for this stream crossing

- Re-route water from cascades through a new crossing location and create new stream and potentially wetlands on the river side (culvert would not need to be designed to pass fish).

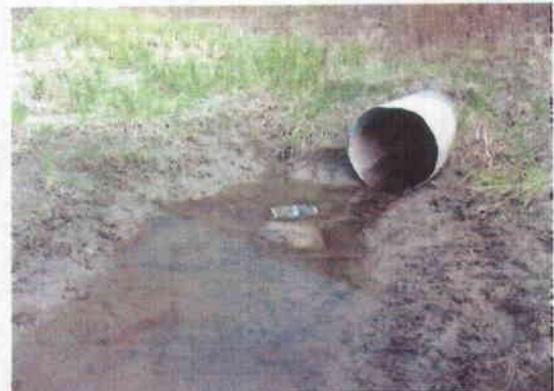
Photo 15. Station 879+75

The SHI identified this stream as supporting rearing coho and Dolly Varden below the culvert. Fish habitat ends at the culvert (see Photo 15). King salmon and Dolly Varden were trapped at the culvert outlet. The stream below the culvert is a slough of the Chilkat River, and is thereby cataloged.

- Fish passage is not required for this stream crossing.

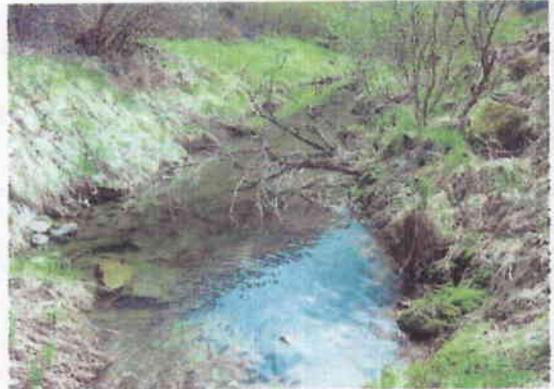
Photo 16. Station 887+90

The Catalog lists this stream as providing rearing habitat for coho salmon and Dolly Varden char, and spawning habitat for coho and chum salmon. The cataloged stream originates from springs on the hillside, and flows through NSRAA's (Northern Southeast Regional Aquaculture Association) incubation boxes. An un-cataloged western tributary collects water from the hillside and joins the cataloged tributary near the culvert inlet (see Photo 16). A trap set in a pond at the uppermost fish habitat extent of the western channel (about 700' upstream of the culvert) didn't catch fish, but king

salmon were caught about 60' downstream of the pond. Dolly Varden char were also trapped in the western tributary.

The road alignment would potentially be moved upslope and would obliterate the existing stream. A new stream would need to be constructed, probably downslope of the existing highway. Additional water that now flows off the hillside and through the highway beyond the existing stream habitat could potentially be intercepted for use in the new stream channel.

- Add the western tributary of 115-32-10250-2060-3002 to the Catalog as supporting rearing king salmon and Dolly Varden char

- Consider intercepting additional water for replacement stream

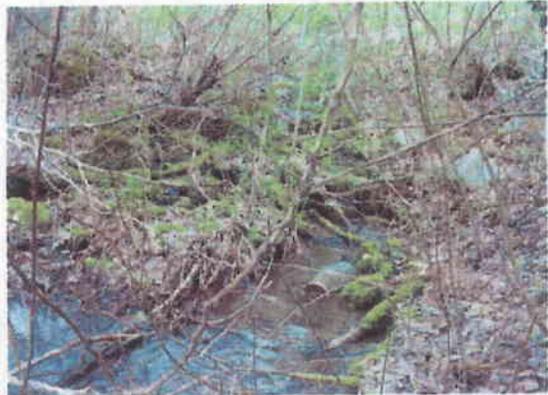
Photo 18. Station 1098+50

This stream may be incorrectly located in the SHI, and is closer to Station 1101+00. The SHI determined that this wasn't a fish stream because a steep drop-off to the Chilkat River. We hiked to the outlet and verified the natural blockage to upstream fish passage. Traps near the culvert outlet (see Photo 18) and 45' upstream of the inlet did not catch fish.

- Fish passage is not required for this crossing location
