Nomination Form  
Fish Distribution Database

Name of Waterway Chilkat River  USGS Name  Local Name

SUBJECT: Haines Hwy MP 3.5-25.3  
Trip Report

The Department of Transportation and Public Facilities (DOTPF) is proposing to widen and realign the Haines Highway between MP 3.5 and 25.3 to bring the highway up to National Highway System standards. The project would impact the Chilkat River and numerous smaller anadromous and resident fish streams. Fish Habitat permits would be required for stream crossings, relocation, and bank stabilization. A *Stream and Habitat Inventory* (SHI) was conducted in 2005 by Inter-Fluve, Inc. that identified fish streams impacted by the project. While many of the streams are documented in the *Catalog of Waters Important to the Spawning, Rearing or Migration of Anadromous Fishes* (Catalog), the survey found anadromous fish in many streams that are not in the Catalog. We conducted a field survey May 9-16, 2006 to supplement the Inter-Fluve survey, and to nominate additional anadromous fish streams to the Catalog.

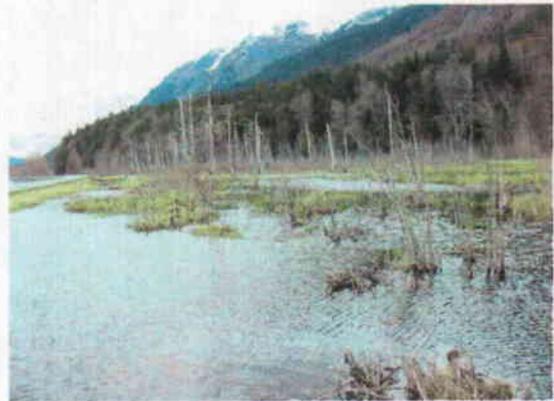
Photo 1. Station 271+25

Traps were set about 60' downstream of the waterfall in the wetlands at the shoulder of the highway, about 500' from the waterfall, and at the inlet to the culvert at Station 269+00. We observed a 5" fish that appeared to be a cutthroat trout near the trap at the waterfall. The trap, however, caught only Dolly Varden. Coho and king salmon were captured in the wetland next to the highway. Coho and king salmon, and Dolly Varden were caught at the culvert at Station 269+00. The presence of coho and king salmon in the wetland adjacent to the highway demonstrates that the wetland is part of Waterfall Creek and should be considered as anadromous waters.

What we believe to be the tributary on the river side of the highway (#115-32-10250-2008-3005) was dry upstream of the culvert at Station 271+25, and may not support fish at this time.

- Include the wetland as part of Waterfall Creek (map as polygon) in the Catalog
- Extend the upstream extent to just below the waterfall, in the Catalog
- Add king salmon rearing habitat to the Catalog
- Update stream location in the Catalog
- Revisit dry stream segment #115-32-10250-2008-3005 to determine if it should be removed from the Catalog
- Design all stream crossings for fish passage

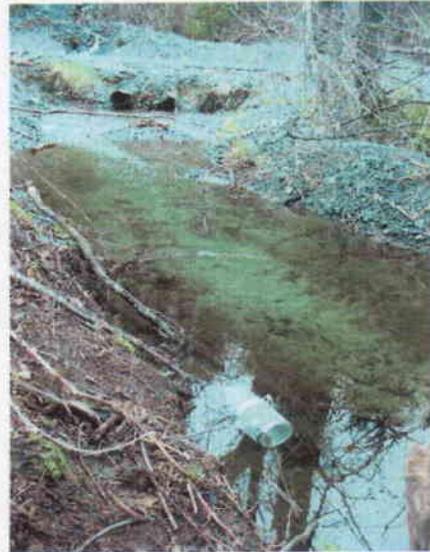
Photo 2. Station 315+50

This stream was identified in the SHI as habitat for rearing coho and Dolly Varden, and potential spawning (redds were observed). Upstream fish habitat is limited to about 50' upstream of the culvert.

A trap set about 40' upstream of the double 24" culverts caught coho salmon, cutthroat trout and Dolly Varden. A trap set about 30' downstream from the outlets caught king and coho salmon, and Dolly Varden (see Photo 2).

- Add to the Catalog as supporting rearing coho and king salmon, cutthroat trout and Dolly Varden
- Design the stream crossing for fish passage

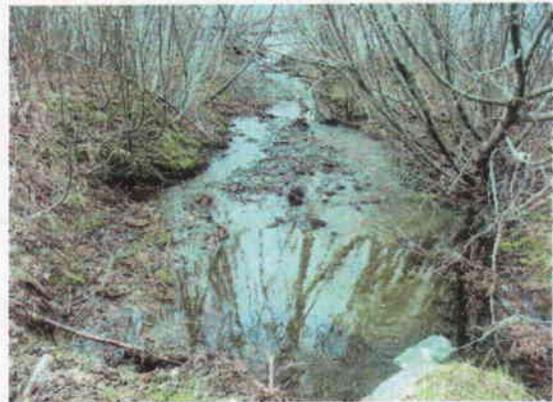
Photo 3. Station 339+00

This stream is below the site of an old cabin located uphill of the highway. It was not identified in the SHI. The clear water channel below the culvert outlet is about 8' wide and up to about 1' deep (see Photo 3). The culvert inlet was about 80% buried. Stream habitat is limited to the channel between the culvert and the Chilkat River (about 30 feet).

- Add to the Catalog as supporting rearing coho and Dolly Varden below the culvert
- Fish passage not required at stream crossing

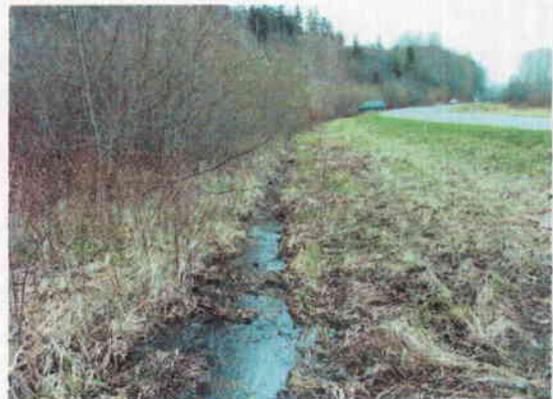
Photo 4. Station 342+00

The SHI identified this stream as supporting rearing coho and Dolly Varden. Coho and king salmon were trapped 300' upstream of the 36" culvert crossing. The culvert is perched and unraveling. The stream meanders along the road upstream of the culvert for about 300', before turning inland (see Photo 4). Potential fish habitat terminates in a high-gradient reach just below a waterfall.

- Add to the Catalog as supporting rearing coho and king salmon

- Design the stream crossing for fish passage

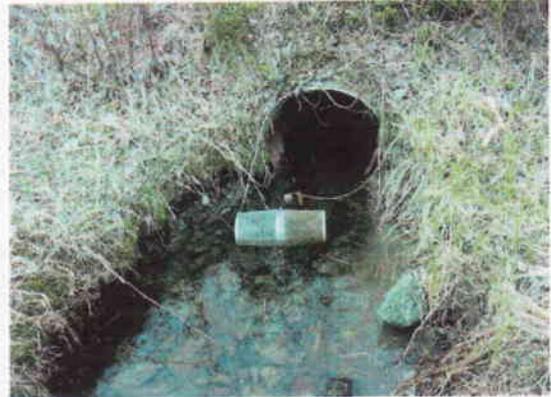
Photo 5. Station 389+25

The SHI identified this stream as supporting rearing coho and Dolly Varden. The stream crosses the highway through a 24" culvert. Coho salmon were trapped at the culvert outlet (see Photo 5), coho and cutthroat were trapped at the inlet. Upstream fish habitat is limited to about 40 feet because of a steep cascade.

- Add to the Catalog as supporting rearing coho salmon and cutthroat trout
- Design the stream crossing for fish passage

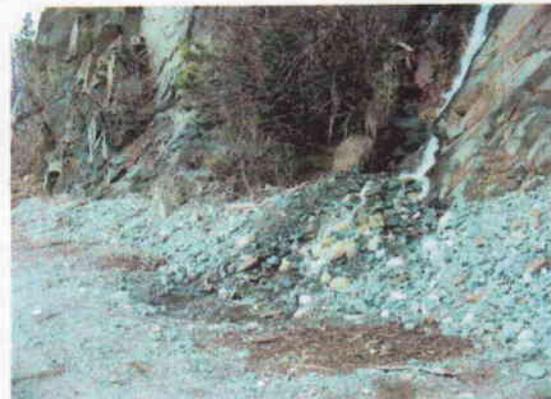
Photo 6. Station 391+75

The SHI identified this stream as providing rearing habitat for coho and Dolly Varden. The stream terminates in a waterfall just upstream of the 24" culvert (see Photo 6). A 10-foot diameter pool identified in the SHI at the bottom of the waterfall was filled with gravel and the stream flowed to the culvert through a shallow gravelly channel. There was no usable habitat above the culvert inlet. The channel above and below the culvert was too shallow to trap. Although not documented, the short stream reach below the culvert probably provides rearing habitat for coho salmon and Dolly Varden char, and good spawning gravels.

- Stream crossing does not need to be designed for fish passage

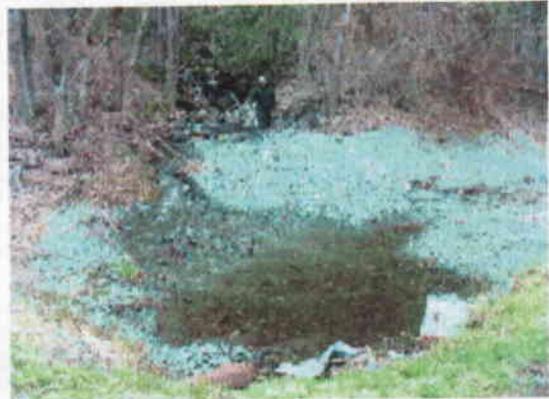
Photo 7. Station 442+75

The SHI identified this stream as supporting rearing coho and Dolly Varden, and possible spawning habitat. The stream crosses the highway through twin 24" culverts that were perched about 6". Fish habitat ends about 75' upstream at a steep cascade (see Photo 7). There was evidence of water flowing across the road as a result of plugged culverts. Coho salmon, steelhead, and cutthroat trout were trapped about 60 feet upstream of the culvert inlet. Coho salmon were trapped just below the outlet.

- Add to the Catalog as supporting rearing coho, cutthroat and steelhead
- Design the stream crossing for fish passage

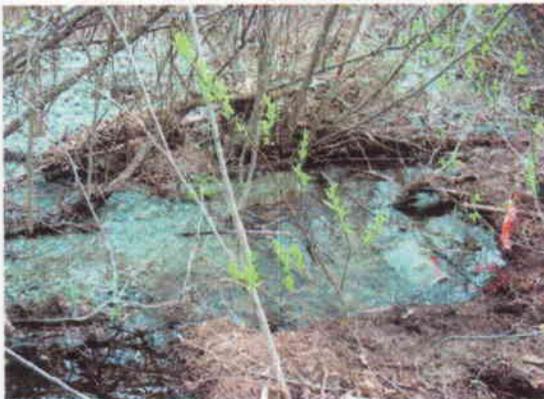
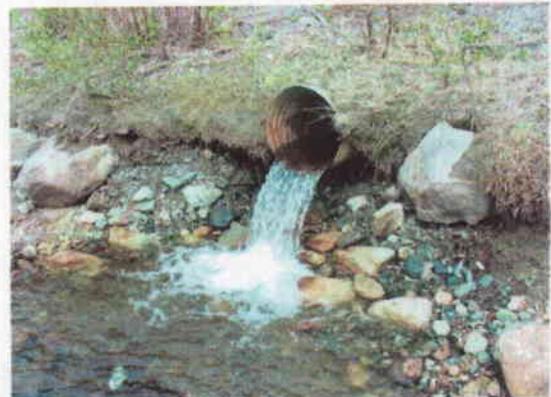
Photo 8. Station 632+00

This stream was not identified in the SHI. A trap placed about 100' upstream from the 24" culvert caught cutthroat and Dolly Varden (see Photo 8). Shortly beyond this point the gradient increases significantly. The culvert is perched about 1' and discharges directly to the Chilkat River (see Photo 9). There is enough good upstream habitat to make it worthwhile replacing the culvert with one that improves fish passage.

- Add to the catalog as supporting rearing cutthroat and Dolly Varden
- Design the stream crossing for fish passage

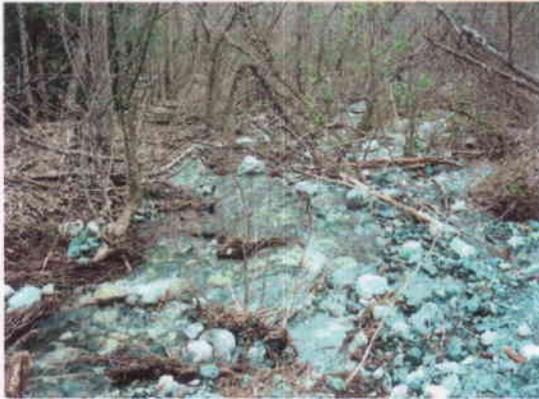
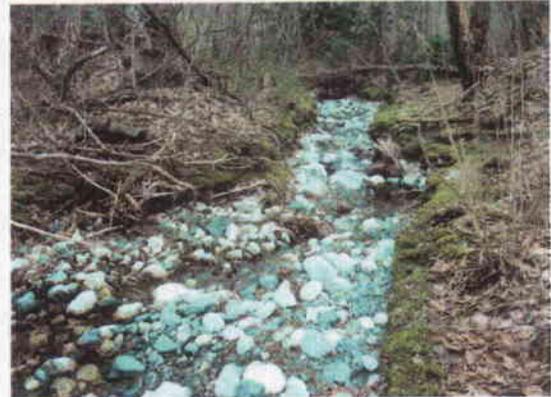
Photo 10. Station 670+00

A recent debris flow has blocked the main channel so that a majority of the flow now goes through a new channel near Station 677+00 (see Photo 10), and flows along the road to twin 36-inch culverts near Station 670+00. We observed three cutthroat trout (about 18", 12" and 4") in the new stream channel about 30' upstream from the road. No fish were caught in traps set farther up in this channel. King salmon and cutthroat trout were trapped in the original main channel about 400' upstream from the culverts. There is an opportunity to improve fish passage in this area. The stream flow is now divided into many channels that are filled with gravels to the extent that flow remains subsurface for much of the way. Habitat could be improved by focusing the flow either back into the old main channel (see Photo 11), or improving the new channel.

We confirmed that Inter-Fluve's description of the area was correct. Debris flows have reduced habitat in the main channel and created new channels. These changes have likely reduced the habitat quality because of the more dispersed flows and sediment accumulation. Stream channel improvements here would be appropriate mitigation for the project. This area will require a more detailed look to determine the best approach to habitat improvements, once road alignment plans have been finalized for this area. The current proposed realignment would move the highway upstream of most of the fish habitat.

- Update Catalog to document the new channel locations and upstream extent of cutthroat spawning, and king and coho salmon rearing.
- Design the stream crossing(s) for fish passage

- Consider channel improvements as mitigation
- Take a detailed look at the hydrology and channel morphology to determine where best to route the flows and which channels to improve

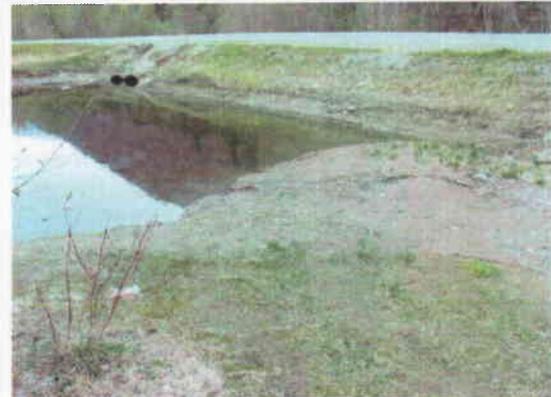
Photo 12. Station 733+50

This stream is cataloged as providing rearing and spawning habitat for coho salmon and Dolly Varden. A slough of the Chilkat River just below the two 36" culverts is used as an informal boat launch area (see Photo 12), resulting in degradation of the stream banks and bed. A trap 45' upstream of the culvert caught coho and king salmon, and Dolly Varden.

- Update the Catalog to add king salmon rearing
- Design the stream crossing for fish passage

- Realign stream to cross more perpendicular to the highway
- Rehabilitate degraded habitat below culvert
- Improve the boat launch area by hardening to reduce habitat degradation, or
- Develop new launching area at a better location and close out this one

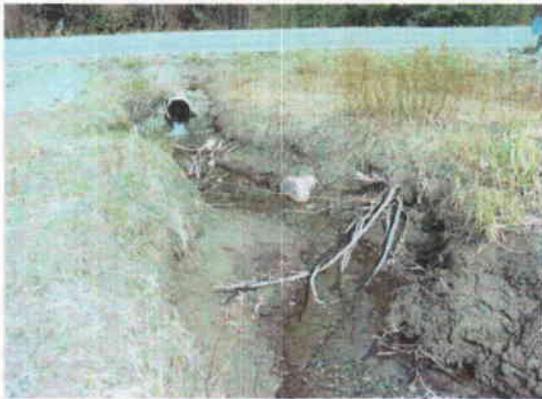
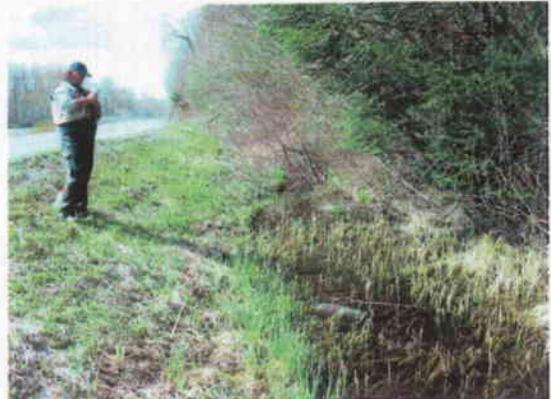
Photo 13. Station 760+00

The SHI identified this stream as supporting rearing coho and Dolly Varden. This un-cataloged stream crosses the highway through a perched 24" culvert (see Photo 13). Three traps set within 175' upstream of the culvert inlet caught king and coho salmon and Dolly Varden (see Photo 14). The stream would be filled by the proposed road alignment.

This short stream that we propose to nominate to the Catalog would be mostly filled by the new road alignment.

- Add to the Catalog as supporting king and coho salmon and Dolly Varden
- Construct new channel on riverside of highway
- Fish passage is not required for this stream crossing

- Re-route water from cascades through a new crossing location and create new stream and potentially wetlands on the river side (culvert would not need to be designed to pass fish).

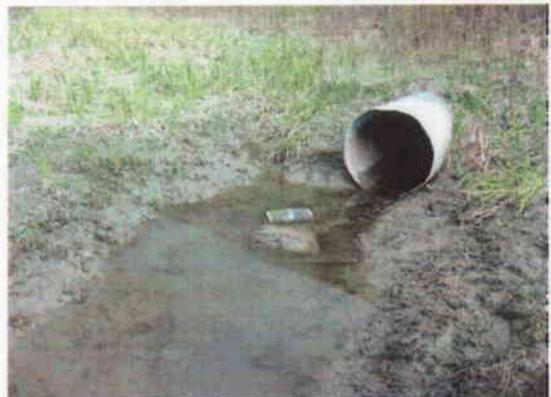
Photo 15. Station 879+75

The SHI identified this stream as supporting rearing coho and Dolly Varden below the culvert. Fish habitat ends at the culvert (see Photo 15). King salmon and Dolly Varden were trapped at the culvert outlet. The stream below the culvert is a slough of the Chilkat River, and is thereby cataloged.

- Fish passage is not required for this stream crossing.

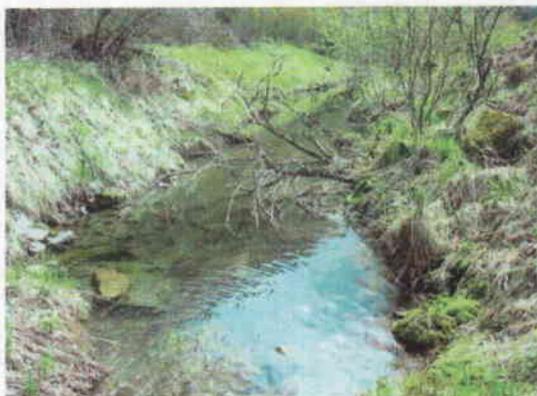
Photo 16. Station 887+90

The Catalog lists this stream as providing rearing habitat for coho salmon and Dolly Varden char, and spawning habitat for coho and chum salmon. The cataloged stream originates from springs on the hillside, and flows through NSRAA's (Northern Southeast Regional Aquaculture Association) incubation boxes. An un-cataloged western tributary collects water from the hillside and joins the cataloged tributary near the culvert inlet (see Photo 16). A trap set in a pond at the uppermost fish habitat extent of the western channel (about 700' upstream of the culvert) didn't catch fish, but king

salmon were caught about 60' downstream of the pond. Dolly Varden char were also trapped in the western tributary.

The road alignment would potentially be moved upslope and would obliterate the existing stream. A new stream would need to be constructed, probably downslope of the existing highway. Additional water that now flows off the hillside and through the highway beyond the existing stream habitat could potentially be intercepted for use in the new stream channel.

- Add the western tributary of 115-32-10250-2060-3002 to the Catalog as supporting rearing king salmon and Dolly Varden char

- Consider intercepting additional water for replacement stream

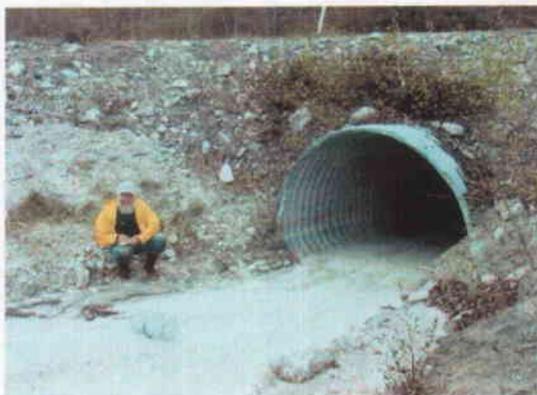
Photo 17. Station 985+00 (dry)

This stream is part of the 19 Mile slide area subject to large influx of gravels from the hillside and upslope streams. The SHI identified this location as rearing habitat for coho salmon and Dolly Varden. The channel was dry upstream and downstream of the culvert to the confluence with Chilkat River (see Photo 17). This is an ephemeral stream that has seasonally heavy flows carrying large amounts of sediment, and may provide fish habitat in the lower vegetated reach.

- Fish passage is not required for this crossing location.

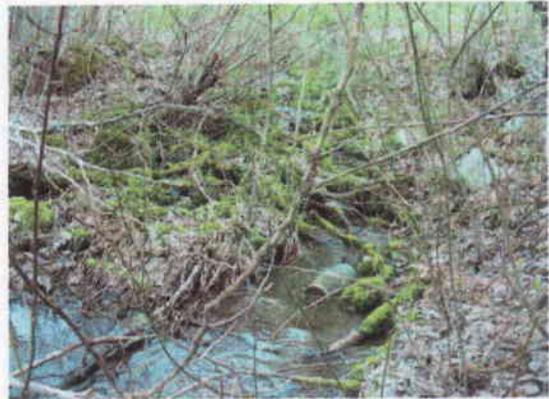
Photo 18. Station 1098+50

This stream may be incorrectly located in the SHI, and is closer to Station 1101+00. The SHI determined that this wasn't a fish stream because a steep drop-off to the Chilkat River. We hiked to the outlet and verified the natural blockage to upstream fish passage. Traps near the culvert outlet (see Photo 18) and 45' upstream of the inlet did not catch fish.

- Fish passage is not required for this crossing location
