State of Alaska
Department of Fish and Game
Sportfish Division

Nomination Form
Fish Distribution Database

SUBJECT: Haines Hwy MP 3.5-25.3
Trip Report

The Department of Transportation and Public Facilities (DOTPF) is proposing to widen and realign the Haines Highway between MP 3.5 and 25.3 to bring the highway up to National Highway System standards. The project would impact the Chilkat River and numerous smaller anadromous and resident fish streams. Fish Habitat permits would be required for stream crossings, relocation, and bank stabilization. A *Stream and Habitat Inventory* (SHI) was conducted in 2005 by Inter-Fluve, Inc. that identified fish streams impacted by the project. While many of the streams are documented in the *Catalog of Waters Important to the Spawning, Rearing or Migration of Anadromous Fishes* (Catalog), the survey found anadromous fish in many streams that are not in the Catalog. We conducted a field survey May 9-16, 2006 to supplement the Inter-Fluve survey, and to nominate additional anadromous fish streams to the Catalog.

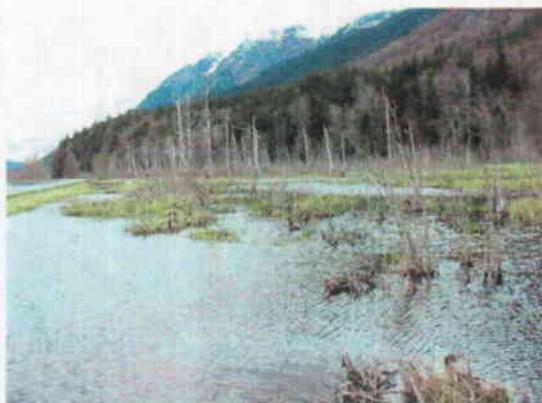
Photo 1. Station 271+25

Traps were set about 60' downstream of the waterfall in the wetlands at the shoulder of the highway, about 500' from the waterfall, and at the inlet to the culvert at Station 269+00. We observed a 5" fish that appeared to be a cutthroat trout near the trap at the waterfall. The trap, however, caught only Dolly Varden. Coho and king salmon were captured in the wetland next to the highway. Coho and king salmon, and Dolly Varden were caught at the culvert at Station 269+00. The presence of coho and king salmon in the wetland adjacent to the highway demonstrates that the wetland is part of Waterfall Creek and should be considered as anadromous waters.

What we believe to be the tributary on the river side of the highway (#115-32-10250-2008-3005) was dry upstream of the culvert at Station 271+25, and may not support fish at this time.

- Include the wetland as part of Waterfall Creek (map as polygon) in the Catalog
- Extend the upstream extent to just below the waterfall, in the Catalog
- Add king salmon rearing habitat to the Catalog
- Update stream location in the Catalog
- Revisit dry stream segment #115-32-10250-2008-3005 to determine if it should be removed from the Catalog
- Design all stream crossings for fish passage

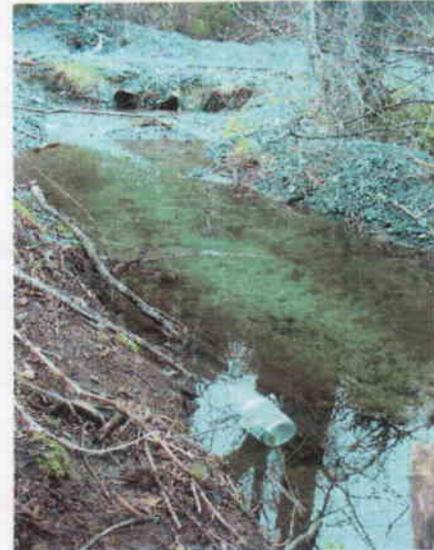
Photo 2. Station 315+50

This stream was identified in the SHI as habitat for rearing coho and Dolly Varden, and potential spawning (redds were observed). Upstream fish habitat is limited to about 50' upstream of the culvert.

A trap set about 40' upstream of the double 24" culverts caught coho salmon, cutthroat trout and Dolly Varden. A trap set about 30' downstream from the outlets caught king and coho salmon, and Dolly Varden (see Photo 2).

- Add to the Catalog as supporting rearing coho and king salmon, cutthroat trout and Dolly Varden
- Design the stream crossing for fish passage

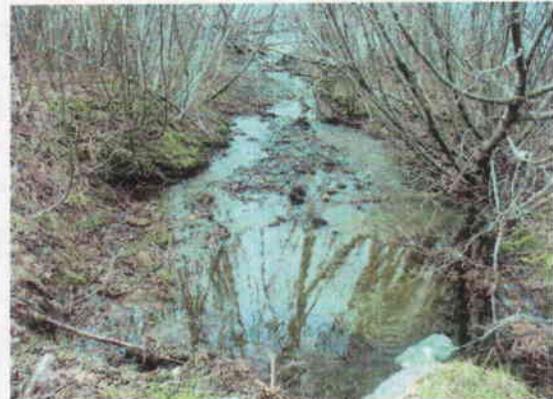
Photo 3. Station 339+00

This stream is below the site of an old cabin located uphill of the highway. It was not identified in the SHI. The clear water channel below the culvert outlet is about 8' wide and up to about 1' deep (see Photo 3). The culvert inlet was about 80% buried. Stream habitat is limited to the channel between the culvert and the Chilkat River (about 30 feet).

- Add to the Catalog as supporting rearing coho and Dolly Varden below the culvert
- Fish passage not required at stream crossing

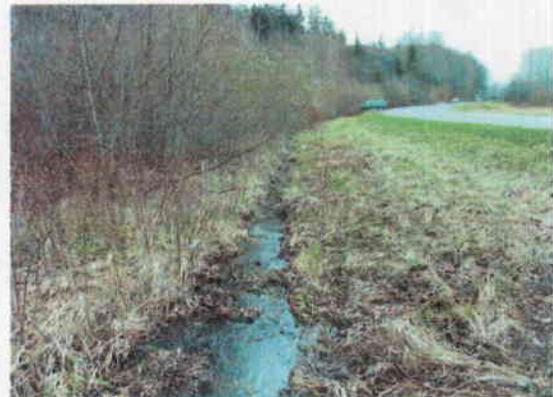
Photo 4. Station 342+00

The SHI identified this stream as supporting rearing coho and Dolly Varden. Coho and king salmon were trapped 300' upstream of the 36" culvert crossing. The culvert is perched and unraveling. The stream meanders along the road upstream of the culvert for about 300', before turning inland (see Photo 4). Potential fish habitat terminates in a high-gradient reach just below a waterfall.

- Add to the Catalog as supporting rearing coho and king salmon

- Design the stream crossing for fish passage

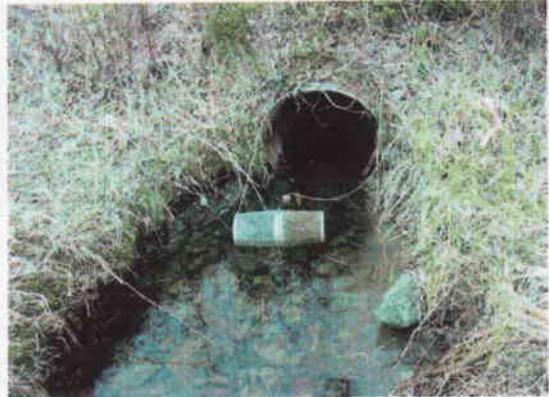
Photo 5. Station 389+25

The SHI identified this stream as supporting rearing coho and Dolly Varden. The stream crosses the highway through a 24" culvert. Coho salmon were trapped at the culvert outlet (see Photo 5), coho and cutthroat were trapped at the inlet. Upstream fish habitat is limited to about 40 feet because of a steep cascade.

- Add to the Catalog as supporting rearing coho salmon and cutthroat trout
- Design the stream crossing for fish passage

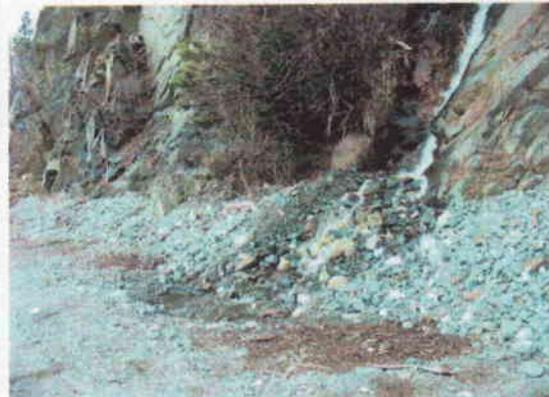
Photo 6. Station 391+75

The SHI identified this stream as providing rearing habitat for coho and Dolly Varden. The stream terminates in a waterfall just upstream of the 24" culvert (see Photo 6). A 10-foot diameter pool identified in the SHI at the bottom of the waterfall was filled with gravel and the stream flowed to the culvert through a shallow gravelly channel. There was no usable habitat above the culvert inlet. The channel above and below the culvert was too shallow to trap. Although not documented, the short stream reach below the culvert probably provides rearing habitat for coho salmon and Dolly Varden char, and good spawning gravels.

- Stream crossing does not need to be designed for fish passage

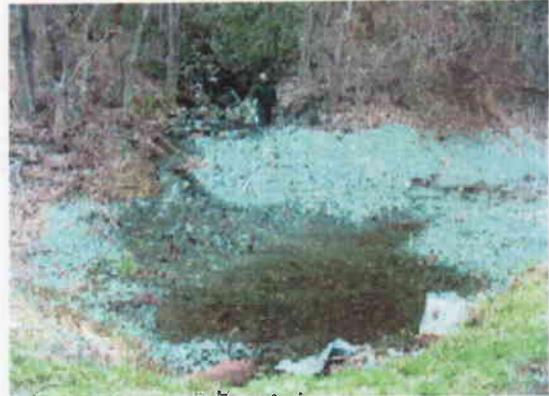
Photo 7. Station 442+75

The SHI identified this stream as supporting rearing coho and Dolly Varden, and possible spawning habitat. The stream crosses the highway through twin 24" culverts that were perched about 6". Fish habitat ends about 75' upstream at a steep cascade (see Photo 7). There was evidence of water flowing across the road as a result of plugged culverts. Coho salmon, steelhead, and cutthroat trout were trapped about 60 feet upstream of the culvert inlet. Coho salmon were trapped just below the outlet.

- Add to the Catalog as supporting rearing coho, cutthroat and steelhead
- Design the stream crossing for fish passage

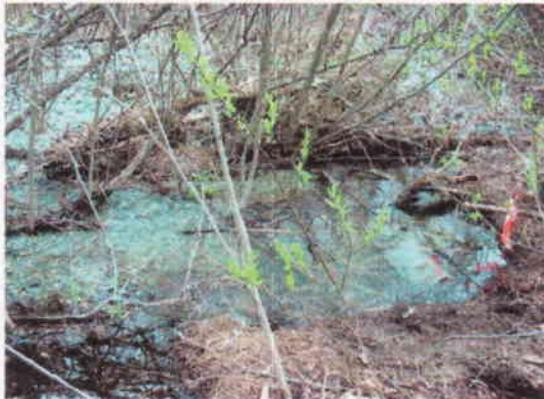
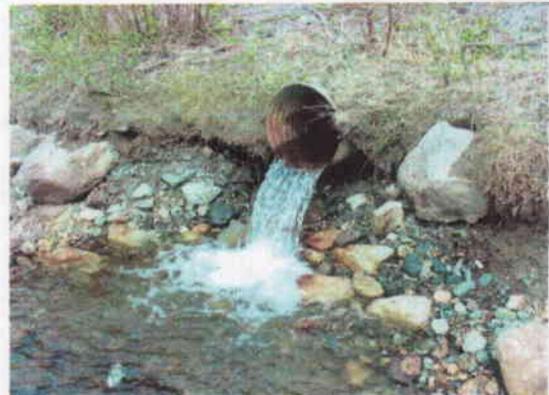
Photo 8. Station 632+00

This stream was not identified in the SHI. A trap placed about 100' upstream from the 24" culvert caught cutthroat and Dolly Varden (see Photo 8). Shortly beyond this point the gradient increases significantly. The culvert is perched about 1' and discharges directly to the Chilkat River (see Photo 9). There is enough good upstream habitat to make it worthwhile replacing the culvert with one that improves fish passage.

- Add to the catalog as supporting rearing cutthroat and Dolly Varden
- Design the stream crossing for fish passage

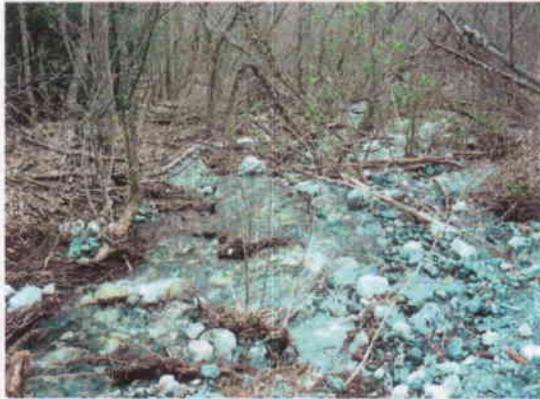
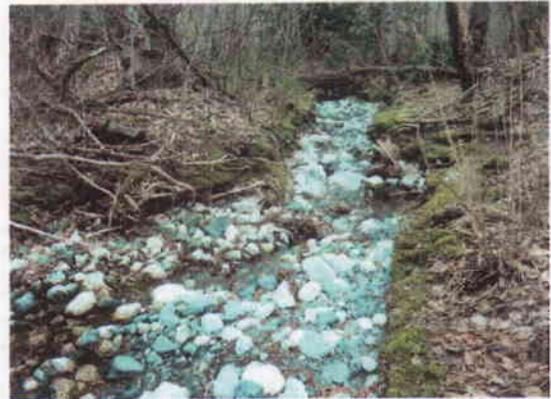
Photo 10. Station 670+00

A recent debris flow has blocked the main channel so that a majority of the flow now goes through a new channel near Station 677+00 (see Photo 10), and flows along the road to twin 36-inch culverts near Station 670+00. We observed three cutthroat trout (about 18", 12" and 4") in the new stream channel about 30' upstream from the road. No fish were caught in traps set farther up in this channel. King salmon and cutthroat trout were trapped in the original main channel about 400' upstream from the culverts. There is an opportunity to improve fish passage in this area. The stream flow is now divided into many channels that are filled with gravels to the extent that flow remains subsurface for much of the way. Habitat could be improved by focusing the flow either back into the old main channel (see Photo 11), or improving the new channel.

We confirmed that Inter-Fluve's description of the area was correct. Debris flows have reduced habitat in the main channel and created new channels. These changes have likely reduced the habitat quality because of the more dispersed flows and sediment accumulation. Stream channel improvements here would be appropriate mitigation for the project. This area will require a more detailed look to determine the best approach to habitat improvements, once road alignment plans have been finalized for this area. The current proposed realignment would move the highway upstream of most of the fish habitat.

- Update Catalog to document the new channel locations and upstream extent of cutthroat spawning, and king and coho salmon rearing.
- Design the stream crossing(s) for fish passage

- Consider channel improvements as mitigation
- Take a detailed look at the hydrology and channel morphology to determine where best to route the flows and which channels to improve

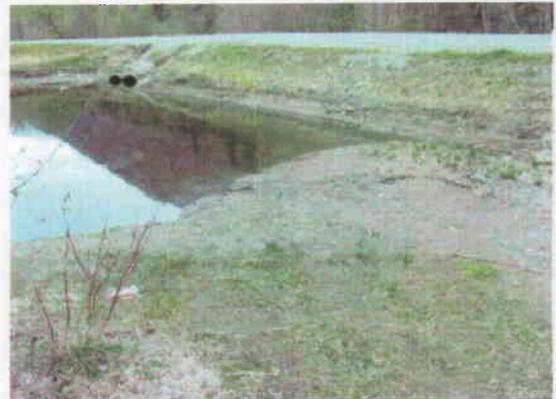
Photo 12. Station 733+50

This stream is cataloged as providing rearing and spawning habitat for coho salmon and Dolly Varden. A slough of the Chilkat River just below the two 36" culverts is used as an informal boat launch area (see Photo 12), resulting in degradation of the stream banks and bed. A trap 45' upstream of the culvert caught coho and king salmon, and Dolly Varden.

This is the location of the informal boat launching area.

- Update the Catalog to add king salmon rearing
- Design the stream crossing for fish passage

- Realign stream to cross more perpendicular to the highway
- Rehabilitate degraded habitat below culvert
- Improve the boat launch area by hardening to reduce habitat degradation, or
- Develop new launching area at a better location and close out this one

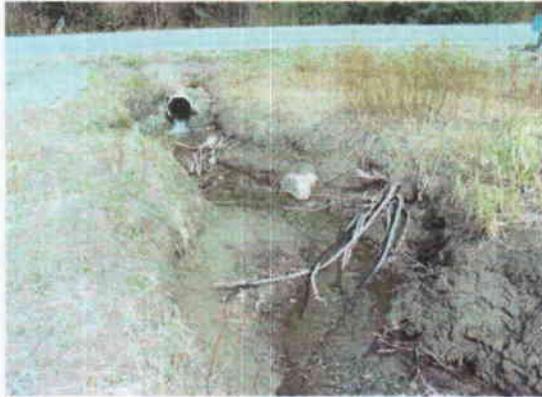
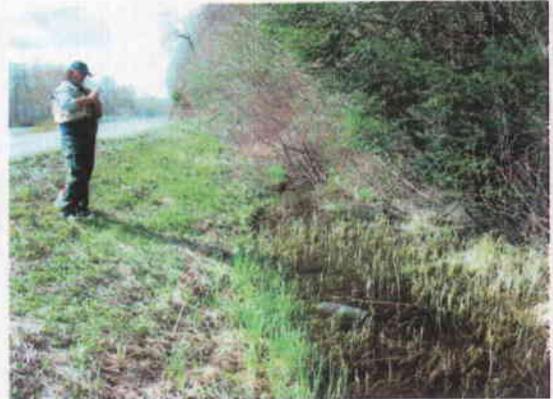
Photo 13. Station 760+00

The SHI identified this stream as supporting rearing coho and Dolly Varden. This un-cataloged stream crosses the highway through a perched 24" culvert (see Photo 13). Three traps set within 175' upstream of the culvert inlet caught king and coho salmon and Dolly Varden (see Photo 14). The stream would be filled by the proposed road alignment.

This short stream that we propose to nominate to the Catalog would be mostly filled by the new road alignment.

- Add to the Catalog as supporting king and coho salmon and Dolly Varden
- Construct new channel on riverside of highway
- Fish passage is not required for this stream crossing

- Re-route water from cascades through a new crossing location and create new stream and potentially wetlands on the river side (culvert would not need to be designed to pass fish).

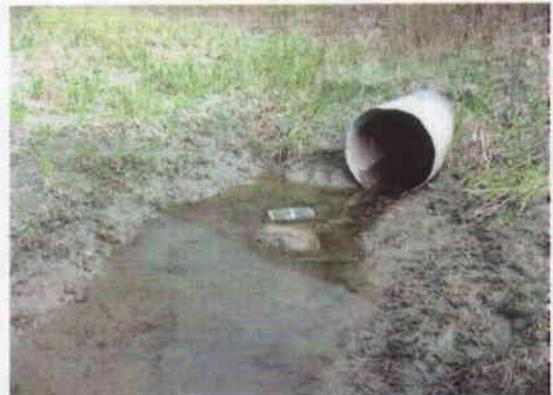
Photo 15. Station 879+75

The SHI identified this stream as supporting rearing coho and Dolly Varden below the culvert. Fish habitat ends at the culvert (see Photo 15). King salmon and Dolly Varden were trapped at the culvert outlet. The stream below the culvert is a slough of the Chilkat River, and is thereby cataloged.

- Fish passage is not required for this stream crossing.

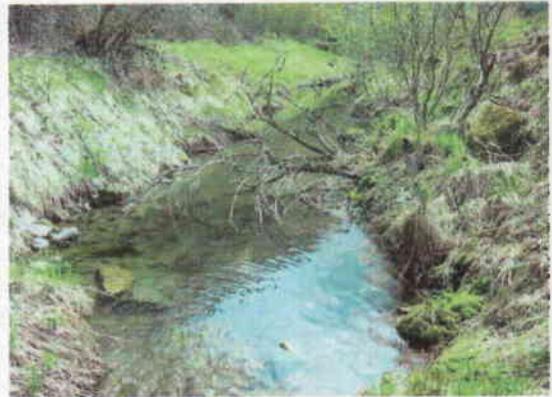
Photo 16. Station 887+90

The Catalog lists this stream as providing rearing habitat for coho salmon and Dolly Varden char, and spawning habitat for coho and chum salmon. The cataloged stream originates from springs on the hillside, and flows through NSRAA's (Northern Southeast Regional Aquaculture Association) incubation boxes. An un-cataloged western tributary collects water from the hillside and joins the cataloged tributary near the culvert inlet (see Photo 16). A trap set in a pond at the uppermost fish habitat extent of the western channel (about 700' upstream of the culvert) didn't catch fish, but king

salmon were caught about 60' downstream of the pond. Dolly Varden char were also trapped in the western tributary.

The road alignment would potentially be moved upslope and would obliterate the existing stream. A new stream would need to be constructed, probably downslope of the existing highway. Additional water that now flows off the hillside and through the highway beyond the existing stream habitat could potentially be intercepted for use in the new stream channel.

- Add the western tributary of 115-32-10250-2060-3002 to the Catalog as supporting rearing king salmon and Dolly Varden char

- Consider intercepting additional water for replacement stream

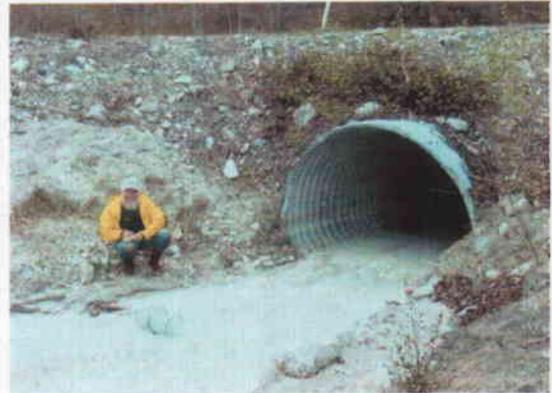
Photo 17. Station 985+00 (dry)

This stream is part of the 19 Mile slide area subject to large influx of gravels from the hillside and upslope streams. The SHI identified this location as rearing habitat for coho salmon and Dolly Varden. The channel was dry upstream and downstream of the culvert to the confluence with Chilkat River (see Photo 17). This is an ephemeral stream that has seasonally heavy flows carrying large amounts of sediment, and may provide fish habitat in the lower vegetated reach.

- Fish passage is not required for this crossing location.

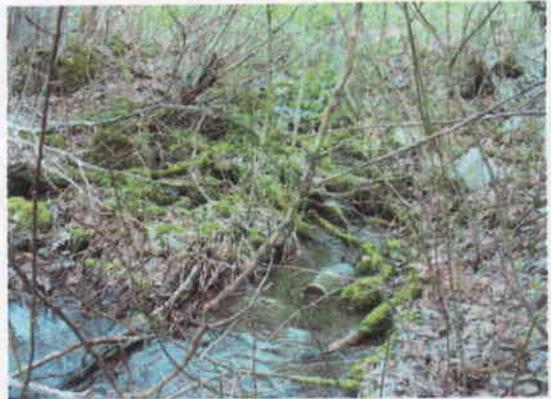
Photo 18. Station 1098+50

This stream may be incorrectly located in the SHI, and is closer to Station 1101+00. The SHI determined that this wasn't a fish stream because a steep drop-off to the Chilkat River. We hiked to the outlet and verified the natural blockage to upstream fish passage. Traps near the culvert outlet (see Photo 18) and 45' upstream of the inlet did not catch fish.

- Fish passage is not required for this crossing location
