State of Alaska
Department of Fish and Game
Sportfish Division

Nomination Form
Fish Distribution Database

Region Southeast USGS Quad(s) SKAGWAY B-3
 Fish Distribution Database Number of Waterway 115-32-10250-2060-3002 - 4001
 Name of Waterway Seventeen Mile Creek USGS Name Local Name
 Addition Deletion Correction Backup Information

SUBJECT: Haines Hwy MP 3.5-25.3
Trip Report

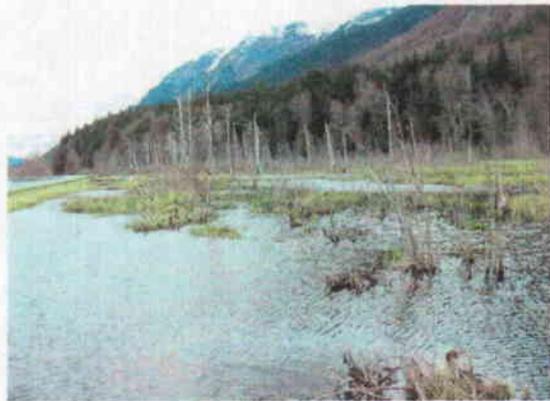
Photo 1. Station 271+25

Waterfall Creek (#115-32-10250-2008) originates below a waterfall next to the road near Station 301+00 and flows eastward parallel to the road at the upslope edge of a wetland. The stream was connected to the wetland, which was flooded to the shoulder of the road between about Station 280+00 and 300+00 (see Photo 1). The stream crosses the highway at two locations: near Station 269+00 through a 36" culvert; and near Station 271+25 through a 24" culvert. The crossing at Station 271+25 connects to un-named tributary (#115-32-10250-2008-3005) on the river side of the highway.

Traps were set about 60' downstream of the waterfall in the wetlands at the shoulder of the highway, about 500' from the waterfall, and at the inlet to the culvert at Station 269+00. We observed a 5" fish that appeared to be a cutthroat trout near the trap at the waterfall. The trap, however, caught only Dolly Varden. Coho and king salmon were captured in the wetland next to the highway. Coho and king salmon, and Dolly Varden were caught at the culvert at Station 269+00. The presence of coho and king salmon in the wetland adjacent to the highway demonstrates that the wetland is part of Waterfall Creek and should be considered as anadromous waters.

What we believe to be the tributary on the river side of the highway (#115-32-10250-2008-3005) was dry upstream of the culvert at Station 271+25, and may not support fish at this time.

- Include the wetland as part of Waterfall Creek (map as polygon) in the Catalog
- Extend the upstream extent to just below the waterfall, in the Catalog
- Add king salmon rearing habitat to the Catalog
- Update stream location in the Catalog
- Revisit dry stream segment #115-32-10250-2008-3005 to determine if it should be removed from the Catalog
- Design all stream crossings for fish passage

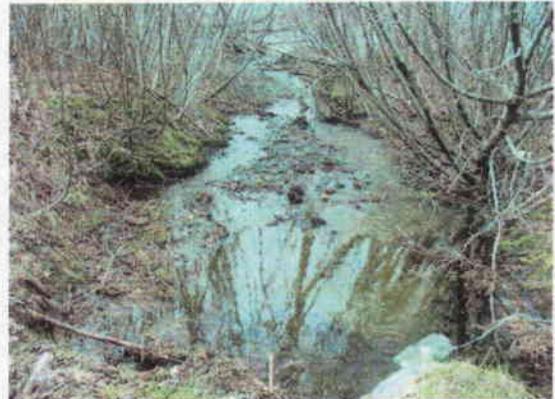
Photo 3. Station 339+00

This stream is below the site of an old cabin located uphill of the highway. It was not identified in the SHI. The clear water channel below the culvert outlet is about 8' wide and up to about 1' deep (see Photo 3). The culvert inlet was about 80% buried. Stream habitat is limited to the channel between the culvert and the Chilkat River (about 30 feet).

- Add to the Catalog as supporting rearing coho and Dolly Varden below the culvert
- Fish passage not required at stream crossing

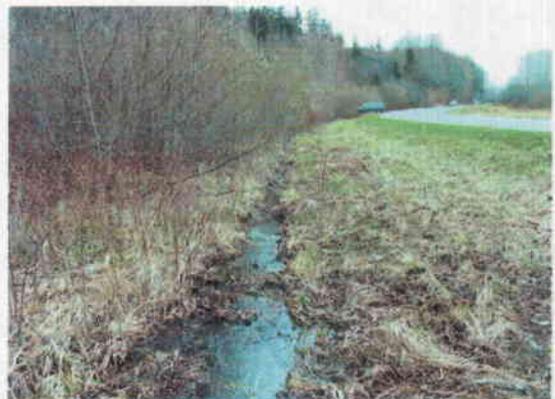
Photo 4. Station 342+00

The SHI identified this stream as supporting rearing coho and Dolly Varden. Coho and king salmon were trapped 300' upstream of the 36" culvert crossing. The culvert is perched and unraveling. The stream meanders along the road upstream of the culvert for about 300', before turning inland (see Photo 4). Potential fish habitat terminates in a high-gradient reach just below a waterfall.

- Add to the Catalog as supporting rearing coho and king salmon

- Design the stream crossing for fish passage

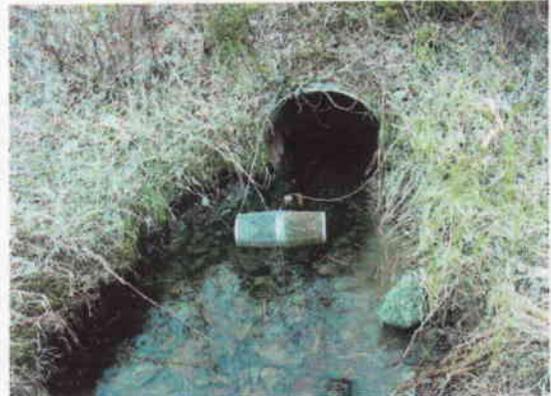
Photo 5. Station 389+25

The SHI identified this stream as supporting rearing coho and Dolly Varden. The stream crosses the highway through a 24" culvert. Coho salmon were trapped at the culvert outlet (see Photo 5), coho and cutthroat were trapped at the inlet. Upstream fish habitat is limited to about 40 feet because of a steep cascade.

- Add to the Catalog as supporting rearing coho salmon and cutthroat trout
- Design the stream crossing for fish passage

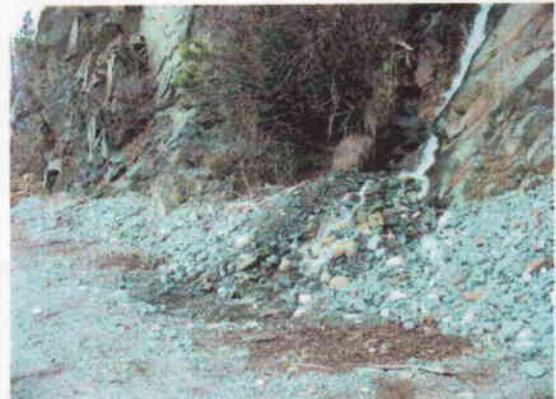
Photo 6. Station 391+75

The SHI identified this stream as providing rearing habitat for coho and Dolly Varden. The stream terminates in a waterfall just upstream of the 24" culvert (see Photo 6). A 10-foot diameter pool identified in the SHI at the bottom of the waterfall was filled with gravel and the stream flowed to the culvert through a shallow gravelly channel. There was no usable habitat above the culvert inlet. The channel above and below the culvert was too shallow to trap. Although not documented, the short stream reach below the culvert probably provides rearing habitat for coho salmon and Dolly Varden char, and good spawning gravels.

- Stream crossing does not need to be designed for fish passage

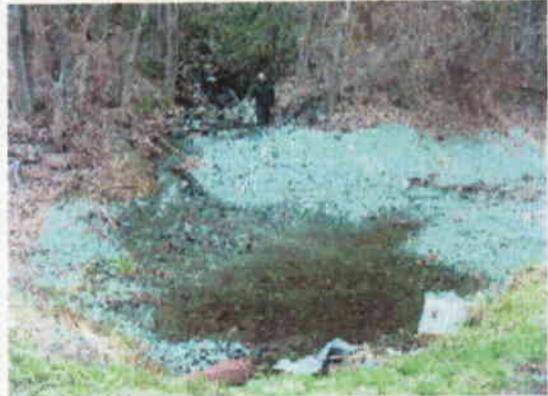
Photo 7. Station 442+75

The SHI identified this stream as supporting rearing coho and Dolly Varden, and possible spawning habitat. The stream crosses the highway through twin 24" culverts that were perched about 6". Fish habitat ends about 75' upstream at a steep cascade (see Photo 7). There was evidence of water flowing across the road as a result of plugged culverts. Coho salmon, steelhead, and cutthroat trout were trapped about 60 feet upstream of the culvert inlet. Coho salmon were trapped just below the outlet.

- Add to the Catalog as supporting rearing coho, cutthroat and steelhead
- Design the stream crossing for fish passage

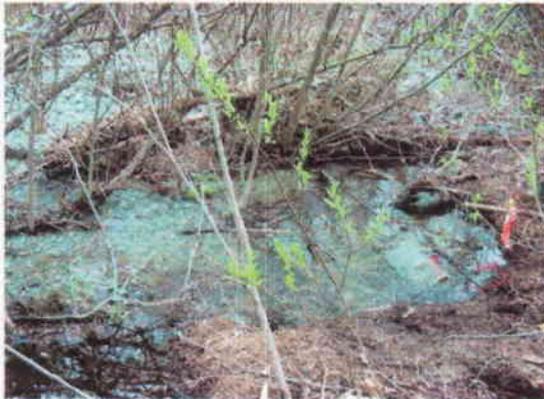
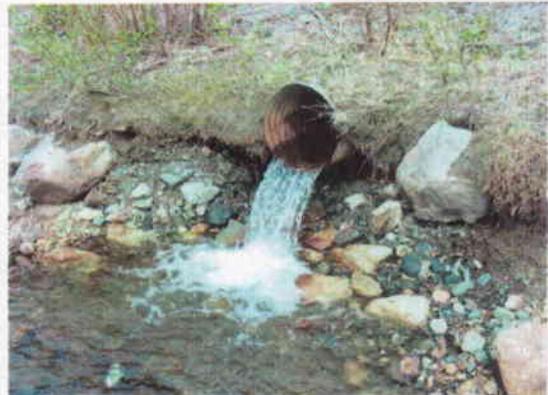
Photo 8. Station 632+00

This stream was not identified in the SHI. A trap placed about 100' upstream from the 24" culvert caught cutthroat and Dolly Varden (see Photo 8). Shortly beyond this point the gradient increases significantly. The culvert is perched about 1' and discharges directly to the Chilkat River (see Photo 9). There is enough good upstream habitat to make it worthwhile replacing the culvert with one that improves fish passage.

- Add to the catalog as supporting rearing cutthroat and Dolly Varden
- Design the stream crossing for fish passage

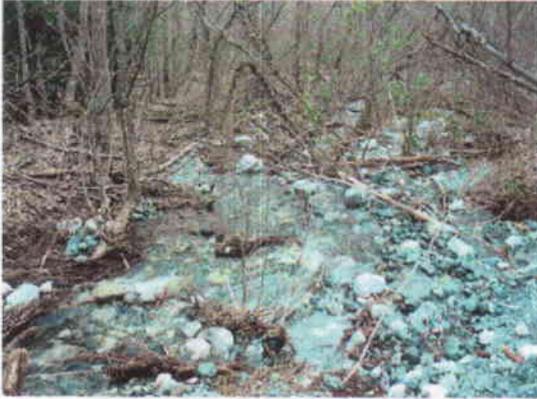
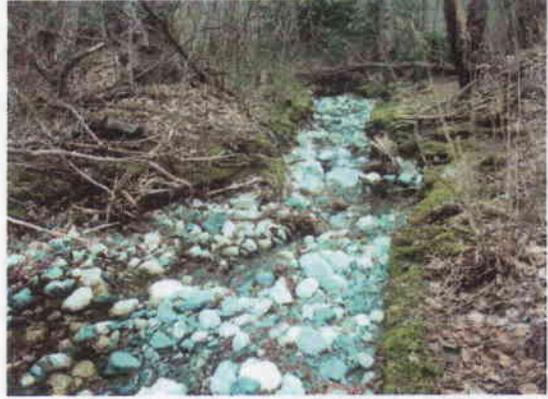
Photo 10. Station 670+00

A recent debris flow has blocked the main channel so that a majority of the flow now goes through a new channel near Station 677+00 (see Photo 10), and flows along the road to twin 36-inch culverts near Station 670+00. We observed three cutthroat trout (about 18", 12" and 4") in the new stream channel about 30' upstream from the road. No fish were caught in traps set farther up in this channel. King salmon and cutthroat trout were trapped in the original main channel about 400' upstream from the culverts. There is an opportunity to improve fish passage in this area. The stream flow is now divided into many channels that are filled with gravels to the extent that flow remains subsurface for much of the way. Habitat could be improved by focusing the flow either back into the old main channel (see Photo 11), or improving the new channel.

We confirmed that Inter-Fluve's description of the area was correct. Debris flows have reduced habitat in the main channel and created new channels. These changes have likely reduced the habitat quality because of the more dispersed flows and sediment accumulation. Stream channel improvements here would be appropriate mitigation for the project. This area will require a more detailed look to determine the best approach to habitat improvements, once road alignment plans have been finalized for this area. The current proposed realignment would move the highway upstream of most of the fish habitat.

- Update Catalog to document the new channel locations and upstream extent of cutthroat spawning, and king and coho salmon rearing.
- Design the stream crossing(s) for fish passage

- Consider channel improvements as mitigation
- Take a detailed look at the hydrology and channel morphology to determine where best to route the flows and which channels to improve

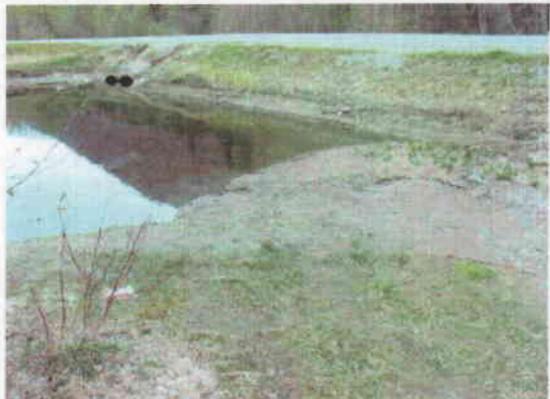
Photo 12. Station 733+50

This stream is cataloged as providing rearing and spawning habitat for coho salmon and Dolly Varden. A slough of the Chilkat River just below the two 36" culverts is used as an informal boat launch area (see Photo 12), resulting in degradation of the stream banks and bed. A trap 45' upstream of the culvert caught coho and king salmon, and Dolly Varden.

This is the location of the informal boat launching area.

- Update the Catalog to add king salmon rearing
- Design the stream crossing for fish passage

- Realign stream to cross more perpendicular to the highway
- Rehabilitate degraded habitat below culvert
- Improve the boat launch area by hardening to reduce habitat degradation, or
- Develop new launching area at a better location and close out this one

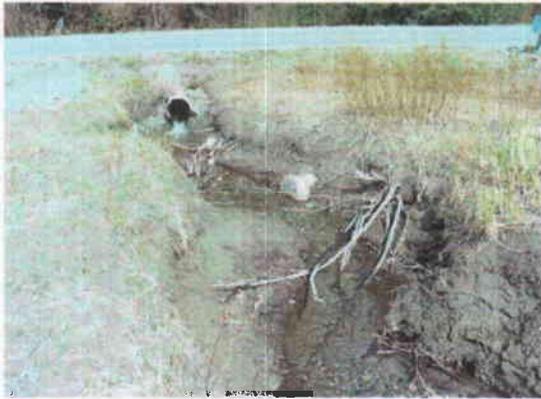
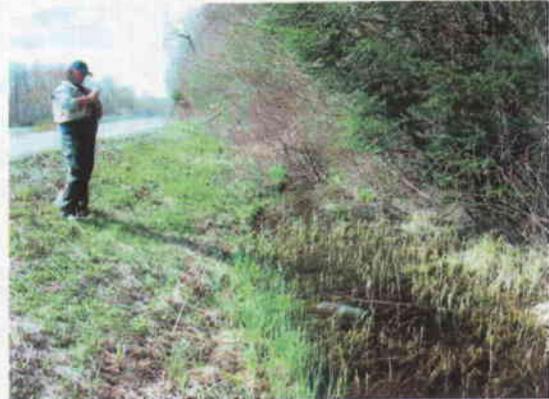
Photo 13. Station 760+00

The SHI identified this stream as supporting rearing coho and Dolly Varden. This un-cataloged stream crosses the highway through a perched 24" culvert (see Photo 13). Three traps set within 175' upstream of the culvert inlet caught king and coho salmon and Dolly Varden (see Photo 14). The stream would be filled by the proposed road alignment.

This short stream that we propose to nominate to the Catalog would be mostly filled by the new road alignment.

- Add to the Catalog as supporting king and coho salmon and Dolly Varden
- Construct new channel on riverside of highway
- Fish passage is not required for this stream crossing

- Re-route water from cascades through a new crossing location and create new stream and potentially wetlands on the river side (culvert would not need to be designed to pass fish).

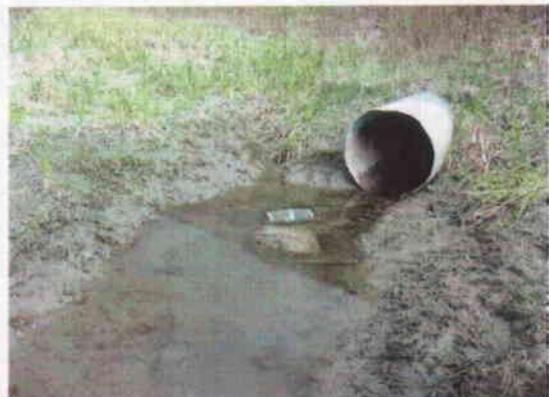
Photo 15. Station 879+75

The SHI identified this stream as supporting rearing coho and Dolly Varden below the culvert. Fish habitat ends at the culvert (see Photo 15). King salmon and Dolly Varden were trapped at the culvert outlet. The stream below the culvert is a slough of the Chilkat River, and is thereby cataloged.

- Fish passage is not required for this stream crossing.

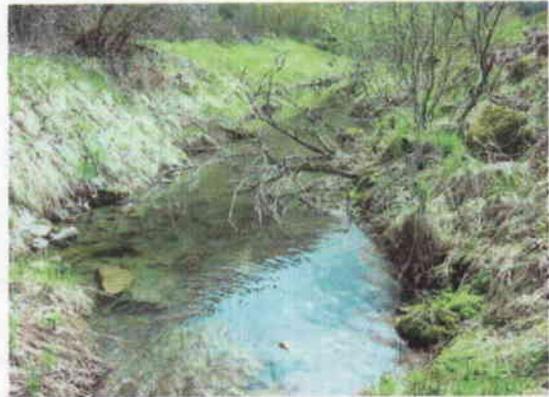
Photo 16. Station 887+90

The Catalog lists this stream as providing rearing habitat for coho salmon and Dolly Varden char, and spawning habitat for coho and chum salmon. The cataloged stream originates from springs on the hillside, and flows through NSRAA's (Northern Southeast Regional Aquaculture Association) incubation boxes. An un-cataloged western tributary collects water from the hillside and joins the cataloged tributary near the culvert inlet (see Photo 16). A trap set in a pond at the uppermost fish habitat extent of the western channel (about 700' upstream of the culvert) didn't catch fish, but king

salmon were caught about 60' downstream of the pond. Dolly Varden char were also trapped in the western tributary.

The road alignment would potentially be moved upslope and would obliterate the existing stream. A new stream would need to be constructed, probably downslope of the existing highway. Additional water that now flows off the hillside and through the highway beyond the existing stream habitat could potentially be intercepted for use in the new stream channel.

- Add the western tributary of 115-32-10250-2060-3002 to the Catalog as supporting rearing king salmon and Dolly Varden char

- Consider intercepting additional water for replacement stream

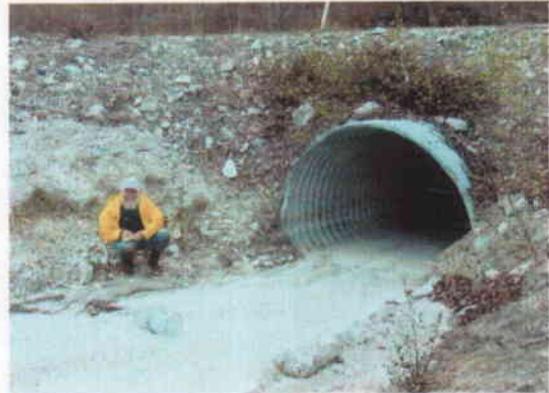
Photo 17. Station 985+00 (dry)

This stream is part of the 19 Mile slide area subject to large influx of gravels from the hillside and upslope streams. The SHI identified this location as rearing habitat for coho salmon and Dolly Varden. The channel was dry upstream and downstream of the culvert to the confluence with Chilkat River (see Photo 17). This is an ephemeral stream that has seasonally heavy flows carrying large amounts of sediment, and may provide fish habitat in the lower vegetated reach.

- Fish passage is not required for this crossing location.

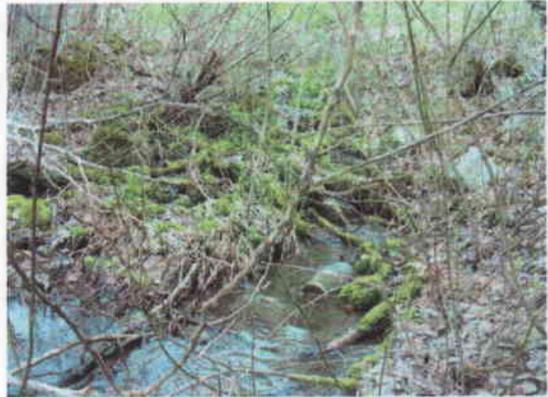
Photo 18. Station 1098+50

This stream may be incorrectly located in the SHI, and is closer to Station 1101+00. The SHI determined that this wasn't a fish stream because a steep drop-off to the Chilkat River. We hiked to the outlet and verified the natural blockage to upstream fish passage. Traps near the culvert outlet (see Photo 18) and 45' upstream of the inlet did not catch fish.

- Fish passage is not required for this crossing location
