Nomination Form  
Anadromous Waters Catalog

Name of Waterway 13 Mile Creek  USGS Name  Local Name

State of Alaska  
 Department of Fish and Game  
 Public Review Nomination for Waters  
 Important to Anadromous Species

SUBJECT: Haines Hwy MP 3.5-25.3  
Trip Report

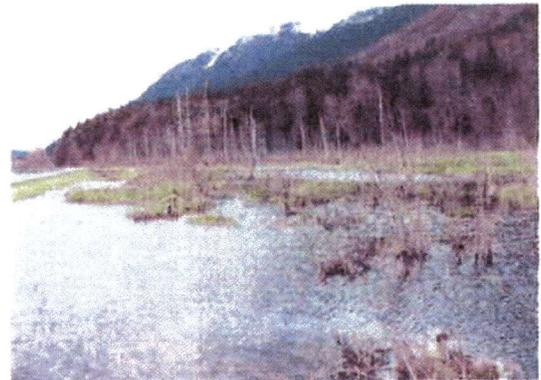
Photo 1. Station 271+25

Waterfall Creek (#115-32-10250-2008) originates below a waterfall next to the road near Station 301+00 and flows eastward parallel to the road at the upslope edge of a wetland. The stream was connected to the wetland, which was flooded to the shoulder of the road between about Station 280+00 and 300+00 (see Photo 1). The stream crosses the highway at two locations: near Station 269+00 through a 36" culvert; and near Station 271+25 through a 24" culvert. The crossing at Station 271+25 connects to un-named tributary (#115-32-10250-2008-3005) on the river side of the highway.

Traps were set about 60' downstream of the waterfall in the wetlands at the shoulder of the highway, about 500' from the waterfall, and at the inlet to the culvert at Station 269+00. We observed a 5" fish that appeared to be a cutthroat trout near the trap at the waterfall. The trap, however, caught only Dolly Varden. Coho and king salmon were captured in the wetland next to the highway. Coho and king salmon, and Dolly Varden were caught at the culvert at Station 269+00. The presence of coho and king salmon in the wetland adjacent to the highway demonstrates that the wetland is part of Waterfall Creek and should be considered as anadromous waters.

What we believe to be the tributary on the river side of the highway (#115-32-10250-2008-3005) was dry upstream of the culvert at Station 271+25, and may not support fish at this time.

- Include the wetland as part of Waterfall Creek (map as polygon) in the Catalog
- Extend the upstream extent to just below the waterfall, in the Catalog
- Add king salmon rearing habitat to the Catalog
- Update stream location in the Catalog
- Revisit dry stream segment #115-32-10250-2008-3005 to determine if it should be removed from the Catalog
- Design all stream crossings for fish passage

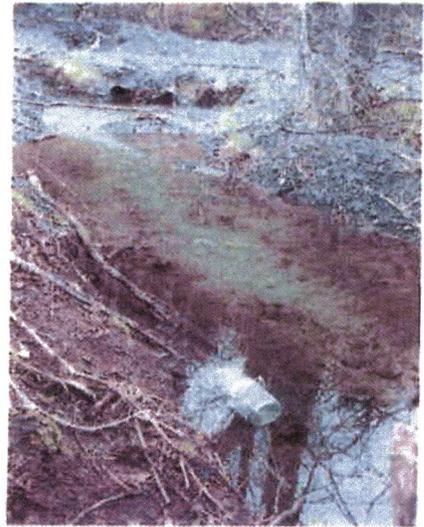
Photo 2. Station 315+50

This stream was identified in the SHI as habitat for rearing coho and Dolly Varden, and potential spawning (redds were observed). Upstream fish habitat is limited to about 50' upstream of the culvert.

A trap set about 40' upstream of the double 24" culverts caught coho salmon, cutthroat trout and Dolly Varden. A trap set about 30' downstream from the outlets caught king and coho salmon, and Dolly Varden (see Photo 2).

- Add to the Catalog as supporting rearing coho and king salmon, cutthroat trout and Dolly Varden
- Design the stream crossing for fish passage

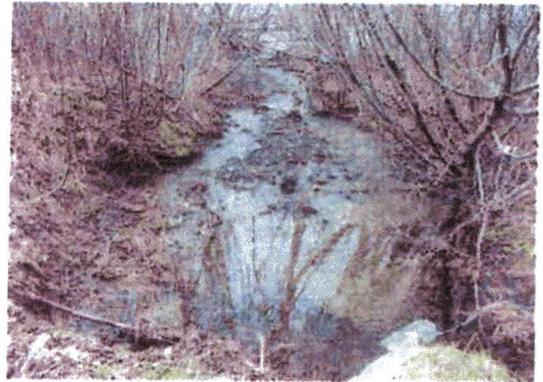
Photo 3. Station 339+00

This stream is below the site of an old cabin located uphill of the highway. It was not identified in the SHI. The clear water channel below the culvert outlet is about 8' wide and up to about 1' deep (see Photo 3). The culvert inlet was about 80% buried. Stream habitat is limited to the channel between the culvert and the Chilkat River (about 30 feet).

- Add to the Catalog as supporting rearing coho and Dolly Varden below the culvert
- Fish passage not required at stream crossing

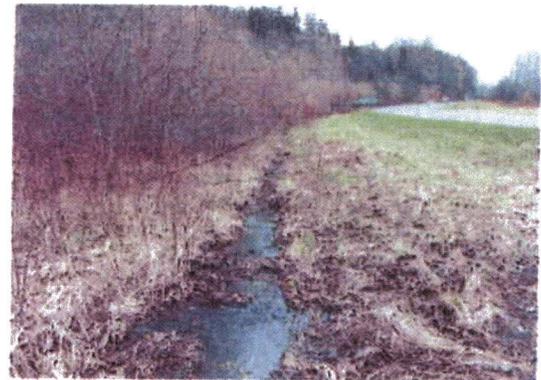
Photo 4. Station 342+00

The SHI identified this stream as supporting rearing coho and Dolly Varden. Coho and king salmon were trapped 300' upstream of the 36" culvert crossing. The culvert is perched and unraveling. The stream meanders along the road upstream of the culvert for about 300', before turning inland (see Photo 4). Potential fish habitat terminates in a high-gradient reach just below a waterfall.

- Add to the Catalog as supporting rearing coho and king salmon

- Design the stream crossing for fish passage

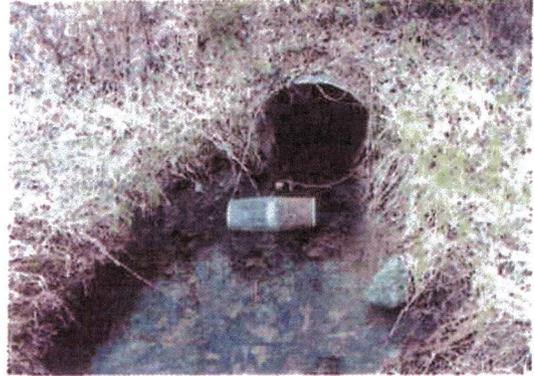
Photo 5. Station 389+25

The SHI identified this stream as supporting rearing coho and Dolly Varden. The stream crosses the highway through a 24" culvert. Coho salmon were trapped at the culvert outlet (see Photo 5), coho and cutthroat were trapped at the inlet. Upstream fish habitat is limited to about 40 feet because of a steep cascade.

- Add to the Catalog as supporting rearing coho salmon and cutthroat trout
- Design the stream crossing for fish passage

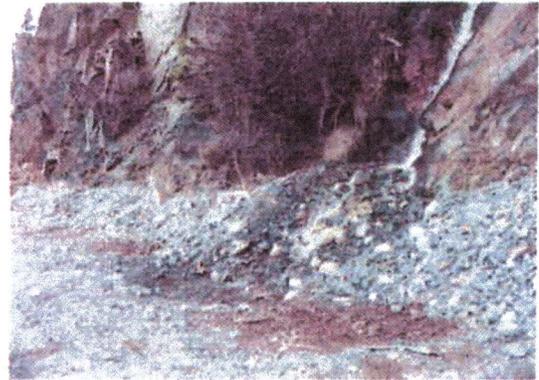
Photo 6. Station 391+75

The SHI identified this stream as providing rearing habitat for coho and Dolly Varden. The stream terminates in a waterfall just upstream of the 24" culvert (see Photo 6). A 10-foot diameter pool identified in the SHI at the bottom of the waterfall was filled with gravel and the stream flowed to the culvert through a shallow gravelly channel. There was no usable habitat above the culvert inlet. The channel above and below the culvert was too shallow to trap. Although not documented, the short stream reach below the culvert probably provides rearing habitat for coho salmon and Dolly Varden char, and good spawning gravels.

- Stream crossing does not need to be designed for fish passage

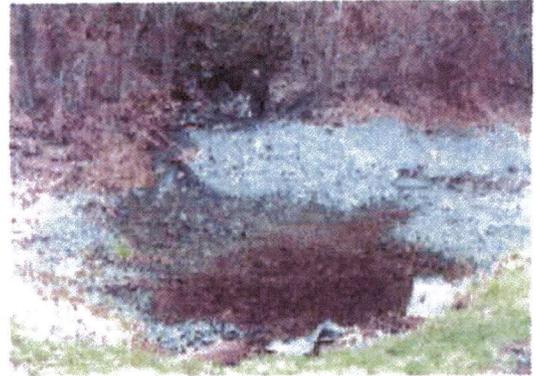
Photo 7. Station 442+75

The SHI identified this stream as supporting rearing coho and Dolly Varden, and possible spawning habitat. The stream crosses the highway through twin 24" culverts that were perched about 6". Fish habitat ends about 75' upstream at a steep cascade (see Photo 7). There was evidence of water flowing across the road as a result of plugged culverts. Coho salmon, steelhead, and cutthroat trout were trapped about 60 feet upstream of the culvert inlet. Coho salmon were trapped just below the outlet.

- Add to the Catalog as supporting rearing coho, cutthroat and steelhead
- Design the stream crossing for fish passage

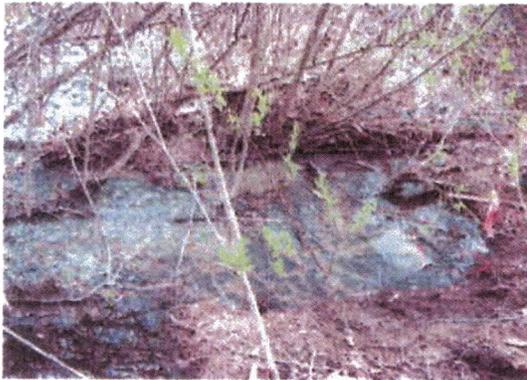
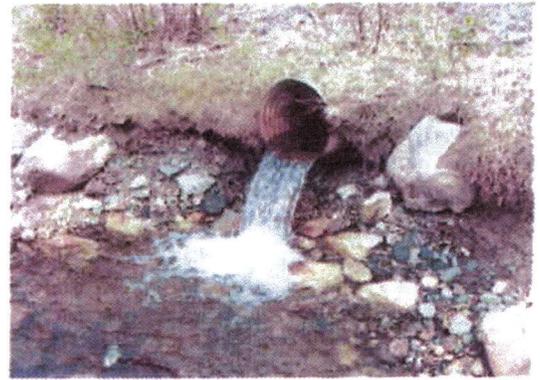
Photo 8. Station 632+00

This stream was not identified in the SHI. A trap placed about 100' upstream from the 24" culvert caught cutthroat and Dolly Varden (see Photo 8). Shortly beyond this point the gradient increases significantly. The culvert is perched about 1' and discharges directly to the Chilkat River (see Photo 9).

There is enough good upstream habitat to make it worthwhile replacing the culvert with one that improves fish passage.

- Add to the catalog as supporting rearing cutthroat and Dolly Varden
- Design the stream crossing for fish passage

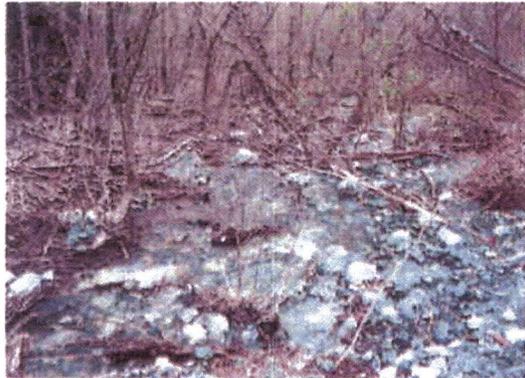
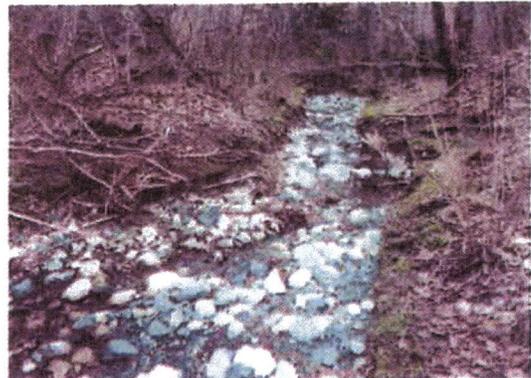
Photo 10. Station 670+00

A recent debris flow has blocked the main channel so that a majority of the flow now goes through a new channel near Station 677+00 (see Photo 10), and flows along the road to twin 36-inch culverts near Station 670+00. We observed three cutthroat trout (about 18", 12" and 4") in the new stream channel about 30' upstream from the road. No fish were caught in traps set farther up in this channel. King salmon and cutthroat trout were trapped in the original main channel about 400' upstream from the culverts. There is an opportunity to improve fish passage in this area. The stream flow is now divided into many channels that are filled with gravels to the extent that flow remains subsurface for much of the way. Habitat could be improved by focusing the flow either back into the old main channel (see Photo 11), or improving the new channel.

We confirmed that Inter-Fluve's description of the area was correct. Debris flows have reduced habitat in the main channel and created new channels. These changes have likely reduced the habitat quality because of the more dispersed flows and sediment accumulation. Stream channel improvements here would be appropriate mitigation for the project. This area will require a more detailed look to determine the best approach to habitat improvements, once road alignment plans have been finalized for this area. The current proposed realignment would move the highway upstream of most of the fish habitat.

- Update Catalog to document the new channel locations and upstream extent of cutthroat spawning, and king and coho salmon rearing.
- Design the stream crossing(s) for fish passage

- Consider channel improvements as mitigation
- Take a detailed look at the hydrology and channel morphology to determine where best to route the flows and which channels to improve

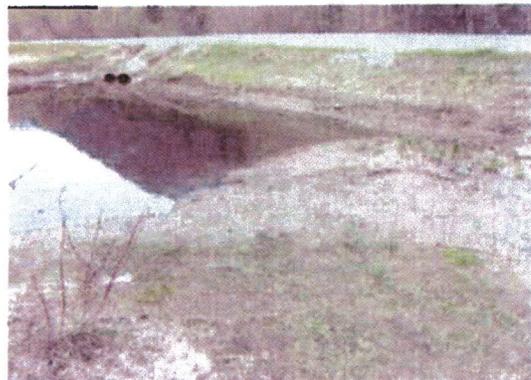
Photo 12. Station 733+50

This stream is cataloged as providing rearing and spawning habitat for coho salmon and Dolly Varden. A slough of the Chilkat River just below the two 36" culverts is used as an informal boat launch area (see Photo 12), resulting in degradation of the stream banks and bed. A trap 45' upstream of the culvert caught coho and king salmon, and Dolly Varden.

This is the location of the informal boat launching area.

- Update the Catalog to add king salmon rearing
- Design the stream crossing for fish passage

- Realign stream to cross more perpendicular to the highway
- Rehabilitate degraded habitat below culvert
- Improve the boat launch area by hardening to reduce habitat degradation, or
- Develop new launching area at a better location and close out this one

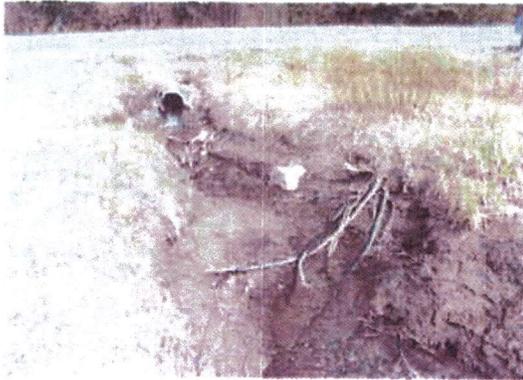
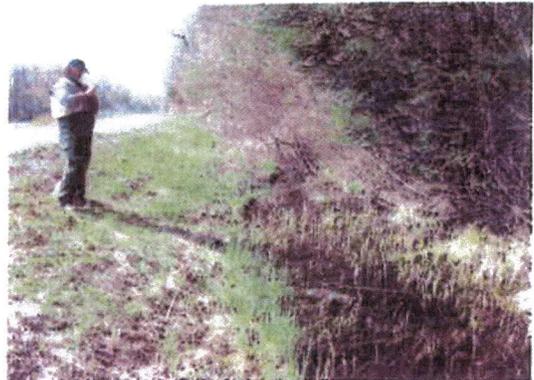
Photo 13. Station 760+00

The SHI identified this stream as supporting rearing coho and Dolly Varden. This un-cataloged stream crosses the highway through a perched 24" culvert (see Photo 13). Three traps set within 175' upstream of the culvert inlet caught king and coho salmon and Dolly Varden (see Photo 14). The stream would be filled by the proposed road alignment.

This short stream that we propose to nominate to the Catalog would be mostly filled by the new road alignment.

- Add to the Catalog as supporting king and coho salmon and Dolly Varden
- Construct new channel on riverside of highway
- Fish passage is not required for this stream crossing

- Re-route water from cascades through a new crossing location and create new stream and potentially wetlands on the river side (culvert would not need to be designed to pass fish).

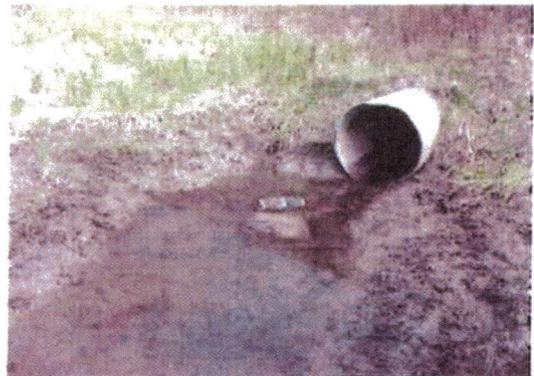
Photo 15. Station 879+75

The SHI identified this stream as supporting rearing coho and Dolly Varden below the culvert. Fish habitat ends at the culvert (see Photo 15). King salmon and Dolly Varden were trapped at the culvert outlet. The stream below the culvert is a slough of the Chilkat River, and is thereby cataloged.

- Fish passage is not required for this stream crossing.

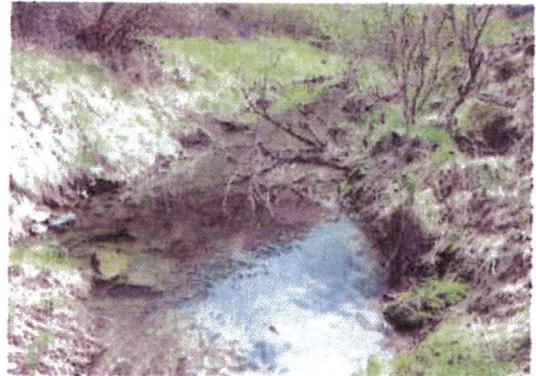
Photo 16. Station 887+90

The Catalog lists this stream as providing rearing habitat for coho salmon and Dolly Varden char, and spawning habitat for coho and chum salmon. The cataloged stream originates from springs on the hillside, and flows through NSRAA's (Northern Southeast Regional Aquaculture Association) incubation boxes. An un-cataloged western tributary collects water from the hillside and joins the cataloged tributary near the culvert inlet (see Photo 16). A trap set in a pond at the uppermost fish habitat extent of the western channel (about 700' upstream of the culvert) didn't catch fish, but king

salmon were caught about 60' downstream of the pond. Dolly Varden char were also trapped in the western tributary.

The road alignment would potentially be moved upslope and would obliterate the existing stream. A new stream would need to be constructed, probably downslope of the existing highway. Additional water that now flows off the hillside and through the highway beyond the existing stream habitat could potentially be intercepted for use in the new stream channel.

- Add the western tributary of 115-32-10250-2060-3002 to the Catalog as supporting rearing king salmon and Dolly Varden char

- Consider intercepting additional water for replacement stream

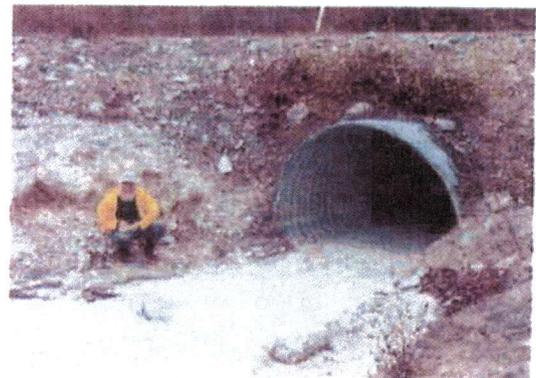
Photo 17. Station 985+00 (dry)

This stream is part of the 19 Mile slide area subject to large influx of gravels from the hillside and upslope streams. The SHI identified this location as rearing habitat for coho salmon and Dolly Varden. The channel was dry upstream and downstream of the culvert to the confluence with Chilkat River (see Photo 17). This is an ephemeral stream that has seasonally heavy flows carrying large amounts of sediment, and may provide fish habitat in the lower vegetated reach.

- Fish passage is not required for this crossing location.

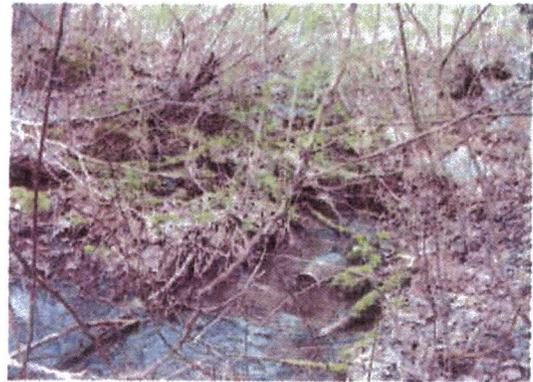
Photo 18. Station 1098+50

This stream may be incorrectly located in the SHI, and is closer to Station 1101+00. The SHI determined that this wasn't a fish stream because a steep drop-off to the Chilkat River. We hiked to the outlet and verified the natural blockage to upstream fish passage. Traps near the culvert outlet (see Photo 18) and 45' upstream of the inlet did not catch fish.

- Fish passage is not required for this crossing location

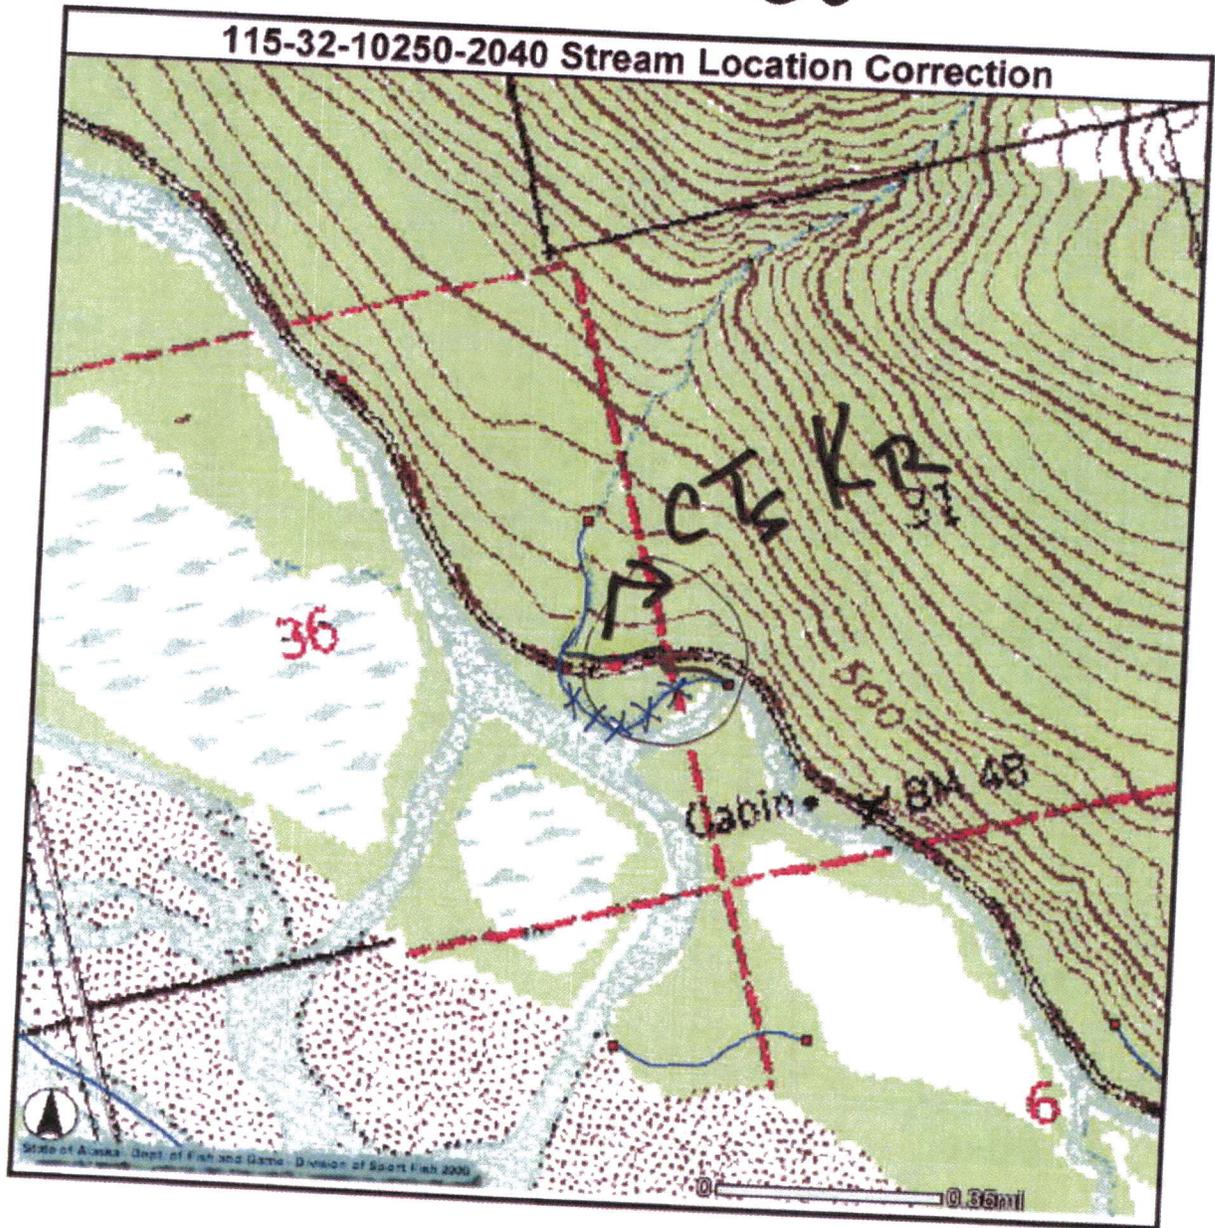
Revise hydrography  
Add CTs, KR to stream
