Nomination Form
Anadromous Waters Catalog

Name of Waterway Campground Creek USGS Name Local Name
 Addition Deletion Correction Backup Information

Campground Creek Route Correction

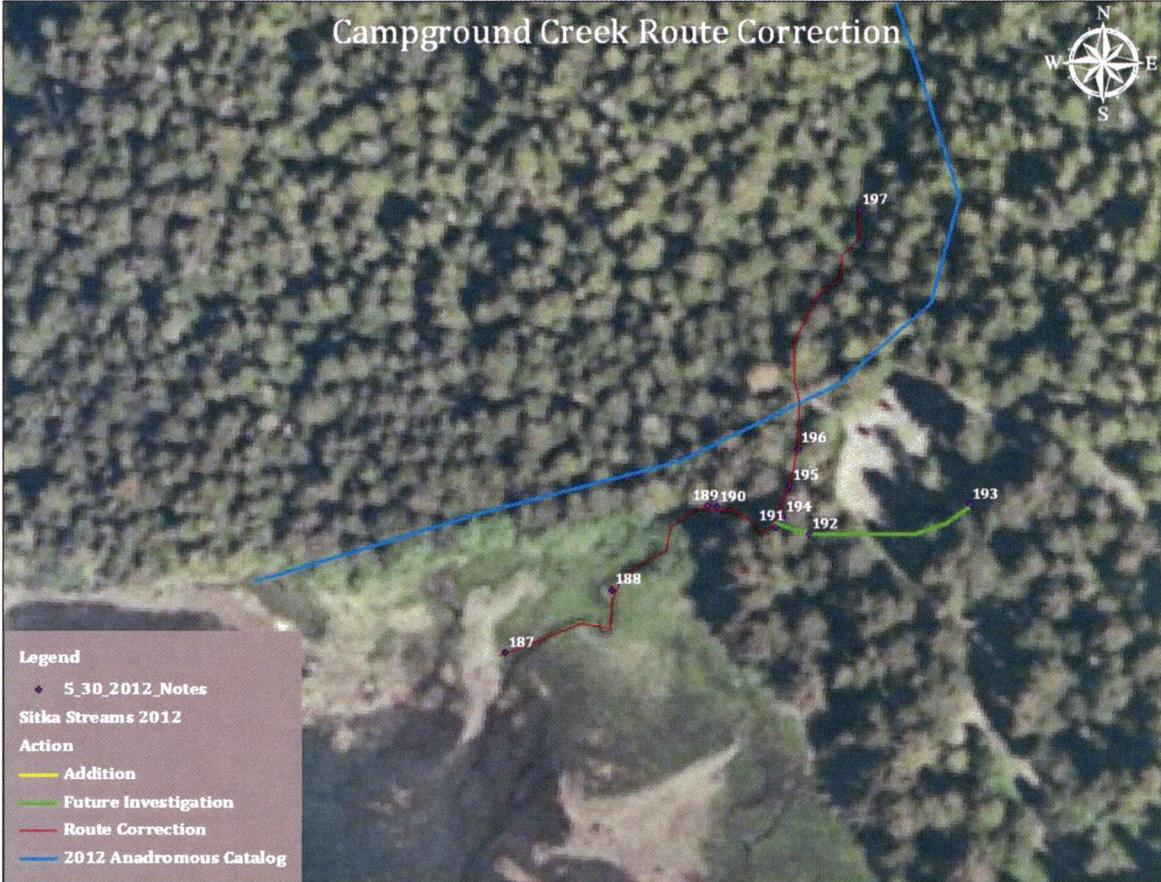
Campground Creek Route Correction

Findings: This stream’s mouth was found to differ from that illustrated in the AWC. The stream flows through a campground, gaining elevation and becoming a small rocky trickle. Adult fish passage is not possible past waypoint 197, and no juvenile fish were captured beyond.

Recommendations: This stream’s mouth location, route, and upper limit should be updated in the AWC to reflect findings in the field.
