Nomination Form
Anadromous Waters Catalog

Region Southeastern USGS Quad(s) Sitka-A-4
 Anadromous Waters Catalog Number of Waterway 113-41-10190-2033
 Name of Waterway 113-41-10190 Tributary Addition 13 USGS Name Local Name
 Addition Deletion Correction Backup Information

Indian River Tributary Addition 13

Stream: Indian River Tributary: 113-41-10190 Tributary Addition 13

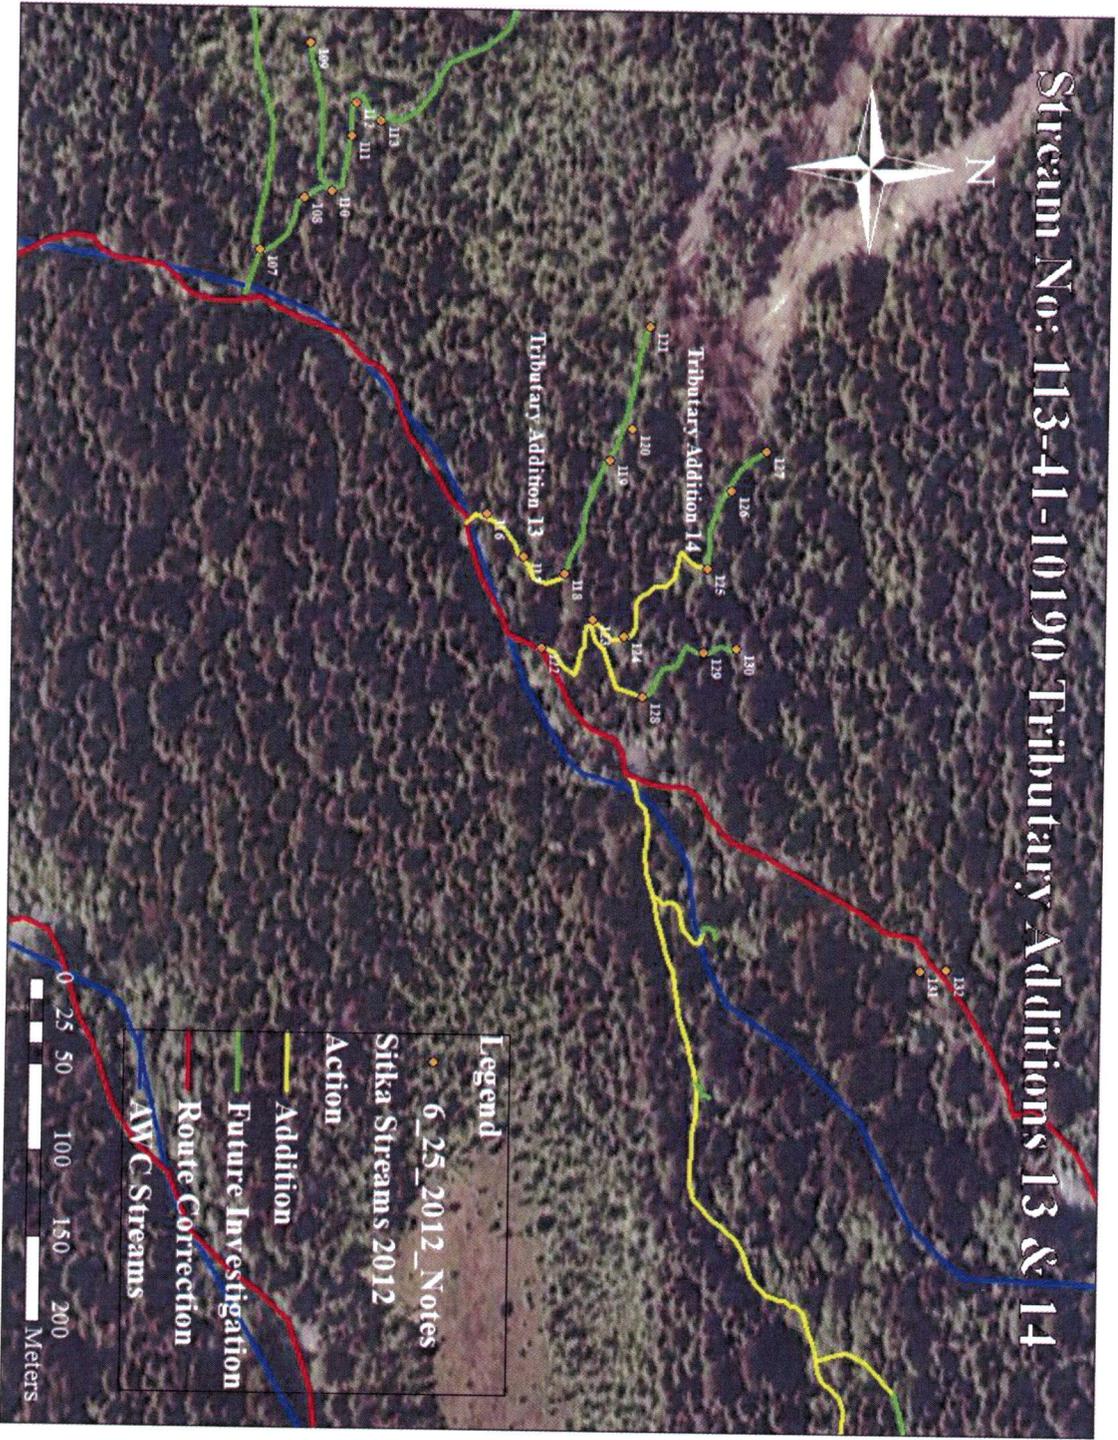
Figure 1. Map of Indian River Tributary: Stream No. 113-41-10190—Tributary Addition 13.

Findings: This short stream provides rearing habitat for coho salmon and Dolly Varden char.

Recommendations: We recommend adding this stream course to the Anadromous Waters Catalog.

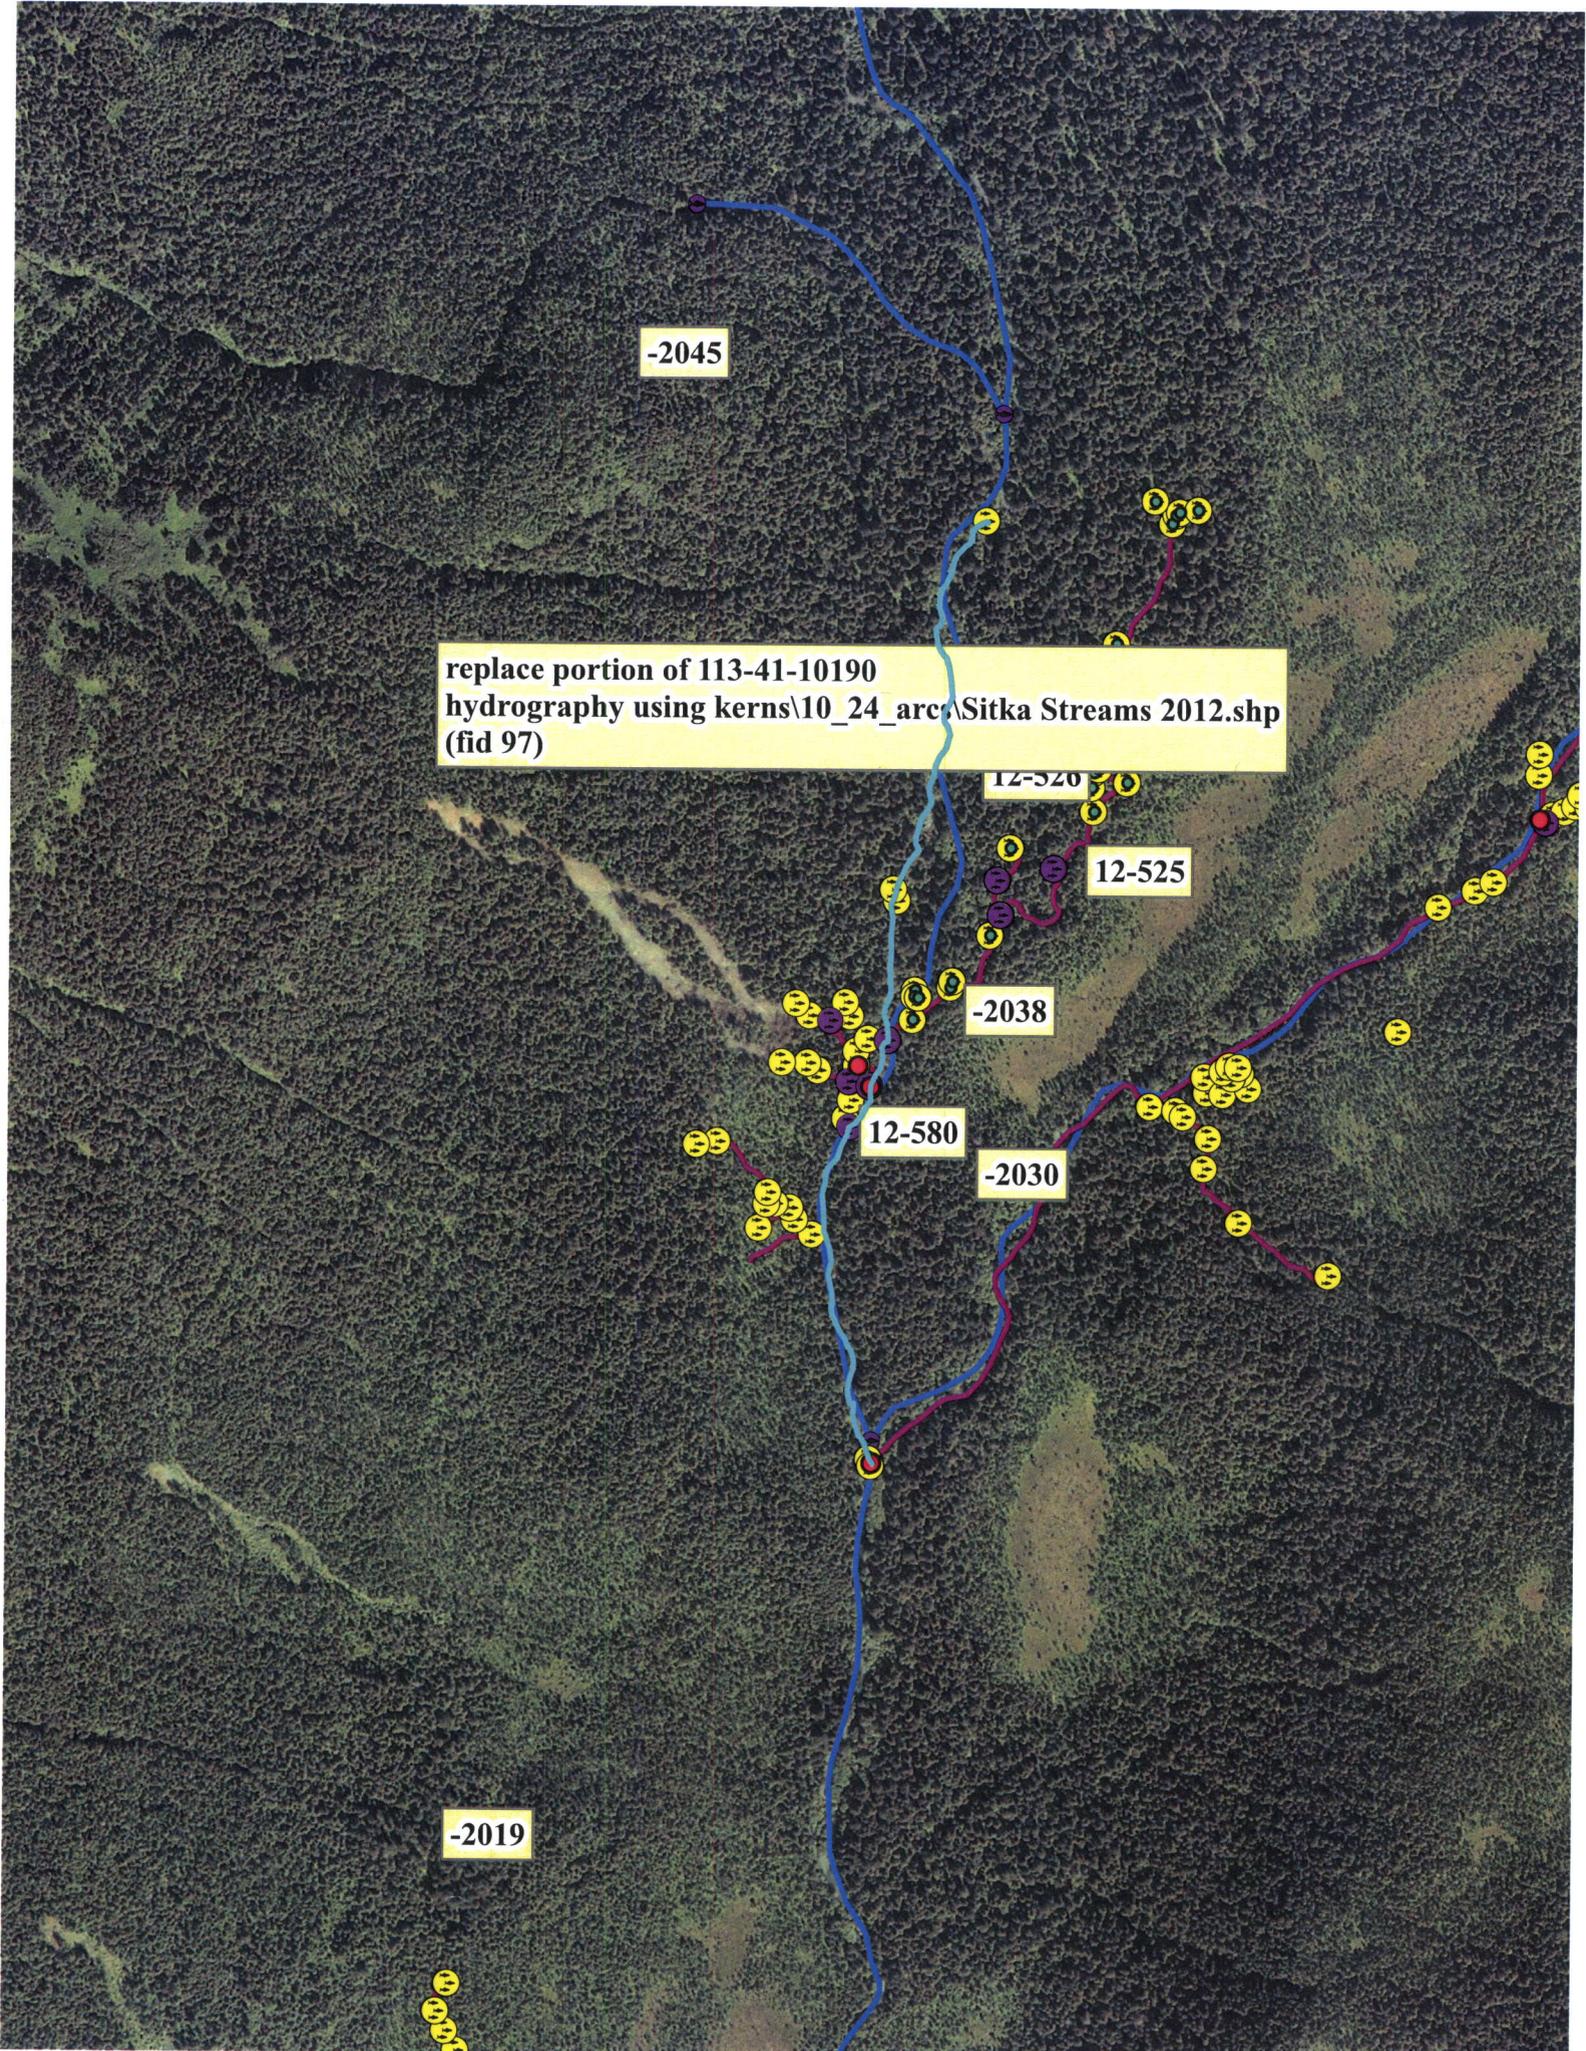
replace portion of 113-41-10190
hydrography using kerns\10_24_arc\Sitka Streams 2012.shp
(fid 97)

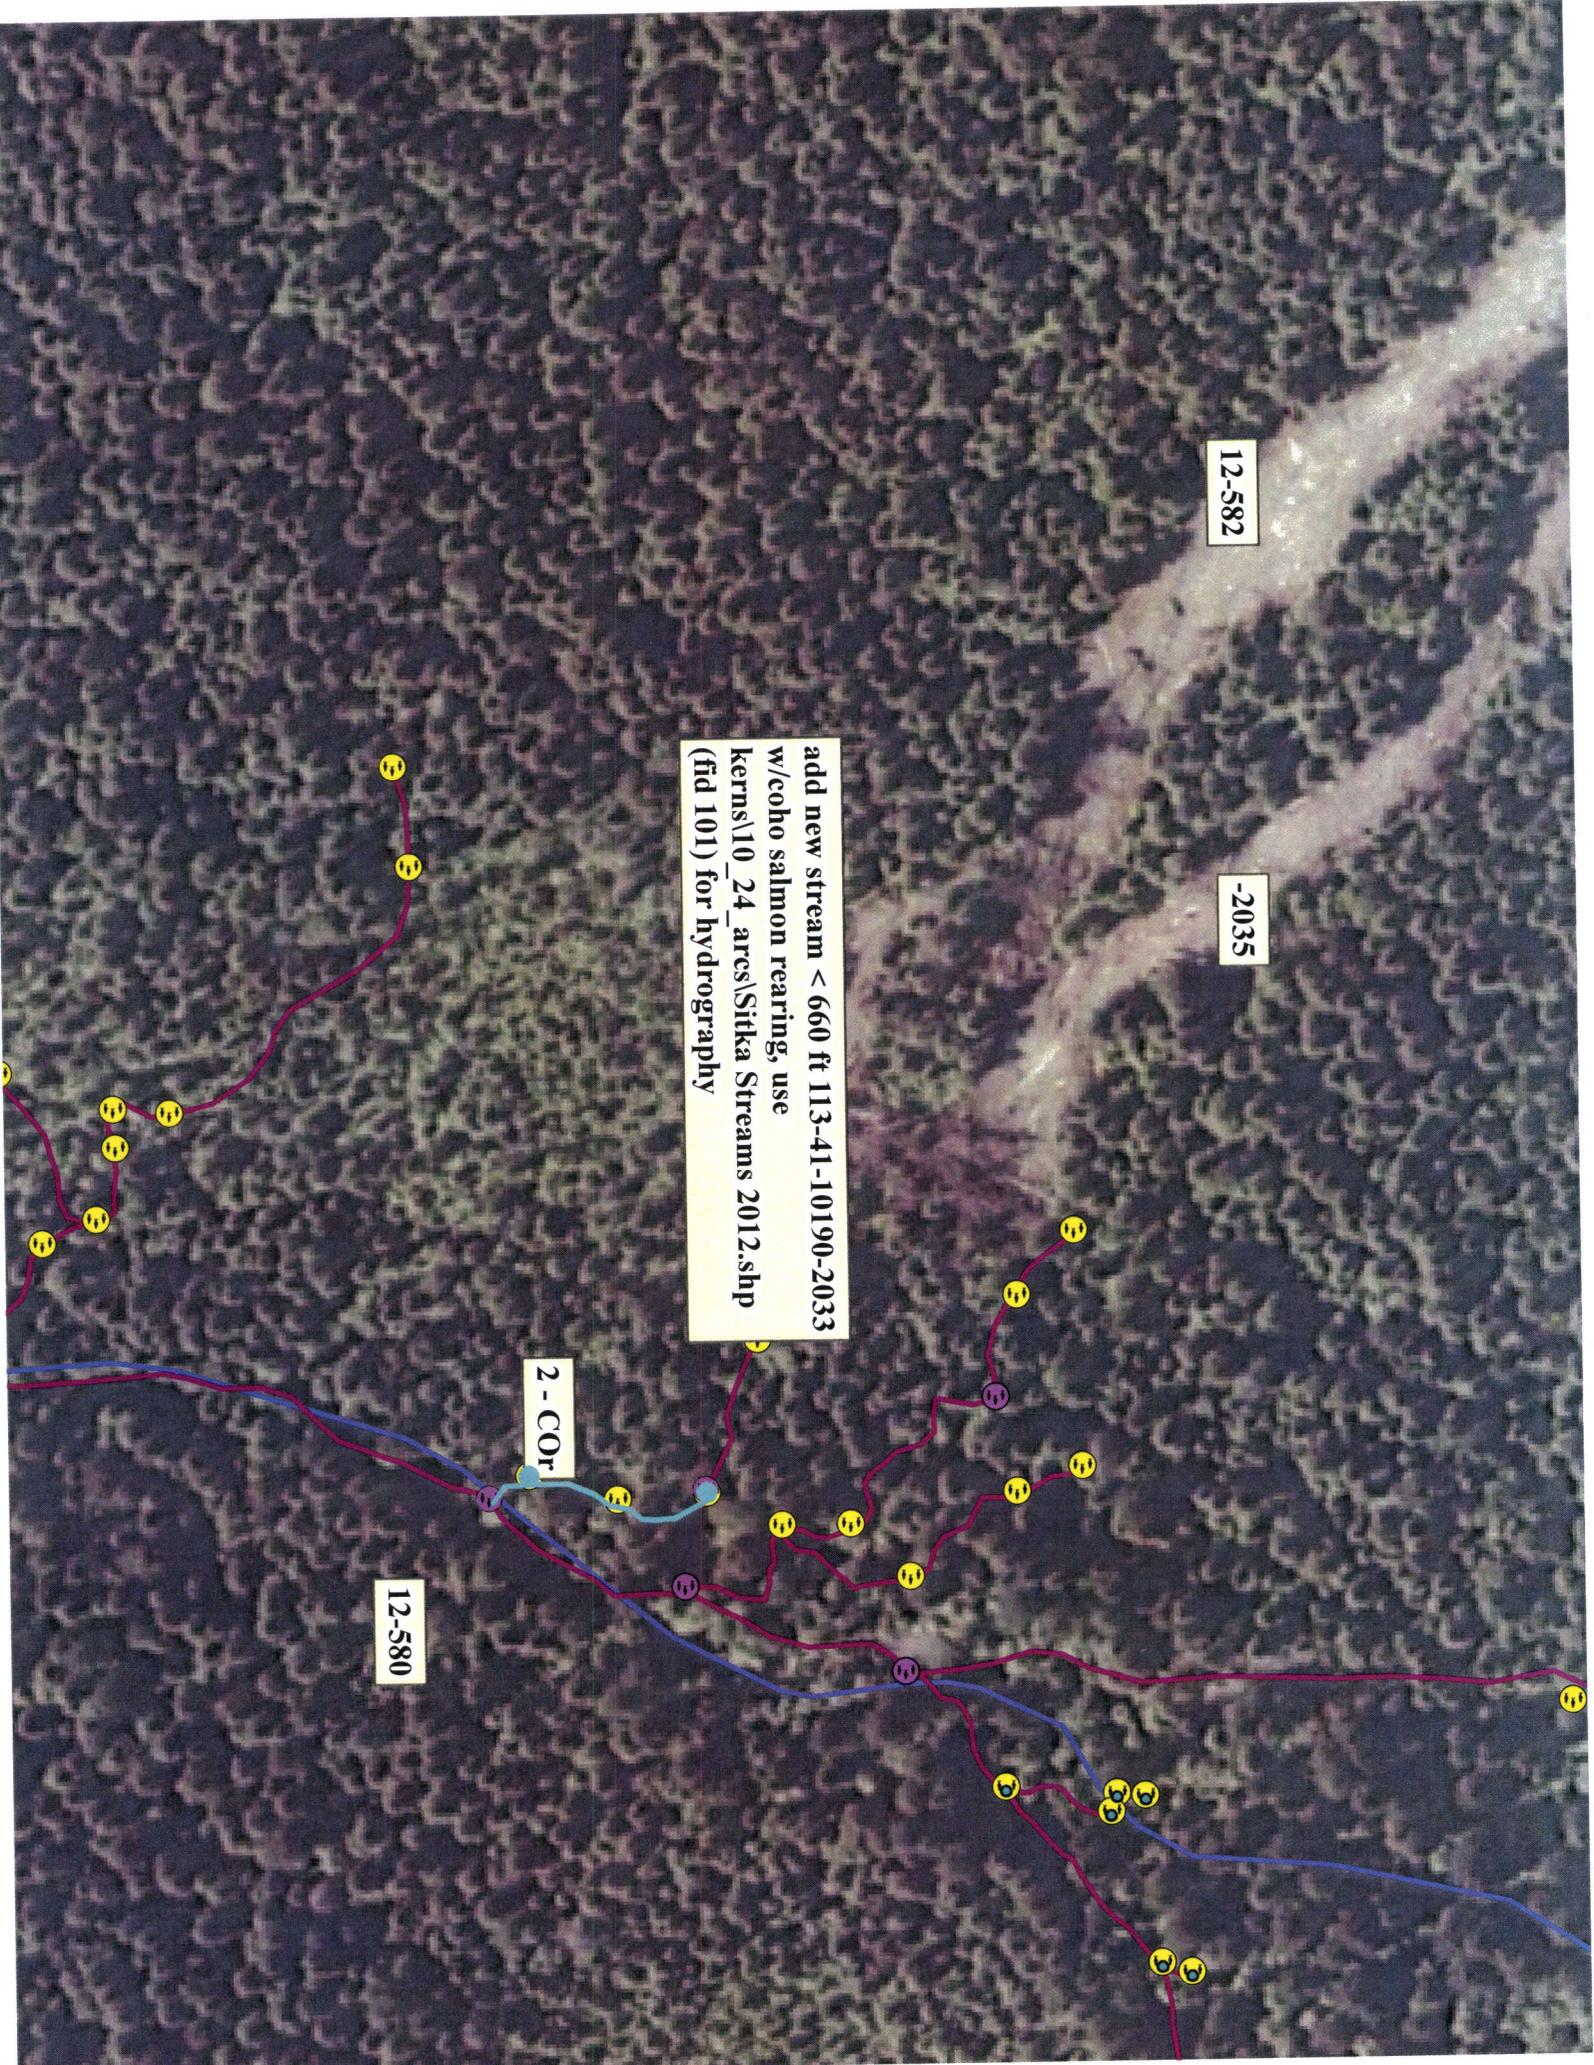
12-580

add new stream < 660 ft 113-41-10190-2033
w/coho salmon rearing, use
kerns\10_24_arcs\Sitka Streams 2012.shp
(fid 101) for hydrography
